AGA KHAN TRUST FOR CULTURE

**CONSERVATION PROJECT OF THE
ASLAM AL-SILAH DAR MOSQUE**

**QUARTERLY PROGRESS REPORT
DECEMBER 2006-FEBRUARY 2007**

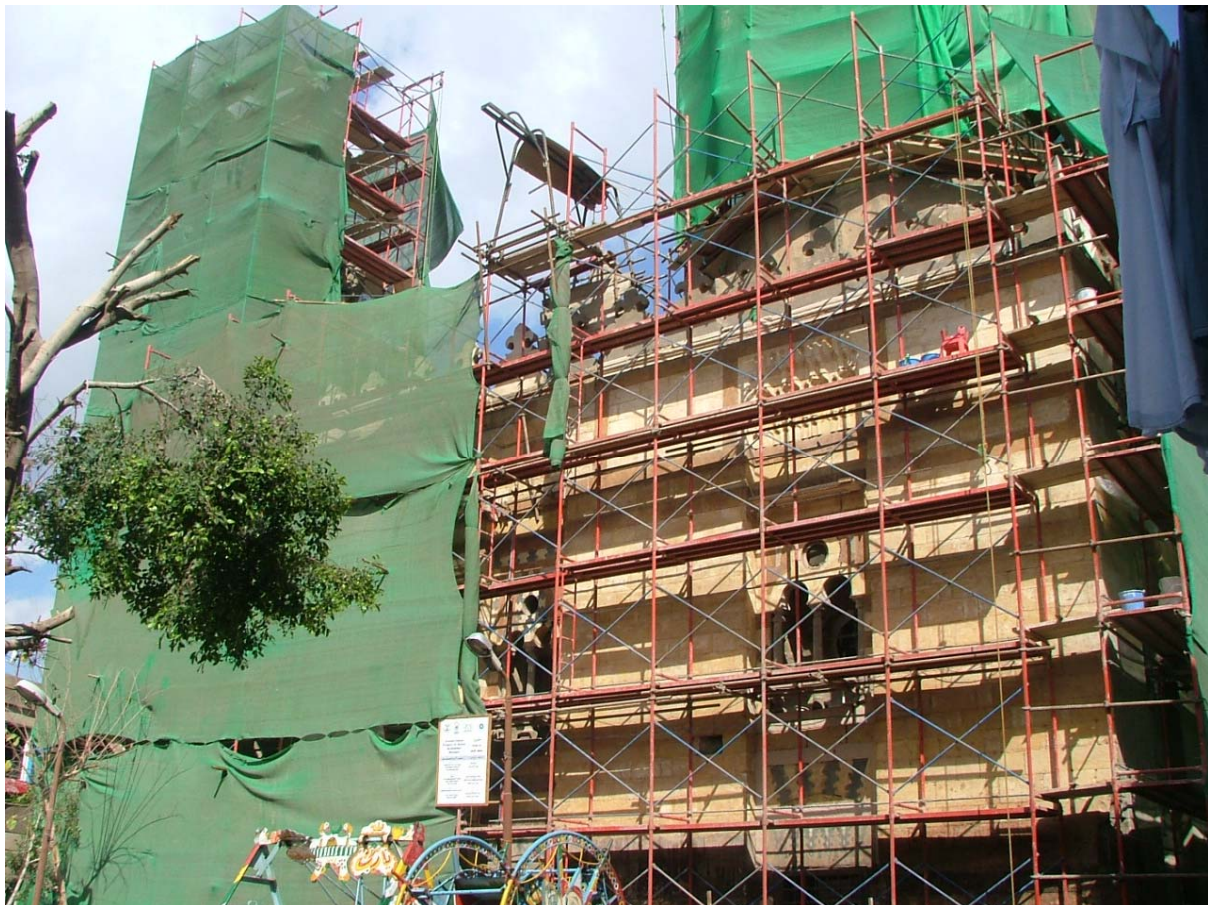
View of the southern elevation of the Aslam al-Silahdar Mosque during conservation

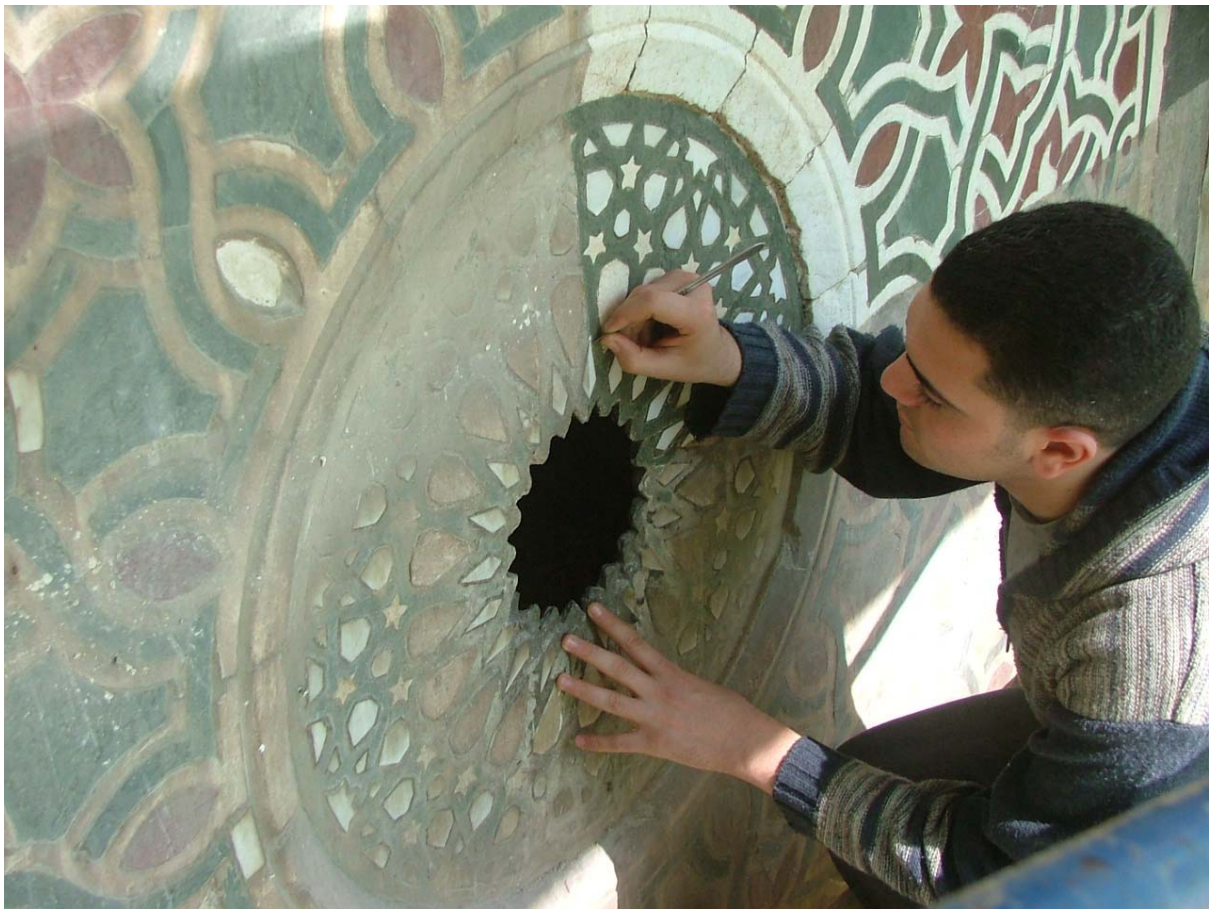
View of the marble panel on the main façade during cleaning

The southern and eastern elevations have been entirely cleaned using humid poultice made of bentonite and paper pulp with a low concentration (3-5%) of Ammonium Bicarbonate. This has revealed the original polychromy of the lime stone made of alternated white and orange horizontal stone courses and has made it possible to identify several stages of construction and restoration.

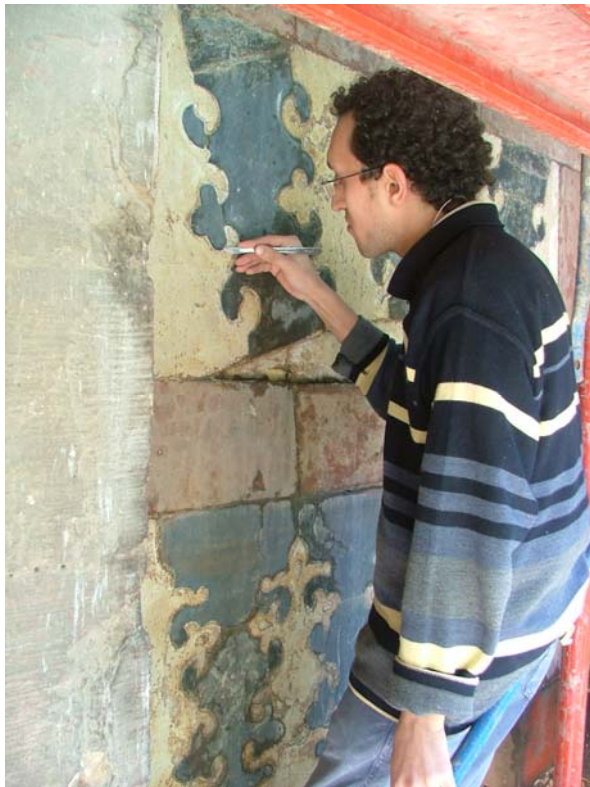
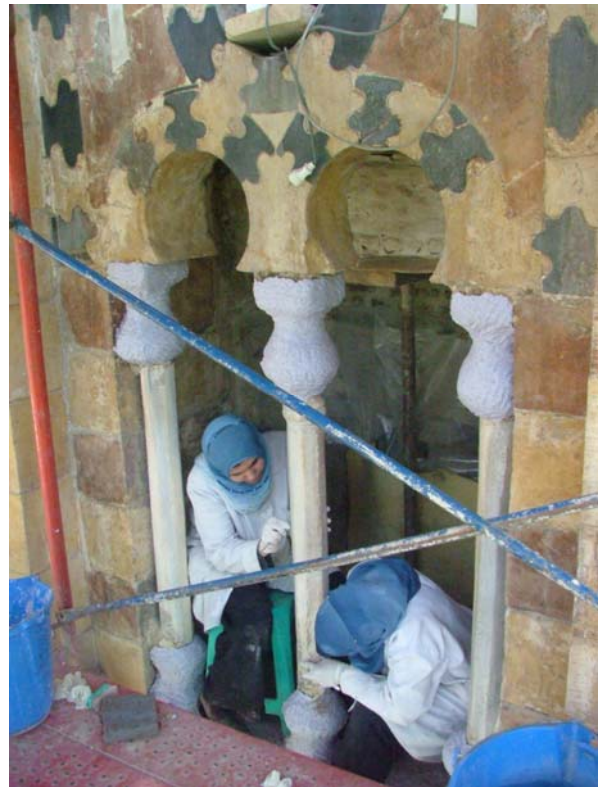
Cleaning of the southern façade by poultices and mechanical techniques

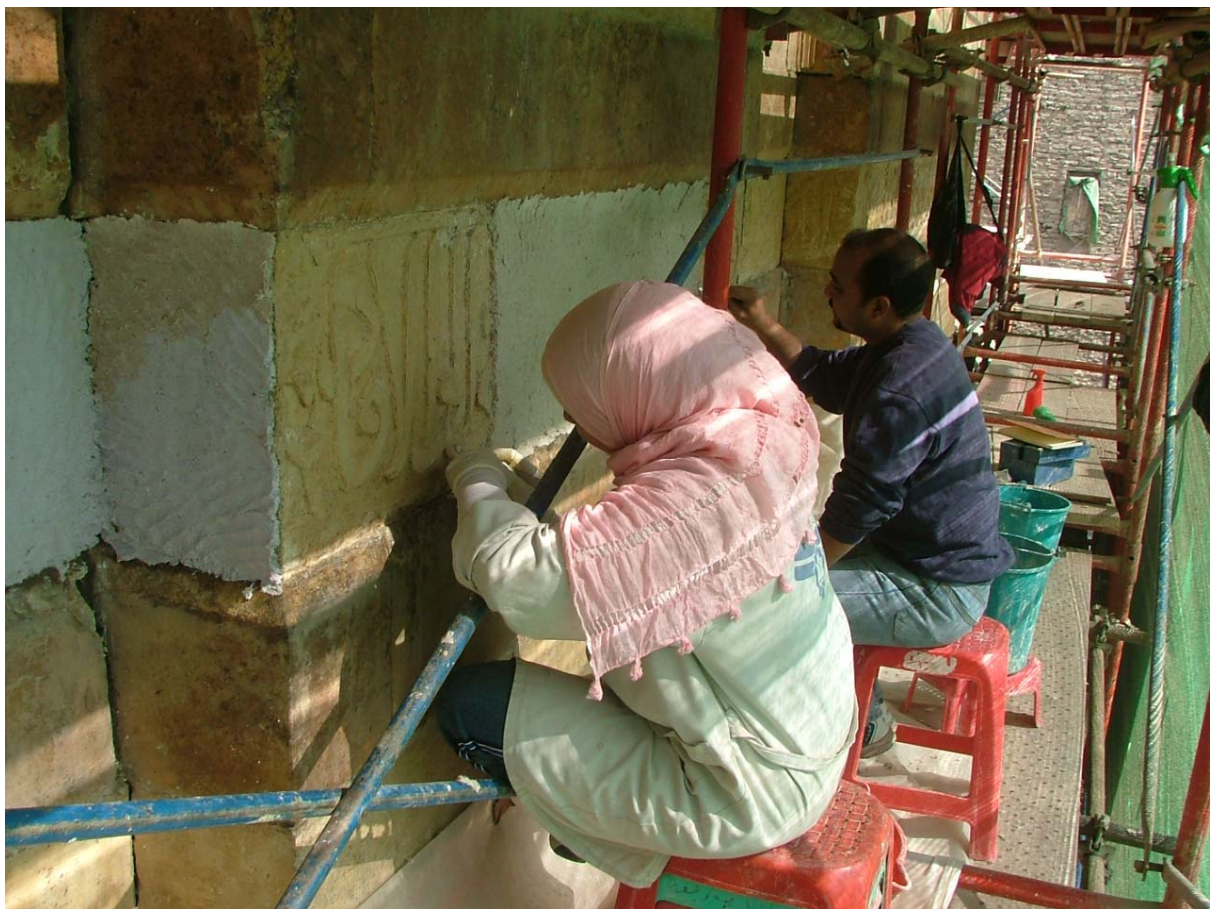
Cleaning of the inscription band on the Eastern façade by poulticing

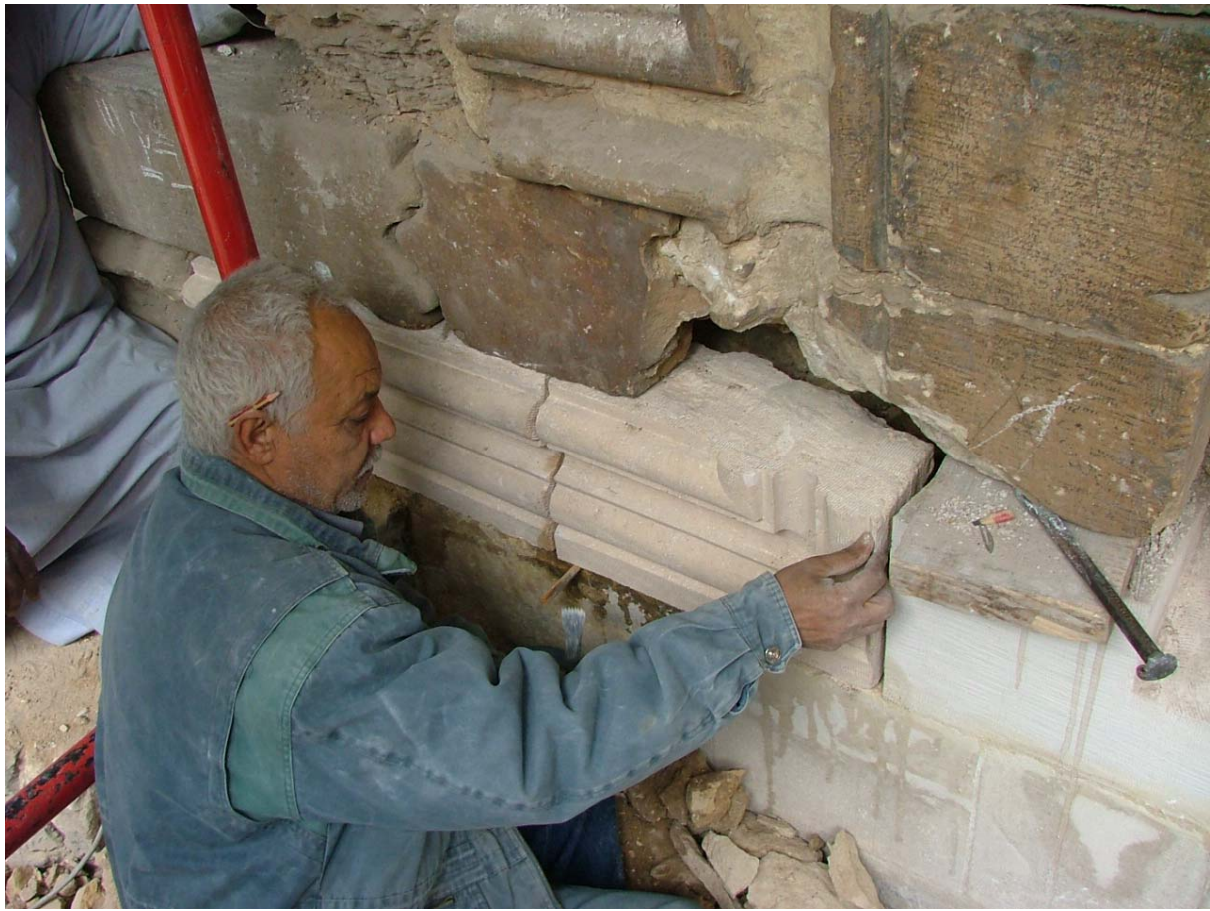
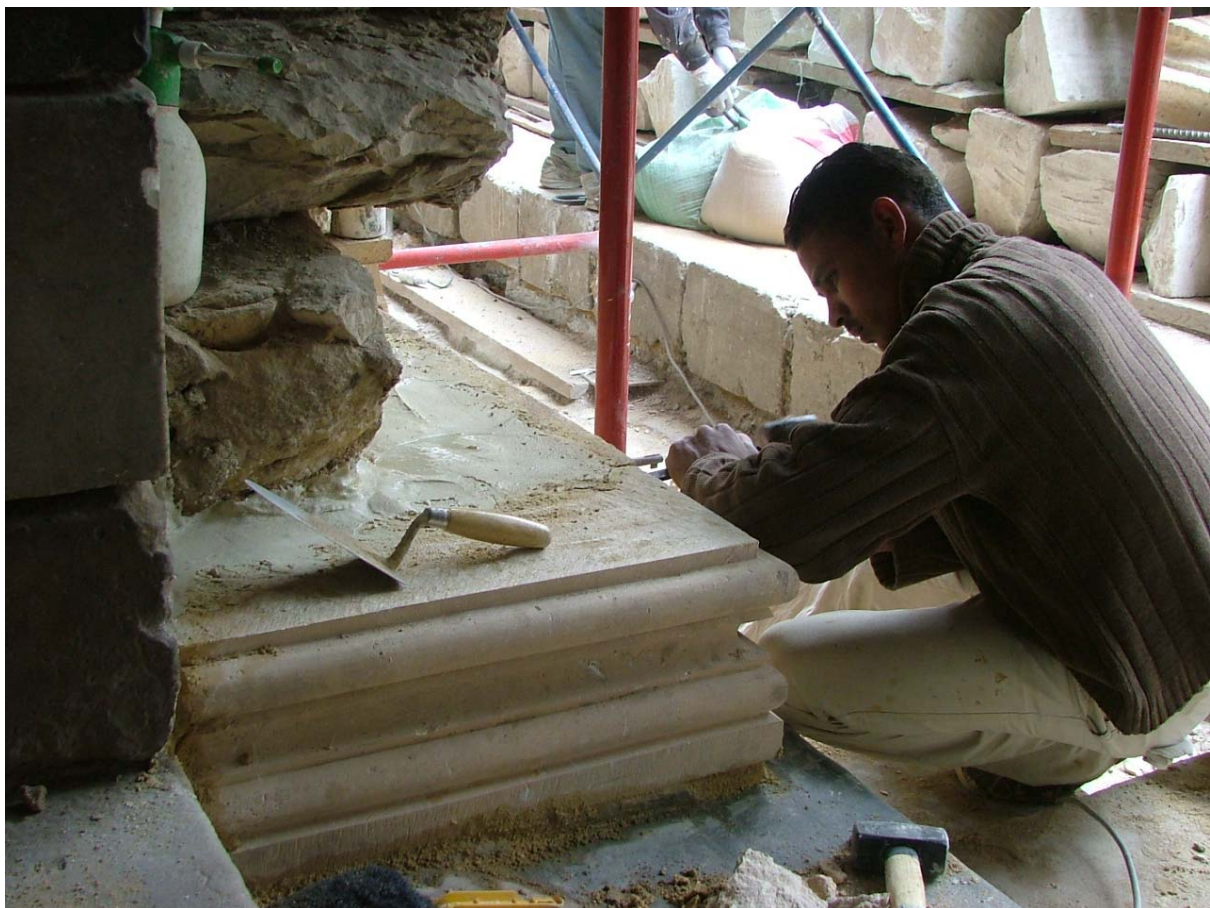
A campaign of selective stone replacement was completed at the southern and eastern facades: damaged plain facing and decorated lime stones were carefully replaced by new stones of a similar nature.

Stone replacement activities taking place on the Southern façade of the mosque

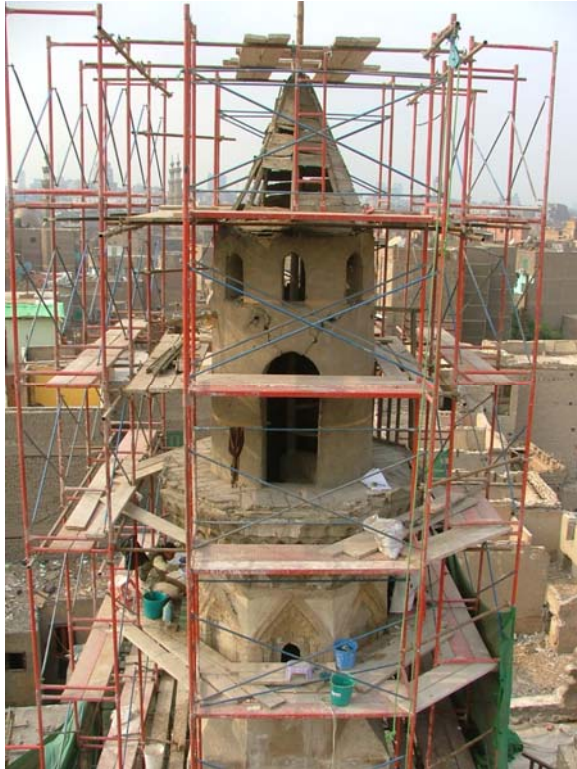
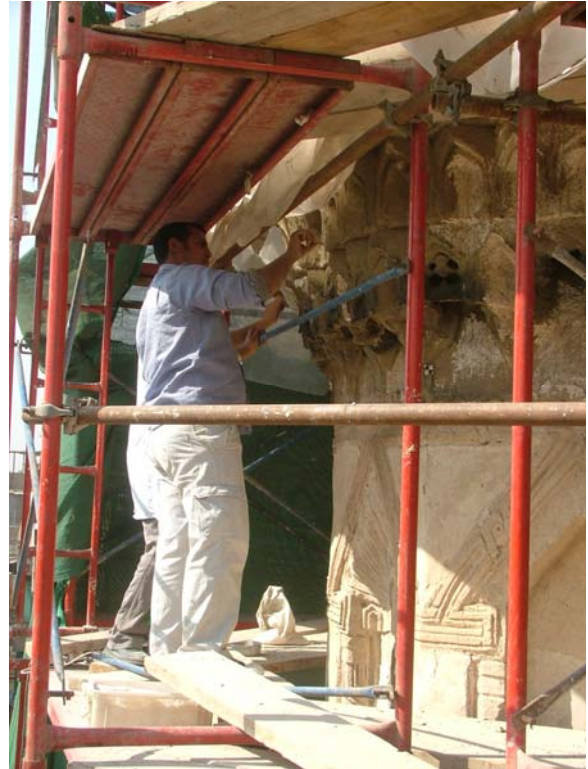
The exterior surfaces of the minaret made of gypsum and lime stucco are under cleaning by micro sand blasters and injection of lime grouts. The deteriorated status of the stucco makes it vulnerable to harsh weather conditions. The upper segment was reconstructed probably during the 19th century (the earliest photographs taken in the 1880's show it similar as today). The pencil shape of the top and the upper part of the brick drum are in a poor condition: the lead roofing is totally ruined, the timber carpentry is almost under collapse and the upper part of the brick drum is affected by serious cracking. A comprehensive restoration is planned in order to re-establish the last documented condition of the minaret as of the 1880's, without attempting to return back to a pre-Ottoman undocumented condition.

Cleaning activities on the minaret by poulticing

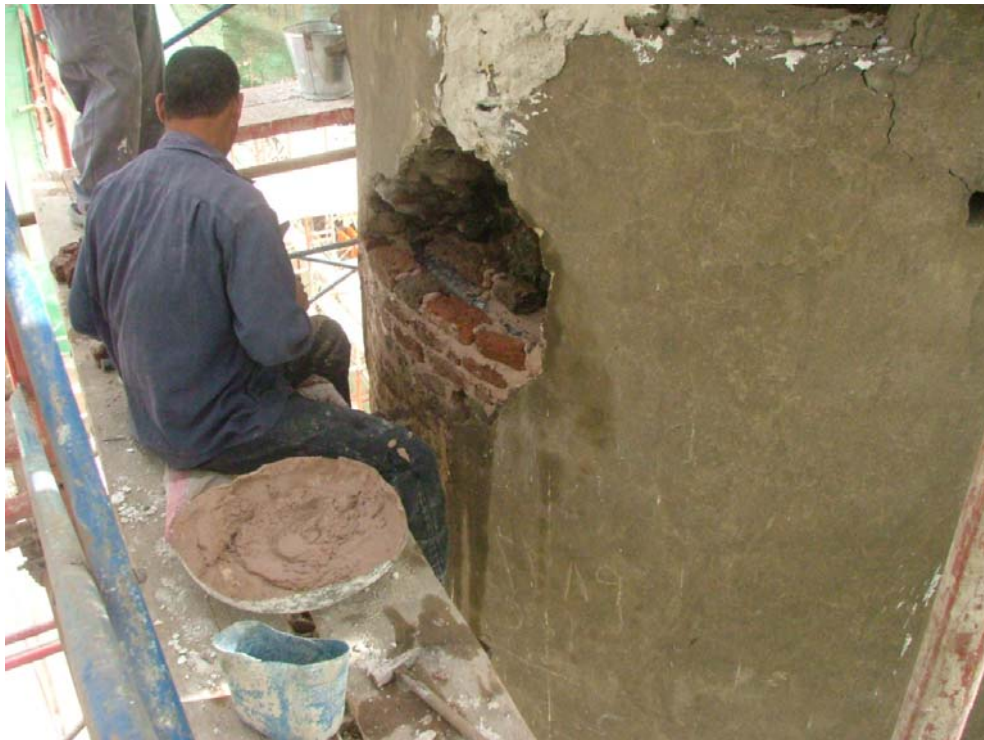
Brick restoration activities taking place on the upper part of the minaret

The exterior surfaces are planned to be cleaned and conserved in order to integrate the restoration and selective reconstruction of the upper segment according to the last documented condition of the minaret as of the 1880's. The restoration will include the construction of a pencil shaped carpentry top, to be covered by lead sheets. The timber handrail of the middle platform will be restored using the design of the few conserved fragments.

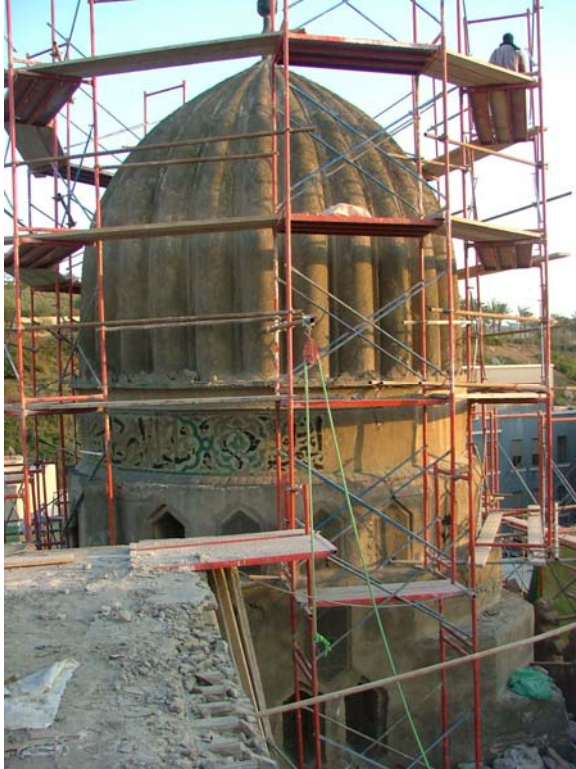
Dome exterior after scaffolding erection

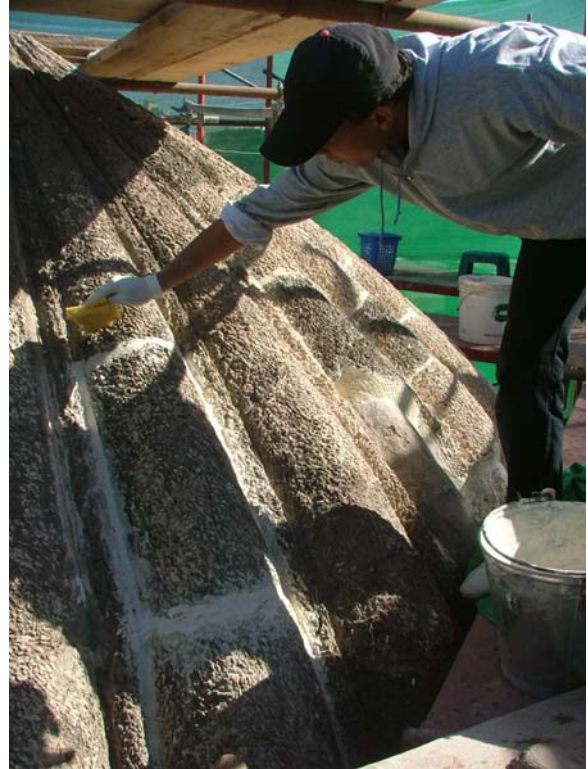
Following the erection of exterior steel scaffolding around the dome, cleaning was initiated by micro-sand blasting and temporary stabilization of the unstable parts was done. The cleaning revealed that the cupola is built with bricks covered by a thick (10-14cm) crust of plaster. Some remains of lime wash are still visible in the recessed angles. Although the cupola is not affected by structural problems, its surfaces and remains of polychrome tiling decoration are in moderately damaged condition.

Stabilization of unstable plaster crusts

The cleaning by micro-sand blasting will be continued and completed. Local injections will re-attach the loose parts of plaster crust. The conservation is currently under testing in order to determine the feasibility of filling the cavities of the upper part of the dome's plaster.

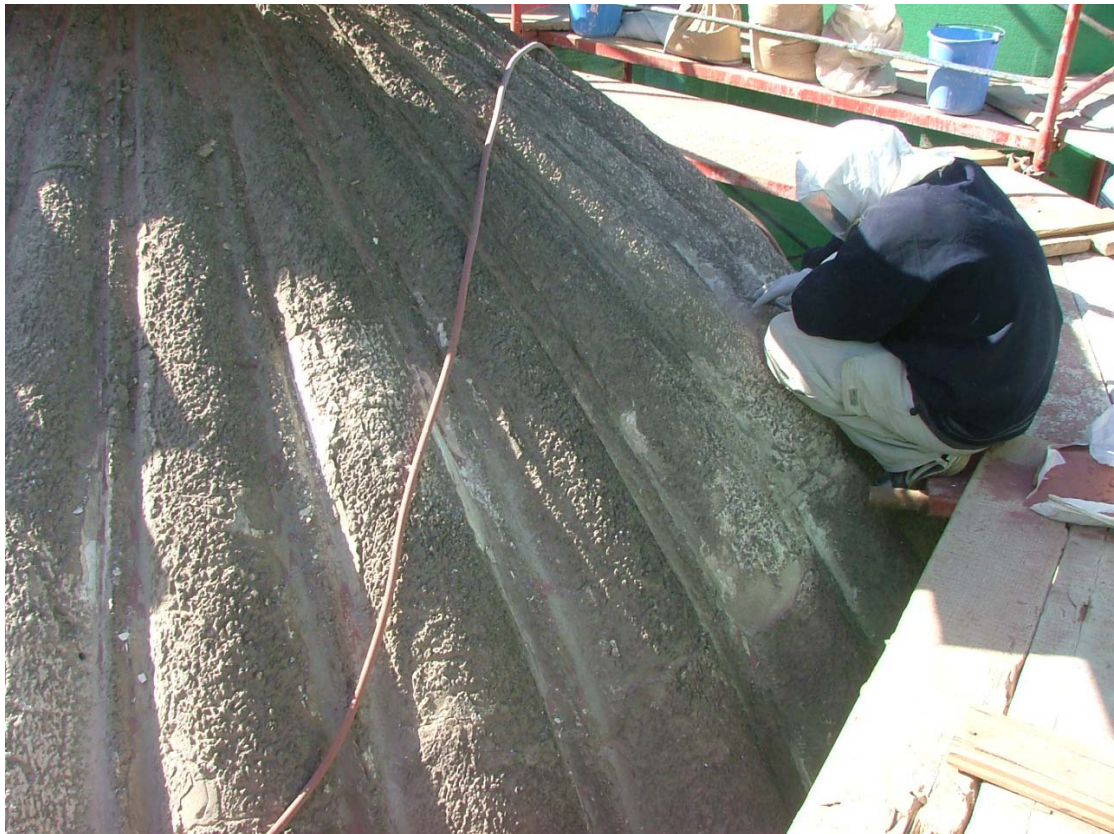
Cleaning of the Cupola by micro-sand blasting

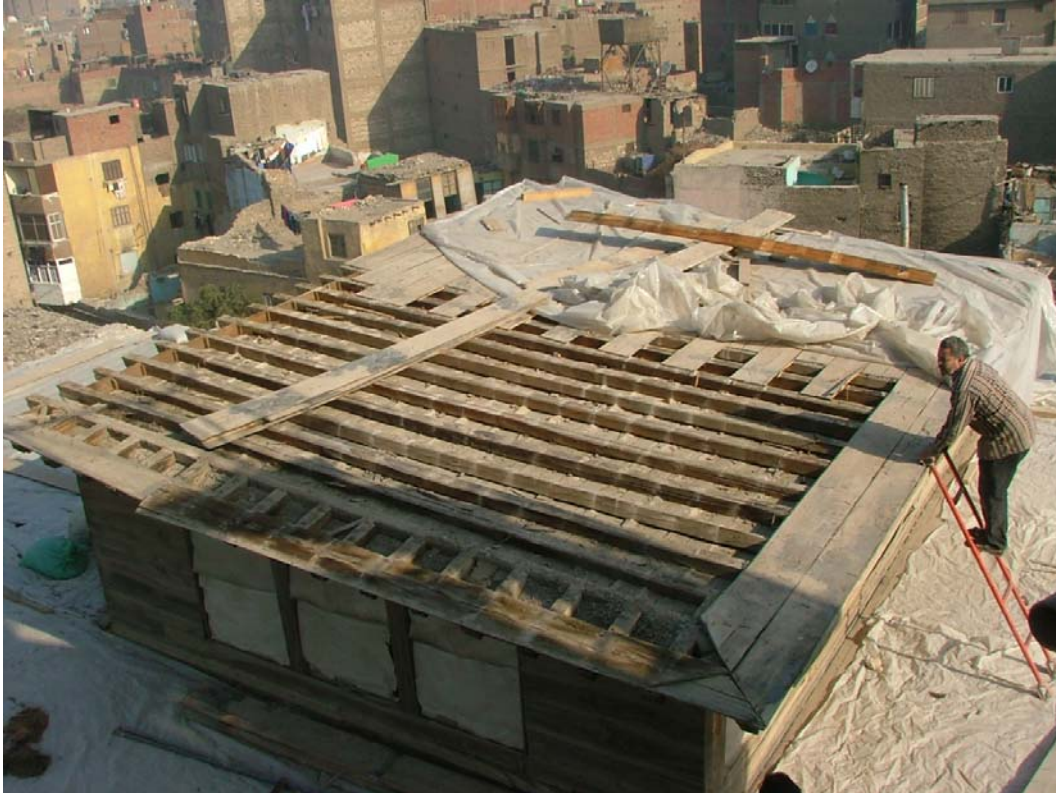
Assessment of wooden shingles and beams of the central shokhsheikha

The replacement of broken and damaged beams was done and more than half the surface of the entire roof was already insulated using a bitumen sheet covered with mortar screed. The carpentry of the central shokhsheikha was restored and the construction made by the Comité in 1908 was maintained. It is planned to be covered with lead sheets in order to minimize the dead load.

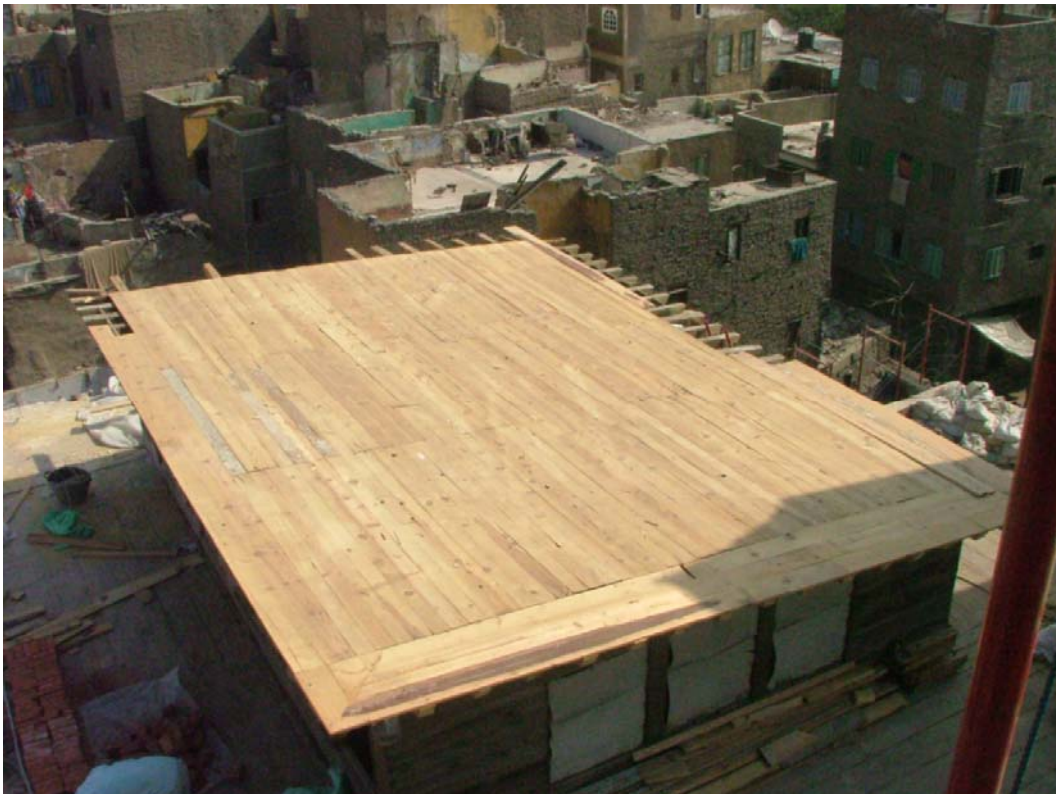
Ceiling after restoration

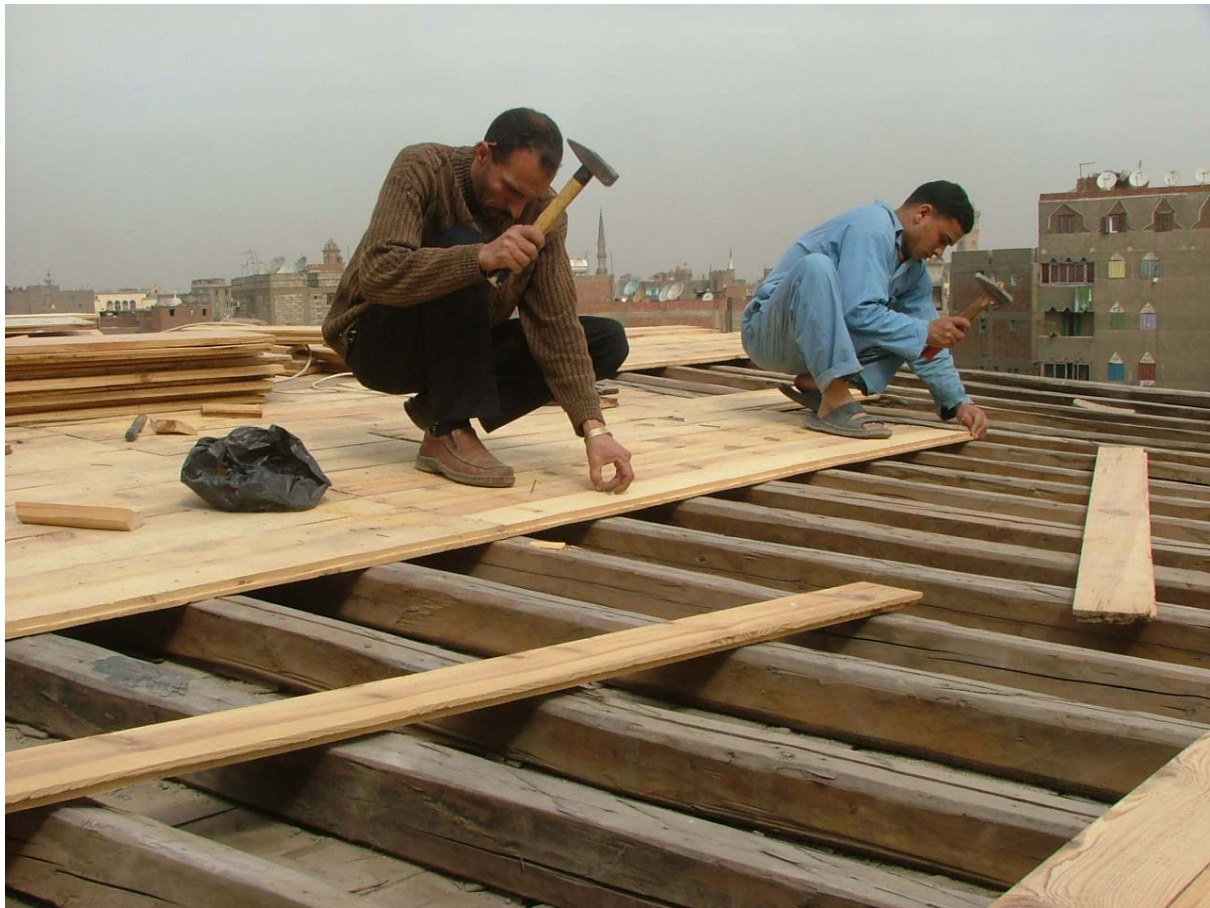
Carpenters replacing damaged wooden shingles

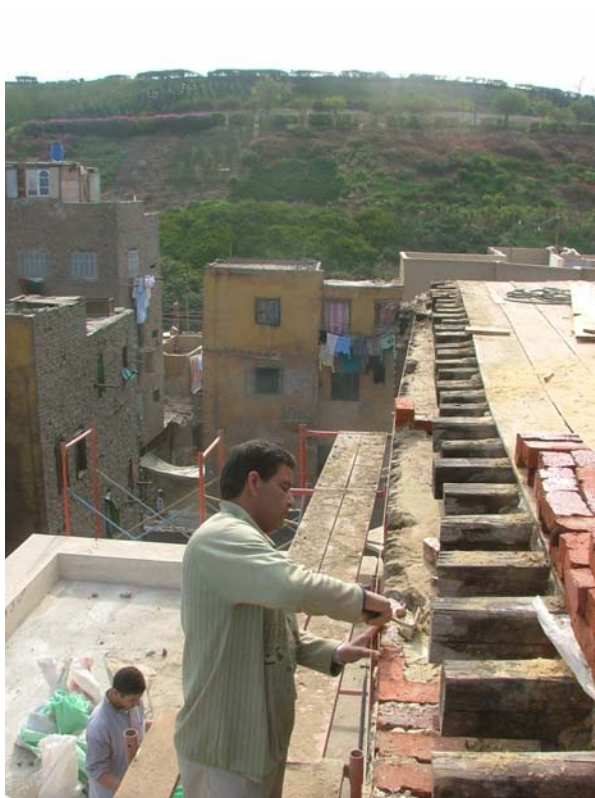
Brick construction of damaged roof parapets

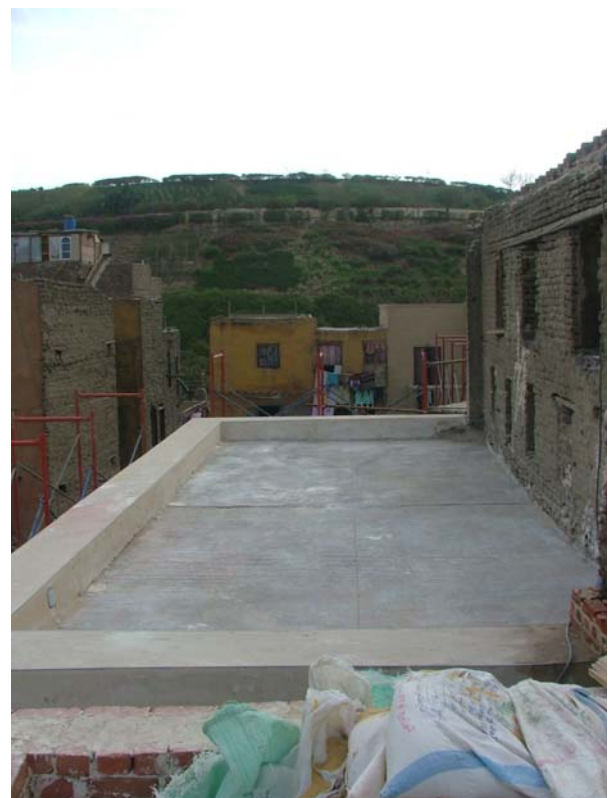
View of roof after insulation

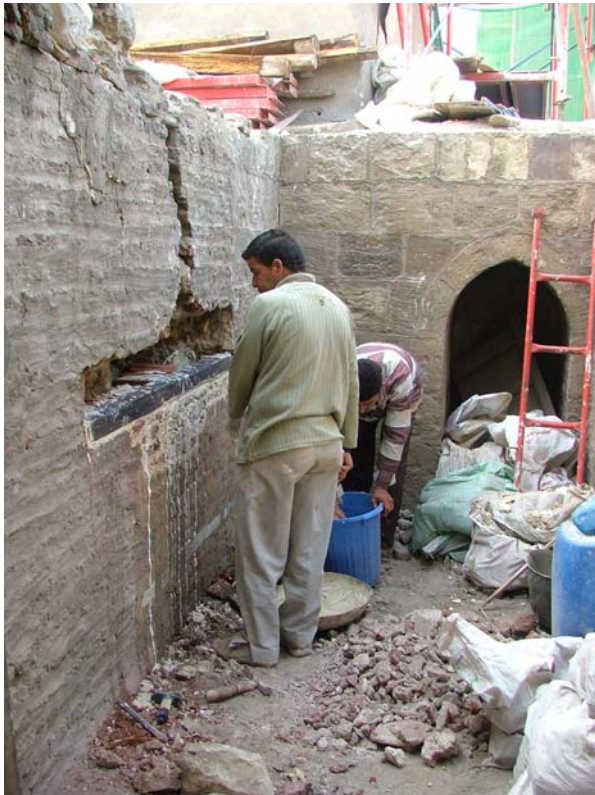
The brick masonry of the first floor rooms was affected locally by vertical cracking caused by earthquake loads. In the areas concerned with this damage pattern, the masonry was repaired by brick stitching. This concerns both southern and northern large rooms and the small qa'a along the western elevation.

Brick repair of cracks in upper level rooms

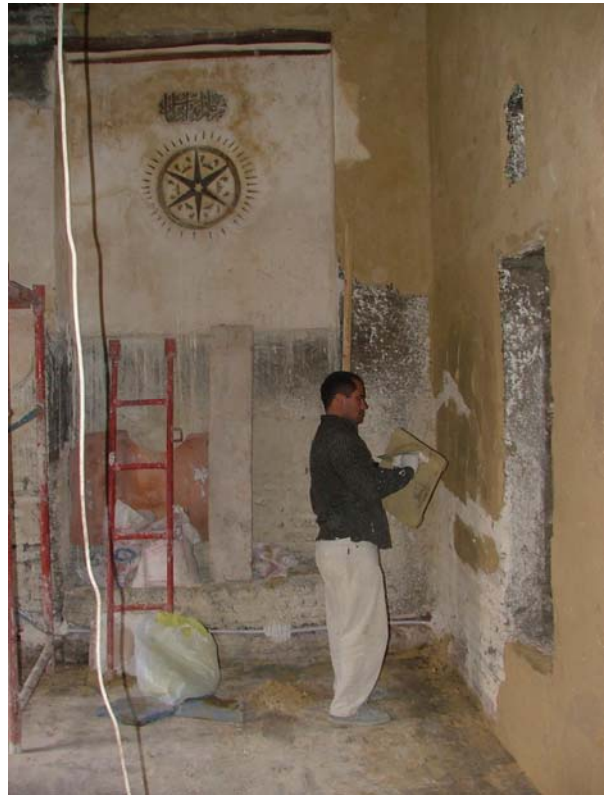
Plastering of rooms on first floor

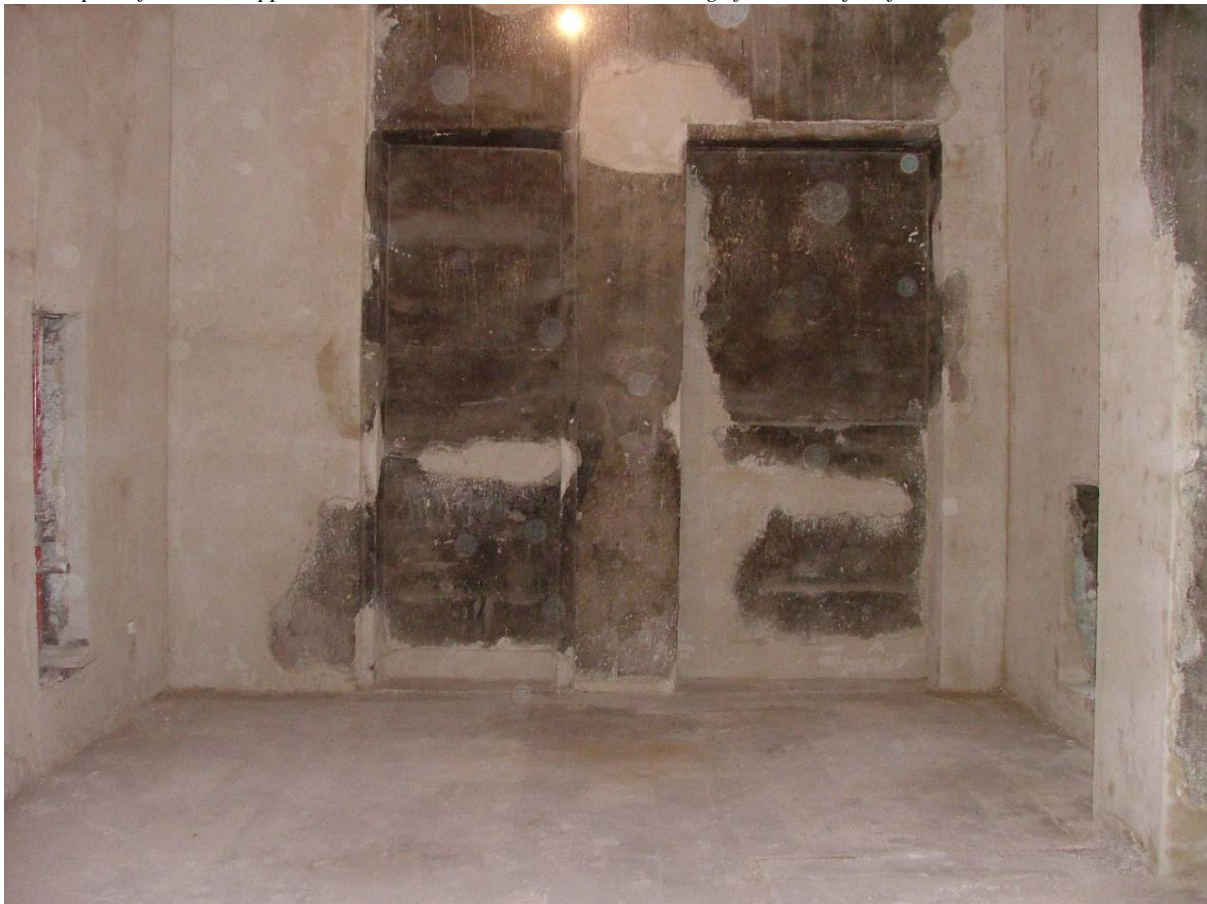
View of room on first floor after brick repair and plastering

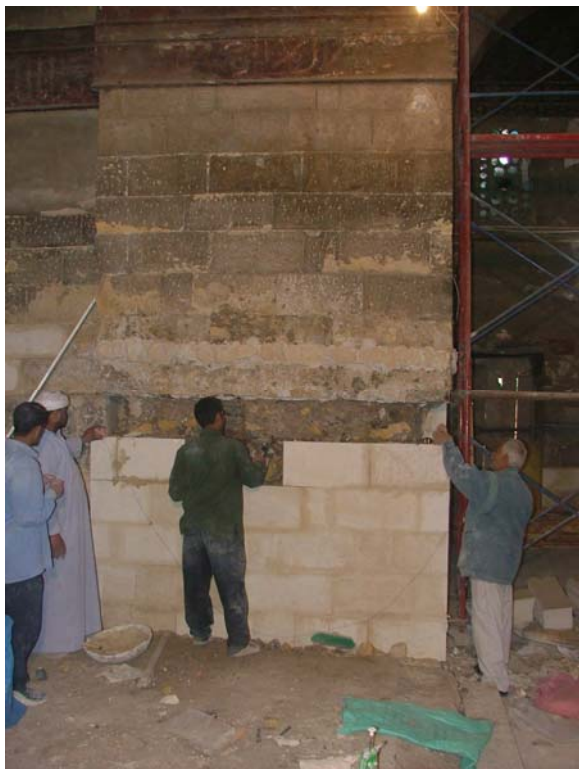
Stone replacement of the damaged lower parts of the walls was performed and is still in progress.

Stone replacement activities in the qibla iwan

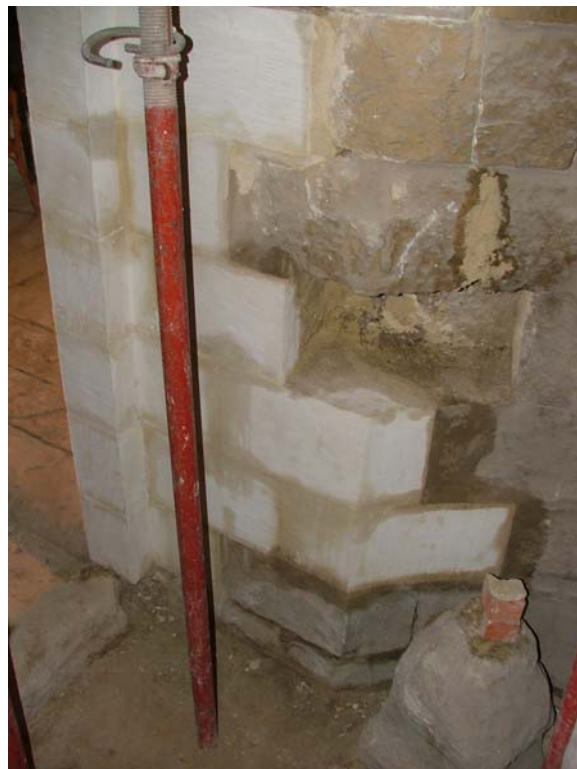
Stone replacement in main staircase

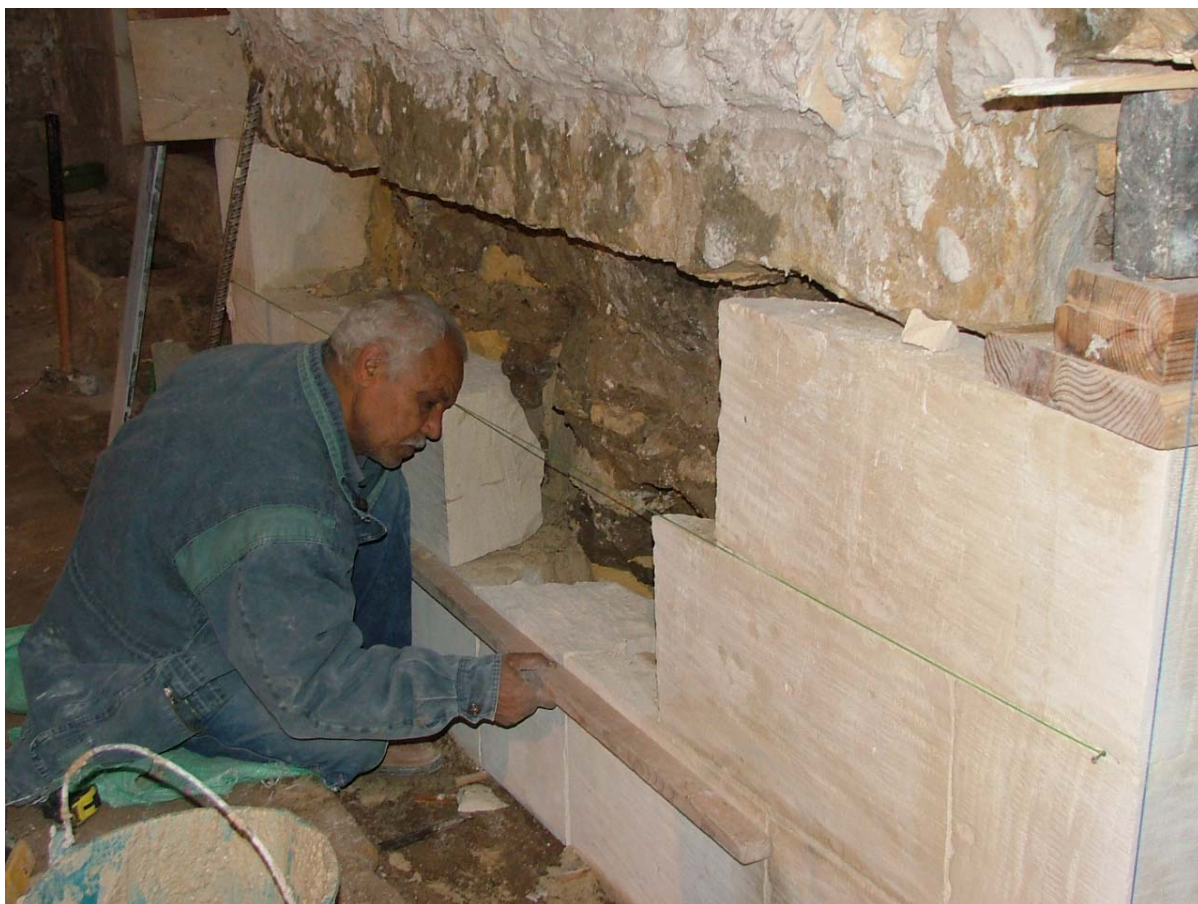
Stone replacement activities in the qibla iwan

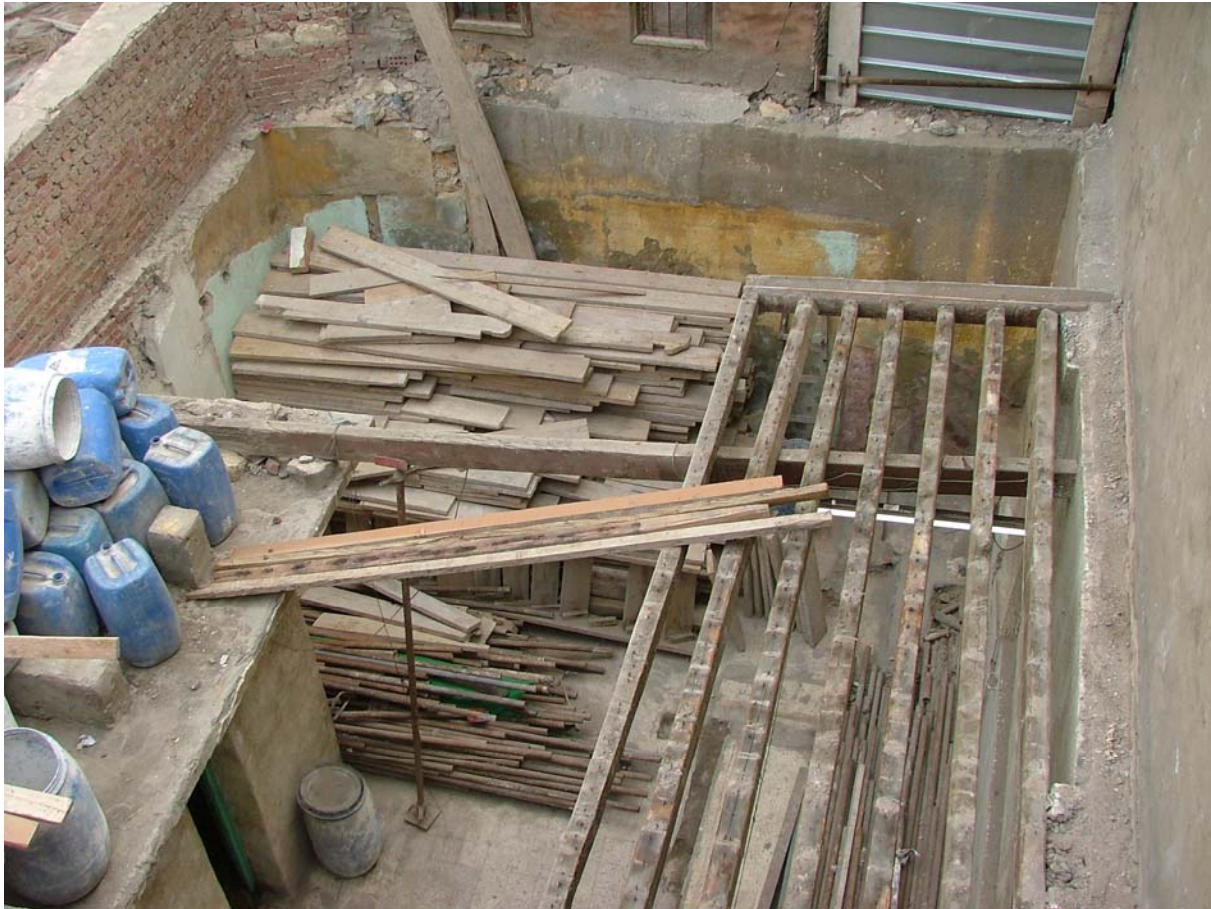
The existing structures of the ablution area were found in an advanced state of deterioration and were dismantled after survey. The location may be used as storage till the second quarter of 2007.

View of ablution area used as storage area

The modern modifications above the ablution area are planned to be dismantled and a remodeling of the area is planned to provide a more rational support for the first floor terrace and to give space to the new ablution area.
