**CONSERVATION PROJECT OF THE  
ASLAM AL-SILAH DAR MOSQUE**

**QUARTERLY PROGRESS REPORT**

**MARCH 2007-MAY 2007**

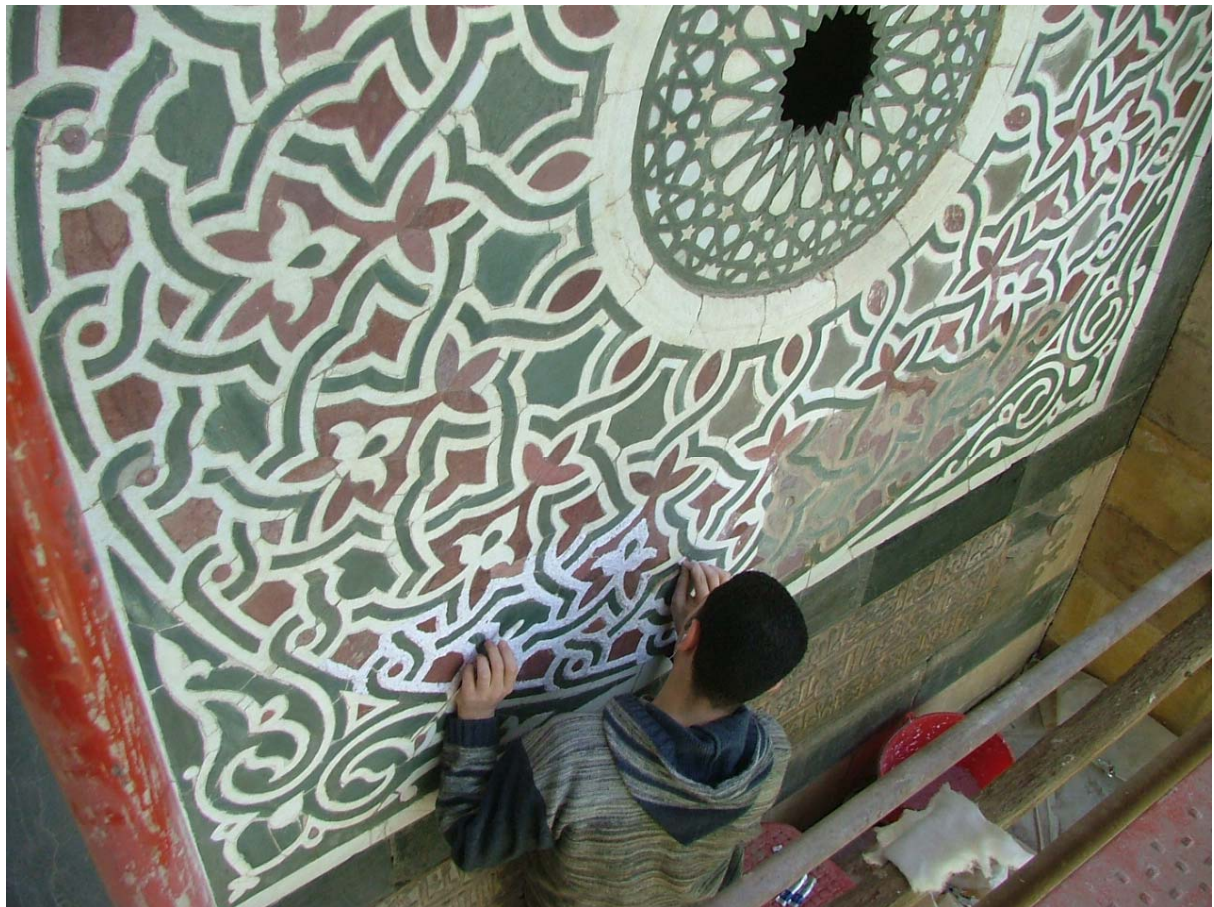
*Cleaning of the marble panel on the southern facade*

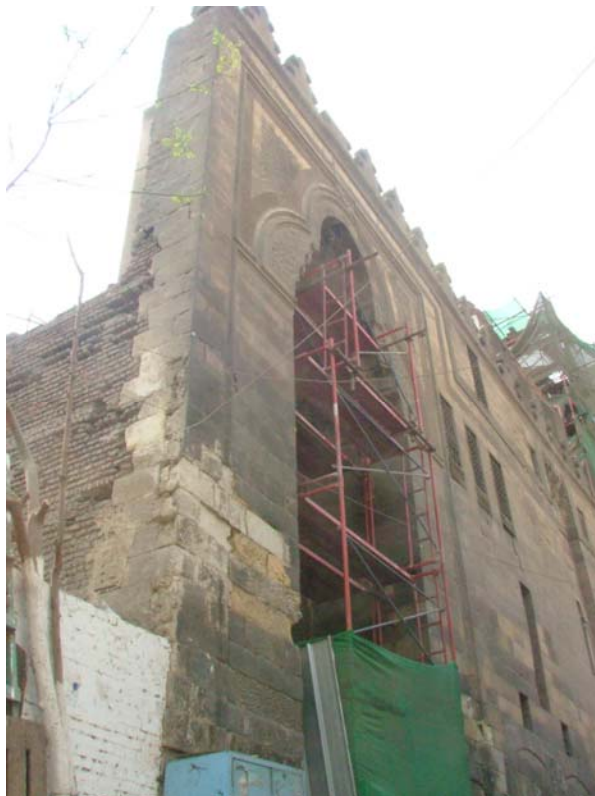
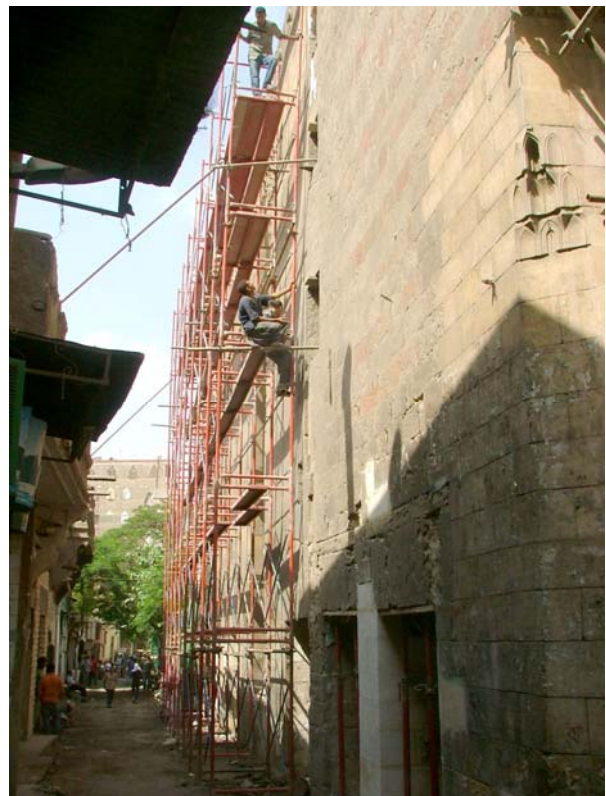
*View of the eastern façade during scaffolding erection*

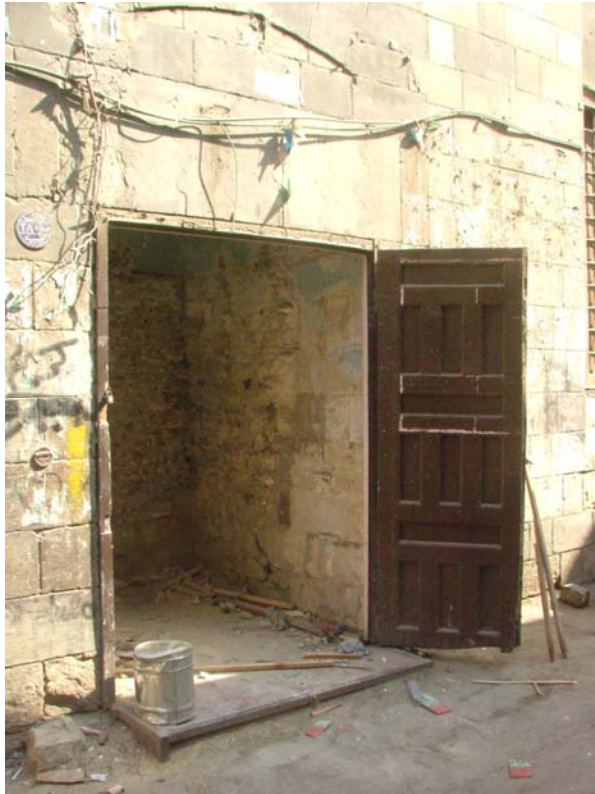
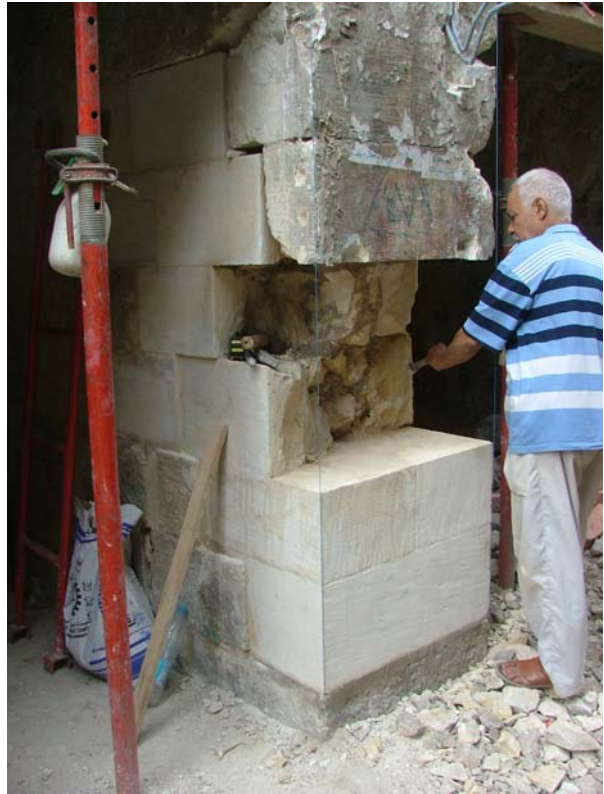
A campaign of selective stone replacement is in progress on the western facade: damaged plain facing and decorated lime stones were carefully replaced by new stones of a similar nature.

*Clearing of shops on the western façade and selective replacement of damaged stones*

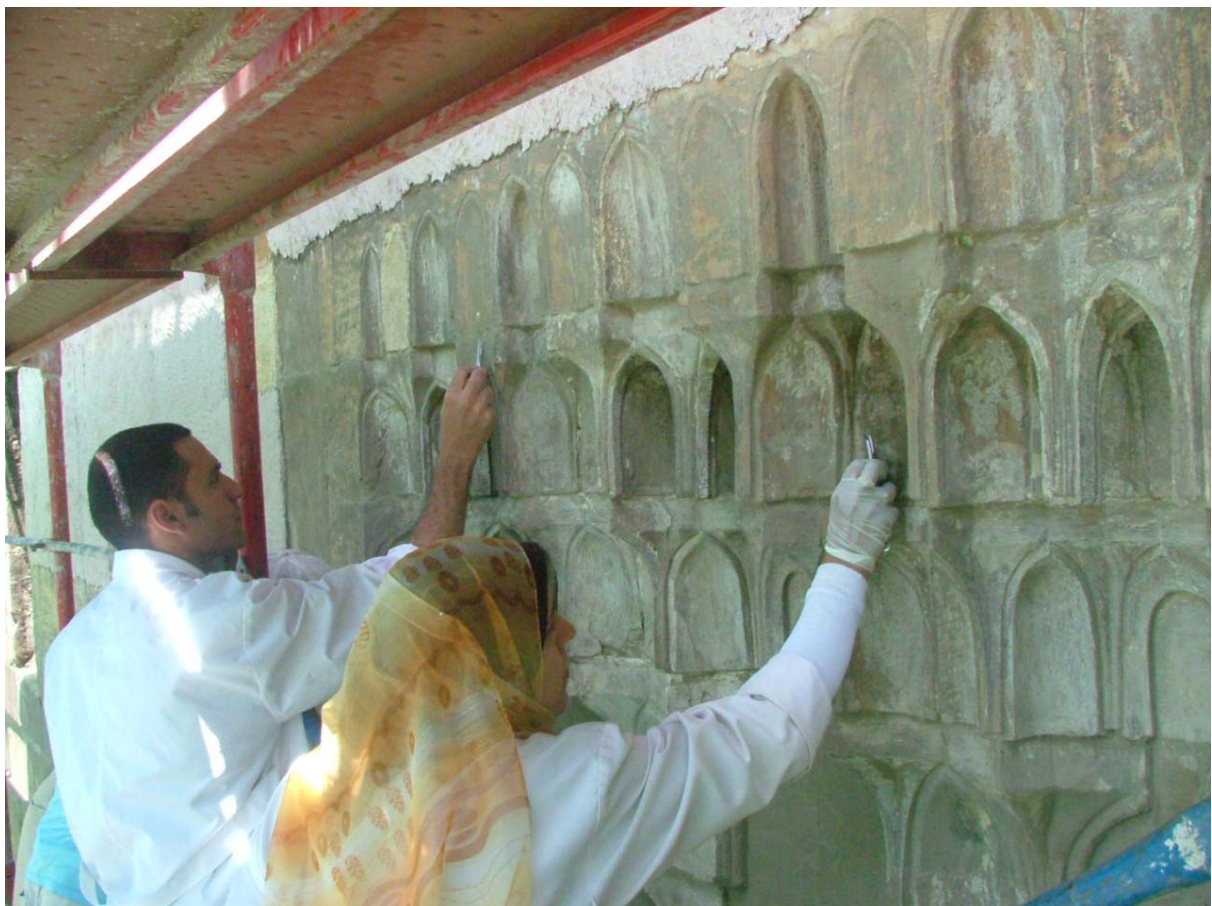
The secondary entrance of the mosque is vaulted by a composite stone stalactite shape which is currently undergoing mechanical cleaning and poulticing.

*Mechanical cleaning of the western façade stalactites*

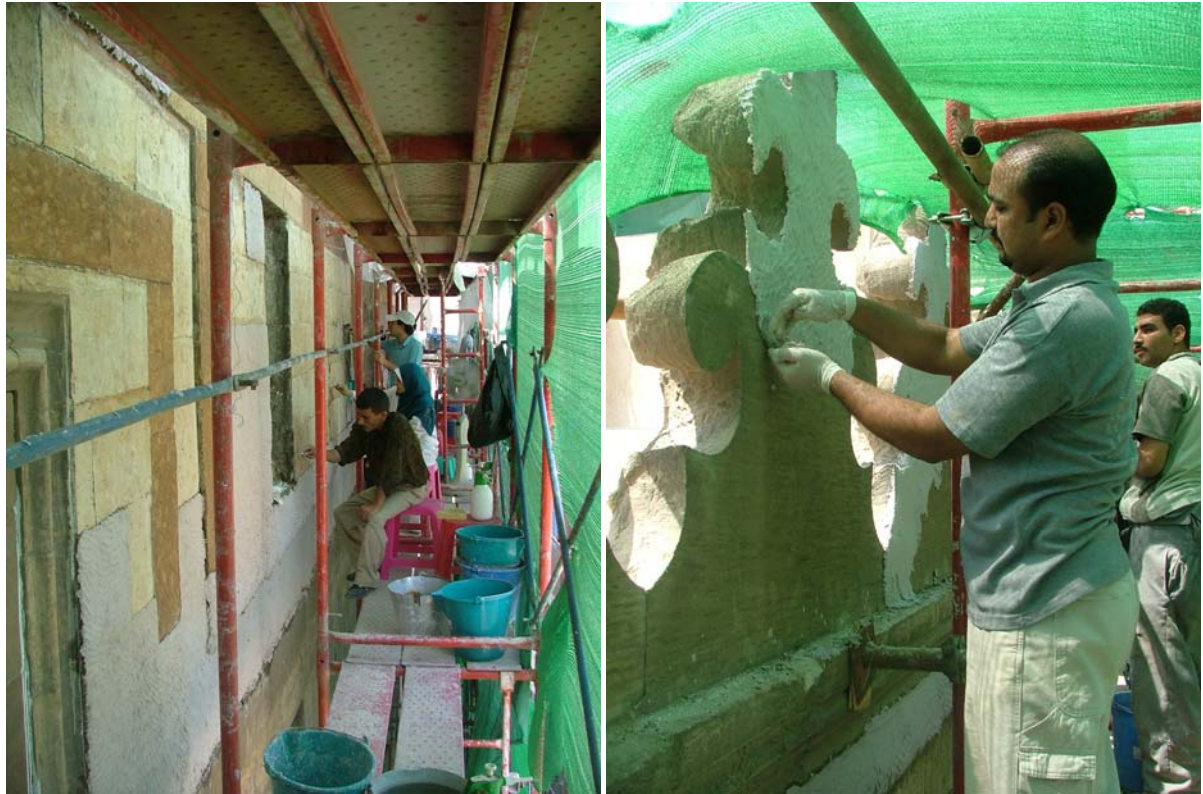
Mechanical cleaning test were started on the western façade in order to determine the state of the lime stones. Following, the fine restoration activities were initiated using poultice made of bentonite and paper pulp with a low concentration (3-5%) of Ammonium Bicarbonate. The same polychromy pattern of the lime stone found on both the southern and eastern façade was revealed.

*Stone cleaning activities through mechanical and poulticing techniques.*

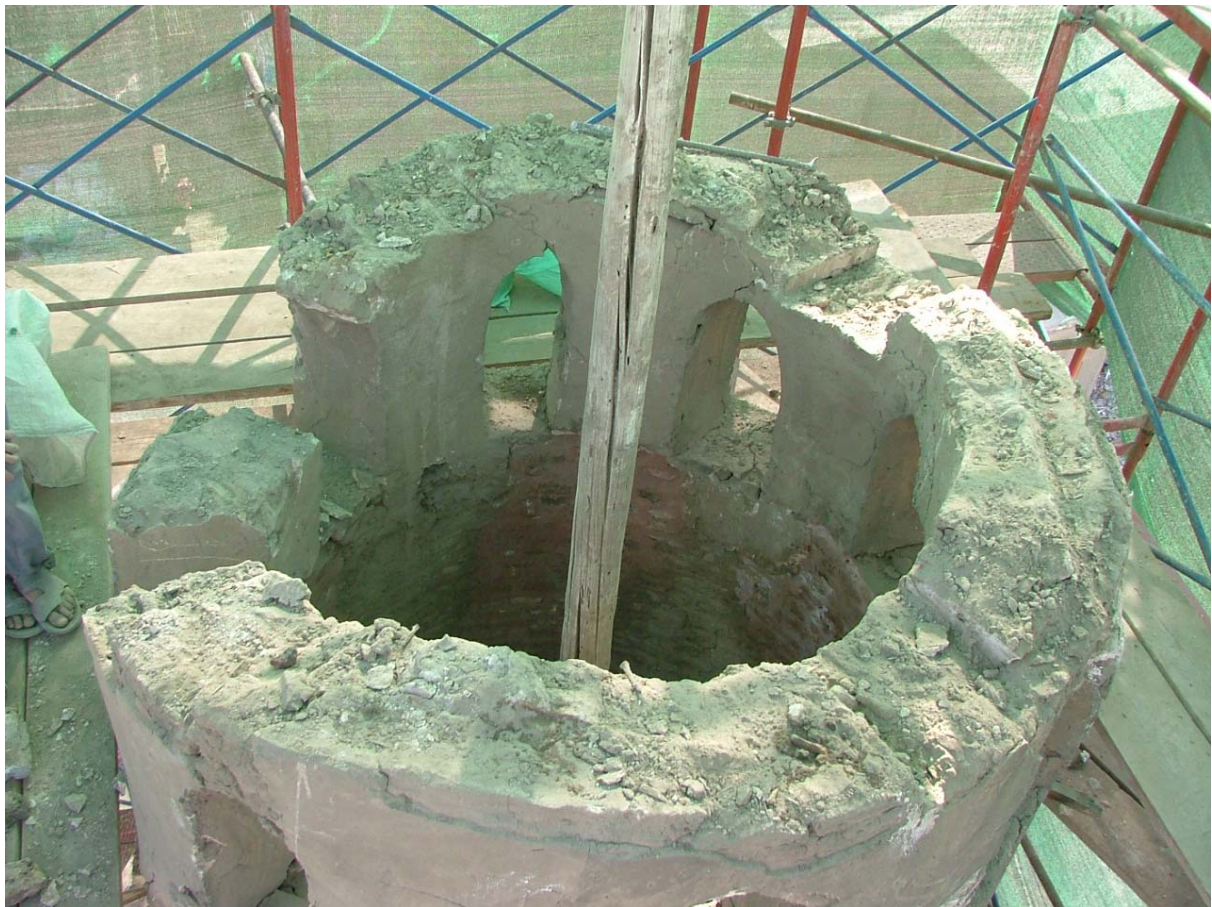
*View of the minaret upper part after the removal of damaged beams.*

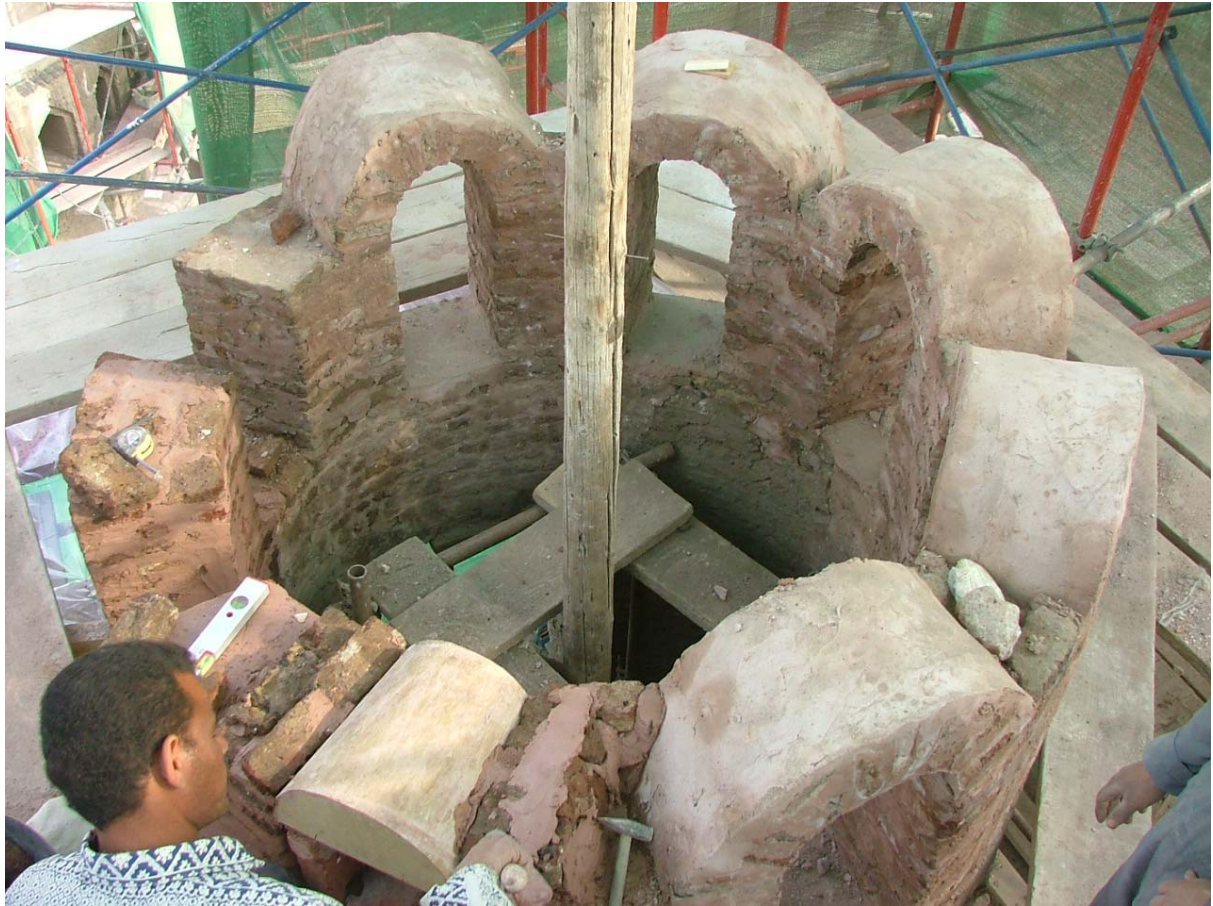
The conservation work included brick repairs on the upper part, the construction of a pencil shaped carpentry top and the cleaning of the interior walls and steps using the sand blasting technique.

*Brick repair activities on the minaret*

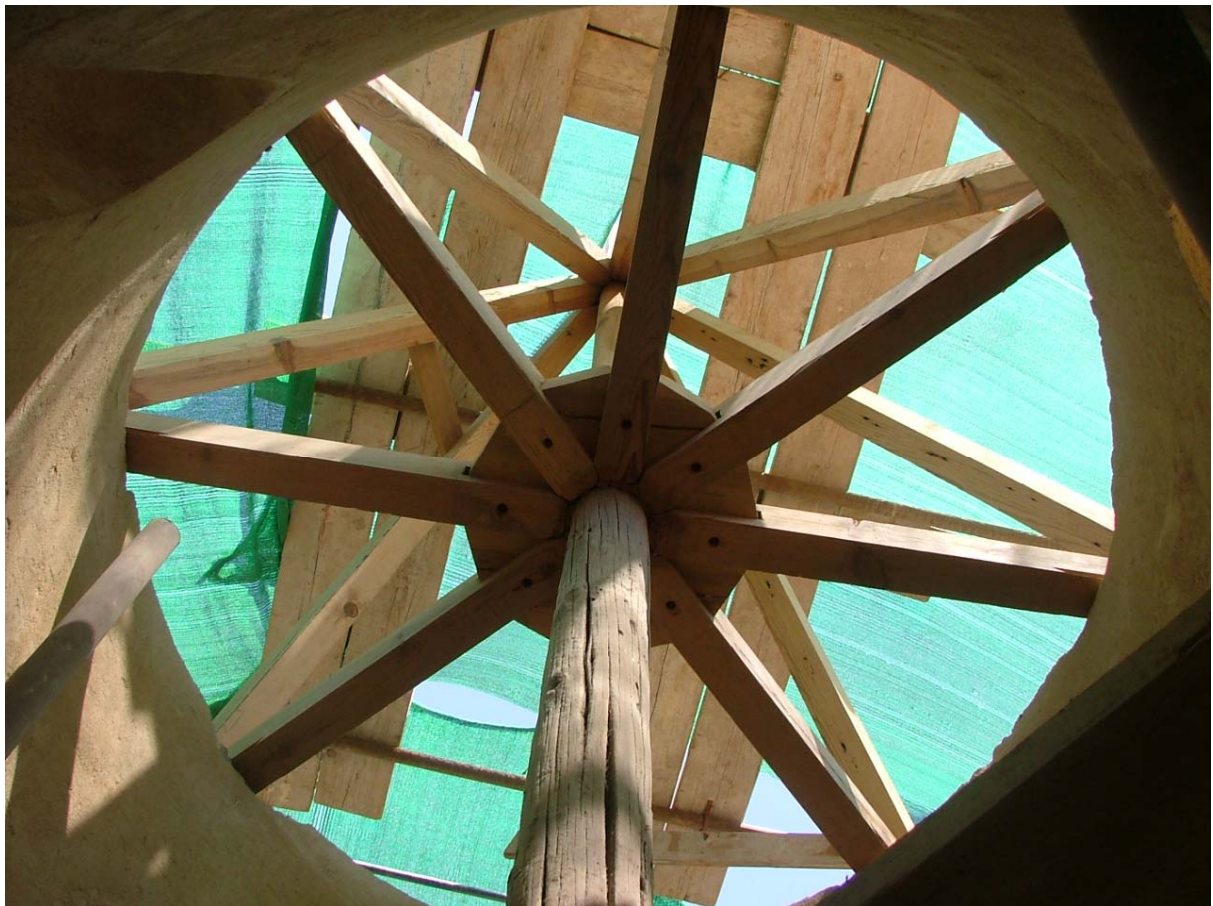
*Inner view of the minaret after the installation of the main supporting beams of the upper part.*

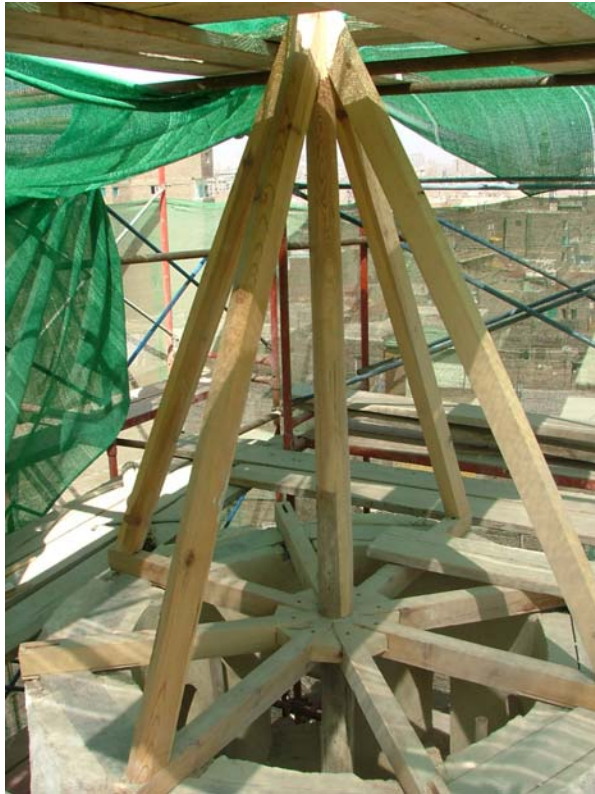
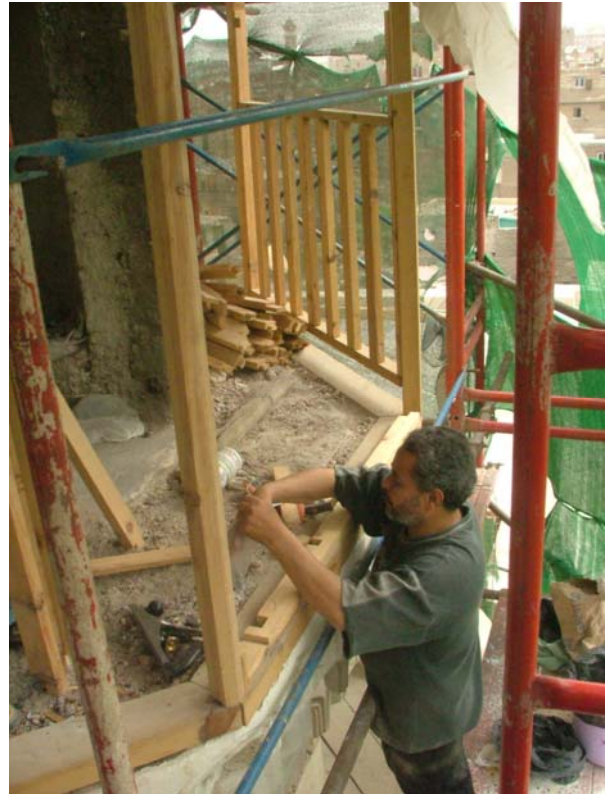
A detailed survey of the upper part of the minaret and tiling in the balcony was completed and a design proposal was prepared for the replacement of the missing tiles and handrail. The timber handrail of the middle platform was restored based on the design of the few conserved fragments. The upper wooden structure will be insulated by lead sheets during the next period.

*Wood manufacturing of the upper part and the surrounding handrail of the minaret balcony*

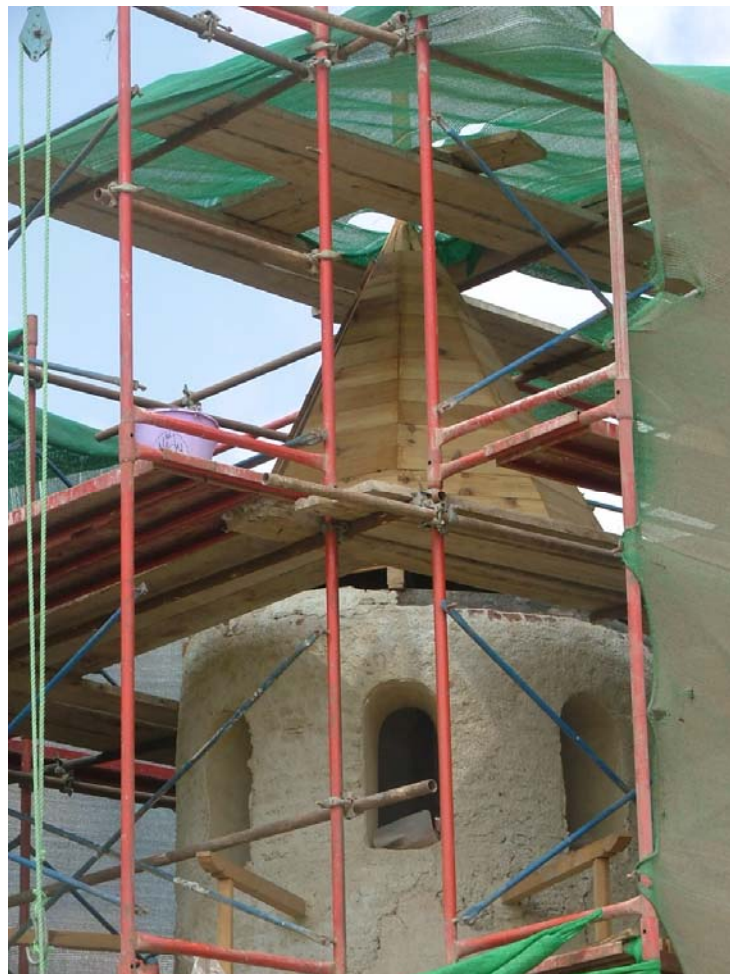
*View of the minaret after the completion of the upper pencil part and during plastering activities*

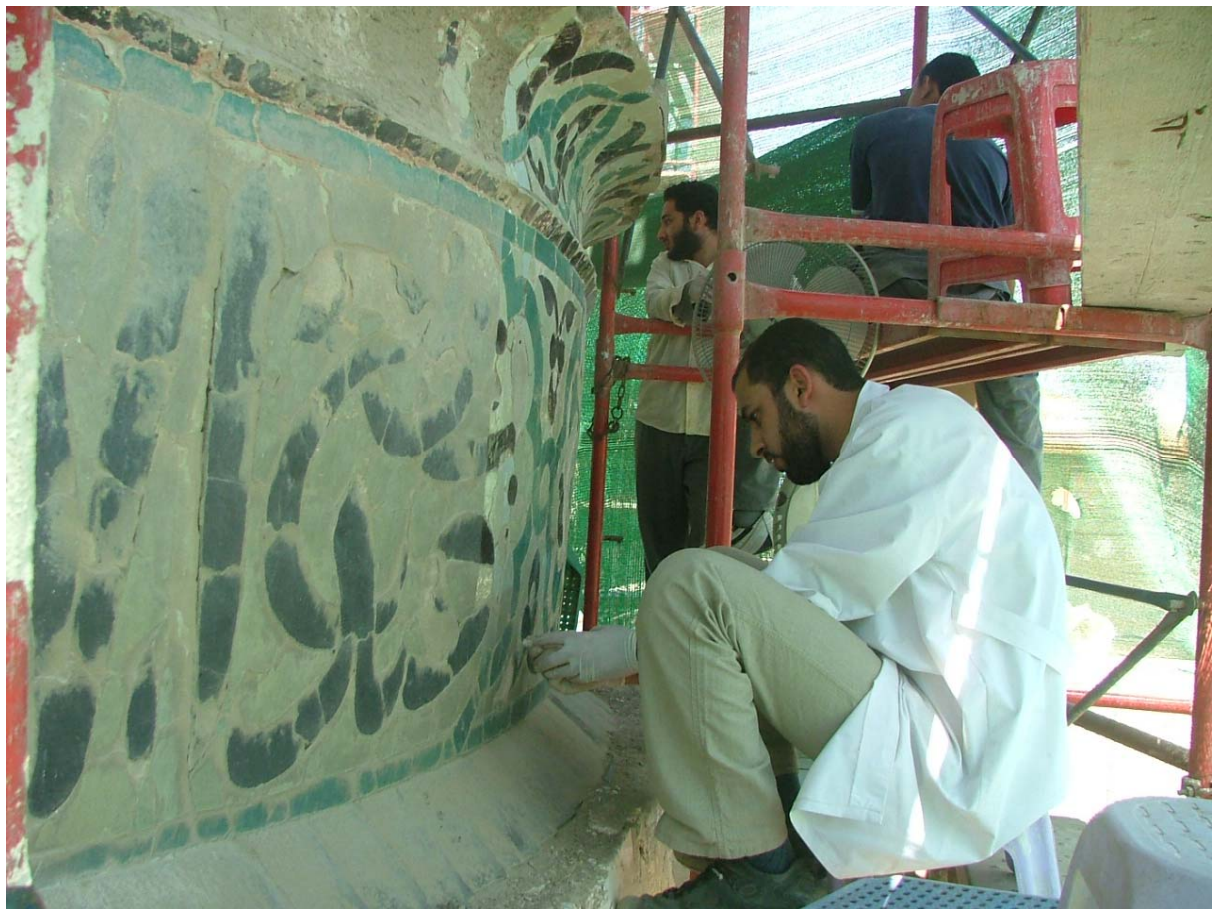
A detailed architectural drawing of the ceramic inscription band of the dome was completed. Cleaning and stabilization of the polychrome tiling decoration was finalised. Retouching of the missing ceramic glazed parts is currently proceeding while mortar samples of the missing upper crenellation are been prepared in order to study the feasibility of replacing all missing ceramic crenellations.

*View of the ceramic inscription band on the dome during cleaning and consolidation of the ceramics*

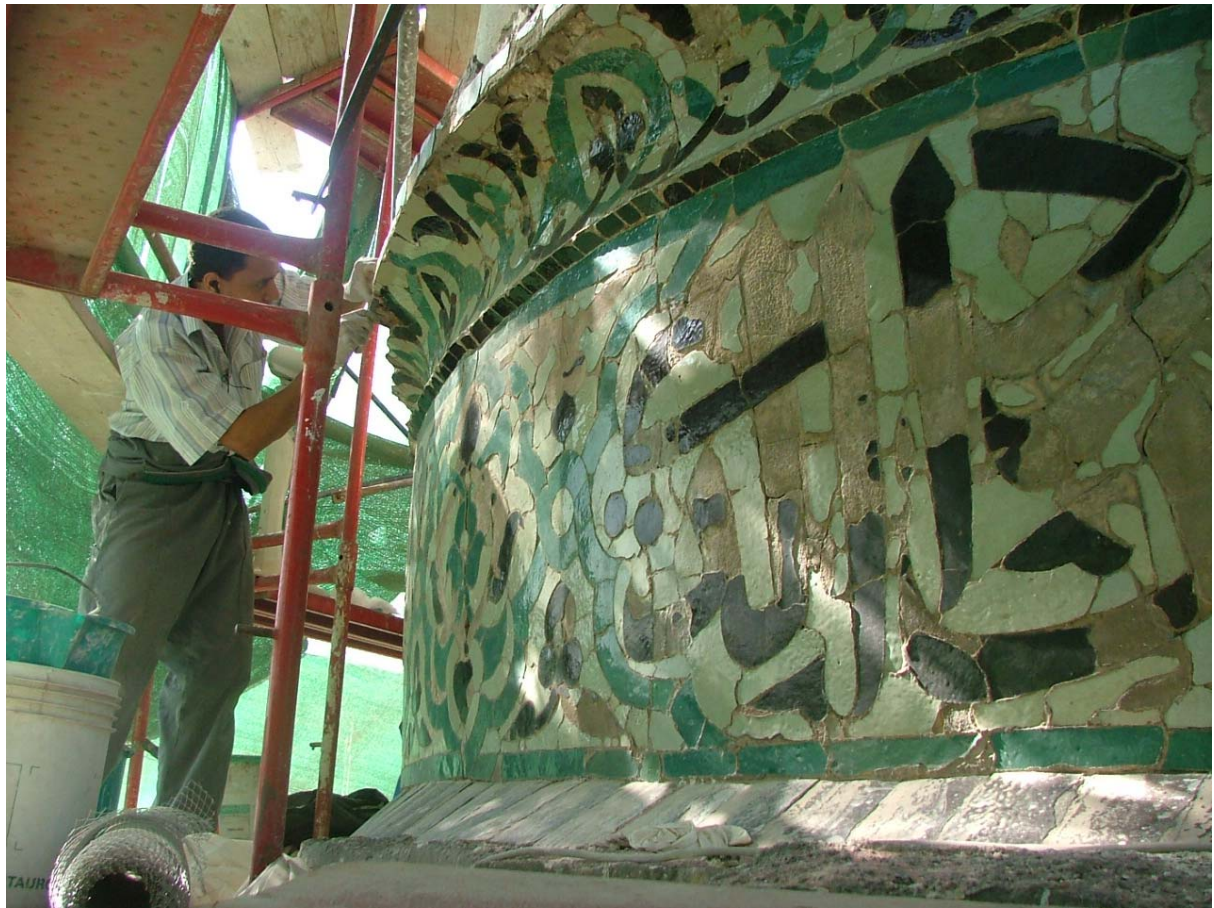
*Mortar completion of the upper missing parts of the Dome Corniche*

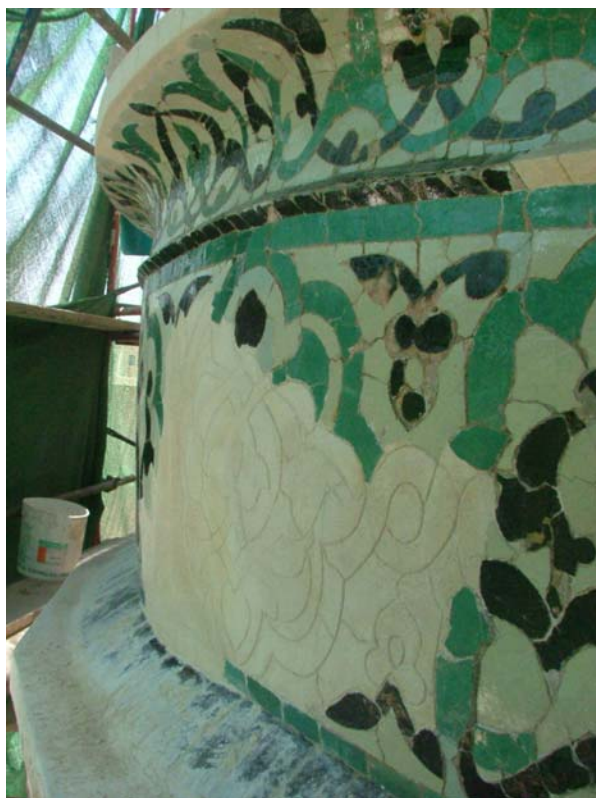
*Mortar and drawing completion of missing parts*

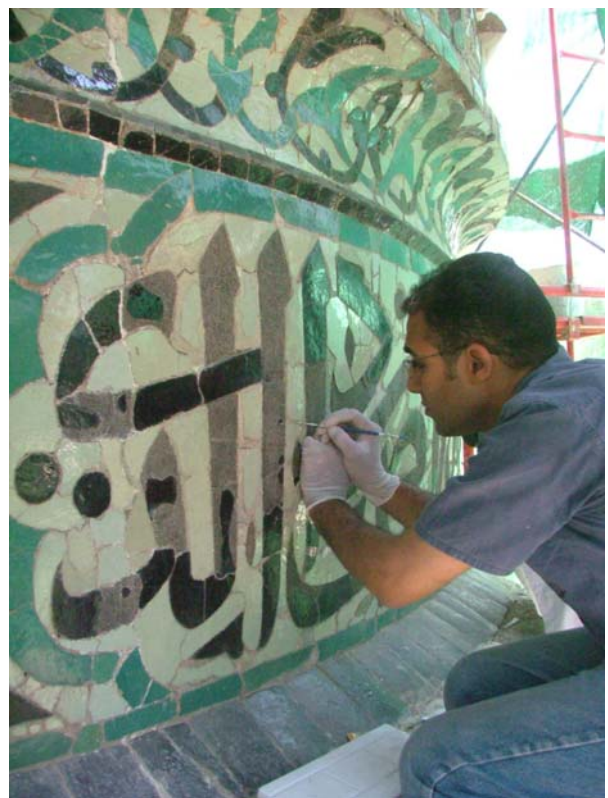
*Retouching of the missing glaze of the inscription*

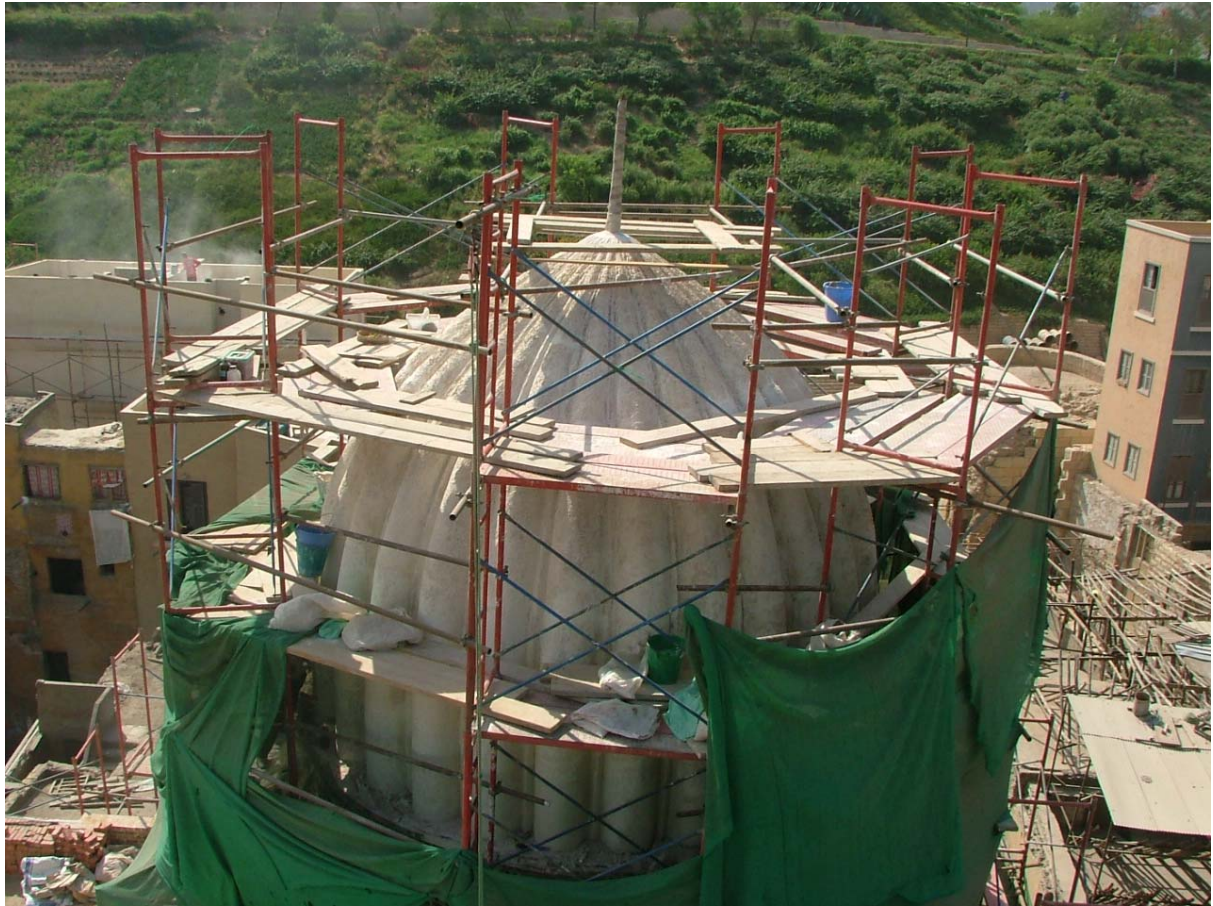
*View of the dome exterior after the cleaning and installation of the copper crescent*

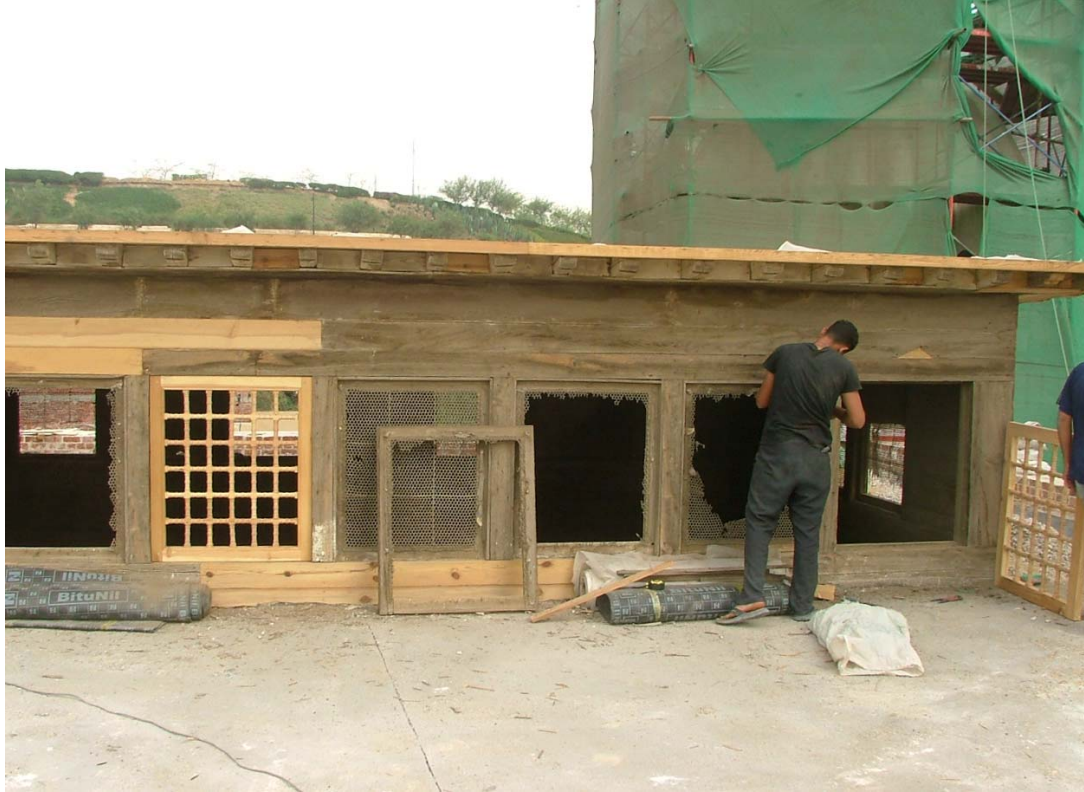
*Central shokhsheikha during restoration and view of the new proposed wooden window*

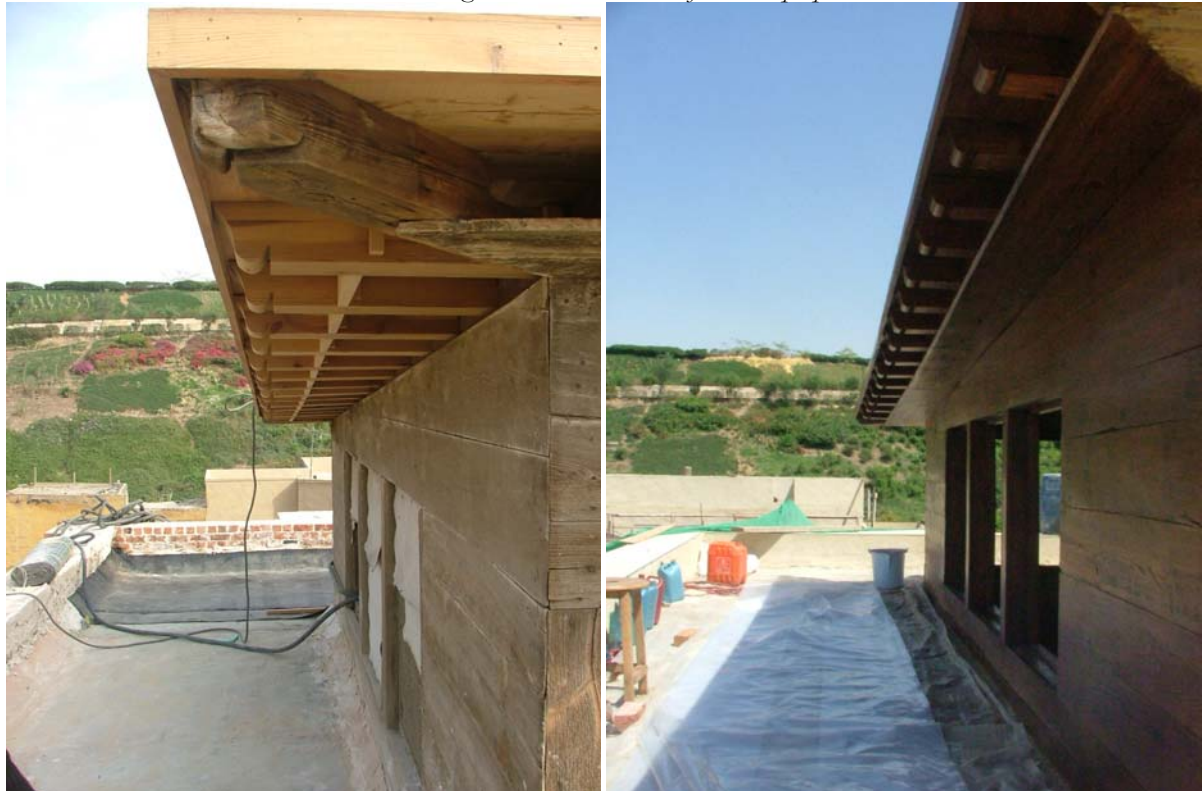
*View of the central shokhsheikha after the replacement of damaged beams and shingles and after painting*

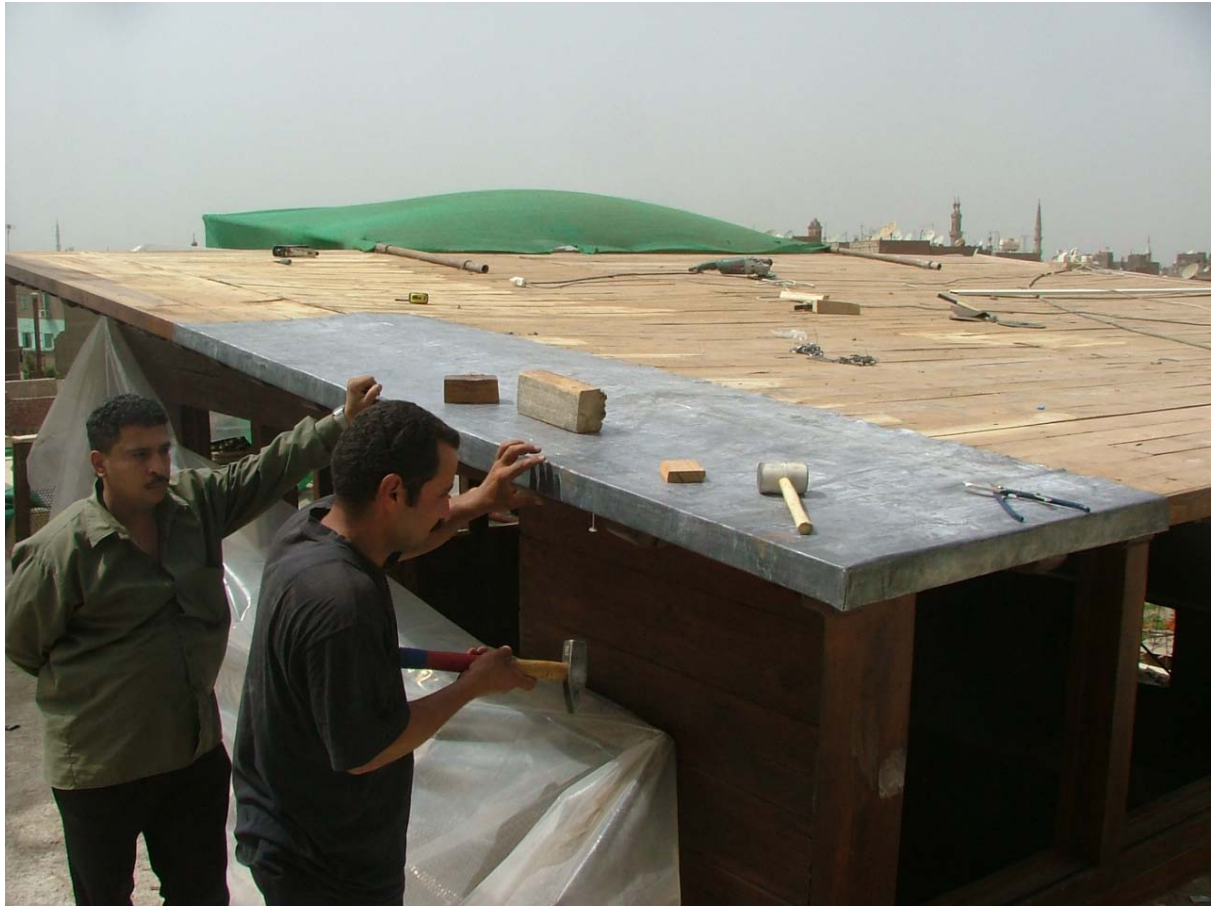
The carpentry of the central shokhsheikha was restored and insulated by lead sheets in order to minimize the dead load.

*Central shokhsbekba during the insulation using lead sheets*

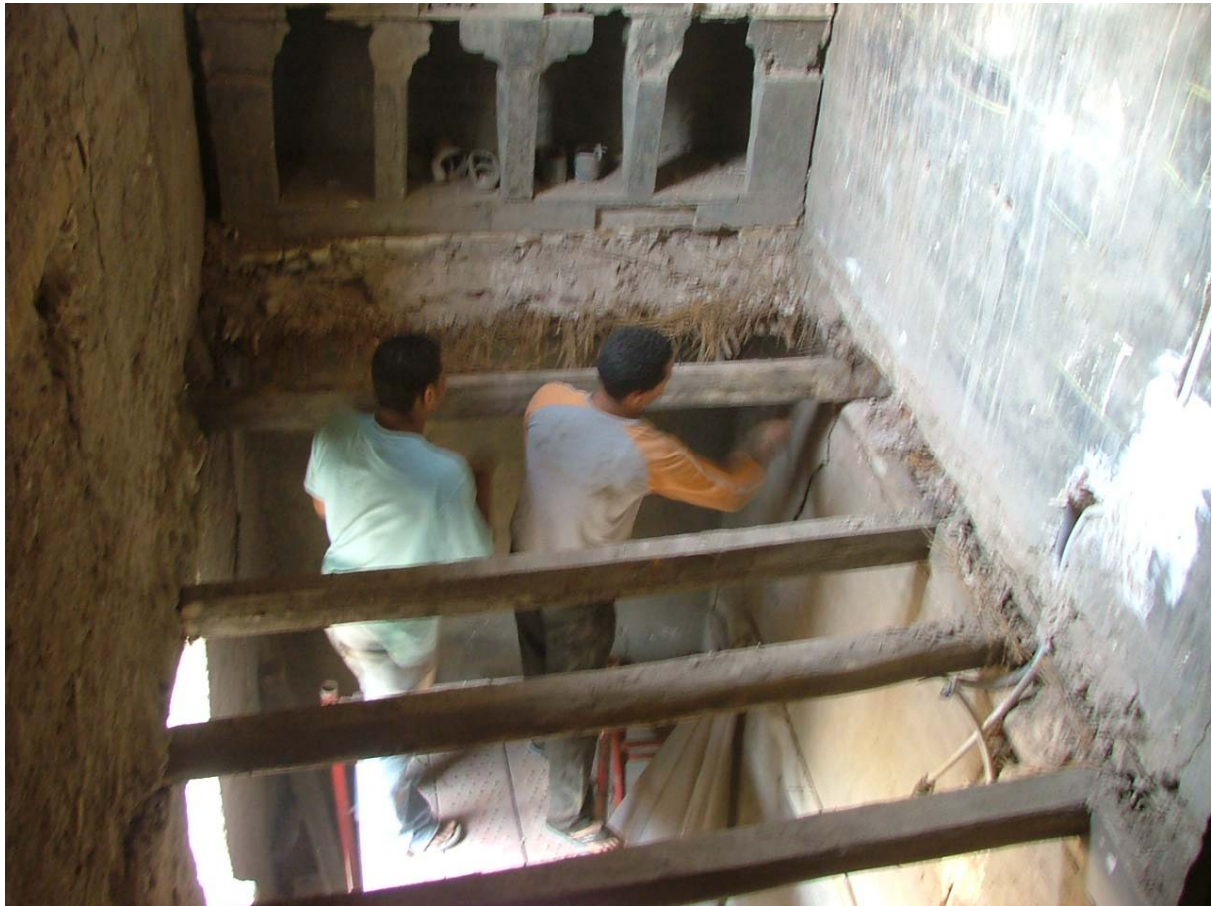
*Room 1.2 during the replacement of the damaged beams*

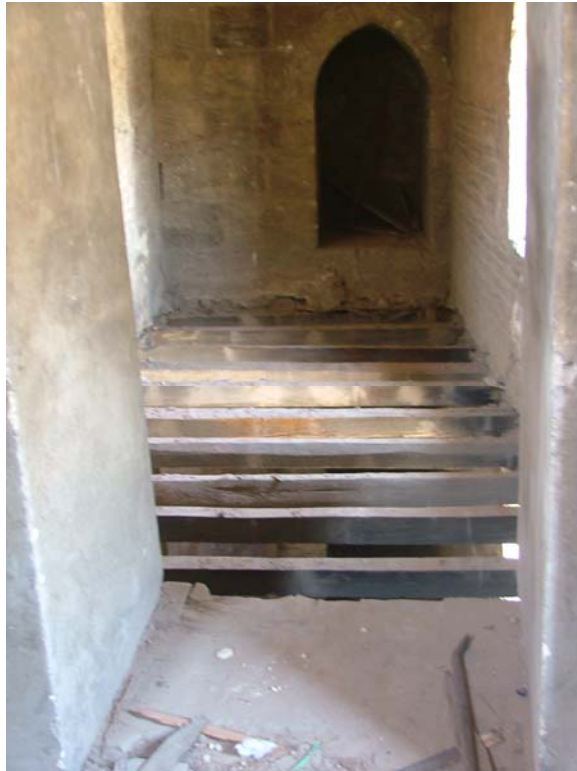
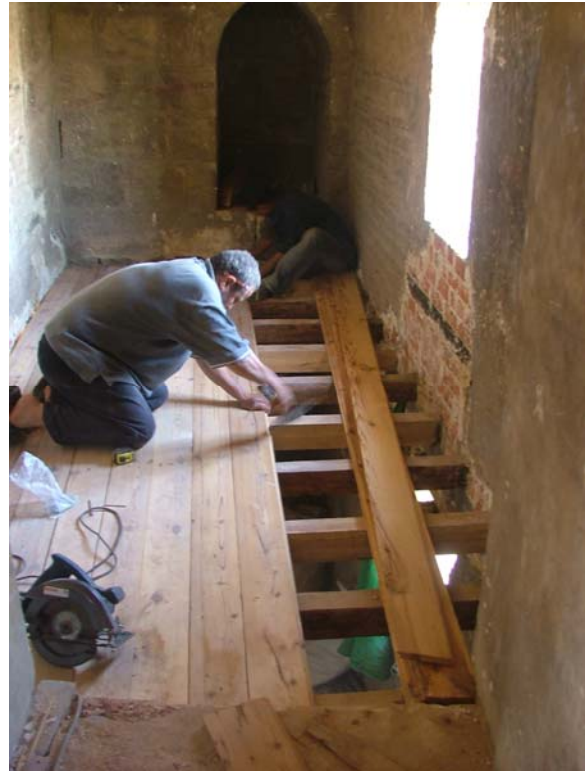
*View of room 2.3 during the replacement of damaged beams and shingles.*

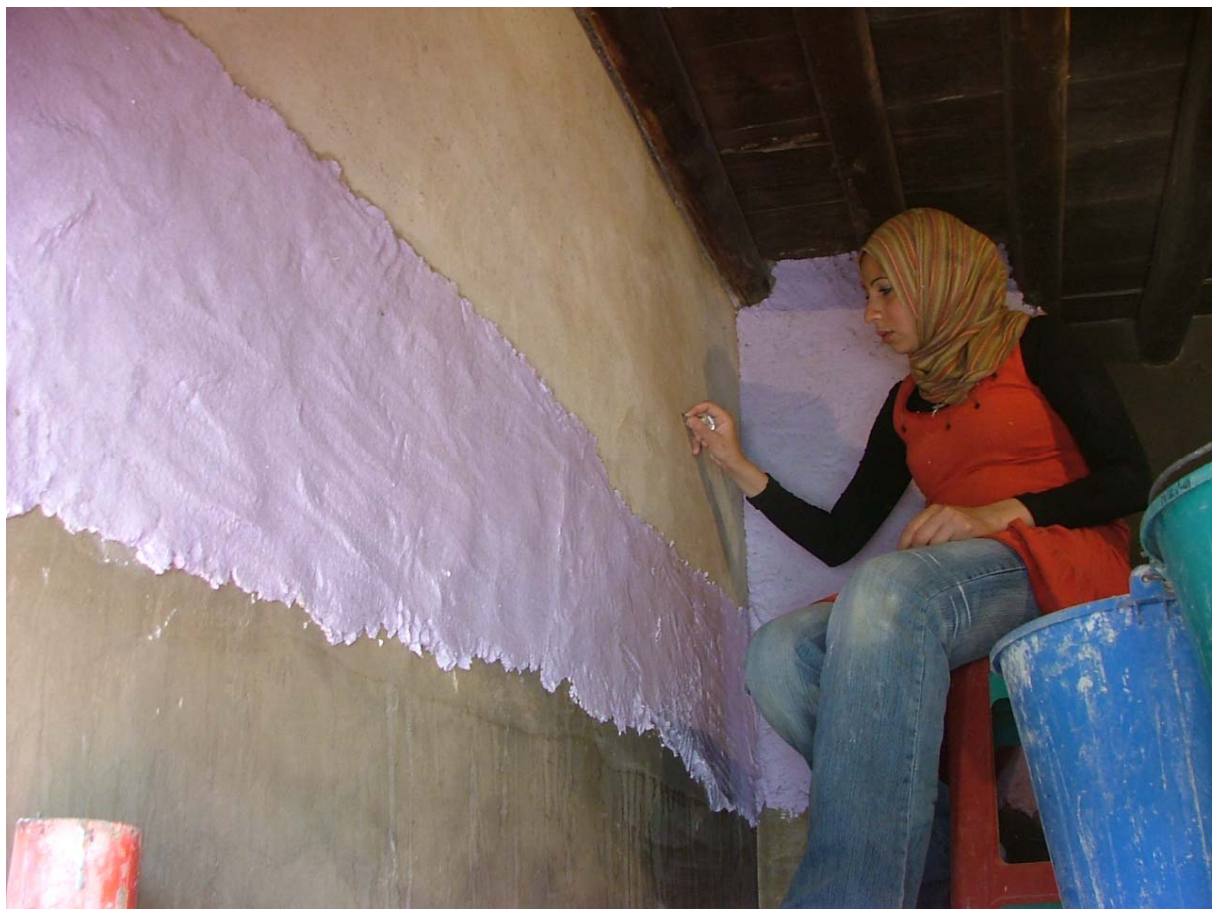
Room 2.1 on the second floor was found in a good condition. Fine restoration and cleaning activities were finalised. Currently conservation of room 2.2 is taking place. Cleaning and conservation techniques include grouting behind detached plaster layers and consolidation of the lime based plasters using poulticing.

*Cleaning of lime based plaster in room 2.2 using poultices after the injection of detached parts.*

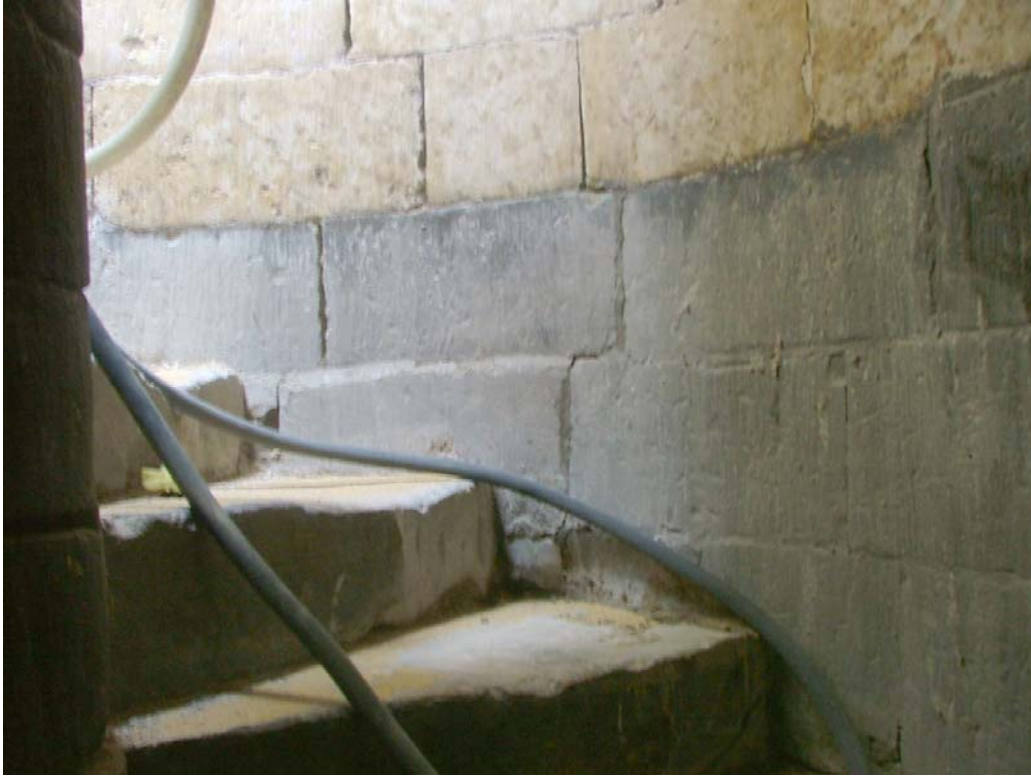
*Interior of the main staircase during cleaning by sand blasting*

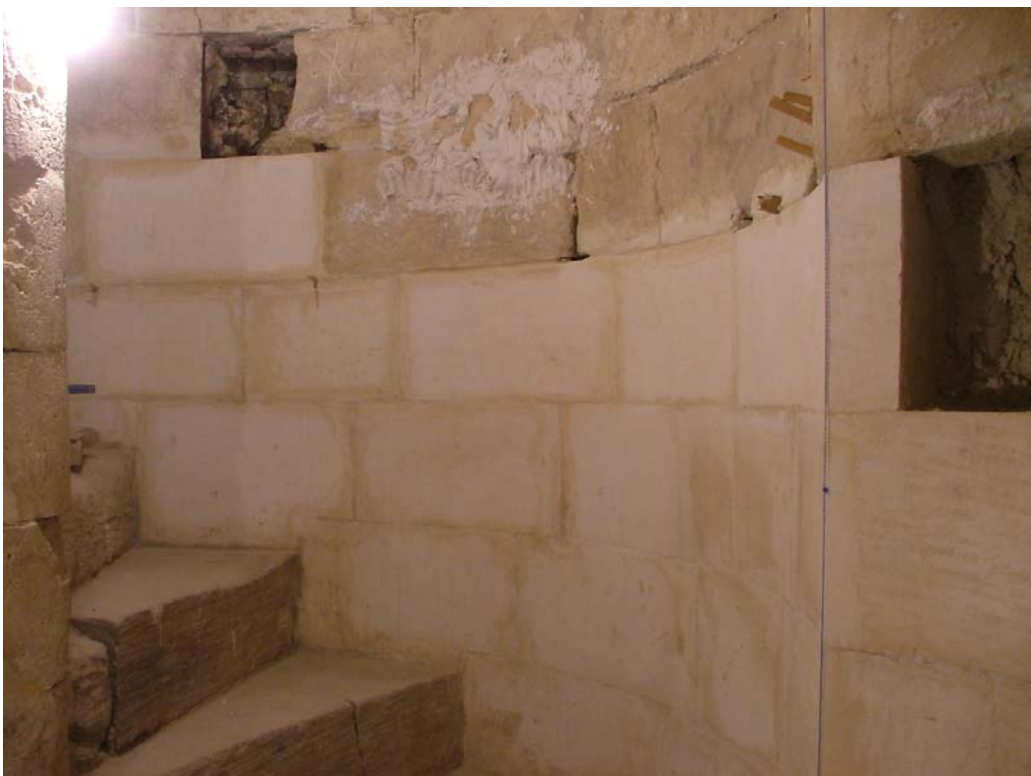
The mosque's main staircase showed many damaged stones which were replaced by new stones of similar nature. The electrical network was also embedded in the stone masonry during the restoration. The walls and steps of the staircase were cleaned by the sand blasting. Repointing of the wall masonry joints was finalised afterwards.

*Stone replacement activities in the staircase*
