**CONSERVATION PROJECT OF THE  
ASLAM AL-SILAH DAR MOSQUE**

**QUARTERLY PROGRESS REPORT**

**MARCH 2007-MAY 2007**

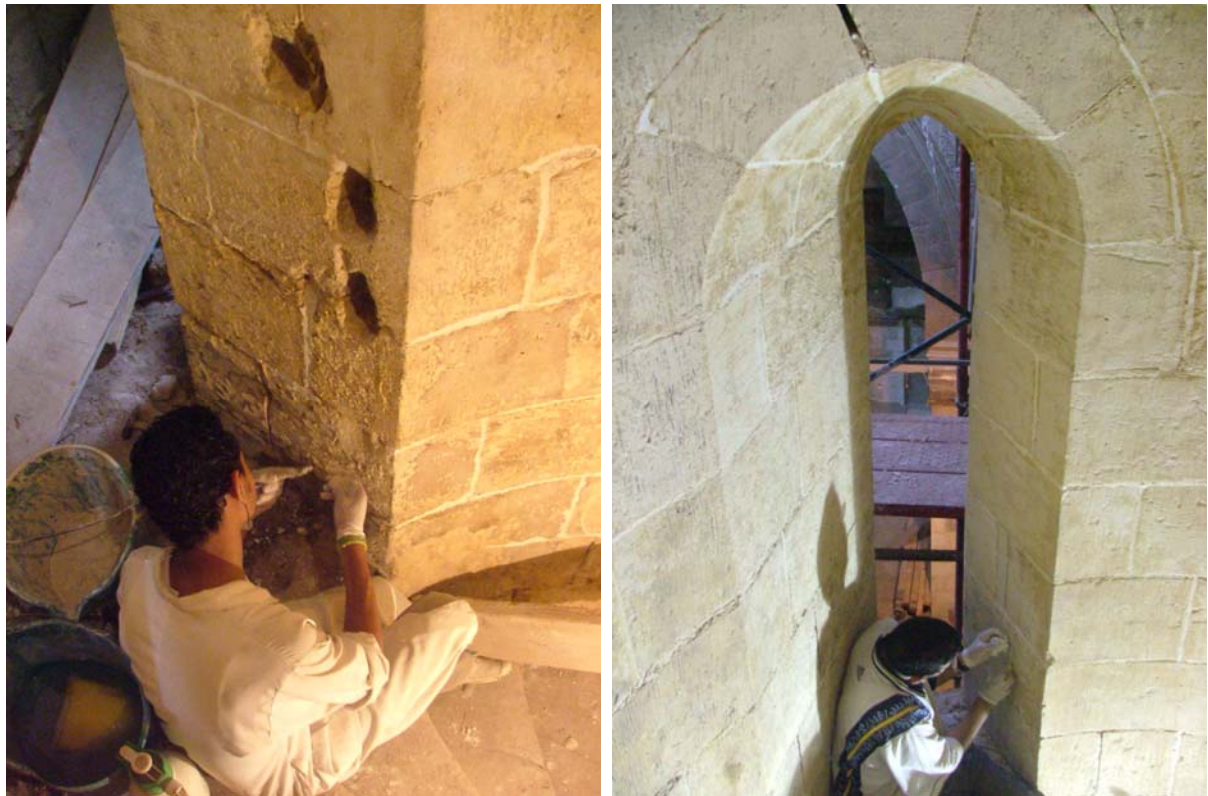
*Repointing of the stone masonry after cleaning*

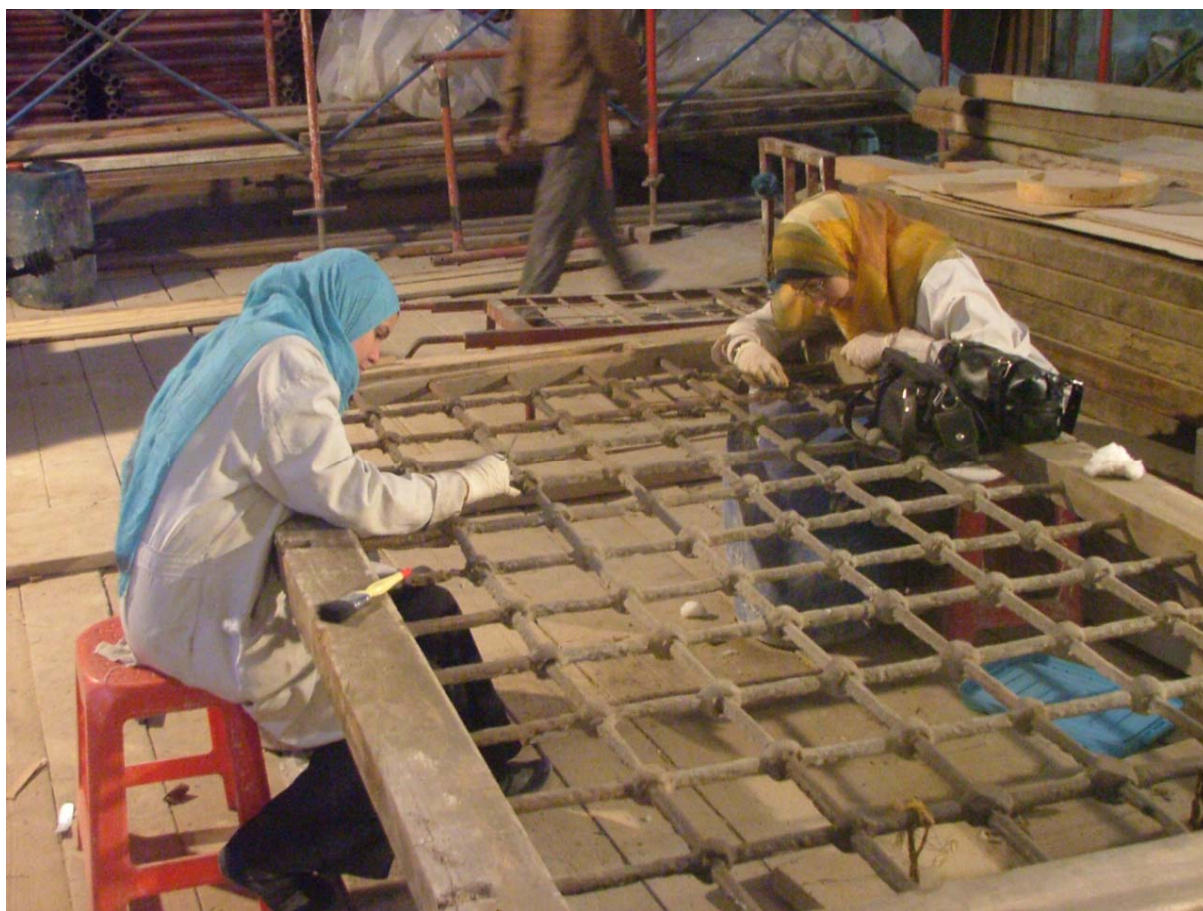
*Cleaning activities of the main façade metal grill and wooden frame*

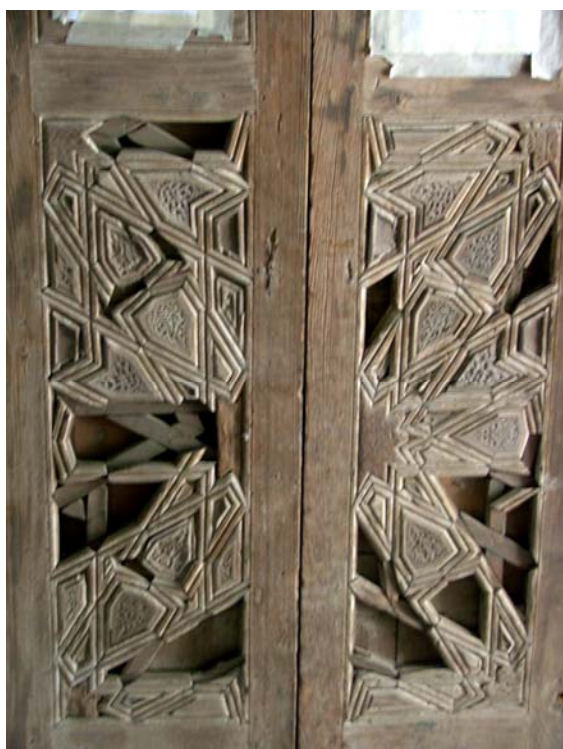
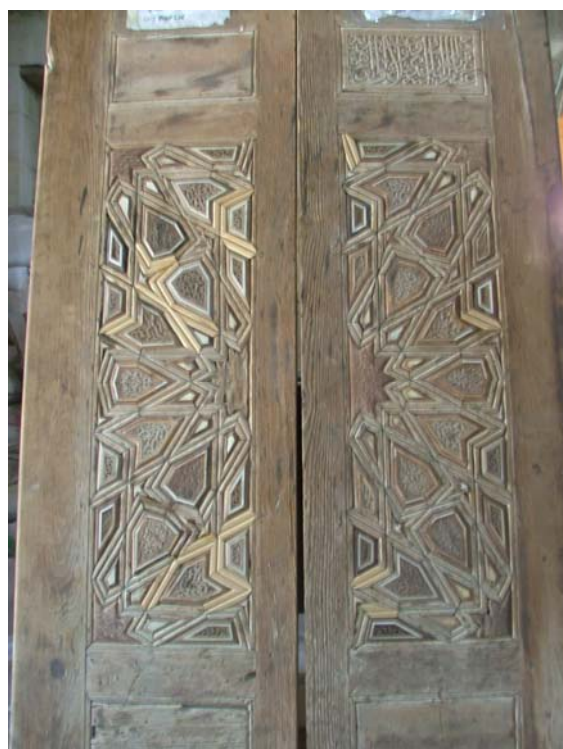
*View of the Eastern façade shutters before and after restoration*

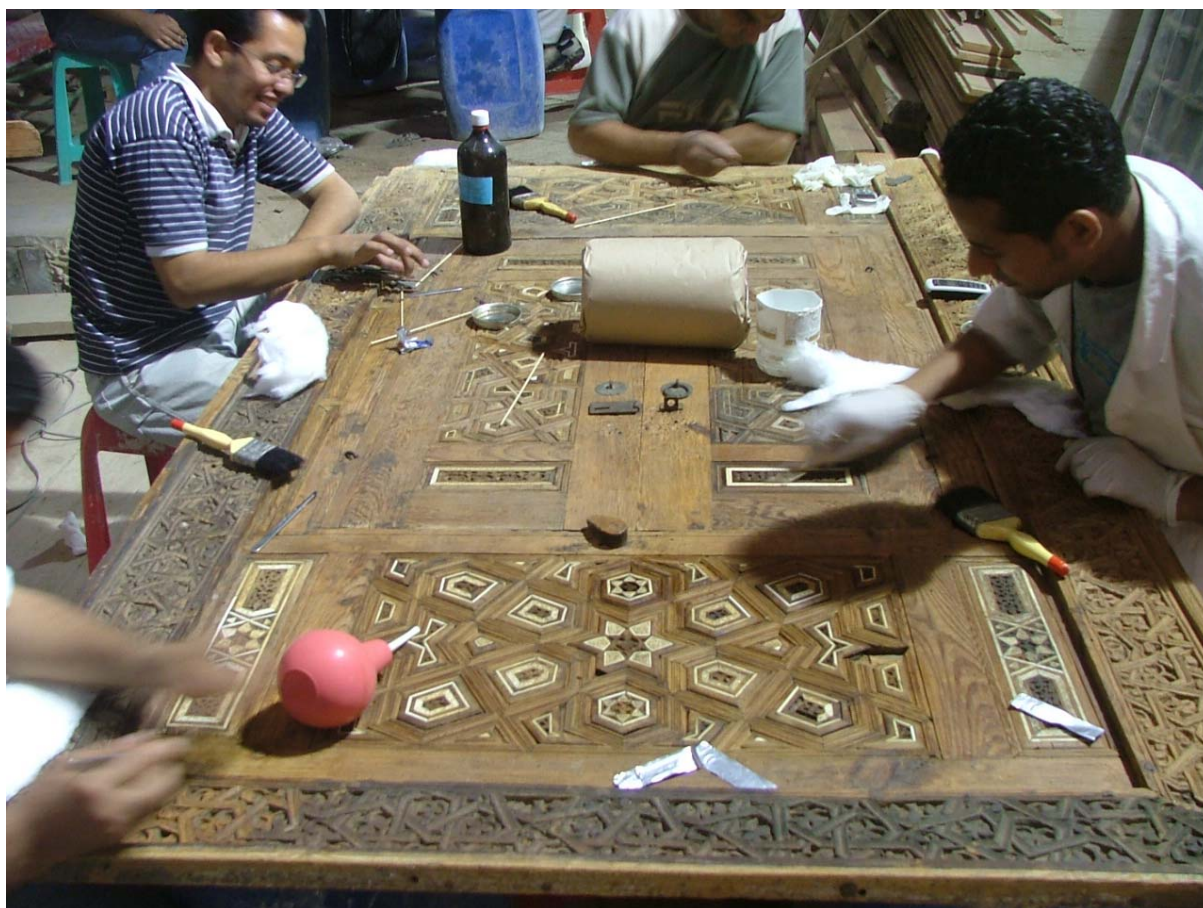
*Inlay wooden cupboard during cleaning and consolidation*
