CONSERVATION PROJECT OF THE  
ASLAM AL-SILAH DAR MOSQUE

QUARTERLY PROGRESS REPORT

September - December 2007

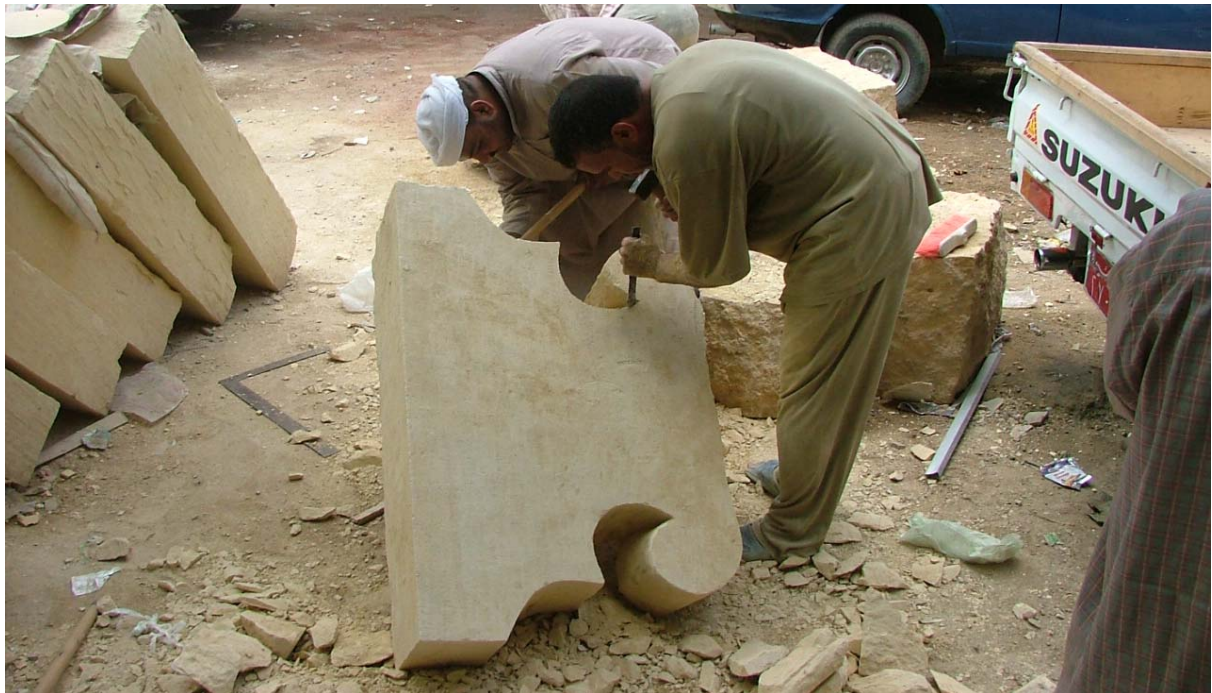
*Carving the missing crenellation of the south (main) façade*

The missing crenellations on the south (main) façade were carved, brought up to the roof and installed in place. The missing crenellations on the right side of the west façade were also carved and erected.

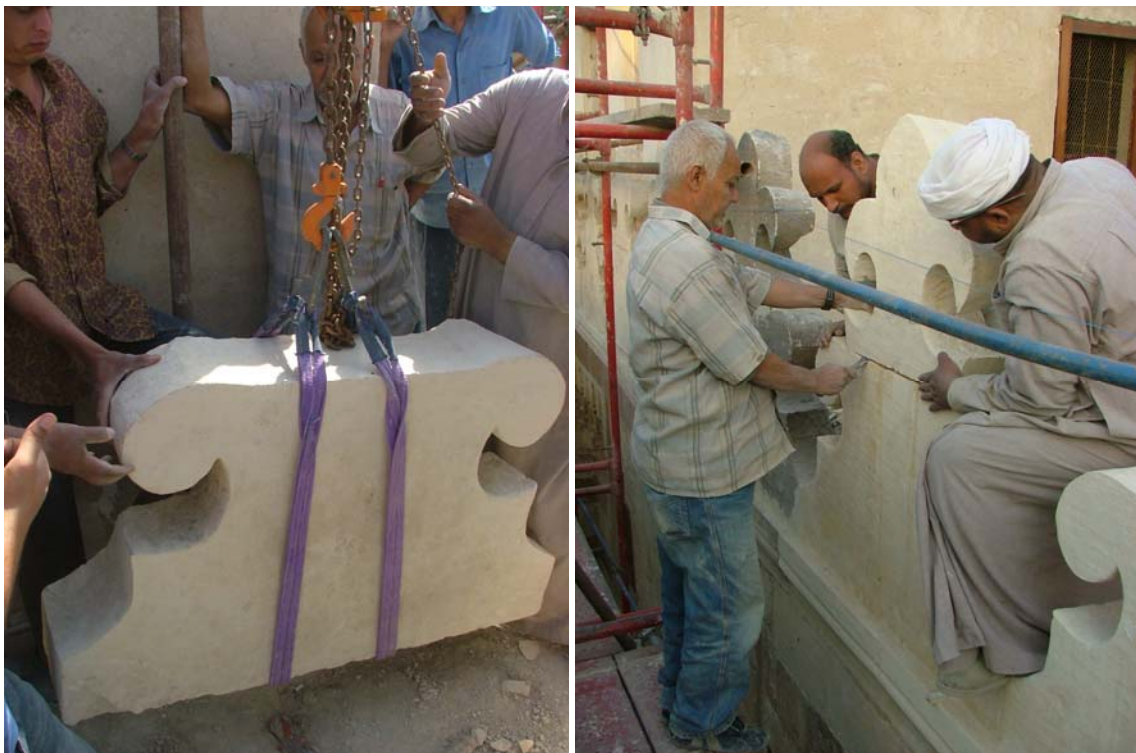
*Activities of placing the missing crenellations*

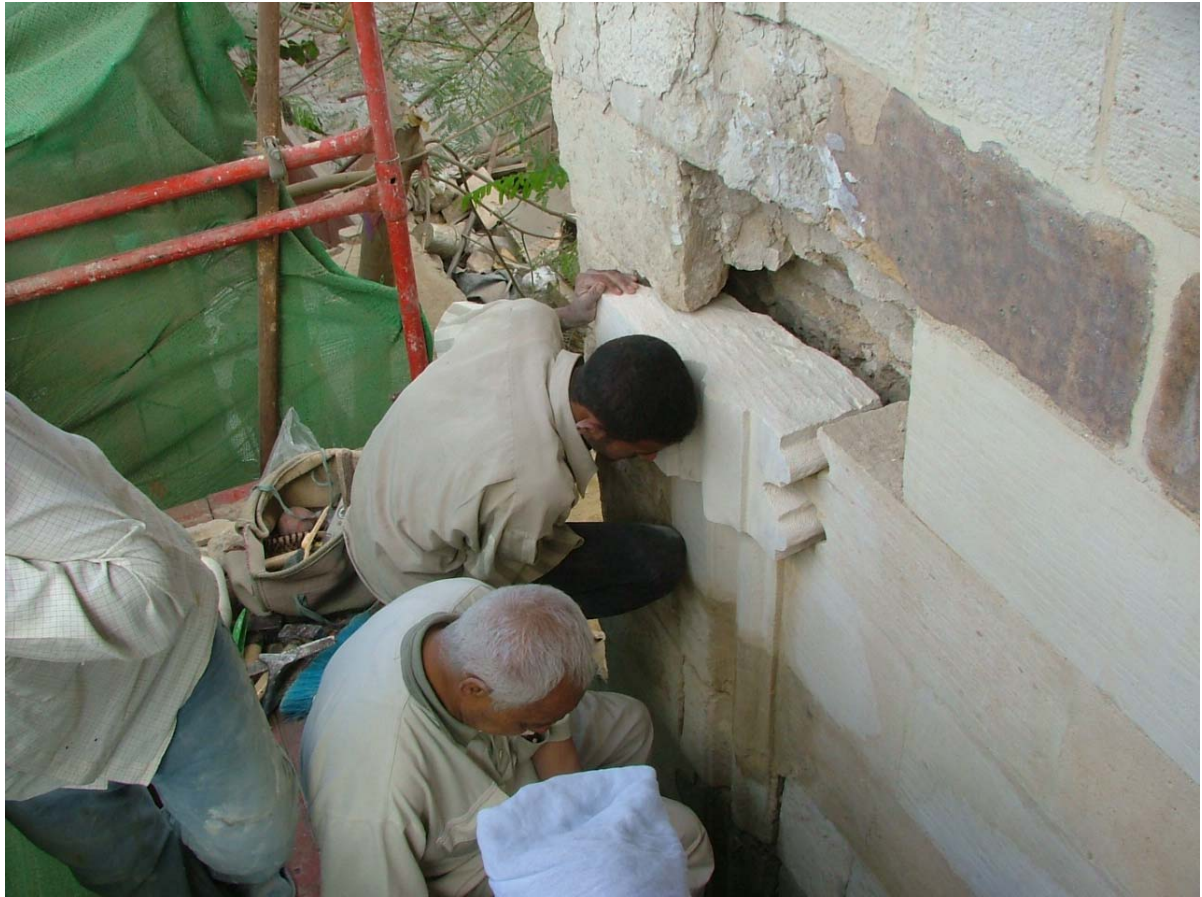
*Stone replacement activities on the lower part of the west façade*

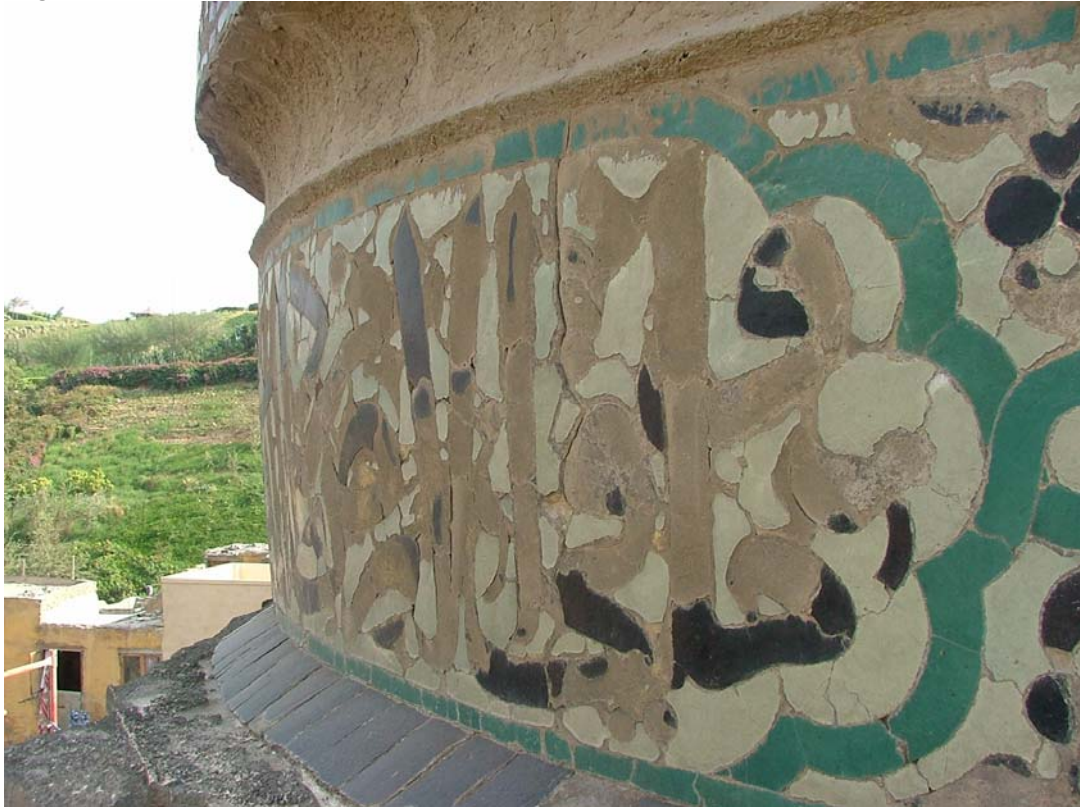
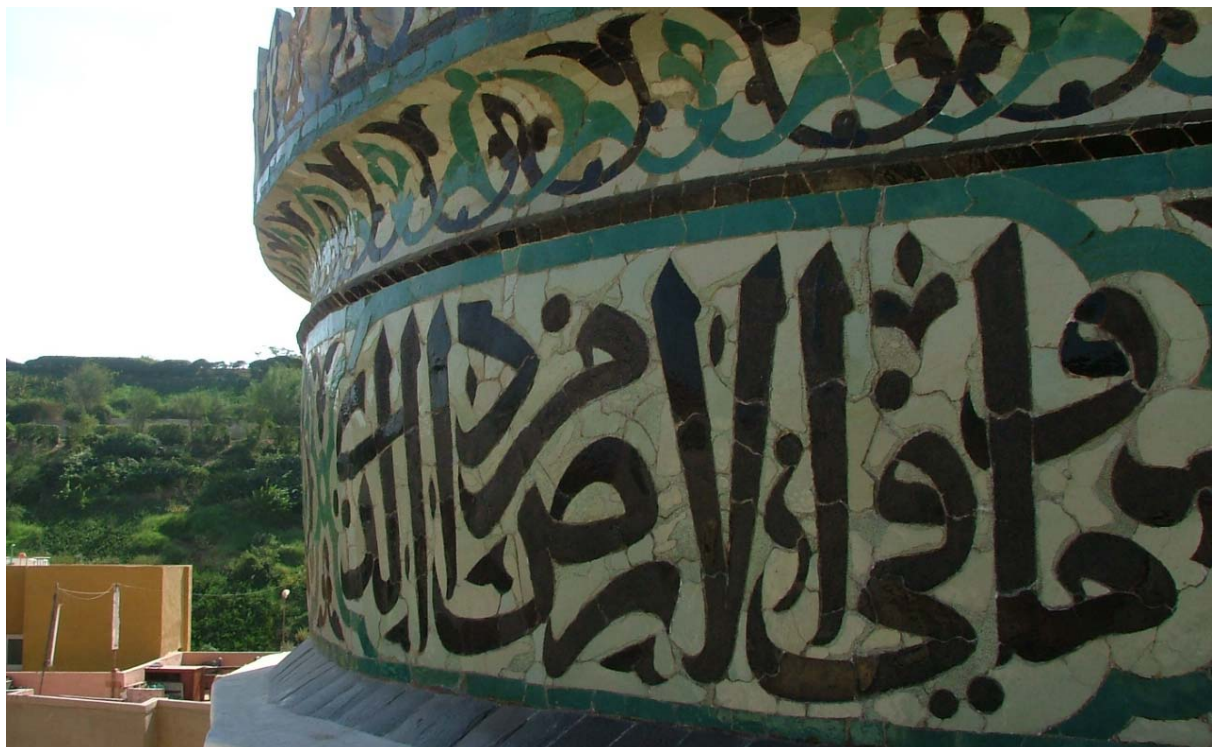
The retouching of the crenellations (made in plaster), the inscription band and its floral decoration was completed. A decision is being studied concerning the completion of the inscription band in the areas where no ceramic tiles are found. The existing gypsum grills with glass on the interior of the mausoleum were cleaned from the outside. As for the exterior gypsum windows (which are missing) designs were proposed to the SCA and discussions are taking place concerning the matter. The scaffolding was dismantled.

*Details of the inscription band on the exterior of the dome before and after intervention*

All activities are completed. Study the possibility of completing the missing part of the inscription.

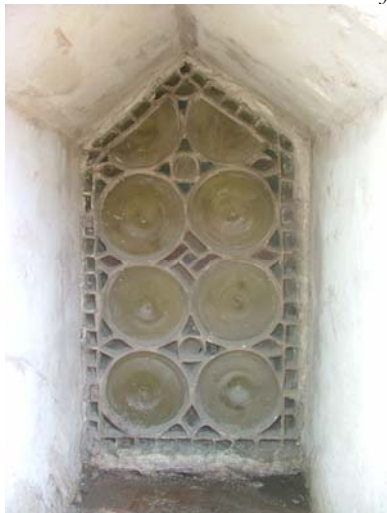
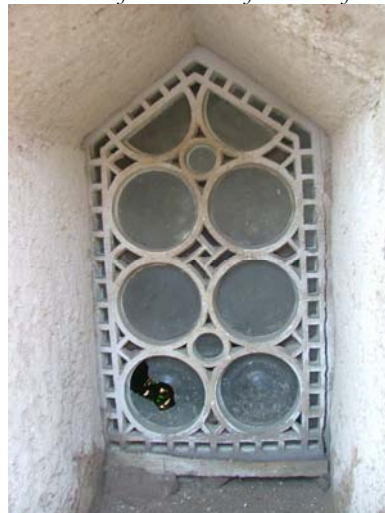
*The exterior façade of the interior gypsum windows with glass (the left one is more historic and the only one remaining; the other ones are recent reconstructions by the Comité)*

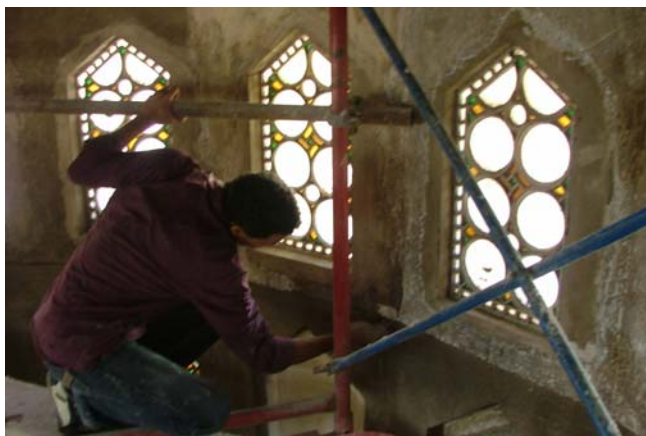
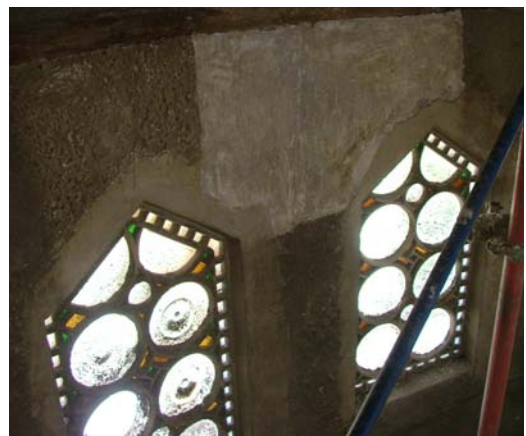
*Activities and details of removing the dust and the recent limewash layer around the first level windows of the mausoleum*

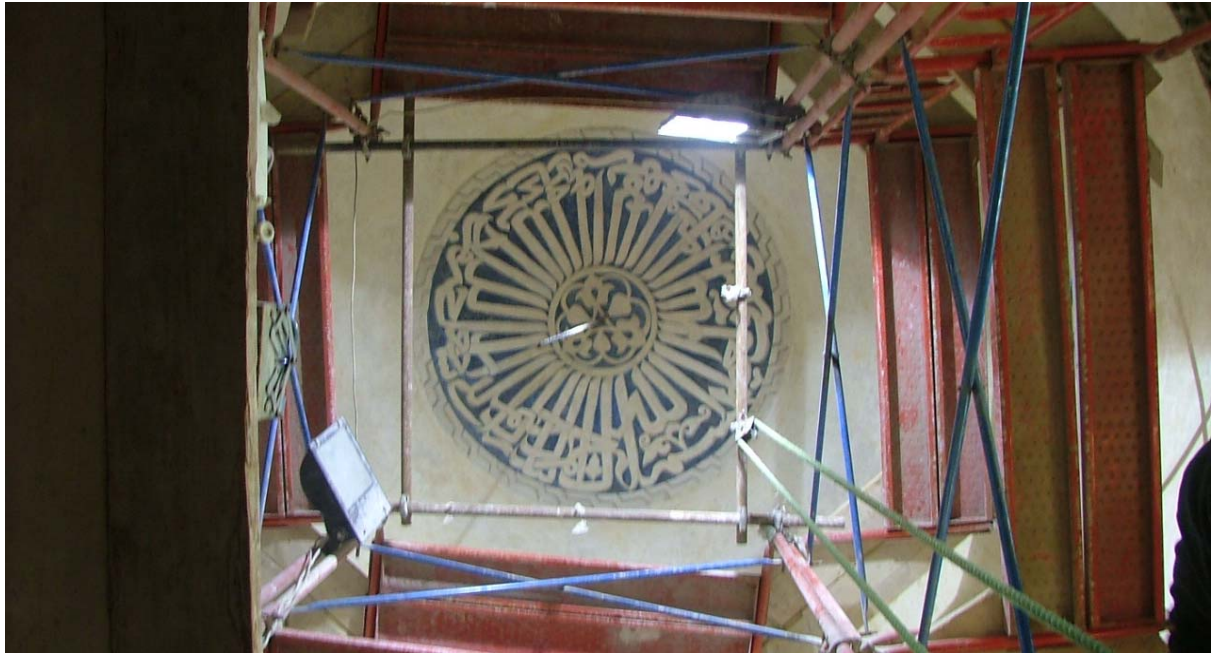
The erection of the scaffolding in the interior of the dome was completed and the fine restoration activities started from the top of the dome. The inscription on the roundel was cleaned and the blue background was fixed where it was flaking and retouched where it was lost. The gypsum plaster was cleaned mechanically removing a recent limewash layer; this was followed by further cleaning of the plaster. The highest level gypsum grills were cleaned from the interior.

*View of the upper roundel after cleaning and retouching the blue background; below: detail of the roundel*

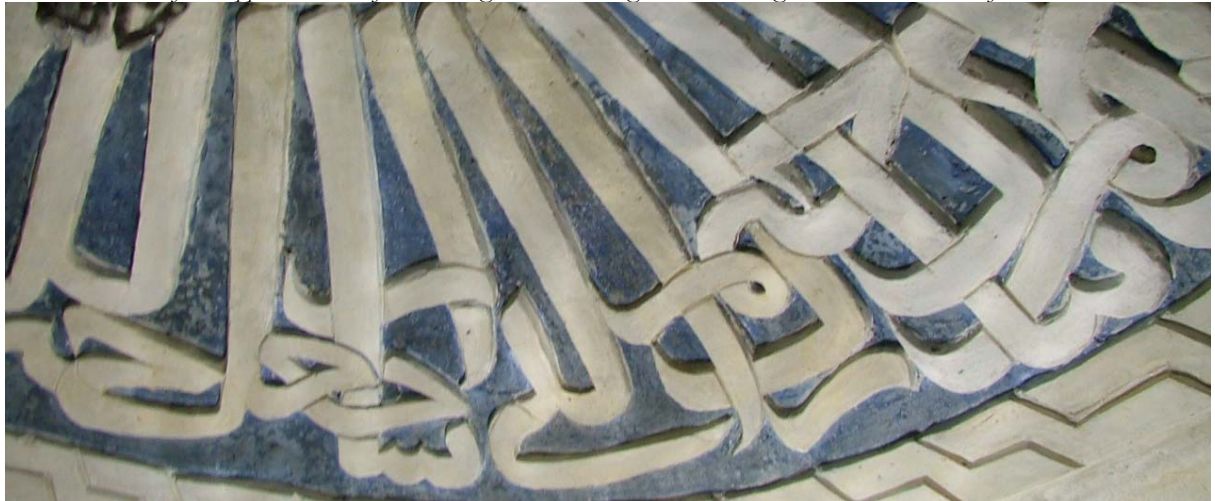
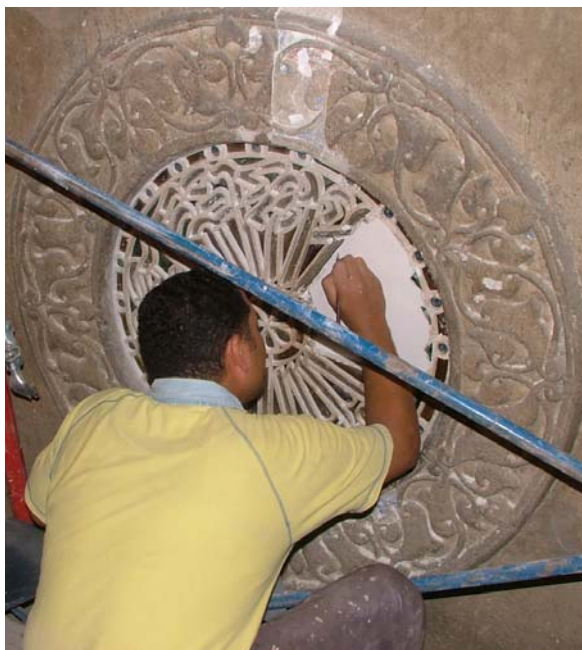
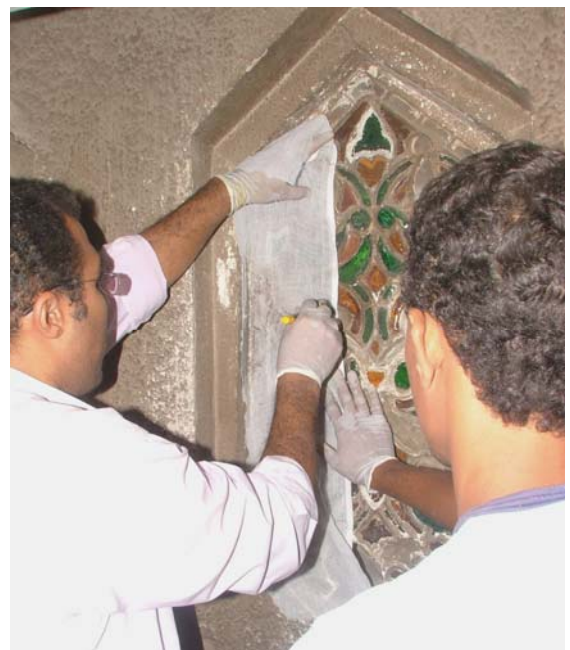
On the lower levels of the mausoleum some gypsum grills and windows were in a very bad condition with numerous missing parts. These are being repaired in-situ. One grill was in a quite bad condition and was dismantled, repaired, cleaned and completed.

*Views of repairing and protecting the gypsum decoration in-situ*

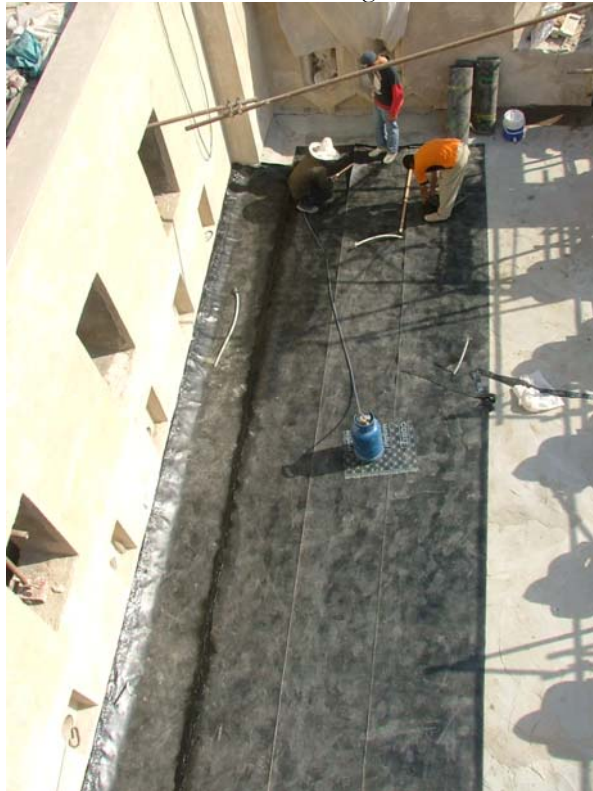
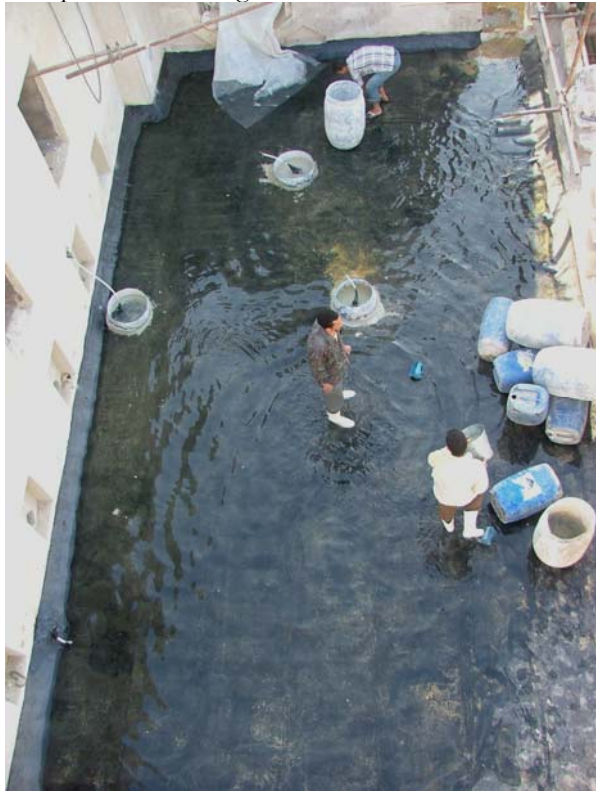
*Insulation activities on the south ceiling and water testing the insulation before applying the upper mortar mix layer*

The southern and eastern ceilings were insulated; this completes all roofing and insulation activities.

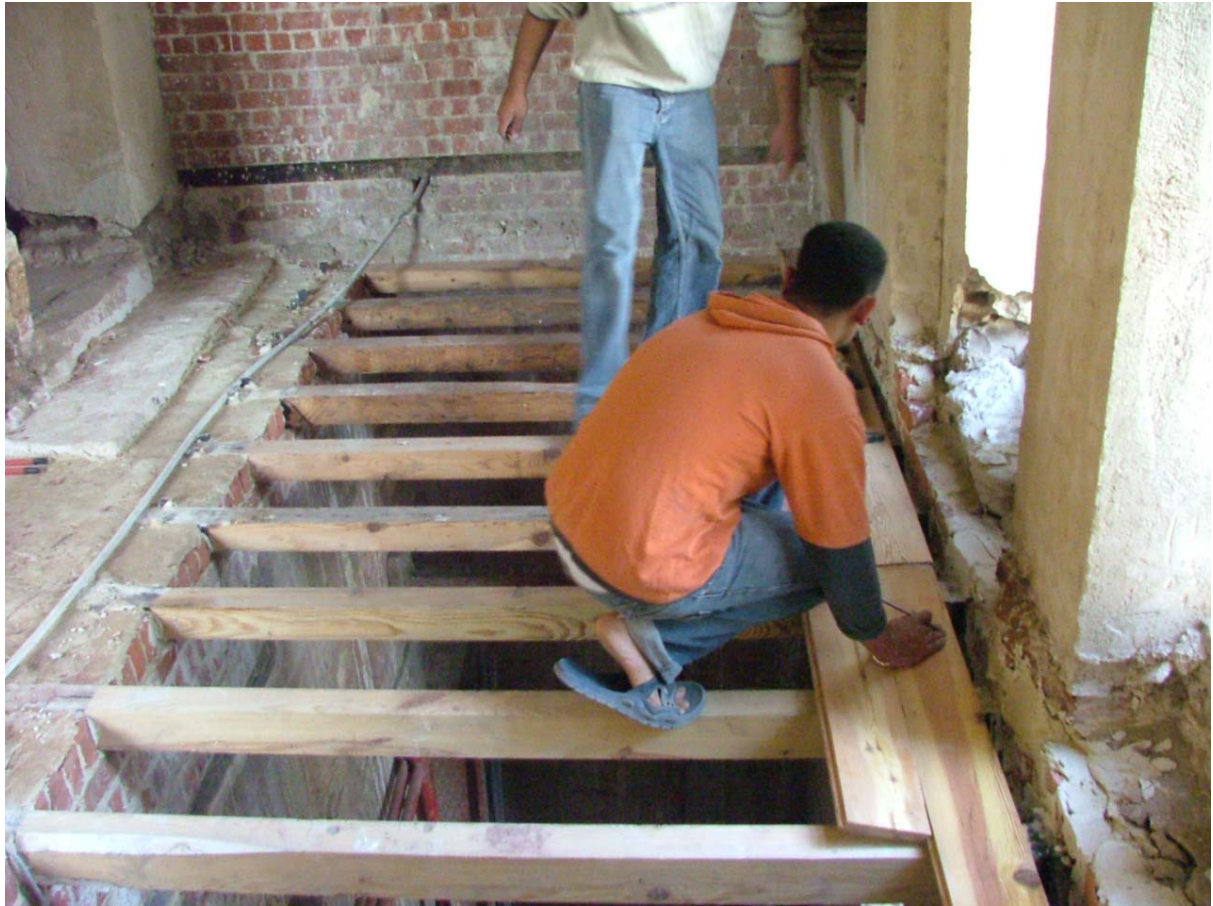
Room M2: the brick repair activities in room M2 was finalized, as well as stitching it to the exterior west wall. The ceiling of the room (also the floor of room 1.3) was in quite a bad condition; the damaged beams and shingles were replaced with new ones.

*Wooden ceiling of room M2 (the floor of room 1.3)*

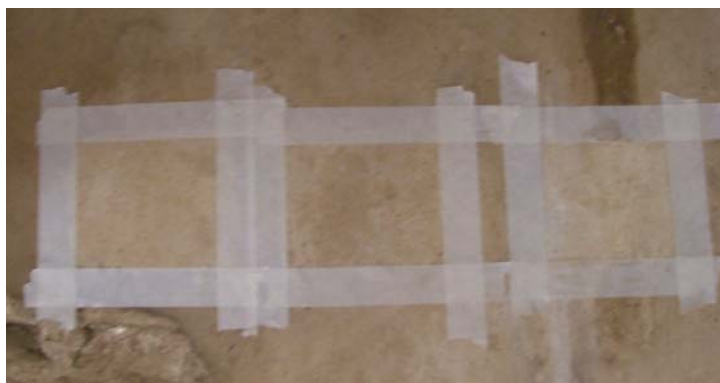
The gypsum plaster was carefully studied and the problems identified. In several areas the plaster is detached from the background brick wall and this needs injection. Also, serious cracks existed and had to be filled. Before the injection activities started, the fine dust covering all the walls was removed with fine brushes. Cleaning tests were also applied to see what kind of method to be applied for cleaning the gypsum. It was decided to use a 2 % ammonium carbonate poultice.

*Samples of cleaning the gypsum mortar with poultice and with mechanical cleaning*

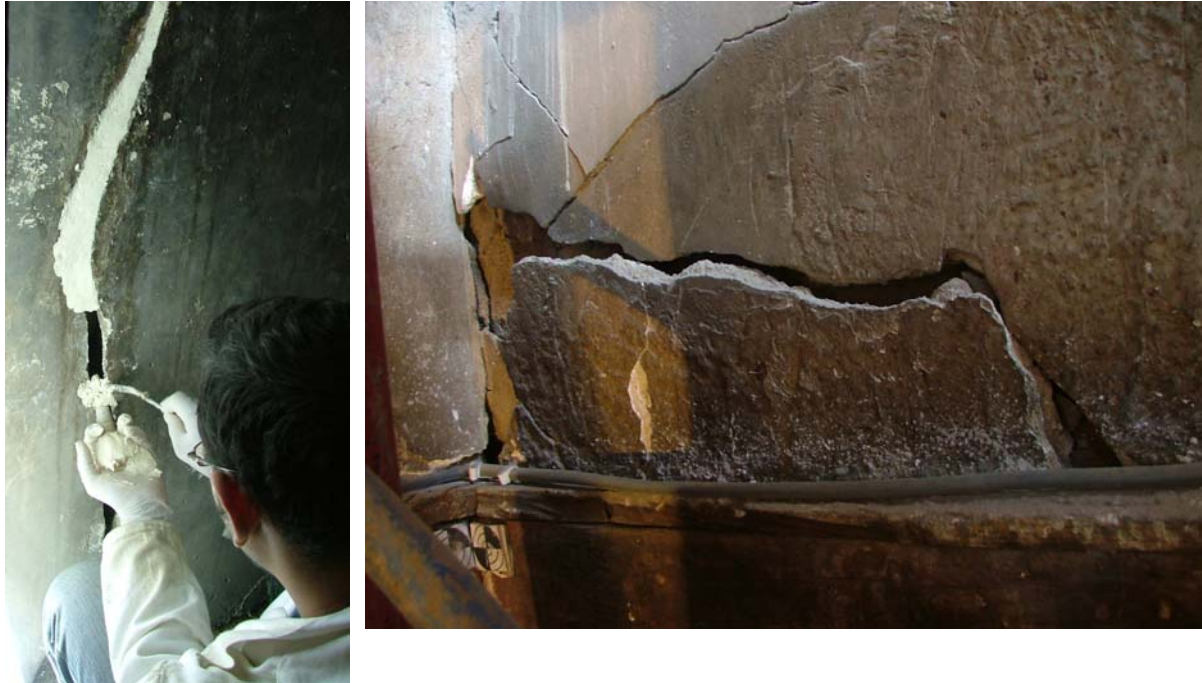
*Example of the condition of the gypsum plaster in the courtyard showing serious cracks and detachment*

Continue the conservation and restoration work of the gypsum plaster in the mosque courtyard and iwans.

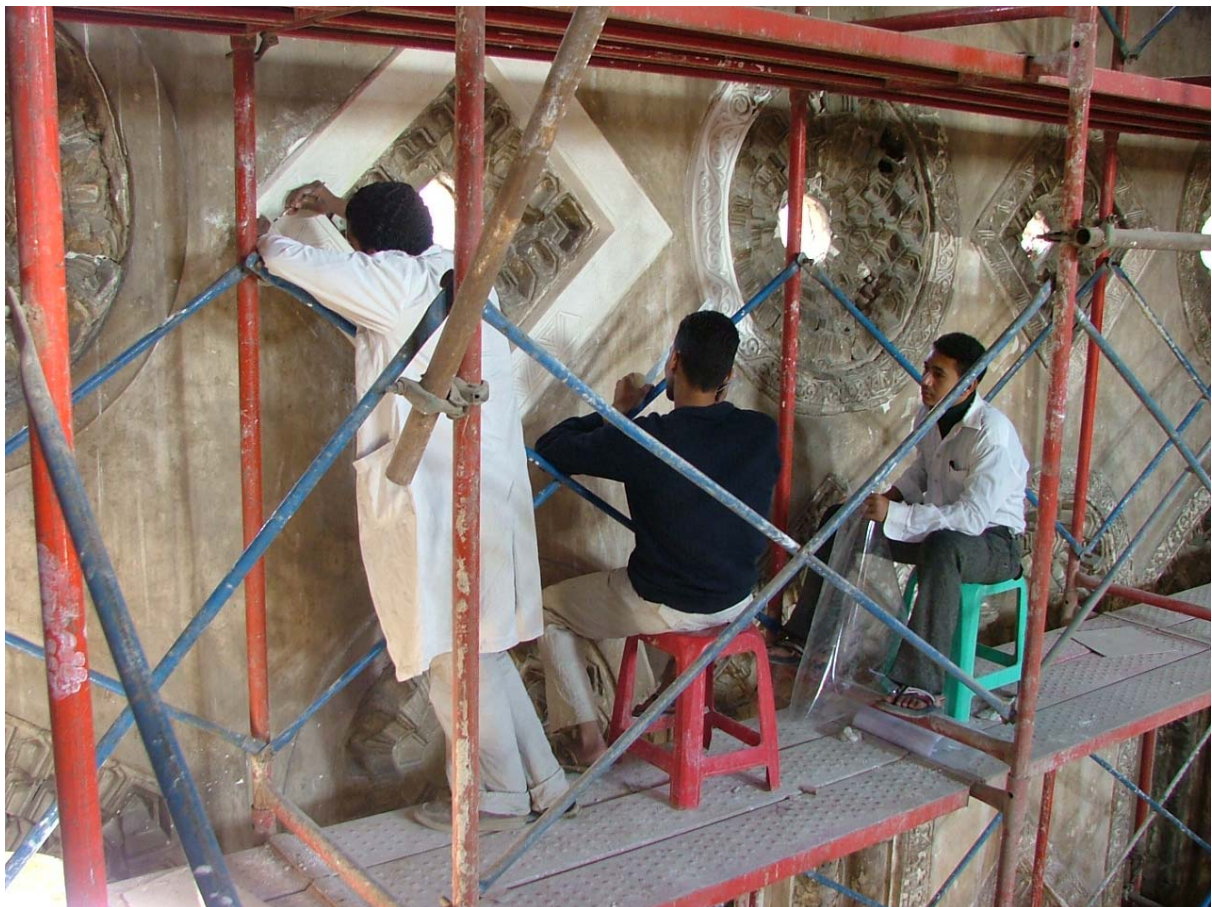
Some of the decorated roundels and lozenges in the courtyard has lost part of its decoration and were re-plastered plainly with no decoration in an earlier restoration intervention. Samples of completing these decorations were carried out.

*Activities of completing the gypsum decoration of the roundels and lozenges in the courtyard*

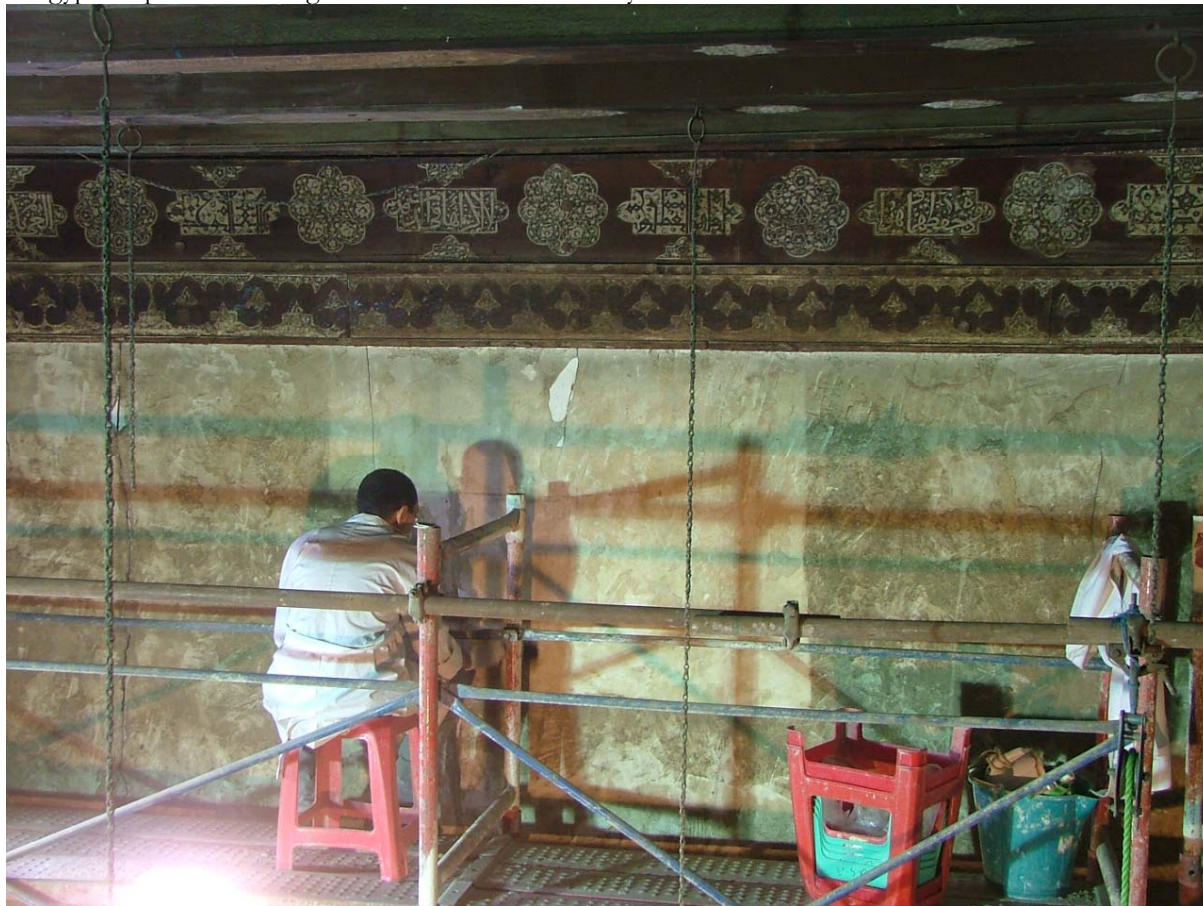
*Activities of removing the fine dust from the walls (middle part cleaned; left and right still with fine dust)*

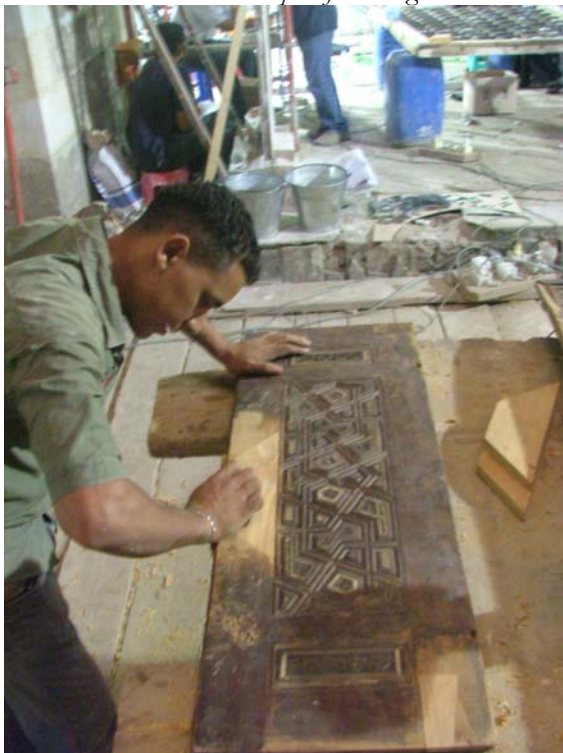
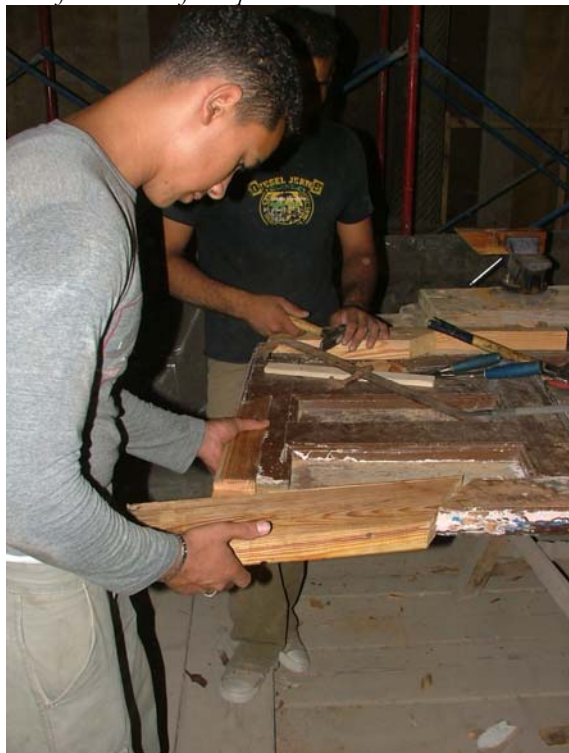
*Architectural repair of damaged parts in the wooden shutters*
