CONSERVATION PROJECT OF THE
ASLAM AL-SILAH DAR MOSQUE

QUARTERLY PROGRESS REPORT

April – June 2008

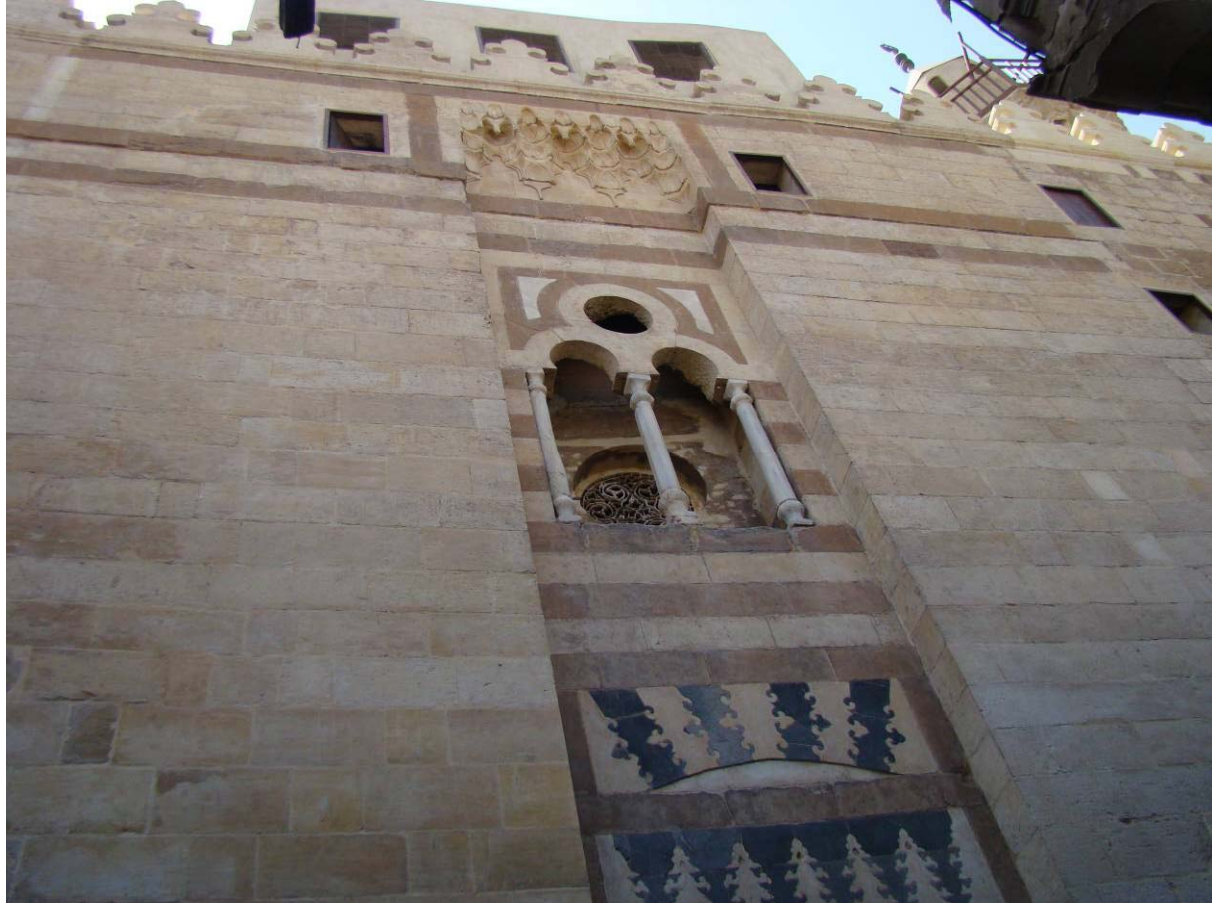
*The west façade after conservation & the removal of the scaffolding
Note: no gypsum nor wire-mesh grilles were placed in the openings yet.*

The dismantling of the scaffolding on the western façade took place. Only the part at the marble side-entrance portal was kept for finishing activities.

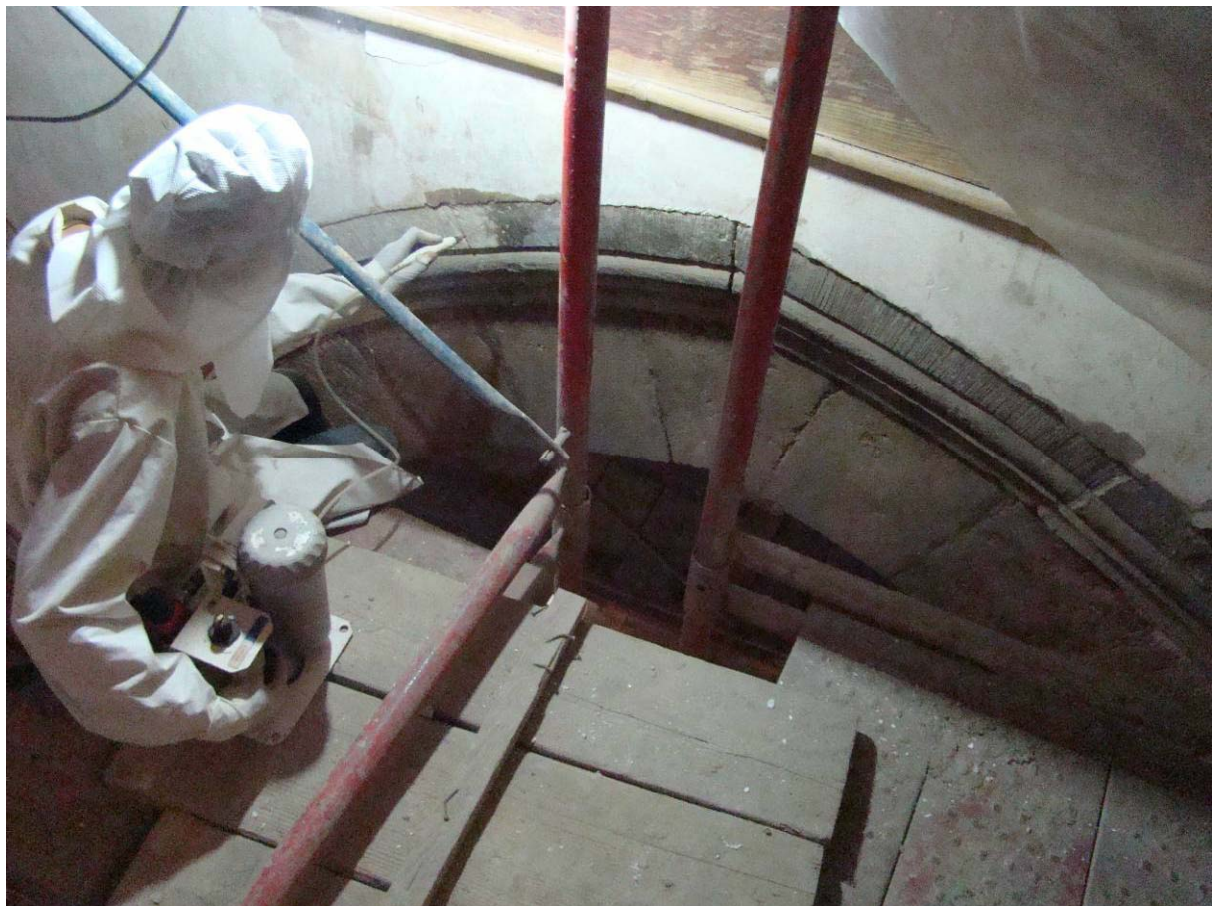
Cleaning the arcades using the micro-sandblaster

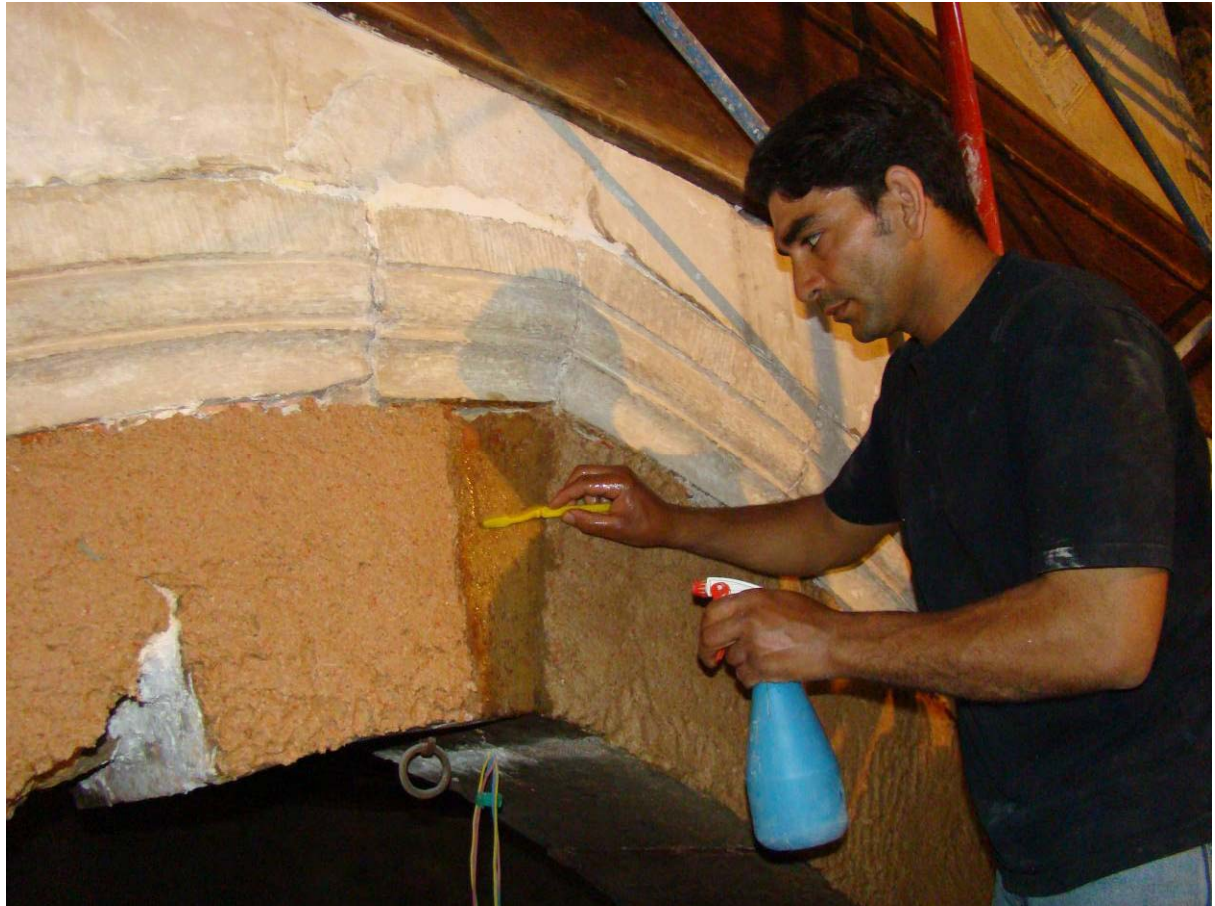
Cleaning the stone arch using poulticing

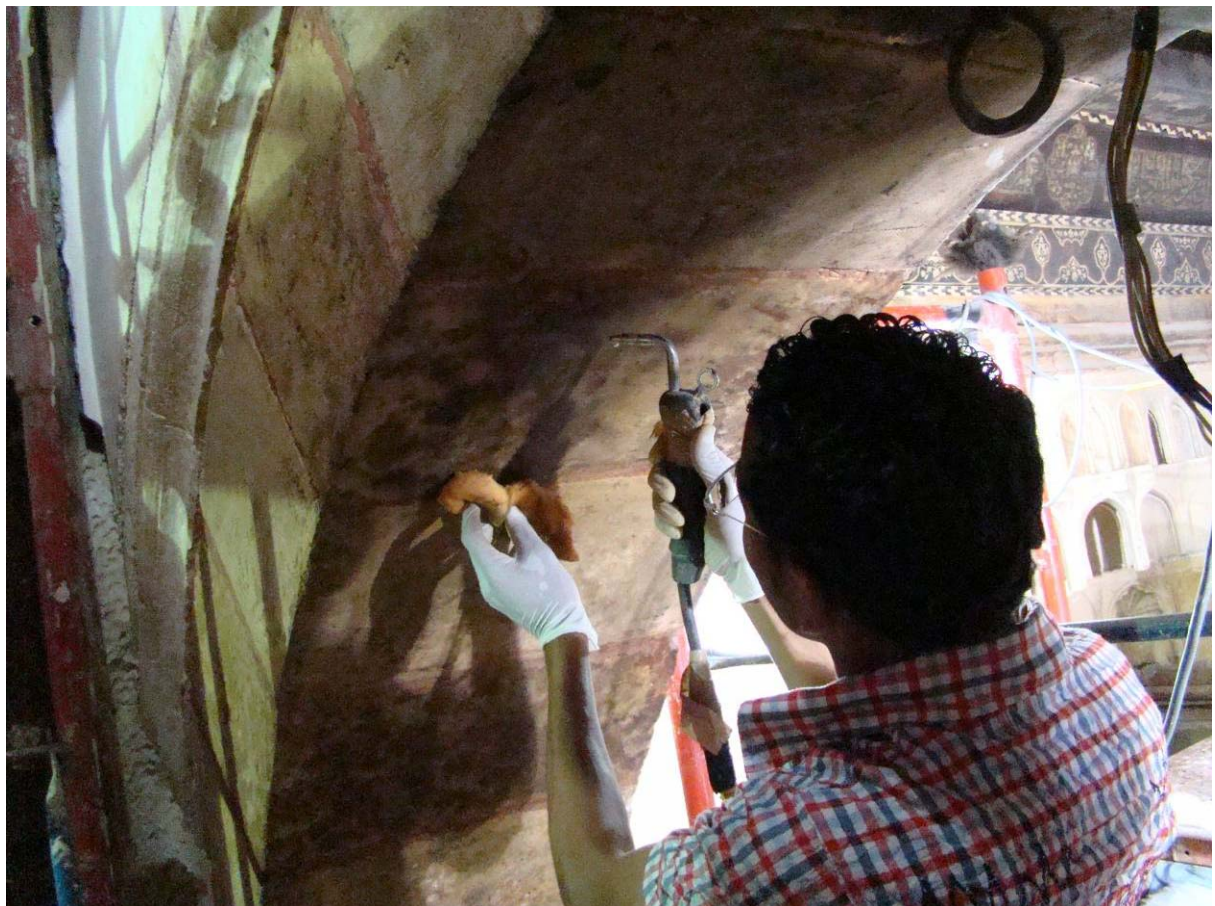
Cleaning the stones using the micro-steamer

The stone arch of the eastern façade: the red stones were cleaned using the micro-steamer; the white stones of the arch will be then cleaned with the micro-sandblaster.

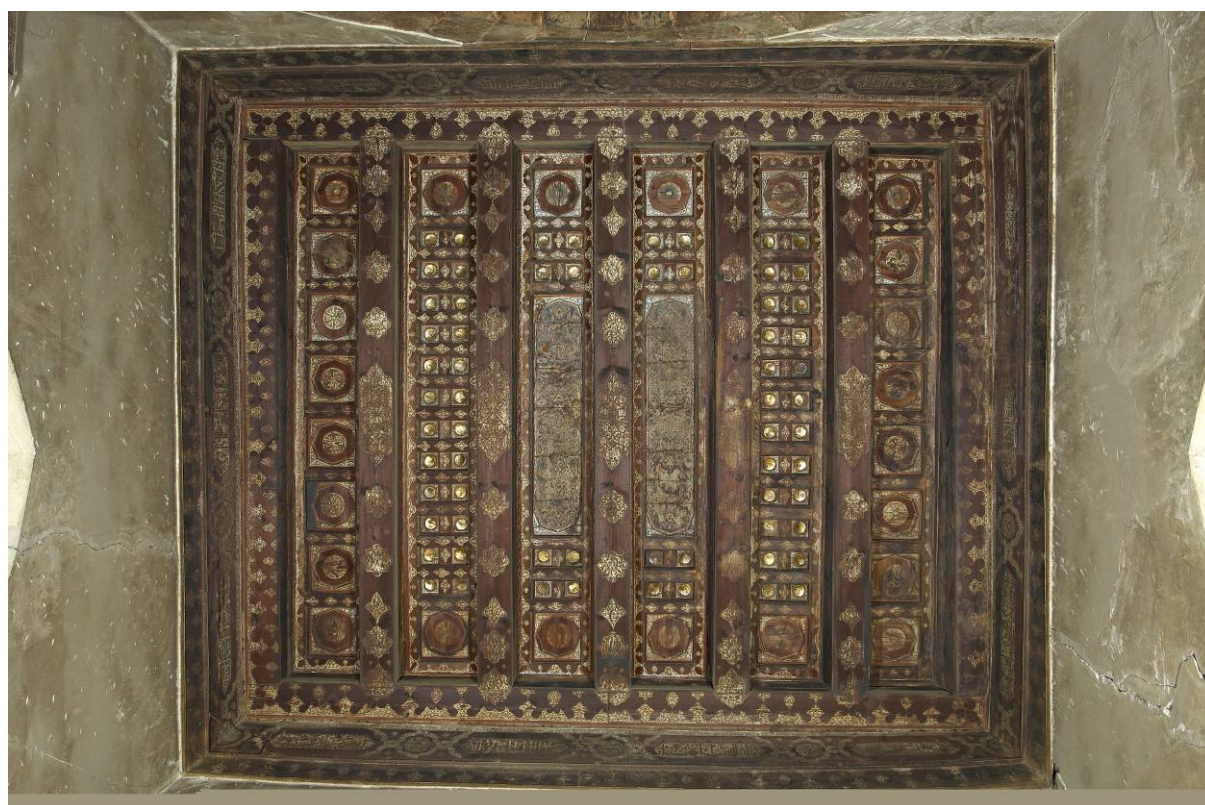
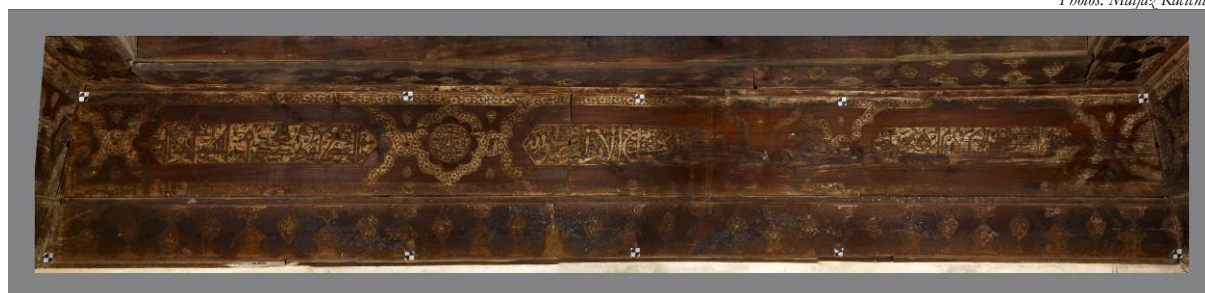
What is very valuable in this ceiling is that it was not restored earlier or at least recently (see picture below-before the intervention), as was the case in the other iwans (this will be discussed below). This ceiling had several layers of dust and spiders hanging from it and some areas were darkened. It was decided to carry out a minimum intervention on that ceiling and to preserve its original state and the fact that it was not restored earlier. A first phase of removing the dust using soft brushes was carried out in a very careful manner in order not to lose any flaking paint. The flaking parts were fixed using Paraloid (less than 2 %). After all the fixation was finalized a second phase of dust removal was carried out. The ceiling was then cleaned using the wishab; after applying some cleaning tests on the darkened areas, it was noted that the ceiling is losing its spirit of age and that the intervention is not necessary; therefore it was decided to limit the cleaning intervention to the use of the wishab. The gaps between the wooden beams and the shingles were filled using the balsa wood and these pieces were retouched using brown color to give visually a complete and non-disturbing view. Otherwise, no retouching of any missing decoration was carried out in order to preserve the fact that this ceiling was never restored or repainted earlier as in other ceilings in the mosque.

Up: The ceiling of the west iwan before intervention; below: compiled photo of inscription band

In brief the main measure taken in these ceiling was to prevent the flaking from continuing to take place and to fill the gaps where possible nesting and damage could take place.

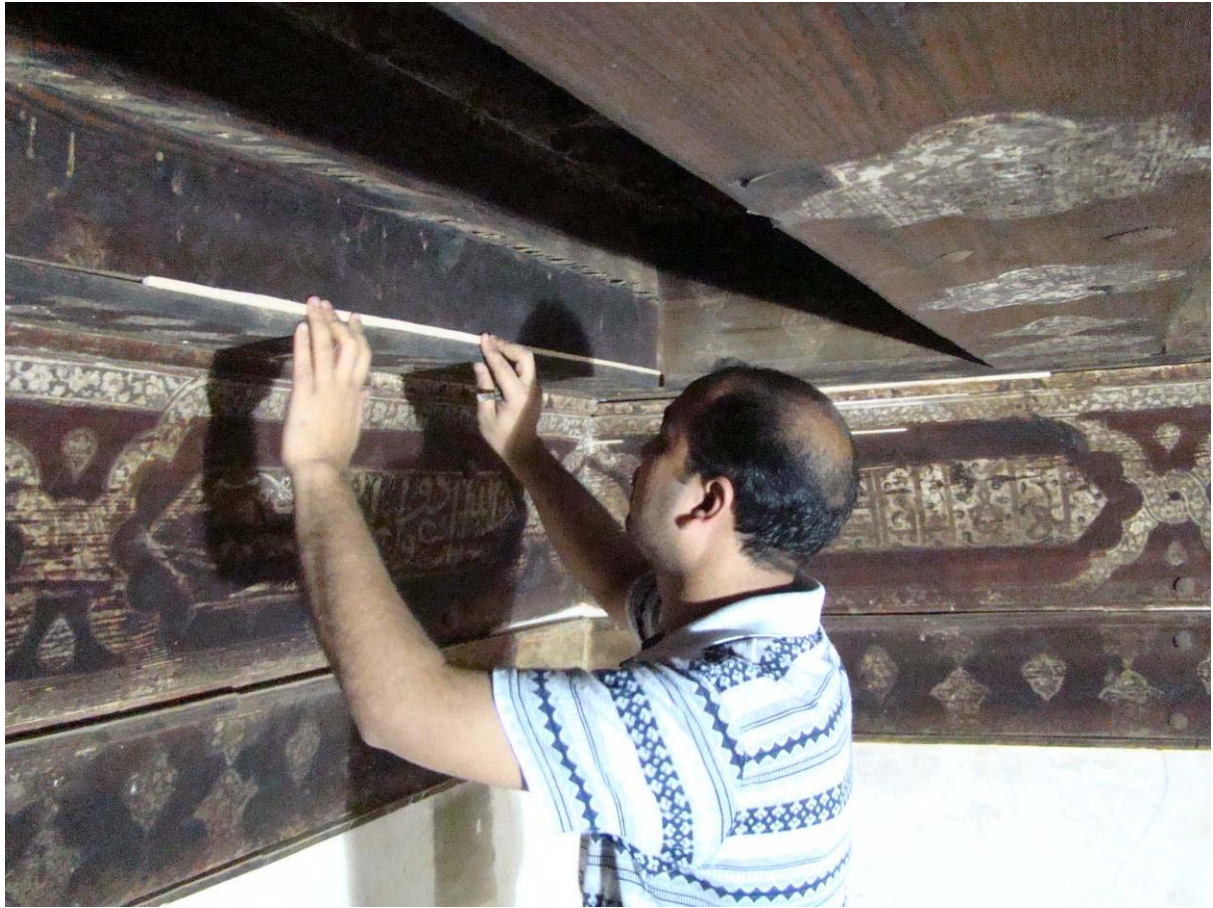
Inserting the balsa wood in the gaps and painting it

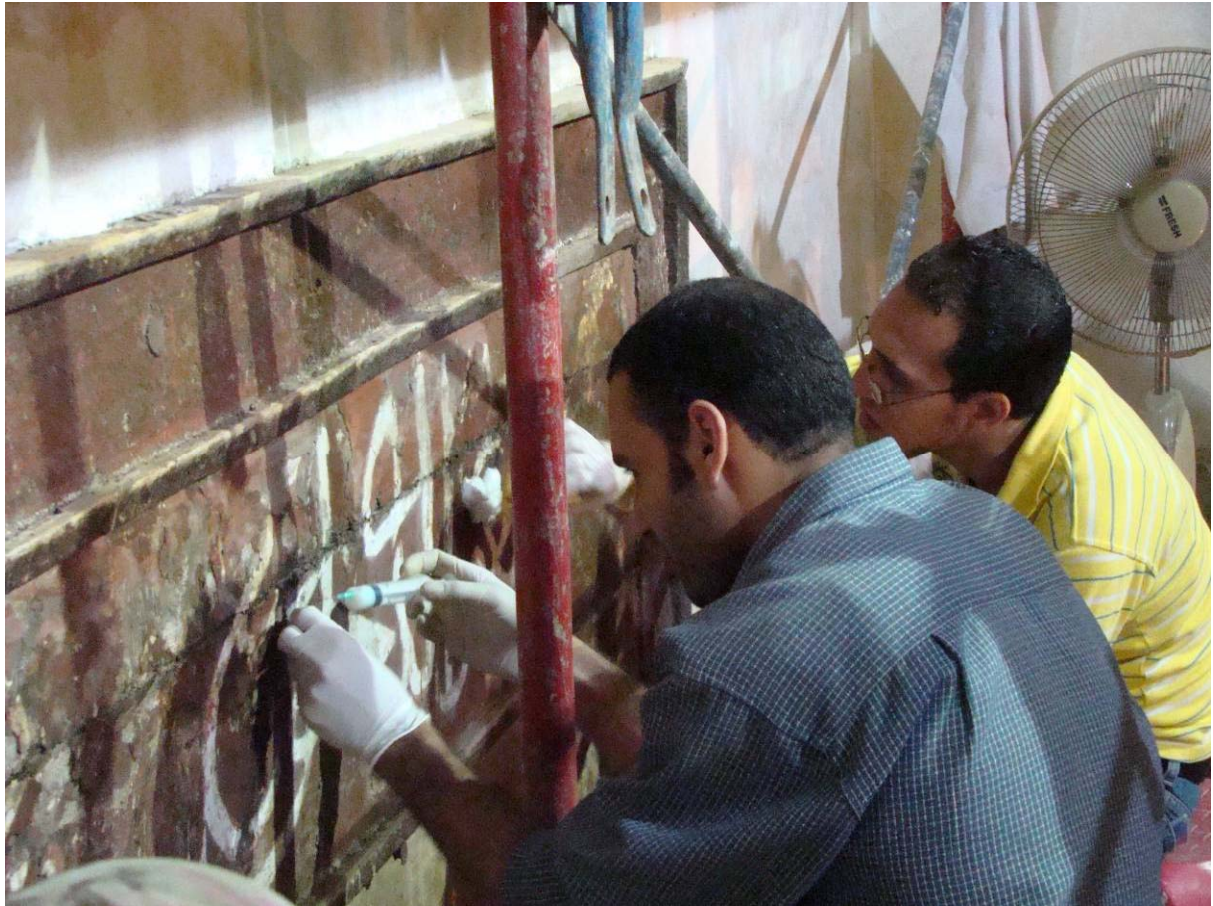
Activities of injecting the flaking parts of the inscription band

The work started by removing the accumulated dust and nests. What was then very important was to fix flaking parts of the painting especially on the sides with the inscription band; this activity is currently proceeding. This will be followed by cleaning activities using the wish-ab and filling the cracks with balsa wood (as was carried out in the western iwan).

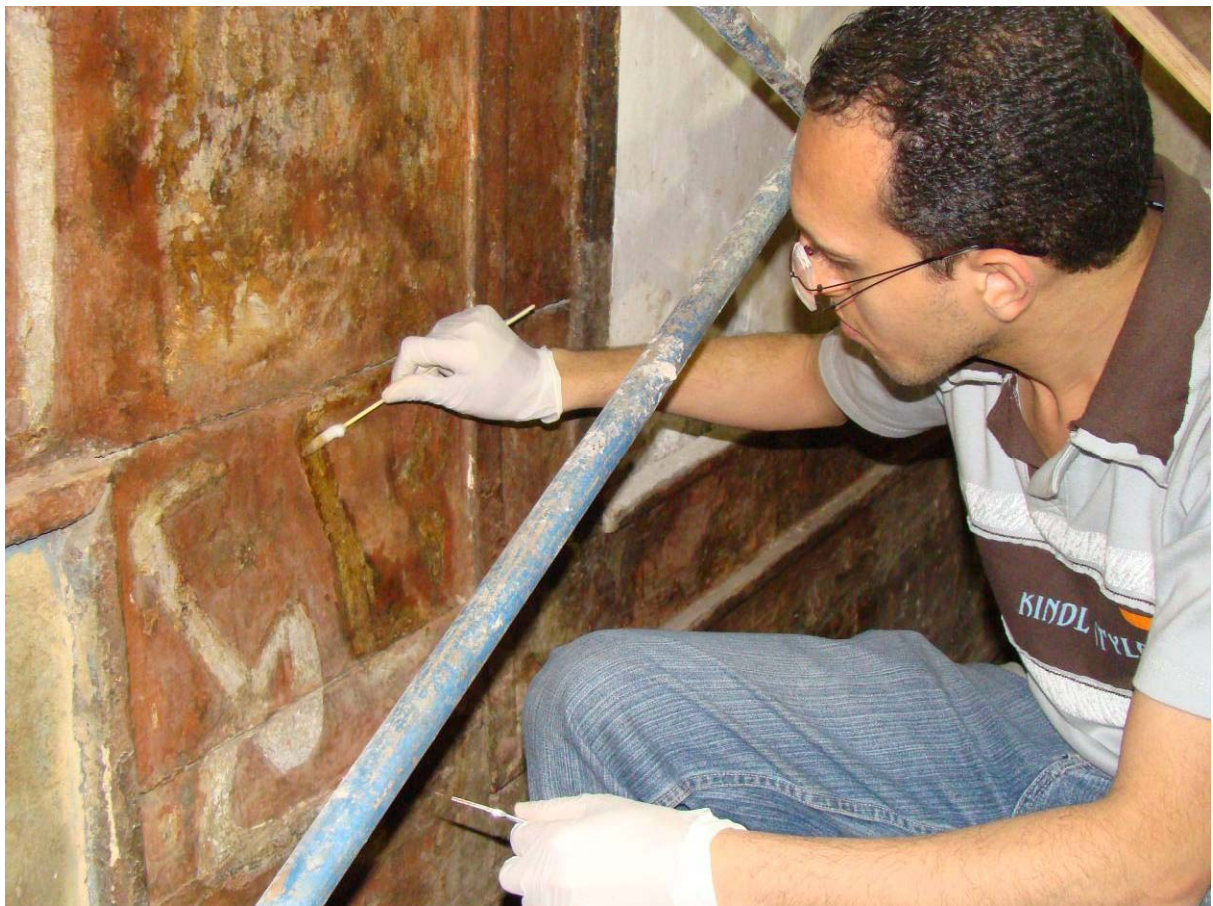
Cleaning the wooden inscription band

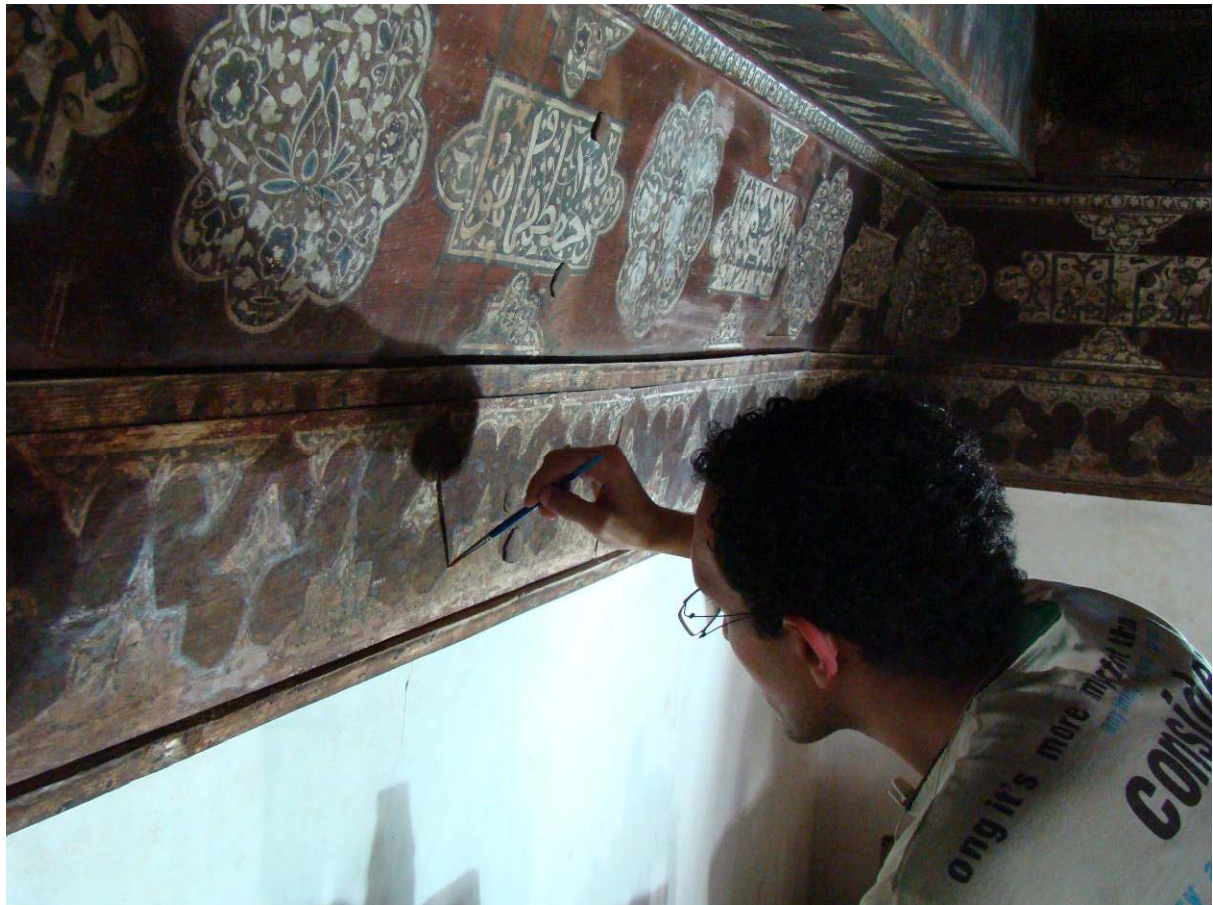
Fixing the edges of the flaking painting

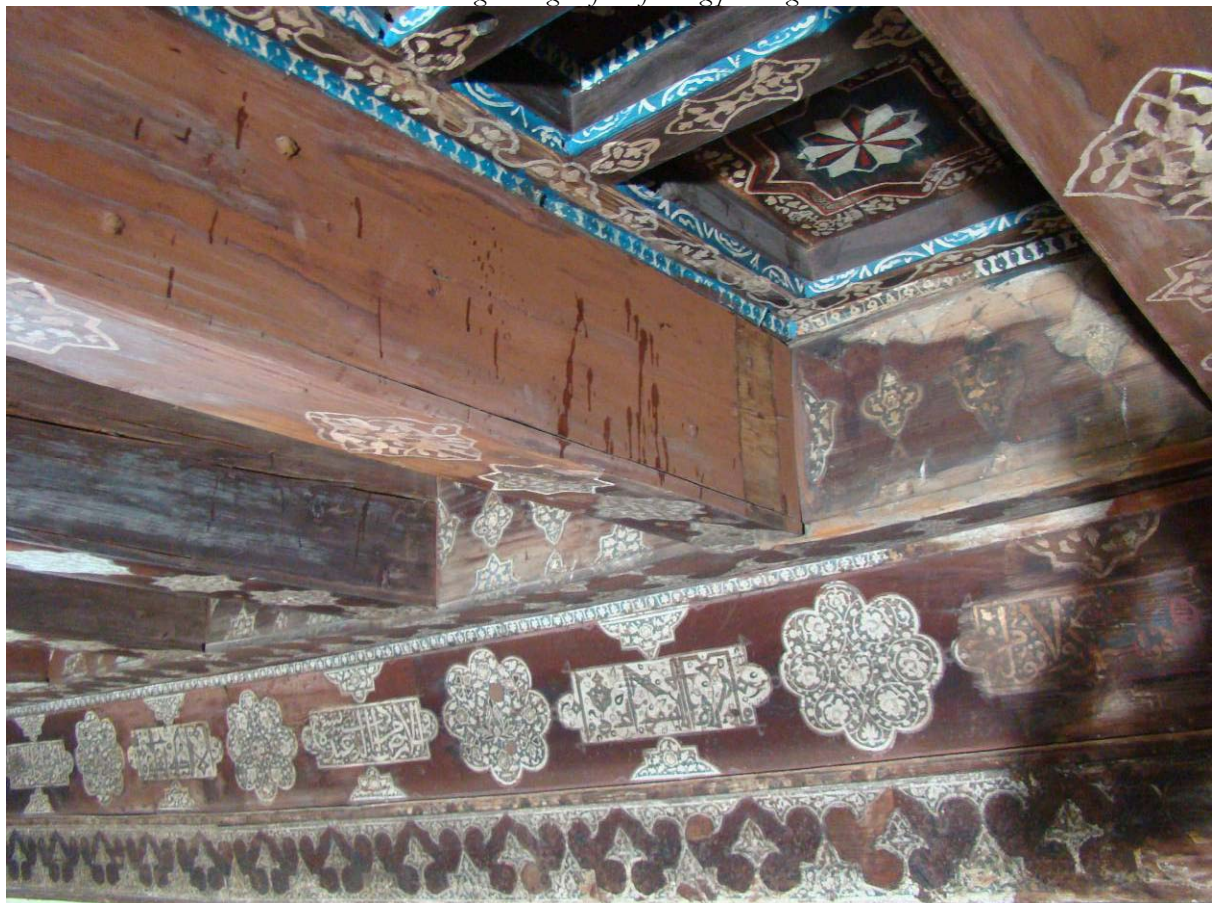
A platform was erected to start activities of cleaning and conservation of the wooden ceiling of the qibla iwan. According to the visual inspection as well as inscriptions painted on the ceiling, the paintings were “restored” in 1996. Actually, the “restoration” that took place is repainting the wooden beams but the work was carried out with a very bad workmanship; several paints leaked on the sides of the wooden beams, too. What is worth mentioning though is that the side parts of the ceiling bearing inscriptions are in a relatively very good condition and were not repainted.

View showing the good inscription of the inscription band and while the recent painting intervention of the beams is done with quite a bad workmanship

Several discussions took place concerning the intervention to take place in the wooden beams of the ceiling; to remove the 1996 paint might result in a complete plain ceiling with no decoration and a consequent shock to the users and visitors of the mosque. Therefore, there is an inclination towards keeping this earlier intervention while carrying out tests to understand if earlier paint layers still remain or not. The sides of the beams painted with a strong red-brown color could be removed along with the leaking paint.

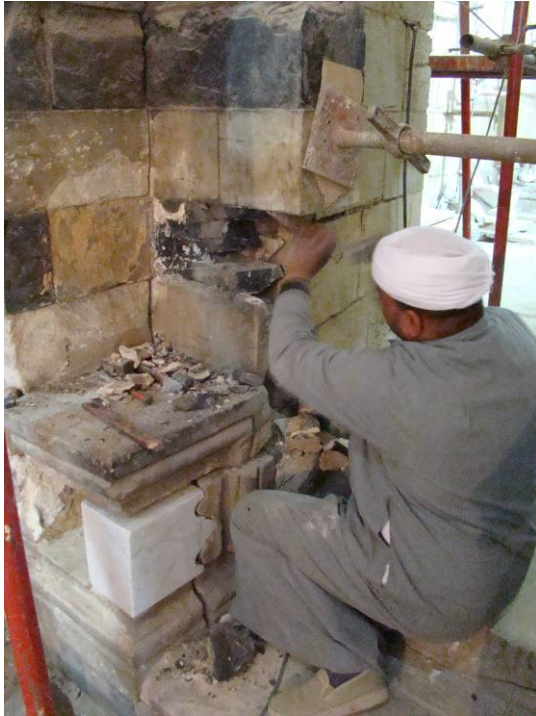
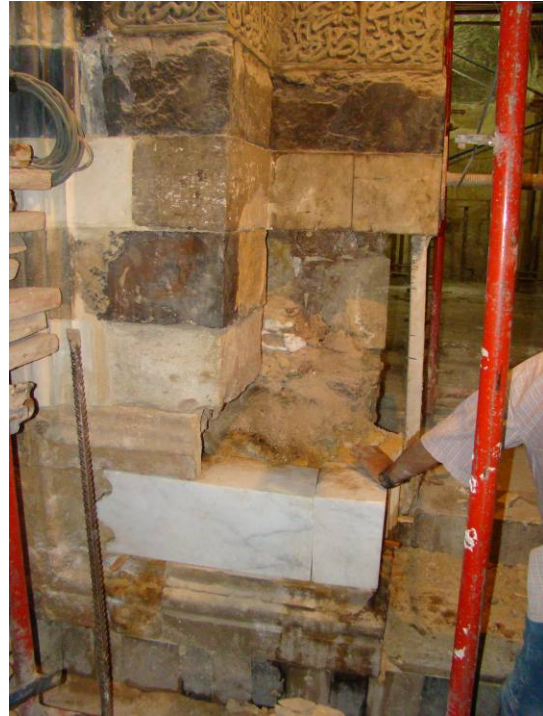
Stone replacement activities of completely damaged marble pieces at the mausoleum entrance

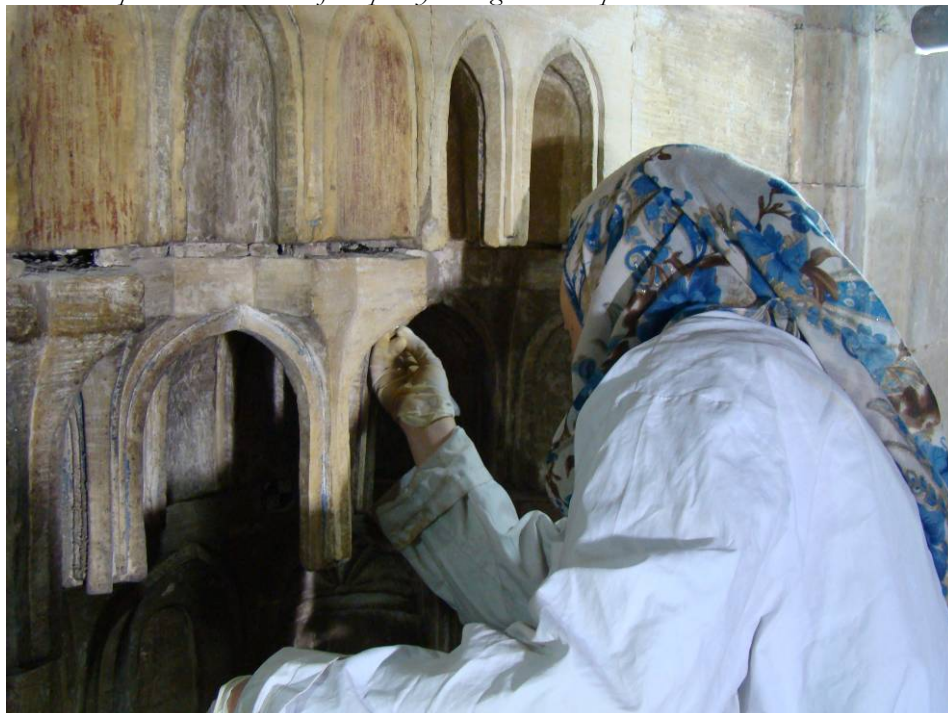
Cleaning the muqarnas of the mausoleum portal

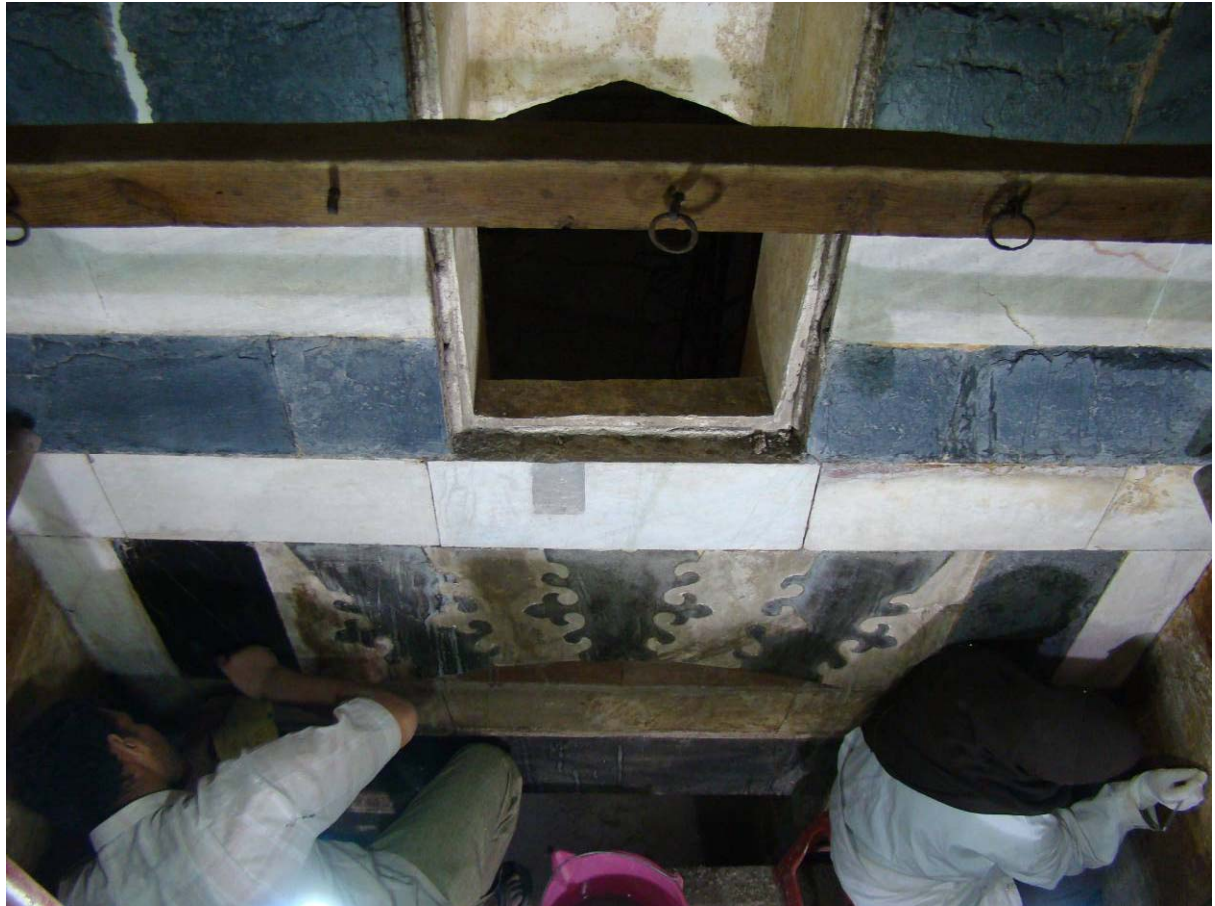
Activities of marble cleaning of the mausoleum entrance

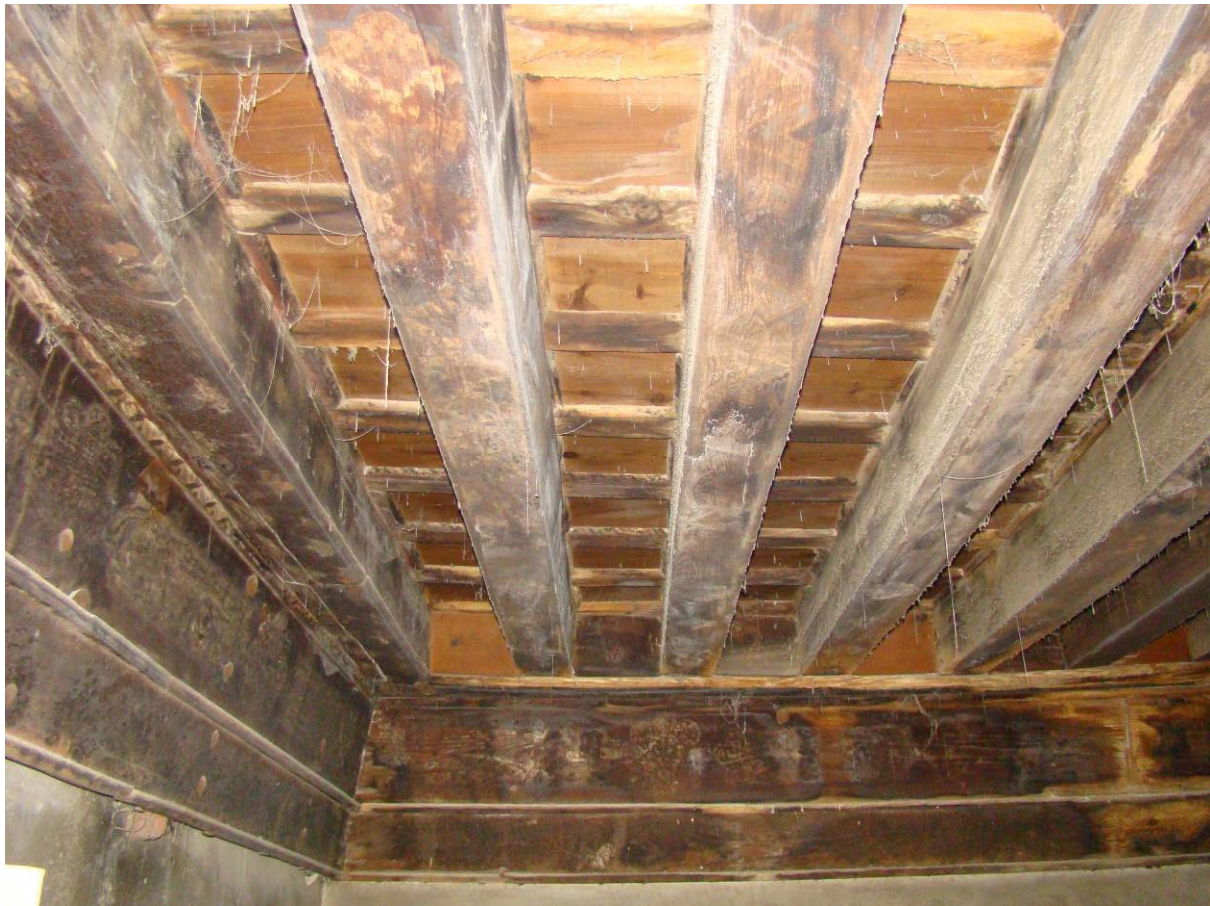
The north iwan was used by the project for a period as a storage. The storage was moved to the west iwan in order to start the restoration activities. The scaffolding was erected and activities started also by removing the dust on the ceiling and from behind the wooden shingles. Unlike the other three iwans, the ceiling of the north iwan is in quite a bad condition and was not restored earlier.

The condition of the ceiling of the north iwan

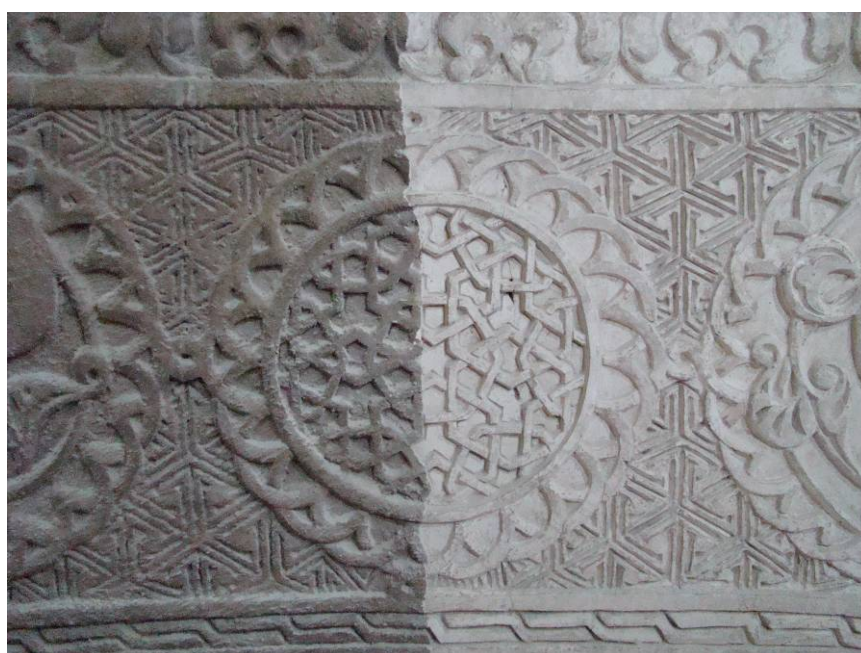
Detail of a the decorative roundel element before and after cleaning

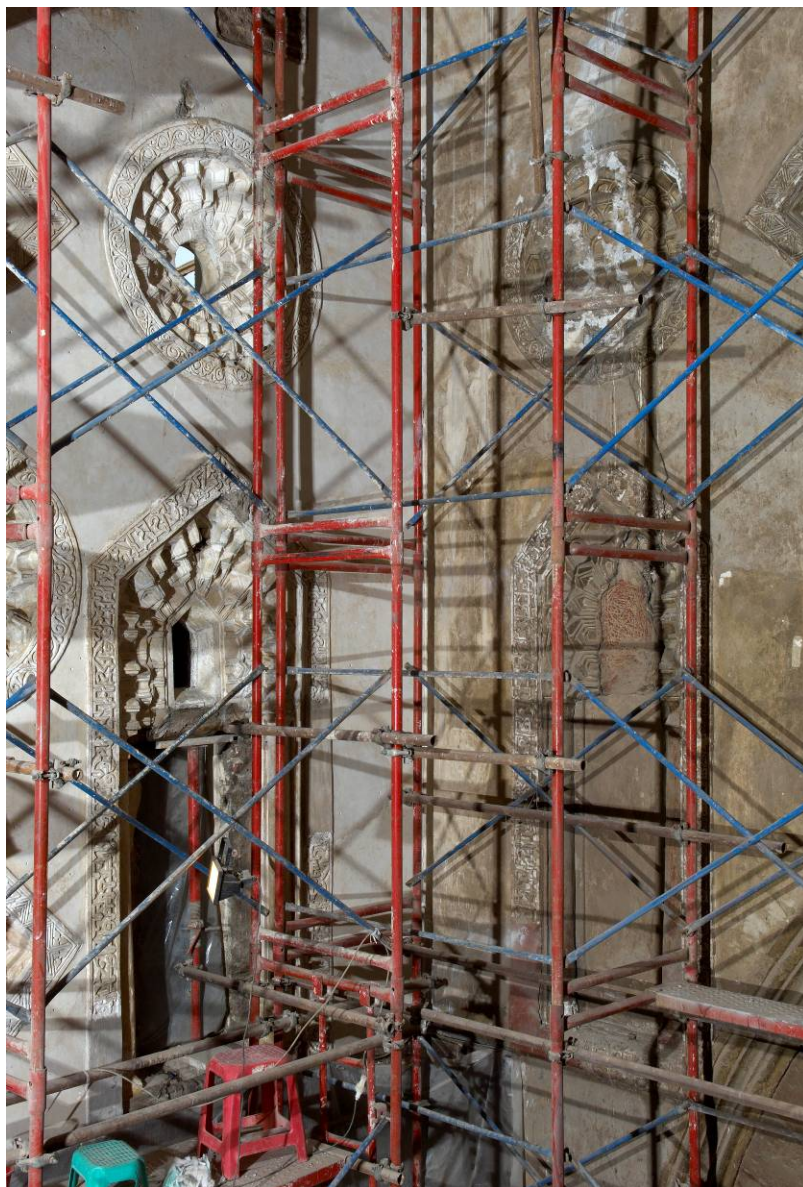
View showing part of the courtyard walls (left after cleaning; right before cleaning)
