CONSERVATION PROJECT OF THE ASLAM AL-SILAHDAR MOSQUE

**QUARTERLY PROGRESS REPORT**

July - September 2008

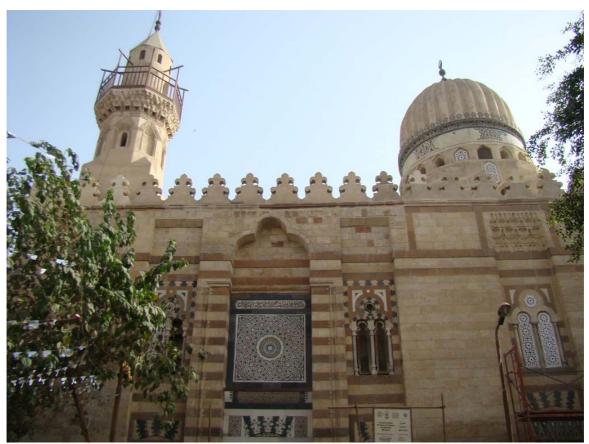
View of the main façade after removing the scaffolding and with sample of the gypsum windows

The scaffolding of the eastern (main) façade was dismantled; samples of the metal-mesh windows and the gypsum grills are placed for the Supreme Council of Antiquities to review and reevaluate their refusal of erecting gypsum windows on the façades.

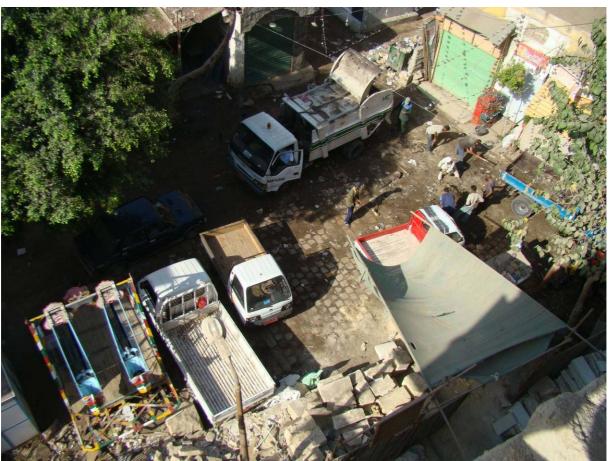
As for the square, the public spaces team of the Aga Khan Cultural Services – Egypt (al-Darb al-Ahmar Company) is proceeding with working on the square in terms of removing the asphalt and other layers. The design of the square is finalized and it is planned to finish the urban treatment activities of the square in parallel with the finishing of the work in the mosque.

Activities of clearing the square

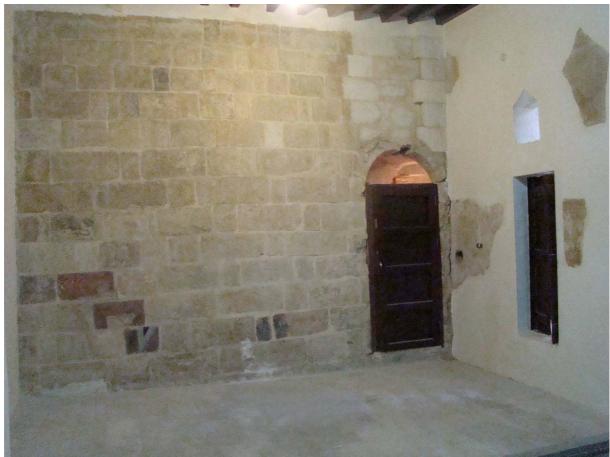
Room 1.1 after the plastering (still to be slightly retouched) and installing the doors and windows;

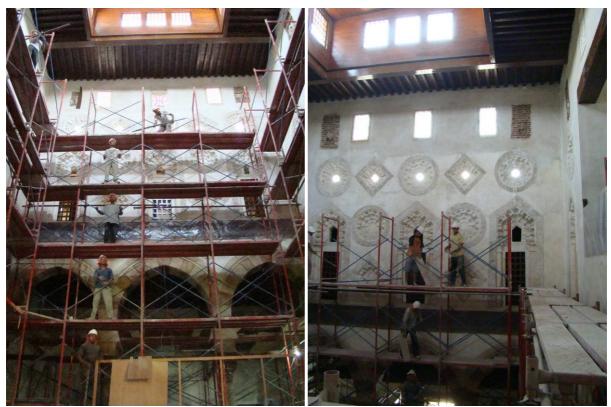
All cleaning and protection activities of the stucco decoration of the courtyard were finalized and the scaffolding removed.

Removing the scaffolding of the mosque courtyard

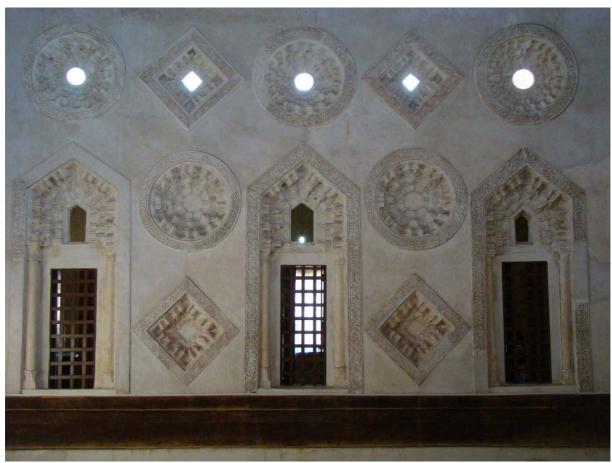
The interior courtyard after dismantling the scaffolding; View showing the façades cleaned; the stucco decoration completed and the windows installed

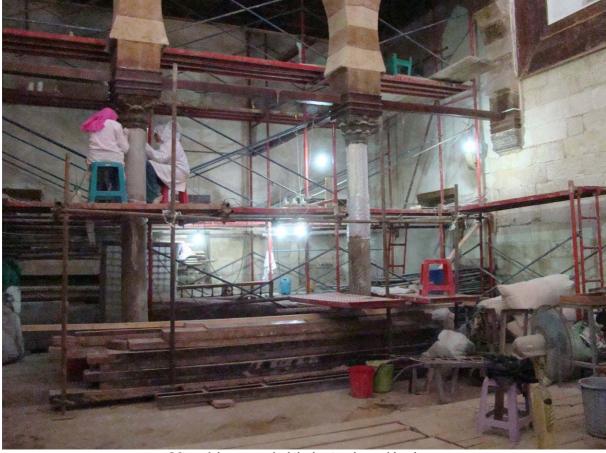
The reused marble columns were also cleaned; currently work wills start on cleaning the column capitals. On the 4 façades, the "windows" in the plaster left by the *Comité* were just cleaned and repointed when necessary and left as they were found. These are a testimony on what the *Comité* found for the earlier structure covering the courtyard.

V iew of the courtyard while cleaning the marble columns

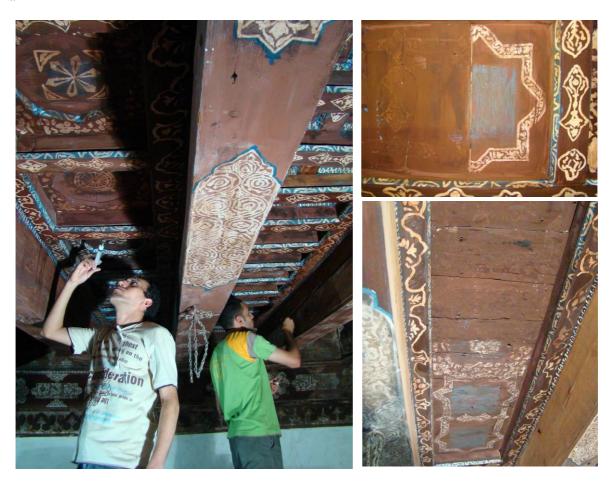
Work was proceeding in cleaning the ceiling. As carried out on the western iwan, a first phase of removing the dust using soft brushes was carried out in a very careful manner in order not to lose any flaking paint. The flaking parts were fixed using Paraloid (less than 2 %). After all the fixation was finalized a second phase of dust removal was carried out. The ceiling was then cleaned using the wishab and the gaps filled with the balsa wood.

Tests were carried out in the areas where the shingles were covered with a brown paint; decorated paintings were discovered underneath; a lot of discussions took place concerning removing the brown paint. By comparing this ceiling with the one on the western iwan, it was noted that all spaces with shingles between the beams are decorated and none of them is simply painted with brown. Therefore it was decided to remove the brown paint and retrieve the painting underneath (even if they are the modern ones that were carried in other parts of this ceiling). Of course, tests were carried out to ensure that no older paints existed below those ones, but none was found.

Activities of protecting the flaking parts of the qibla ceiling; right: sample of removing the brown paint

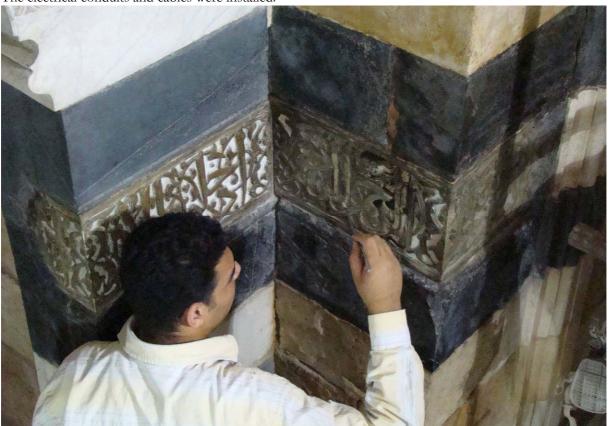
3. South iwan:
The cleaning and repointing activities of the portal of the mausoleum were finalized. Work is proceeding in the ceiling in the same manner as in the other ceilings in the mosque.

Cleaning the marble inscription band of the entrance to the mausoleum and detail (below)

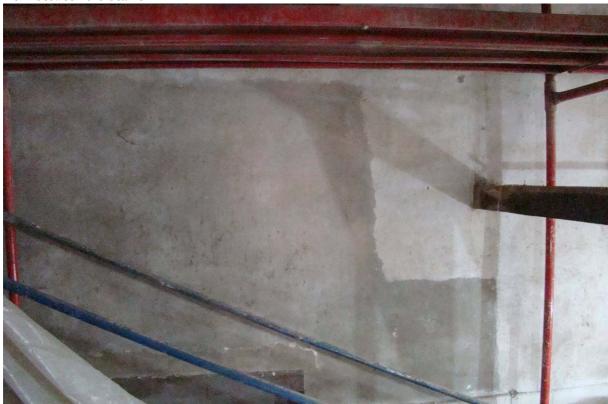
Work proceeded on cleaning the plaster walls and the stones and carrying out repointing. As mentioned in the previous report, a team of trainees were carrying out these activities under the supervision of a senior conservator.

The walls of the north iwan showing parts before and after cleaning

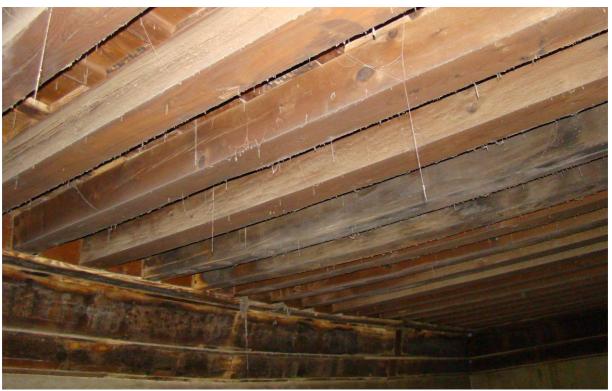
Primary activities of cleaning the ceiling took place removing a great amount of accumulated the dust from between the beams.

The ceiling of the north iwan before cleaning

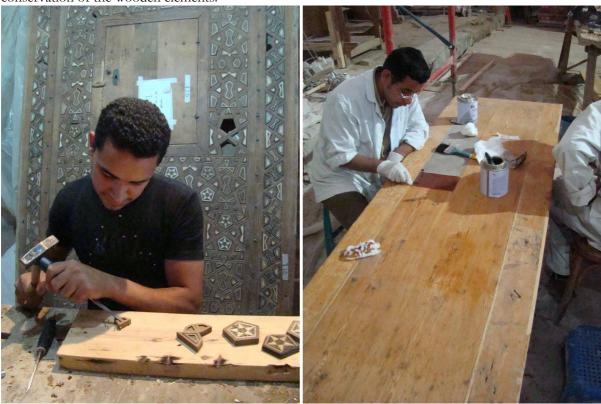
As mentioned in the previous reports, the woodwork restoration of doors, windows and shutters is currently in progress and will be proceeding during the following months. In general, depending on the state of conservation of the item, carpentry restoration takes place followed by fine cleaning and conservation of the wooden elements.

Activities of woodwork repair and cleaning

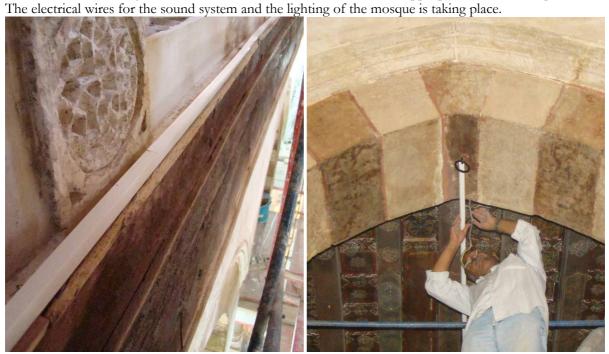
Placing the cable trays for the electrical wires and the electrical wires

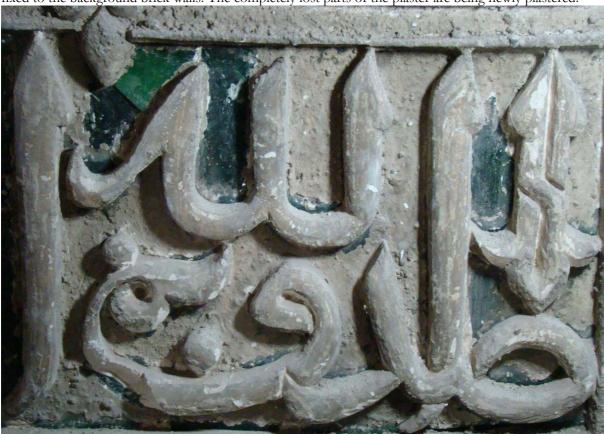
The cleaning of the upper inscription band was finalized.

Detail of an inscription in the dome's grills

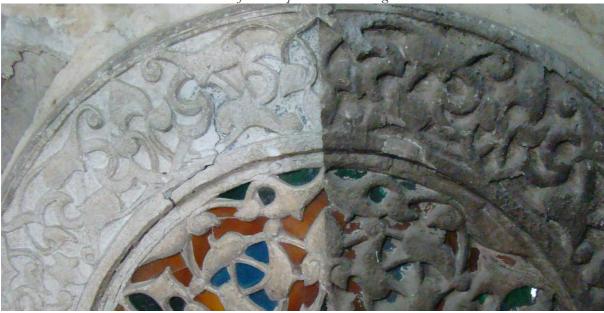
Detail of a roundel in the dome showing before and after cleaning

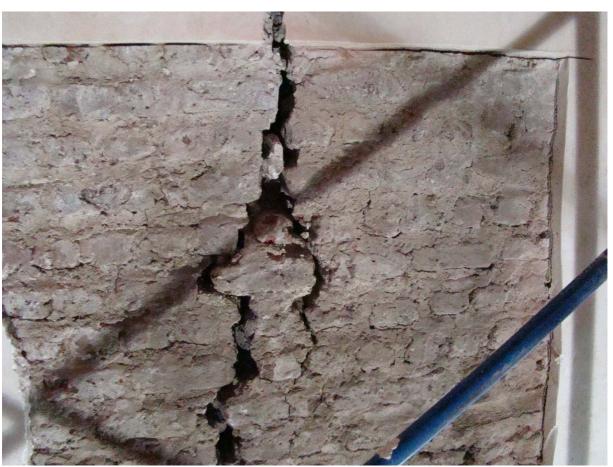
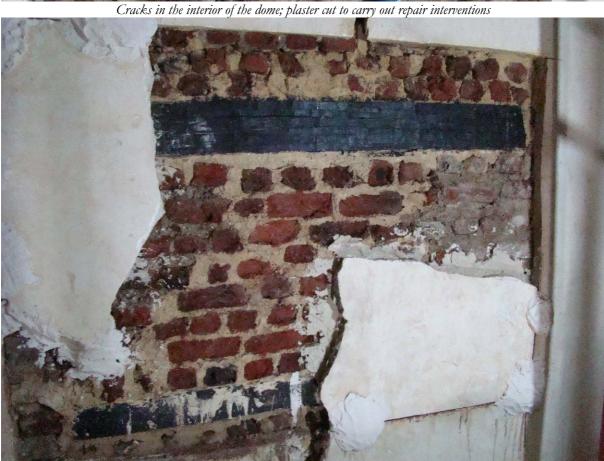
The major activity that took place during this period was the fixation of the plaster layers and the working on the cracks. In the dome several major structural cracks existed and the plaster layers were detached from the walls. A long study took place concerning what to do with the heavy plaster. Although this plaster is not historic, it was decided to protect it and keep it. But in order to fix the cracks in the bricks and also the damaged bricks, the detached plaster was cut in pieces using the grinder and kept. This was followed by working on restoring the bricks and the cracks. Then the plaster pieces were returned and fixed to the background brick walls. The completely lost parts of the plaster are being newly plastered.

Brick repair activities and returning back the moved plaster

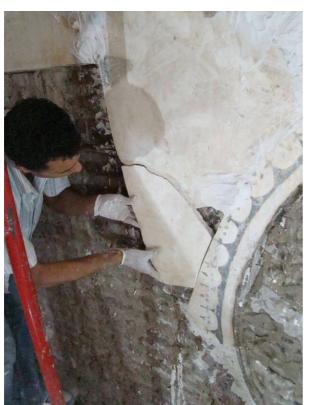
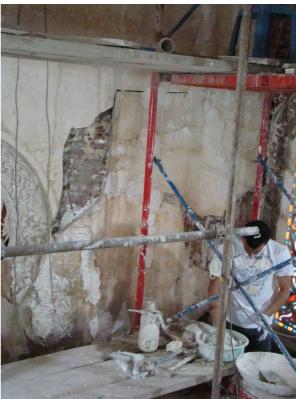
Returning back the plaster pieces to the walls

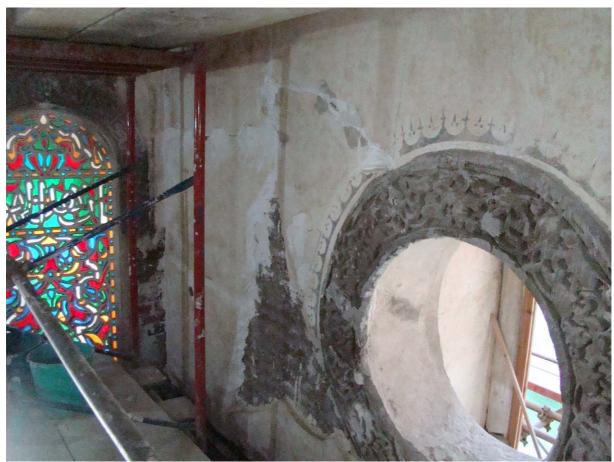
Parts of the stucco decoration returned to their place

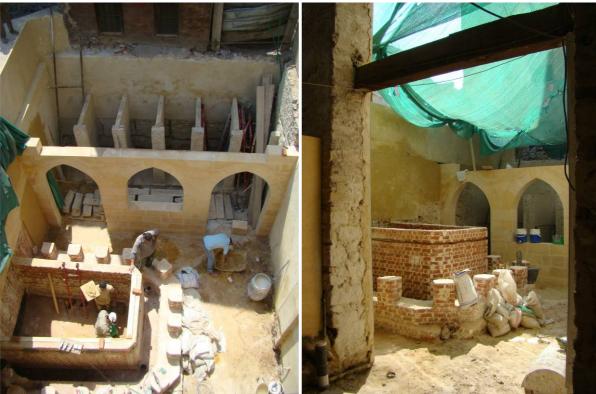
The construction of the ablution and washing system and seats was constructed and the water supply and drainage systems installed. This was followed by finishing the walls and seats with marble.

Construction of the ablution (washing) area

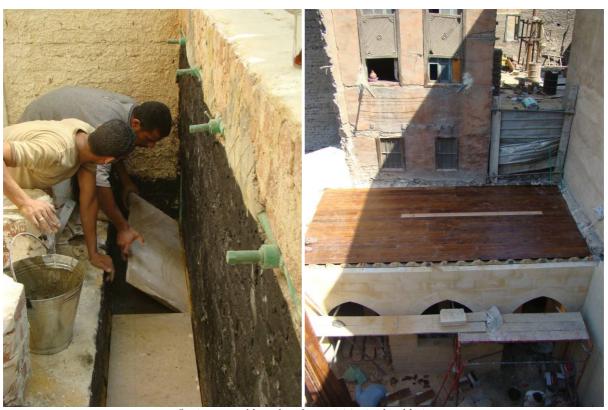
The brick construction of the toilets were finalized. The wooden ceiling was erected, painted and prepared to be insulated. The first plaster coat was applied. The toilet fittings were installed and the ceramics tiles were put in place on the walls and marble tiles were put on the floors.

Sanitary, marble and roofing activities in the ablution

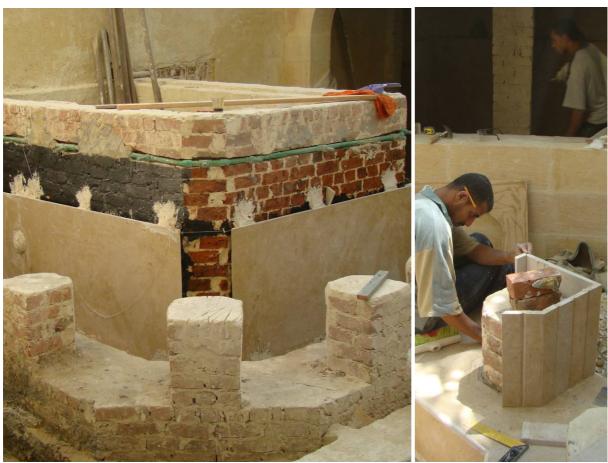
Marble cladding activities
