ANNUAL REPORT

December 2006 – December 2007

“Conservation of the Mosque of Aslam al-Silahdar in Darb al Ahmar, Cairo”

**QUARTERLY PROGRESS REPORT
DECEMBER 2006-FEBRUARY 2007**

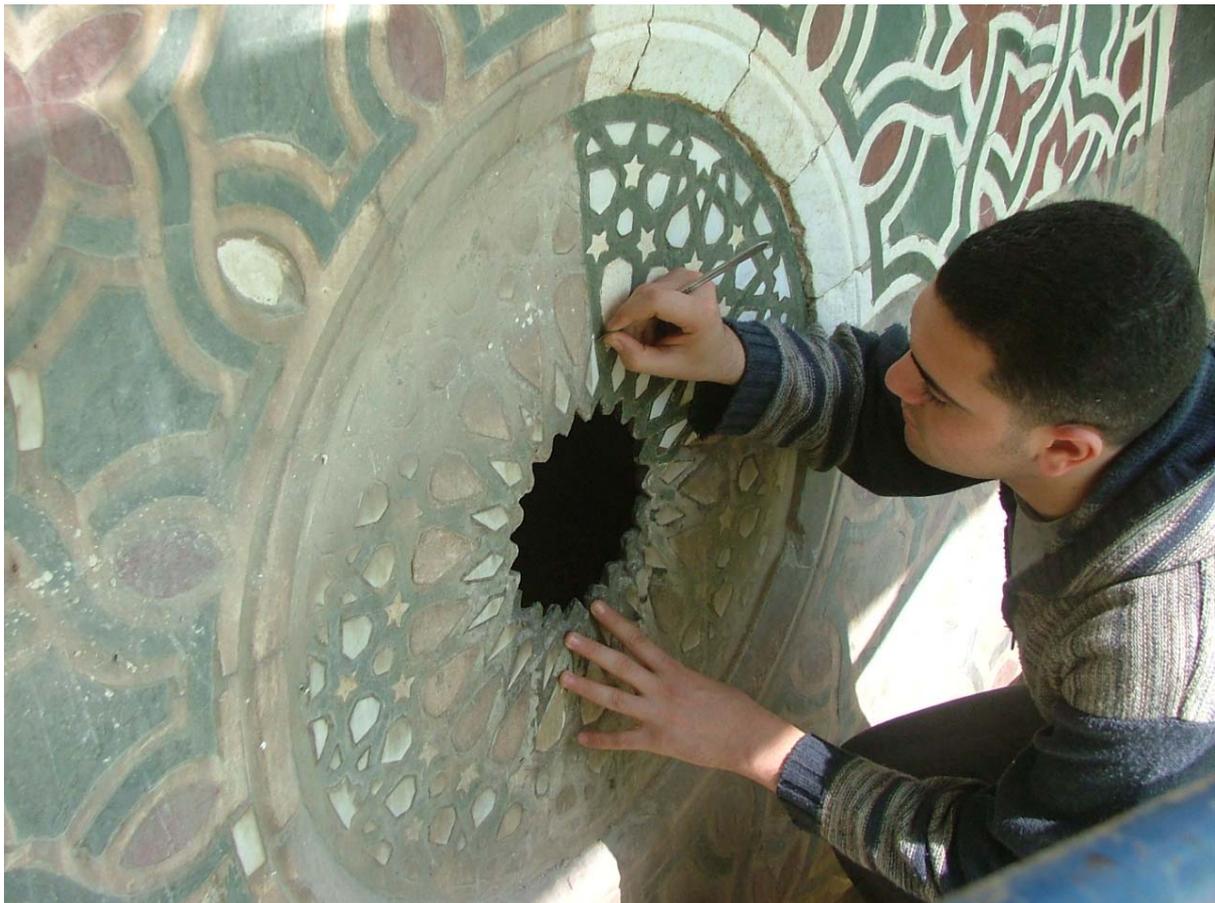
View of the marble panel on the main façade during cleaning

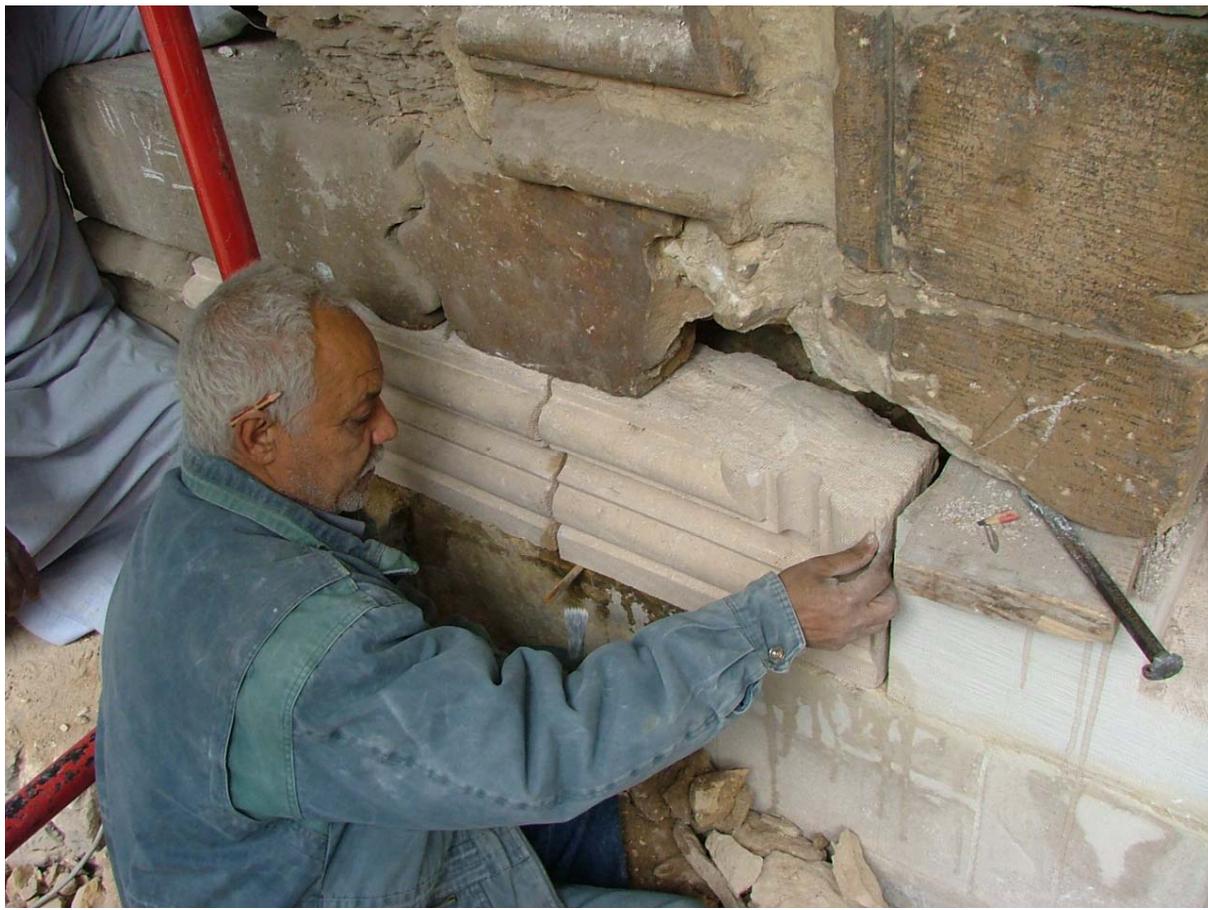
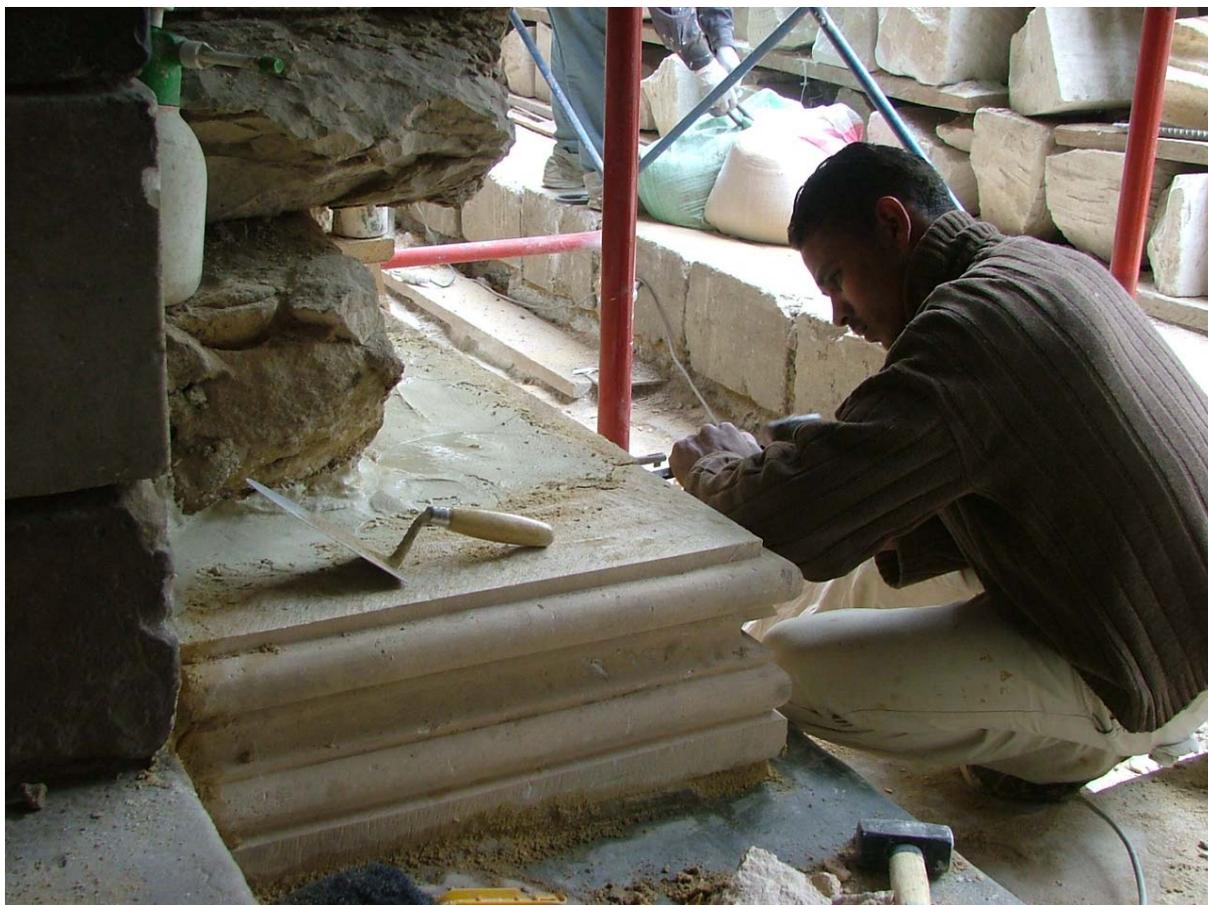
Stone replacement activities taking place on the Southern façade of the mosque

A campaign of selective stone replacement was completed at the southern and eastern facades: damaged plain facing and decorated lime stones were carefully replaced by new stones of a similar nature.

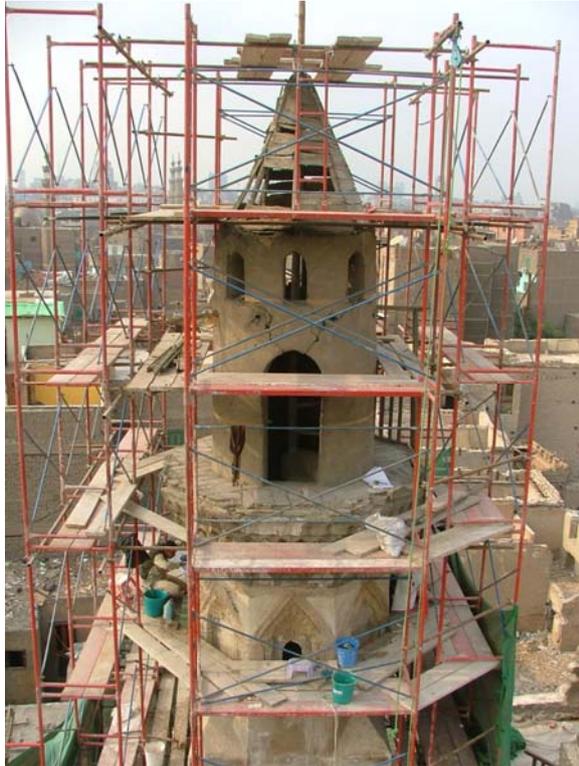
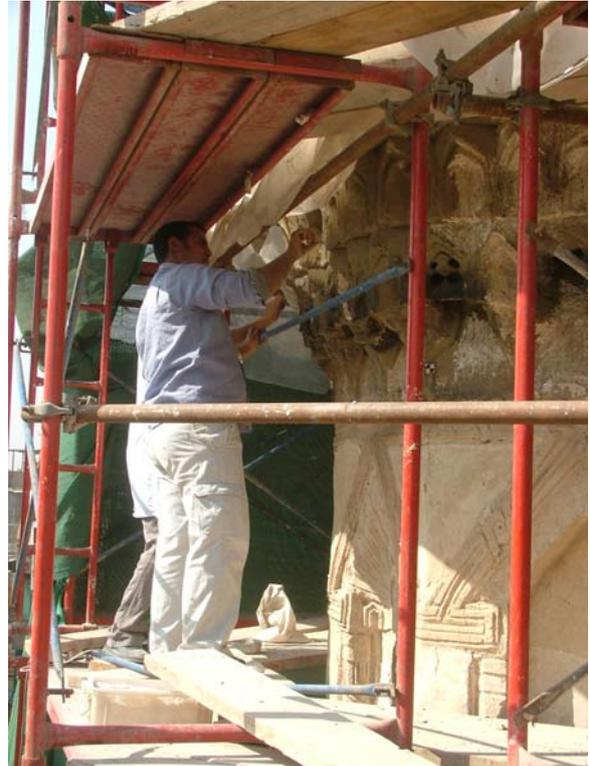
Cleaning activities on the minaret by poulticing

The exterior surfaces of the minaret made of gypsum and lime stucco are under cleaning by micro sand blasters and injection of lime grouts. The deteriorated status of the stucco makes it vulnerable to harsh weather conditions. The upper segment was reconstructed probably during the 19th century (the earliest photographs taken in the 1880's show it similar as today). The pencil shape of the top and the upper part of the brick drum are in a poor condition: the lead roofing is totally ruined, the timber carpentry is almost under collapse and the upper part of the brick drum is affected by serious cracking. A comprehensive restoration is planned in order to re-establish the last documented condition of the minaret as of the 1880's, without attempting to return back to a pre-Ottoman undocumented condition.

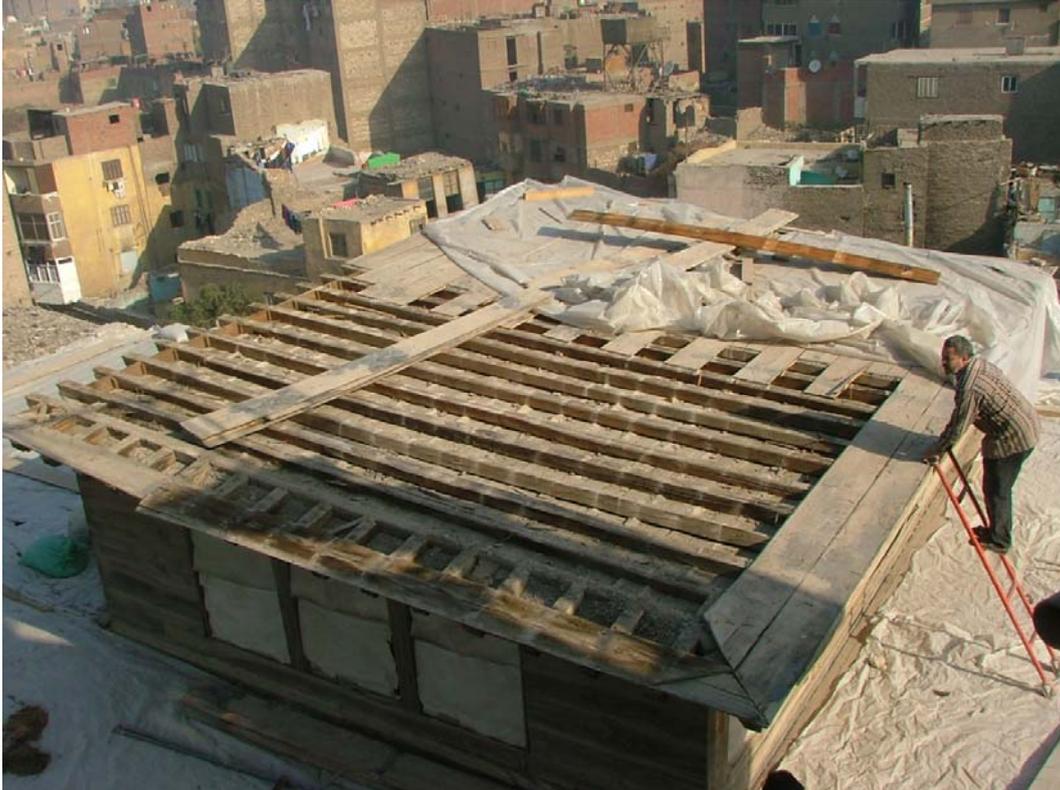
Assessment of wooden shingles and beams of the central shokhsheikha

The replacement of broken and damaged beams was done and more than half the surface of the entire roof was already insulated using a bitumen sheet covered with mortar screed. The carpentry of the central shokhsheikha was restored and the construction made by the Comité in 1908 was maintained. It is planned to be covered with lead sheets in order to minimize the dead load.

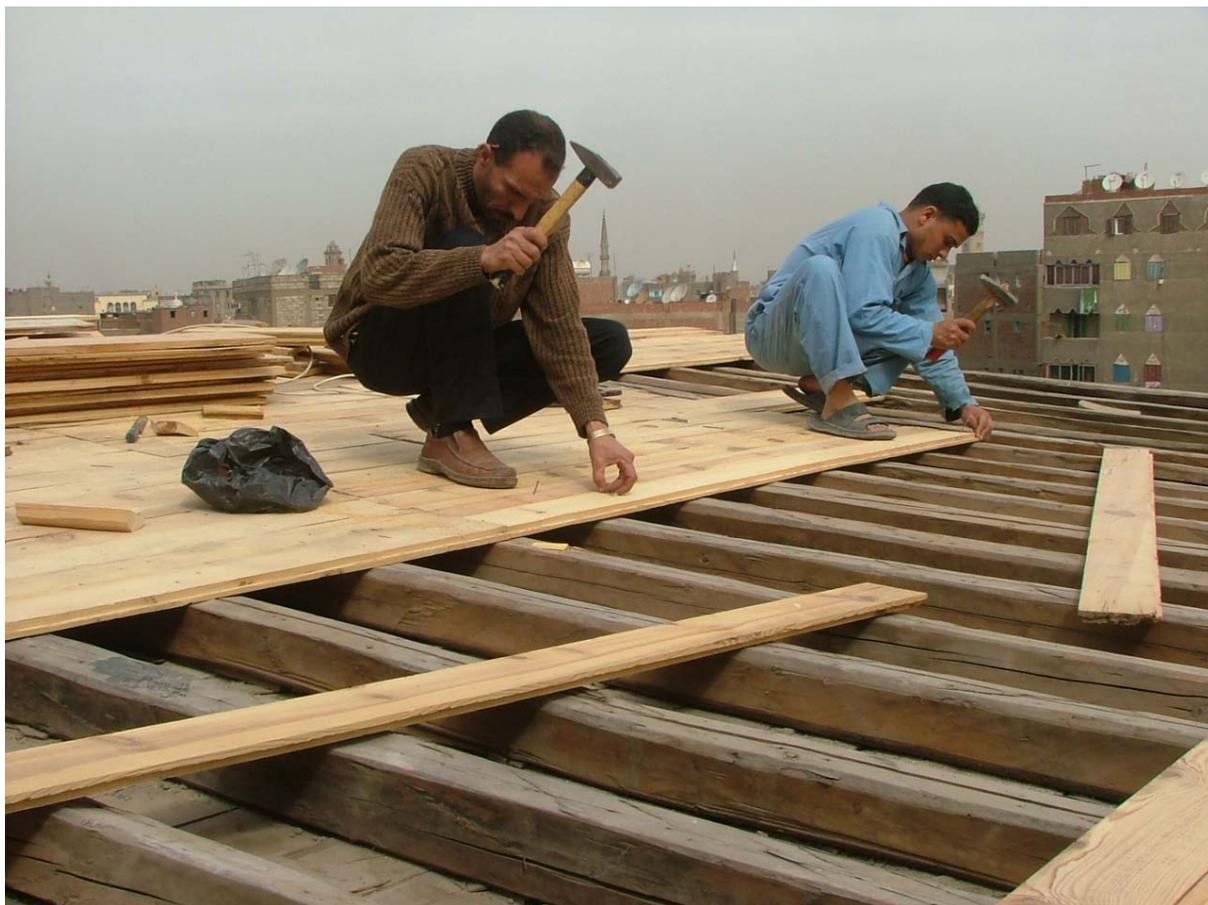
Carpenters replacing damaged wooden shingles

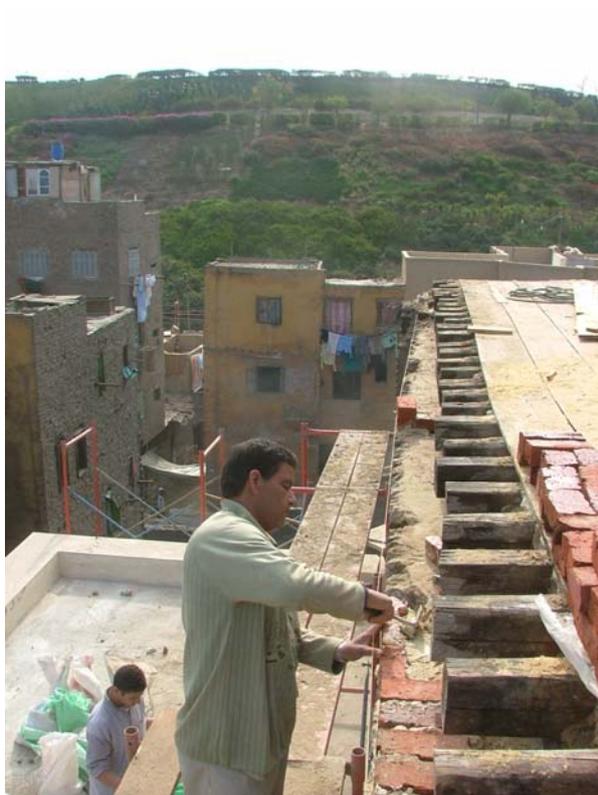
Brick construction of damaged roof parapets

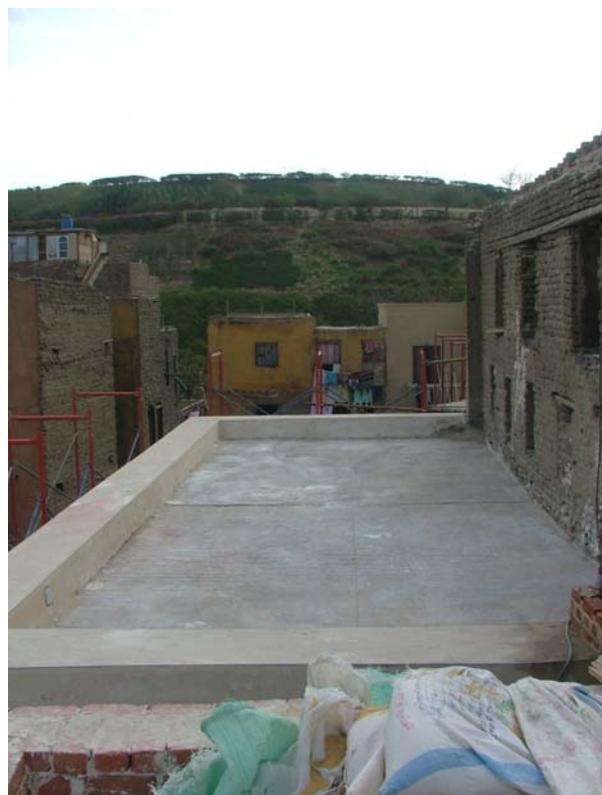
View of roof after insulation

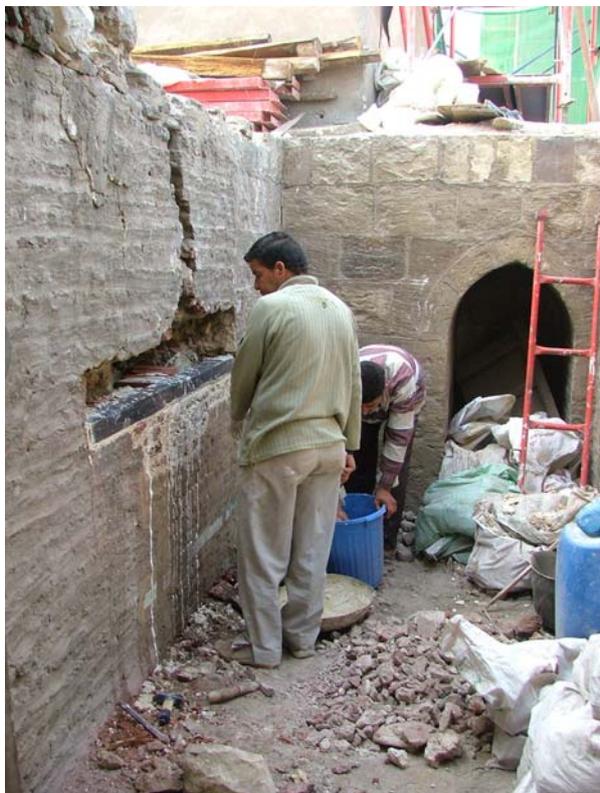
The brick masonry of the first floor rooms was affected locally by vertical cracking caused by earthquake loads. In the areas concerned with this damage pattern, the masonry was repaired by brick stitching. This concerns both southern and northern large rooms and the small qa'a along the western elevation.

Brick repair of cracks in upper level rooms

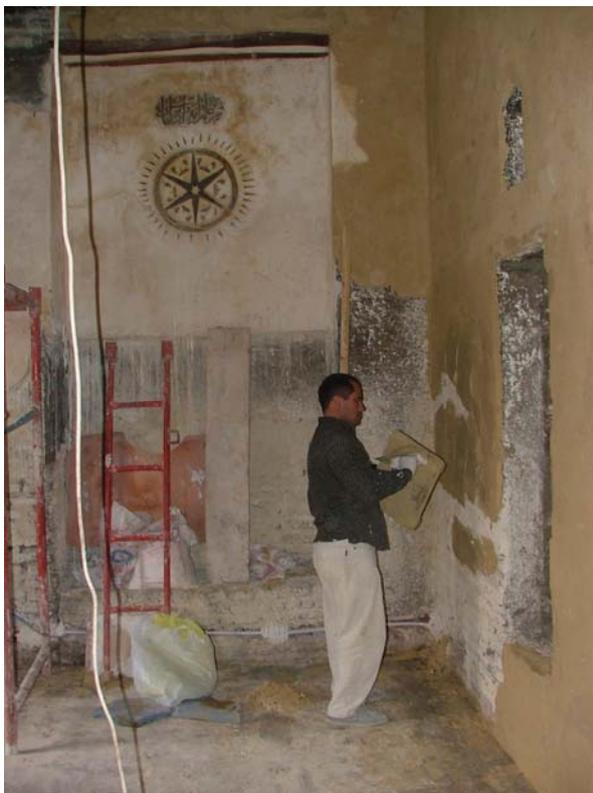
Plastering of rooms on first floor

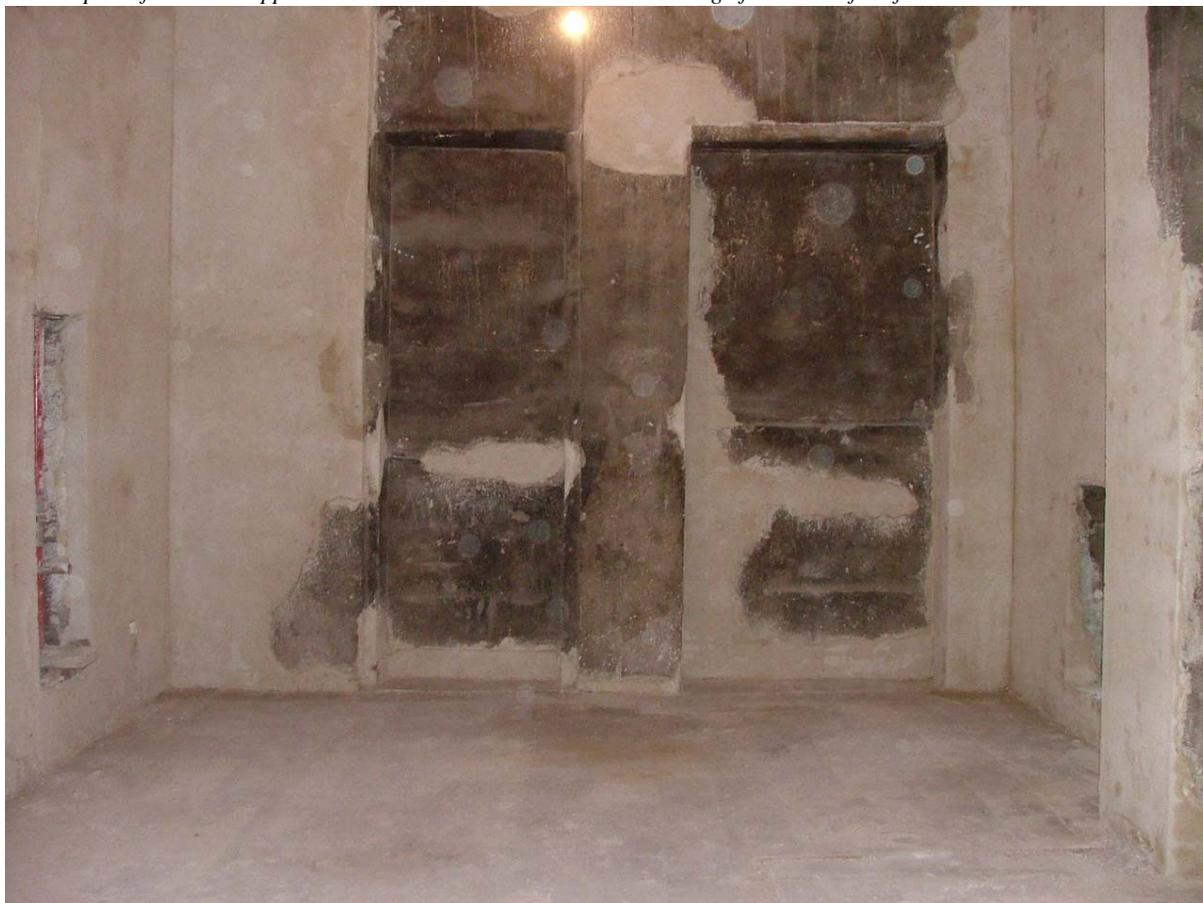
View of room on first floor after brick repair and plastering

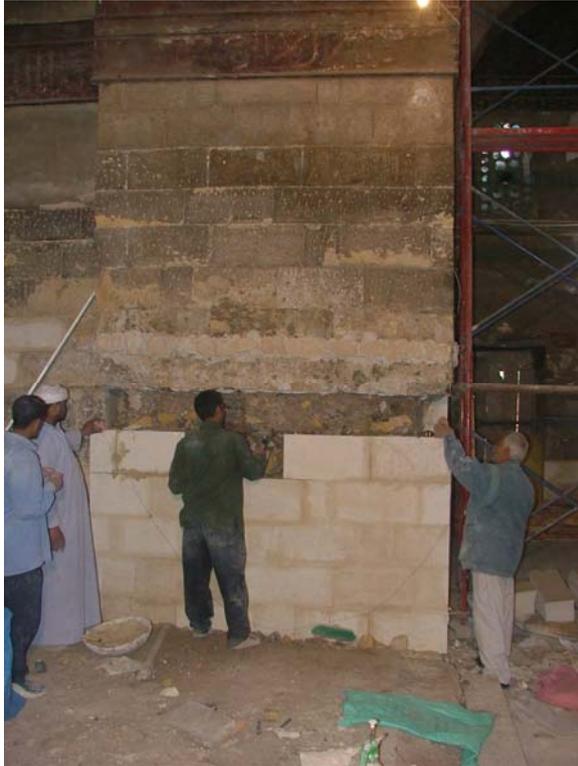
Stone replacement activities in the qibla iwan

Stone replacement of the damaged lower parts of the walls was performed and is still in progress. No conservation intervention of the surfaces of walls and ceilings will take place before September 2007.

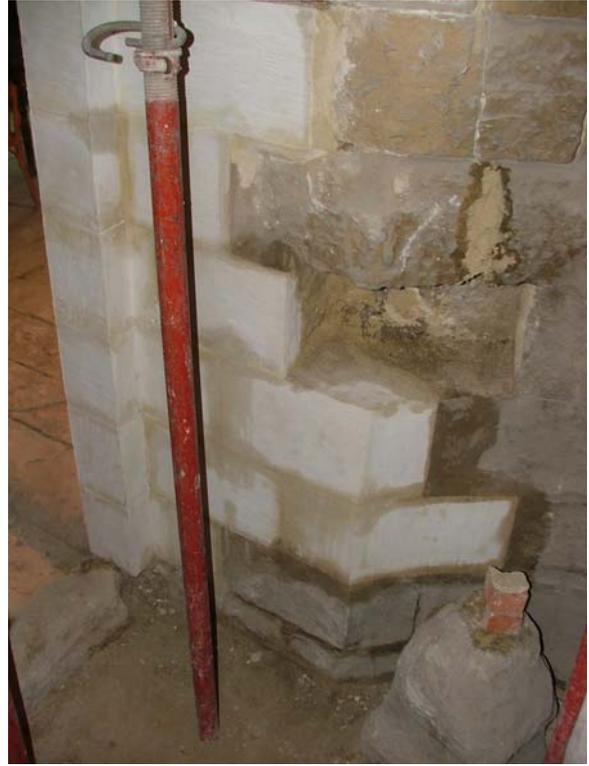
Stone replacement in main staircase

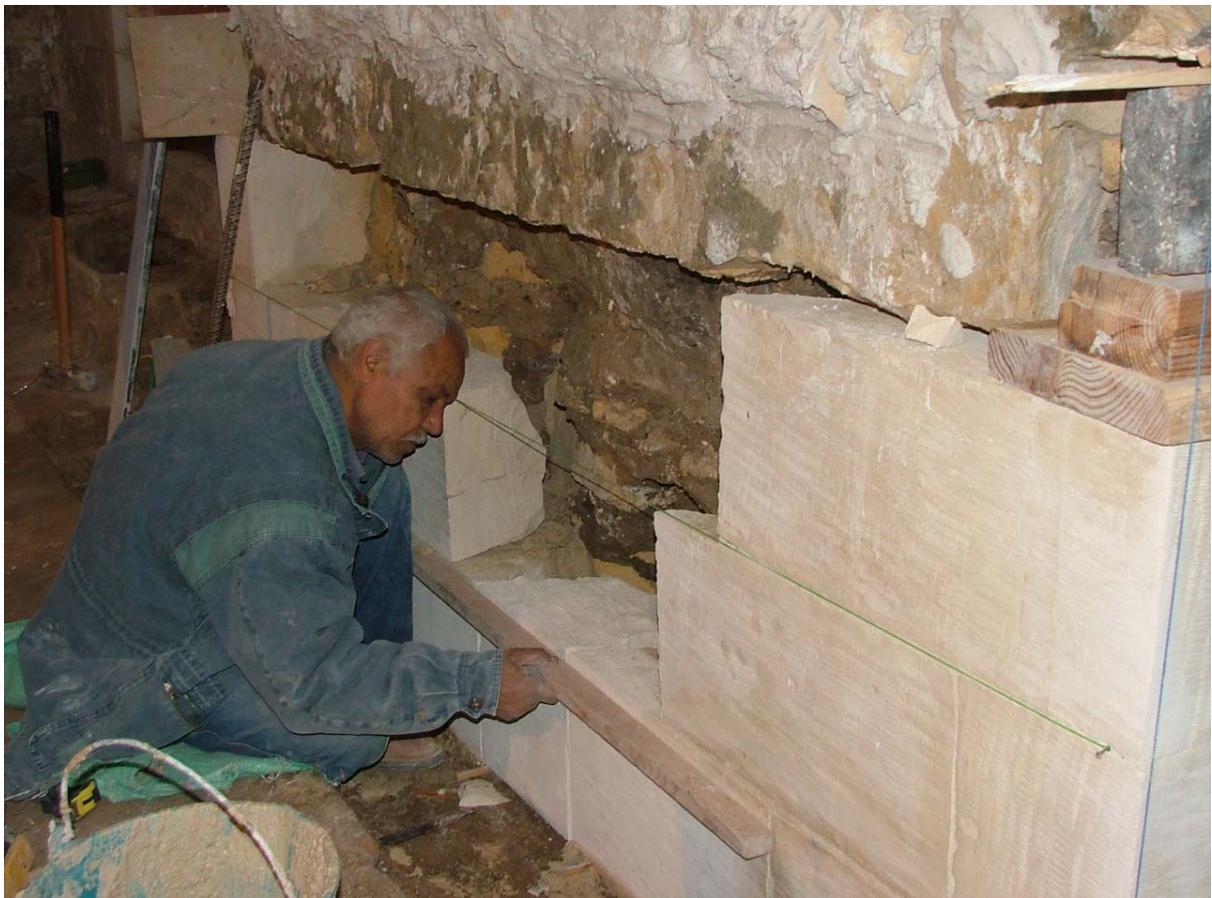
Stone replacement activities in the qibla iwan

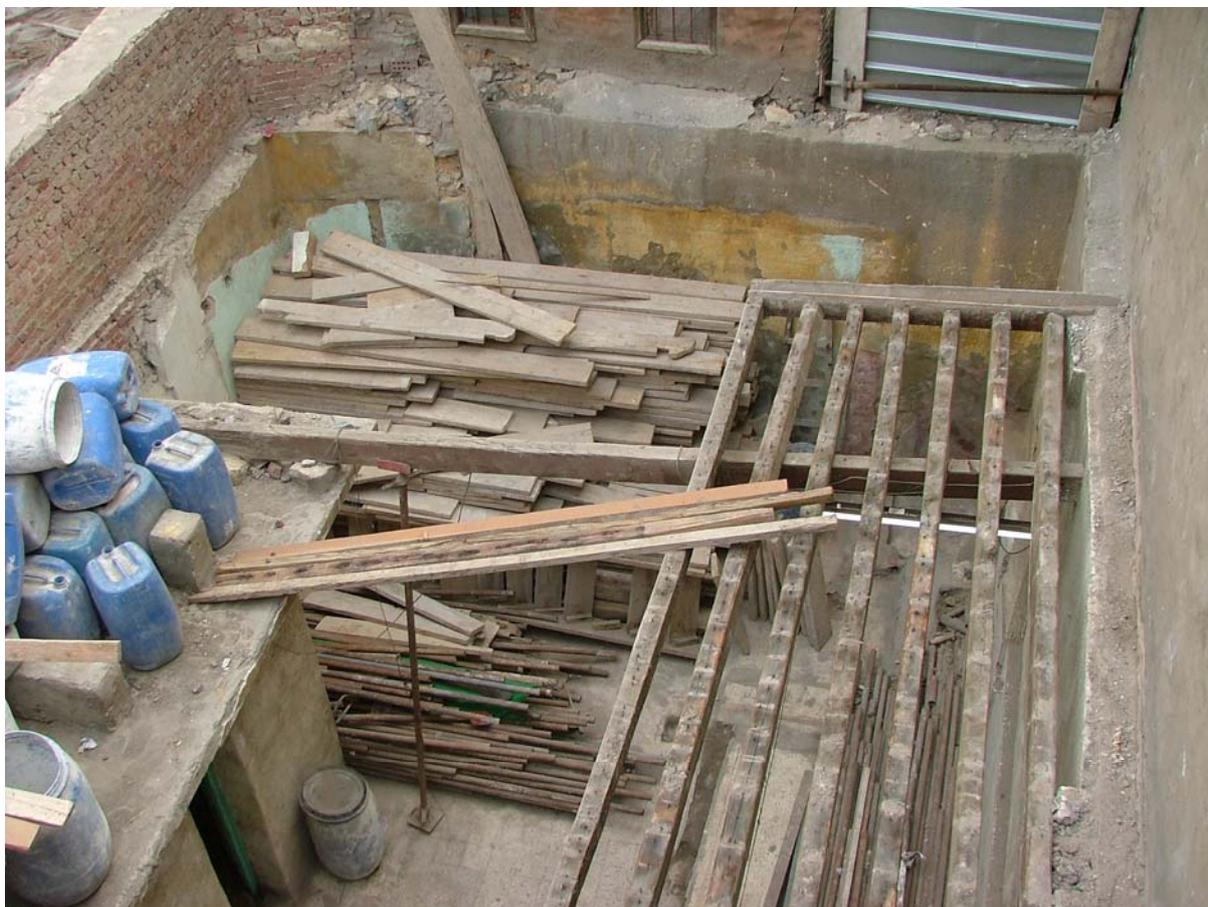
The existing structures of the ablution area were found in an advanced state of deterioration and were dismantled after survey. The location may be used as storage till the second quarter of 2007.

View of ablution area used as storage area

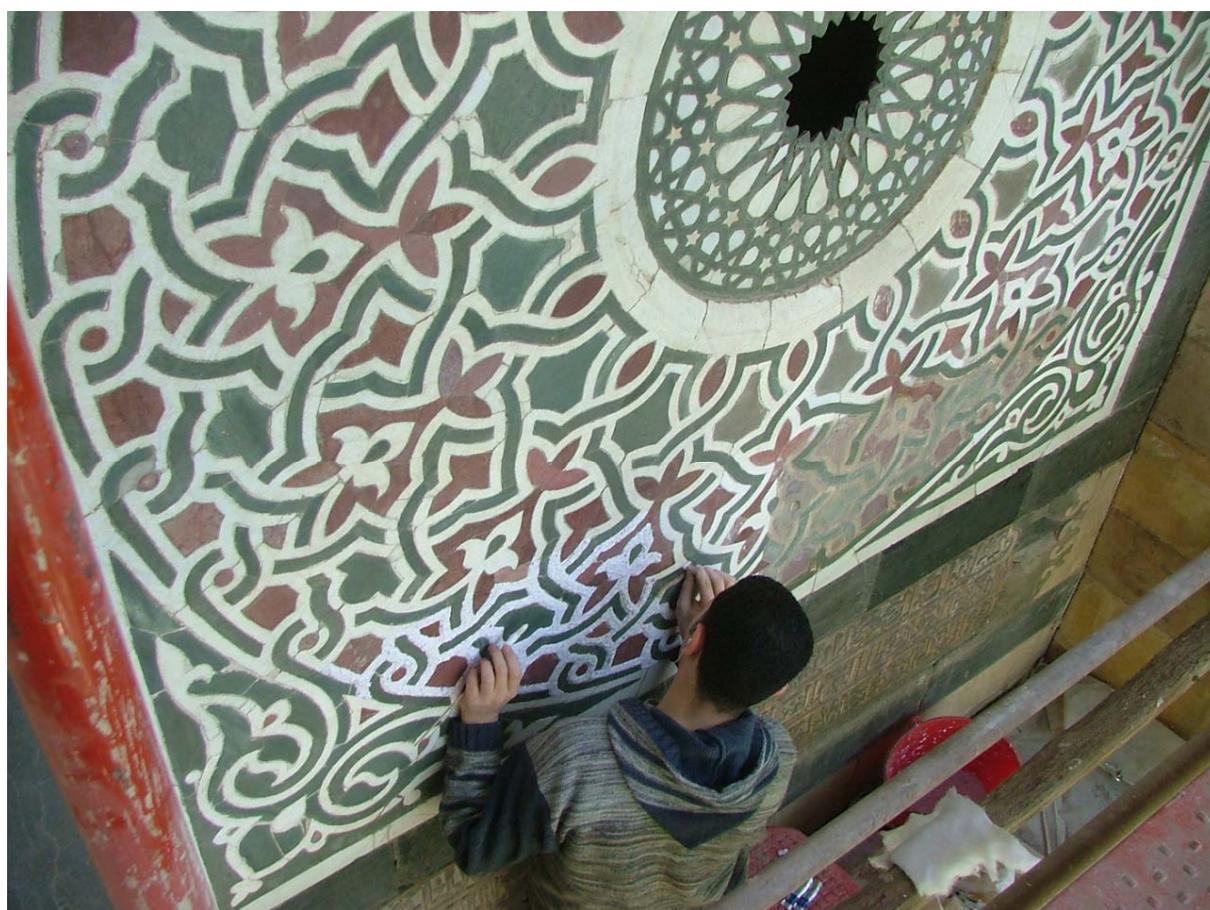
Cleaning of the marble panel on the southern facade

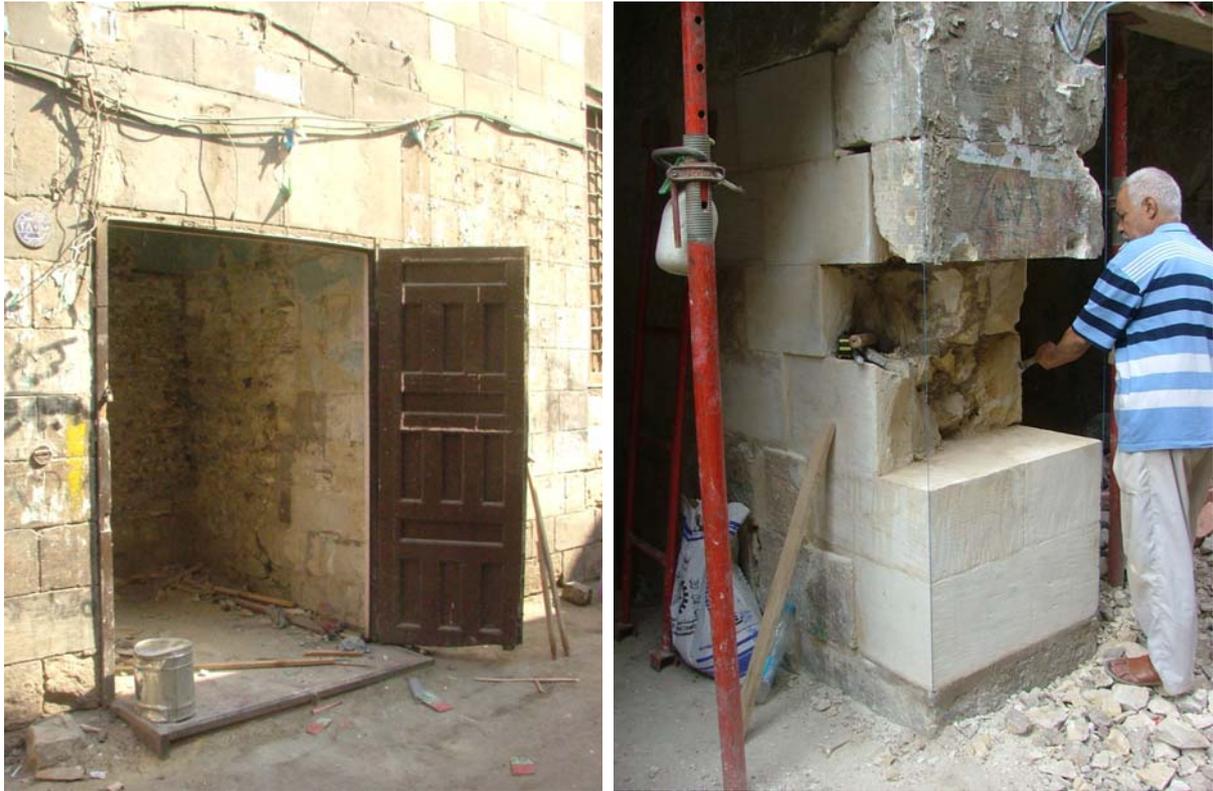
Clearing of shops on the western façade and selective replacement of damaged stones

The ground floor private shops on the western façade were cleared temporarily by the tenants and brick repair works started. Upon restoration, shops will be handed back to the tenants.

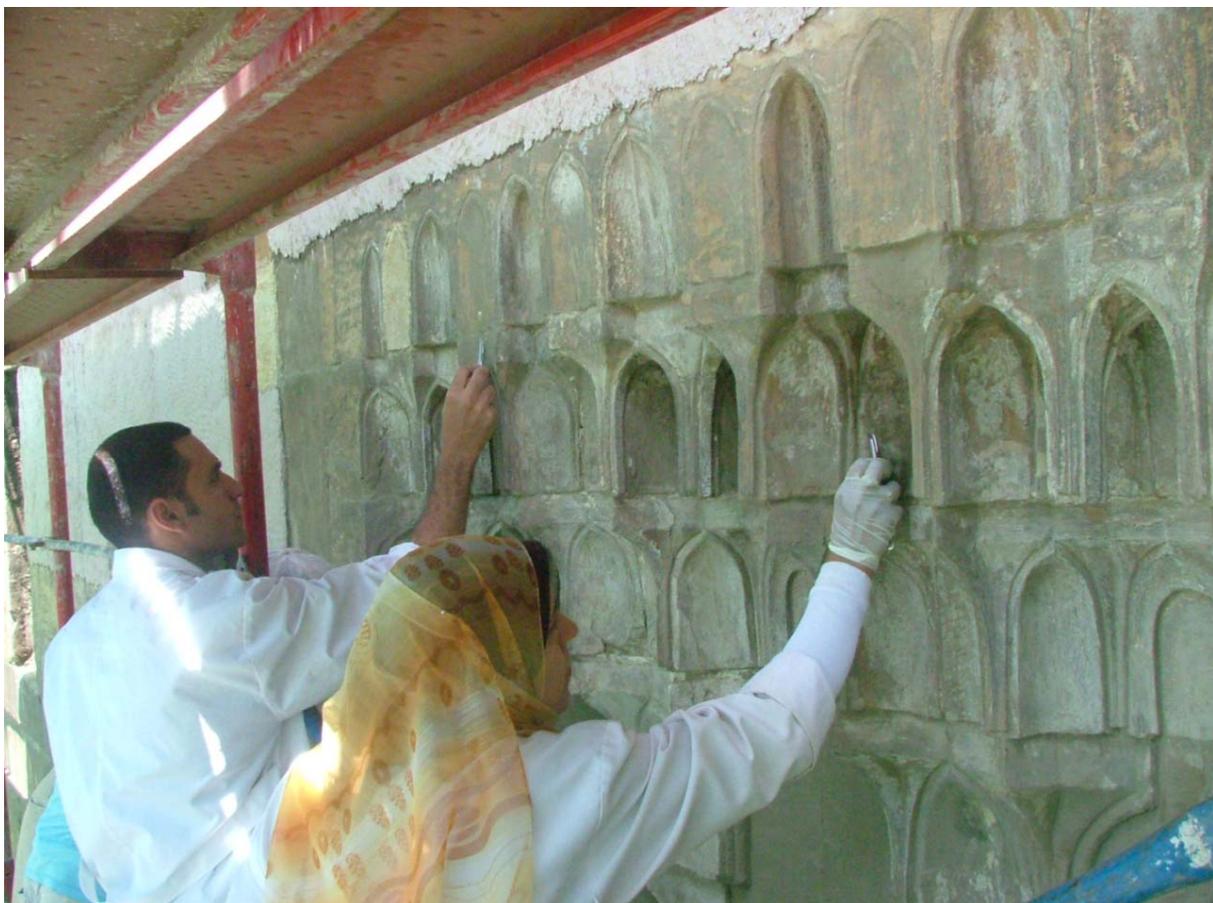
Mechanical cleaning of the western façade stalactites

Mechanical cleaning test were started on the western façade in order to determine the state of the lime stones. Following, the fine restoration activities were initiated using poultice made of bentonite and paper pulp with a low concentration (3-5%) of Ammonium Bicarbonate. The same polychromy pattern of the lime stone found on both the southern and eastern façade was revealed.

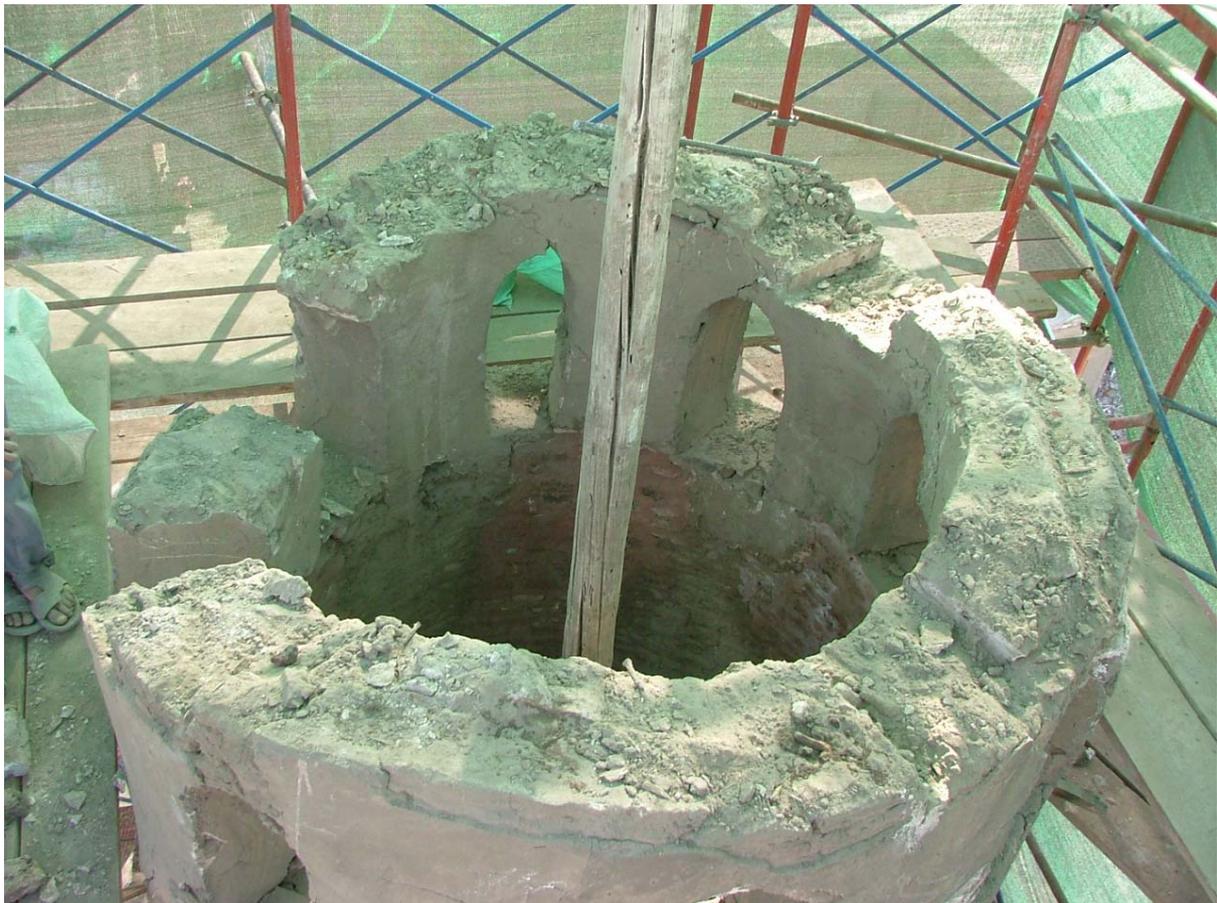
View of the minaret upper part after the removal of damaged beams.

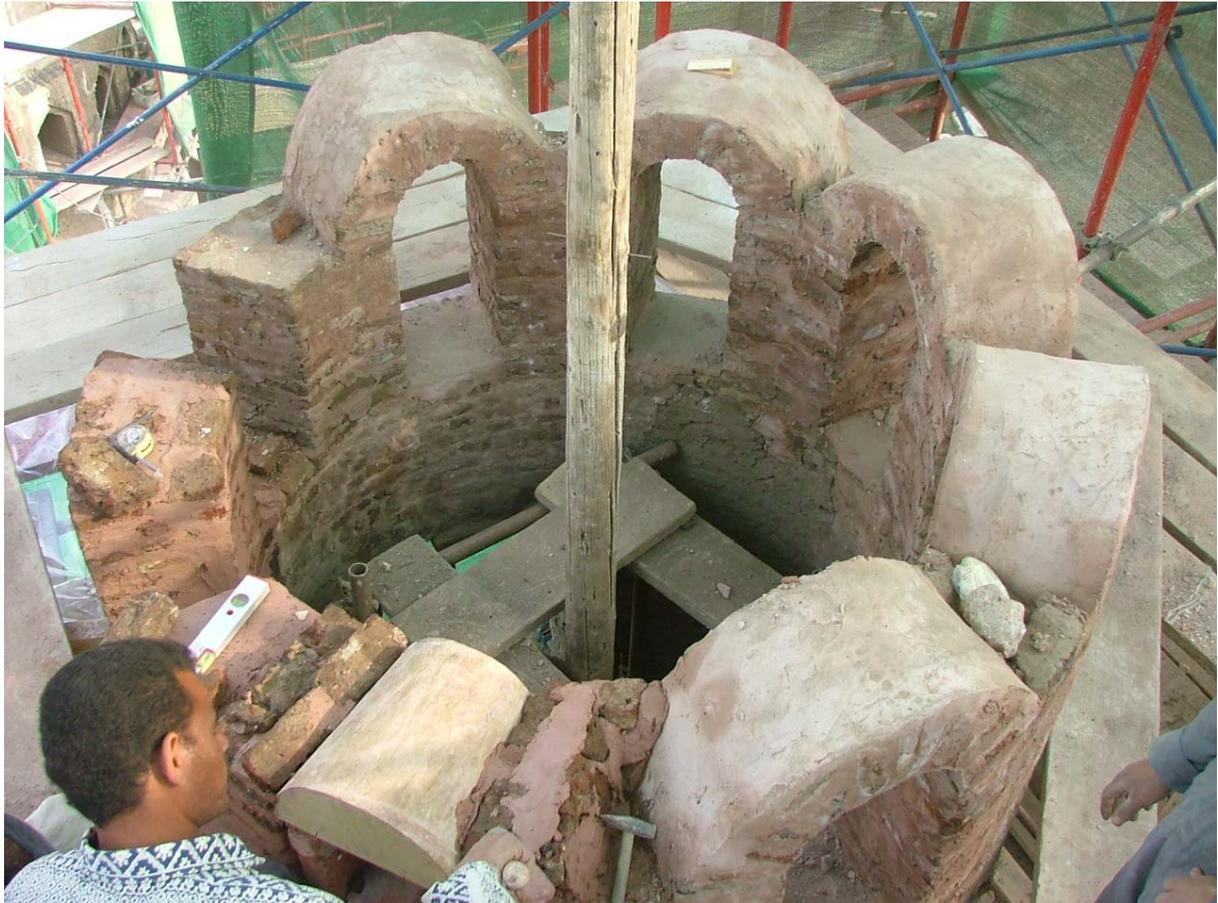
Brick repair activities on the minaret

The conservation work included brick repairs on the upper part, the construction of a pencil shaped carpentry top and the cleaning of the interior walls and steps using the sand blasting technique.

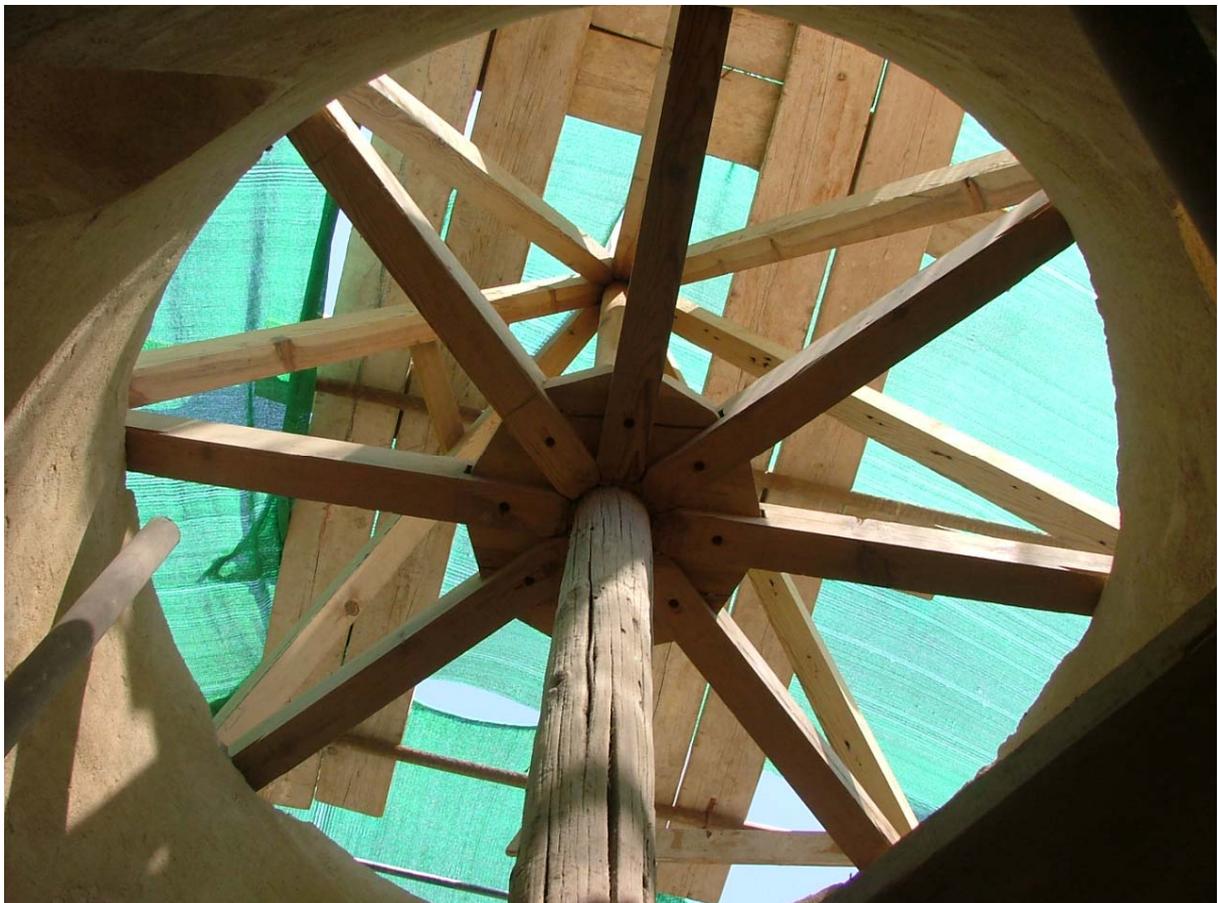
Inner view of the minaret after the installation of the main supporting beams of the upper part.

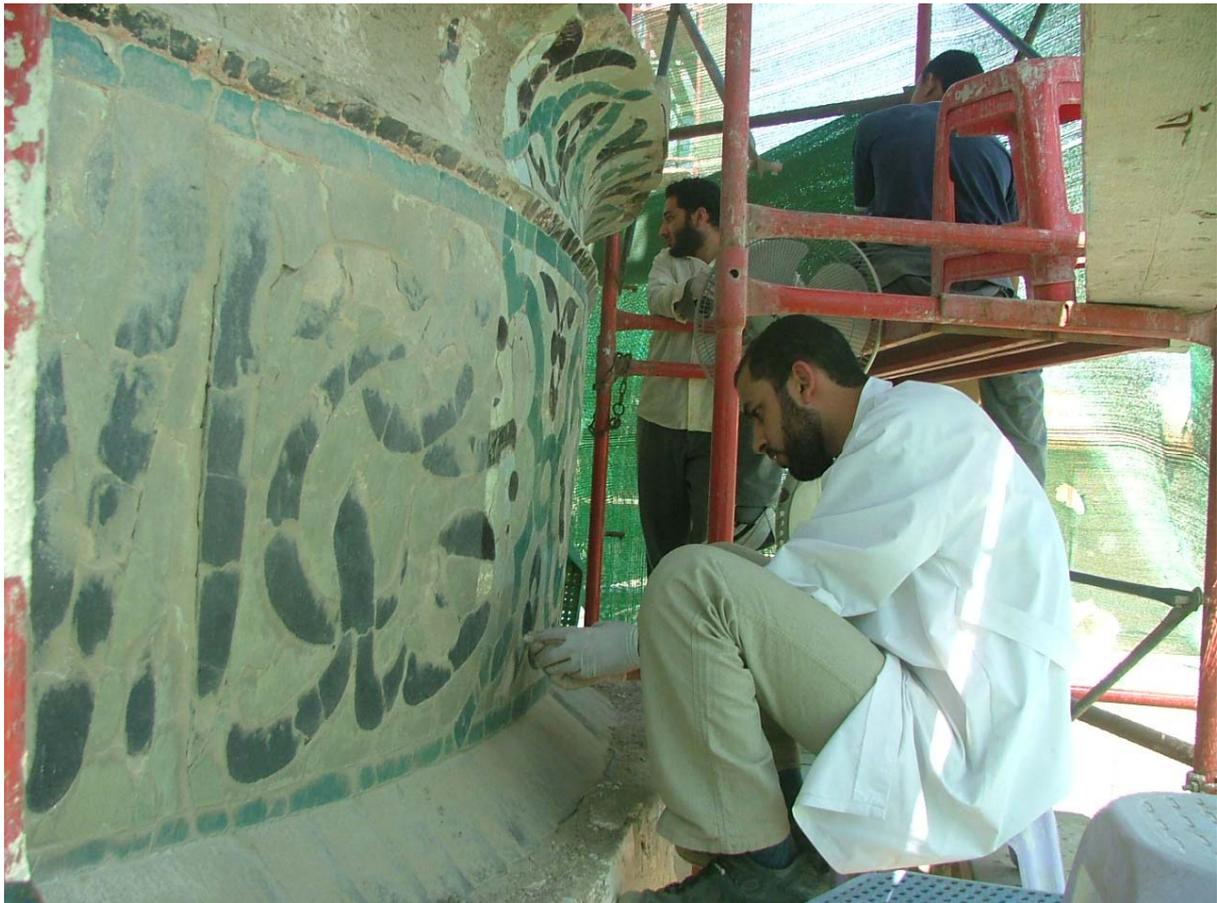
View of the ceramic inscription band on the dome during cleaning and consolidation of the ceramics

A detailed architectural drawing of the ceramic inscription band of the dome was completed. Cleaning and stabilization of the polychrome tiling decoration was finalised. Retouching of the missing ceramic glazed parts is currently proceeding while mortar samples of the missing upper crenellation are been prepared in order to study the feasibility of replacing all missing ceramic crenellations.

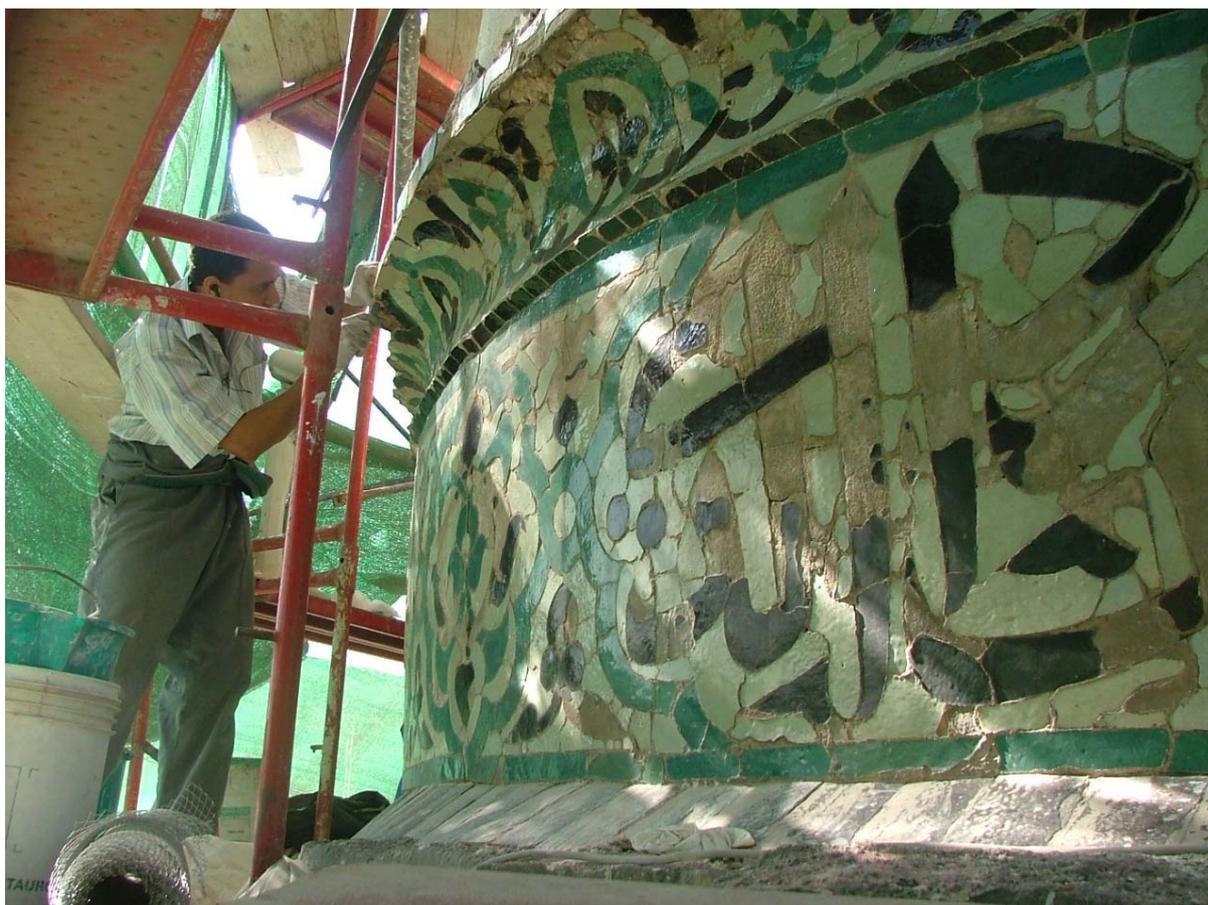
Mortar completion of the upper missing parts of the Dome Corniche

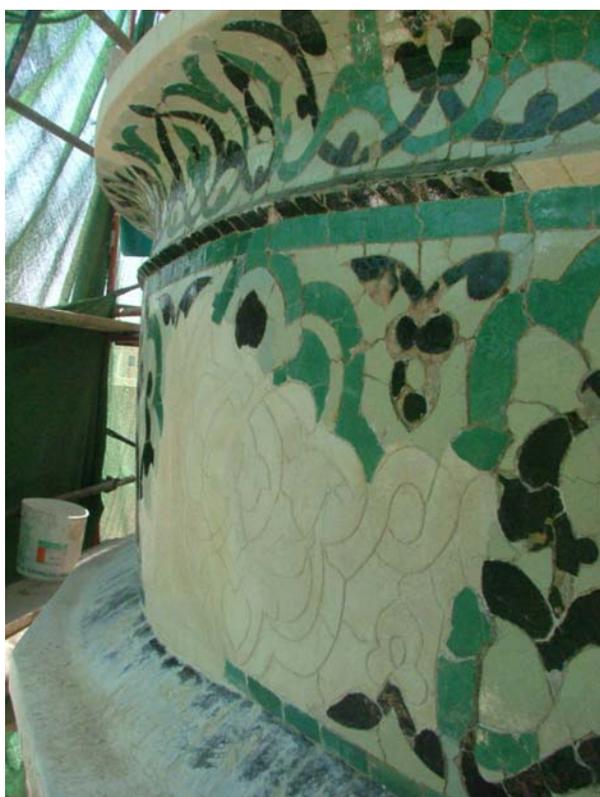
Mortar and drawing completion of missing parts

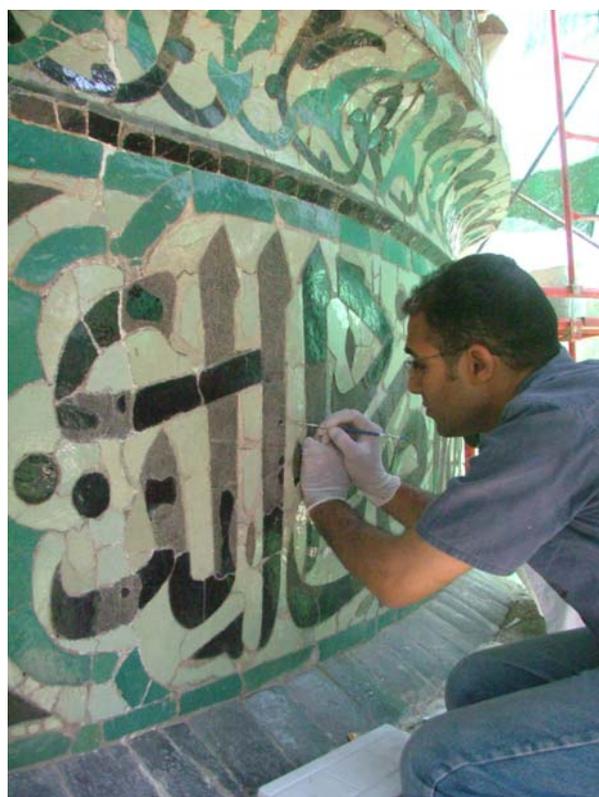
Retouching of the missing glaze of the inscription
