ANNUAL REPORT

December 2006 – December 2007

“Conservation of the Mosque of Aslam al-Silahdar in Darb al Ahmar, Cairo”

**QUARTERLY PROGRESS REPORT
DECEMBER 2006-FEBRUARY 2007**

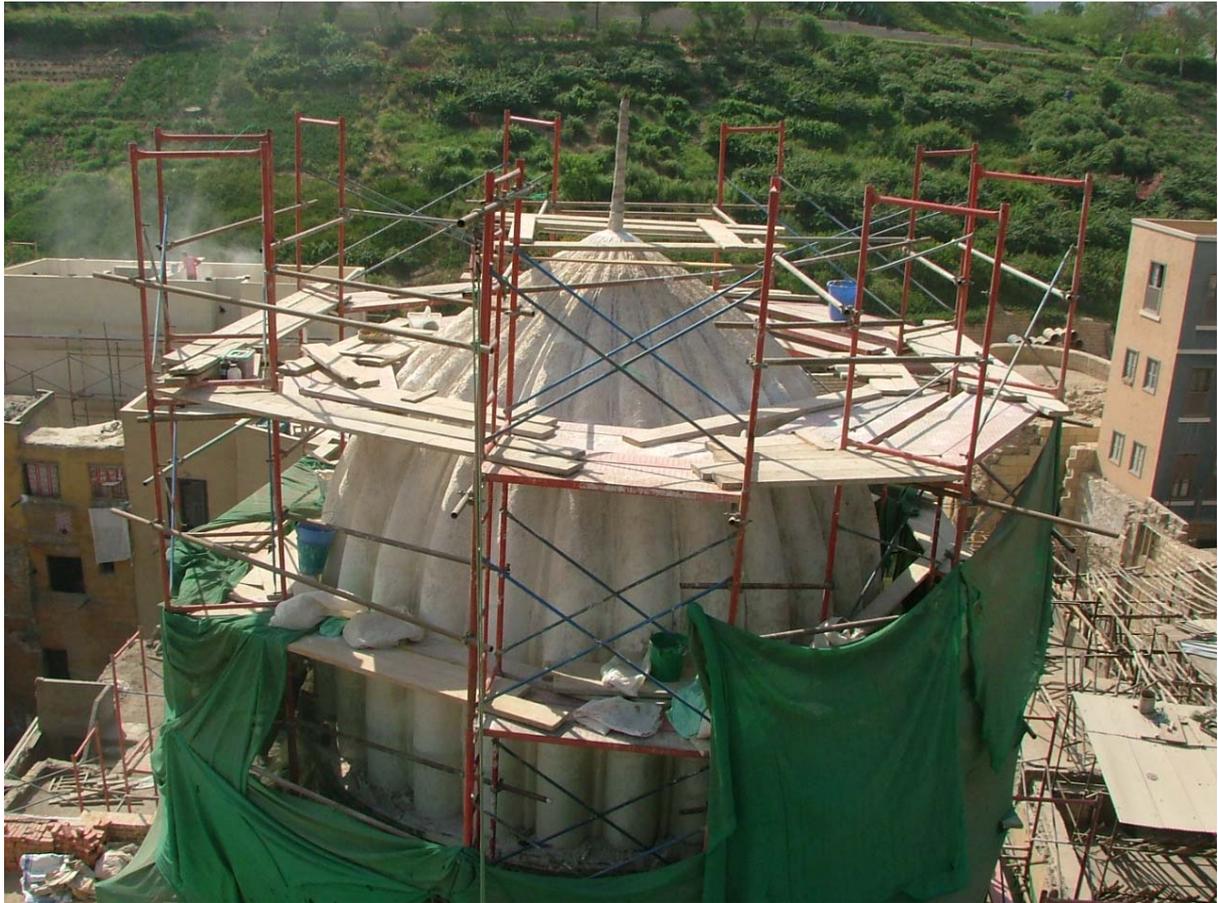
View of the dome exterior after the cleaning and installation of the copper crescent

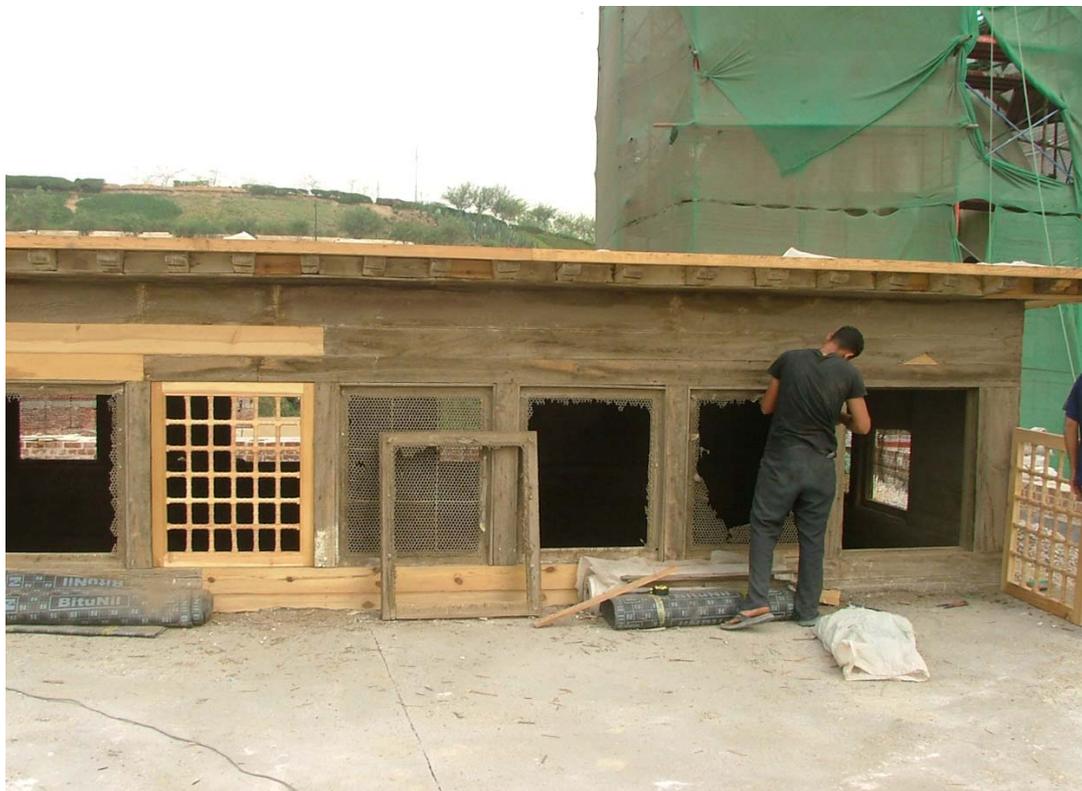
Central shokhsheikha during restoration and view of the new proposed wooden window

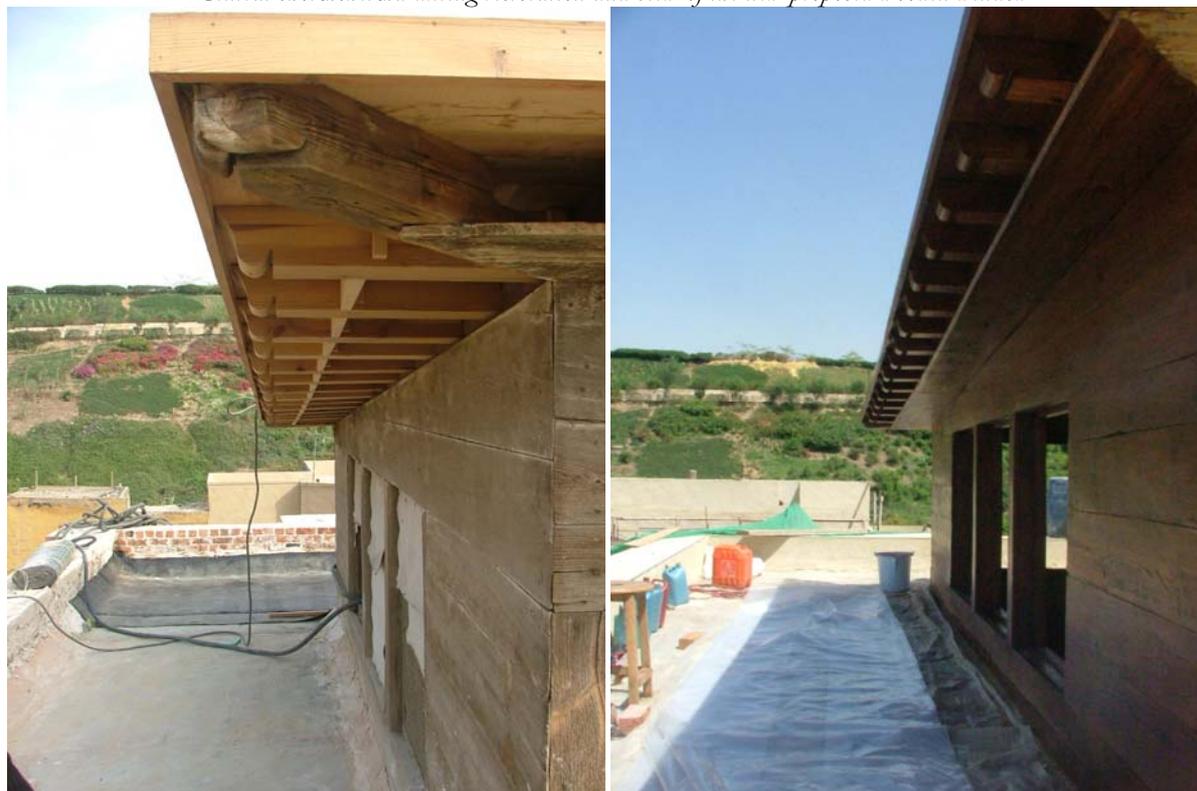
View of the central shokhsheikha after the replacement of damaged beams and shingles and after painting

The replacement of broken and damaged beams of all the roofs of the mosque was completed. The insulation of roofs was also finalised using bitumen sheets covered with mortar screed. The southern and qibla roofs will be insulated after the dismantling of the dome and minaret scaffoldings.

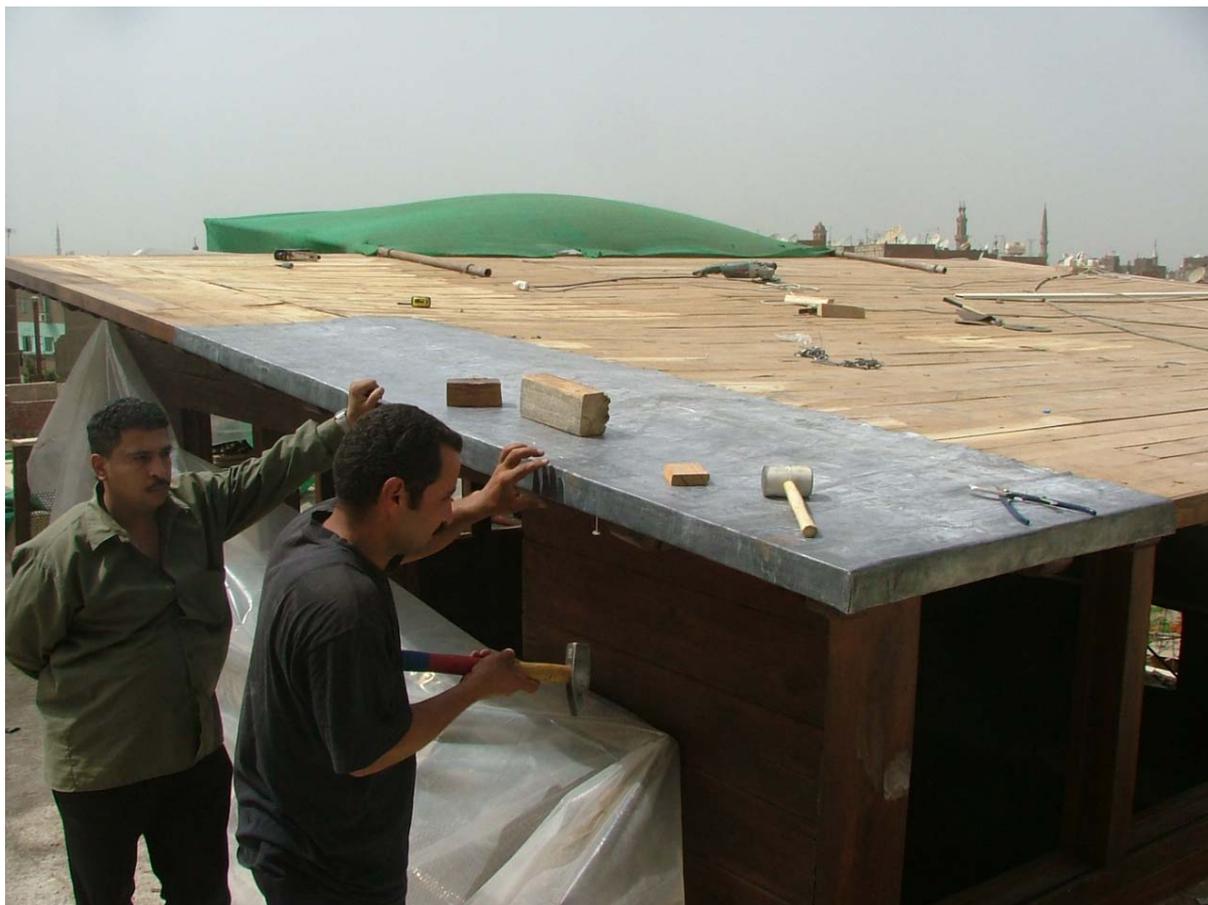
Central sbokhsbekba during the insulation using lead sheets

The carpentry of the central shokhsheikha was restored and insulated by lead sheets in order to minimize the dead load.

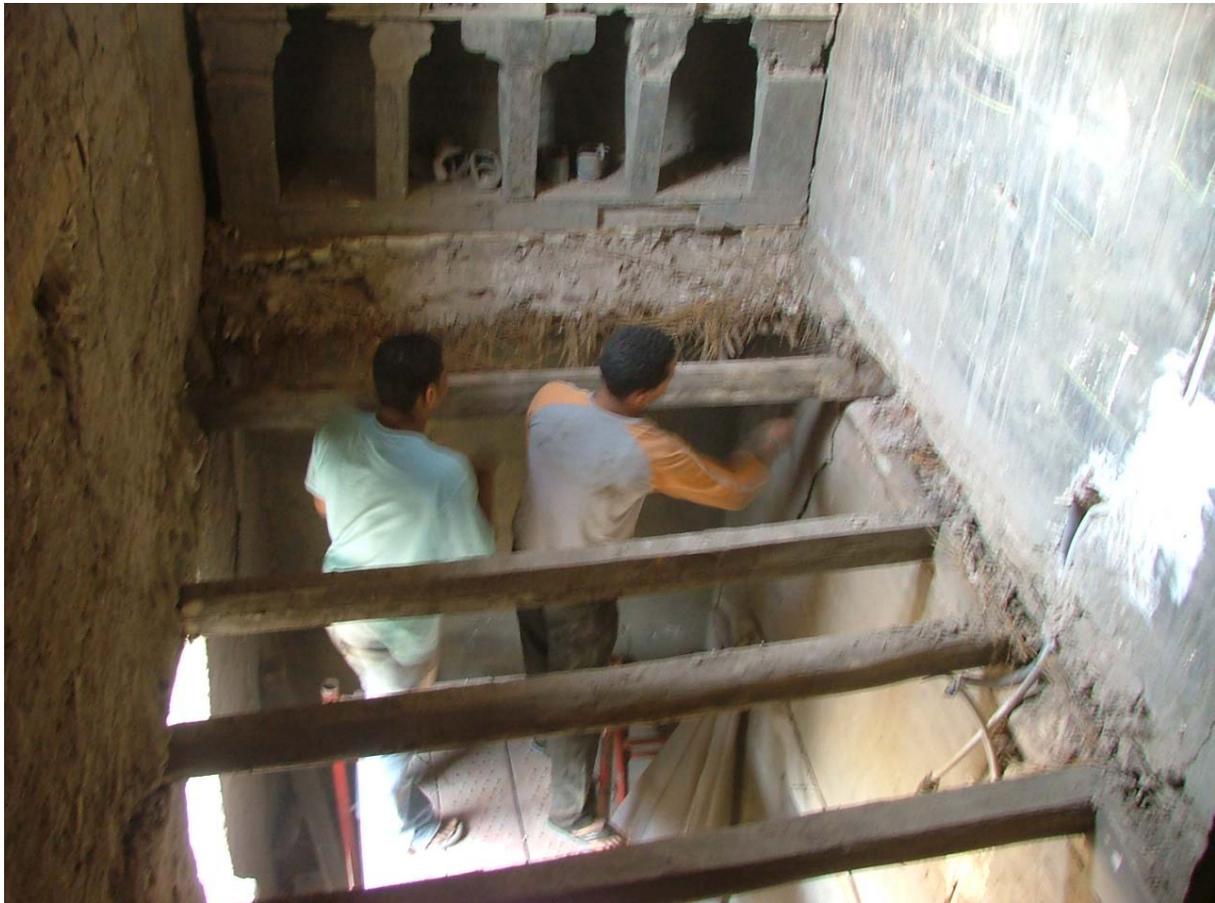
Room 1.2 during the replacement of the damaged beams

The brick masonry of the mezzanine and first floor rooms which was affected locally by vertical cracking caused by earthquake loads has been repaired by brick stitching. In the areas concerned with this damage pattern, the masonry was repaired by brick stitching. First Floor rooms, 1.1 and 1.4 were restored and plastered. The site office was moved into room 1.4. the roofs of room 1.2 and 2.3 have been uncovered and damaged beams and shingles were replaced.

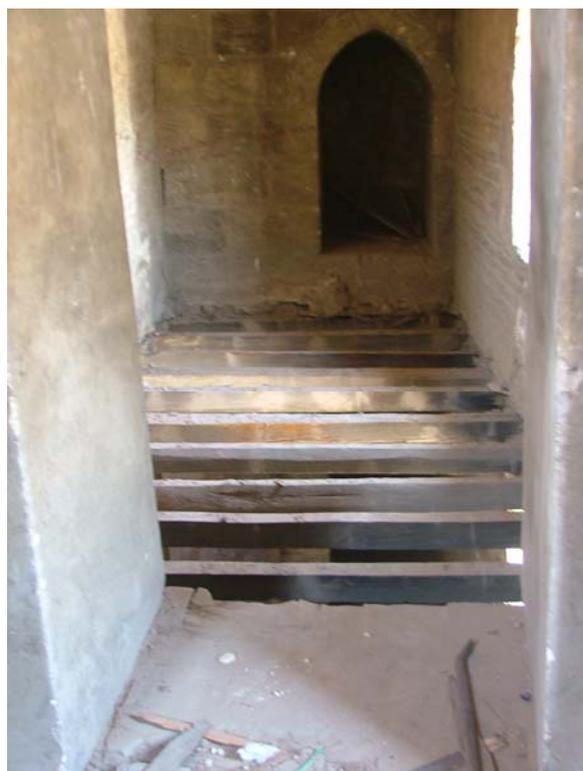
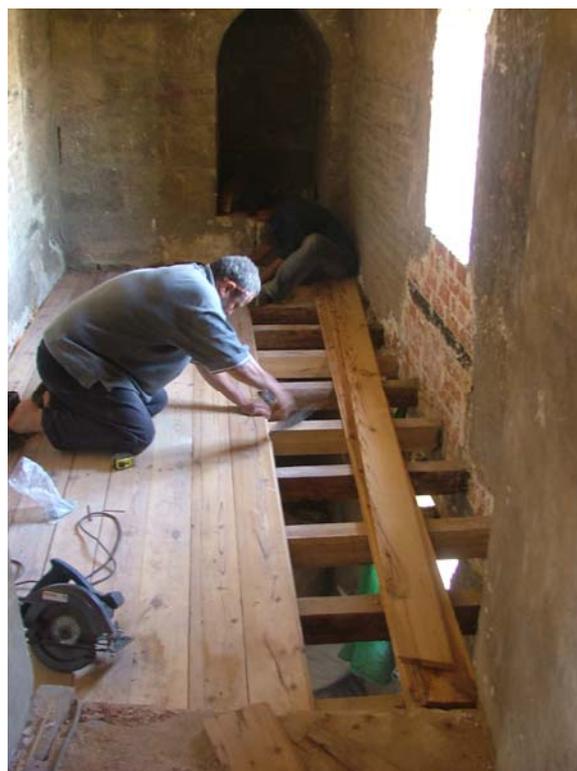
View of room 2.3 during the replacement of damaged beams and shingles.

Brick stitching in room 2.3 was completed and plastering and conservation of the remaining stone facing and plaster is on going. Electrical network has been embedded into the brick masonry.

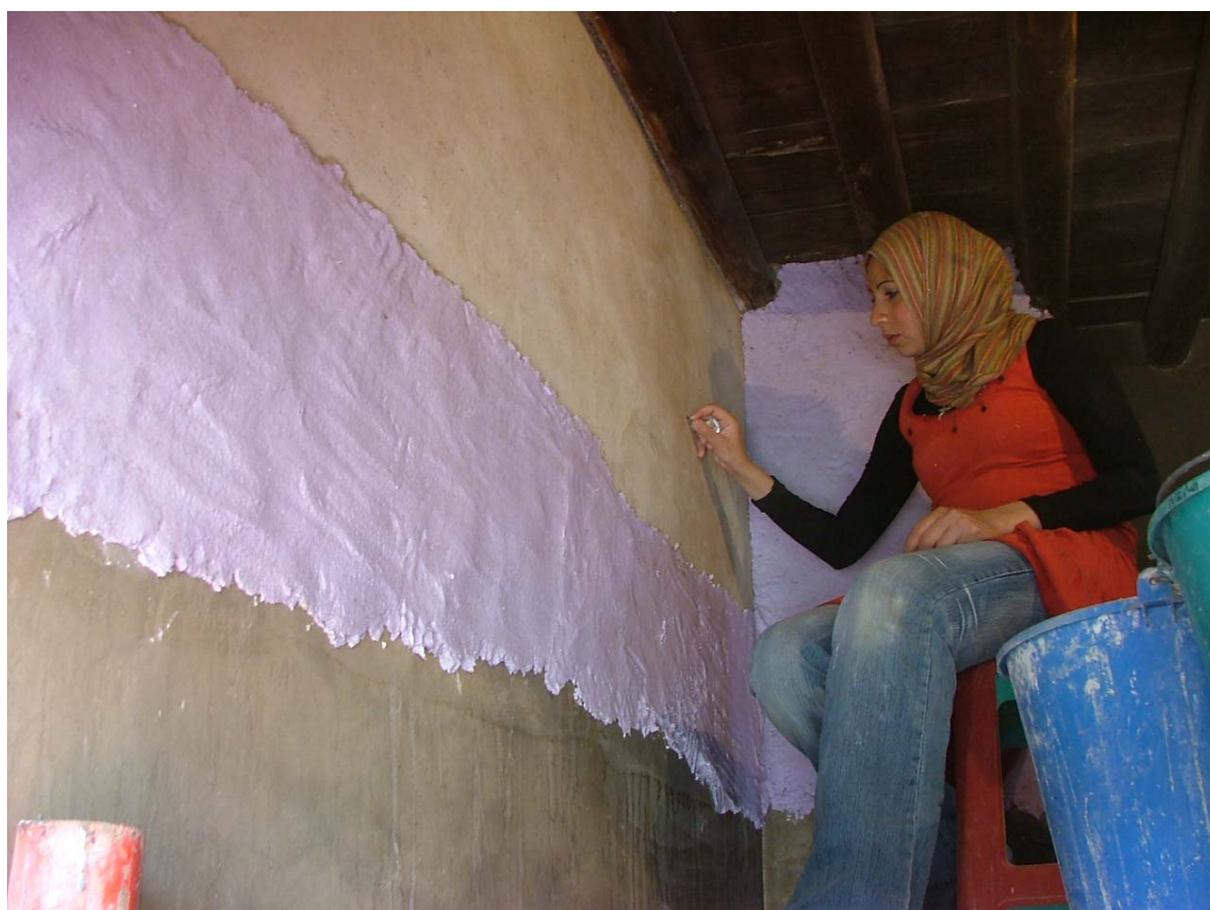
Cleaning of lime based plaster in room 2.2 using poultices after the injection of detached parts.

Room 2.1 on the second floor was found in a good condition. Fine restoration and cleaning activities were finalised. Currently conservation of room 2.2 is taking place. Cleaning and conservation techniques include grouting behind detached plaster layers and consolidation of the lime based plasters using poulticing.

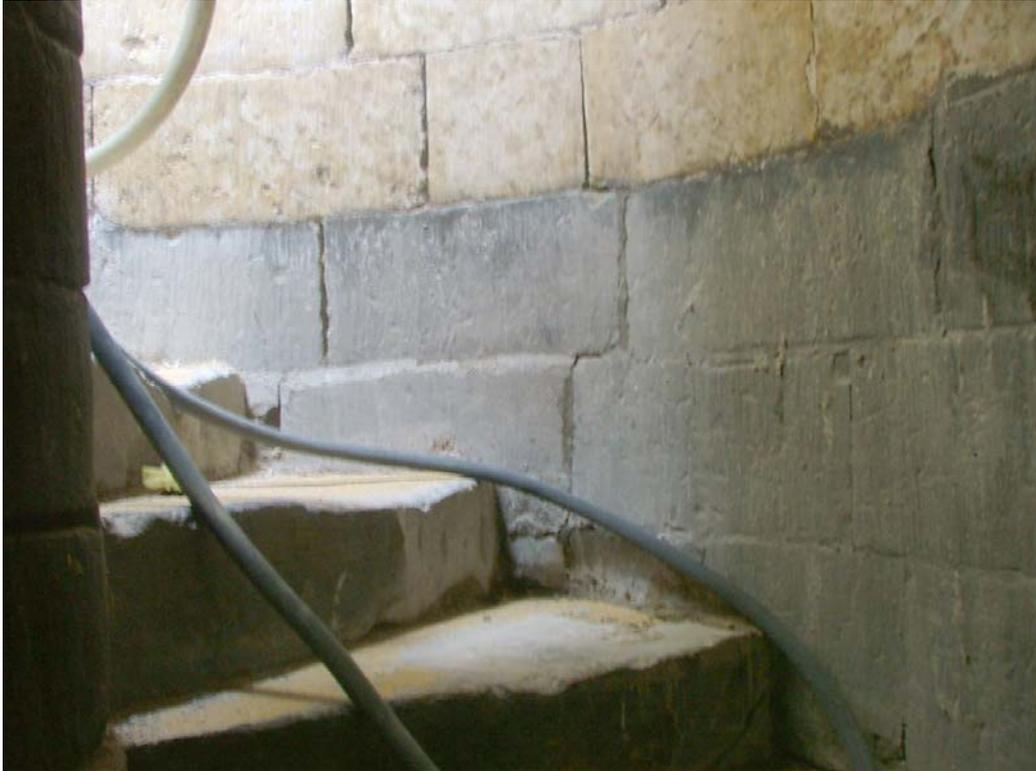
Interior of the main staircase during cleaning by sand blasting

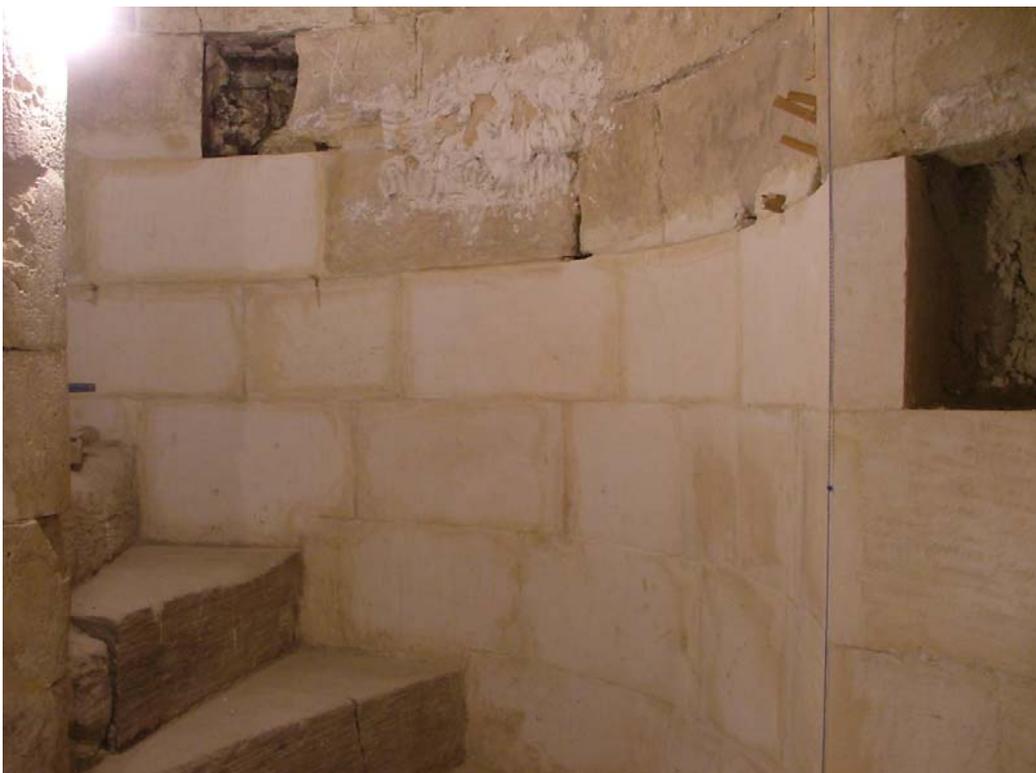
Stone replacement activities in the staircase

The mosque's main staircase showed many damaged stones which were replaced by new stones of similar nature. The electrical network was also embedded in the stone masonry during the restoration. The walls and steps of the staircase were cleaned by the sand blasting. Repointing of the wall masonry joints was finalised afterwards.

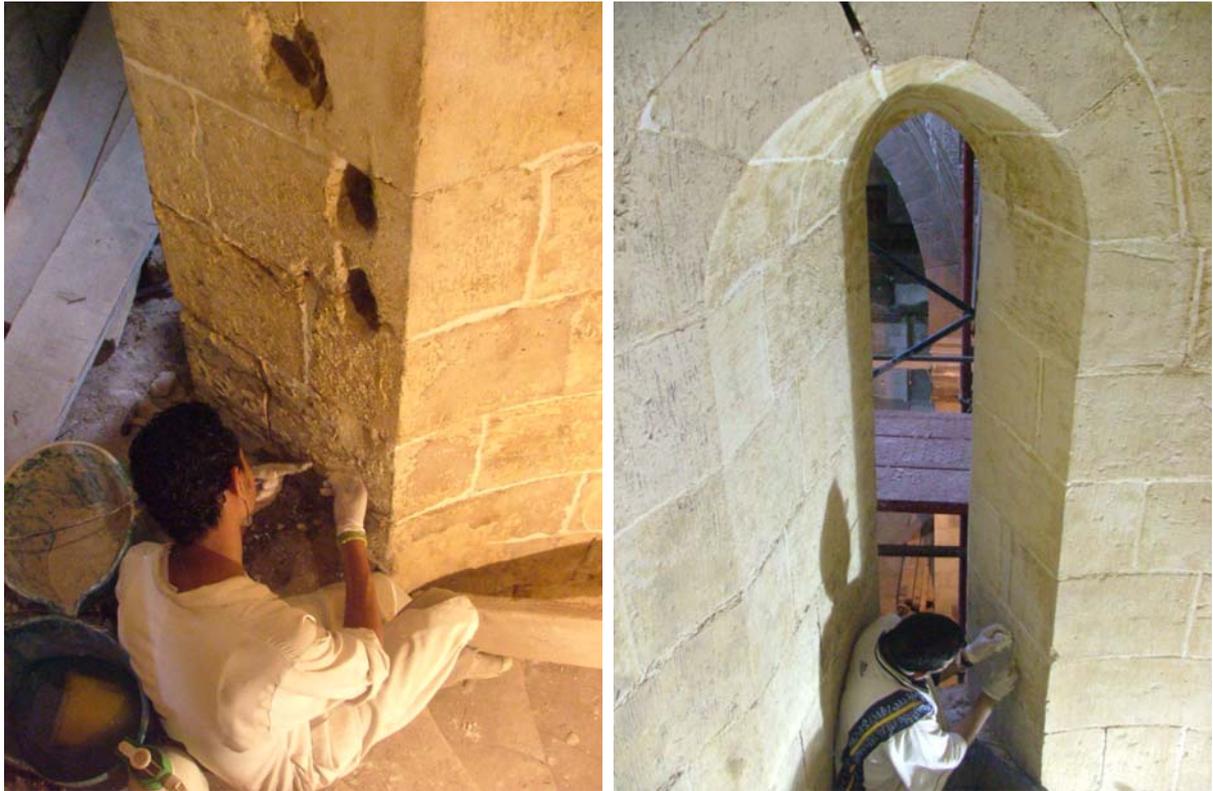
Repointing of the stone masonry after cleaning

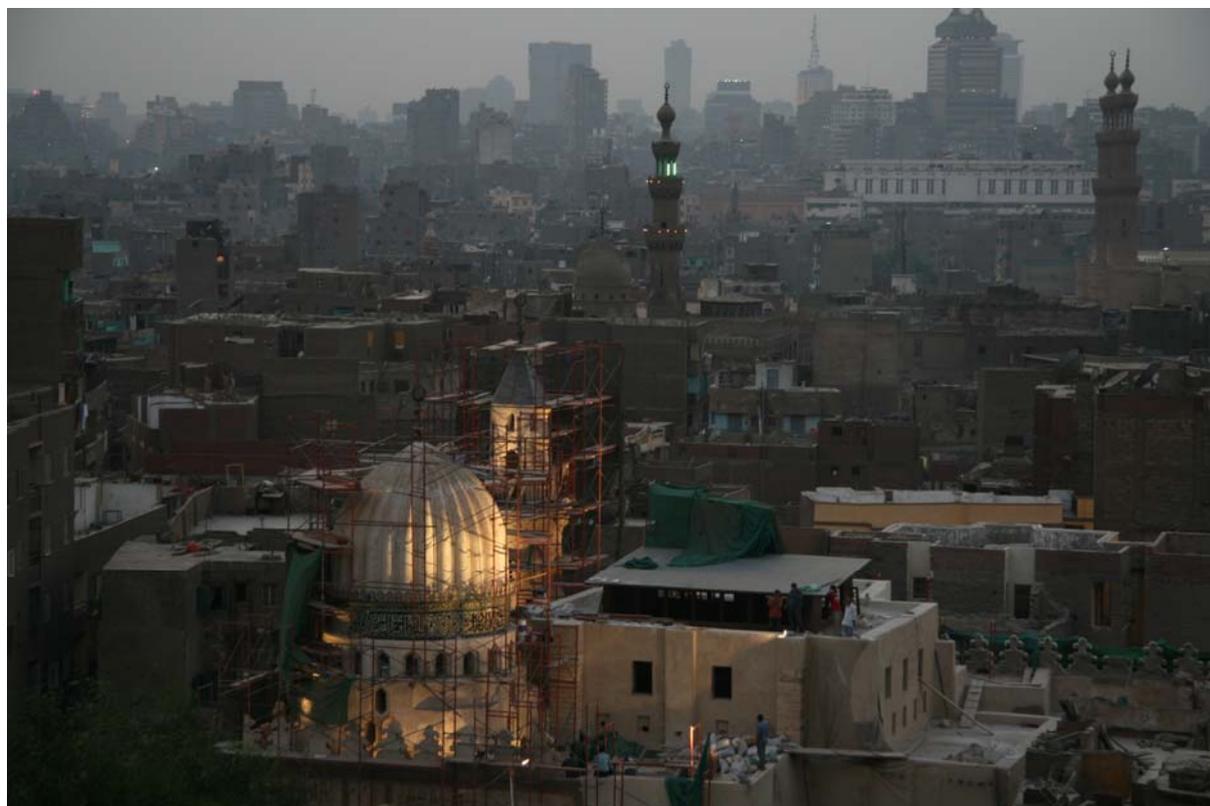
View of the exterior of the mosque during the lighting test. The photo also shows the completed activities of the exterior of the dome and minaret, as well as the shobkshaykha's insulation.

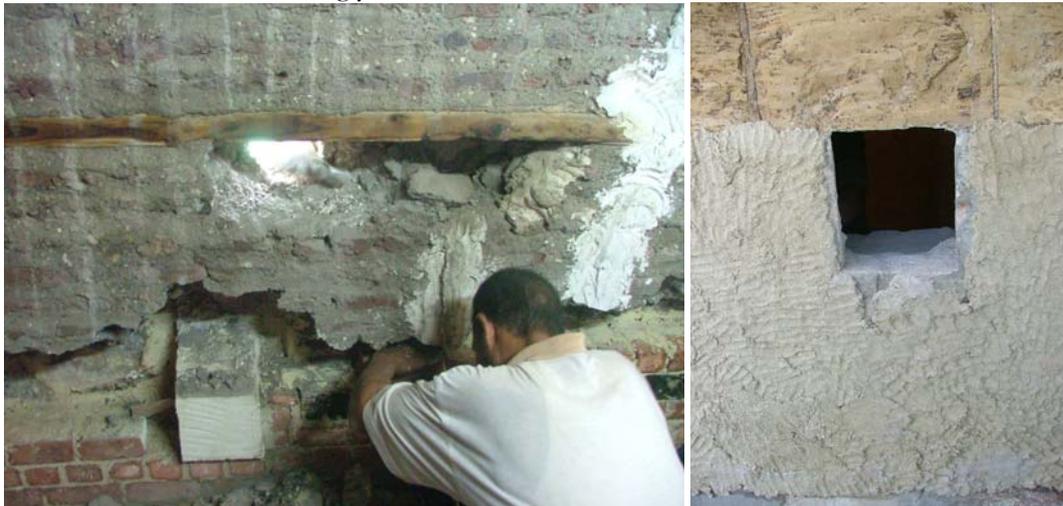
The western façade shows bulging in more than one area as well as cracks that appear from the interior of the rooms behind the façade. After investigation it was clear that the bulging and the cracks are due to the type of construction of this façade. The thickness of the wall is in some areas less than 45 cm and is composed of a stone wall on the exterior and a thin brick wall in the interior; these two are not connected and tend therefore to detach. Therefore it was decided to reconnect the two elements of the wall by removing some stones and prolonging them into the brick wall; in some areas stainless steel bars were also inserted into the stones also protruding up to the brick wall; in few areas the thickness of the brick part of the wall had to be slightly enlarged.

View of the interior of the room (1.2) on the western façade during brick repair activities and extending the stones into the brick wall (left photo shows the opening for the stone before placing it into the wall showing the thin thickness of the wall).

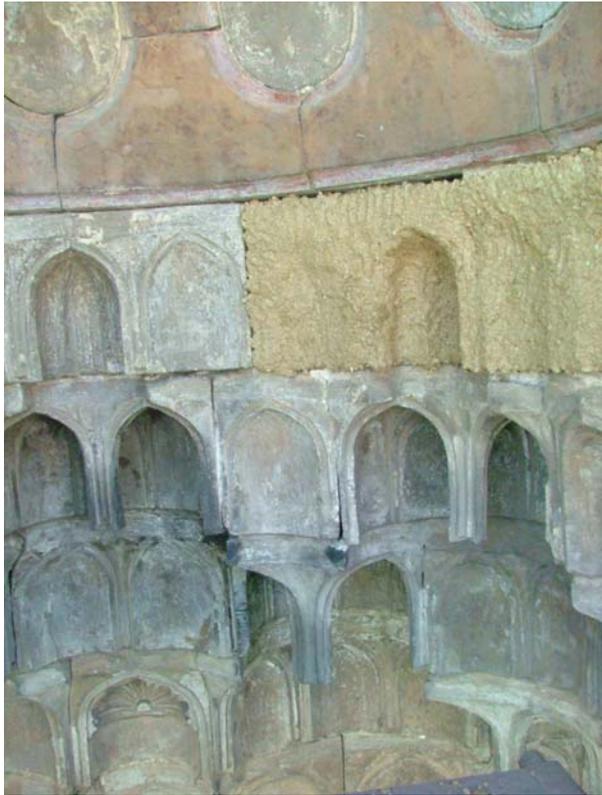
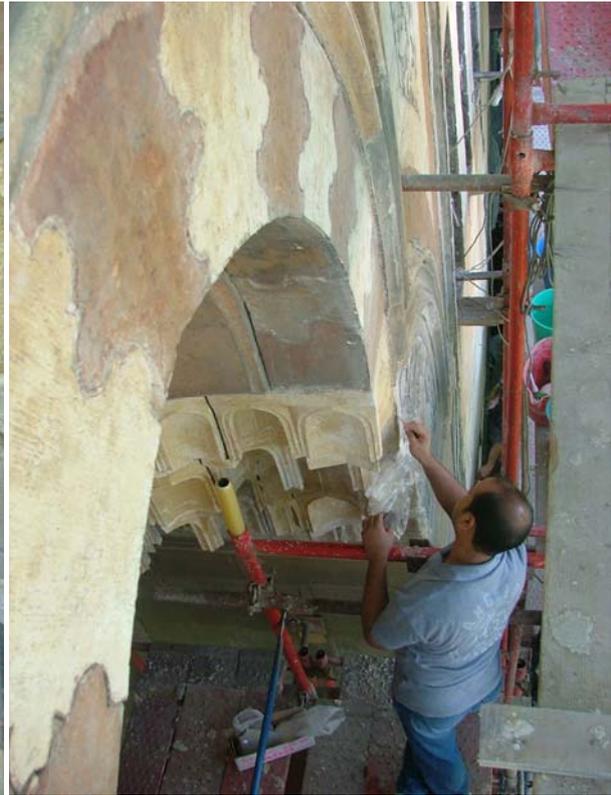
Poulticing and cleaning of the muqarnas entrance porch and its results

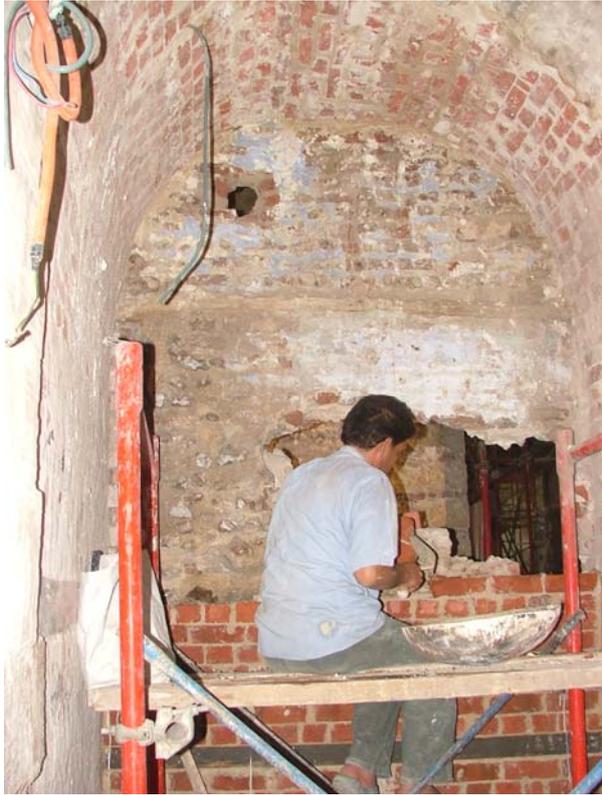
Some of the shops were in a bad structural condition and required a lot of brick repair of their vaults and walls; during this activity, electrical wires were also installed to fit the use requirements of the shop owners. The shops were then plastered. The shops with stone vaults are currently being cleaned.

Brick repair and reconstruction activities of damaged and crumbling brick walls in the shops on the western façade

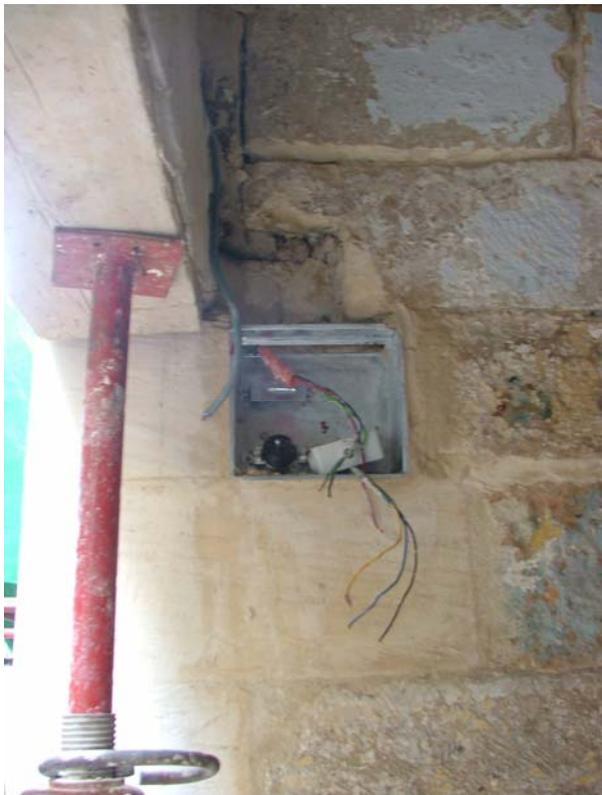
Electrical boxes for the shops

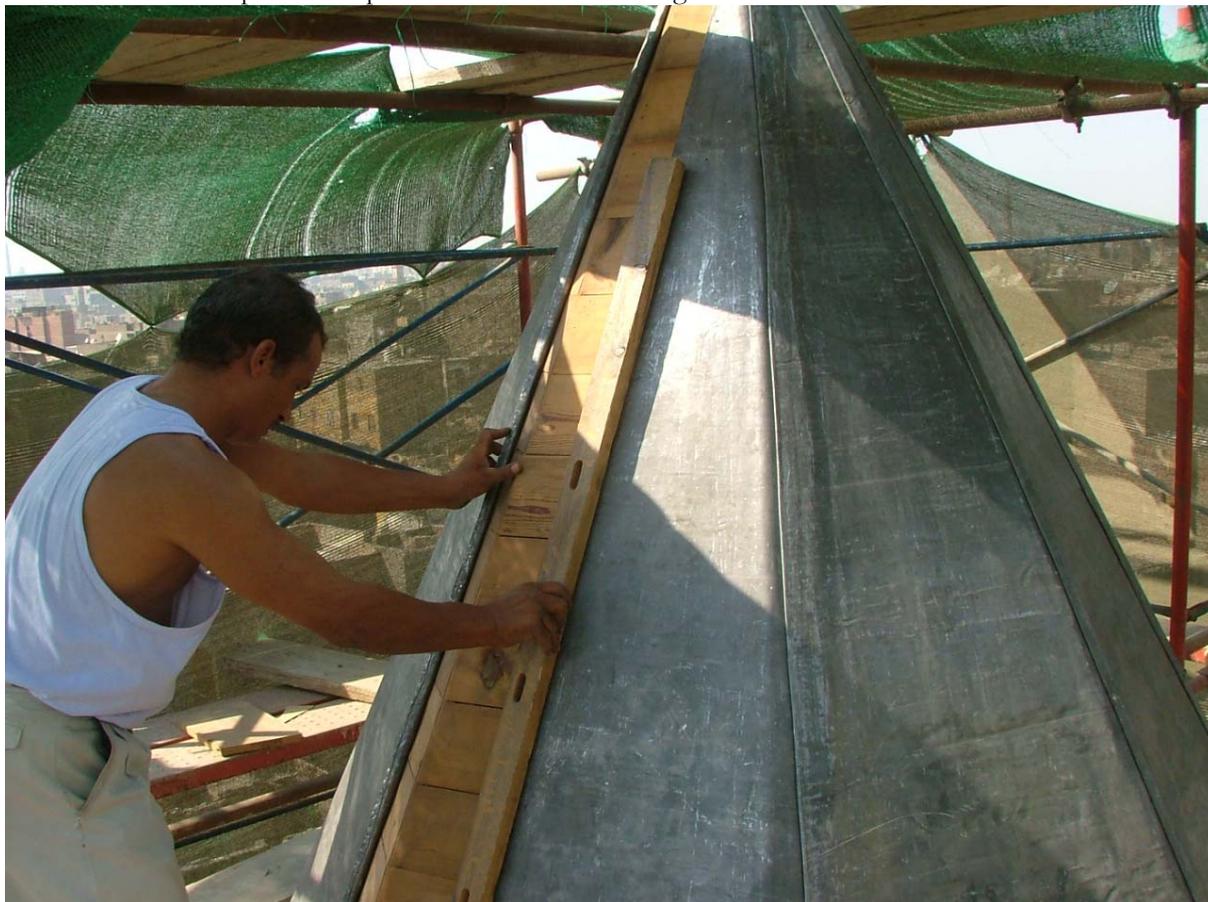
Placing the lead sheet of the insulation of the minaret

All remaining activities on the minaret were finalized: the balcony was tiled, the insulation of the upper wooden part was insulated in lead and the missing part of the crescent was manufactured and put in place. The outer and inner parts were plastered and the interior lights were installed.

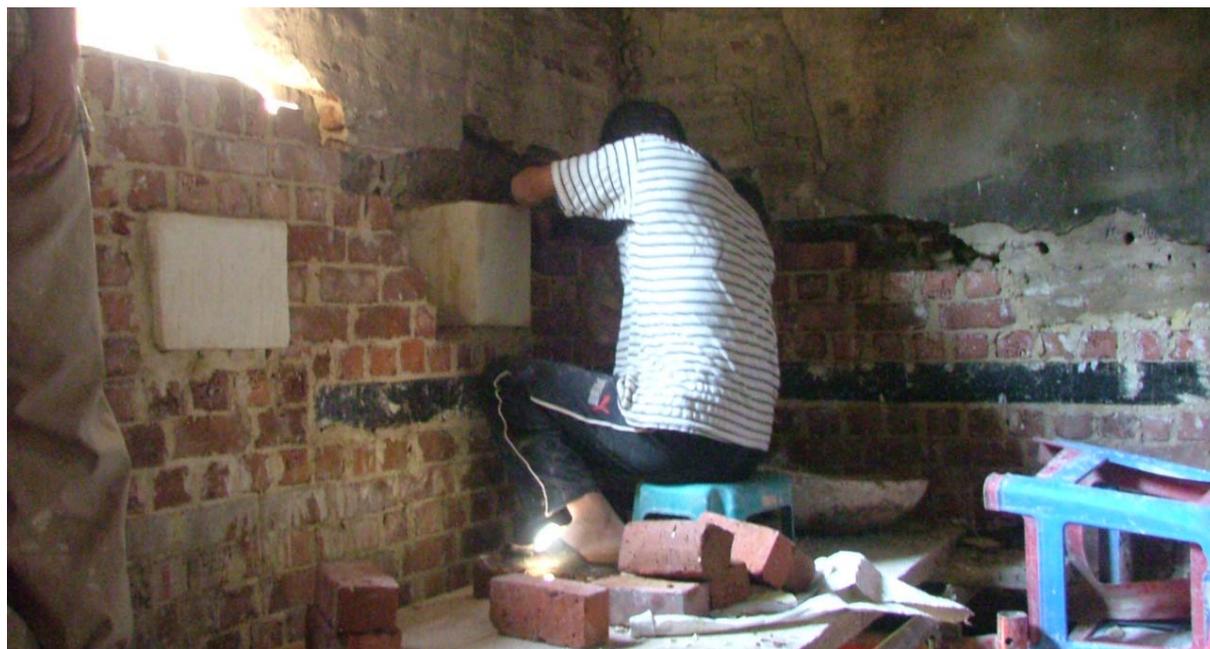
Brick repair and stitching activity in room M1

Brick repair activities took place in room M1, also in relation to the western façade to ensure the bonding between the exterior stones of the façade and the brick part in the rooms, as mentioned earlier in the report. The wooden beams and shingles of the ceiling of room M1 (being the flooring of room 1.2) were in a very bad condition and were replaced with new ones. This was followed by brick repair activities in room 1.2 and bonding with the western façade. This activity was completed and currently the room is being plastered.

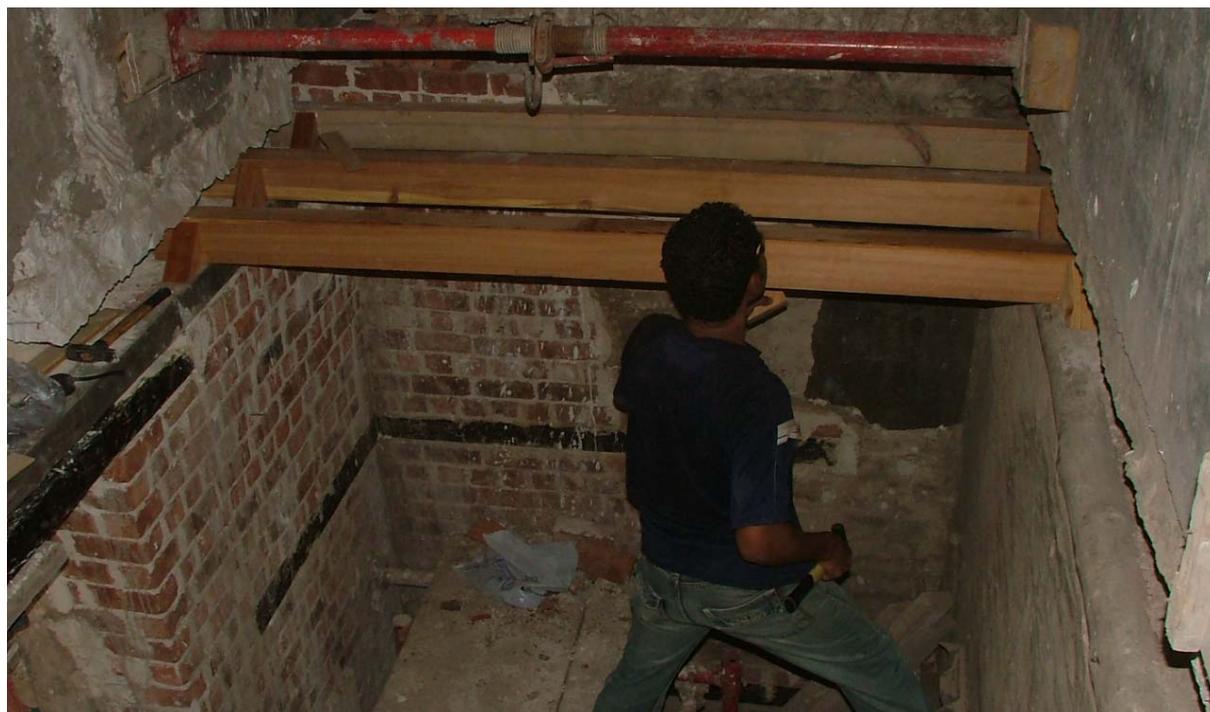
Erecting the wooden ceiling of room M1

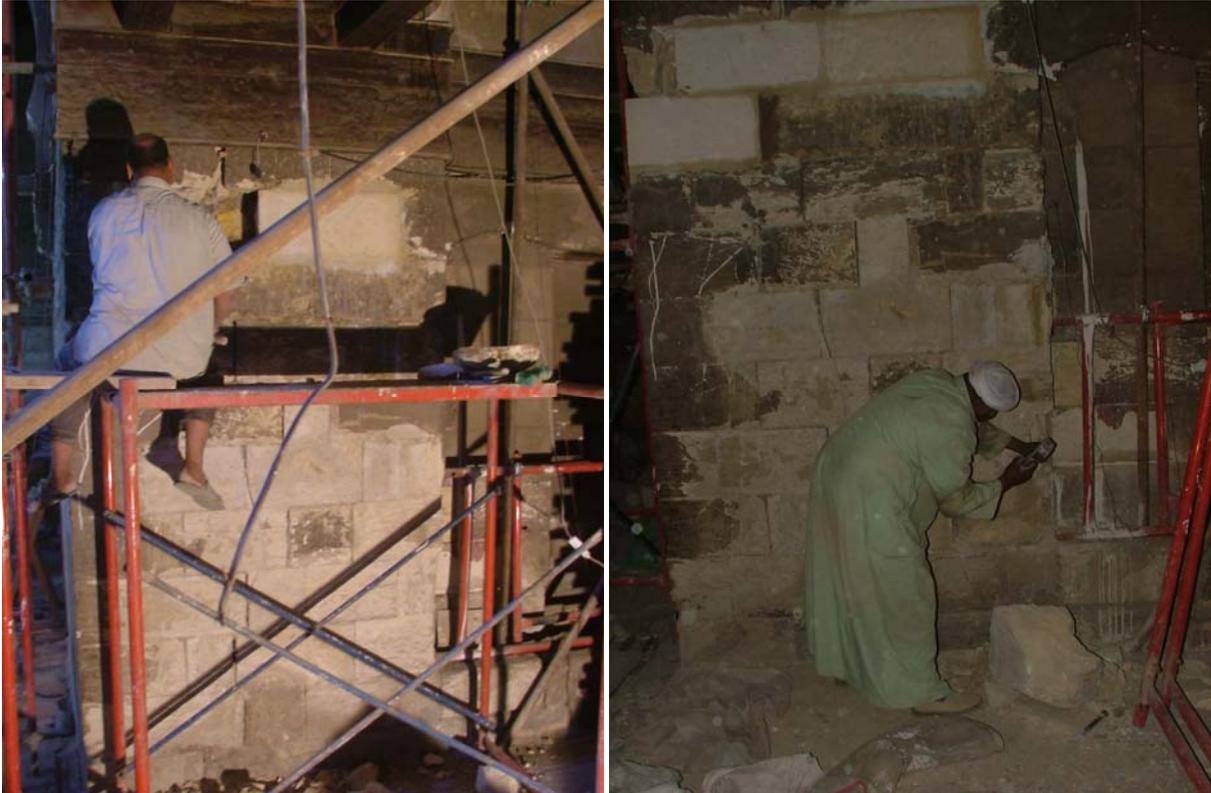
Stone replacement activities in the west iwan

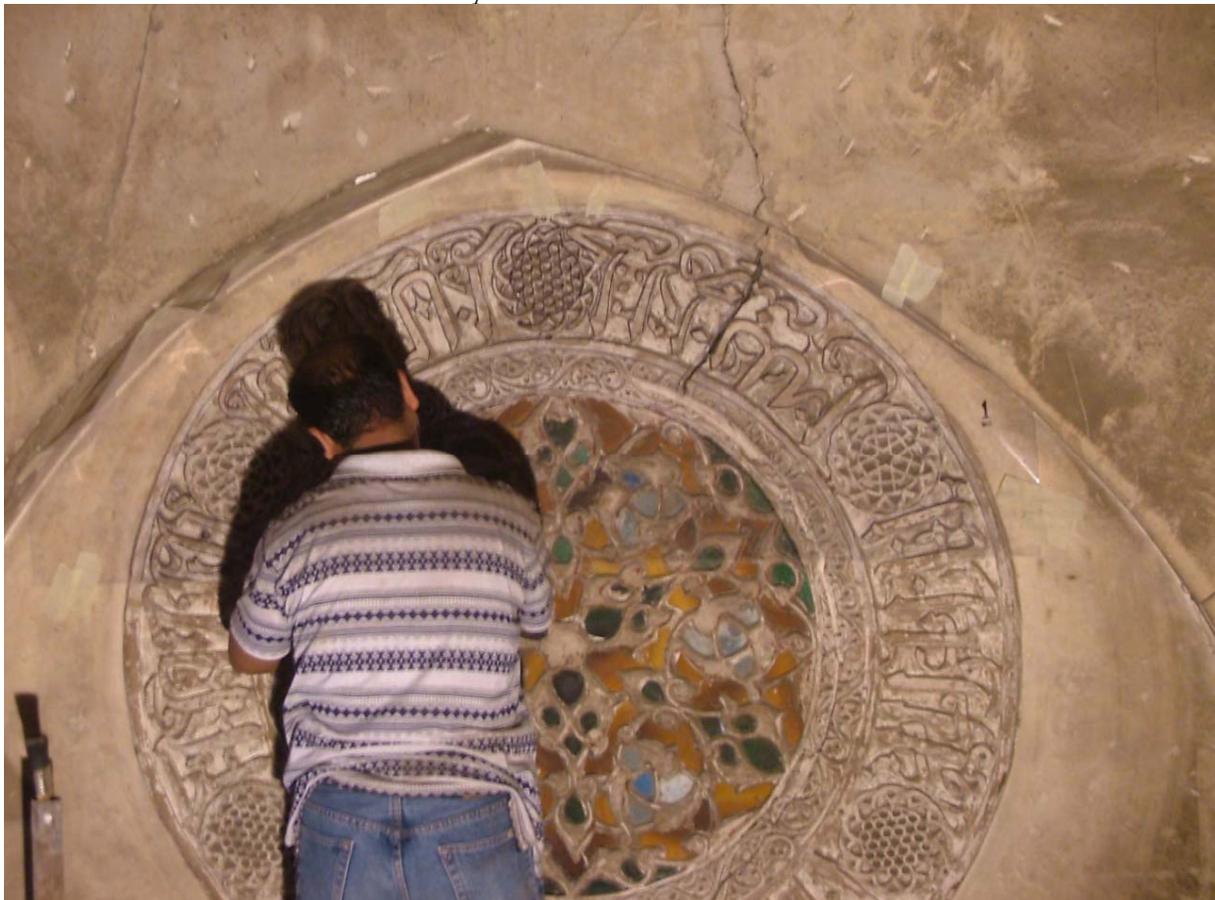
Documenting the stucco roundel in the west iwan

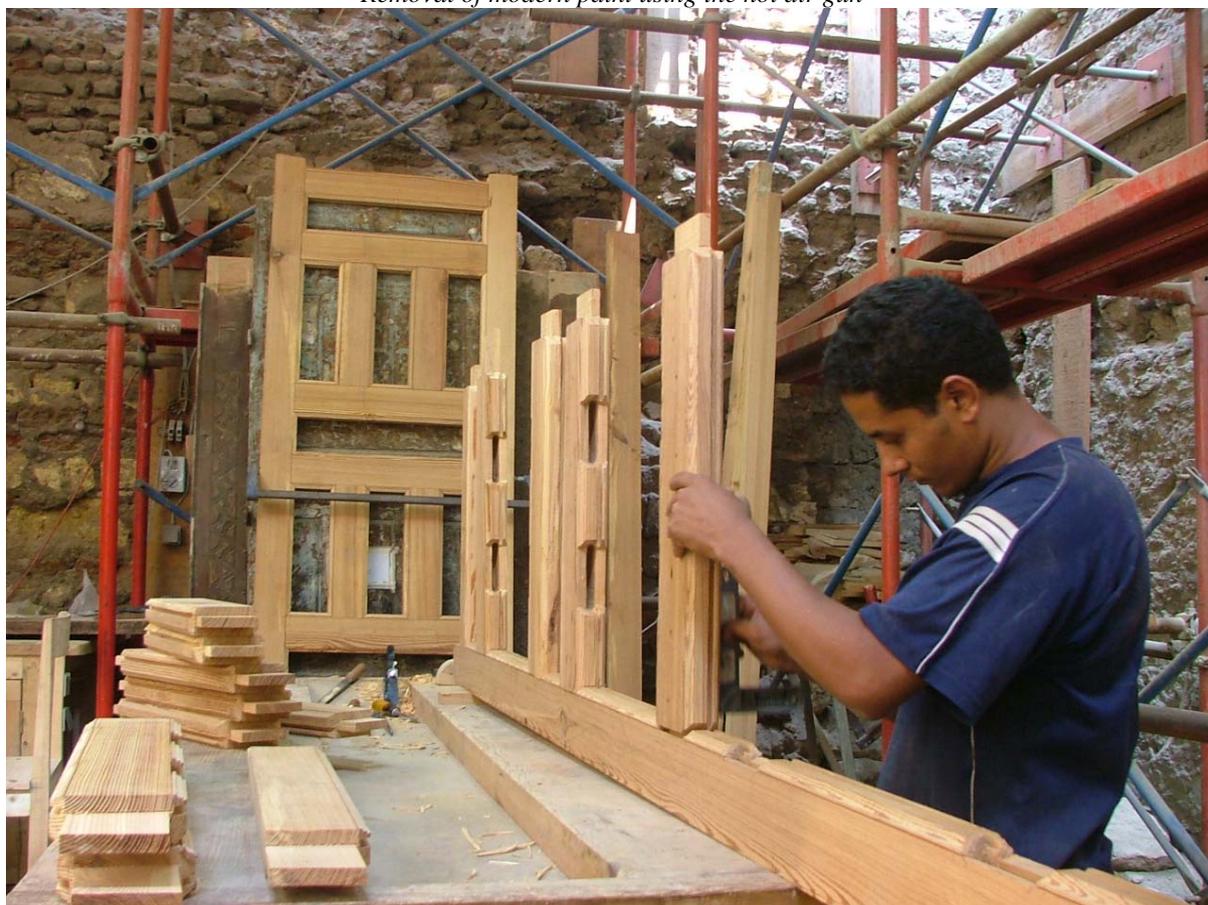
Manufacturing a new wooden door replacing the damaged one of shop 5

The wooden doors of the shops were repaired; their modern paint layer was cleaned using the paint remover and in other cases the hot air gun. The wood of the last shop's door was in a very bad condition and a new door was accordingly manufactured.

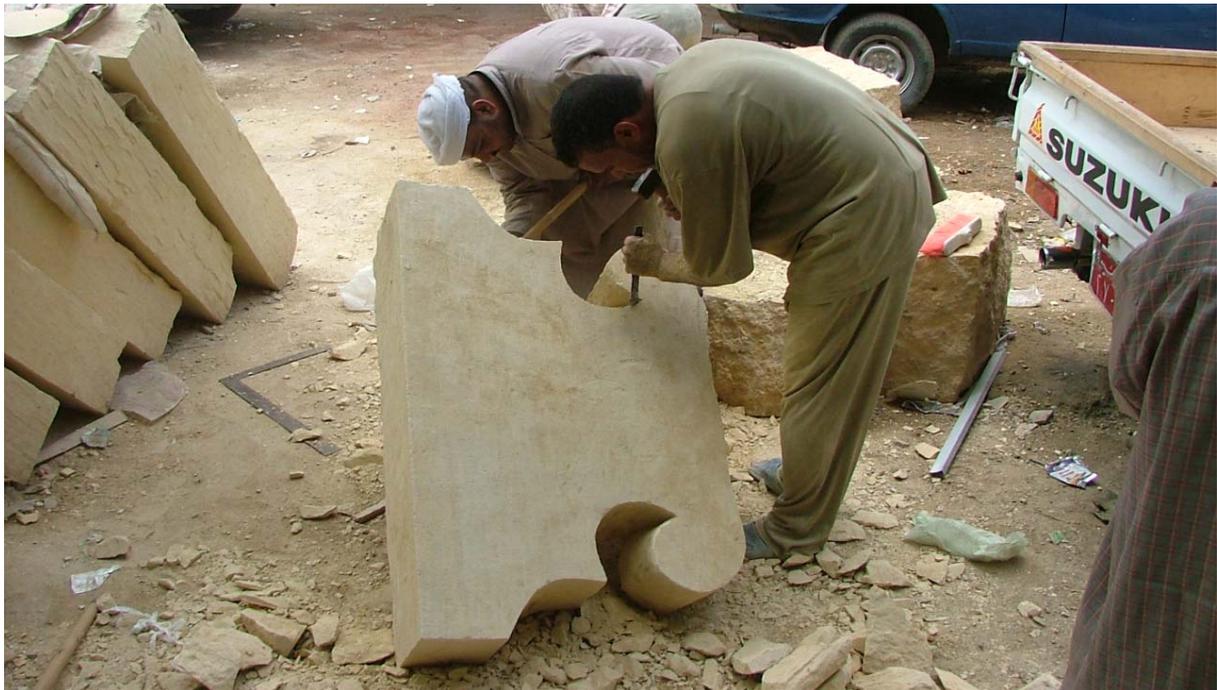
Carving the missing crenellation of the south (main) façade

The missing crenellations on the south (main) façade were carved, brought up to the roof and installed in place. The missing crenellations on the right side of the west façade were also carved and erected.

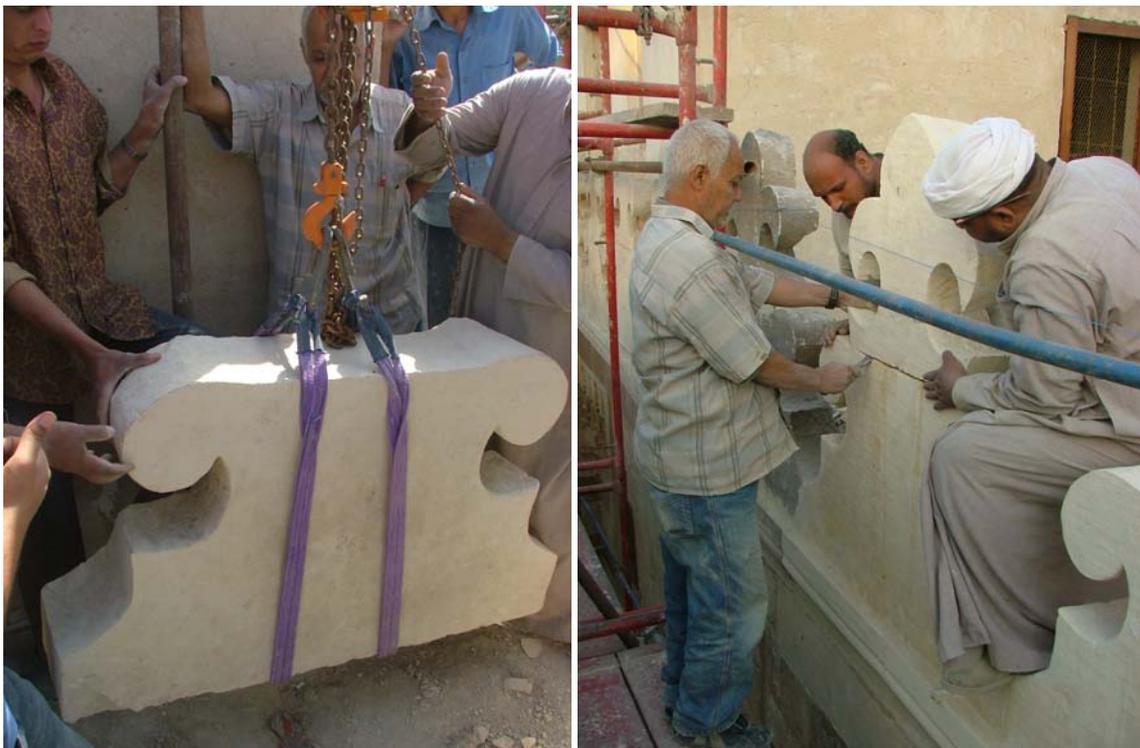
Activities of placing the missing crenellations
