ANNUAL REPORT

December 2006 – December 2007

“Conservation of the Mosque of Aslam al-Silahdar in Darb al Ahmar, Cairo”

**QUARTERLY PROGRESS REPORT
DECEMBER 2006-FEBRUARY 2007**

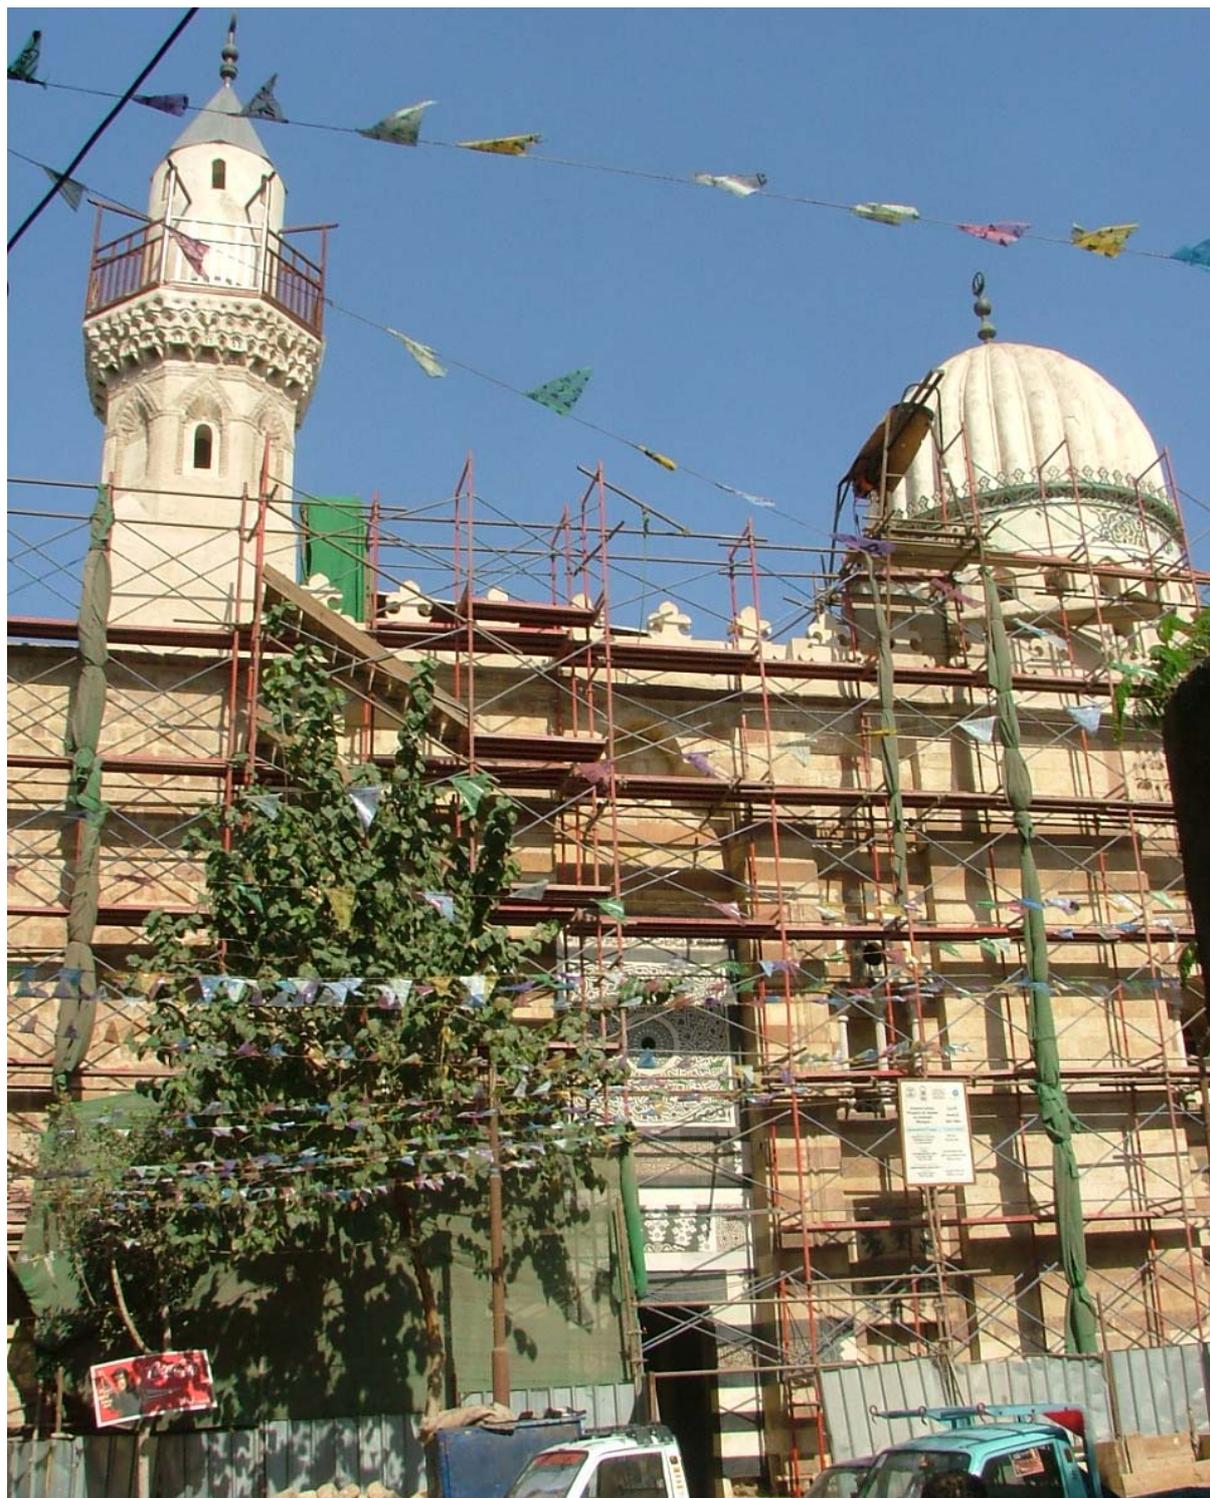
General view of the South façade

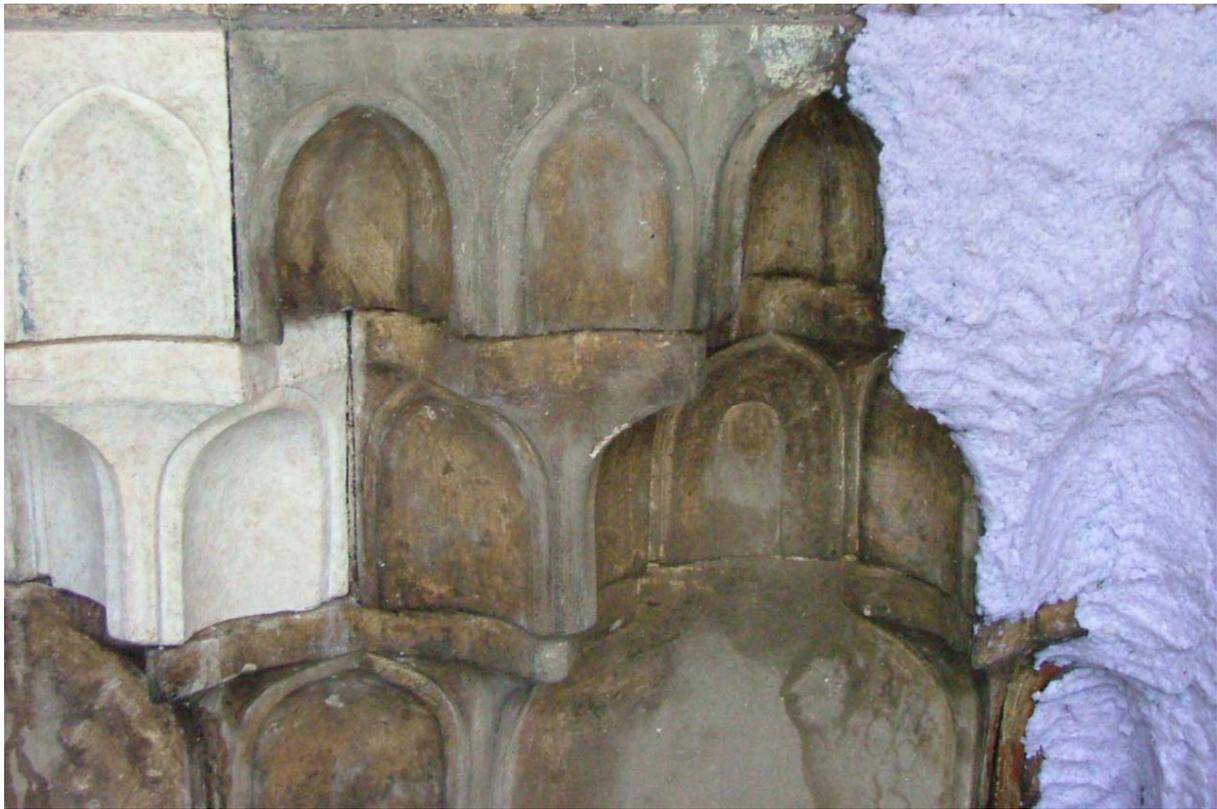
Detail showing the muqarnas on the side entrance portal

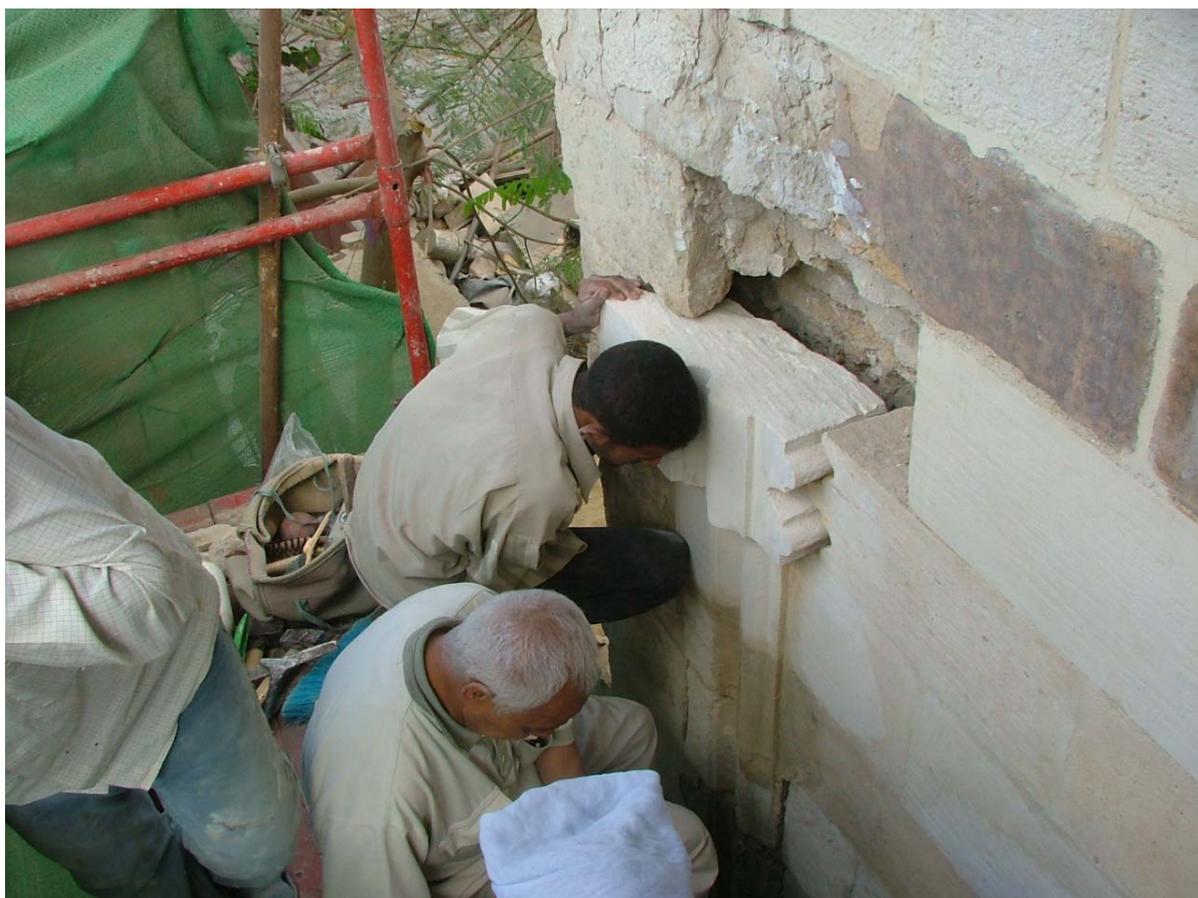
Stone replacement activities on the lower part of the west façade

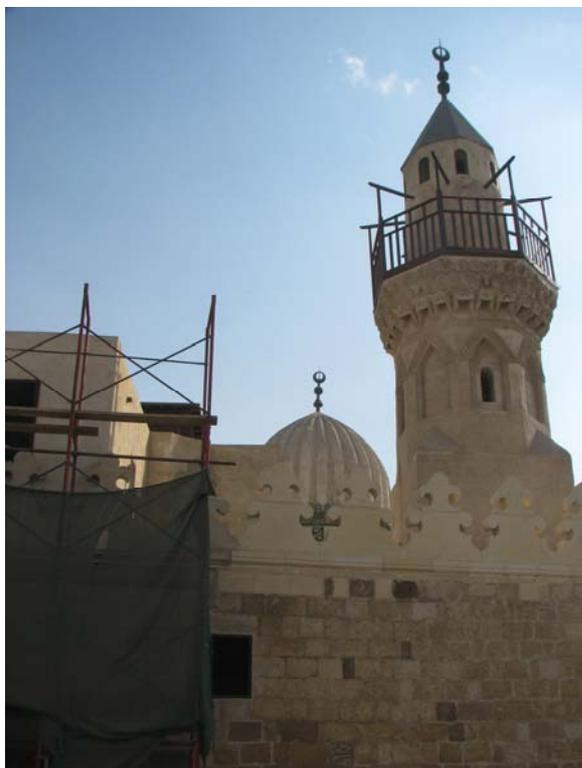
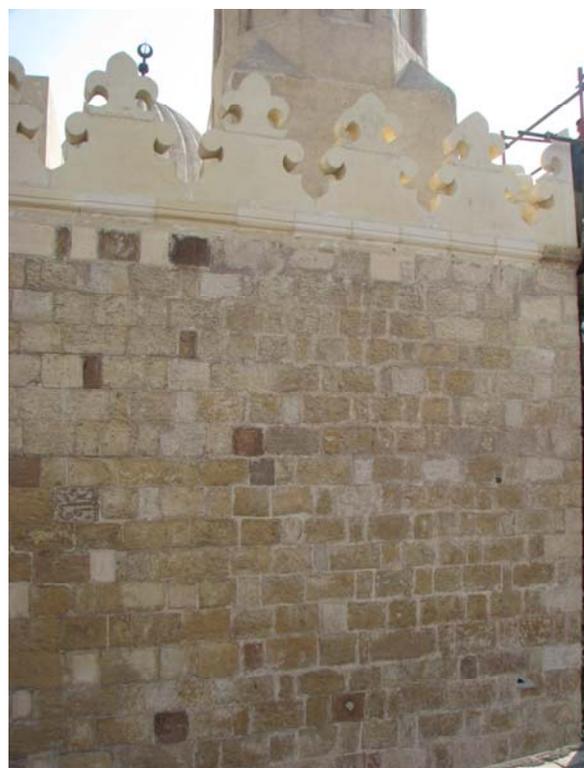
Views of the west façade after cleaning and inserting the restored wooden elements

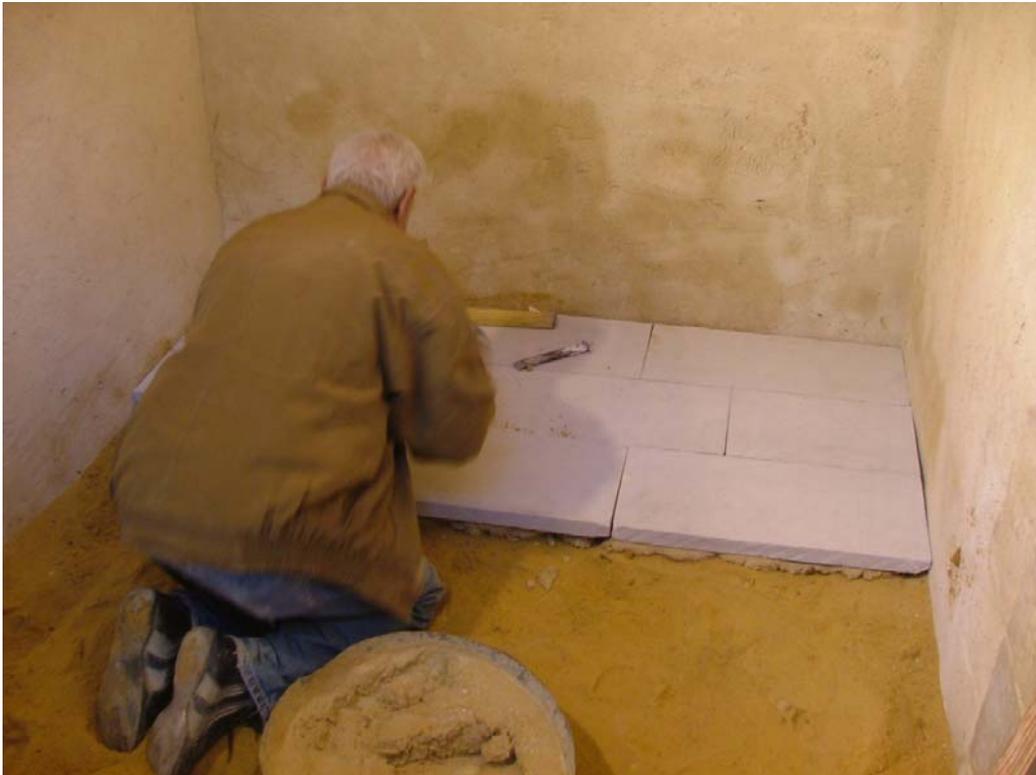
Tiling activities of one of the shops on the west façade

All remaining activities in the five shops were finalized; the walls were plastered and the floors were tiled. Some remaining activities of stone replacement and stone cleaning were also finalized.

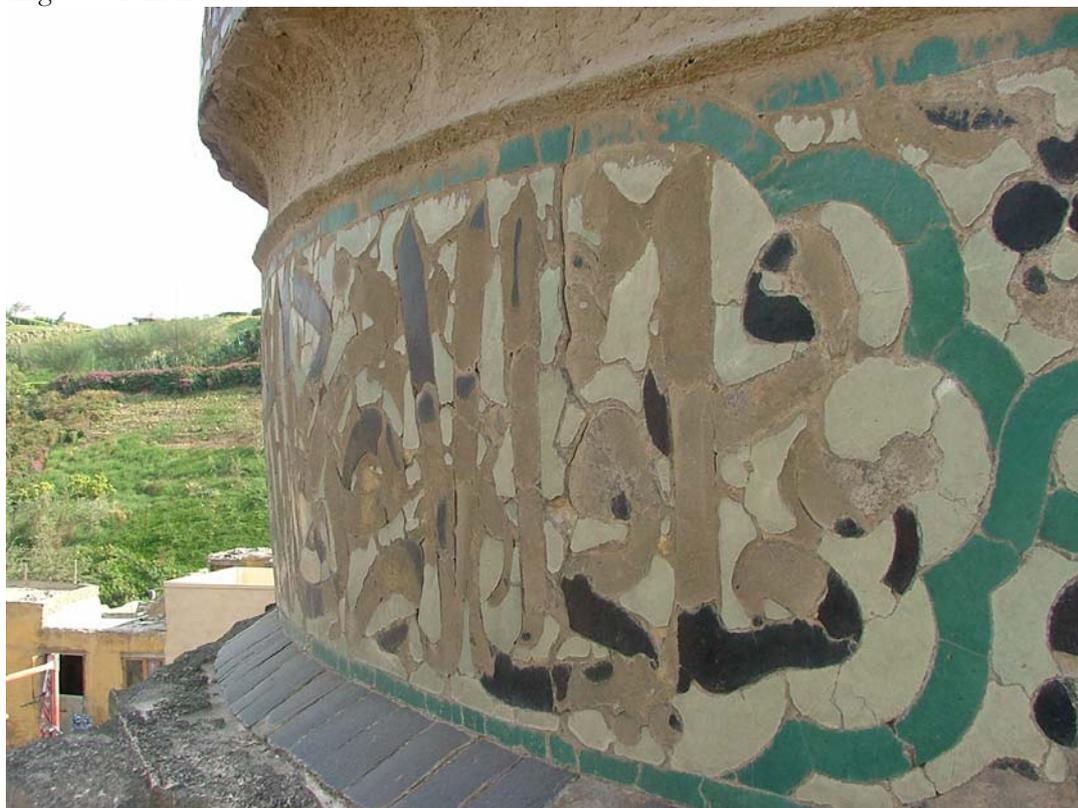
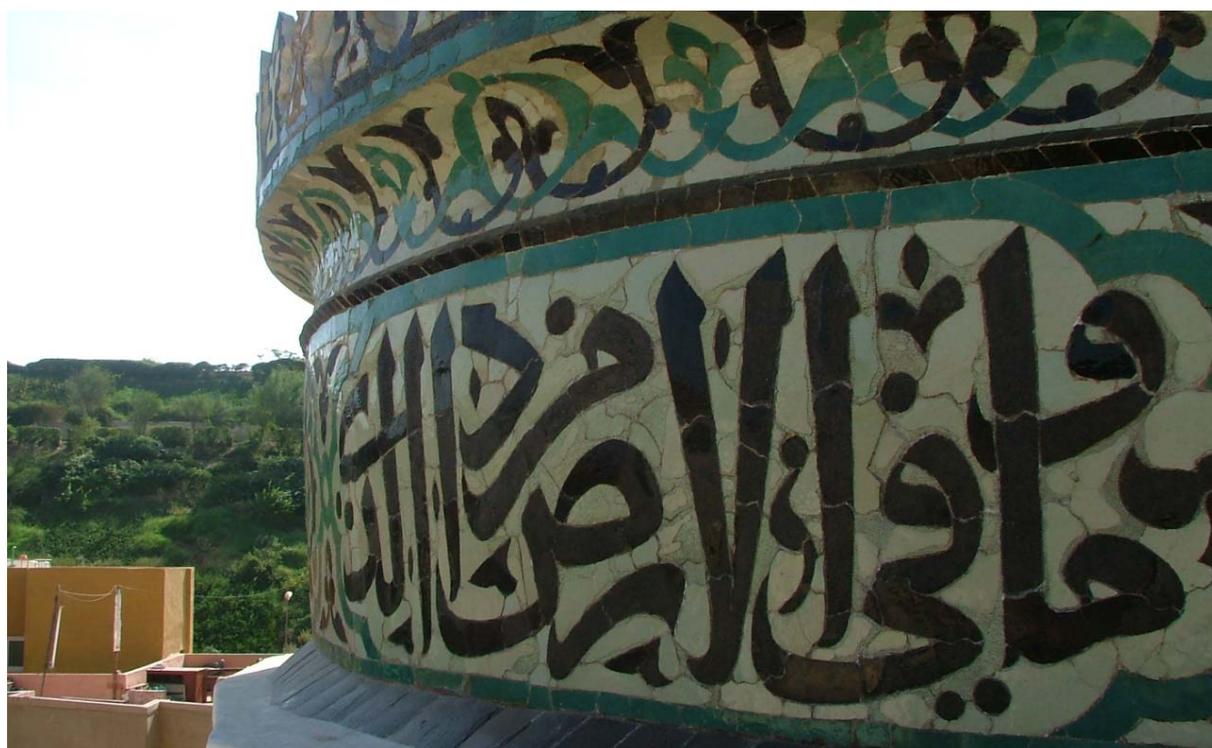
Details of the inscription band on the exterior of the dome before and after intervention

The retouching of the crenellations (made in plaster), the inscription band and its floral decoration was completed. A decision is being studied concerning the completion of the inscription band in the areas where no ceramic tiles are found. The existing gypsum grills with glass on the interior of the mausoleum were cleaned from the outside. As for the exterior gypsum windows (which are missing) designs were proposed to the SCA and discussions are taking place concerning the matter. The scaffolding was dismantled.

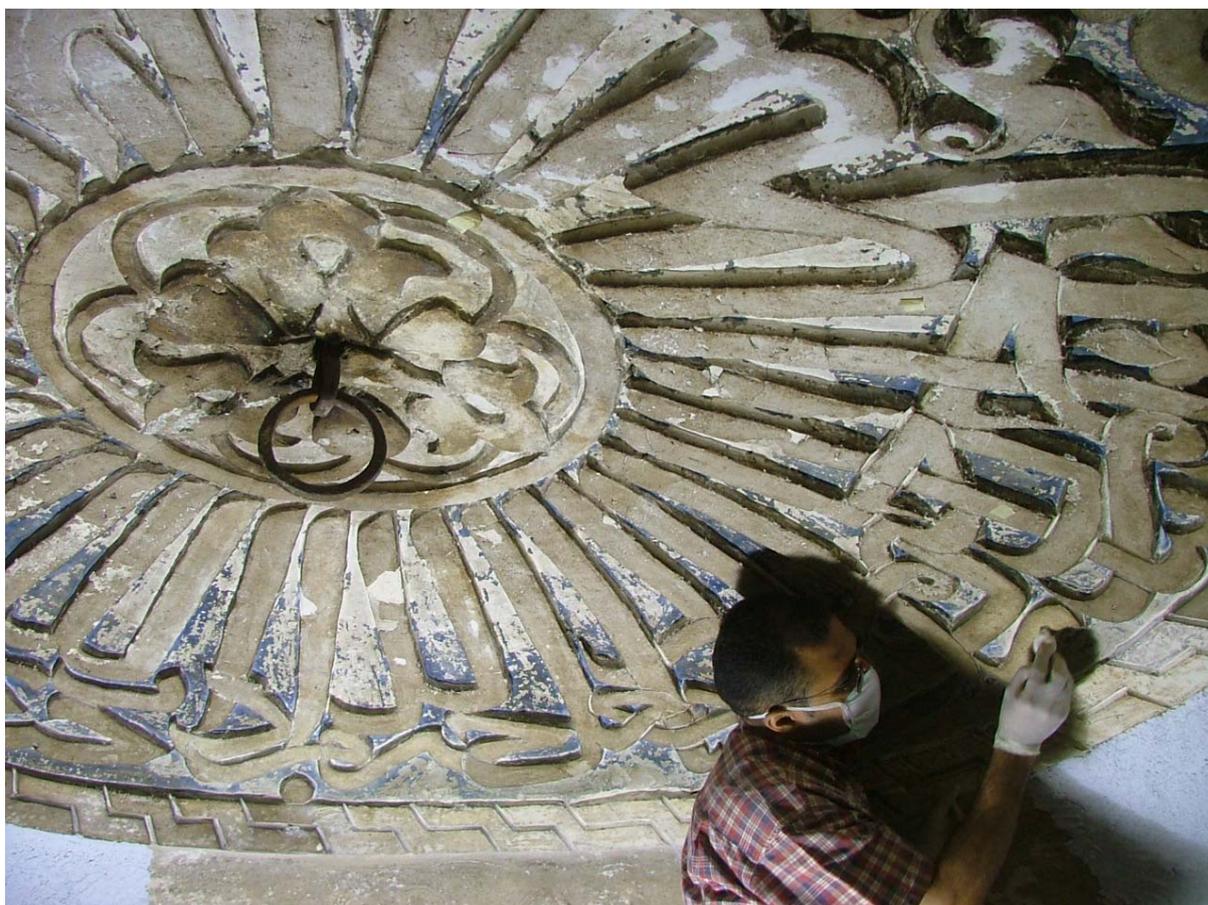
View of the roundel during cleaning

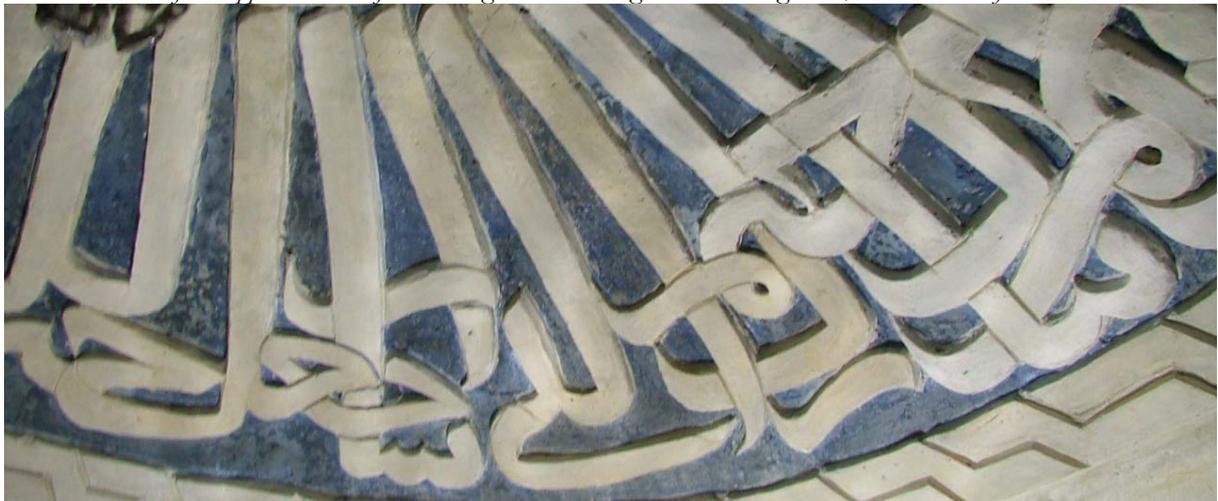
On the lower levels of the mausoleum some gypsum grills and windows were in a very bad condition with numerous missing parts. These are being repaired in-situ. One grill was in a quite bad condition and was dismantled, repaired, cleaned and completed.

Views of repairing and protecting the gypsum decoration in-situ

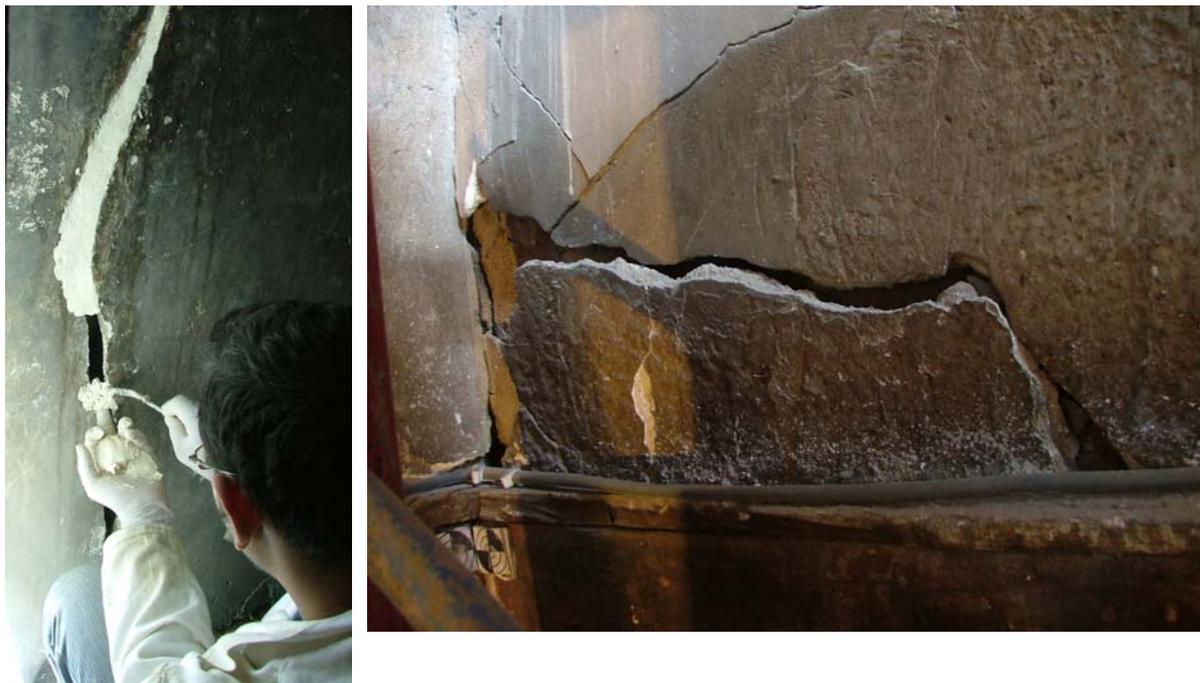
Example of the condition of the gypsum plaster in the courtyard showing serious cracks and detachment

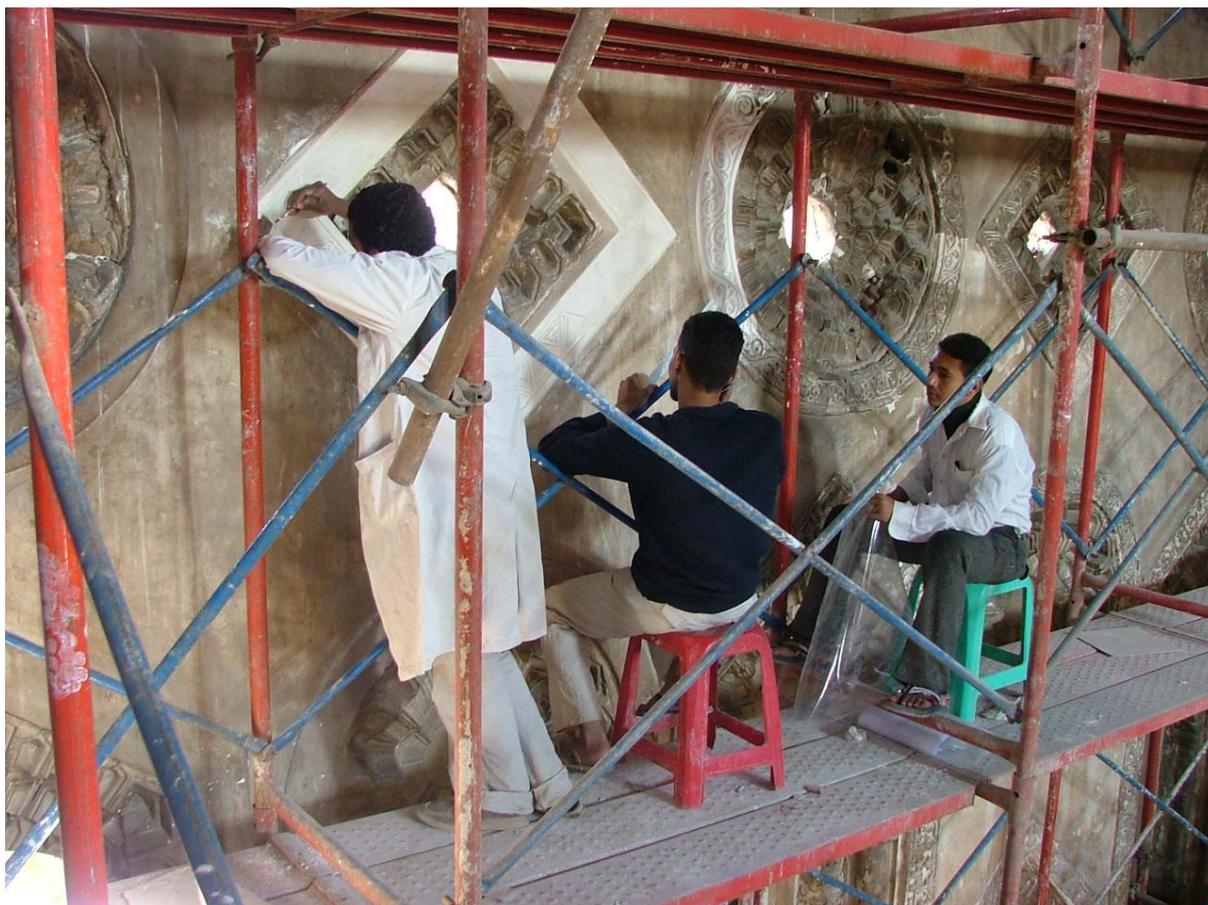
Activities of completing the gypsum decoration of the roundels and lozenges in the courtyard

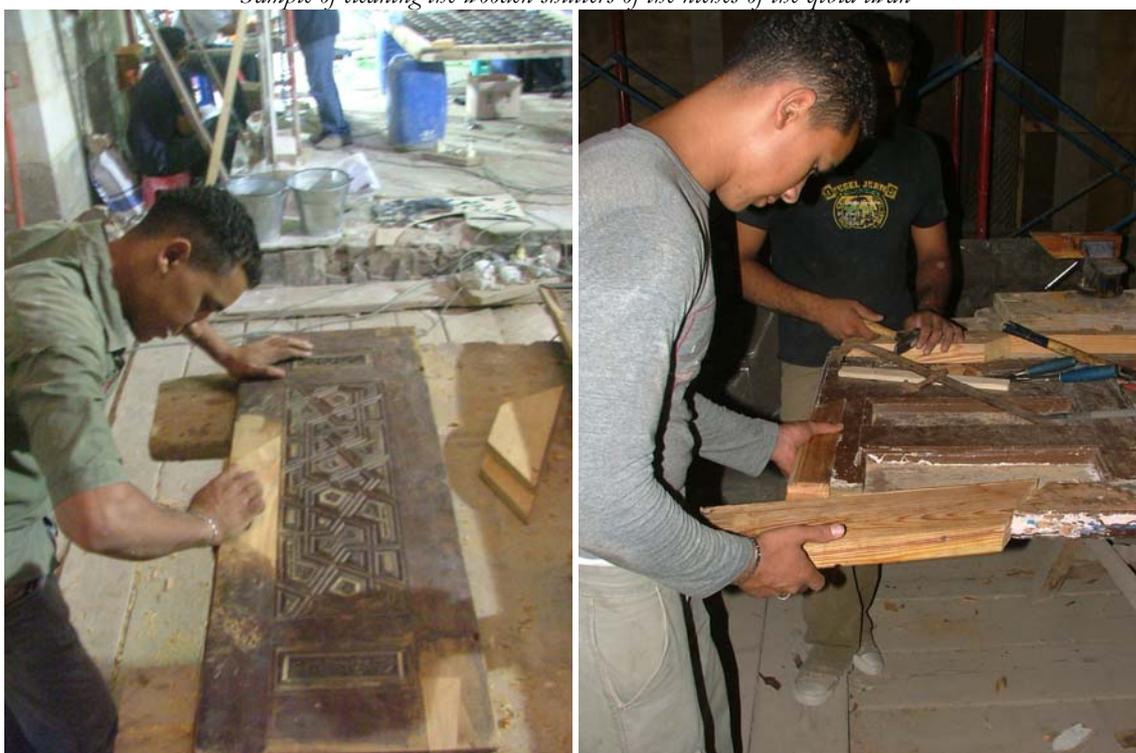
Architectural repair of damaged parts in the wooden shutters
