AGA KHAN TRUST FOR CULTURE

CONSERVATION PROJECT OF THE
ASLAM AL-SILAH DAR MOSQUE

QUARTERLY PROGRESS REPORT
JUNE-AUGUST 2006

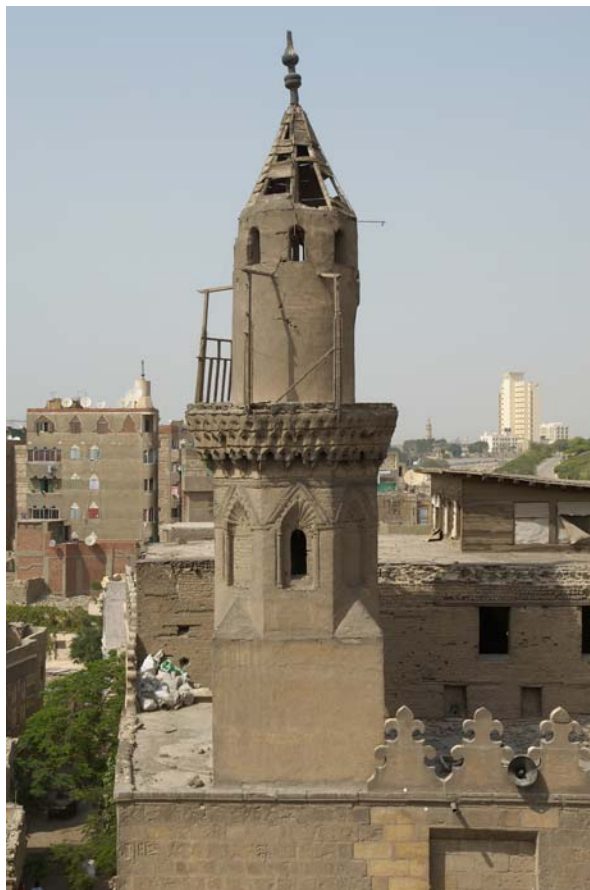
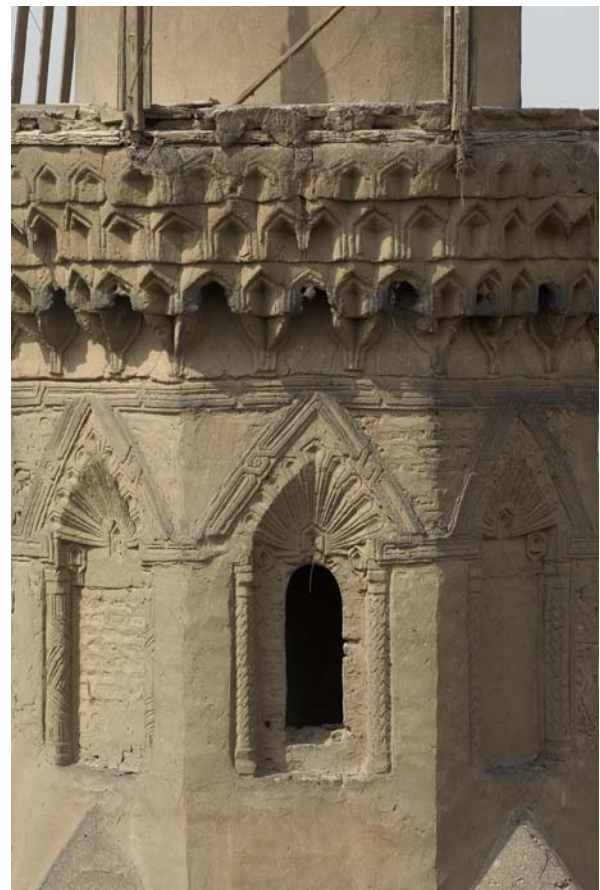
The assessment of the stability of the minaret is one part of the structural study that was performed. The minaret was found stable but is in an advanced condition of deterioration. The elevations, roof and platforms of the minaret will be subject to global conservation and restoration intervention. The plaster and stucco molding surfaces will be cleaned and injected, while the wooden roof and handrail will be restored. The roofing of the pencil-shape minaret will be made of lead sheets.

The southern elevation of the minaret (general view and detail) (photo M. Kacicnik)

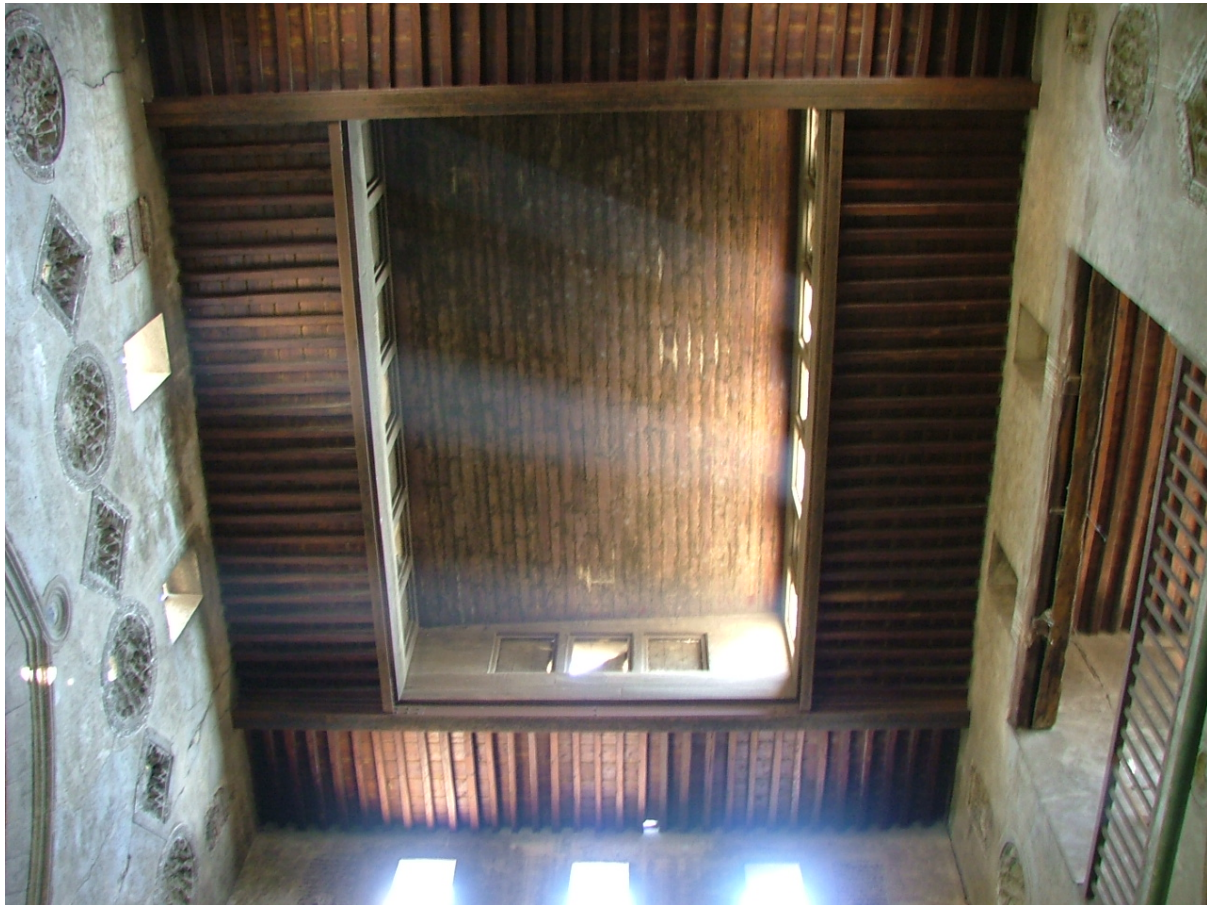
A campaign of cleaning and removal of fill was carried out in order to expose the shingles and assess their condition. Part of the structural study was the assessment of the bearing capacity of roof ceilings.

The roof of the prayer area prior to conservation work start

A provision of old recycled wood (azizi), insulation sheets and roofing materials were delivered. The entire surface of roof covering the mosque and the adjacent rooms will be subject to a carpentry and roofing restoration. The shingles will be partially replaced, and insulation sheet made of bitumen will be applied on top of the shingles and a roofing package of mortar screed with additives will be laid. The upper part of the brick walls will be restored in order to provide adequate support to the roof.

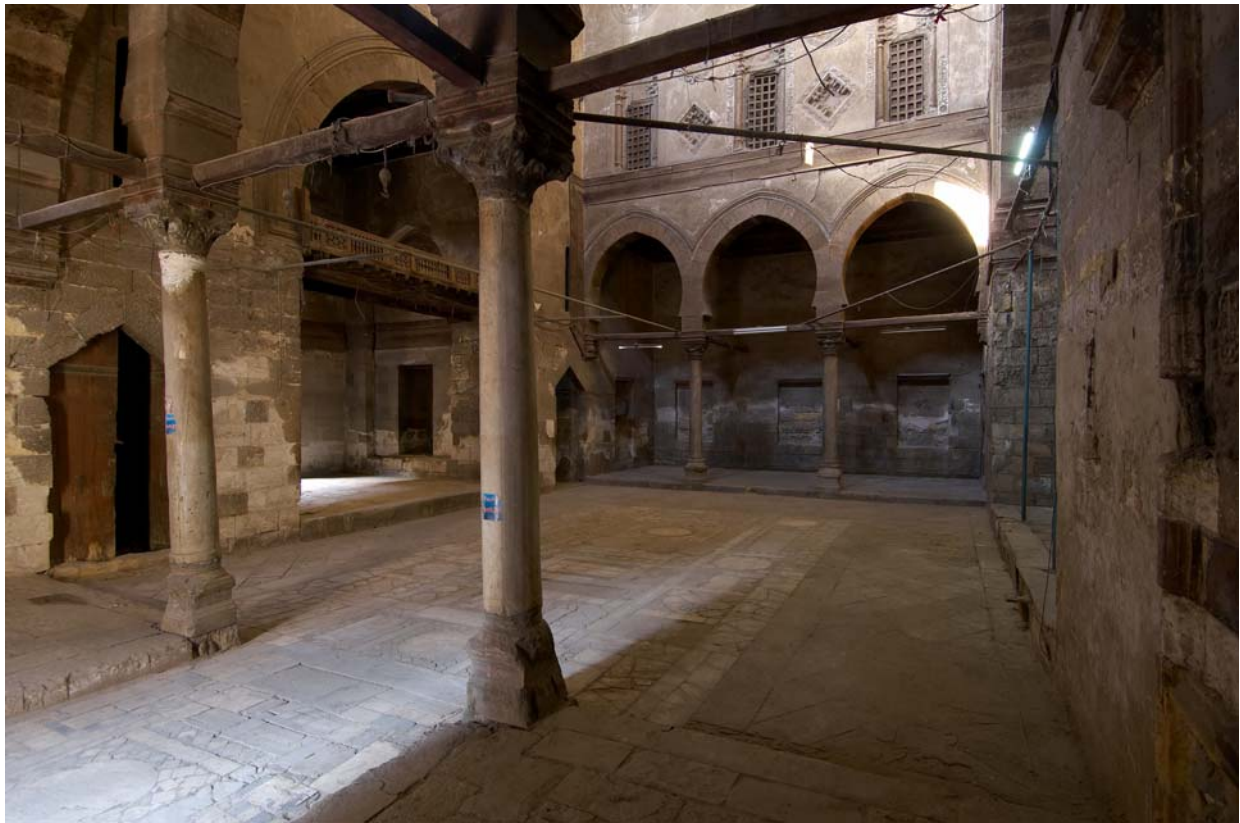
A campaign of cleaning was carried out in order to be able to survey and assess the condition of surfaces. All mechanical, sound and lighting fittings, carpets and furniture belonging to the Waqf were dismantled and taken away by the Waqf Authority.

The interior space of the mosque prior to conservation (photo M. Kacicnik)

The interior spaces of the mosque are not planned to be restored prior to mid 2007. This location may be used as a storing place for materials and equipment till the second quarter of 2007.
