CONSERVATION PROJECT OF THE
ASLAM AL-SILAH DAR MOSQUE

QUARTERLY PROGRESS REPORT

October – December 2008

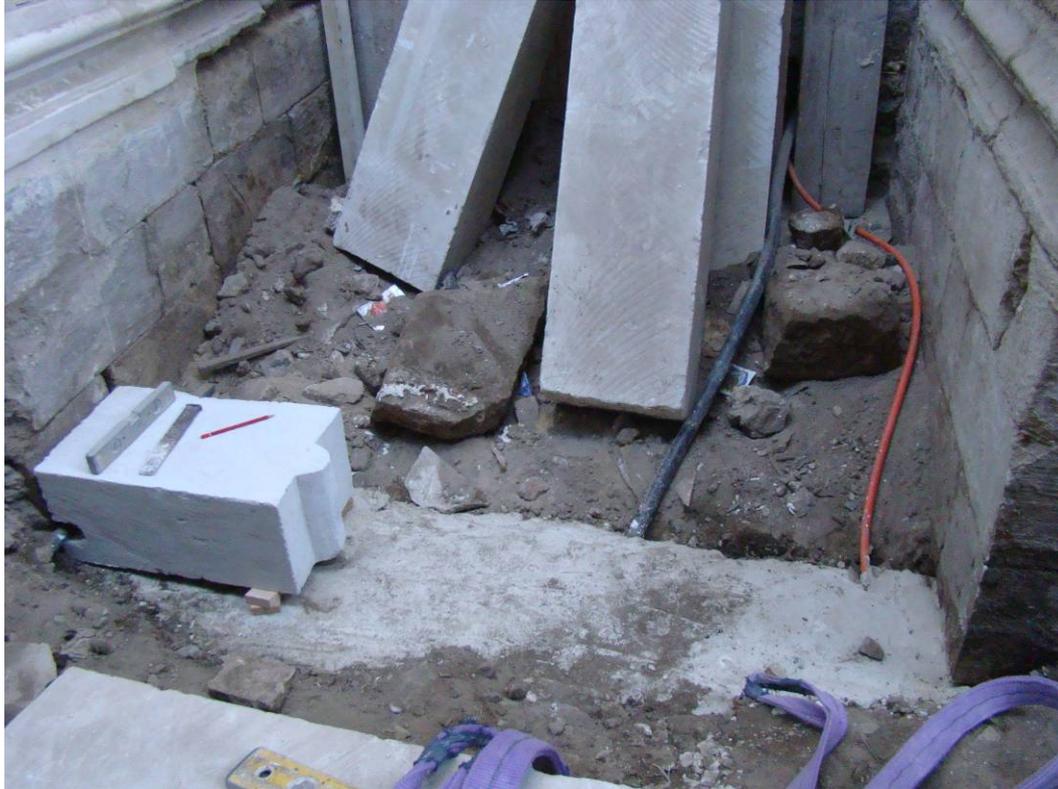
Work progress on the Western portal entrance

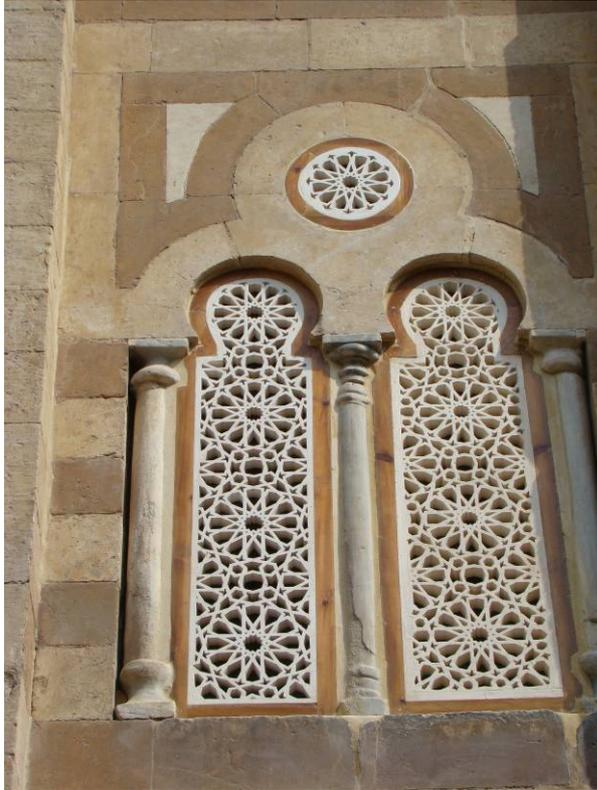
Sample of the proposed gypsum windows

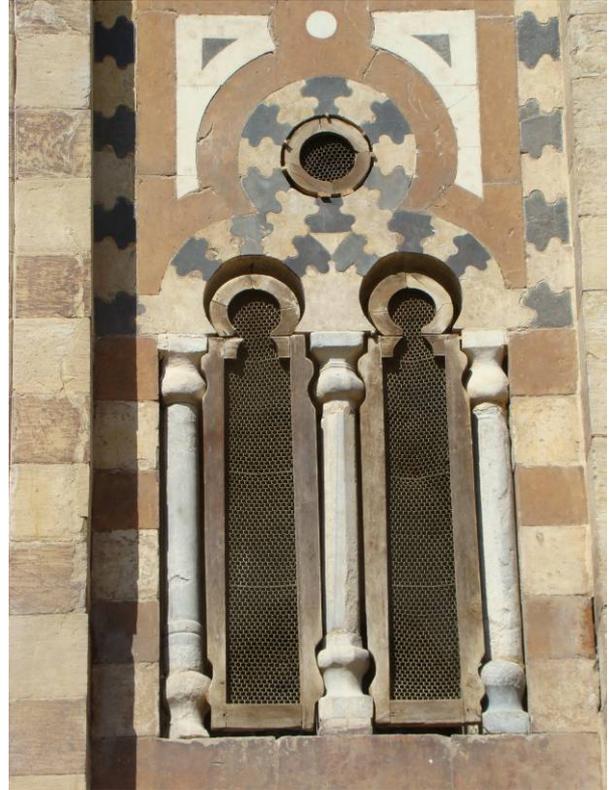
Comite mesh windows

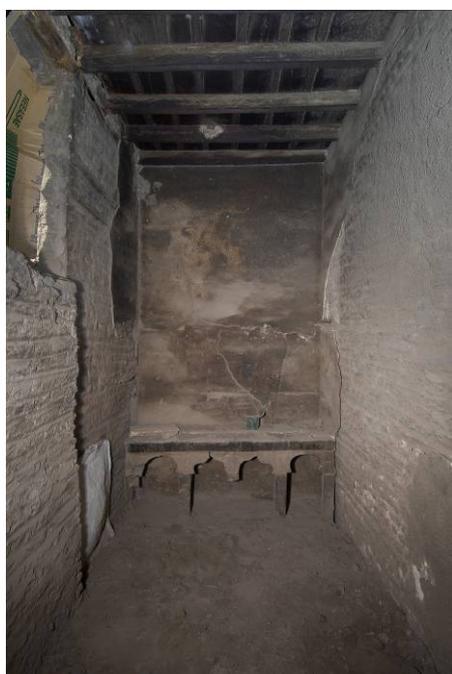
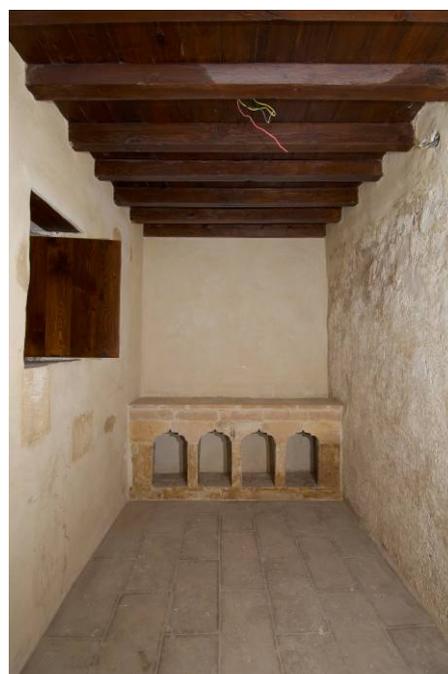
Room M1 and 1.2 before and after restoration (photos: Matjaz Kacicnik)

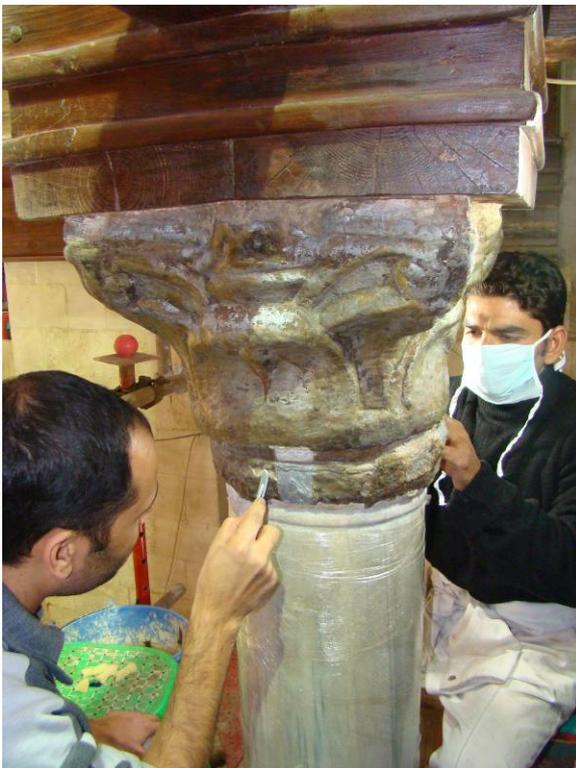
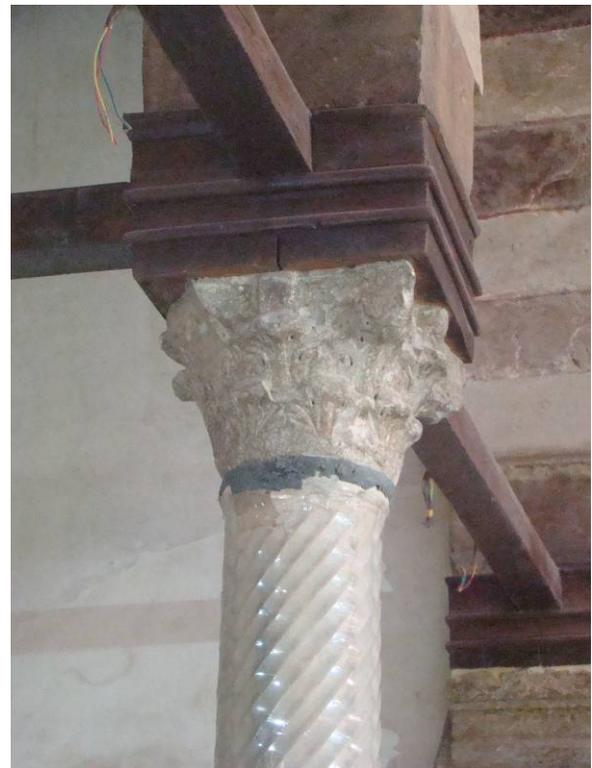
The courtyard columns capitals during and after the cleaning

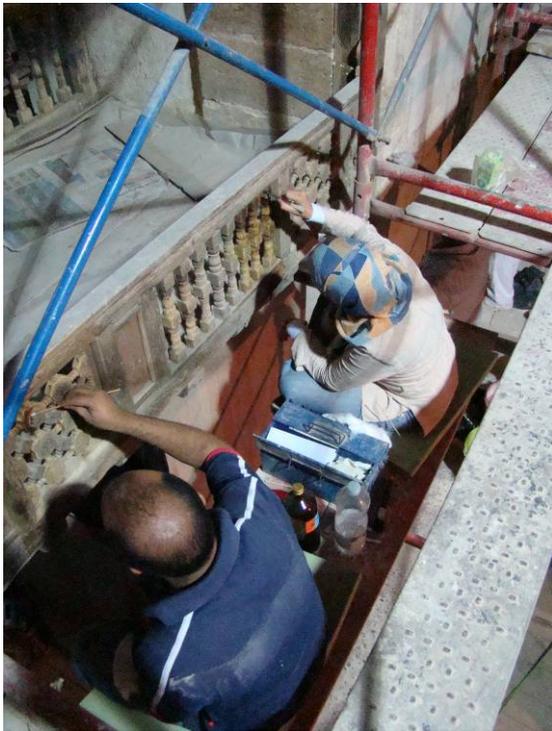
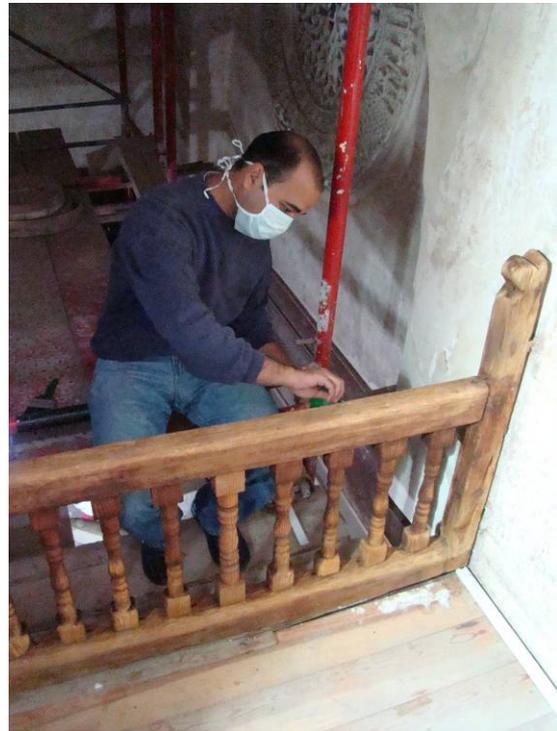
- Cleaning of the wooden dikka on the western façade of the courtyard was initiated. A significant section of the dikka was restored during the period of the *Comité* and several wooden parts were replaced. On the other hand, the original parts were found to be in a weak and deteriorated shape. The cleaning proceeded first mechanically to remove a layer of red paint underneath which appeared traces of the original paintings. This was followed by the consolidation and protection of the wood.

Cleaning and consolidation of the wooden Dikka;

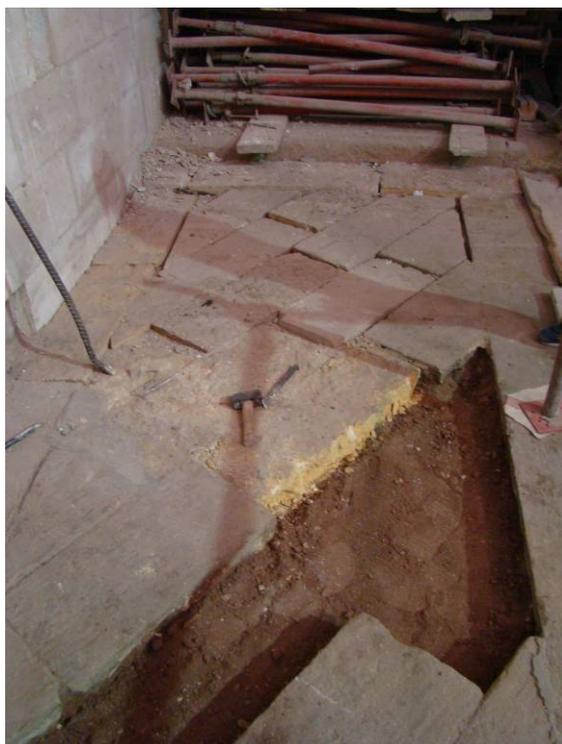
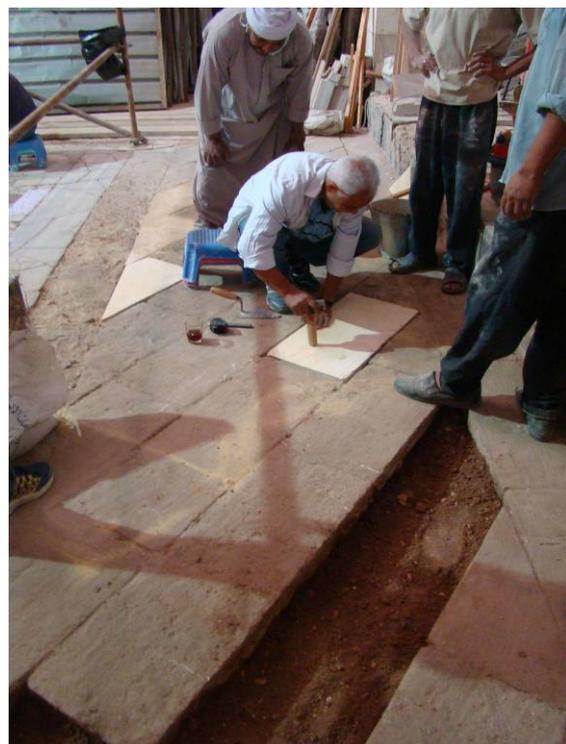
- Cleaning and stone replacement of the stone tiles of the mosque courtyard is in progress.

Cleaning Stone replacement activities in the mosque courtyard

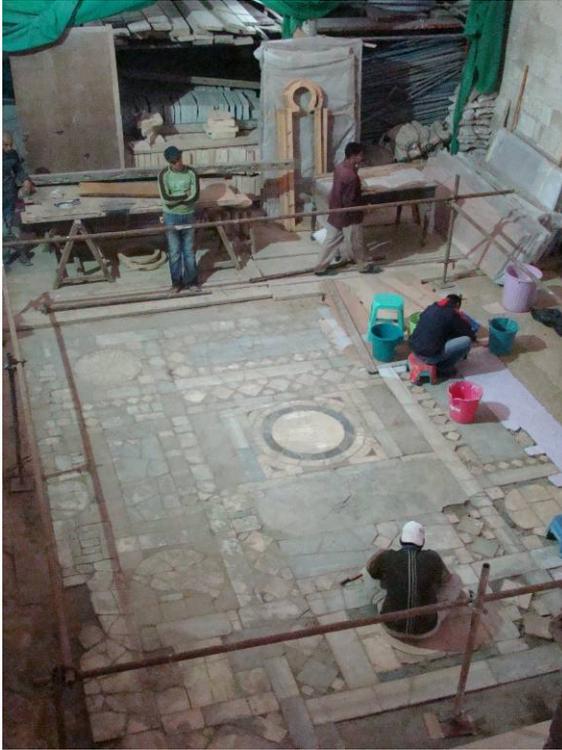
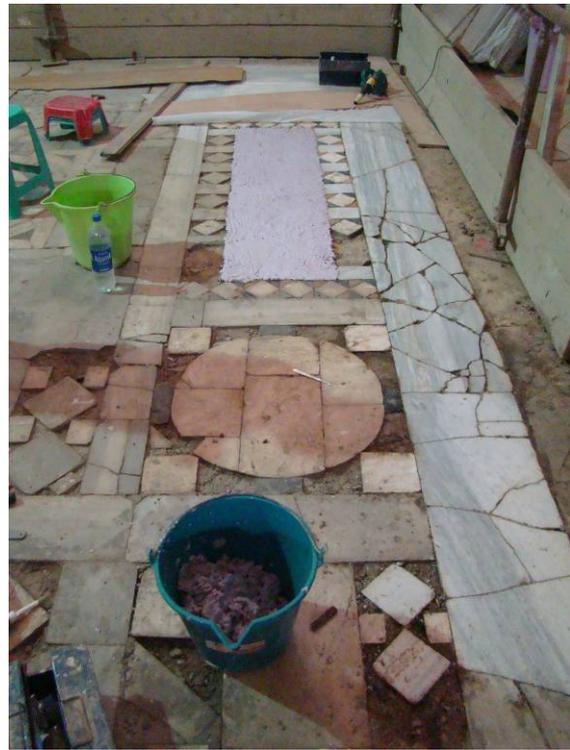
- Currently the main focus in the mosque courtyard is on the marble tiling. The first phase begun with the cleaning of the marble tiles using poultices. Meanwhile, the layout and design of the tiling were being studied in order to find the original pattern given that big sections of the marble were replaced at a certain time by cement, mortar or marble tiles, placed in a random manner. Following the removal of mortar and cement tiles, samples of the similar marble (black, red and white) were found in order to complete the missing sections. Filling of the cracks of the original tiles of significant size was completed. The filling consisted of a mixture of epoxy and marble powder.

Cleaning activities of the marble tiling and removal of additional cement tiles and mortar

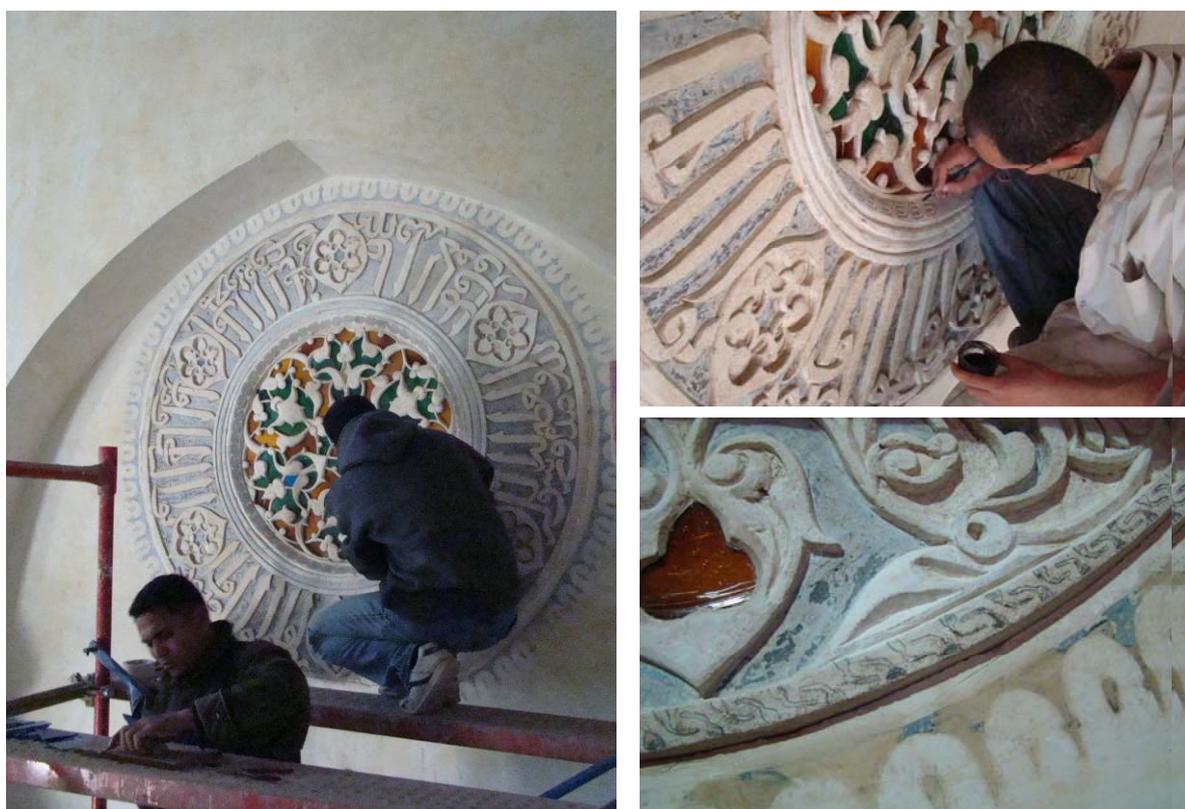
Scaffoldings were dismantled in the Qibla iwan upon the finalization of the restoration of the painted wooden ceiling. The same case of blue traces that were found on the gypsum roundel decorations were found on the three facades of the iwan. After identifying the pattern of the color, the retouch took place and the scaffoldings were dismantled.

Traces of the original blue paint found underneath the lime layers and the decoration surrounding the gypsum roundel

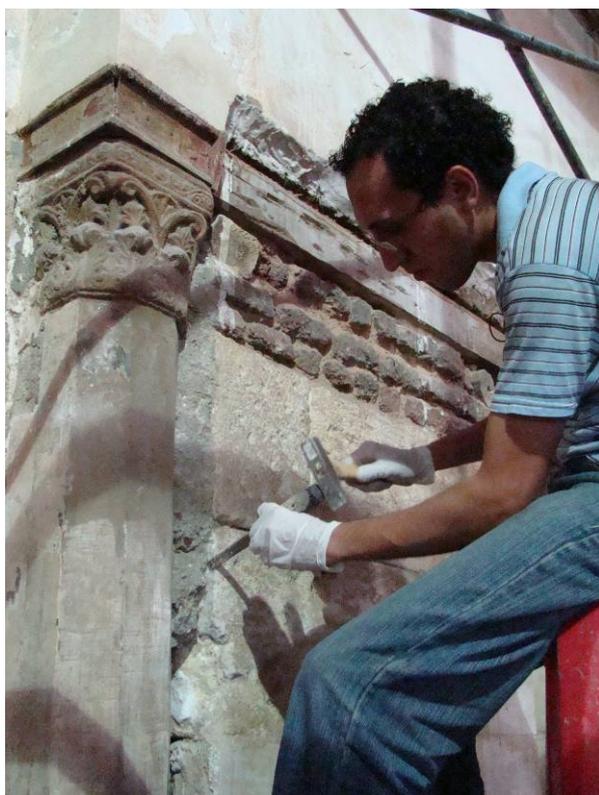
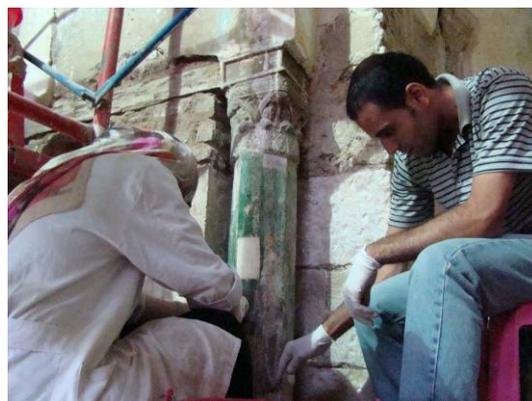
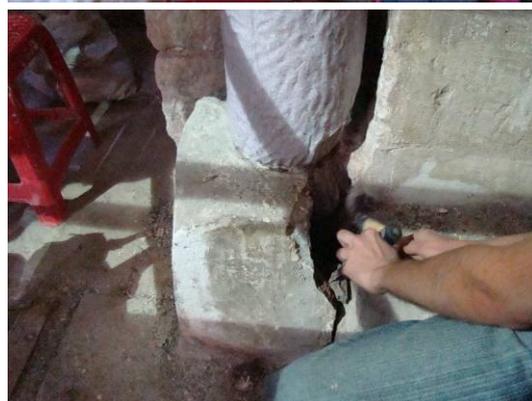
Cleaning of the columns and capitals has taken place. Firstly, a layer of new green paint was removed, underneath which was a layer of lime. Finally, the surface of the marble column and the capitals was found to be in a good condition. Only the two bases were terribly deteriorated and covered in cement and will need to be replaced.

Cleaning of the marble columns in the qibla and removal of the cement layers covering the base

Complete the cleaning and consolidation of the wooden inscription band and octagon. Finalize the cleaning of the stucco on the mihrab. Manufacture of the new bases for the marble columns and install them. Plastering of the lower area and finalizing tile replacement.

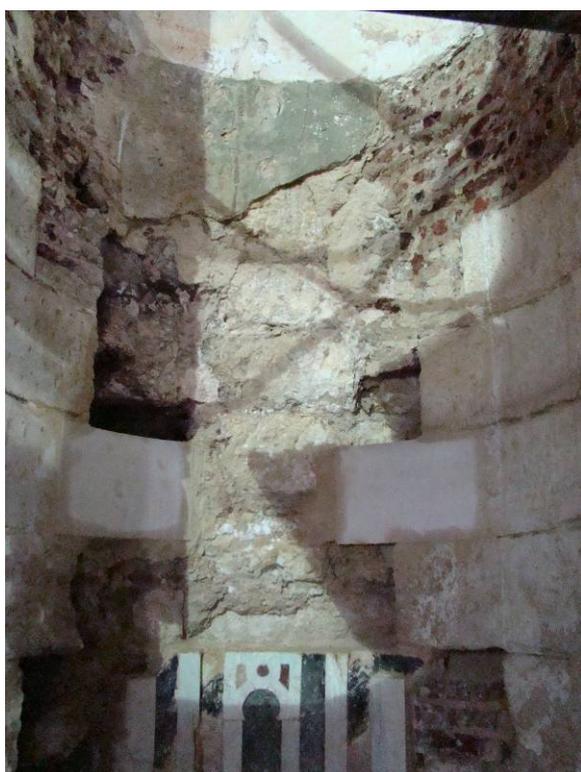
The cleaning of the few marble pieces of the mihrab was finalized. Afterwards, it was necessary to dismantle the pieces given their bad condition and the need to replace some stones in the mihrab itself. Marble pieces were numbered and dismantled and a pattern was found which enabled us to identify the original design of the marble and hence replace the missing pieces and complete the marble pattern.

View of the mihrab before dismantling the marble and during stone replacement

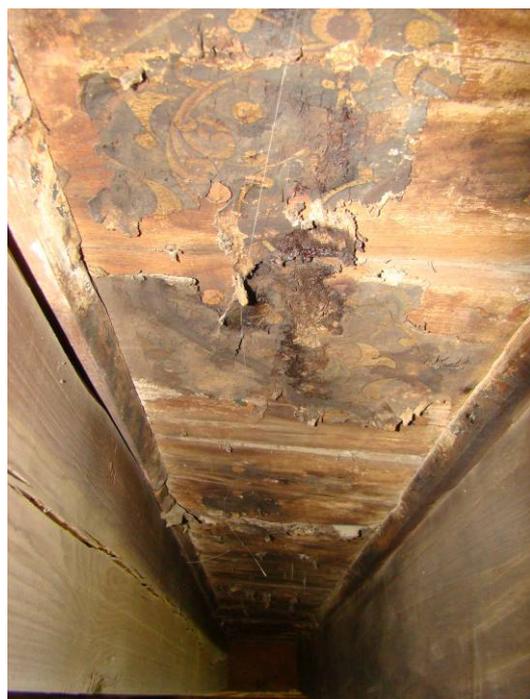
The cleaning and conservation of the iwan facades was finalized. As for the ceiling, it was found to be in the worst conditions of all four iwans. This is probably due to the fact that the upper room was in a state of collapse (shown in earlier photographs) and hence lack of insulation and leaking from the roofs. Most of the inscriptions and decoration are non-existent. The few remaining are hardly visible, in addition the bad condition of the wooden shingles and beams which have become damp given the constant leakage of water. The restoration work began by mechanical cleaning, followed by the consolidation of the remaining layers of colors and the slight cleaning of the wooden parts containing the inscriptions in order to make them more visible. A large section of the ceiling was restored during the period of the *Comité*. Those beams which do not have any decorations were painted in order to unify the colors of the whole ceiling. The facades were also finalized and the scaffoldings were dismantled.

View of the paint deterioration on the wooden beams

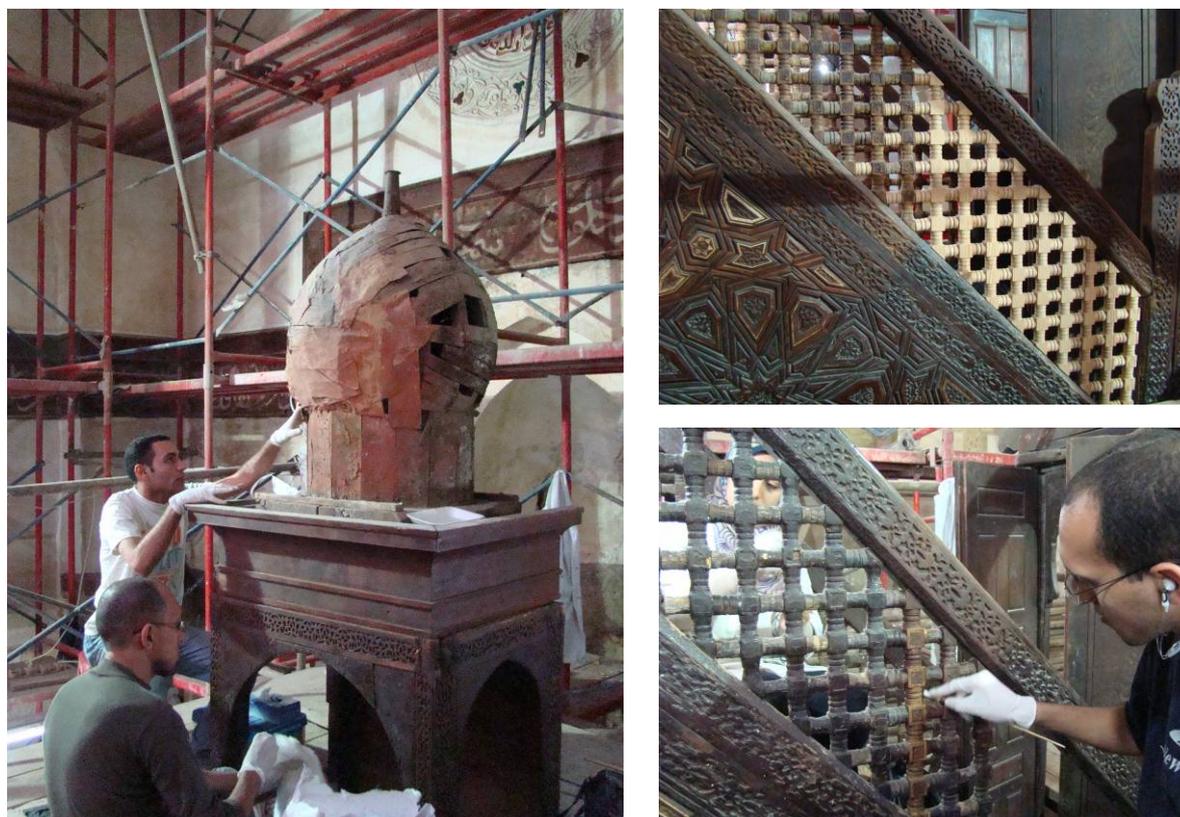
Cleaning and restoration activities on-going on the woodwork

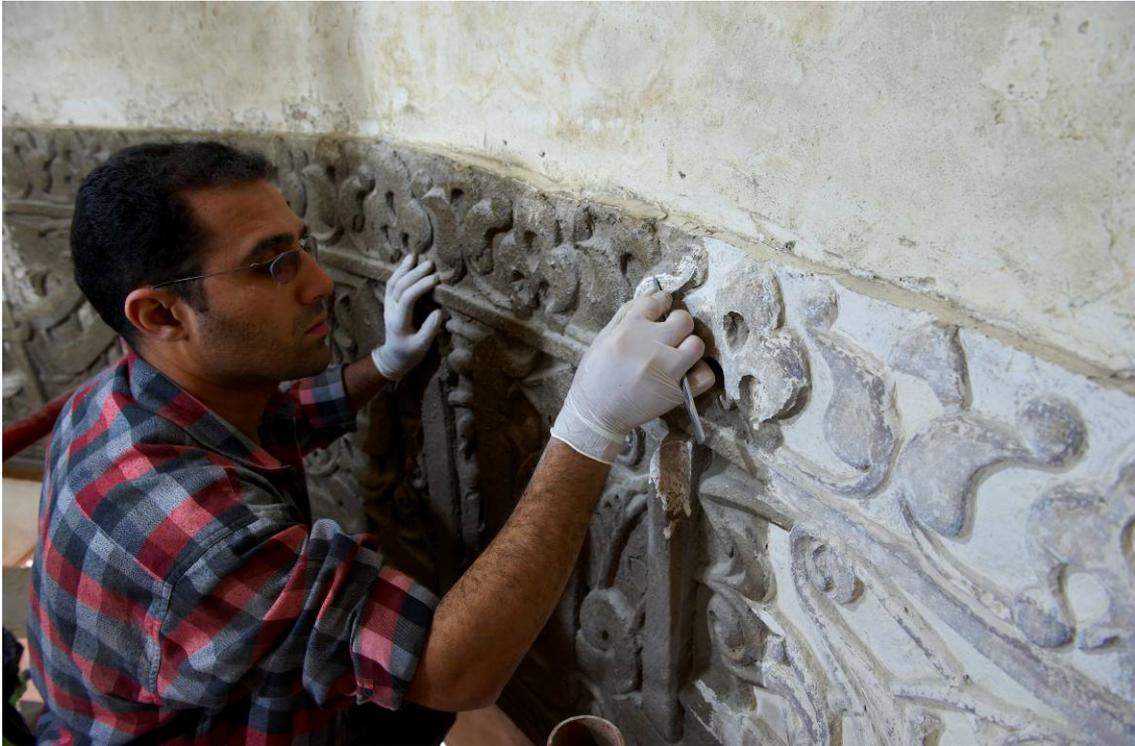
The cleaning of the upper gypsum inscription band was completed. After the removal of the thick layer of lime wash and dirt covering the gypsum surface, blue and red colors appeared. In order to protect the gypsum surface and the remains of color, a layer of lime water was applied on the band in order to solidify the powdering surface and preserve the original colors.

Cleaning of the gypsum inscription band in the dome interior

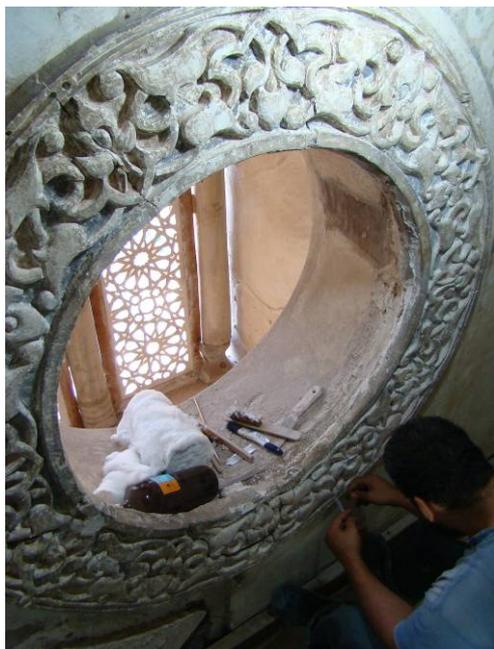
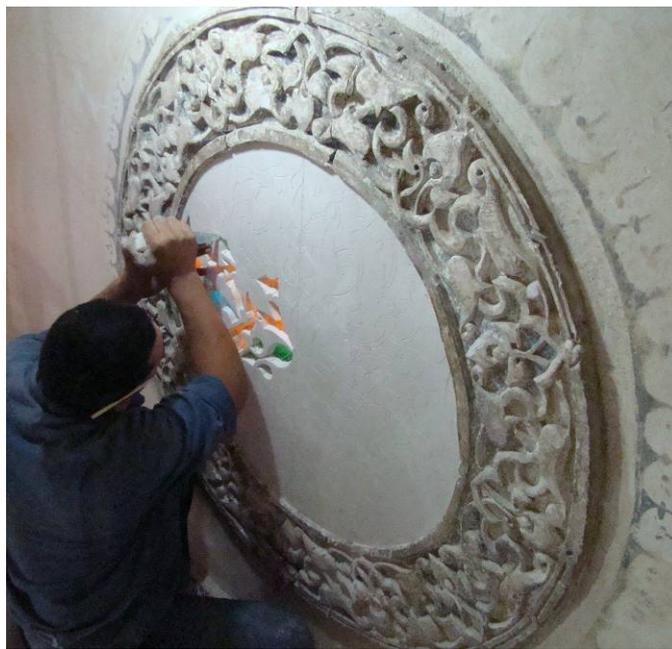
Consolidation and fixation of the detached parts of the plaster is finished and re-touch of the blue color around the four gypsum roundels was also finalized, as similar traces to those in the mosque were found on the four facades of the mausoleum. The missing inner gypsum window on the southern façade was manufactured in place.

View of the missing gypsum window before and during manufacturing

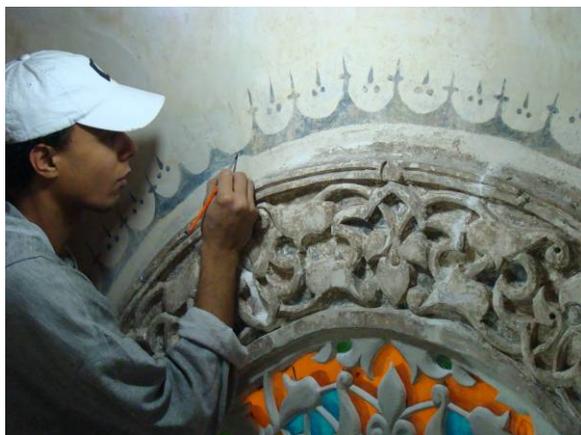
Re-touch of the blue colors on the gypsum roundels

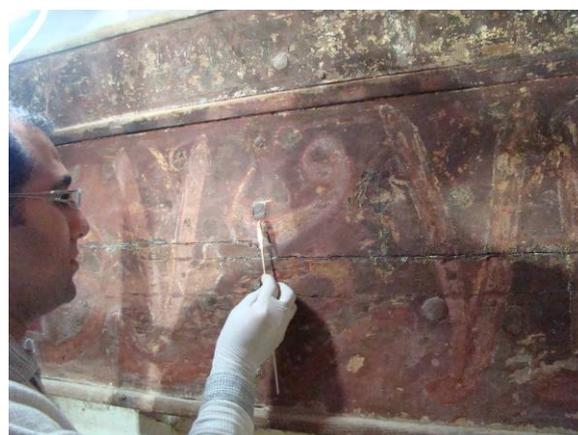
Cleaning of the lower wooden inscription band begun and clear traces of the original inscription and decoration was found underneath a recent layer of red paint applied to the band. Chemical removal of the

Cleaning and consolidation of the wooden inscription band

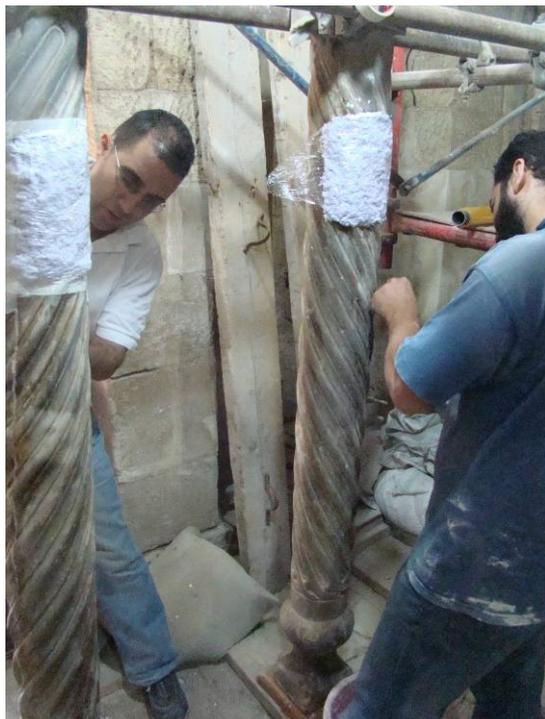
Cleaning the marble columns was also finalized by using poultices given the thick layers of dirt and oils found on their surfaces. This is probably due to the later re-use of the mausoleum spaces as a cooking area during the Ramadan fast for the local community.

Cleaning of the mausoleum marble columns

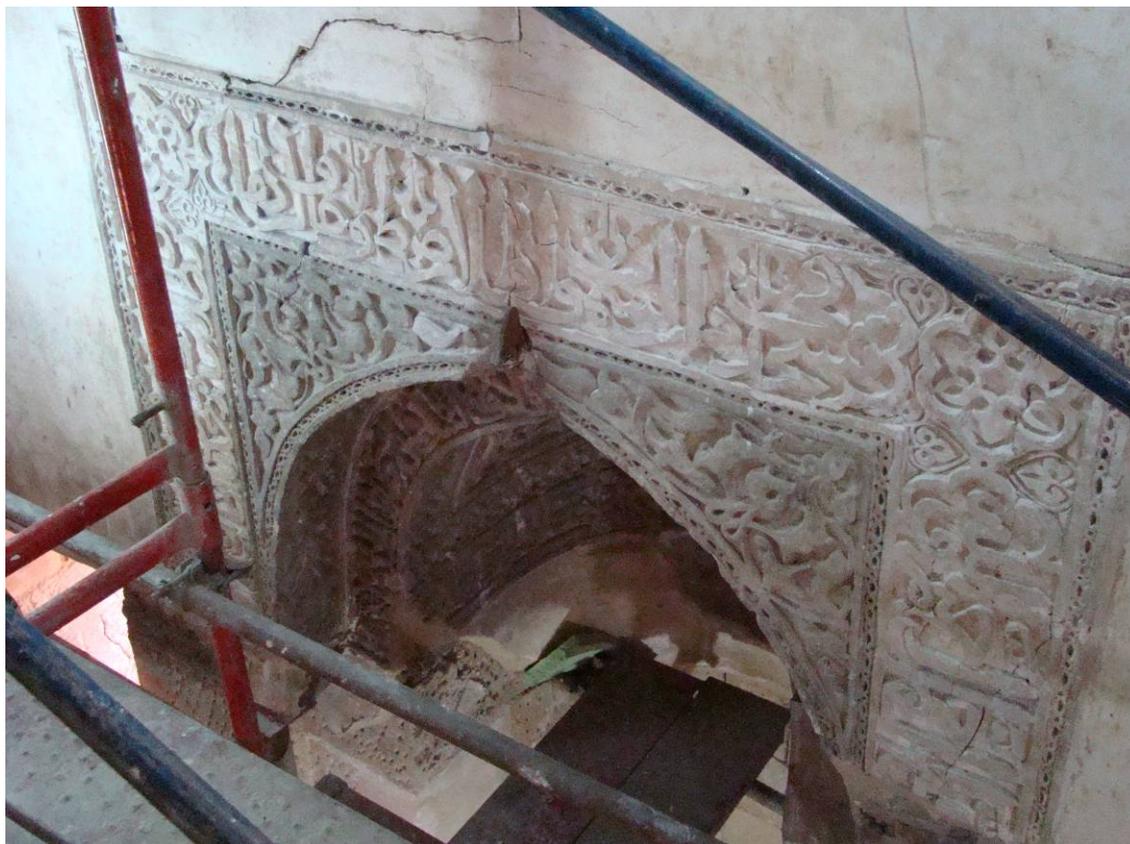
The stucco decoration of the mausoleum mihrab during cleaning
