CONSERVATION PROJECT OF THE
ASLAM AL-SILAH DAR MOSQUE

QUARTERLY PROGRESS REPORT

January-March 2009

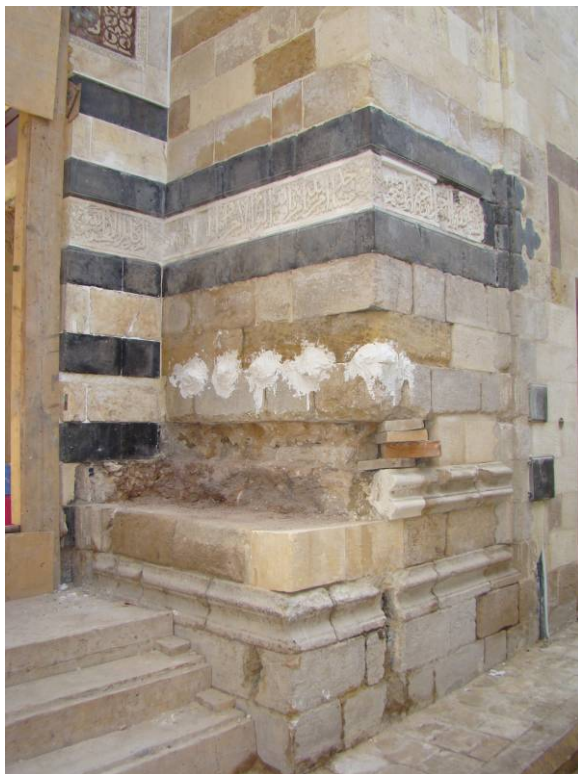
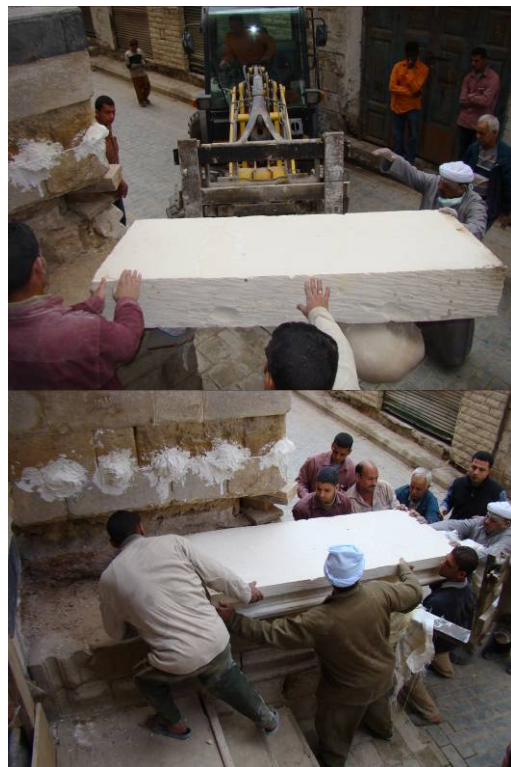
Replacement of the Maksala stone on the western portal

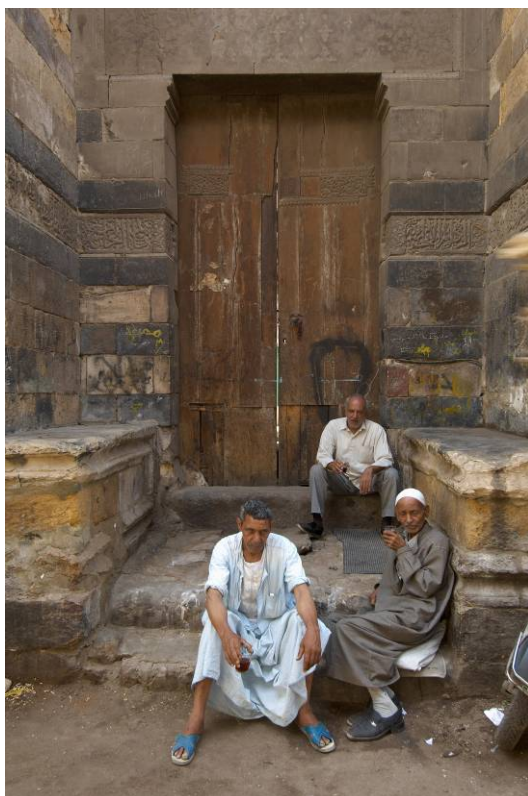
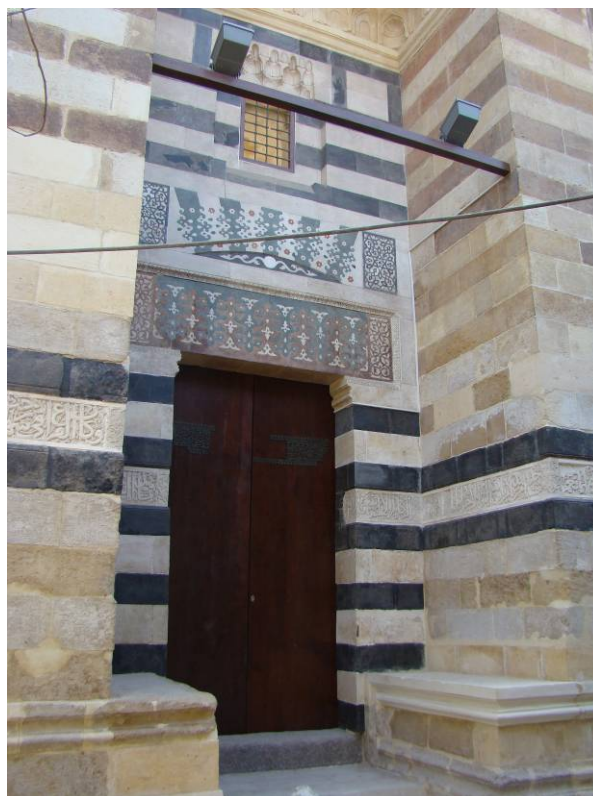
View of the western façade portal before and after completion

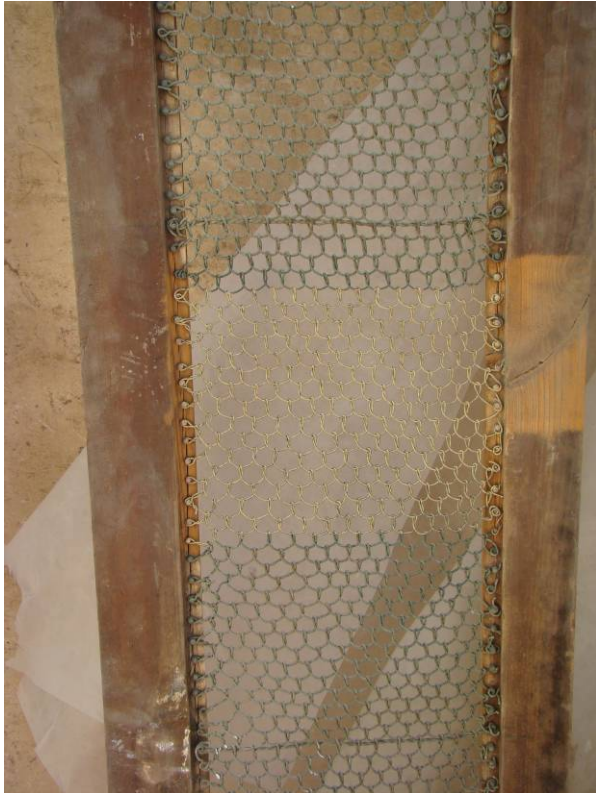
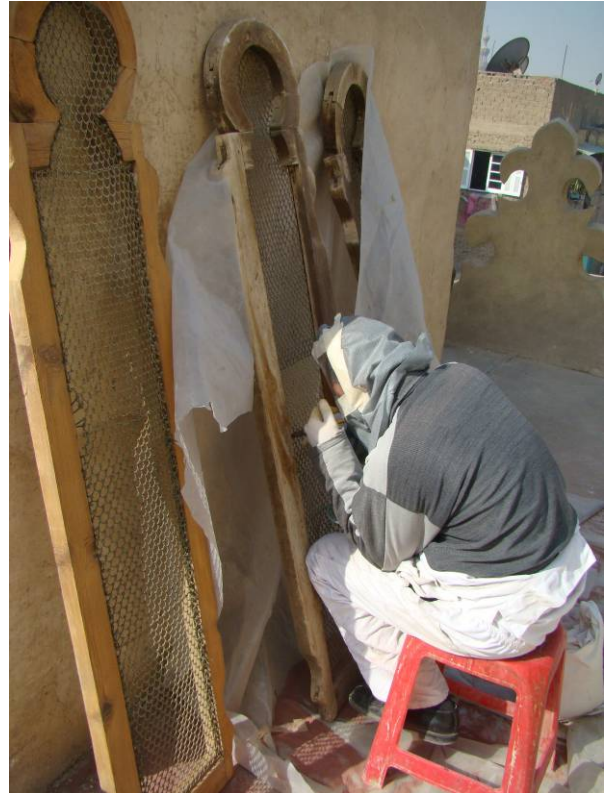
Cleaning and completion of the missing mesh parts of the façade windows

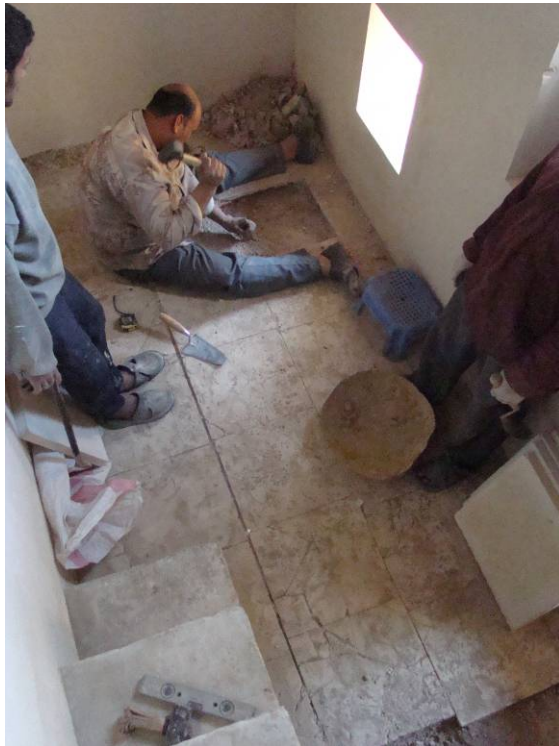
Stone tiling replacement in M2

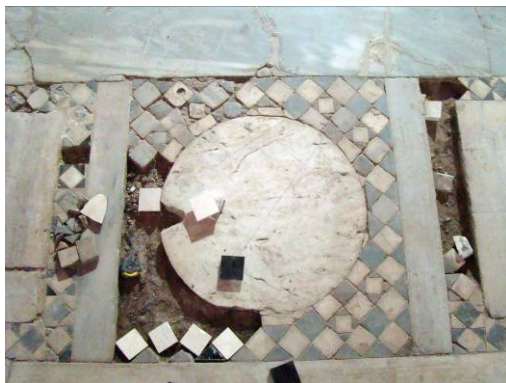
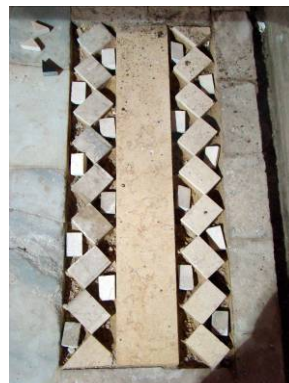
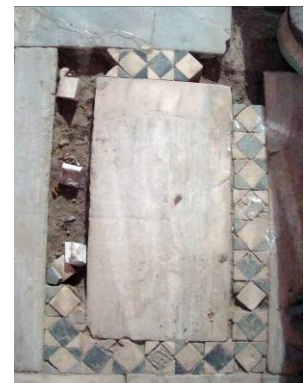
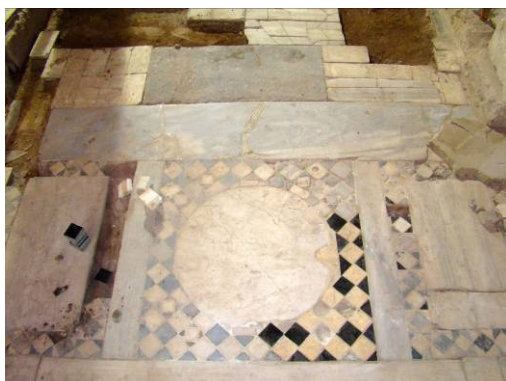
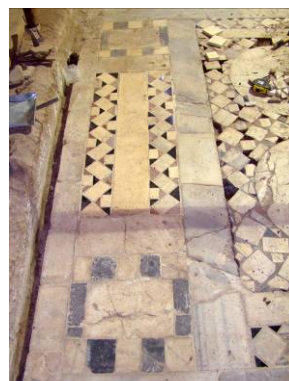
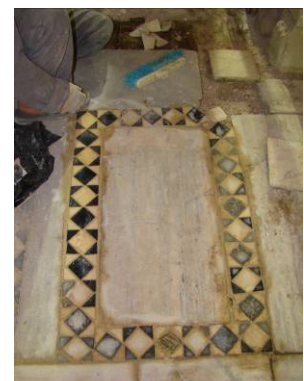
View of the marble replacement in the courtyard

- The replacement and cleaning of stone tiles in the courtyard was completed.
- Conservation and cleaning of the marble tiling was completed. Damaged and missing parts of the marble were replaced following the original pattern.
- The conservation of the wooden *dikka* was finalized. After cleaning, the consolidation of the weak parts of the wooden took place following which the *dikka* was painted with a layer of micro-crystalline wax acting as a protection layer.

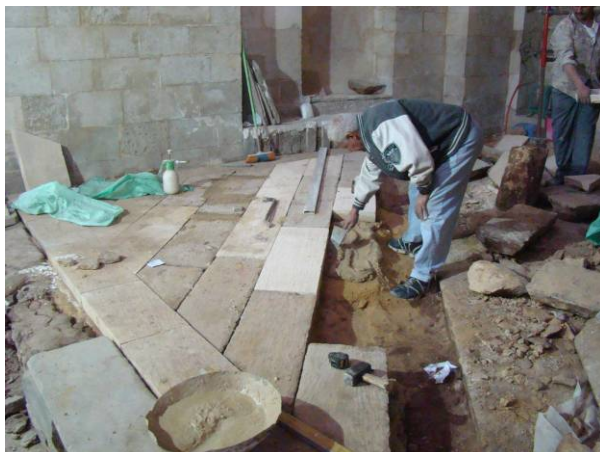
- The tiling of the qibla iwan was in a very bad condition; the surface of the stone tiles was eroded, the levels were uneven due to a certain settlement which was in return filled with cement patches. It was found necessary to dismantle the whole *iwan* tiling in order to re-adjust the levels and install the electric wiring for the lighting and sound system. During the process, damaged stones were replaced when necessary and others were cleaned mechanically and re-used.
- The alternating, black and white tiles on the *qibla* step were cleaned and the missing ones were replaced.

Stone tile replacement activities

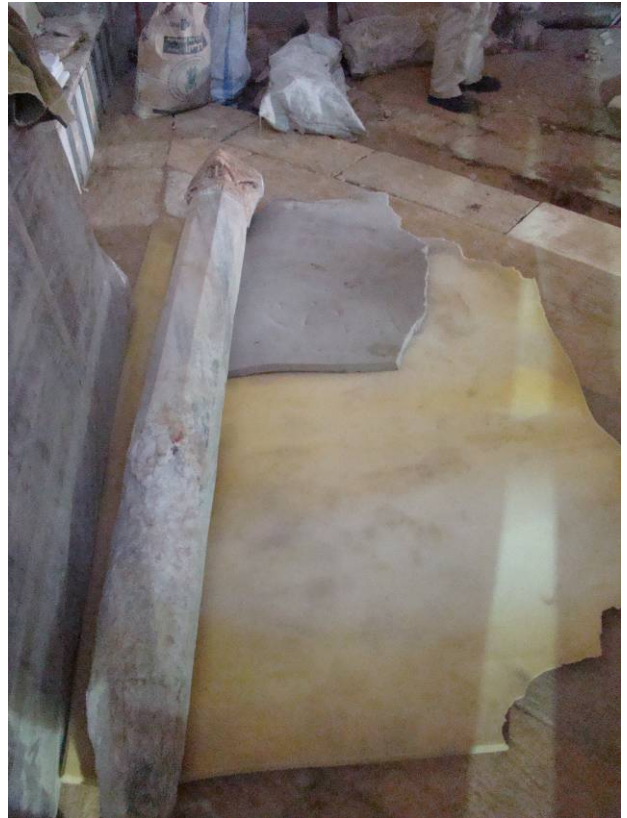
- The cleaning and conservation of the two marble columns was also finalized. The left column was damaged and badly deteriorated; however, it was decided not to change it given the difficulty of finding a similar type of marble and as a matter of conserving the original column. Therefore, both columns were dismantled in order to change the base and complete the eroded parts.
Completing the eroded octagonal marble column was done on several stages; first, a wooden cast was made surrounding the column to enable completing the column. Following that, each side of the column was filled with epoxy mixed with marble powder which gives the blend a similar color to that of the marble. This was repeated several times giving the mixture time to settle and dry.

View of the badly eroded lower section of the column

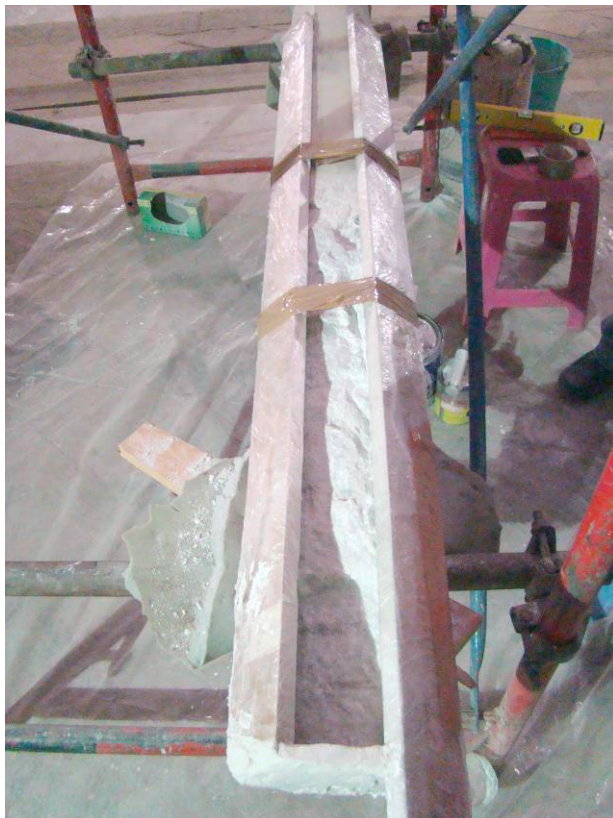
View of the cast surrounding the column

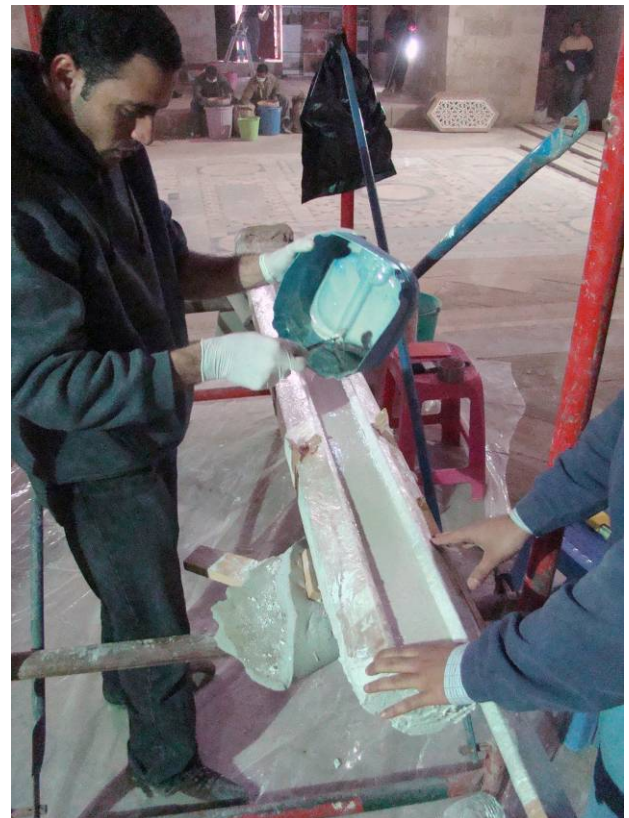
The filling procedure

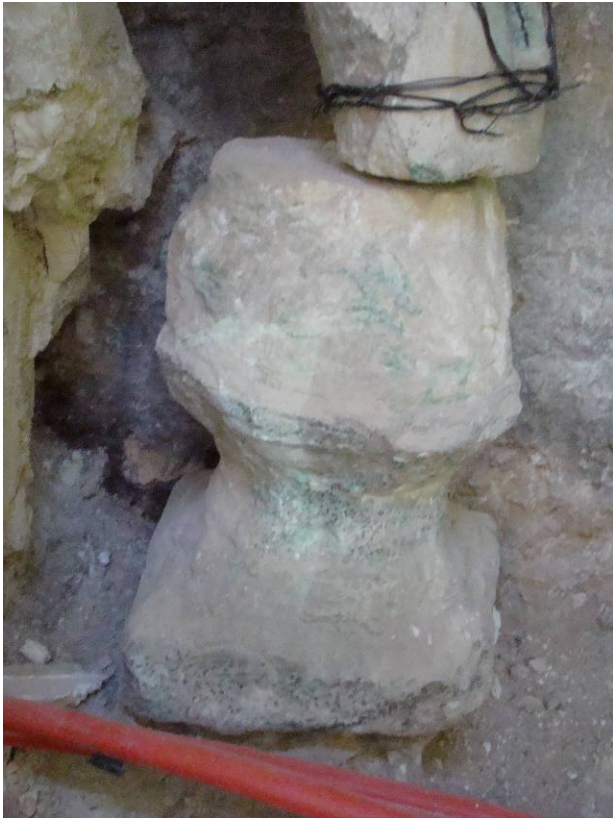
- The two marble bases of the marble columns in the *mihrab* façade were badly damaged and had to be replaced. The design was done following the shape of the old base.

View of the old marble base of the mihrab

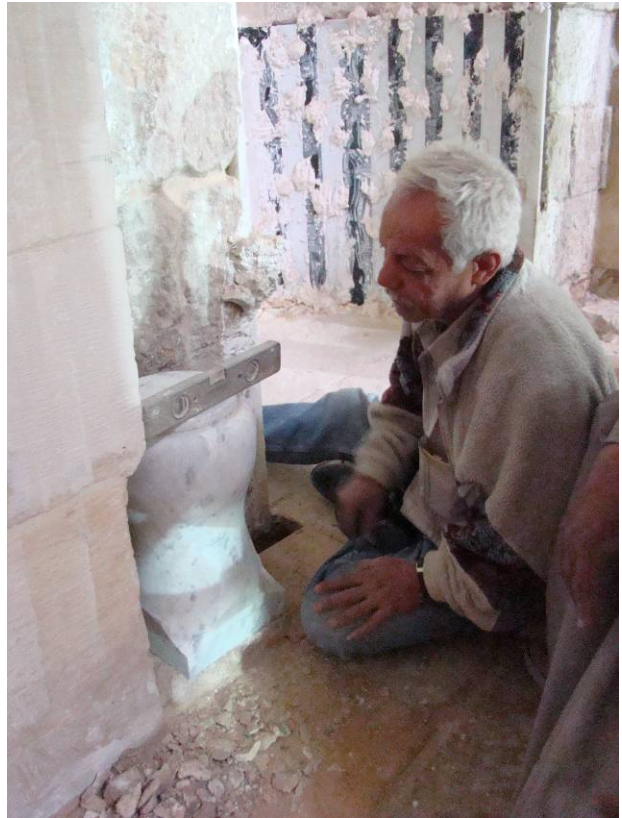
Installing the new marble column base

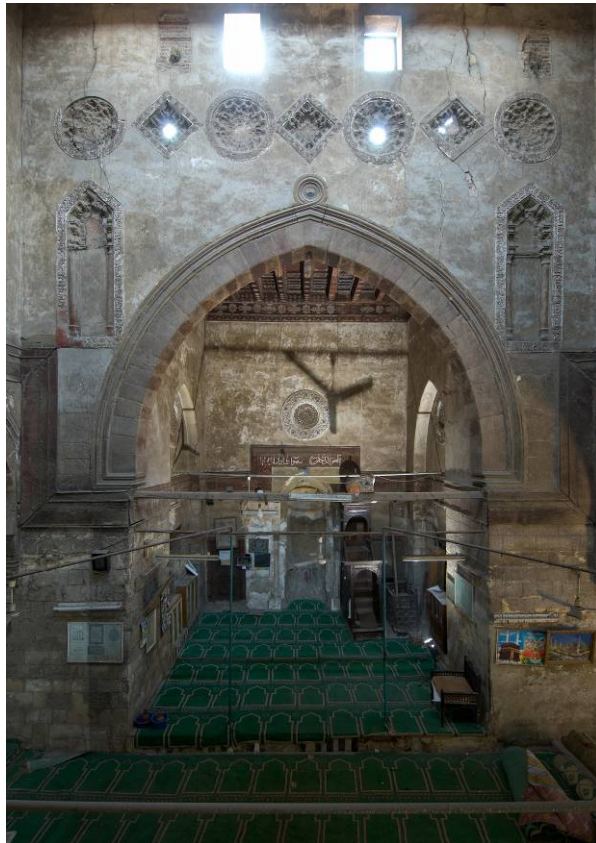
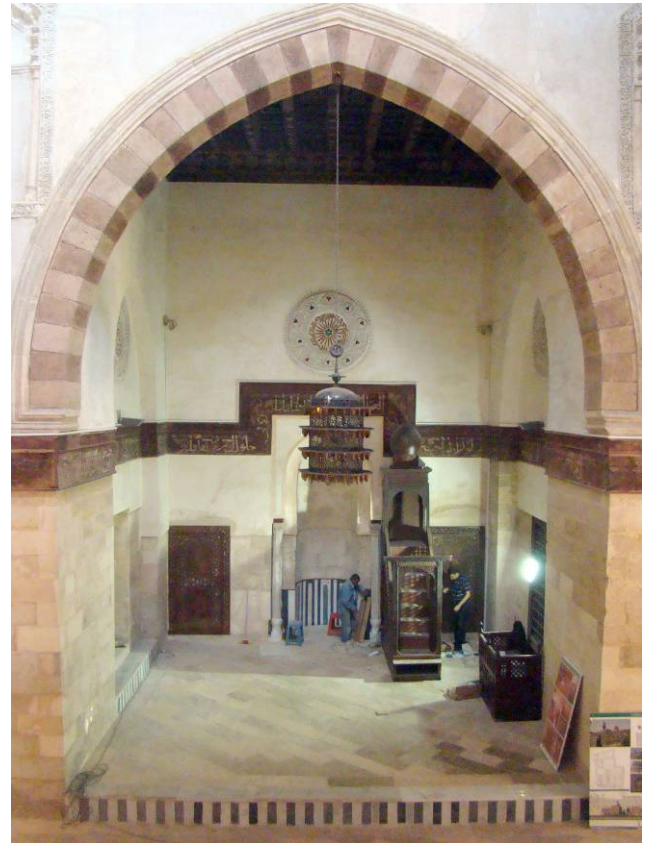
View of the Qibla Iwan before and after conservation

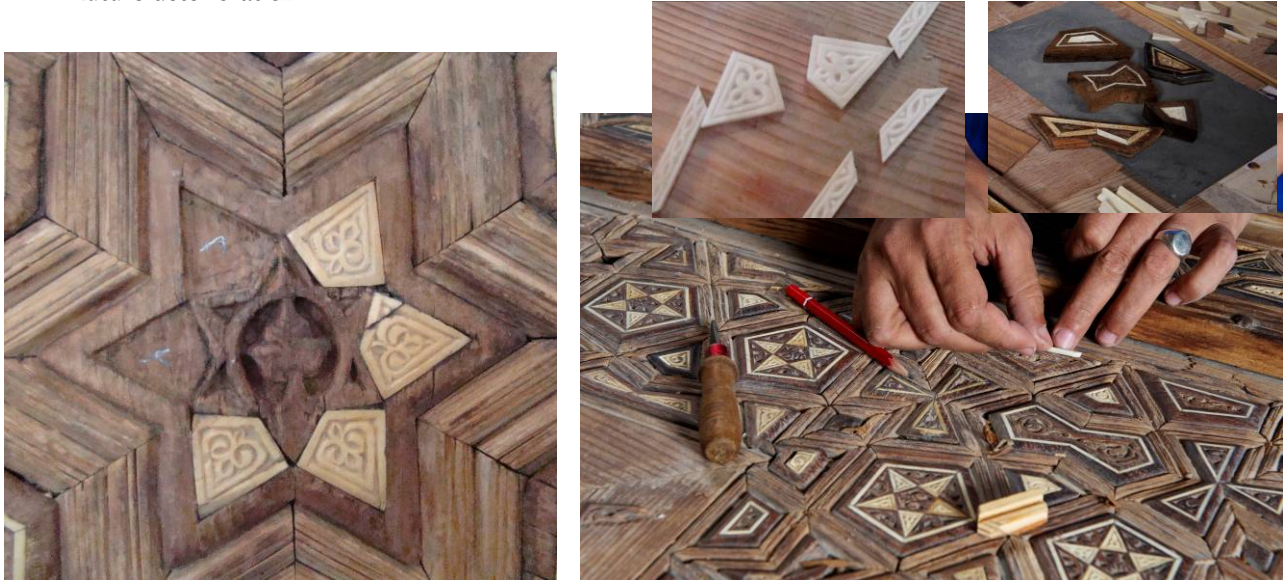
Restoration work on inlaid wooden doors; missing pieces replaced by carved camel bones

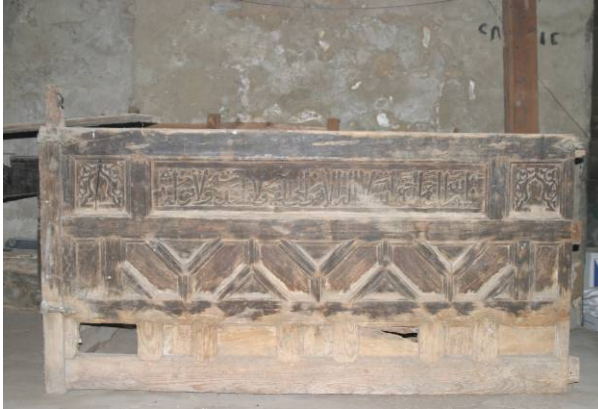
- The cleaning of the mausoleum wooden *shabed* was completed.
The structure was found in several pieces which were in a relatively deteriorated condition. Mechanical cleaning was done first; following architectural wooden restoration took place. Several parts of the *Shabed* and few carved wooden panels were missing. Those were replaced by new ones. The structure was painted, assembled and put in its place in the mausoleum.

View of the shabed before restoration

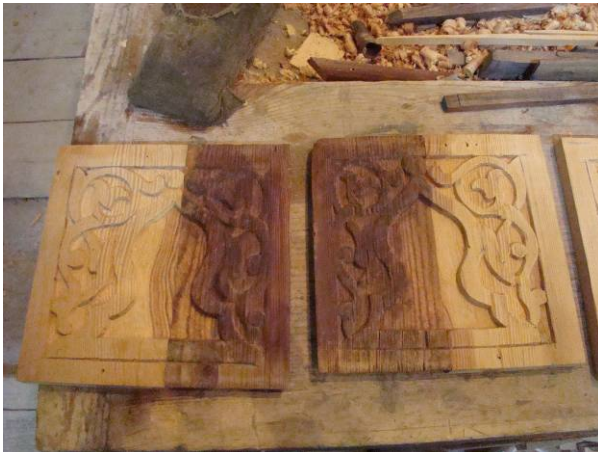
Restoration of the missing parts of the wooden panels

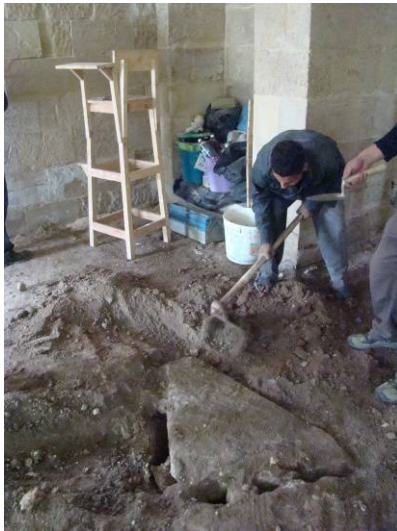
- The tiling of the mausoleum was in a very bad condition due to the thin thickness of the original tiles and to an obvious settlement that had occurred previously. Therefore, it was decided to remove the damaged tiles in order to excavate and check the structural condition of the tombs below. The tomb opening was filled with rubble and dust. After the cleaning, the entrances to two chambers were revealed, having quite a distinguished angular design, each blocked by a large stone (door).

View during excavation in the mausoleum

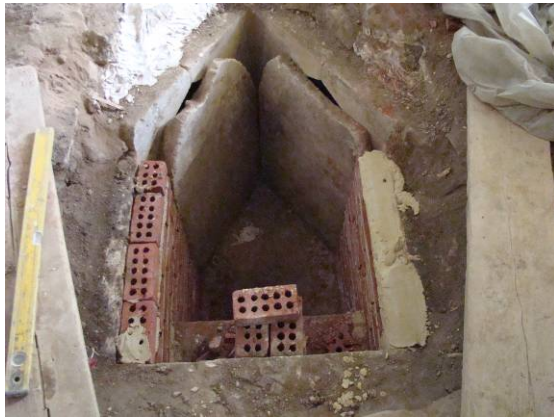
Following the stabilization and surveying of both chambers, the stone doors was put in place and two side brick walls were build to support the original stone which was covering the entrance. Blocks of stone were put in place next to the original triangular one in order to block the entrance and avoid it been filled rubble and fill in the future, hence preserving the entrance.

View of the brick wall built to support the stone blocks
