RED MONASTERY AUTUMN 2018

**ARCHITECTURAL CONSERVATION
&
SITE MANAGEMENT WORKS**

AMERICAN RESEARCH CENTER IN EGYPT

TECHNICAL REPORT

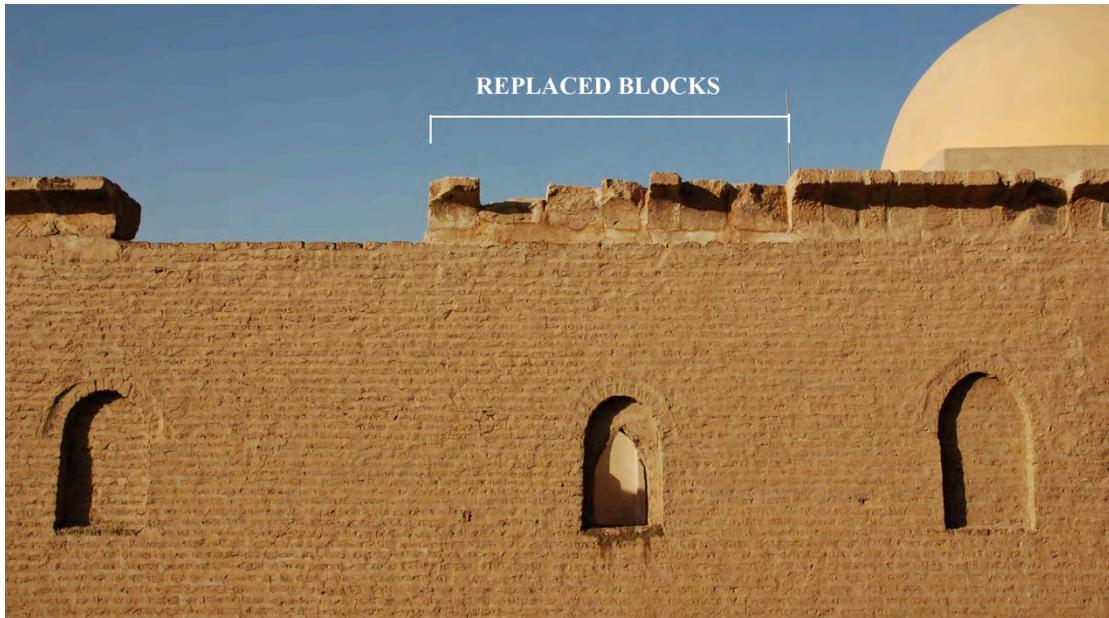
A total of seven original cornice blocks that had fallen from the cornice of the external wall of the church were re-installed on the top of the east wall using an external scaffolding and electric winch. There are no remaining blocks on the ground.

Fig 1. Seven replacement cornice blocks after re-installation on the east wall of the church

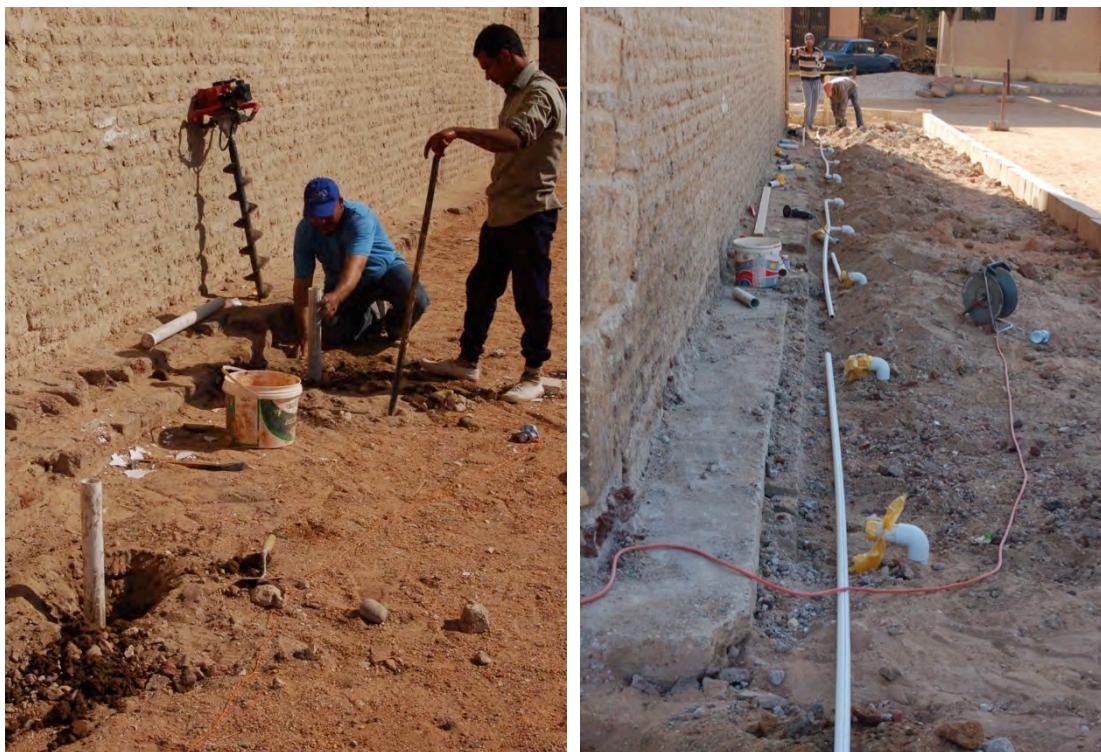
The ring of subsurface pipes around the church that was installed on the east side of the building in May-June 2018, was extended on the north, west, and south sides of the church to complete the termite protection works.

The method employed was sub-surface saturation of liquid chemical deterrent. At a distance of one metre from the wall, a line of vertical 5 cm diameter one-metre-long perforated PVC pipes was installed at intervals of 2.5 metres using an auger drill to minimise the possible damage to archaeological remains in the vicinity of the church. A total of 80 pipes were installed around the perimeter of the church. Each pipe was perforated along the lower 70 cm of its length, with a bottom cap to prevent the injected liquid from draining directly into the ground and to encourage its horizontal dispersal. The installation was designed to be capable of repeat applications of insecticide in the future, on a recommended cycle of five years. The pipes were divided into separate groups of five pipes, each of which was connected horizontally by a welded 5 cm diameter PVC feeder pipe with a single insertion point for the insecticide. This will also facilitate repeat applications as only fewer insertion points for the insecticide are required. The insertion points are identified by limestone or sandstone paving slabs with circular holes drilled through them that protect the tops of the pipes. The slabs are either located in sandstone pavement around the church (on the east side) or within the 60 cm-wide perimeter mortar screed at the base of the external walls of the church (on the north, south, and west sides). After the application of the chemical deterrent, the caps on the tops of the pipes were buried in a soft lime mortar that can easily be removed prior to repeat applications.

Fig 2. Termite protection system during installation showing auger drill (left) and line of insertion points through connected PVC pipes running parallel to the west wall of the church (right)

Termite treatment: it is recommended that anti-termite treatment be repeated on an biennial basis, especially on the east side of the church owing to the prevalence of termites in this area. This can be easily carried out by removed the lime mortar fill inside the circular cut-outs indicating the position of the refill pipes and unscrewing their caps.

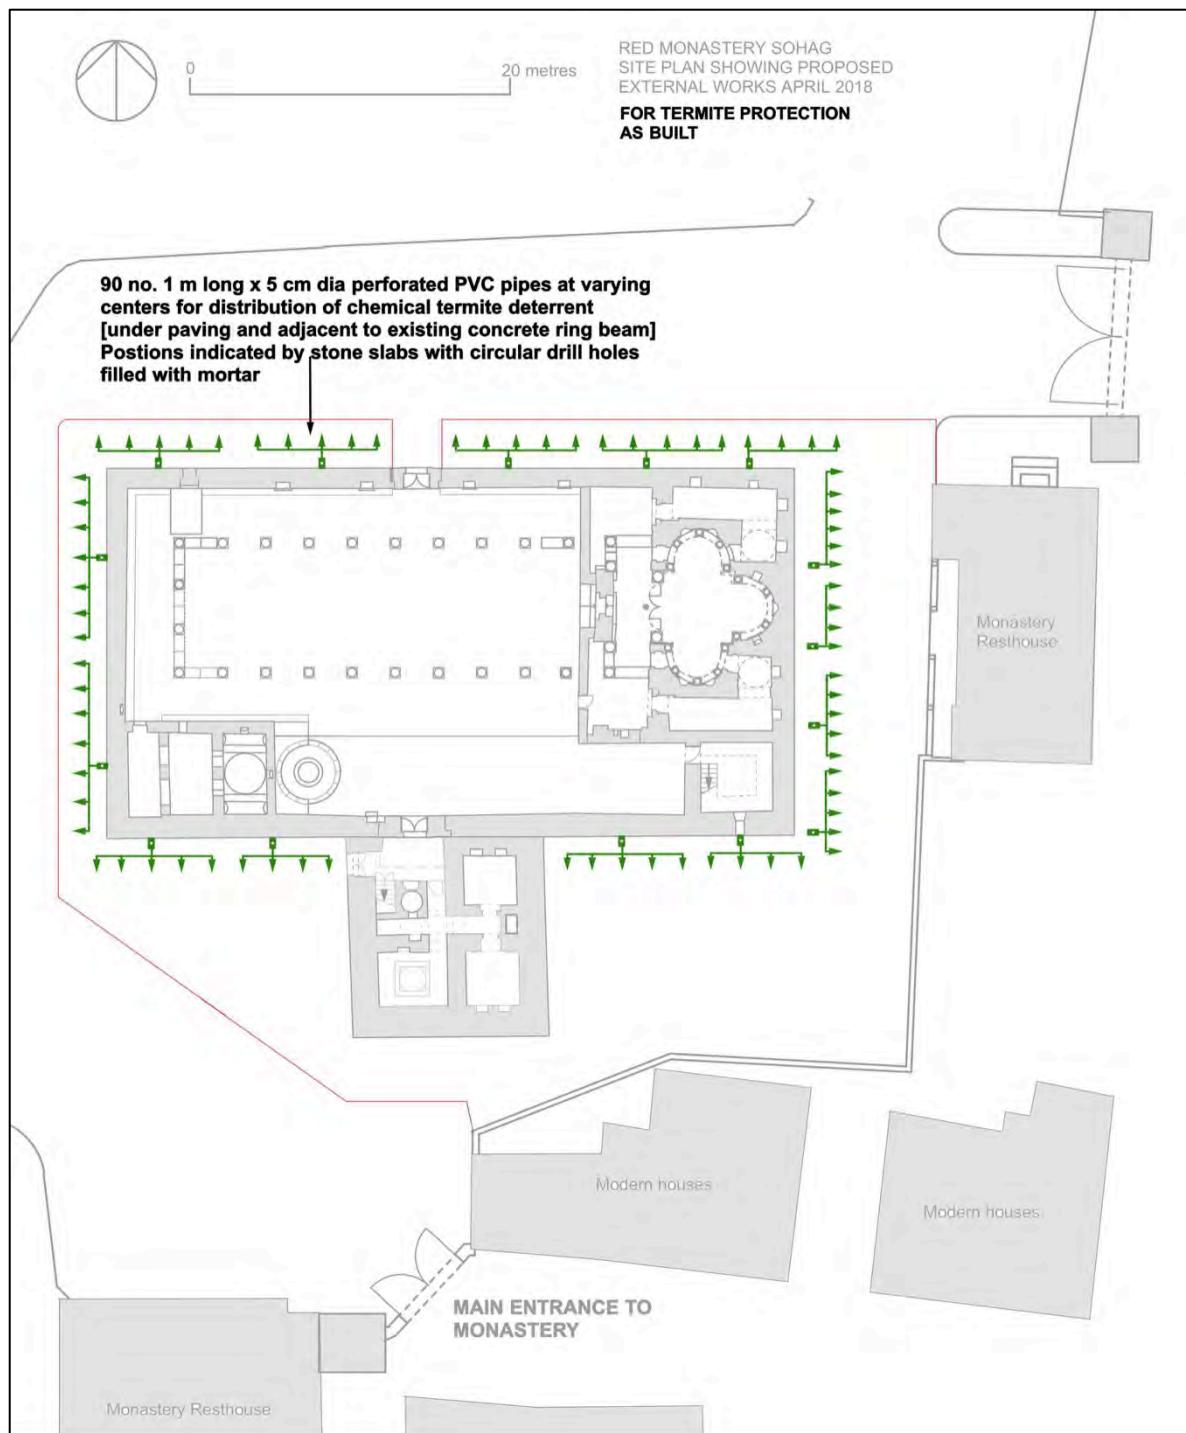
Fig 3. Plan of the church showing anti-termite system

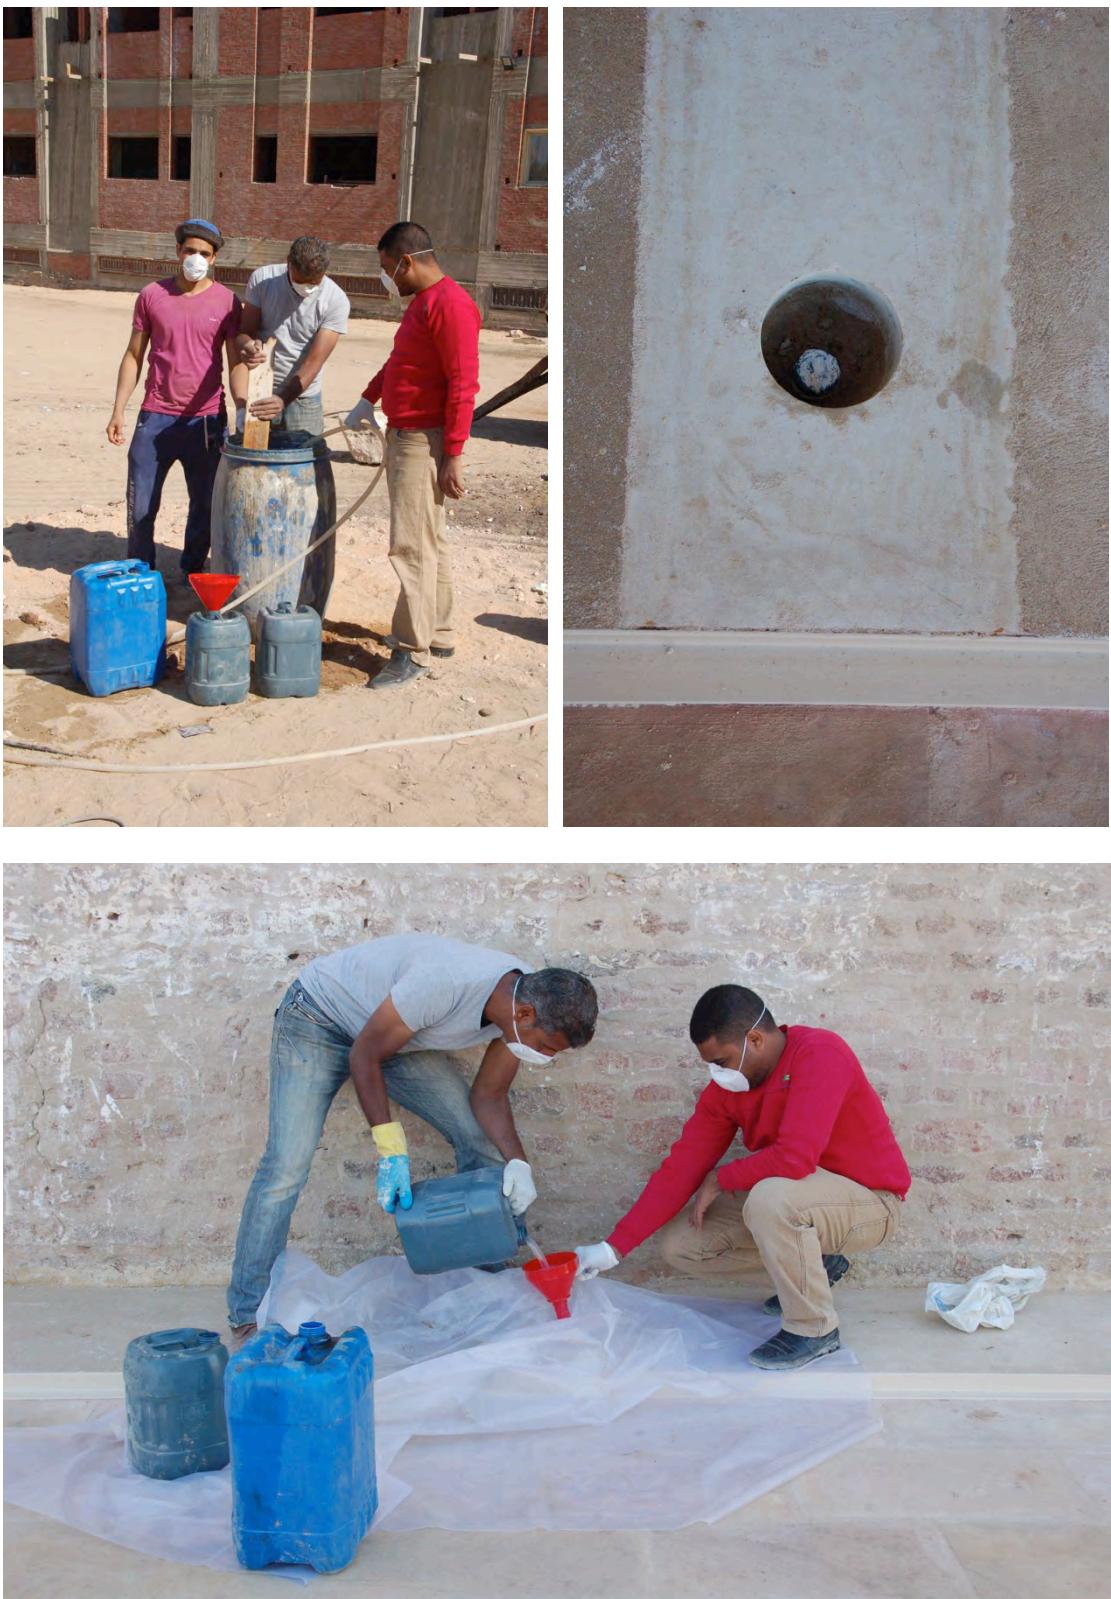
A single application of chemical deterrent was made through the pipes. The chemical compound used as the deterrent was a chemical compound with the trade name “Coach 20% SC” (+/- 5 amino – 1-2,6-dichloro-trifluoro-p-tolyl-4-trifluoromethylsulfinylpyrazole-3-carbonitrile) which has as a constituent the PERSUAP approved chemical “Fibronil” – a broad-spectrum insecticide with no health side effects on mammals. The “Coach 20% SC” was used in a dilute solution with water and diesel in the proportion 50 cl deterrent to 80 litres of water and 20 litres of diesel. A total of 400 litres of deterrent was inserted into the pipes manually using a funnel. This volume was divided between the different lines around the perimeter of the church, as required by surface absorption rates.

Fig 4. Preparing and applying chemical deterrent

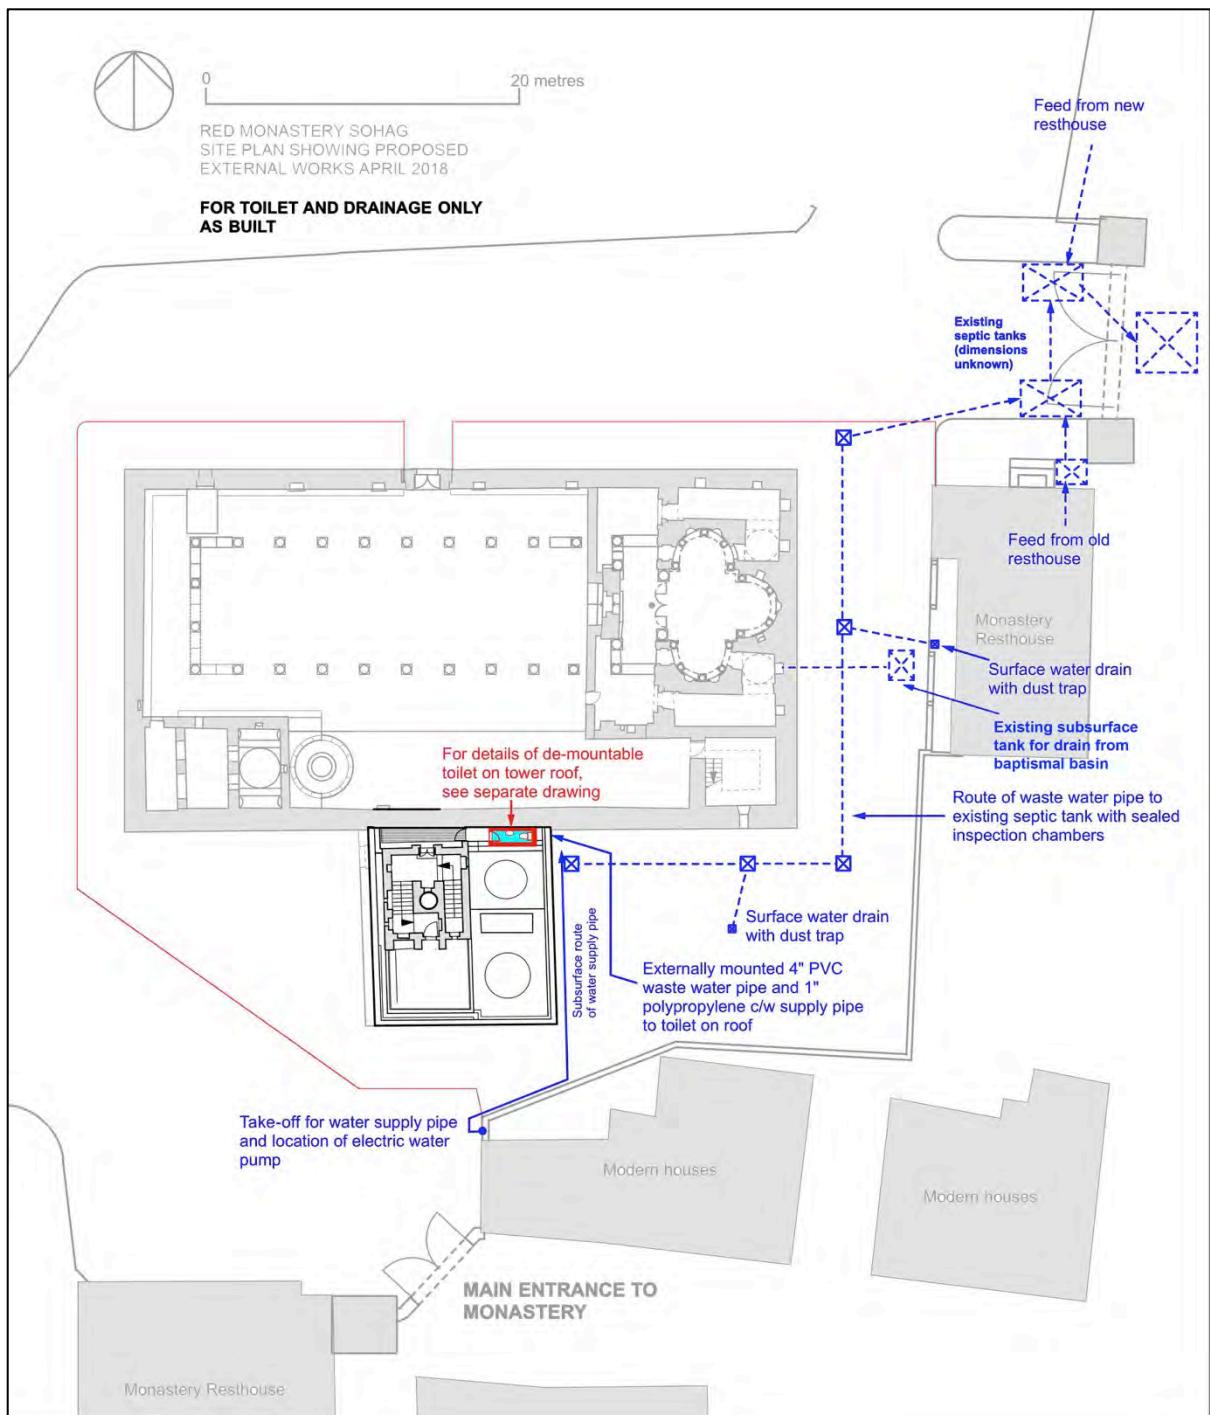
At the base of the tower, soil waste enters a sealed PVC trap, from where it passes into a 15 cm diameter pipe, laid to fall, that connects with an existing septic tank to the northeast of the church, next to the eastern entrance gate to the monastery. Along the route of the pipe are five completely sealed PVC inspection chambers with screw down covers. The position of these inspection chambers is marked in the paving by white limestone slabs that can be easily removed for access if required. Prior to final connection, a waste extract tanker emptied the destination septic tank.

Two additional surface water drains with dust traps were also installed along the path of the drain to allow for the drainage of any unusual volumes of rainwater. One of these is on the south side of the church, and the other is on the east side in the entrance area of the rest house. The drain pipe from the baptismal basis inside the south domed side chamber of the church was retained, as it had its own dedicated dispersal tank in front of the entrance to the old resthouse and is only very rarely used.

Fig 5. Plan of the church showing as built drainage systems now in use

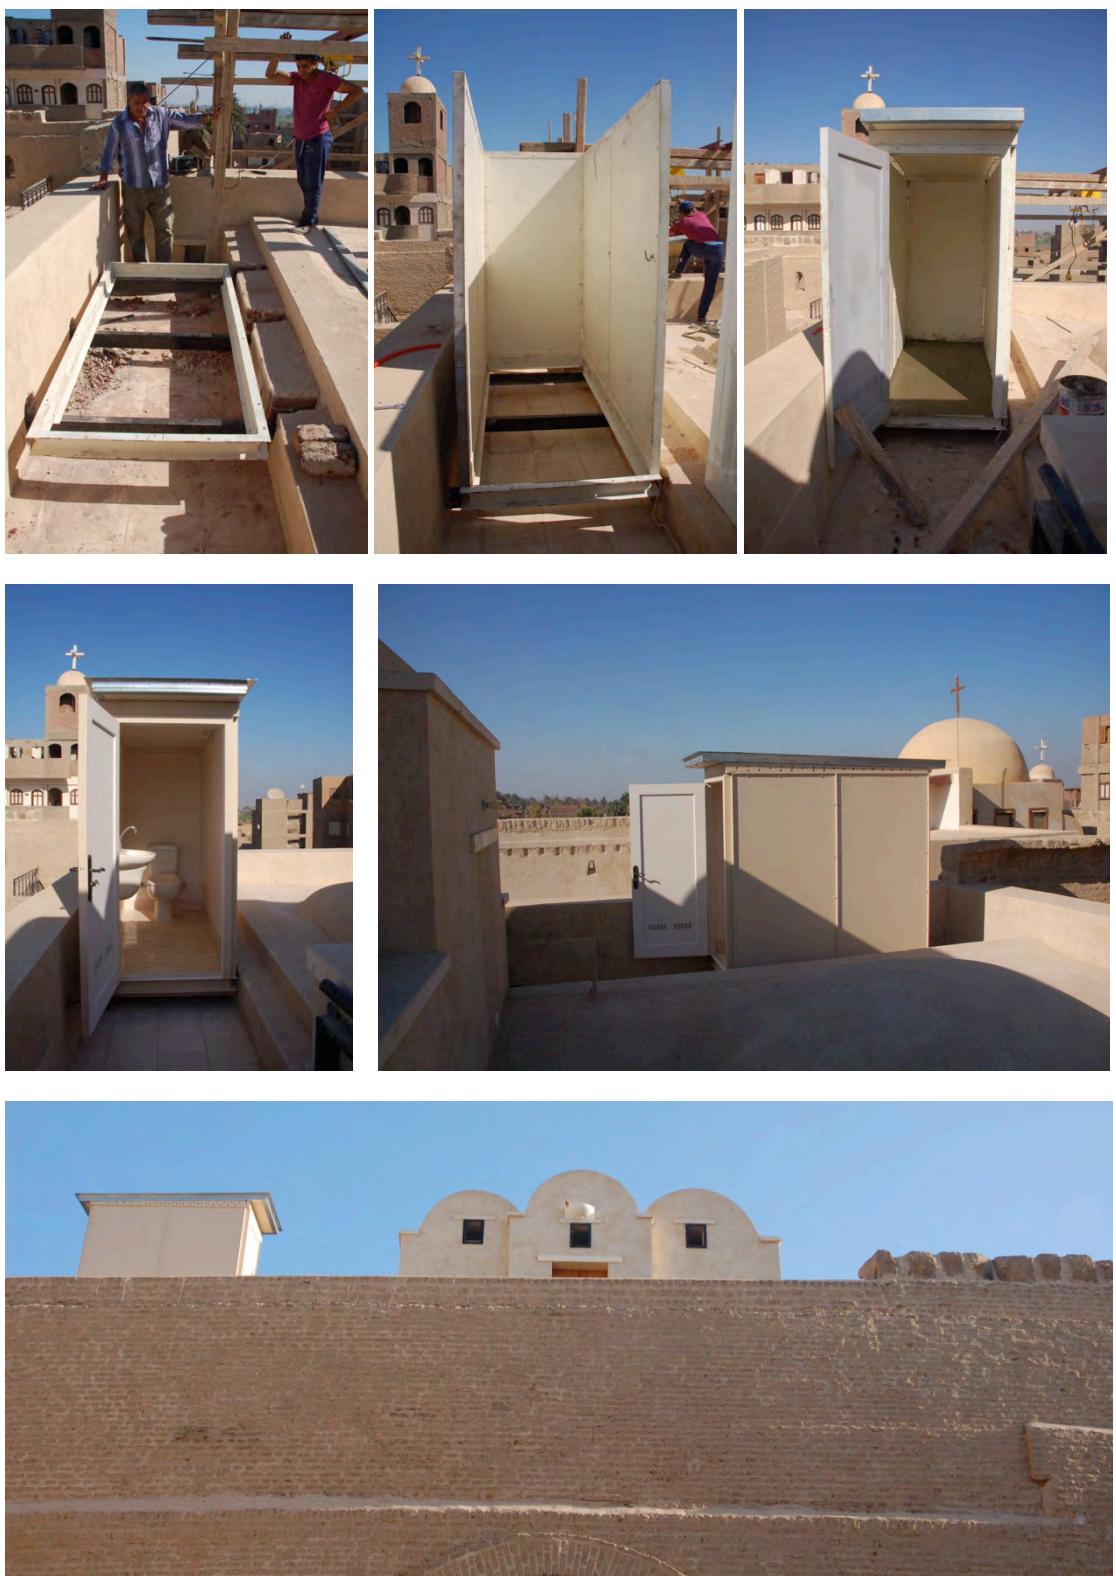
In order to prevent a possible inappropriately executed installation of a toilet in the tower by the monastery, a completely freestanding toilet cabin was installed on the roof of the tower in an area that had already been reinforced structurally to accommodate the weight of this element. This cabin is completely, and easily, de-mountable and contains a sink with cold water supply and a flushing toilet. The water supply is through a 1" polypropylene supply pipe connected to a pump adjacent to the incoming monastery water supply from the street. The supply pipe is externally mounted on the northeast corner of the tower at its junction with the south wall of the church. A 12 cm diameter ventilated soil waste pipe, made of high-grade PVC runs vertically in the same corner. Both supply and waste pipes are fixed to the exterior brickwork of the tower using galvanised metal clamp fixings and a minimal number of screws.

Fig. 6 Sequence of installation of enclosed toilet on roof of tower and final external appearance

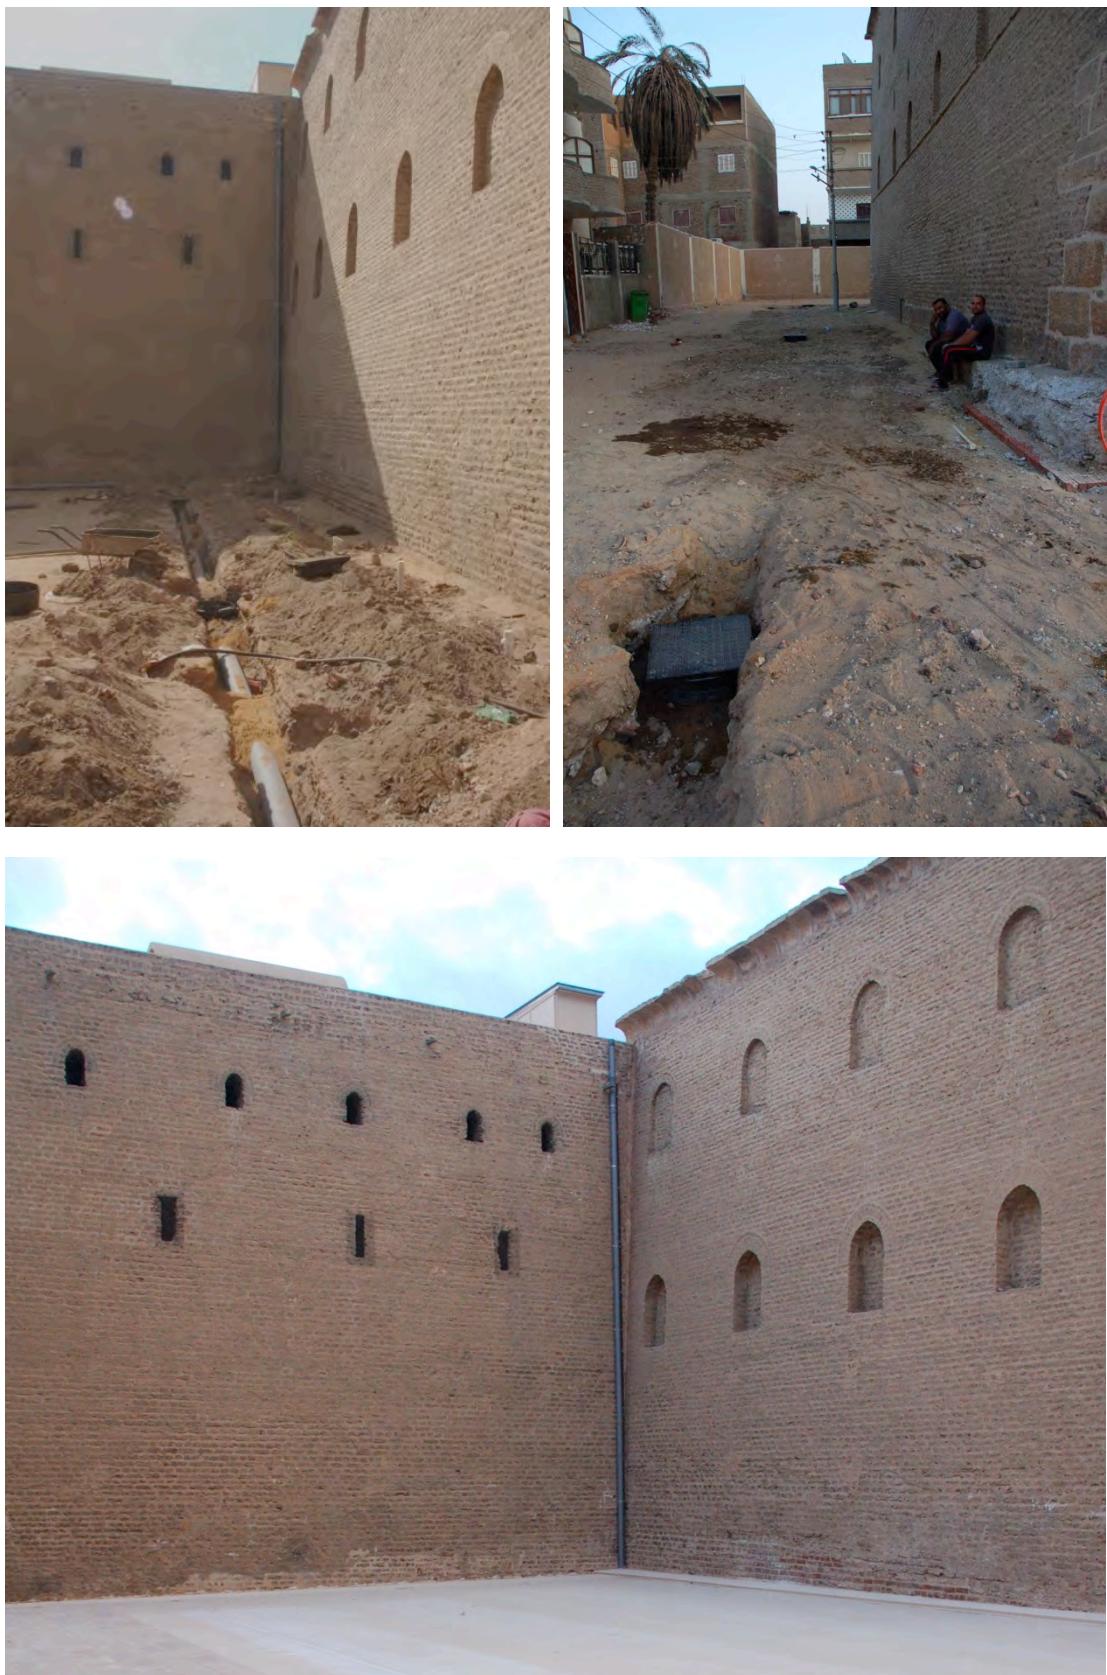
Fig. 7 Sequence of installation of subsurface waste pipes and inspection chambers (top) and final external appearance of toilet and external waste pipe on east face of tower (bottom)

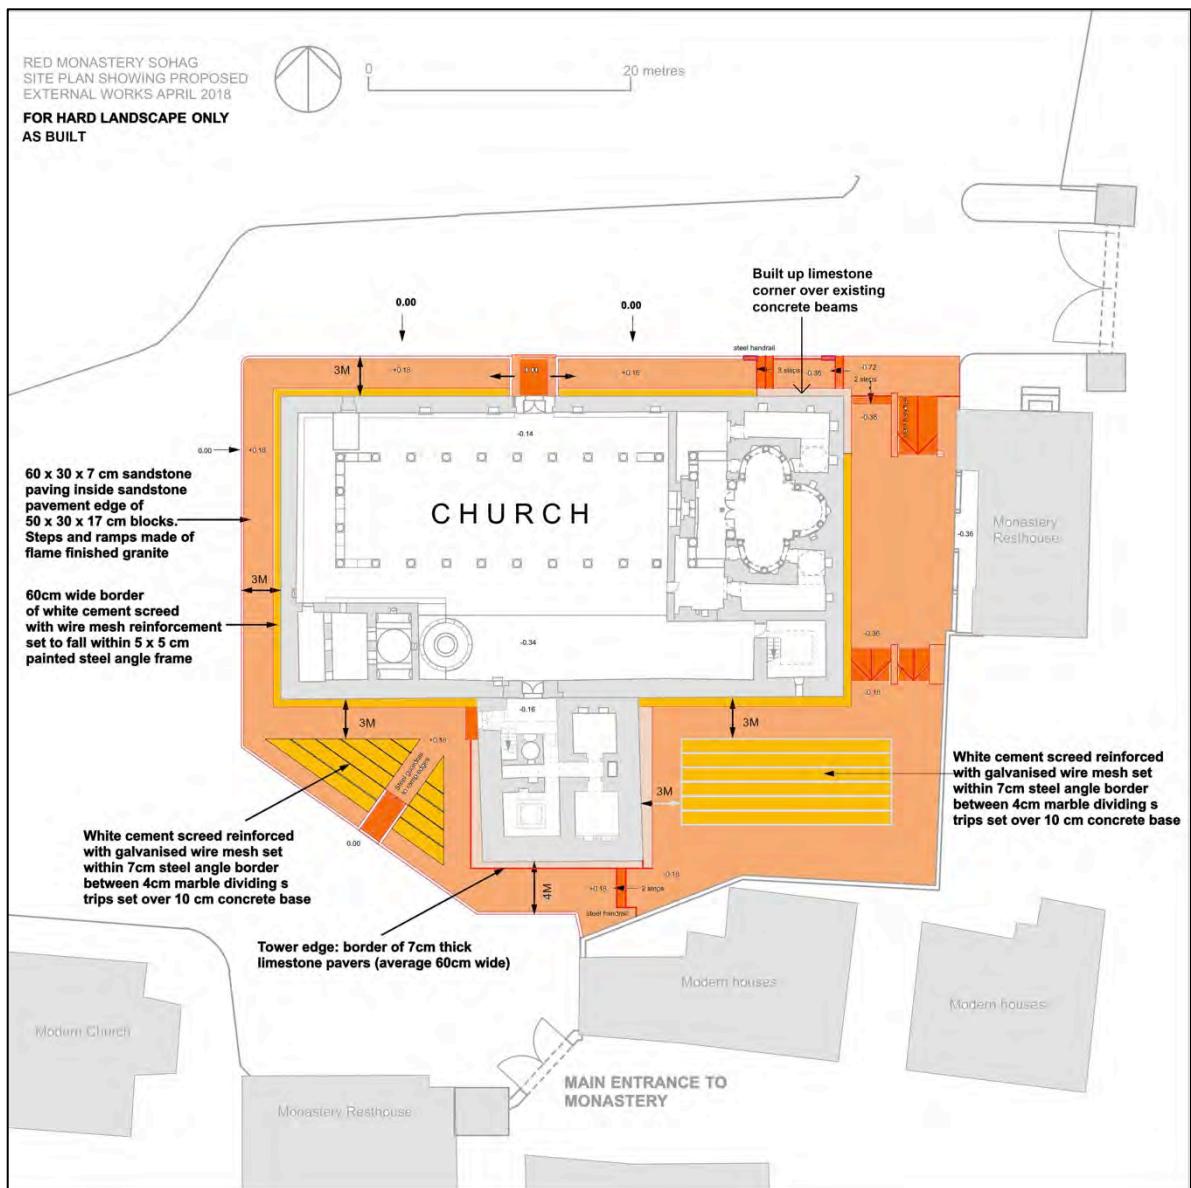
The hard landscaping around the church was executed using sandstone, limestone, granite, and areas of white cement screed defined by painted steel frames. A total of 720 m² of paving plus 160 m² screed was used. The main intention of the project was to prevent vehicles from driving around the church as well as to stop them parking next to the church. With this objective, a sandstone kerb (50 x 30 x 17cm), with a height varying from 18cm to 25cm above the external compacted sand surface, was installed over a minimal concrete footing. The sandstone and limestone pavers (60 x 30 x 7cm) were laid over a sand base. The granite (solid steps of 100 x 18 x 30cm and pavers of 60 x 30 x 4cm) was flame finished throughout to prevent slippage and was employed in areas of maximal wear. A single large block of granite (200 x 12 x 60cm) was placed in front of the main entrance to the church from the tower. The perimeter of church was surrounded by a raised border of white cement screed set within a 5 x 5cm painted steel angle frame, set to a slight fall to the exterior. This border is designed not only to shed water away from the face of the walls, but also to discourage people from placing chairs against the walls. It also provides the base of

Fig 8. Plan of the church showing as built hard landscaping

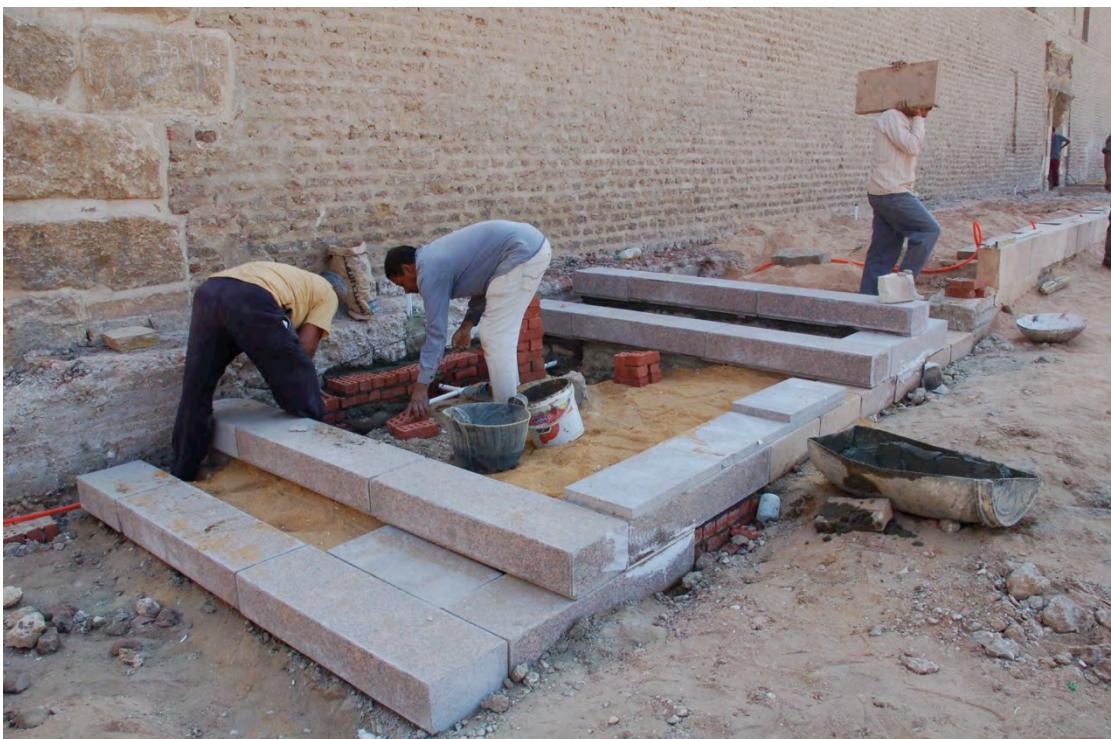
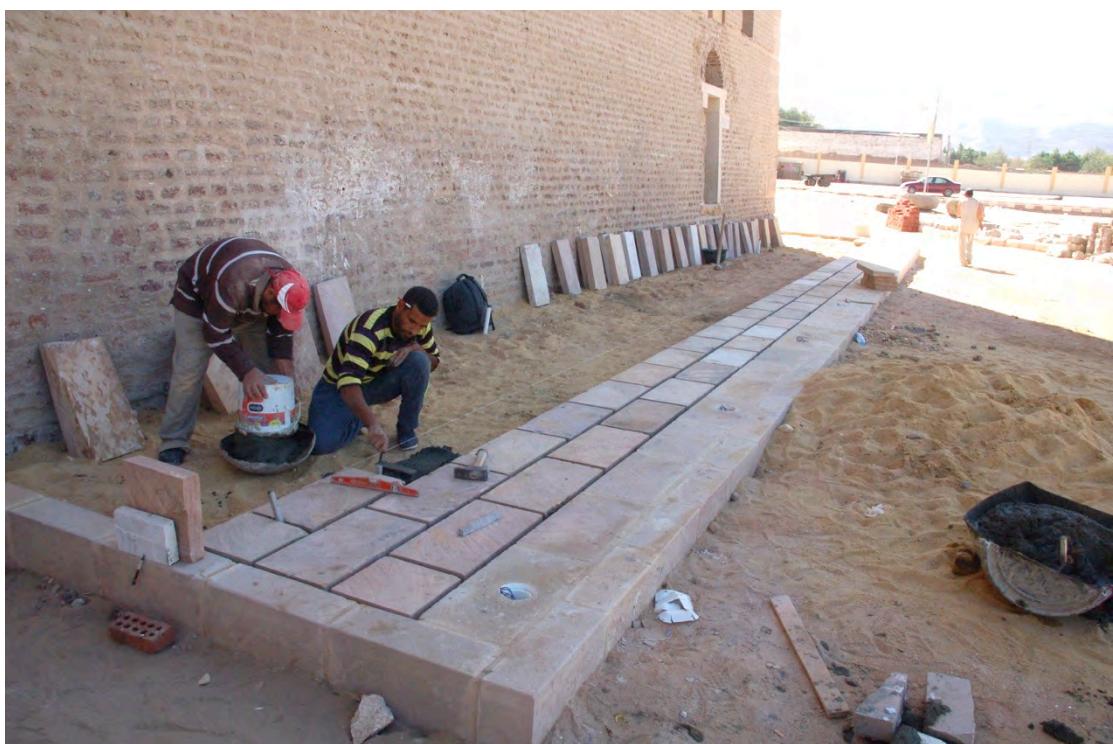
Fig 9. Installation of steps and paving in process

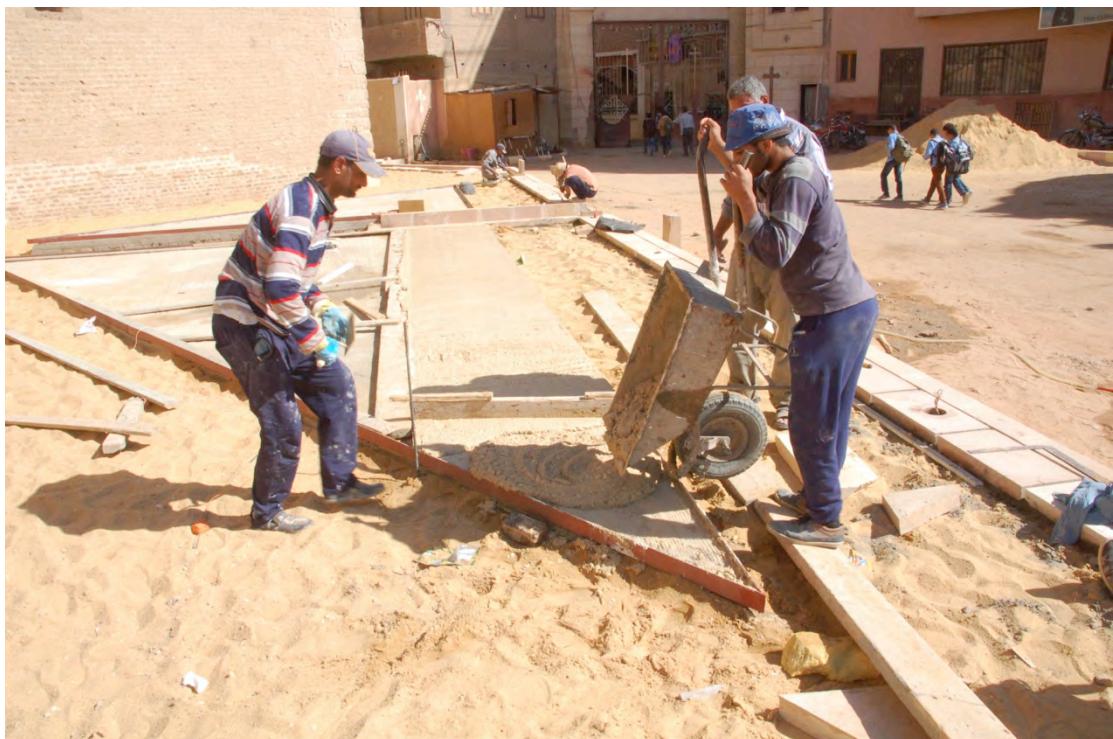
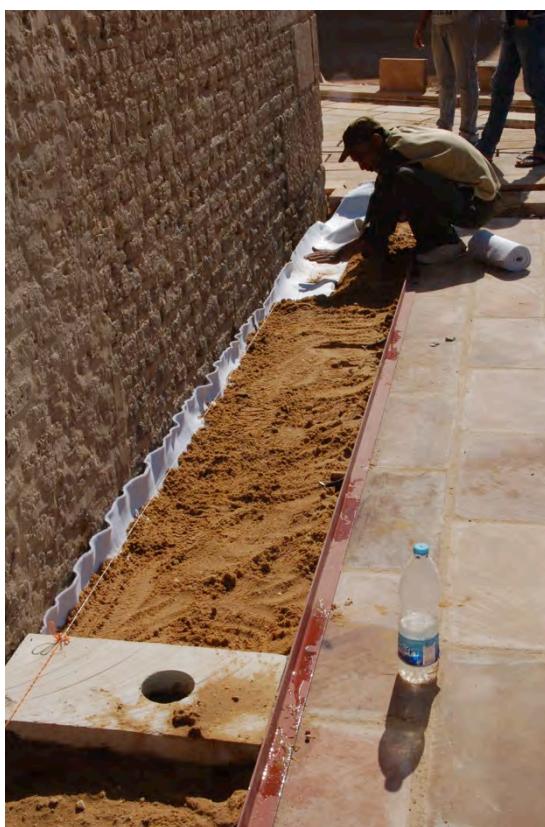
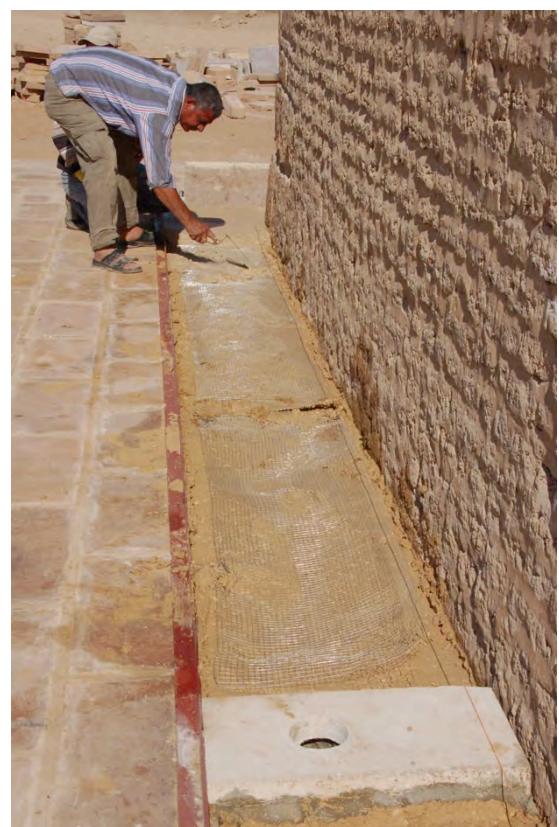
Fig 10. Installation of white cement screed in progress with geotextile separation to critical edges of external wall (bottom left)

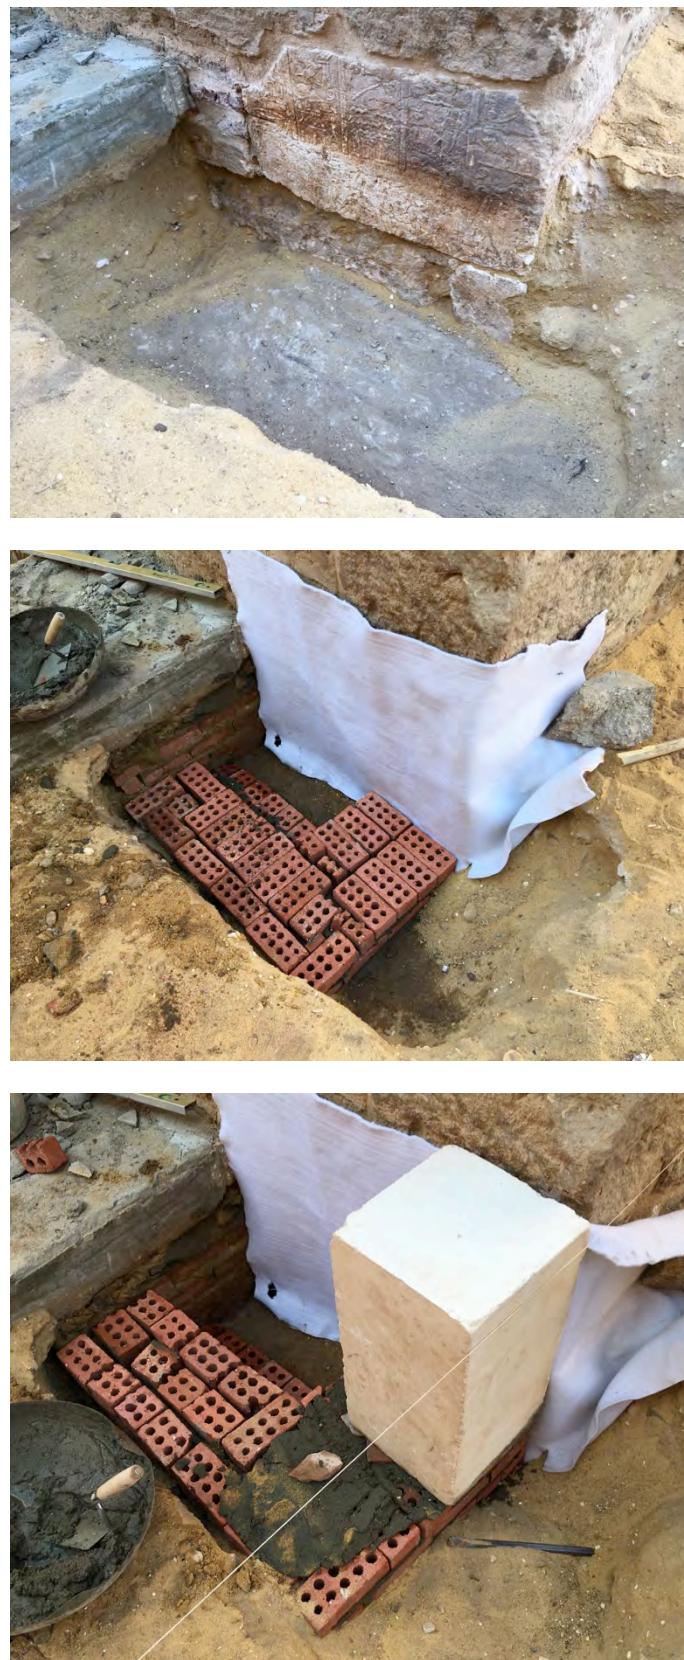
the walls with a visual frame. Two pharaonic blocks built into the walls at their base – on the southeast corner of the tower and midway along the length of the east wall – required special protection measures. The blocks (which have been recorded in past seasons), were covered with a geotextile fibre before being protected by new limestone walls and pavers within areas infilled with clean sand. A geotextile fibre was also used to protect the perimeter of the enclosure wall of the church on its northeastern corner where the original, and unrestored, condition of the brickwork of this wall survives.

Fig 11. Sequence of protecting the pharaonic relief block on the southeast corner of the tower

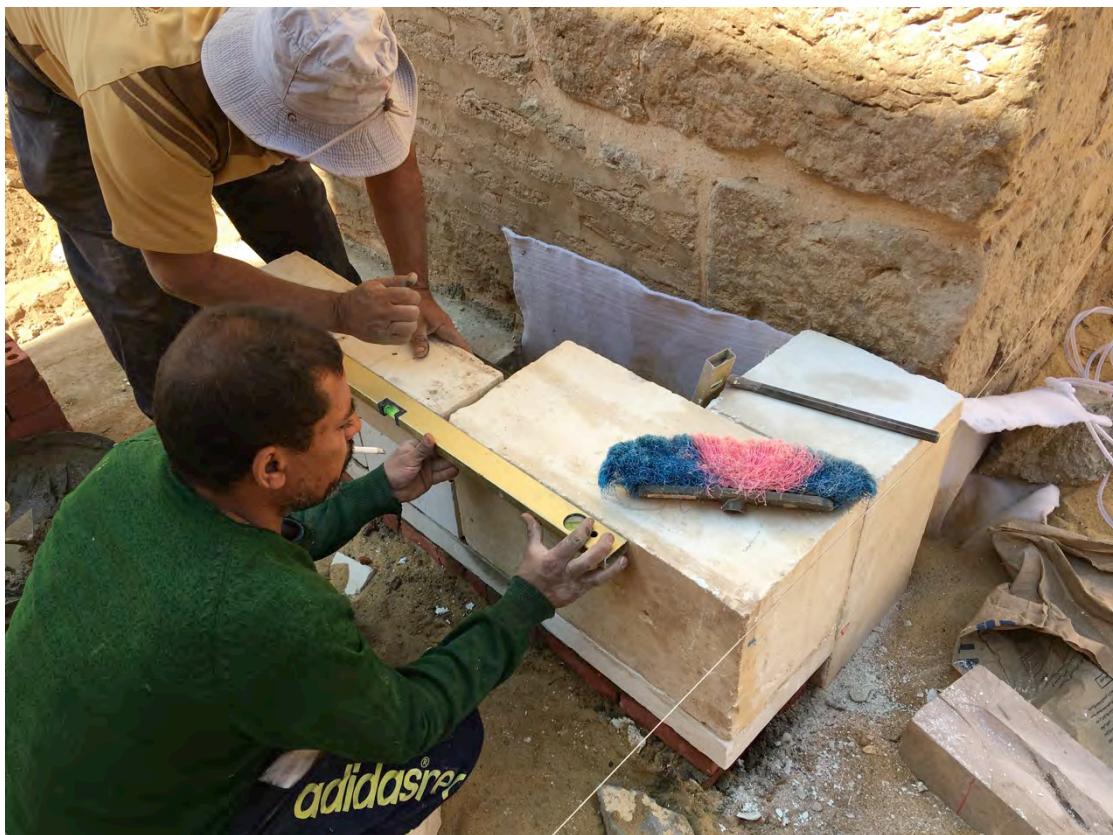
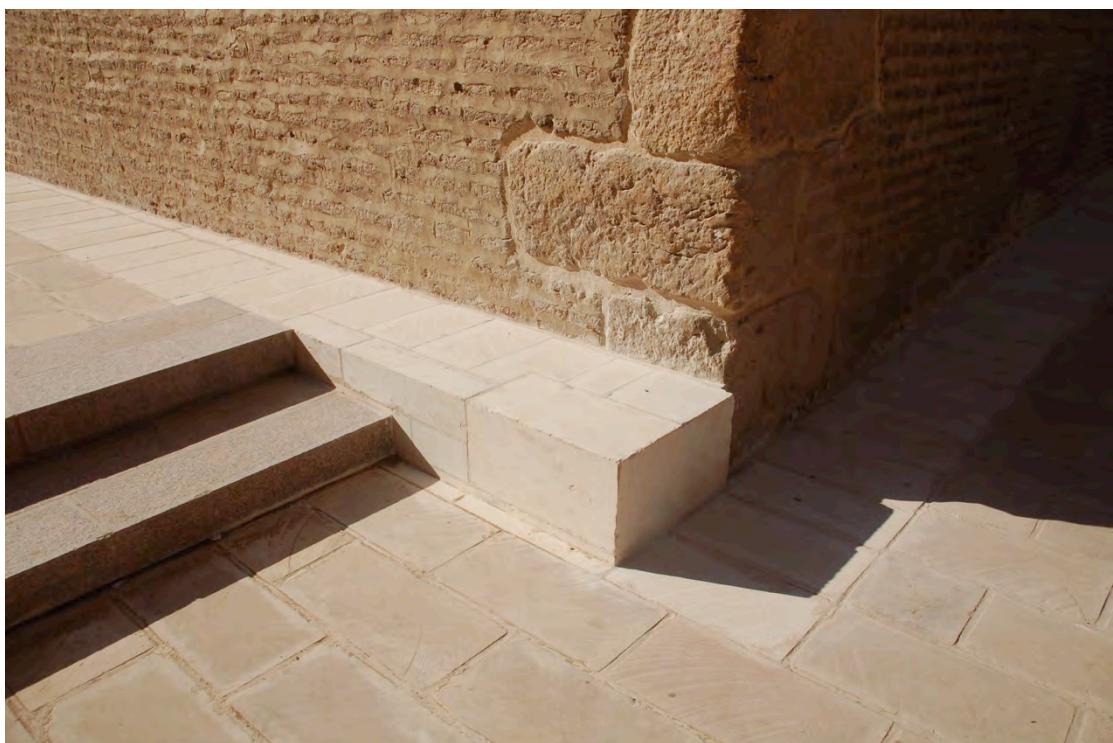
Fig 12. Limestone wall protecting the pharaonic relief block on the southeast corner of the tower during (top) and after works (bottom)

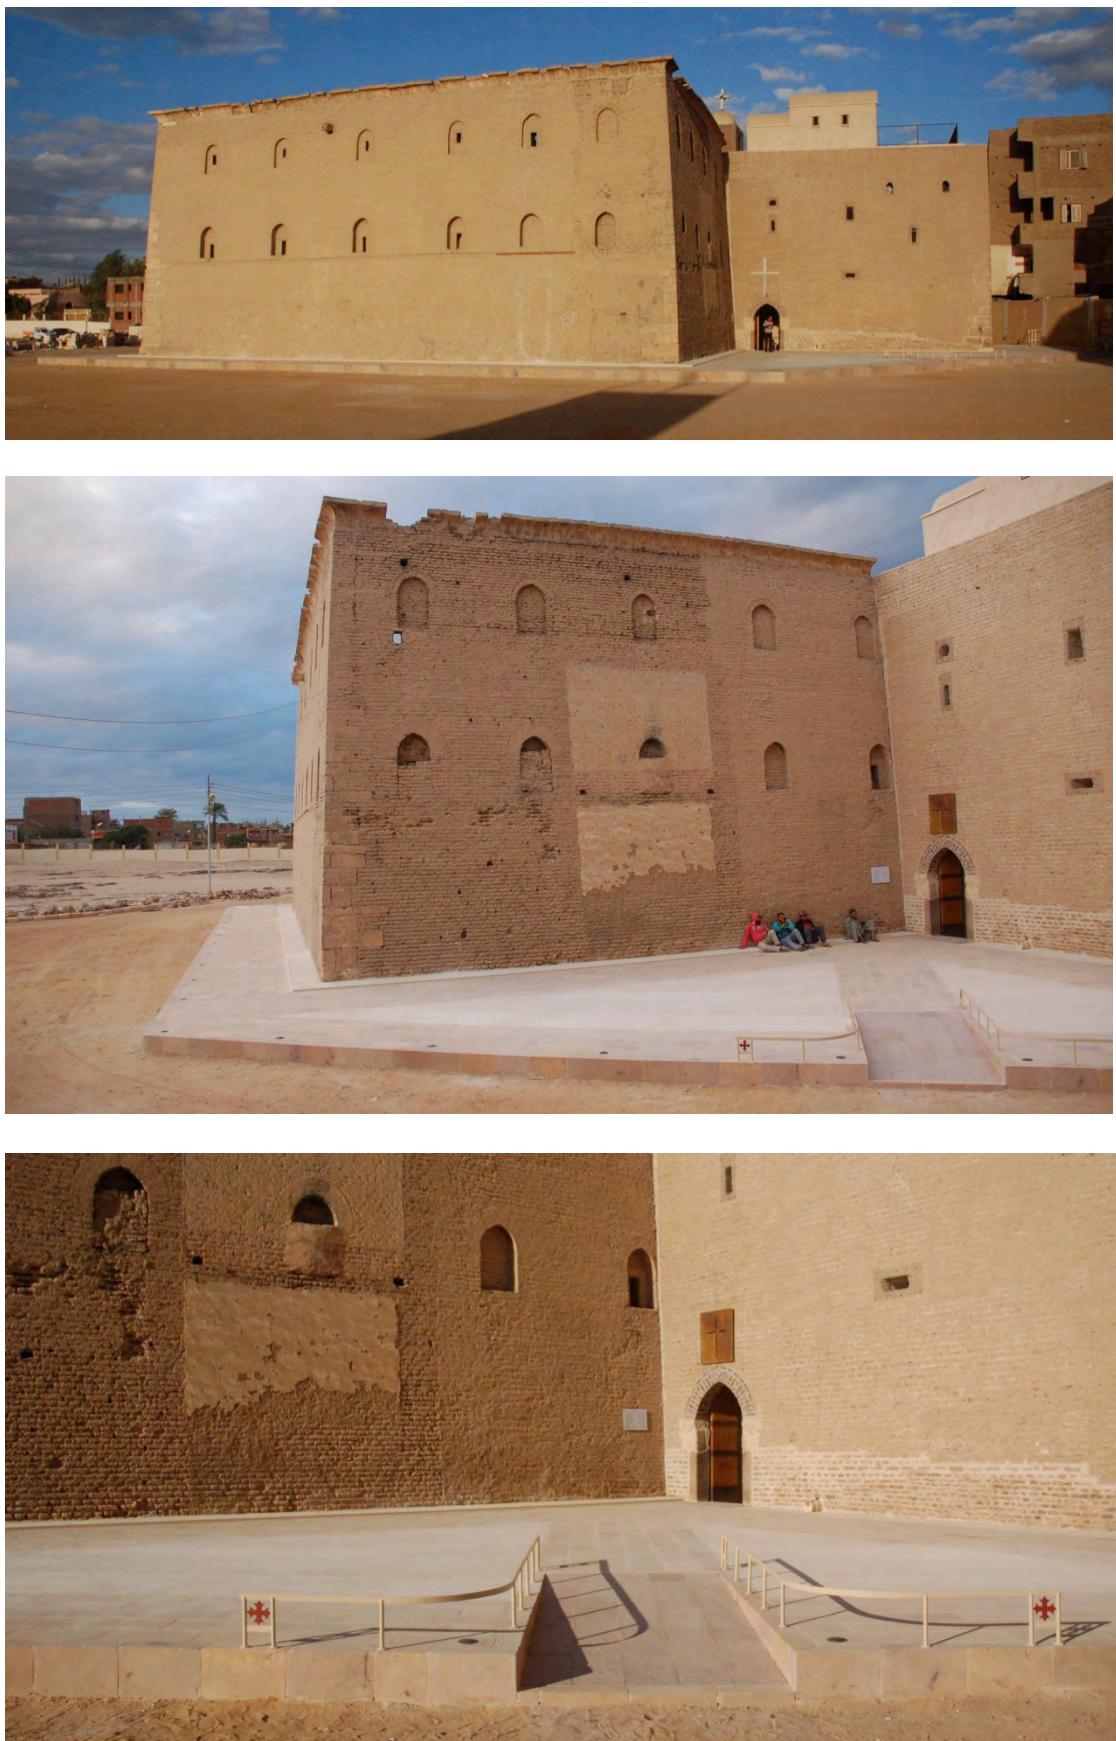
Fig 13. Completed paving around the church from west (top) and southwest (center and bottom)
