RED MONASTERY AUTUMN 2018

**ARCHITECTURAL CONSERVATION
&
SITE MANAGEMENT WORKS**

AMERICAN RESEARCH CENTER IN EGYPT

TECHNICAL REPORT

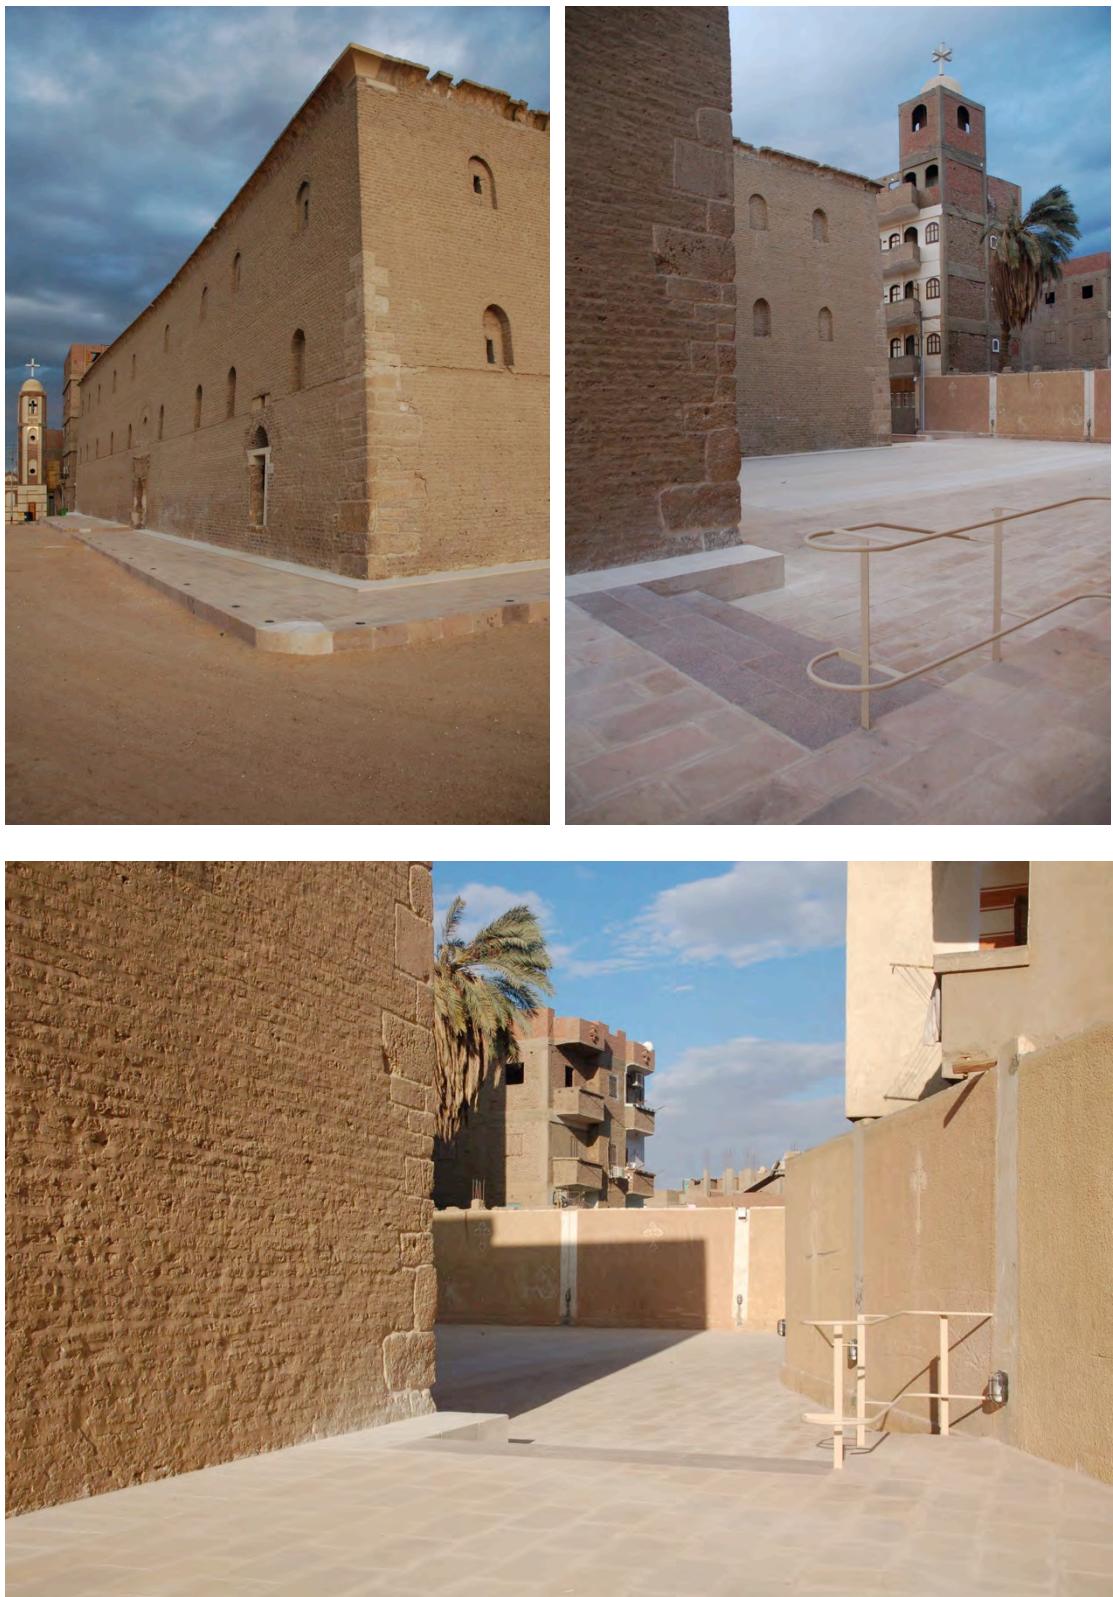
Fig 14. Completed paving around the church from west showing north façade (top left) and southwest area (top right and bottom)

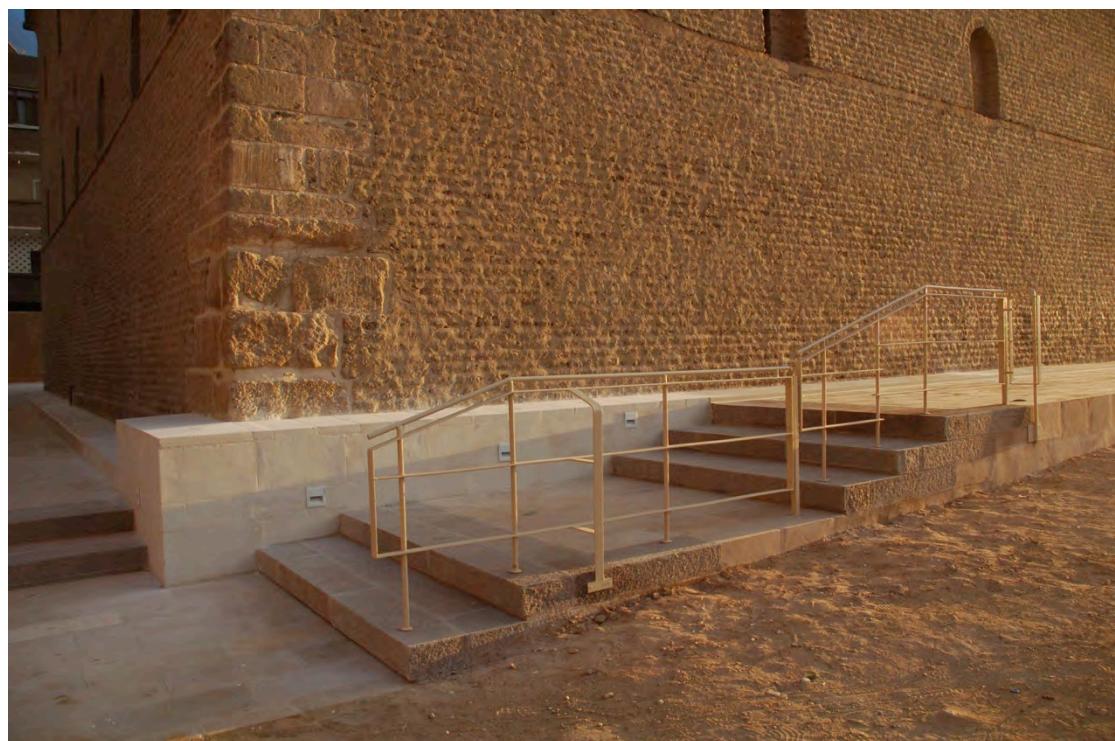
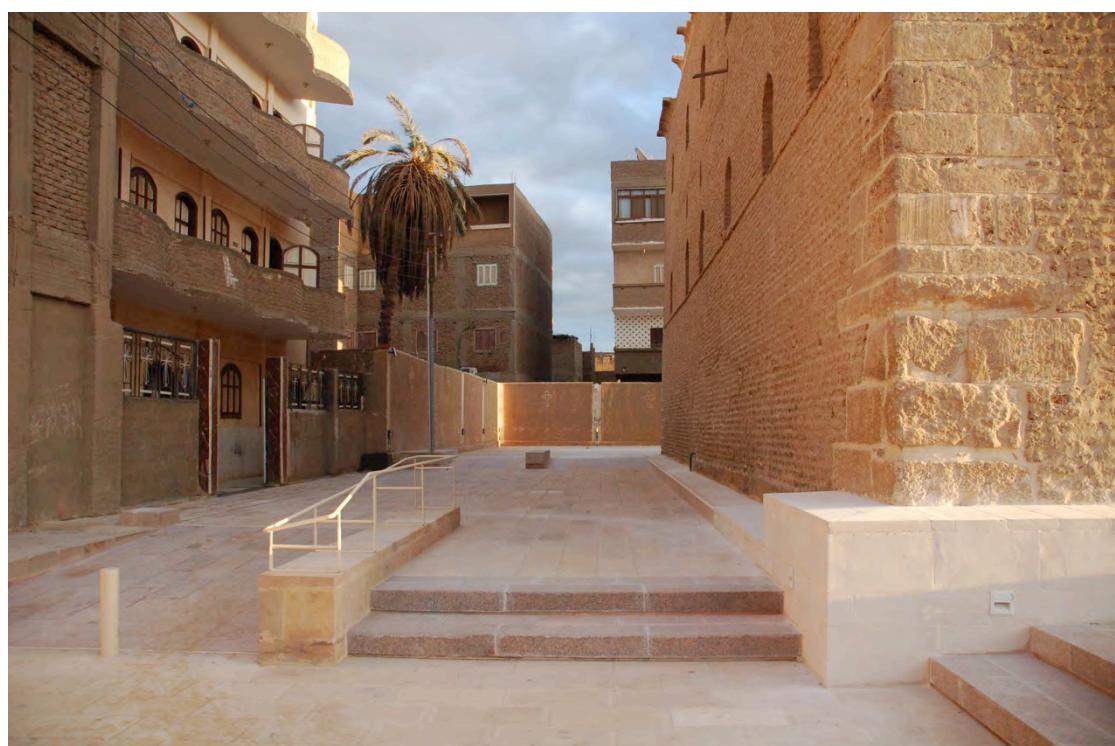
The northeast corner of the church required special treatment owing to presence of a large amount of concrete in this area. A limestone cladding wall was constructed to obscure this, with the choice of stone dictated by the proximity to the original limestone quoins of the corner of the church. Disabled ramps were provided at key points to provide full access by the handicapped to all levels of the exterior, and painted steel handrails were installed in all locations with a change in level of 36cm or more.

Fig 15. Completed paving around the church showing northeast corner

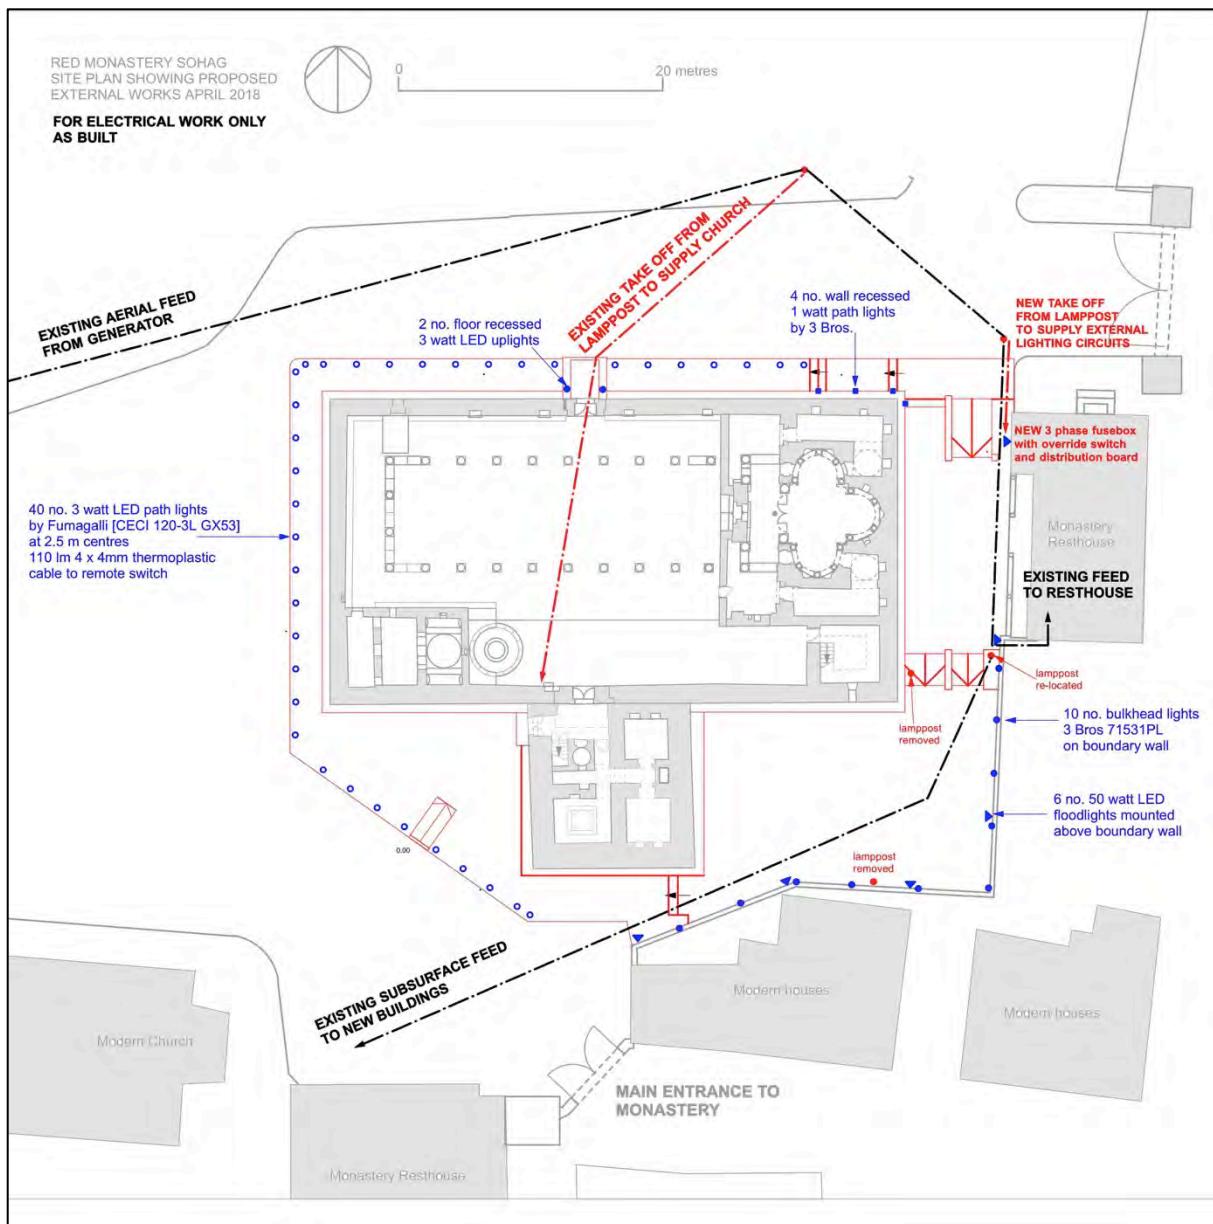
A new electricity network was installed to provide power to all external lighting. Power was obtained from the lamppost immediately adjacent to the northwest corner of the old monastery resthouse, and a new distribution board placed on the wall of the resthouse. Output is controlled by a photocell, which is also capable of being overridden if desired. The new circuits are only for the provision of lighting, as follows:

Fig 16. Plan of the church showing as built electrical provision and existing network

Electrical network: The present electrical provision to the church, and all buildings to its south, east, and northeast should be reconsidered. It is recommended that a new subsurface cable be installed leading to the area of the recently installed external distribution board, with further subsurface feeds made to the church, old resthouse and new resthouse under construction. The buildings to the south and southwest of the church should be supplied directly from the substation that is located nearby.

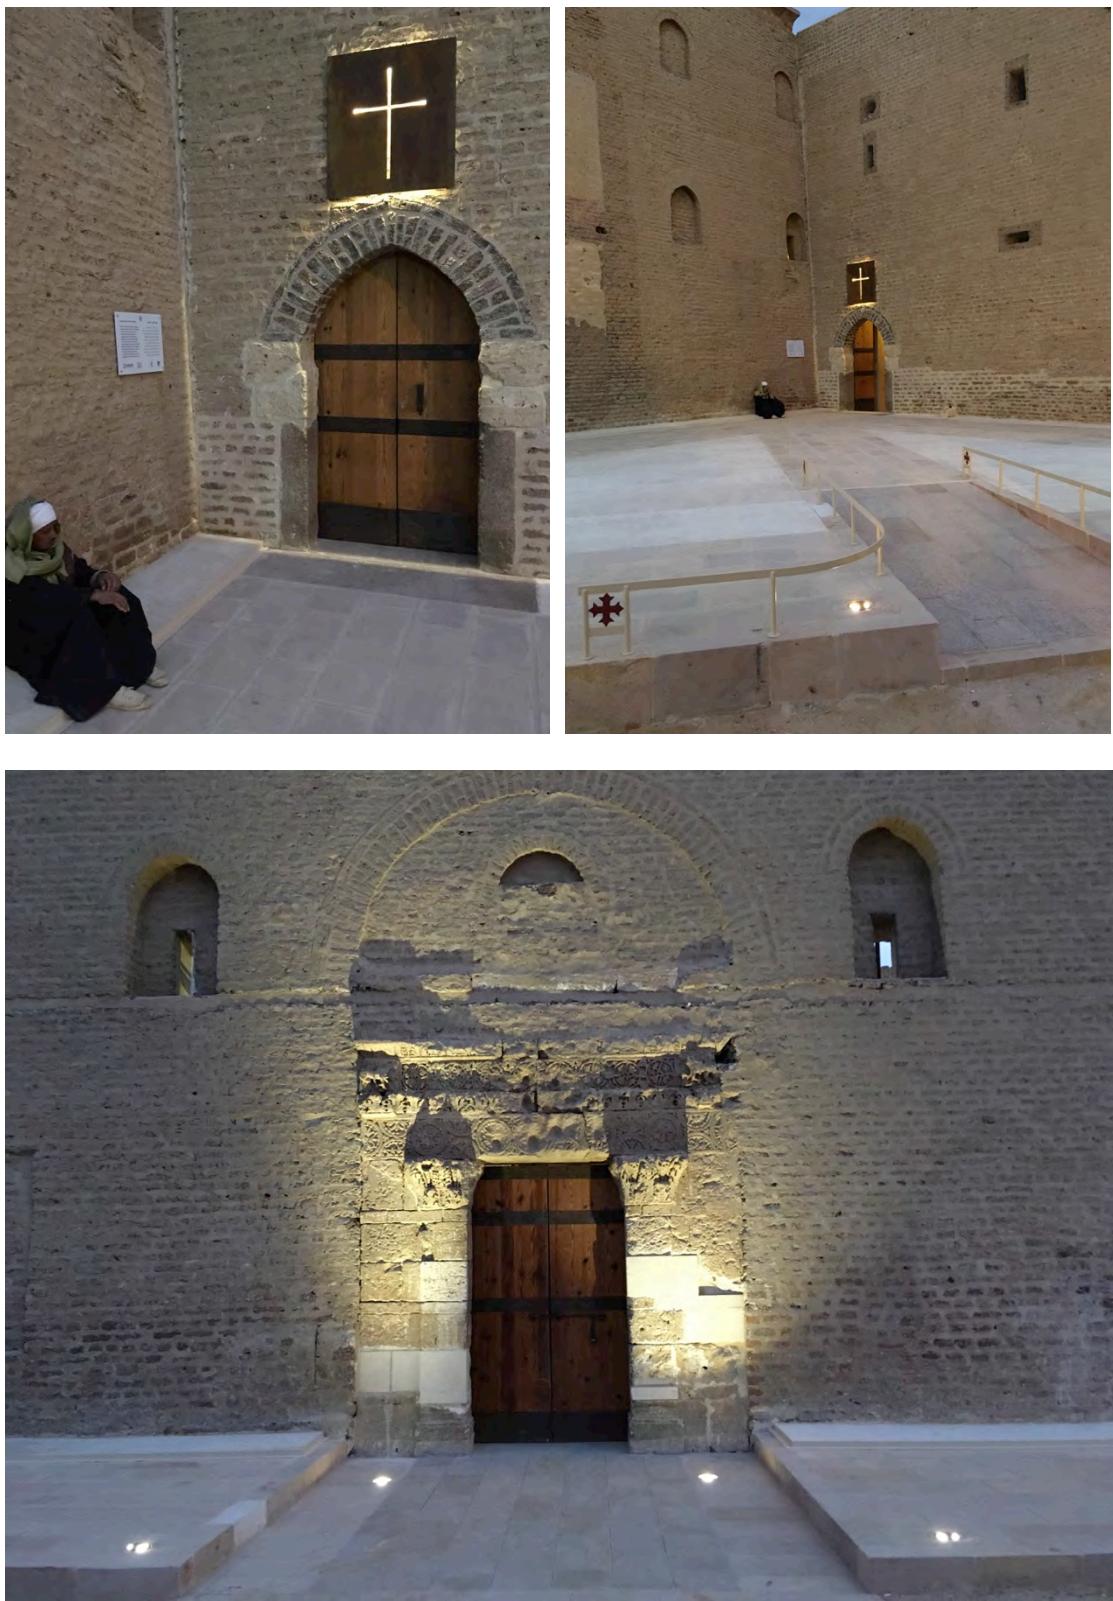
A new lighting system was introduced over the main entrance door. This was a metal plate with a laser-cut cross mounted on a wooden frame. Three internal LED lights provided illumination of the cross as well as the threshold of the door below.

Fig 17. Lighting over the main entrance (top) and to the north portal (bottom)

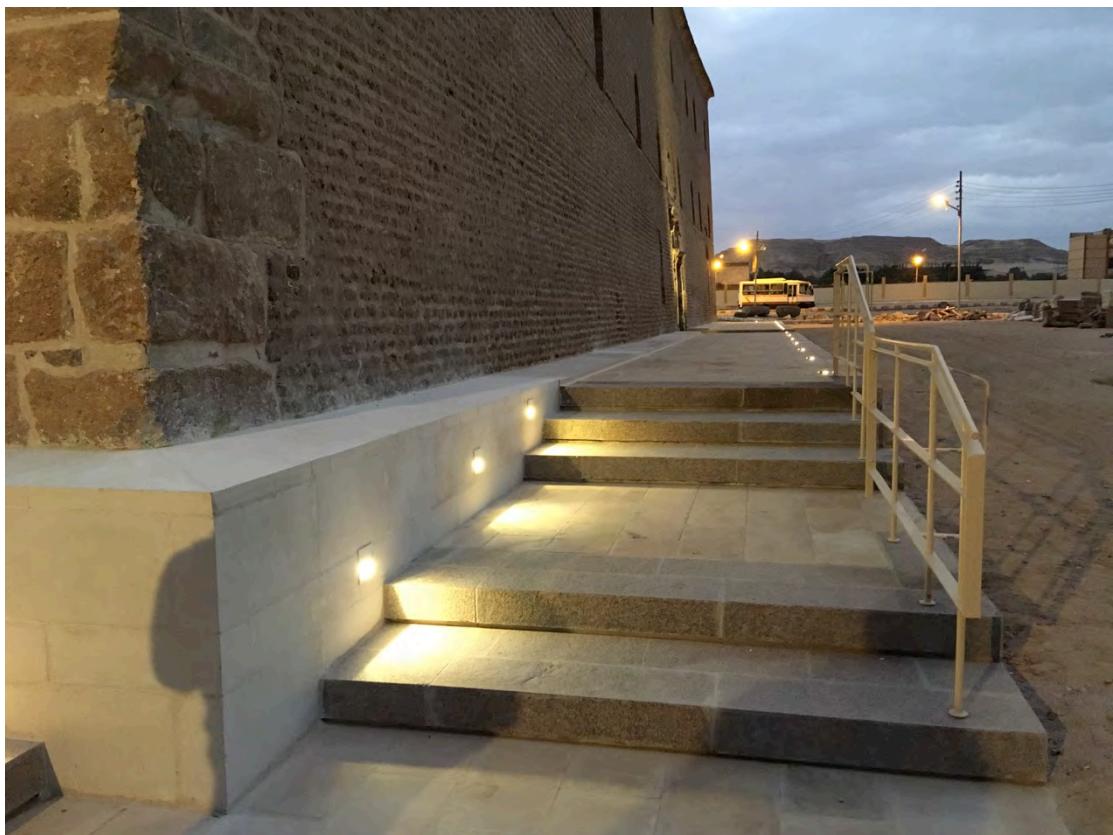
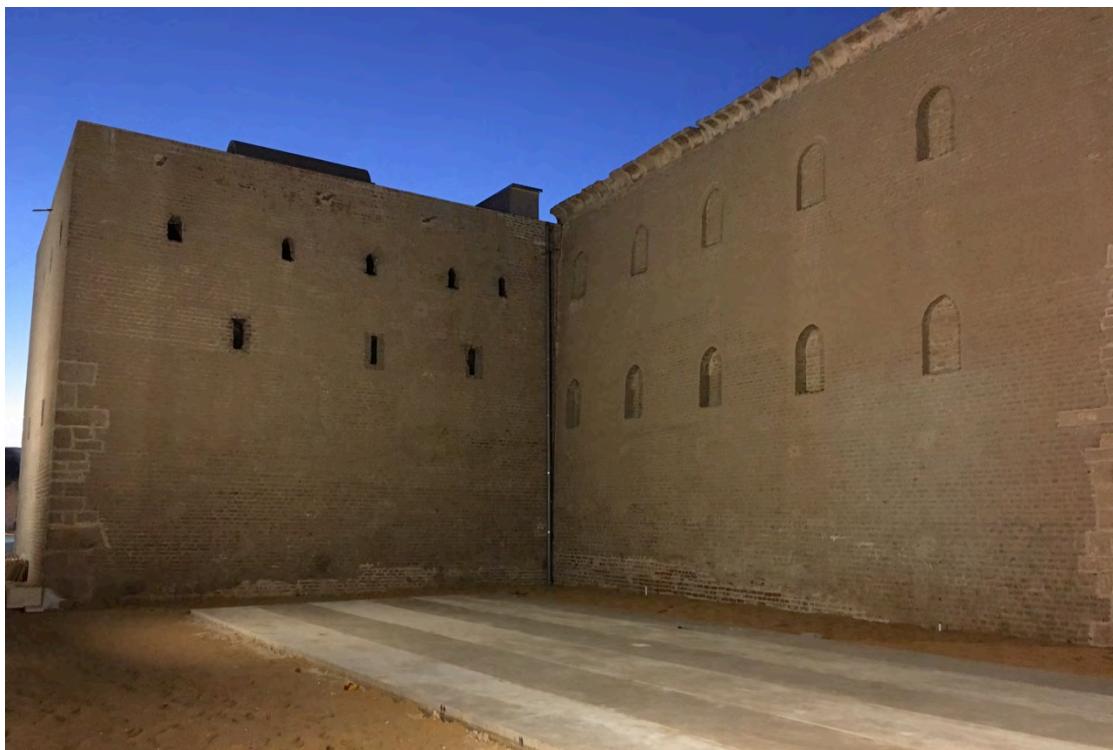
Fig 18. Lighting on northeast corner (top) and southeast area (bottom)

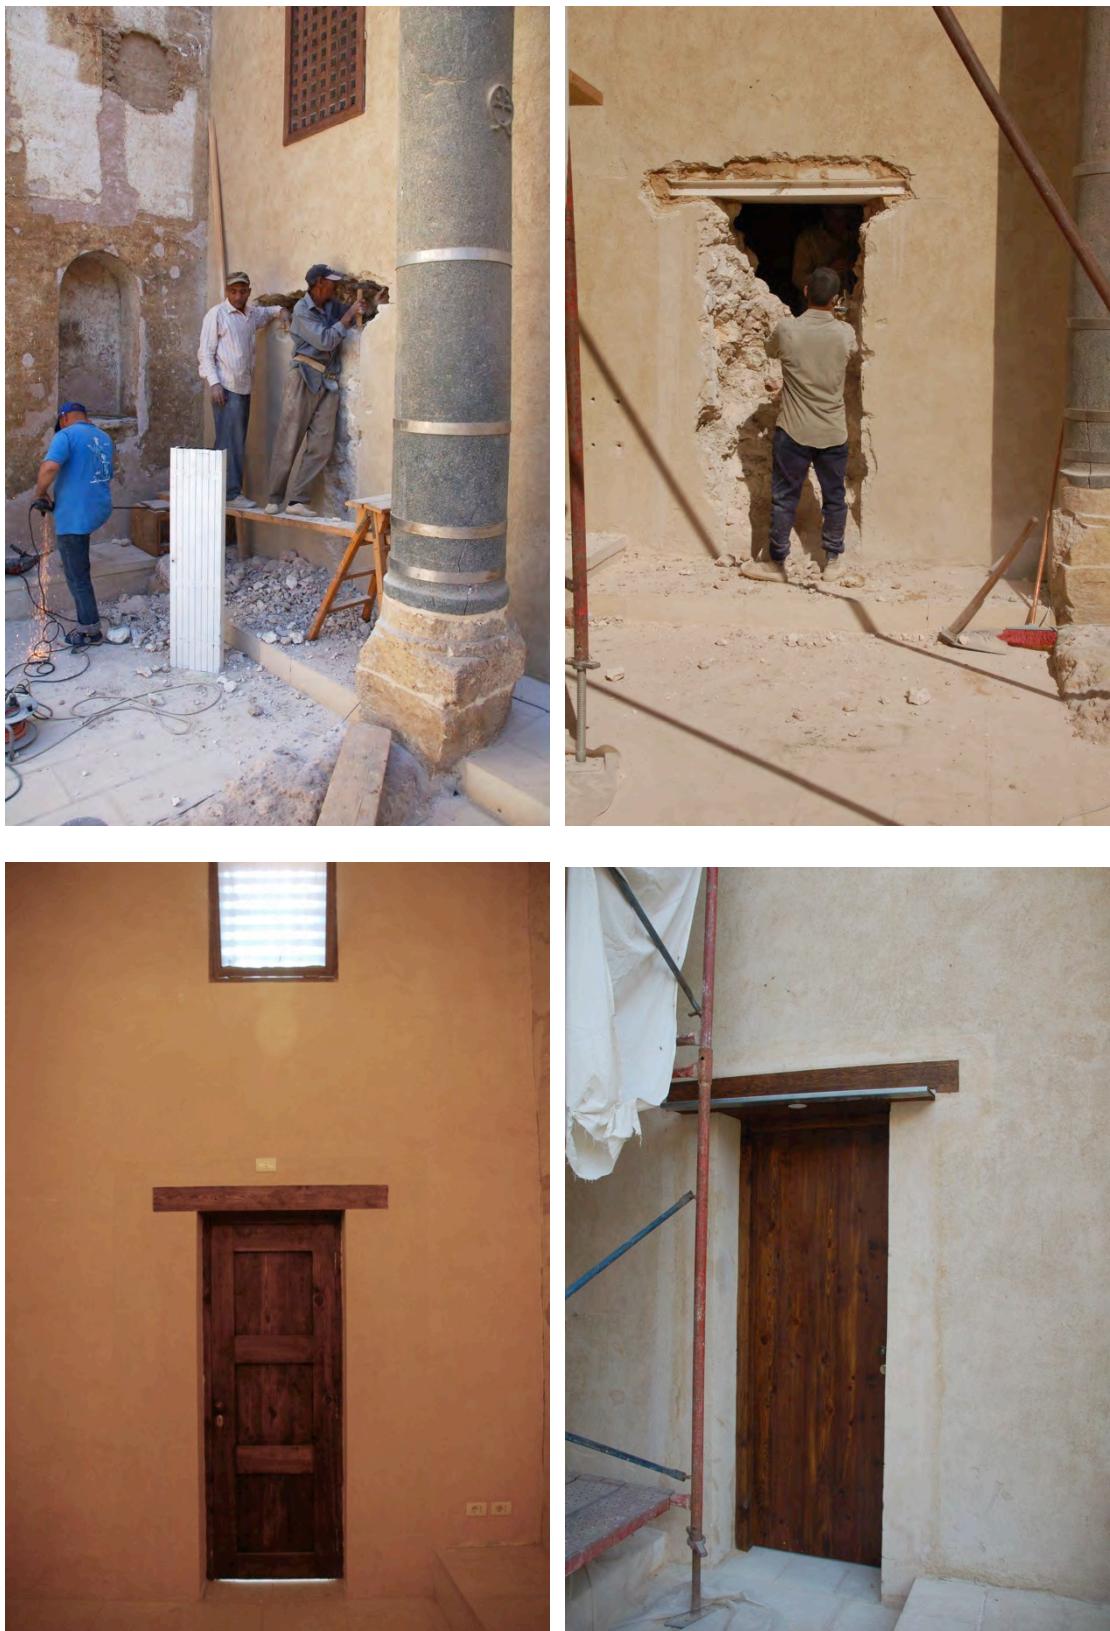
A new opening for a door was made on the north side of the Comité wall, constructed of limestone rubble in lime mortar in 1912, underneath the north window in this wall. The design of the door matched the design of the existing door on the south side of the wall. All timber was treated prior to installation to discourage termite attack, and the plaster surfaces were made good on both the inside and outside of the door.

Fig. 19. The new door in the Comité wall during and after installation

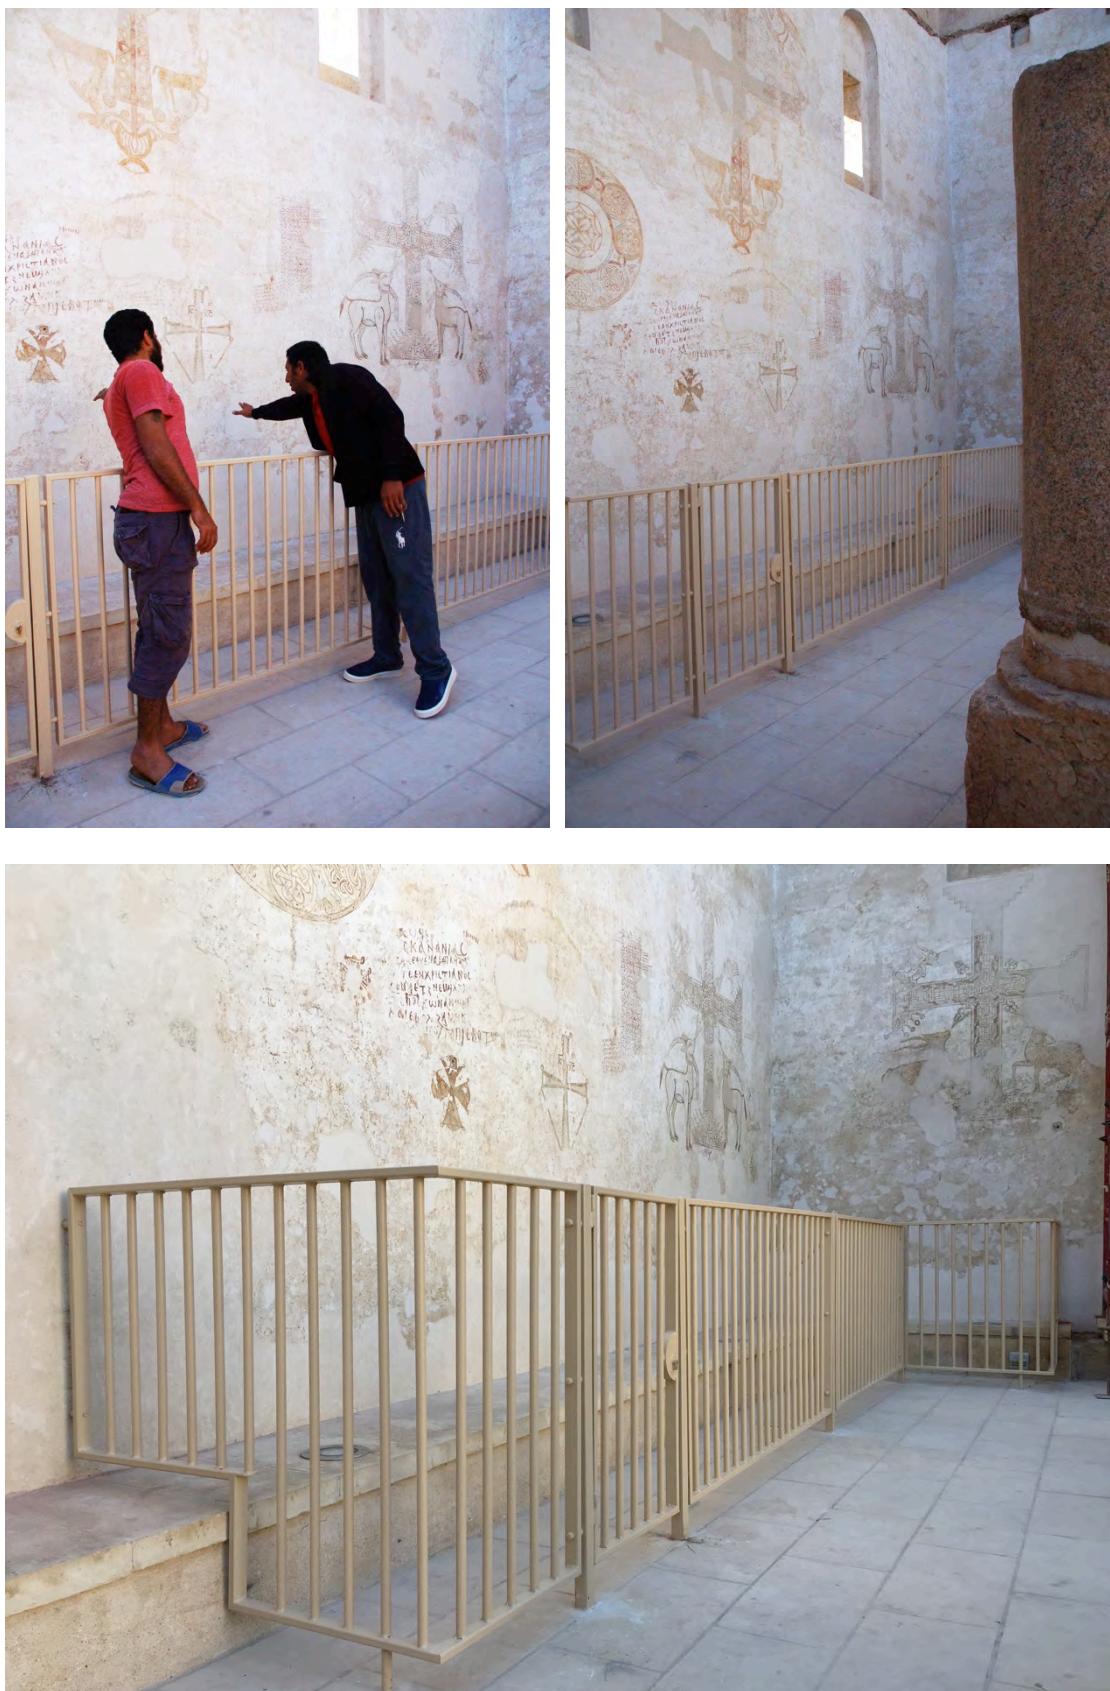
The handrails in the northwest corner of the nave are positioned 1.2 metres away from the walls in order to prevent visitors from touching any painted surfaces within reach. An internal gate in the railing provides access for cleaning the enclosed area.

Fig. 20. Protective painted steel handrail at the west end of the nave

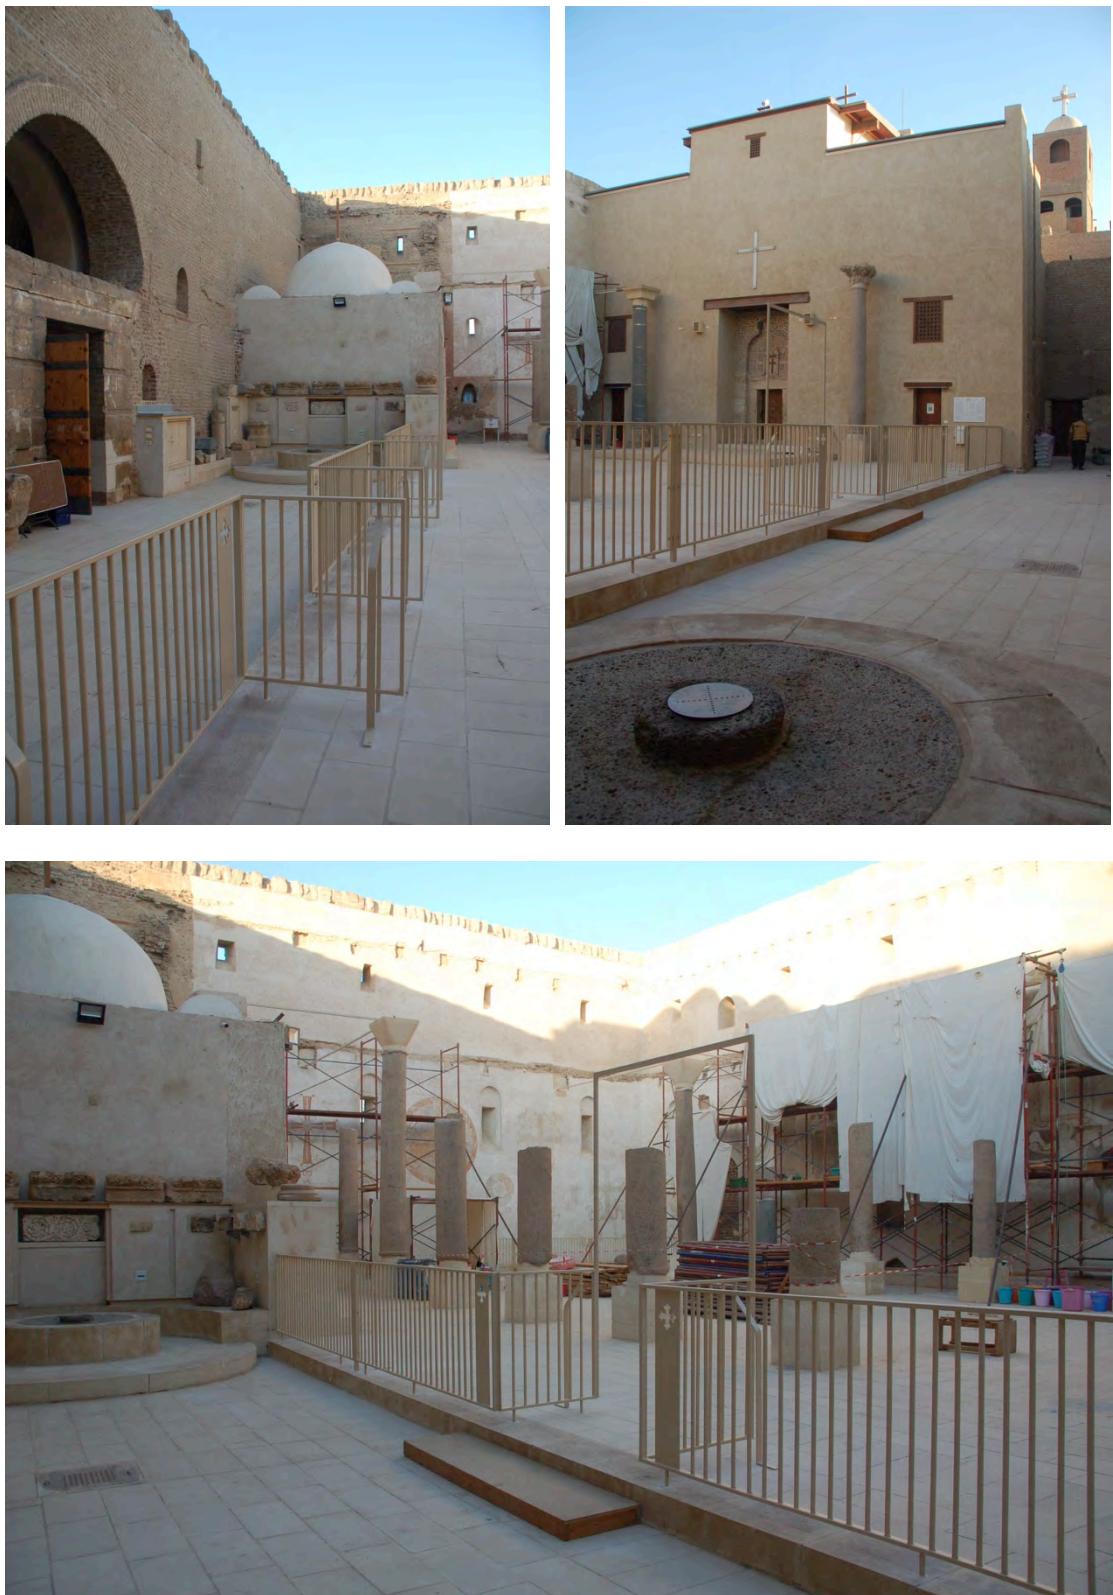
The handrails on the south of the nave follow the original line of the missing wall separating the nave from the south hall, and are broken by two openings located in the positions of original openings identified by the 1962 Darmstadt Survey of the church. The central opening, on the axis between the north and south portals, as further defined by a simple steel section frame that delineated the approximate size of the door that once stood in this position.

Fig. 21. Painted steel handrail separating south hall from nave of the church to prevent accidental falling of visitors

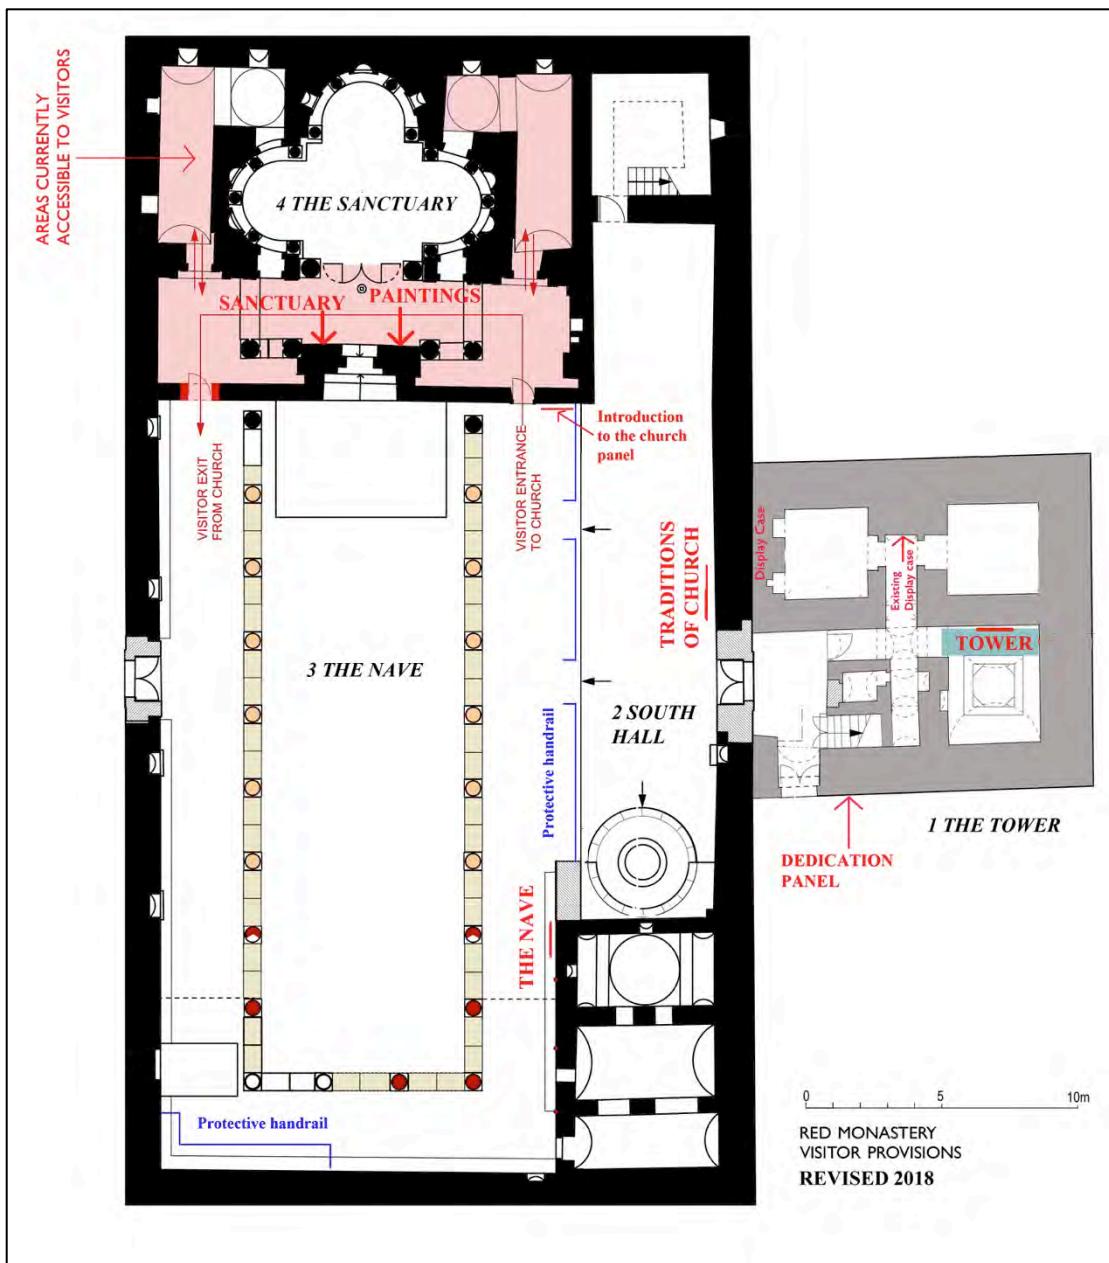
Fig. 22. Plan showing location of visitor panels and protective handrails

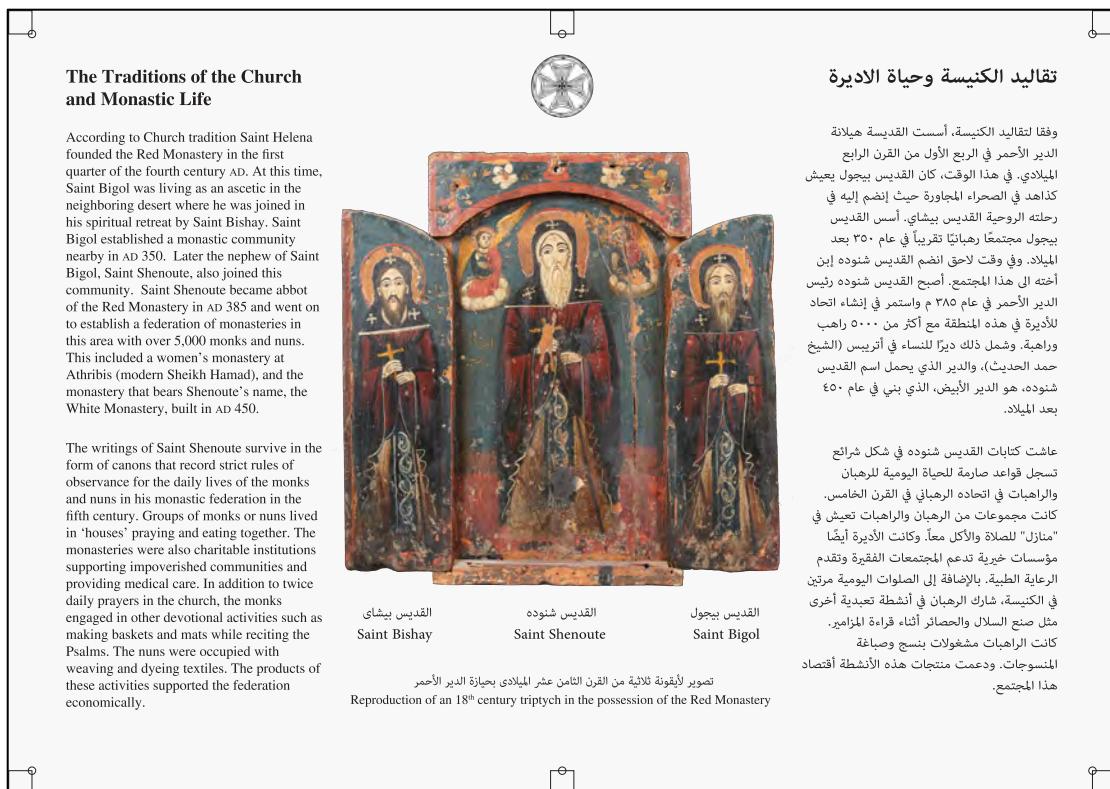
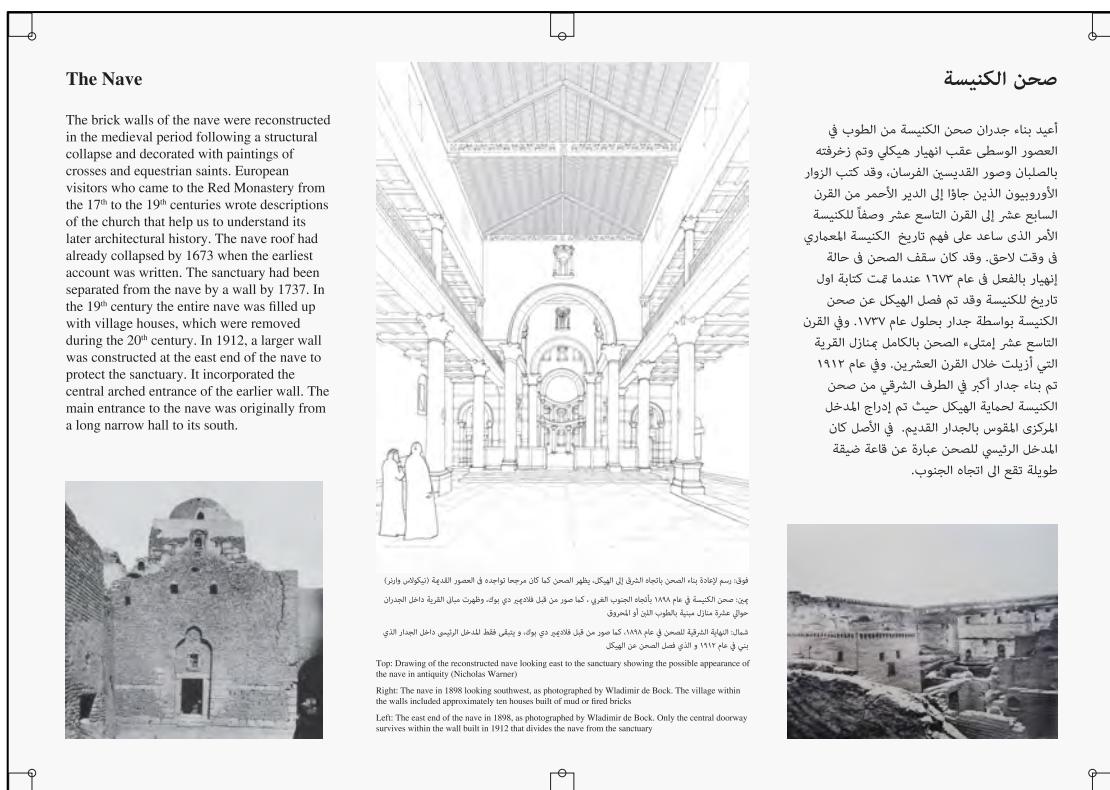
6 The Traditions of the Church and Monastic Life. Owing to an undetected error in the text of this panel it was rejected and not installed on this occasion. A replacement panel will be fabricated and installed at a later date.

Fig. 24. Traditions of the Church panel (top) and Nave panel (bottom). Note: the 'Traditions of the Church' panel was not installed owing to an undetected textual error.

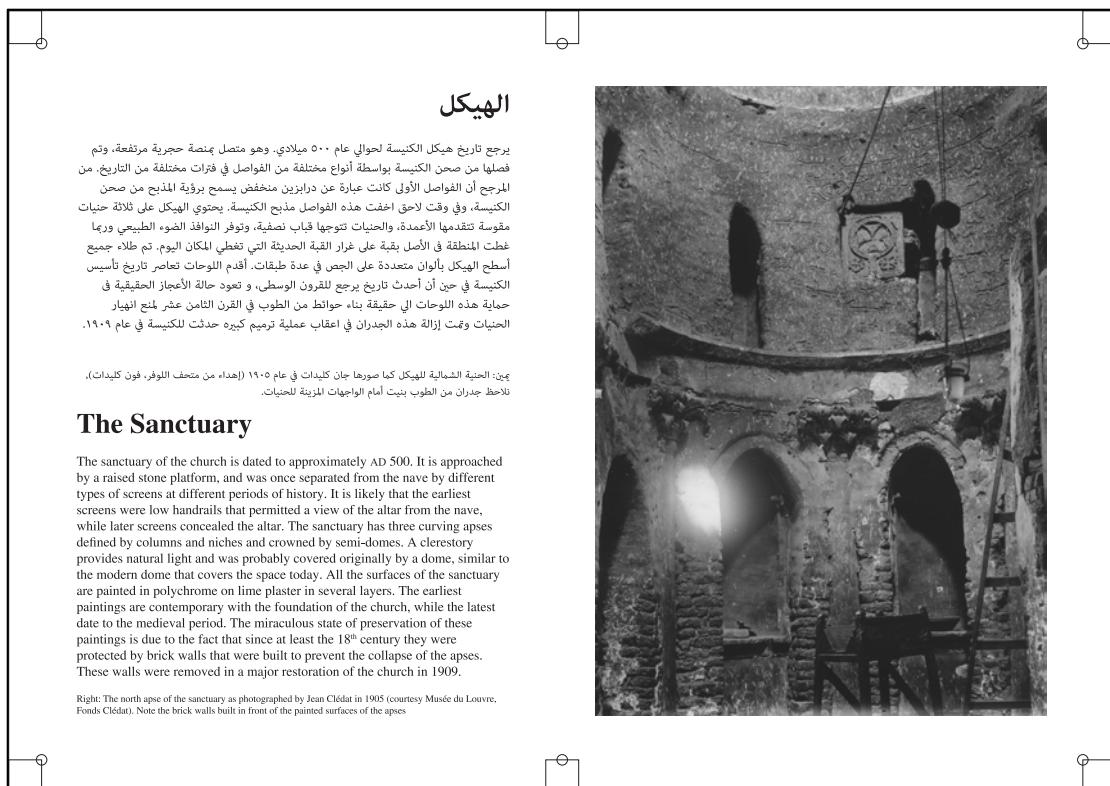
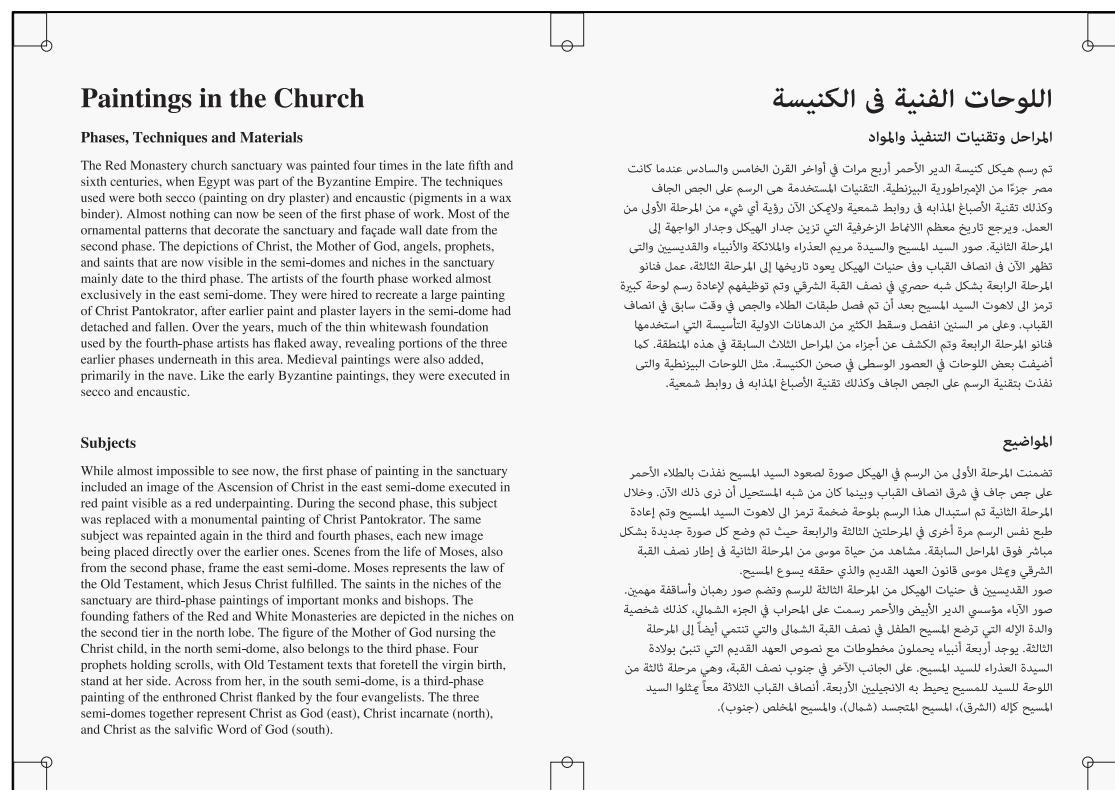
Fig. 25. Sanctuary panel (top) and Paintings in the Church panel (bottom)

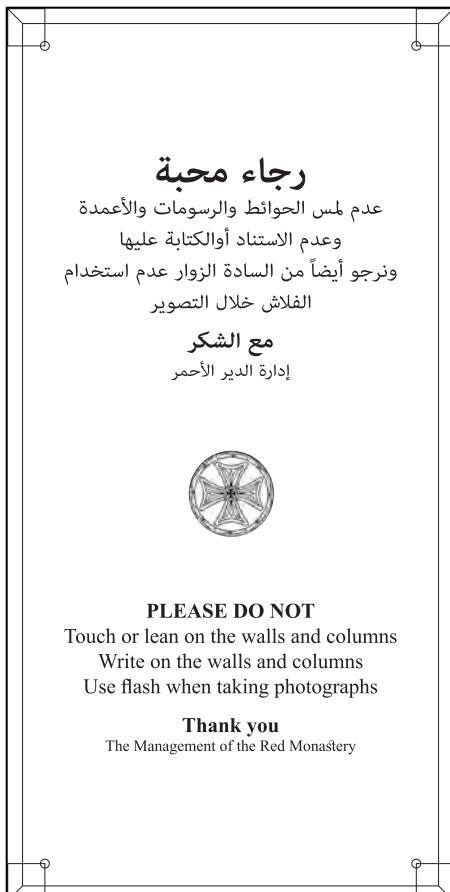
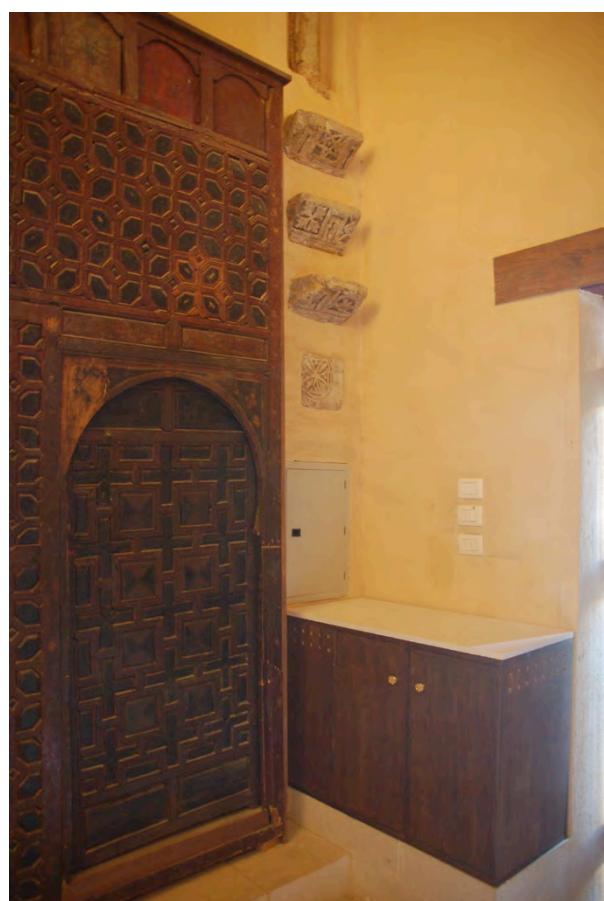
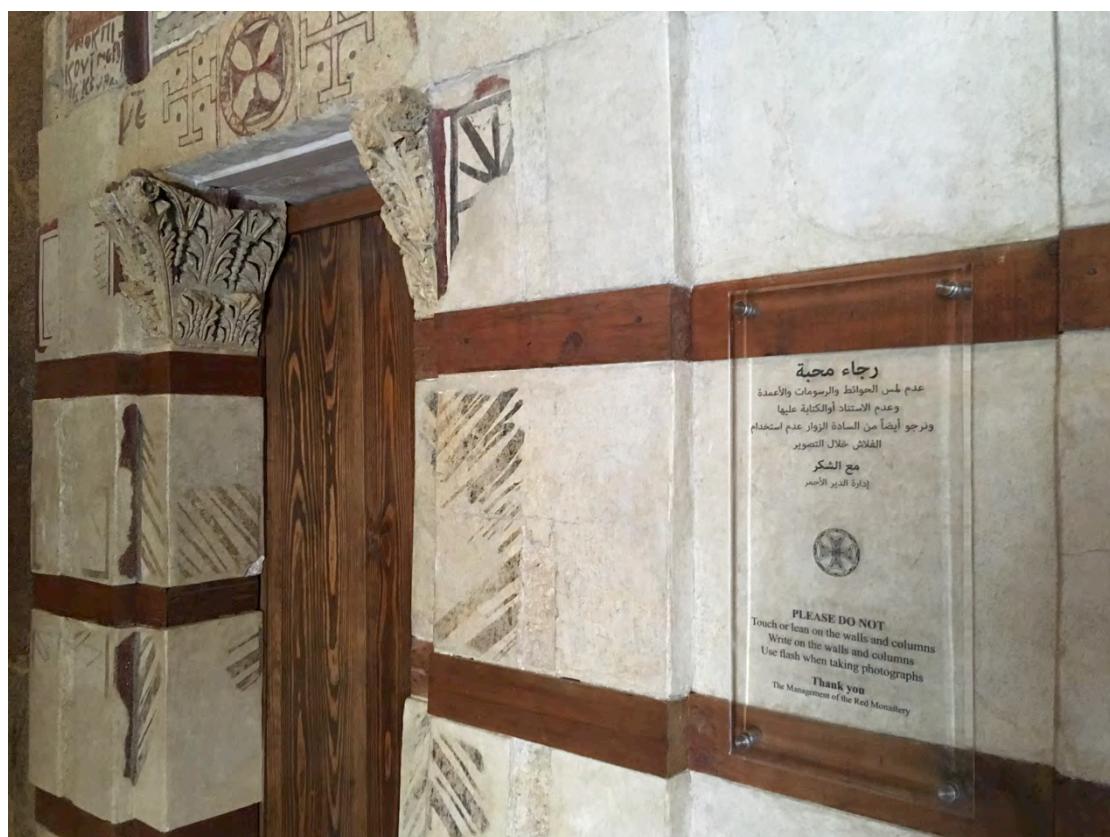
A new ventilated timber cupboard with a marble top was installed immediately to the right of the south entrance to the church to house a new electricity stabiliser unit dedicated to the lighting circuits within the church only. The sound system control unit was also installed in the same cupboard.

Fig. 26. Prohibition sign layout (top left) and installed (bottom). New ventilated electricity cupboard as installed (top right)
