# **ARCHITECTURAL CONSERVATION RED MONASTERY FALL 2016**

## **THE TOWER**

**TECHNICAL REPORT**

**14 December, 2016**

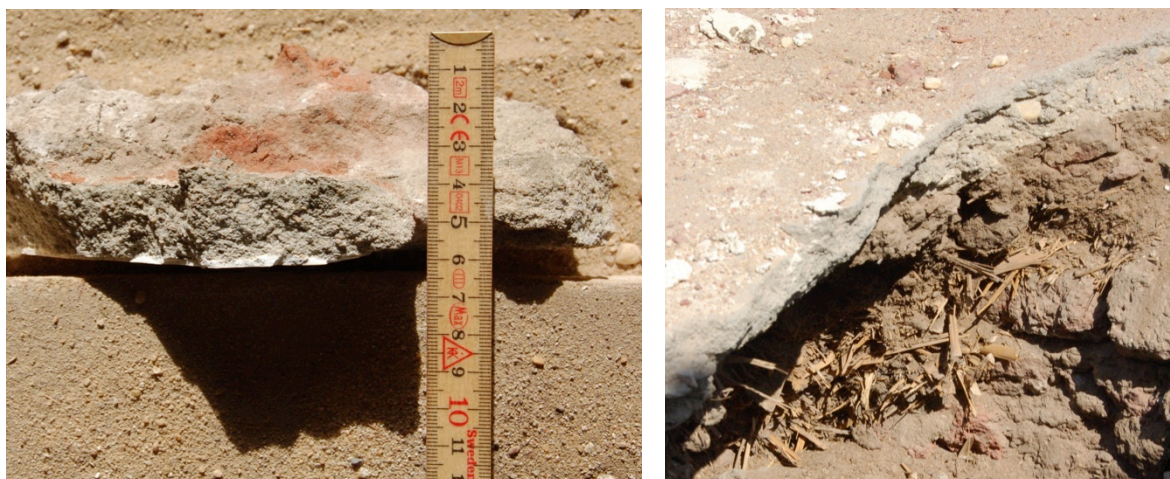
One of the most significant problems relating to the conservation of the tower is that almost all internal wall surfaces were plastered during the 1980s with an exceptionally dense cement render that was subsequently covered with a layer of gypsum and emulsion paint. This inappropriate intervention led to build-ups of between 5 and 10 cm on wall faces – almost the thickness of an entire brick. The removal of this cement render results in significant damage to the original fired brick substrate and so this activity was confined to areas which had been badly affected by damp or by structural displacement.

Section of typical 5cm thick cement render from the interior of the tower (left) and cement renders over organic fill on roof (right)

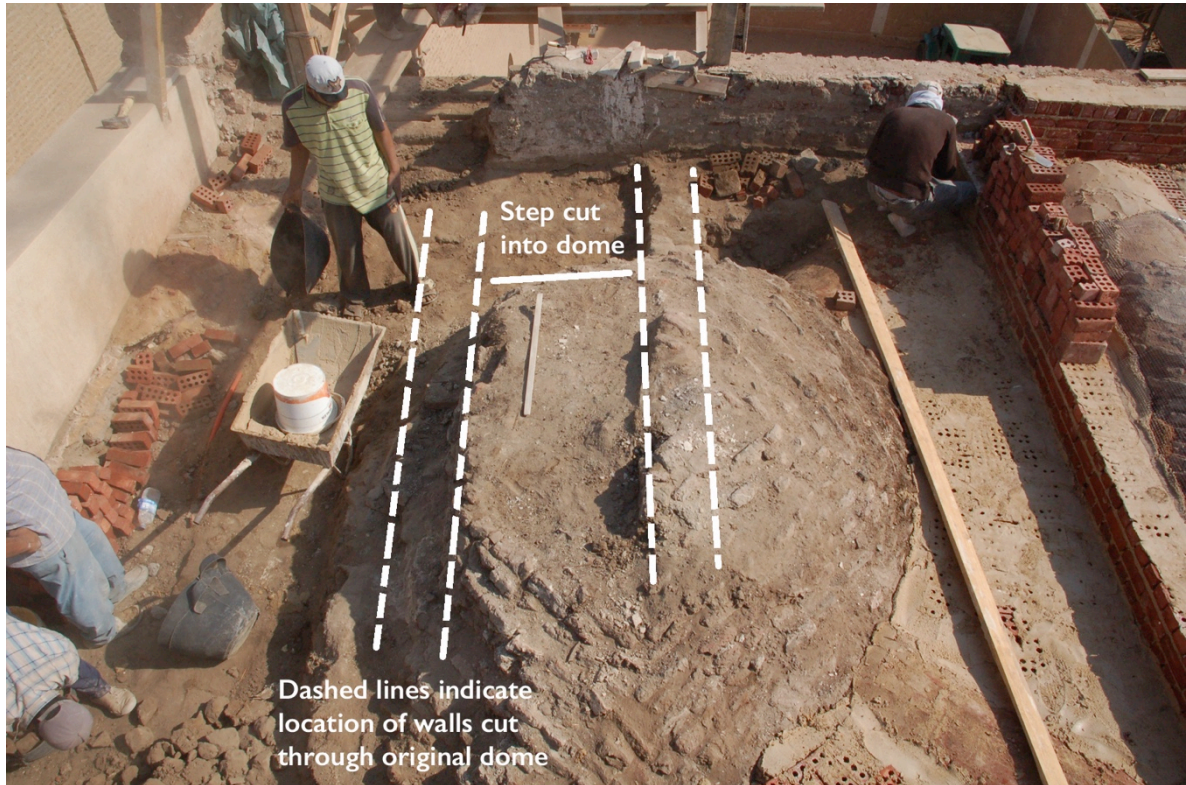
Following clearance, the two domes with ‘sailor’ vaults, located to either side of an inclined elliptical vault, were fully revealed. All were built from a mixture of fired bricks and mud bricks laid with a silt mortar that had been badly attacked by termites. The domes and vault were all in a fragile condition. It was also noted that some sections of wall supporting the south side of the northern dome were also built with mud brick, possibly indicative of earlier repairs carried out when the building was converted to domestic use. The dome to the north is slightly smaller than that to the south, and was severely damaged by later structures that cut into its structure. The elliptical vault was laid with an inclination towards the west, and had rounded ends. The character of the brickwork would suggest that these structures were all part of a single build on the roof, possibly in the late 17<sup>th</sup> century or early 18<sup>th</sup> century (by correlation with the now demolished dome over the *khurus* of the main church which has a *terminus ante quem* of 1737, the date of the visit by Richard Pococke to the Monastery).

Diagnostic view of north dome showing secondary damage

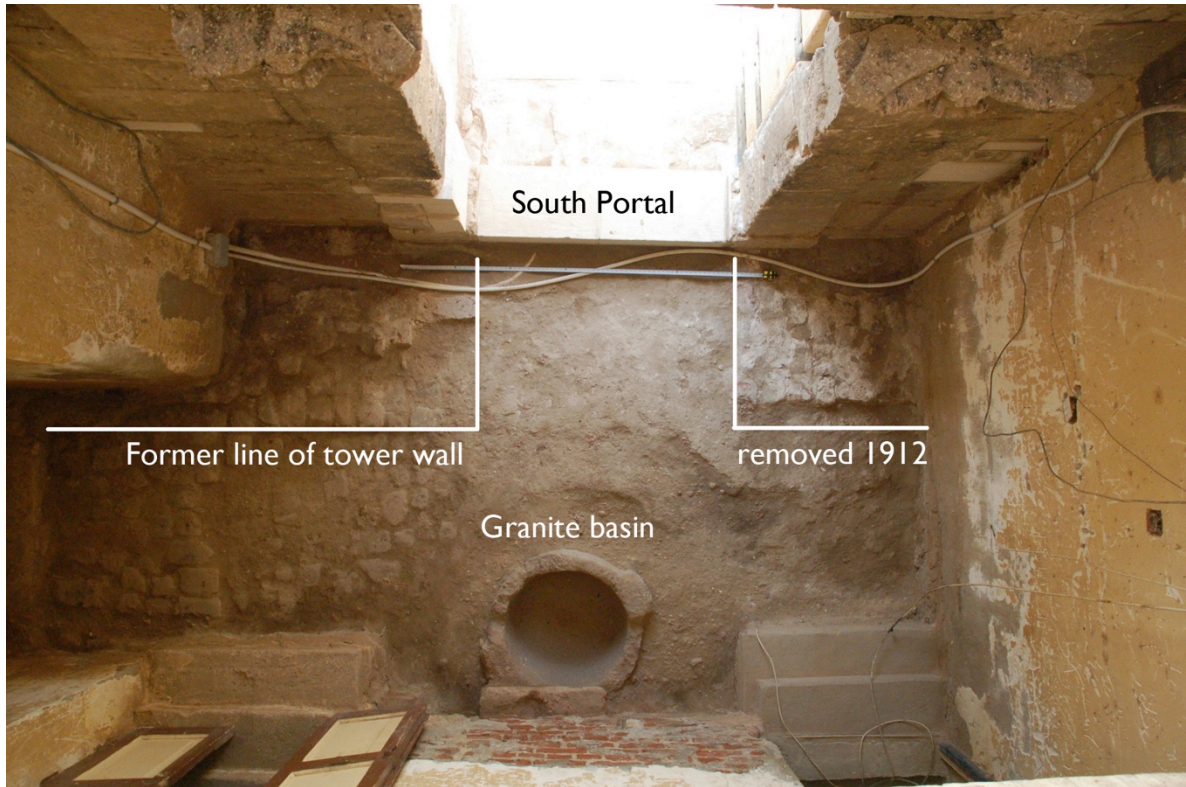
Condition of entrance area seen from above before treatment

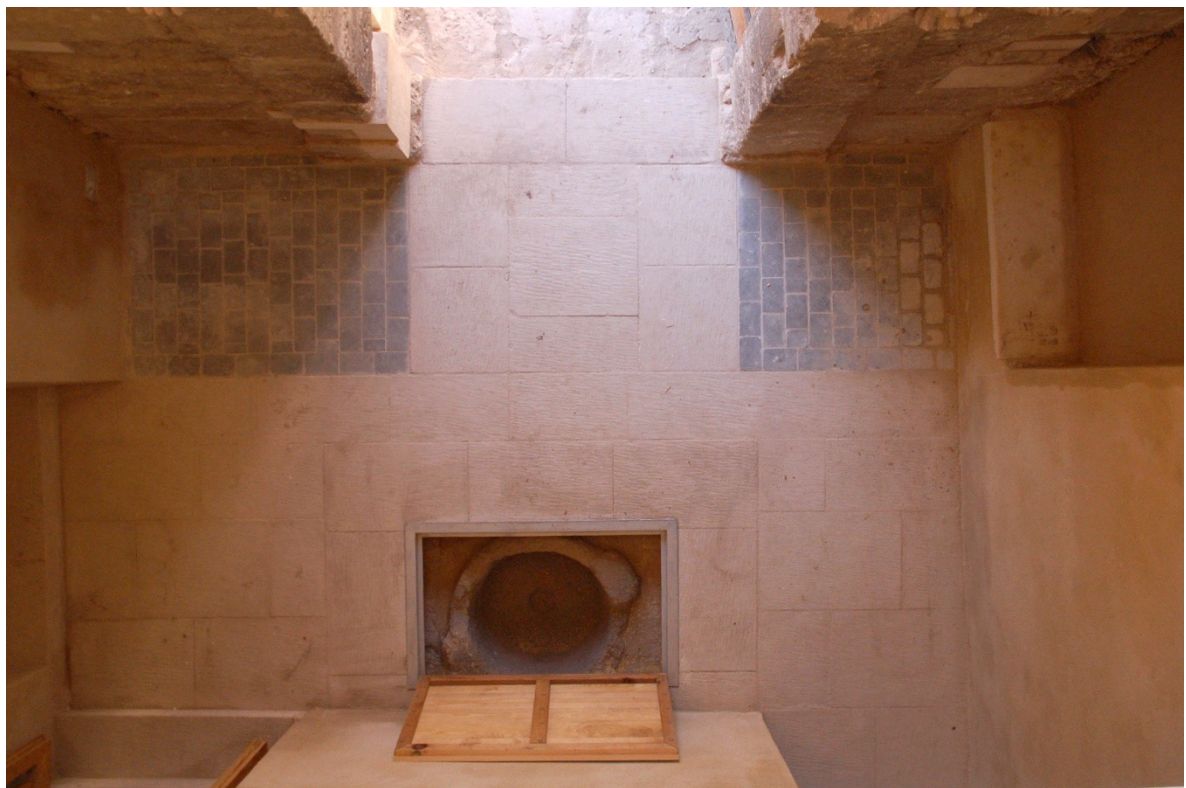
Condition of entrance area seen from above after treatment with trapdoor over granite basin

In the entrance area of the tower, the granite basin discovered in April 2016 was framed by 15 cm thick hand-finished limestone slabs and covered with an opening trap door made with stainless steel sections and pitch pine planks. To indicate the former location of the east wall of the tower that was removed by the Comité in 1912, the position of this wall was shown in the paving pattern by areas of basalt blocks.

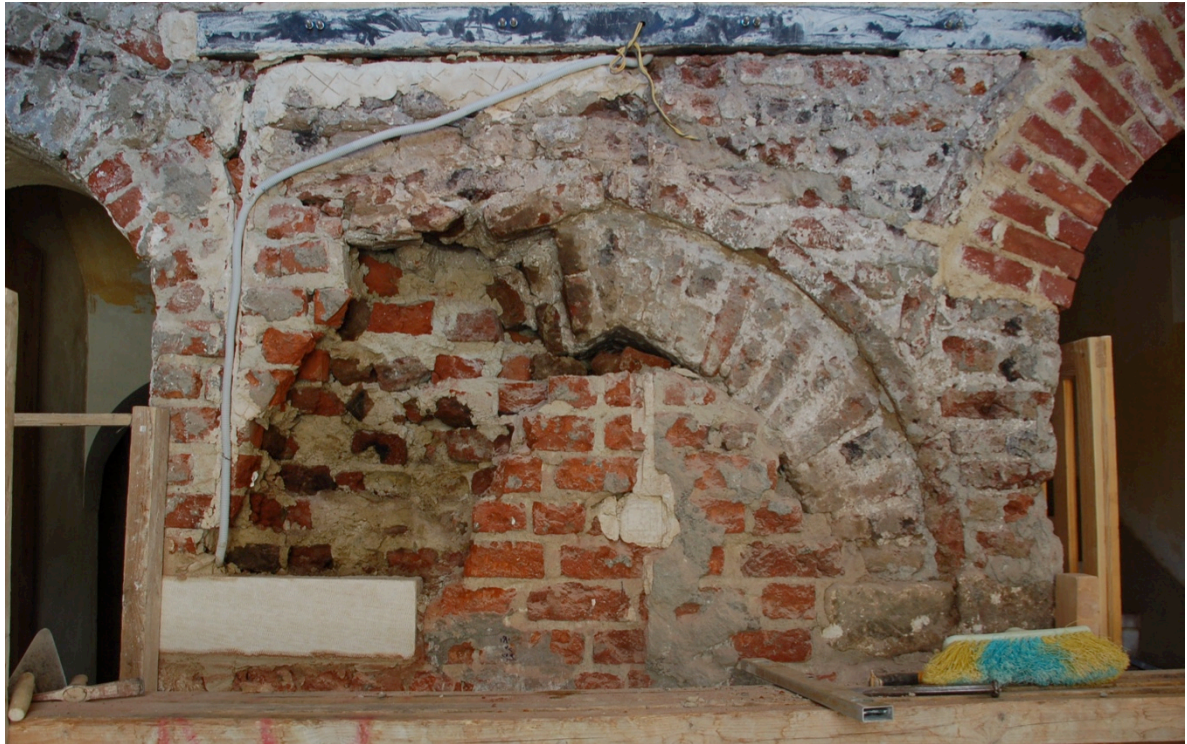
Arch over blocked opening to well during reconstruction of missing section

The pointed arch of the opening into the well inside the entrance area was restored with re-used old bricks springing from a new limestone impost block. The existing modern brickwork beneath the arch was only cut back in the area immediately below the arch to a depth of 25 cm to avoid further structural problems in this area while still expressing the form of the original opening. The brickwork of the arch itself (both original and restored) was left exposed.

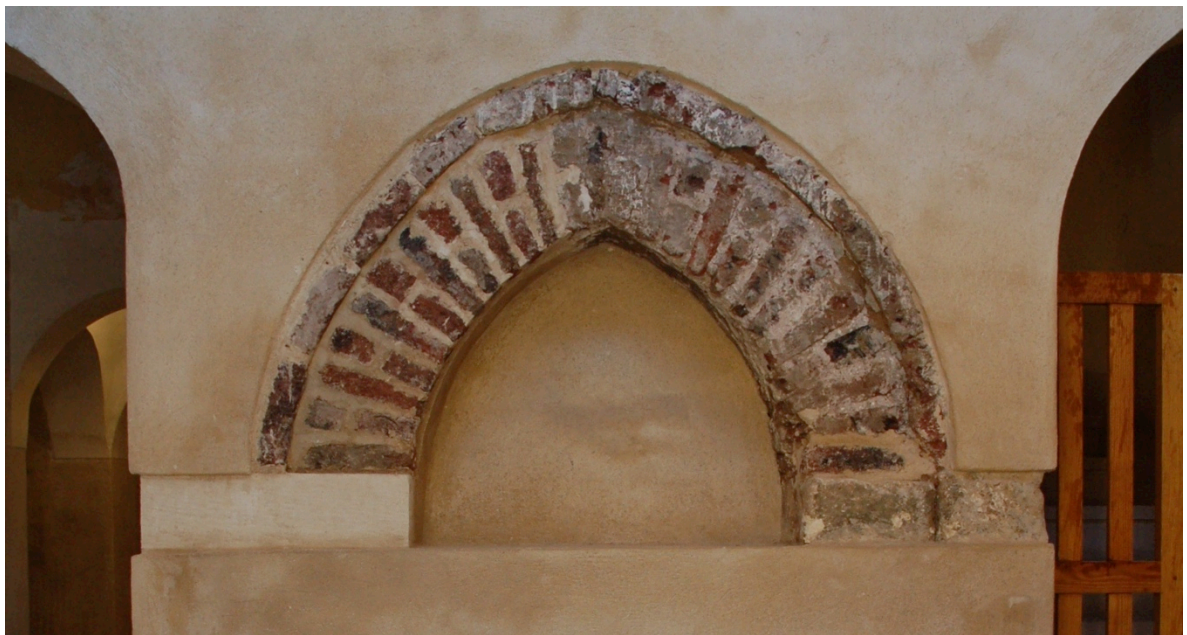
Arch over blocked opening to well after reconstruction of missing section

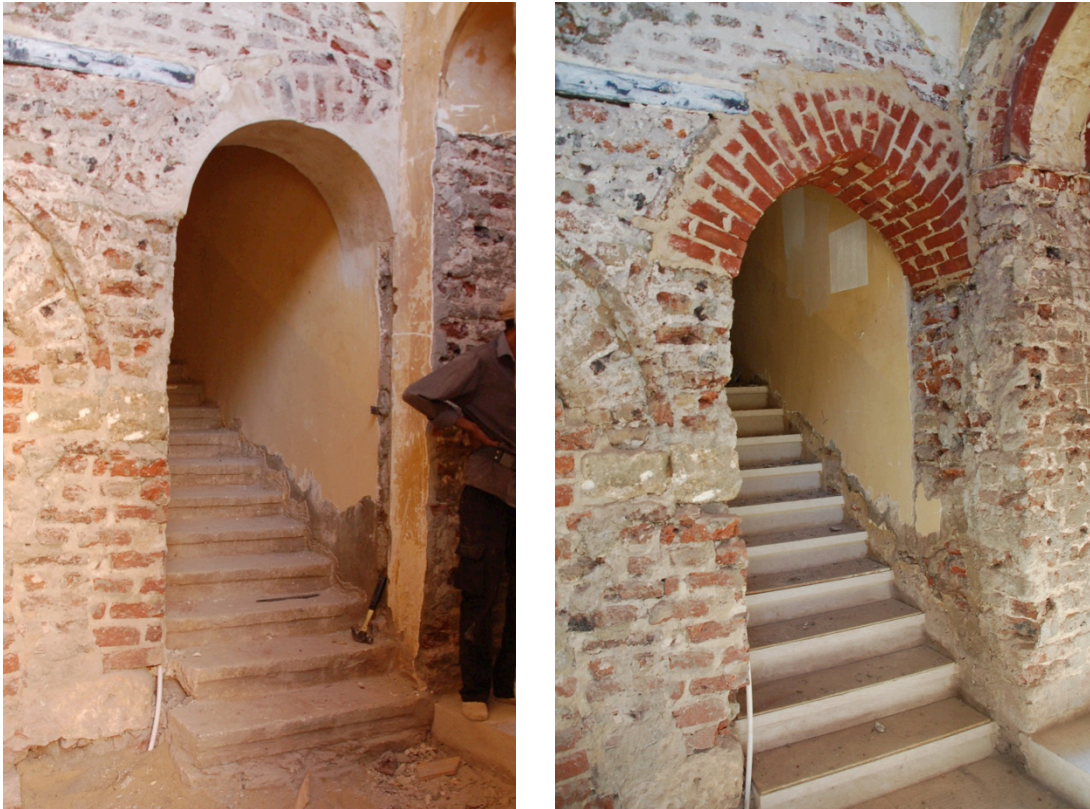
Arch over first flight of staircase before (left) and after (right) rebuilding

The arch over the entrance to the staircase, which had been restored incorrectly as a semicircular arch last season was rebuilt with a pointed arch following surviving traces of the original arch, and matching the style and size of the other door to the interior of the tower.

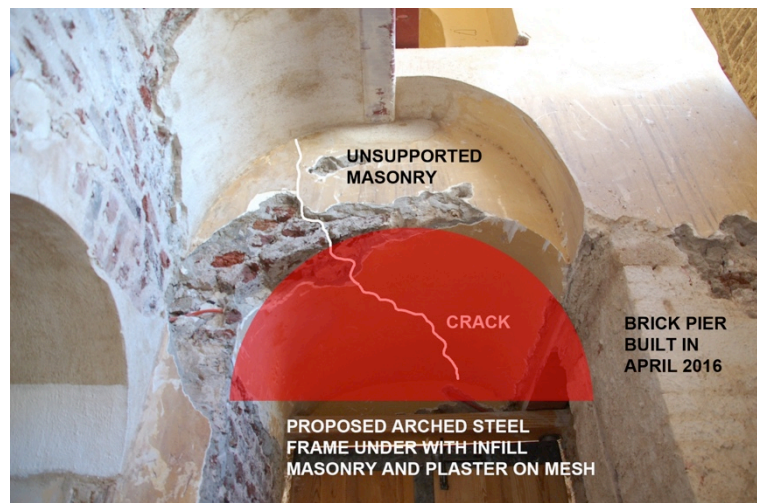
Upon investigation, the vault immediately inside the main entrance to the tower was found to be defective owing to the fact that its supporting arched brickwork had been removed at some point in the past, leading to structural cracking. To rectify the situation, a purpose made curved steel supporting arch made from two channel sections (10cm x 8cm) was installed under the vault to provide additional stability.

Diagnostic view of defective arch in entrance area and proposed treatment

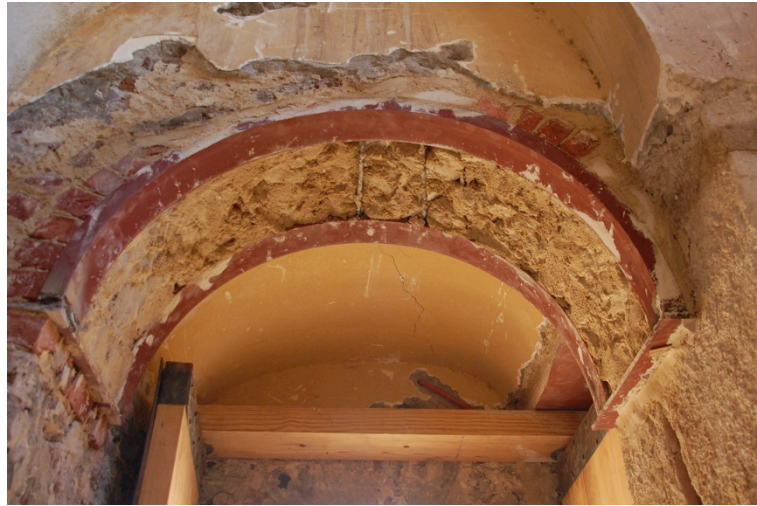
Supporting steel frames during installation

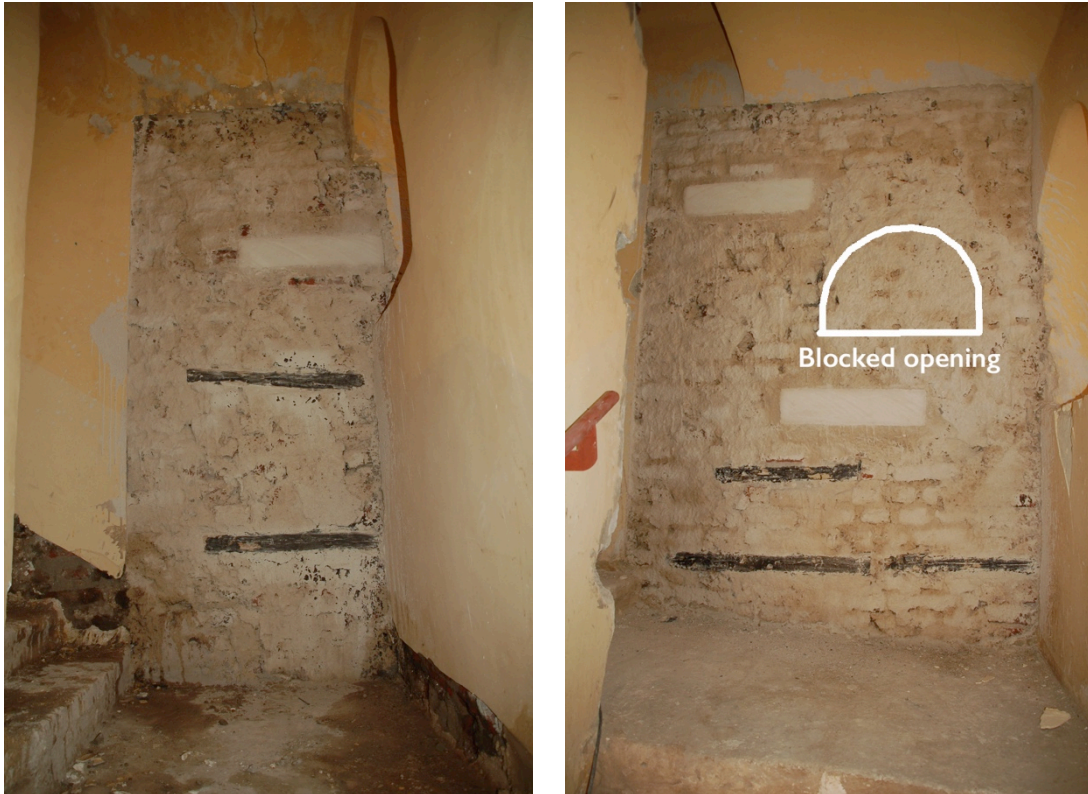
Timber and stone stitches in the south wall of the stair at lower (left) and upper (right) levels

Cracks in the vaulting and arches of the staircase were cleaned out, packed with limestone chips set in lime mortar. Two sections of the south wall of the stair enclosure, which had previously been stitched in the 1980s with timber and re-stitched with limestone blocks in April 2016 were totally stripped back to brickwork and replastered with lime after cracks had been packed. The section on the upper wall showed traces of an arched opening that would have connected with a niche on the north side of the southwest room on the first floor. This had been blocked in the 1980s, possibly as a reaction to the extensive cracking in this part of the building that extends to the exterior of the west wall of the tower. These cracks should be monitored.

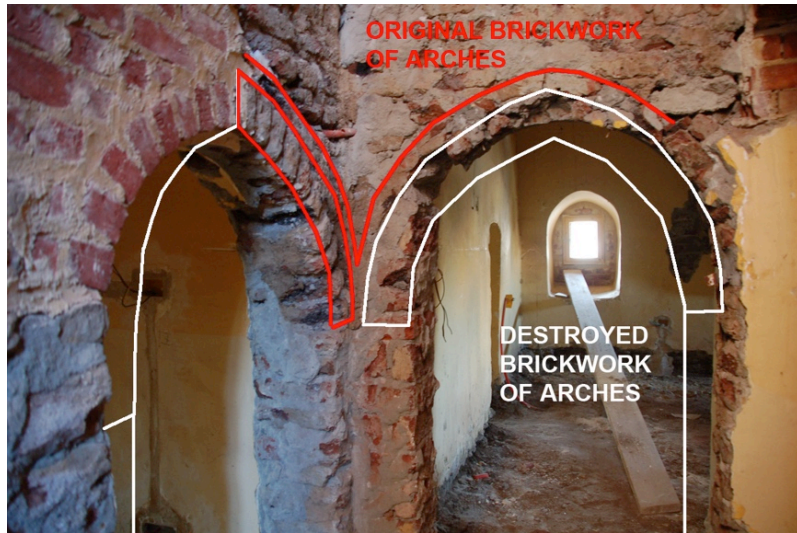
Diagnostic view of entrances to first floor rooms from staircase after removal of cement render

The two door openings into the rooms at first floor level were returned to their original size and shape following traces discovered after the removal of the thick cement render that surrounded them. They had at some point been widened, incurring damage to their jambs and tops that originally took the form of pointed arches. Limestone thresholds were also fitted on these two doors. Treated pitch pine doors were installed here and at two other locations on the first floor, following a traditional design with top and bottom pivots.

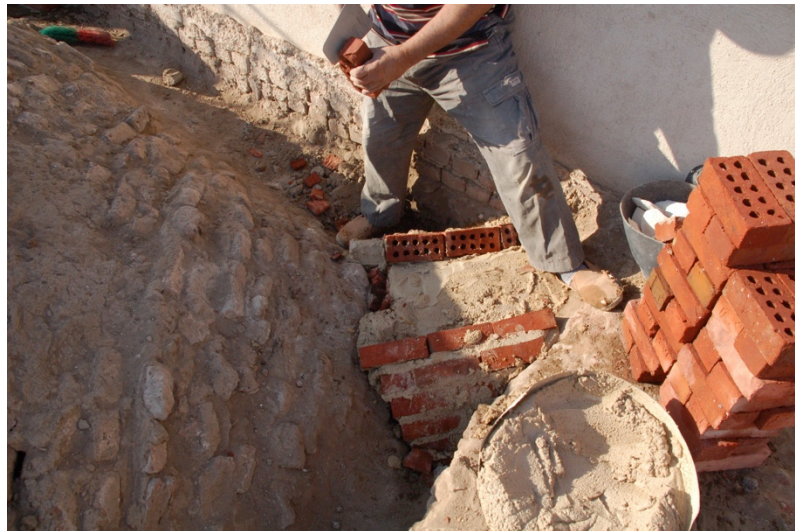
Construction of relieving arch over corner pendentive of a dome

The corners of the domes were built up over new brick arches designed to take the stress off these important but weakened parts of the original structure. Then a series of brick courses were laid cantilevering in towards the domes' perimeter from the surrounding walls. This brickwork was constructed with a fall to external rainwater spouts on the east side of the terrace. Facing walls to the damaged interior edge of the parapet were built with new openings for four galvanised steel rainwater spouts projecting 40 cm from the outer face of the building. Three different levels were introduced onto the terrace to minimise the amount of new brickwork required to achieve the required falls across the width of the roof. The uppermost level included the south dome and elliptical vault, with a step down to a lower level around the south, east and west sides of the north dome. Two further steps down on the north side of the north dome bring the level down to a final floor finish equivalent to the viewing deck on the north side of the stair enclosure. The steps were emphasized with re-used limestone stair treads to indicate the best route to avoid treading on the domes and barrel vault.

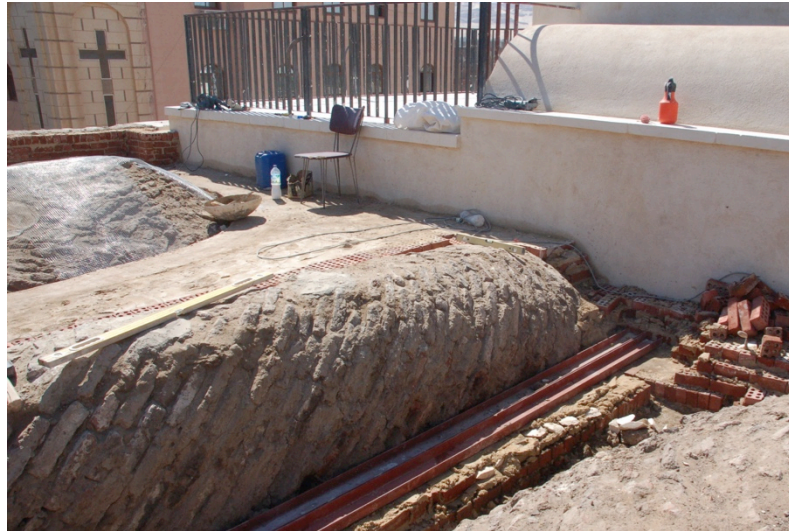
View from northeast of elliptical vault showing location of new steel reinforcement during installation

Steel reinforcement, in the form of 10 x 8 cm channels of 4.5 m length was installed in two locations. The first was along the north edge of the elliptical barrel vault to prevent further cracking in the wall below. There was a significant loss of original masonry in this area and the wall below was thinner (70 cm) than the corresponding wall under the southern springing of the vault (1 m).

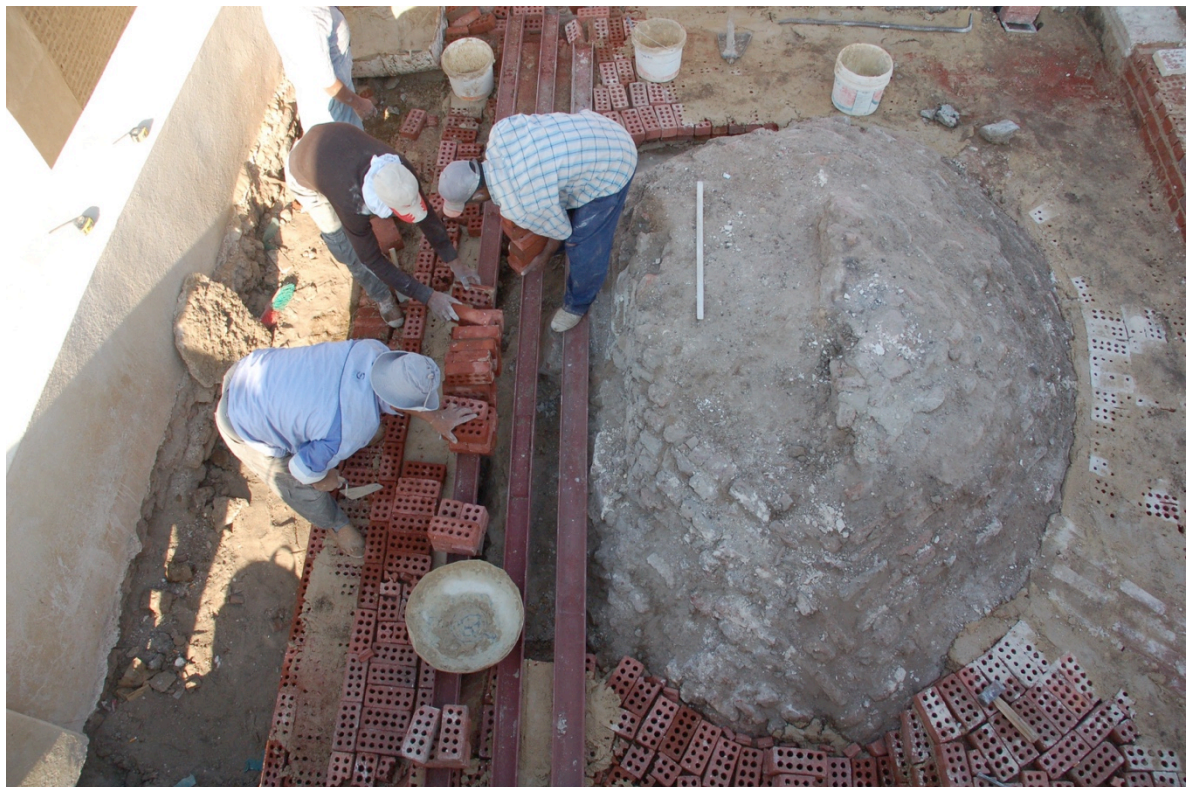
View from west of three new steel beams during installation on north side of north dome to take loading off weakened section of dome

The other location where reinforcement was introduced was along the north edge of the north dome where the original structure of the dome had been seriously compromised by the removal of a significant percentage of its masonry. It was considered that any further superimposition of masonry on this area would result in the collapse of the structure. Three channels (4.5 m x 10 cm x 8 cm) were positioned marginally above the edge of the dome spaced to provide a total width of 60 cm. 7cm thick limestone pavers were placed above these channels, and new masonry constructed above this to complete the missing profile of the dome.

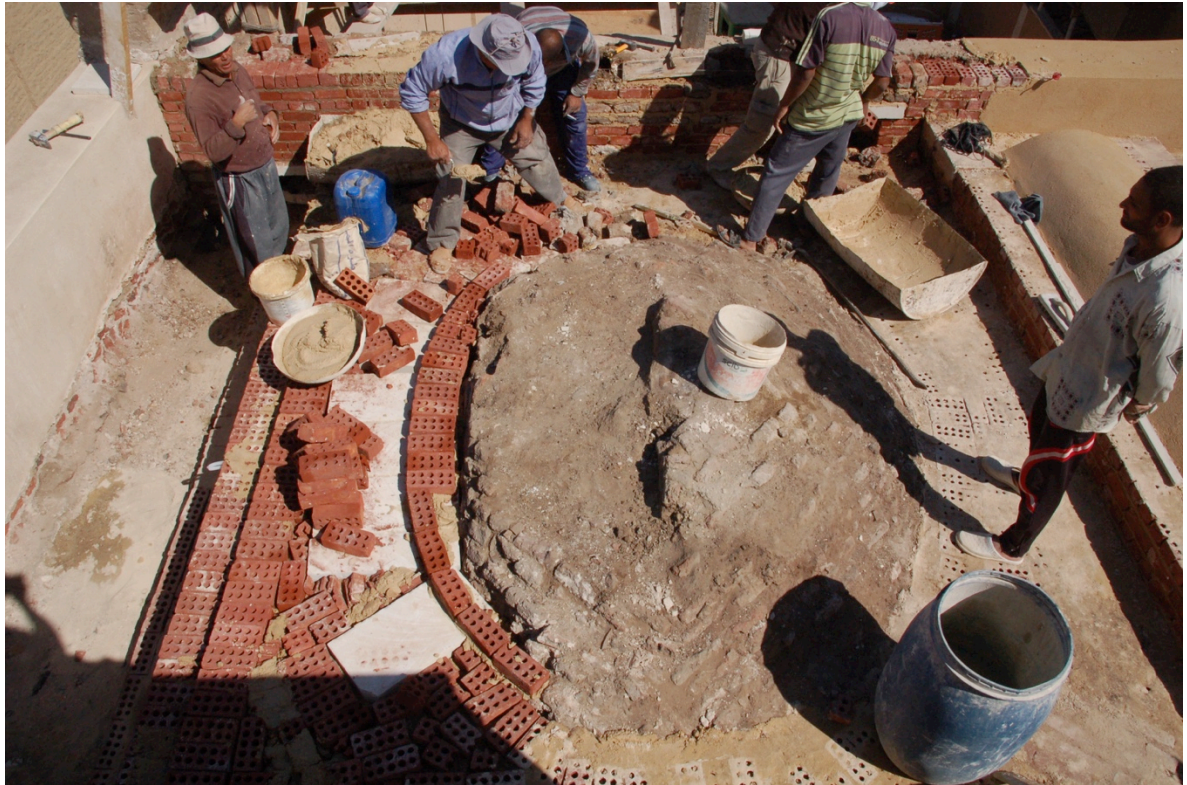
View from west of cantilevered stone slabs and brickwork on north side of north dome

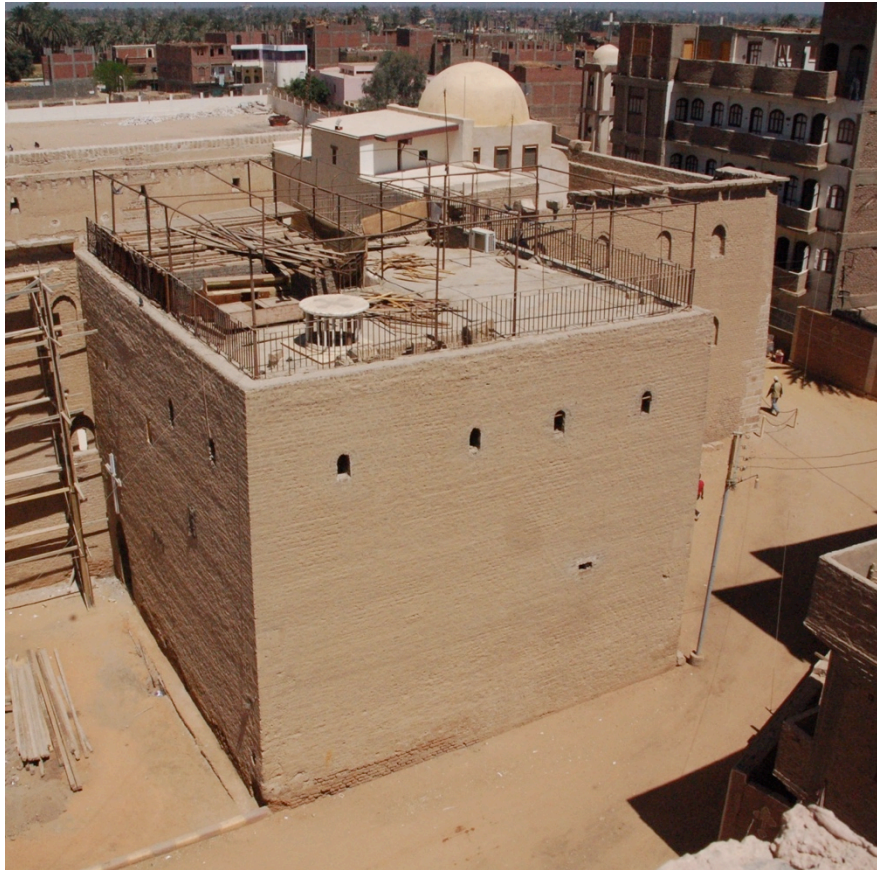
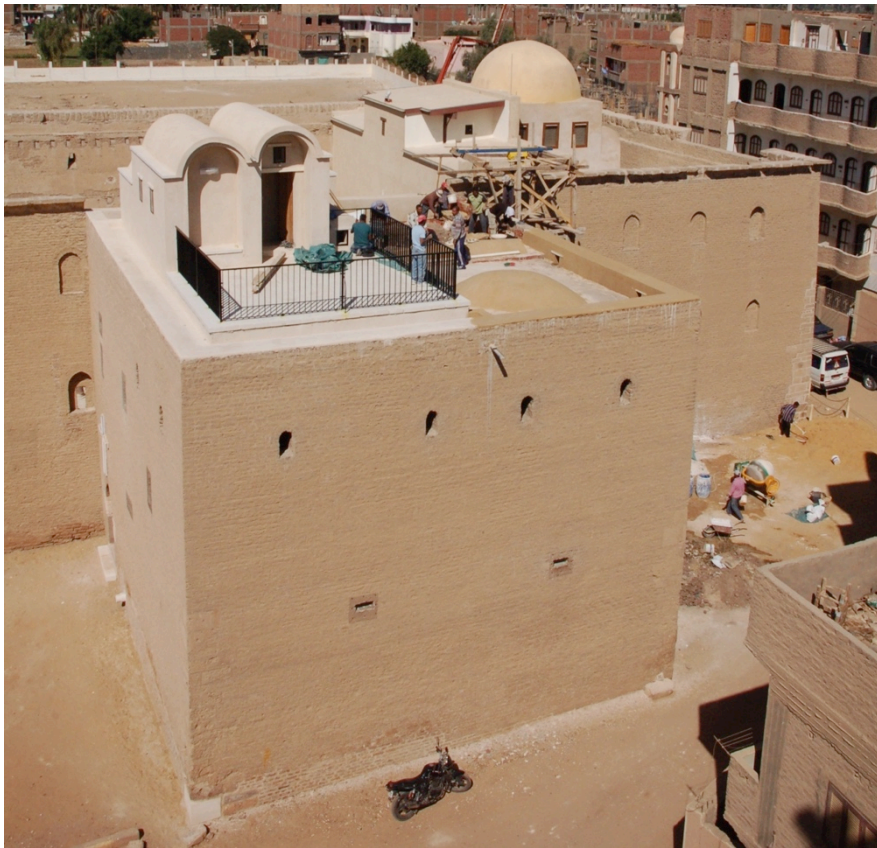
Views of the roof of the tower from the south before (top) and during (bottom) interventions
