RED MONASTERY CONSERVATION PROJECT 2015

TECHNICAL REPORT 3: 26th November 2015

1 TECHNICAL REPORT ON SITE ACTIVITIES: SEPT 28 – NOV 26

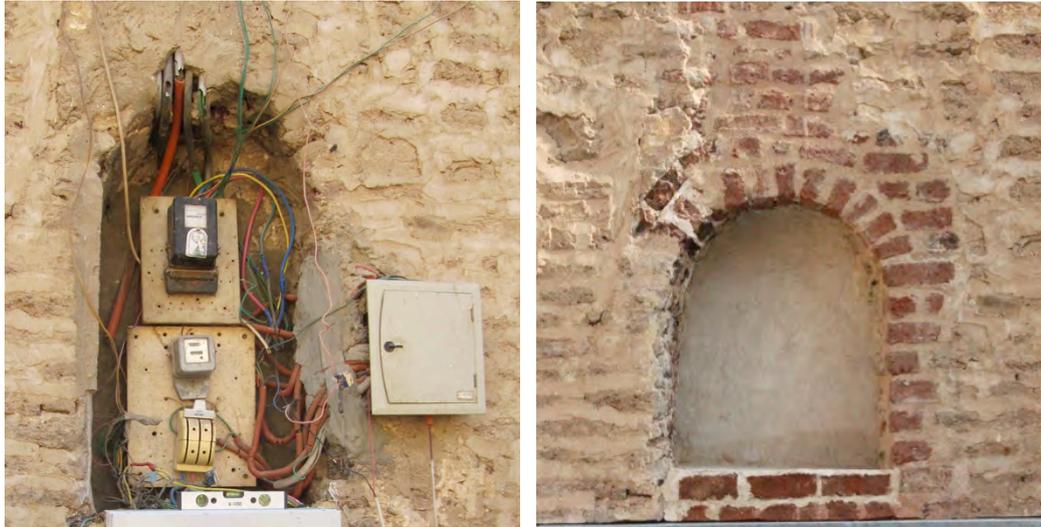
Niche above electrical cupboard on south wall before and after intervention

A new heavy-duty reinforced brass-core cable was installed, running from a high-level post supply on the north side of the church under the north portal threshold to the location of the existing motherboard on the south side of the nave. The new line of supply is directly connected to the monastery's own substation and generator. This action permitted the removal of the former supply line and posts on the south side of the church, and the removal of redundant electricity meters and override switches from the niche above the electrical cupboard on the south side of the nave.

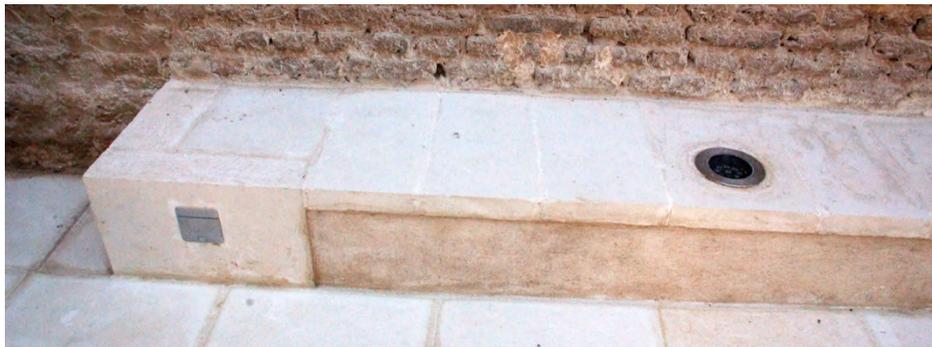
Recessed electricity socket and uplight installed in perimeter mastaba

New power and lighting circuits were run to the new mastabas on the north and west walls of the nave. Three new waterproof brushed aluminium sockets and nine new lights were installed. The LED uplights are located directly below arched windows, and provide ambient light for the nave as well as accent light for the windows.

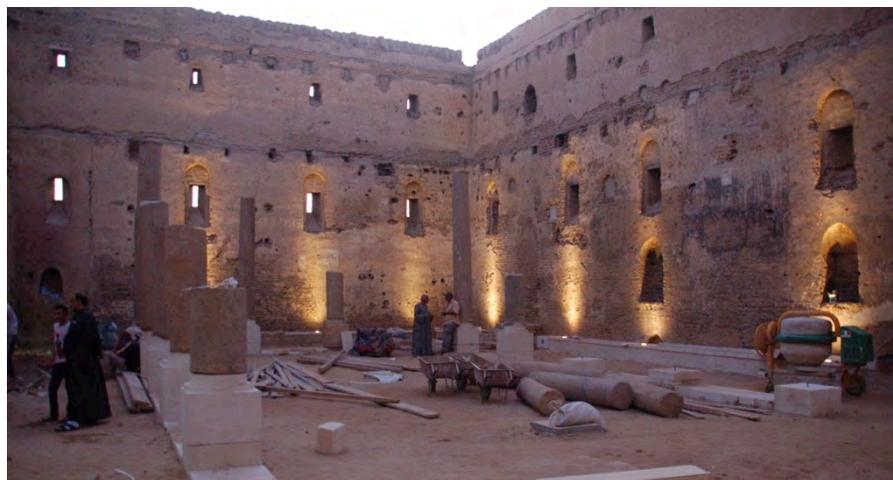
Photo showing uplighting installed in perimeter mastaba

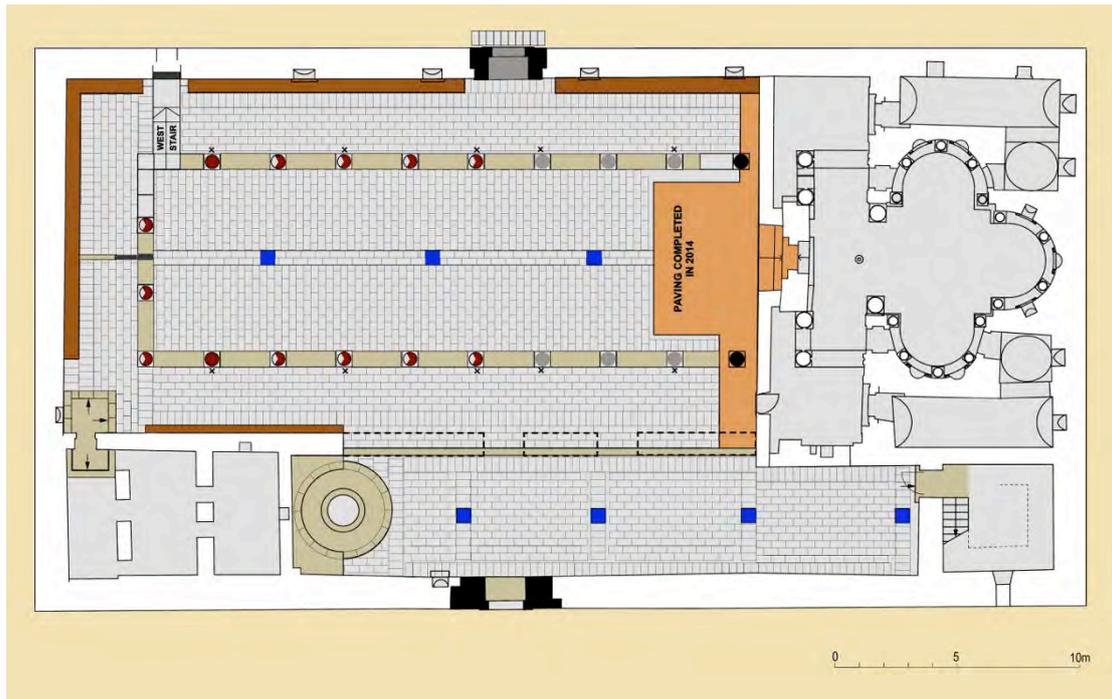
Paving plan of the nave

Taking these criteria into account, two basic levels were established: one for the south hall determined by the original paving within the south portal, and the other in the nave determined by the level of the paving already installed at the east end of the nave as well as the single original paver at the northwest corner of the nave. These two levels differed by 18 cm – the equivalent of a single step. A new limestone step was therefore created along the edge of the presumed separating wall between the south hall and the nave, which will be incorporated into the reconstructed wall on this line, if approved, in 2016. Two localized levels were adopted in addition to these two general levels. One of these in front of the door leading to the church of al-Adhra, 18 cm below the general nave level, and the other inside the north portal 15 cm above the general nave level.

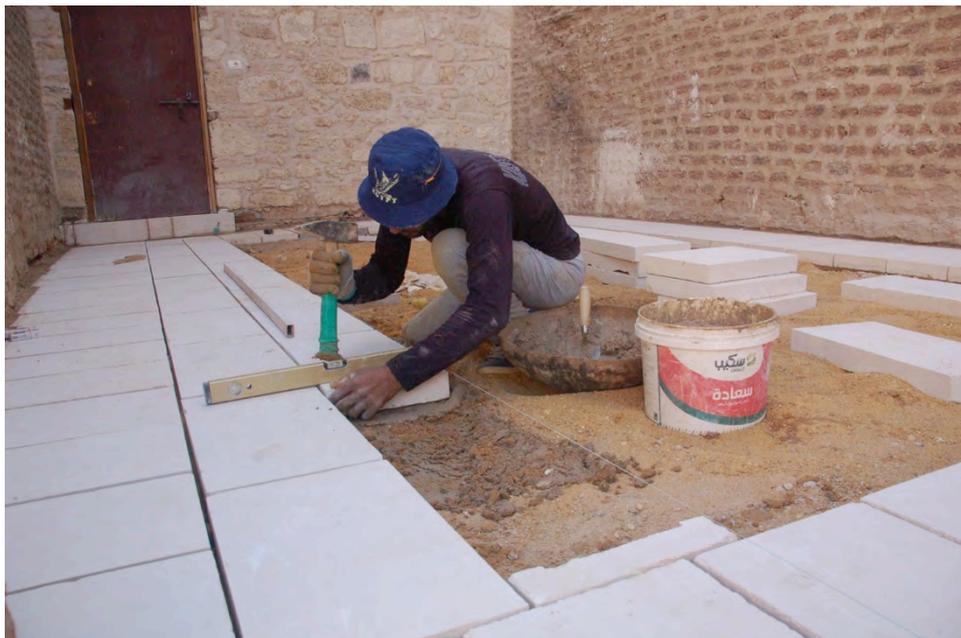
Laying limestone pavers in the south hall

All paving was executed using 7 cm thick 60 x 30 cm or 60 x 40 cm hand-polished limestone pavers set on lime mortar. Blocks following the lines of the colonnade were made from 15 cm thick limestone, 65 x 30 cm, which were also hand-polished. Steps and other raised elements were generally finished with a toothed hand-adze. Inside the threshold of the north portal, where no existing paving remained, granite thresholds were installed. A layer of lime was spread on the surface of the ground prior to paving in order to discourage the activity of termites. At the west end of the nave, two original rectangular granite paving stones were set into the floor to mark the central axis of the nave.

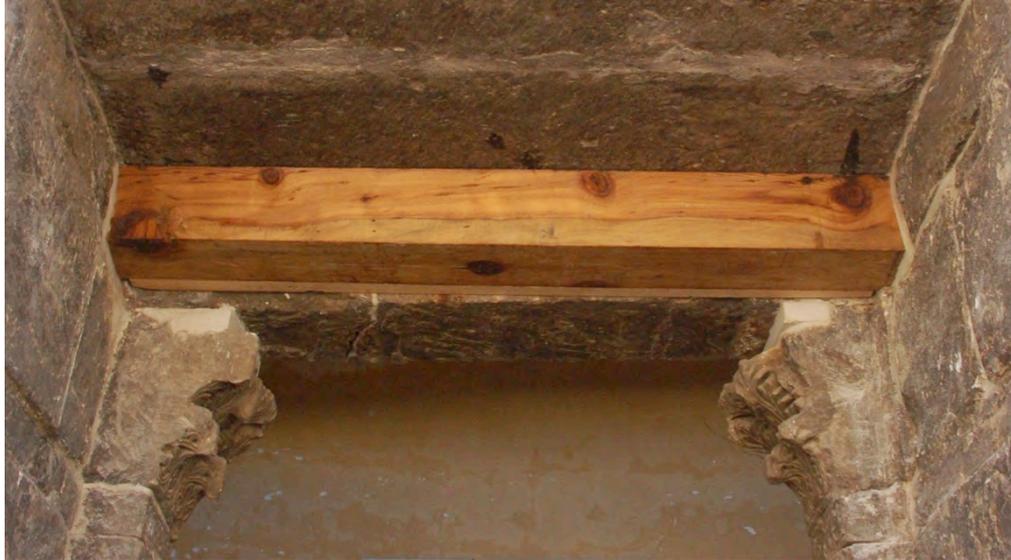
Condition of lintel to south portal after installation of secondary timber lintel

A secondary 20 cm x 20 cm treated azizi pitch pine timber lintel was installed in front of the new stainless steel angle installed in Phase 1 in the position of the original timber lintel in this location. Empty mortar joints around the lintel were filled locally using lime mortar.

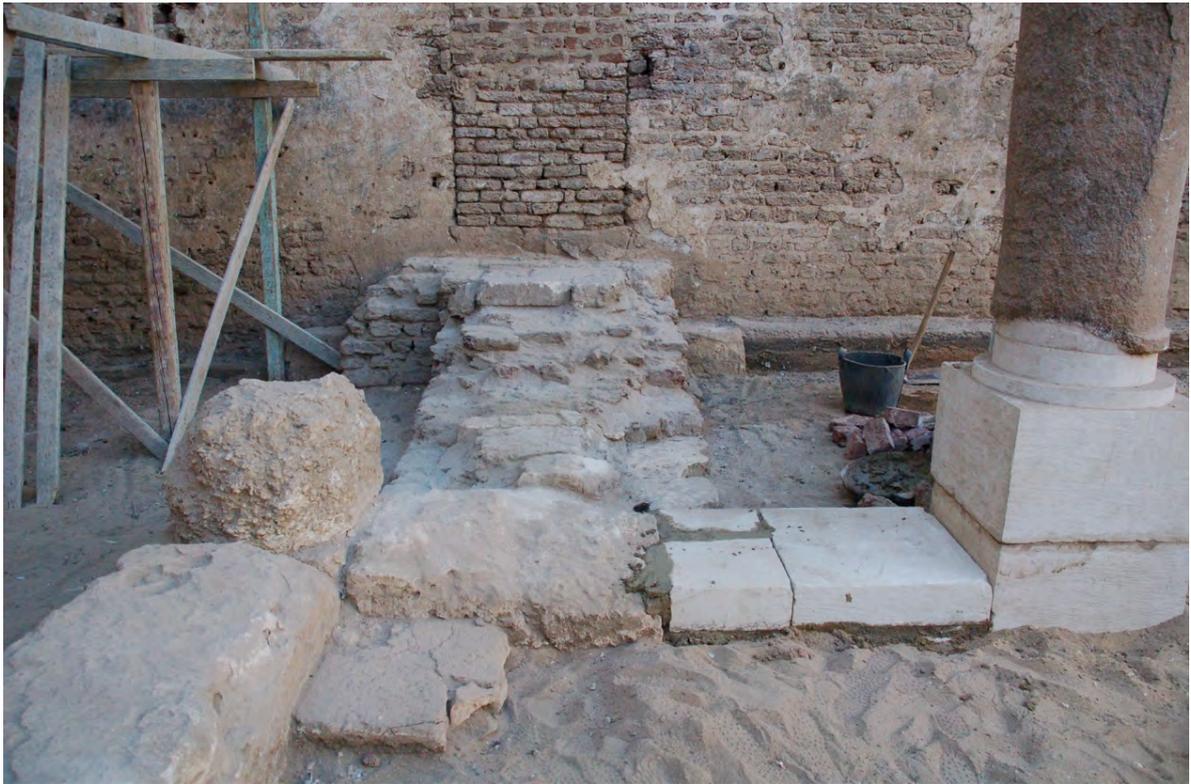
The steps were built directly over the paving of the nave, also covering the original limestone mastaba that ran along the inside face of the north wall. It consists of two landings with a step in between. The lower landing is at the height of the original raised stylobate at this end of the church, and the upper landing is 21 cm lower than the threshold of the blocked doorway in the north wall. The structure is made of fired brick set in lime mortar with surviving limestone pavers.

The steps leading to the blocked door in the north wall prior to intervention

The brickwork of the staircase was repaired using a lime mortar, and new limestone treads were installed as required. Existing limestone features were consolidated with a lime mortar.

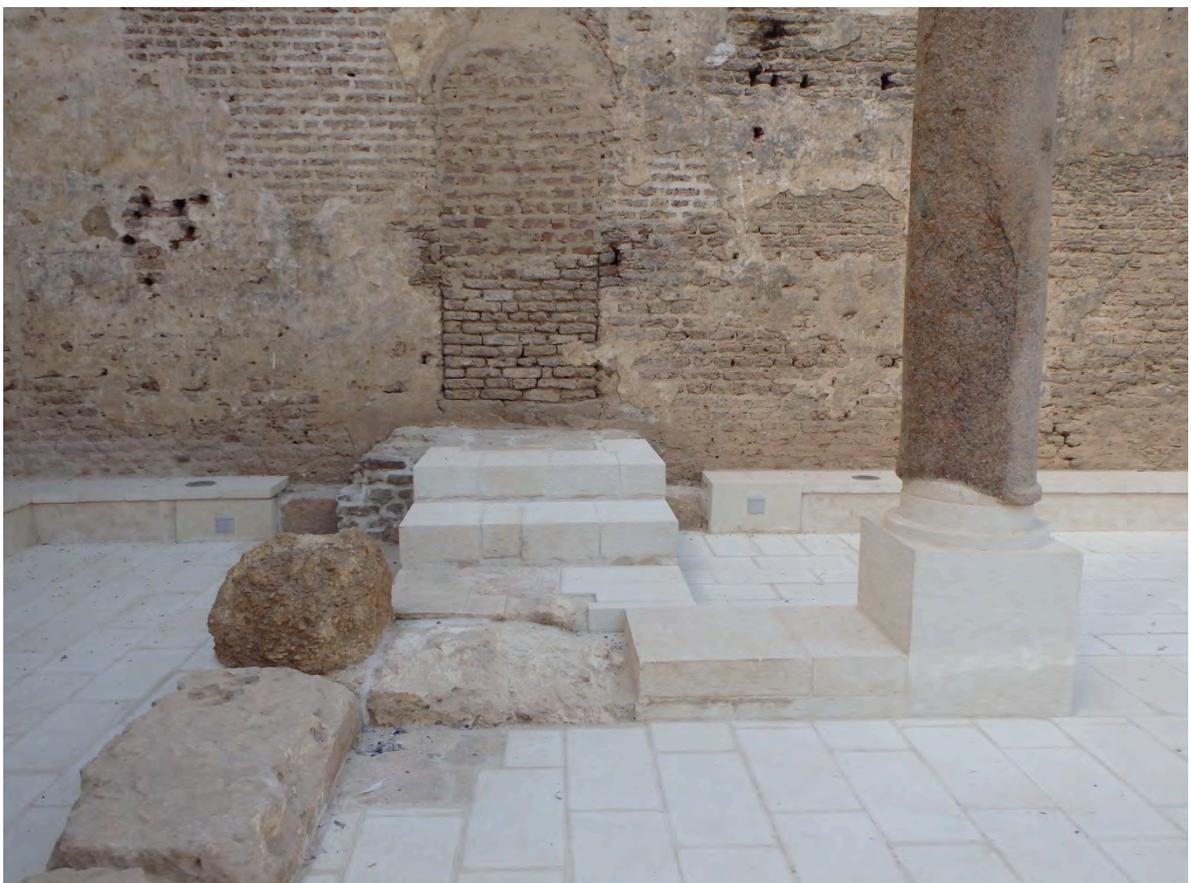
The steps leading to the blocked door in the north wall after intervention

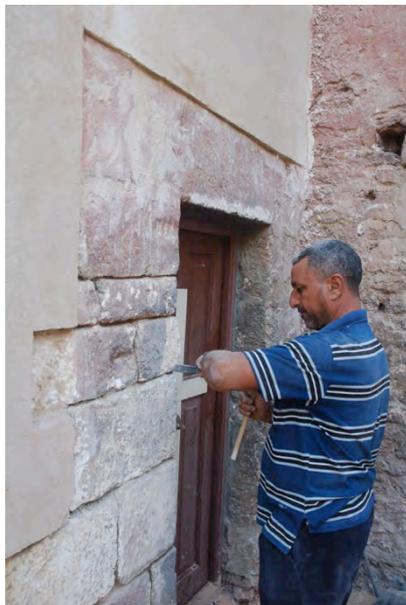
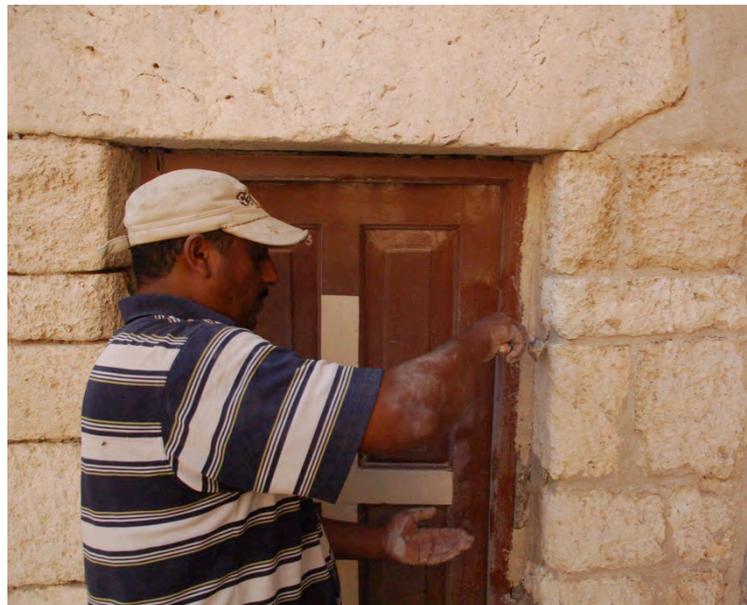
Photos showing the process of cleaning and repointing the limestone doorway of the church of al-Adhra

All secondary plaster was stripped from the façades of the church and the exterior was re-plastered with a lime render. Modifications were made on the north façade as detailed on the attached drawing. The most significant of these was the insertion of a new steel lintel over the central window. This was done in order to strengthen the opening in case the south wall of the proposed shelter at the west end of the nave would be built over it. Windows were modified to accommodate both extract fans and panes of fixed glazing. The position of the air-conditioning split units was modified so that pipework for the condensate was concealed from view, running in a new polypropylene pipe to the well. A wooden cross was added to the dome, matching the design of the larger cross over the main church. The paving level immediately in front of the door of the church was also lowered by 18 cm in order to increase the height of the door opening. This required the partial removal of subsurface concrete in this area. The limestone doorjamb and lintel of the entrance to the church were severely encrusted by dirt and cement, and were cleaned by mechanical abrasion before being re-pointed with lime mortar.

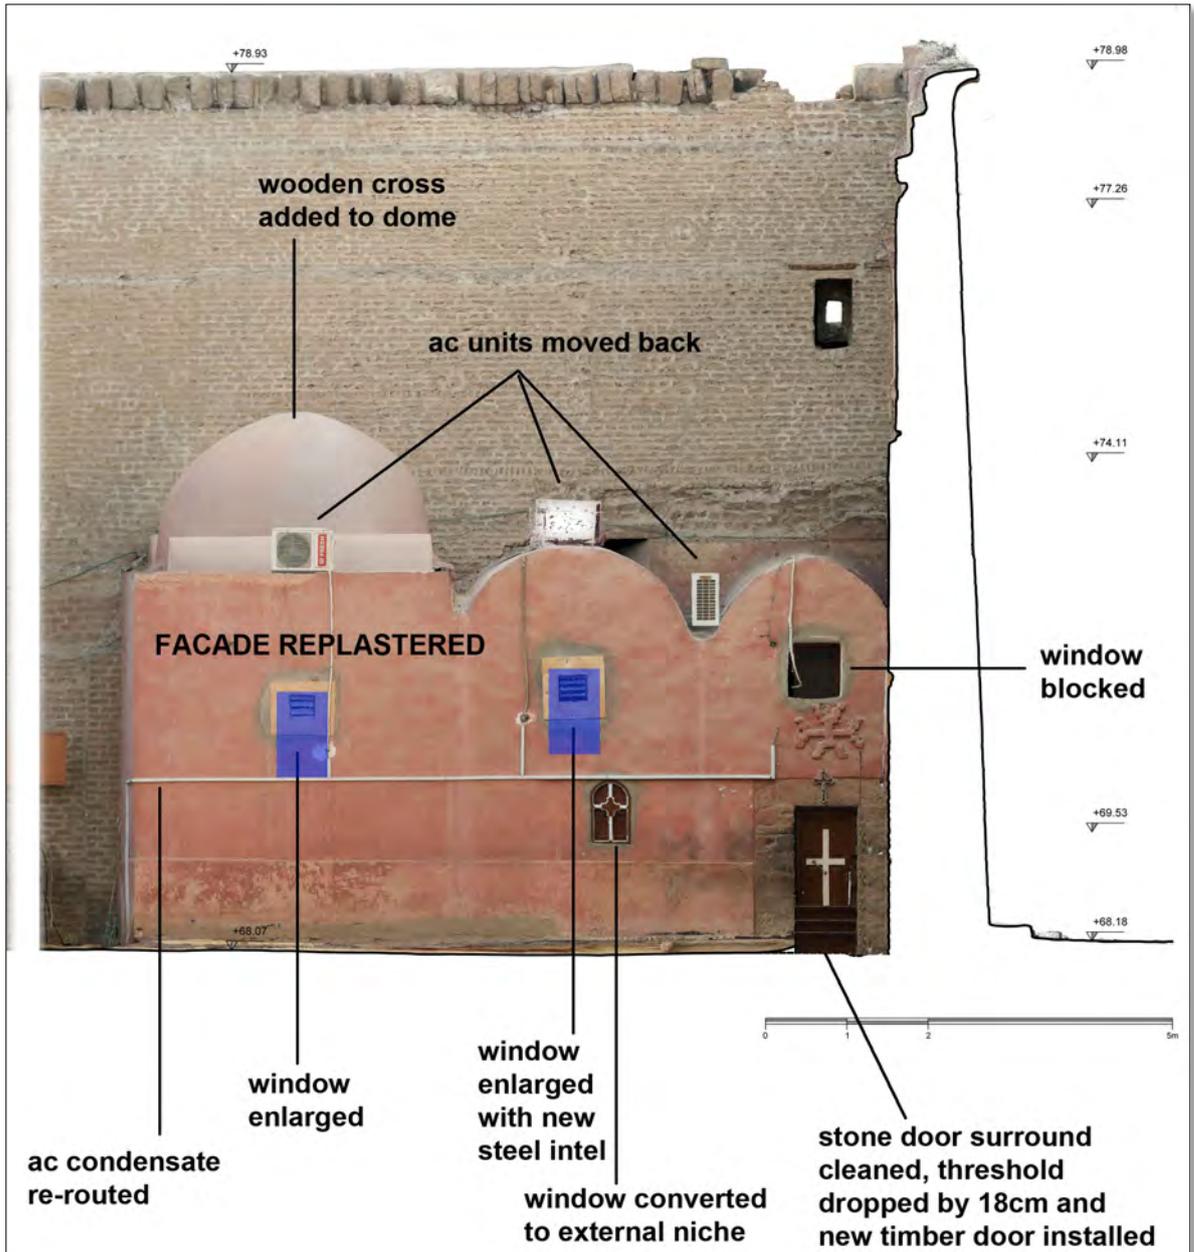
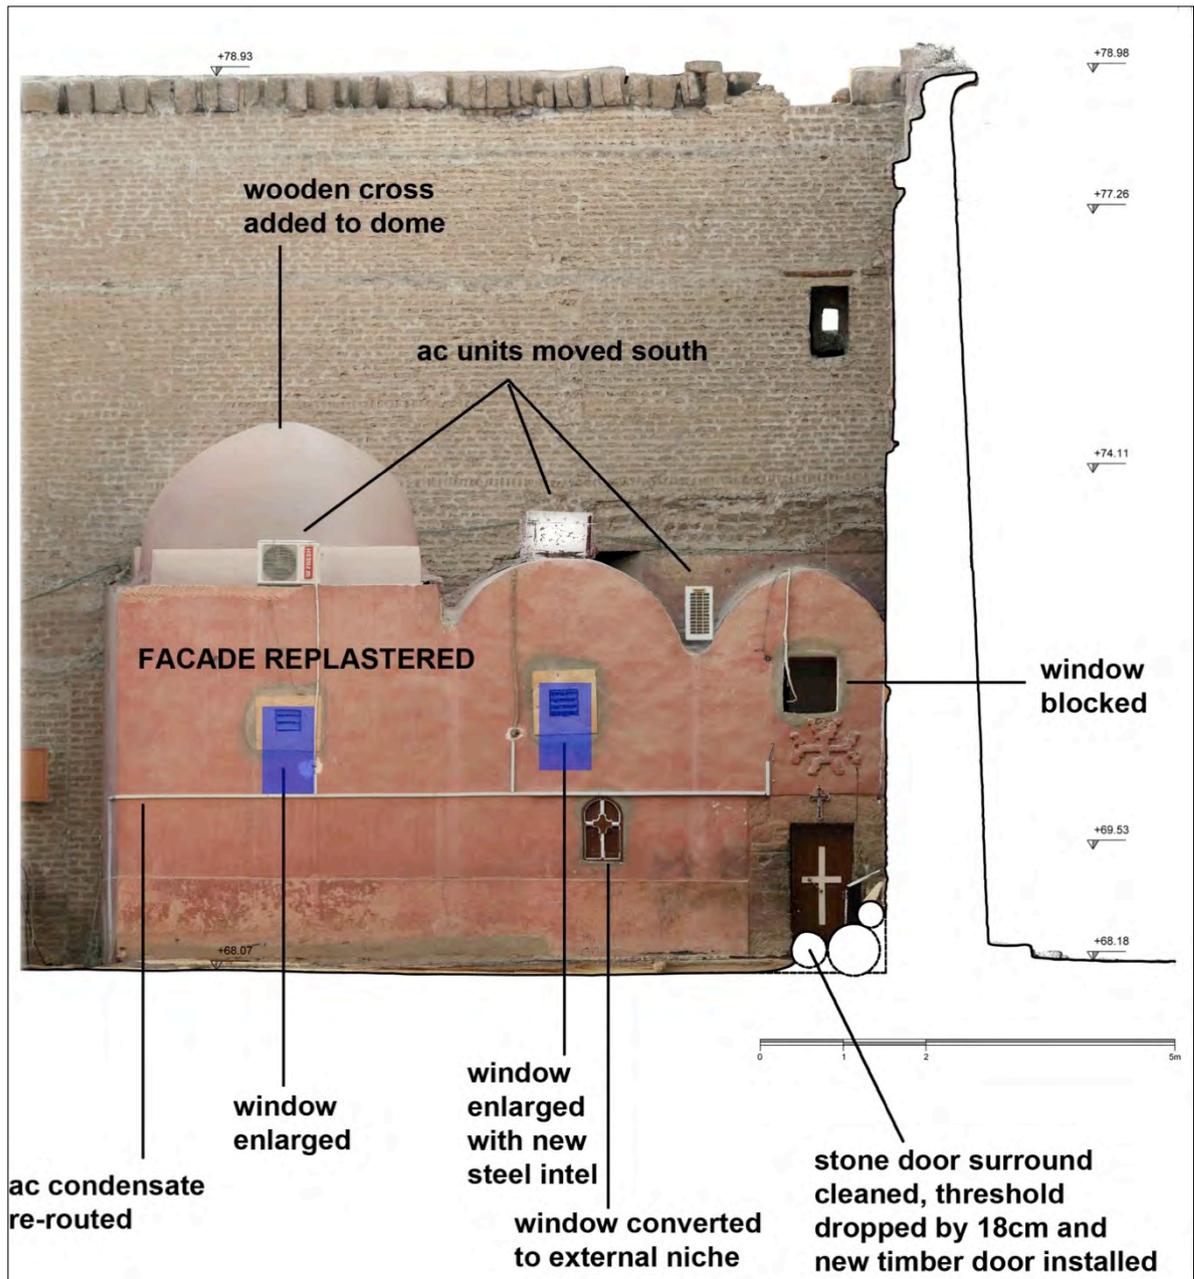
Scanned elevation of the church of al-Adhra showing 2015 interventions

The Church of al-Adhra was almost totally rebuilt in the 1980’s, more or less following the footprint of the earlier building that stood in the southwest corner of the nave. Its walls were plastered with cement, inside and out. Traces of the earlier building can be seen in the limestone doorframe and lower sections of brickwork. This masonry employed a silt mortar. The building is highly serviced, with three ac units and two extract fans, all installed in a rather ad hoc manner. It was the intention of the monastery to retain these services, and the monastic authorities also made specific requests that certain features of the building be adapted to present needs.

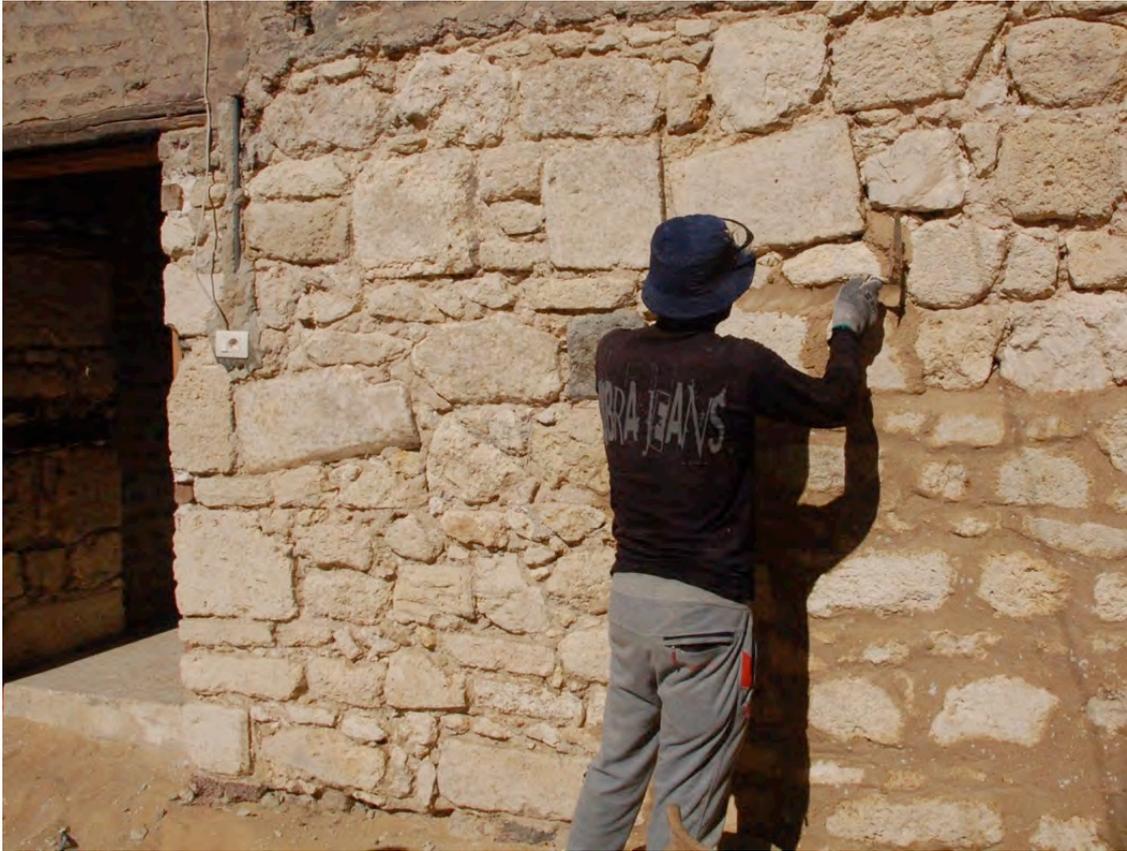
Re-pointing the cleaned section of limestone masonry at the east end of the south hall

At the east end of the south hall, a section of limestone rubble wall measuring 2.2 metres in height was mechanically cleaned and all cement removed from joints prior to re-pointing using lime mortar. A new limestone step was installed to the staircase area beyond, and the existing door was refurbished. The original paving level of the area at the base of the east stair was exposed at the bottom of the stair. A new terrazzo floor had been installed by the Monastery 15 cm above this at some point in recent history. It is recommended that this later floor at the bottom of the stair well be removed, and the original floor level restored as necessary.

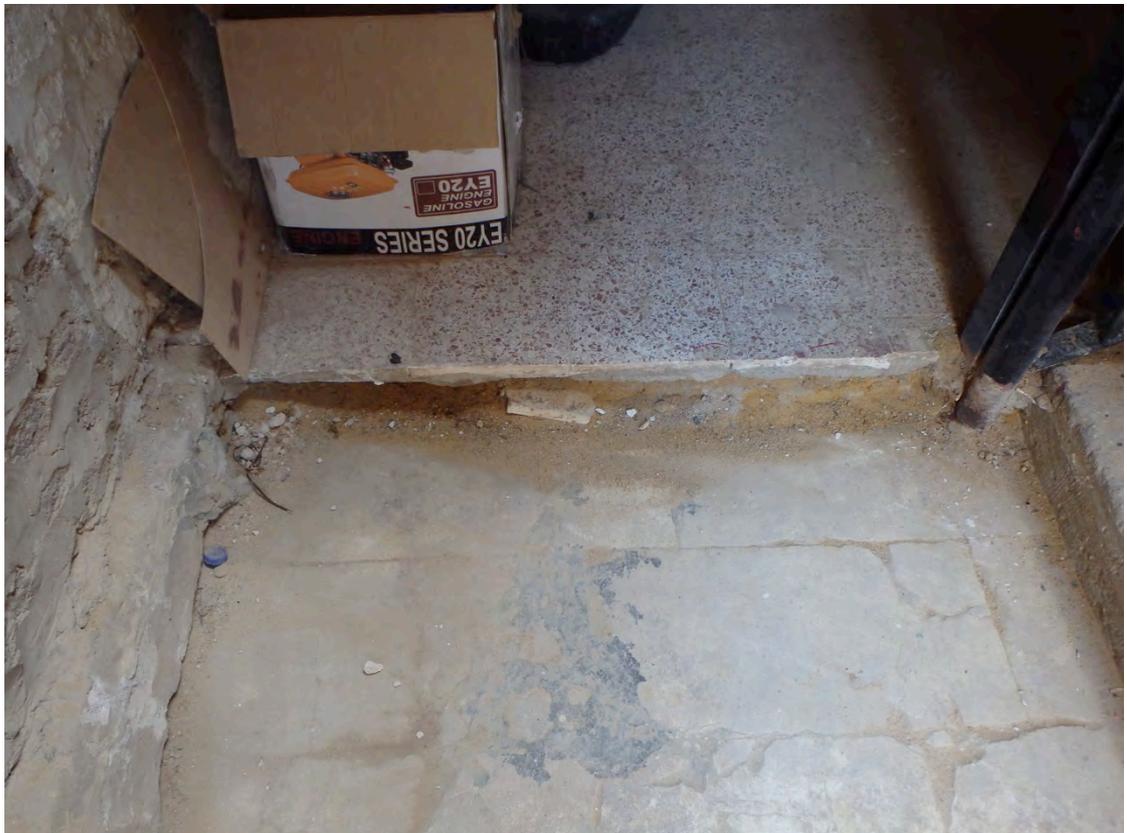
Original and later flooring in the area of the east staircase
