Bianca Madden
Conservator of Wall Painting and Polychrome Sculpture
The Garden Flat 5 Rawlinson Road Oxford OX2 6UE
07789067364/01865 513144 bianca@biancamadden.com
www.biancamadden.com

CONSERVATION OF WALL PLASTERS AND TEXTS
WEST WALL, RED MONASTERY
OCTOBER – NOVEMBER 2019

Report No: BMRM1219 Date: 1 December 2019 Author: Bianca Madden, Conservator of Wall Painting and Sculpture, The Garden Flat 5 Rawlinson Road Oxford OX2 6UE; T: 07789067364/01865 513144; E-mail: bianca@biancamadden.com

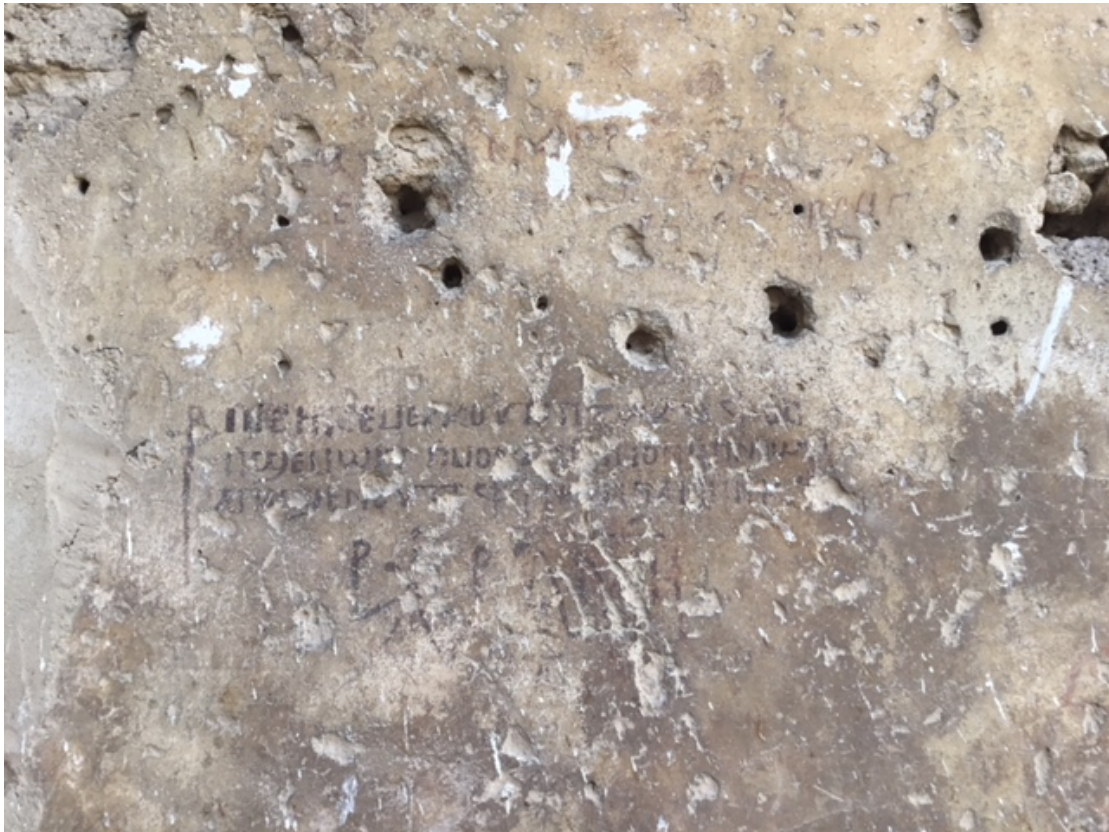
The upper red (barely visible) text, and lower dark red four line text, before conservation

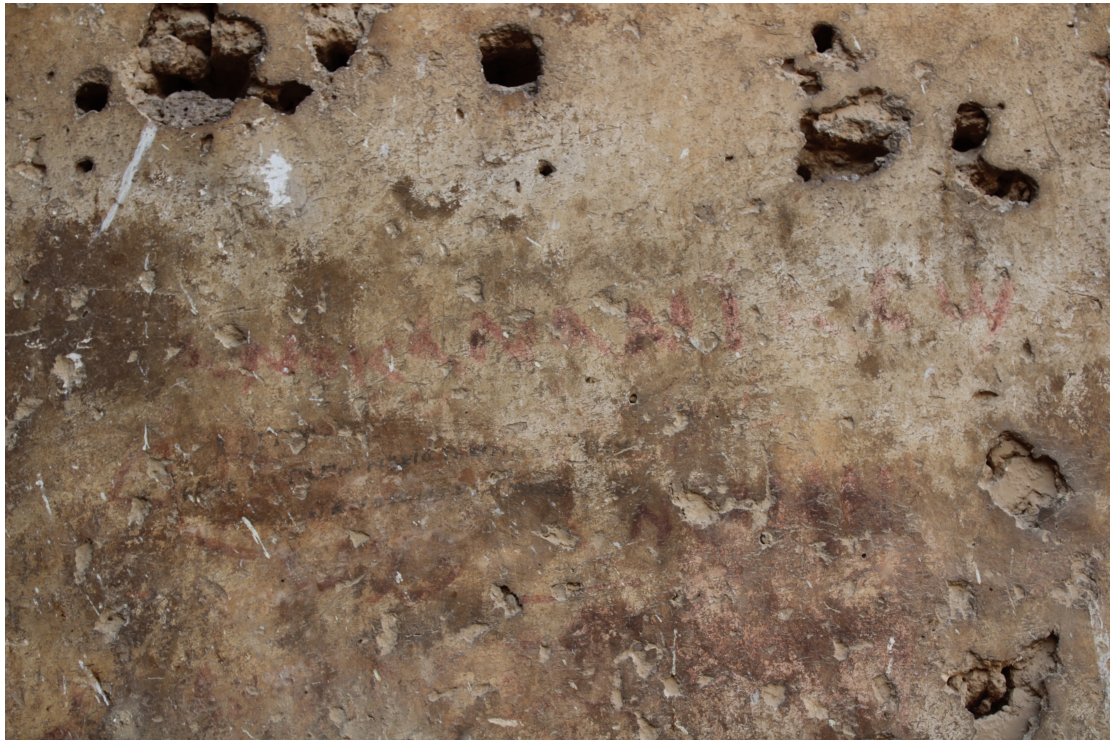
The blurred red text with the internal, later, black text, before conservation

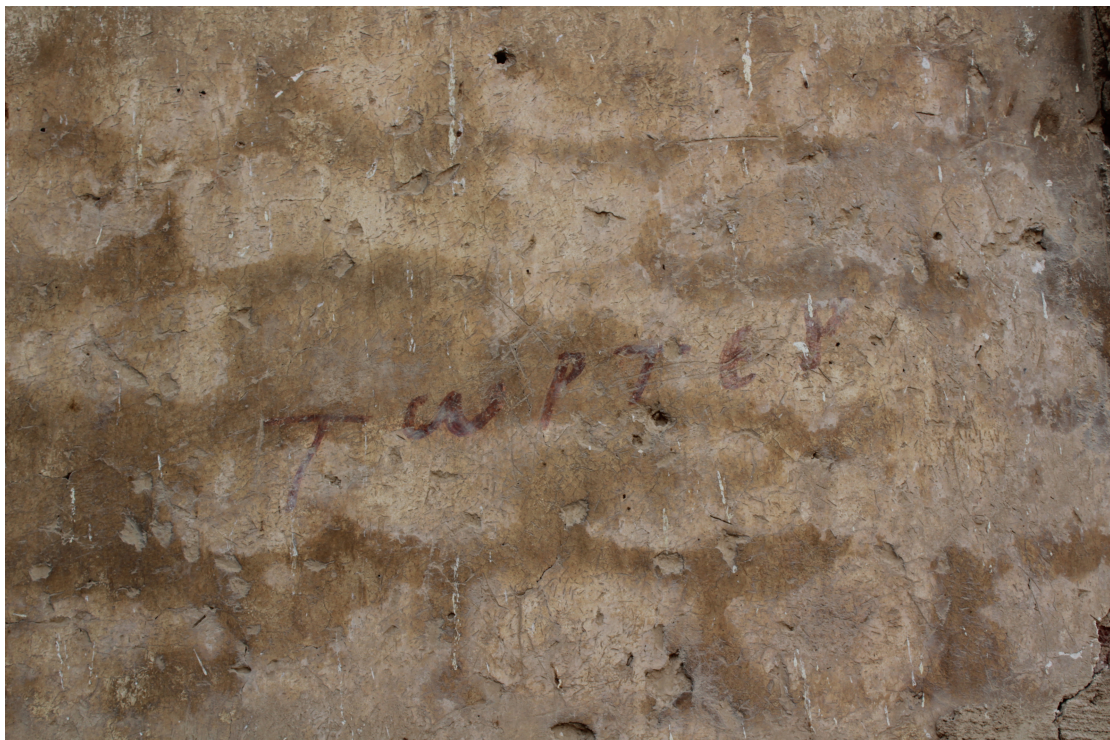
The single line red text, before conservation

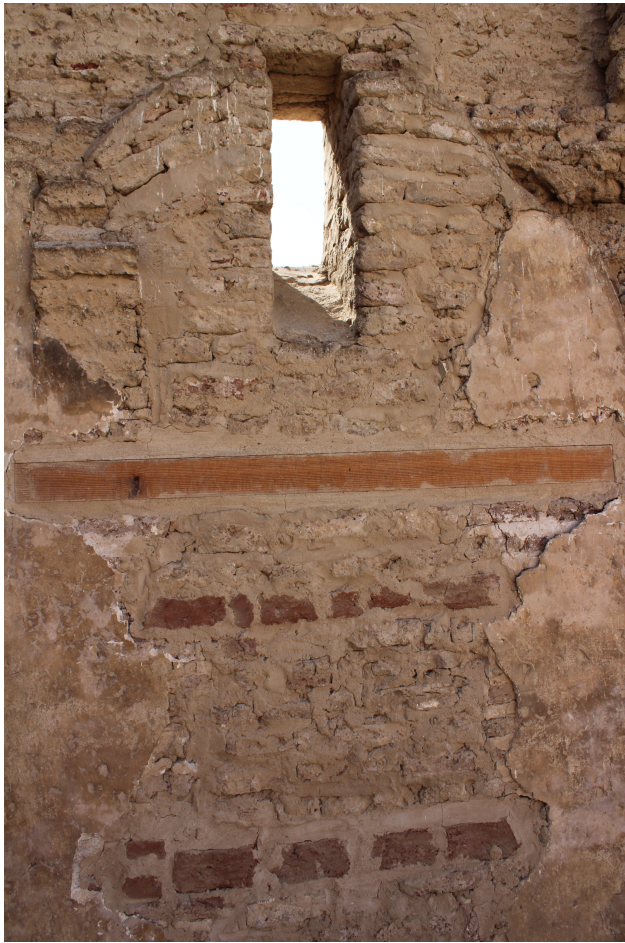
Detail of one of the wooden beams and associated materials used in the stabilisation of the section of wall

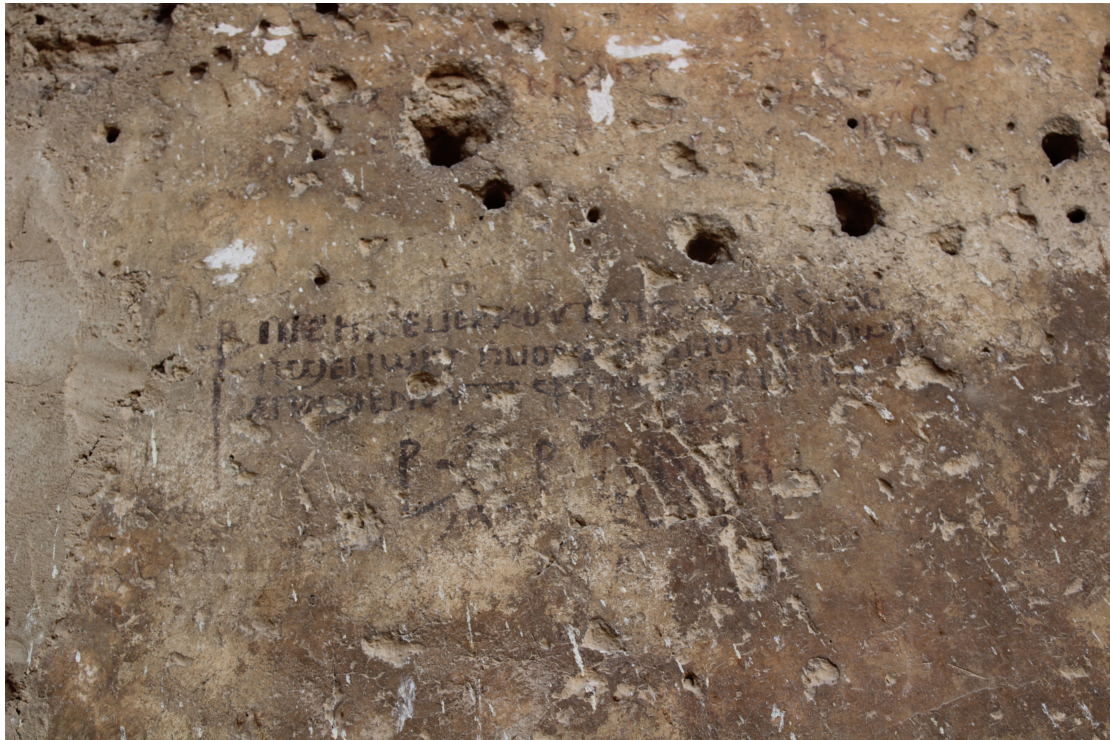
Cement repair to the left of the dark red text, at the junction with the south wall

The cement and gypsum repairs were removed mechanically, as possible, gently trimming them away from the original plaster using a scalpel and removing the bulk with a chisel once a channel had been opened up, or by reducing the lumps of splattered cement by slowly removing the upper material using a chisel or scalpel. Cement was not fully removed where it abutted broken areas of original plaster, or as it directly bonded to original surfaces as its removal was likely to risk damaging the original.

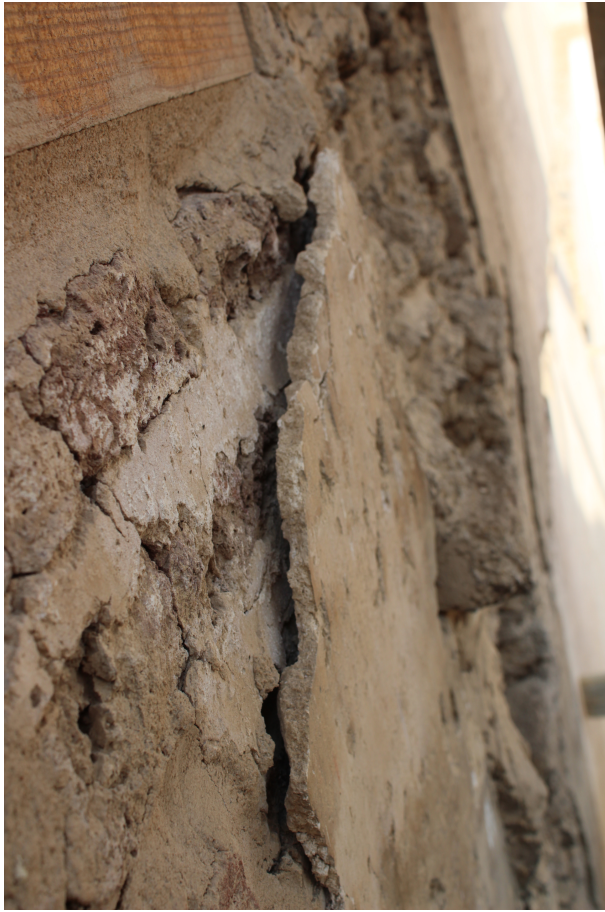
The losses of large areas of plaster, as well numerous smaller holes had left the remaining plaster in the area unsupported and detaching from the walls, this was particularly the case around the structurally repaired section of wall. Here areas of plaster were not only detaching and hanging away from the wall, but there was also a lot of detachment in the section of plaster to the left of the repair – it is likely that this occurred during the movement of the wall which caused the structural instability – and may have been further exacerbated by the work necessary to achieve the two structural interventions.

Detail of detaching plaster

Loose and detaching plaster was secured by grouting behind the detached areas with a lime based grout developed for the treatment of wall plasters. This was introduced by syringe and allowed the reattachment of the vulnerable areas. Edge repairs using a lime mortar were used to support vulnerable edges.

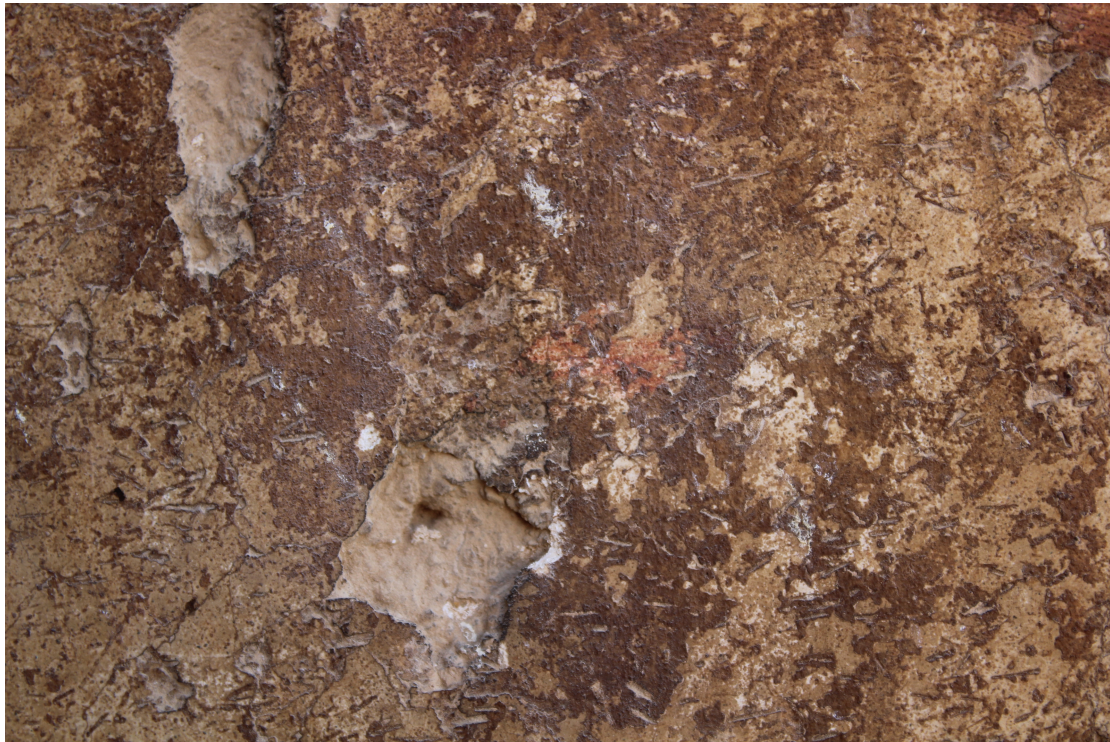
The plaster surface was covered in encrustations of dirt, sand, sulfation, as well as calcite deposits from the lime within the plaster and what appeared to be historic microbiological growth. There were also sooty deposits, likely dating from the time that housing existed in the nave. This soot was particularly heavy on the upper section of plaster at the sw corner.

Detail, build up of surface deposits

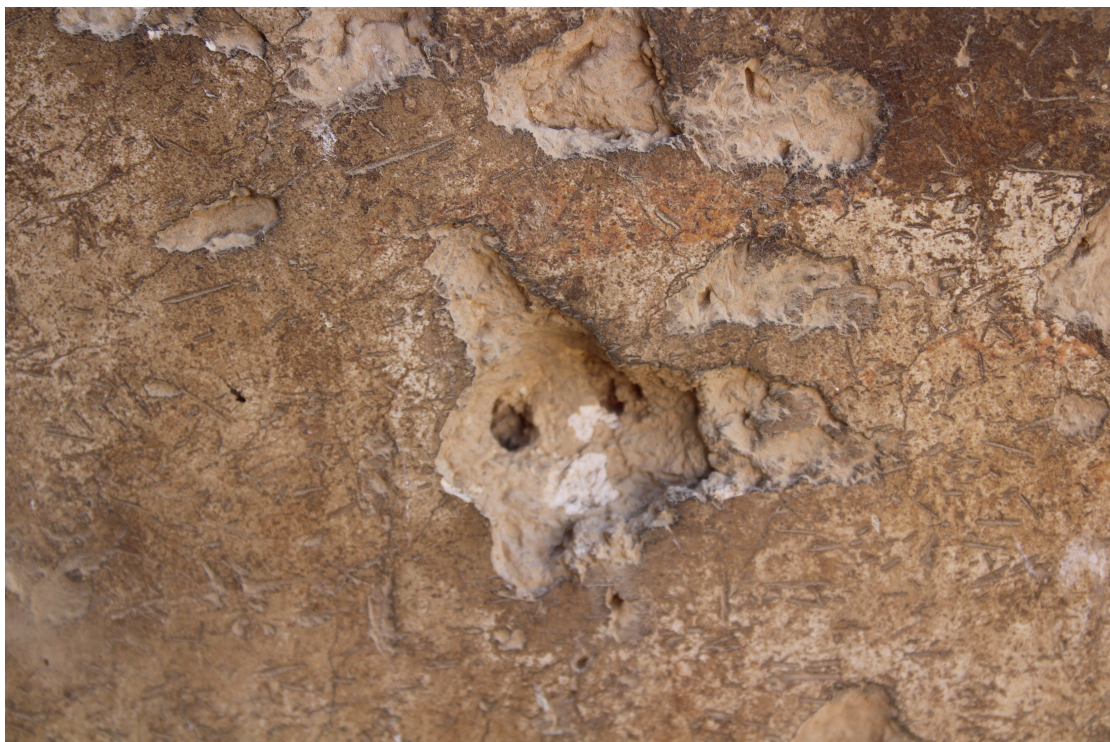
The surface was also pitted, due to erosion from windblown sand, numerous small losses (in addition to the large areas of plaster loss, associated to the movement of the substrate) from scratches, blows and other incidental damage as well as holes from the activity of masonry bees. Bird lime covered the surfaces.

Small holes and losses and masonry bee damage

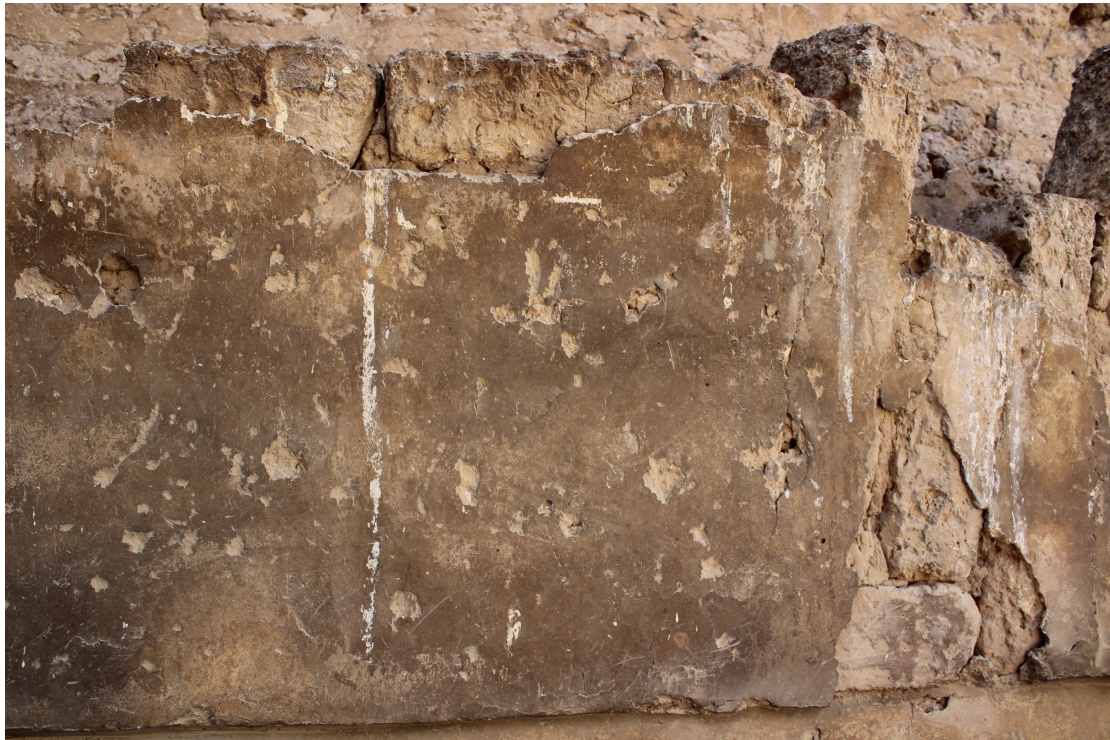
Bird lime and sooty deposits
