ARCHITECTURAL CONSERVATION RED MONASTERY SPRING 2017

THE TOWER

TECHNICAL REPORT

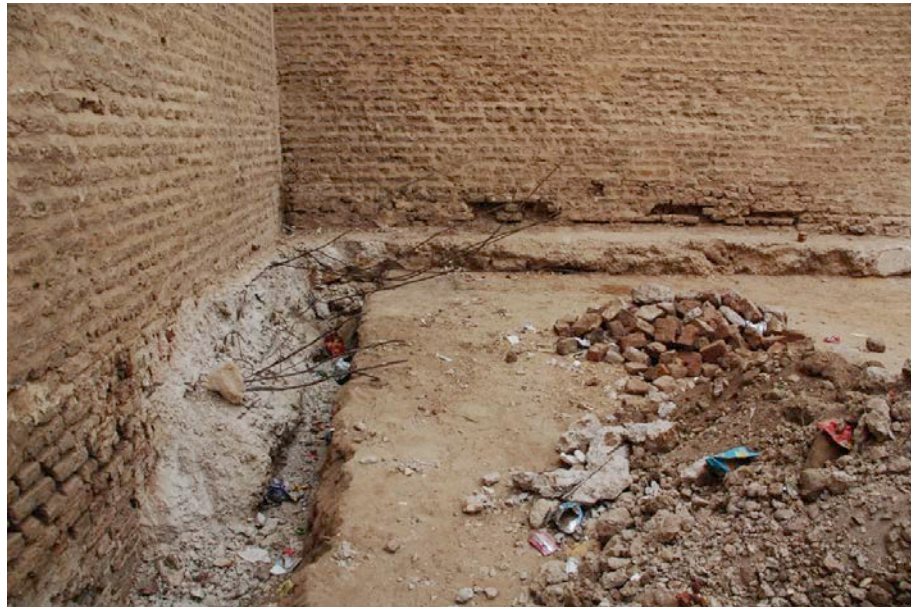
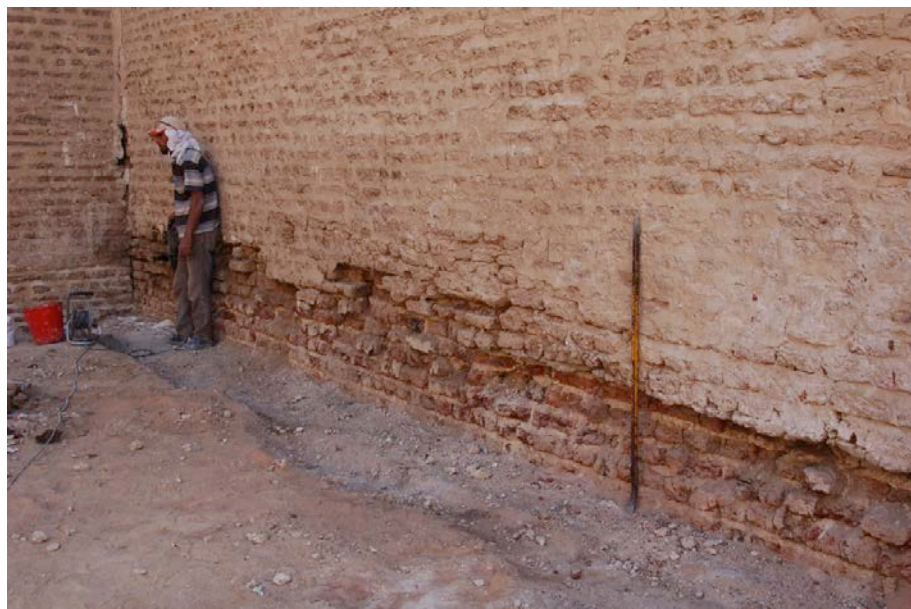
Reinforced concrete beams (40cm wide x 60cm deep) were installed parallel to the east wall of the tower and south wall of the church in the 1980s. These were cast over a 40cm deep x 60cm wide mass concrete base. On the east side of the tower, the RC beam was removed manually, leaving the mass concrete in situ. Beside the south wall of the church only the section of the reinforced beam that was protruding above ground level was removed. On the south wall of the church at its west end, a reinforced concrete trough, dating to the period when a house abutted the church in this corner, was also removed. The voids left after the removal of the concrete were backfilled with clean sand.

Removal of reinforced concrete from southeast corner junction of tower and church (top) and condition of south wall after removal of concrete (bottom)

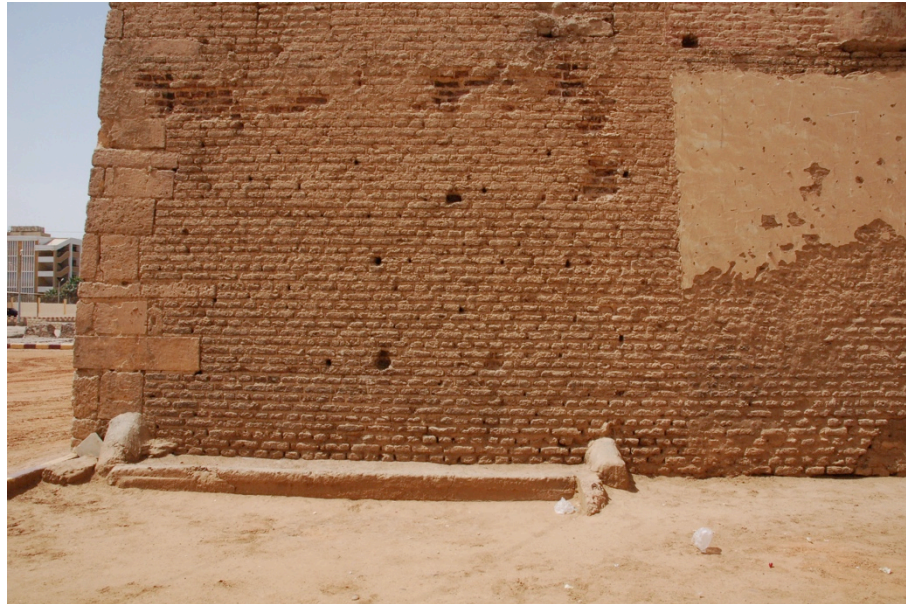
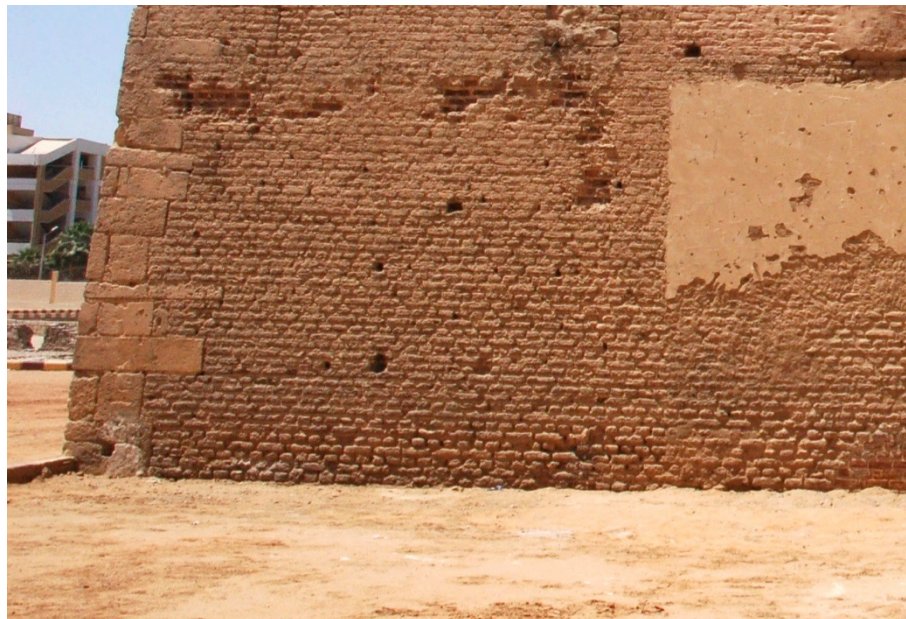
Reinforced concrete on southwest corner of church before (top) and after removal (bottom)

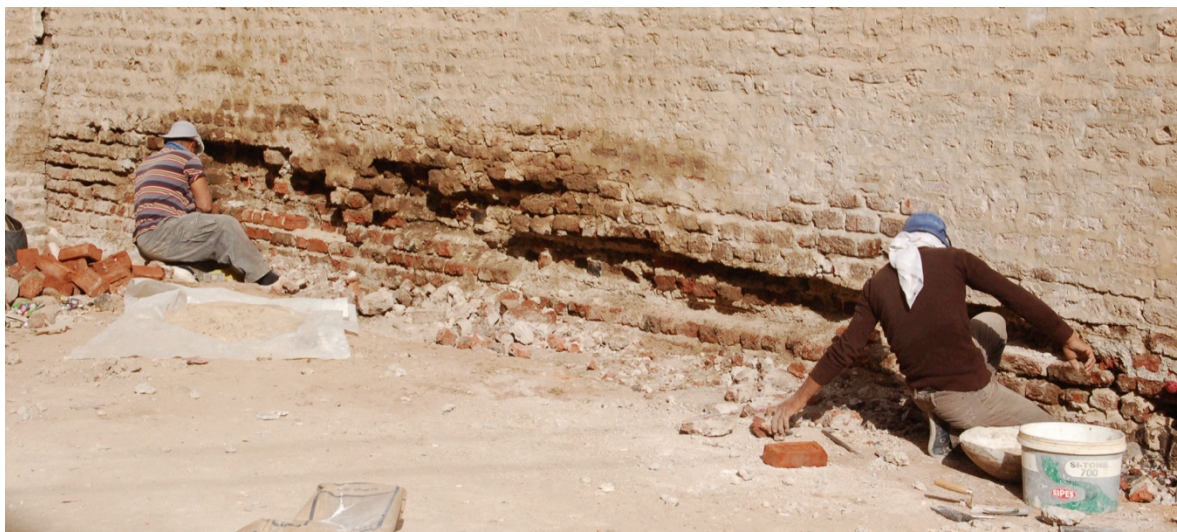
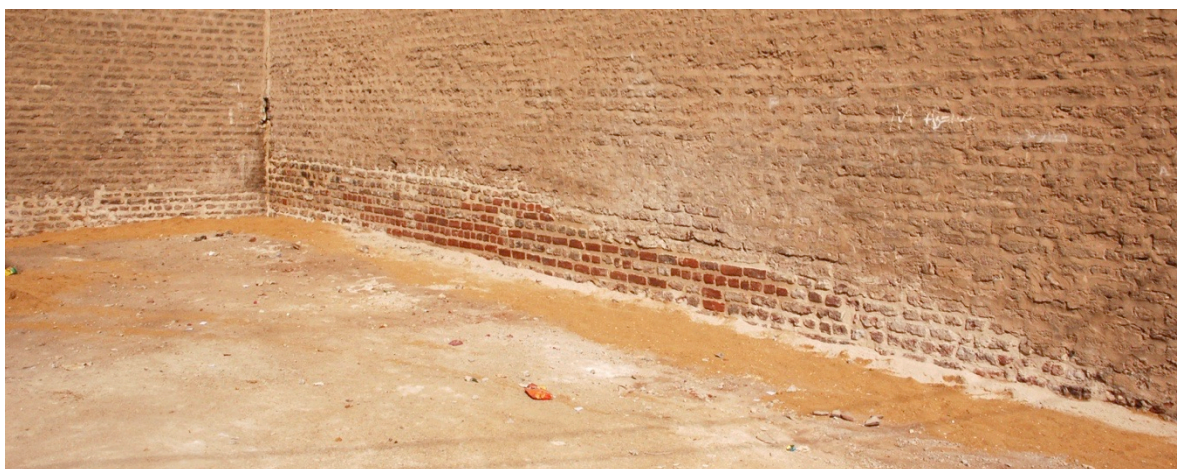
The removal of the reinforced concrete beam revealed significant areas of damaged brickwork on the east face of the tower and south wall of the church to the east of the tower. These areas required selective brick replacement and re-pointing. On the west wall of the tower, additional re-pointing of defective mortar joints was carried out to complete the work carried out in November 2016. On the south wall of the church to the east of the tower, another area of brickwork at low level that had been badly damaged by water infiltration and the installation of the concrete beam was cut out and replaced with new brickwork laid in lime mortar with recessed pointing. All brick replacements were carried out using low temperature fired 'baladi' bricks (21 x 7 x 10.5cm). On the south wall of the church to the west of the tower, another area of low level brickwork previously damaged by water and crudely patched was cut out and replaced with new brickwork laid in lime mortar with recessed pointing.

Area of replacement brickwork on south wall of church to east of tower during (top) and after (bottom) intervention

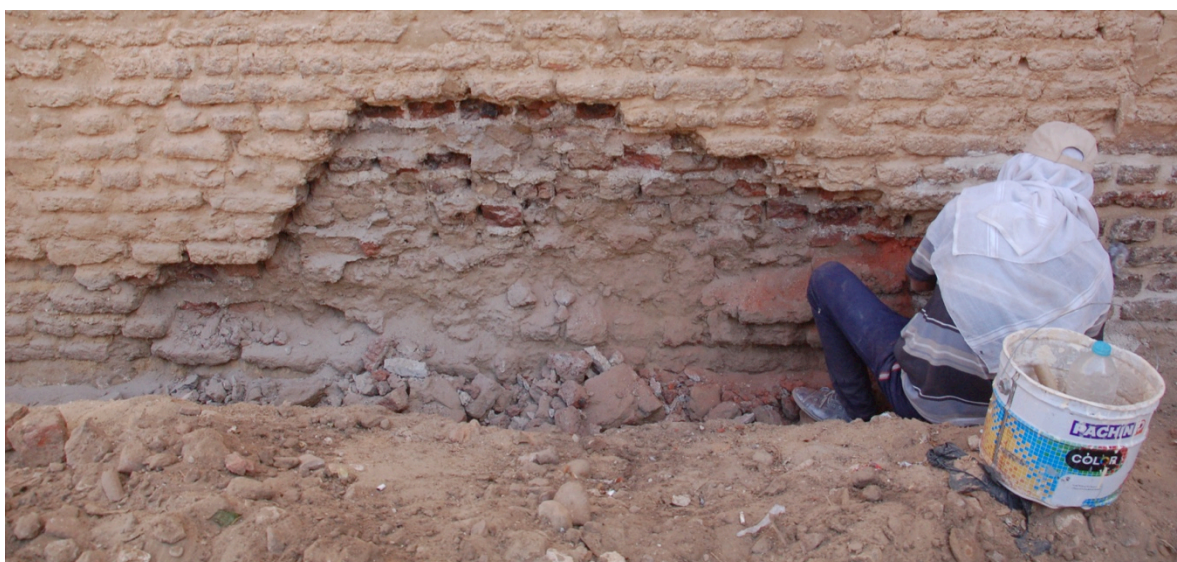
Area of damaged brickwork on south wall of church to west of tower after removal of defective fill

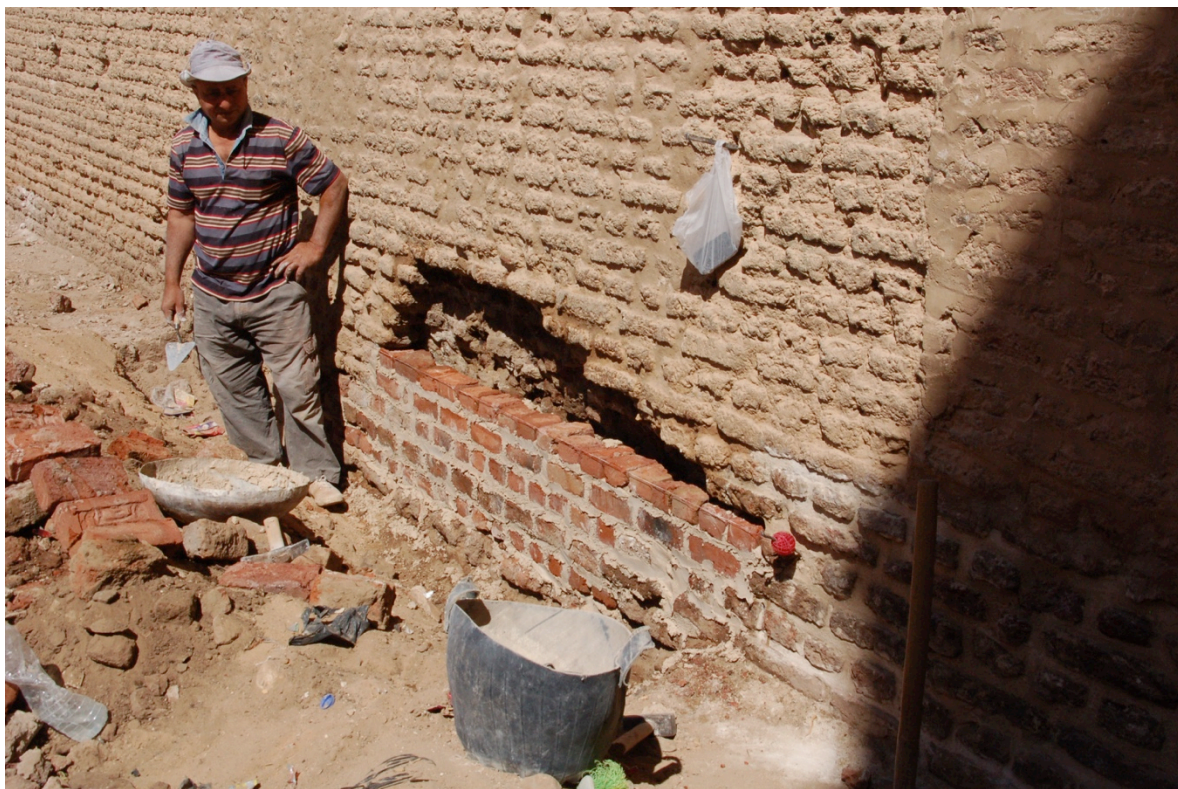
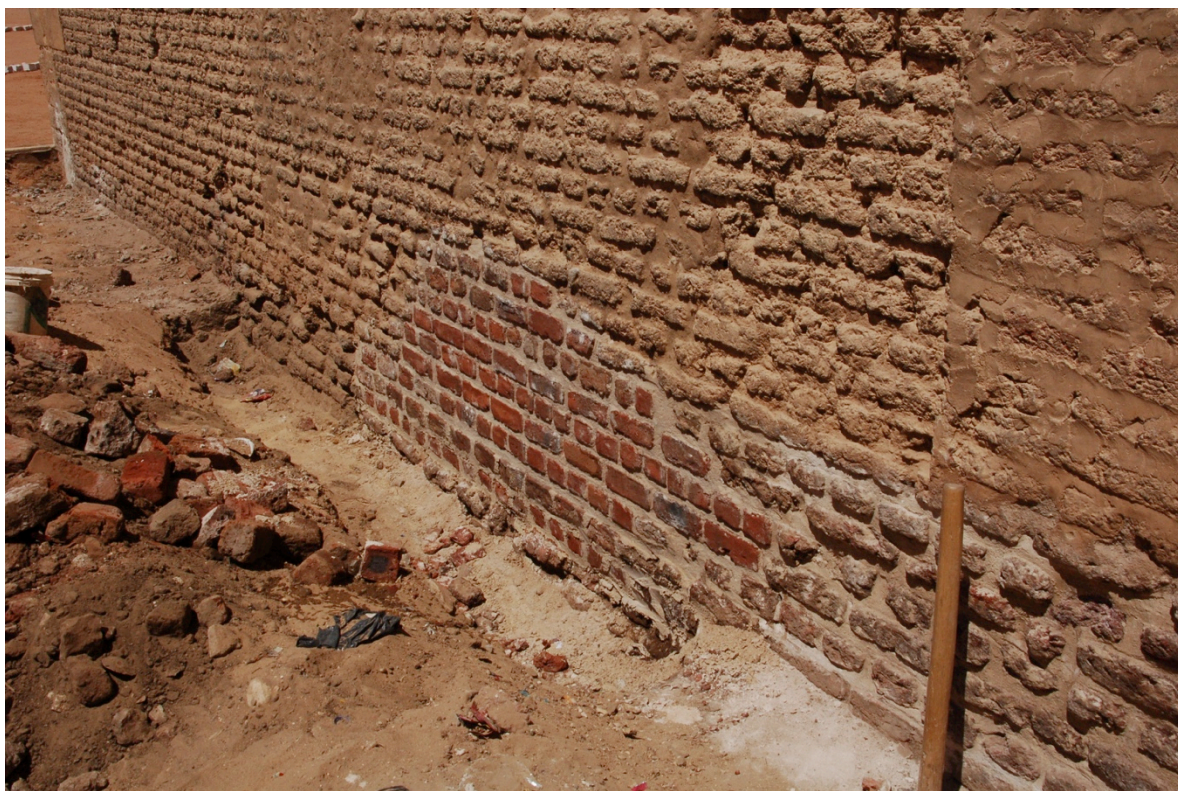
Area of damaged brickwork on south wall of church to west of tower during (top) and after (bottom) replacement and pointing

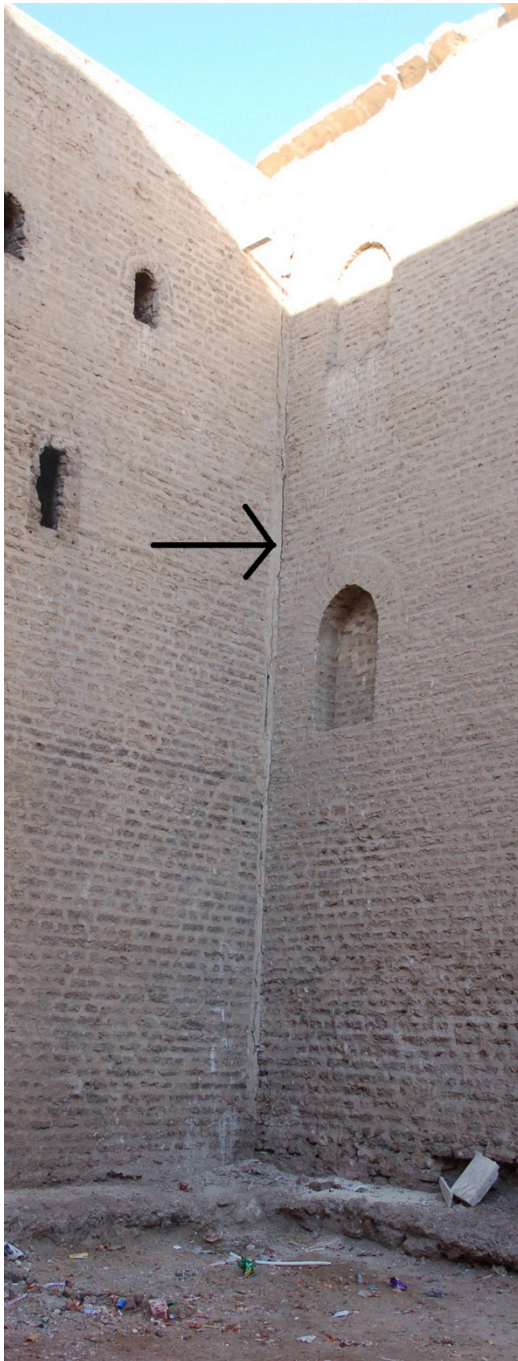
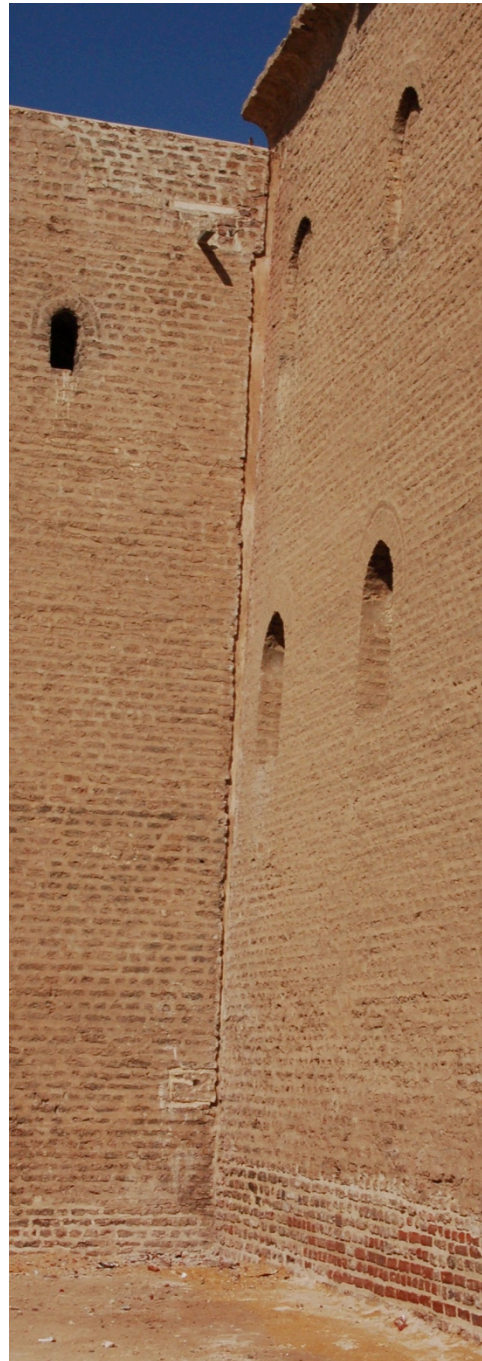
A full height timber scaffold was installed at the junctions of the walls of the tower with the south wall of the church. The gaps between the two structures, on both the east and west sides of the tower, of a width varying between 2 cm and 20 cm, had previously been filled with cement and plaster and were cracked in a very irregular way. Accordingly, and to make it visually clearer that the church and the tower are entirely separate constructions with no bond between them, the filling of the gap was raked out and re-filled with brick set in lime mortar and plastered with lime mortar. The face of the new fill is 5cm back from the face of the brickwork of the tower.

Junction of tower with south wall of church (east side) before (left) and after (right) treatment. The same treatment was applied to the junction on the west side

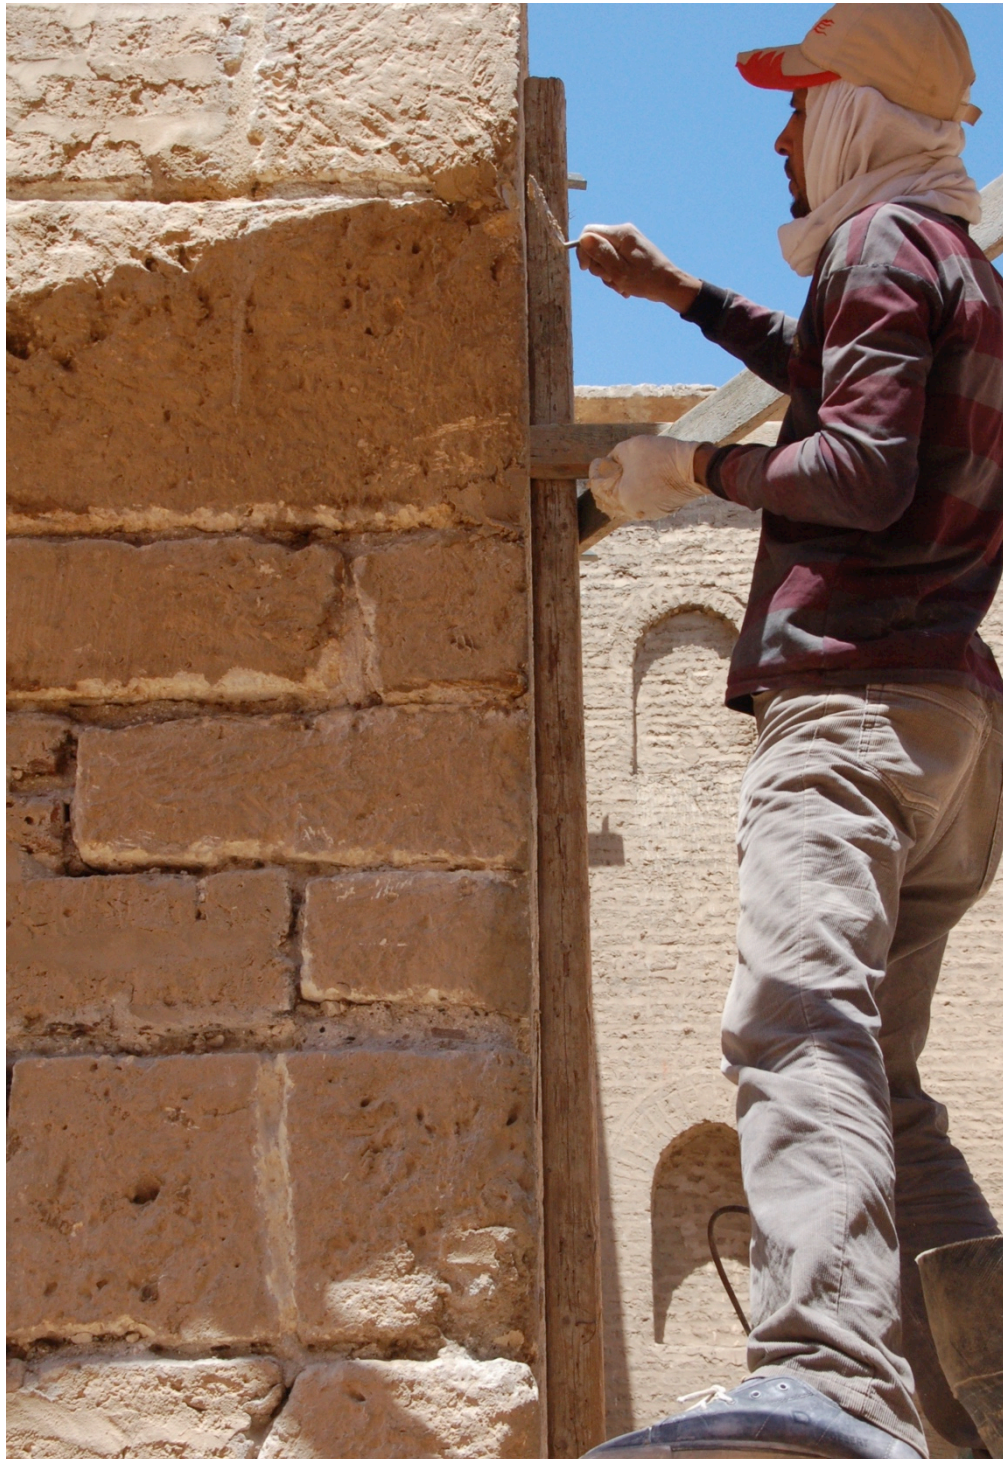
The cemented joints of the limestone corners of the tower were cleaned and all joints were repointed using a lime / sand mortar. New pointing was recessed from the face of the existing stonework. Some sections of the stonework surround to the main door that had not been previously treated were also completed using the same technique.

Pointing of stone quoins in progress

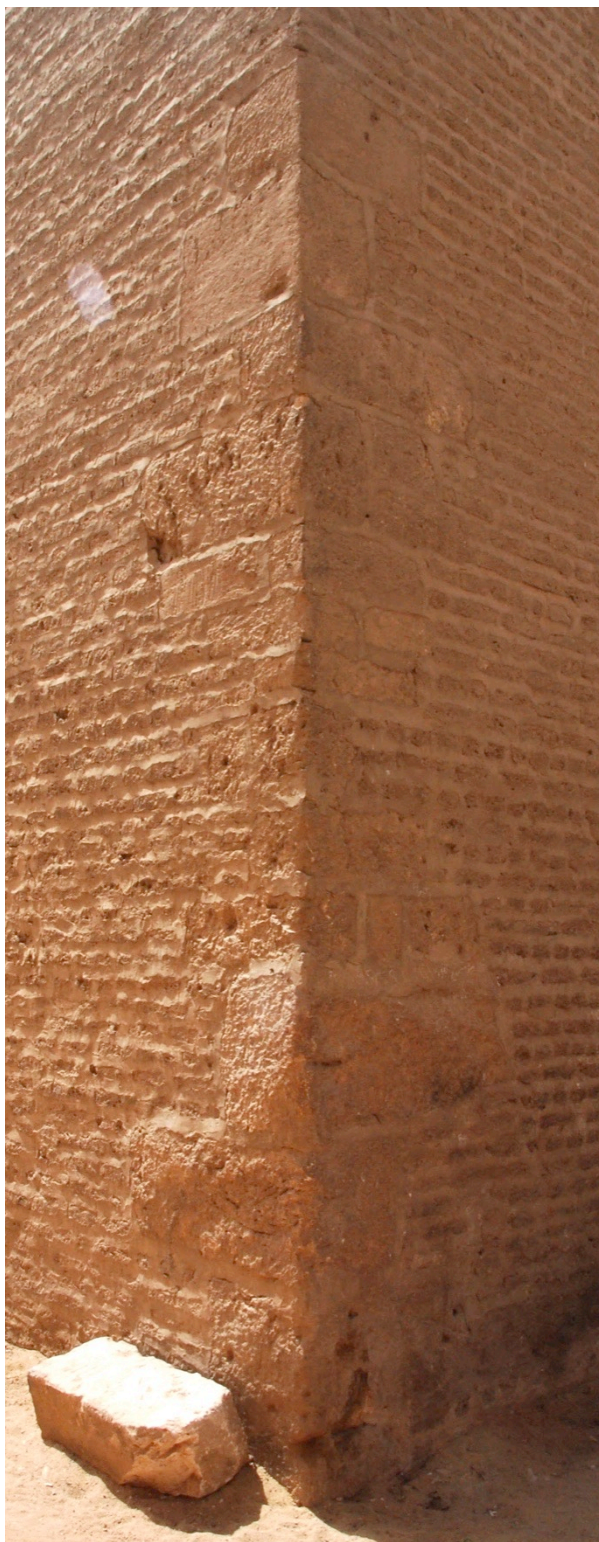
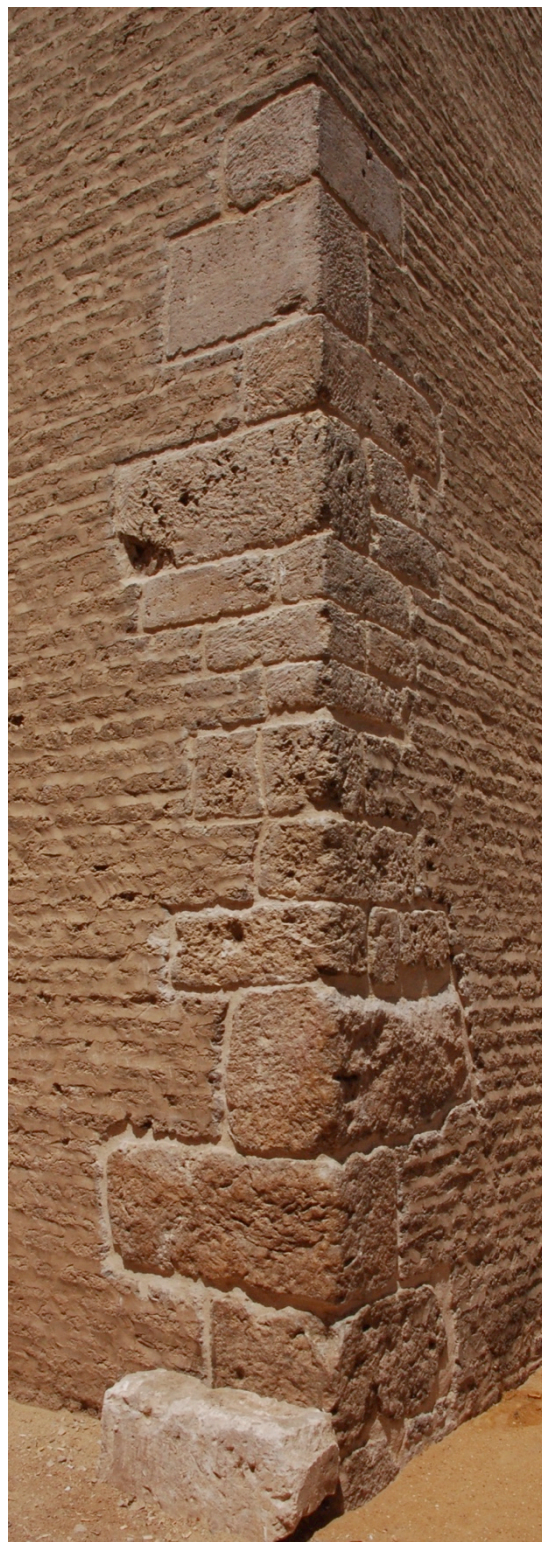
Southeast corner of tower before (left) and after (right) repointing with lime mortar. The same treatment was applied to the southwest corner

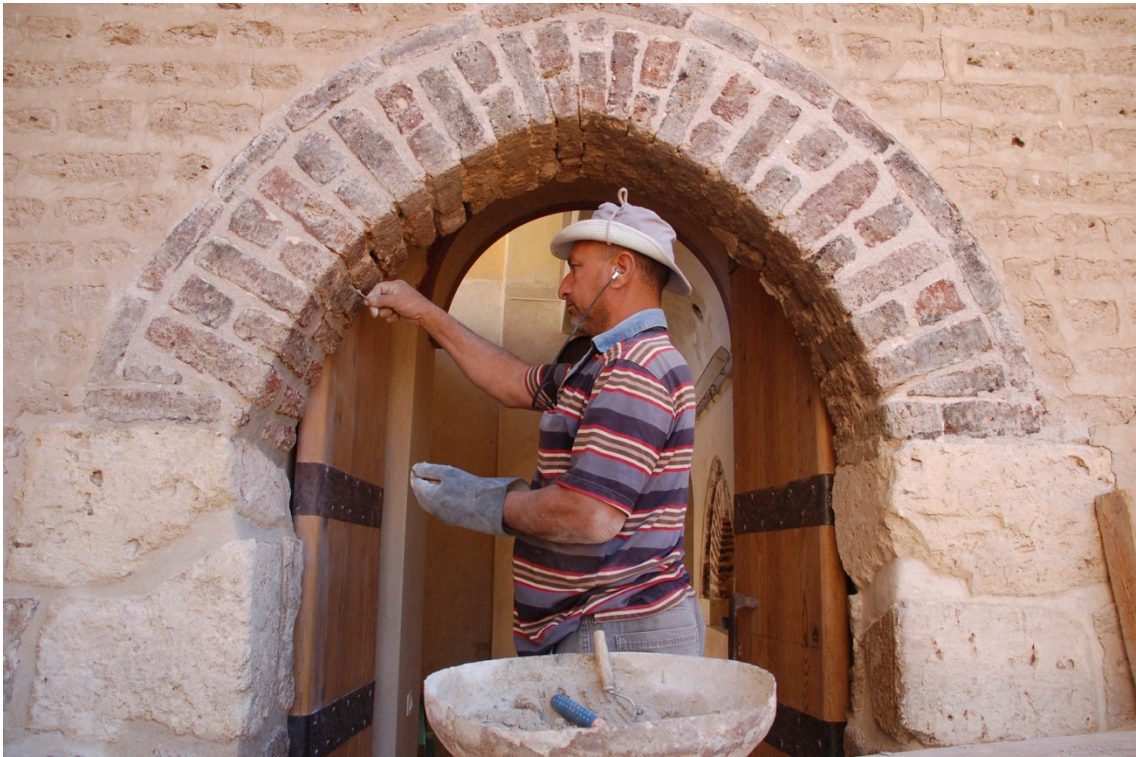
The cemented joints of the brick pointed arch above the door were cleaned and re-pointed using a mortar composed of sand, lime, and fly ash.

Pointing of brick arch over entrance door in progress

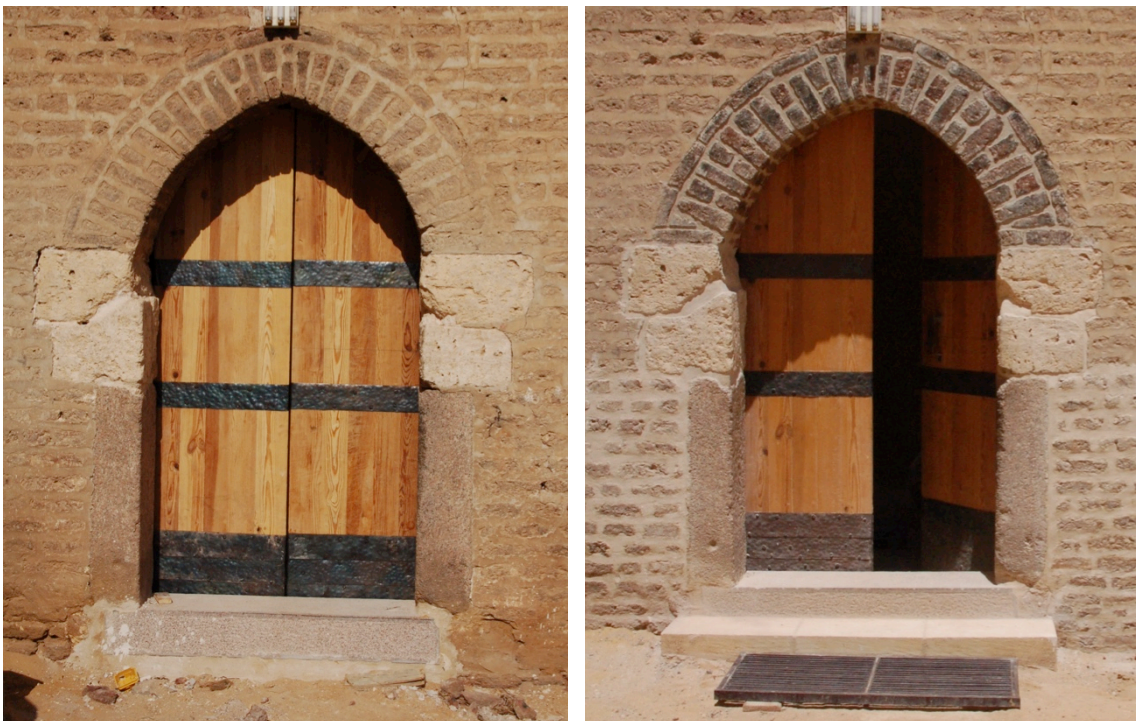
Main entrance to tower before (left) and after (right) treatment

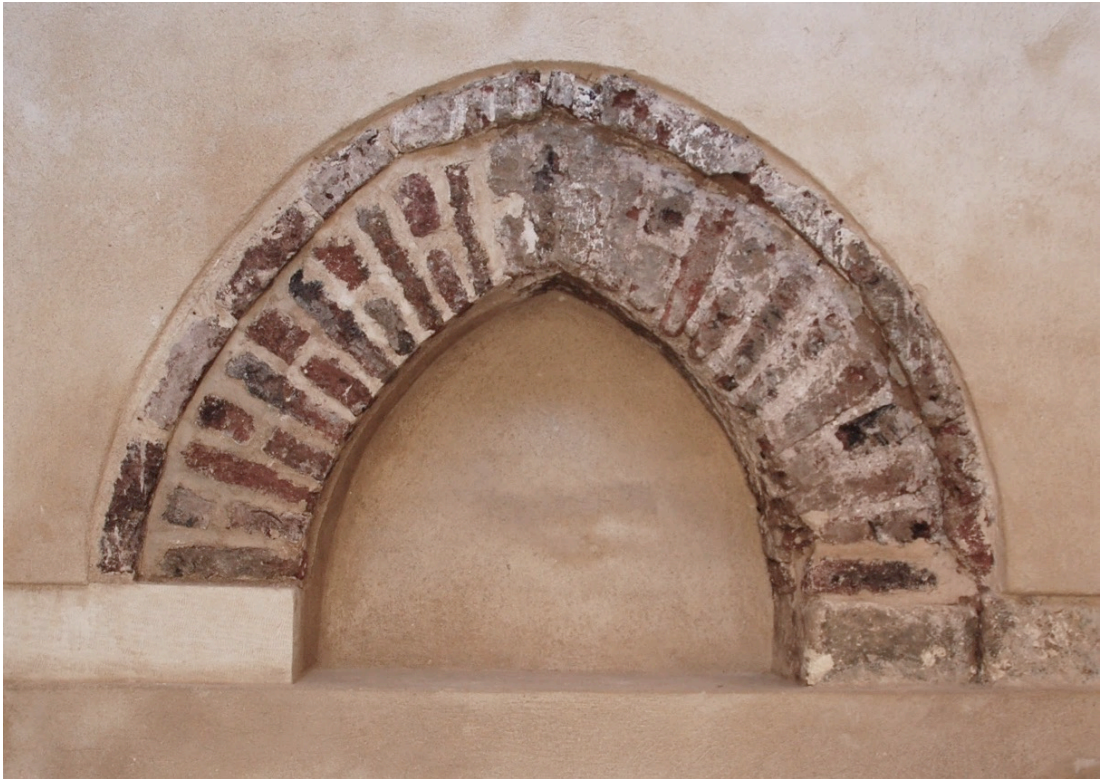
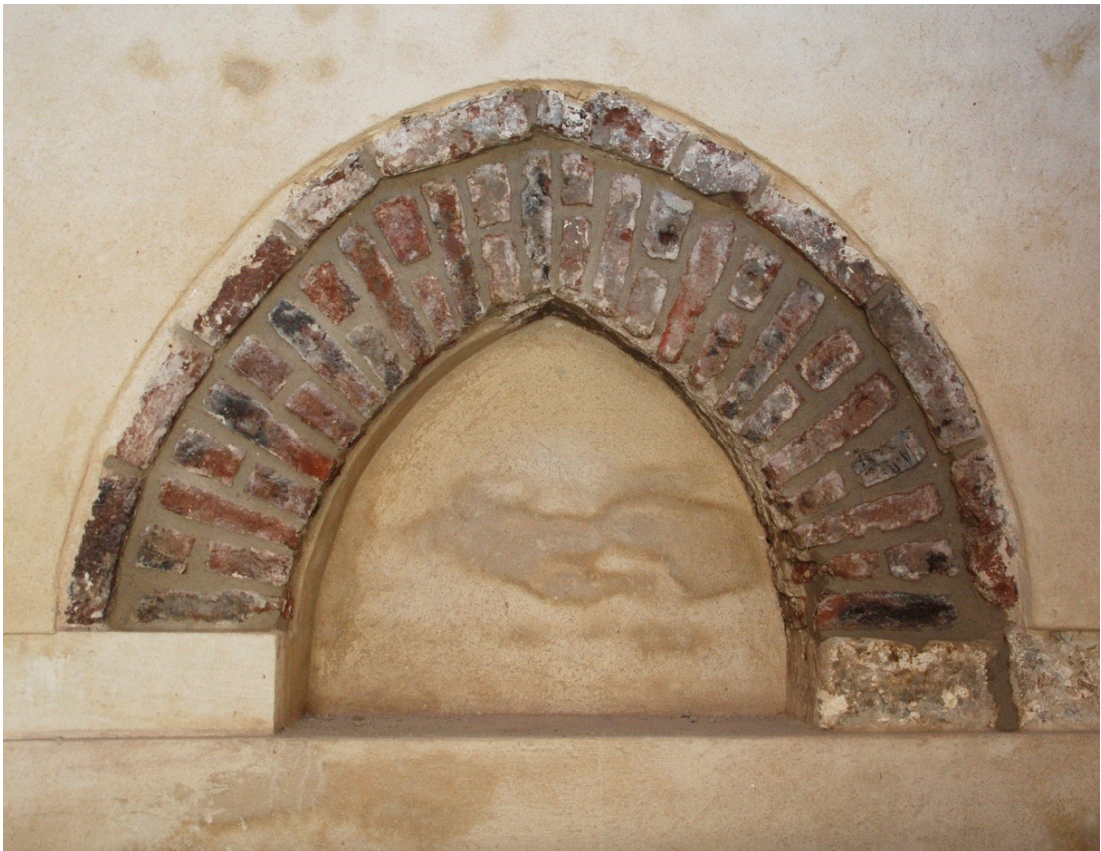
At the request of the Conservation Department, the pointing of the brick arch inside the entrance area of the tower was also replaced using mortar made of sand, lime, and fly ash.

Brick arch inside entrance area of tower before (top) and after (bottom) treatment

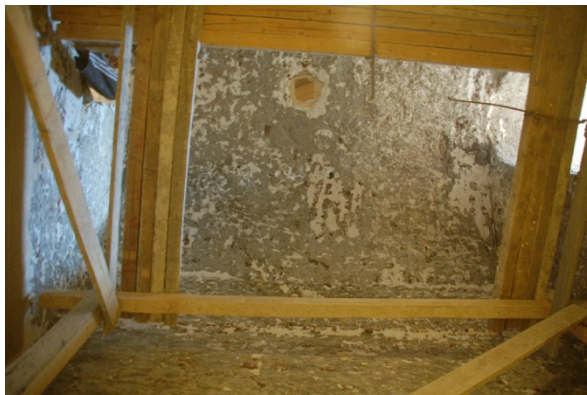
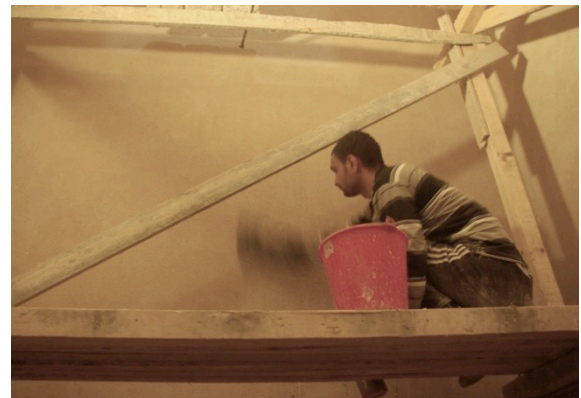
The existing cement and gypsum plaster layers covering the upper sections of the room, including the window embrasures and barrel vault, were manually removed back to the original brickwork. The lower sections of the wall that had already been re-plastered with lime plaster in 2016 were keyed. The entire room was then re-plastered with a plaster whose composition (and sample) had been approved on site in 2016 by Mr. Essam Rushdi, Director of Conservation, Sohag. When completed, this room was visited and approved by Mr. Rushdi, Mr. Saad Osman, and Mr. Ali Zaghloul. The approved sample contains 4 buckets of finely sieved sand, 2 buckets of lime, and 250 ml of Addibond 65 to improve adhesion. The surface of the walls was also coated with a dilute solution of Addibond 65 prior to plastering.

Southeast vault after removal of gypsum plaster (left) and re-plastering with lime in progress (right)

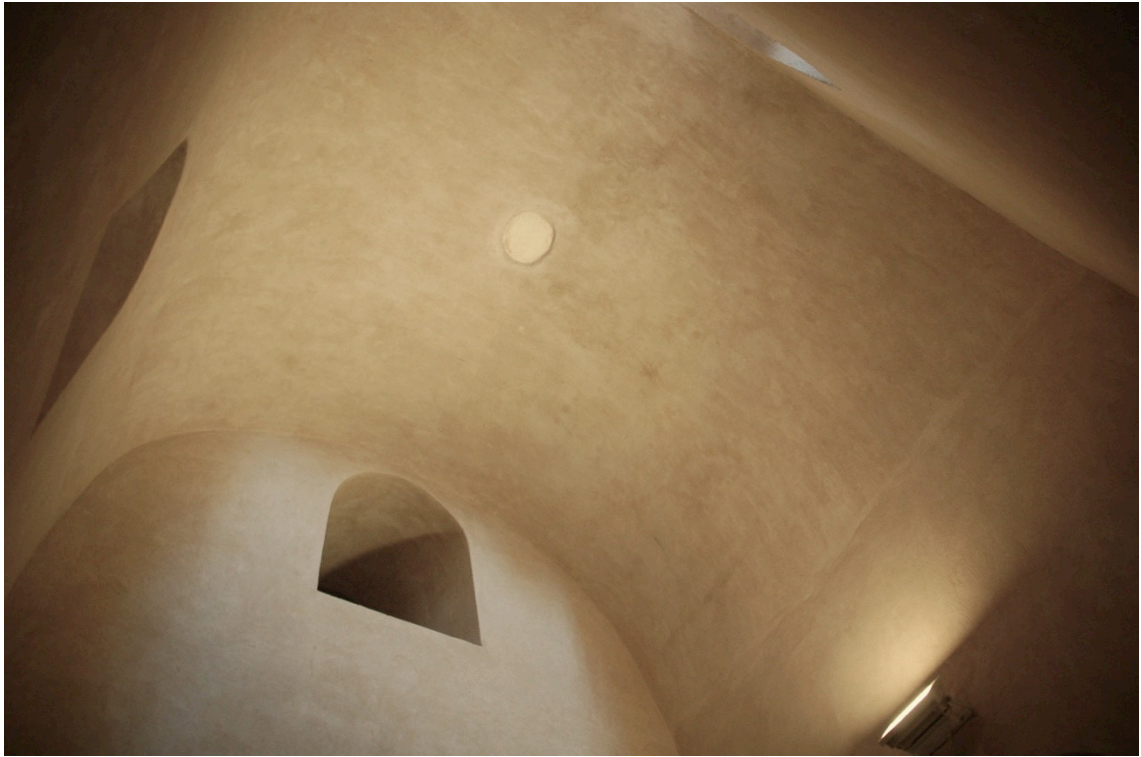
Vault of southeast room after re-plastering

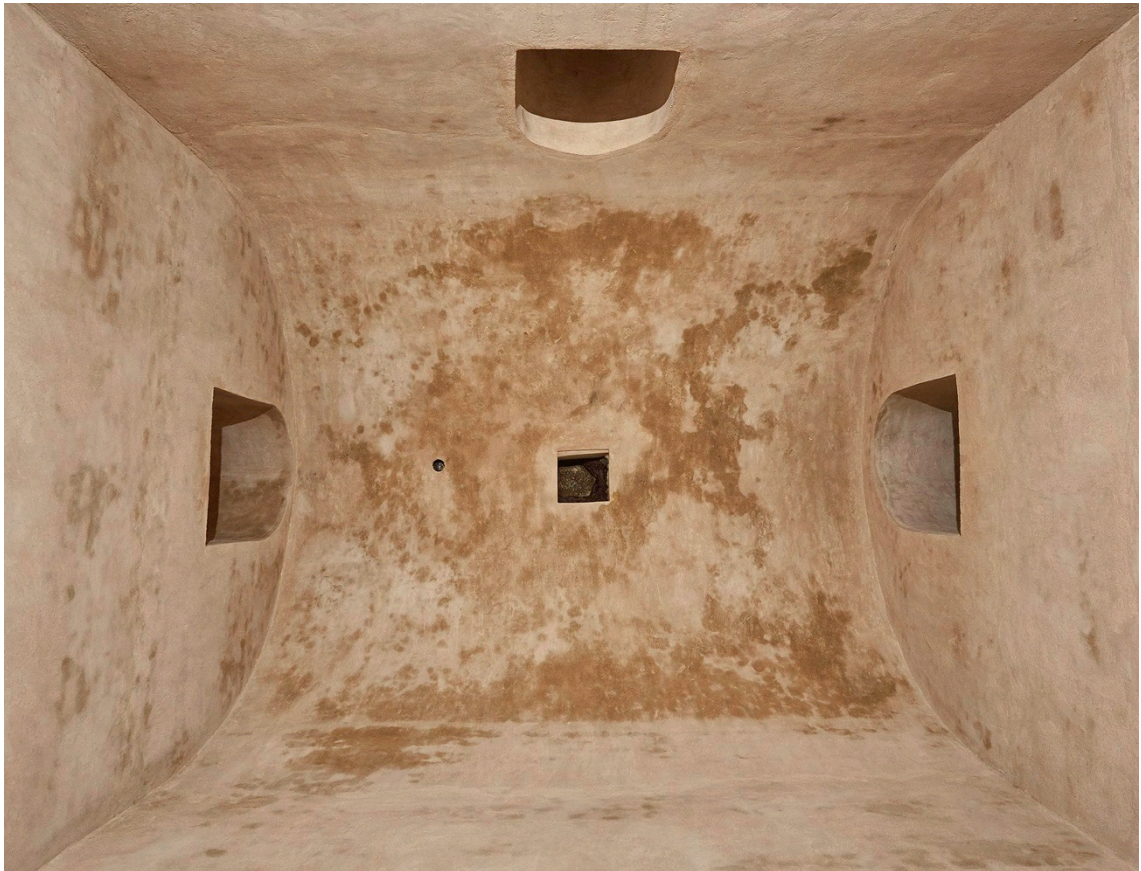
Treatment was applied as in the southeast room. Note that the removal of gypsum plaster from the barrel vault over this room revealed the presence of a circular ceramic pipe embedded in the structure and a square opening in the centre that was covered with a stone slab. These enigmatic archaeological features were left open to view after the re-plastering was completed.

Vault of southwest room after re-plastering showing openings to first floor (photo: M. Kacicnik)

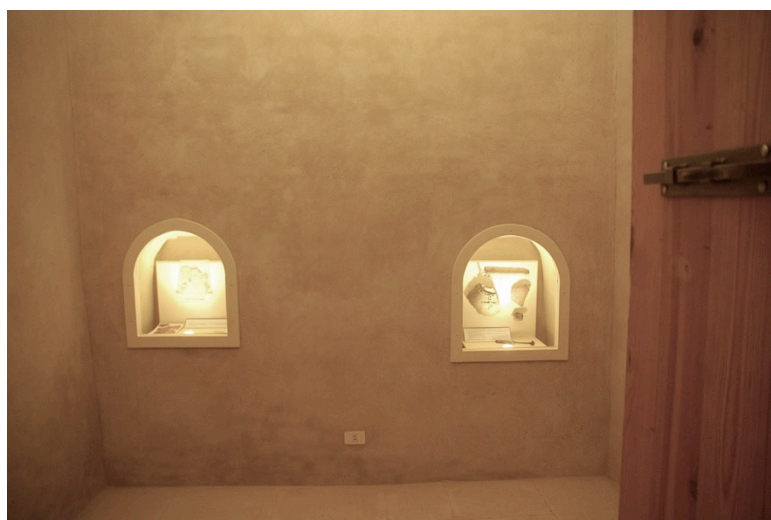
Treatment was applied as in the southeast room. Only a part of the west wall of this room had been previously plastered with lime, so almost the entire surface of the room was re-plastered. The two existing niches in the north wall of the room were fitted with new showcases made from steel angle frames with painted timber facings to house archaeological finds from the clearance of the tower in 2016 [see 3.2 below].

Interior of northeast room after re-plastering showing new showcases

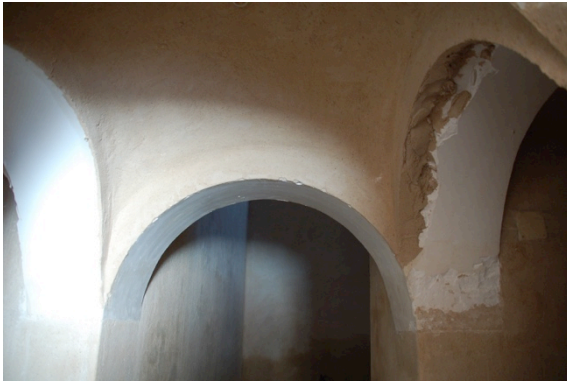
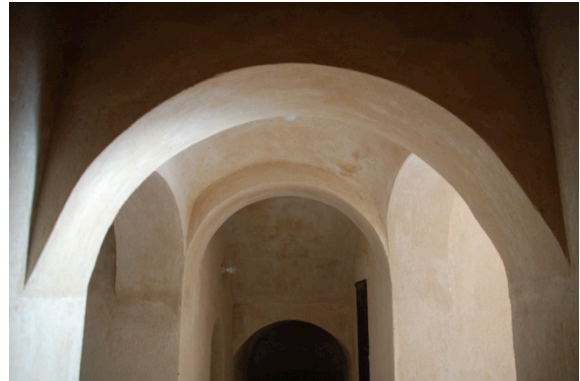
Treatment was applied as in the southeast room. The dome under the staircase landing had been previously treated in 2016 with a gypsum plaster, and this was removed prior to re-plastering with new lime plaster.

Dome in passage under landing during (left) and after (right) treatment

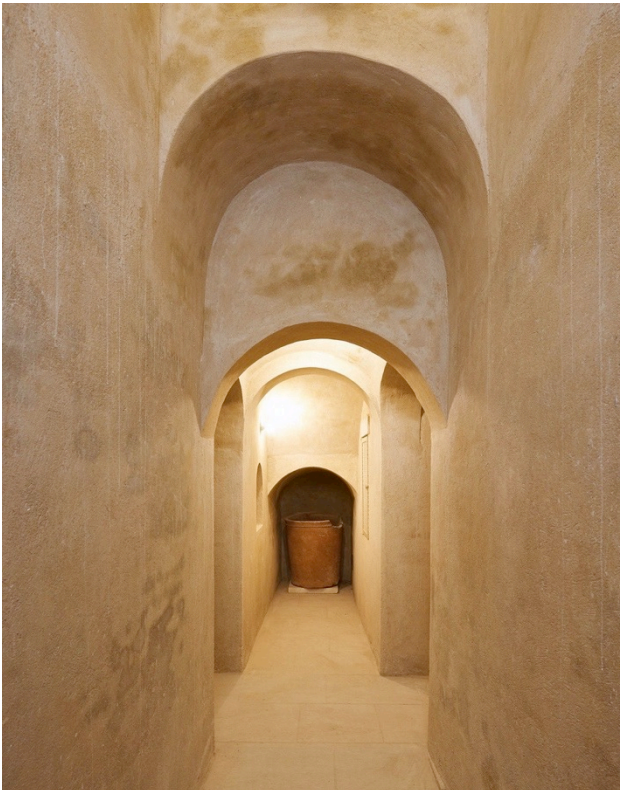
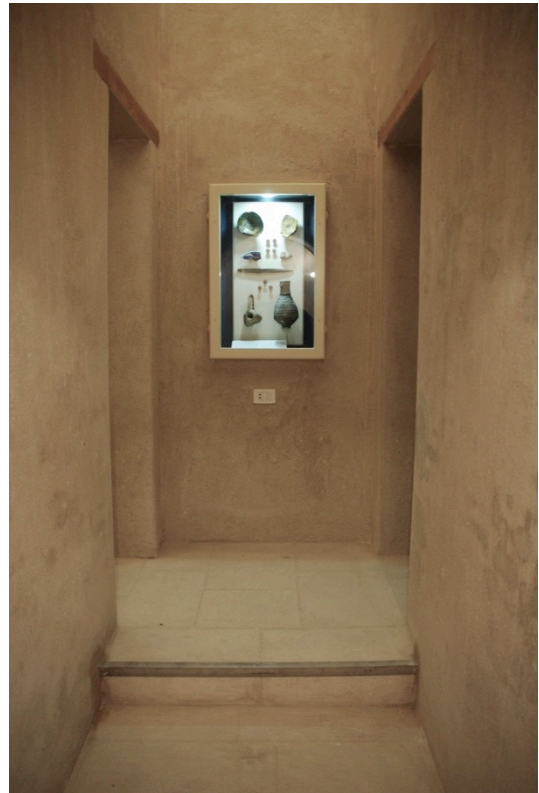
East-west passage after works looking to west (left, photo: M. Kacicnik) and to east (right) with stainless steel edging to limestone step

A stainless steel angle was added to the top of the step in front of the showcase to improve its visibility and thus reduce the risk of tripping. All the timber doors in the tower were given a coat of linseed oil and 'navda rumi'. Three timber doors at ground level, and two on the first floor, had new steel throw-bolts installed to an improved design, with a better closing detail.

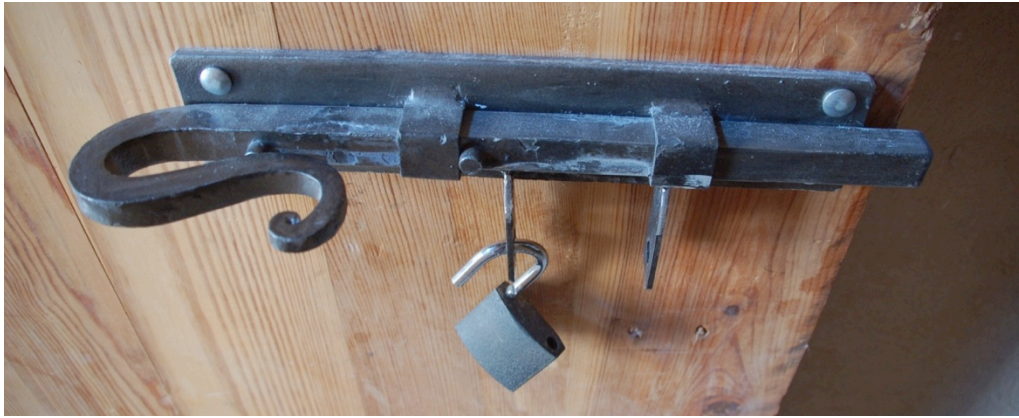
Example of new steel door bolt to improved design

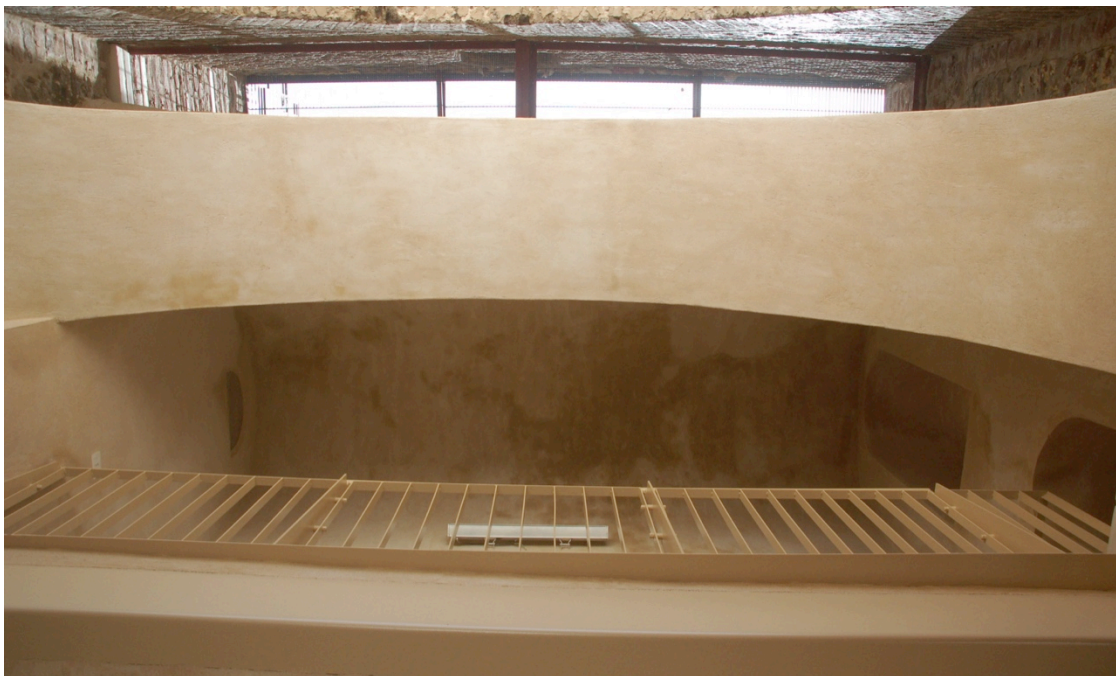
The entrance area had already been re-plastered (after the complete removal of cement and gypsum layers) in 2016 up to the height of the balcony. This plaster was retained, and the remainder of the space treated in accordance with the approved sample. A special note should be made of the large arch on the north side of the entrance area that was built by the Comité in 1909-1912 using a hollow terracotta type of brick. This material is extremely brittle, so it was decided not to hack off the cement render that covered it in order to avoid unnecessary damage to the structure itself. Only the outer gypsum layer was carefully removed by hand prior to re-plastering, and cracks were packed with potsherds in lime mortar as required.

View of arch and balcony above entrance area looking up after treatment

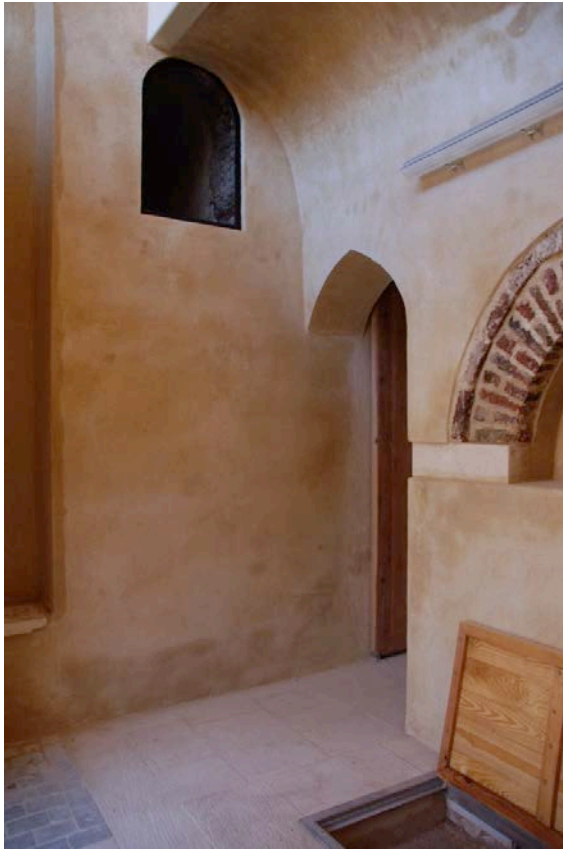
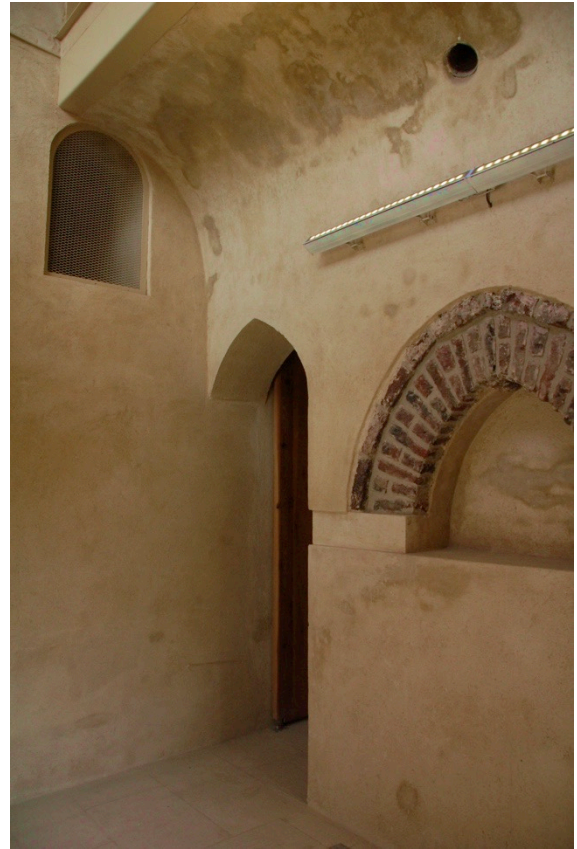
General view of entrance area looking east before (left) and after (right) treatment
