ARCHITECTURAL CONSERVATION RED MONASTERY SPRING 2017

THE TOWER

TECHNICAL REPORT

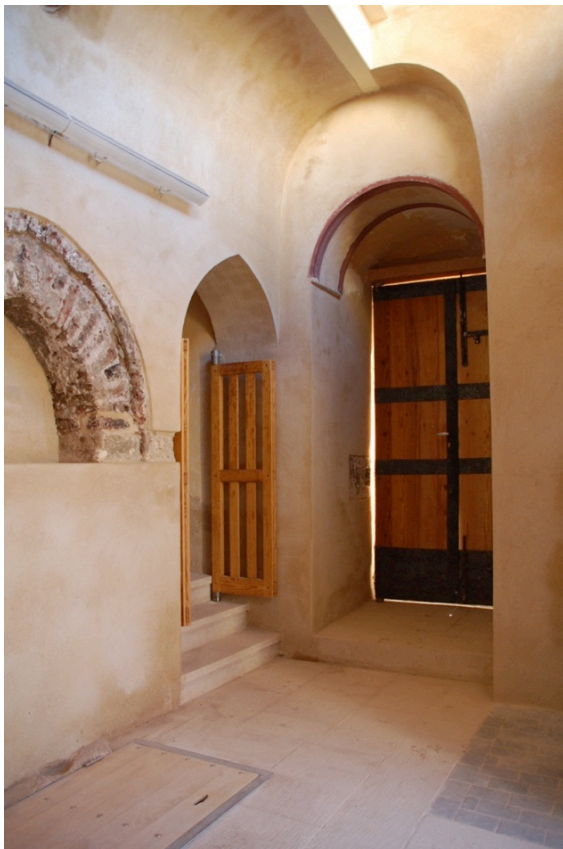
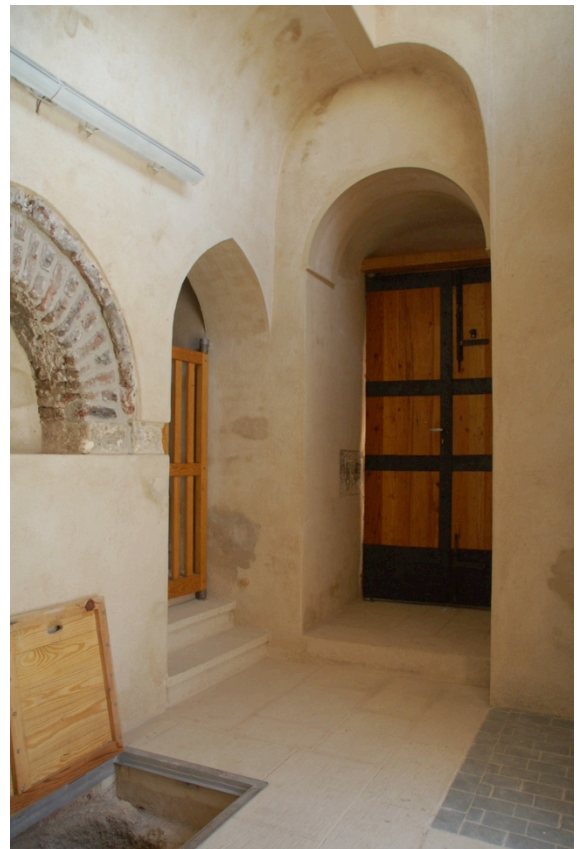
General view of entrance area looking west before (left) and after (right) treatment

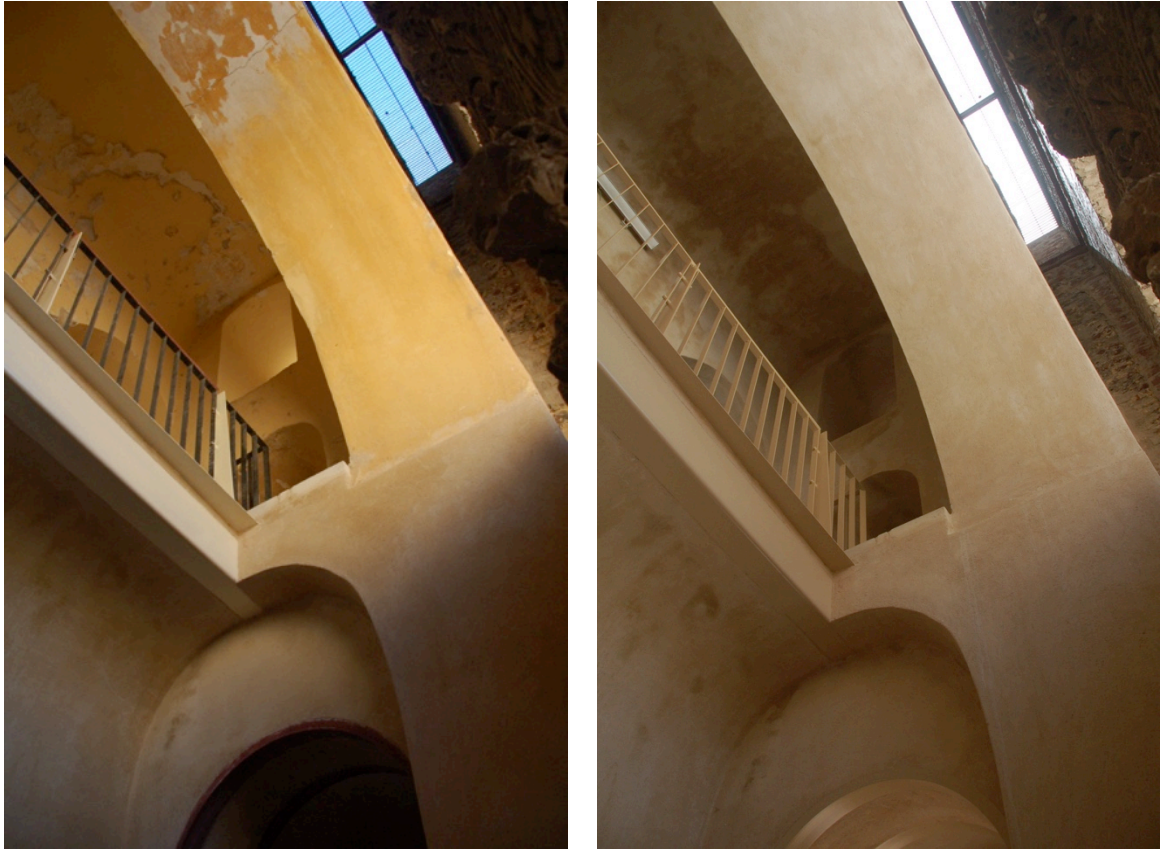
View of entrance area balcony and arch before (left) and after (right) treatment

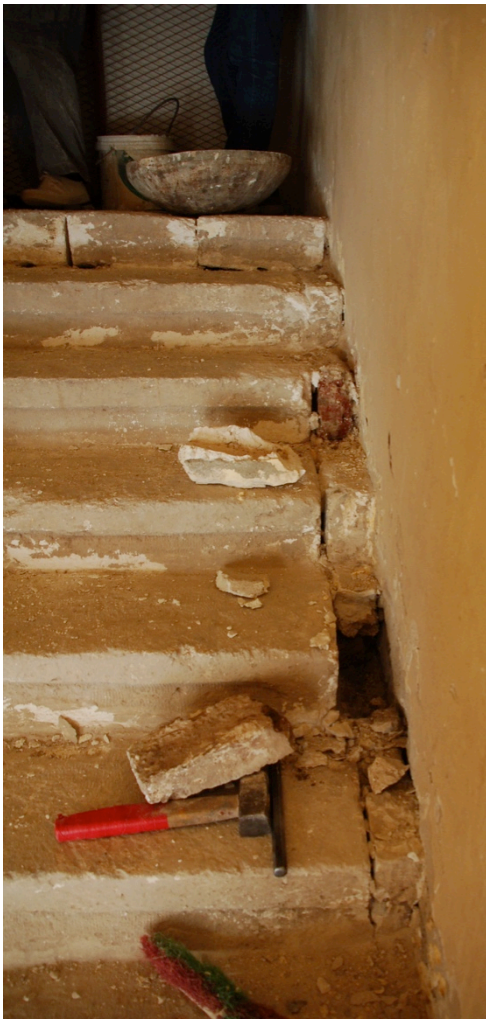
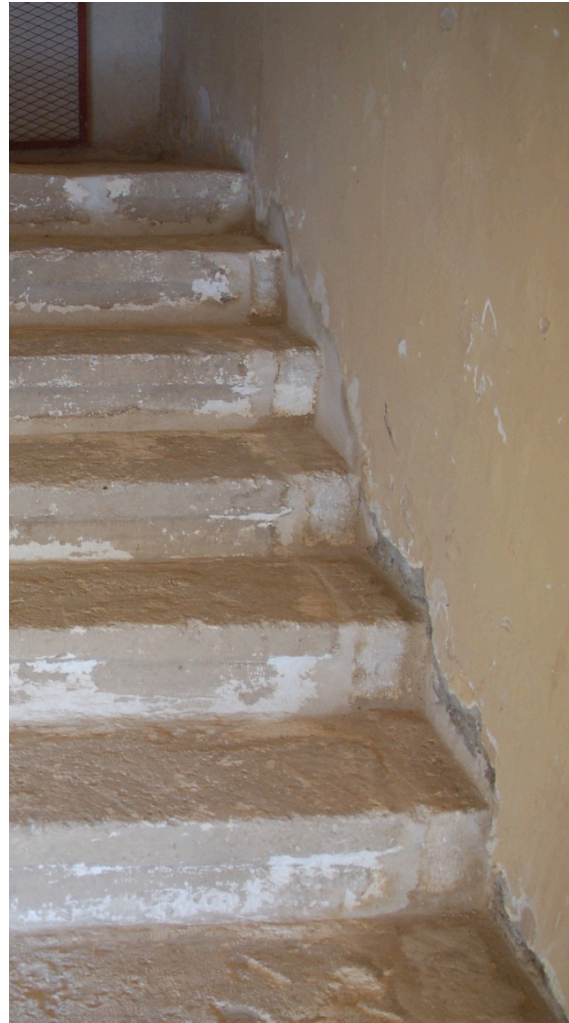
The first flight of the staircase was replaced with new limestone treads during the conservation works of 2016. This season, the remainder of the stone treads of the staircase, dating to the 1980s, were cleaned of encrustations of cement and gypsum and repointed using a lime mortar. One flight of the staircase had been filled in to either side with fired bricks set in gypsum. These were removed and solid limestone fills were substituted.

Modern limestone treads of staircase during (left) and after (right) repairs

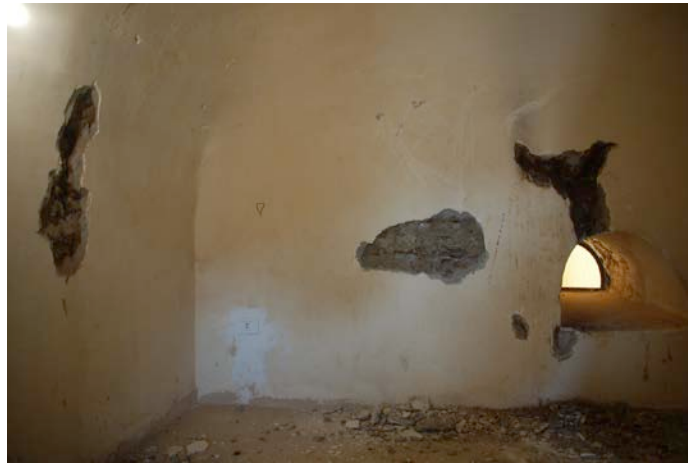
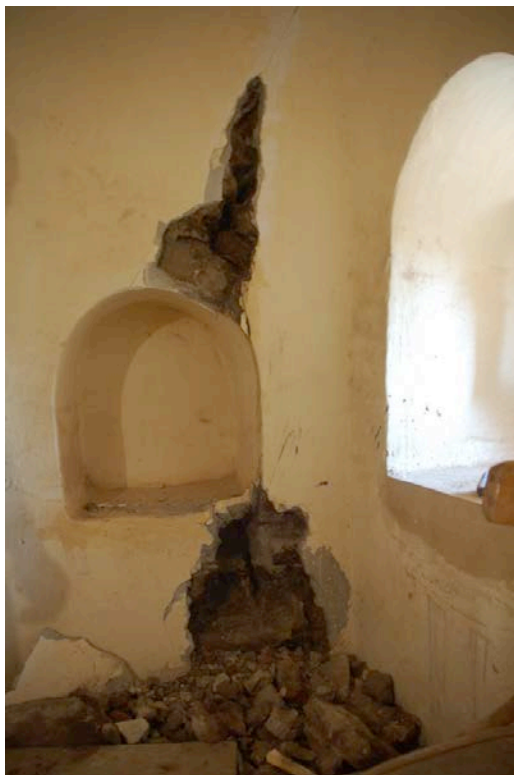
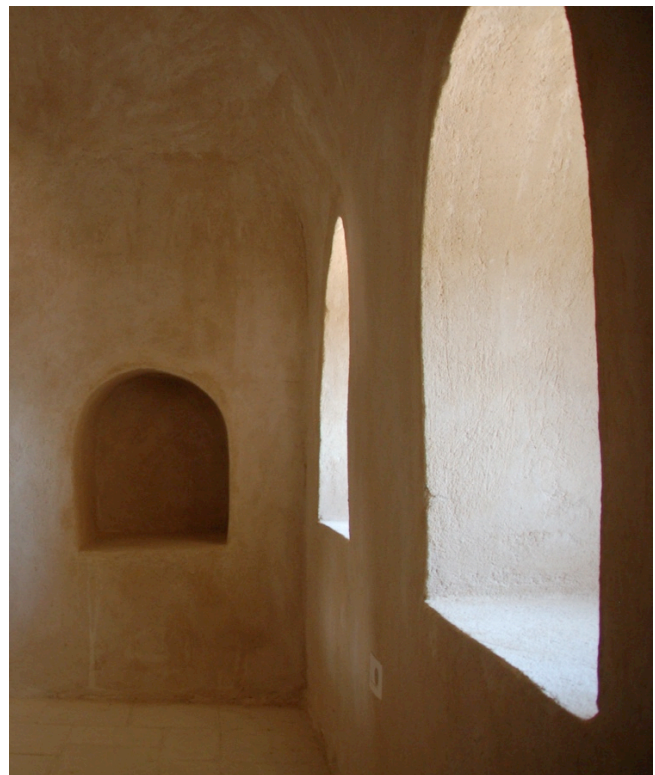
In the southwest room, cement and gypsum plaster layers were removed from the walls and the exposed brickwork re-plastered with the same lime plaster used on the ground floor. Owing to the strength of the cement render applied, however, it was not removed from all locations to avoid extreme damage to the underlying brick masonry. This was the case in the two domed spaces and vaulted passage on the southeast side of the tower that are constructed from bricks that are set in a silt mortar. The removal of the cement render would have caused serious damage to the fragile original construction, so only the gypsum layer was carefully removed by hand and the surfaces re-plastered with the same lime plaster used elsewhere in the tower. Prior to plastering, all major defects and cracks in the underlying brickwork were consolidated with new brickwork set in lime mortar.

Repairs to cracks in northeast domed room during works (left) and the same area after re-plastering (right)

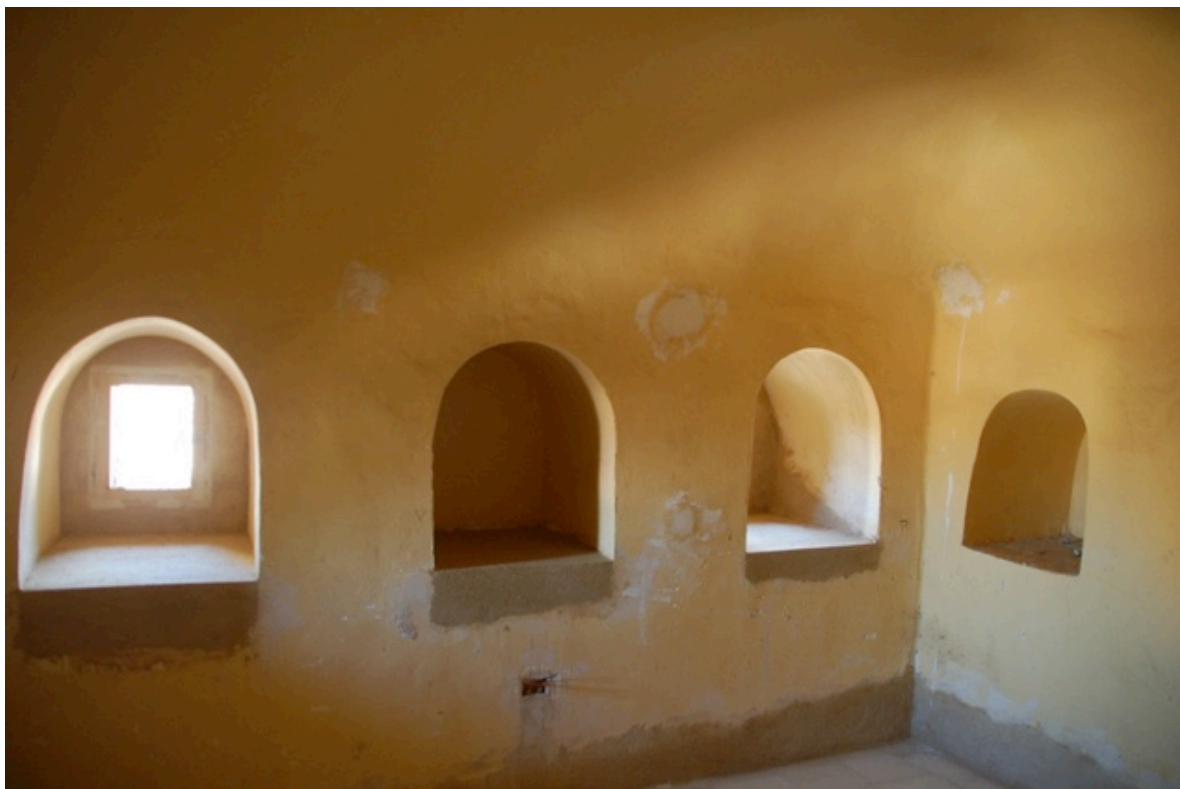
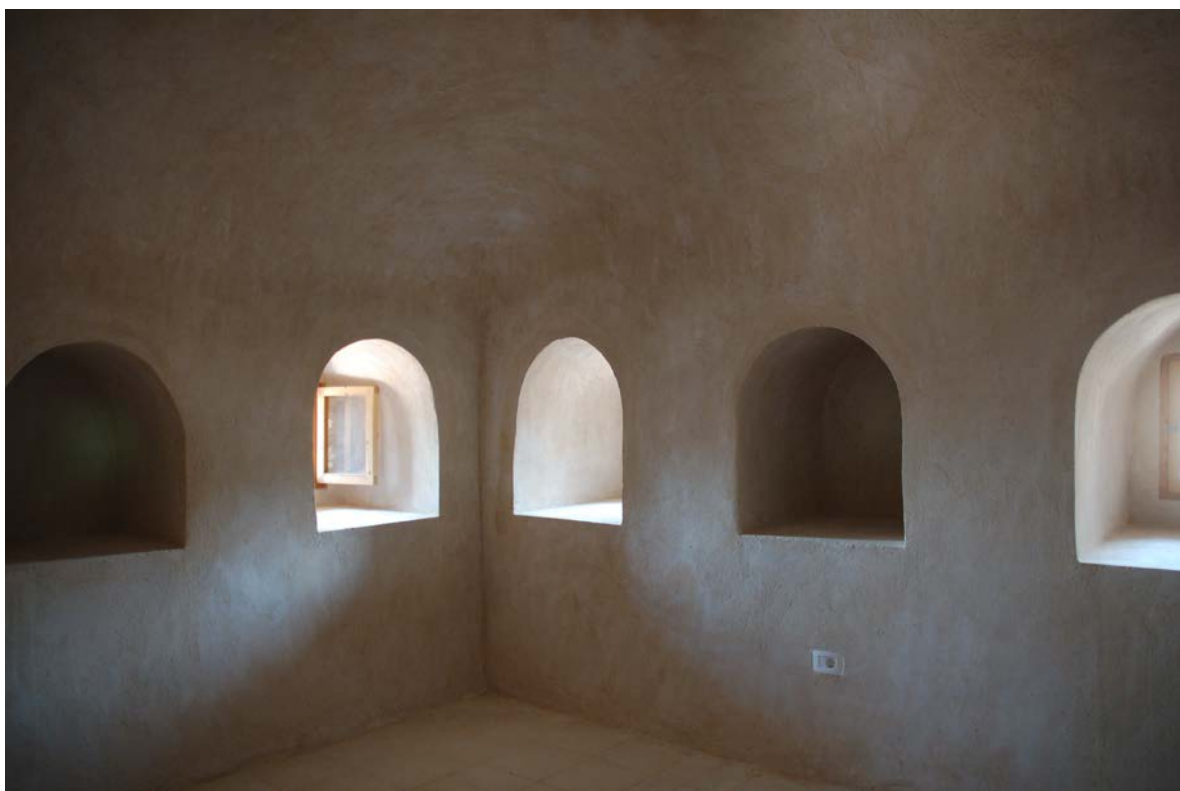
Windows and niches in southeast room before (top) and after (bottom) re-plastering

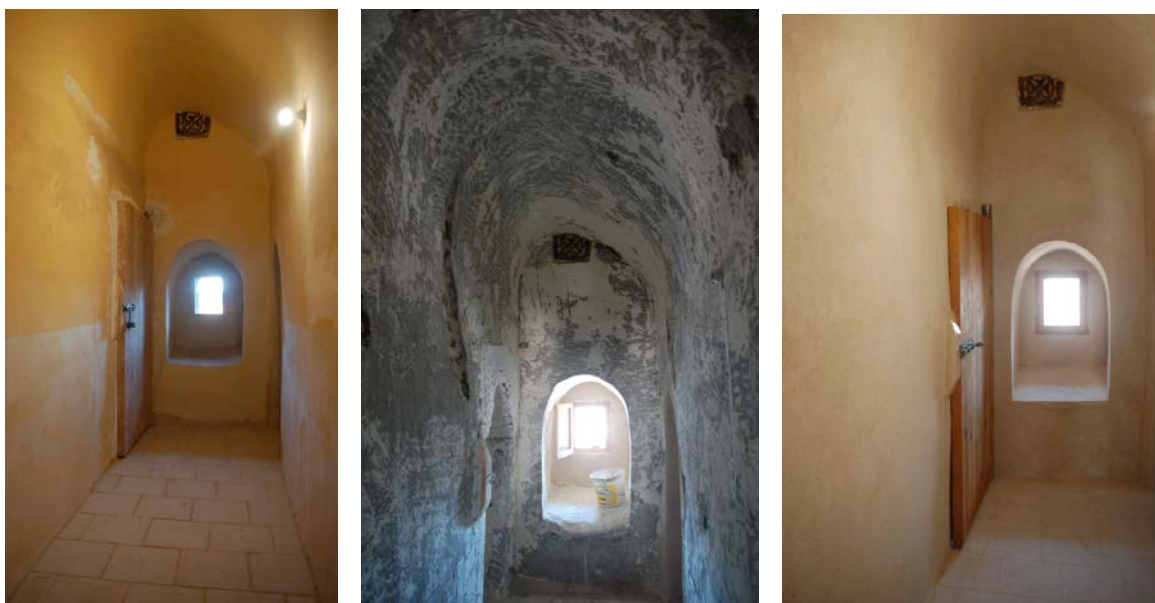
Views of first floor corridor looking east before works (left), after removal of gypsum plaster layer (center, and upon completion of re-plastering (right)

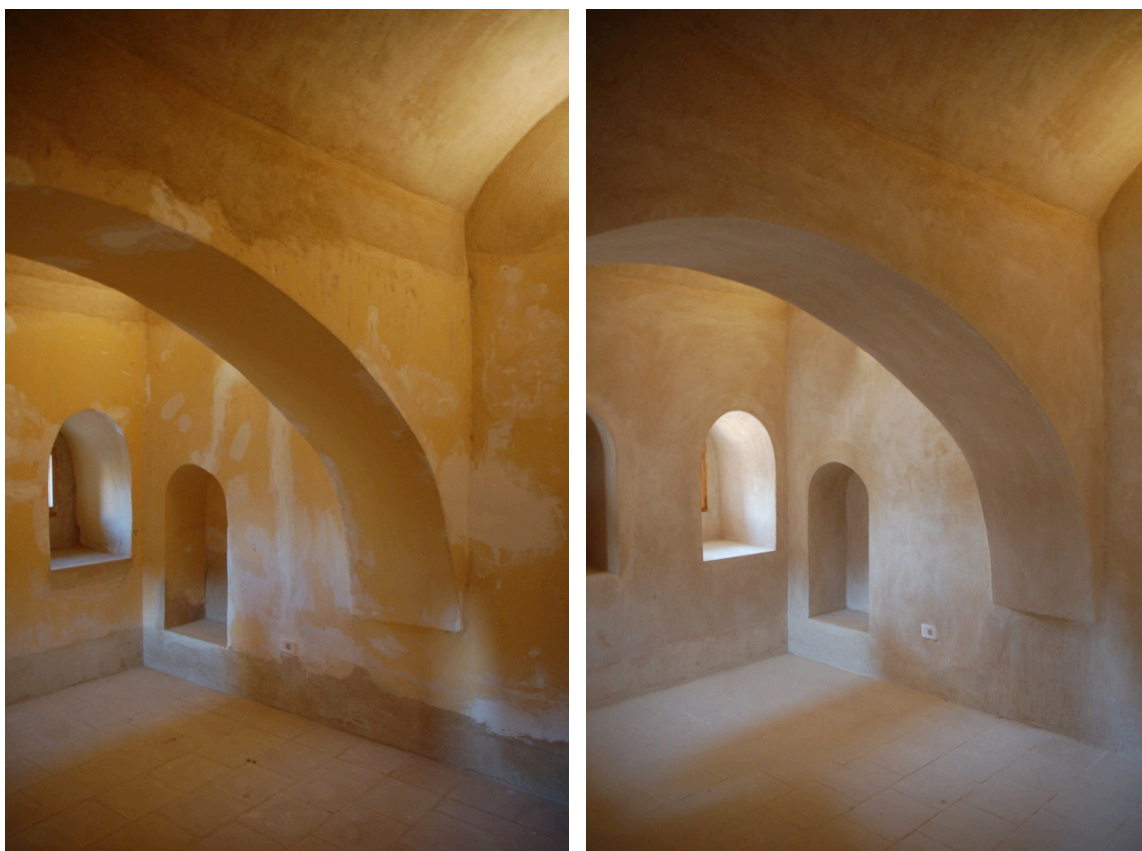
General view of southwest room before (left) and after (right) works
