SPECIALIST REPORT

“Red Monastery Architectural Conservation Project”

Cultural Heritage Tourism Project (APS)

October 2013 – June 2014

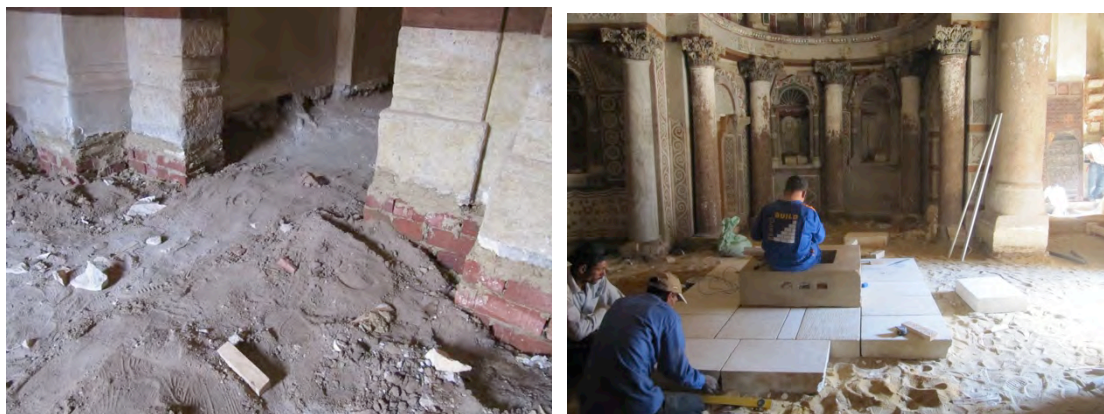
Prior to the commencement of the flooring, the bases of walls and some columns in the sanctuary were consolidated in eroded areas with new brickwork set in lime mortar. The location for the new altar in the center of the sanctuary was also established with a new brick base: the altar will be completed at the end of the project. The base of the altar also serves as a major electrical junction box.

Consolidation of bases of wall with new brickwork in lime mortar (left) and construction of base of new altar in sanctuary (right).

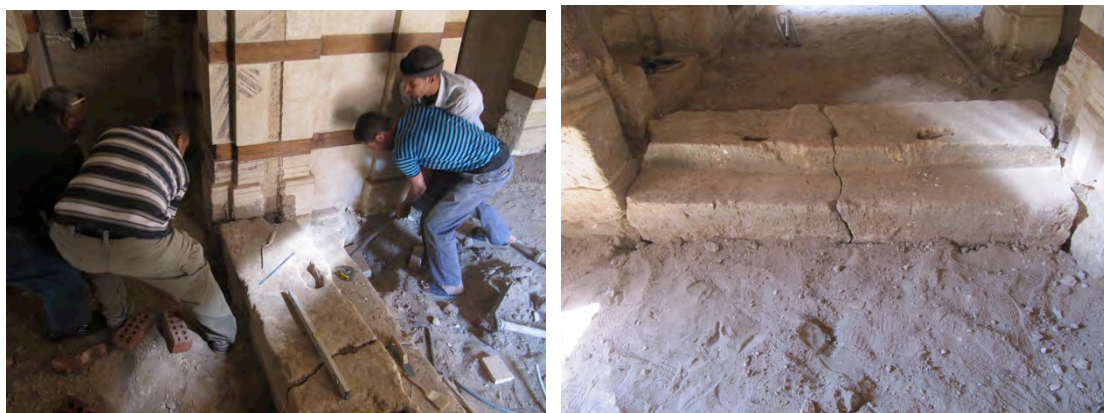
In order for this level of the new floor to be consistent, it was necessary to raise the cracked limestone block on the south side of the projecting platform by 5 centimetres. This block is now level and does not pose a trip hazard for visitors. Cracks and postholes in the platform steps were filled using lime mortar and fine gravel, after documentation. The limestone step in front of the north side chamber was completed with a single new dressed limestone block, while the step on the south side was completed entirely in new dressed limestone blocks following the original alignment. This alignment returns along the south wall of the khurus.

Lifting east side of broken stylobate block 5cm to achieve level condition (at right)

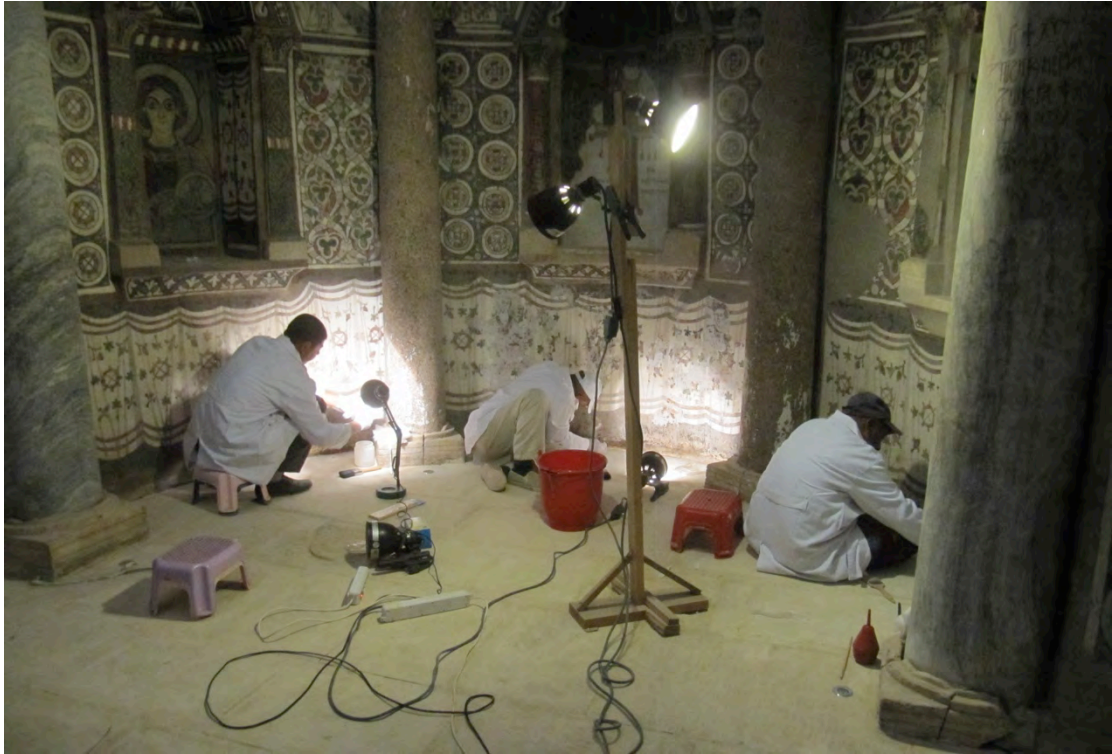
The fine conservation team consolidated all gaps at the bottoms of the walls using a fine lime mortar. All cracks in the column bases in the sanctuary were also consolidated, as well as losses around doorframes. All grooves cut for the new electrical installation were also filled. Areas of new fill and replacement were treated with a surface coloring to match original adjacent finishes or earlier repairs as appropriate.

Fine conservation team filling losses at the base of the triconch walls

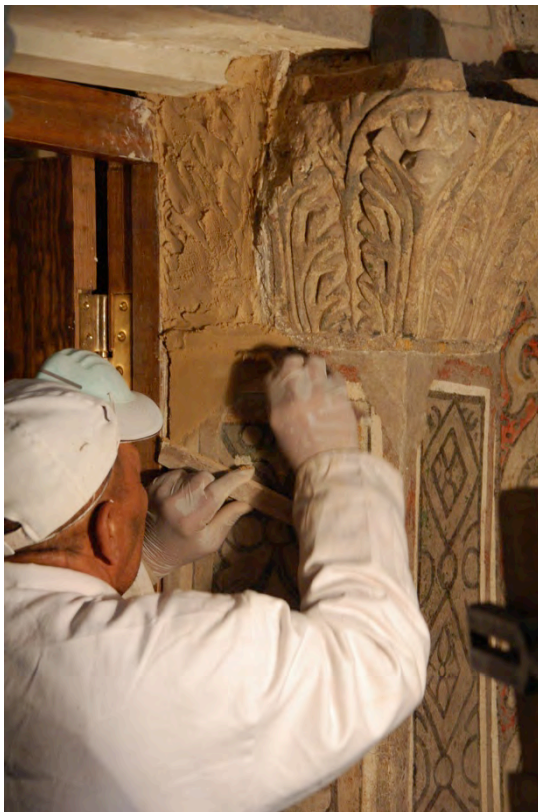
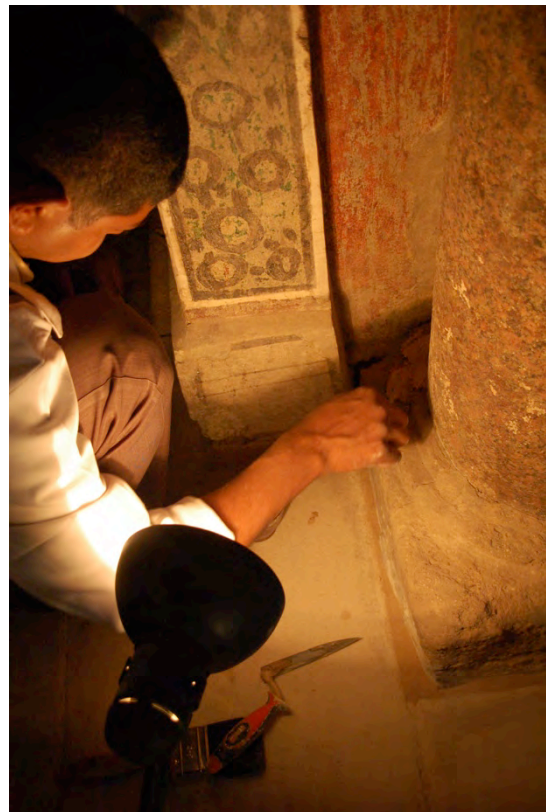
Fine conservation team filling losses around doorways and column bases

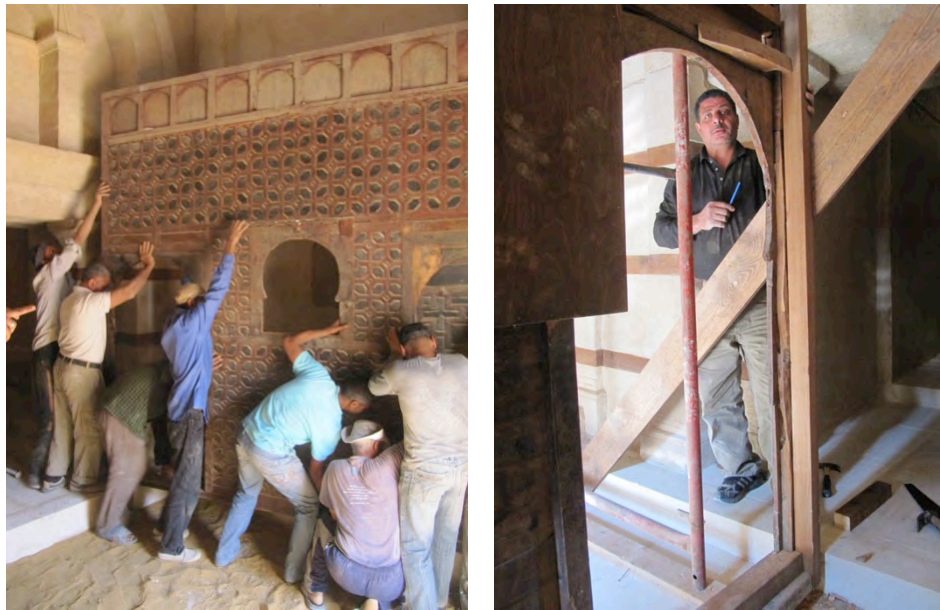
The Heikal screen was moved to a position on the south wall of the khurus. It was then repaired with a new secondary subframe and fixed to the wall prior to cleaning. The gap between the top of the screen and the south wall of the khurus was filled with an overlapping timber roof. The central window of the screen has a built in cupboard to prevent rubbish from being thrown behind the screen. This cupboard can also serve as a receptacle for the written prayers that are frequently left by visitors to the church.

Moving the screen to its new position against the south wall of the khurus (left), and detail of new secondary frame on inside of screen (right).

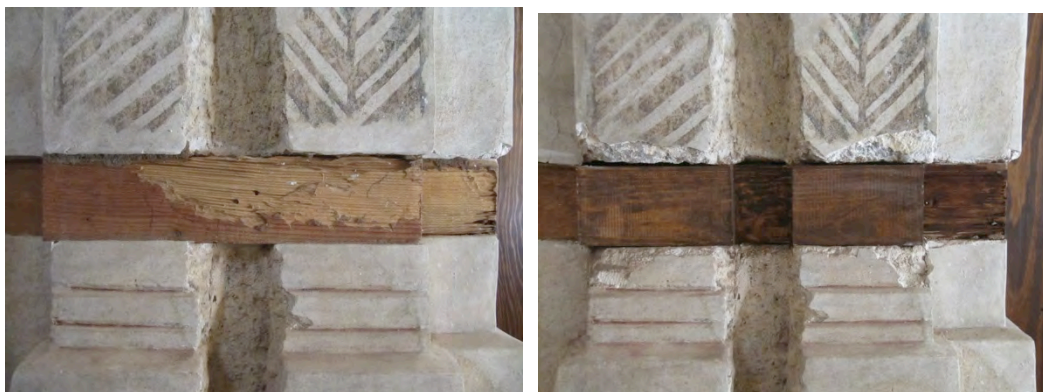
8.1 On the lower north side of the sanctuary façade, a section of timber banding which had been partially eaten by termites was replaced. This proved that the termite damage was superficial and did not extend to the inside of the wood. The new wood (azizi seasoned pitch pine) was treated with ‘Woodserve’ although there was no evidence of current termite activity. It was then stained to match surrounding wooden elements.

Detail of termite damaged wooden banding (left) and replacement timber (right).

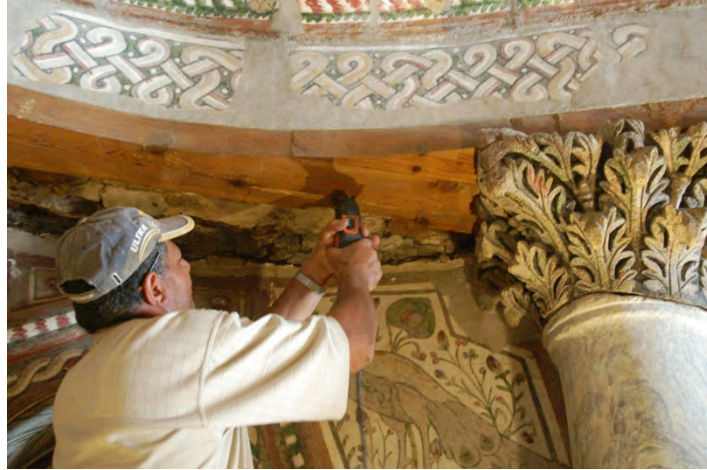
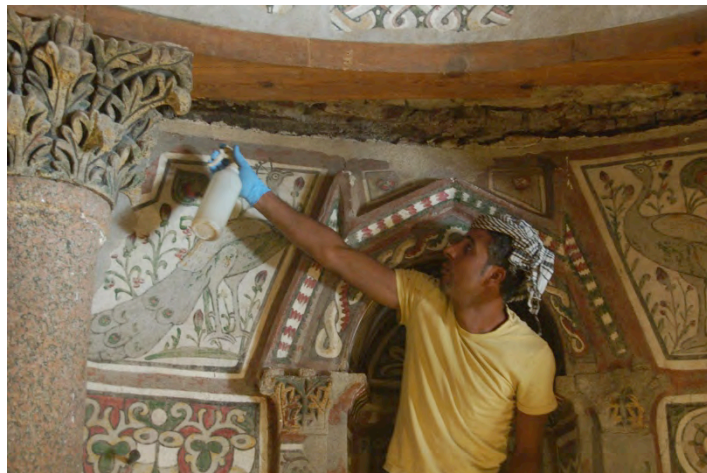
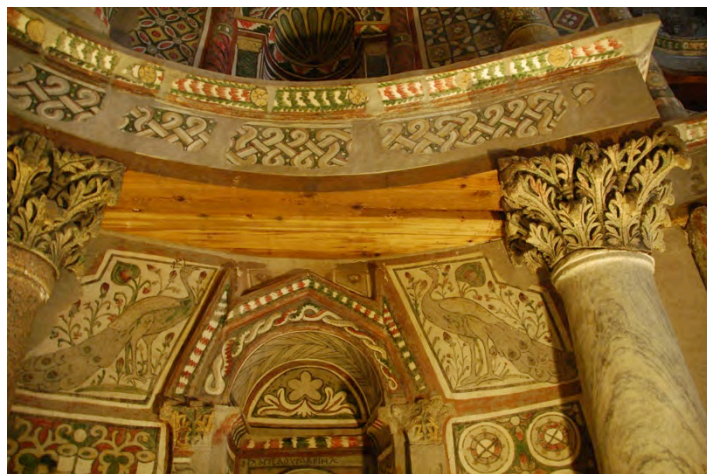
8.2 In the east lobe lower cornice, low level termite activity was detected, but there was evidence that quite a large area of woodwork had been attacked. The affected areas were cut out and replaced with sections of seasoned and treated pitch pine (*azizi*) after thorough cleaning of internal areas and spraying with 'Woodserve' preservative.

Sequence of treatment of termite damaged timber in east lobe of triconch

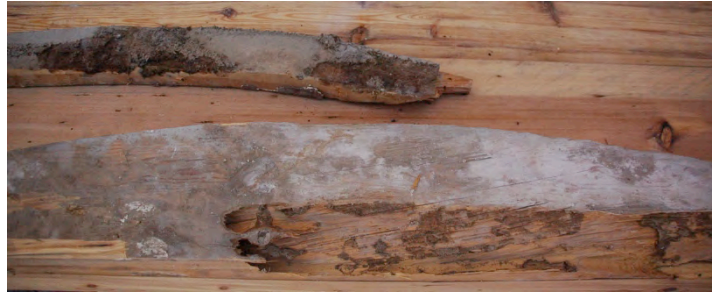
Sections of termite damaged lintels removed from the east lobe.

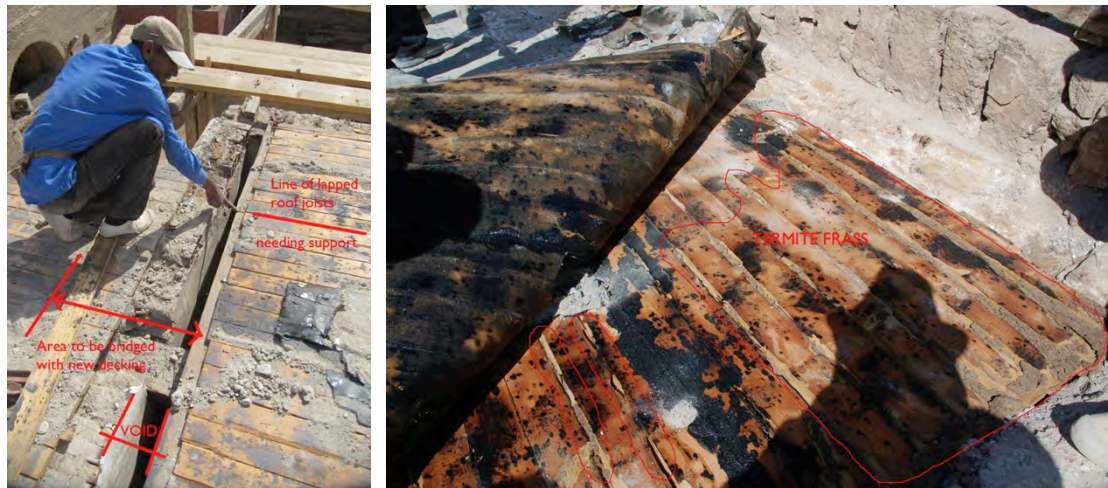
- 1 The timber decking, dating to 1995, was not continuous between the roof over the central part of the khurus and the overhangs to either side. There was a gap of 20cm between these two sections of roof that was only bridged by the existing bitumen sheet.
- 2 The roof beams above the platform over the trilobe portal were not continuous but had lapped joints, forming an extremely weak connection liable to failure [Drawing 1 and 2].
- 3 There was a severe infestation of termites in the lower roofs affecting the timber boarding.
- 4 Additionally, it was noted that holes made to allow rainwater to drain off lower sections of the roof were not fitted with rainwater spouts.

Condition of high level roof above khurus looking west before works [left] and condition of low level north roof showing partial extent of termite activity [right]

- 1 The gap in the decking of the upper roof was bridged with new timber decking.
- 2 The roof beams of the upper roof were strengthened with steel clips
- 3 The timber decking of the lower roofs was replaced with new 1" decking, treated with chemicals against insects and painted with red oxide to match the surface finish of the existing roof.

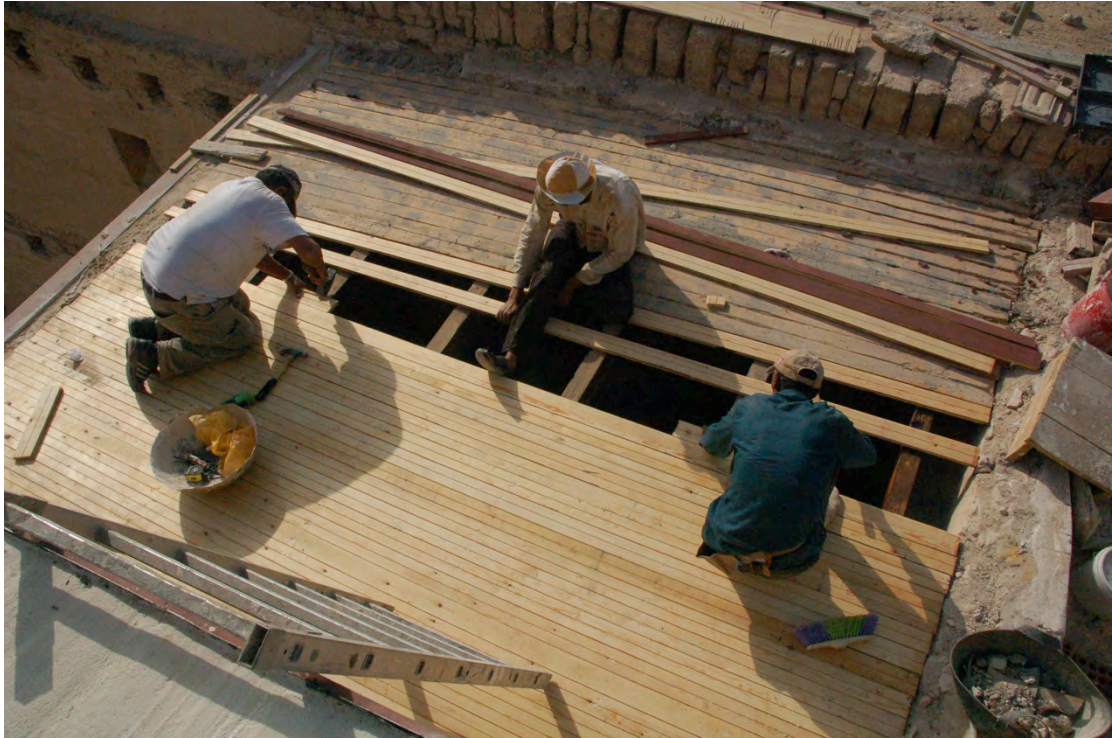
Replacement of termite damaged roof decking with new treated timber

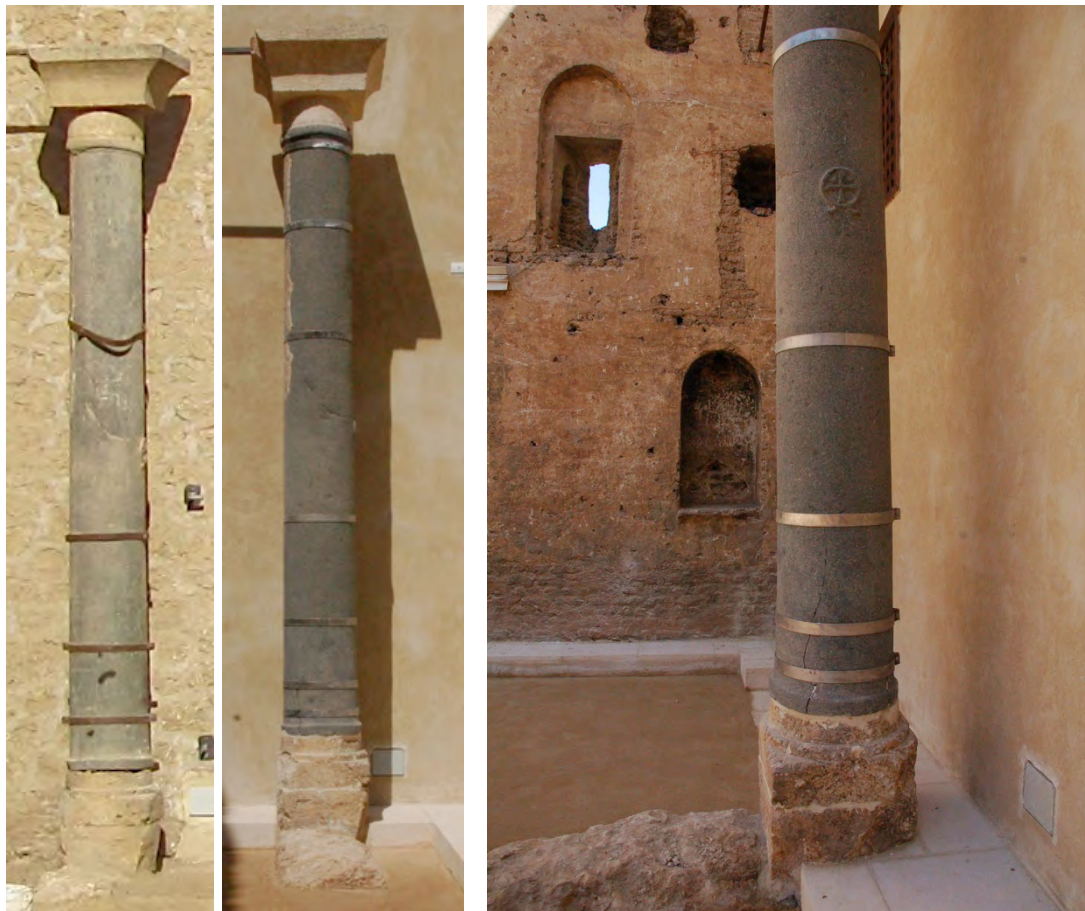
10.1 The existing grey granite column shaft, with its limestone capital dating to 1909, standing on the north side of the nave was cleaned. The existing rusted metal bands were replaced with seven new stainless steel bands to stop the column from fragmenting due to vertical cracks. It was discovered that the limestone base of the column had no adequate foundation, and so it was stabilized by setting new 18cm thick limestone blocks around its edges. The open joint between the column base and the adjoining stylobate block was filled with lime mortar. *Note: the column is not vertical, and there are no pins connecting base to the shaft or the shaft to the capital, so any possible movement should be visually monitored.*

The grey granite column before and after conservation [left and center] and detail of new stainless steel banding around fragmented shaft.

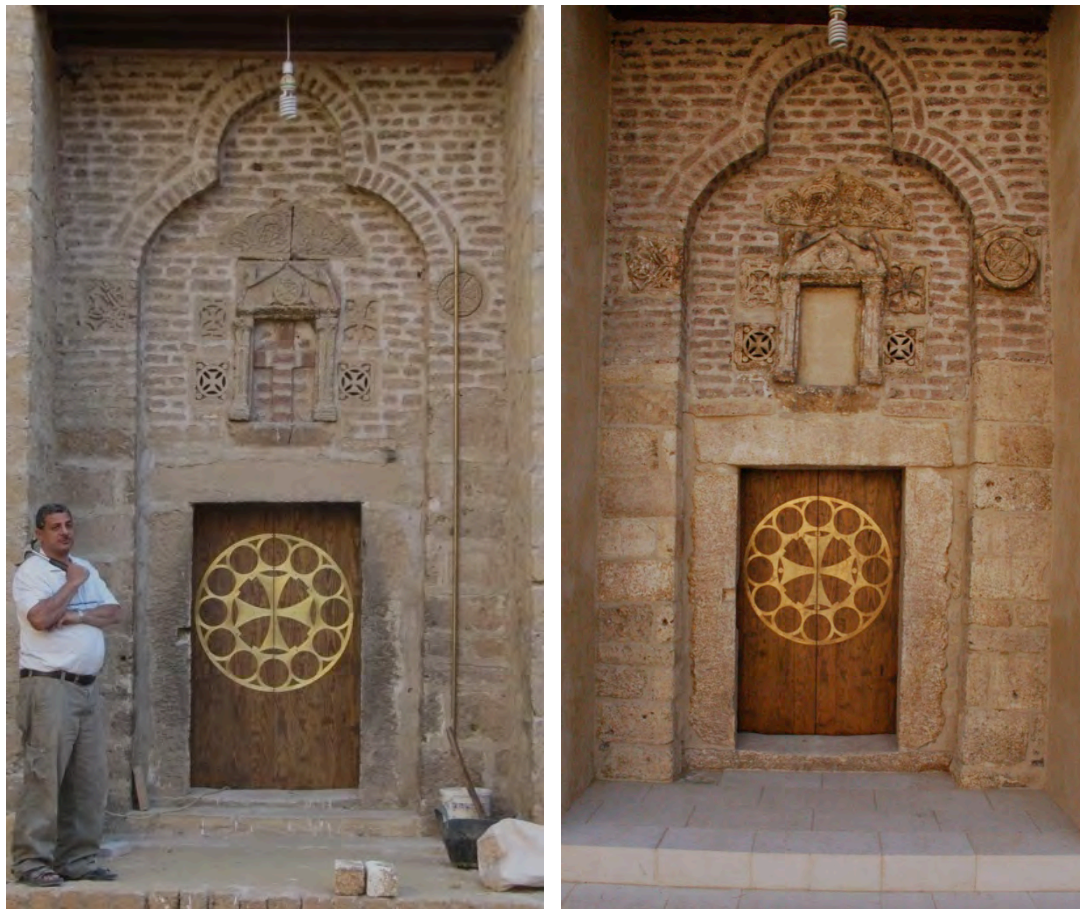
10.3 The existing trilobe portal at the center of the façade was conserved. All cement was removed from joints, revealing that the original masonry was laid in a silt mortar. The lower undecorated blocks were cleaned and repointed using a lime mortar. The carved blocks in the upper section of the portal were cleaned through the application of poultices with dilute ammonia, and all joints repointed with lime mortar.

Trilobe portal before and after cleaning

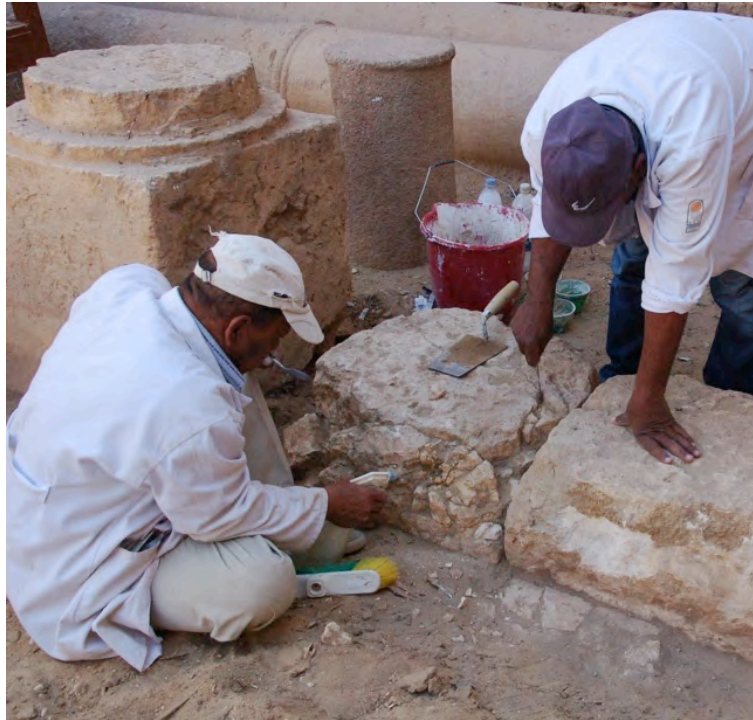
10.4 At the west end of the nave, badly damaged existing limestone stylobate blocks were consolidated with lime mortar and new infill masonry as required.

Consolidation of stylobate blocks at west end of church in progress.

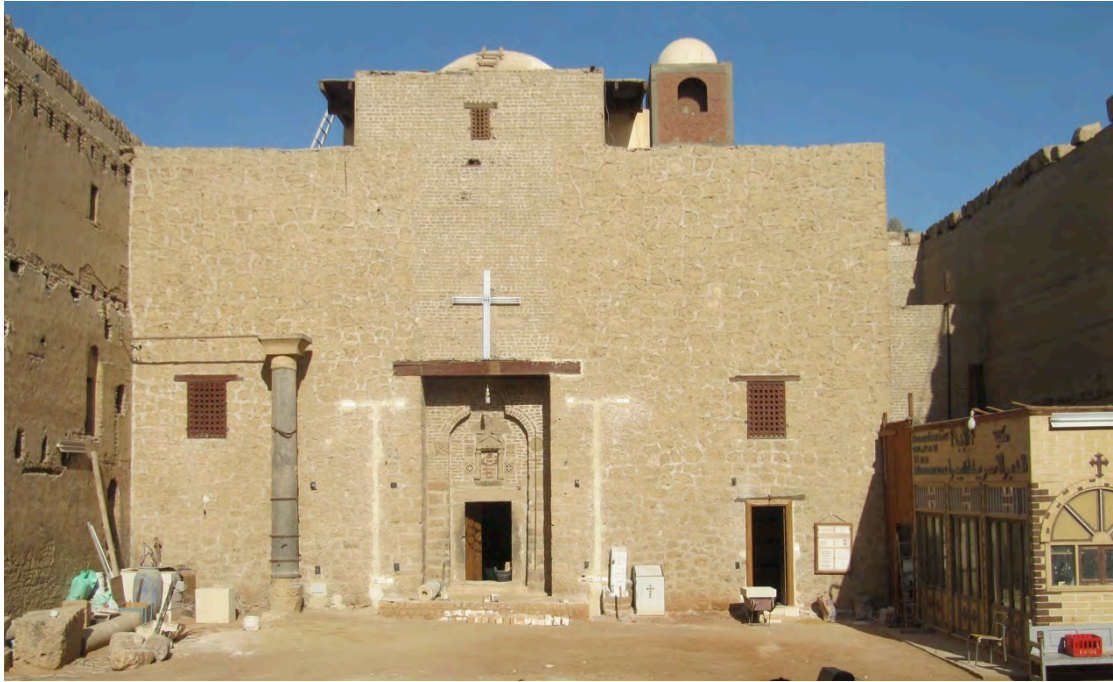
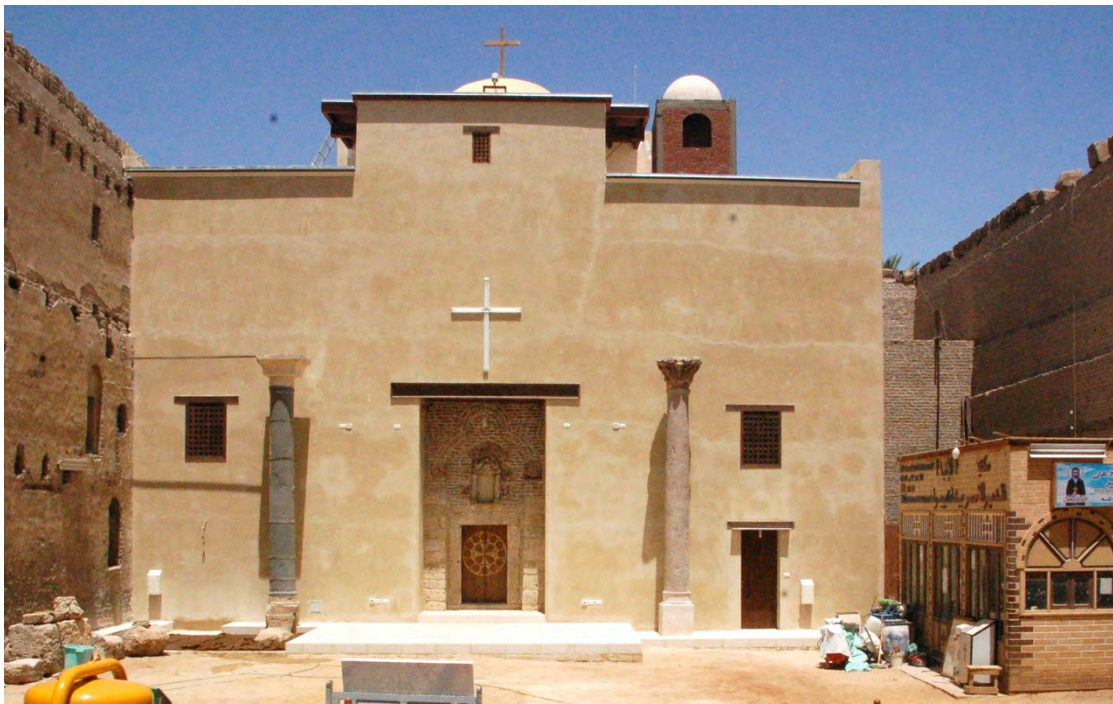
11.1 Exterior: The stone rubble exterior of the Comité 1912 wall was plastered with a new lime render through its full height. The timber lintels of all windows and doors were given new timber fascias. The two lower windows were also given new frames to act as plaster stops. The south door was recessed within the wall and a new projecting timber hood was provided to shade the door opening. Owing to the denial of Permanent Committee approval, it was not possible to make the opening for the north door during the period of work.

Comité façade wall before [top] and after [below] intervention

The surface of the Comité wall up to the height of the former gallery of the church, and the returns of the wall to the sanctuary façade were smoothed with a lime/plaster fill and painted with a neutral beige lime wash and 'Primal' coating to prevent surface powdering.
