ARCHITECTURAL CONSERVATION RED MONASTERY SPRING 2016

Part I: The Church

PRELIMINARY REPORT TO MINISTRY OF ANTIQUITIES

Dr. Nicholas Warner, April 28, 2016

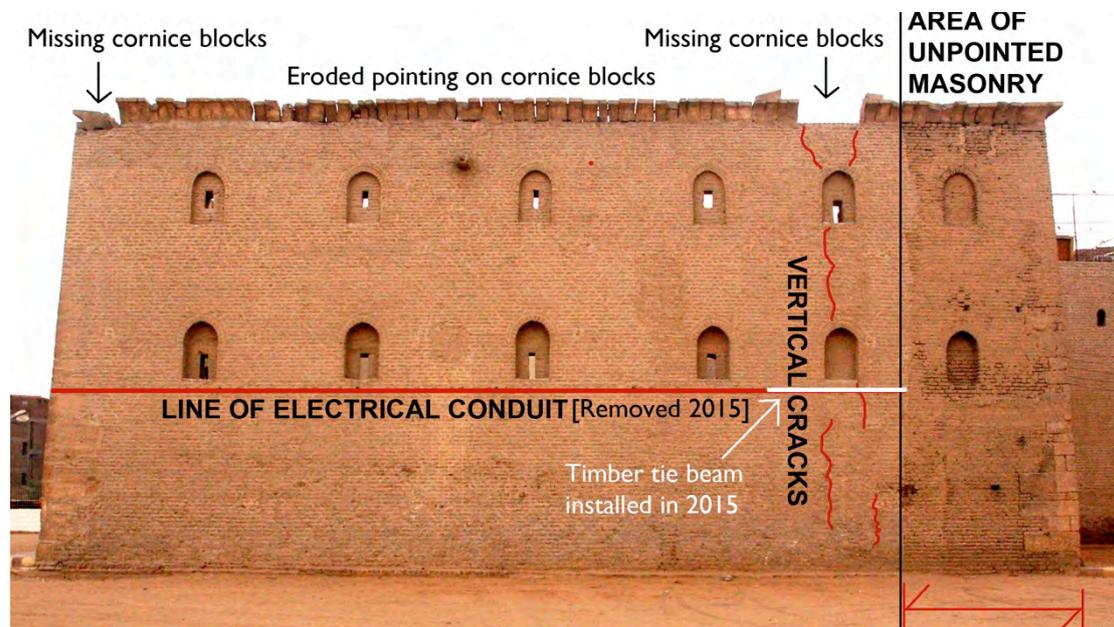
The northwest corner block of the cornice, together with adjacent blocks to the south, was missing. Two minor cracks, running almost the full height of the façade, were present on the south side of the façade. At high level, a brickwork repair had been carried out in the 1990s through the full depth of the wall with inadequate ties on the inner face. At this time, two cornice blocks were removed and laid on their sides above other corner blocks, with no attempt made to reposition them correctly. In 2015, a new treated timber tie beam was installed in the position of a horizontal channel cut for electricity cables at low level.

Fig.1.1 Diagnostic of west façade showing condition prior to intervention

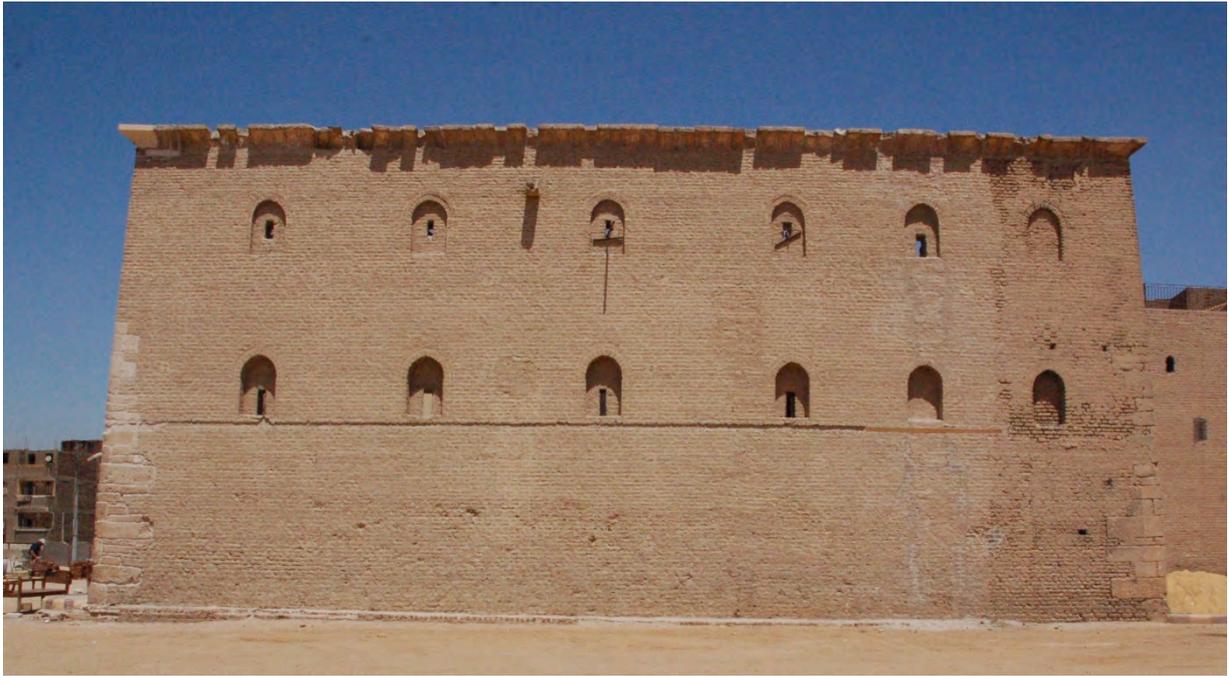
Fig.1.2 West façade after intervention

A new limestone corner cornice block, matching the profile of the original cornice, was installed on the northwest corner of the façade. This was partly supported on a new limestone base block, cut to match the dimensions of a missing original block. To the south of the corner block, two original cornice blocks were re-installed to complete the area of the missing cornice in this location. Five replacement blocks were also reinstated in the gap in the cornice on the south end of the façade. The entire length of the cornice was repointed with a lime mortar on its upper and outer surfaces [the inner face was repointed in 2015]. Above the line of the existing timber tie beam installed in 2015, the vertical cracks on the south end of the façade were stitched using 1mm thick x 90cm long helical stainless steel ties set 7cm within the masonry following horizontal mortar beds. These ties were bedded in a syringe-applied lime mortar bed that was then pointed. The vertical cracks in the façade were then raked out and repointed with a lime mortar.

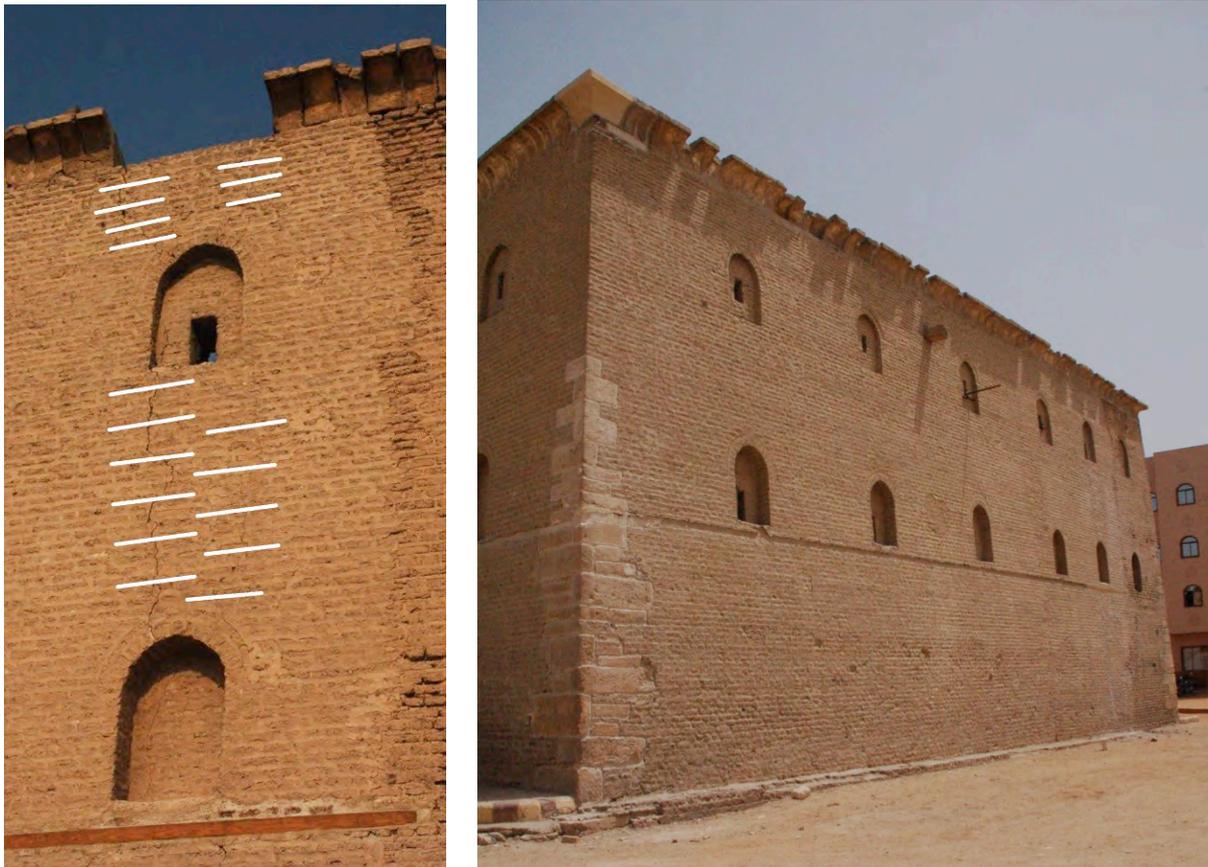
Fig.1.3 Detail of west façade showing indicative locations of stainless steel helical ties (left) and diagonal view from northwest after intervention (right)

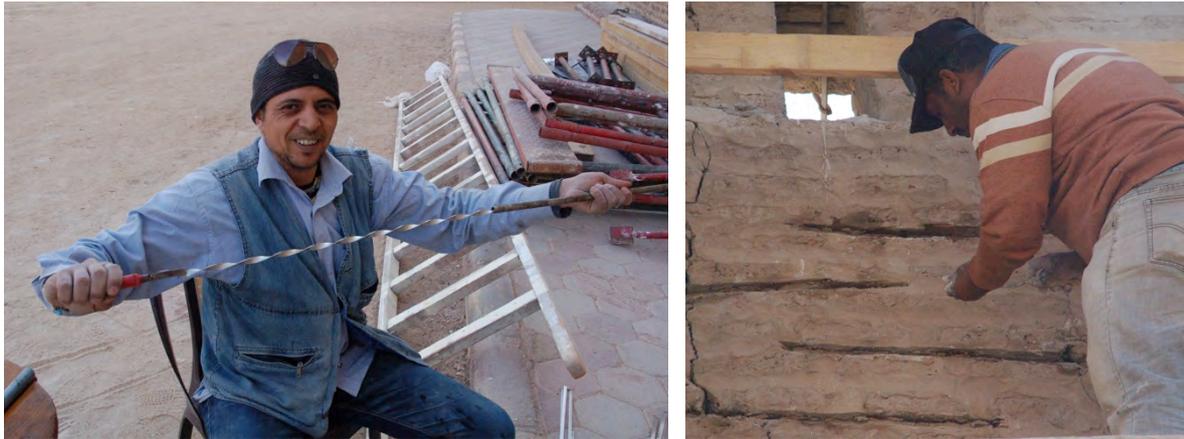
Fig. 1.4 A helical stainless steel tie being made (left) and ties being pointed in place on the west wall (right)

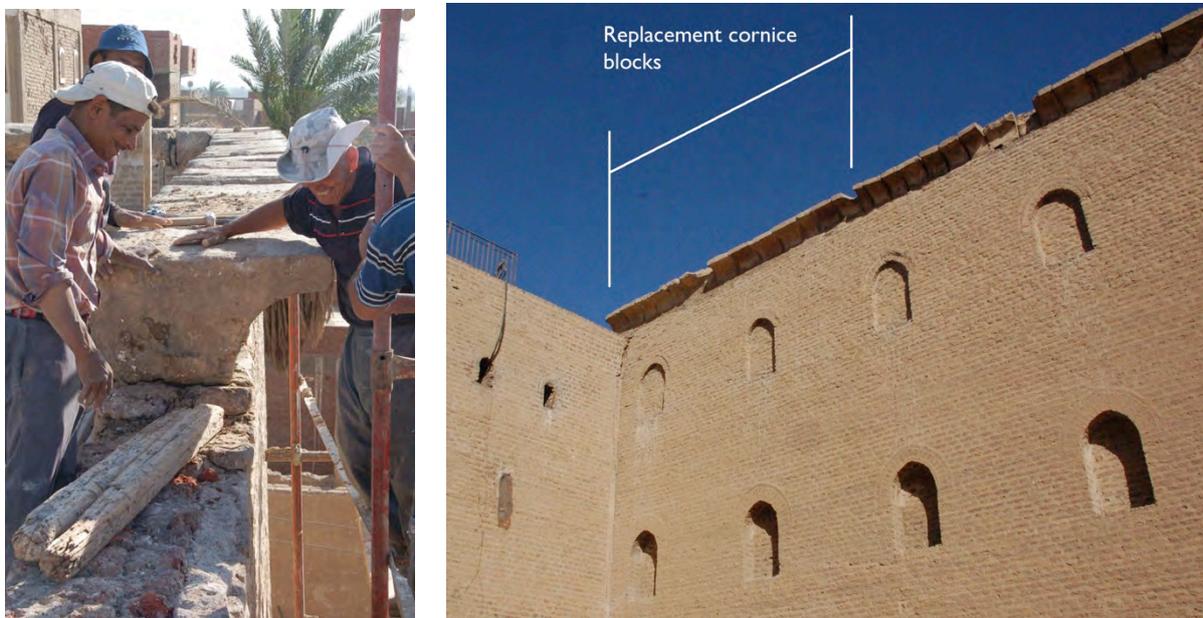
Existing condition: All existing cornice blocks on the south wall had defective pointing. Additionally, a crack was opening up at high level in the brick masonry immediately below the corner cornice block at the west end of the elevation. A number of electrical fittings were also still attached to the wall.

Fig. 1.5 Installation of replacement cornice blocks on south façade in progress (left) and completed line of replacement blocks (right)

Interventions: All existing cornice blocks were repointed using lime mortar, and a total of 12 original blocks were replaced on the east half of the wall. These were taken from the roof of the tower. The crack at the west end of the elevation was stitched with two stainless steel helical ties. All electrical fixtures were removed from the face of the wall.

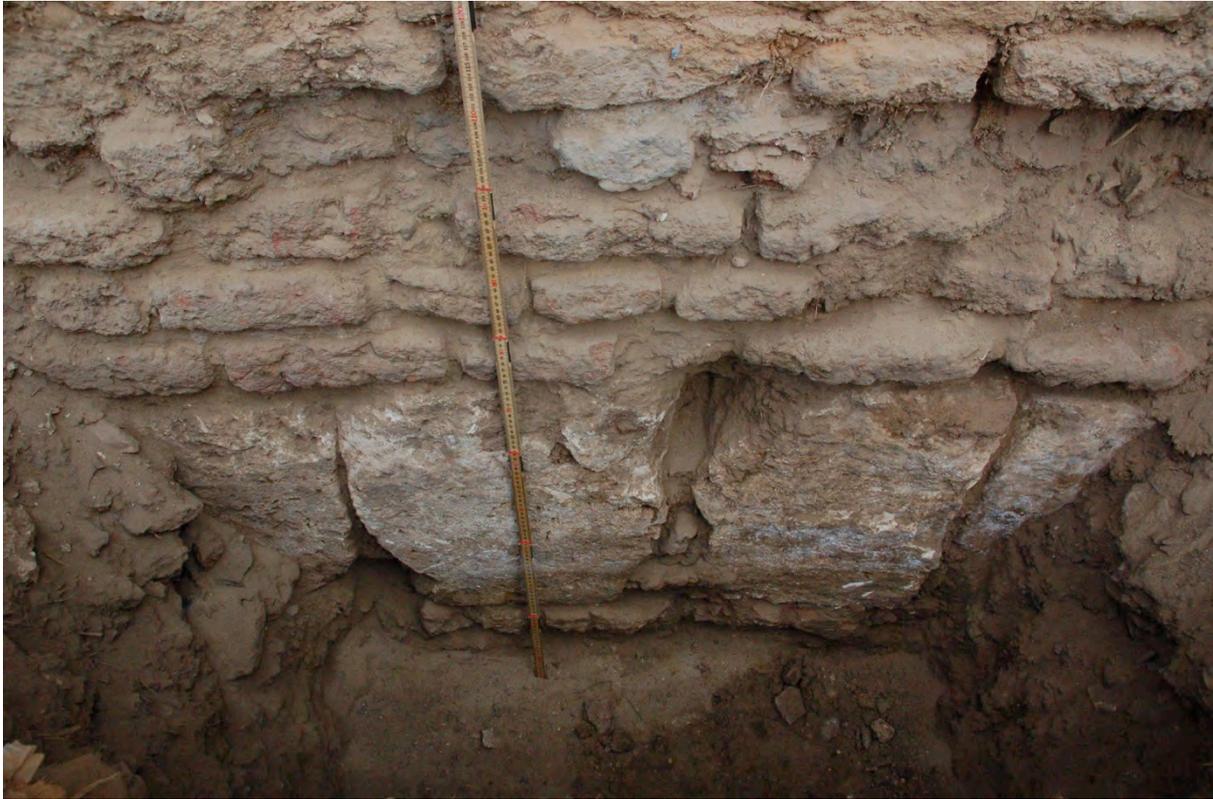
In addition to the conservation work on the south wall, a test trench was excavated at its base in the only area where it was possible to make an assessment of the character of the original foundations of the exterior walls of the church. This revealed that the foundation of the

building is on clean sand at a depth of one metre below present grade, and is formed of one or two courses of fired brick followed by one course of limestone blocks 50 cm in height. There is no evidence of a stepped foundation of any kind, and all construction is carried out using a lime mortar. The material removed from the trench was composed of an organically rich soil with remnants of demolished mud brick buildings that had been built against the walls of the church at some period.

Fig. 1.6 Test trench showing foundation of perimeter wall on south face

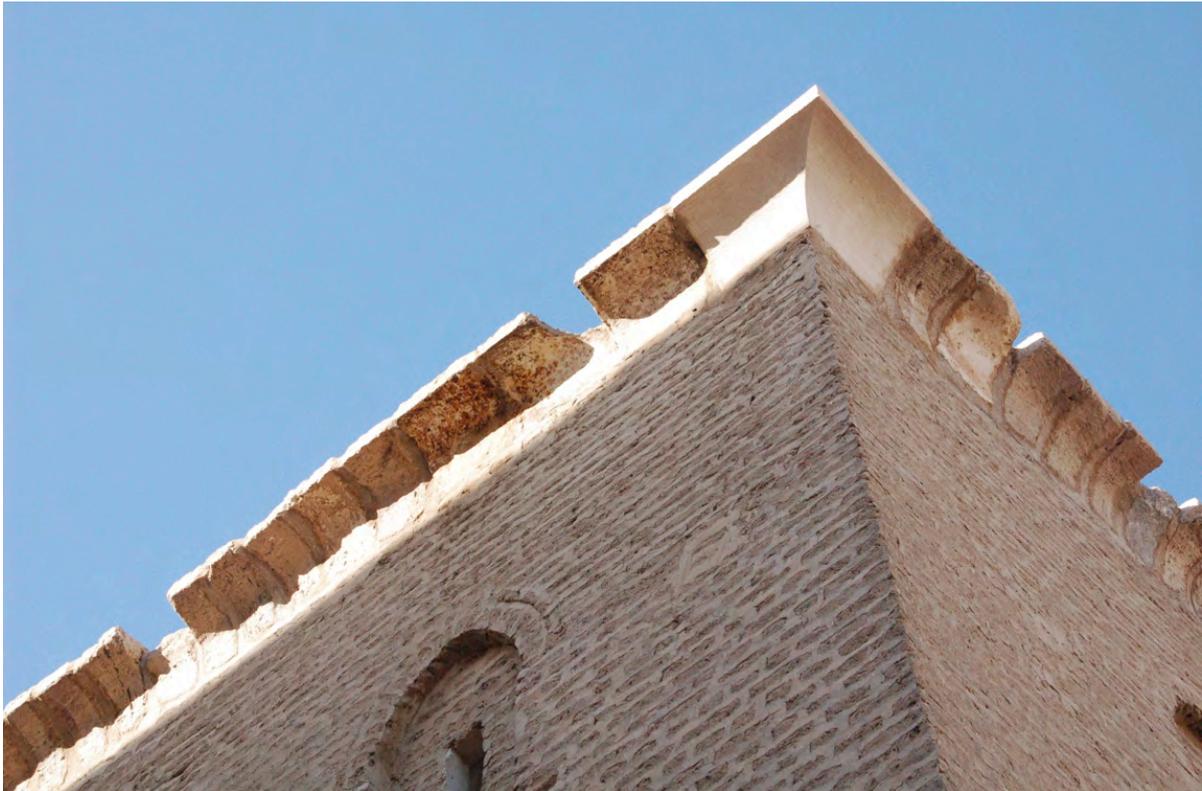
Existing condition: Cornice blocks were missing at high level at the eastern end of the north façade, and an arched door on the west side had been crudely blocked at an unknown point prior to 1856 which is the earliest date of the archival imagery for this façade. At high level, the blocking had fallen away, revealing a vertical ceramic pipe emplacement within the wall, centered slightly to the east of the axis of the doorway.

Fig. 1.7 The northeast corner of the perimeter wall showing new corner cornice block and replacement blocks on the north and east façades

1.3.1 Cornice: Five original cornice block replacements were made at the eastern end of the façade, as well as a new limestone corner block.

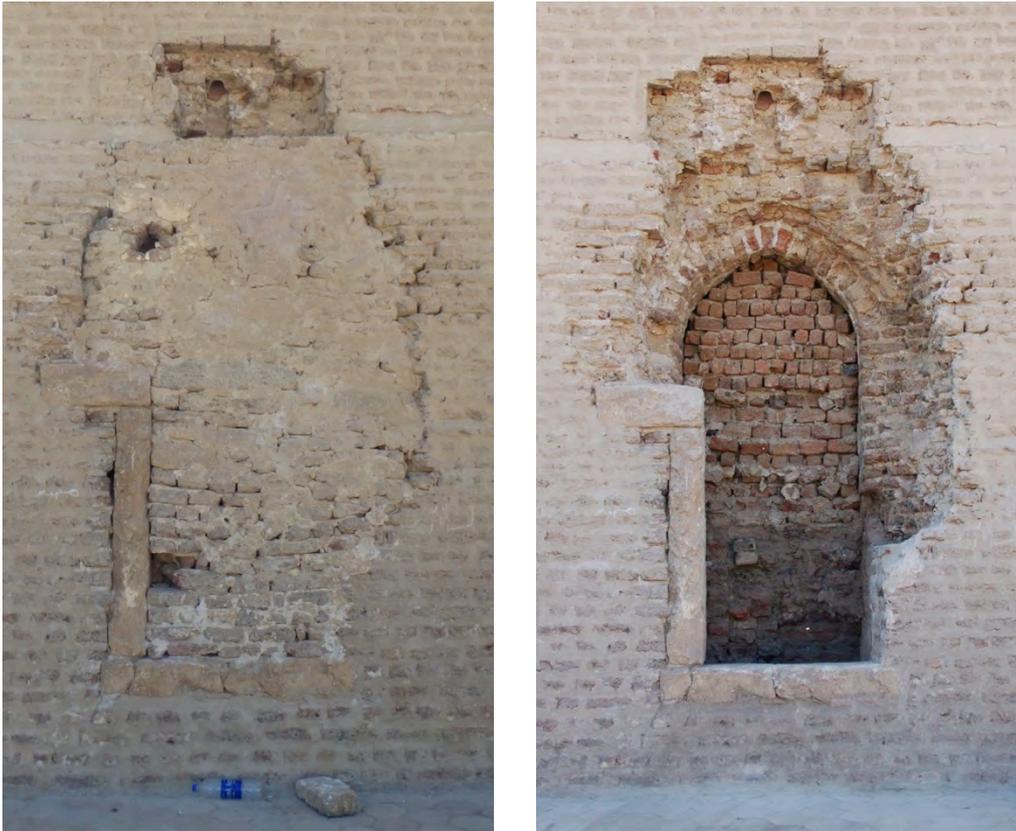
1.3.2 West door: The blocking masonry of brick and stone laid in a variety of mortars (silt and lime) was removed by hand from the interior of the west door. This revealed that:

- 1 The pointed arch of the door was partially preserved
- 2 The limestone pavement was preserved, complete with a door pivot position on the west side of the door
- 3 The external limestone threshold of the door was raised 20 cm above the level of the internal paving
- 4 A stone emplacement for an internal timber beam survived on the east side of the door [15 cm high x 20 cm wide x 20cm deep]
- 5 An emplacement for an internal timber bolt survived on the east side of the door [20 cm high x 12 cm wide x 1.1m deep]
- 6 The east stone jamb survived to a height of 153 cm.
- 7 Traces of a rectangular brick frame around a lost recessed panel survived above the door, immediately below the embedded ceramic pipe and centered on this feature rather than the door below. The panel's size could be reconstructed as 127 cm wide x 28 cm high

Fig 1.8. West door in North Wall before (left) and after (right) removal of blocking

Interventions: The intervention in the west door itself constituted a full reconstruction using all available evidence for its original appearance. The missing west jamb was replaced as a mirror image of the east jamb with new limestone masonry. The height of the surviving emplacement for the door-pivot beam was used to determine the position of the stone lintel of the door. The missing beam itself was replaced with two treated pitch pine timbers (15 x 20 cm section). Repairs were made to the brickwork of the flanking walls of the doorway re-using old bricks. The profile of the pointed arch seen on the inner face of the door was continued through to the exterior using old bricks. A new blocking wall was built from modern bricks (1.5 bricks thick) directly off the surviving limestone pavement inside the door. On the inner face of the door this wall was set back 10 cm from a section of ancient blocking at the base of the door. The rectangular panel above the exterior of the door was restored, and the inset ceramic pipe was kept visible within this panel. The two cornice blocks discovered in the blocking were incorporated in the lapidarium display inside the chitch (see below). The column shaft fragment will be used in a future anastylosis of the nave.

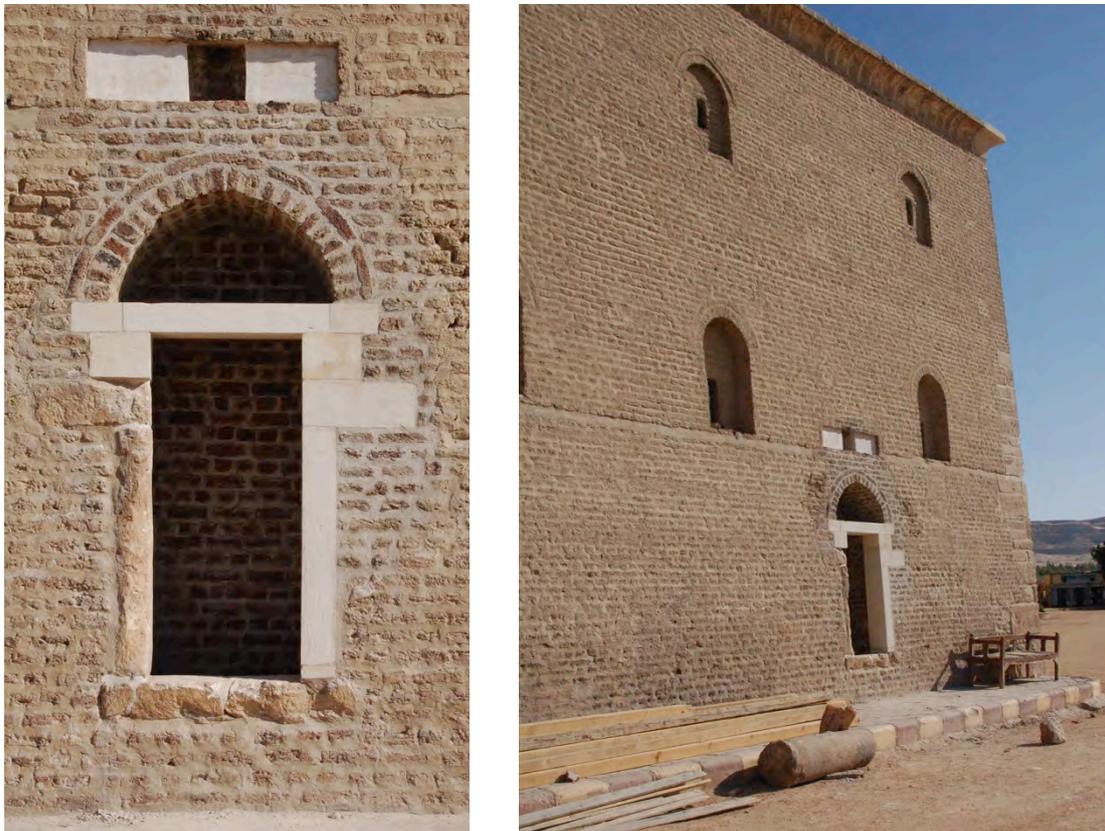
Fig.1.9 West door in North Wall after restoration (front and lateral views)

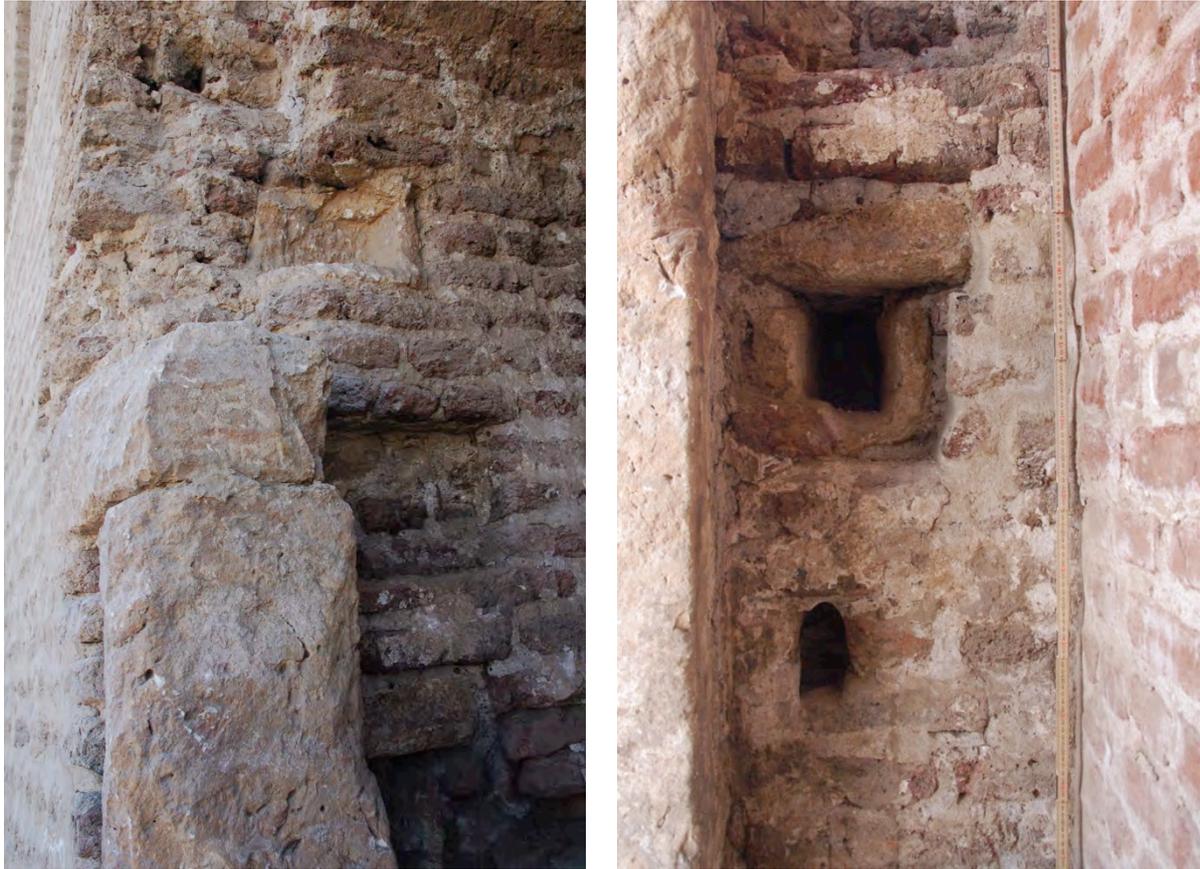
Fig. 1.10. Detail of limestone beam emplacement (left) and door bolt housing (right) in west door

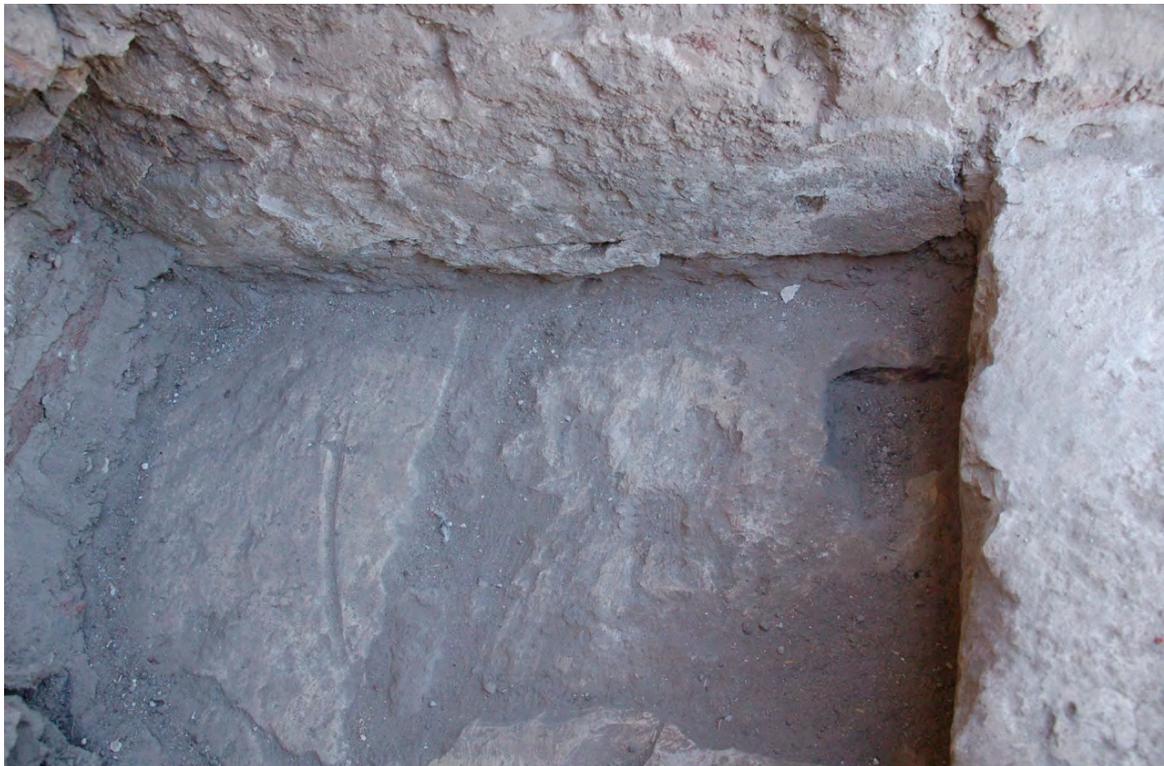
Fig. 1.11 Detail of limestone pavement and door pivot in west door [beside west jamb]

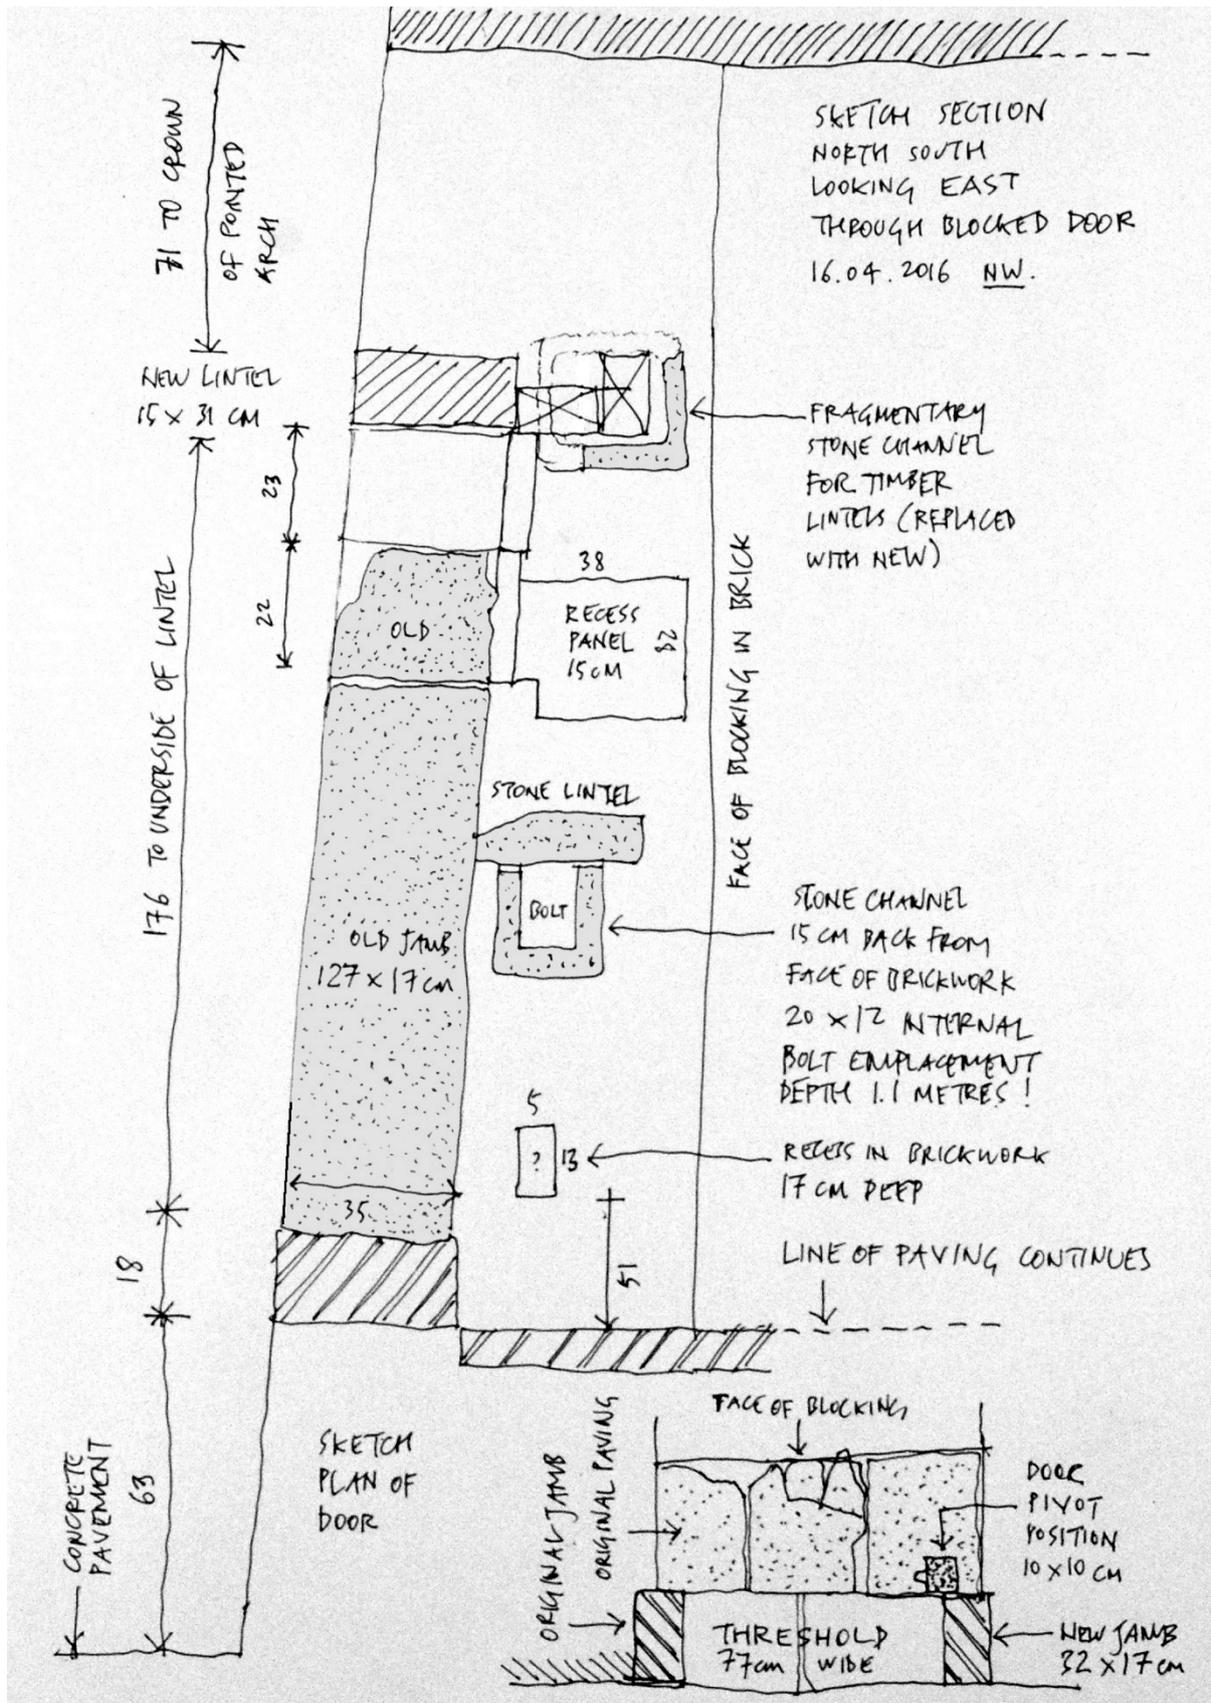
Fig. 1.12 Sketch section and plan through west door looking east showing original features

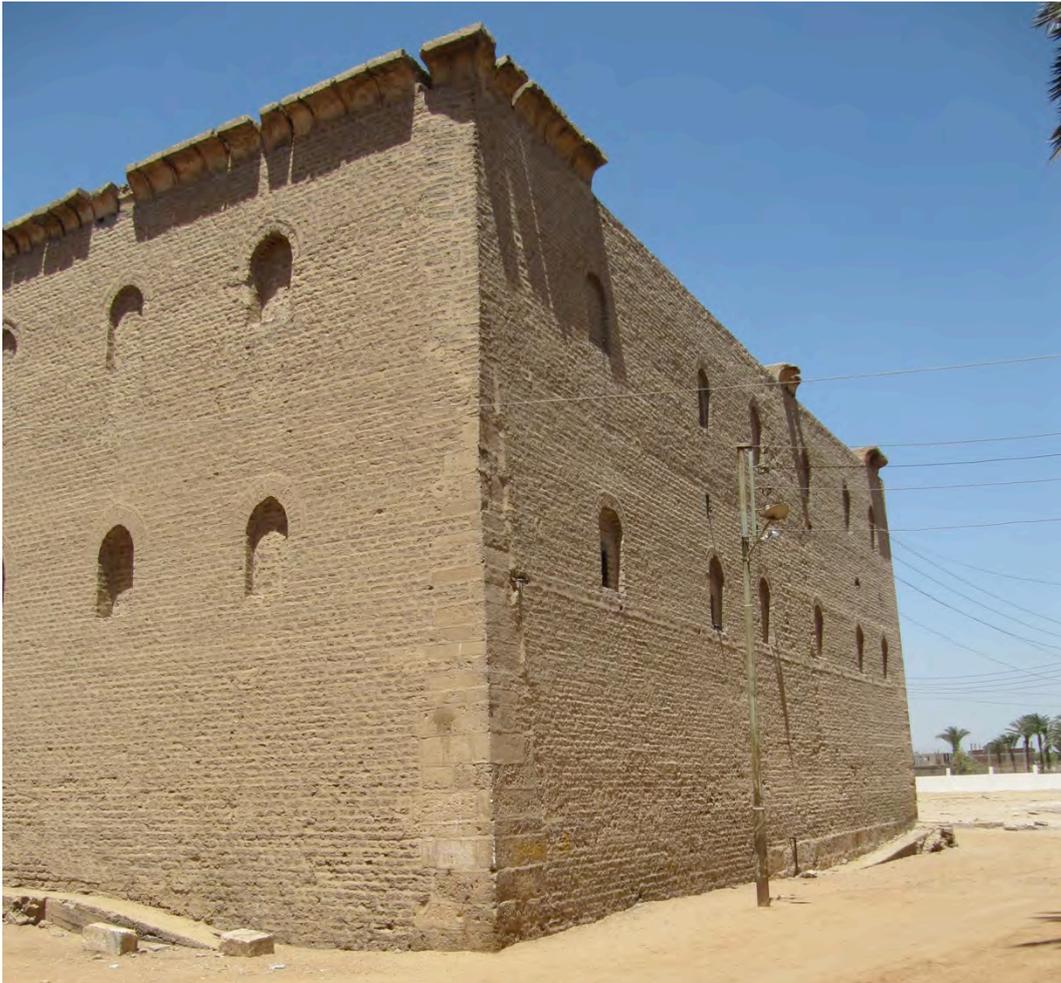
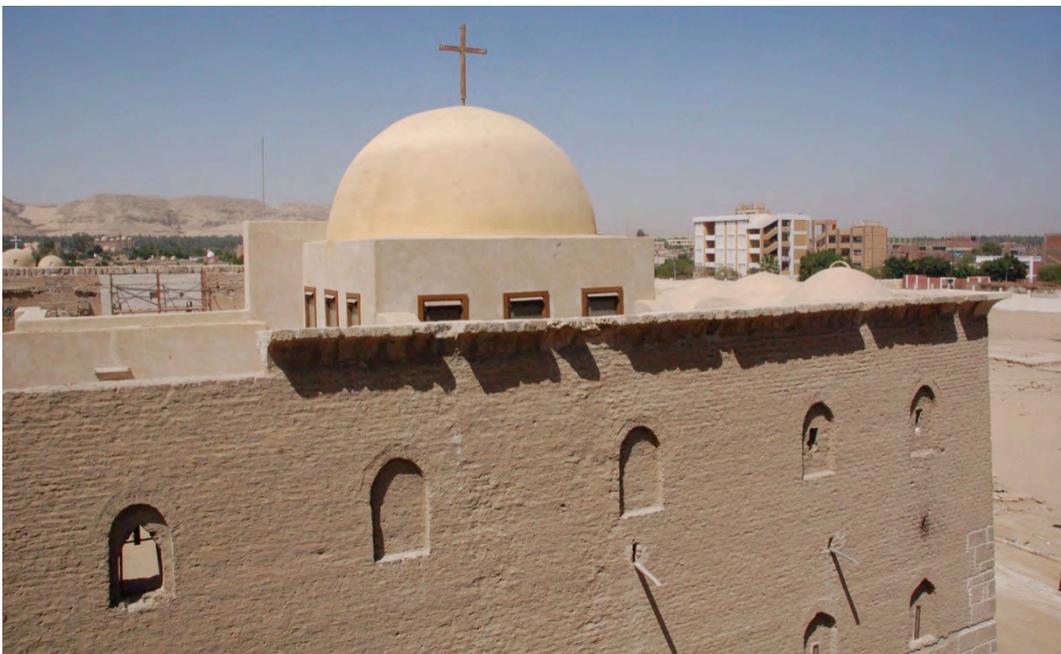
Existing condition: A large number of cornice blocks were missing from this elevation, and there was an accumulation of frass from an inactive wasps' nest under the cavetto of blocks at the north end of the elevation.

Fig 1.16. View of east façade from southeast prior to intervention (top) and view of reinstated cornice blocks at high level on same (bottom)

Interventions: Wasps' nests were removed manually from the overhangs of the cornice. Forty original cornice block replacements were made, starting from the northern end of the façade, as well as a new limestone corner block. After the completion of work on the cornice, a further three cornice blocks were subsequently discovered in the debris on top of the tower. These will be incorporated into the restored cornice during the next campaign.

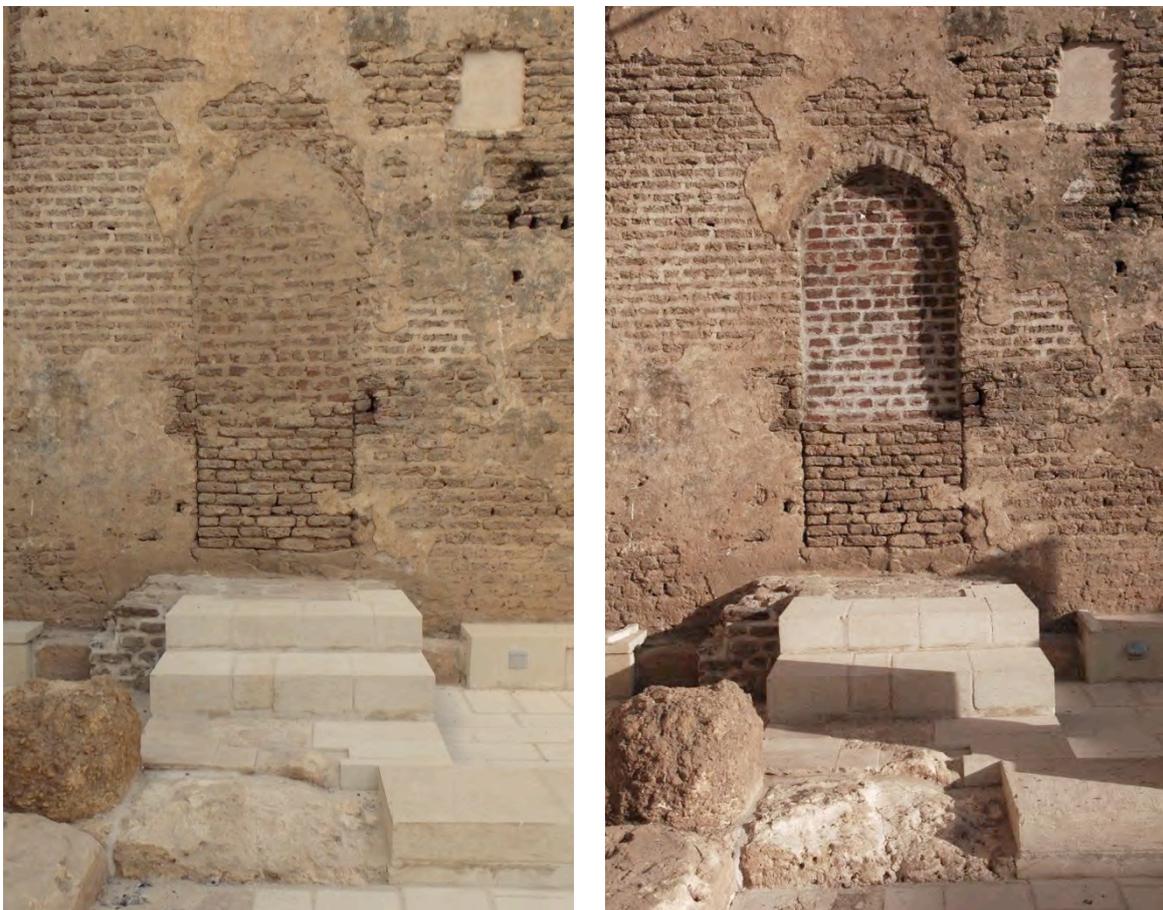
Existing condition: The blocked door in the north wall exhibited two phases of blocking: one historical with traces of plaster on its surface and one modern executed with cement mortar and set flush with the original masonry face.

Fig. 2.1 The blocked door in the north wall before (left) and after (right) intervention

Interventions: The intervention in the blocked door on its exterior has been described above. On its inner face, the modern brick blocking was removed and replaced with a new brick blocking set back 10 cm from the face of the wall in order to delineate the line of the arch of the door, which was also restored at its apex. The new brickwork may be given a coat of limewash in a future campaign to harmonise it with the plaster surfaces of the adjacent wall after cleaning.

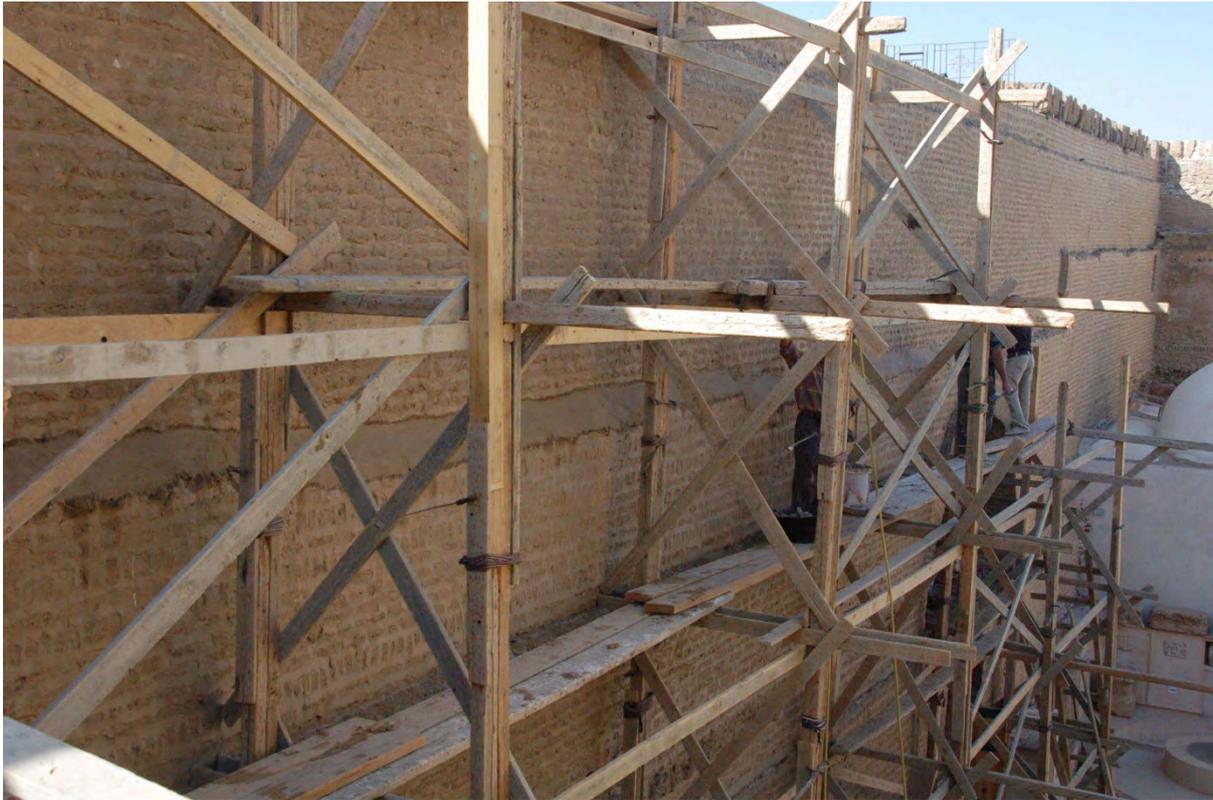
Existing condition: With the exception of the south wall, the inner faces of all other walls inside the perimeter were conserved in 2015.

Fig. 2.2 Installing a chamfered mortar cap on a roosting ledge of the south wall

Interventions: The main roosting ledge for birds was given a 45 degree chamfered mortar cap as a deterrent. The cornice blocks on the south wall were also repointed on their inner faces using a lime mortar.

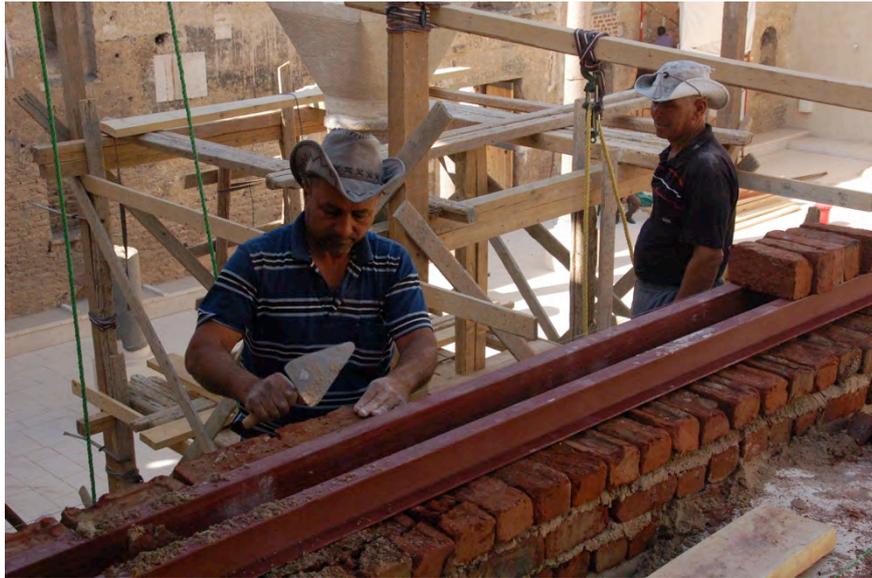
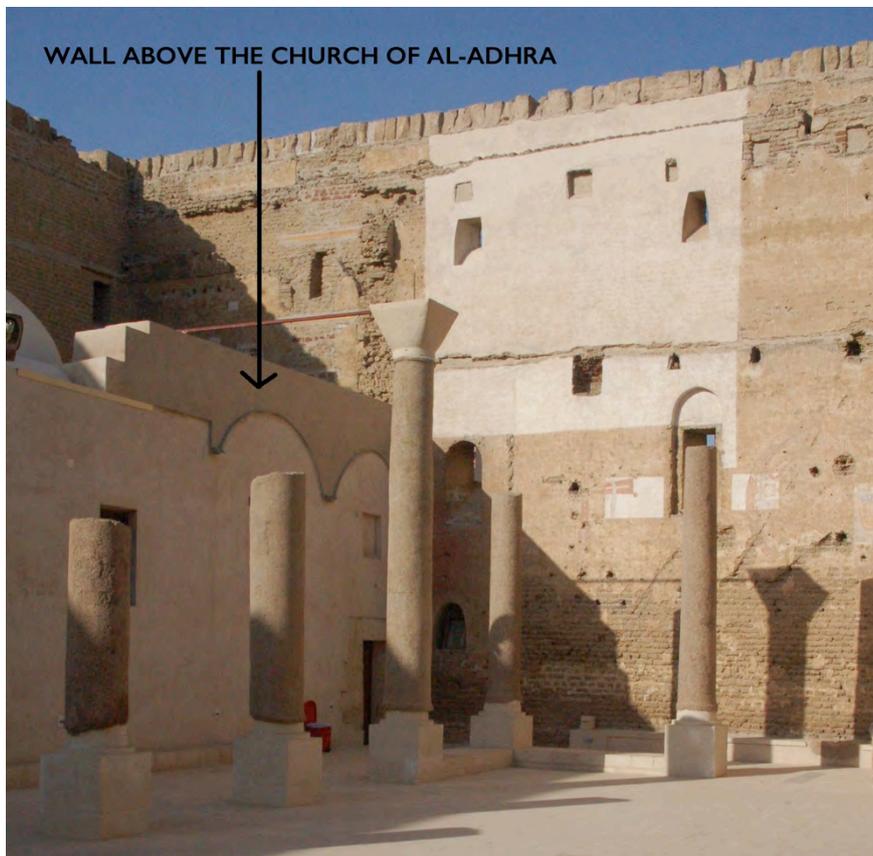
Existing condition: The Church of al-Adhra is a modern structure, having been substantially rebuilt in the 1980s over the foundations of an earlier church in this location. At this time, some of the architectural features of the earlier church were changed: for example, an entirely new dome was created over the sanctuary. The alignment of the north wall of the church, however, respected the original alignment of the south wall of the nave of the main church that once divided the nave from a long hall to its south.

Fig. 2.3 Wall above the church of al-Adhra during construction with steel lintels over vaults (top) and seen from the nave after completion (below)

Interventions: A section of the missing south wall of the nave was rebuilt above the Church of al-Adhra to a height in alignment with the top of the column capitals of the colonnade under the former gallery of the nave. This was done to provide future support for the planned shelter in the southwest corner of the nave. Construction of the new wall was carried out using red bricks set in lime mortar, and covered with a lime render. Galvanised metal rainwater spouts were installed in the troughs between the arches of the vaults of the church. A galvanised metal trim was also added above the vaults of the church to clearly distinguish between these vaults and the wall above them. Two 12 cm deep steel channels were inserted into the masonry of the new wall to provide better weight distribution for the planned shelter above and to reduce the loads transmitted to the wall of the church below. The new wall is not of uniform thickness: at its east and west ends it follows the thickness of the original wall, seen in the scarring on the wall at its junction with the west wall of the nave. In the middle, where it is not visible from below, the wall is two bricks thick to reduce its weight. The wall was stepped at its east end to indicate its continuation in an easterly direction.

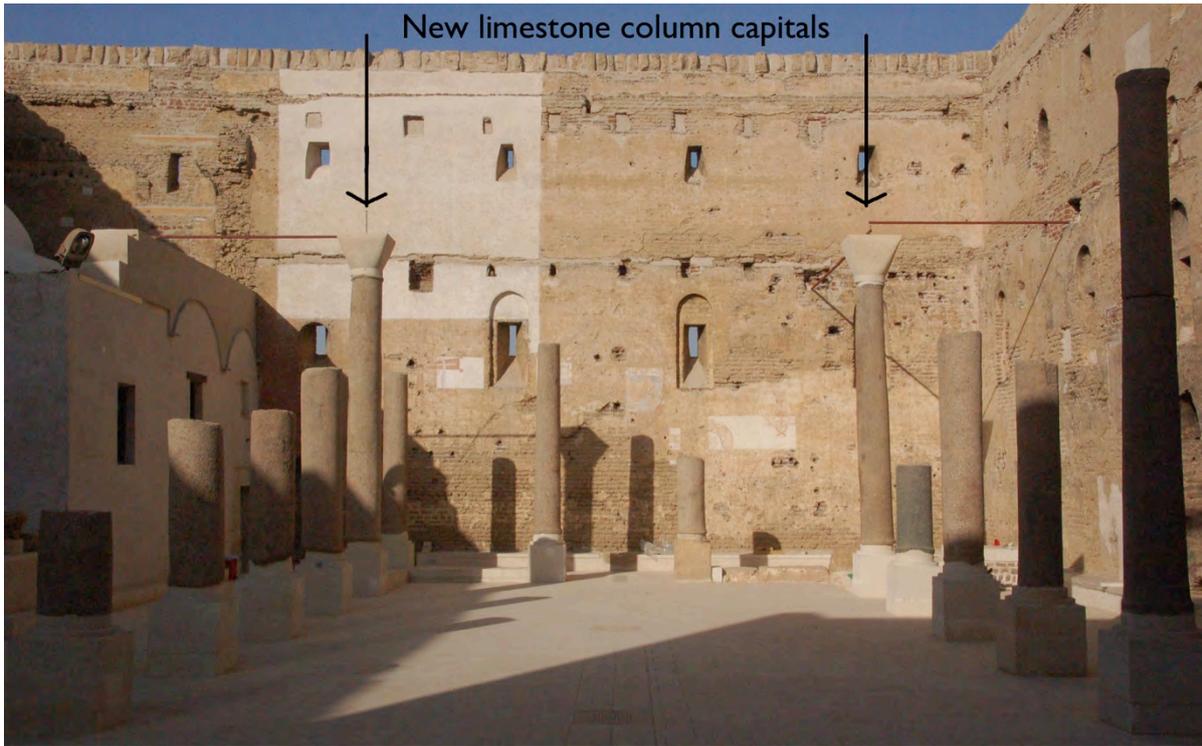
Fig. 2.4 View to west end of nave showing new limestone column capitals

Two new limestone column capitals were installed above the complete shafts erected at the west end of the nave. After erection of the capitals it was decided to install temporary 4 x 4 cm steel box section ties to fixings in the perimeter walls as a safety precaution. These will be removed in the next phase of the work when the shelter is installed.

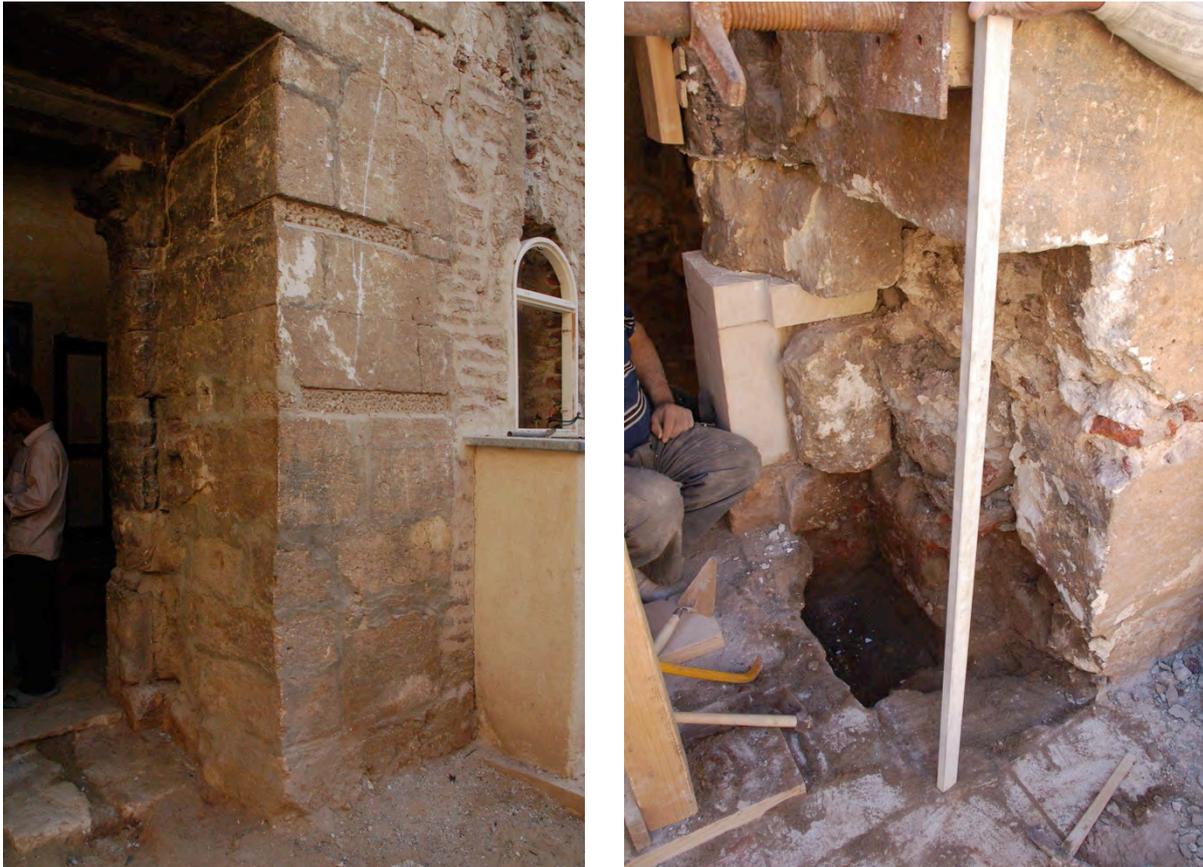
Existing condition: The stone lintel of the south portal was restored in 2015. Owing to water damage from rising damp, the west jamb of the south portal had suffered severe deterioration over time in its lower section. This damage had been crudely repaired with random stone blocks set in cement mortar, ignoring the coursing of the original ashlar blocks. On the south face of the portal, other inappropriate stone rubble replacements had been made in place of ashlar elements, also using cement mortar. The final course of the stone masonry on the northern face of the portal contained blocks that had been badly re-set in a silt mortar.

Fig. 3.1 West jamb of the South Portal before intervention (left) and after removal of defective masonry (right)

Interventions: The portal was fully propped, after which the defective stonework was removed and replaced with limestone masonry set in lime mortar. The replacements totalled 12 new blocks in all. Three displaced high-level blocks on the top of the north face of the portal were lifted and reset using a lime mortar. A new limestone threshold, consisting of two blocks 15 cm high was also introduced to determine the level of future paving inside the tower entrance. Finally, a new single leaf pivoting pitch pine door, treated with linseed oil and ‘navda rumi’, was installed in the original location of the door with a timber bolt on its inner west side. This door had heat-treated steel banding applied to its inner and outer faces using hand made nails: the bands matching the distribution of the carved stone bands on the portal itself.
