ARCHITECTURAL CONSERVATION RED MONASTERY SPRING 2016

Part I: The Church

PRELIMINARY REPORT TO MINISTRY OF ANTIQUITIES

Dr. Nicholas Warner, April 28, 2016

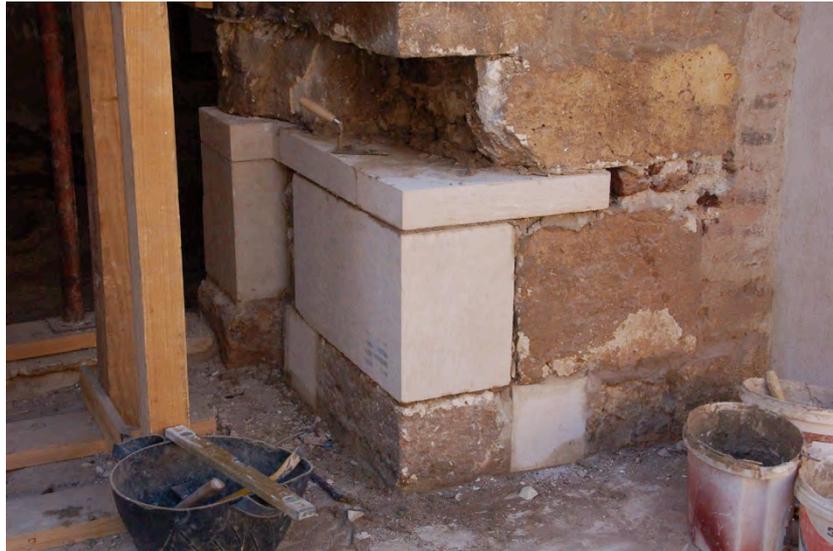
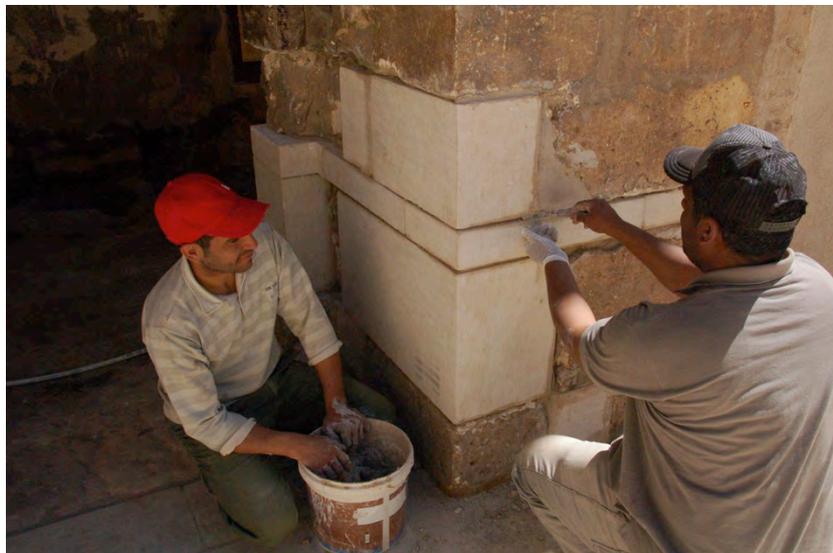
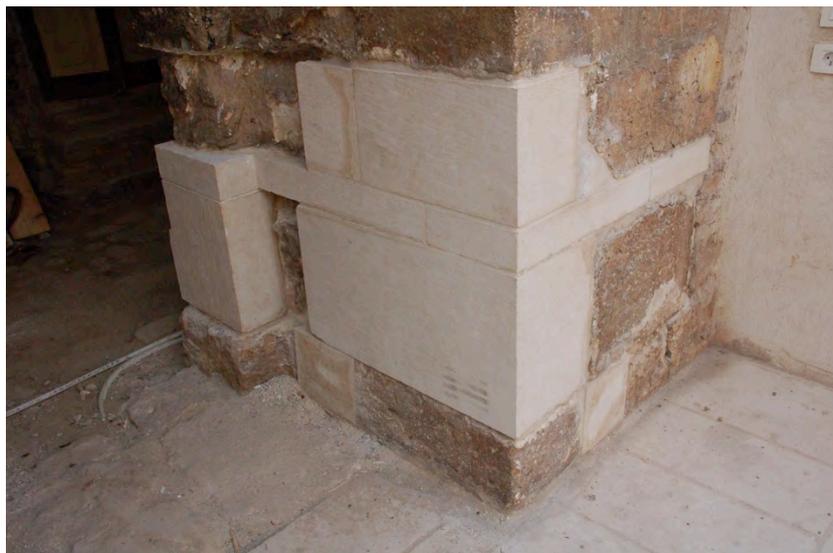
Fig. 3.2 Sequence of repair of the west jamb of the South Portal

Interventions: The portal was fully propped, after which the defective stonework was removed and replaced with limestone masonry set in lime mortar. The replacements totalled 12 new blocks in all. Three displaced high-level blocks on the top of the north face of the portal were lifted and reset using a lime mortar. A new limestone threshold, consisting of two blocks 15 cm high was also introduced to determine the level of future paving inside the tower entrance. Finally, a new single leaf pivoting pitch pine door, treated with linseed oil and ‘navda rumi’, was installed in the original location of the door with a timber bolt on its inner west side. This door had heat-treated steel banding applied to its inner and outer faces using hand made nails: the bands matching the distribution of the carved stone bands on the portal itself.

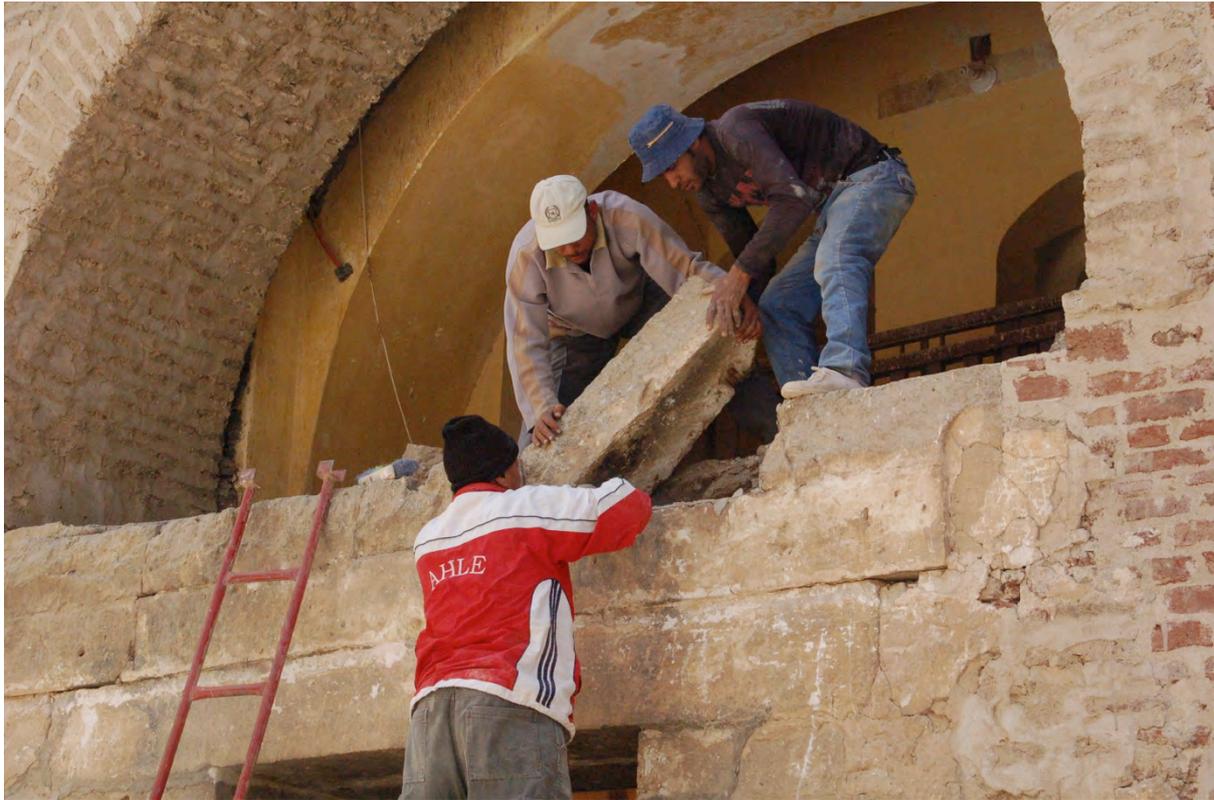
Fig. 3.3 Re-setting blocks of the upper course on the north face of the South Portal

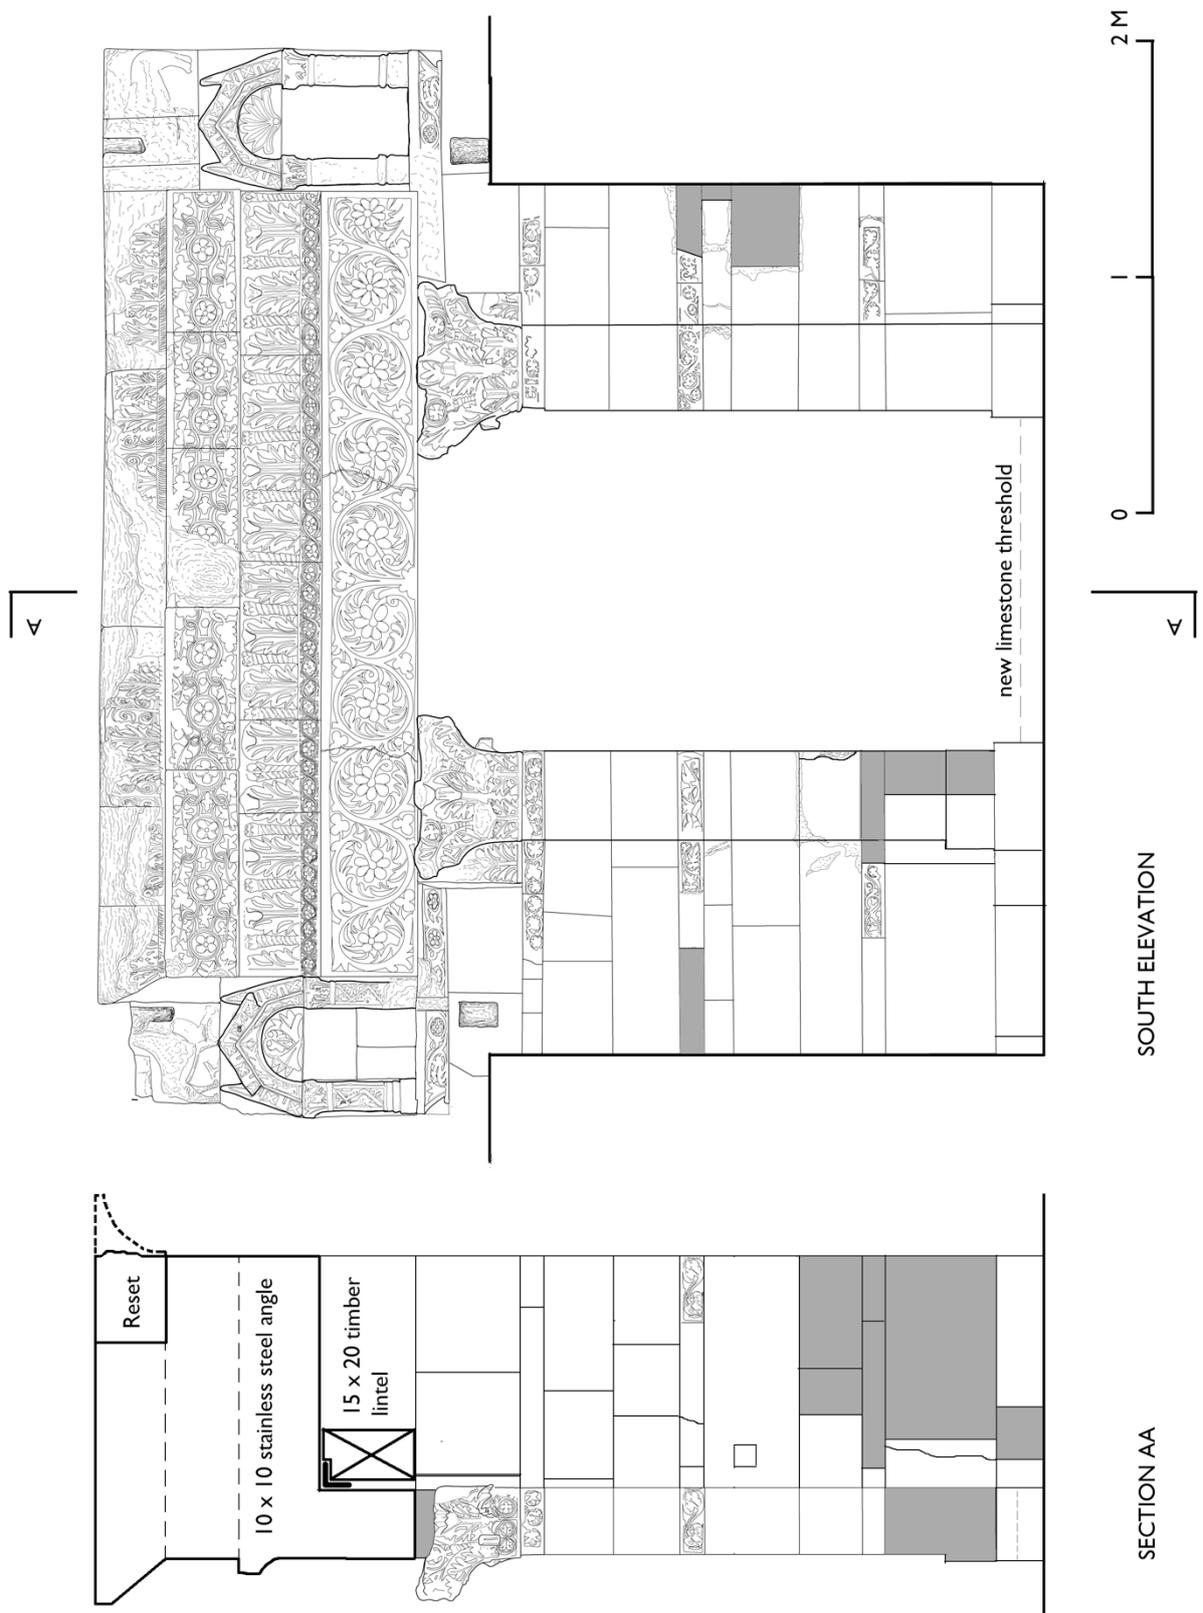
Fig. 3.5 South Portal elevation and section showing ashlar block replacements

Note: The limestone masonry of the portal requires further fine conservation treatment including complete cleaning and repointing with lime mortar. This is scheduled to be carried out by the Italian team during their next campaign of work.

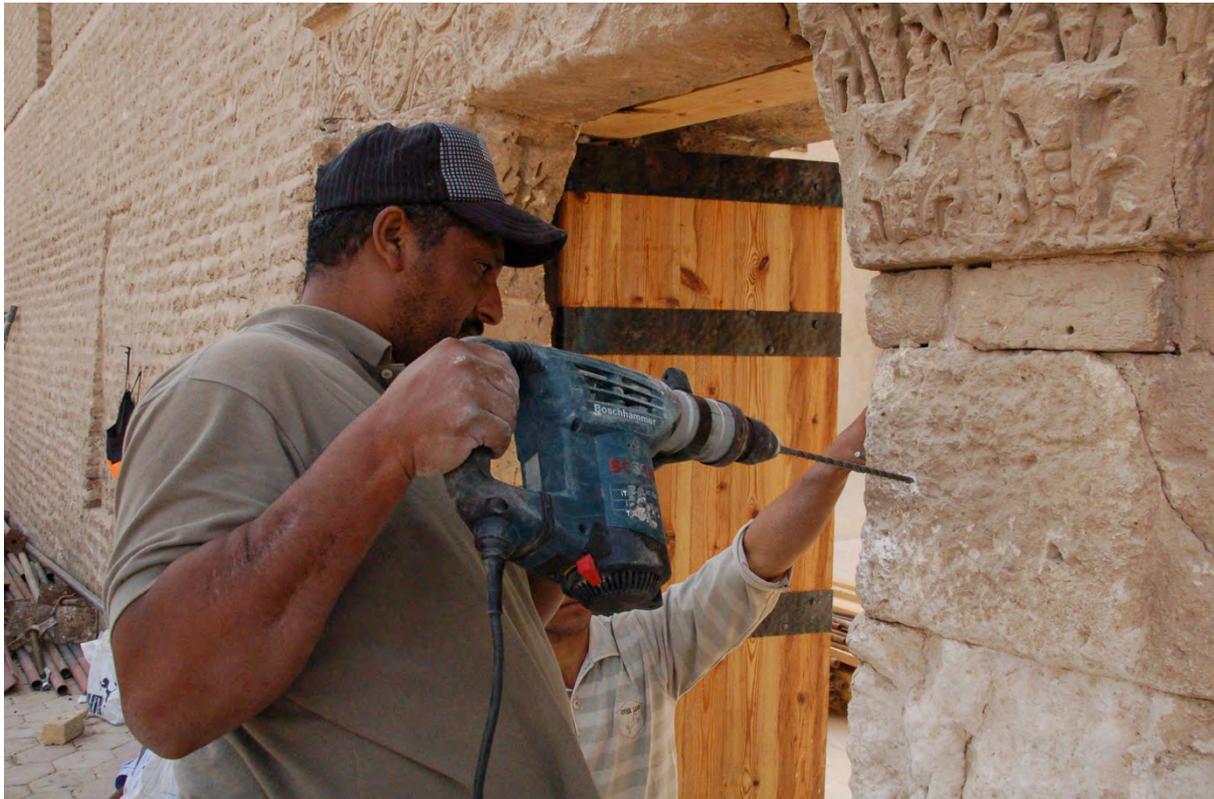
Fig. 4.1 Drilling a fractured block on the west jamb of the North Portal for the insertion of stainless steel threaded rod and epoxy ties

Interventions: The defective or seriously damaged stonework of the portal was removed and replaced with limestone masonry set in lime mortar. A total of eight block replacements were made. A new double leaf pivoting pitch pine door, treated with linseed oil and ‘navda rumi’, was installed in the original location of the door with a new timber lintel for its upper pivots. This door had heat-treated steel banding applied to its inner and outer faces using hand made nails: the bands matching the distribution of the carved stone bands on the portal itself. The pivots were made of stainless steel. The door was provided with an exterior bolt and padlock.

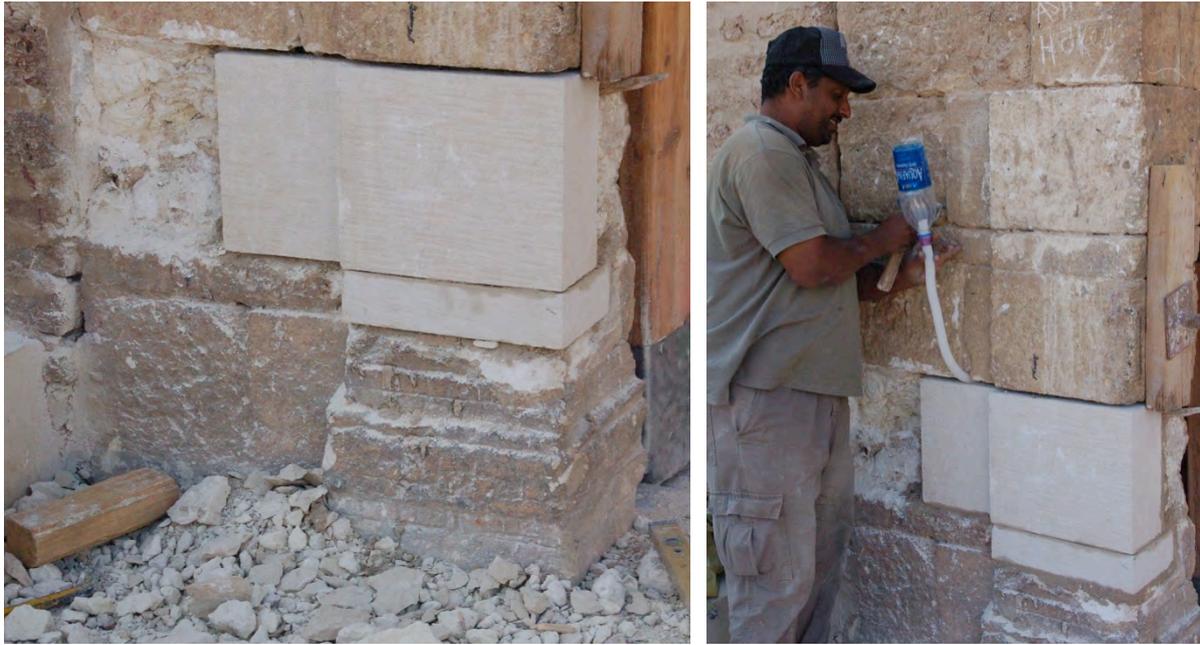
Fig. 4.2 Replacement limestone masonry on east jamb of North Portal (left) and gravity grouting of same (right)

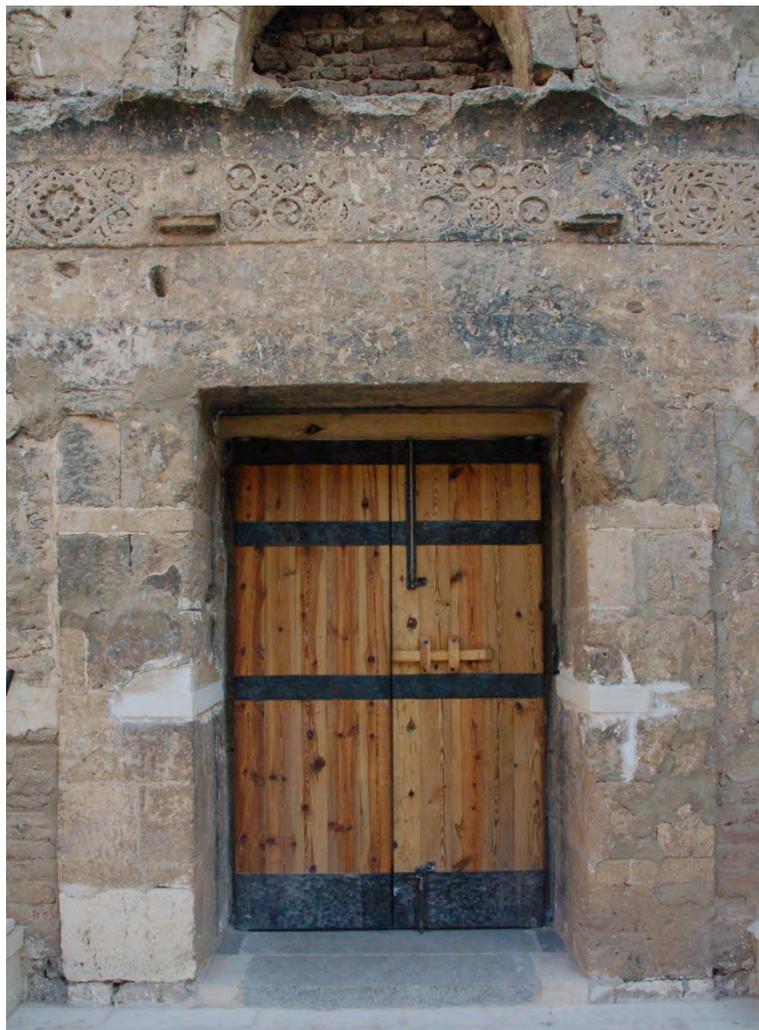
Existing condition: The exterior of the north portal was found to have been patched in its lower areas with limestone rubble randomly set in gypsum. Steel double doors had been inserted on its interior in cement pockets, causing considerable damage to the original stonework.

Fig. 4.3 Interior of North Portal showing replacement limestone masonry and new timber double leaf door with steel banding

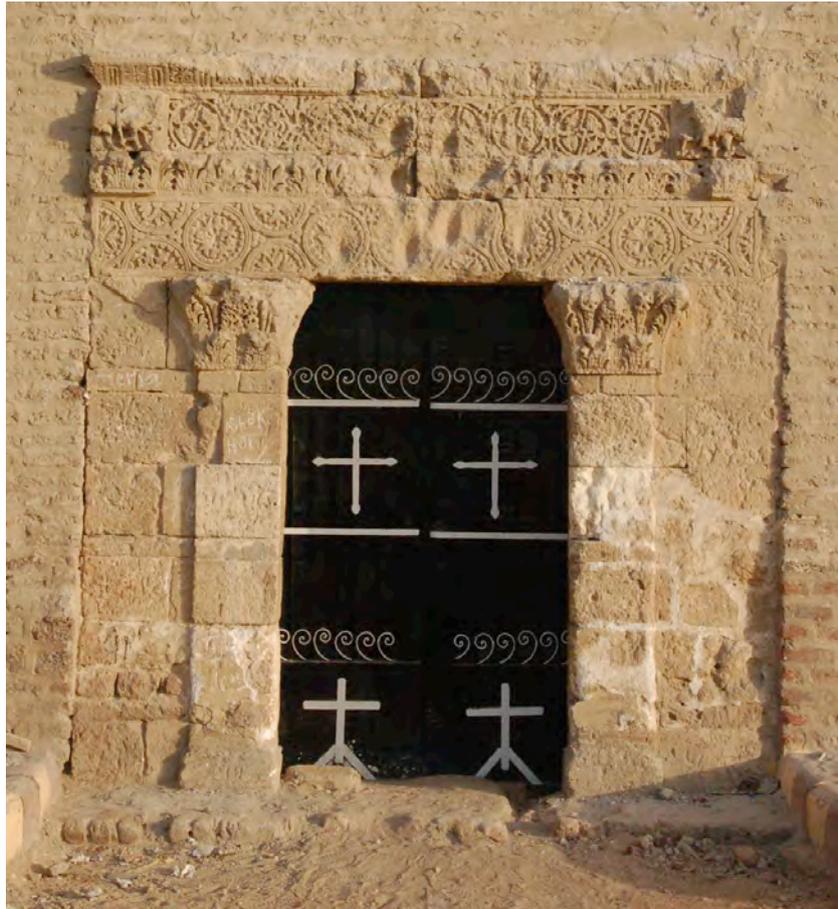
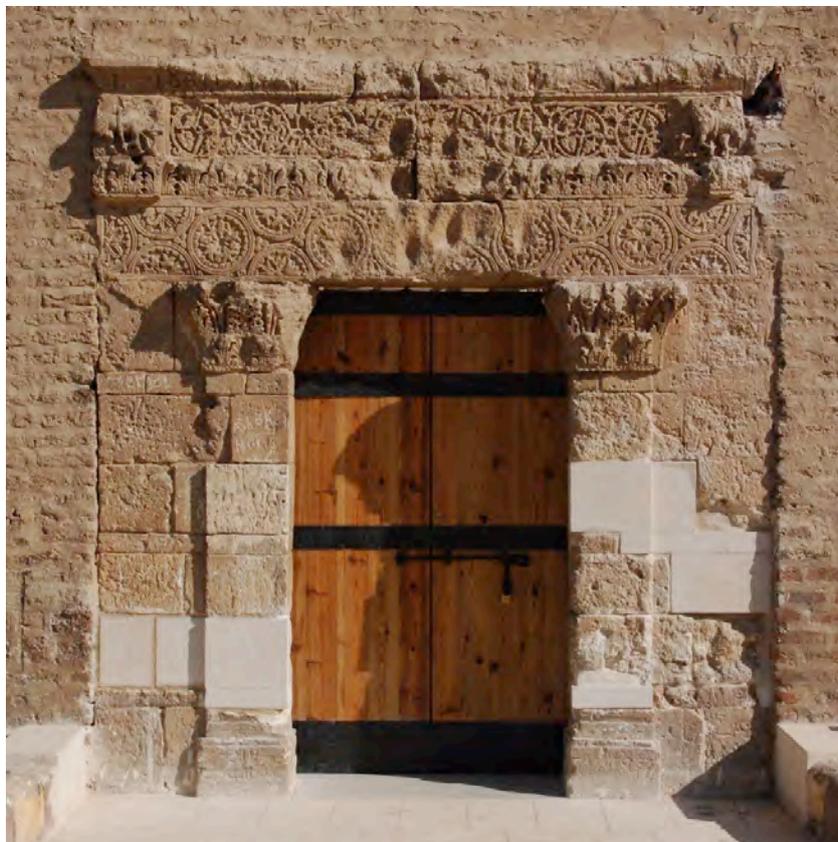
Fig. 4.4 Exterior of North Portal before (top) and after (bottom) replacement of limestone ashlar blocks

Note: The limestone masonry of the portal requires further fine conservation treatment including complete cleaning and repointing with lime mortar. This is scheduled to be carried out by the Italian team during their next campaign of work.

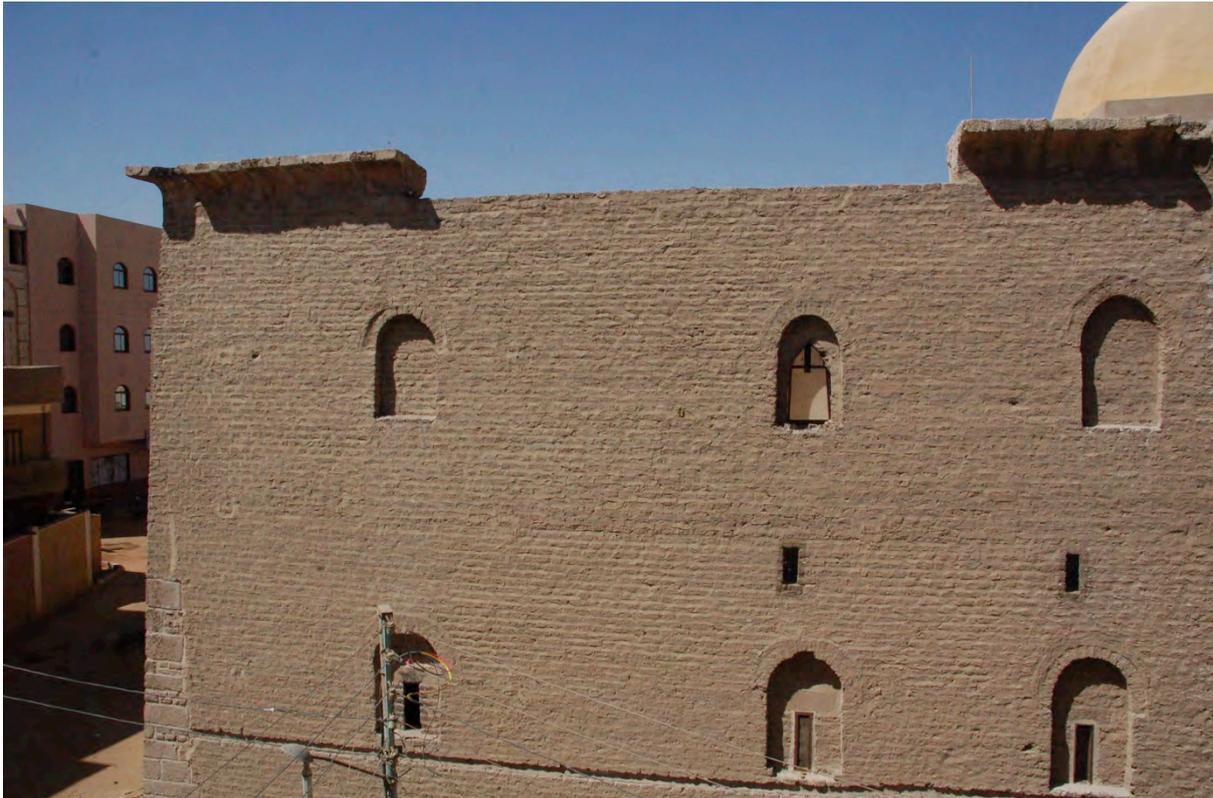
Fig. 5.1 View of the east façade of the church showing the last remaining location of missing cornice blocks

5.1 Reinstatement of three original cornice blocks on east façade and additional installation of five linear metres of new limestone cornice blocks (to match originals) in the last remaining location where cornice blocks are missing on the façade. This will complete this distinctive architectural feature of the church.
