**ARCHITECTURAL CONSERVATION
RED MONASTERY SPRING 2016**

Part II: The Tower

PRELIMINARY REPORT

Dr. Nicholas Warner, April 28, 2016

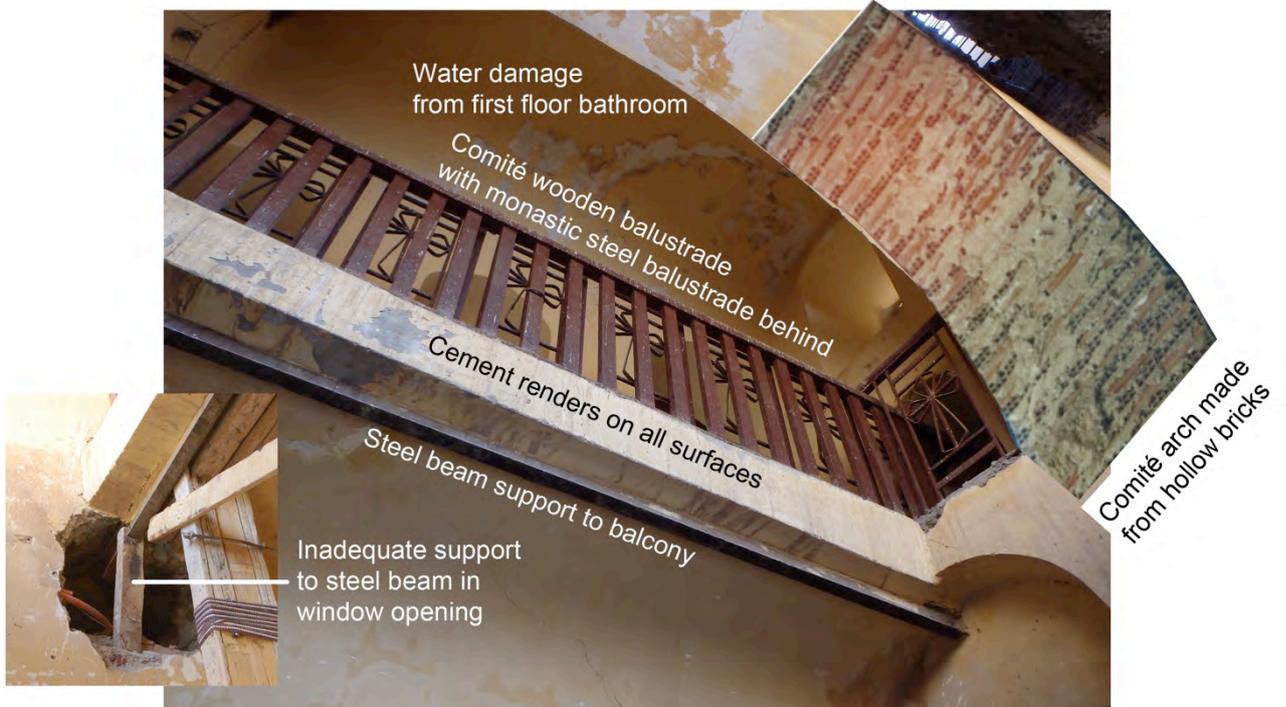
Fig. 6.2 Diagnostic view of upper area of entrance to tower showing Comité construction of arch using hollow bricks set in lime mortar, later plastered with cement during the intervention of 1995-96, and other interventions discussed below

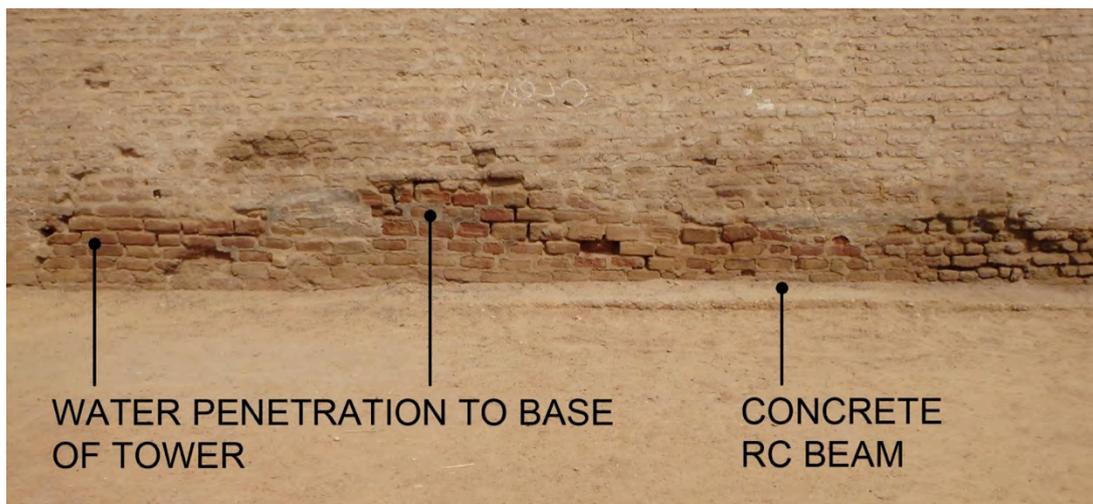
Fig. 6.3 Diagnostic of condition at tower base showing the top of the reinforced concrete beam and water damage.

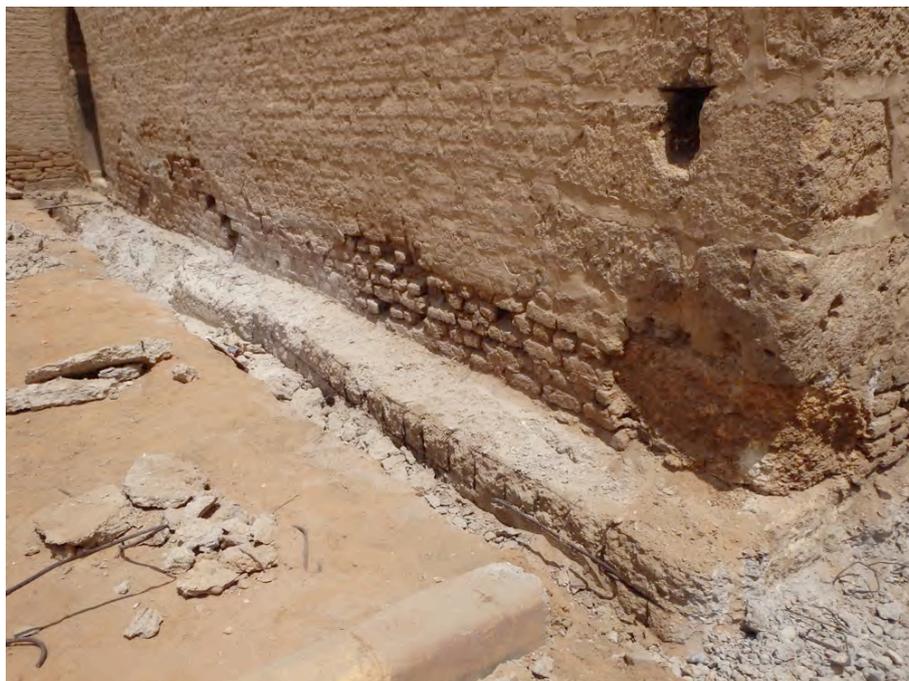
Fig. 6.4 View of west wall of tower showing reinforced concrete beam at commencement of removal. Note the badly eroded limestone corner block

Fig. 7.18 Manual removal of reinforced concrete beam on the west face of the tower

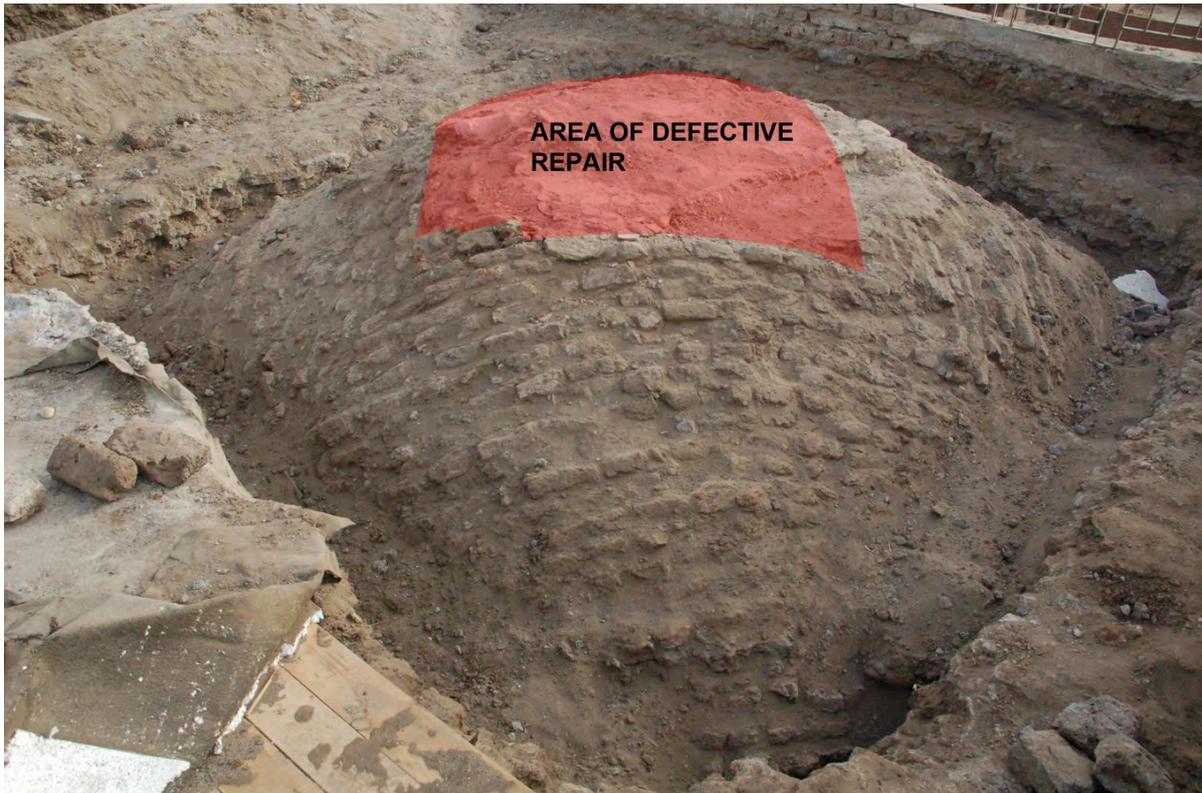
Fig. 6.6 The southeast dome after partial clearance showing area of defective repair, carried out without understanding of the structure of the dome

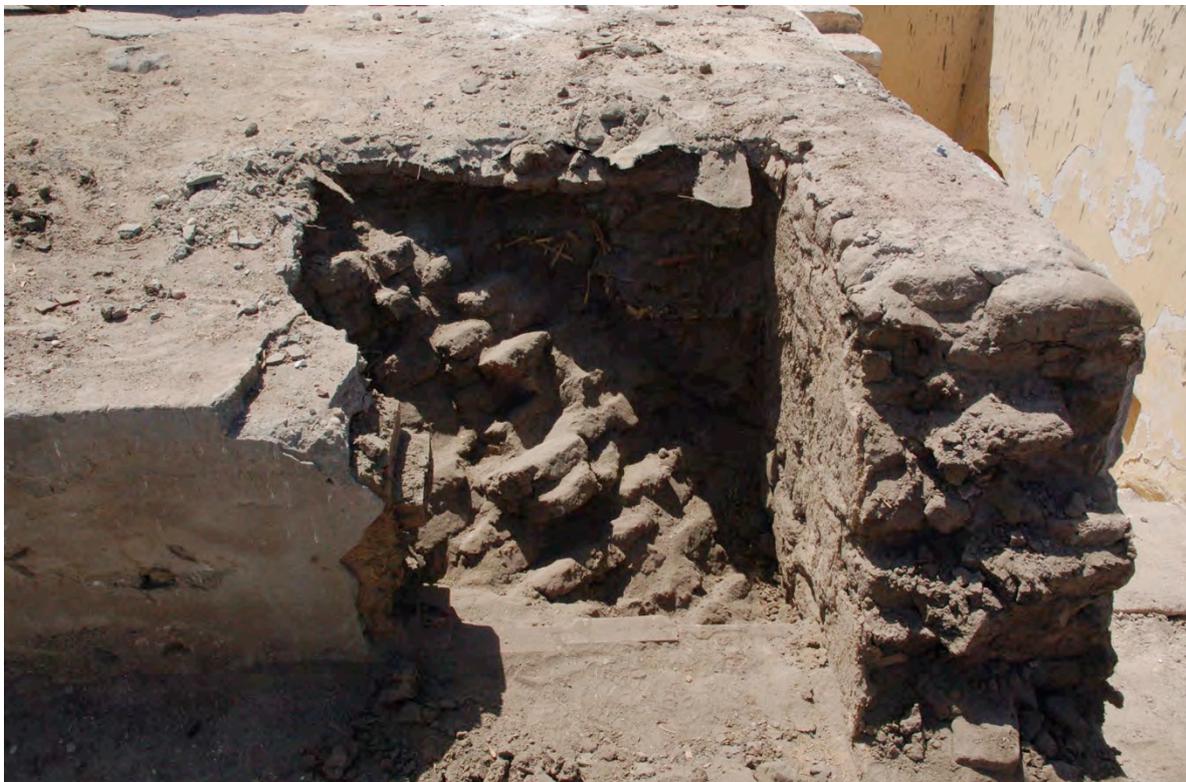
Fig. 6.7 Corner of the northeast dome after test clearance showing condition of northwest pendentive within later fill and blocking walls

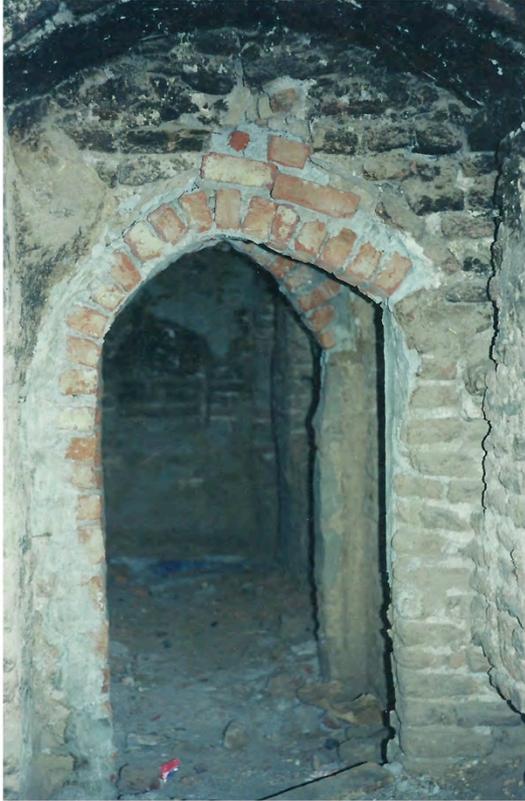
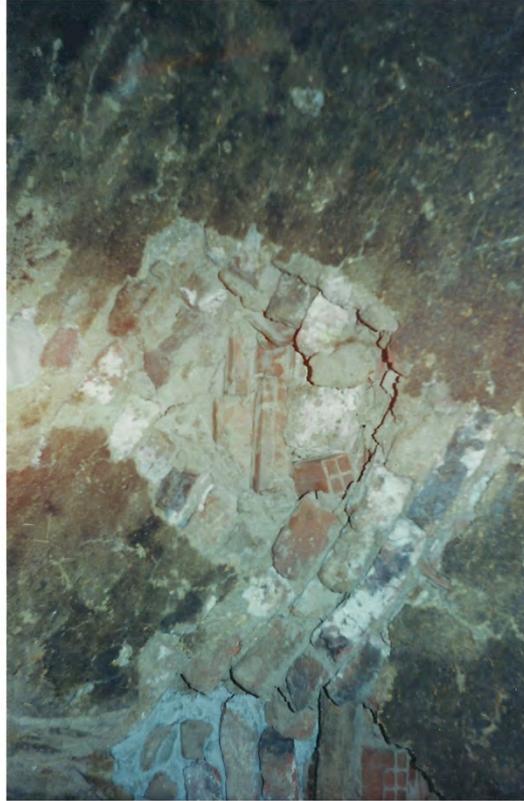
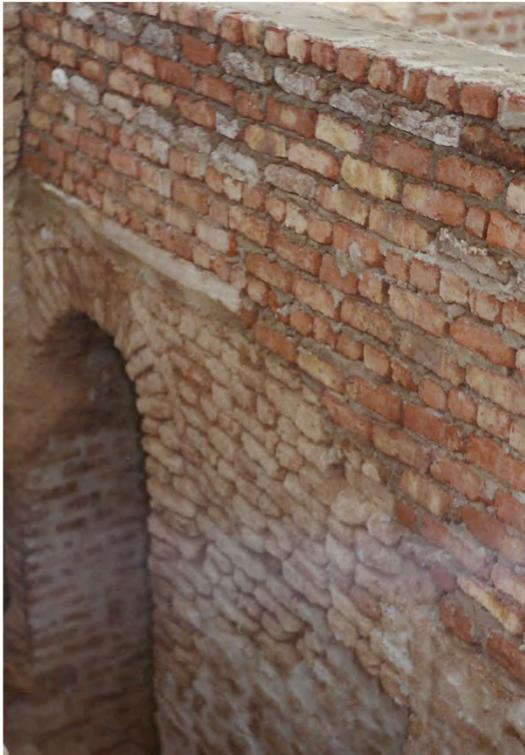
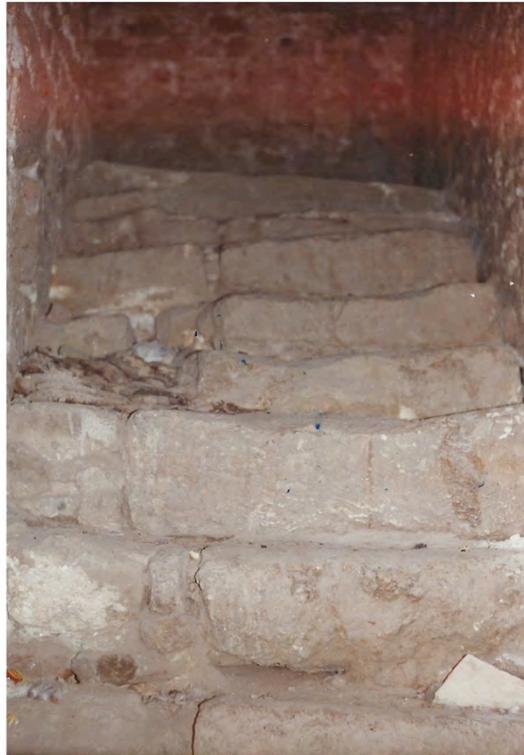
Fig. 6.8 Defective repairs of arches (top left), southeast dome from below (top right) and masonry above staircase (bottom left) with cement mortar used above bricks laid in silt mortar. The original appearance of the stairs is seen at bottom left, replaced in 1995-96.

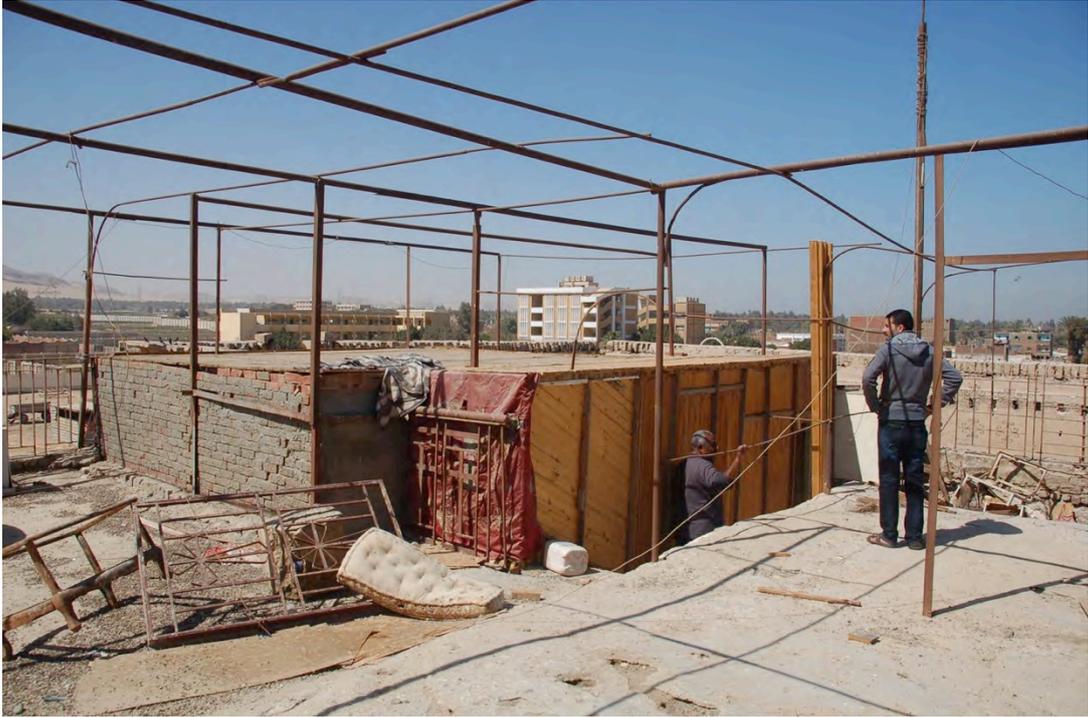
Fig. 6.9 The roof of the tower showing secondary structures prior to clearance.

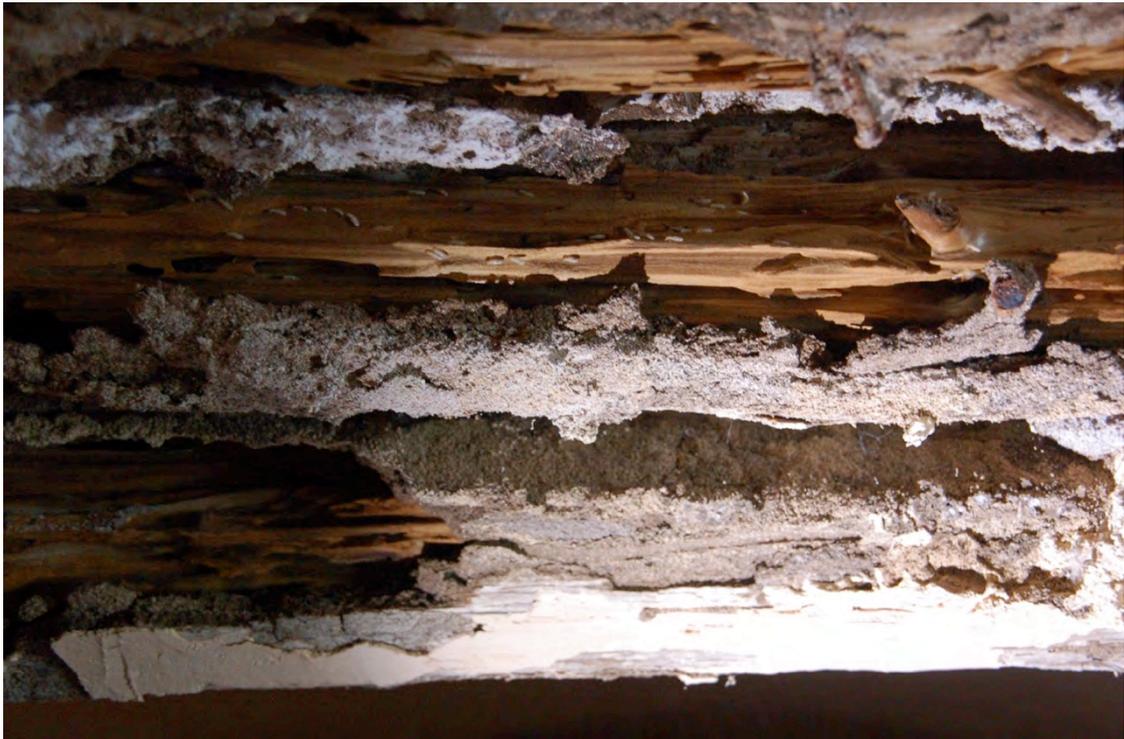
Apart from water damage, the tower had also suffered in other ways during its conversion into a dwelling. Numerous concrete slabs, up to 35cm thick, had been poured in a number of rooms, with ceramic or terrazzo/mosaico floors laid over them. This substantially increased the dead loading on the structure, reduced floor to ceiling heights on the first floor, and trapped moisture at ground level. Cement renders had been applied in many areas, particularly at ground level, creating further problems for the masonry due to lack of permeability. Some of these renders were up to 10 cm thick. Two wooden beam roofs had been installed over the southwest corner room at first floor level in c. 2001 covered with polystyrene, bitumen, and a thin screed of cement. This construction provided an excellent environment for termites.

Fig. 6.10 Termites and frass in decayed timber lintels on the ground floor of the tower

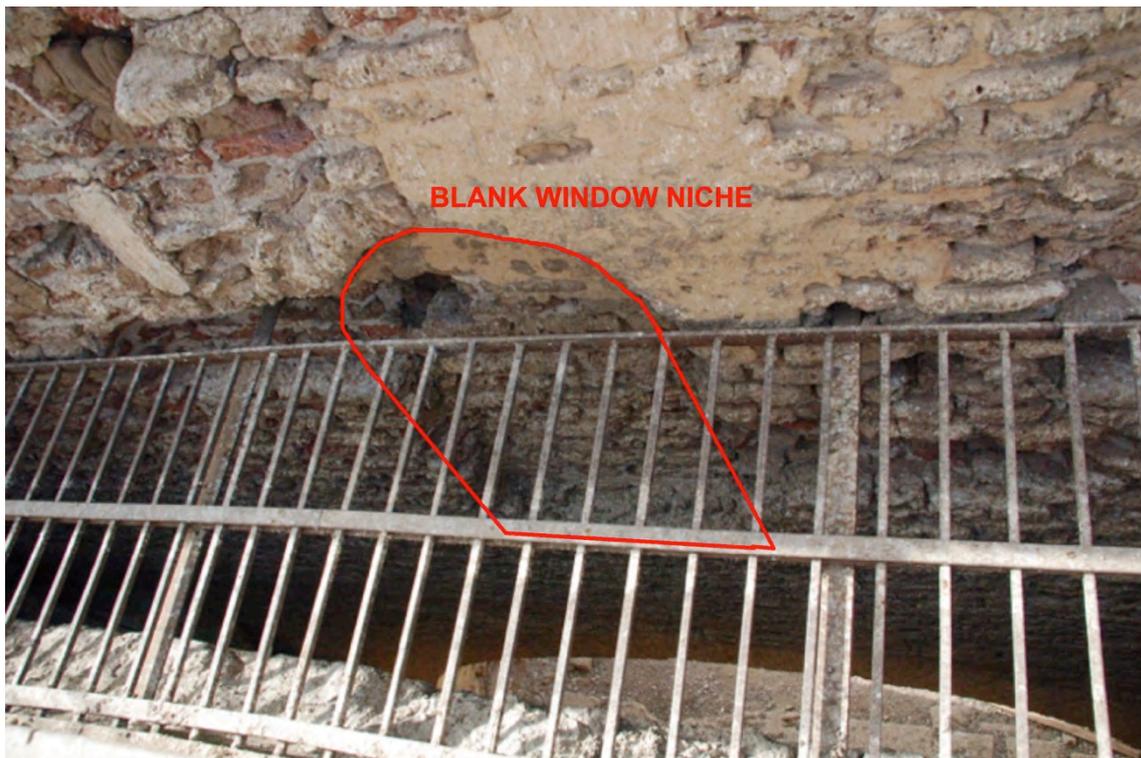
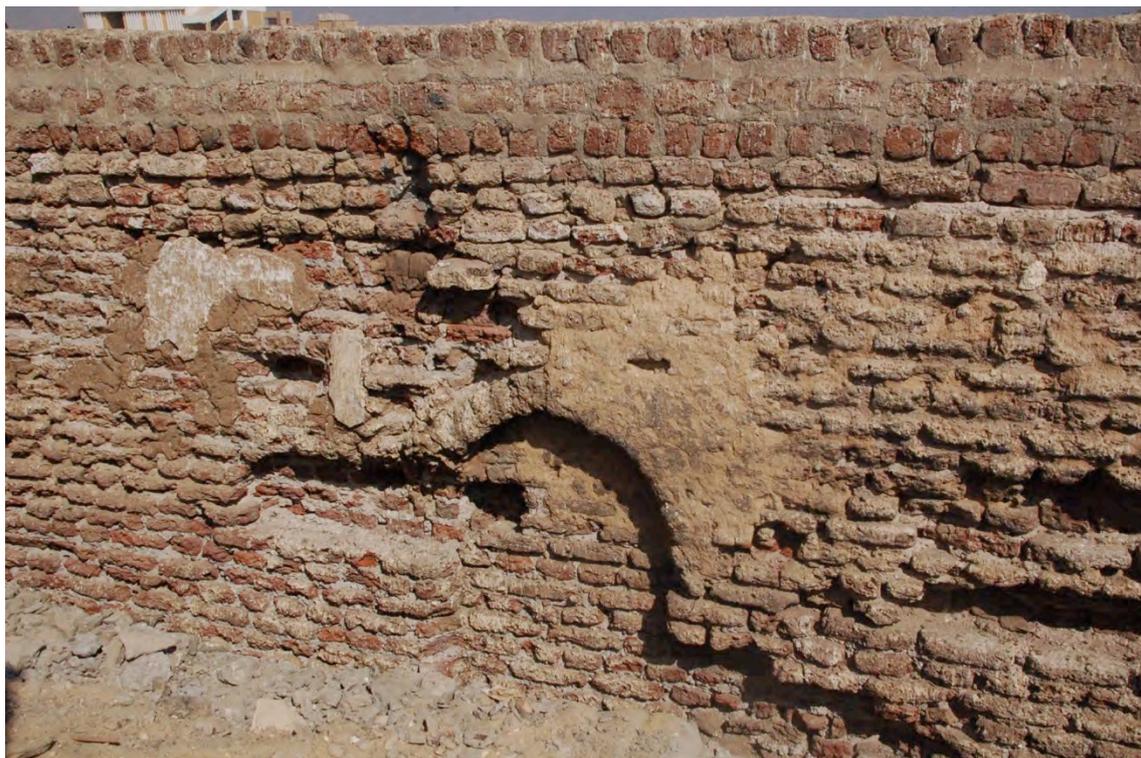
Fig. 7.10 The blank window niche in the south façade of the church showing inappropriate level of steel grating and damage (top). The same area after removal of grating and prior to conservation (bottom)

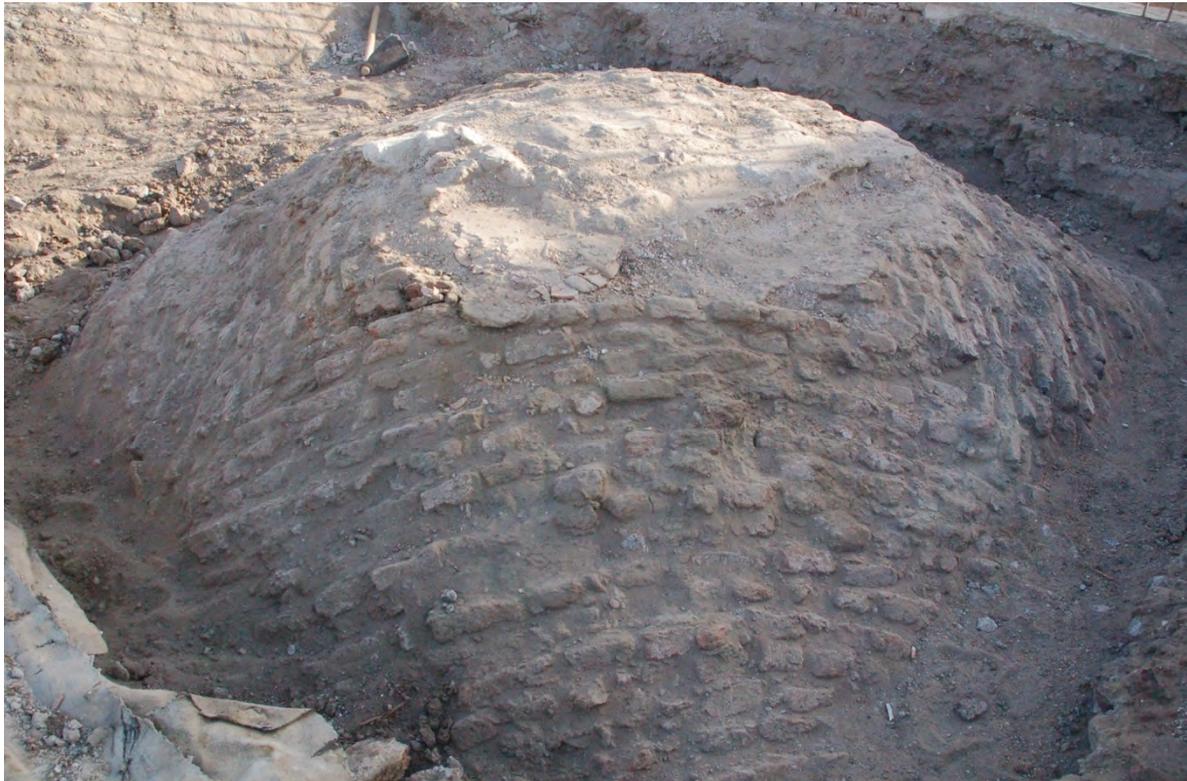
Fig. 7.13 The 'sailor vault' over the southeast room of the first floor of the tower after clearance showing poor quality repair of apex with cement mortar and brick rubble

The two domes and one barrel vault on the eastern half of the roof of the tower are made of bricks set in silt mortar and are in a very poor condition. This has been exacerbated by inappropriate past repairs carried out with cement mortar and rubble. It is unlikely that these structures would survive the removal of these repairs, so it is proposed that they be covered by new protective vaults and that the whole eastern section of the roof be rendered with lime render laid to fall to external rainwater spouts.

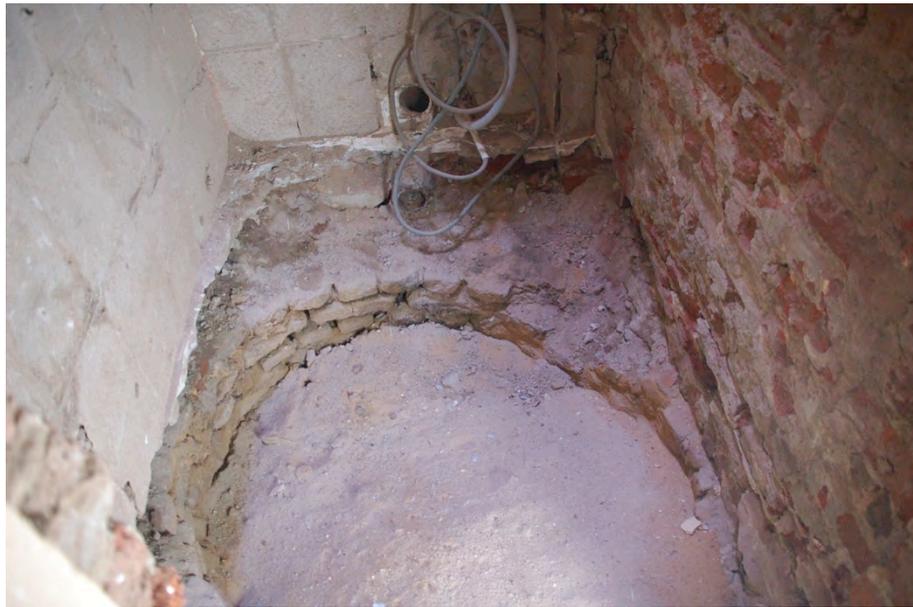
The insertion of the toilet into the well caused the near complete destruction of this key feature of the building and modern replacement brick masonry had failed on the east side of the well owing to the lack of any secure foundation. The defective masonry was propped, and the concrete slab over the well removed. The well was then filled with clean coarse sand to provide a safe working platform. The original diameter of the well was restored with new brickwork set in lime mortar and a new stone foundation to the southeast corner of the masonry surrounding the well was provided. A small opening was left in the south wall of the core to allow future access to the well.

Fig. 7.23 View of well showing damage to masonry caused by insertion of square toilet room, after removal of concrete slab and backfill with clean sand

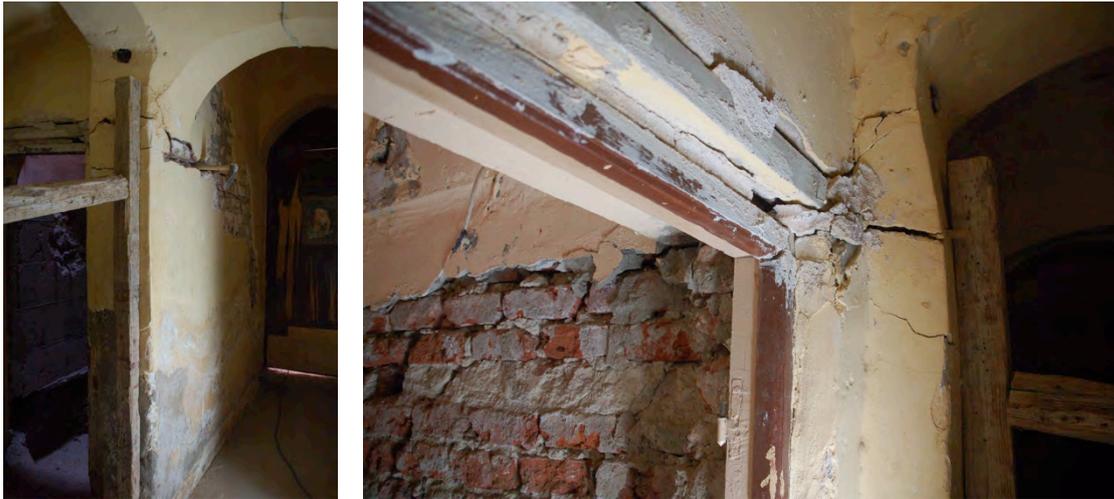
Fig. 7.25 Condition of masonry of southeast corner of staircase core of tower prior to work

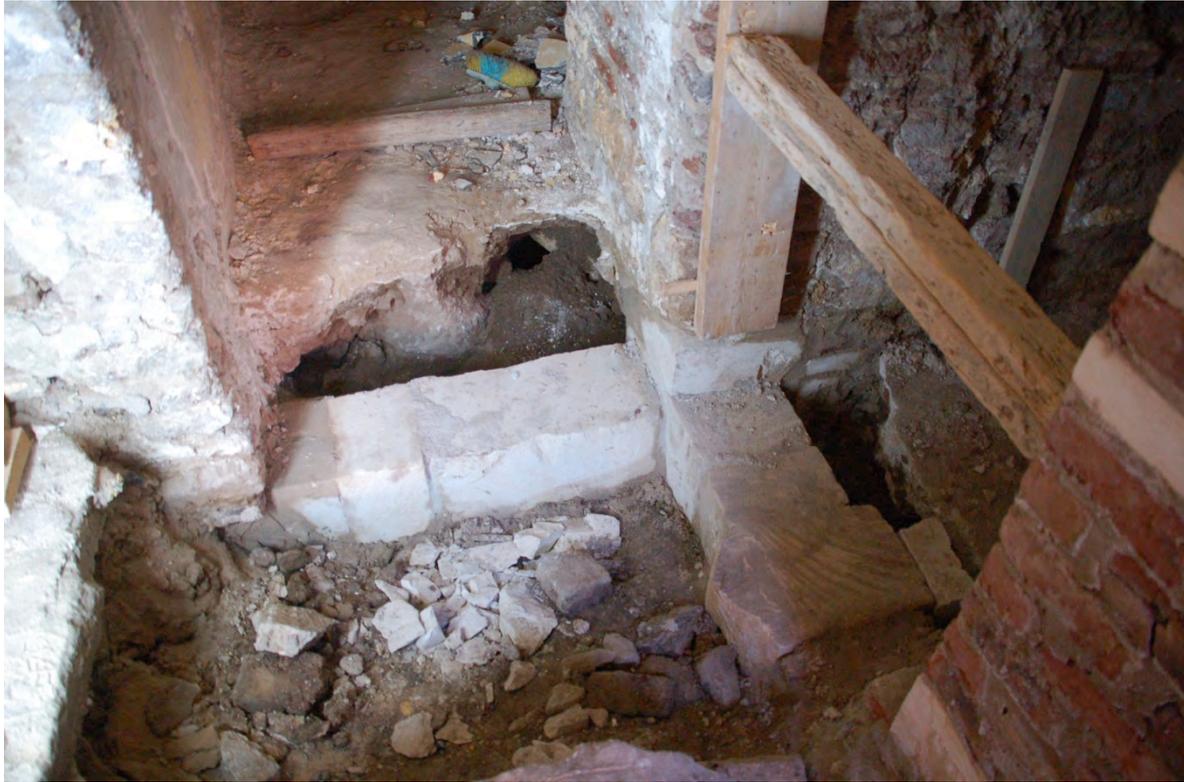
The foundations of the tower, as has been observed above, suffered greatly from water-induced erosion. In some areas, historic repairs had been effected by the insertion of large irregular blocks of gravel underneath the walls and protruding from their face. The strategy employed for the repair of the foundations was to remove as much of the rubble and silt as possible adjacent to the bases of the walls and reintroduce large limestone blocks in their place set in lime mortar with limestone flake packing where needed. In particularly badly damaged locations, such as the ground floor entrance passages, a series of limestone bracing blocks, running across the width of the passages, was introduced. Sometimes these blocks went underneath the walls themselves. The intention was to provide a rigid ‘frame’ at the base of the walls that would prevent any further movement in the walls.

Fig. 7.27 View of the entrance area inside the tower during consolidation work on foundations showing limestone block bracing between eroded sections of the walls. Note, at top, the concrete slab prior to removal with a large void below it.

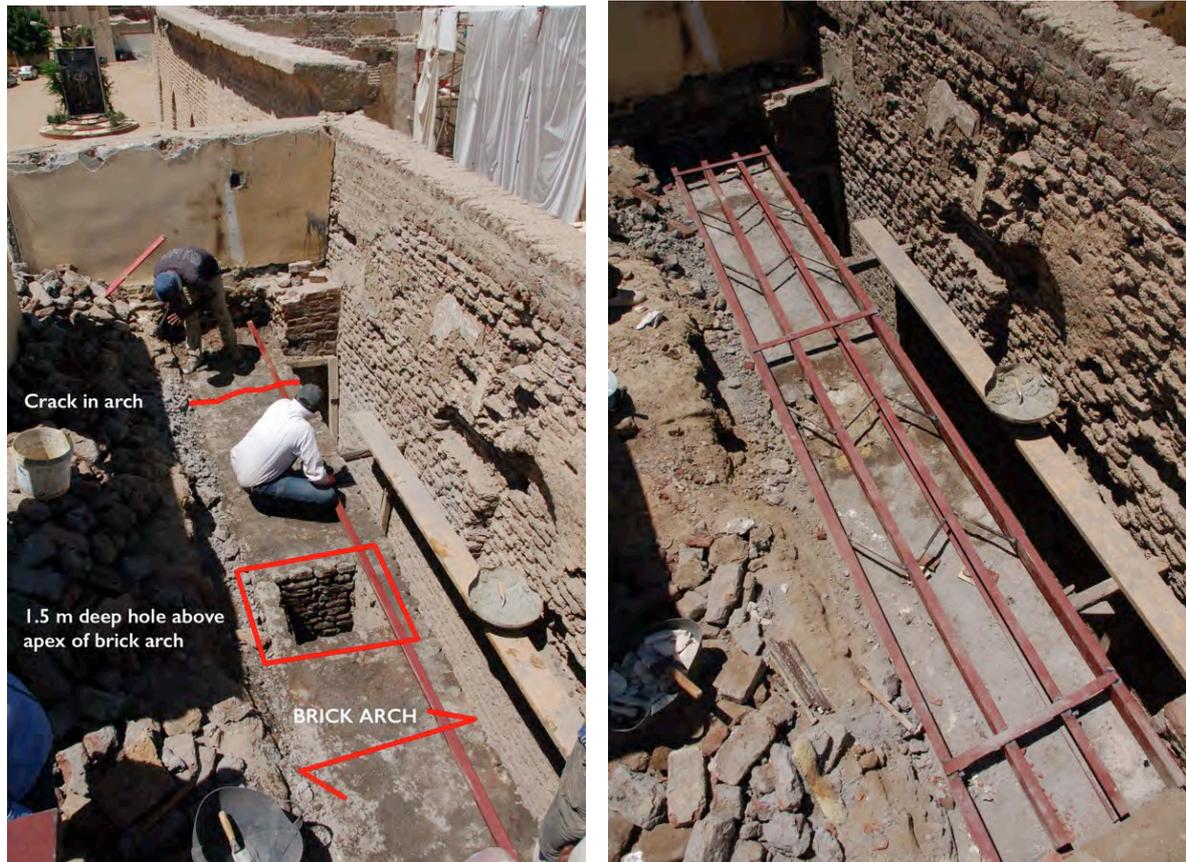
After removal of fill and defective brickwork, a crack was found in the large north arch of the tower at its west end. The masonry of the arch also contained a 50x 50 cm x 1.5 m deep brick lined hole immediately above its apex. To solve these structural deficiencies, four new steel channels 12 cm in depth were introduced in order to minimise any future loading on the arch from the planned superstructure of the tower around the staircase. The hole was packed with dry bricks and sand.

Fig. 7.32 View of the brick north arch of the tower before and after insertion of steel reinforcing beams

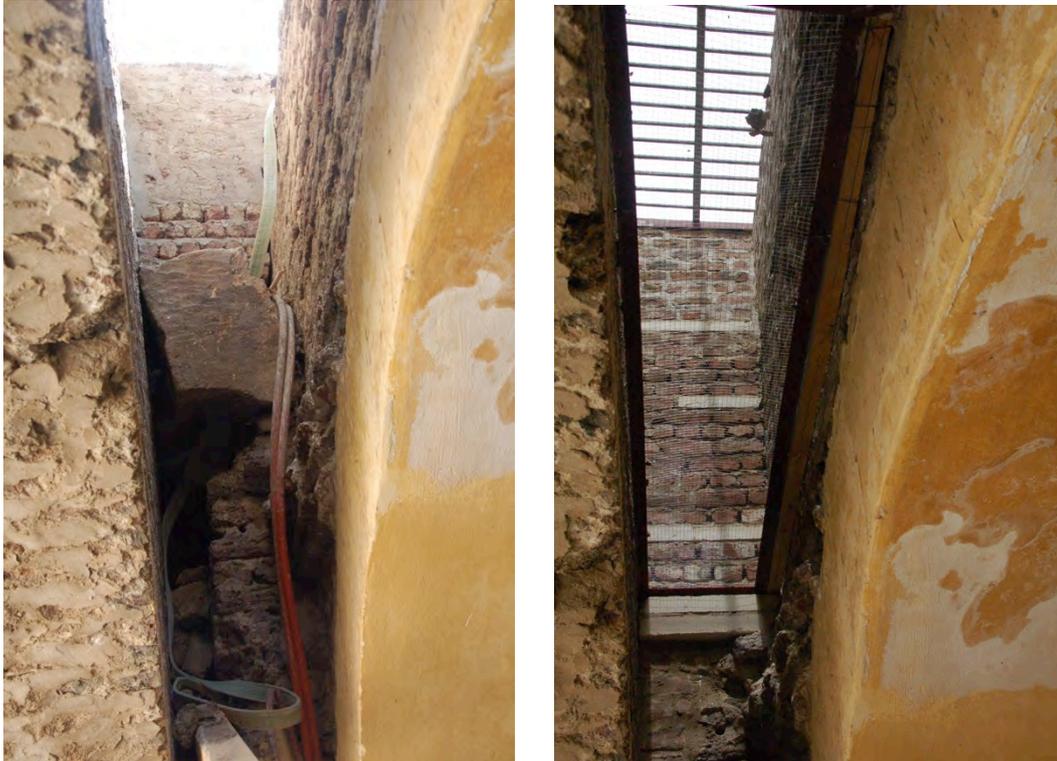
Fig. 7.33 Views of gap between the north wall of the tower and the south wall of the church (east side) showing condition before (left) and after (right) intervention. Note the cornice block wedged between the walls (left) and the new blocking masonry and anti-pigeon screens (right)

The gap between the north wall of the tower and the south wall of the tower was an area so infested by pigeons that it created a health hazard. After completion of new blocking masonry to the full height of the gap, and the consolidation of the top of the arch in the north wall, two pigeon barriers were installed at low and high level. The low level barrier was a steel mesh on a steel angle frame, approximately 45 cm wide and 4.8 m long made in two sections. The

frames can be demounted for cleaning. The upper level barrier is temporary, and consists of a mesh laid over the modified grating that originally covered the gap. This is supported on steel angles running north-south, and will be replaced in a future phase of the project with a stainless steel grating that can be walked on. The level of this grating runs above the existing blank window niche at high level in the south wall of the church.

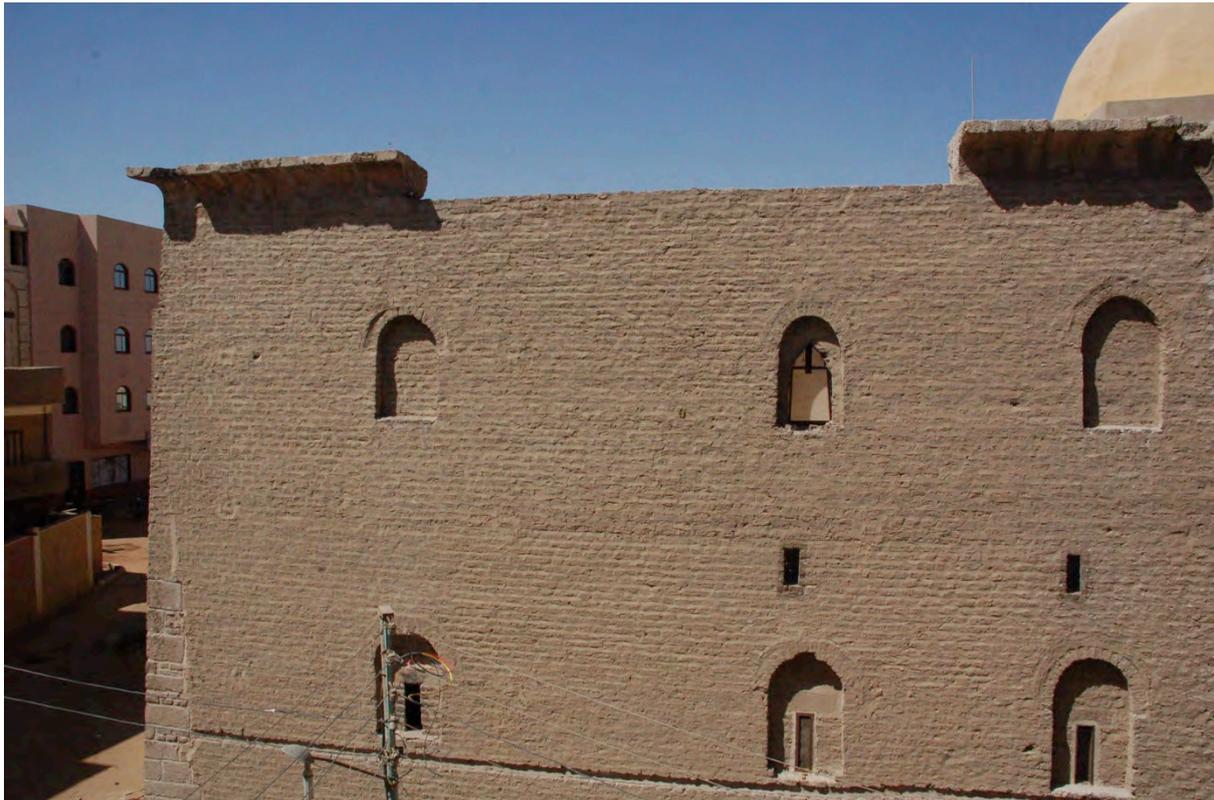
Fig. 8.1 View of the east façade of the church showing the last remaining location of missing cornice blocks

Reinstatement of five original cornice blocks on east façade and additional installation of four linear metres of new limestone cornice blocks (to match originals) in the last remaining location where cornice blocks are missing on the façade. This will complete this distinctive architectural feature of the church.
