**PRELIMINARY FIELD REPORT No1: Vol 2-Final Structural Report**

**DOCUMENTATION and CONSERVATION  
of the SHUNET el ZEBIB MONUMENT  
(c. 2,700 BC) Abydos, Egypt**

**VOLUME 2 - FINAL STRUCTURAL REPORT**

produced by Conor Power, PE, Structural Technology, Inc. for

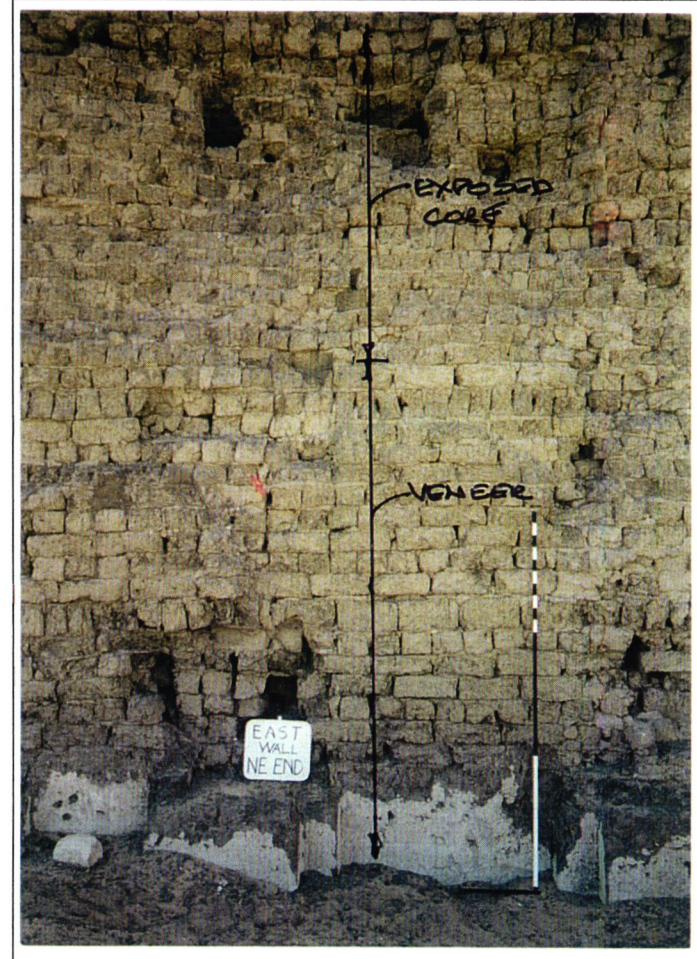
As indicated by example in Photograph Nos. 8 and 9, the exterior veneer has largely disappeared from the upper portions of the construction but very occasionally portions of the two width brick pattern can be discerned. This information, while not of significant structural use can be used to determine the approximate face of the wall and provides a numerical indication of deterioration near the observed location.

Photograph No. 8 Veneer and Exposed Core

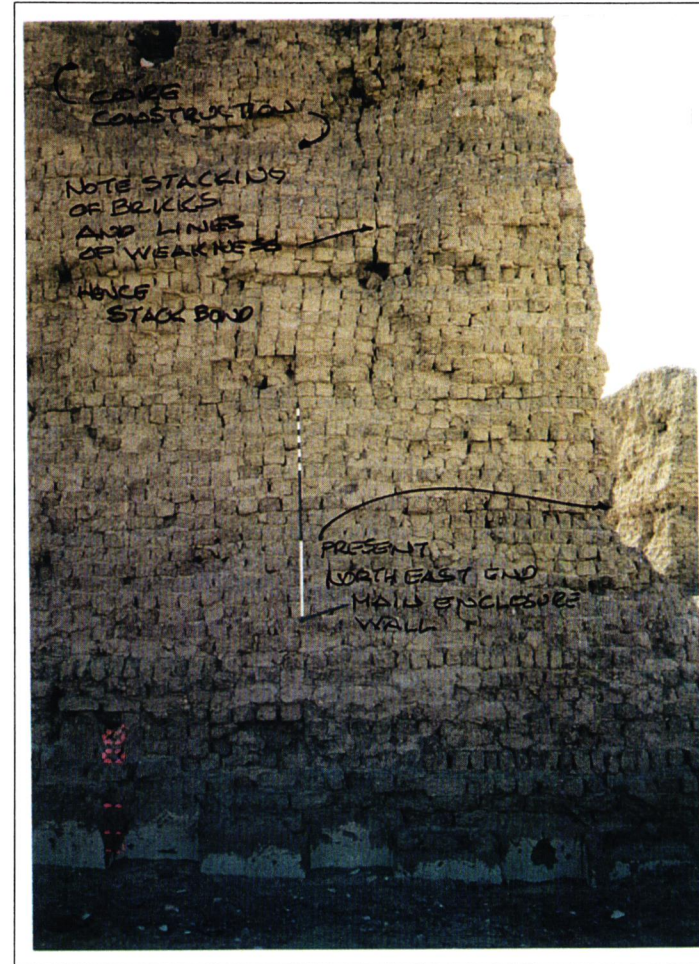
Photograph No. 10 Interior Core Construction

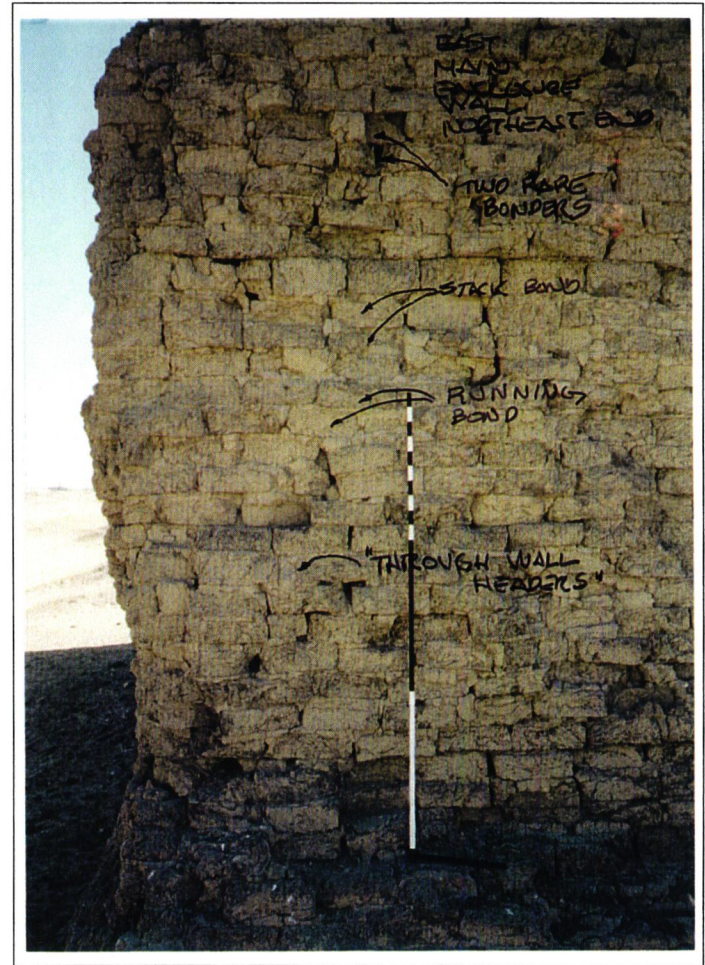
Because of the absence of the veneer noted above, the interior core is the primary structural element of concern today. Its construction is radically different from that of the veneer. Photograph Nos. 9 and 12 illustrate the typical appearance of core brick throughout the Shunet. Note that in elevation as indicated by Photograph Nos. 9 and 10 bricks are stacked one above the other with all of their ends oriented toward the face of the wall. In this state the bricks are said to be stack bonded along the length of the wall. Intuitively, this condition creates vertical lines of weakness and in fact modern building codes require that longitudinal metal reinforcement be added in any construction in which this method of bonding is employed. Note also that the vertical (head) joints, between stacks are generally not well filled with mortar resulting in limited adhesion.

It should be noted that in rare cases these stacks are joined by bonders; two examples are shown in Photograph No. 12. In other situations the bricks in one layer are not stacked but have been laid diagonally along the wall or a joint reinforcement using fiber matting has been employed in the bed joints. We must stress, however, that such situations are rare.

In marked contrast, a section through the wall, depicted by Photograph Nos. 11 and 12, indicates that the construction in transverse section is characterized by bricks that generally overlap one another in a lengthwise arrangement known as running bond. In the transverse direction, therefore, the walls may be considered to be highly resistant to vertical cracking.

Photograph No. 12 Transverse View Core

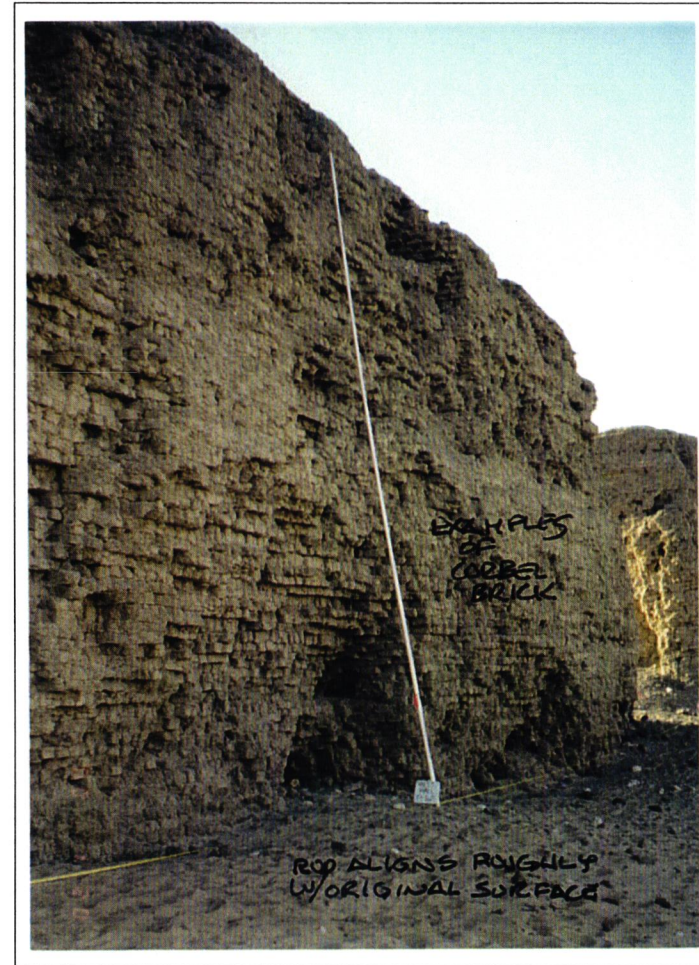
One other feature of such construction is that bricks will tend to corbel over degraded areas and large openings rather than arch over them. Arching refers to the ability of brick to span longitudinally over openings. Corbelling simply refers to bricks which are stepped upward and outward from the wall. Photograph Nos. 14 and 15 illustrate areas where corbelling predominates; the west wall shown is severely undercut, but, due to the strength of construction in the transverse direction, failure of the upper section has not taken place. Similarly, the resulting ovoid surface shape over the large monastic cells shown in Photograph No. 16 and many other openings present elsewhere results primarily from corbelling rather than arching. Note that the corbelling present in one of the cells extends nearly to the top of the wall. This construction property is of great use when structurally evaluating the significant observed defects in the present structure.

Photograph No. 14 Corbelled Brick Example

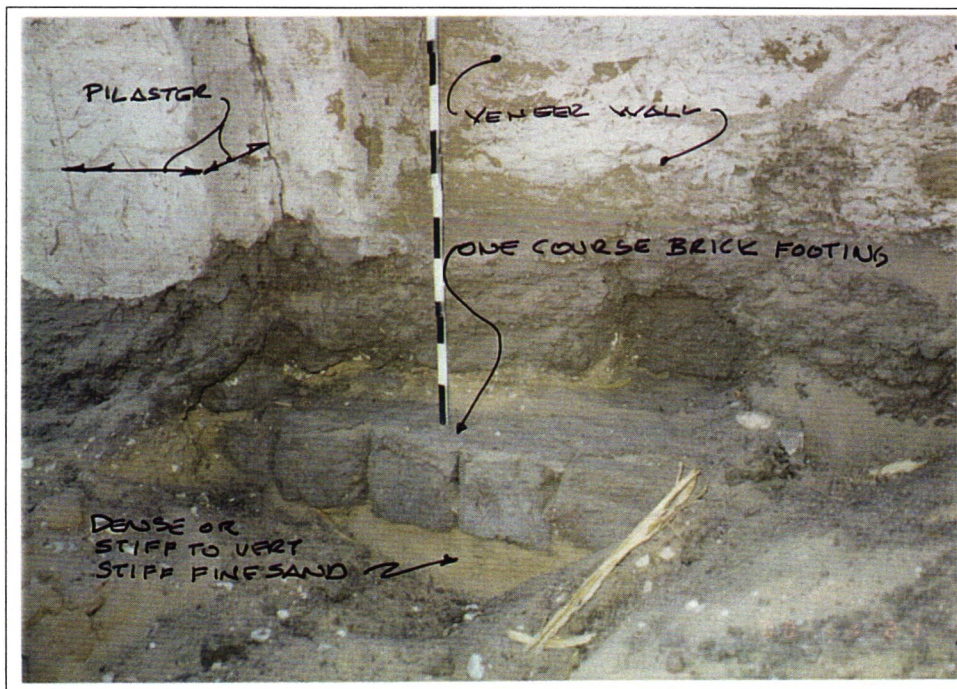
Two local excavations were undertaken by Matthew Adams, Associate Project Director that were used to determine the foundation properties for the structure. As depicted by Photograph No. 18 the Shunet's walls and pilasters rest upon a one course thick brick footing that bears on what can be described as a "dense or stiff to very stiff fine sand". The most common method of determining soil bearing capacities today consists of using a Standard Penetration Test during soil boring operations. The test involves the use of a 140 pound hammer, a split barrel sampler and requires a boring rig. While producing accurate results for different strata, the use of this method is somewhat impractical at Abydos and in the author's opinion unnecessary for the following reasons:

Photograph No. 18 Foundation Characteristics

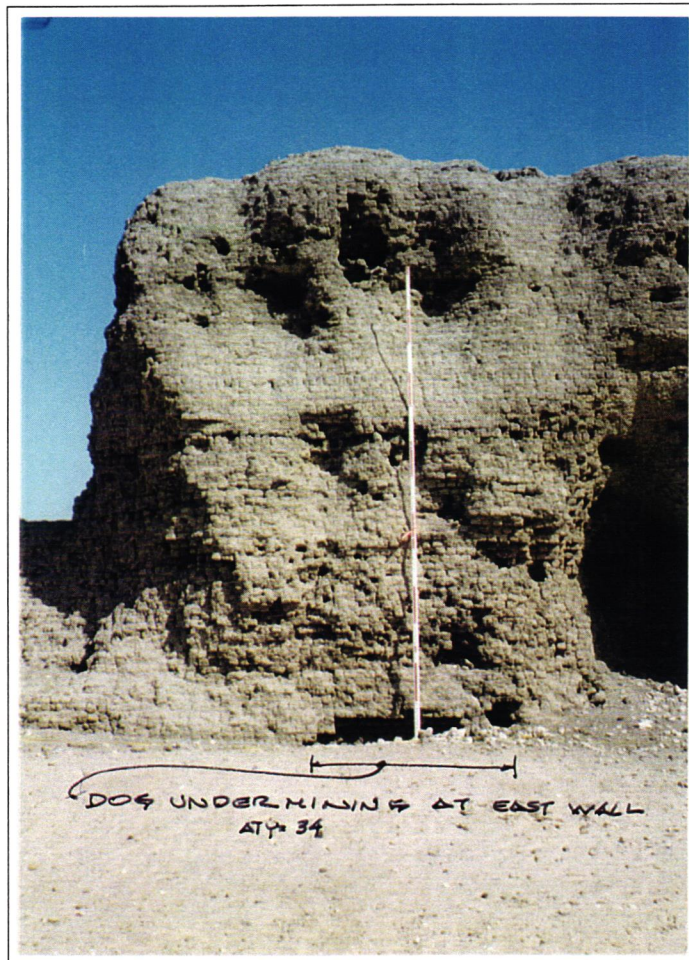
Photograph No. 19 Base Undermining

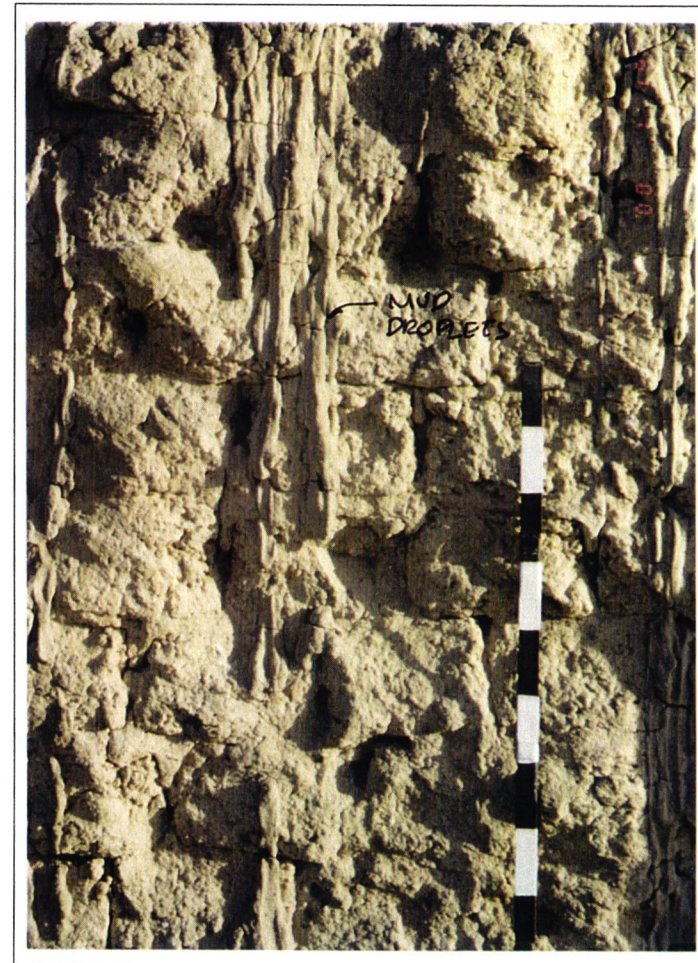
Photograph No. 24 Mud Wash and Droplets

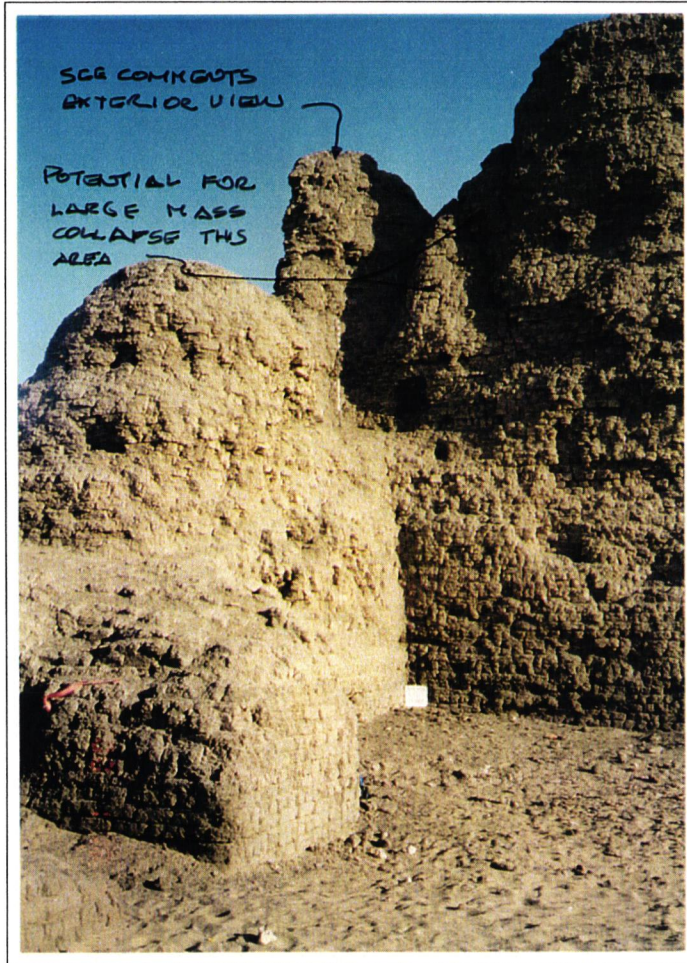
Photograph No. 31 Southeast Corner Cracking

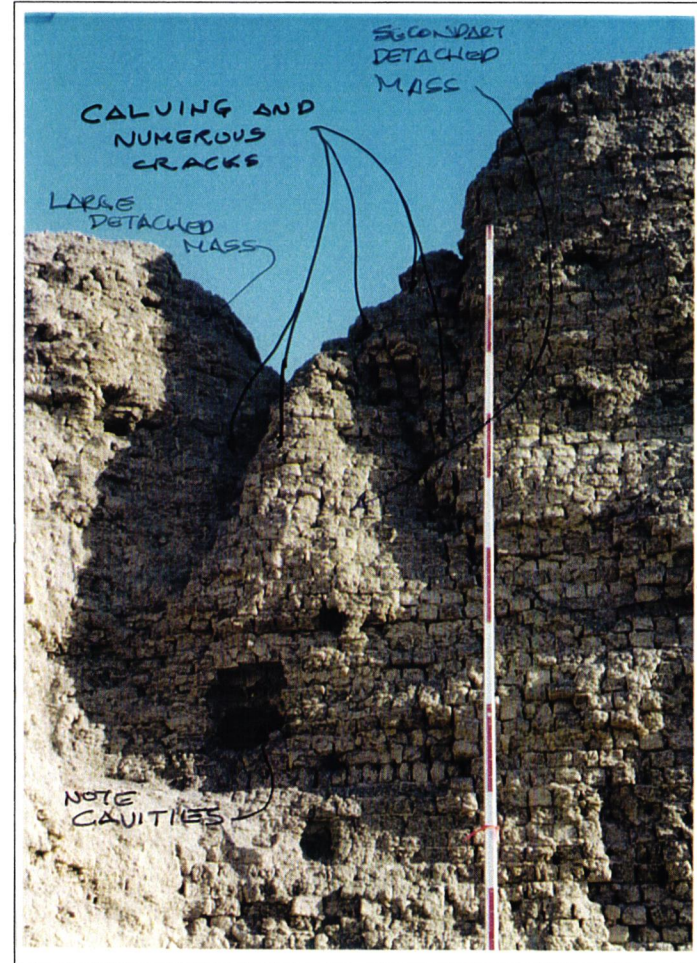
Photograph No. 32 Southeast Corner Cracking

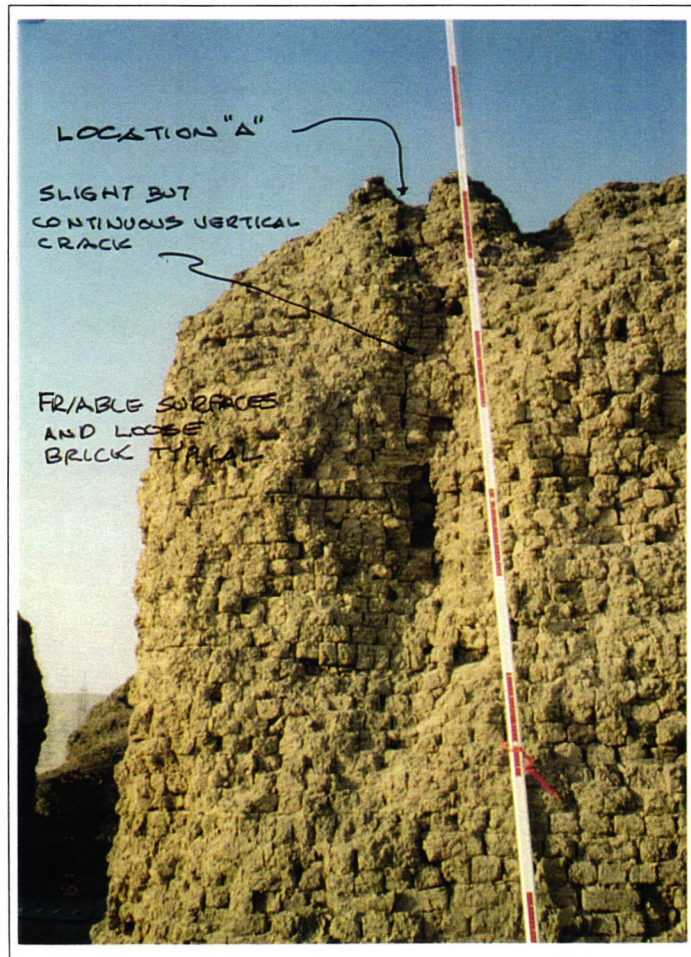
Photograph No. 36 Location "A" Vertical Wall Crack

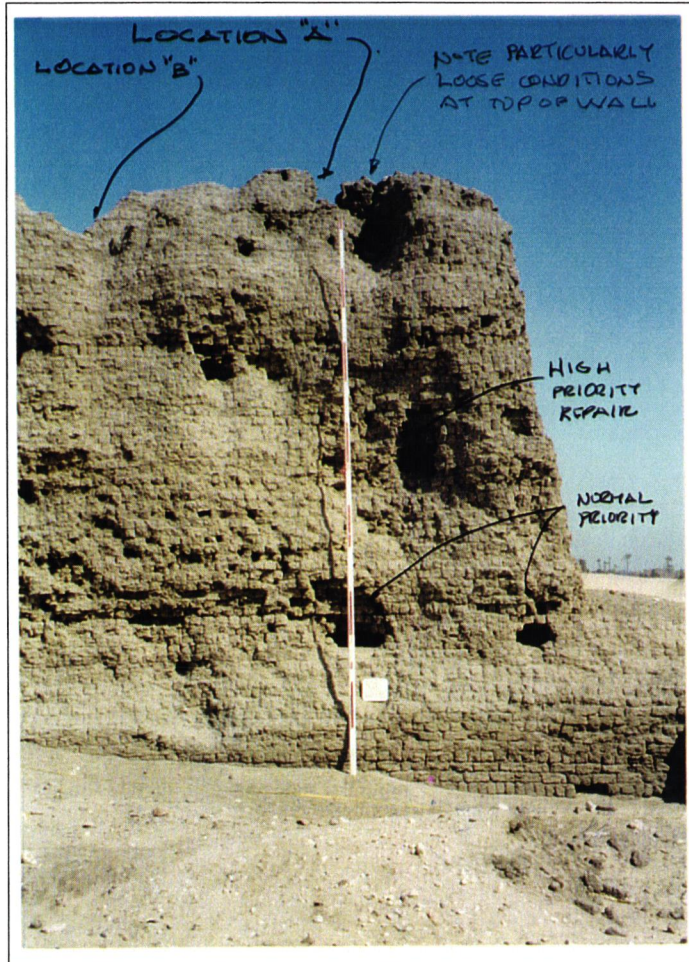
Photograph No. 37 Location "A" Vertical Wall Cracking

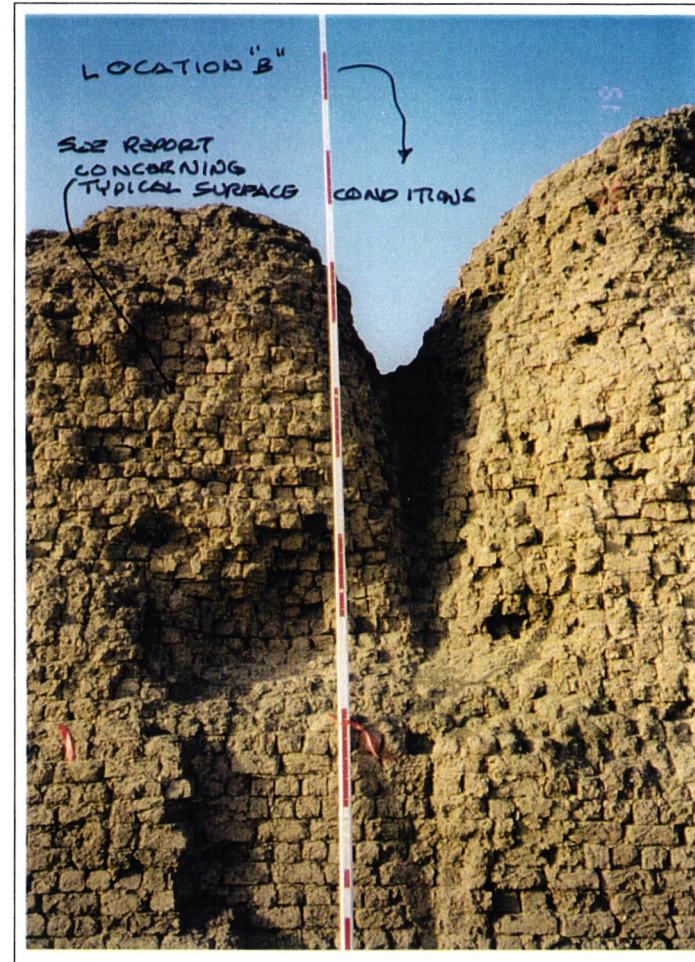
Photograph No. 38 Erosion at Location "B"

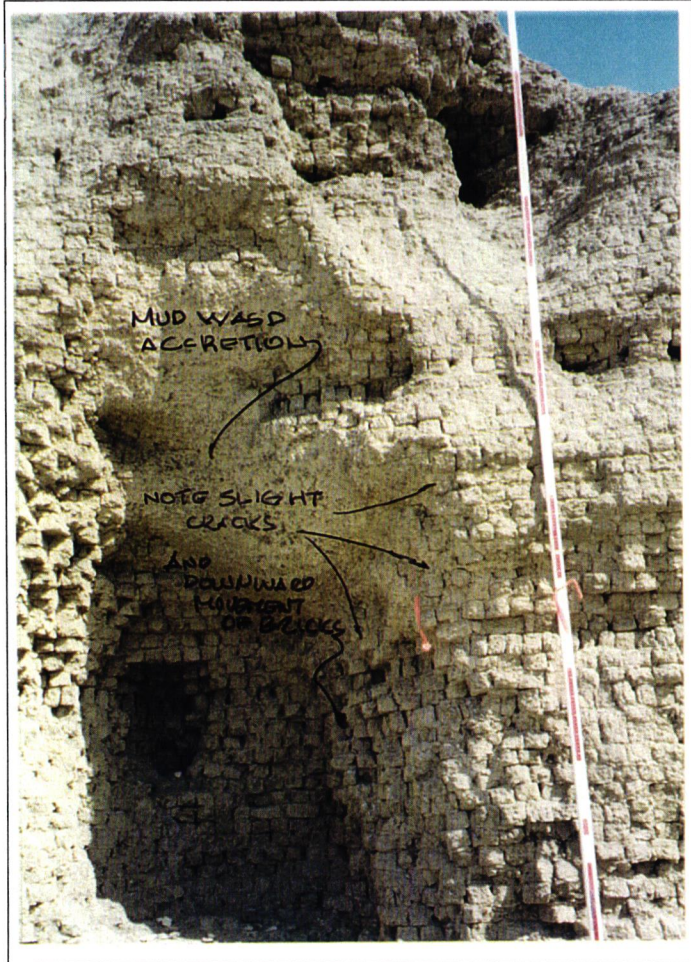
Photograph No. 41 Cracking at Location "F"

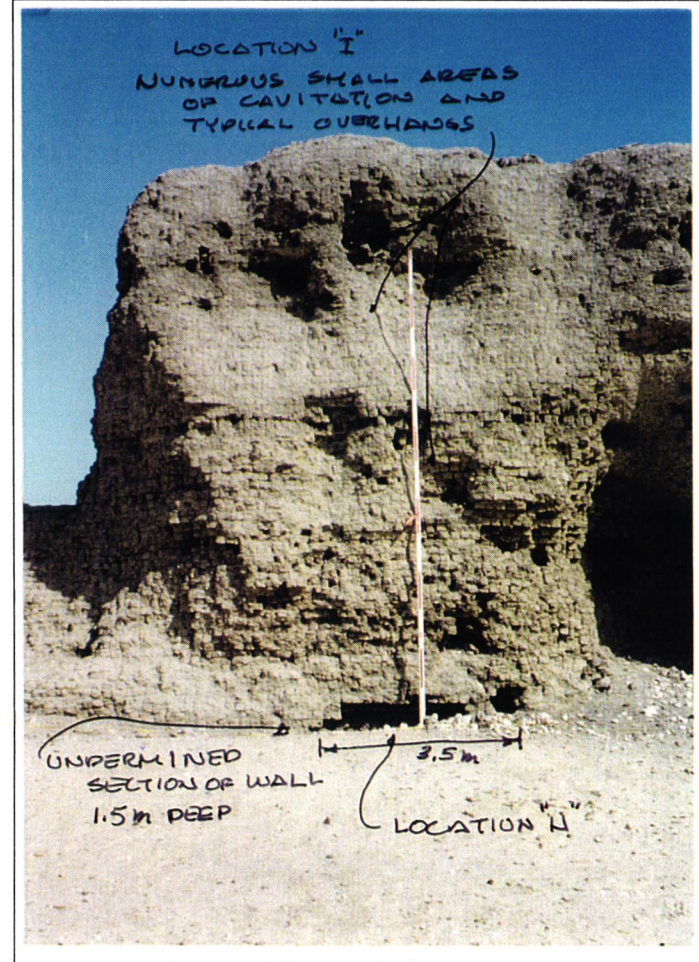
Photograph No. 42 Undermining at Location "H"

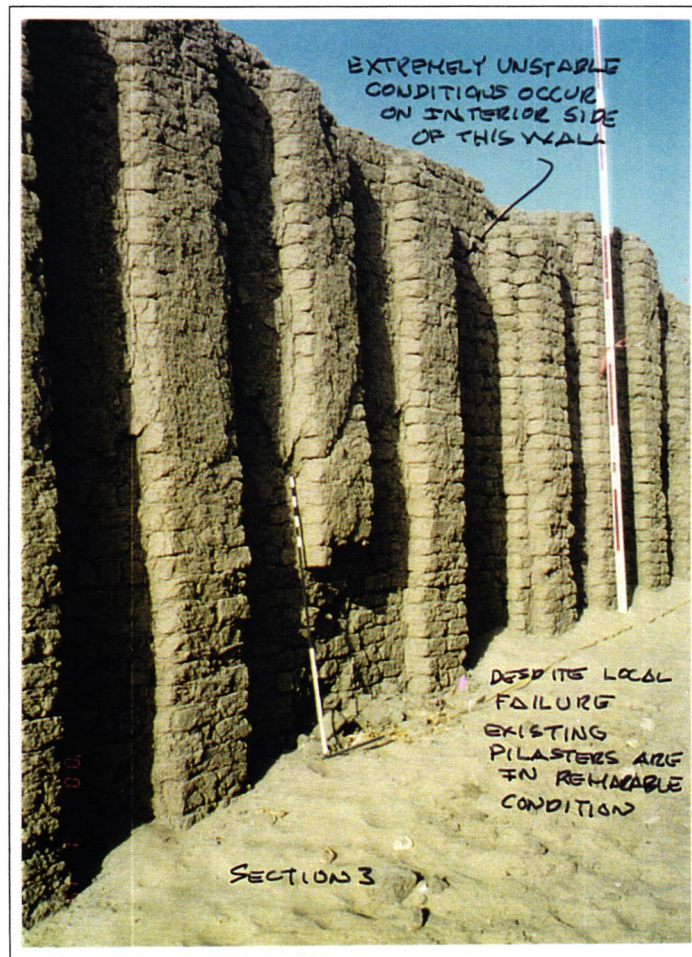
Photograph No. 46 Local Failures at East Main Enclosure Wall

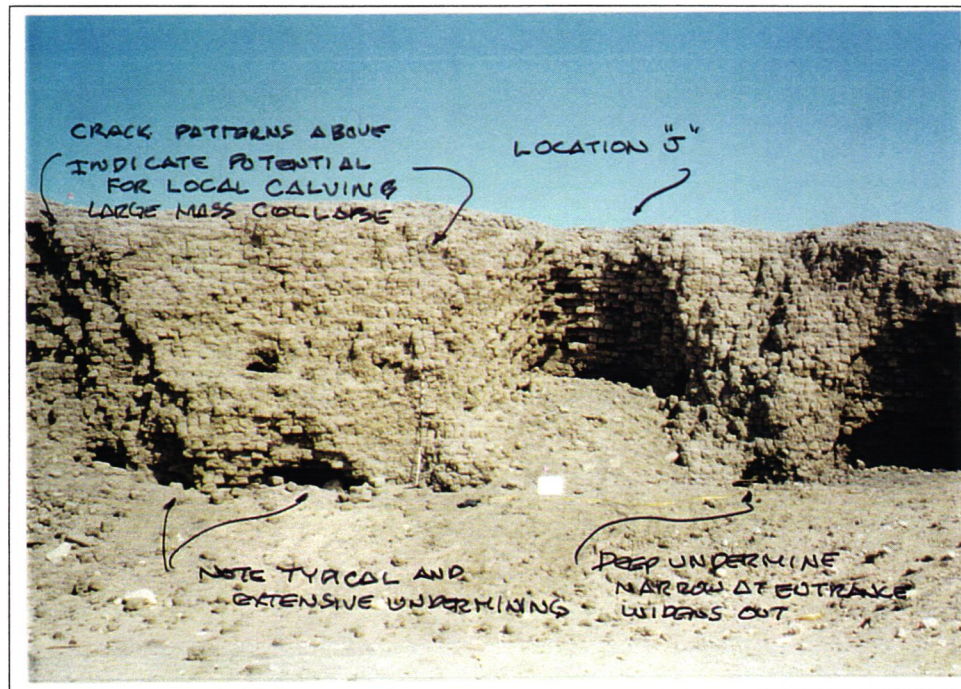
Photograph No. 48 Failures at "Section 3"

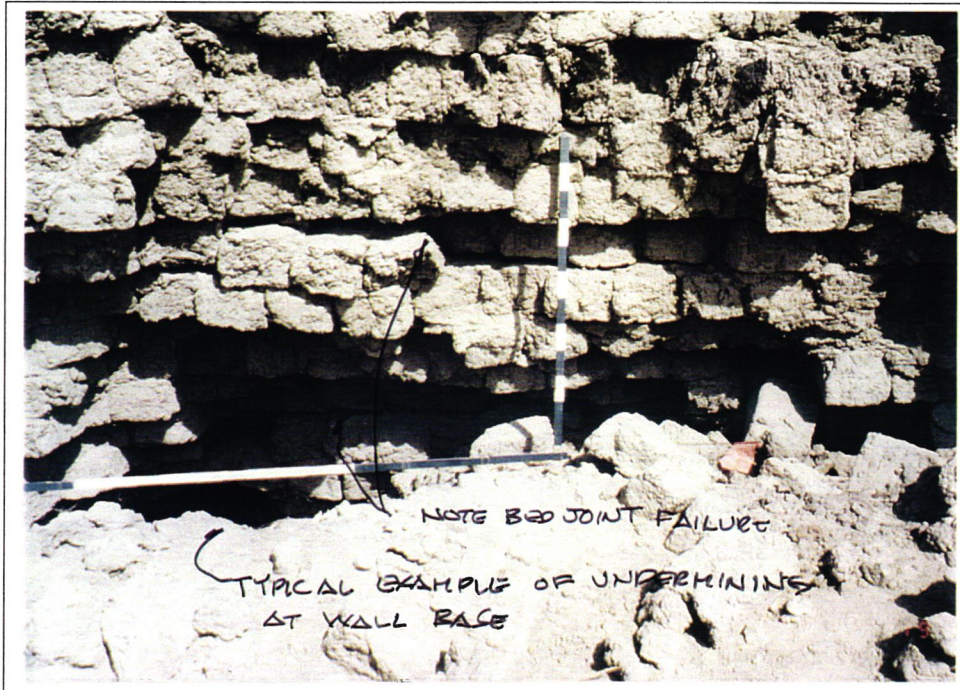
Photograph No. 49 Undermining at East Main Enclosure Wall

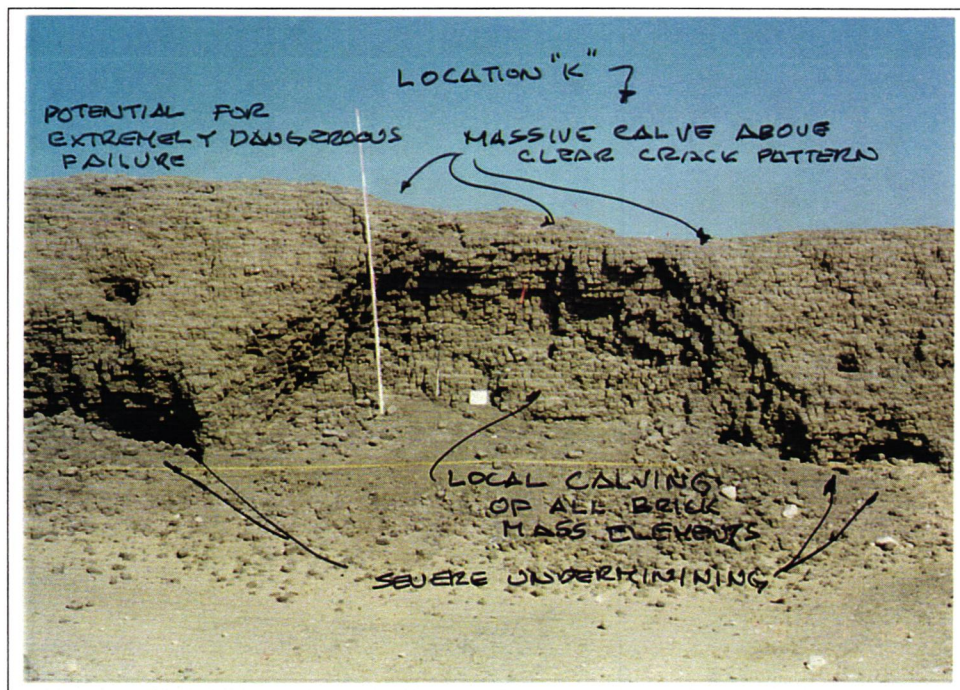
Photograph No. 52 Failures at "Section 3" Interior

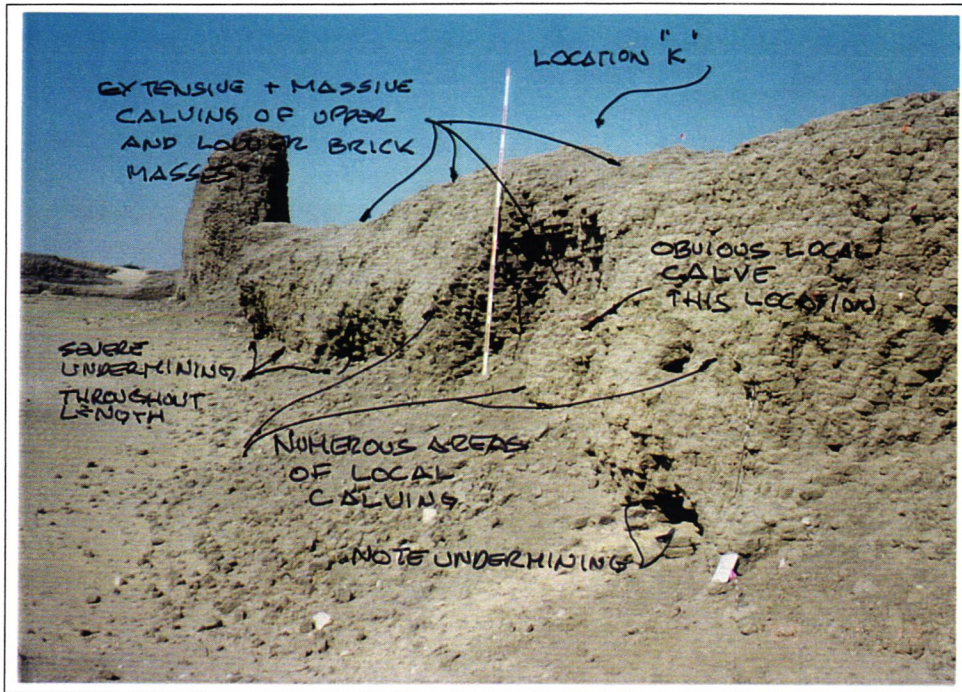
Photograph No. 53 Massive Calving at "Section 3" East Main Enclosure Wall

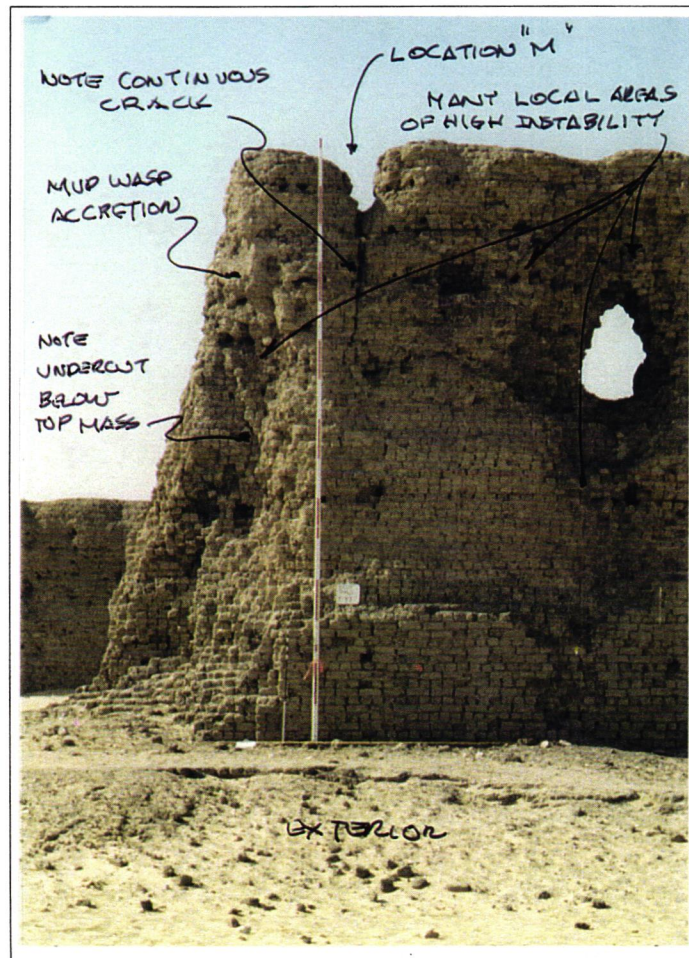
Photograph No. 58 Cracking at South End of "Section 4"

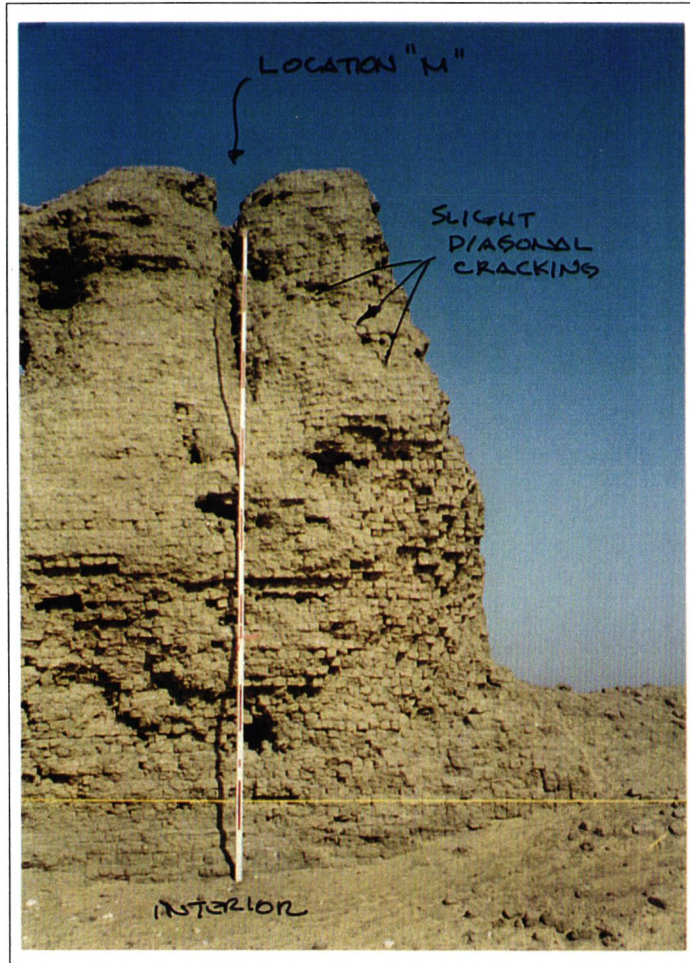
Photograph No. 59 Cracking at South End of "Section 4"

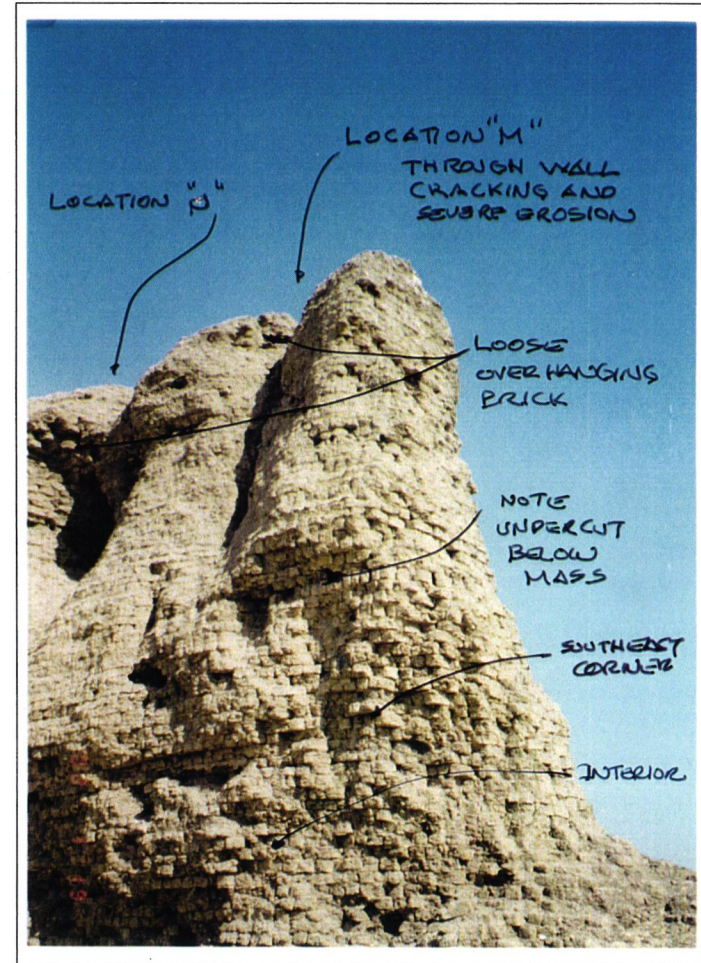
Photograph No. 60 Cracking at South End of "Section 4"

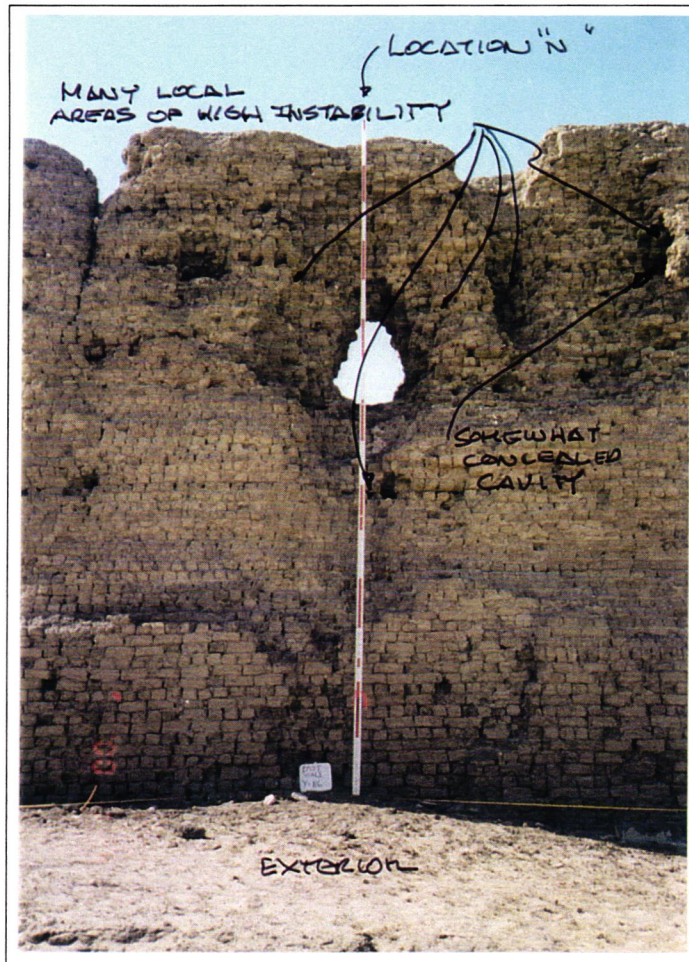
Photograph No. 61 "Section 4" Deficiencies at Location "N"

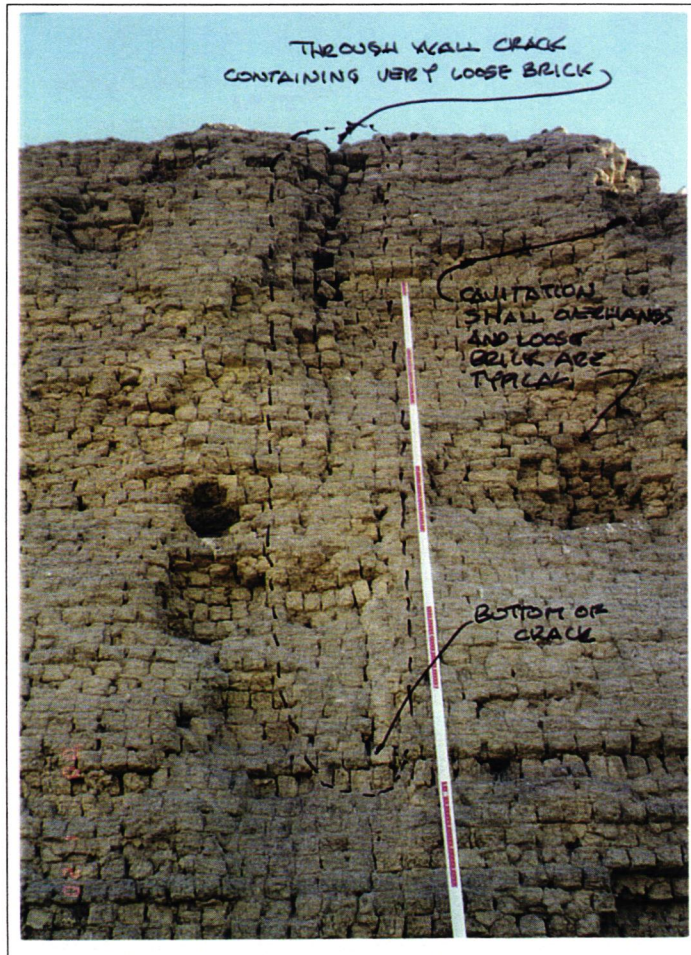
Photograph No. 73 Vertical Cracking Near Location "B"

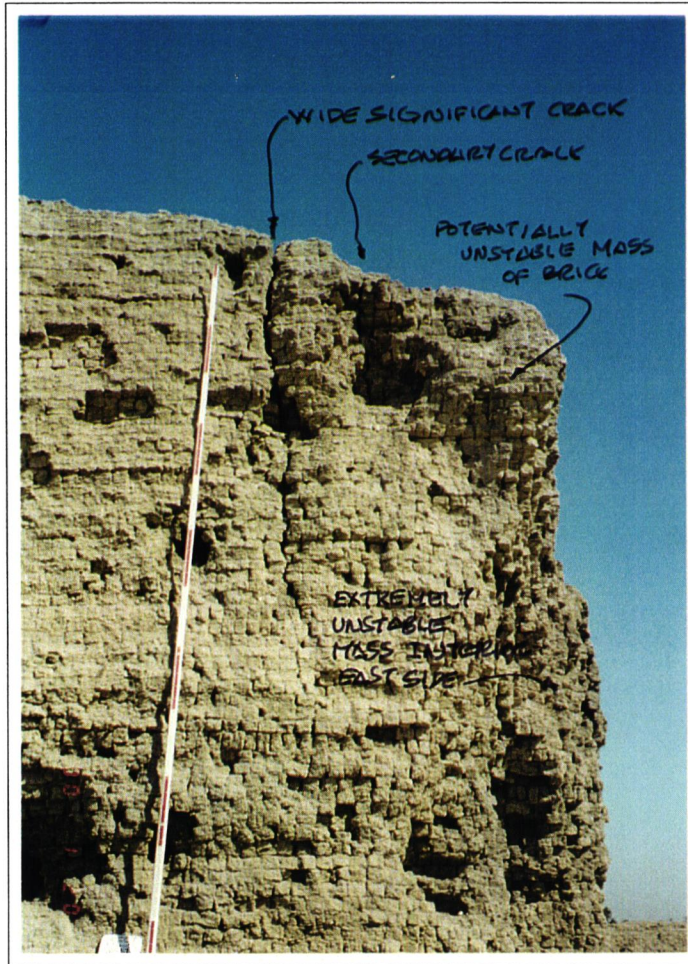
Photograph No. 91 Instability at North Side West Entrance

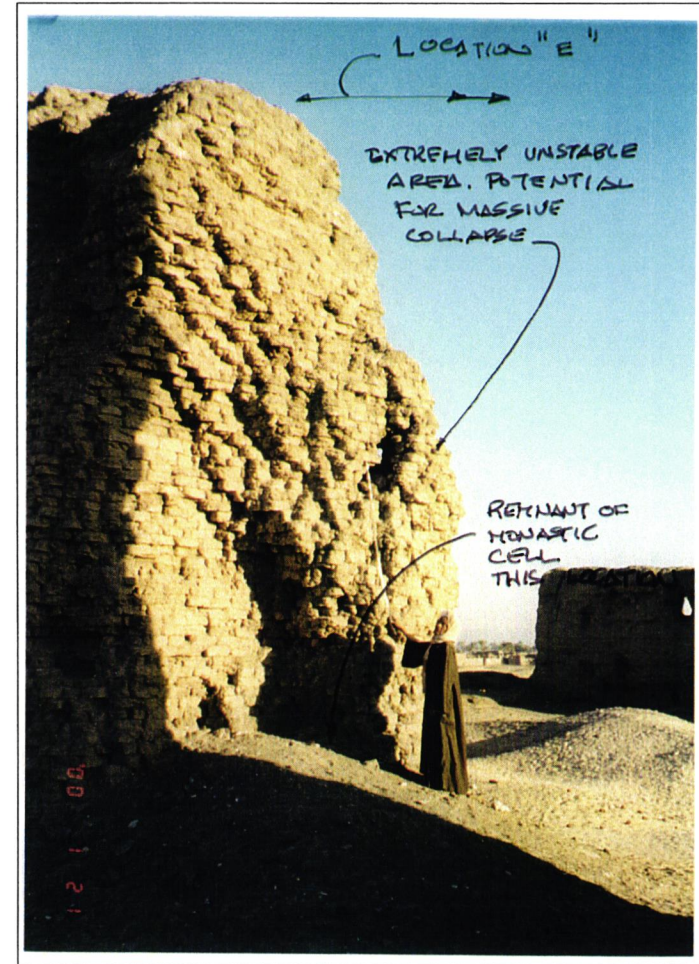
Photograph No. 92 Potential Failure Location at West Entrance

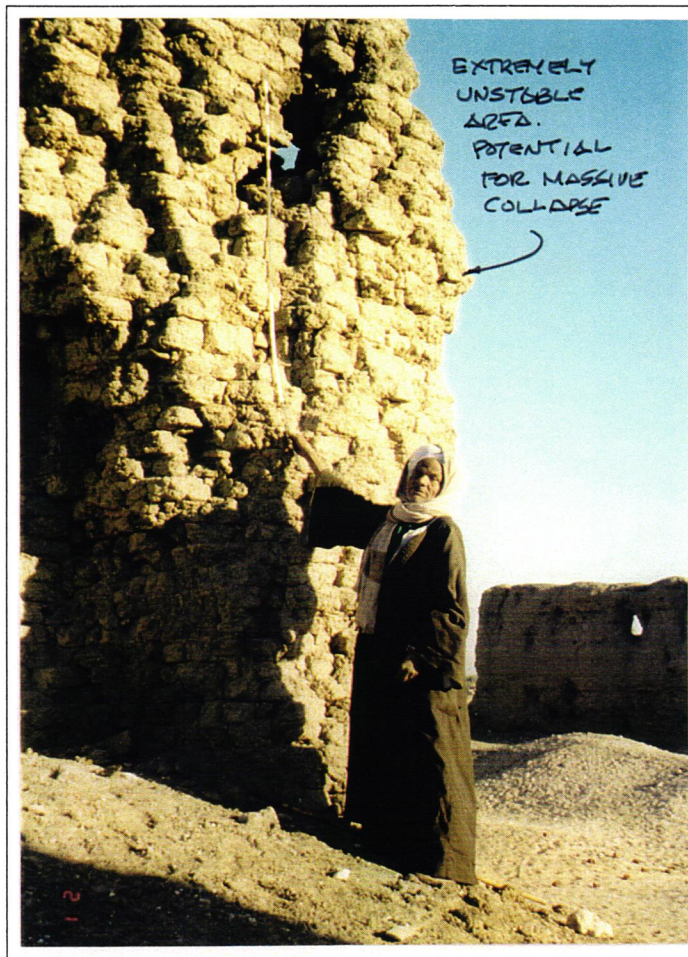
Photograph No. 93 Potential Failure Location at West Entrance

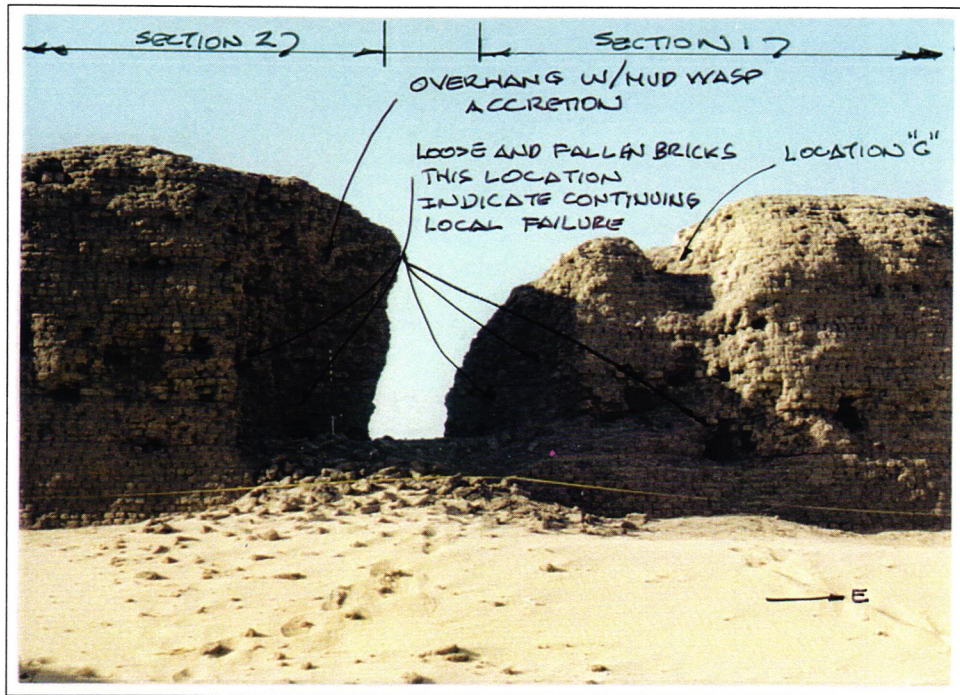
Photograph No. 107 Central Failure North Main Enclosure Wall

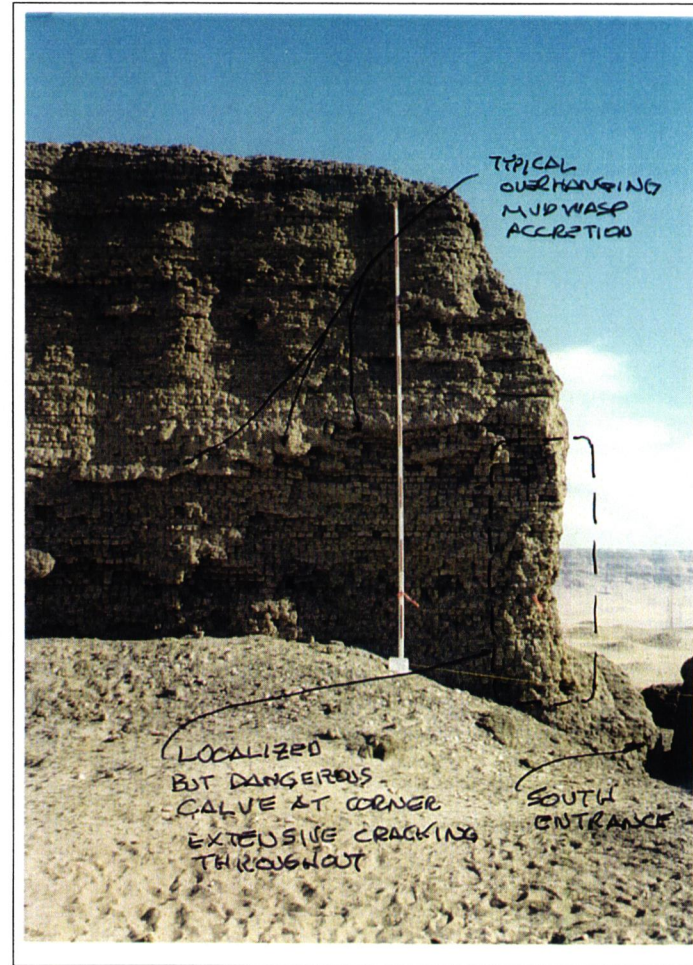
Photograph No. 125 Unstable Corner Near South Entrance

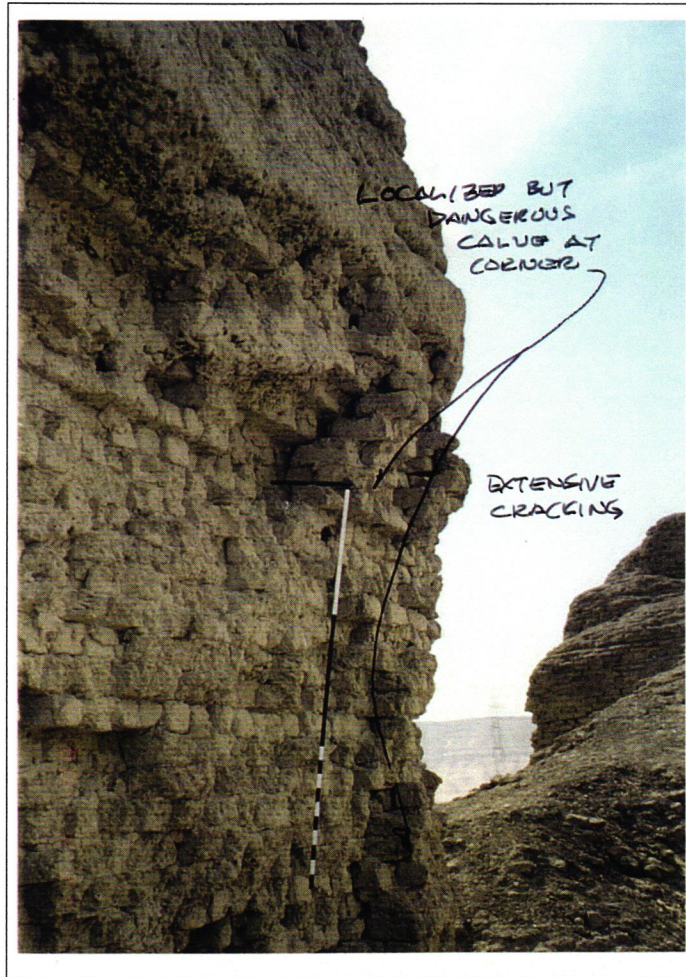
Photograph No. 126 Detail View of Dangerous Corner Near South Entrance, South Main Enclosure Wall
