PRELIMINARY FIELD REPORT No1: Vol 3-Mud Brick Conservation

**DOCUMENTATION and CONSERVATION
of the SHUNET el ZEBIB MONUMENT
(c. 2,700 BC) Abydos, Egypt**

**PRELIMINARY FIELD REPORT NO. 1
(IN THREE VOLUMES)**

**VOLUME 3 - MUD BRICK CONSERVATION
FIELD REPORT No. 1**

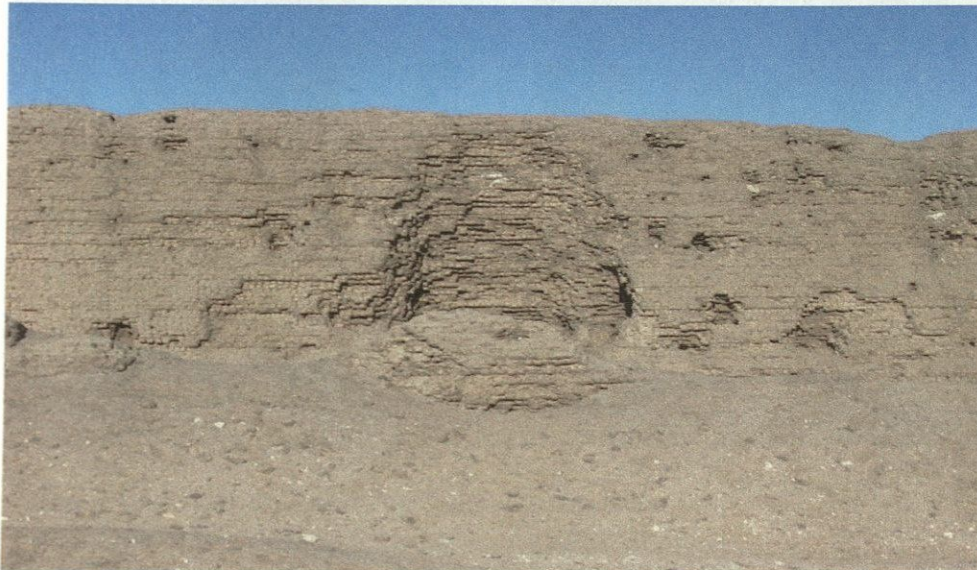
Figure 4: A detail of the west side of the west wall showing the visual impact of one of the Coptic cells cut into the wall.

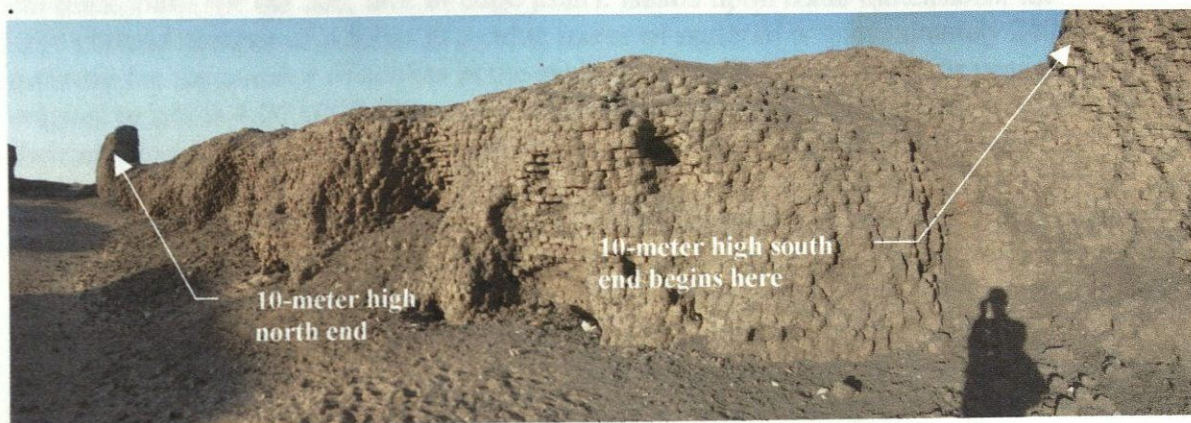
Figure 13: A panorama of the east wall. The image distorts the length of the wall but the relative similar height of this center portion does not appear to be the result of a normal natural decay process.

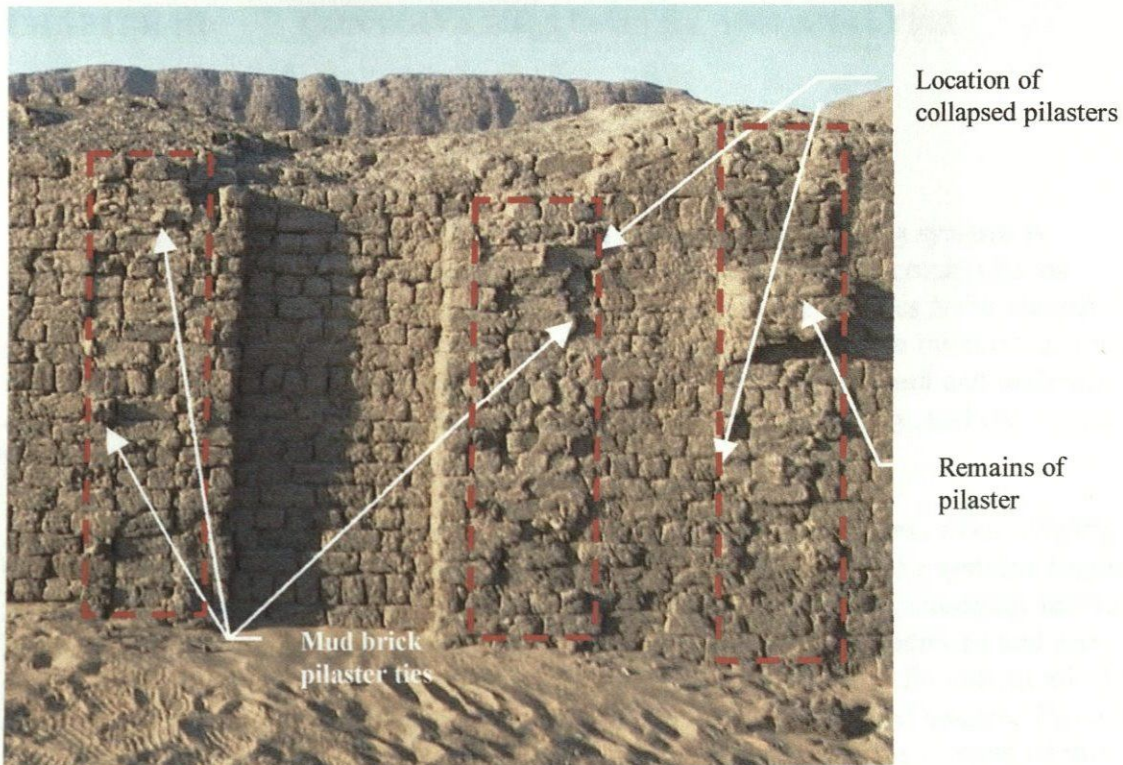
Figure 17: Detail of pilasters on east wall showing locations of missing pilasters and remains of the mud brick ties.

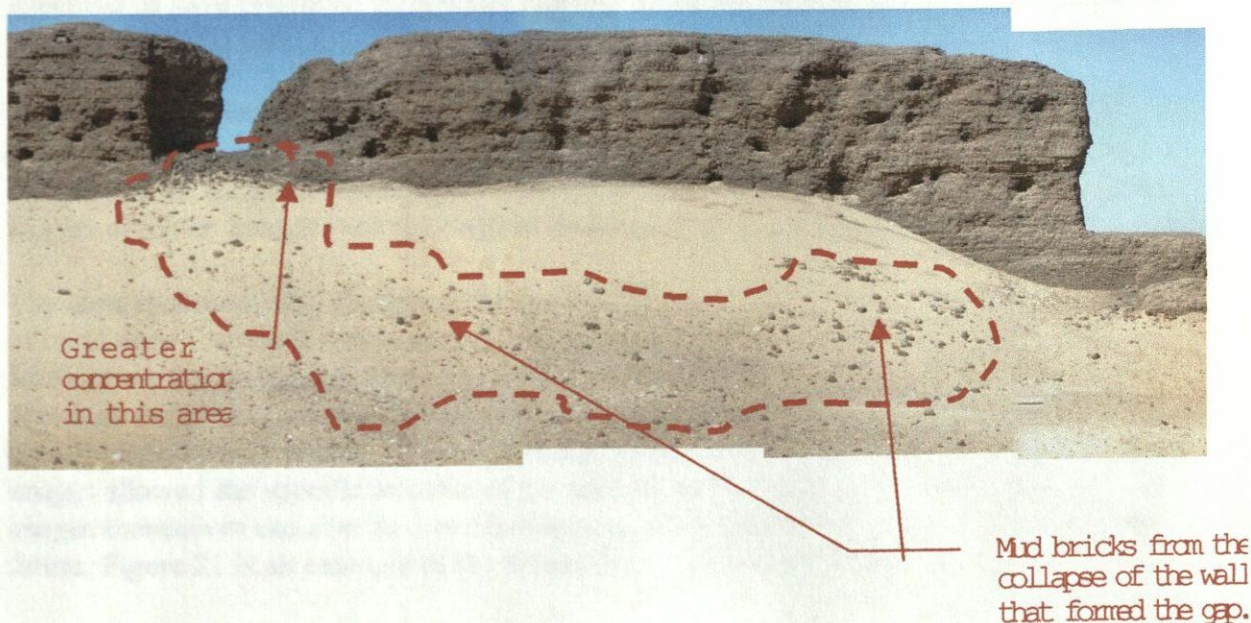
Figure 19: A digitized composite image of the south elevation of the north wall showing the gap and the accumulation of mud bricks, which probably came from the collapse.

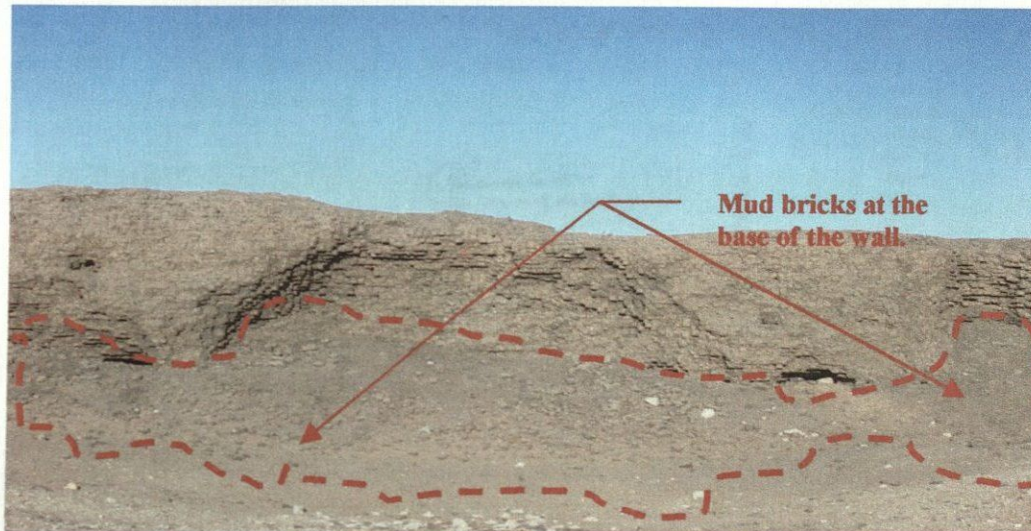
Figure 20: Center portion of the east elevation of the east wall showing a large accumulation of mud bricks on the surface of the ground.

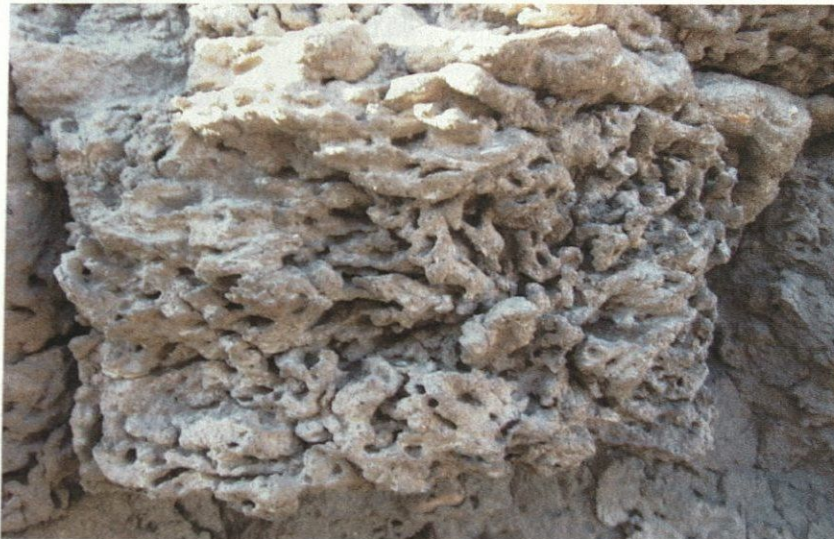
Figure 22: Detail of a typical mud brick that has these same surface decay patterns through its matrix.

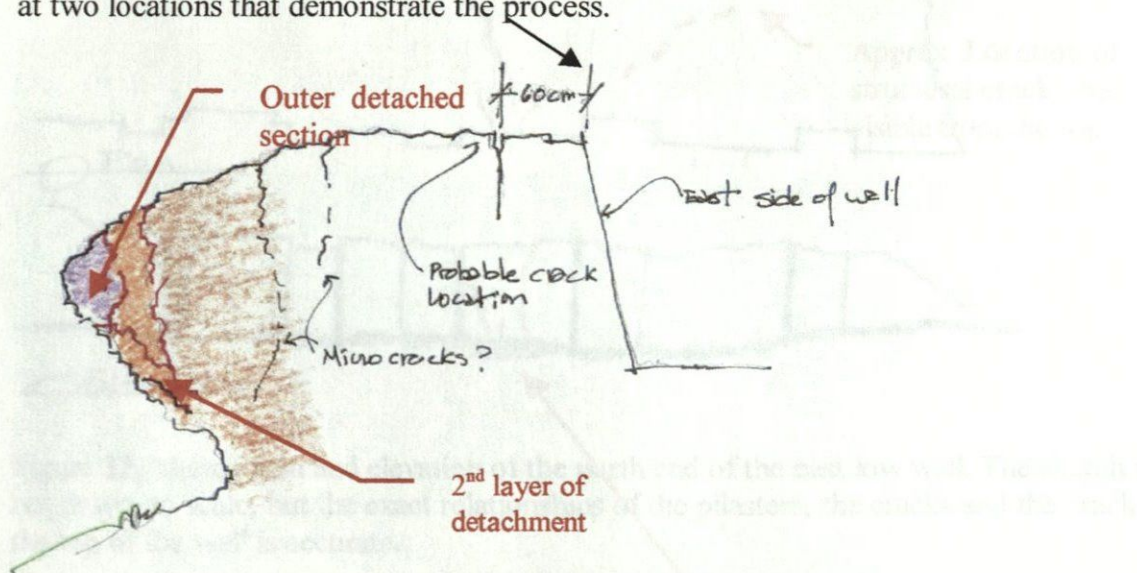
Figure 30: Sketch Section showing the typical detachment sequence on the west side of the east wall looking south.

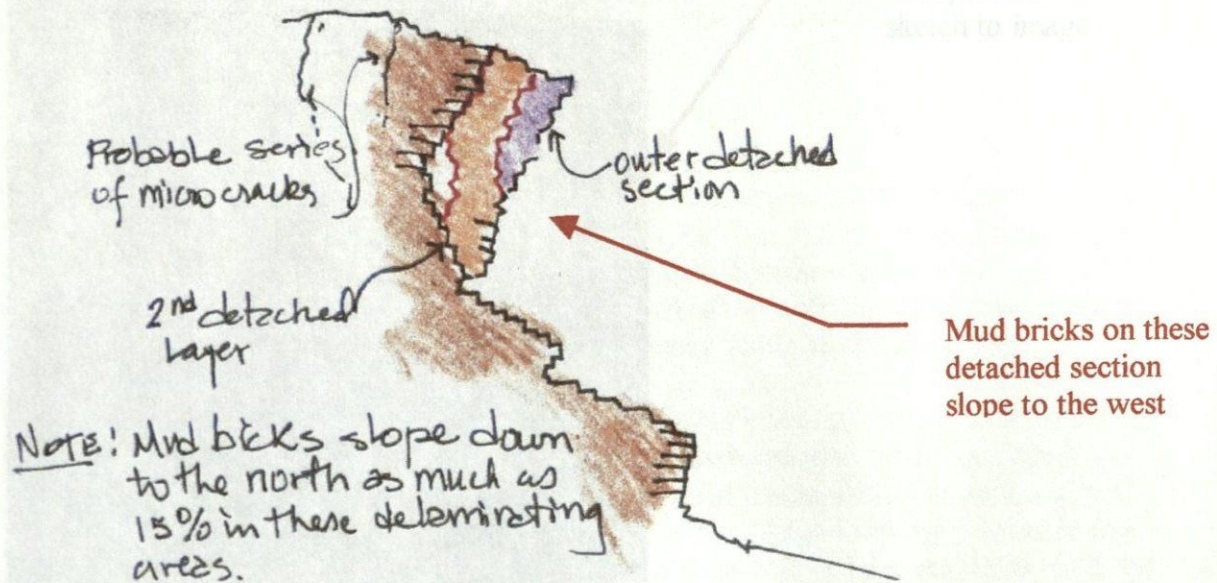
Figure 31: Sketch of detachment of the east wall near the south end of the low center section looking south.

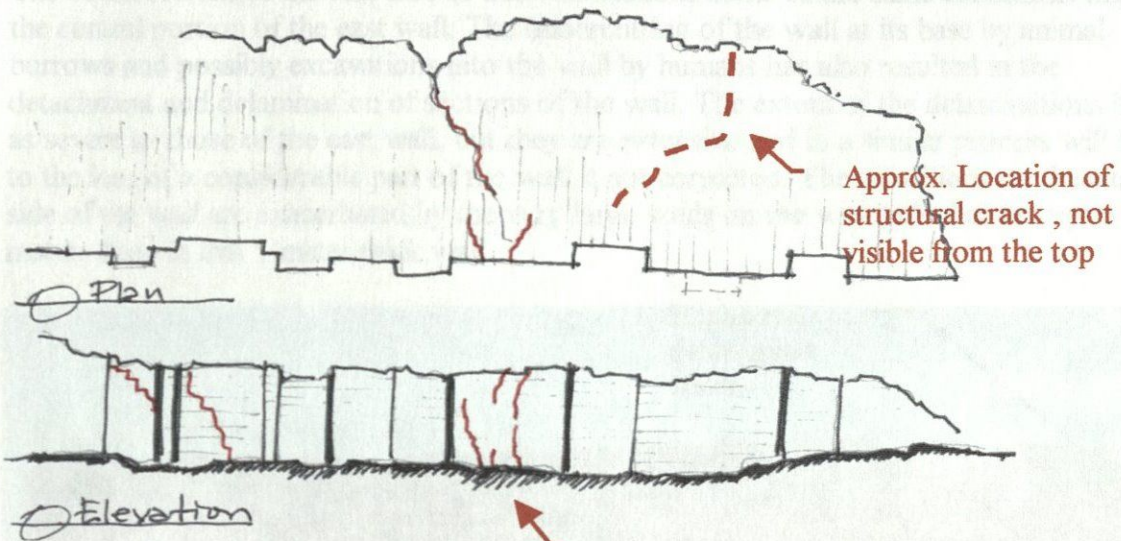
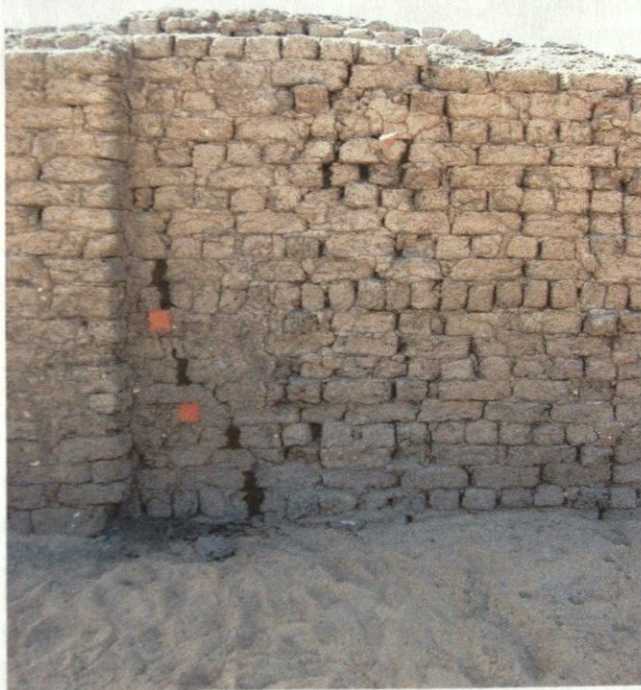
Structural crack extend completely through the wall as well, and may be related to the overall stresses placed on the structure by the undercutting of the wall. Figures 32, and 33, show one area where this is occurring.

Figure 32: Sketch plan and elevation of the north end of the east low wall. The sketch is not drawn to scale, but the exact relationships of the pilasters, the cracks and the crack on the top of the wall is accurate.

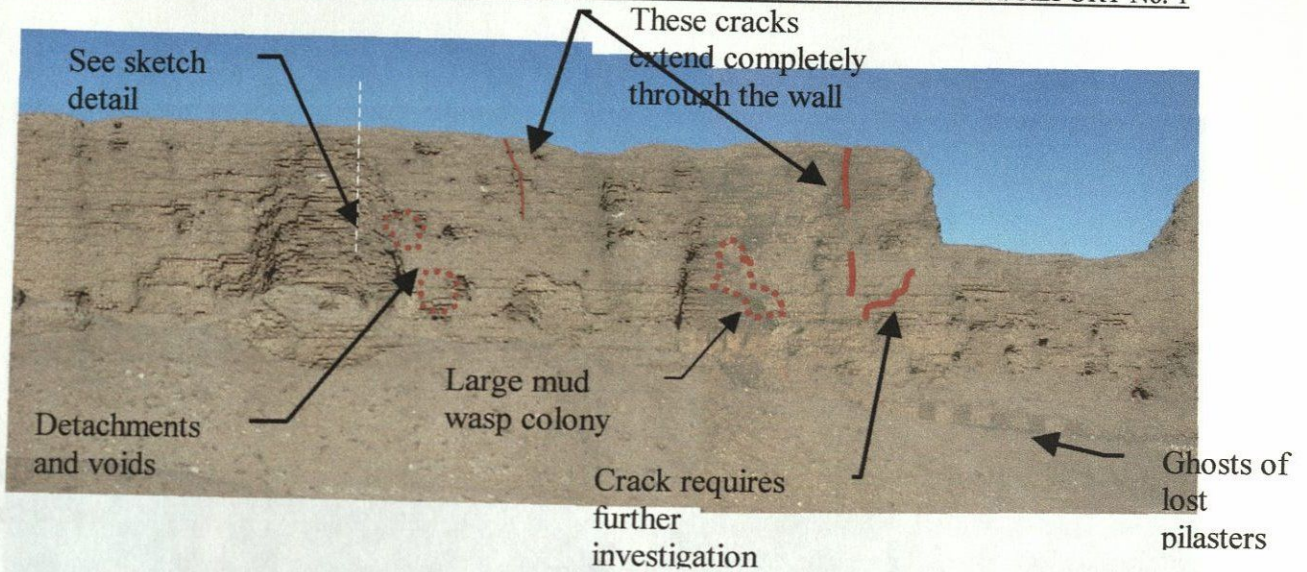
Figure 35: A portion of the west elevation of the west wall showing some of the overall and typical conditions.

The vertical cracks on the upper portions of the wall section are through wall cracks. The crack patterns continue lower in the walls near the ends of the wall section. In the case of the west wall, the most critical areas are the wall ends near the west gateway.

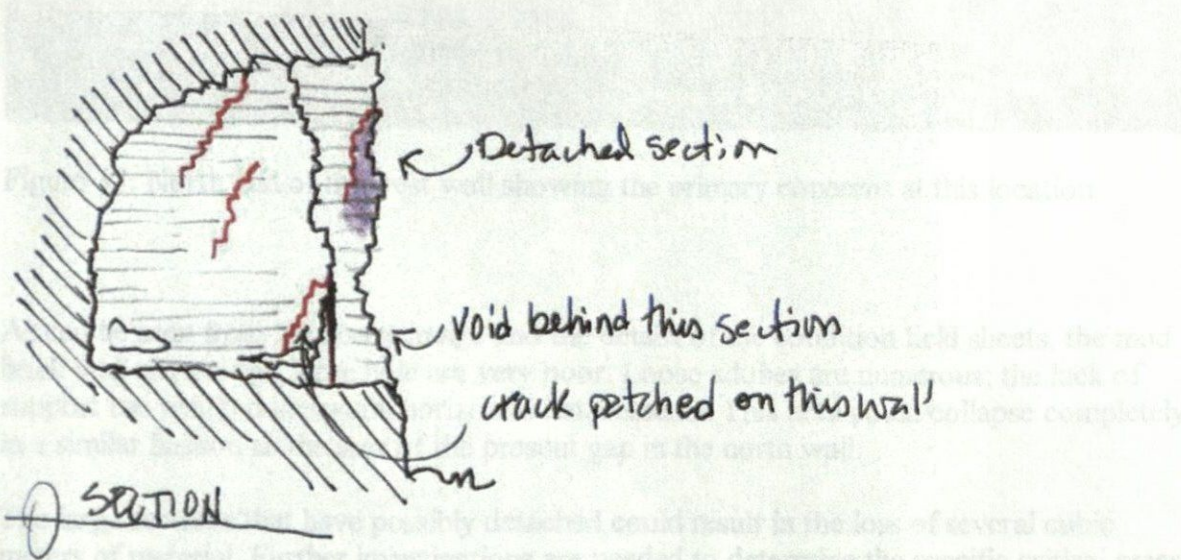
Figure 36: Partial section looking south through "cell" showing void, detachments and area of "tell tale" mud patch.

The above sketch is not drawn to scale, but the scale drawing through this same void is in the report of the structural engineer, Conor Power. It does show more or less typical conditions of voids, detachments, or delaminations, and associated structural cracks.

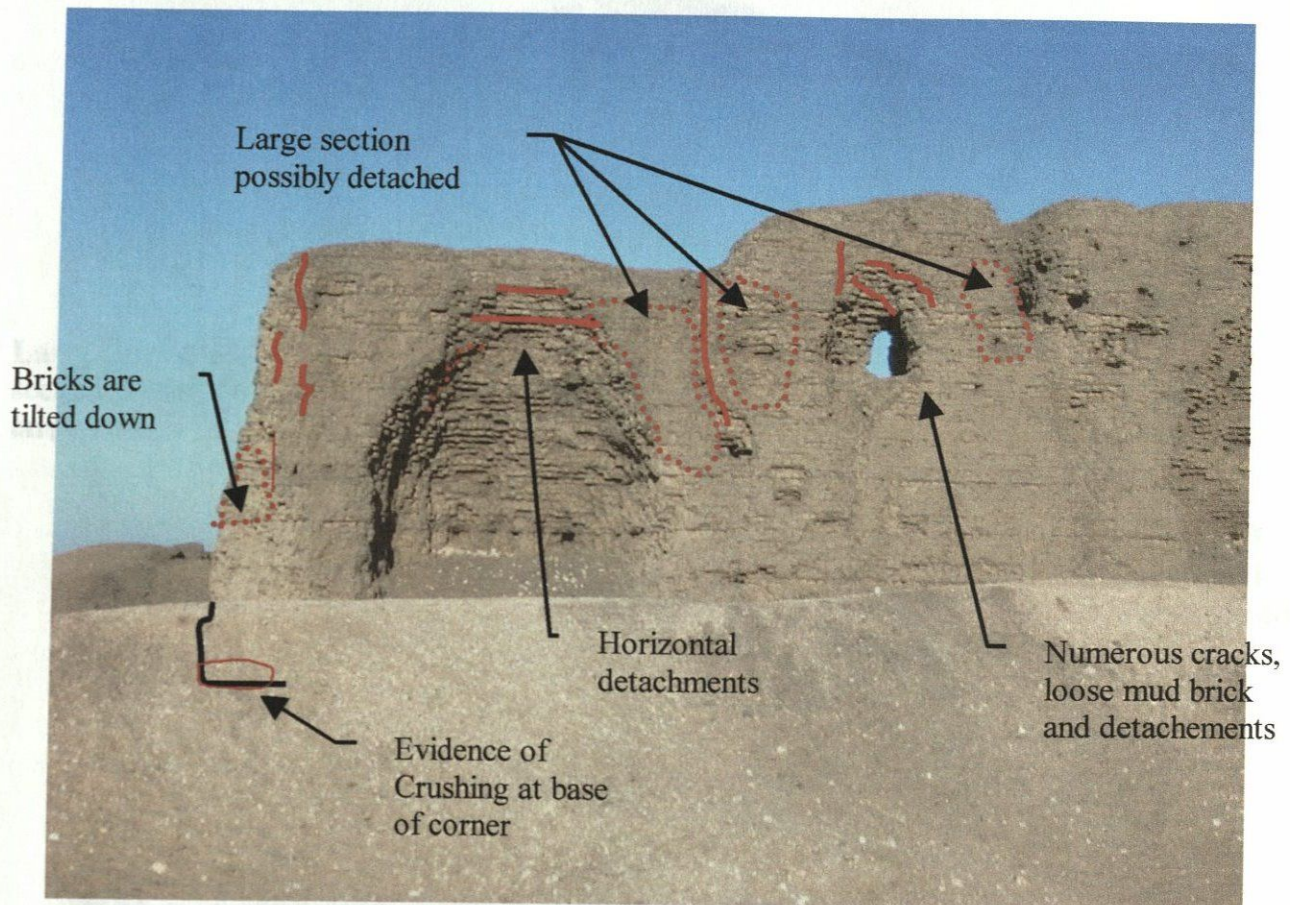
Figure 37: North end of the west wall showing the primary concerns at this location.

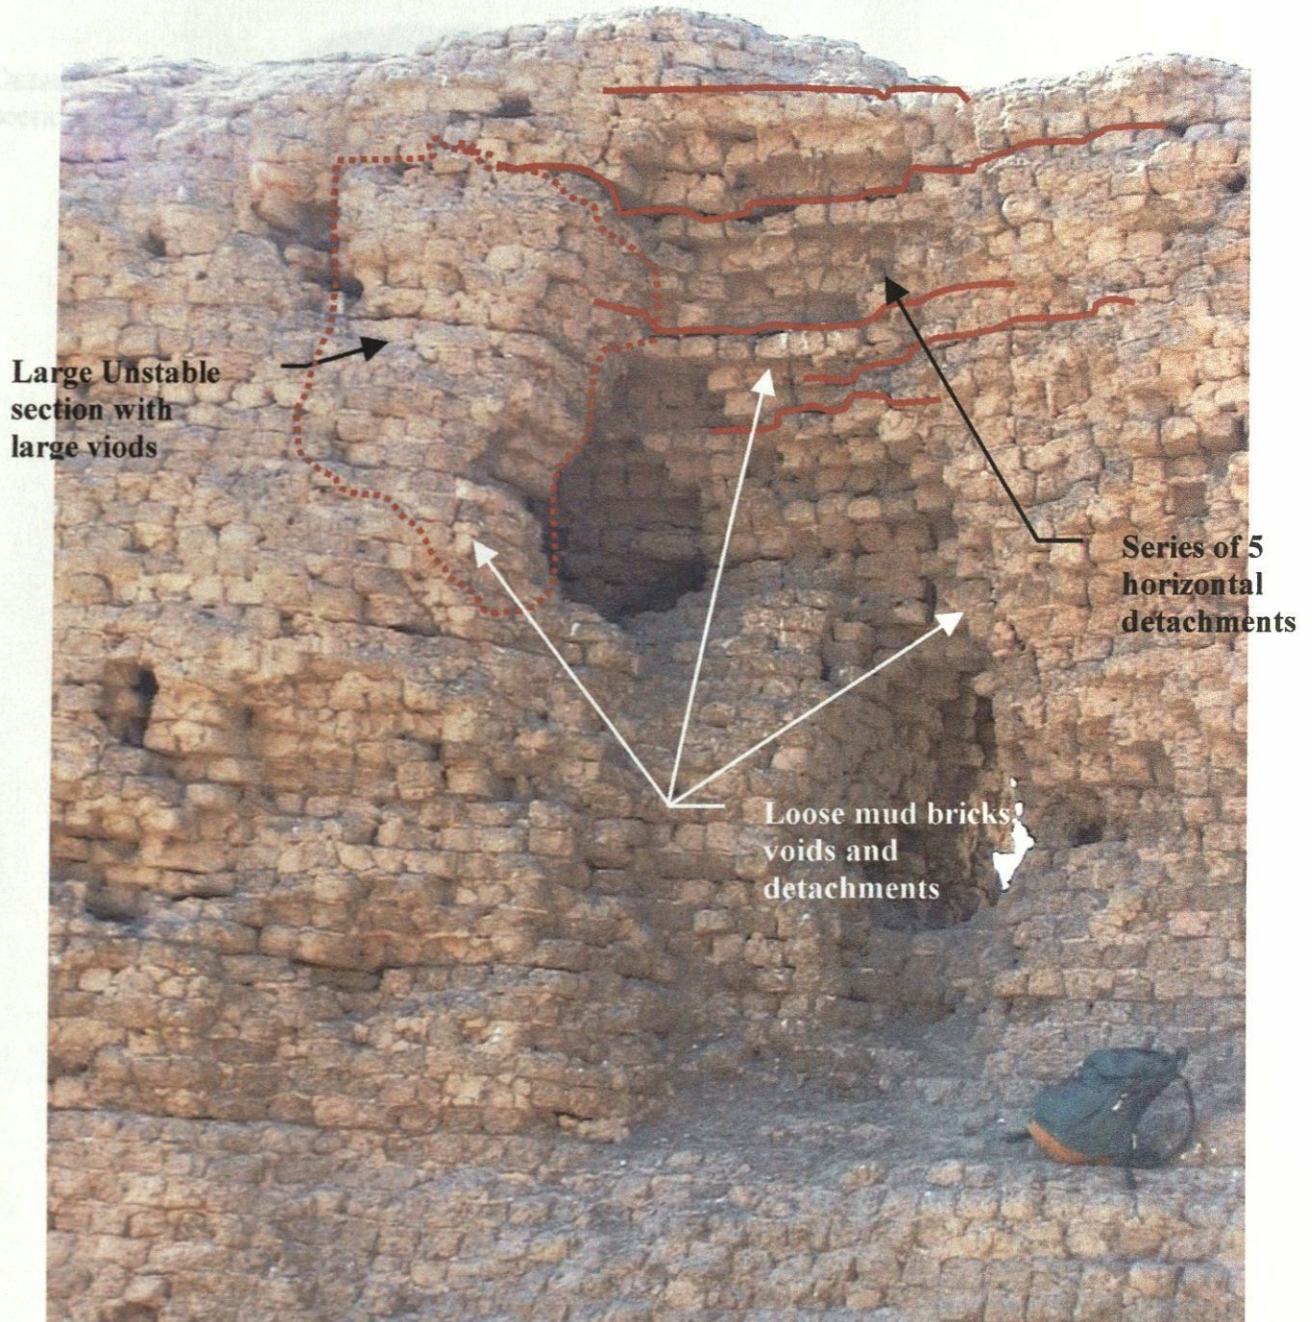
Figure 38: Detail of the north end of the west wall from the east.

The entire section of the wall in the image above is very unstable. Immediate conservation interventions are necessary to prevent additional traumatic loss. Loose mud bricks, and some of the delaminated portions could be lost at any time. It may be that the normal process will continue with the loss of small portion of the wall will continue until the entire section collapses in a manner similar to what must have happened to produce the gap in the north wall.

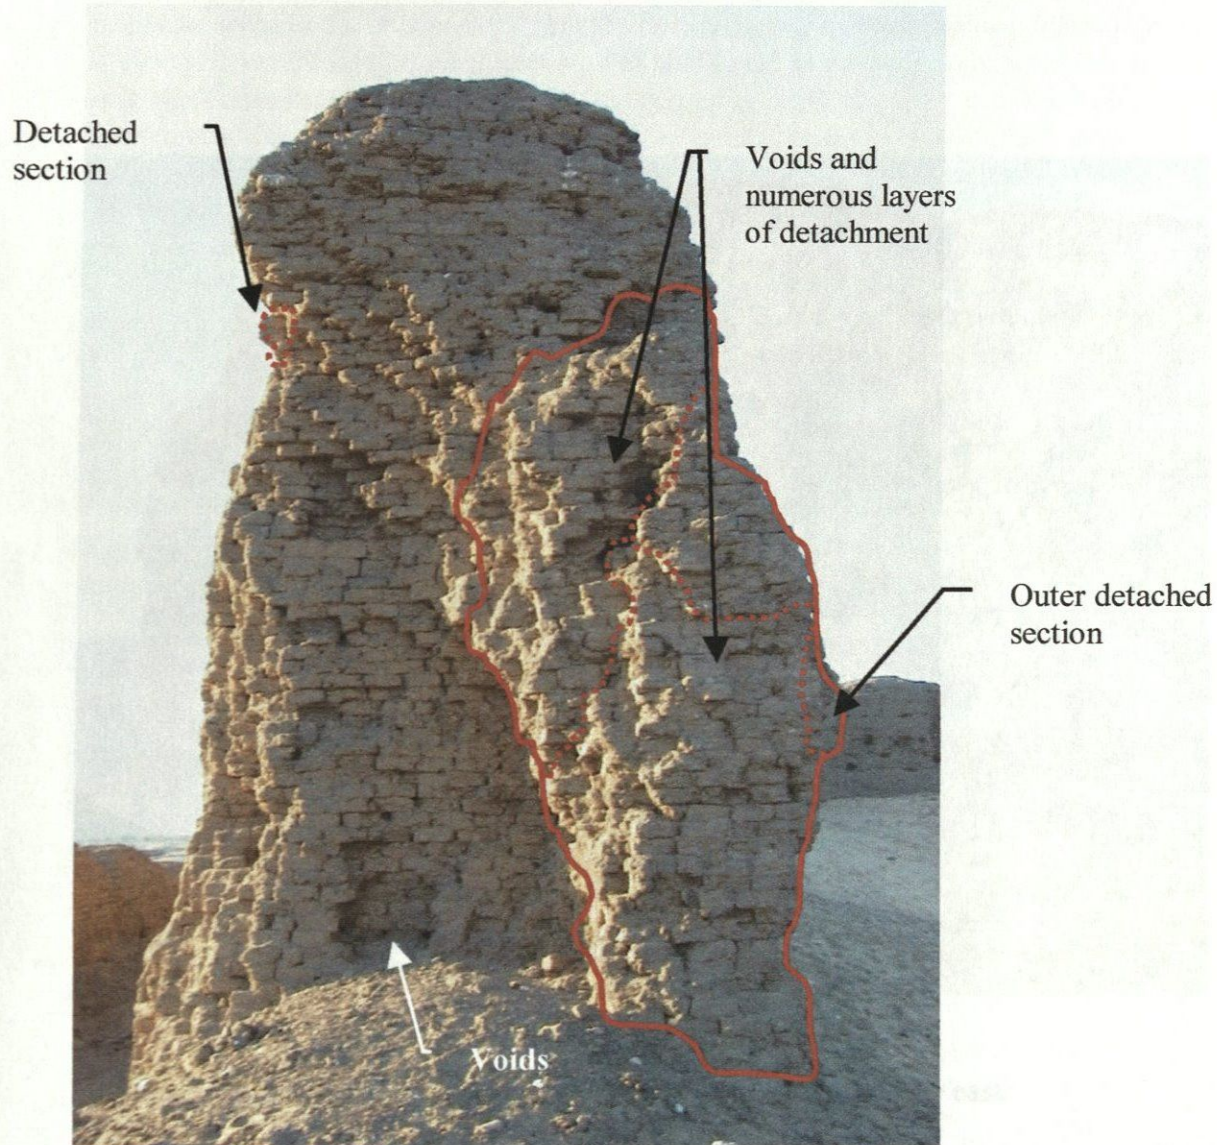
Figure 39: The south end of the north section of the west wall at the west gateway.

The entire right section of the wall could collapse with the loss of a minimal of approximately 10 cubic meters. The section has voids, cracks, loose mud bricks, detached sections and both vertical and horizontal delamination cracks. There are also some active mud wasps which may have led to some of the loss and the potential for more dramatic future loss, but again the poor structural condition seems primarily to be the result of the removal of a large part of the wall material to create a "cell". The estimated loss of ca. 10 cubic meters will only be the first or the next step. With its loss, when it happens whether all at once or by a series of lesser losses, the wall to the north, which is presently reasonably stable, will also be affected and its integrity will be compromised. A long vertical through wall crack located several meters from this corner may then be the next "line of retreat" for the stability of the wall. Figure 40 shows the area of this crack from the east side; it was patched with a mud patch so that future movement could be more easily detected.

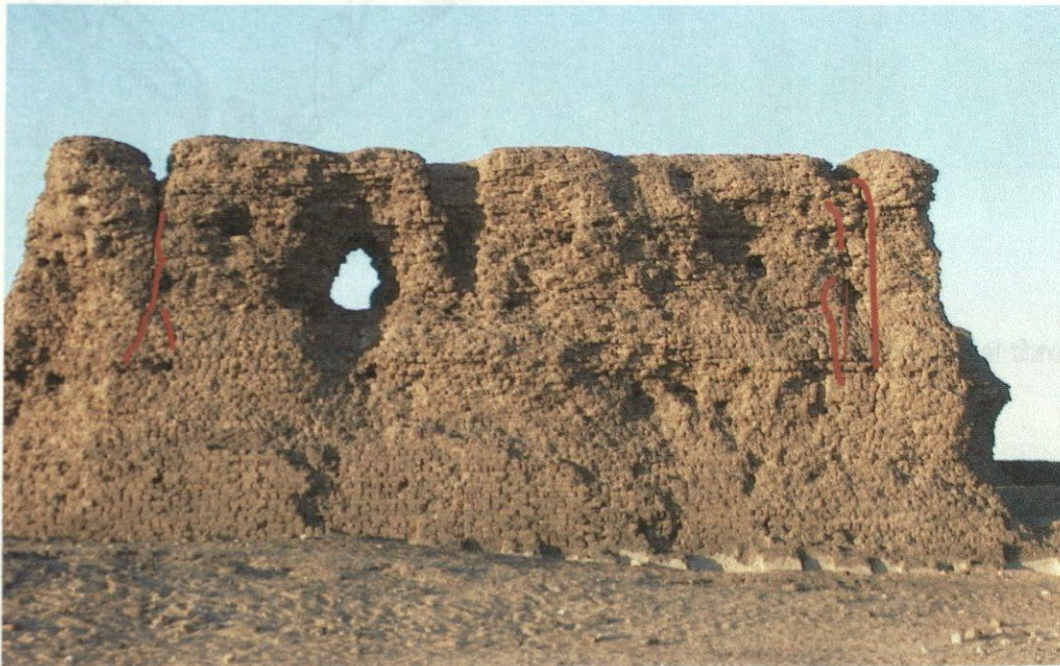
Figure 48: East side of the north section of the east wall showing the pattern of cracks at the ends of high walls.

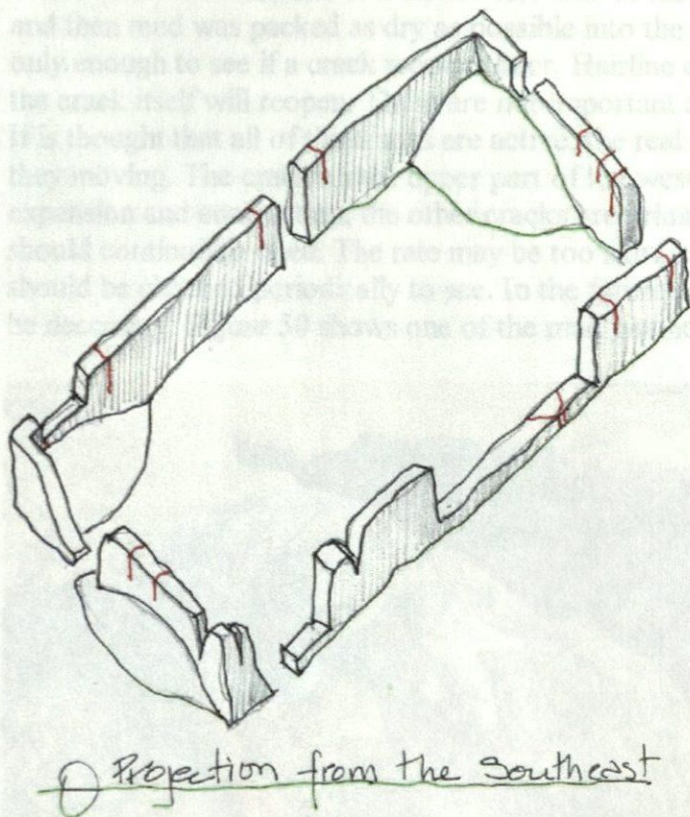
Figure 49: Sketch of the Shunet showing the general locations of the vertical through-wall cracks.

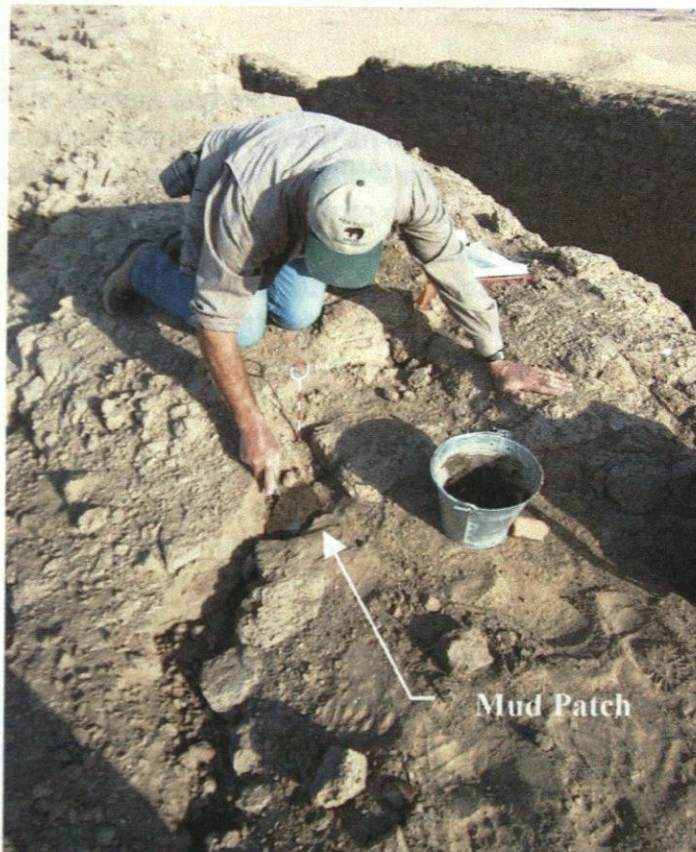
Figure 50: Patching large on the top of the east wall to monitor movement.

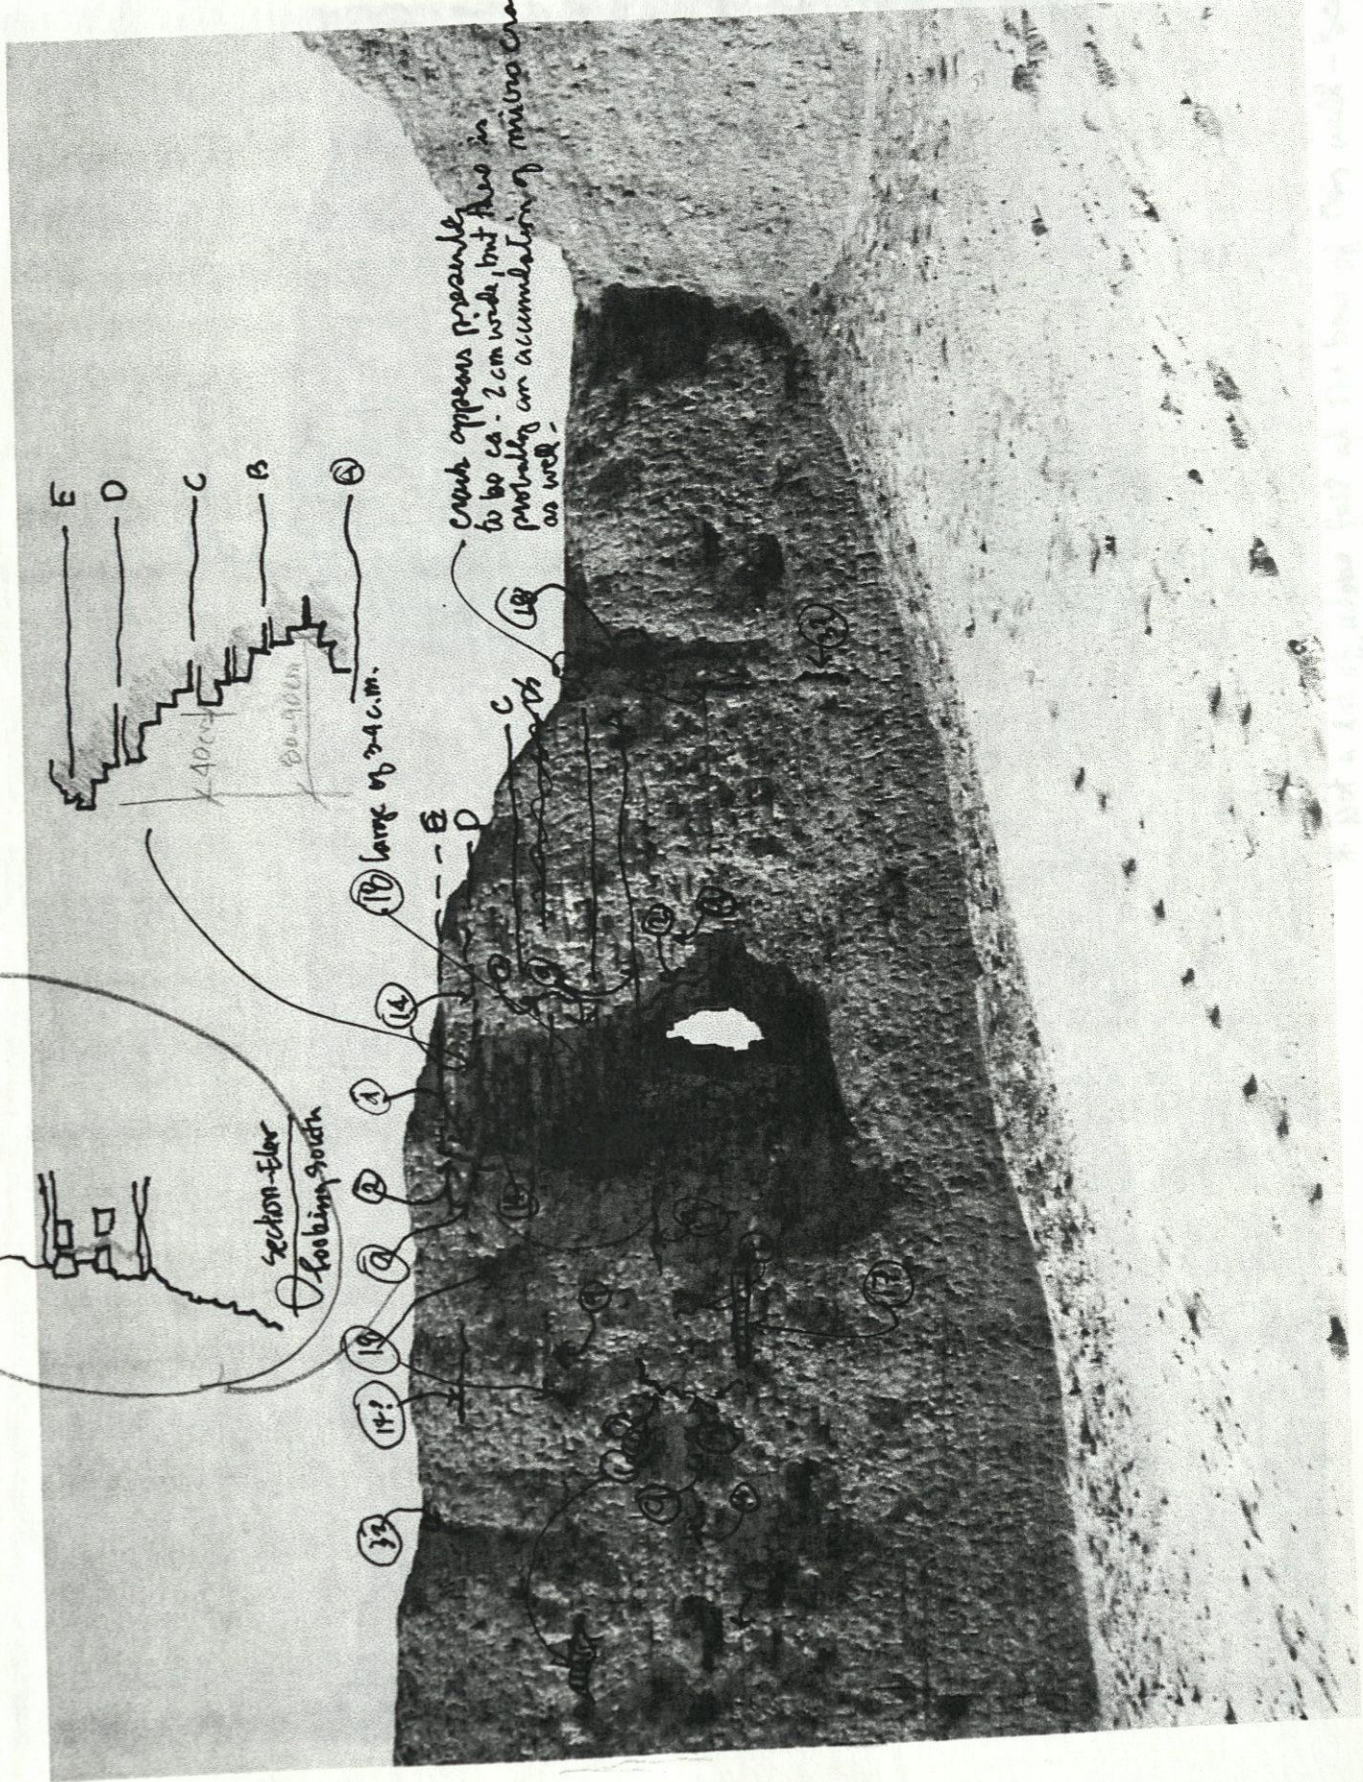
Crack appears possibly to be ca. 2cm wide, but also probably an accumulation of mineral matter as well.

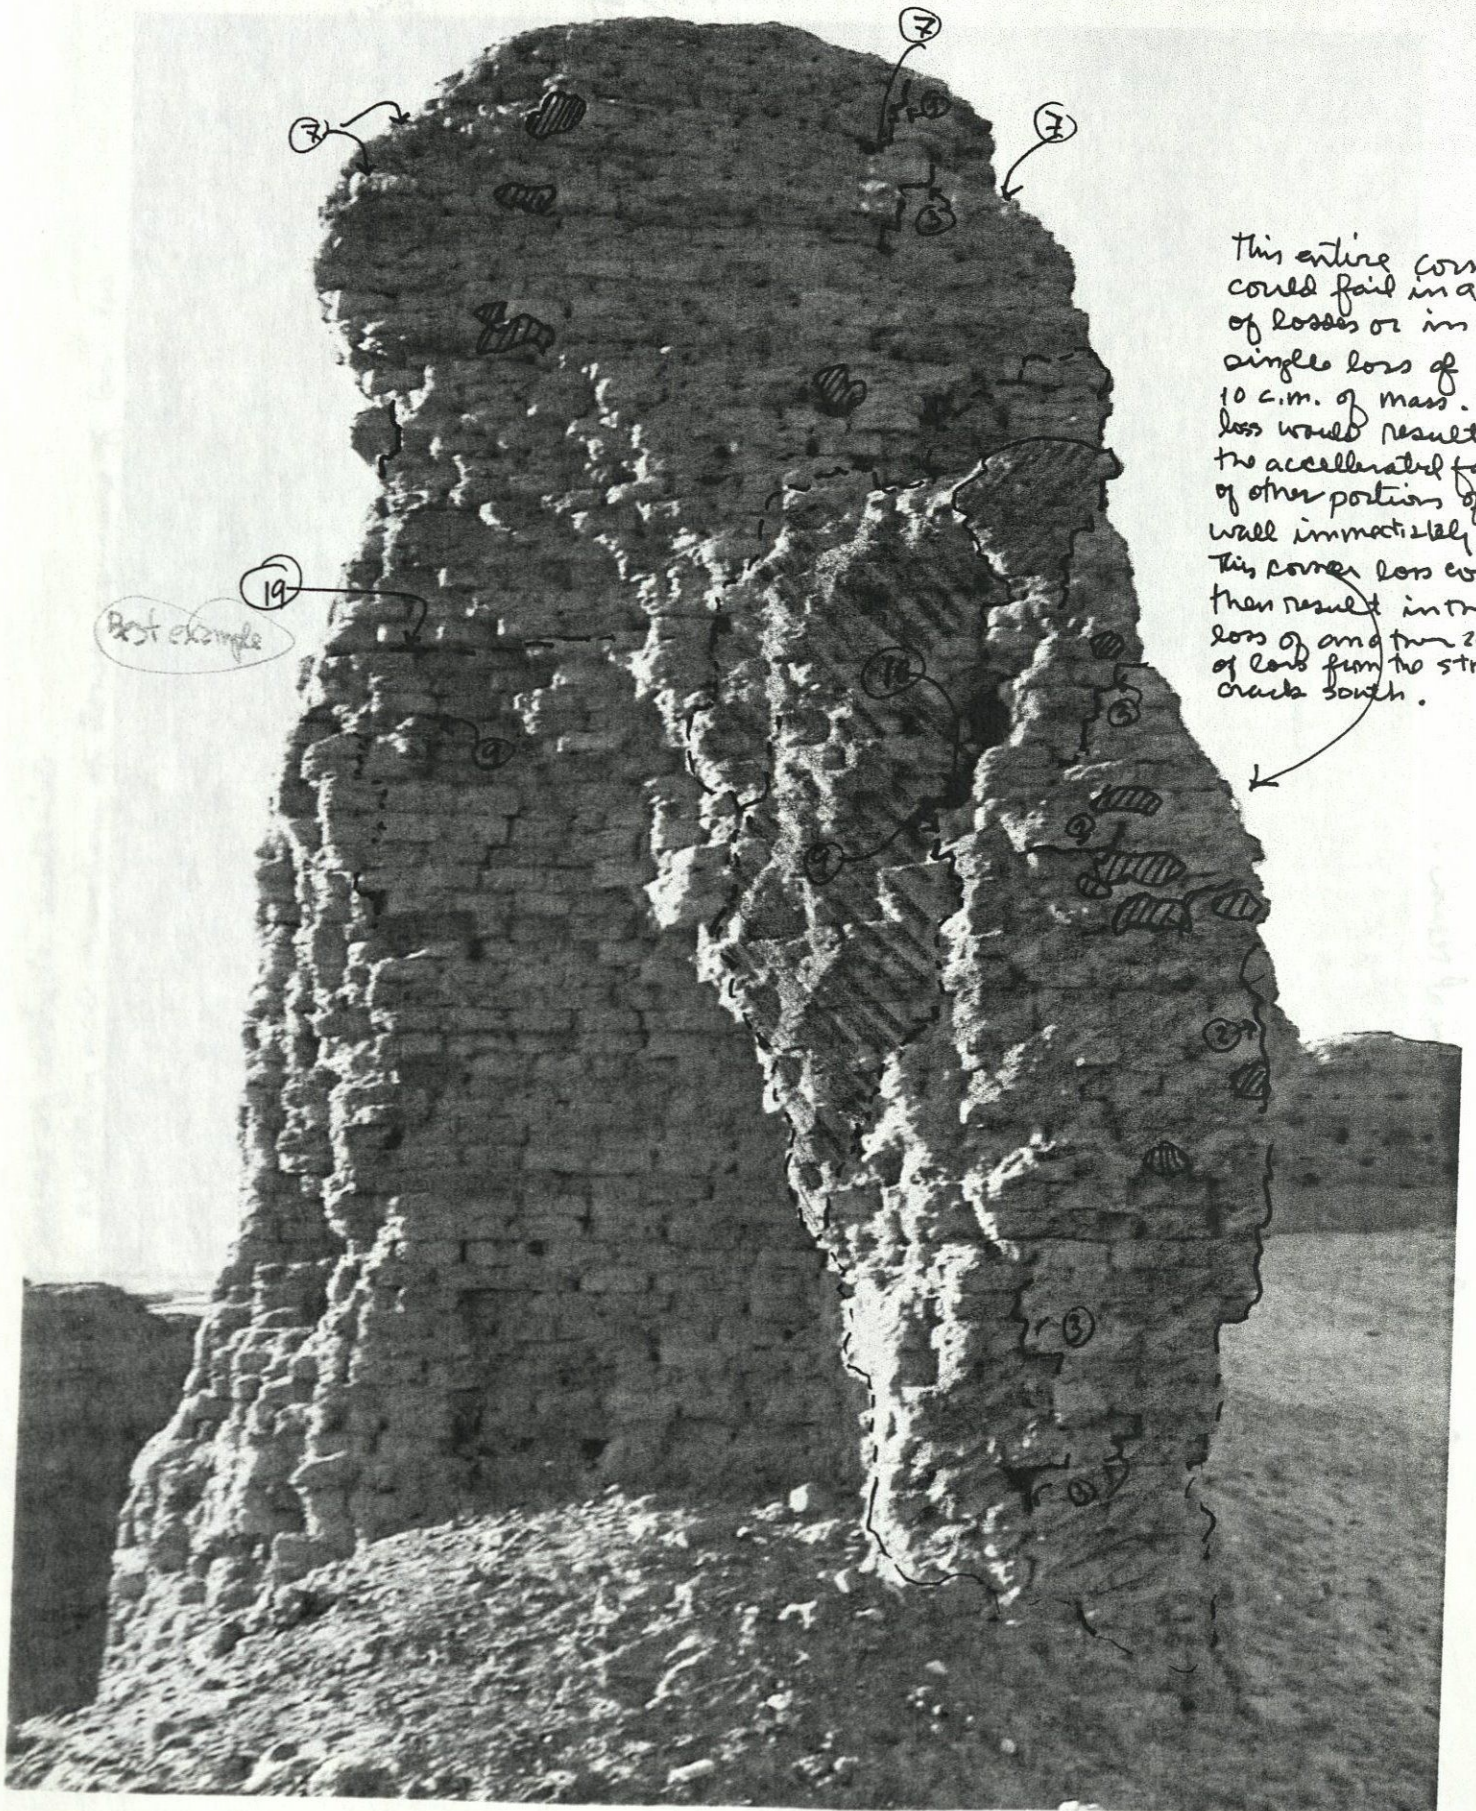
This entire corner could fail in a series of losses or in one single loss of ca 10 c.m. of mass. That loss would result in the accelerated failure of other portions of the wall immediately adjacent. This corner loss could then result in the loss of another 20 cm of length from the structure south.
