TECHNICAL REPORT

“Conservation of the Shunet el-Zebib, Abydos”

***“Conservation of King Khasekhemwy’s Funerary Monument at Abydos”  
Technical Report on 2012 Fieldwork***

Matthew Douglas Adams  
Institute of Fine Arts, New York University

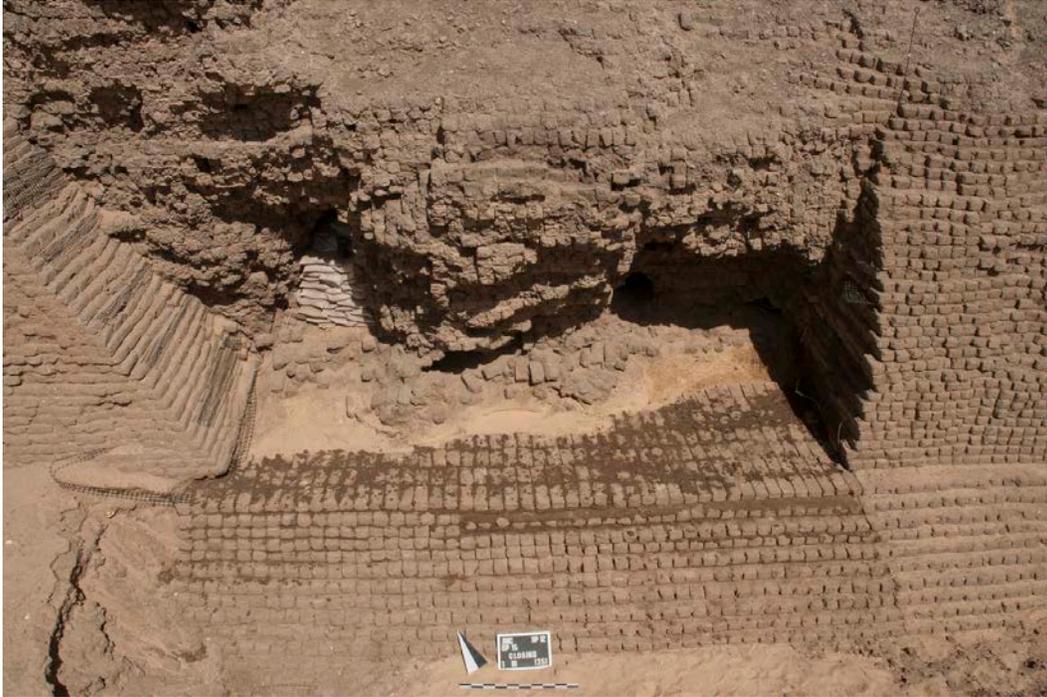
Figure 8 – The brick foundation in Operation 15 that serves to stabilize the sand under the original wall and as a platform for the construction of new masonry to support the surviving original fabric of the wall above. Photo by Greg Maka for the Institute of Fine Arts, NYU.

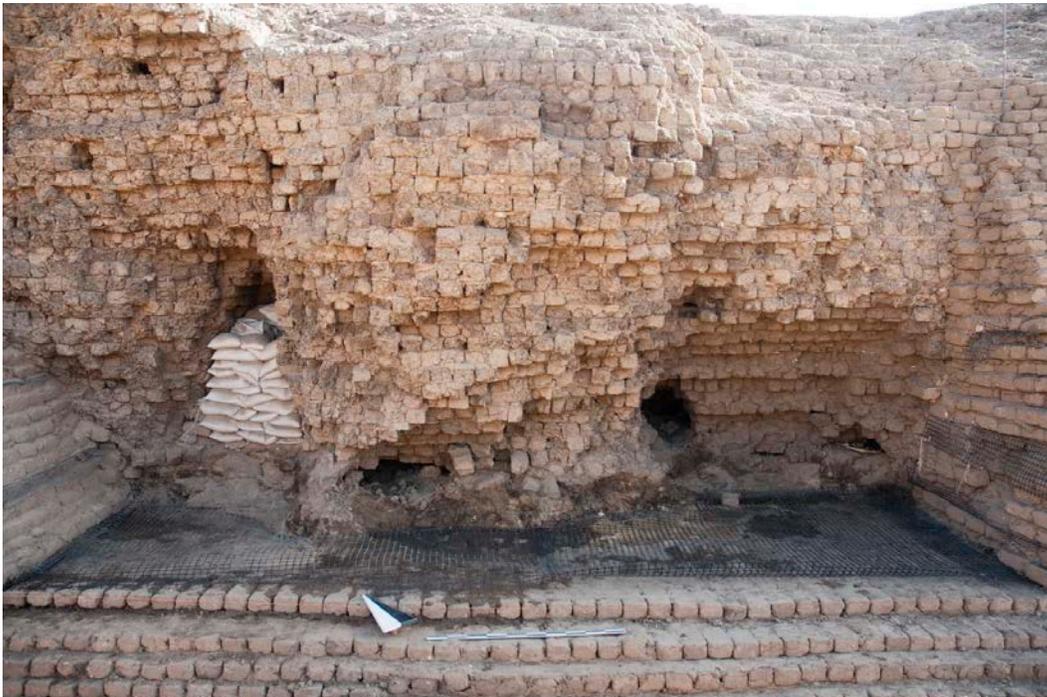
Figure 9 – At the top of the foundation, a layer of geo-textile was put down that both provides horizontal stabilization and permits the new masonry built on the foundation to be structurally bonded with construction north (left) and south (right) from earlier seasons. Photo by Greg Maka for the Institute of Fine Arts, NYU.

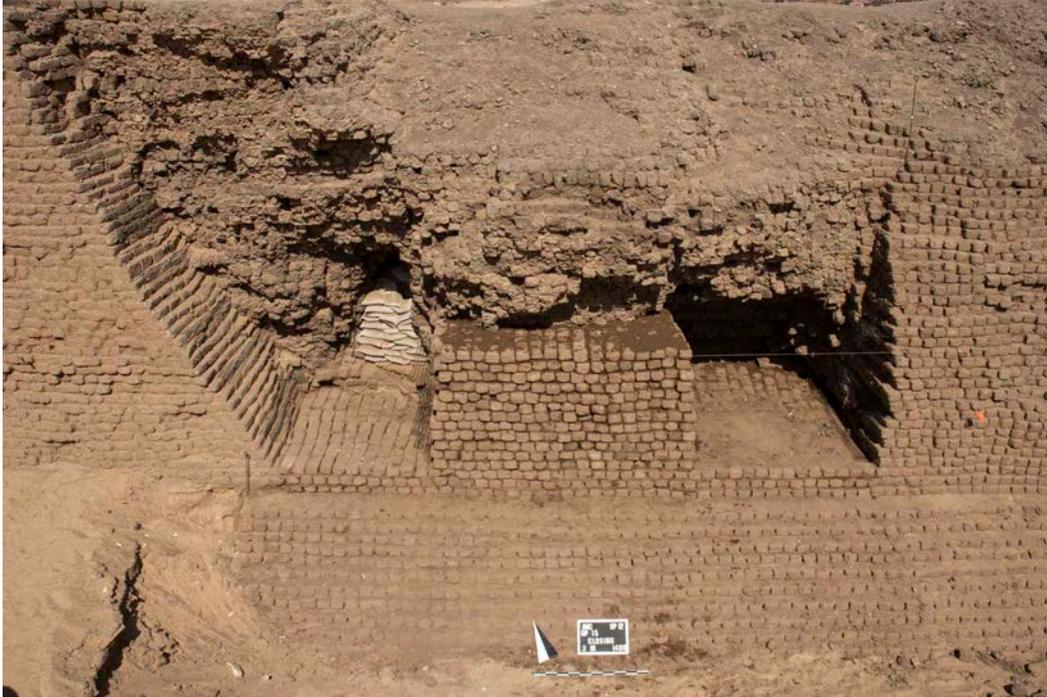
Figure 10 – The large central area of overhanging masonry, part of a mass detached by cracks and in active rotation away from the wall, was stabilized first for safety. Photo by Greg Maka for the Institute of Fine Arts, NYU.

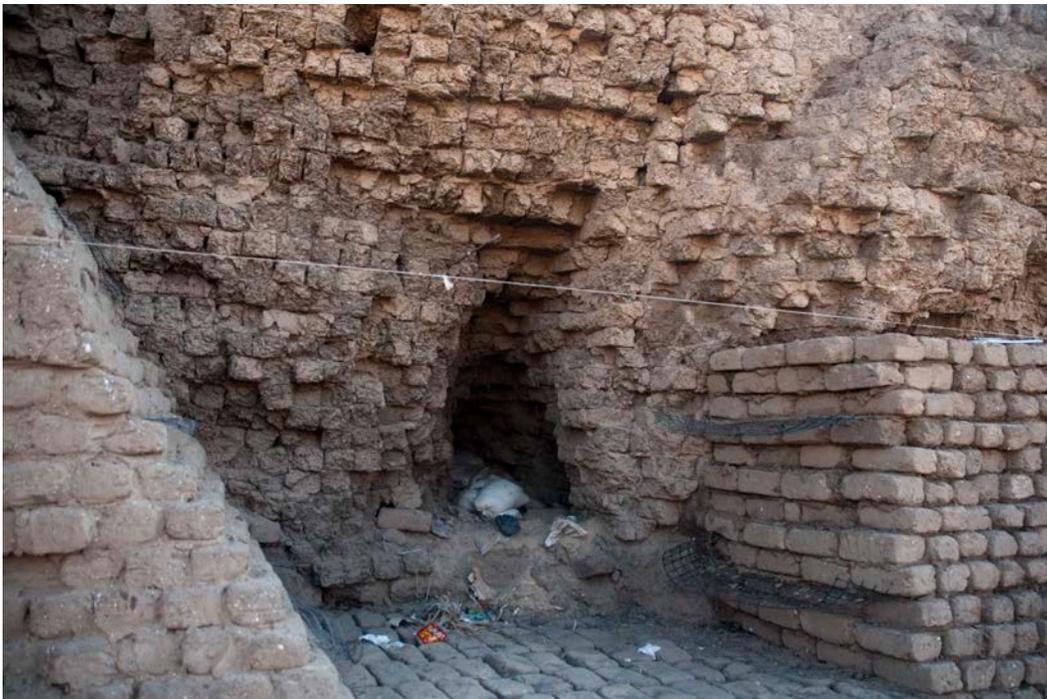
Figure 11 – A large animal burrow existed on the north side of the detached masonry mass in Operation 15. Once the detached mass had been stabilized by the new construction at right, work could proceed with the hole. Photo by Greg Maka for the Institute of Fine Arts, NYU.

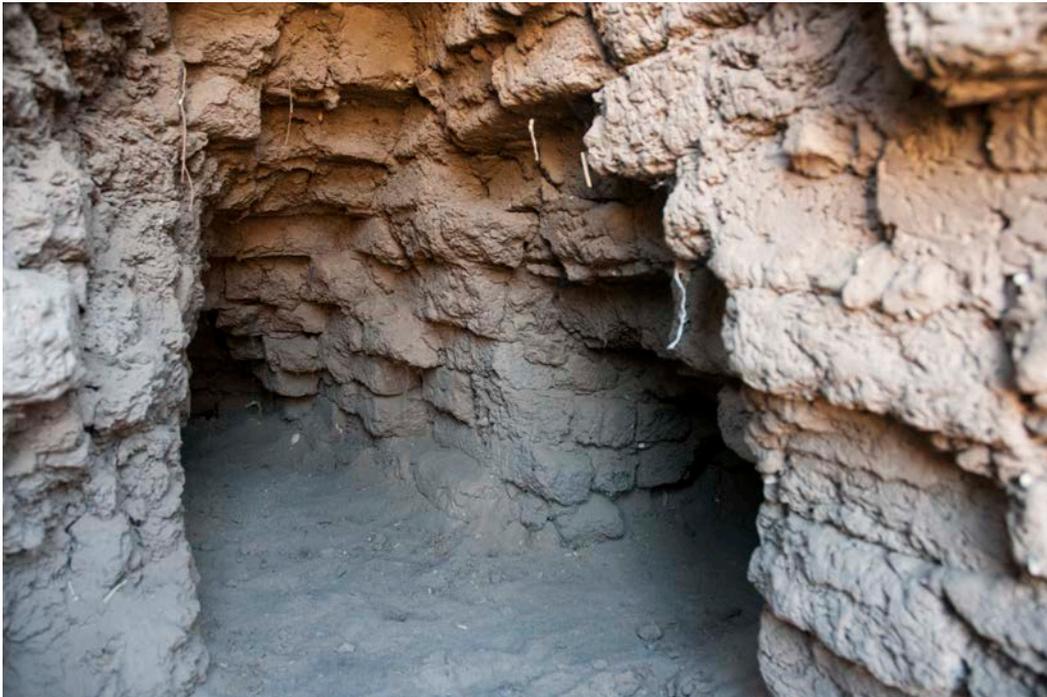
Figure 13 – The largest animal burrow in Operation 15, after cleaning. One branch penetrated nearly completely through the wall east-west, while a side branch penetrated several meters toward the south behind the mass of masonry that was detached from the wall by cracks. Photo by Greg Maka for the Institute of Fine Arts, NYU.

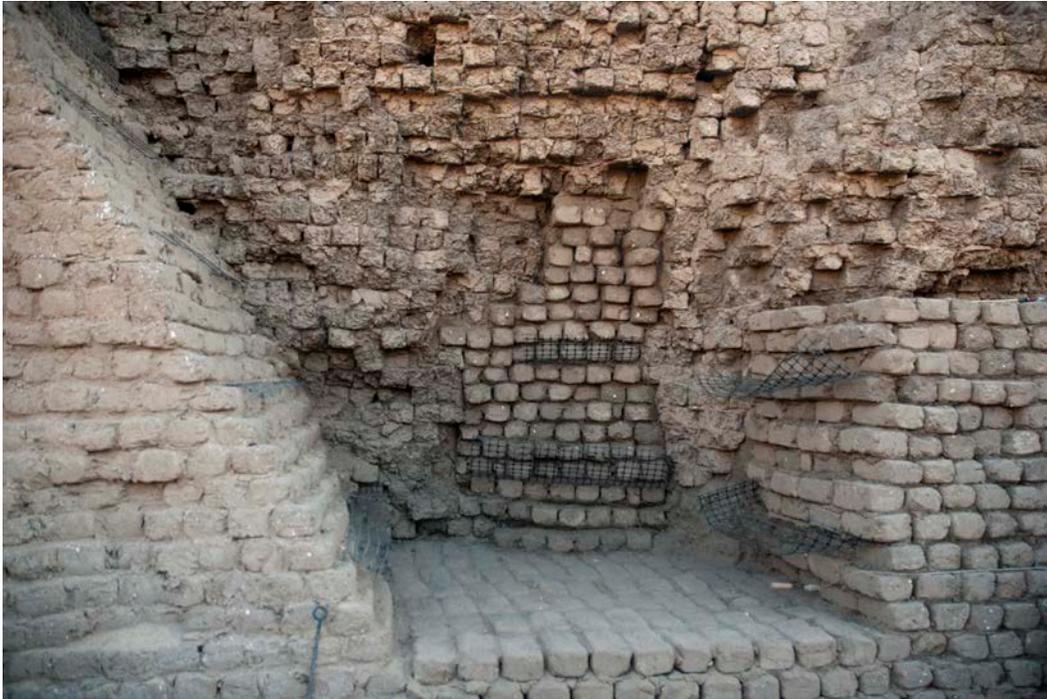
Figure 14 – The largest of the animal burrows in Operation 15, filled with new masonry. Photo by Greg Maka for the Institute of Fine Arts, NYU.

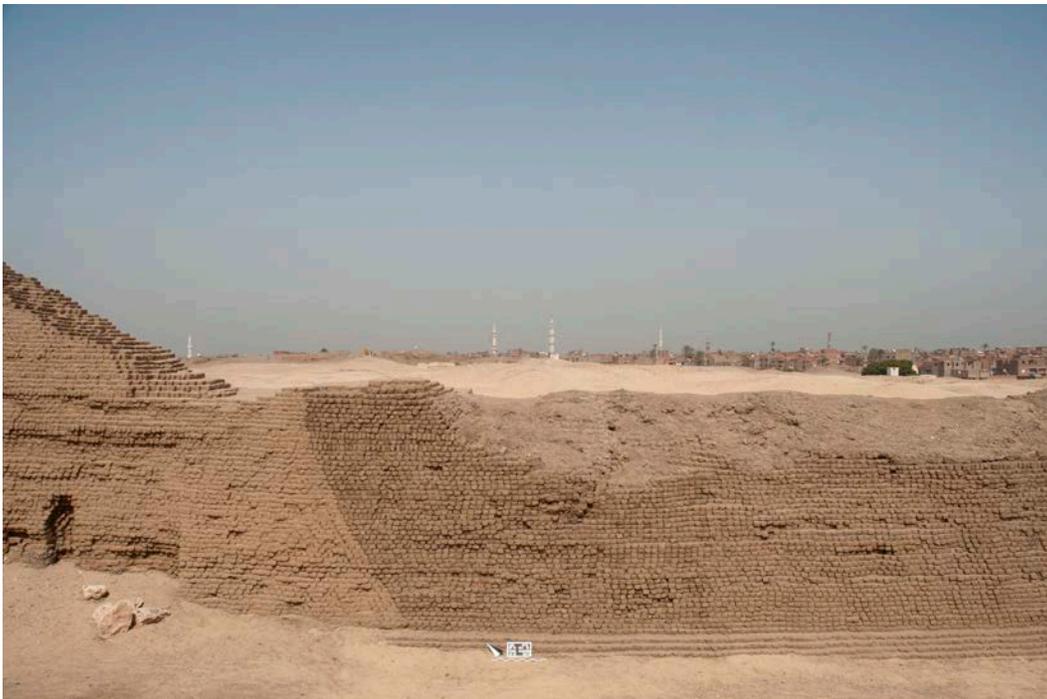
Figure 17 – Operation 15 at the close of the 2012 season. The discernibility of the boundary at left between construction done in previous seasons and that from 2012 will lessen over time. The visible top of the foundation, near ground level, will be covered by sand and not visible at the close of the conservation program at the Shuneh. Photo by Greg Maka for the Institute of Fine Arts, NYU.

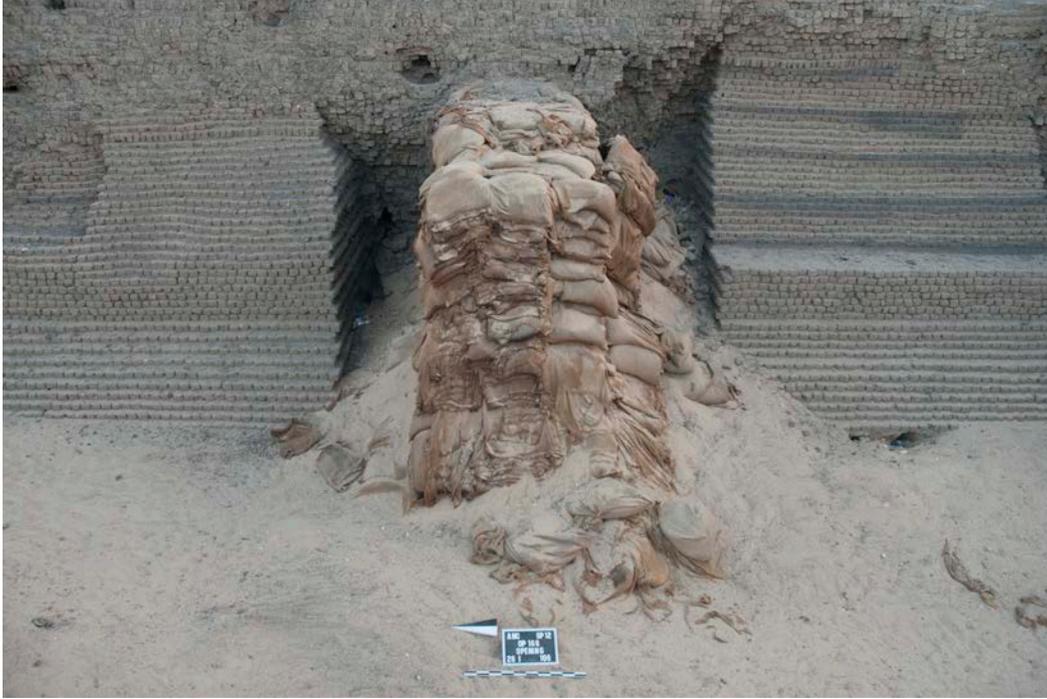
Figure 18 – Remains of the sand bag buttress constructed in 2001 in Operation 21. Photo by Greg Maka for the Institute of Fine Arts, NYU.

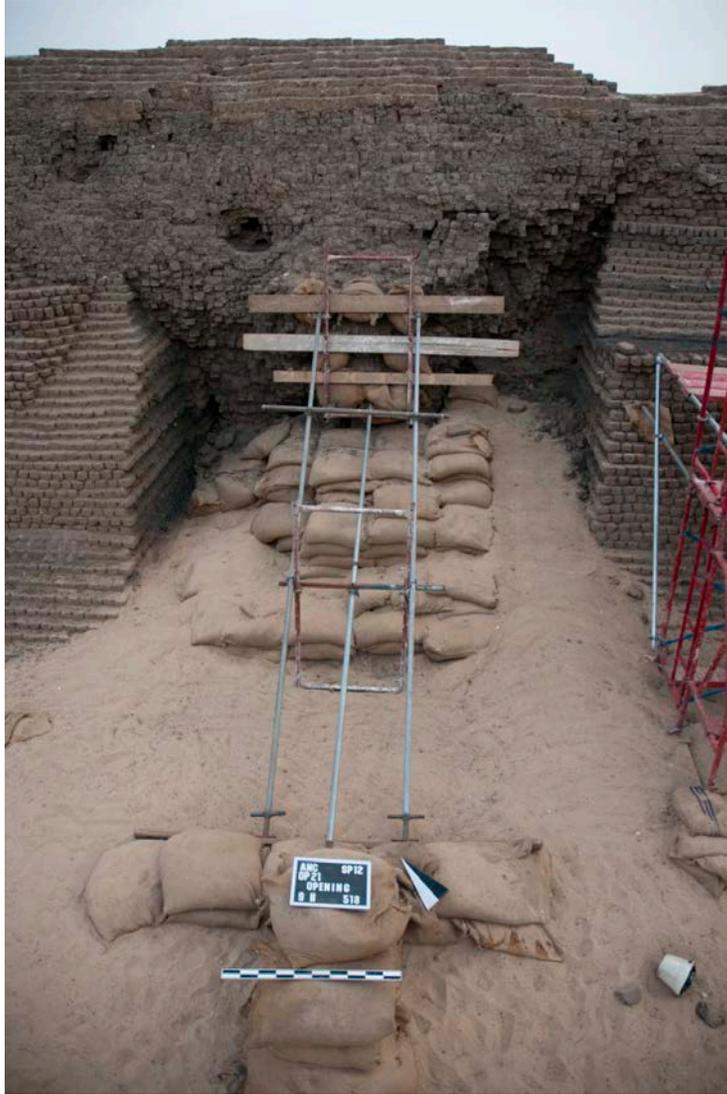
Figure 20 – Temporary shoring supporting unstable areas of masonry during work in Operation 21. Photo by Greg Maka for the Institute of Fine Arts, NYU.

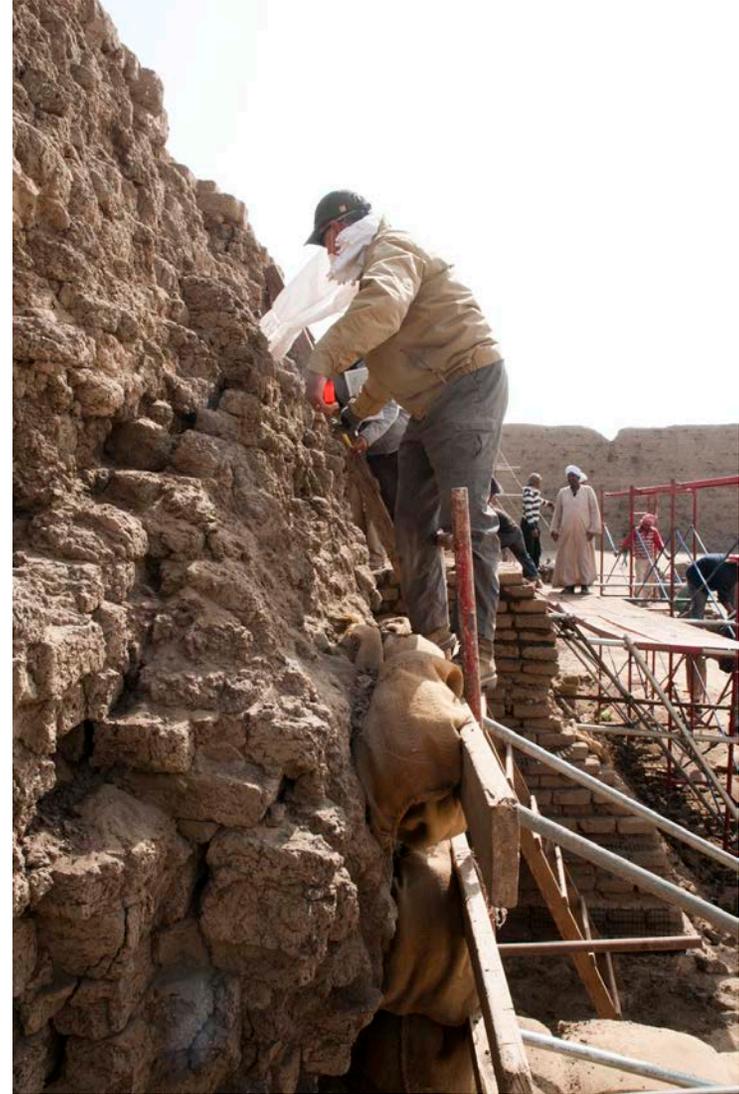
Figure 21 – Preservation architect Anthony Crosby defining structural cracks separating unstable areas of masonry from the main mass of the wall in Operation 21. Photo by Greg Maka for the Institute of Fine Arts, NYU.

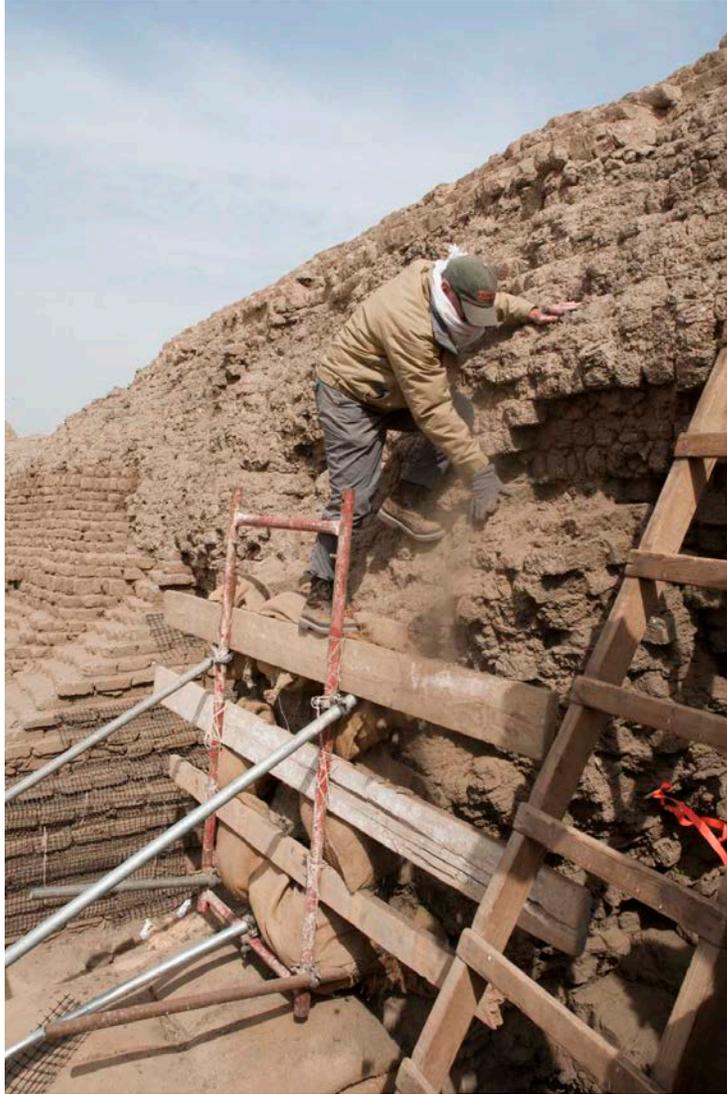
Figure 22 – Anthony Crosby removing unstable masonry in Operation 21.  
Photo by Greg Maka for the Institute of Fine Arts, NYU.

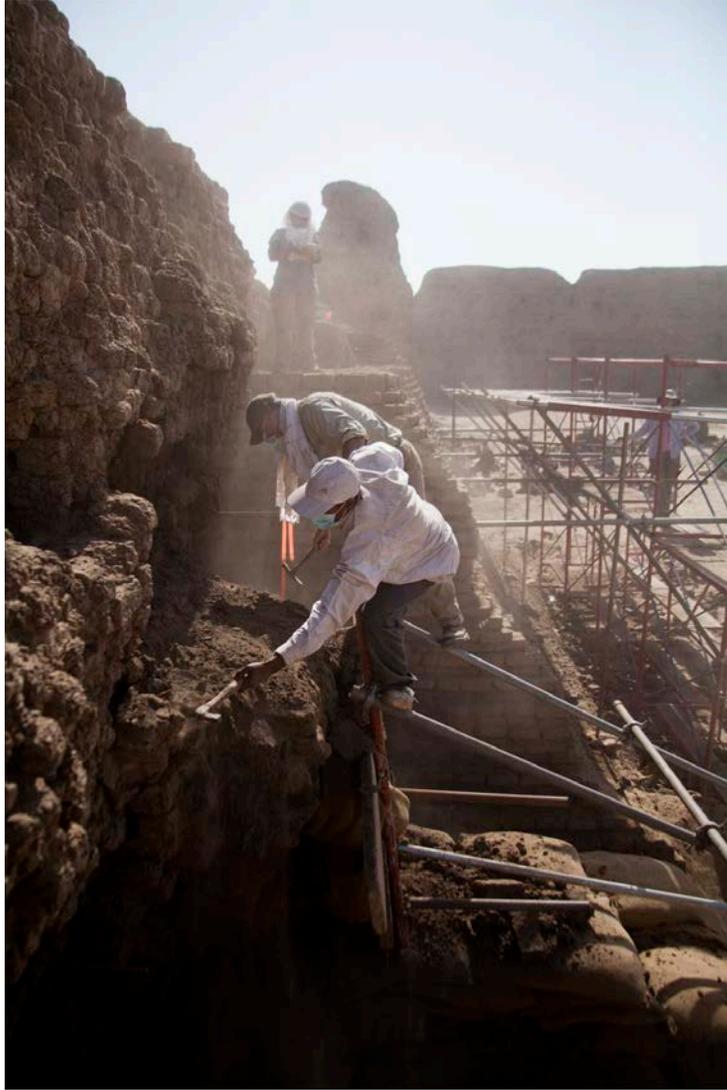
Figure 24 – Preservation architect Anthony Crosby and senior mason Nabil Fahmy el-Seman remove dangerously unstable masonry in Operation 21. Photo by Greg Maka for the Institute of Fine Arts, NYU.

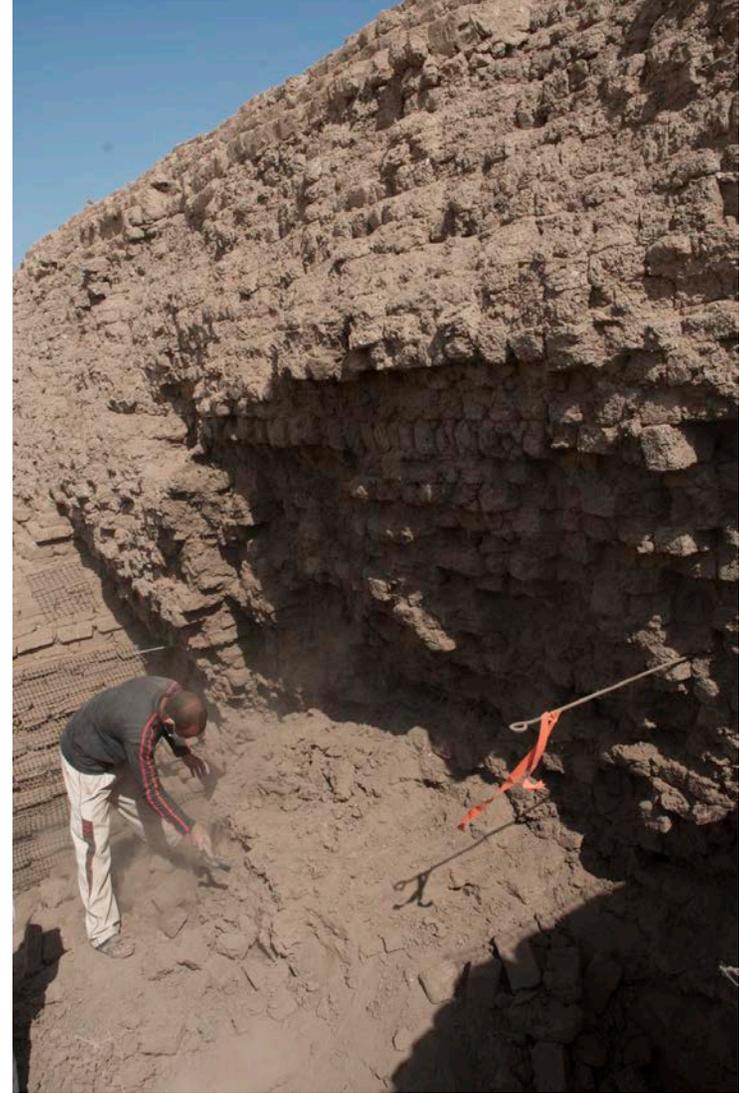
Figure 25 – Removing dangerously unstable masonry in Operation 21 after disassembly of the temporary shoring. Photo by Greg Maka for the Institute of Fine Arts, NYU.

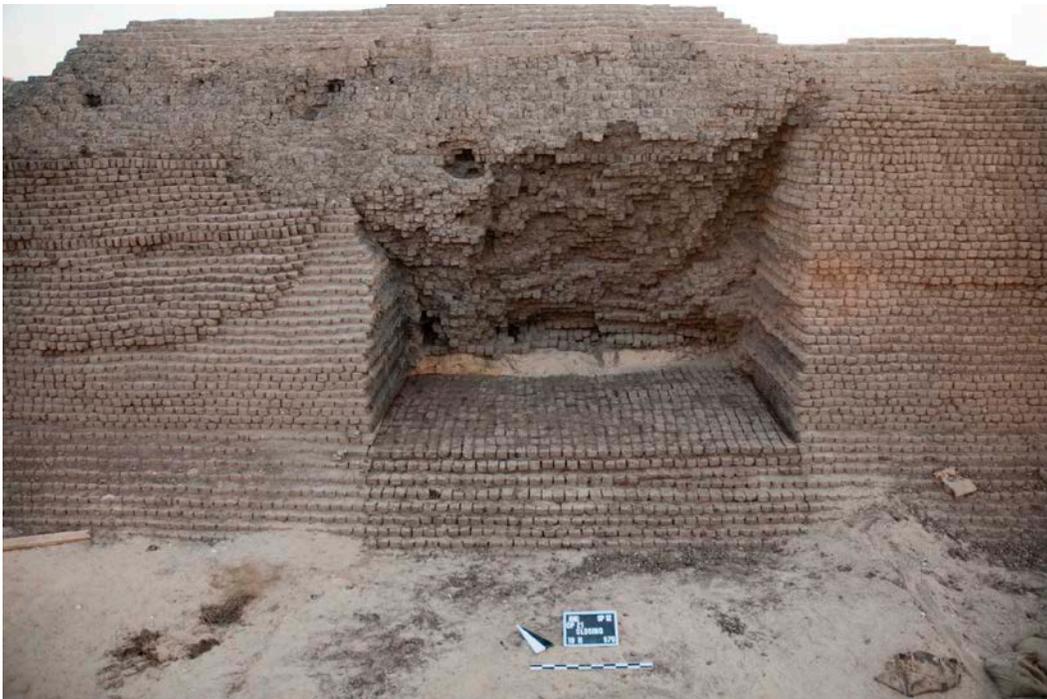
Figure 29 – The completed foundation platform in Operation 21. The foundation buttresses the remaining basal sands under the wall and provides a stable base on which new masonry can be constructed to support the original wall above. Photo by Greg Maka for the Institute of Fine Arts, NYU.

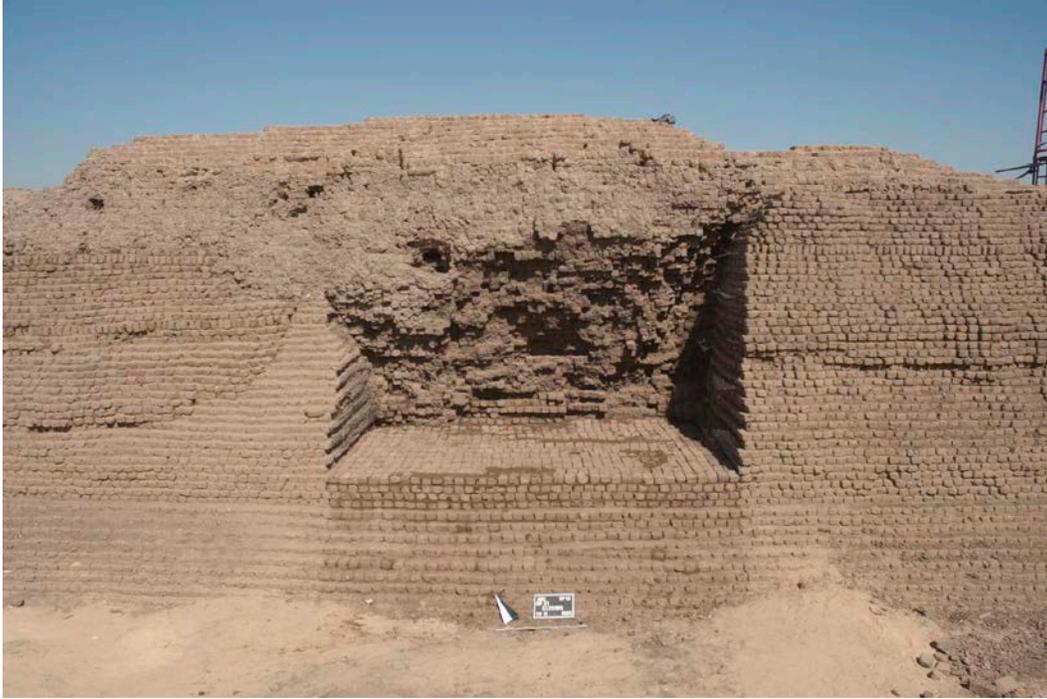
Figure 30 – New construction on the foundation platform in Operation 21 supports the original fabric of the wall. Photo by Greg Maka for the Institute of Fine Arts, NYU.

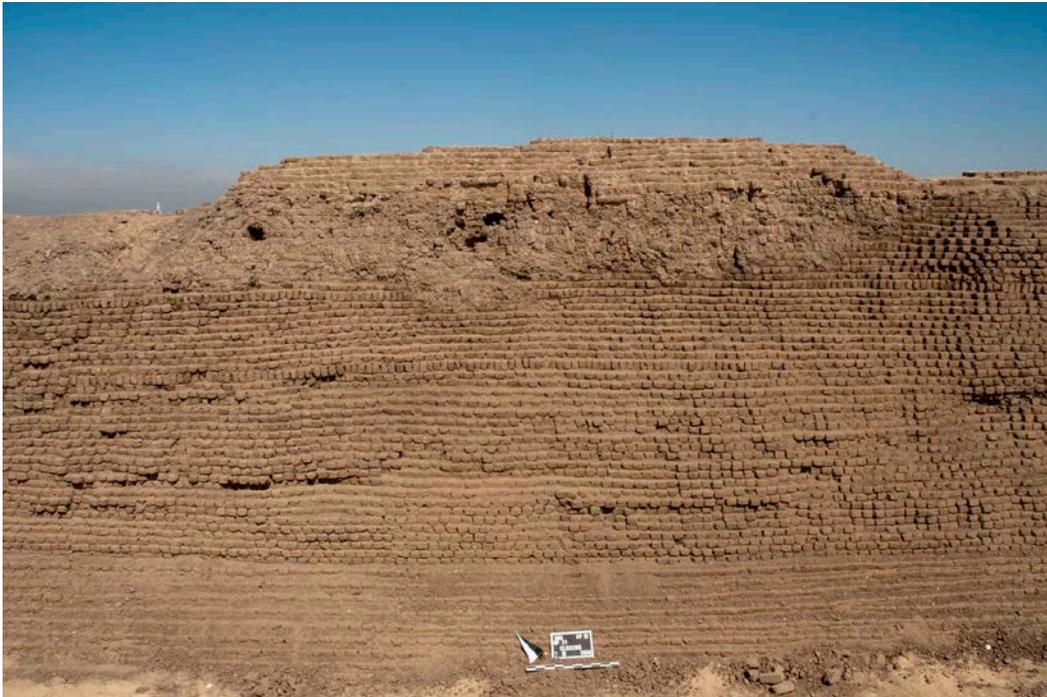
Figure 31 – Completed stabilization work in Operation 21. Photo by Greg Maka for the Institute of Fine Arts, NYU.

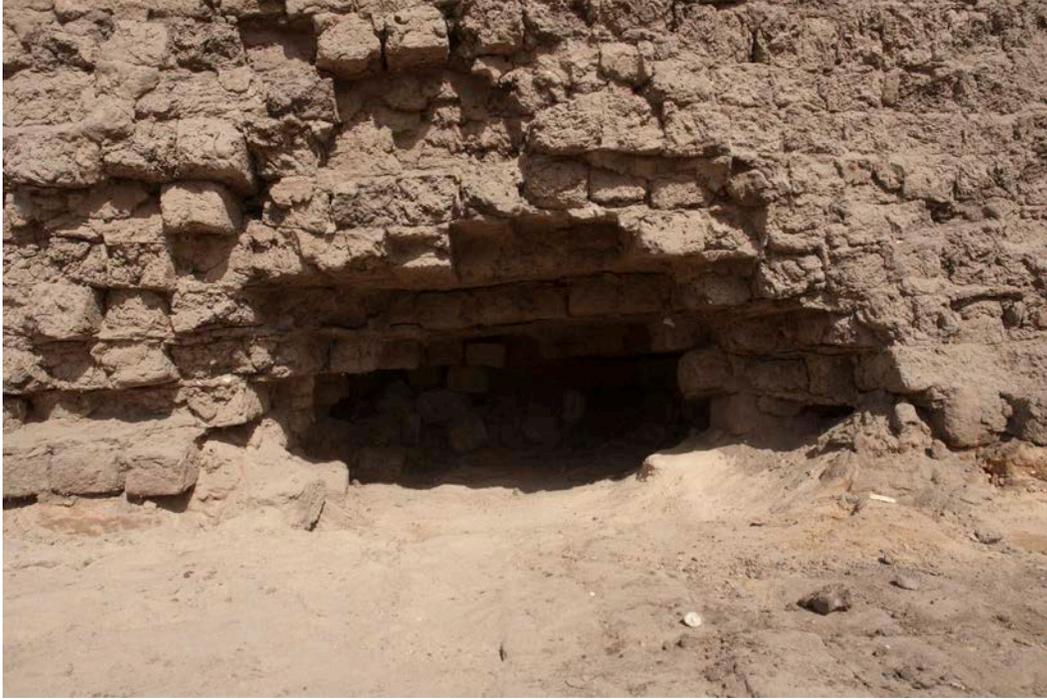
Figure 36 – A large animal burrow at the base of the wall in Operation 35, after cleaning. Photo by Greg Maka for the Institute of Fine Arts, NYU.

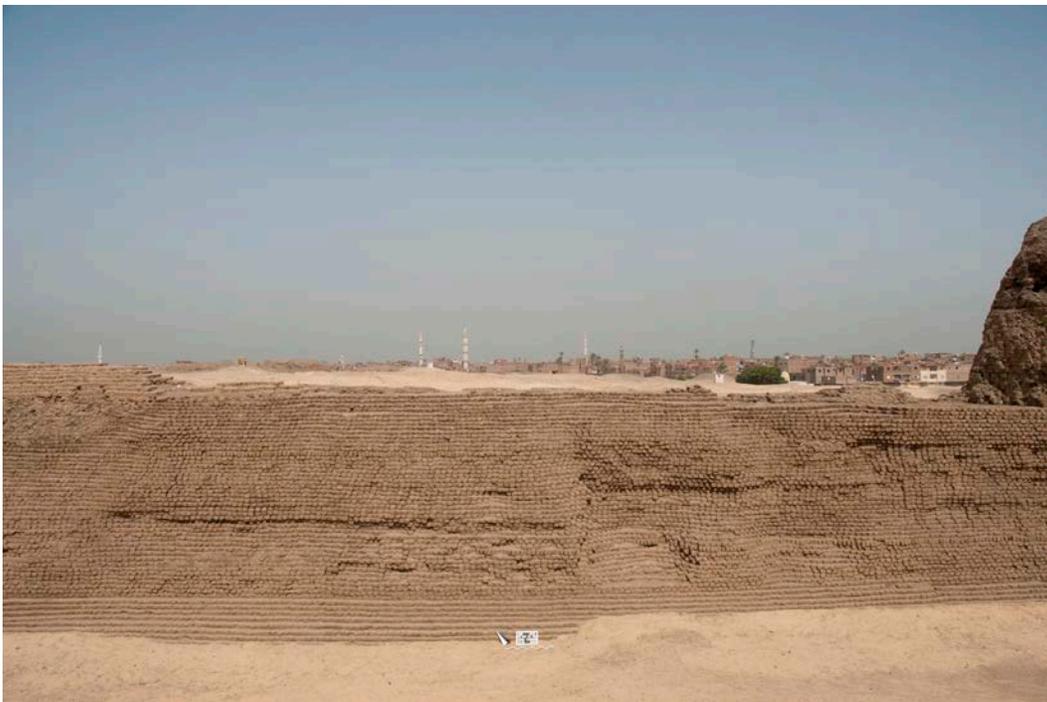
Figure 41 – The new masonry in Operation 35 at the close of work in 2012, integrated into the comprehensive treatment of the interior side of the wall. Photo by Greg Maka for the Institute of Fine Arts, NYU.

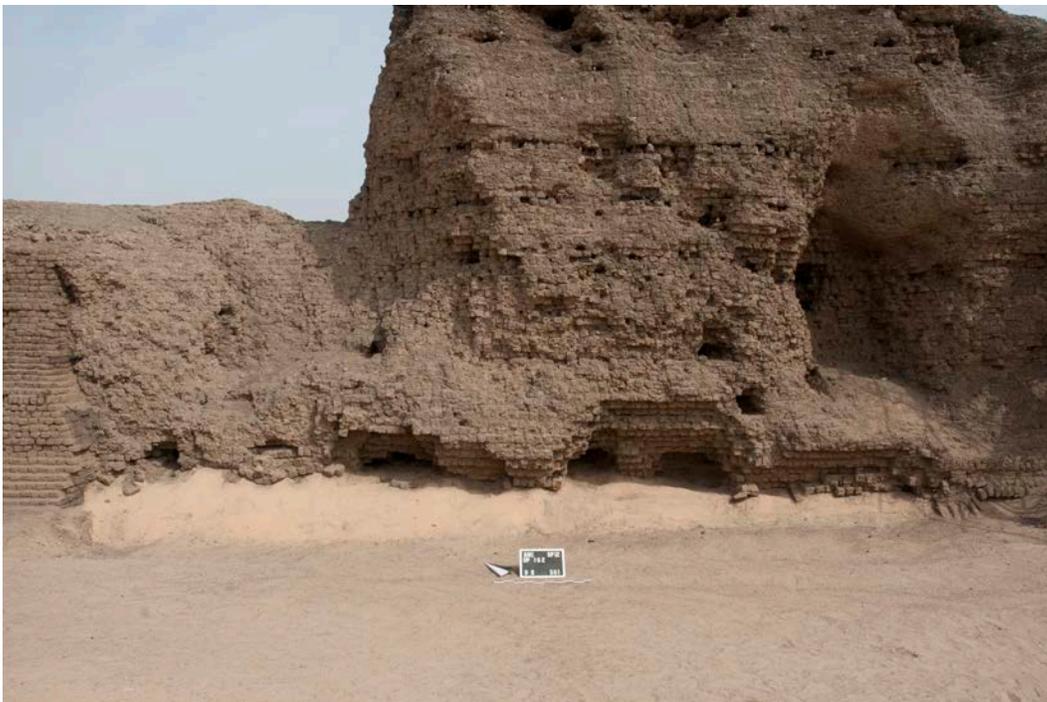
Excavation in Operation 162 showed that the undermining of the wall there was not as severe as to the north, although still significant (Figures 42, 43). It seems likely that Mariette's sondage may not have been as deep in this area, perhaps out of concern for the stability of the section of wall near the east corner gateway, which stands to near its original height. The same basic approach to stabilization was taken, with the basal sand cut back to near the existing line of the wall, wetted, and compacted (Figure 44), creating a base for the construction of a supporting foundation (Figure 45). Given that the

Figure 43 – Excavation along the base of the east wall, interior side, in Operation 162. The undermining here was not as severe as to the north. Photo by Greg Maka for the Institute of Fine Arts, NYU.

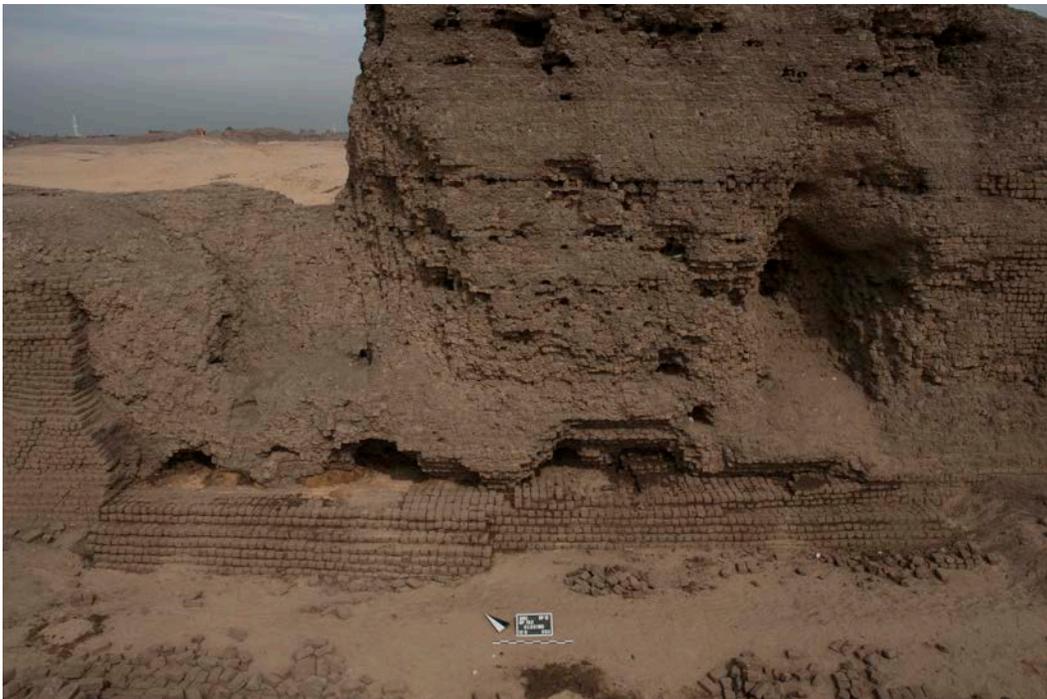
Figure 45 – The completed foundation in Operation 162. Because the undermining at the base of the wall was less severe than to the north, and the concavities requiring infilling smaller, the foundation was not as deep nor as massive as in nearby areas. Photo by Greg Maka for the Institute of Fine Arts, NYU.

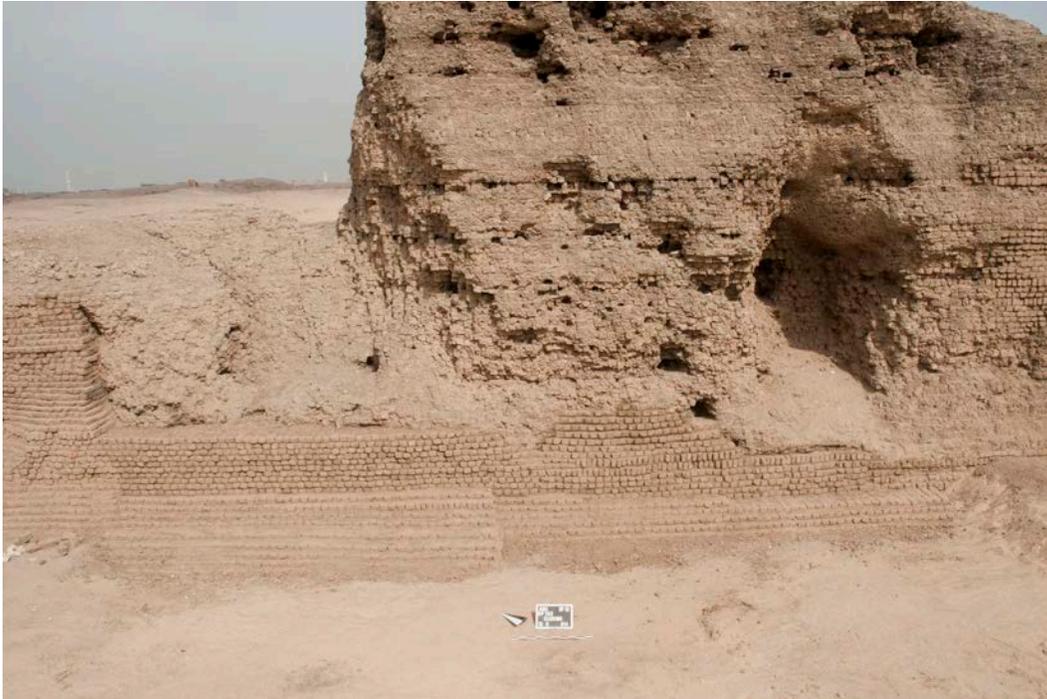
Figure 46 – Work in progress in Operation 162. The taller area of new masonry at left is in Operation 106. The large concavity at right, which may have been the “start” of a never constructed monastic cell, is seen before cleaning. Photo by Greg Maka for the Institute of Fine Arts, NYU.

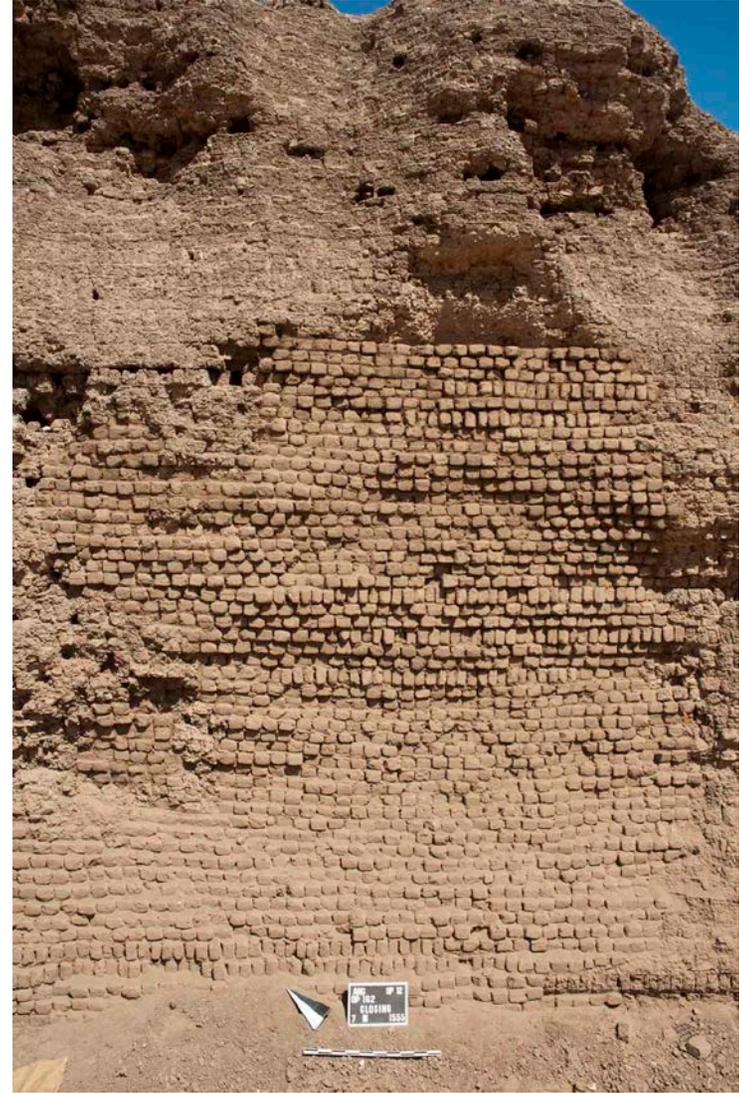
Figure 51 - The stabilized void in the tall southern section of the east wall of the main enclosure at the close of work in 2012. The small area at the top will be completed in a future season. Photo by Greg Maka for the Institute of Fine Arts, NYU.

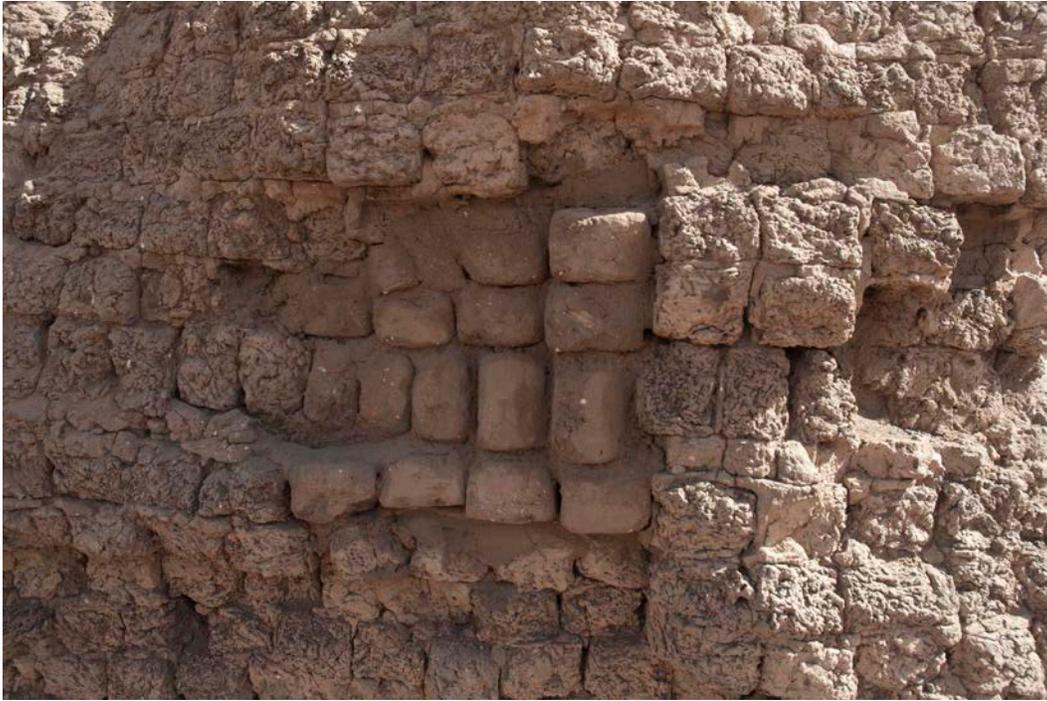
Figure 56 – The hole shown in Figures 54 and 55, after it was filled with new mudbrick masonry. Photo by Greg Maka for the Institute of Fine Arts, NYU.

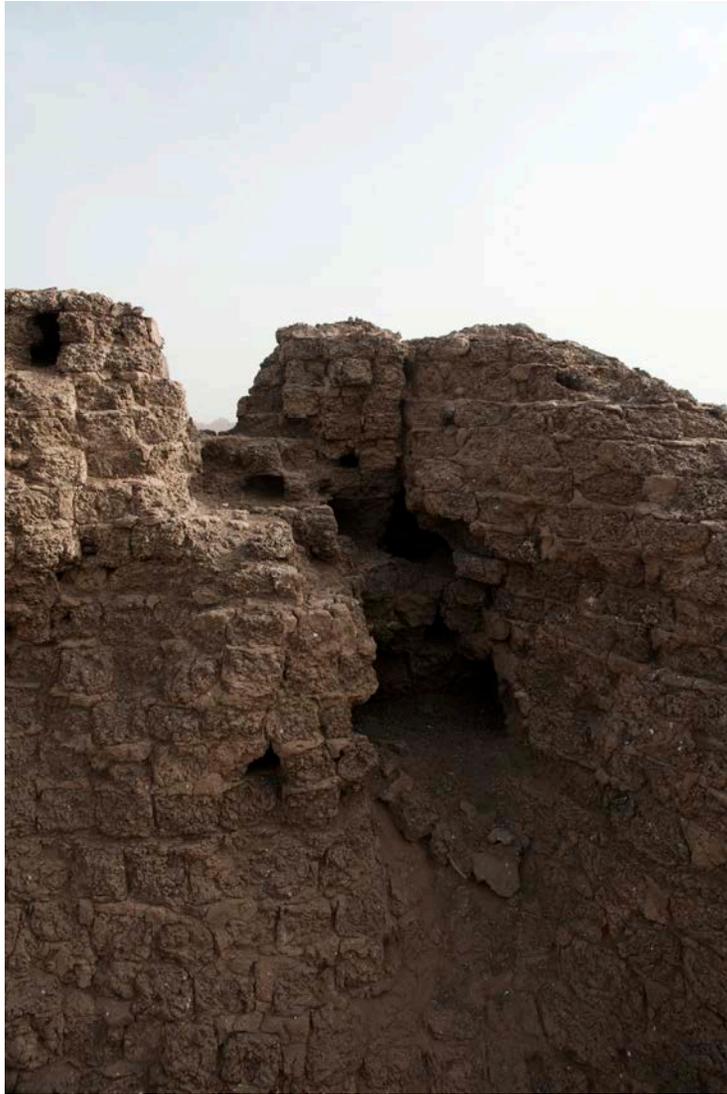
Figure 58 – A large and deeply eroded crack in the top of the east wall of the main enclosure, just north of the east corner gateway, before treatment. Photo by Greg Maka for the Institute of Fine Arts, NYU.

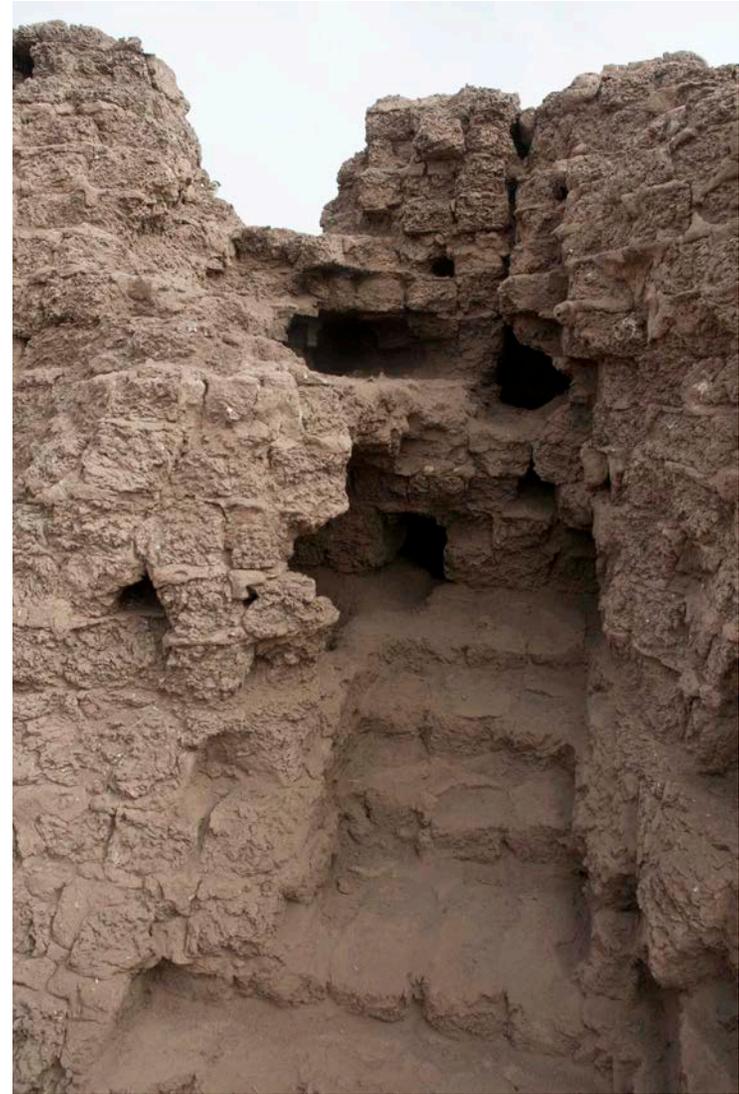
Figure 59 – The area shown in Figure 58, after cleaning preparatory to stabilization. Photo by Greg Maka for the Institute of Fine Arts, NYU.

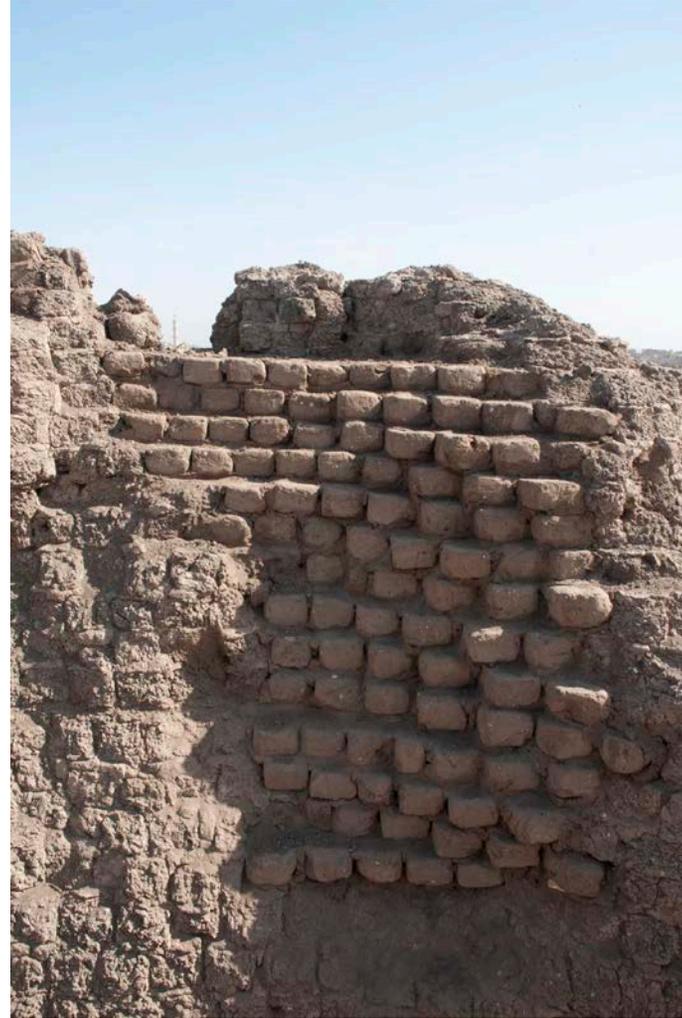
Figure 61 – The crack shown in Figures 58-60, after stabilization with new masonry. The flat top of the infill will eventually be incorporated into a general capping of the wall top in a future season, which will eliminate the visual abruptness of the top of the infill. Photo by Greg Maka for the Institute of Fine Arts, NYU.
