TECHNICAL REPORT

“Conservation of the Shunet el-Zebib, Abydos”

***“Conservation of King Khasekhemwy’s Funerary Monument at Abydos”  
Technical Report on 2012 Fieldwork***

Matthew Douglas Adams  
Institute of Fine Arts, New York University

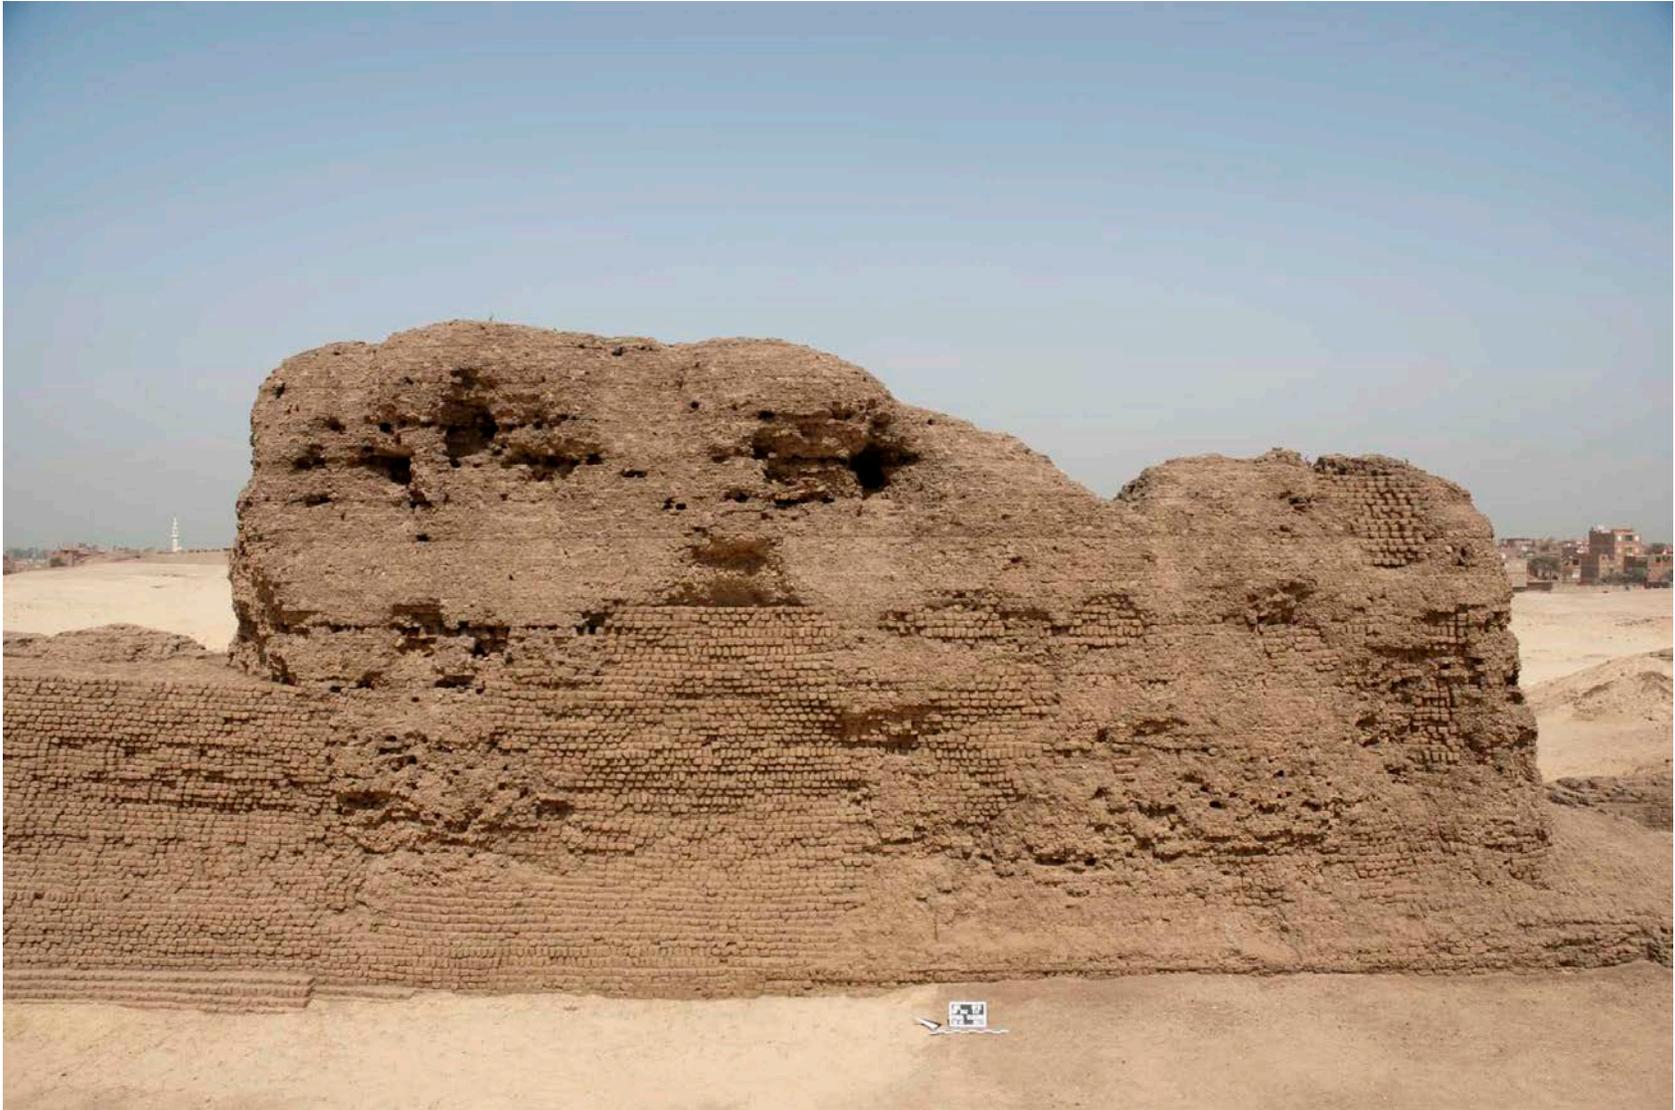
Figure 62 – The tall southern section of the east wall of the main enclosure at the end of the 2012 field season. Compare against the view in Figure 42, above. Additional work remains to be done on the upper part of this section, particularly the left, northern half. Photo by Greg Maka for the Institute of Fine Arts, NYU.

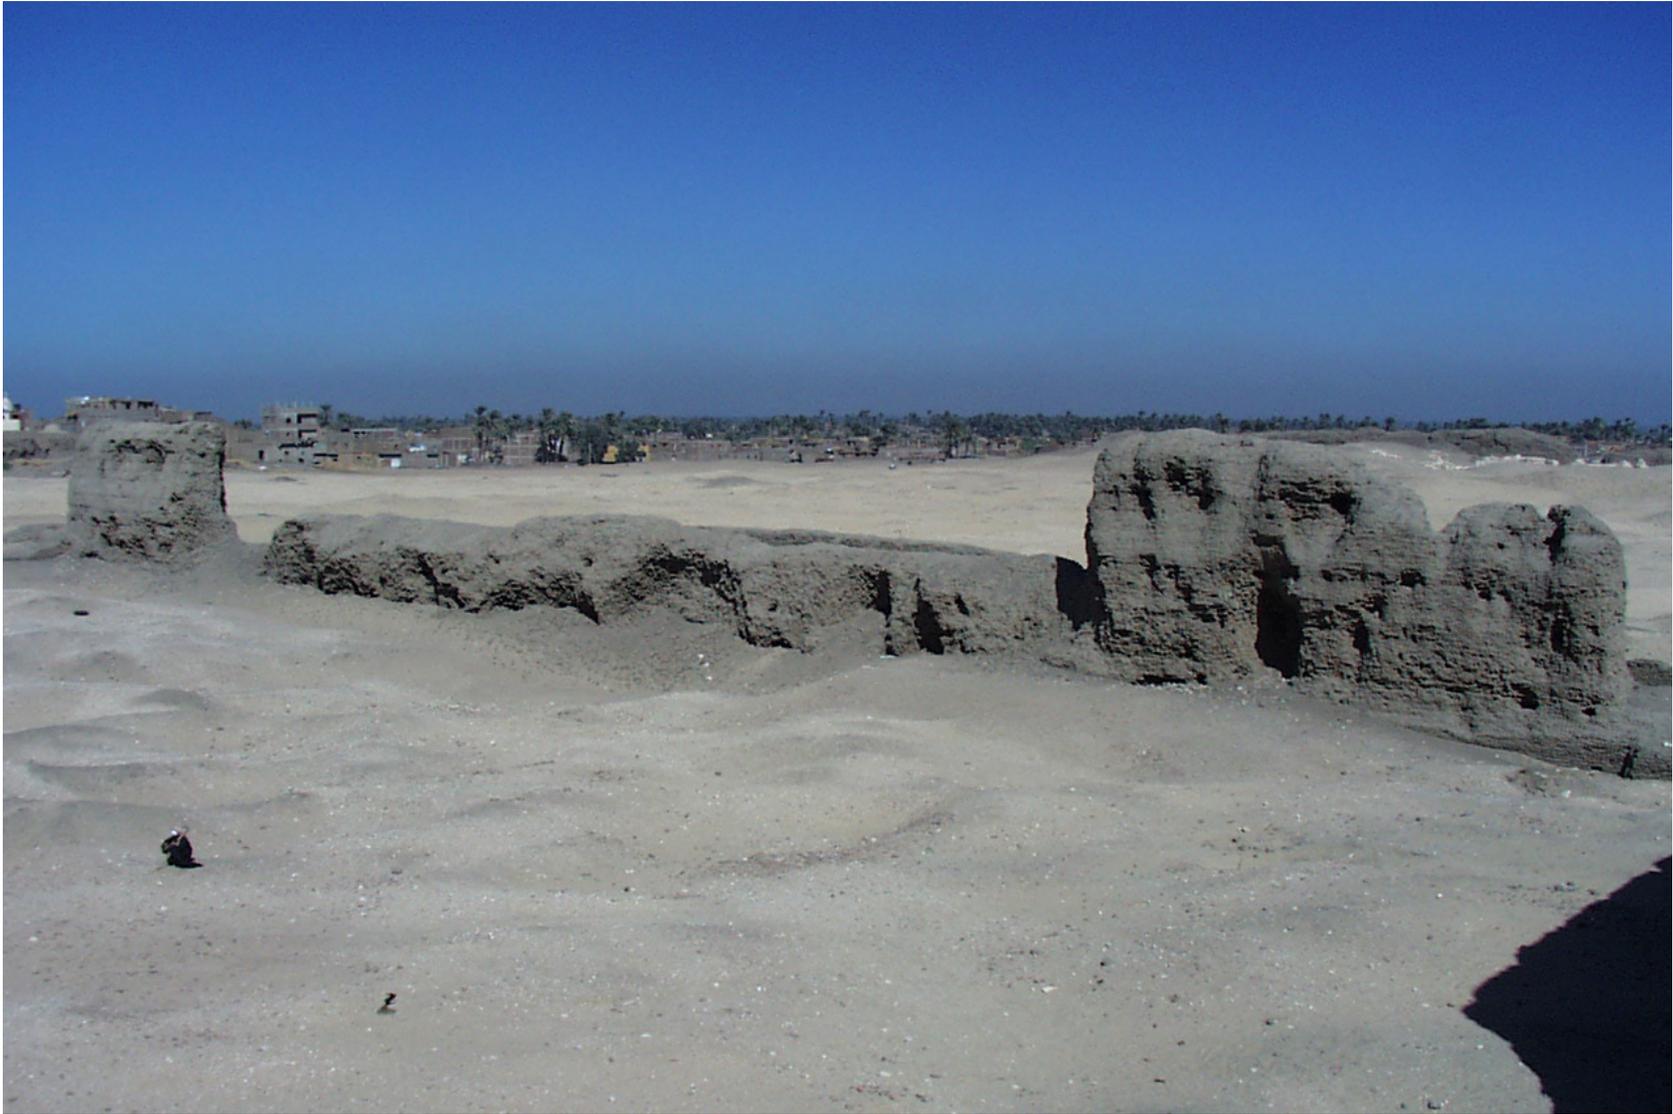
Figure 63 – General view of the interior side of the east wall of the main enclosure in 1999, prior to any conservation intervention. Photo by Matthew Adams for the Institute of Fine Arts, NYU.

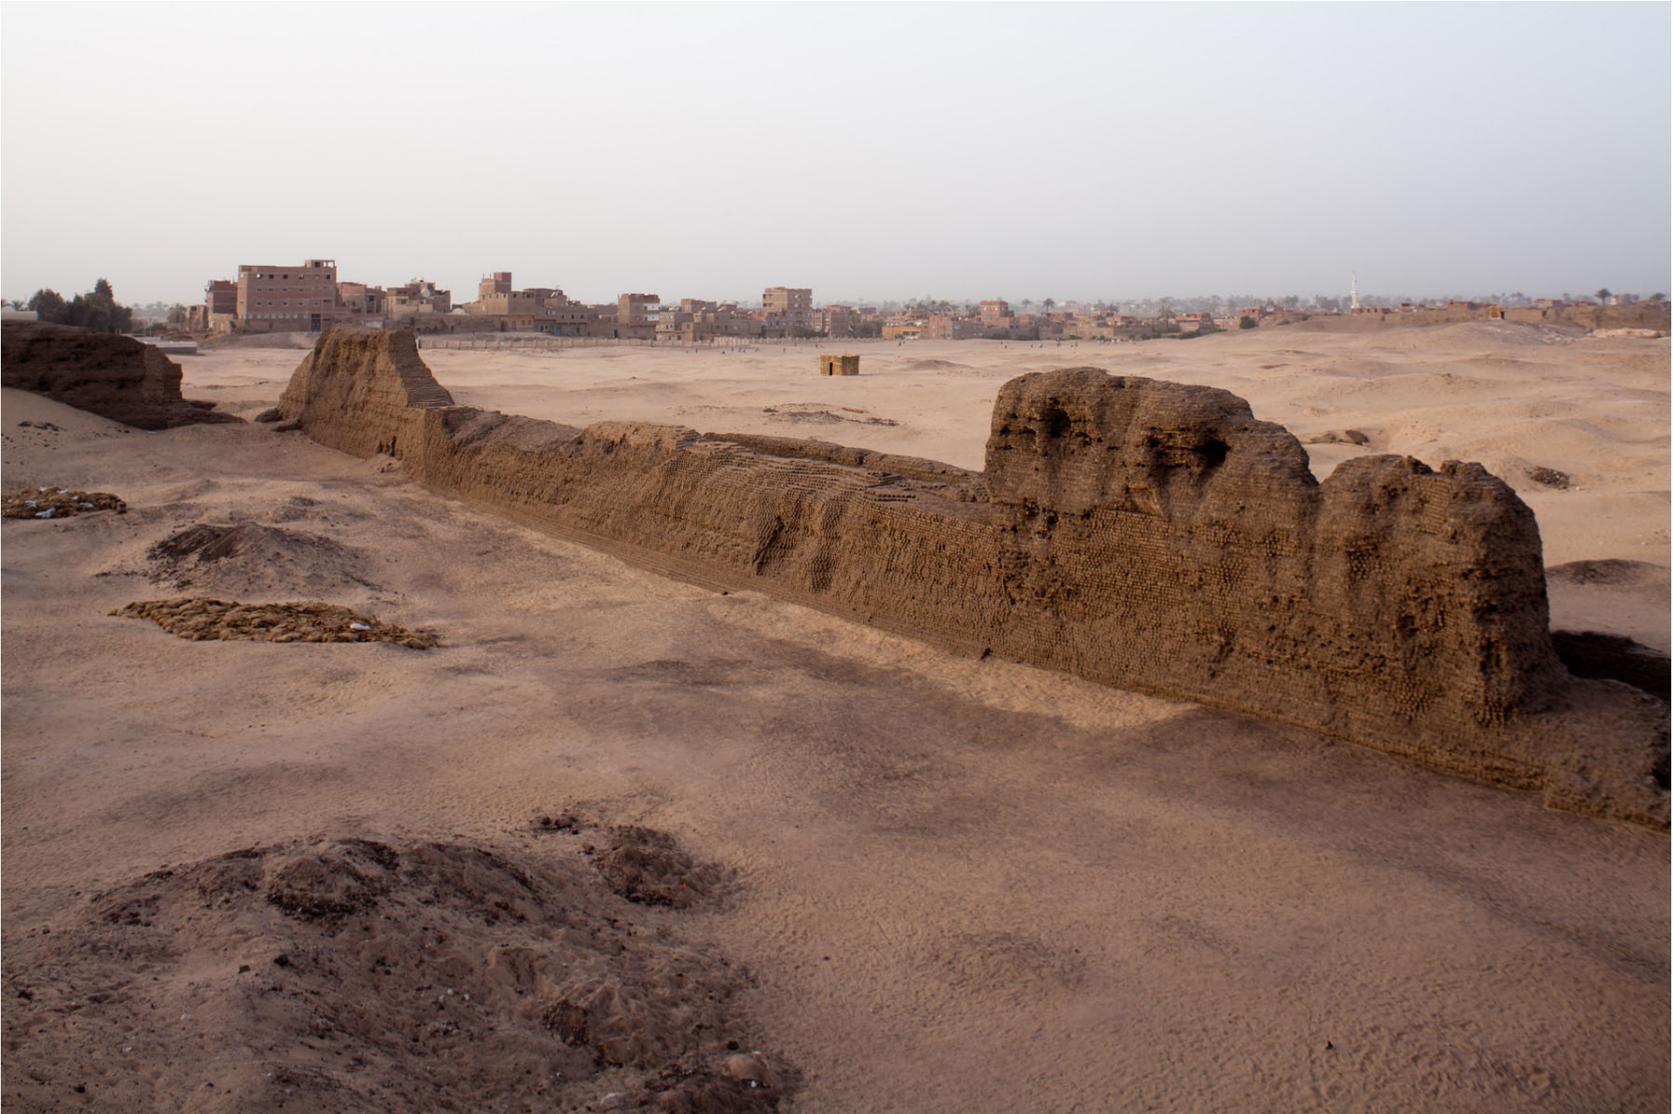
In the views of the east wall of the main enclosure in 2012 in Figures 64-66, a distinct horizontal line is visible just above ground level. This is the top of the masonry foundation that is intended to be below-grade at the completion of work at the monument. In a future season, the area adjacent to the wall will be leveled with sand such that nothing of the foundation will remain above grade. Only masonry within the original footprint of the wall will be visible.

Figure 64 – General view of the interior side of the east wall of the main enclosure at the close of work in 2012. The stabilization of the highly threatened low middle part of the wall has been completed. The top of the below-grade foundation, visible here and in Figures 65 and 66, are not intended to remain visible and will be covered by sand at the completion of the conservation program. Photo by Greg Maka for the Institute of Fine Arts, NYU.

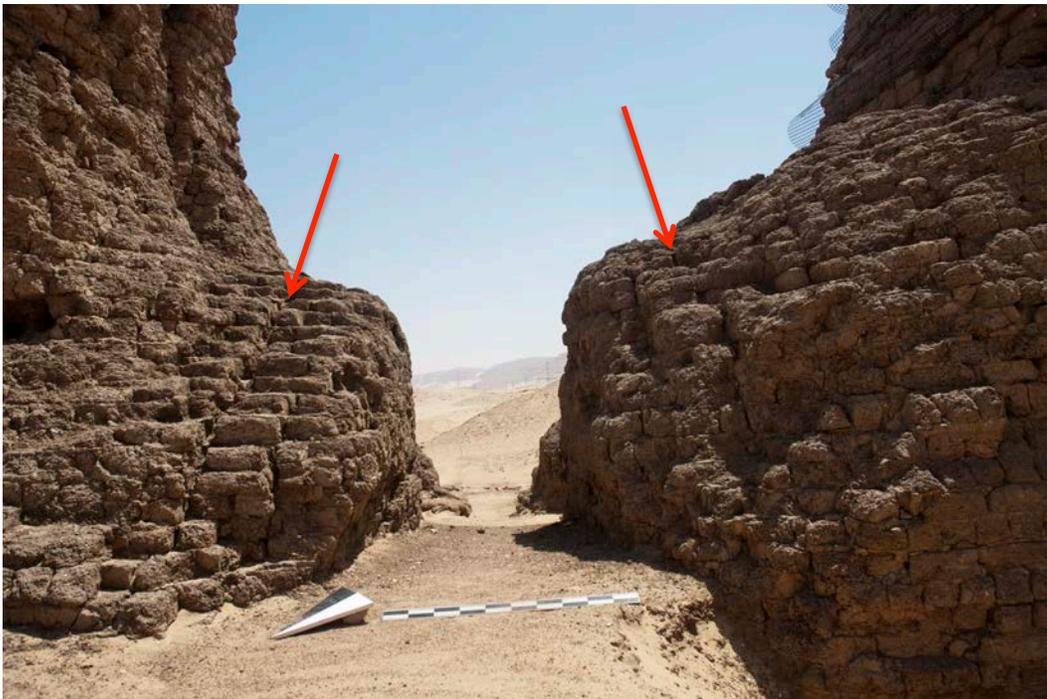
Figure 74 – The south gateway through the main, inner enclosure wall, seen from the interior side. Note the cracks marked by the arrows. Photo by Greg Maka for the Institute of Fine Arts, NYU.

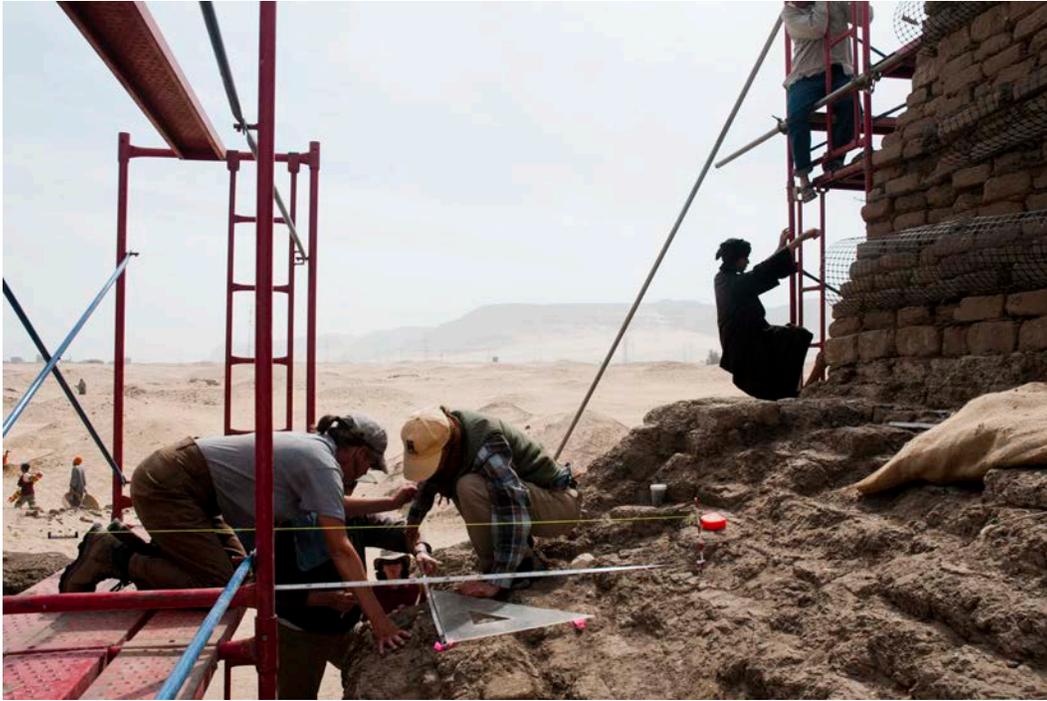
Figure 75 – Members of the architectural illustration team documenting a crack on the west side of the south gateway in the main enclosure, Kay Barnett, left, and Shanna Diederichs, right, assisted by Dr. Donna Glowacki, below in the background. Photo by Greg Maka for the Institute of Fine Arts, NYU.

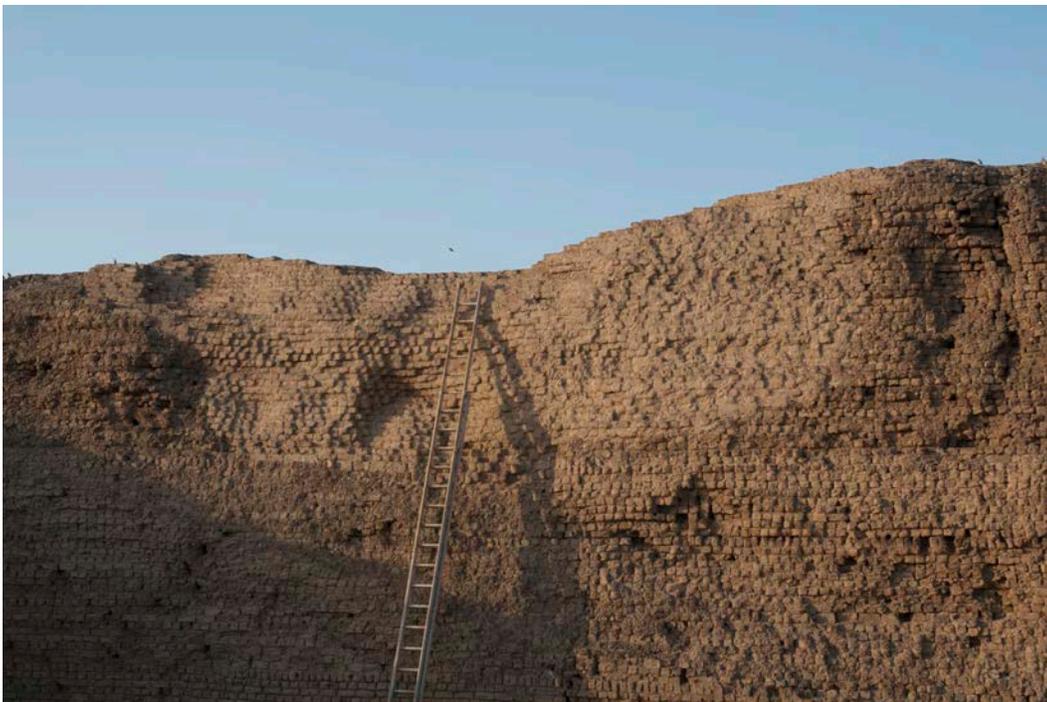
Figure 76 – This photo illustrates the undesirable reflectivity of the mud wash applied to the new masonry infill of the large notch (WII 65) in the top of the west wall of the main enclosure, near the southwest corner. The wash was removed in 2012. Photo by Greg Maka for the Institute of Fine Arts, NYU.

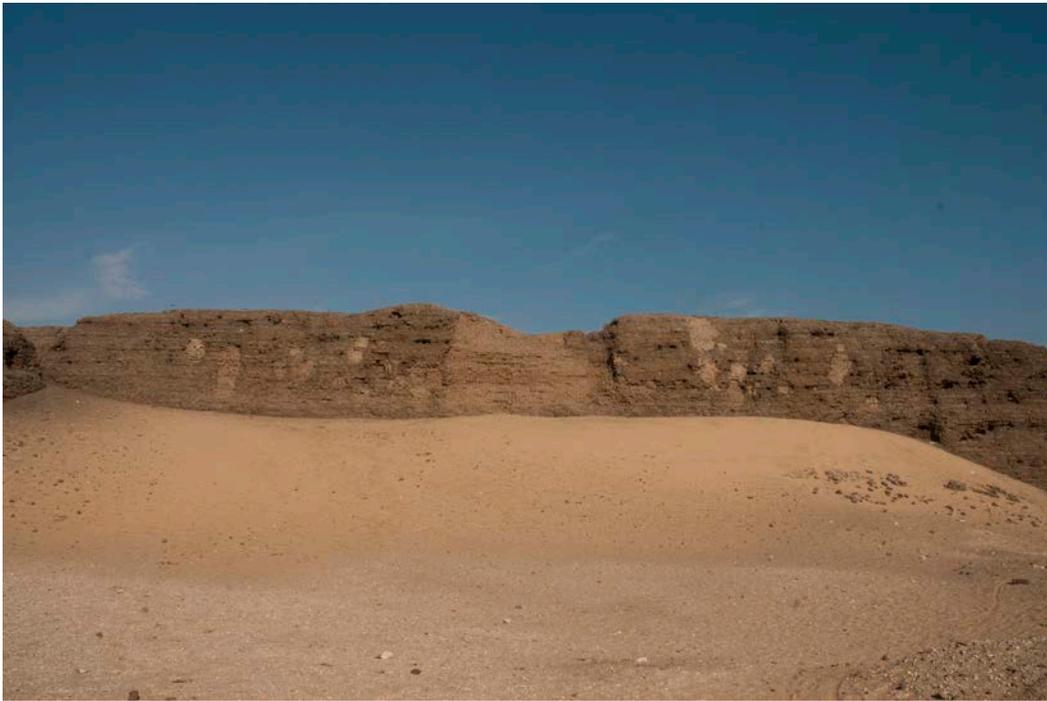
Figure 77 – General view of the interior side of the north wall of the main enclosure. The too reflective mud wash applied to a number of hole infills in previous seasons created an undesirable visual effect, where the infills are too prominent. Photo by Greg Maka for the Institute of Fine Arts, NYU.

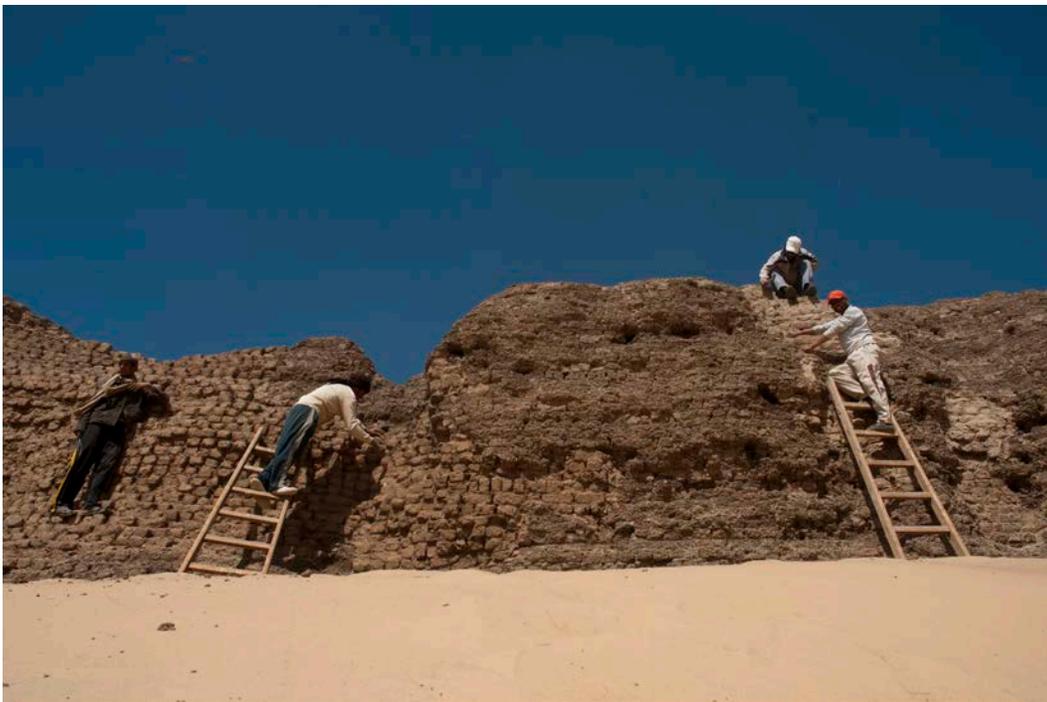
Figure 78 – Workers are here shown on the interior side of the north wall of the main enclosure, removing mud wash from the new masonry of hole infills and opening joints in the large notch infill NII 27, at left. Photo by Greg Maka for the Institute of Fine Arts, NYU.

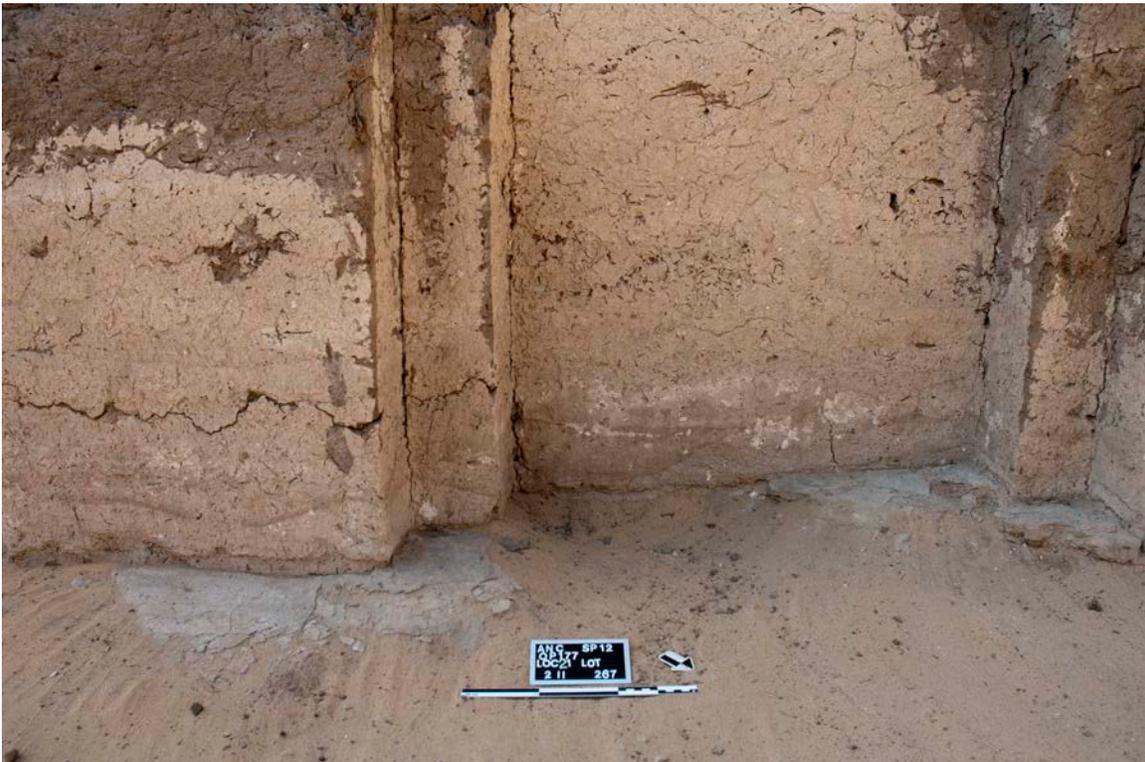
Figure 82 – Lenses of plaster wash eroded from the south wall of the main enclosure. Photo by Greg Maka for the Institute of Fine Arts, NYU.
