**"Conservation and Display of Roman Mosaics  
Kom el-Dikka, Alexandria"**

**6th Progress Report  
Conservation and Landscaping**

submitted by Dr Wojciech Kołataj, the Project Director

May 23, 1999

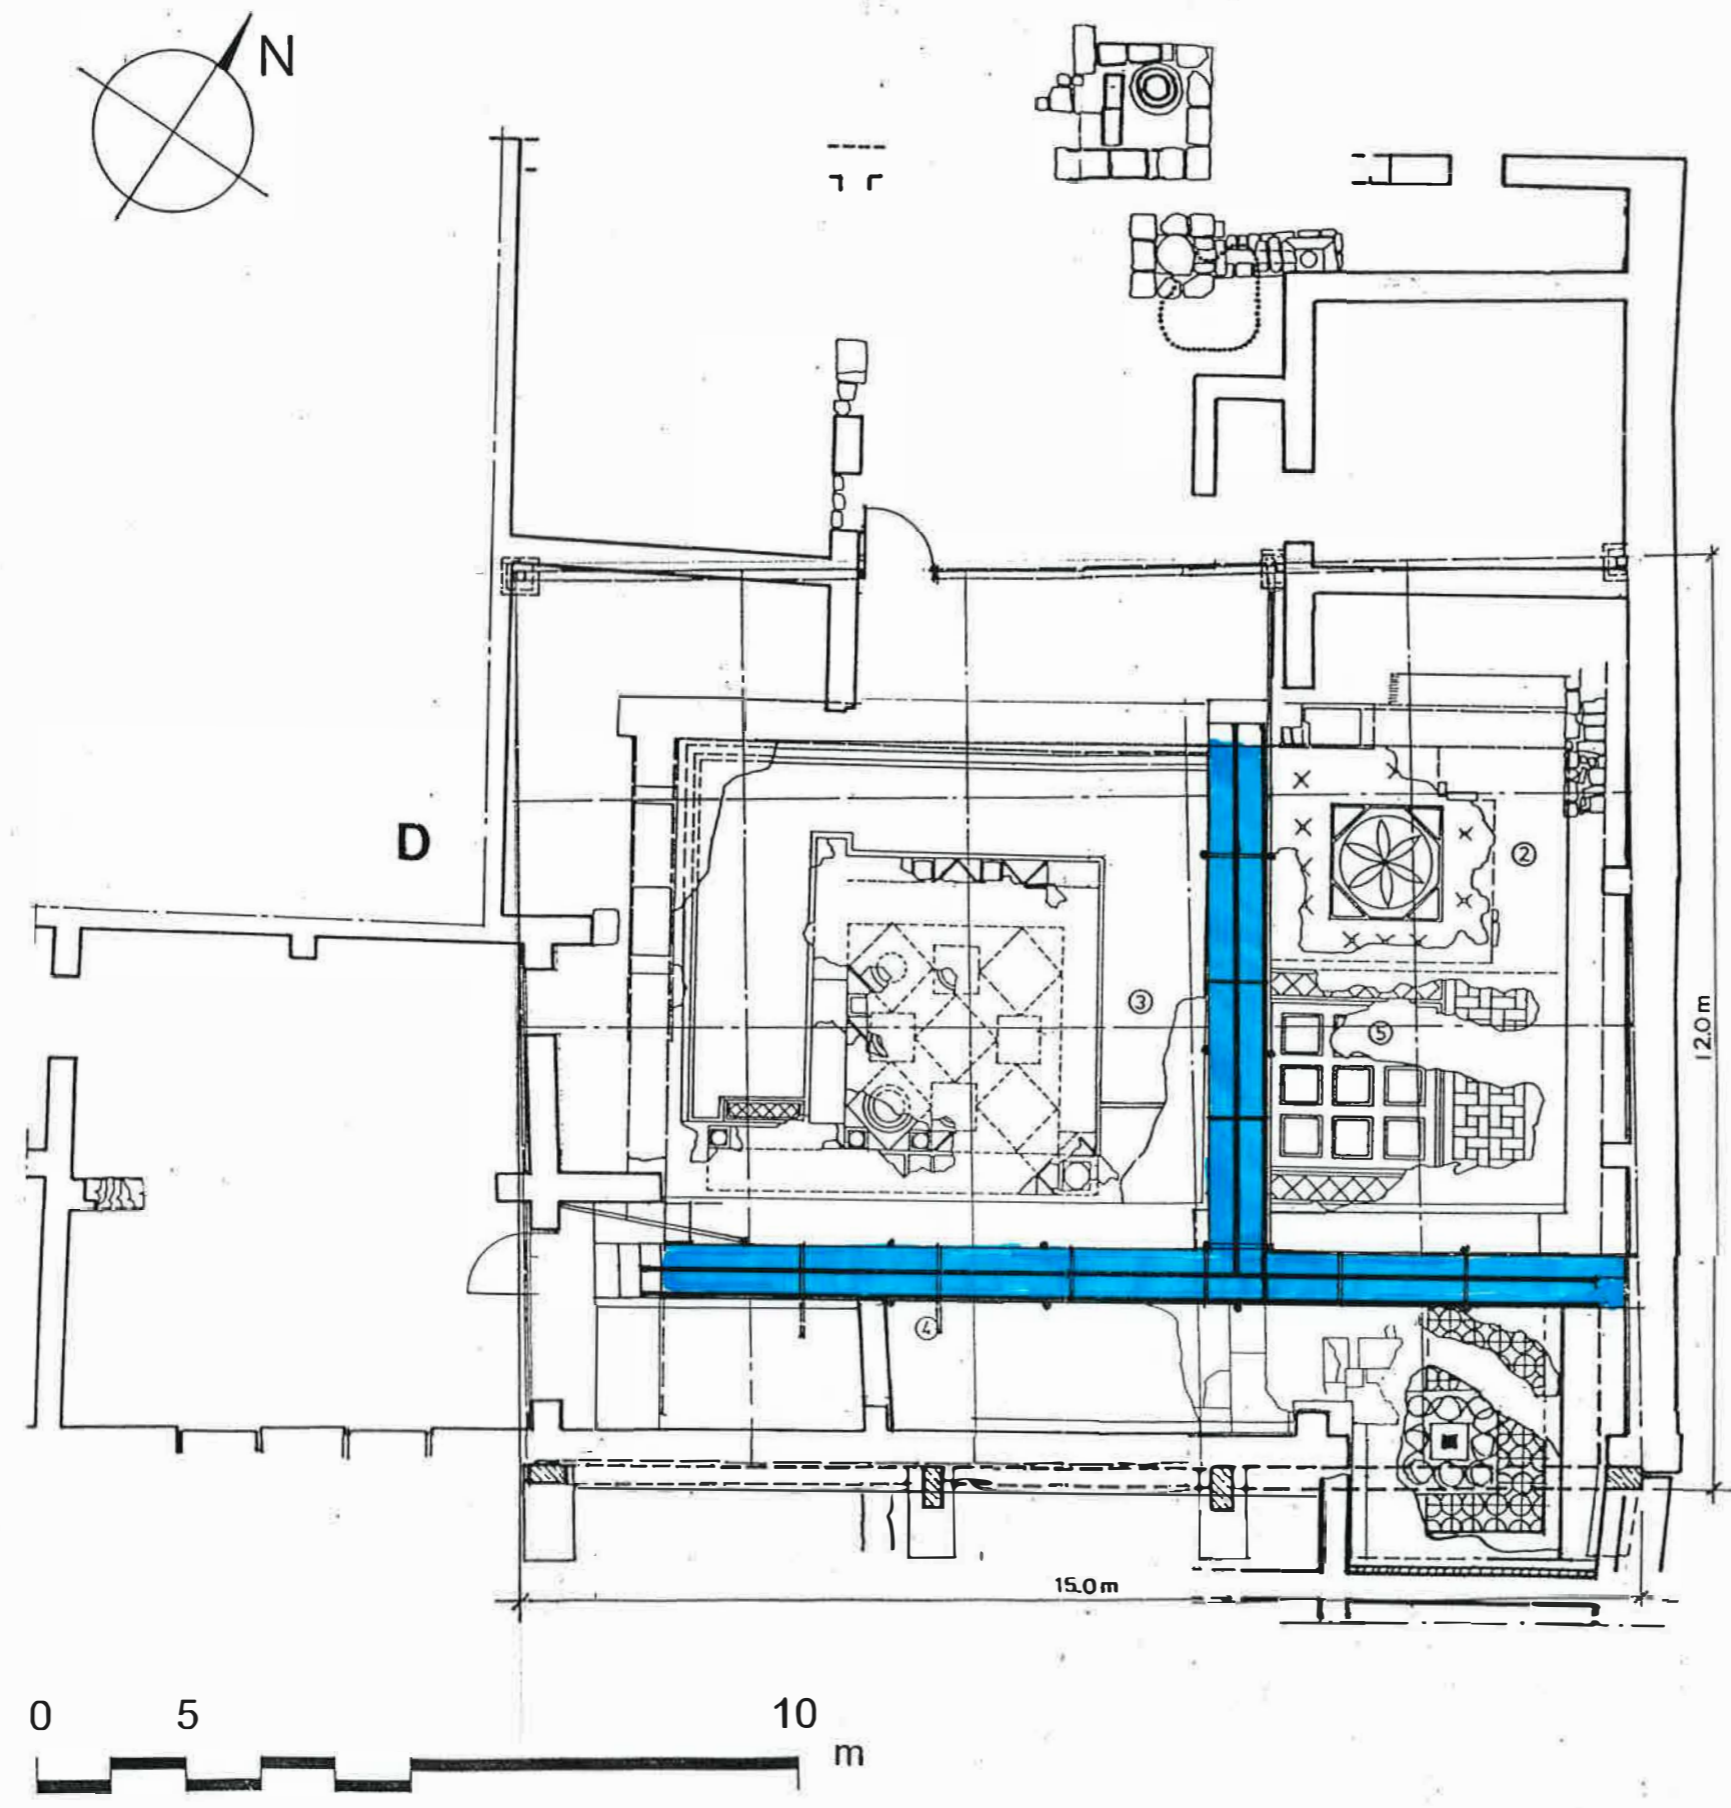
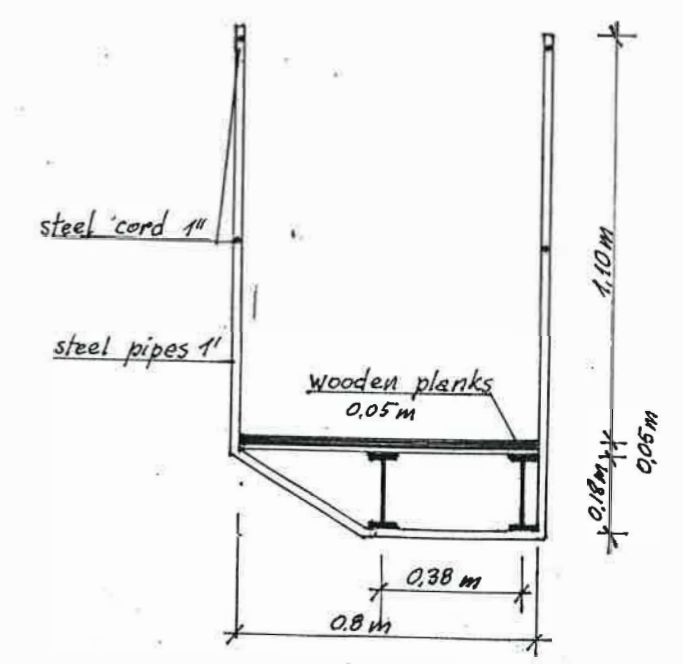
**FOOT-BRIDGE  
STRUCTURE AND LOCATION**

- The existing construction has been additionally reinforced with parallel eye-bars I 180 mm added to the both segments of the foot-bridge. Newly introduced eye-bars were joined with steel angles  $\perp$  50 x 50 mm welded on top in equally spaced distances (150 cm). Those angles at the same time serve as mounts for bridge timber flooring. (Phot. No. 1 and Drawing )

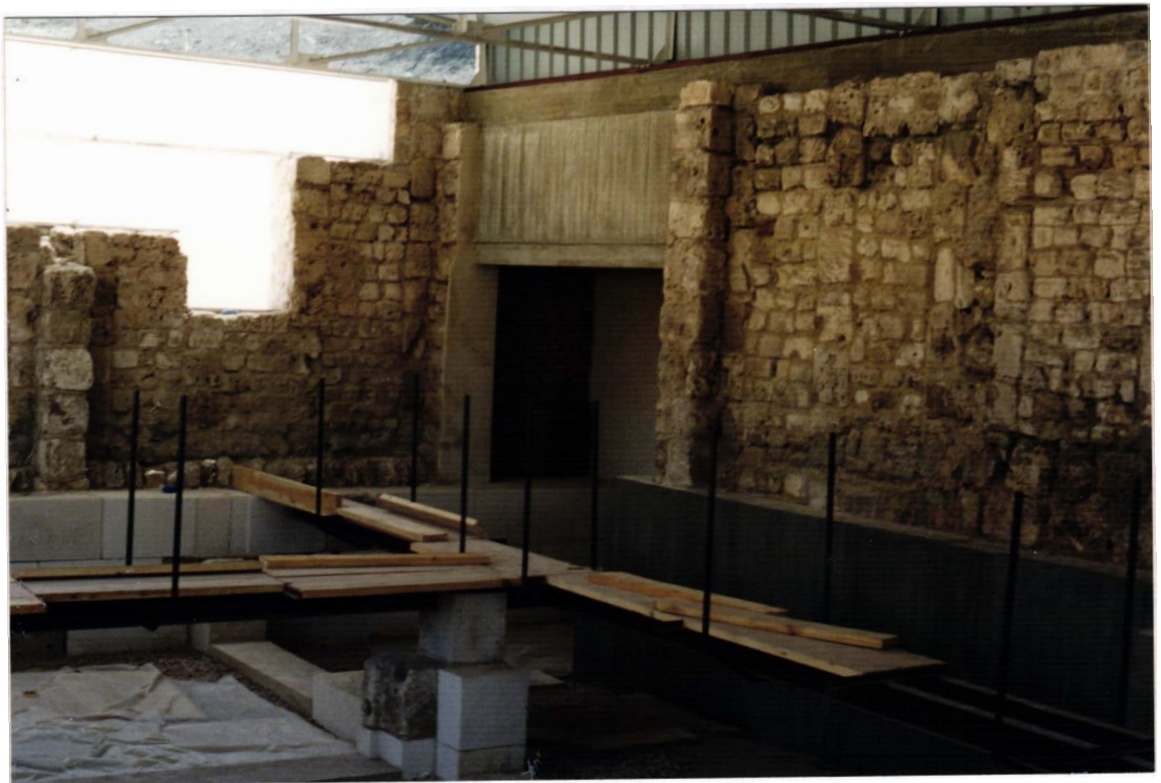
Phot. 1, 2. Foot-bridge construction.

- The railing posts were made of steel pipes (1"). U-shaped posts were welded to the bottom of the foot-bridge.(Phot. no. 2). In order to avoid the visual effect of "overloading" and to secure unimpeded view for the visitors, a steel wire was introduced instead of traditional wooden hand-rail. Two wires ( $\phi$  6 mm) are to be stretched on two levels, between the railing posts.. Similarly made railing secures also the southern edge of the entrance platform.

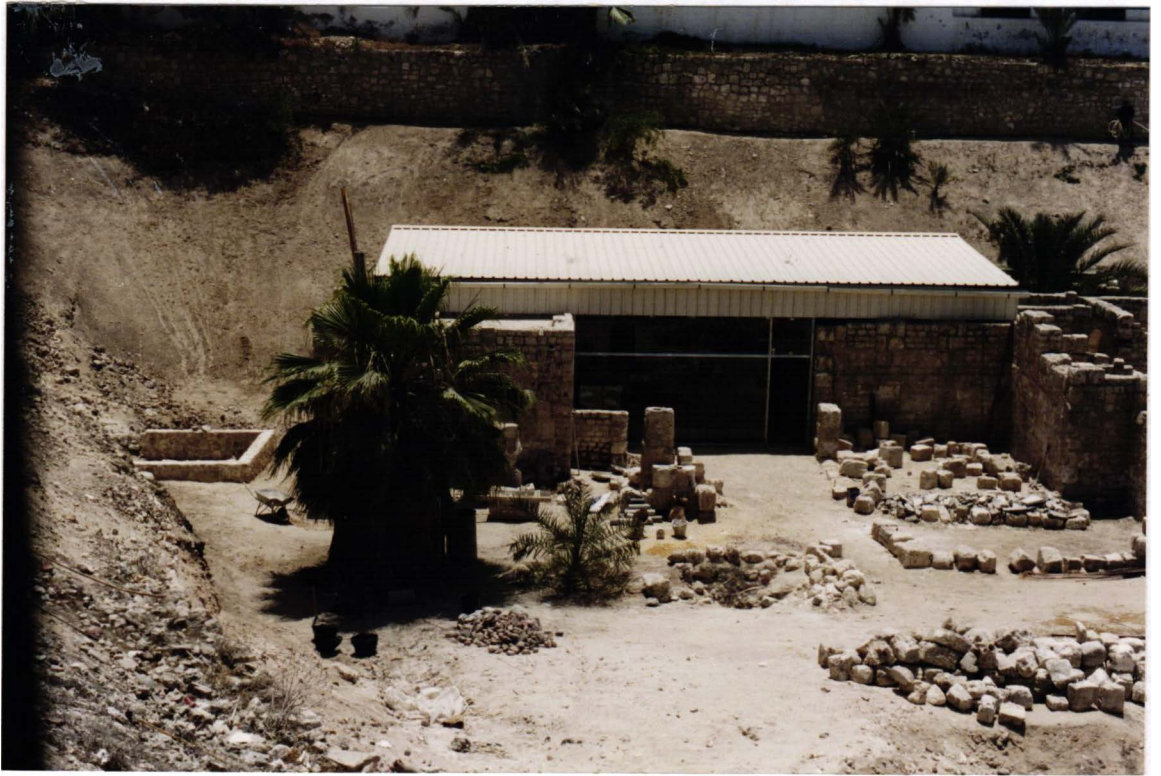
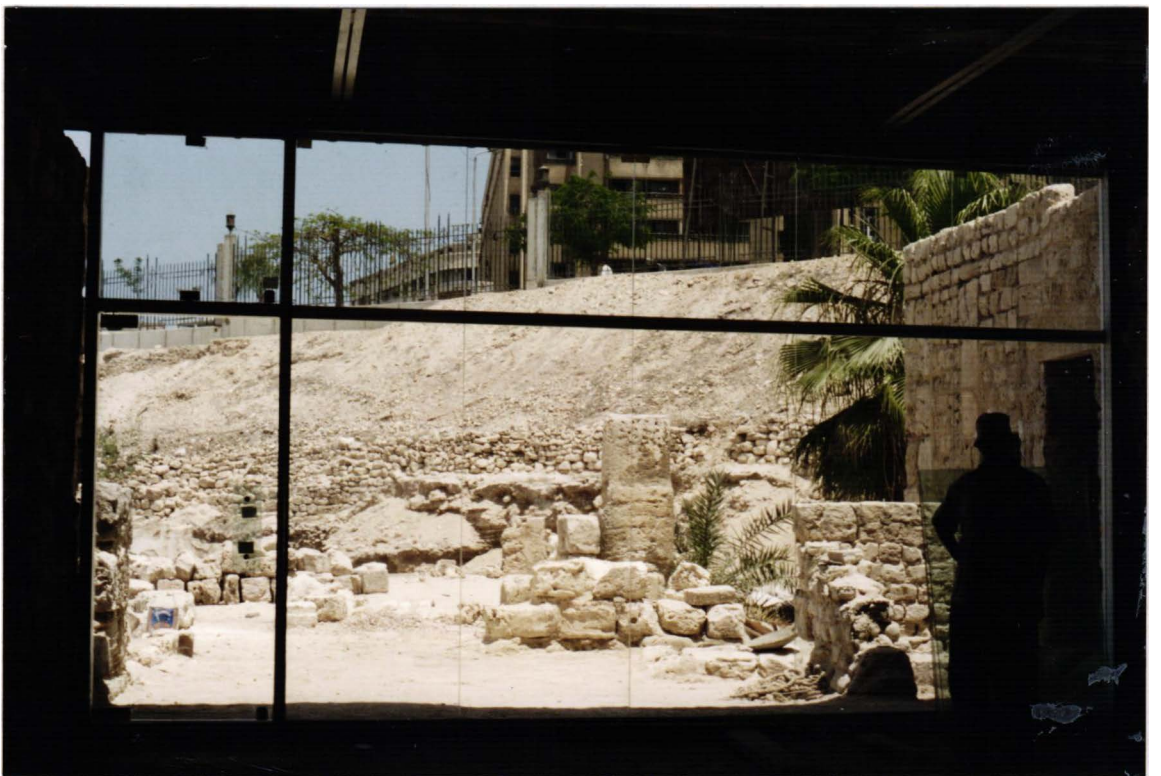
Phot. 3, 4. Northern panel glass-wall.

- Assembling of the western, eastern and northern panel glass walls has been completed. Gables have been screened with smoked security glass (8 mm thick). (Phot. Nos. 3-8).

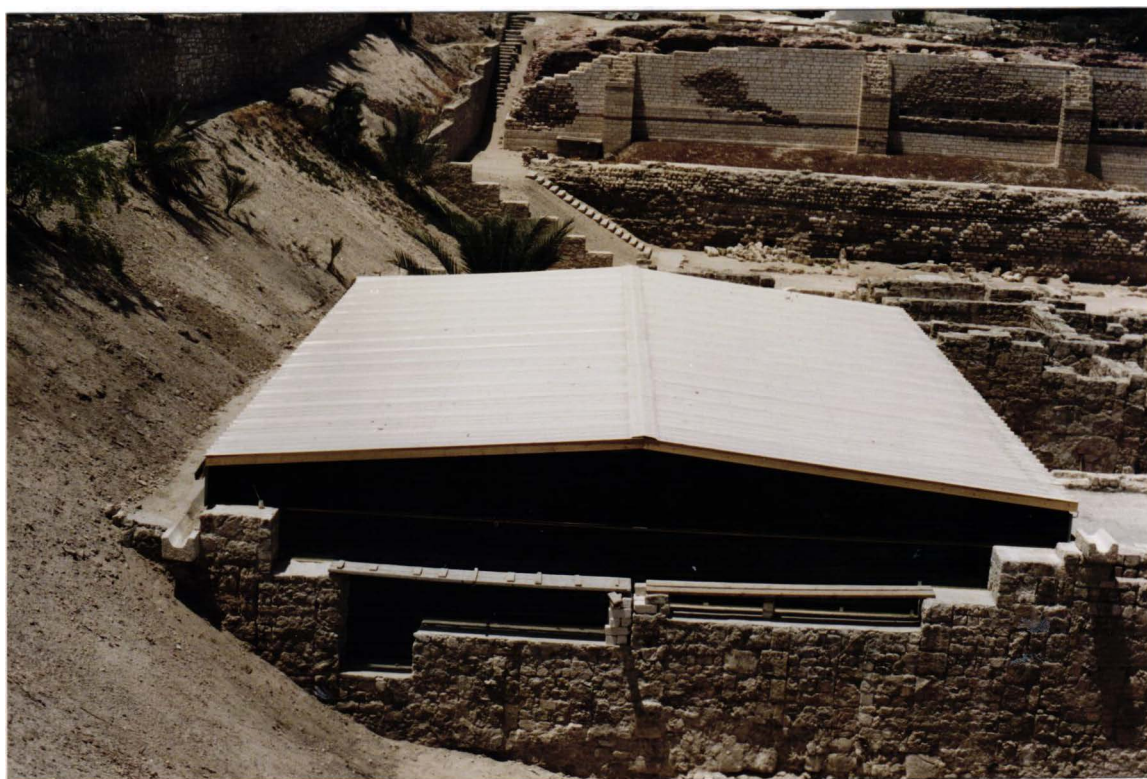
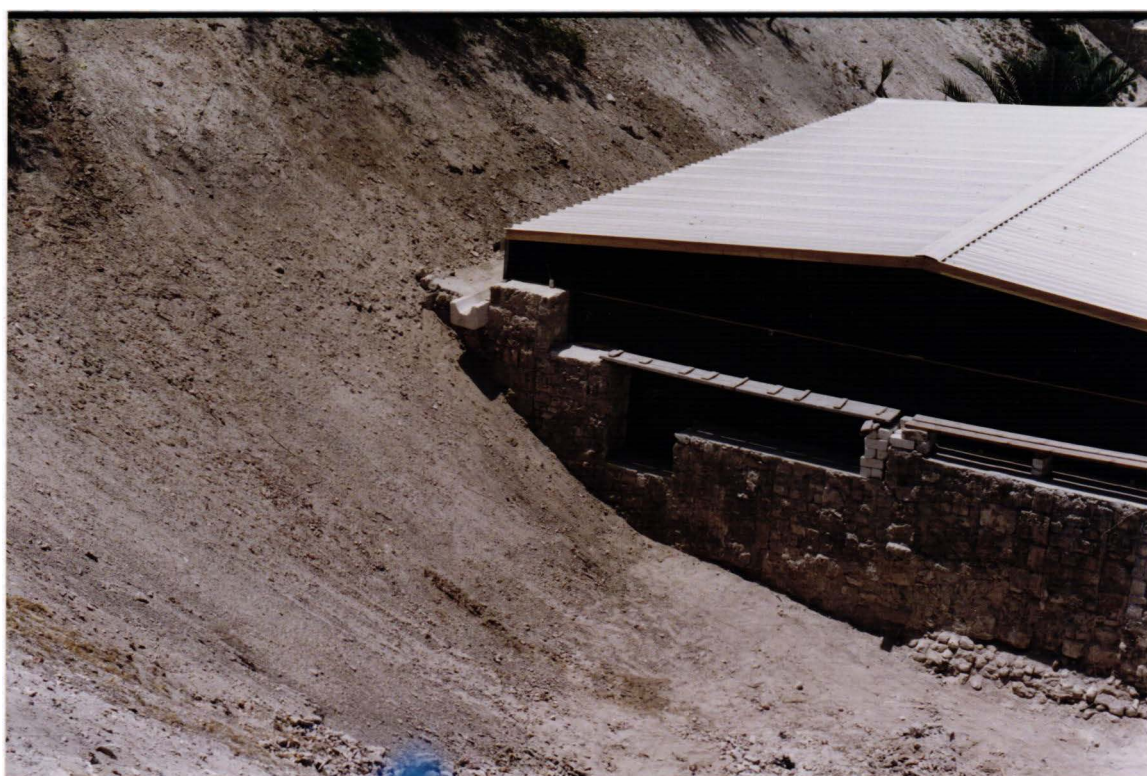
Phot. 5, 6. Eastern panel glass-wall and escarpment.

- Southern and eastern escarpments and surrounding ground were re-shaped and arranged. Escarpment footing was additionally encased with low walls in order to prevent water penetration during raining season or watering. (Phot. Nos. 5-6).

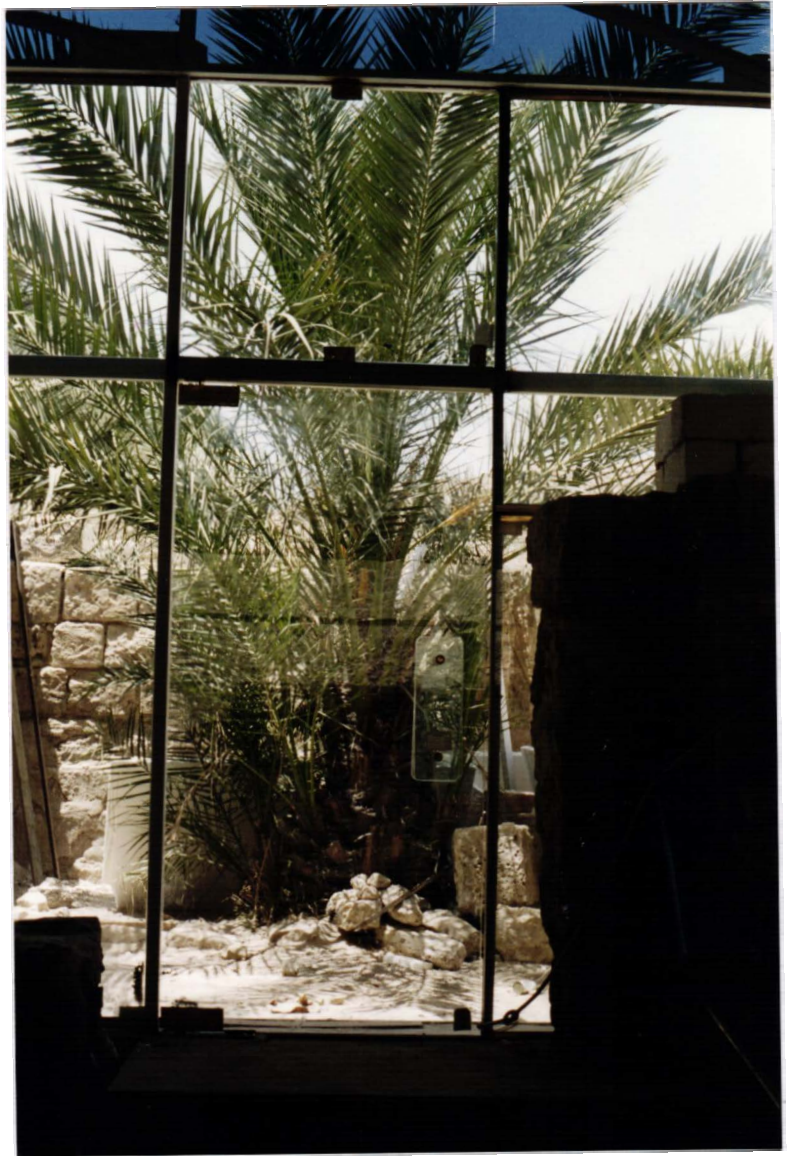
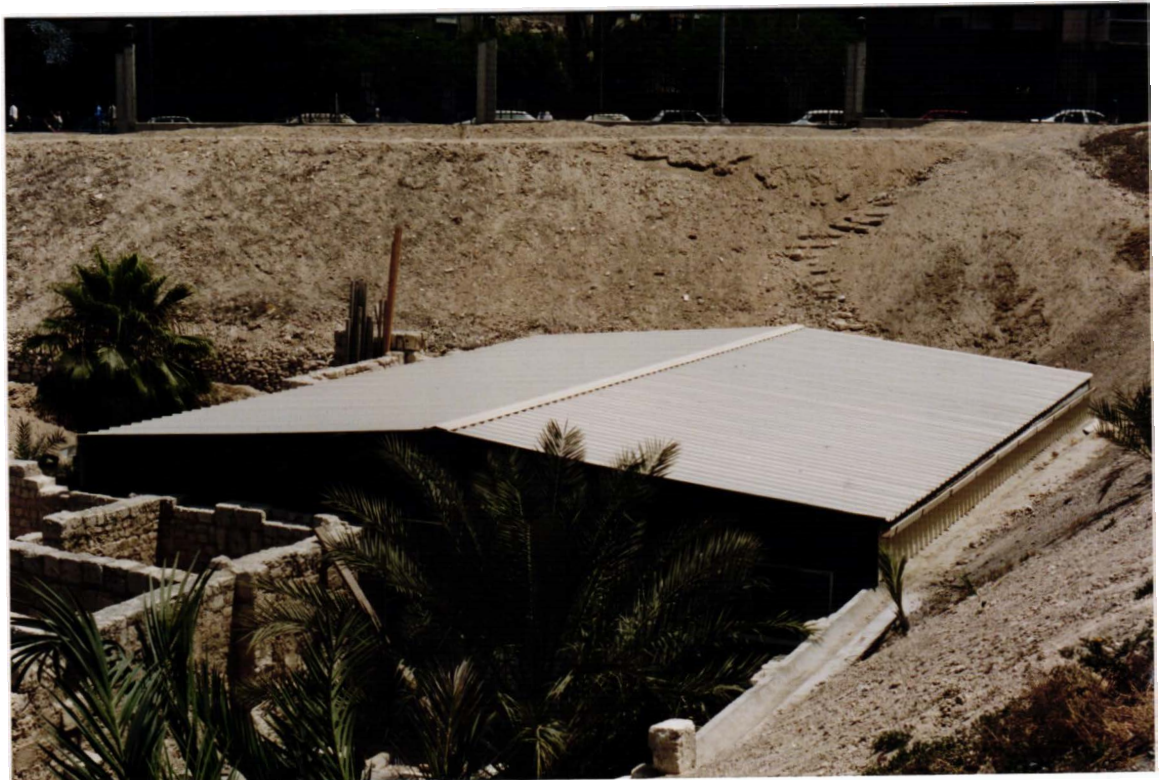
Phot. 7, 8. Western glass-wall and exit patio.

- The exit patio from the shelter was arranged, and ivy was planted along the southern wall of the abutting Byzantine building D. (Phot. Nos. 7-8)

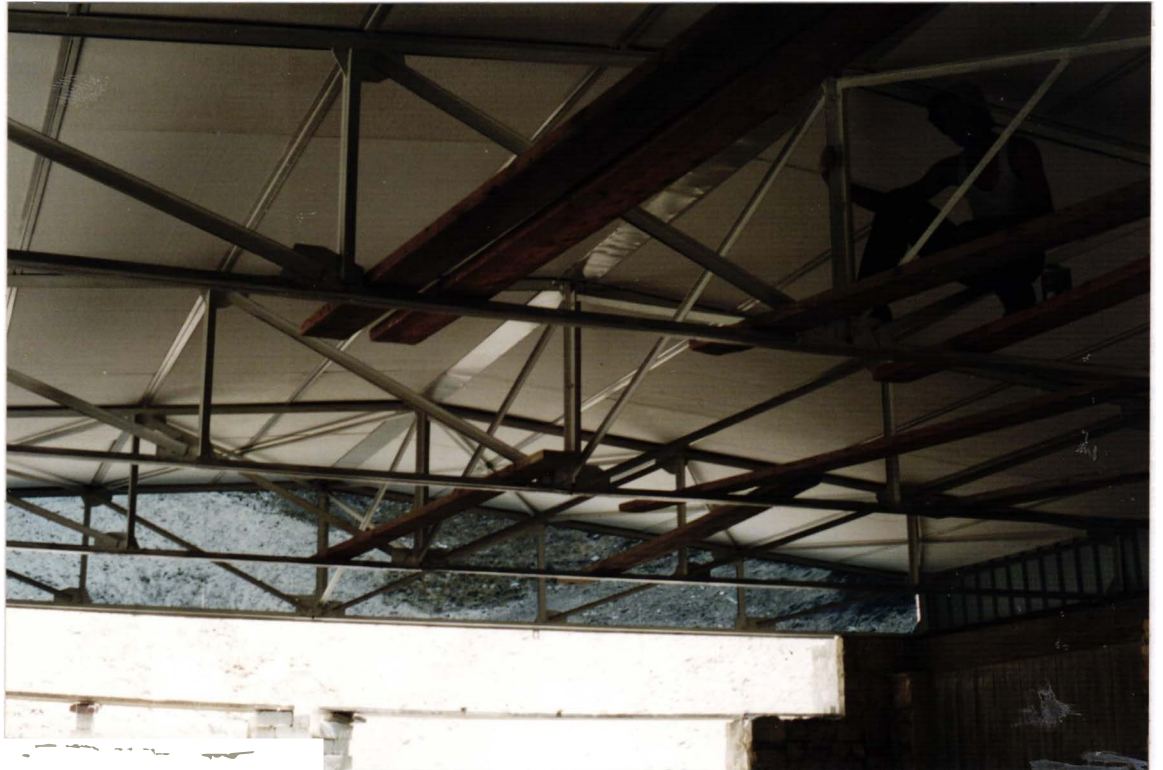
Phot. 9. Roof thermal insulation.

- Roof thermal insulation was made of hardened Styrofoam panels (2 x 1 m, and 4 cm thick).(Phot. no. 9). Styrofoam panels were fixed to the purlins with wooden stringers.

- Roof supporting structure was first coated with primer and then twice painted white.(Phot. no. 9).
- Gutters fixed along the southern elevation were equipped with stone gargoyle supplemented with hanging chains in order to redirect rain splash away from the structure. Rain-water will be drained off to a channel running along the eastern elevation of the shelter towards the ancient sewage system.

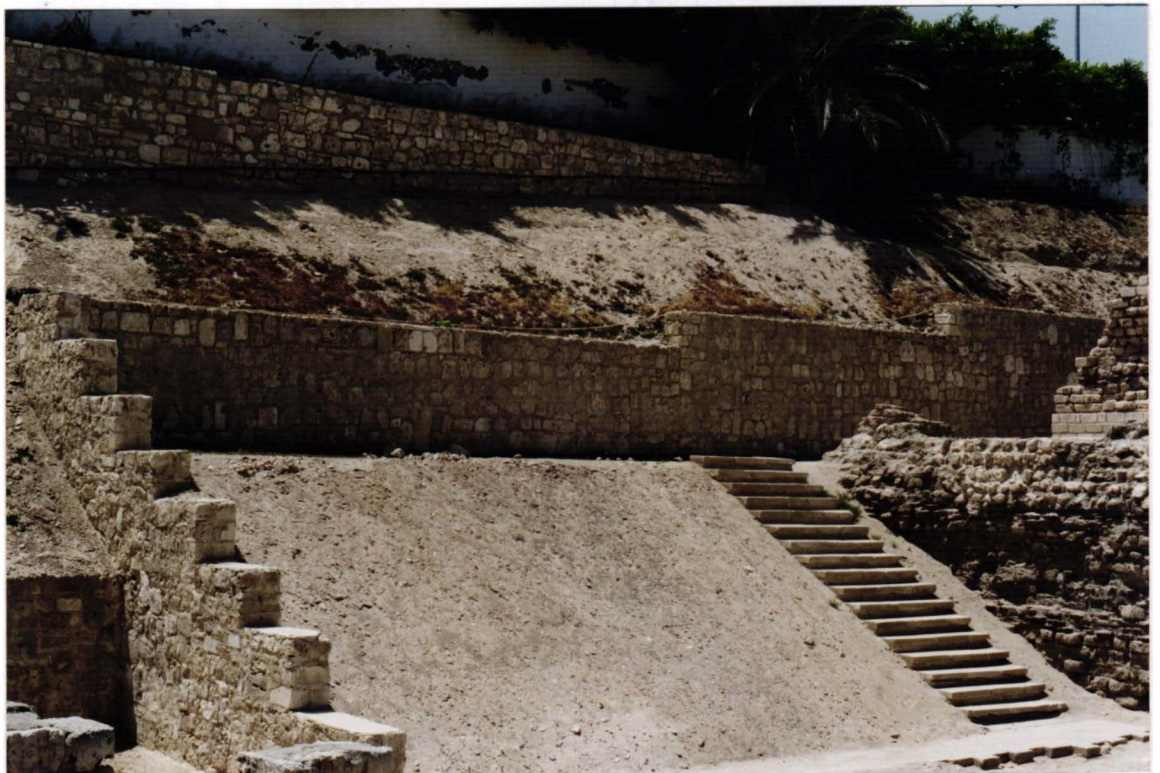
Phot. 10. Water supply pipe along the southern escarpment.

- Along the entire section of escarpment comprised between the theatre and the south-east corner of the site (close to the Saphia Zaghoul Street, i.e. some 150 m) a water supply was introduced. Taps for watering were installed every 50 m. (Phot. No. 10).

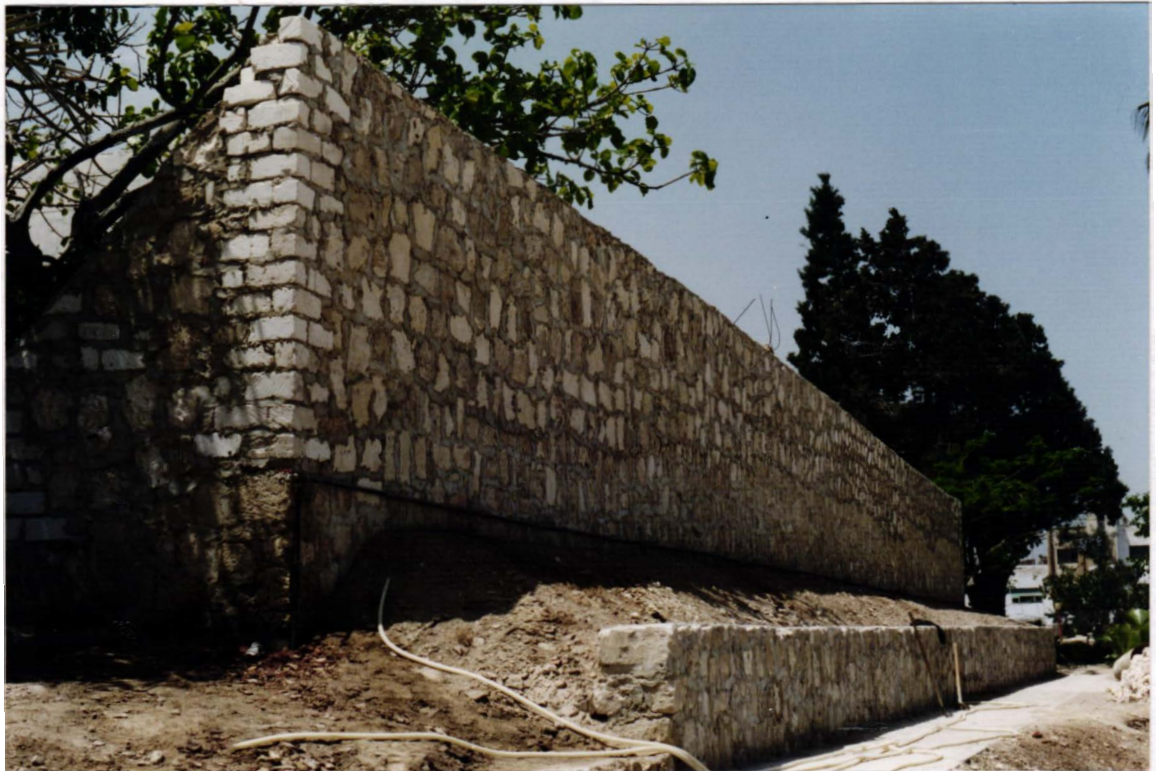
Phot. 11. Screening wall along the Fire Brigade area.

- Along the southern perimeter of the area, a screening wall ( some 40 m long and 4 m high) was built in order to prevent littering and to create visual background. (Phot. No. 11).

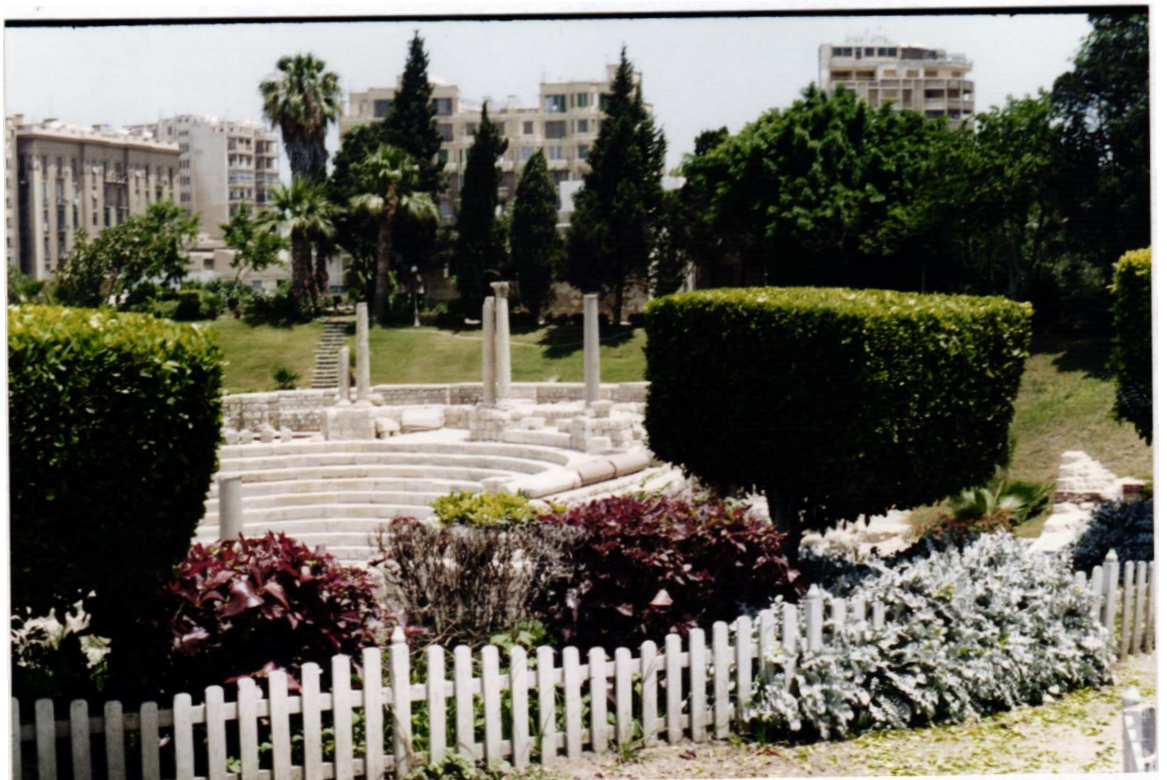
Phot. 12. Beginning of the tourist pathway.
