THE FUNERARY MONUMENT OF KING KHASEKHEMWY AT ABYDOS (ca. 2700 BCE): CONSERVATION AND ARCHAEOLOGY, 1999-2006

Final report on the "Documentation and Conservation of King Khasekhemwy's Funerary Monument at Abydos," a sub-project of the Egyptian Antiquities Project of the American Research Center in Egypt

2007

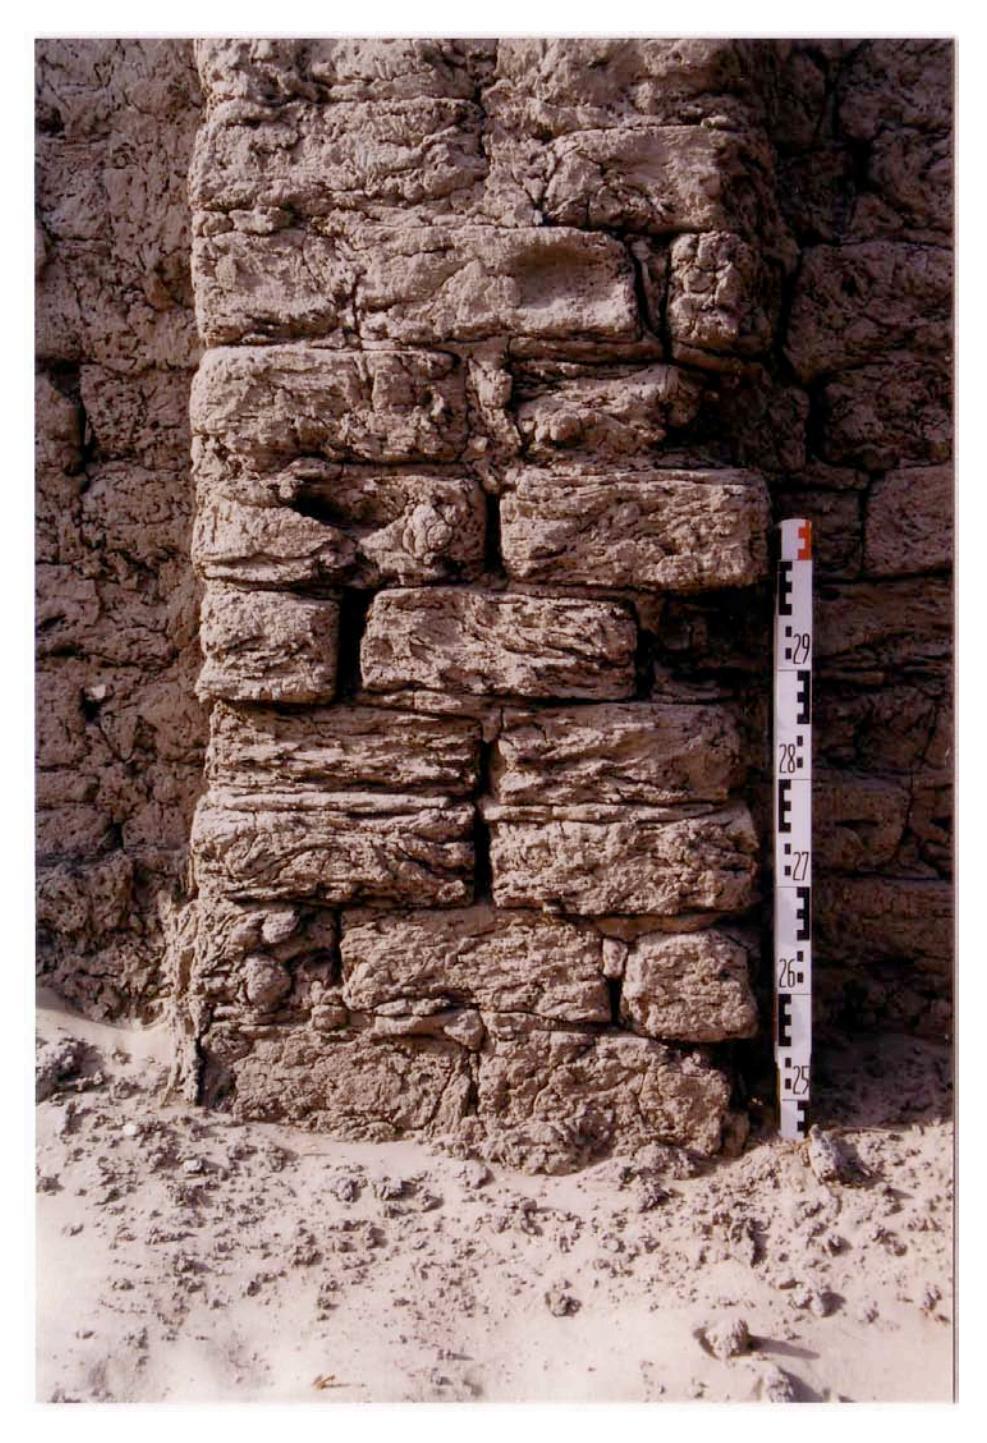
Figure 44. Detail of wind erosion at the exterior base of the east main enclosure wall. (Photo: William Remsen 2000)

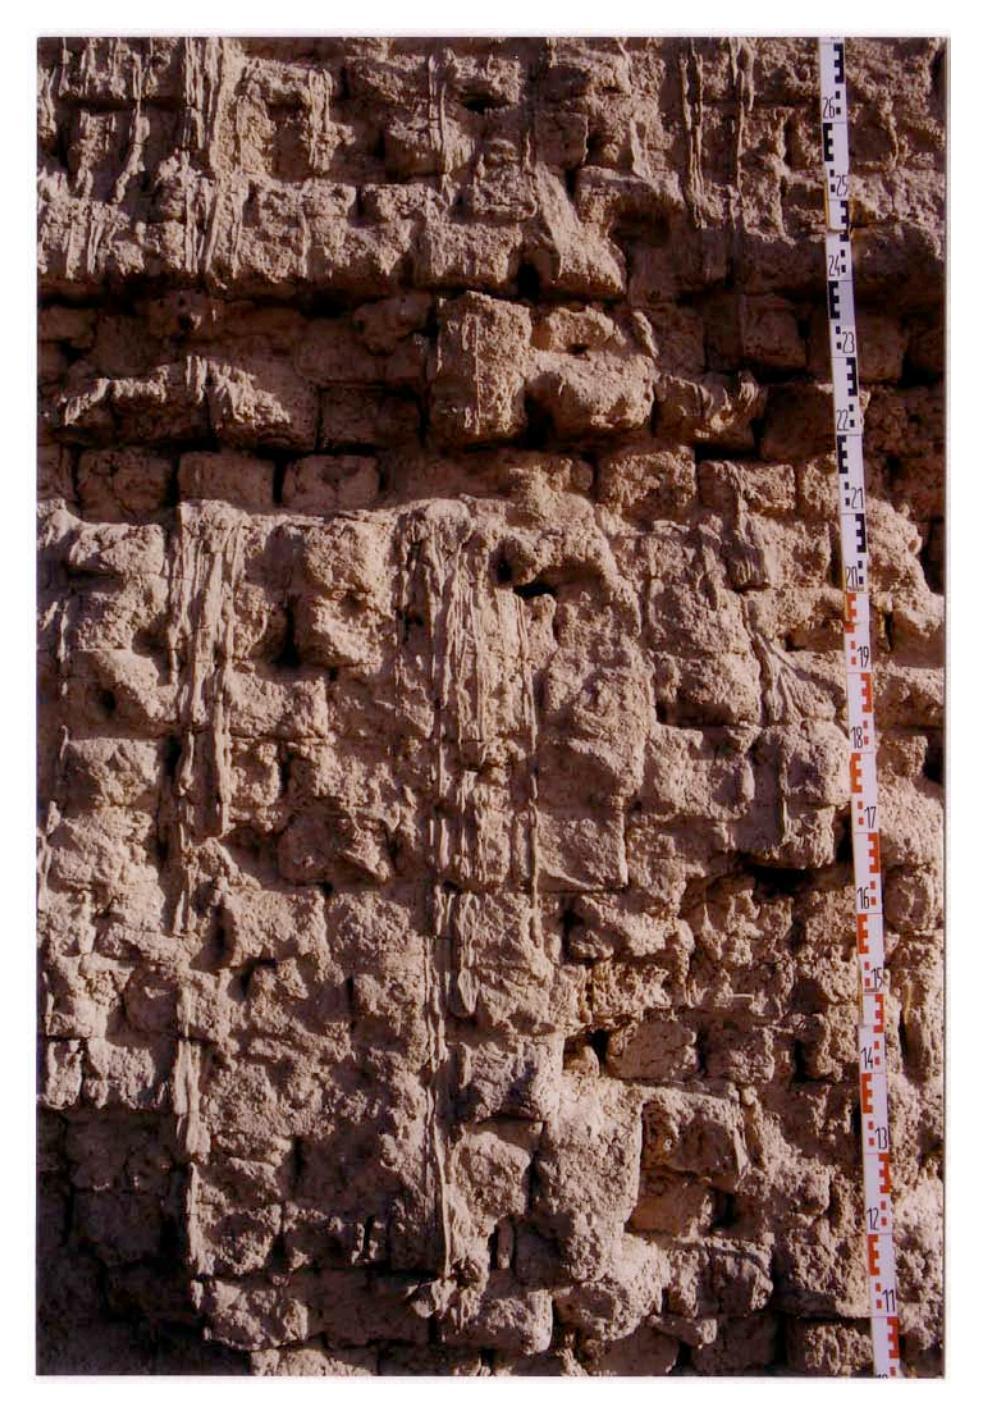
Figure 46. Detail of mud-drip concentrations on the exterior face of the north main enclosure wall. (Photo: William Remsen 2000)

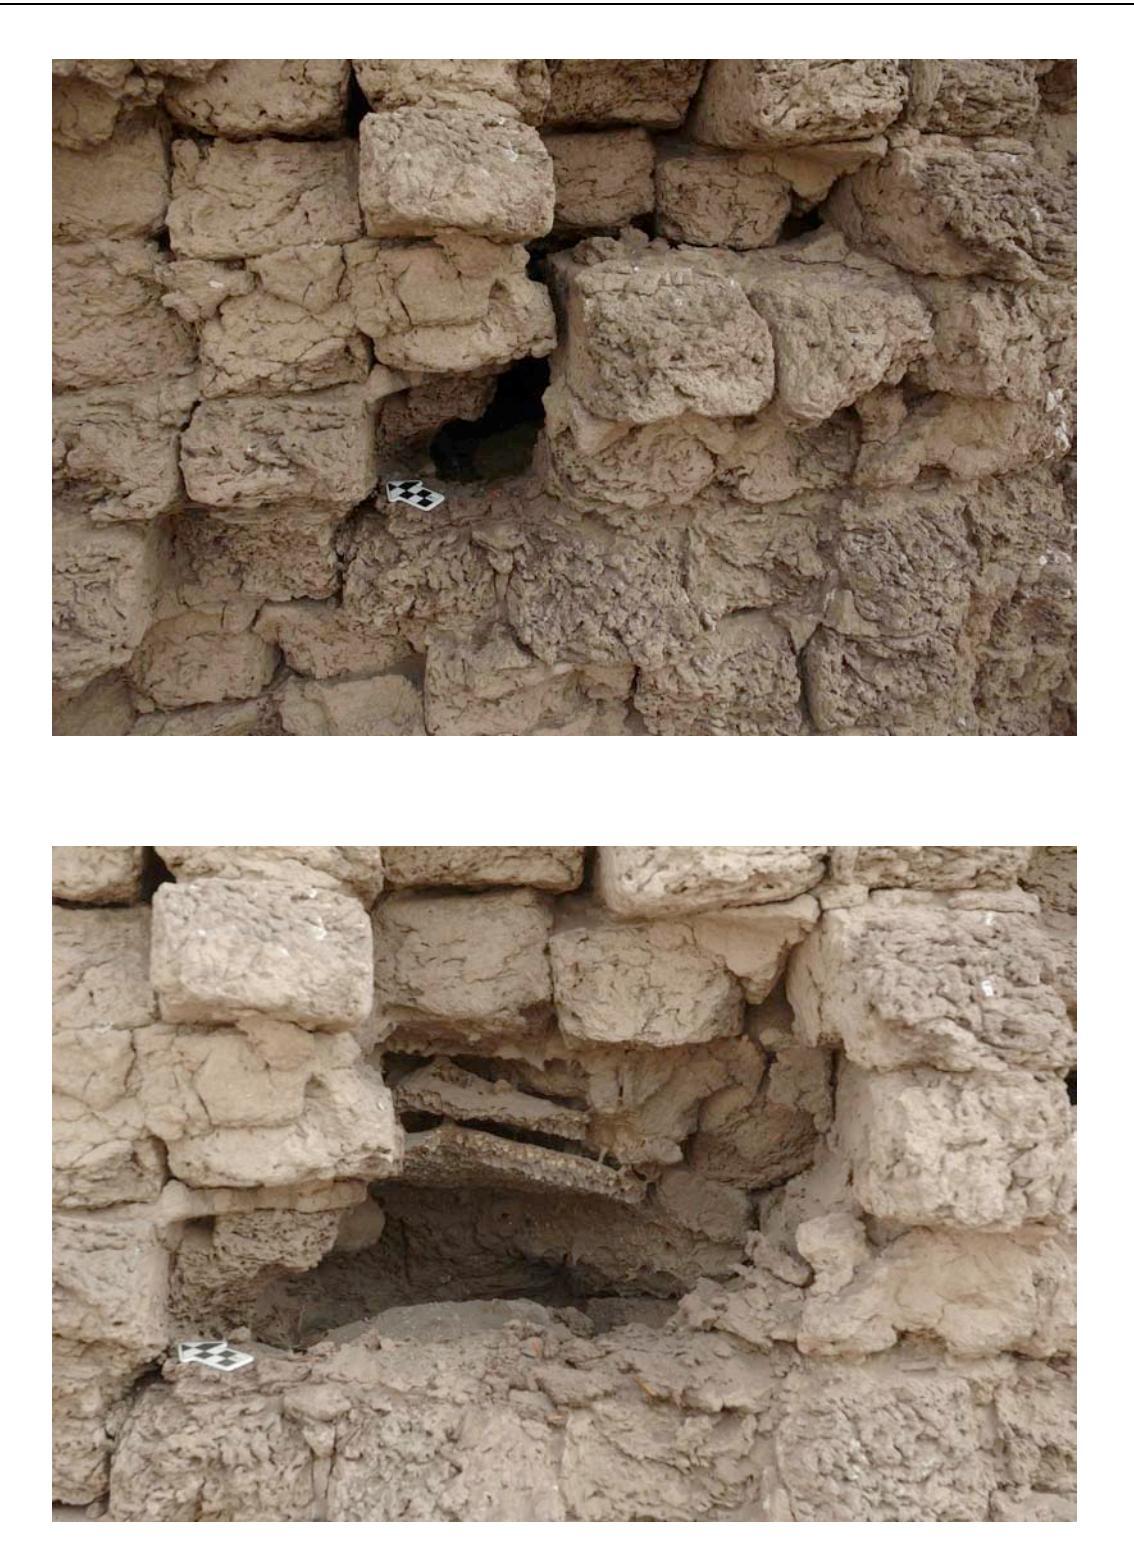
Figures 53, 54. A small hole surrounded by loose brickwork in the west main enclosure wall (top) concealed this multi-layered, paper nest and large cavity (bottom), which is typical of the damage caused by Oriental Hornet nesting throughout the monument. (Photos: Jason Goodman 2005-2006)

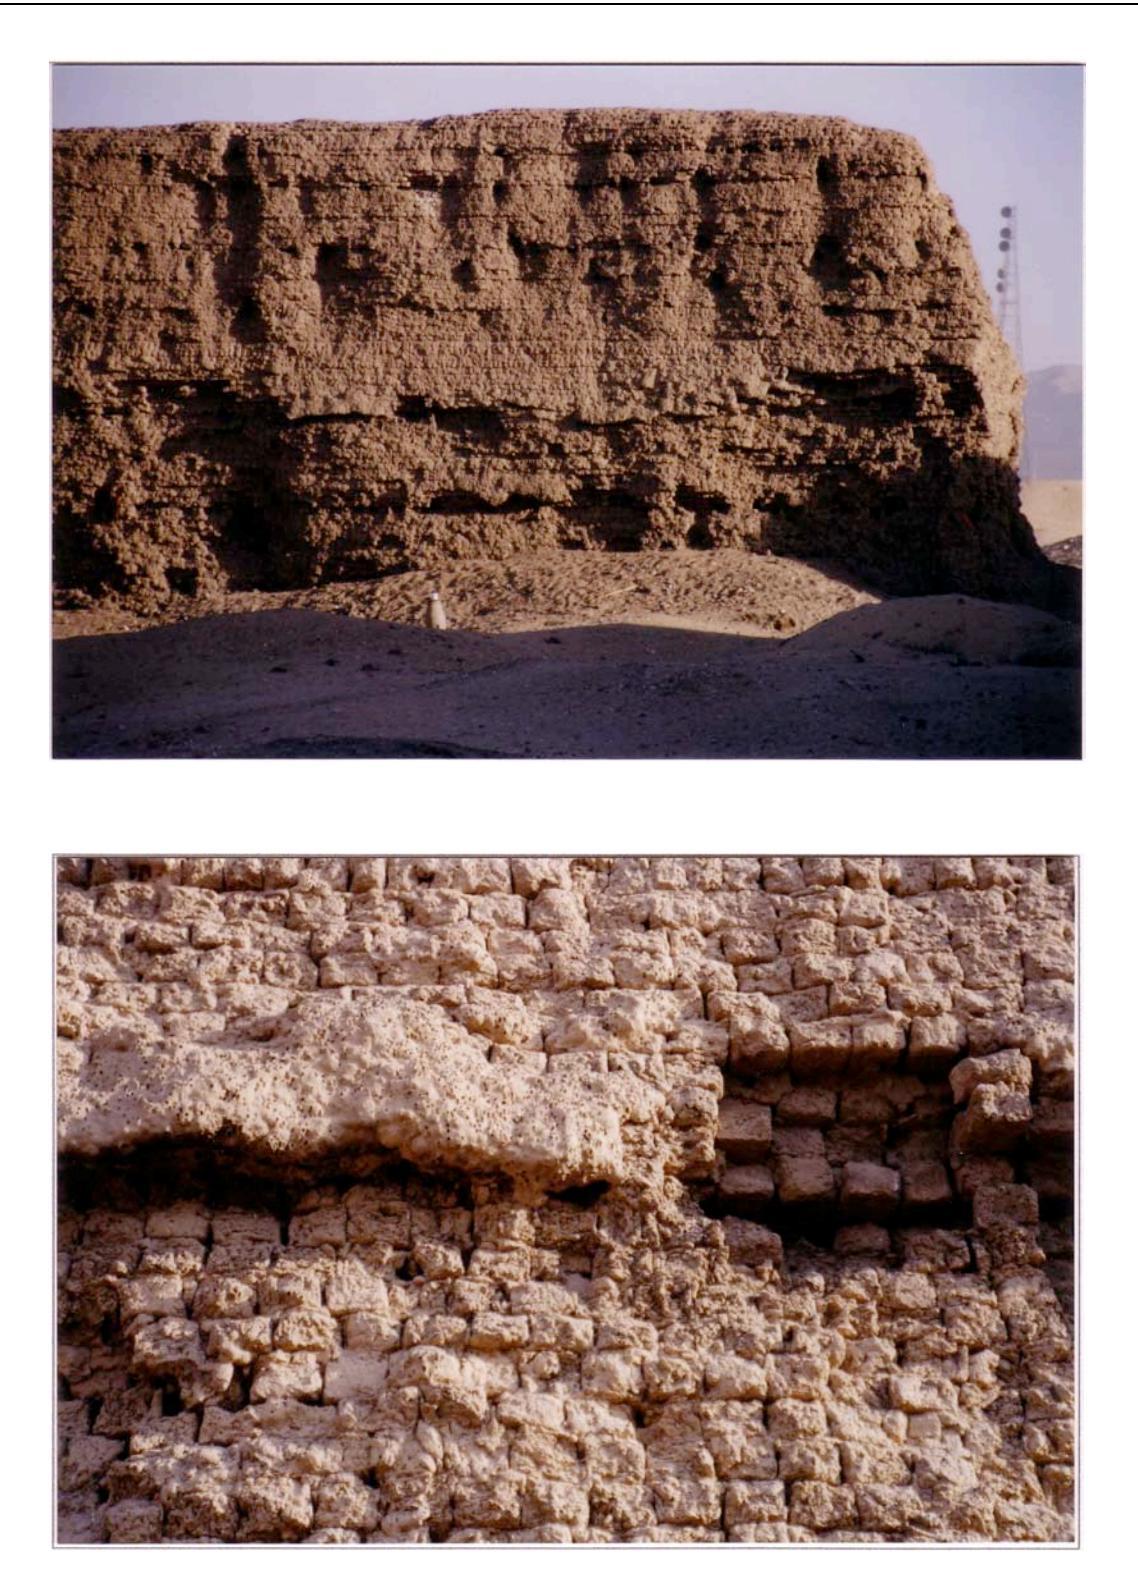
Figures 55, 56. Elevation and detail of the undercutting caused by mud-wasp nest accretion on the interior side of the south main enclosure wall (top and bottom, respectively). (Photos: William Remsen 2000)

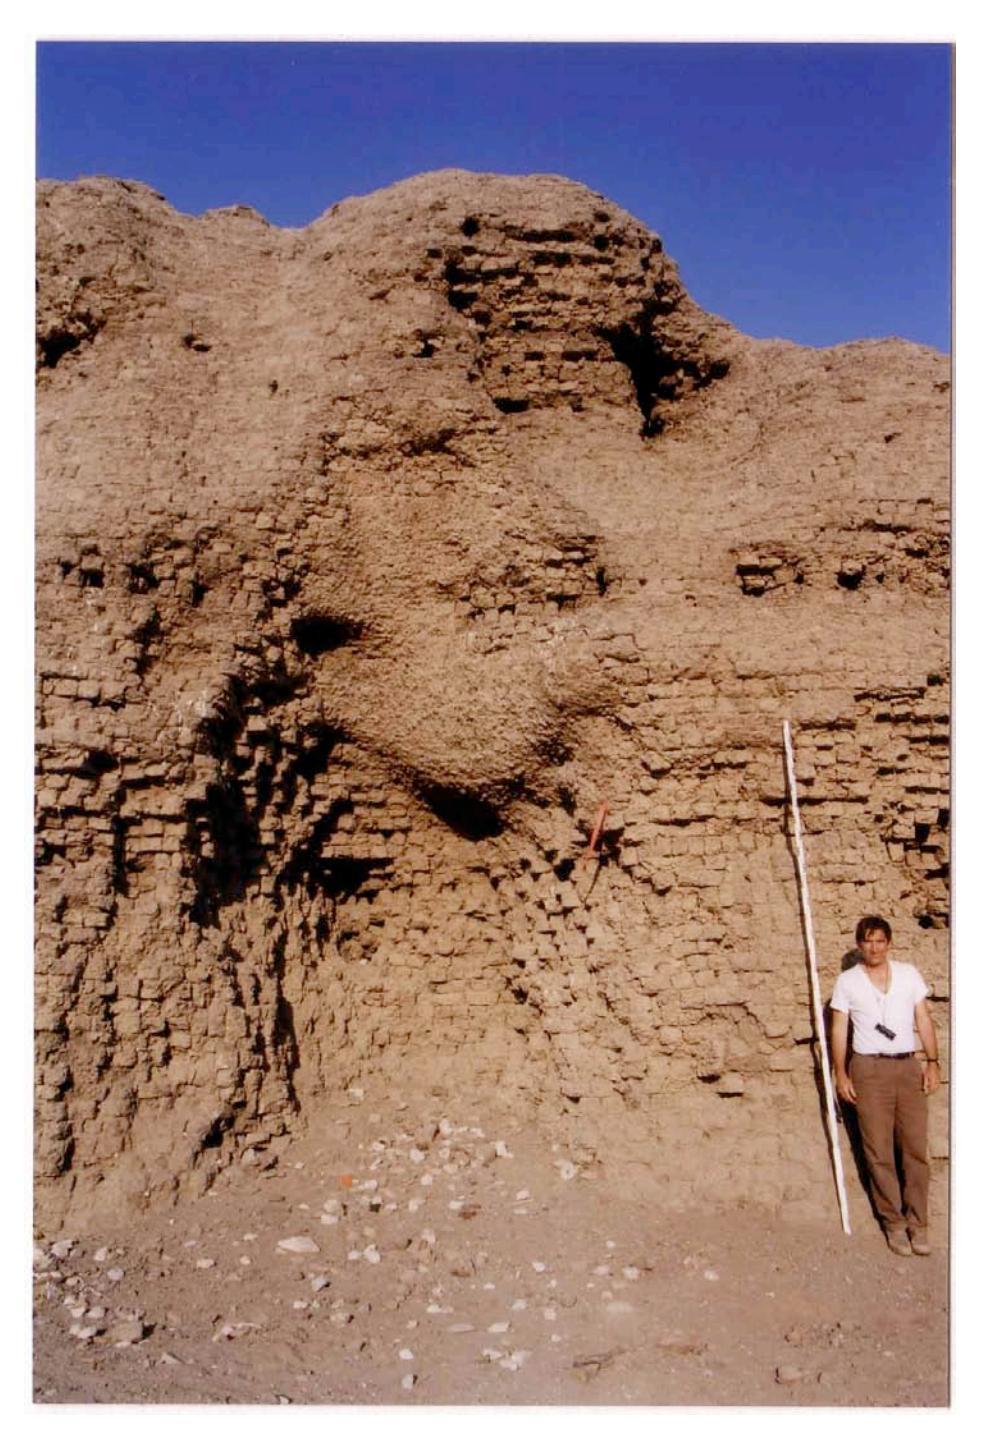
Figure 57. Detail of an active mud-wasp nest colony (at center) on the southern, interior face of the east main enclosure wall. (Photo: William Remsen 2000)

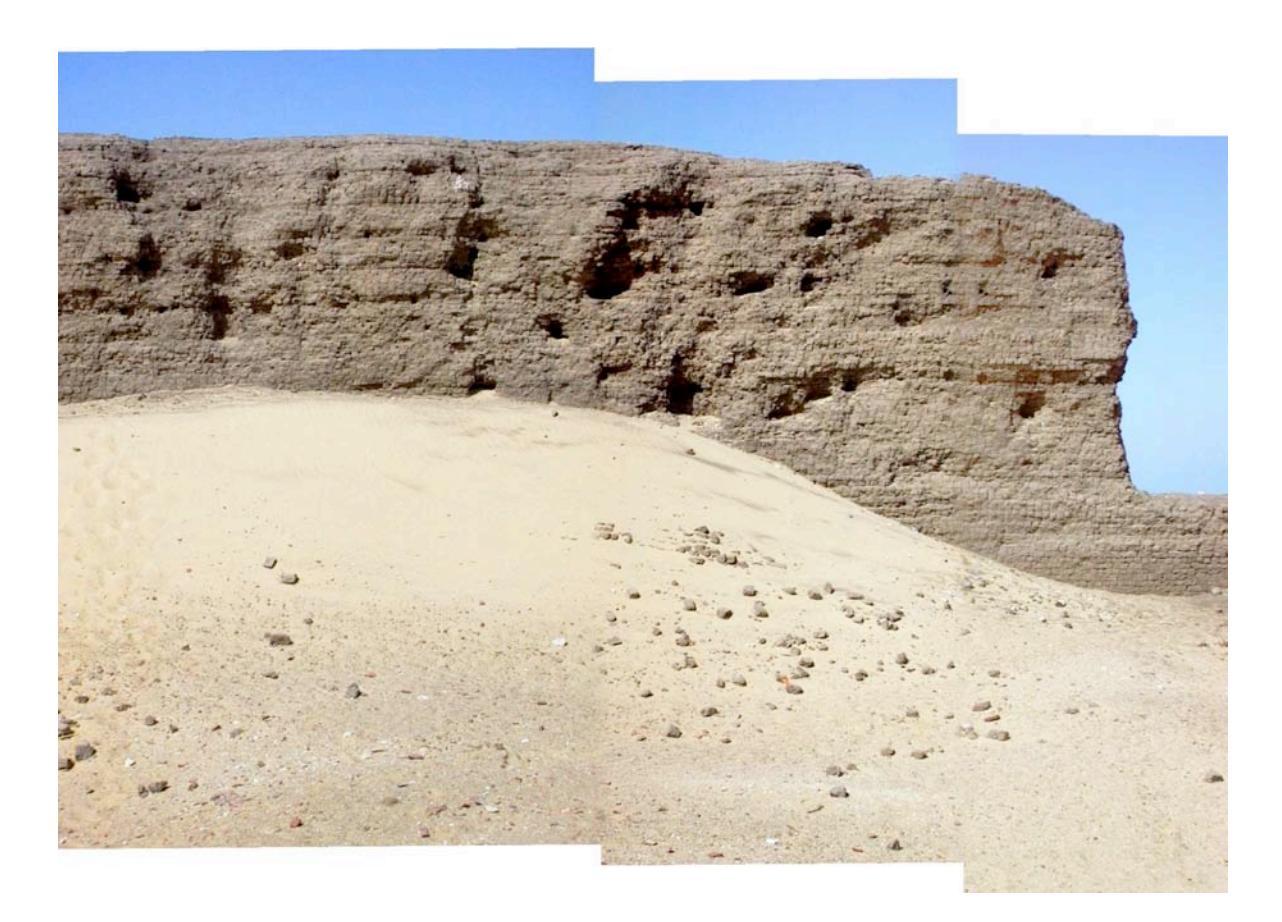
Figure 60. Surface conditions caused by nesting insects and birds on the western, interior face of the north main enclosure wall; the smaller holes concentrated at right are typical of bird activity. (Photo: Anthony Crosby 2000)

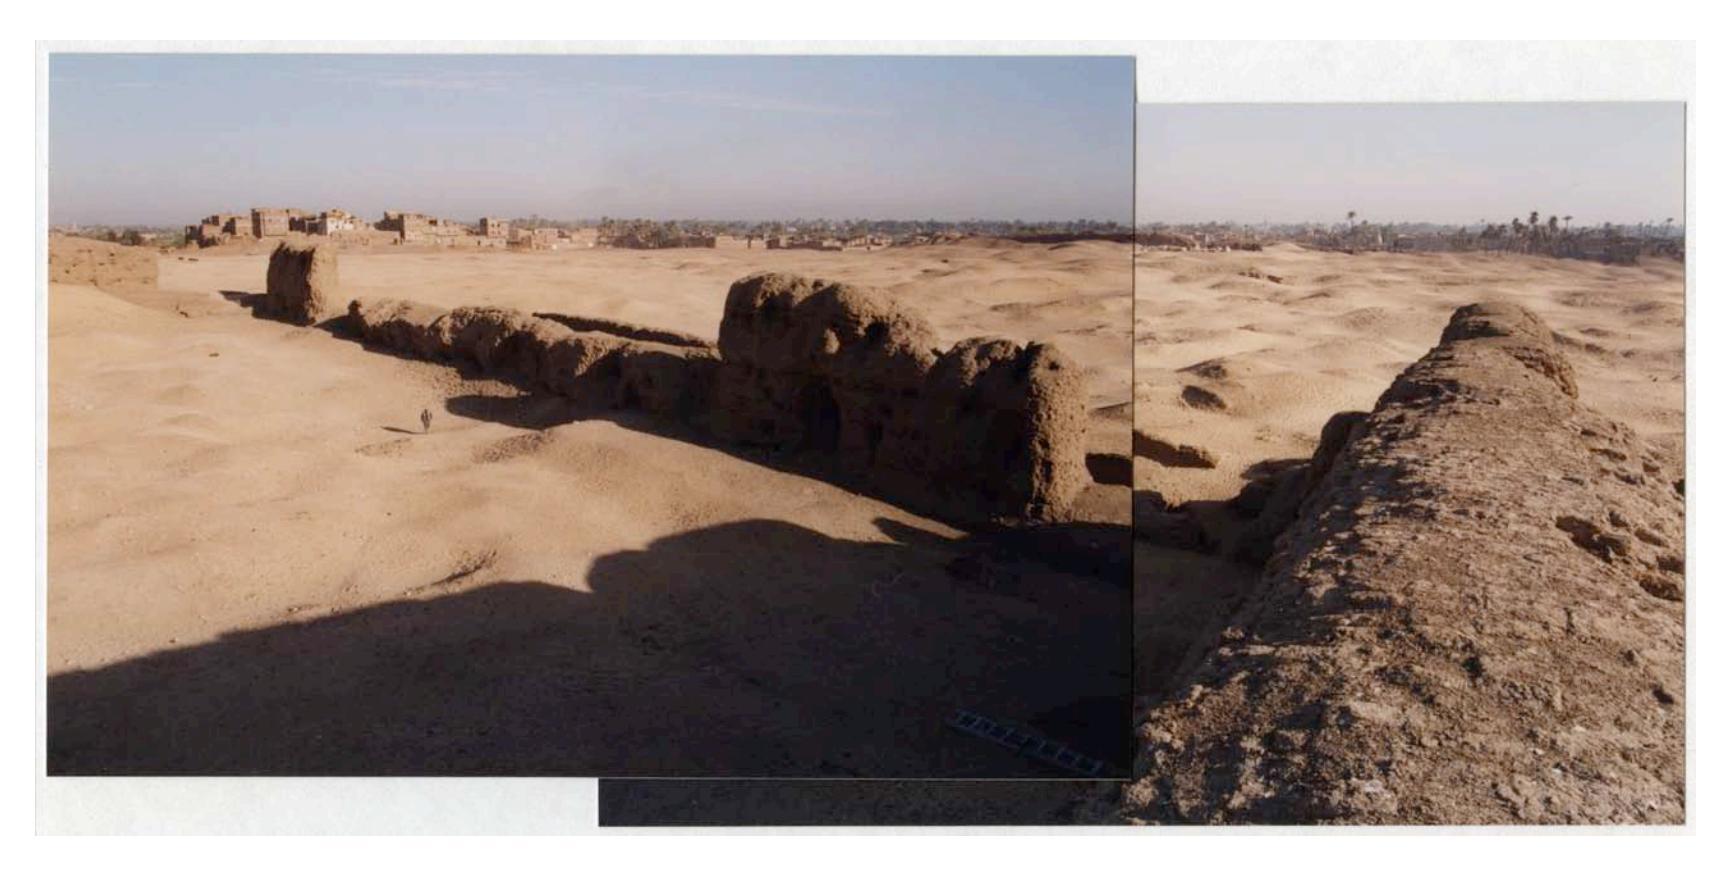
Figure 71. General structural conditions on the interior side of the east main enclosure wall (at left), seen from the top of the south main enclosure wall (at right); note especially the extent of missing fabric due to collapse, as well as the undermining and gradual loss of remaining surface on the east wall. (Composite photo: William Remsen 2000)

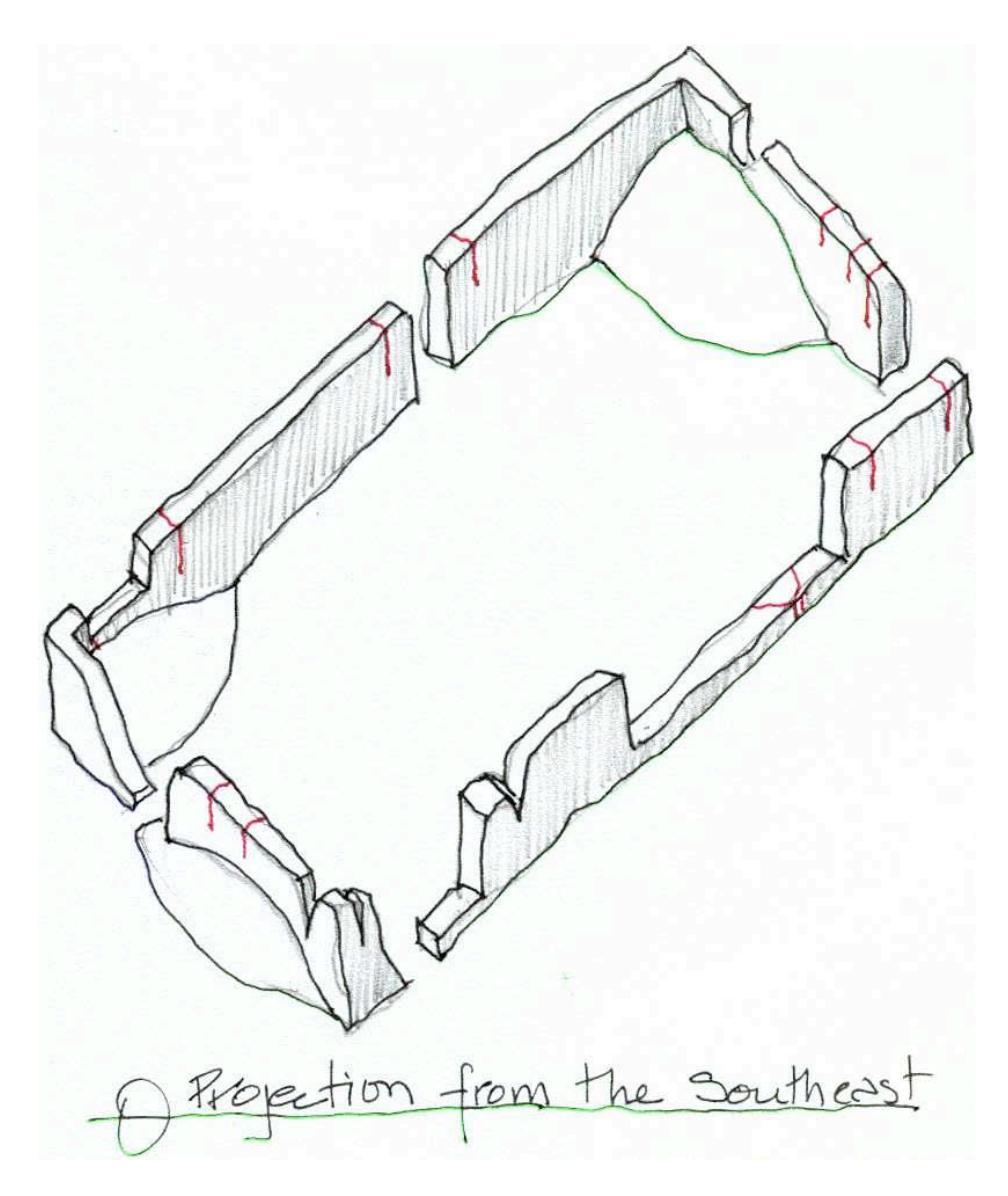
Figure 72. General locations of vertical, through-wall cracks in the main enclosure wall (noted in red). (Graphic: Anthony Crosby 2000)

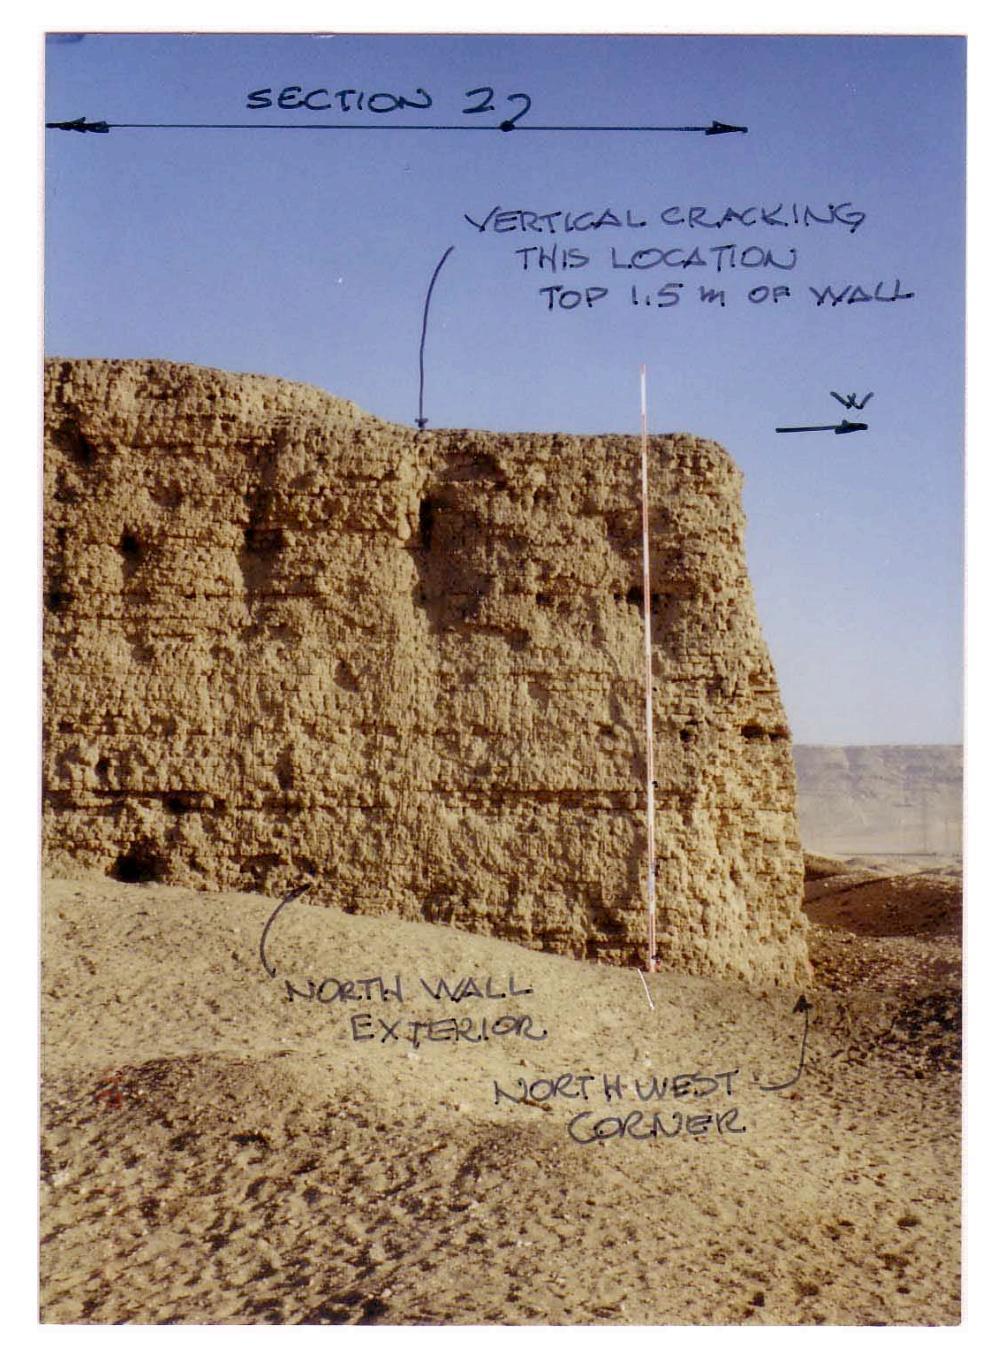
Figure 80. Detail of surface erosion and cracking at the western, exterior end of the north main enclosure wall. (Photo: Conor Power 2000)

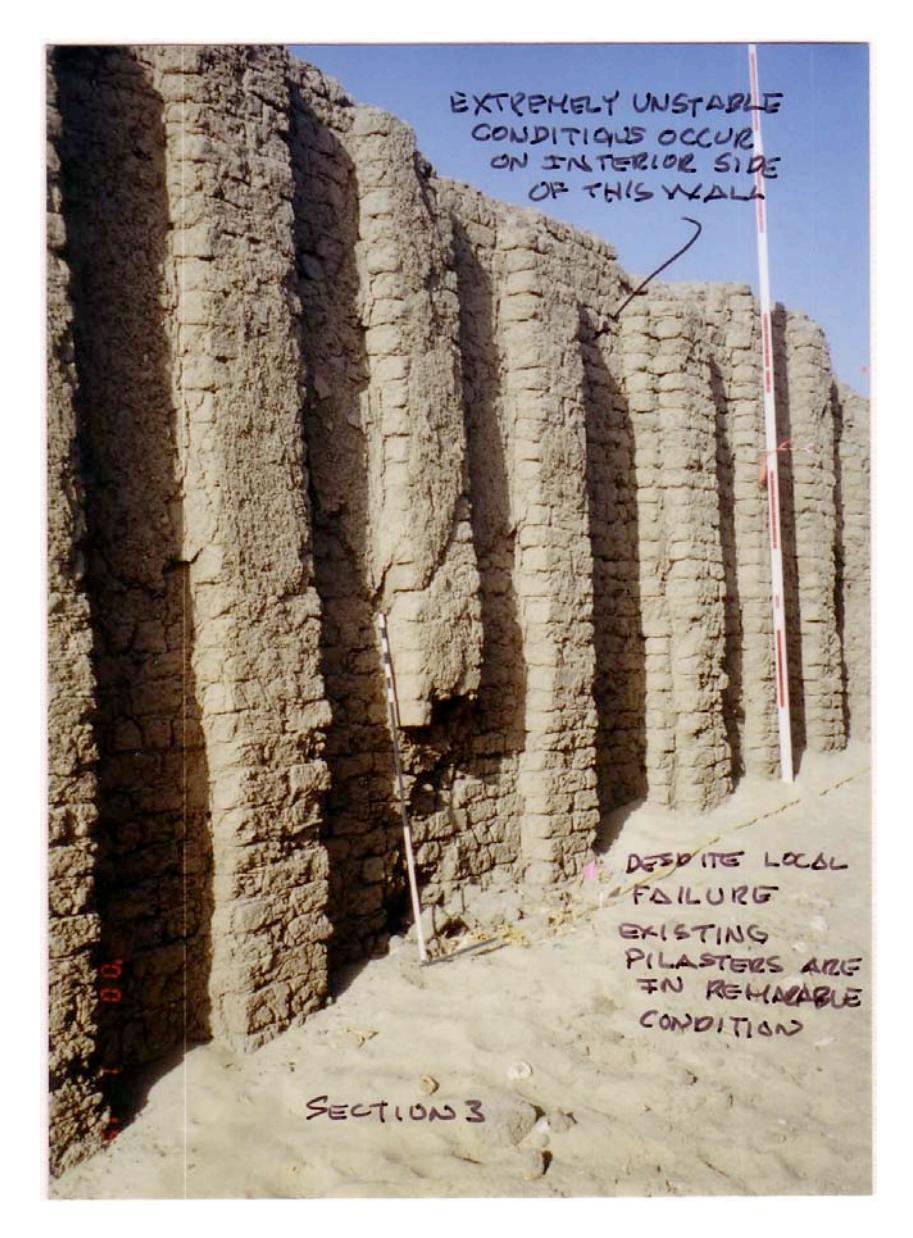
Figure 96. Detail of local failures on the central, exterior face of the east main enclosure wall. (Photo: Conor Power 2000)

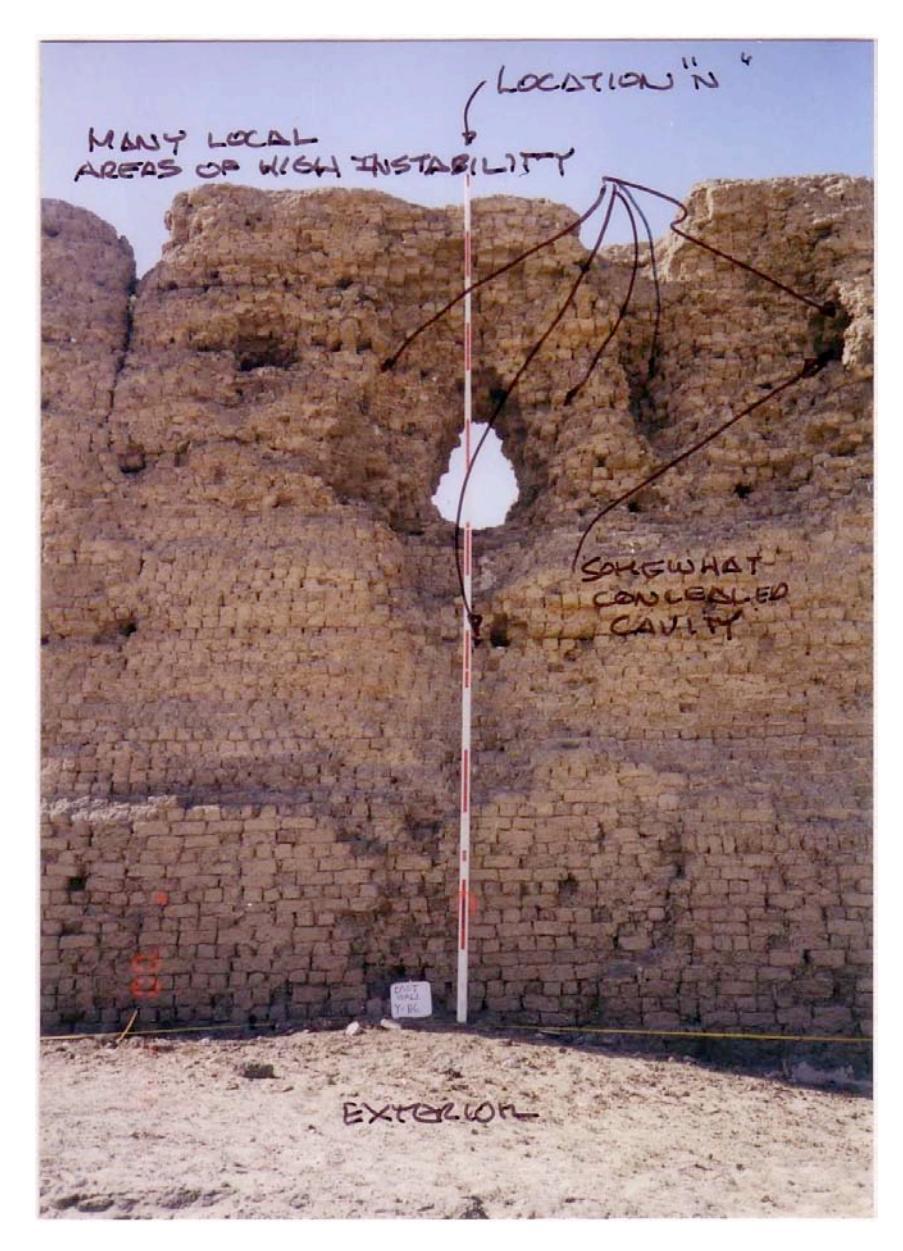
Figure 109. Exterior detail of through-wall cavitation in the northern pier of the east main enclosure wall (noted as location N). (Photo: Conor Power 2000)

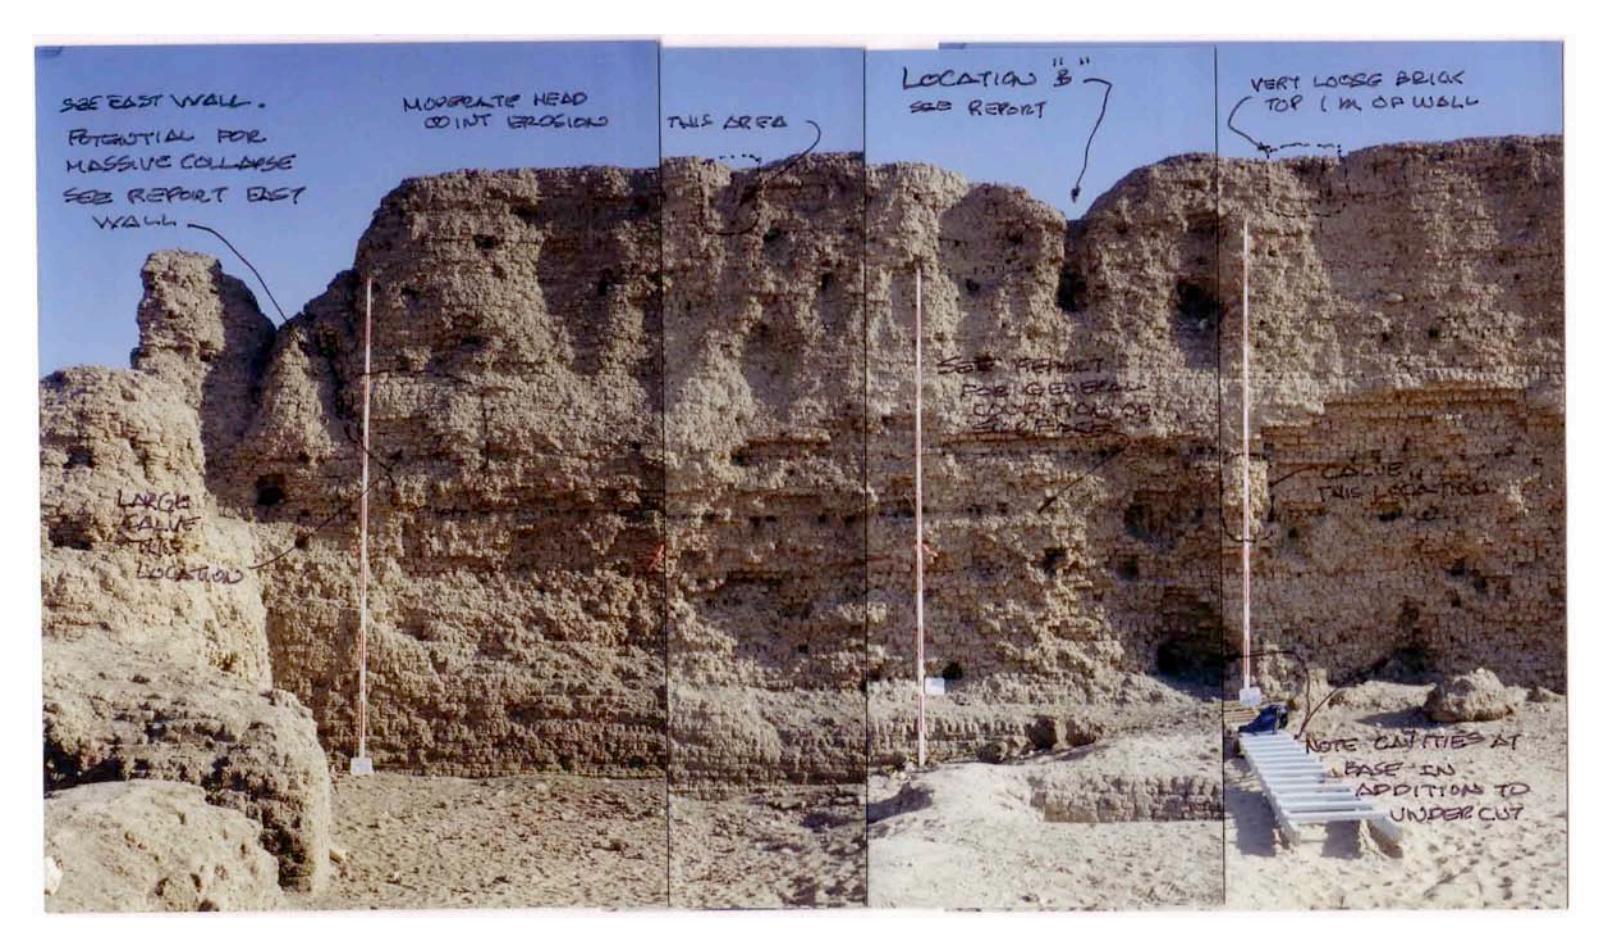
Figure 123. Details of undercutting, cavitation and erosion on the interior face of the south main enclosure wall, as well as urgent-priority erosion in the wall top, noted as location B (see also Figure 121, above); note the fallen mud-wasp nest accretion at lower right. (Composite photo: Conor Power 2000)

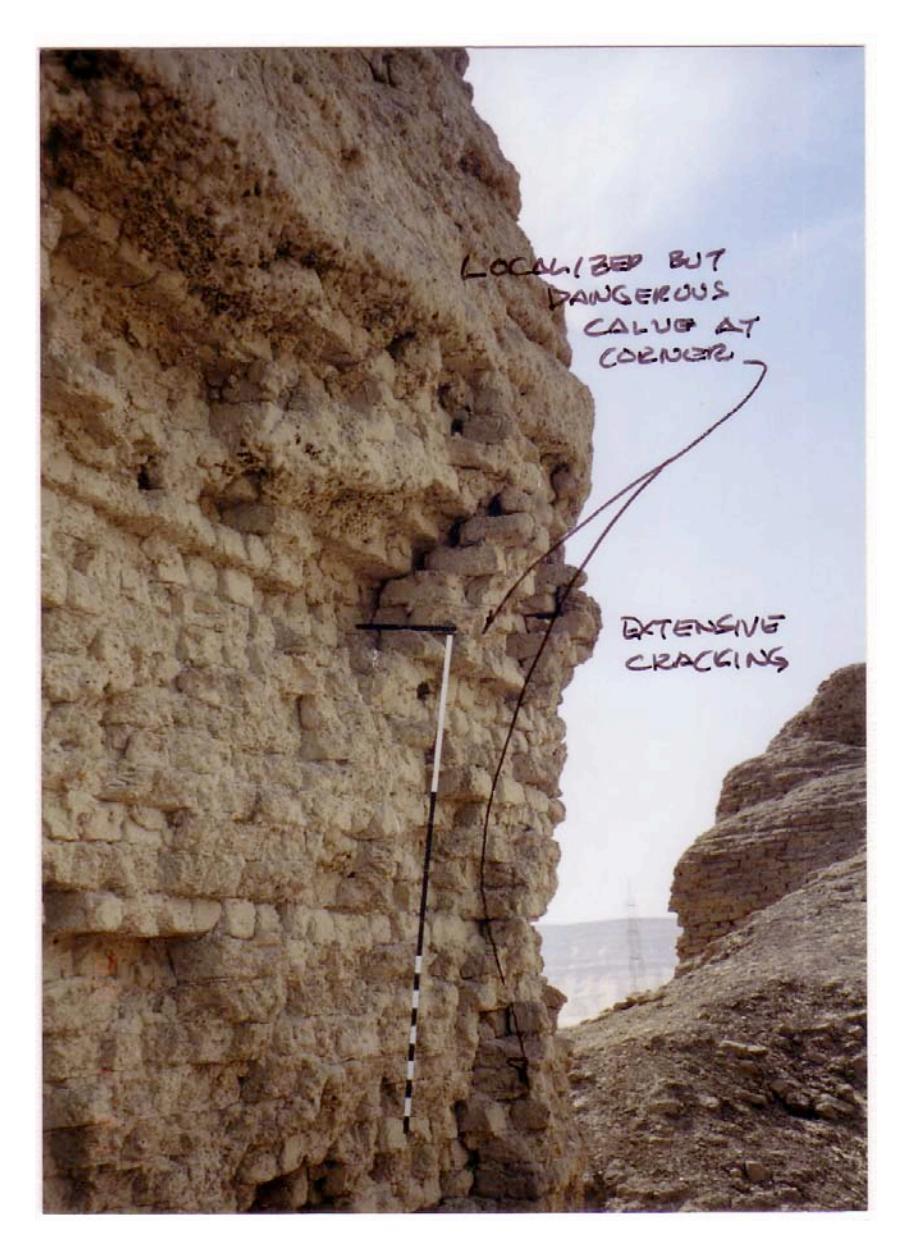
Figure 125. Interior detail of cracking and calving behind the eastern, vertical end of the south gateway. (Photo: Conor Power 2000)

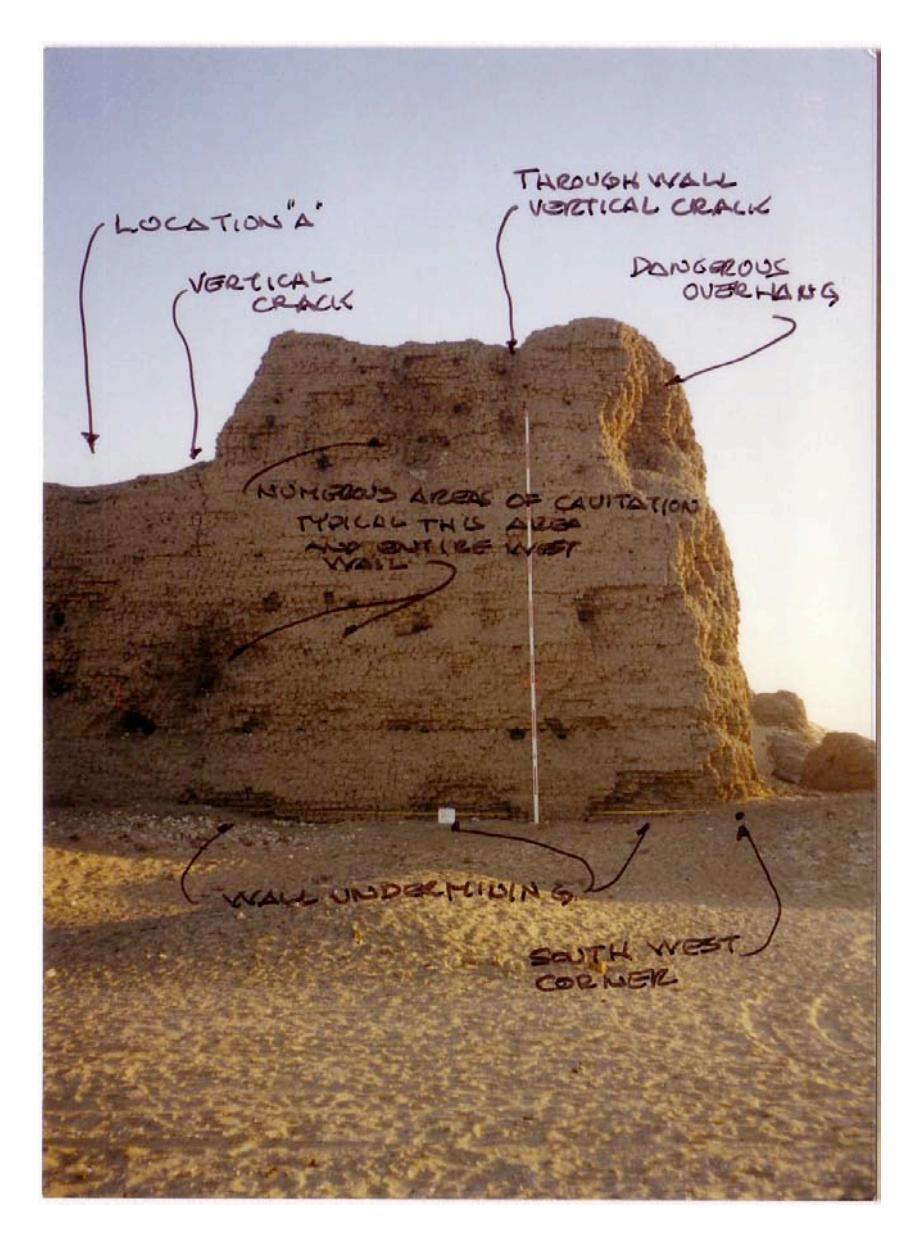
Figure 136. Structural conditions at the southern, exterior end of the west main enclosure wall. (Photo: Conor Power 2000)

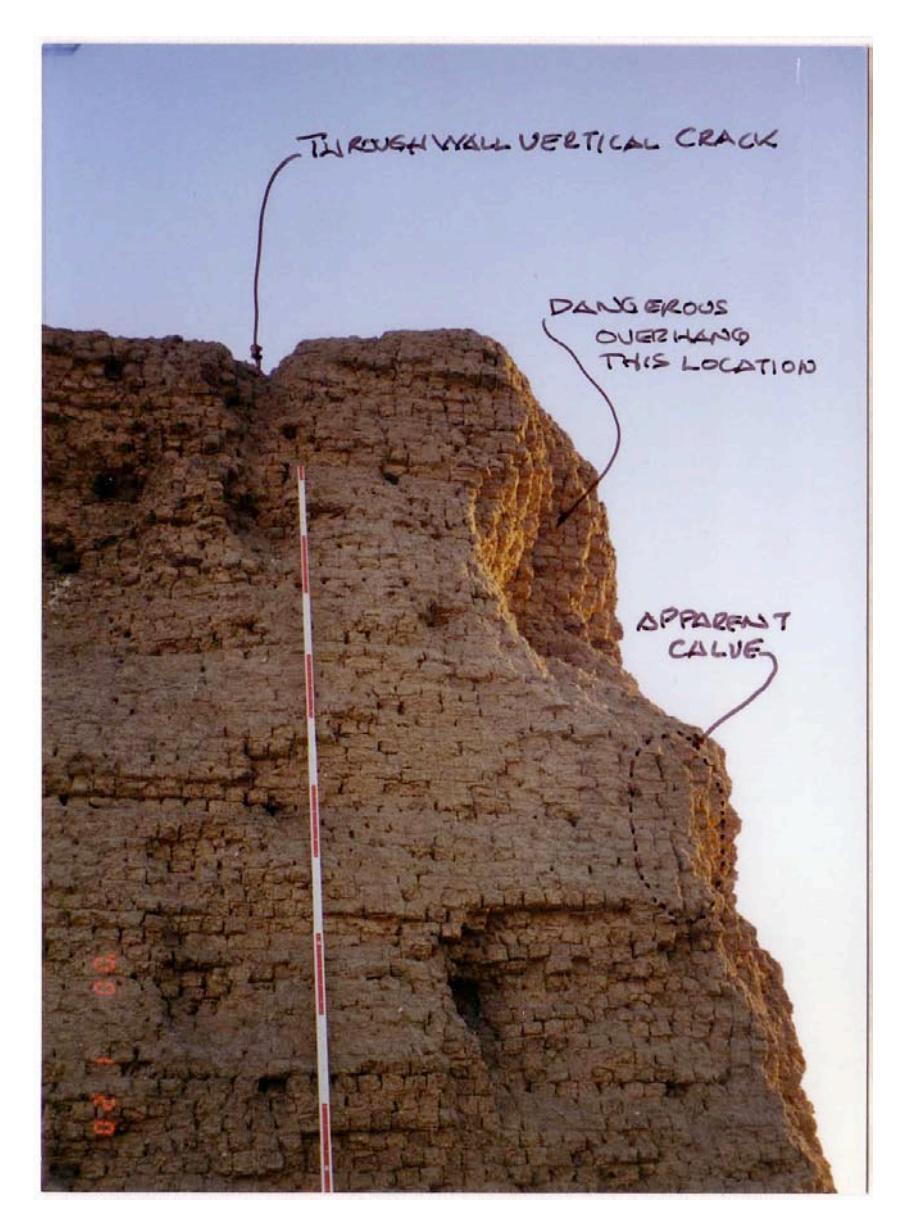
Figure 137. Detail of a through-wall crack and high-priority overhang at the top, southern corner of the west main enclosure wall. (Photo: Conor Power 2000)

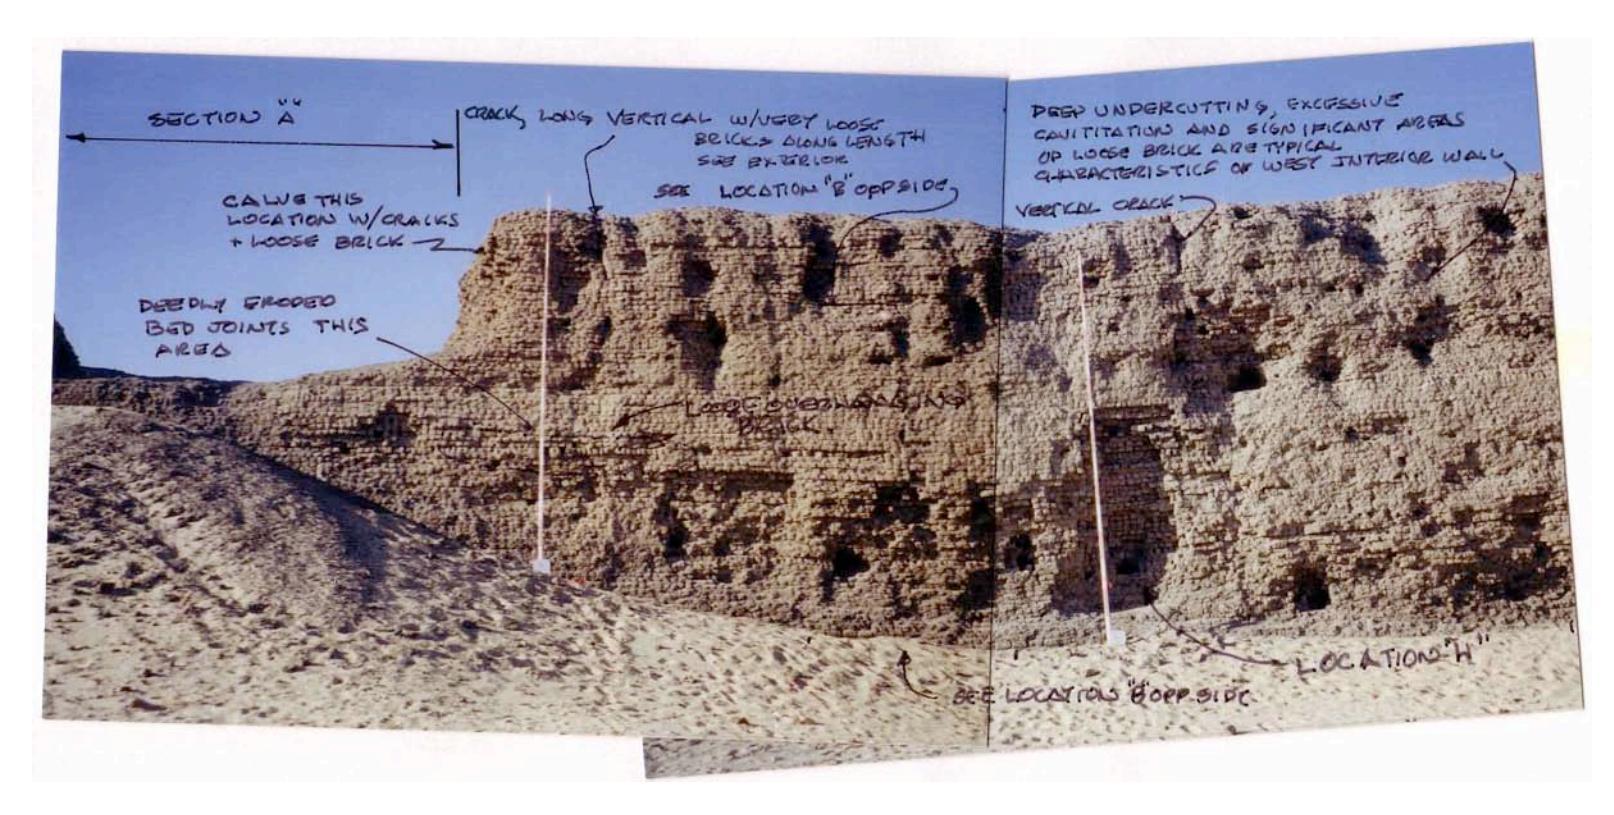
Figure 149. Structural conditions on the southern, interior face of the west main enclosure wall. (Composite photo: Conor Power 2000)
