THE FUNERARY MONUMENT OF KING KHASEKHEMWY AT ABYDOS (ca. 2700 BCE): CONSERVATION AND ARCHAEOLOGY, 1999-2006

Final report on the "Documentation and Conservation of King Khasekhemwy's Funerary Monument at Abydos," a sub-project of the Egyptian Antiquities Project of the American Research Center in Egypt

2007

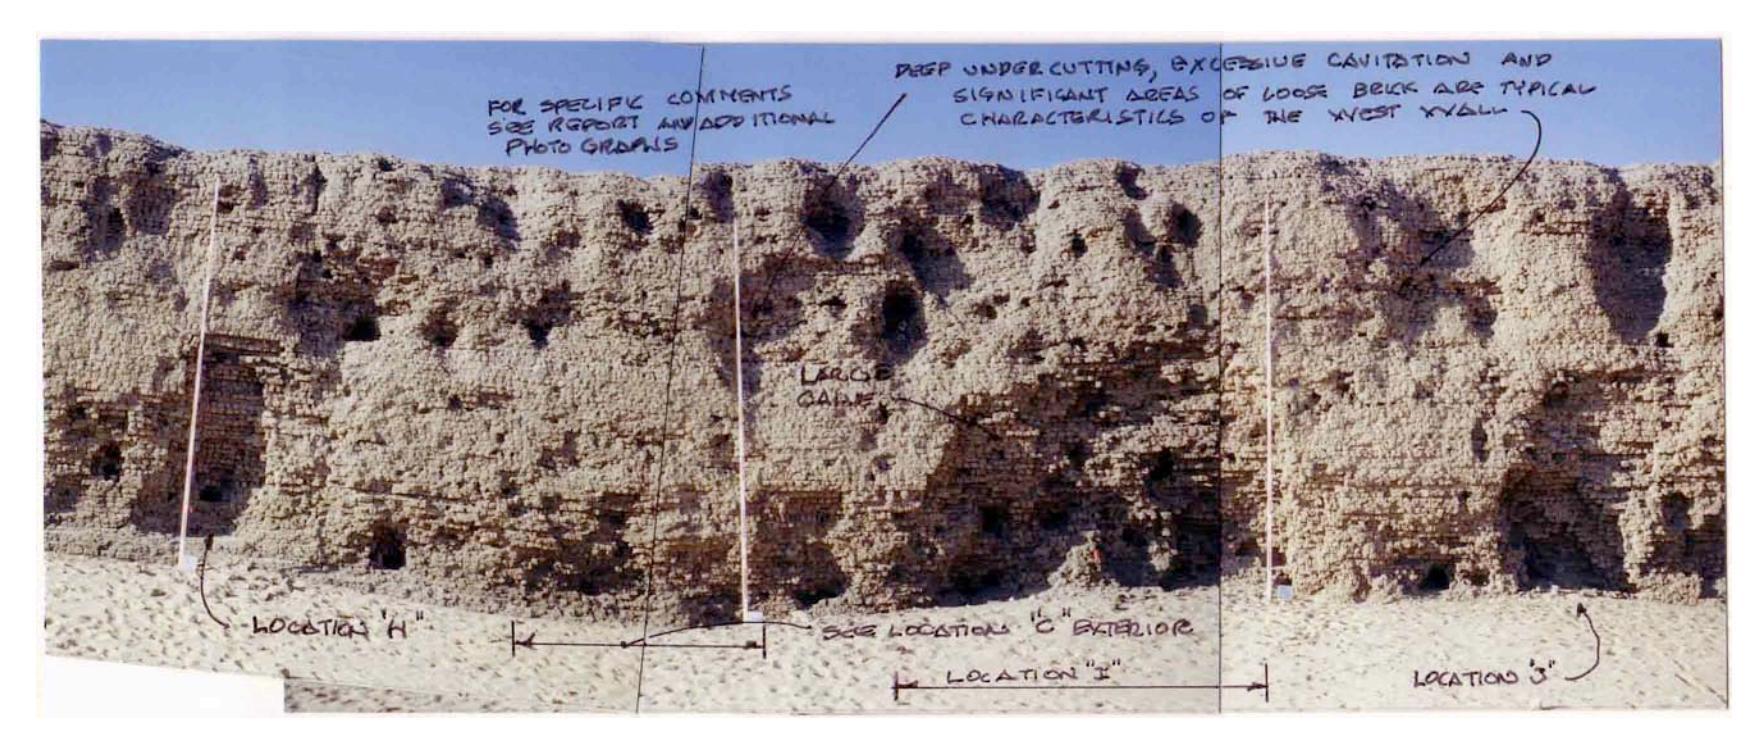
Figure 150. Detail of the deep undercutting and cavitation resulting from canine and insect activity on the southern, interior face of the west main enclosure wall (noted as locations H, I and J). (Composite photo: Conor Power 2000)

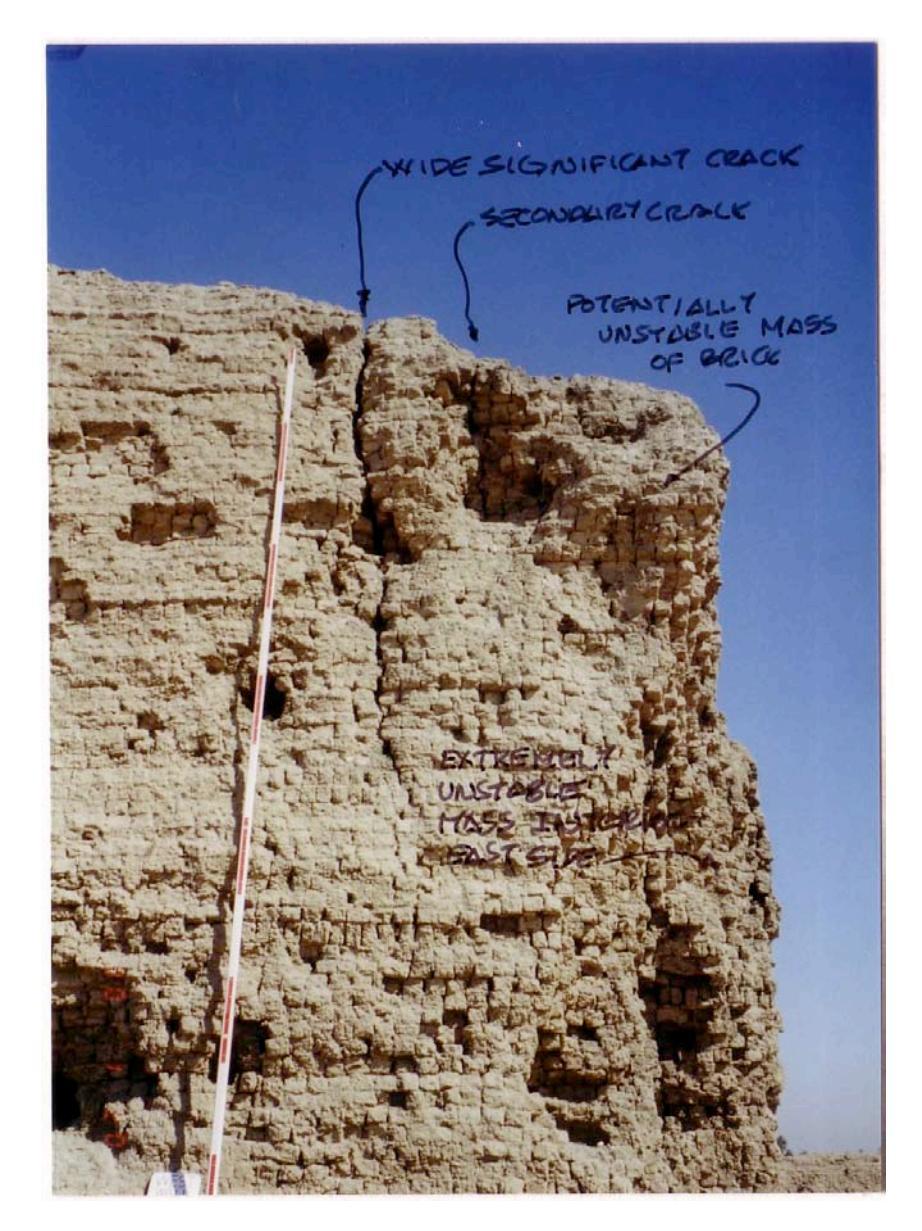
Figure 157. Exterior detail of a through-wall crack behind the northern, vertical end of the west gateway (noted as location E in Figures 153-155, above). (Photo: Conor Power 2000)

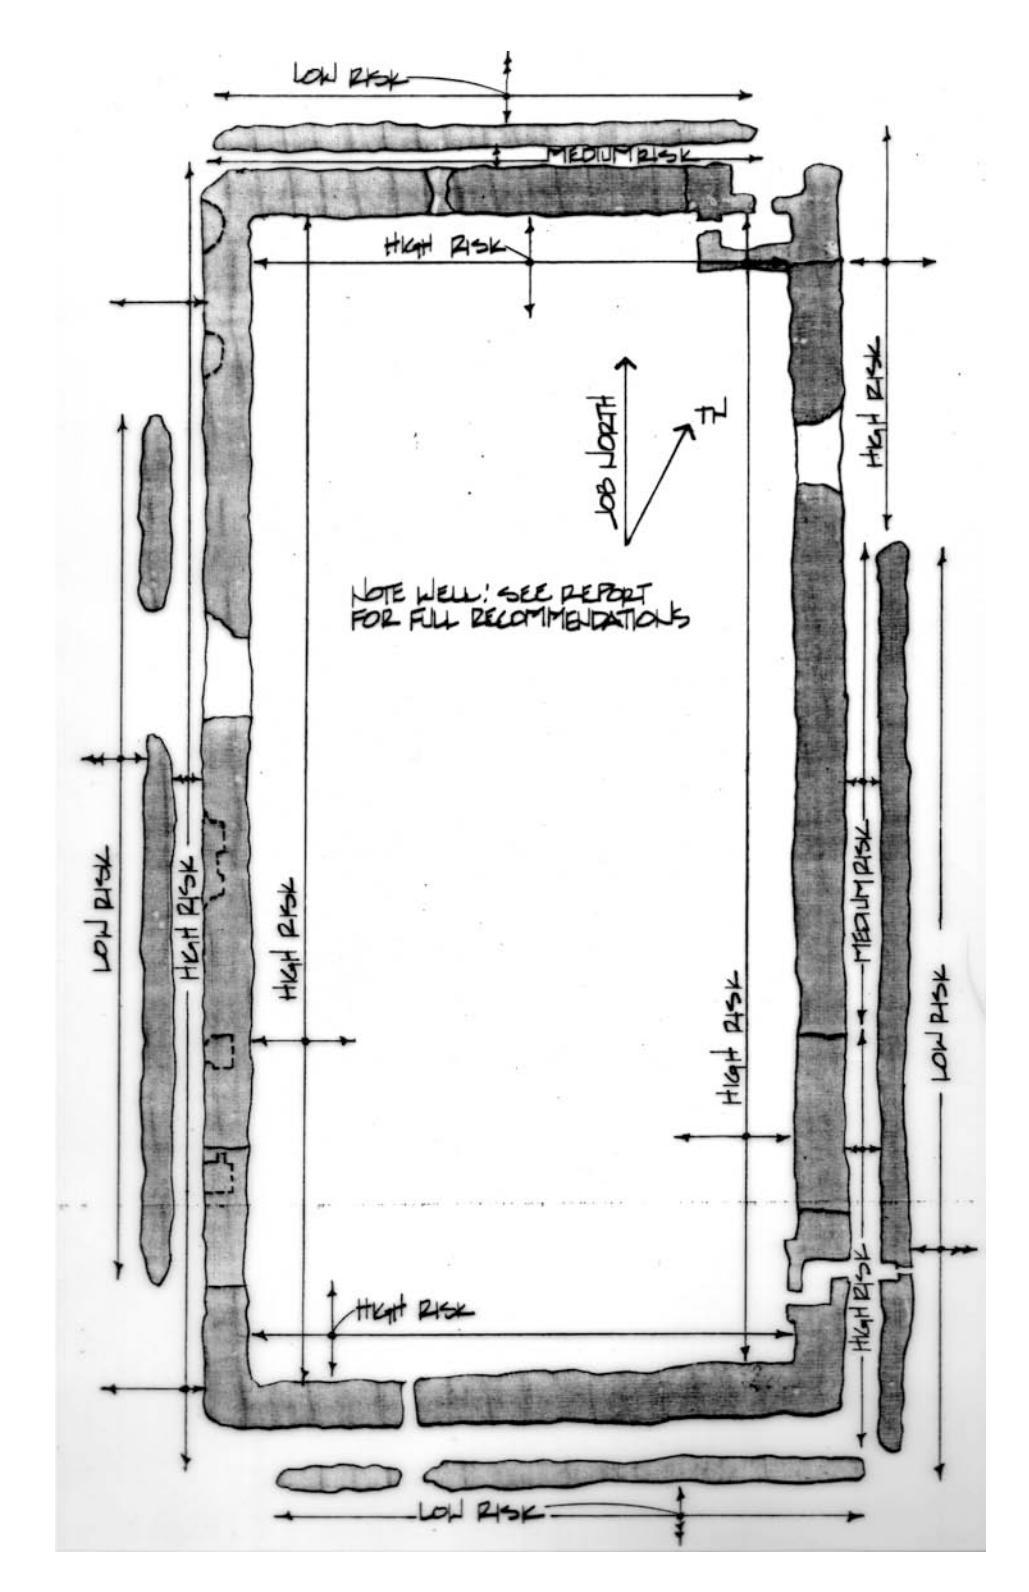
Figure 158. Plan of existing conditions and low to high-risk areas for structural failure at the enclosure of Khasekhemwy in 2000. (Conor Power 2000)

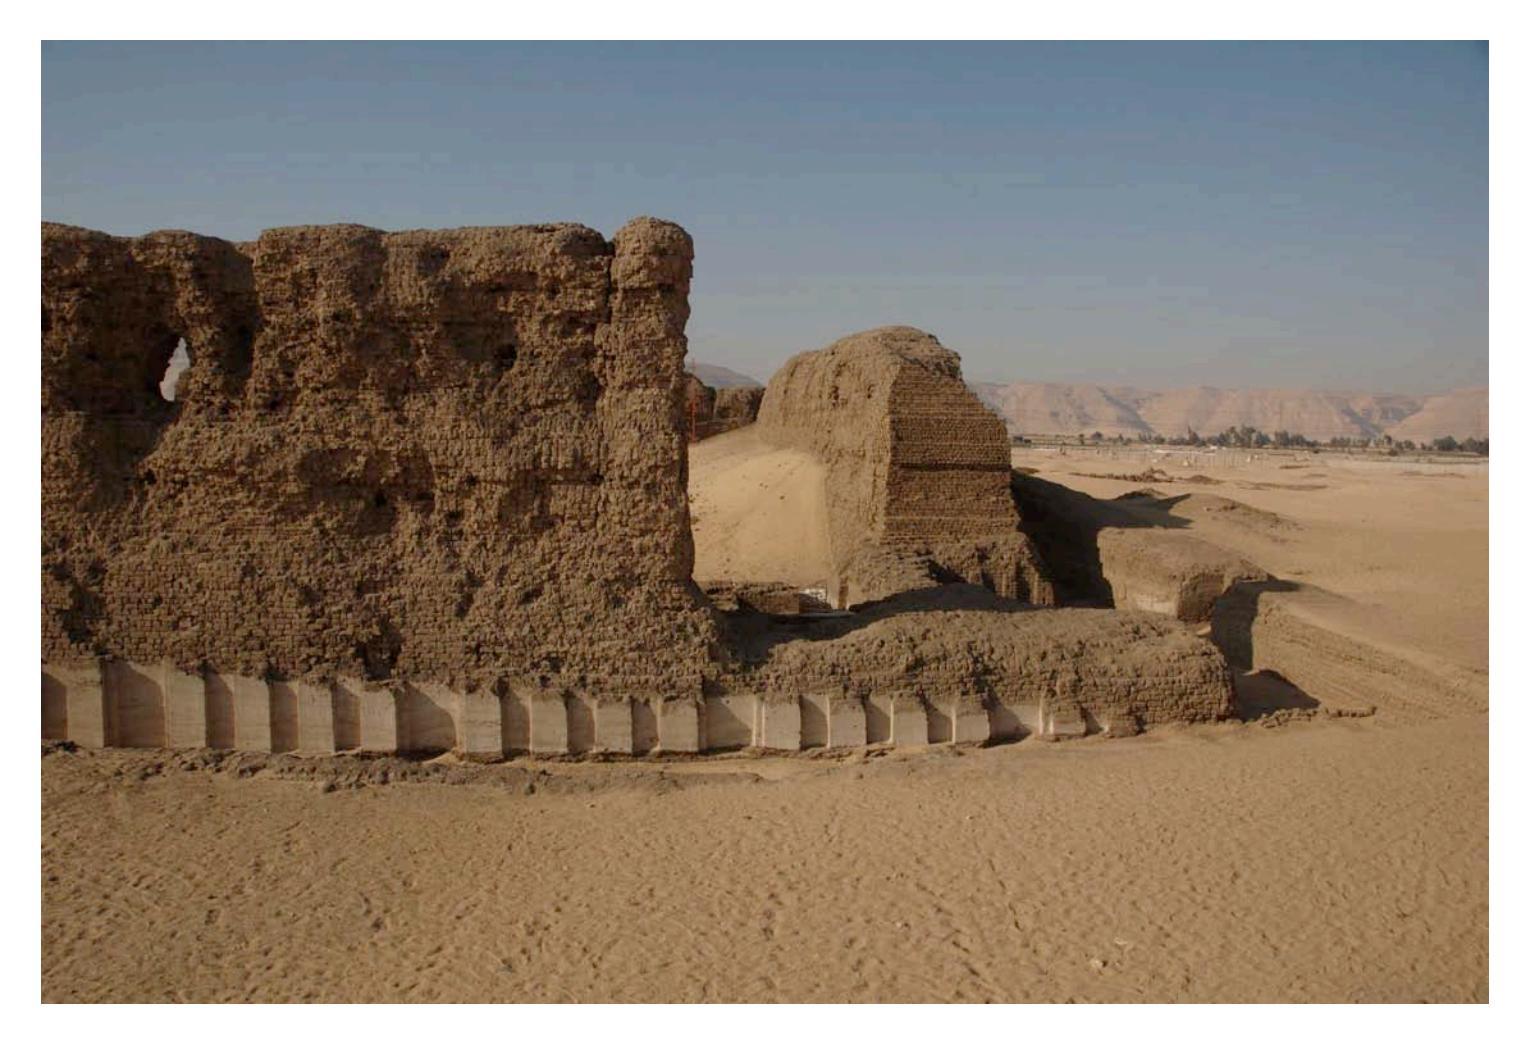
Figure 200. The highly unstable northern end of the east main enclosure wall (left center, adjacent to the north gateway) prior to architectural stabilization; note the deep structural crack behind the vertical face of the wall end. (Photo: Robert Fletcher 2004-2005)

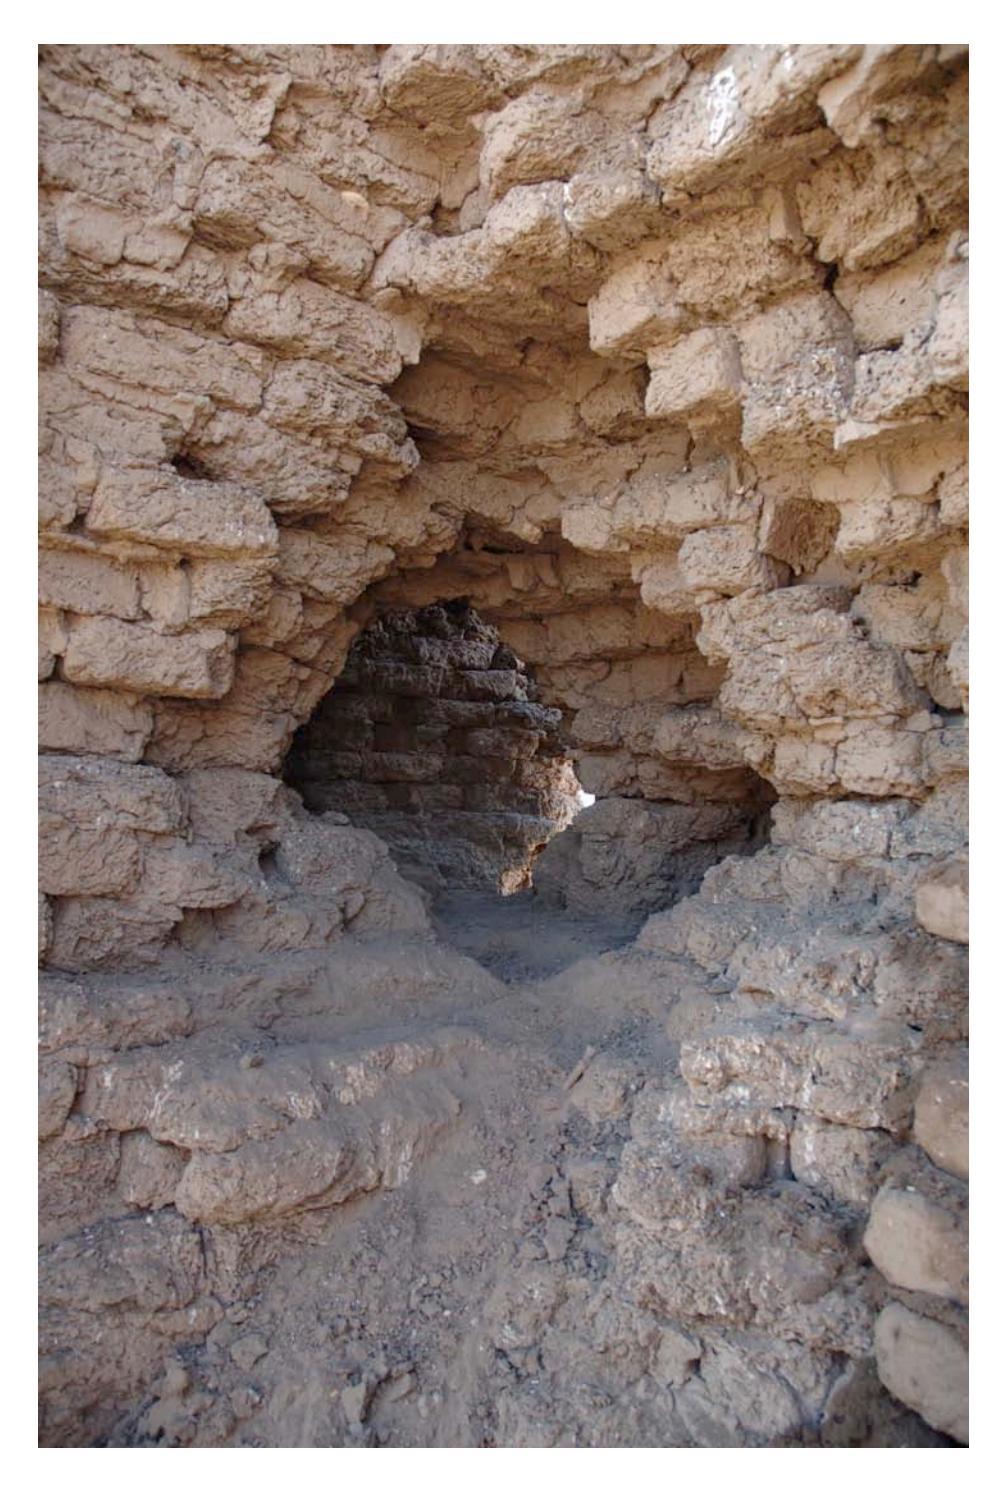
Figure 242. Interior detail of the through-wall hole system pictured in Figure 230, above, prior to stabilization. (Photo: Robert Fletcher 2004-2005)
