Tomb of Anen Protection

TT 120, Sheikh 'Abd el-Qurna, West Bank, Luxor
Lyla Pinch-Brock, Director
Final Submission, January, 2003

Cover photo: Completed protection for the paintings in the tomb of Anen, showing the doors open on the Amenhotep III and Tiy scene (photo: E.C. Brock no.6 S 253 02).

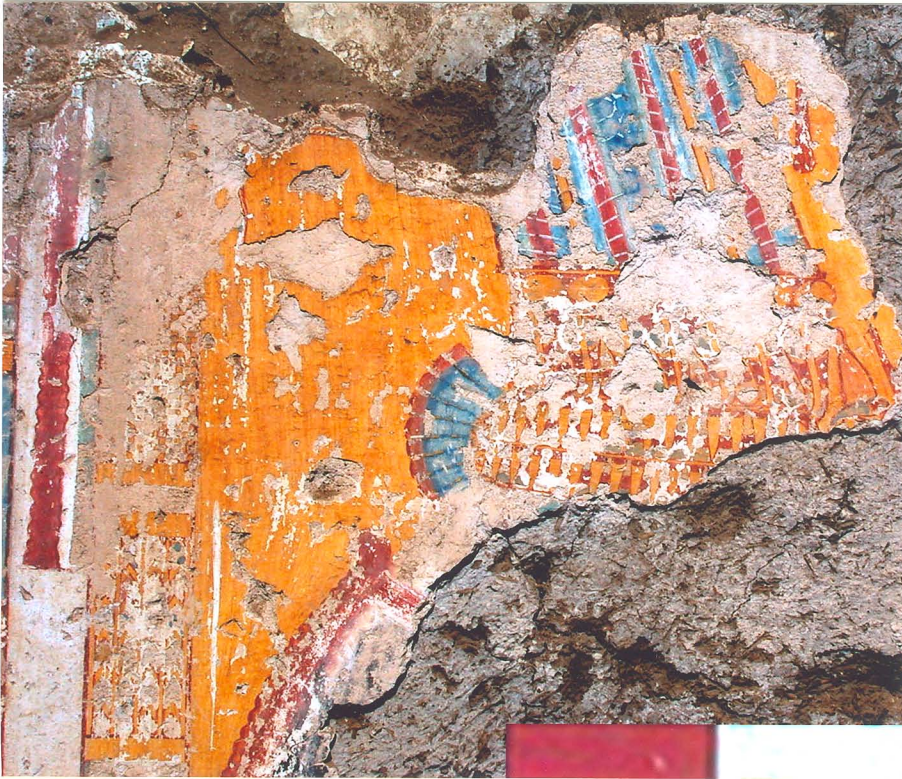
A: Queen Tiy's vulture crown as depicted in the Amenhotep III and Tiy scene (photo: Edwin C. Brock, no. EG 13 S 252 02).

TT 120 must have been built before the court moved to Amarna because in the scene of Amenhotep III and Tiy enthroned on the west wall of the Hall, Tiy wears the vulture crown, symbol of the goddess Mut, wife of Amun (pl. 2A), which became anathematized after the Aten gained supremacy. Fragments of painted plaster with a *shebyu* collar have been found in the debris of the Hall about a meter from the painting of the king. Peter Brand, who is studying the *shebyu* collar believes the use of the collar by Amenhotep III can be dated to the later part of his reign (Brand 2002); examples in several Theban tombs show the king wearing the collar, and fragments of painted plaster depicting a *shebyu* collar were found in the debris of the Hall about a meter from the painting of the king. This information seems to indicate that Anen was buried before Amenhotep III passed away. However, the style of this painting, with its lively depiction of animals, clearly presages the change that would subsequently come to characterize the art of the Amarna Period.

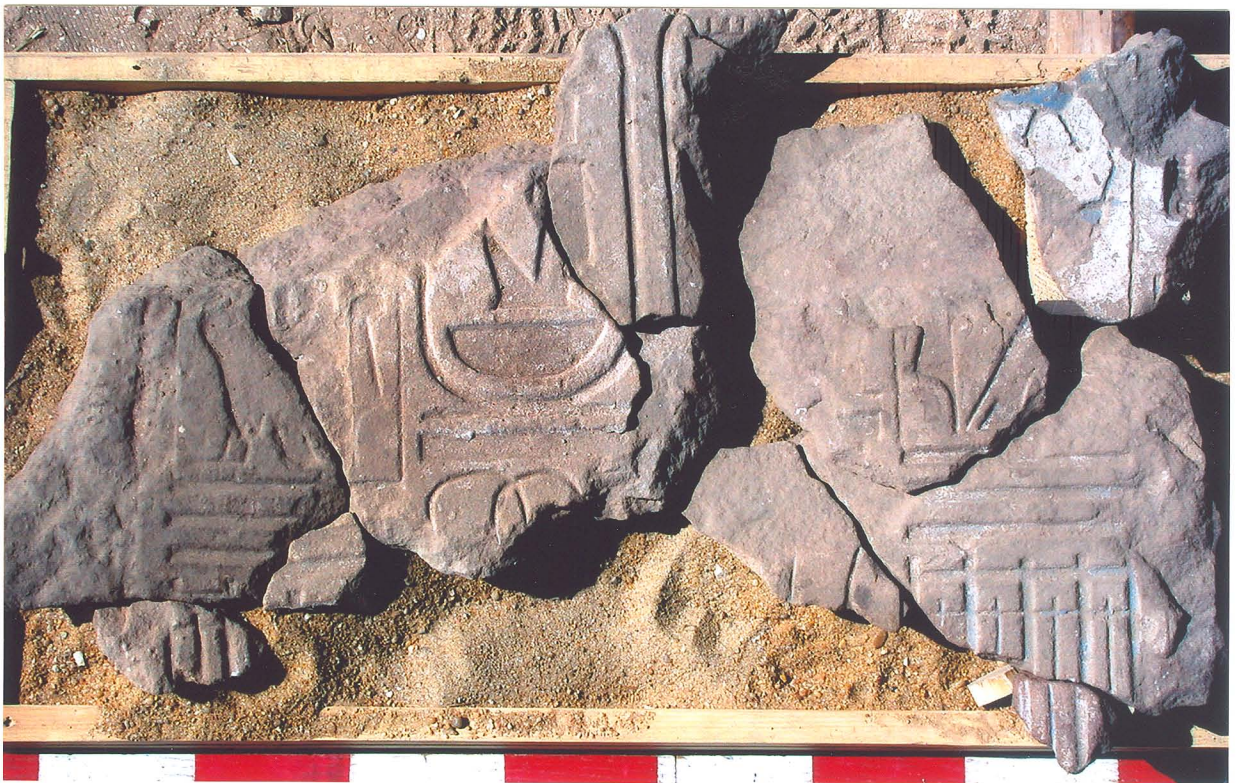
B: Fragments of red quartzite lintel found in the Inner Room (photo: Edwin C. Brock, no. EG 4 S 254 02).

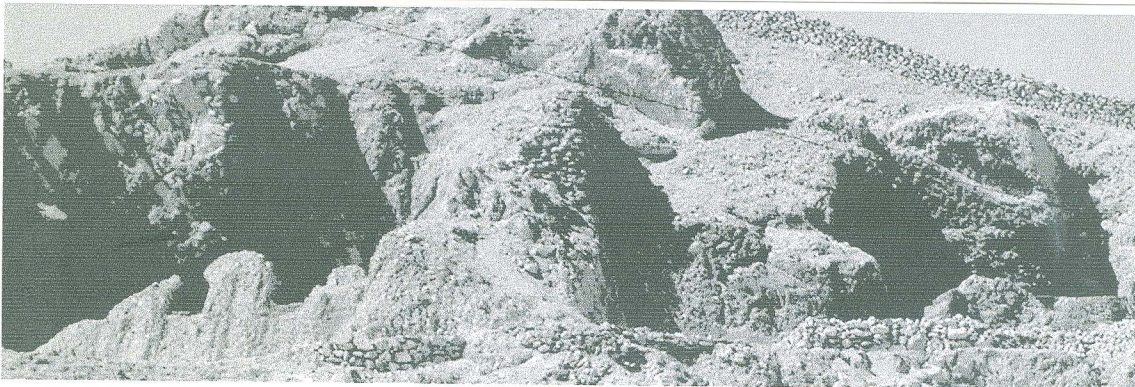
Plate 3 : Deterioration of the tomb of Anen from 1930-1995.

C: View of tomb of Anen taken in 1995 (L.P. Brock). Some more of the doorway seems to have fallen away.

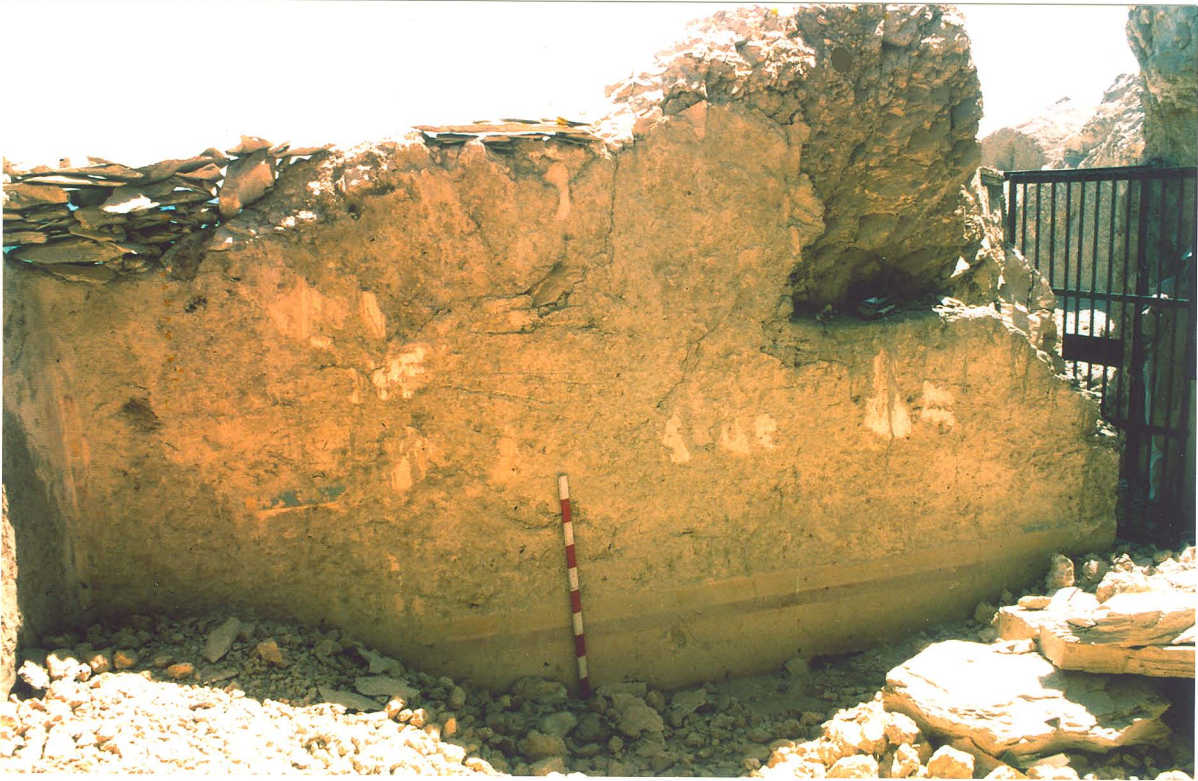
A: East wall of Hall looking east showing debris levels in 1994.
(Photo, L. Pinch-Brock)

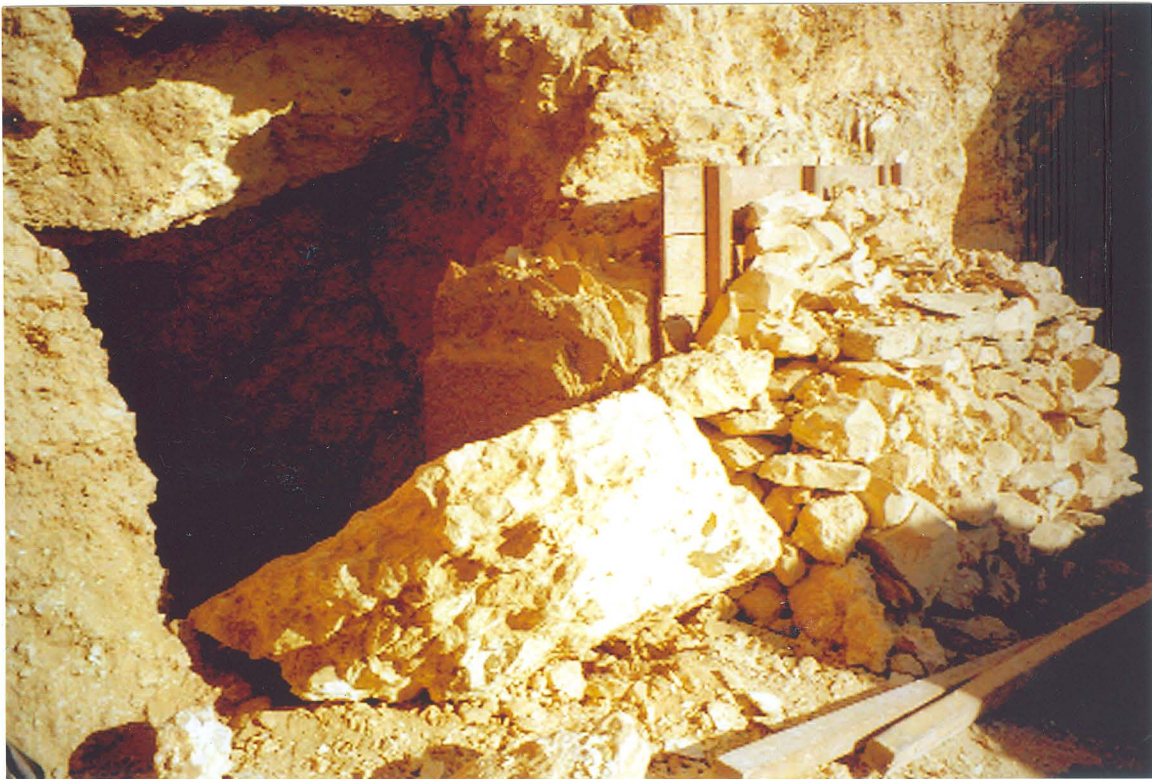
B: West wall of Hall looking north; boulder blocks entrance to Inner Room and the Amenhotep III and Tiy painting is almost completely covered with rocks.
(Photo: L. Pinch-Brock, 1994).

The Davies had left the Amenhotep III and Tiy scene on the west wall boarded-up and these boards barely protruded through the top of the debris (pl. 6B). We removed some of the stones covering the painting and found wads of cotton and a couple of mud bricks. Later we would come to realise this was evidence the antiquities thieves had disturbed the area to get at the painting.

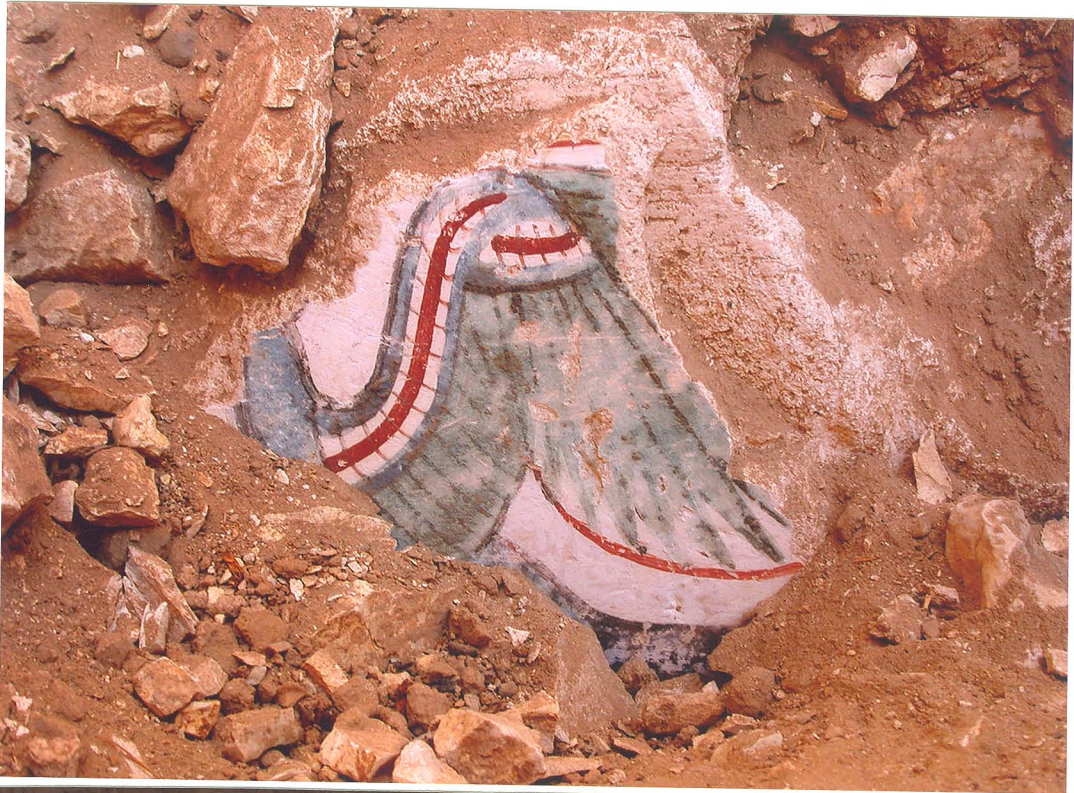
A. Discovery of the *rekhyt* frieze in January, 2002 (digital photo, L. Pinch-Brock).

In preparation for the conservation work, I collected the fragments I thought matched the *rekhyt* scene from the boxes containing material retrieved from the south end of the Hall during previous seasons, mainly from excavating directly in front of the west wall south of the entrance to the Inner Room. Norman de Garis Davies mentioned in his notes that he had recovered one large fragment from the south-east corner, although he did not know of the scene it had come from: "A loose fragment of adoring *rekhyt* birds on baskets within a later block border..." The fragment that Davies referred to – the only large one found – was in the Inner Room when I entered in 1994. It had glue on it, apparently an attempt by Davies to replace some of the broken-off pieces lying nearby.

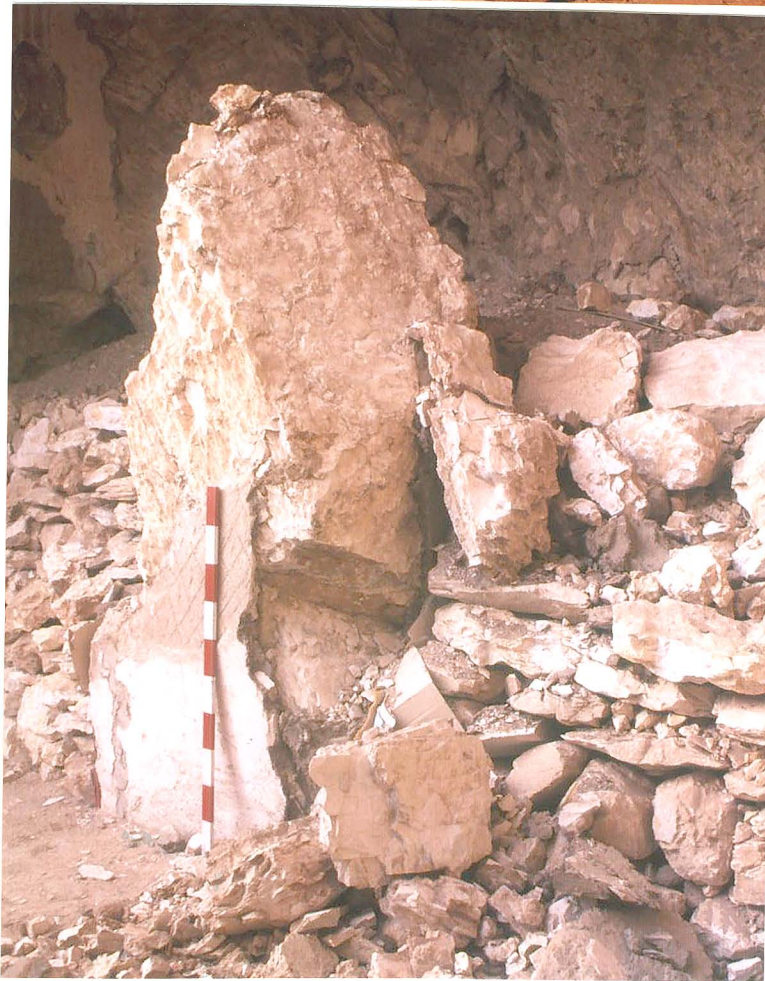
B. Pillar 4 collapsed after the end of the season in February, 2002. (Photo: E.C. Brock, no. EG S 251 02).

The second order of business was to repair Pillar 4. A small (approximately 30 cm) area was cleared immediately west of the pillar in order to facilitate work. Warris, gathered up the fallen fragments to see what could be replaced. This pillar is the only one of the four in the Hall not yet consolidated, since it was still enveloped by debris. From October 3rd to October 8th, Warris rebuilt and consolidated the north and west sides of the pillar, re-installing any fragments he could, using a of three parts *hib* to one part slaked lime mixture, with a small addition of Primal AC 33 (about 1:10) to provide elasticity.¹⁴ The body of the pillar was strengthened by interleaving the mortar with slices of limestone, a technique used in ancient times, and still visible elsewhere in the tomb.

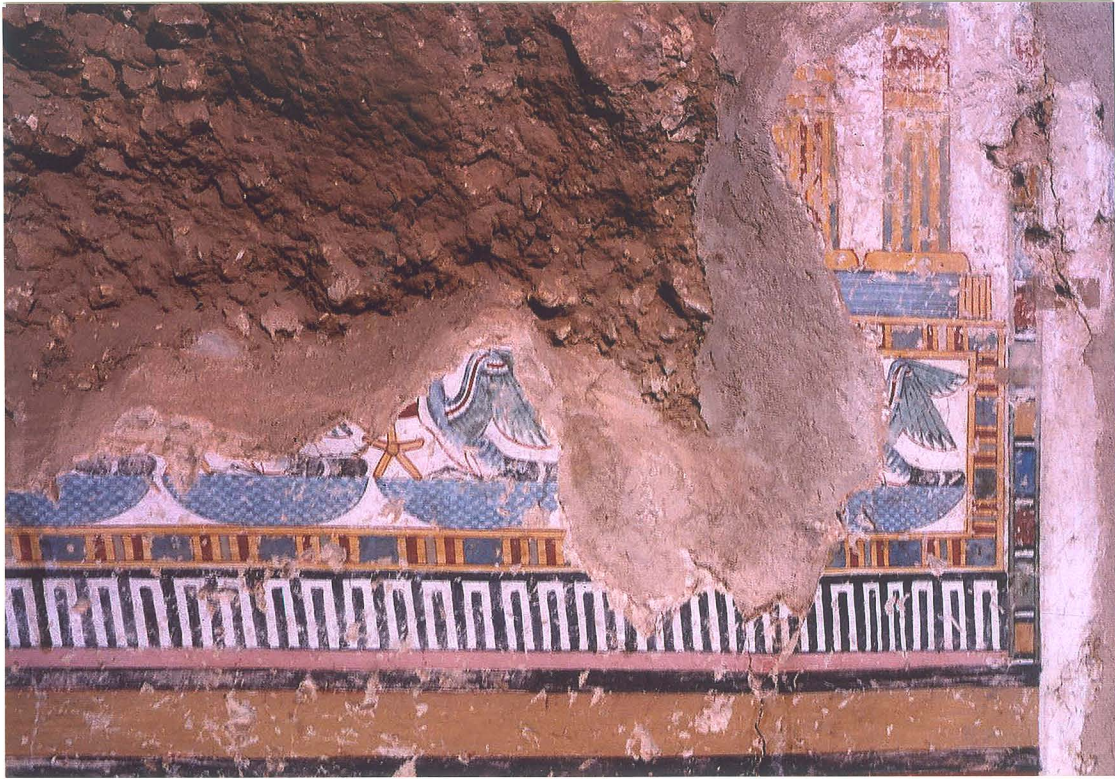
A: *Rekhyt* scene before conservation (photo: E.C. Brock no. EG 2 S 251 02).

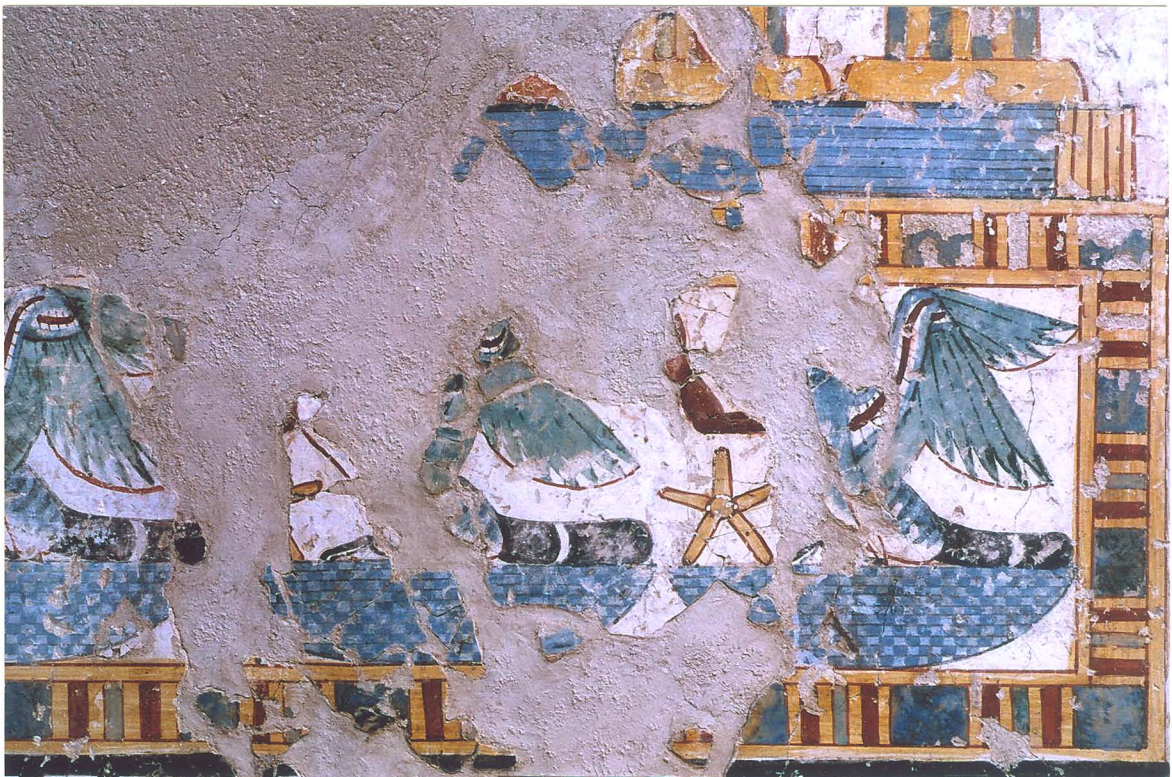
B: *Rekhyt* scene in last stages of conservation with many fragments replaced (photo: F. Dzikowski, no. EG 19 S 252 02).

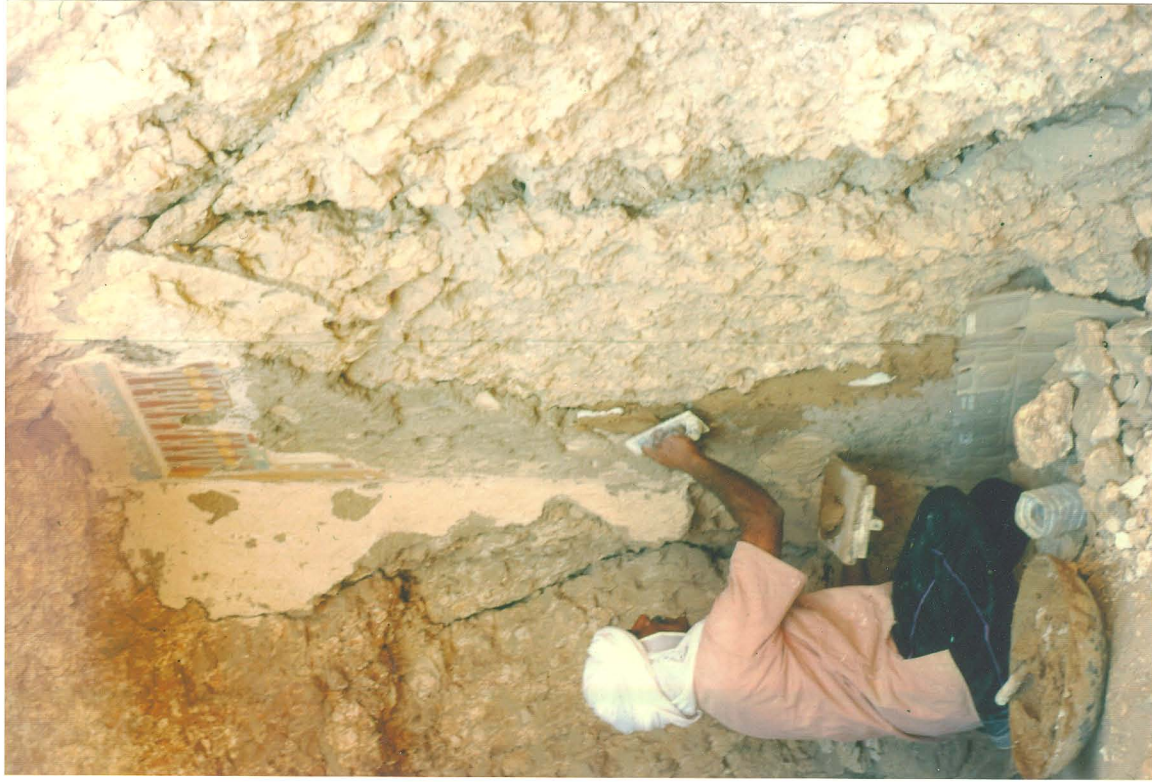
A: Mohammed 'Abd el-Warris applying mud mortar to rough rock surface of *rekhyt* area. (photo: L. Pinch-Brock no. EG 18 S 252 02).

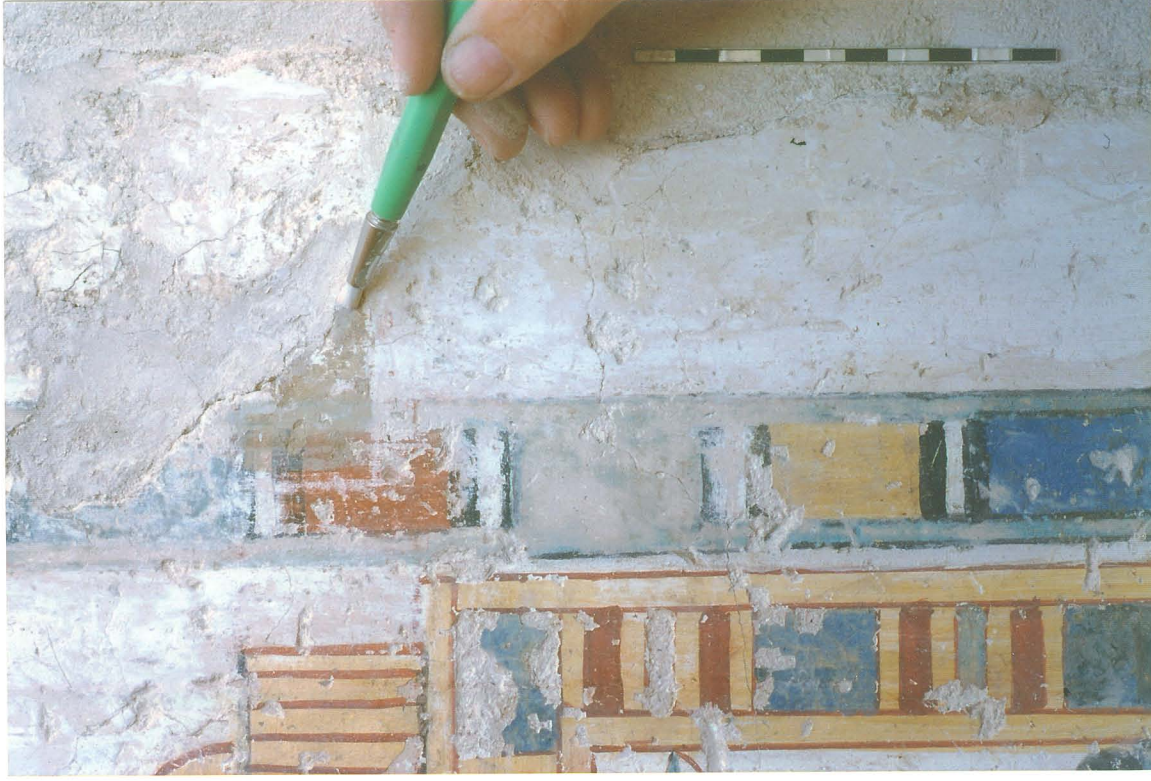
B: Ewa Parandowska cleaning surface of *rekhyt* area. Note difference between cleaned and uncleaned surface (photo: F. Dzikowski EG 7 S 252 02).

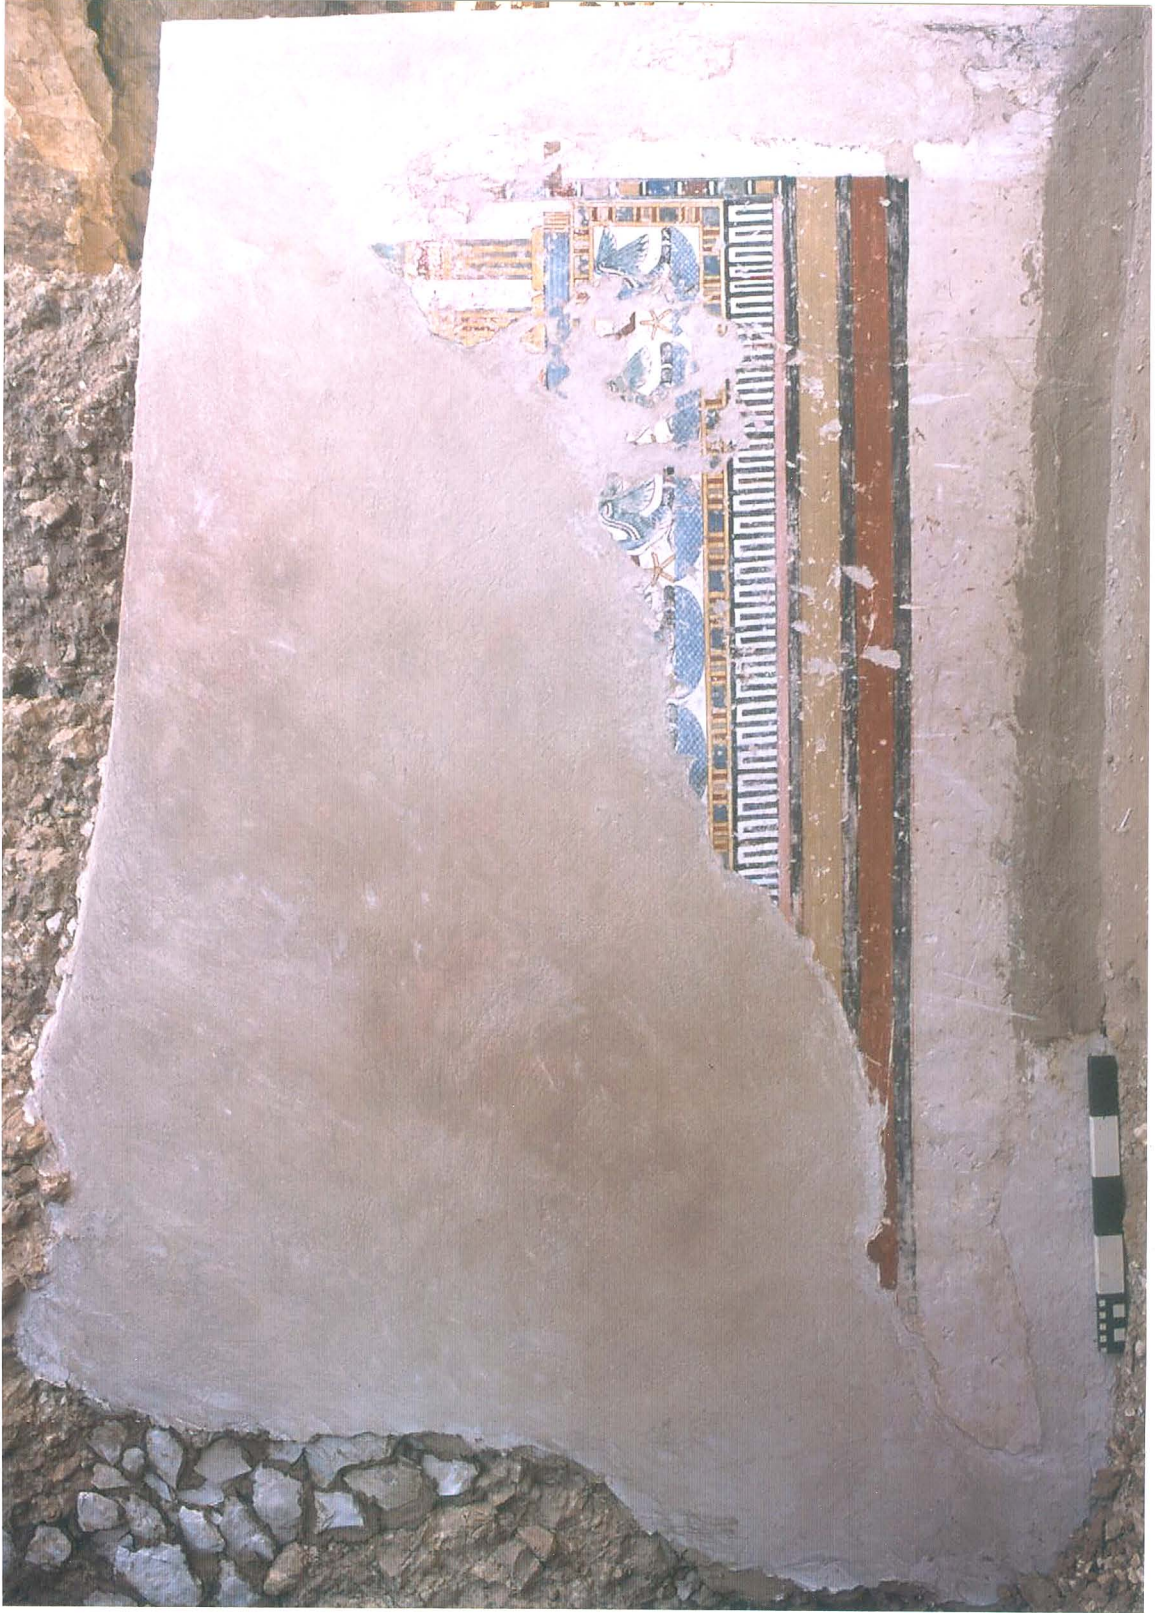
Plate 11: Complete *rekhyt* scene after conservation. Note consolidation of rough rock surface above (photo: F. Dzikowski no. EG 8 S 252 02).

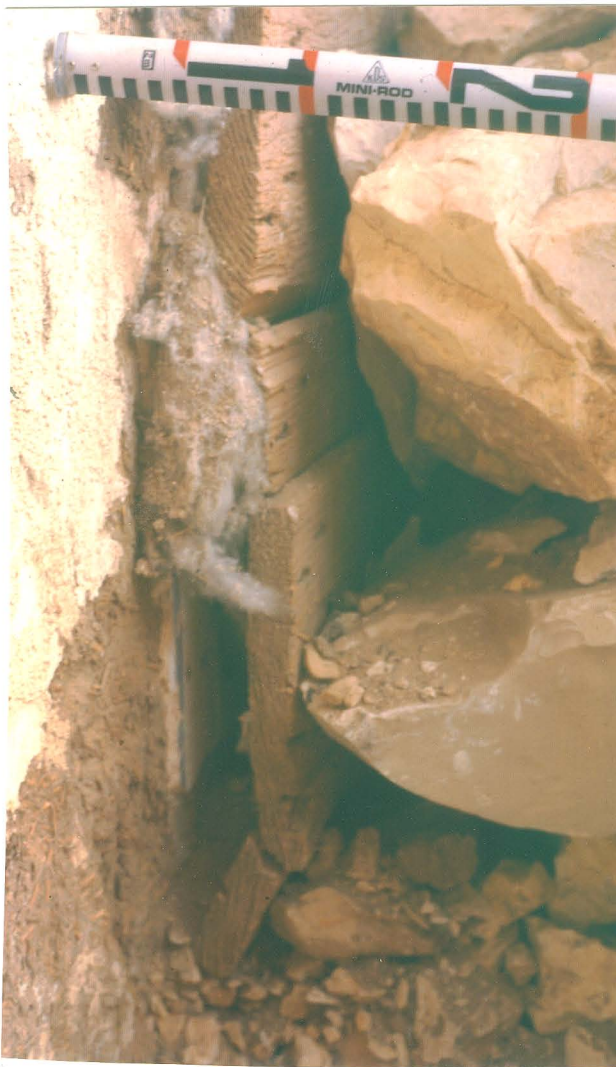
Plate 12

A: Layer of cotton, wood, rocks and debris against the painting, viewed from the south end (photo: E.C. Brock no. EG16S 252 02).

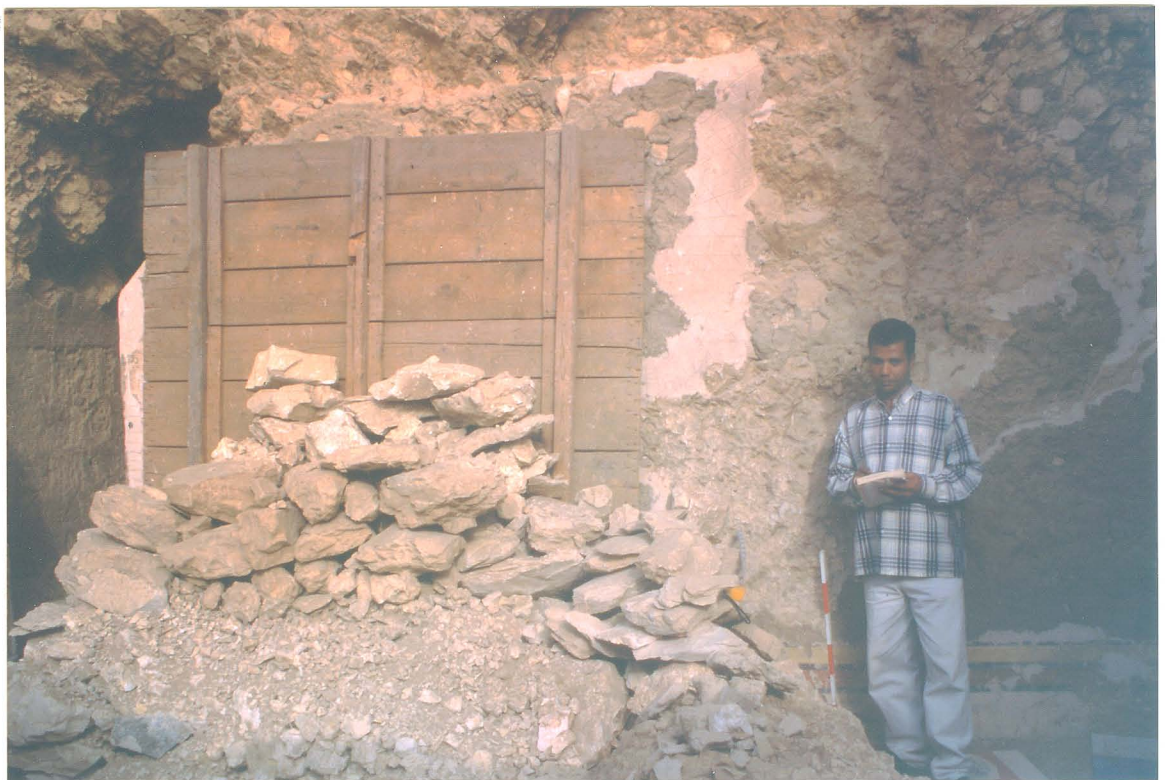
B: Inspector Hassan beside boarded-up painting. The wood was a MMA packing crate. (Photo: E.C. Brock no. EG 12 S 252 02).

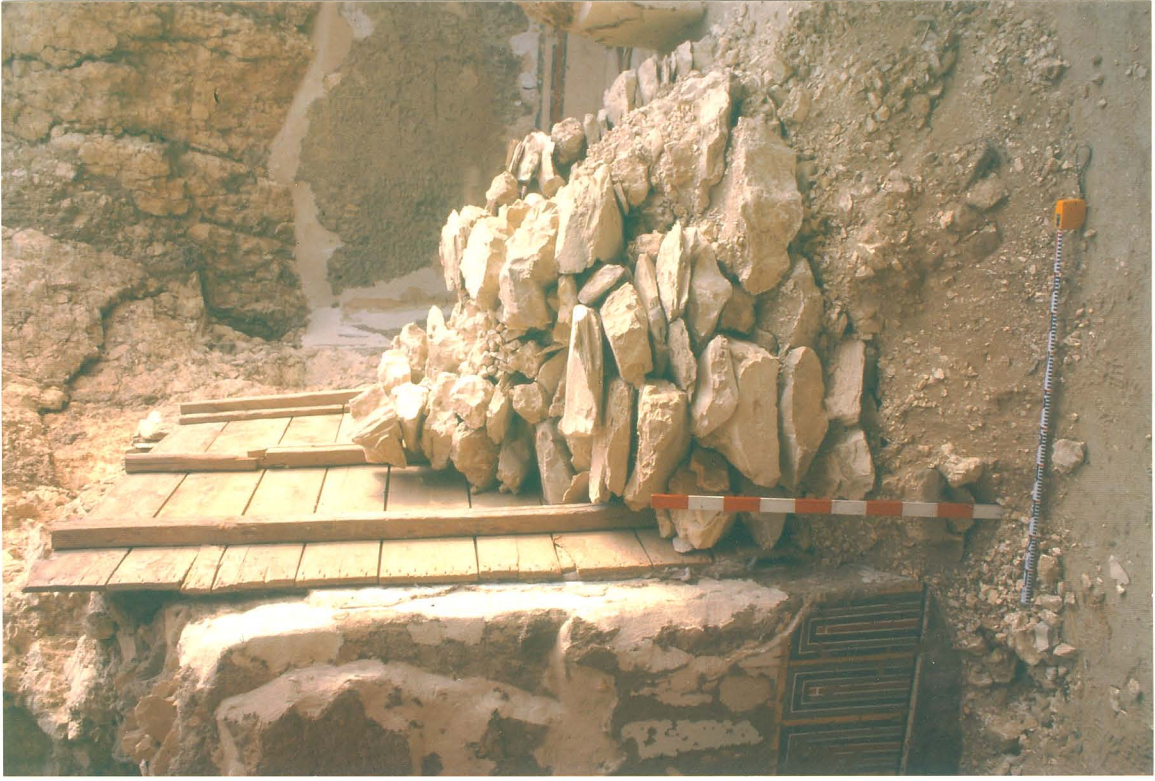
A: View looking north of debris levels in front of painting.
(Photo: L.P. Brock no. EG 20 S 251 02).

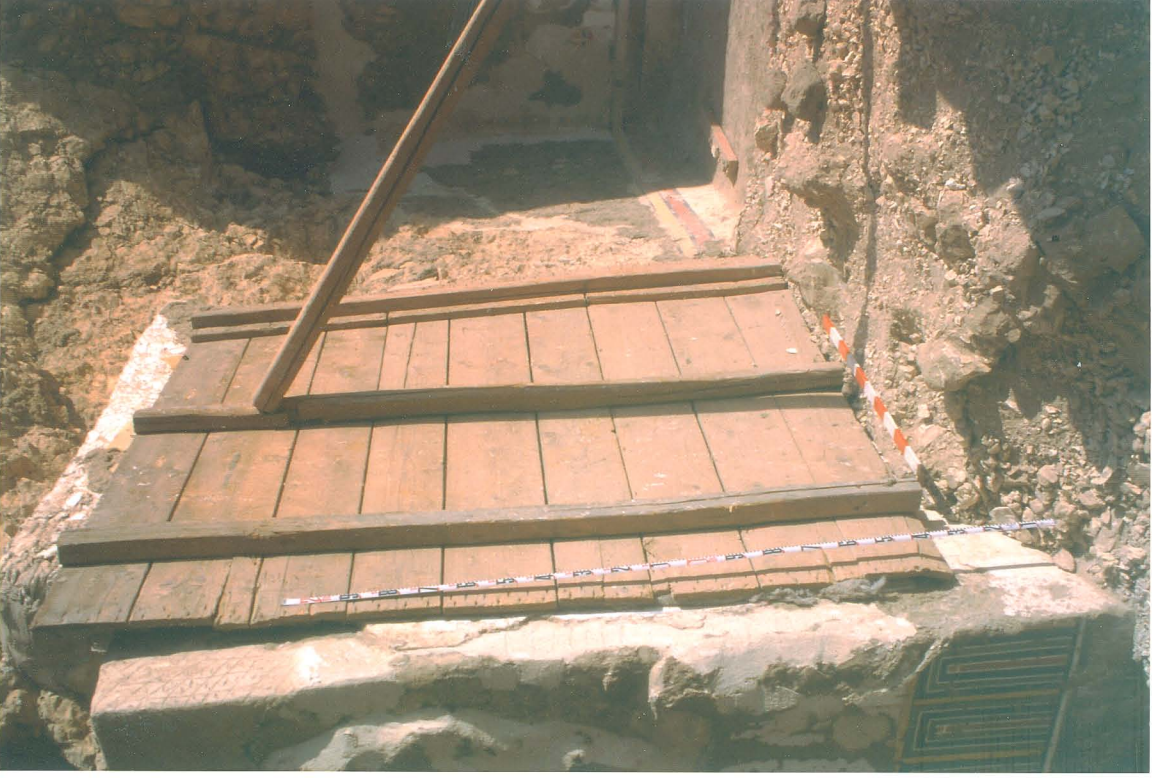
B: Similar view showing rocks cleared and remaining archaeological material (Photo: L.P. Brock no. EG 6 S 2 02).

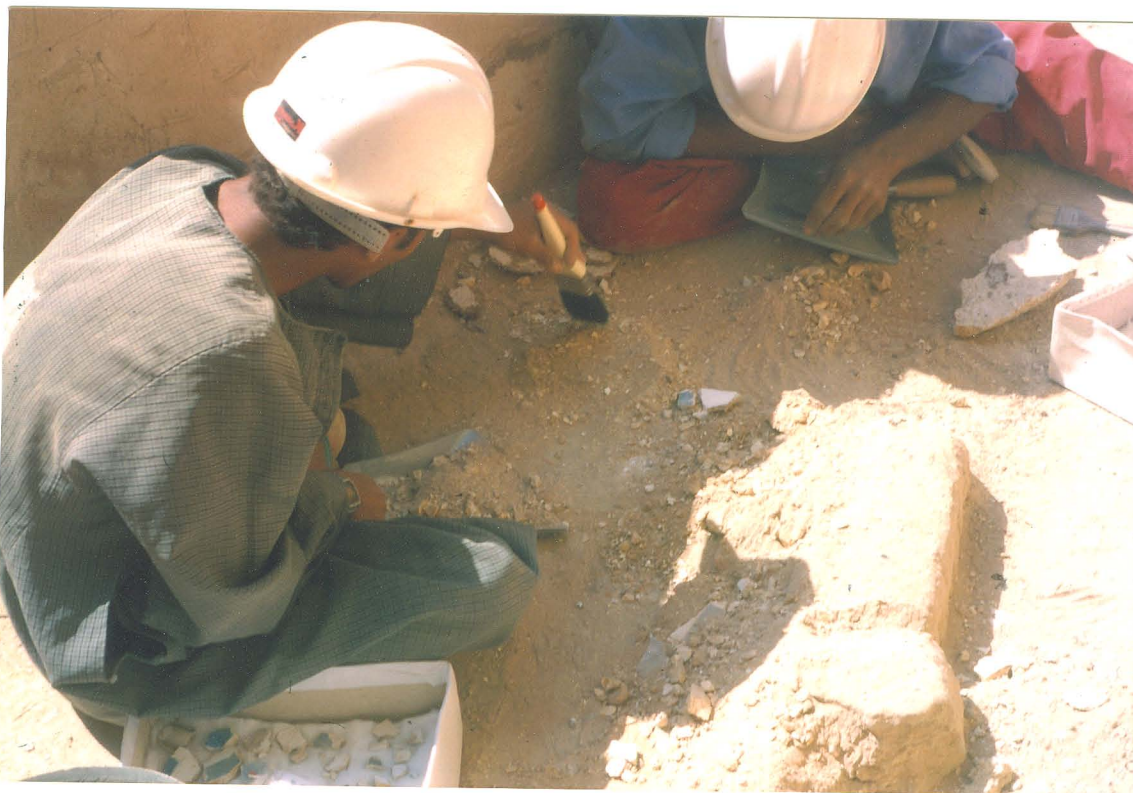
A: Excavating upper level of area which included mud brick and plaster (photo: L. Pinch-Brock no. EG 10 S 252 02).

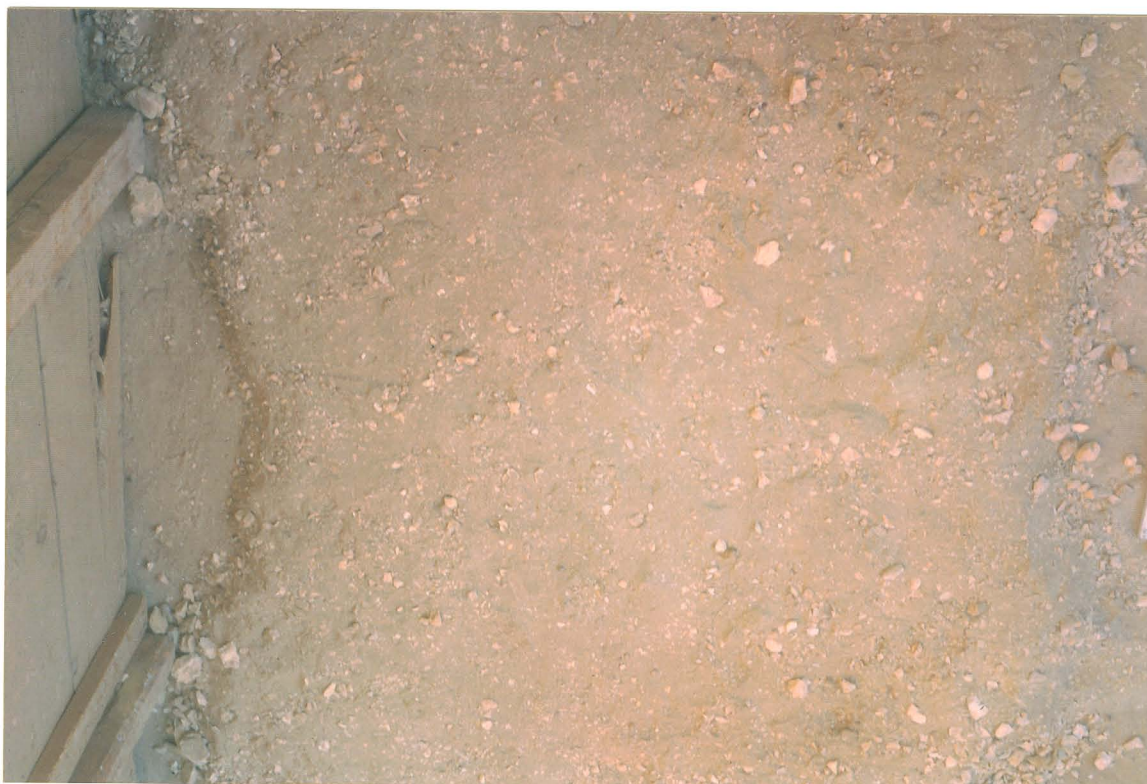
B: Lower level of area showing composition of mostly silt and plaster fragments (photo: L. Pinch-Brock no. EG 14 S 252 02).

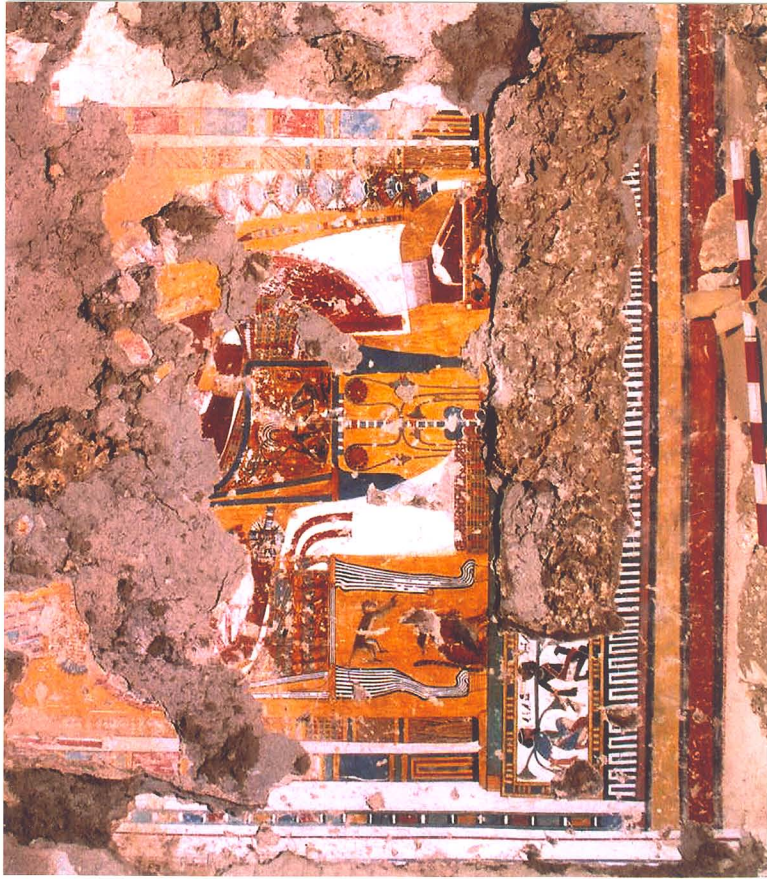
A: The Amunhotep III and Tiy painting revealed: (photo: E.C. Brock no. EG 5 S 252 02). B: Close-up of area showing cushion and chisel marks: (photo: E.C. Brock no. EG 17 S 252 02).

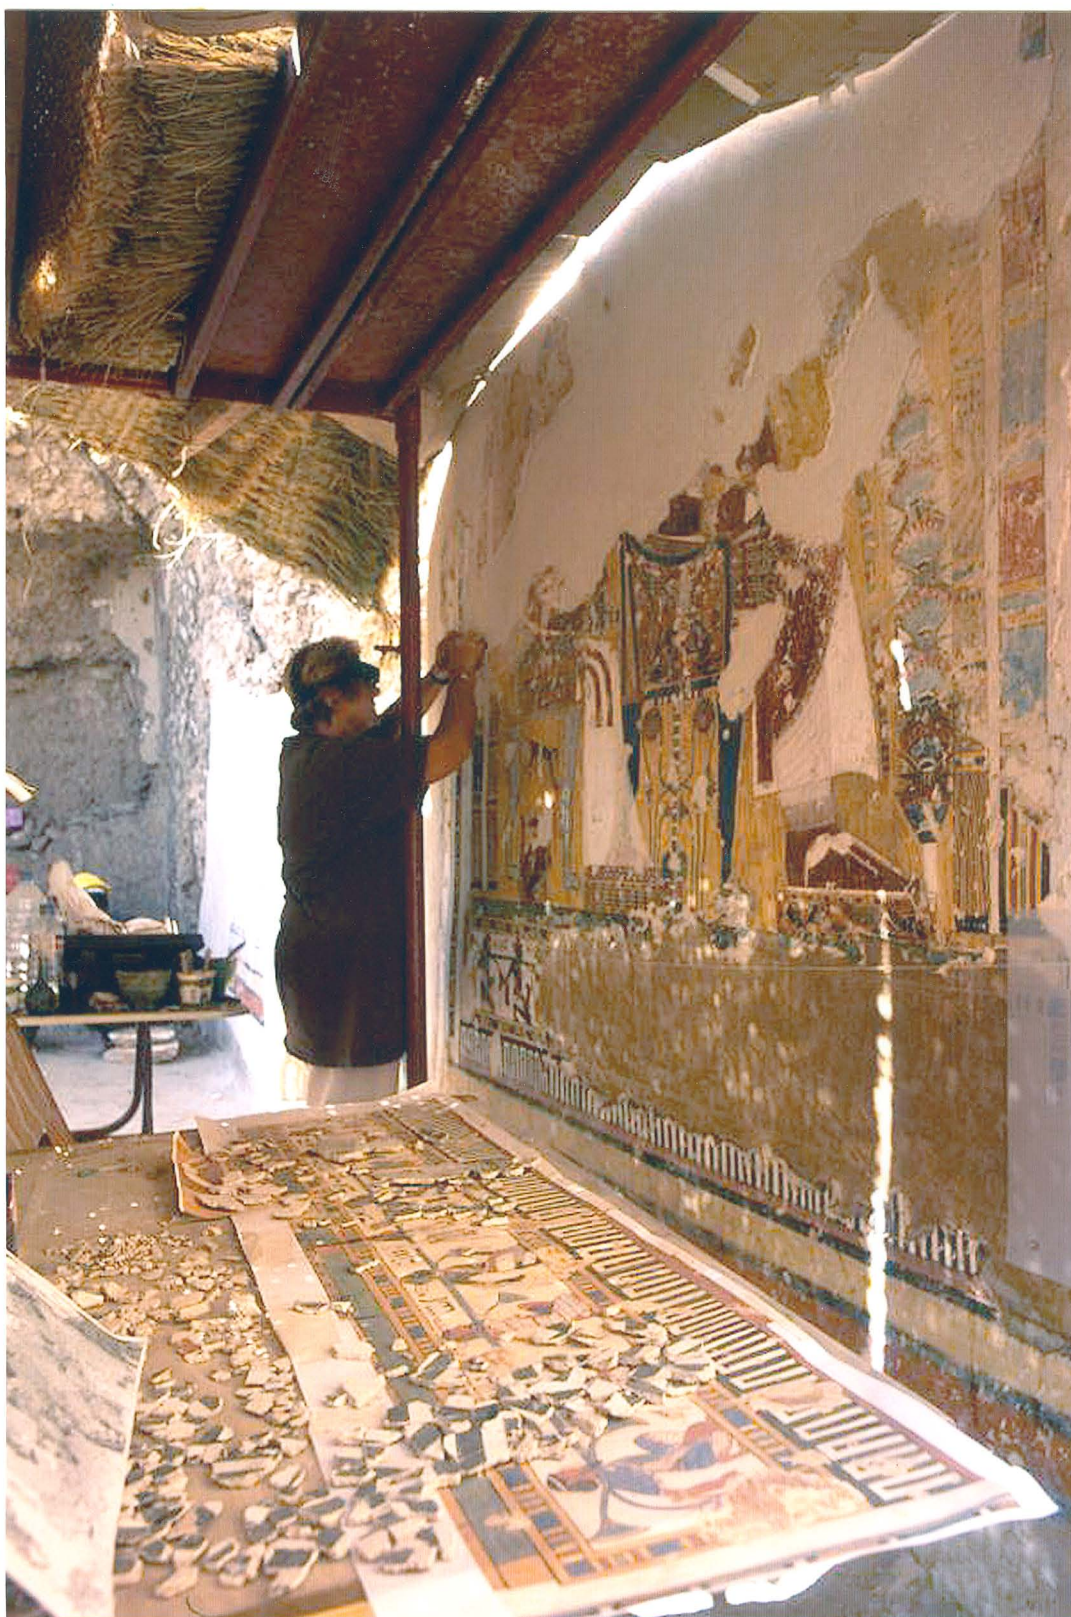
Plate 16: Ewa parandowska re-installing fragments belonging to the baldachin (photo: F. Dzikowski no. EG 3 S 252 02).

Parandowska inspected the exposed painting for loose and missing plaster. We had Burton’s photo and a photograph of the MMA facsimile to work with, and on this basis, could see that the only fragments missing from the upper part of the painting were parts of the supports for the baldachin on the upper left side (pl. 16). Parandowska lightly brushed away dirt and cotton debris using soft brushes. Any loose plaster was injected with a 50% ethanol-water solution followed by injections of 15-30% Primal AC 33 in water. Once the plaster was considered secure, large and deep areas of damage were first filled with the same lime, mud and chaff mortar that was used above the painting to fix it to the rock. After this layer was completely dry, the second, fine coat of mud and lime mixture was applied.

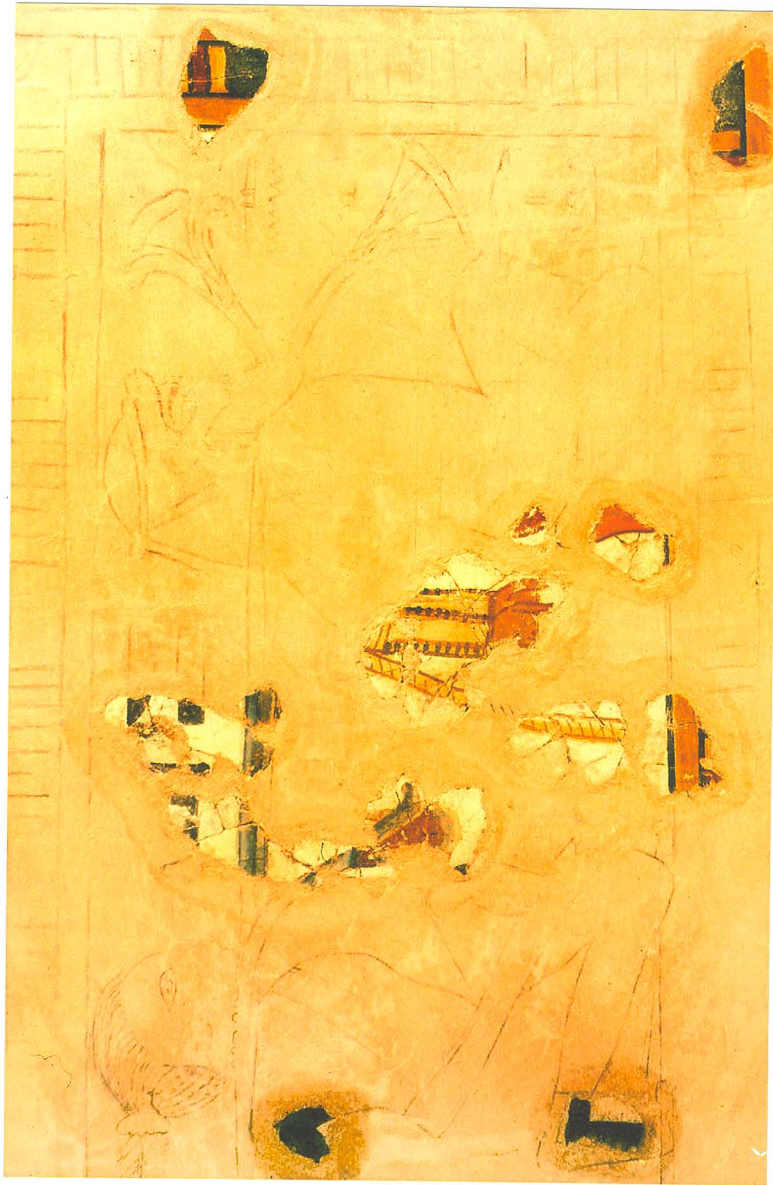
A: Insertion of fragments was based on the preliminary pencil sketch (photo: E.C. Brock no. EG 15 S 252 02).

I enlarged the illustrations from the Davies publication to match the size of the two extant figures at the south end of the painting, then used a 2B pencil to trace the enlargements on the reverse for transfer to the new wall surface (pl. 17B). Parandowska inserted the relevant fragments using the penciled-in figures as guides. (pl. 17A). Once this was done, I painted in the outlines using a 0 paintbrush and a mixture of one part raw red ochre, one part Arabic gum (*samgh baladi*) and one part Primal (without Primal the mixture tended to smear) (16c). The red outline of the decorative border (color block border) and the stems of the lotus and papyrus plants were accomplished by masking the line with masking tape, and then daubing the unmasked area with a sponge coated with the red paint. This was done to give the impression of a string line, which is how the ancient artist would have laid down a line. In our case, actually using a string dipped in red paint was found to be too messy and

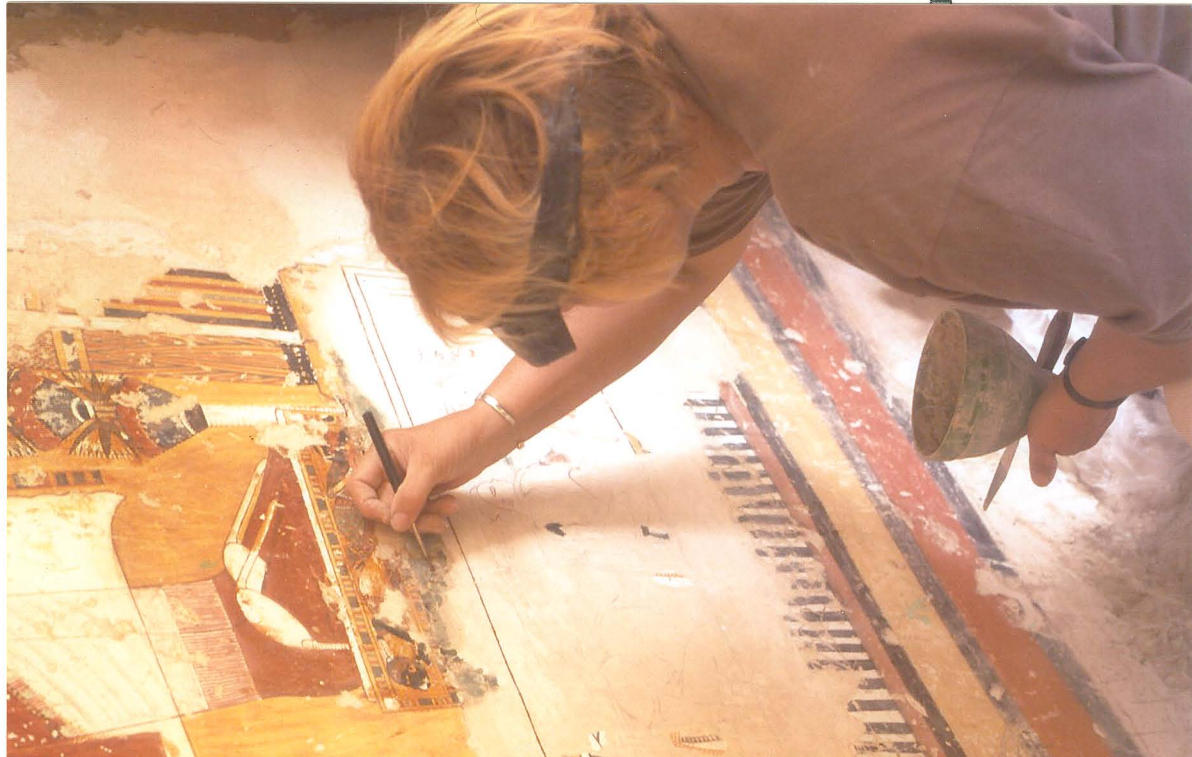
Łwa Parandowska retouching the green frit fragments.
(photo: E.C. Brock no. EG 1 S 253 02).
