Tomb of Anen Protection

TT 120, Sheikh 'Abd el-Qurna, West Bank, Luxor
Lyla Pinch-Brock, Director
Final Submission, January, 2003

Cover photo: Completed protection for the paintings in the tomb of Anen, showing the doors open on the Amenhotep III and Tiy scene (photo: E.C. Brock no.6 S 253 02).

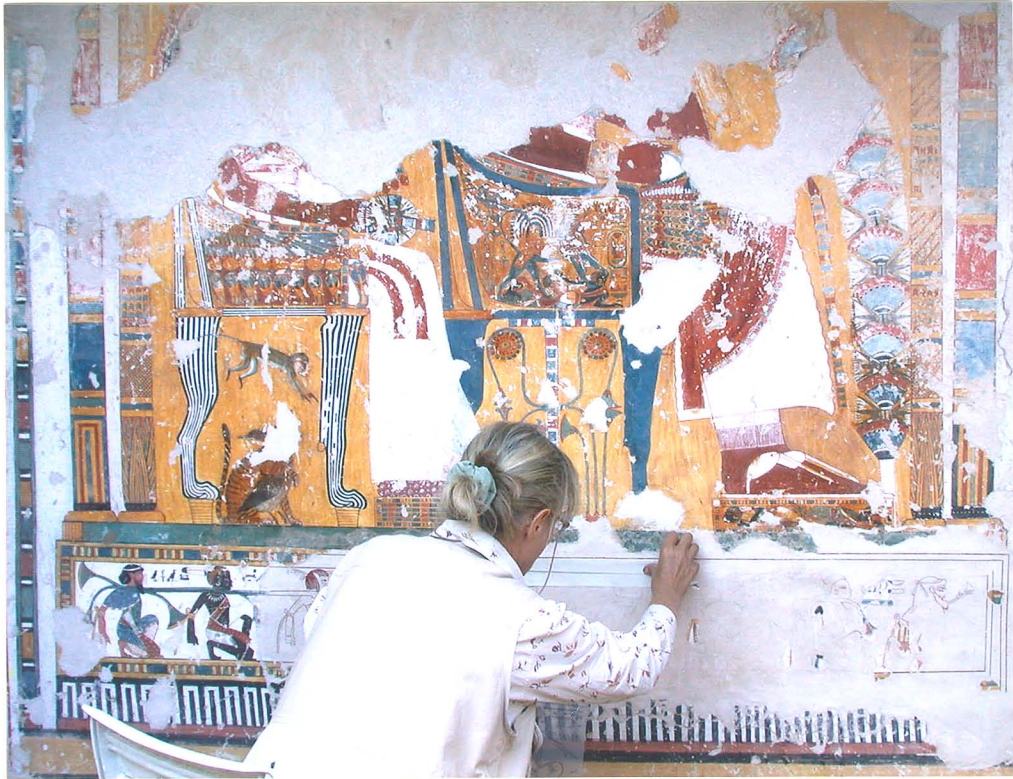
Plate 18 C: Two views of the fully-conserved painting: Above; Lyla Pinch-Brock putting finishing touches on the red outlines of the "Nine Bows" (photo: E.C. Brock no. EG 16 25102), and below, the painting framed and protected by the new cabinet (photo: E.C. Brock no. EG 6 S 253 02).

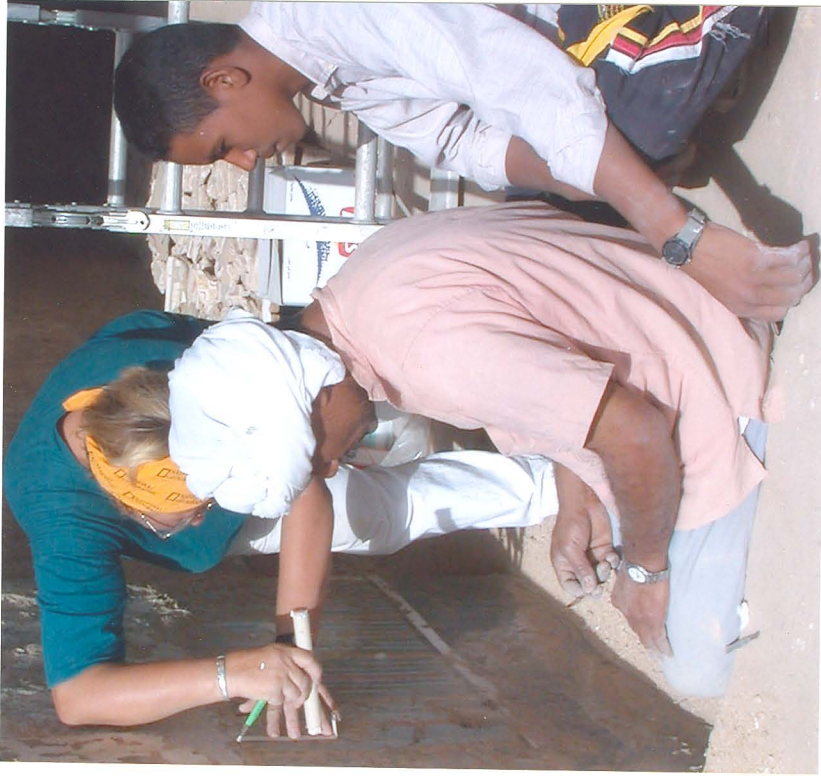
A: Ewa Parandowska showing Mohammed 'Abd el-Warris and his son Hamad how to clean a painting using a Plexiglass brush (digital photo by L. P. Brock).

Mohammed 'Abd el-Warris repaired the upper parts of the reveals at the entrance to the Inner Room, employing the same technique and materials he had used on the pillars. Parandowska cleaned the lower parts using a scalpel, Wishab sponge and Plexiglas brushes, finally consolidating the very thin and fragile plaster with a solution of 30% OK glue in water. One goal of this project was to give some training to local conservators. To this end, she demonstrated to Warris and his son, Hammad, how to clean painted surfaces without resorting to chemicals, using the reveals as a demonstration area (pl 19A,B).

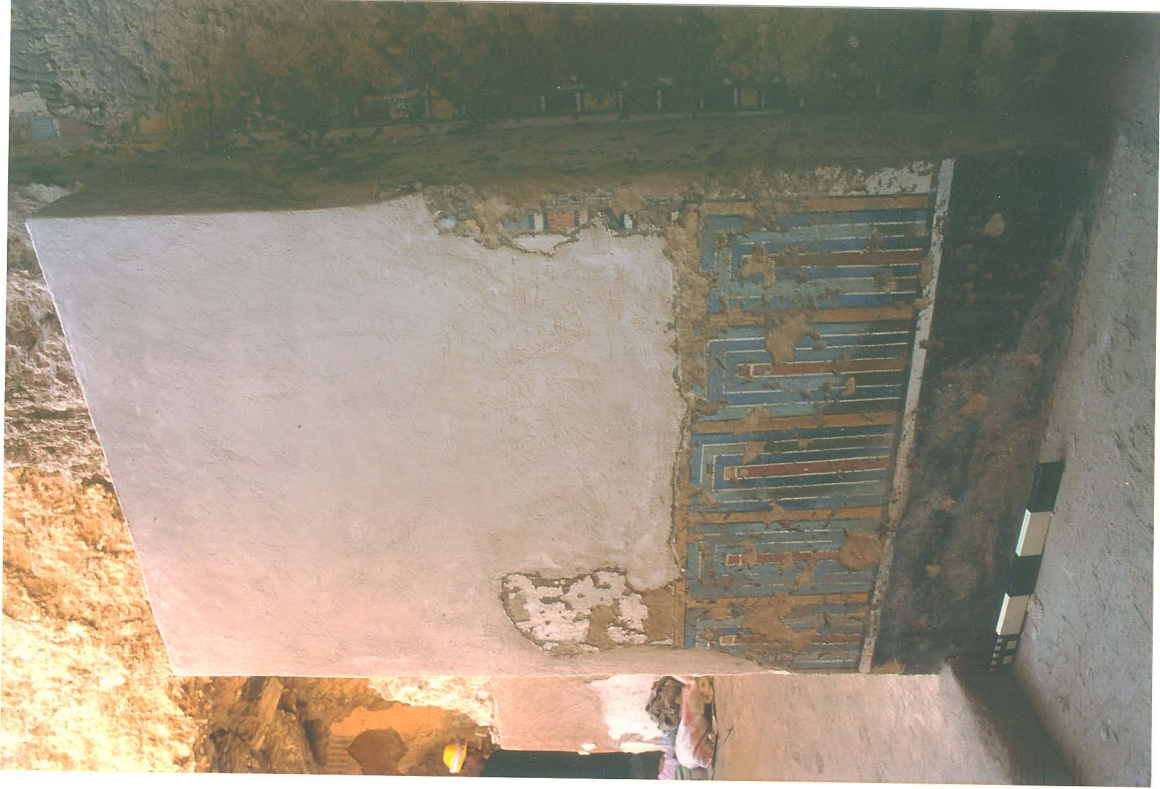
B: South reveal after repairs and cleaning by Parandowska and Warris (photo: F. Dzikowski no. EG 2 S 254 02).

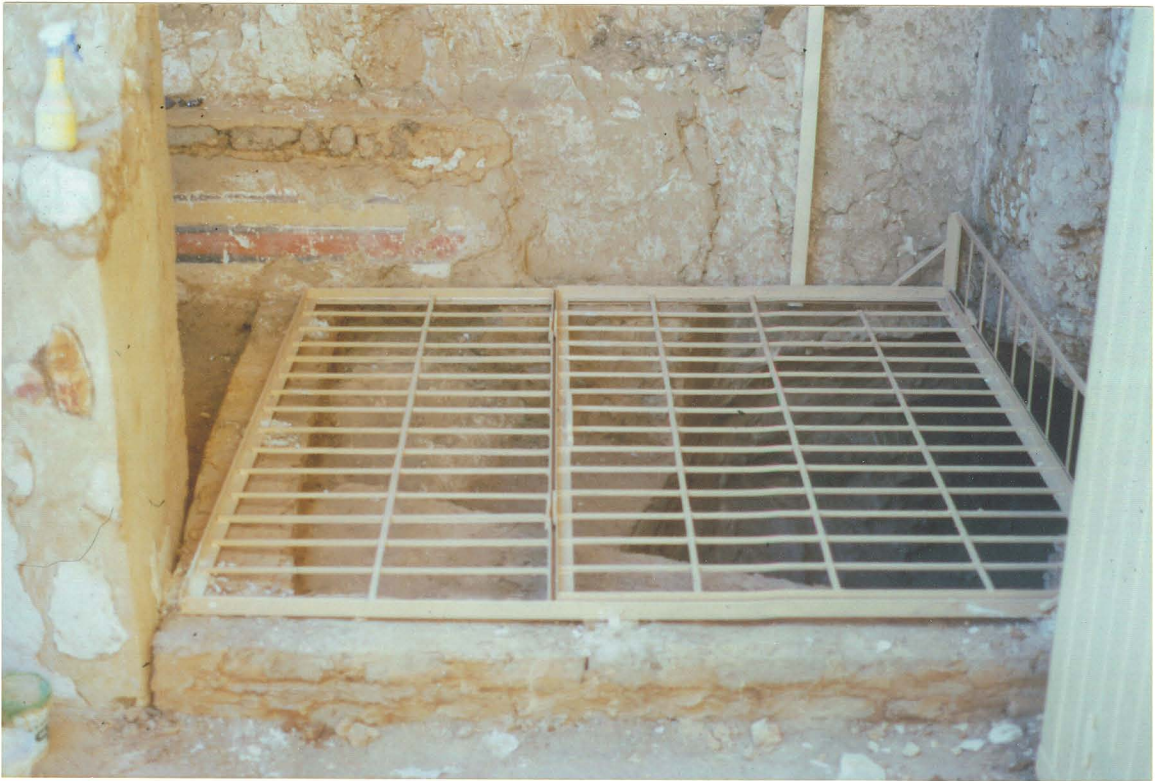
A: Grid installed over burial chamber (photo E.C. Brock no. EG 18 S 252 02).

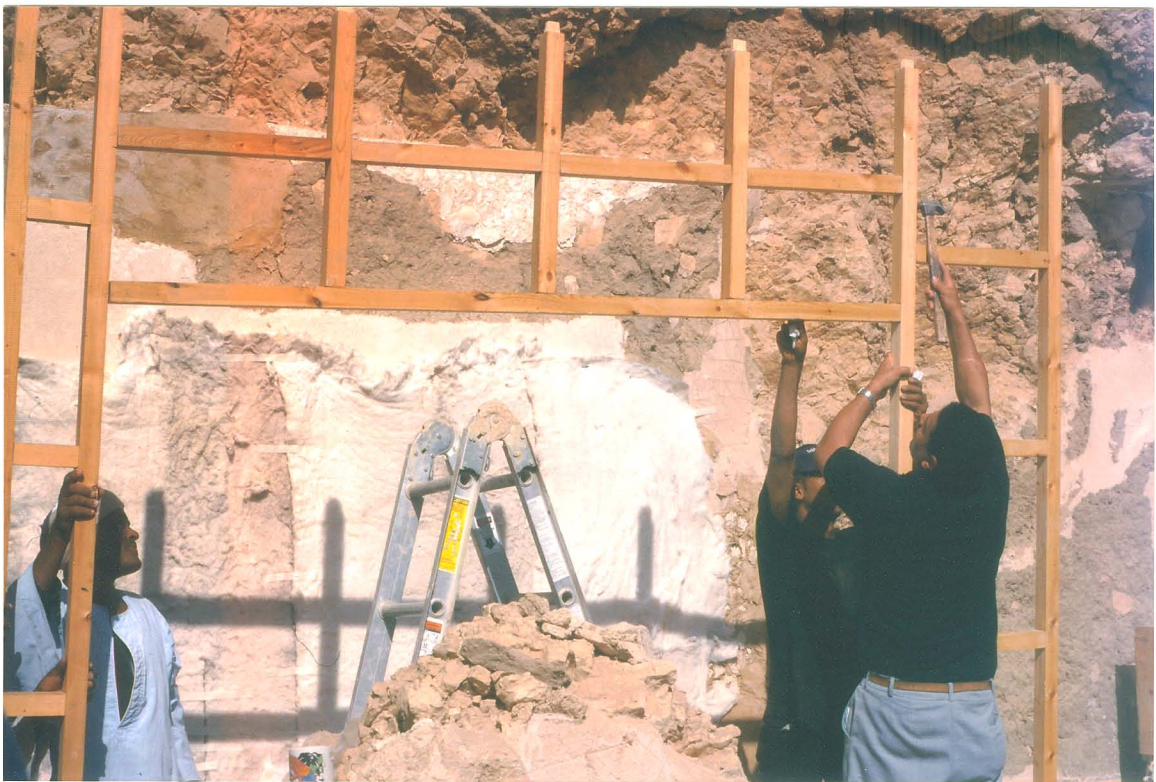
B: Constructing the frame for the cabinet (digital photo by L.P. Brock).

In front of the important wall paintings a localized cover, designed as a piece of cabinet joinery with doors that can be opened to reveal the paintings to visitors (figs. 11,12, 13, 14, 15), has been installed (fig. 8). This item was made off-site and assembled in position. This

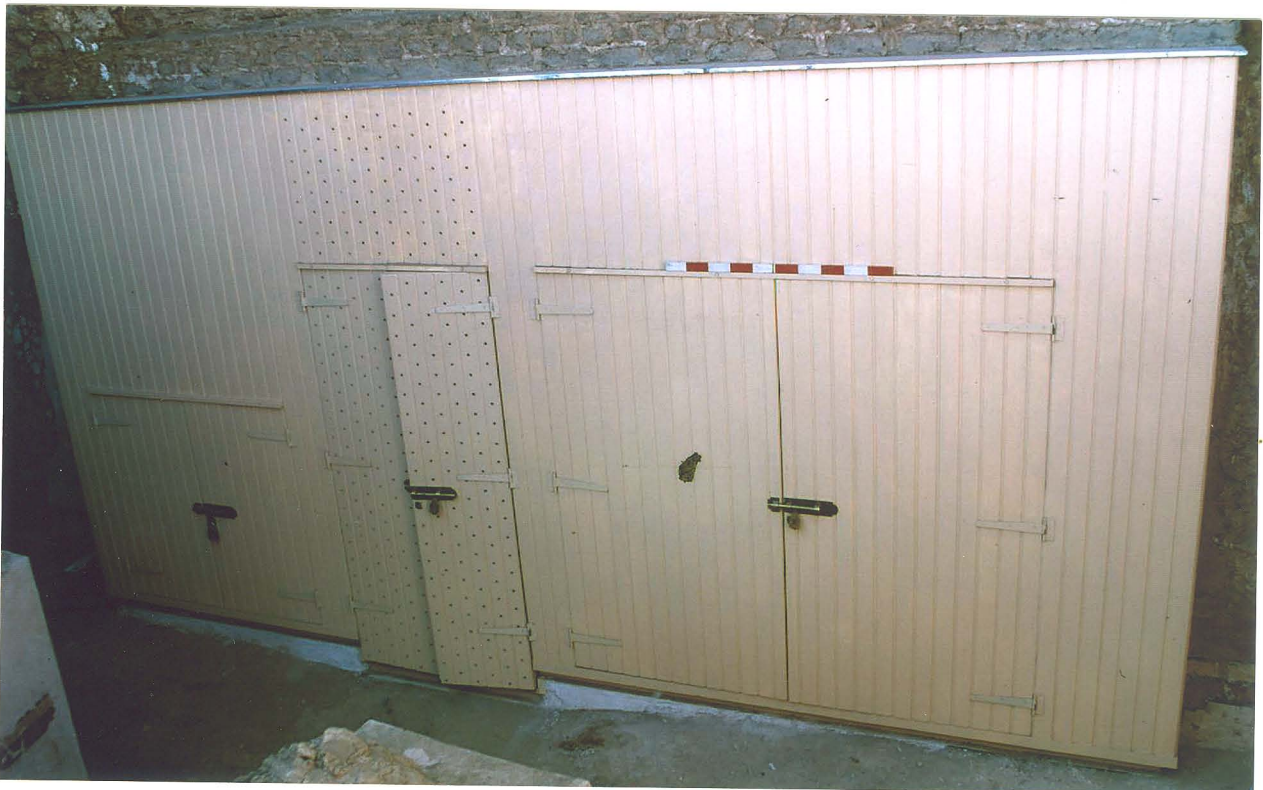
Plate 21: Cabinet enclosing paintings in Hall.

B: Completed cabinet with two openings for paintings and doorway to Inner Room (photo, E.C. Brock, no. EG 9 S 252 02).

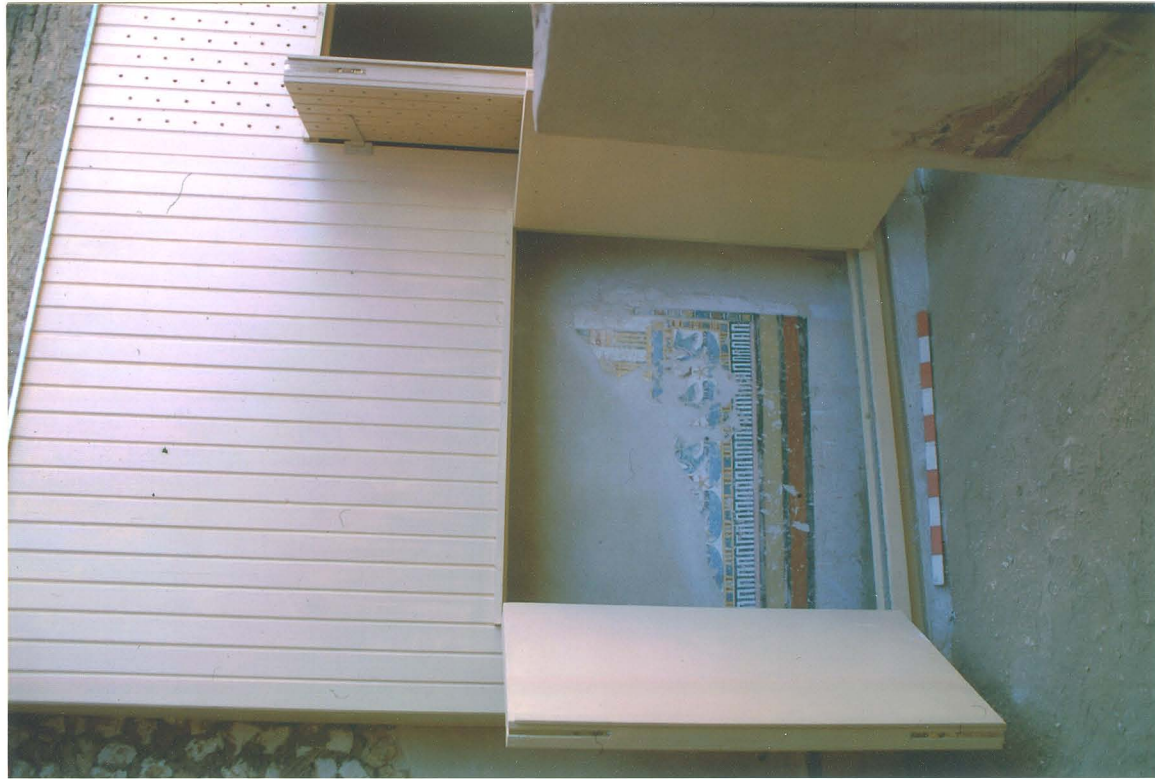
A: Doors of cabinet open to display *rekhyt* scene (photo, E.C. Brock, no. EG 2 S 253 02).

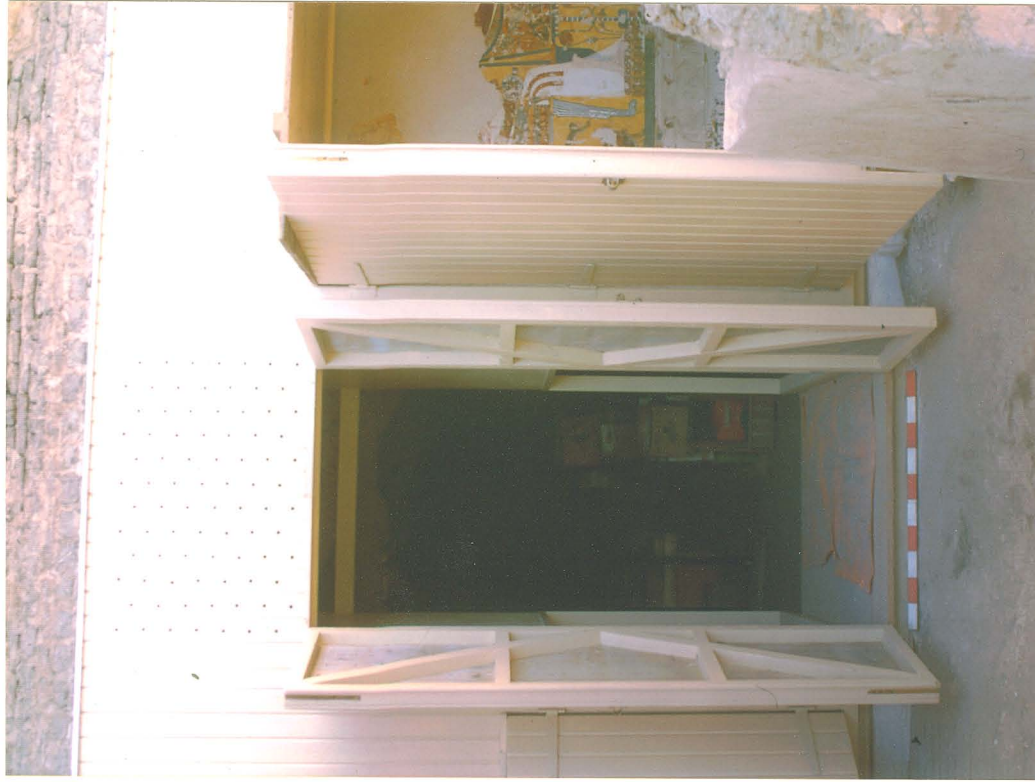
B: Doors open into the Inner Room, now our storage area (photo, E.C. Brock no. EG 17 S 253 02).

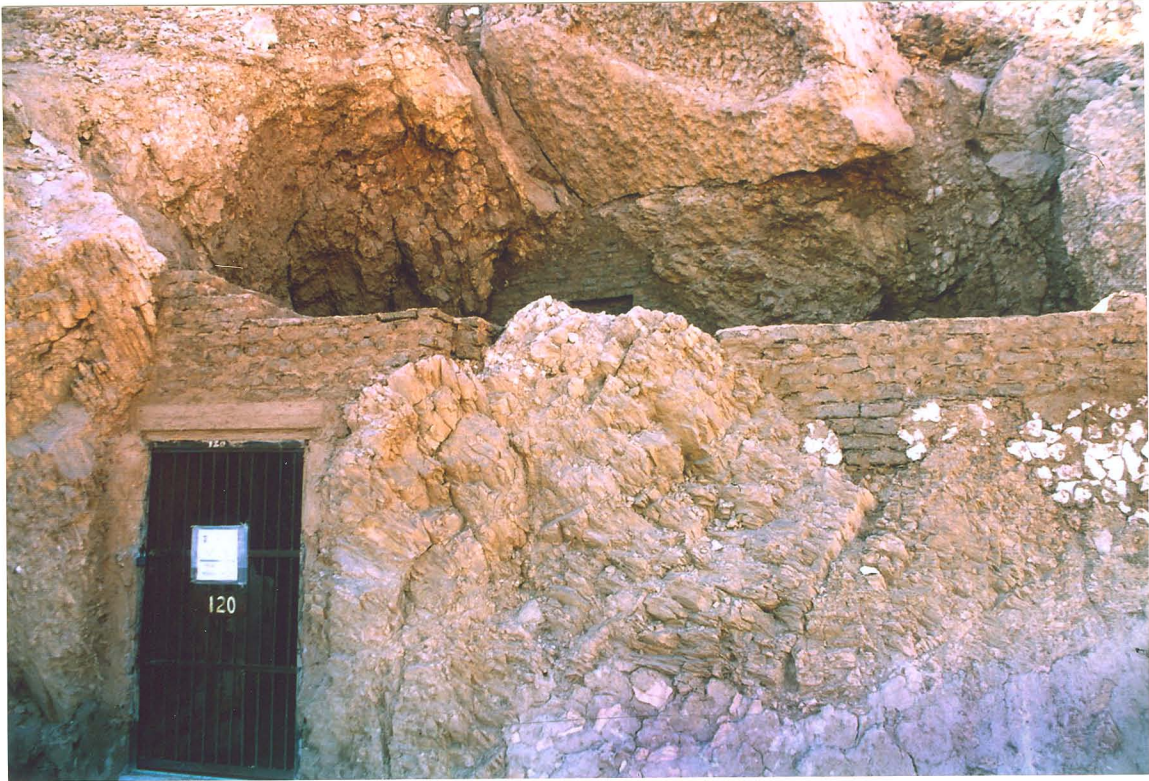
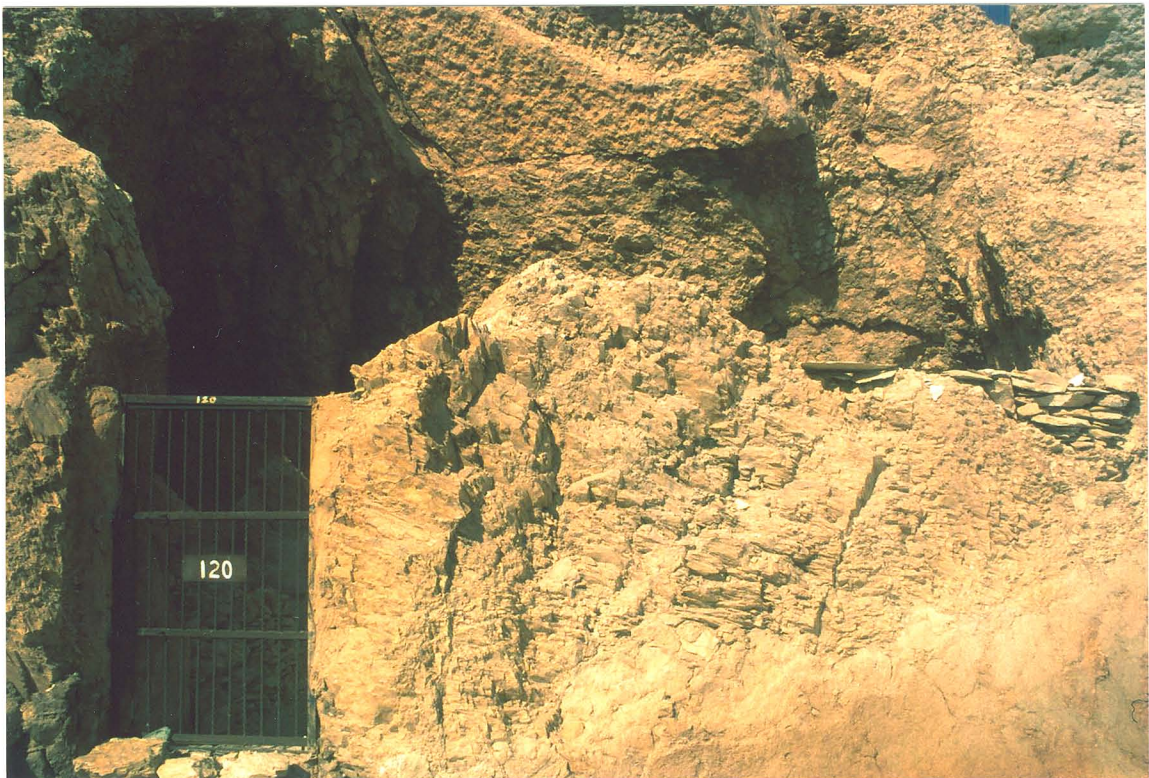
Plate 23: East wall of Inner Room, exterior, before and (above) after conservation.
Photos, E.C. Brock, nos. EG 15 S 253 02, EG 1 S 252 02 .

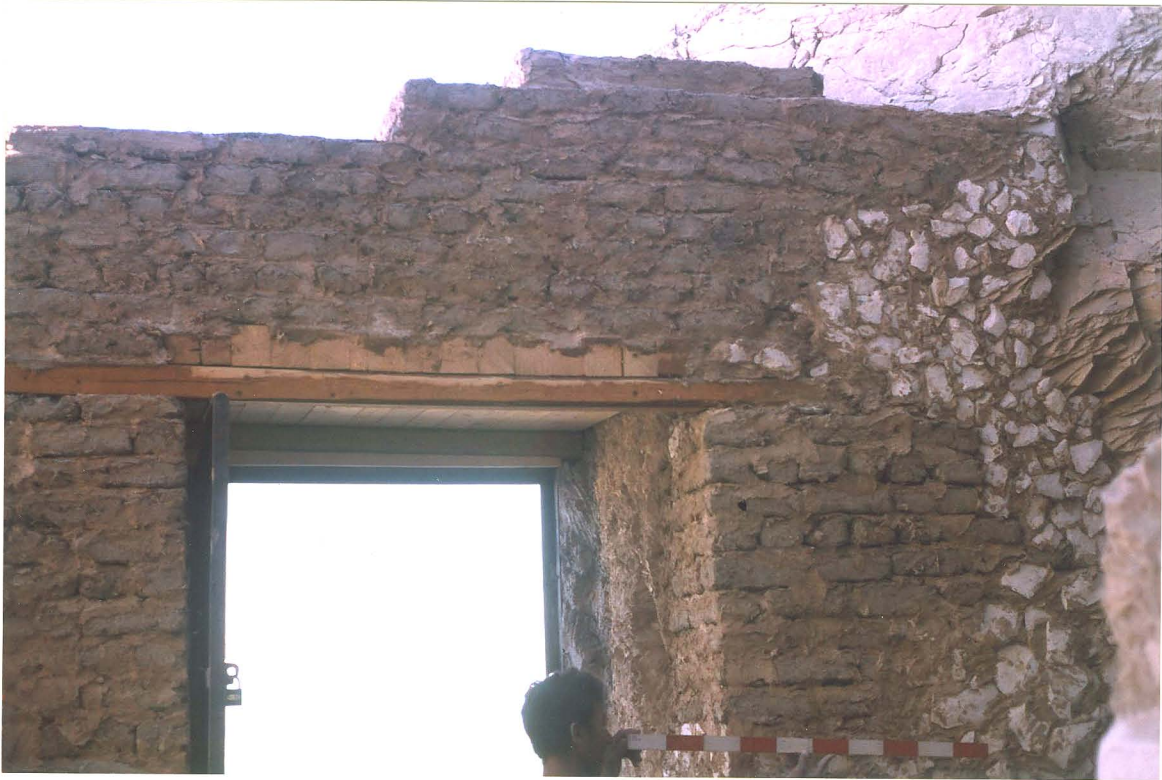
A: View of new lintel made of mud brick looking east (photo, E.C. Brock, no. EG 19 S 253 02).

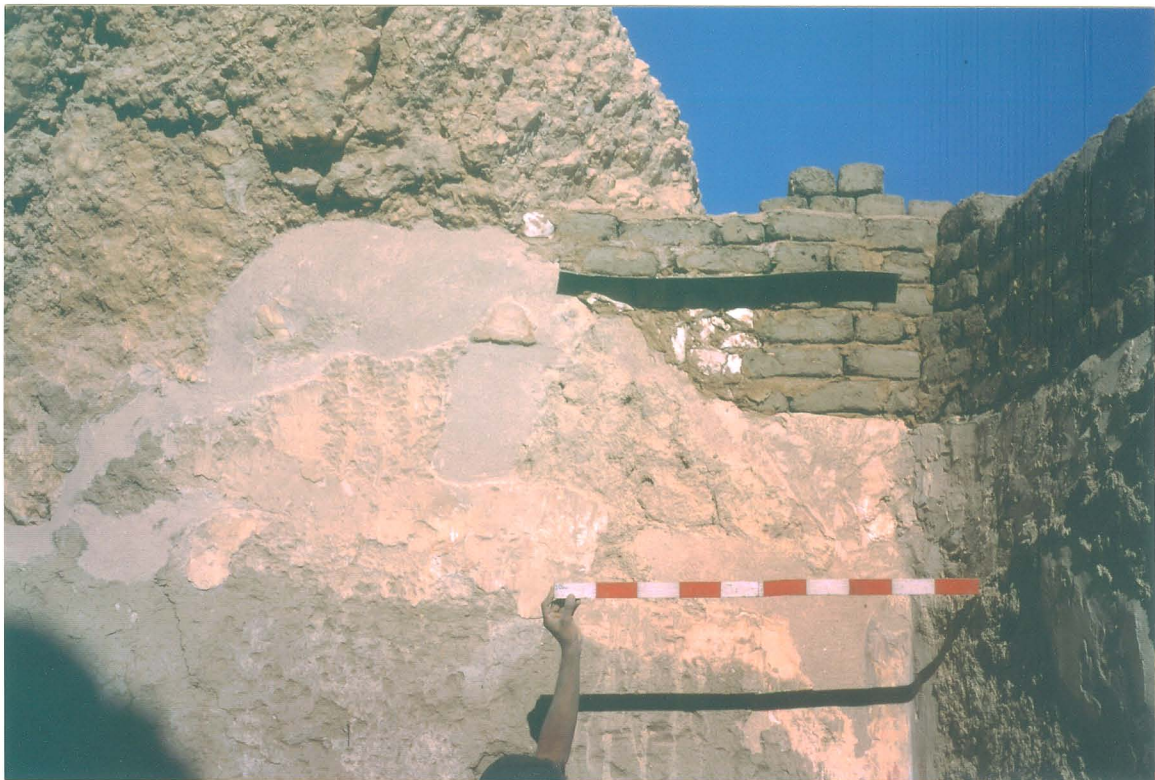
B: Inner Hall, north end, showing installation of flashing to prevent entry of rainwater. Photo: E.C. Brock, no. EG 4 S 253 02)

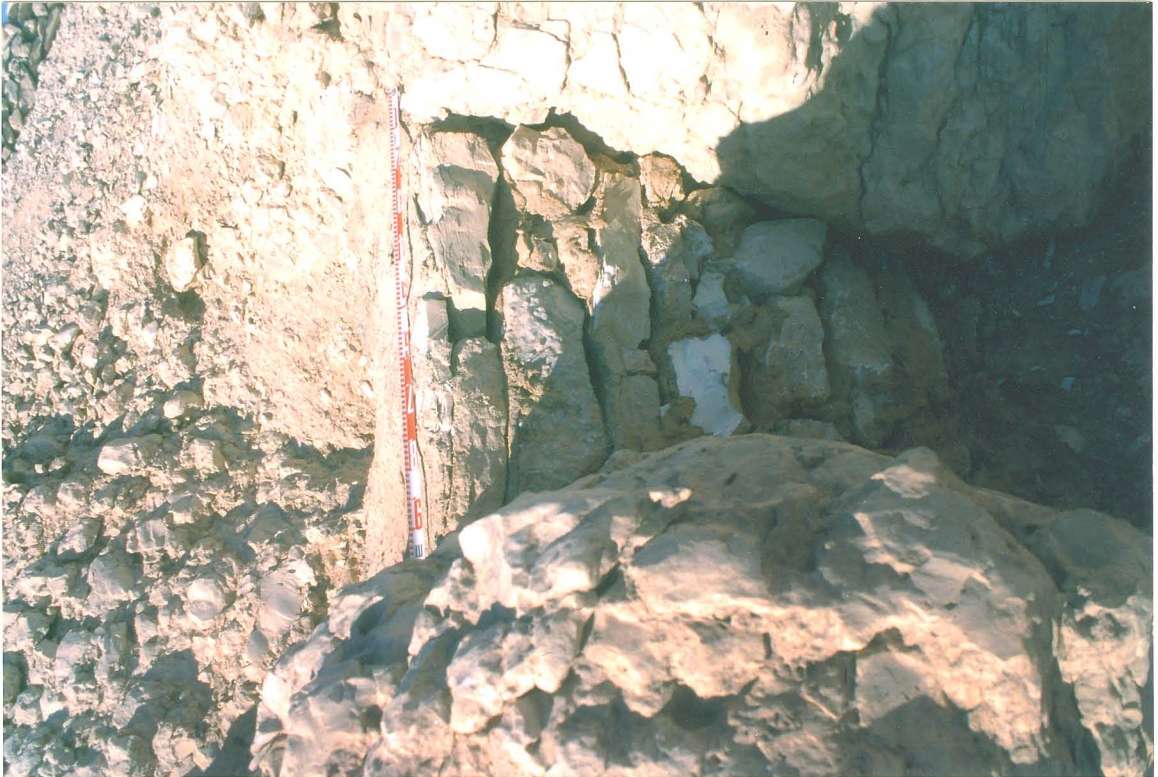
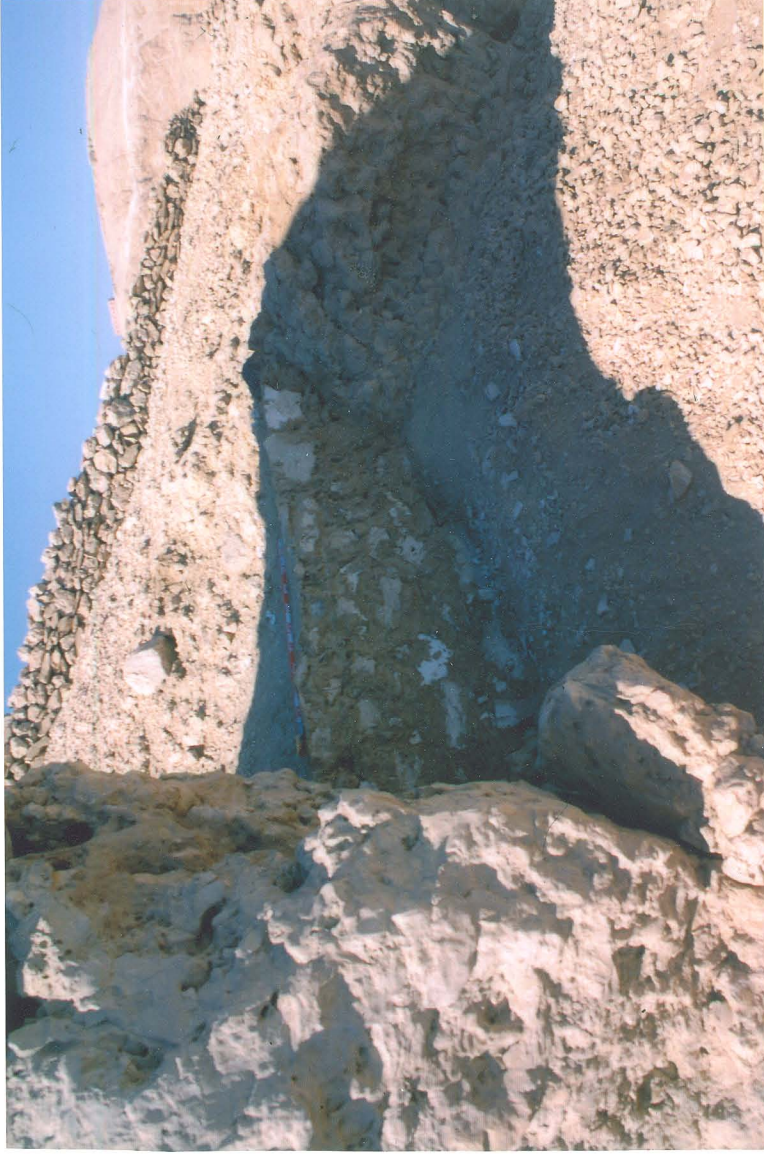
Plate 25: Two rubble walls built above the tomb to prevent the entry of rainwater, rocks and debris (photos: E.C. Brock nos. EG 20 S 235 02 and EG 12 S 253 02).
