Tomb of Anen Protection
TT 120, Sheikh Abdul Gurna, West Bank, Luxor
Lyla Pinch-Brock, Director
Progress Report Number 1, October 31st, 2002

ARCE Egyptian Antiquities Project
Tomb of Anen Protection

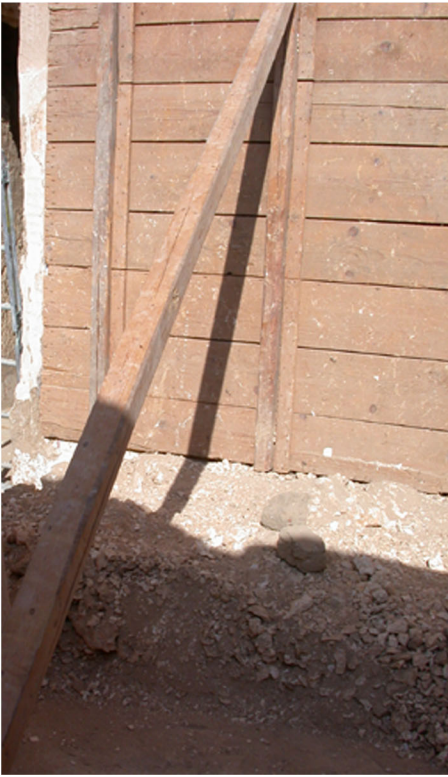
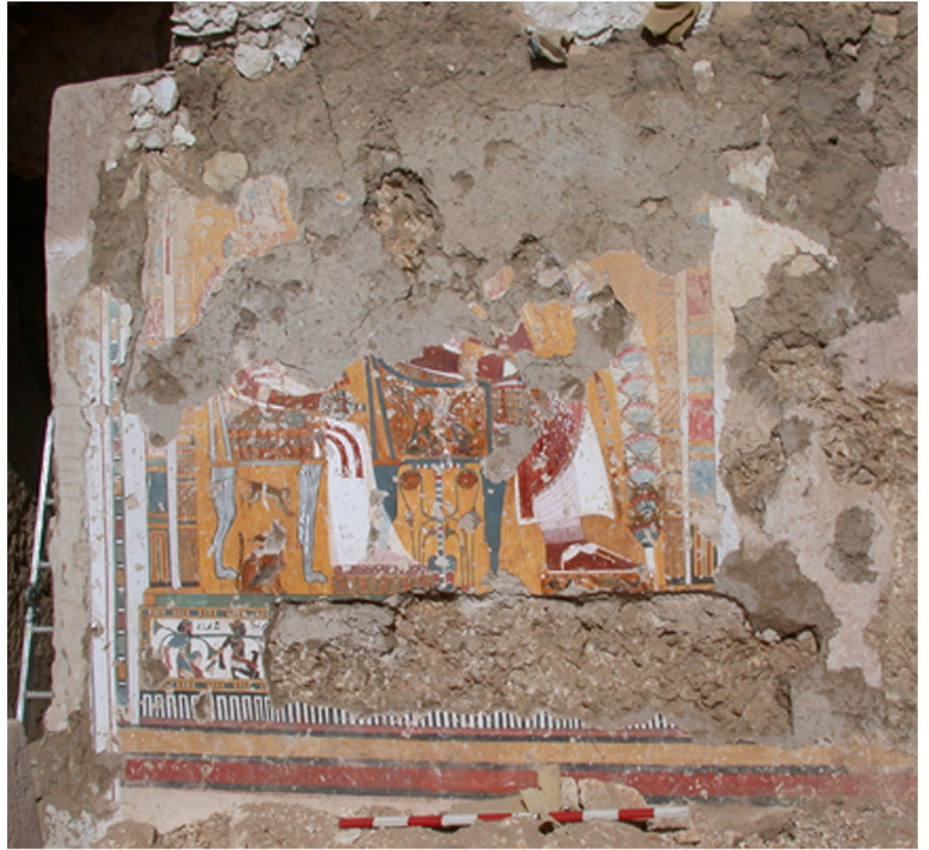
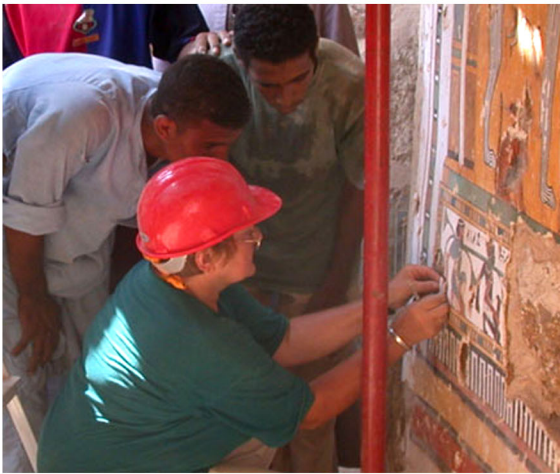
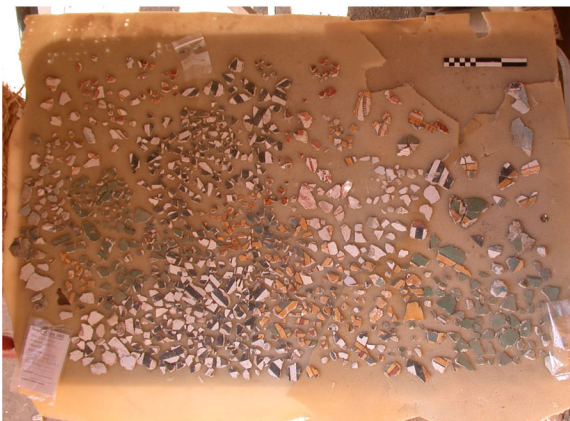
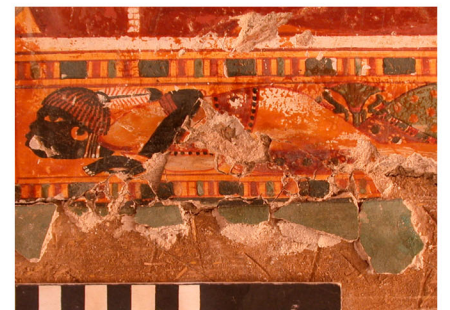
Clockwise from lower left:
Fragments found in debris
Parandowska replacing fragments
Layer of original material
Painting revealed October 8th
Burton's 1930 photo
Some fragments replaced

On October 8th, when we had removed the stones and the bottom of the boards were exposed, the workmen lifted the barrier away from the painting. It was immediately obvious that seven out of ten of the "foreigners" in the frieze below the throne had been carefully cut out. Indications in the arrangement of the debris suggested that enough stone had been taken away to facilitate entrance at the north end in order for someone to go inside and hack out the plaster pieces. Chisel marks were evident. Since the last record we have of

the painting's intact state is late 1930 (photo taken by Harry Burton) the theft must have occurred sometime between then and 1994, when the tomb was first entered by PB. At that time it was deeply buried in debris. Since many painted plaster fragments were taken from the Theban necropolis in the 1940's, the theft probably occurred at that time.

Ewa Parandowska inspected the painting and lightly brushed away dirt and cotton debris using soft brushes. Any loose plaster was injected with a 50% ethanol-water solution followed by injections of 15-30% Primal AC 33 in water. Once the plaster was considered to be secure, Lyla Pinch-Brock and the workmen began to clear a strip 30 cm wide by 3.50 m long immediately below the painting, digging by hand and sieving the material. In this way we were able to recover over 200 fragments of the painting, most extremely thin and fragile, and some no more than a couple of millimetres in size. These came from not only the hacked-out area, but also areas shown as blank in the facsimile made by Nina de Garis Davies for the Metropolitan Museum of Art in 1929. Since their work, the only plaster that had actually fallen off was on the upper left, part of one of the supports of the baldachin. Parts of the painting exist that were not included in their facsimile, like Tiye's crown, some glyphs above this and on the far right, and the lower part of a "ramp" leading up to the dais.

Large and deep damage to the background of the Amenhotep and Tiye painting was first filled with lime, mud and chaff mortar. After this layer was completely dry, the second, fine coat of mud and lime mixture (six parts mud, 3 parts slaked lime) was applied. This fine, light-coloured mortar was applied along the edges and in the missing parts of the painted surface 1 – 2 mm deeper than the original level. Since the collected fragments began to dry out rapidly, they were consolidated from the back using a pipette filled with a 20% solution of Primal AC 33 in water. From the 8th of October up until this writing, Ewa Parandowska, assisted by Lyla Pinch-Brock, has been steadily replacing these missing fragments. Upon a request by Lyla Pinch-Brock, on the basis of the unexpected extent of damage to the painting, to have two more weeks of Ewa Parandowska's time, Michael Jones indicated in an email on October 28th that a modification to the present agreement with EAP may be possible and asked for the necessary information be supplied for consideration. Lyla Pinch-Brock emailed this the same day. It is anticipated that the project may be completed by the 14th of November if this modification is allowed. Our work has been greatly facilitated by the digital photos supplied by the MMA. This was vital in our search for the origin of recovered fragments.

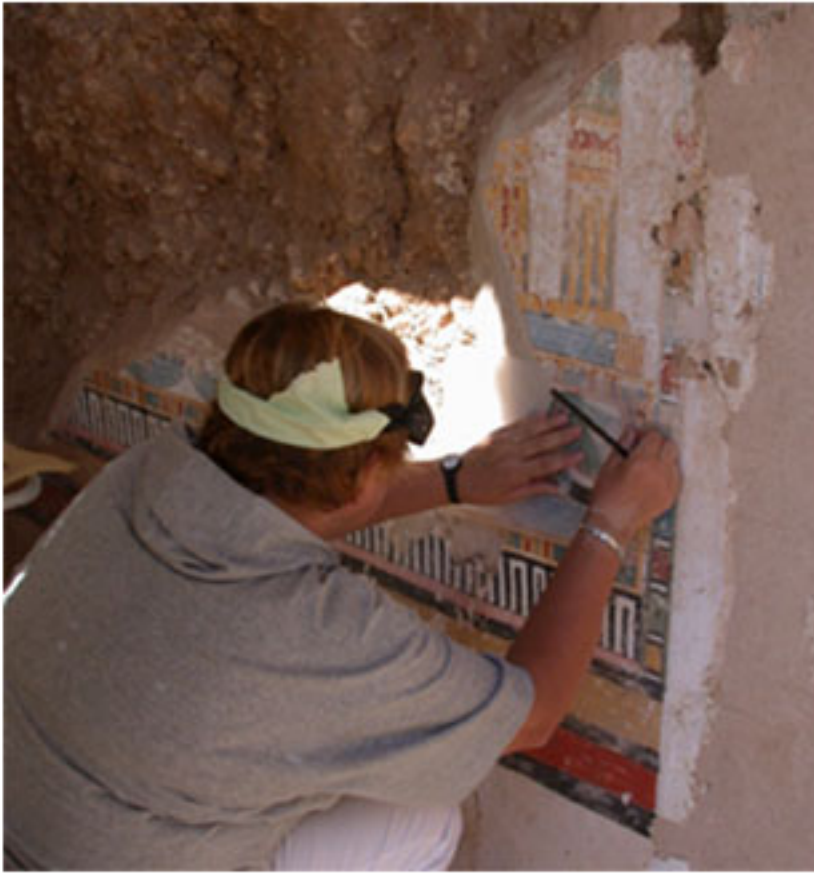
Above: rekhyt fragments found during excavations.

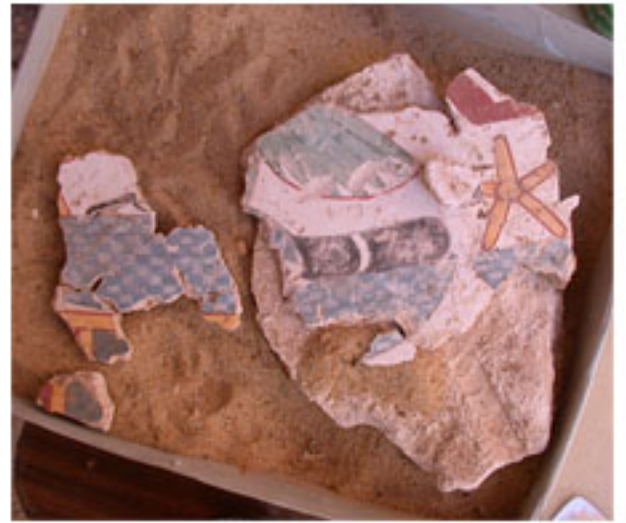
Left: Ewa Parandowska creating template for replacing fragments.

Since the frieze was a repetitive one, Ms. Parandowska prepared a drawing of a more or less complete creature to use as a model for replacing fragments. The fragments were cleaned, joined with a glue (30% solution of Primal AC 33 in water) and fixed (relocated) back on the wall. The "lacunae" of the missing plaster were filled with the mortar of choice. The same mortar was applied along the edges of the painting. The wall above the painting was extremely friable, and Mohammed Abdul-Warris reinforced it, using the mortar of choice combined with slices of limestone. Once the masonry work on this wall was completed, Ewa Parandowska cleaned the surface of the painting mechanically with the help of soft and hard brushes (fibreglass if necessary), scalpels and *Wishab* sponges to

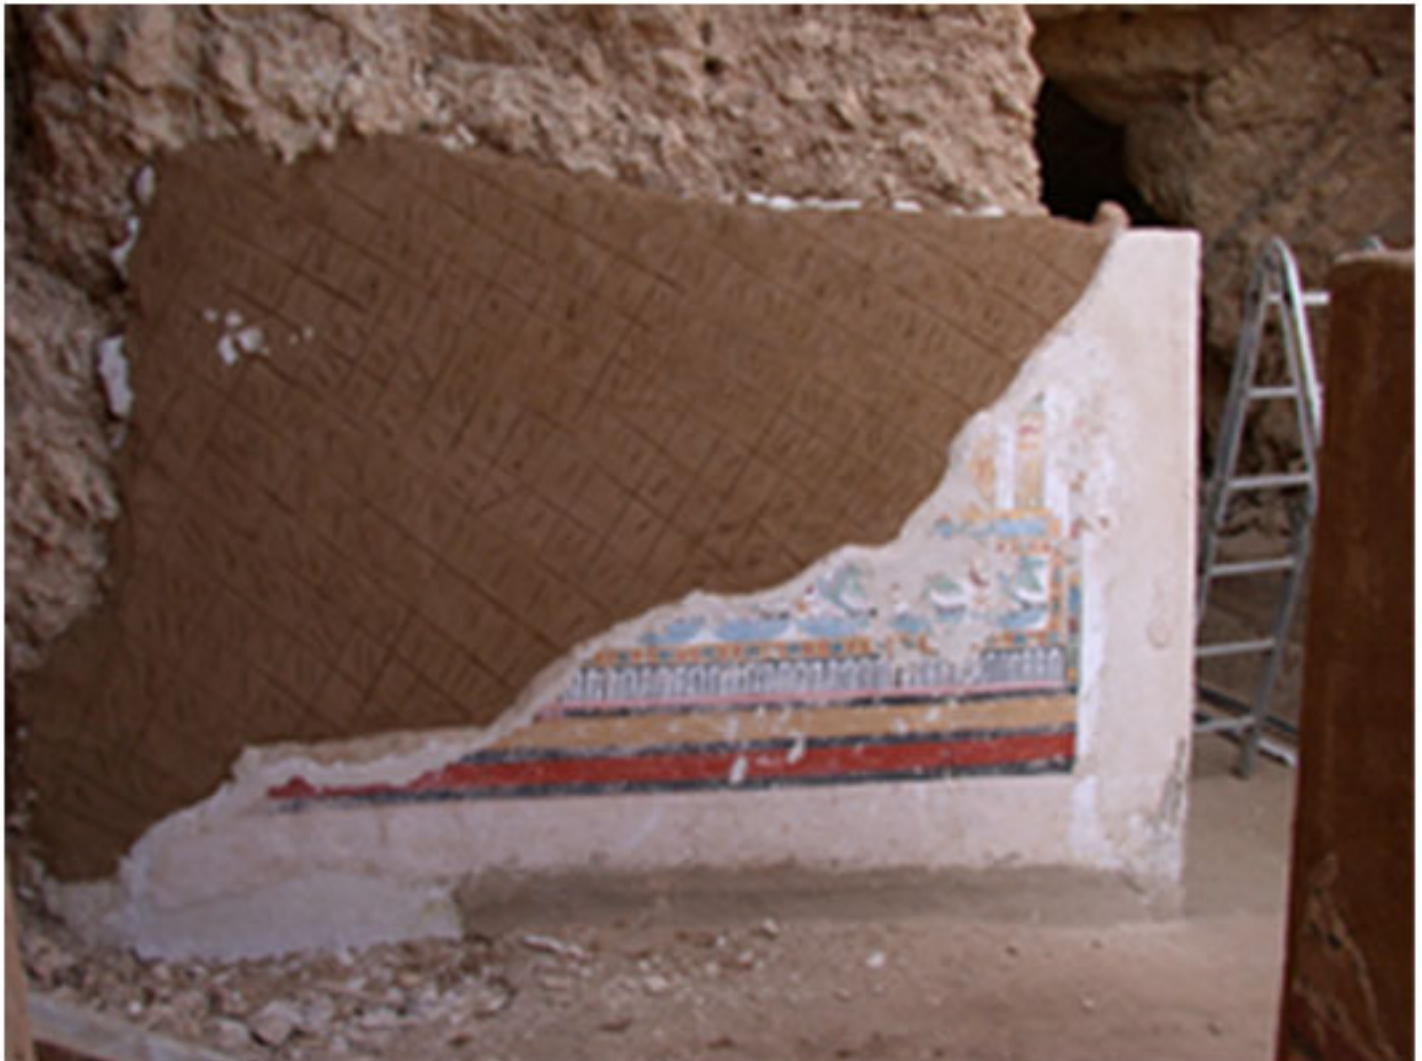
Below: rekhyt frieze nearing completion.

When discovered in January of 2002, this painting was literally falling off the wall. At that time Mohammed Abdul-Warris affixed it to the rock wall with a thick band of cement mortar along the edges as a stop-gap measure. That old band was removed this season after reinforcement and replastering of the rocky support above the remains of the painted plaster with stone chips and mud-chaff mortars.

remove the dust, dirt and mud deposits. A testimony of uncleaned surface was left in the right upper corner of the painting to show the painting's pre-conserved state. Mohammed Abdul-Warris finished the upper part of this area with lime-*hib* mortar to match the infill of the fragments. The *rekhyt* scene was completed on October 30th.

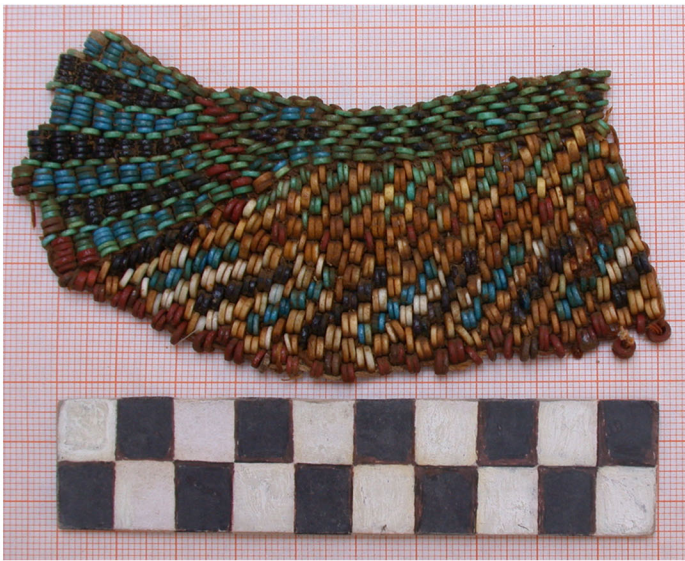
Clockwise from lower left:
Mohammed Abdul-Warris repairing damage to Pillar 4
Beaded applique of winged scarab found in debris in SE corner of Hall
Note written by Nina Davis found in Inner Room

cm) area was cleared immediately west of the pillar in order to facilitate work. Mohammed Abdul Warris immediately began to gather the fragments of the pillar together to see what could be replaced. This pillar is the only one of the four in the Hall not yet consolidated, since it is still enveloped by debris. Over the following five days, Mohammed Abdul-Warris rebuilt and consolidated the north and west sides of the pillar, re-installing any fragments possible, using a mortar similar to the original; three parts *hib* to one part slaked lime (sifted powdered limestone) with a small addition of Primal AC 33 (about 1/10th) for elasticity. (hereafter called *hib*-lime mortar) The body of the pillar was strengthened with the addition of slices of limestone. This is exactly the same method used in the original construction of the tomb.
