CONSERVATION PROJECT OF THE
ASLAM AL-SILAHDAR MOSQUE

QUARTERLY PROGRESS REPORT

January - March 2008

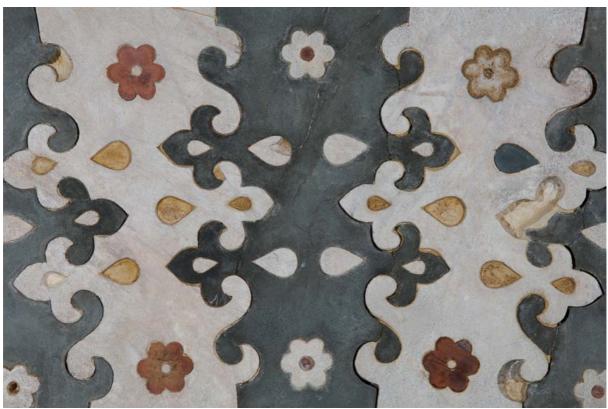
Detail of the marble decoration of the west façade – after cleaning

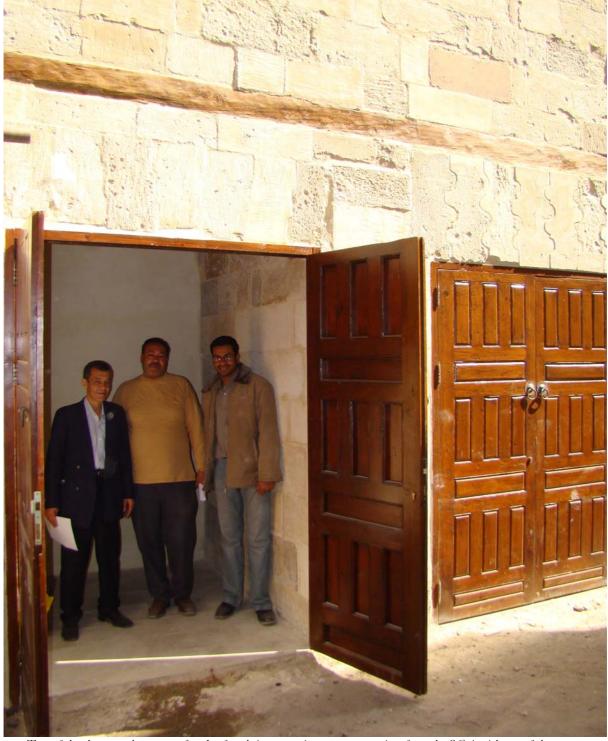
Two of the shops on the western façade after their restoration – representatives from the SCA with one of the owners

The restoration of the shops on the western façade were finalized, their wooden doors completely restored and installed in place. The shops were returned to their owners through the Supreme Council of Antiquities.

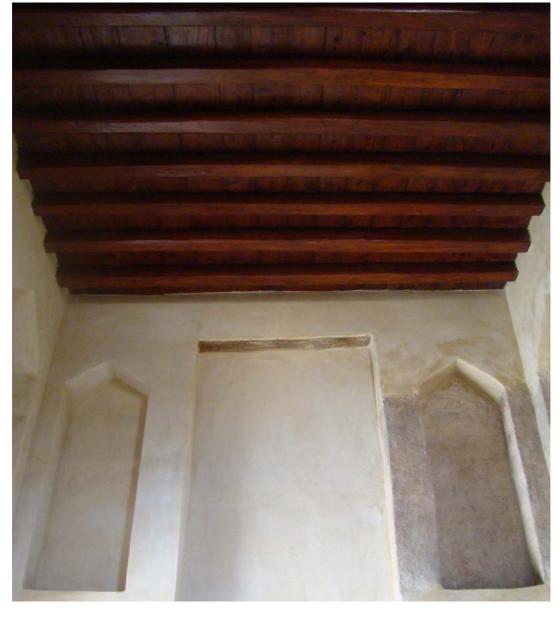
Room 1.3 after finalizing the painting of the ceiling

- Mezzanine, first floor and second floor rooms
- Painting of the wooden ceilings of the rooms started and is in progress.
- The wooden grills of the rooms' windows were manufactured, painted and put in place.
- Applying the plaster layer in rooms were brick repairs took place is proceeding.
- Applying the final finish plaster layer of the rooms started and is in progress.

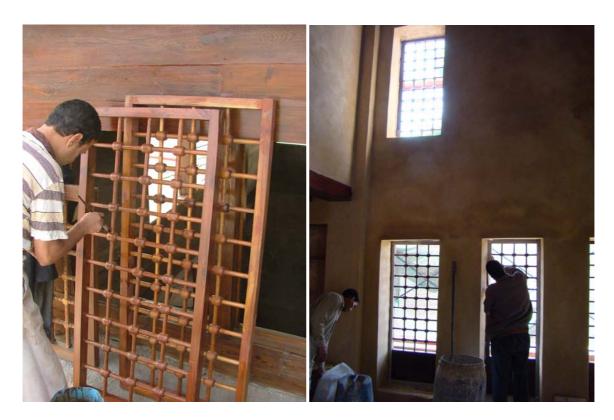
Painting the wooden grills and installing them in the rooms

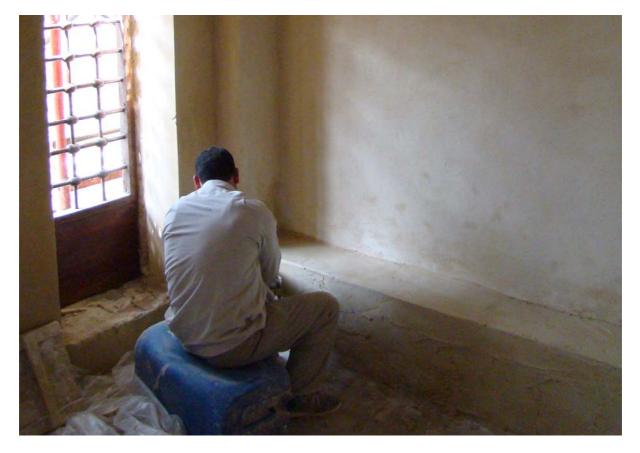
Plastering activities in the rooms

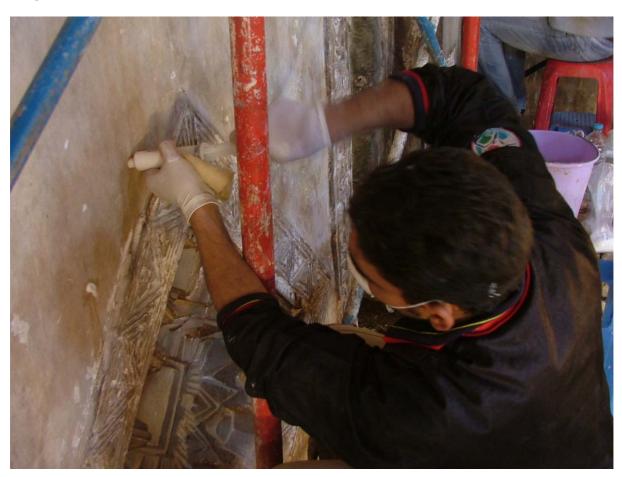
Injection activities of the plaster

The injection activities continued and are now finalized. Cleaning the plaster layer as well as the stucco decorations of the roundels, the lozenges and the inscriptions around the windows is proceeding. First, the non-decorated surfaces were cleaned using poulticing. As for the roundels, the lozenges and inscription, if a recent limewash layer was applied this is removed mechanically; then depending on the situation poulticing is applied.

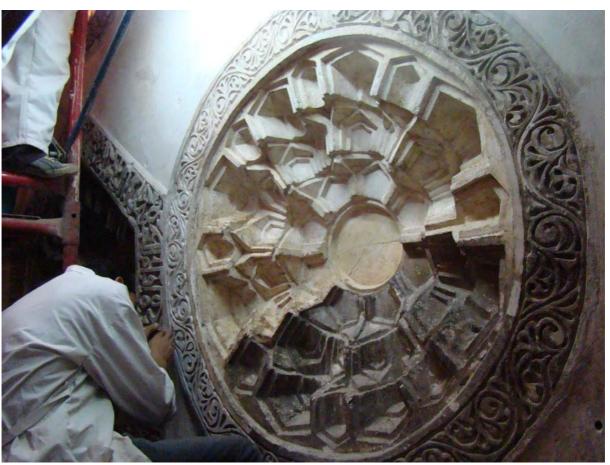
Activities of cleaning the gypsum decoration

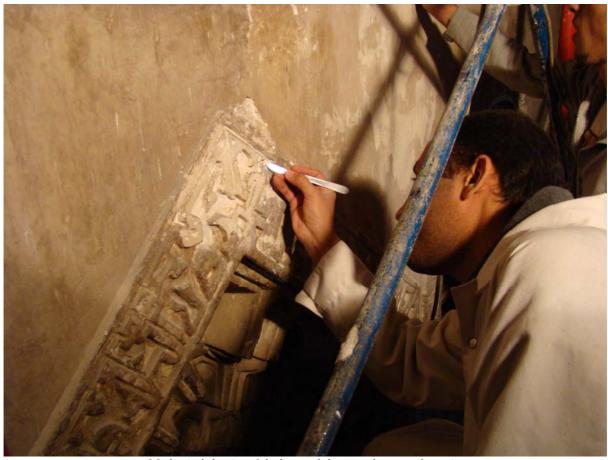
Mechanical cleaning of the limewash layer on the stucco decoration

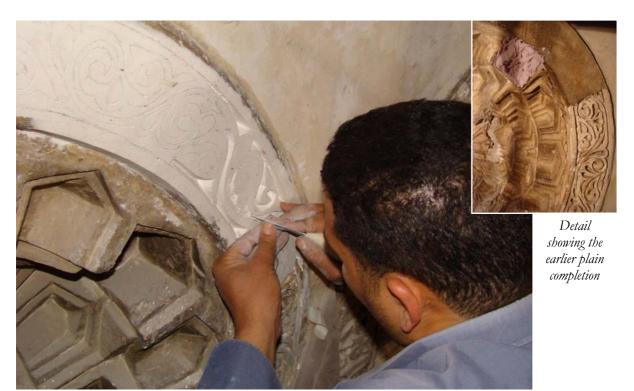
Completing the roundel with gypsum decoration as the original existing design pattern

Some roundels and lozenges were completely lost and completed in an earlier restoration in a plain manner, meaning without completing the decoration. As the pattern was known, it was decided for the roundels and lozenges to complete them with gypsum as they were originally.

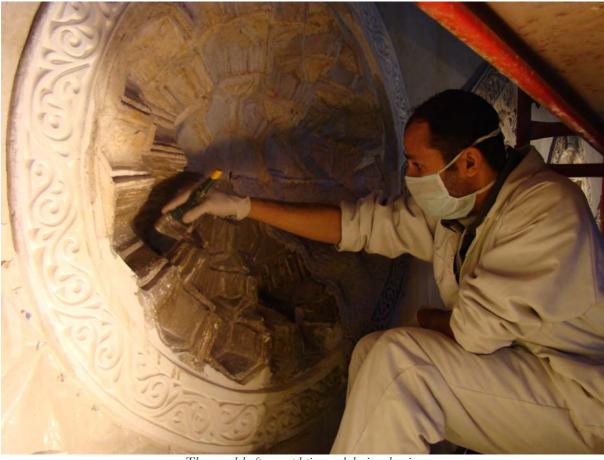
The roundel after completion and during cleaning

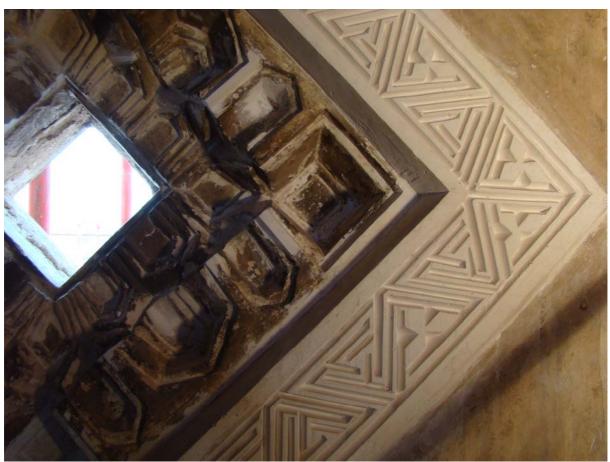
Stucco decoration reconstruction

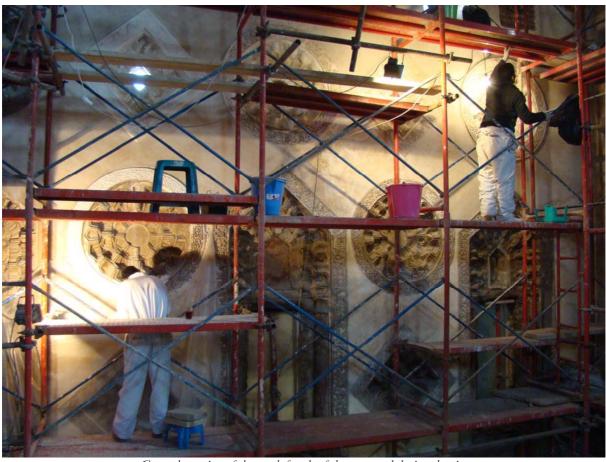
General overview of the north façade of the courtyard during cleaning

As mentioned in the previous reported, during December 07, cleaning tests were carried out for the stucco decorations of all four sides of the courtyard, as well as injection activities and removal of the fine dust. The work is proceeding on the northern, southern and western wall, while the eastern wall will start later to document by pictures the difference of the condition before and after intervention.

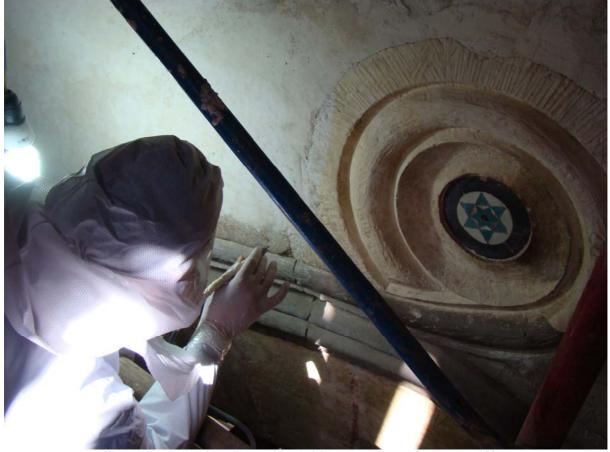
Cleaning the stone arch on the west façade of the courtyard using the micro-sand-blaster

The stone arch of the western façade was cleaned using the micro-sand-blaster.

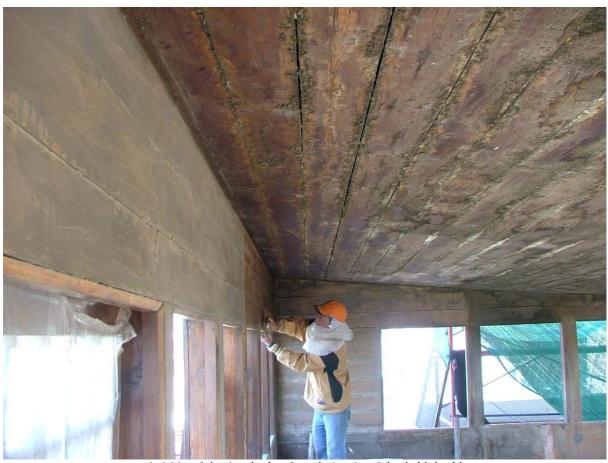
Activities of cleaning the dust from the interior of the shokhshaykha

After cleaning the wood of the *shokhshaykha* covering the central courtyard, it was painted; the work is completed.

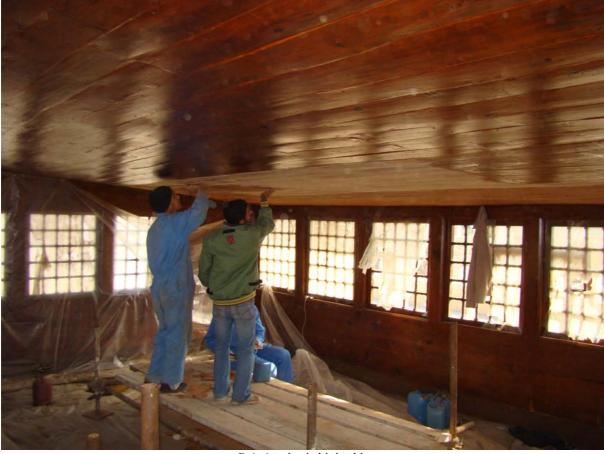
Painting the shokhshaykha

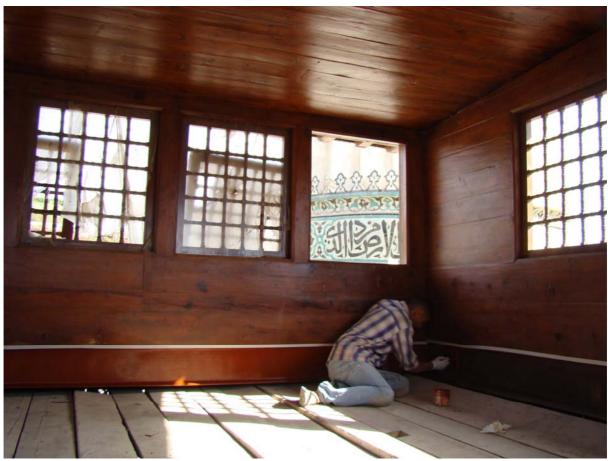
Painting the steel beams carrying the wooden shokhshaykha

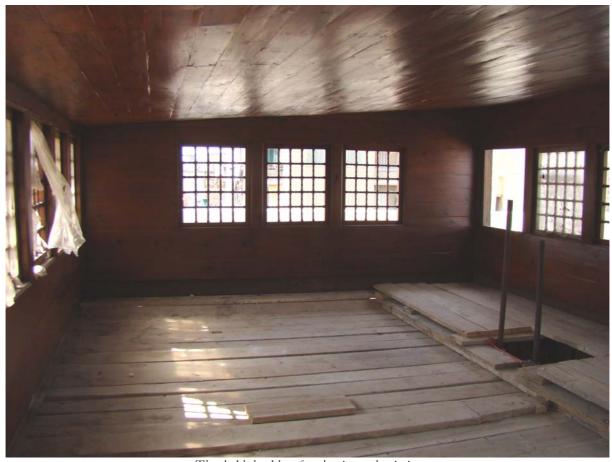
The shokhshaykha after cleaning and painting

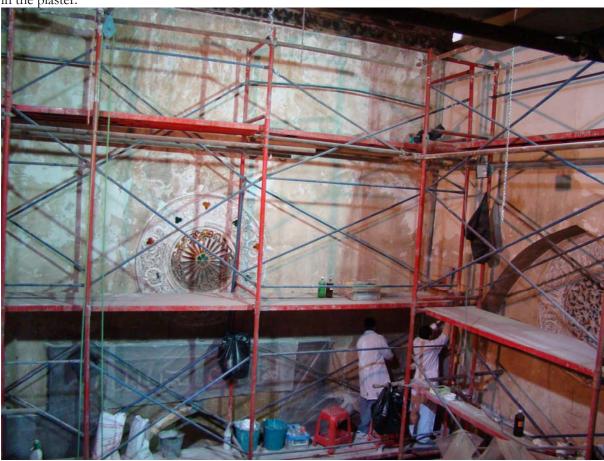
Activities of injecting the mortar; view of the iwan before cleaning

The activities in the 3 iwans started by similar treatment of the plaster like for the plaster of the courtyard in terms of injection, plaster cleaning using poulticing, cleaning of stucco decoration and filling the cracks

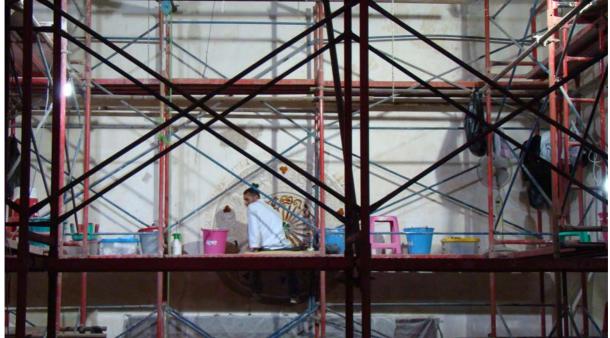
View of the qibla iwan after cleaning the upper part of the main façade of the qibla iwan

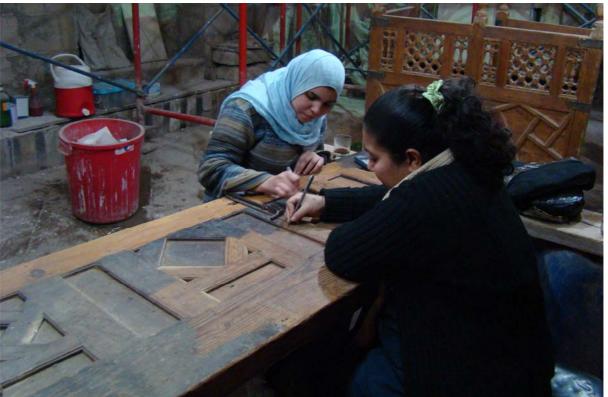
Cleaning activities of the wooden door of the entrance of the mausoleum (D2)

As mentioned in the previous report, the woodwork restoration of doors, windows and shutters is currently in progress and will be proceeding during the following months. In general, depending on the state of conservation of the item, carpentry restoration takes place followed by fine cleaning and conservation of the wooden elements.

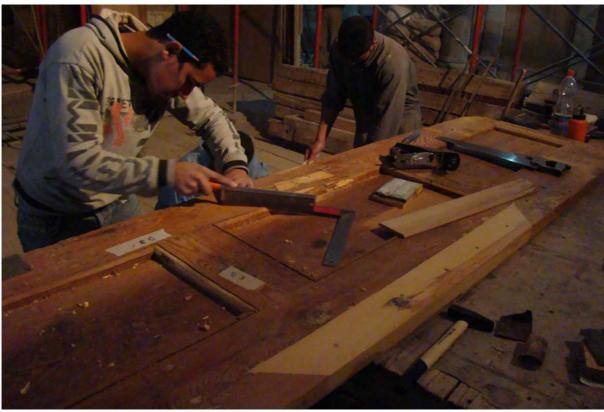
Architectural repair of damaged parts in the wooden shutters (D3)

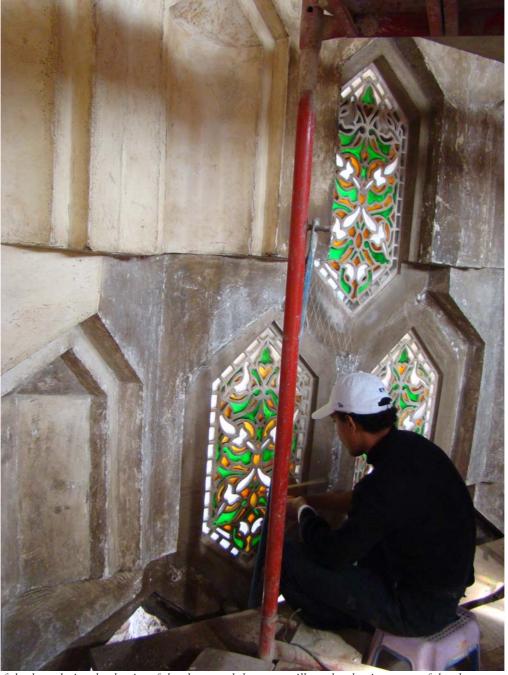
View of the dome during the cleaning of the plaster and the stucco grills — also showing a part of the plaster not cleaned

On the upper part of the dome, cleaning and injecting the plaster surfaces was taking place along with cleaning the stucco grills. The conservator, Erico Peintner started also short mission and with the team carried out some cleaning tests on the upper stucco inscription band.

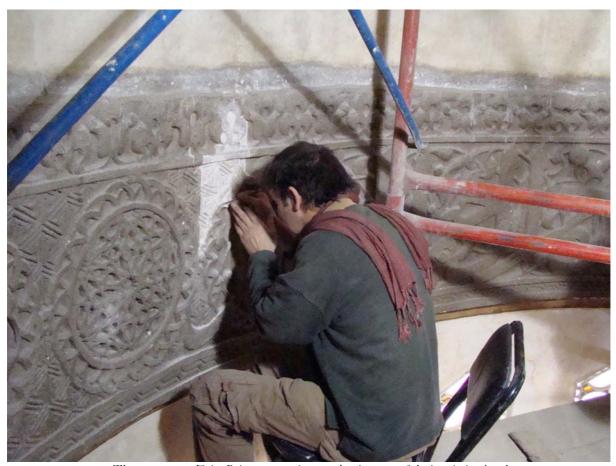
The conservator, Erico Peintner, carrying out cleaning tests of the inscription band

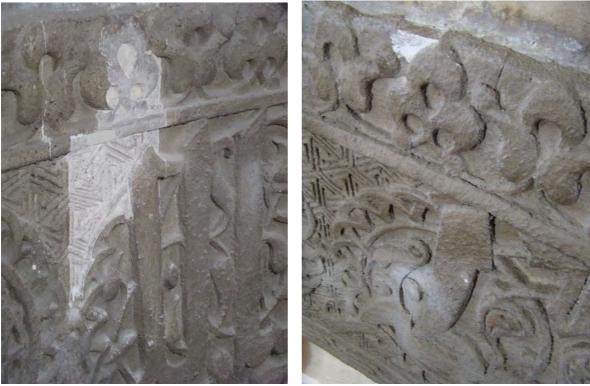
Different views of the inscription band covered with a hard crust of limewash and dust

Start the cleaning of the stucco inscription band.

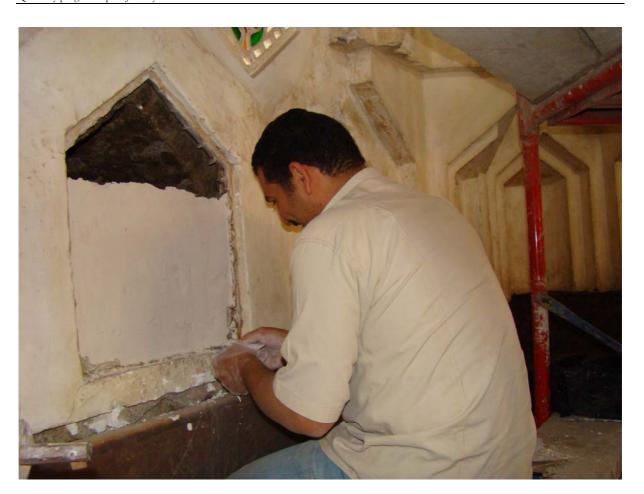
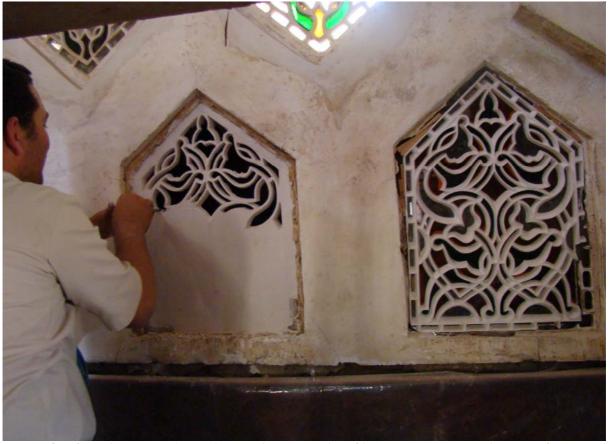
Completing the stucco windows and carving them in-situ where old stucco was remaining (right one complete)

Manufacturing the second level windows (on the square part) started and is in progress. As some remains existed it was decided to complete and carve them in-situ.

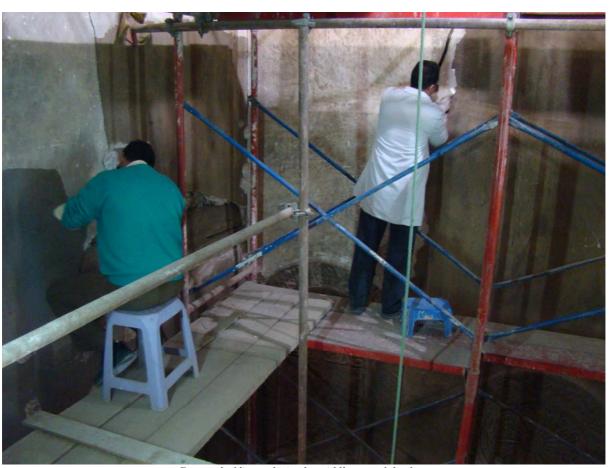
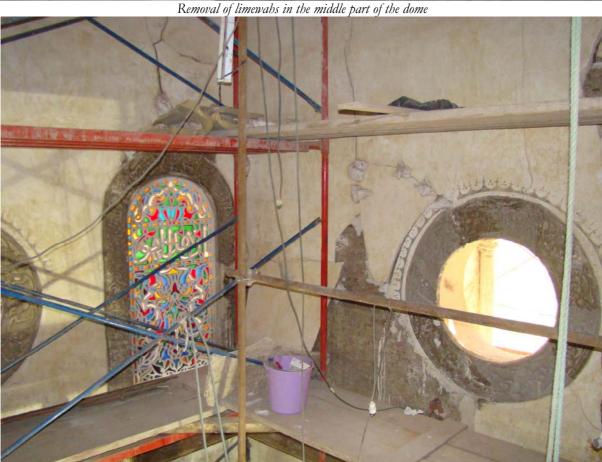
The middle part of the dome after the cleaning of the plaster surfaces: The cracks will be treated in April-May, as well as the cleaning of the stucco carved decoration around the windows.

The work in the middle part of the dome concentrated on injecting the plaster and its cleaning mechanically by removing the limewash and then by poulticing. There are several cracks in the lower part and these will be repaired in April and May.

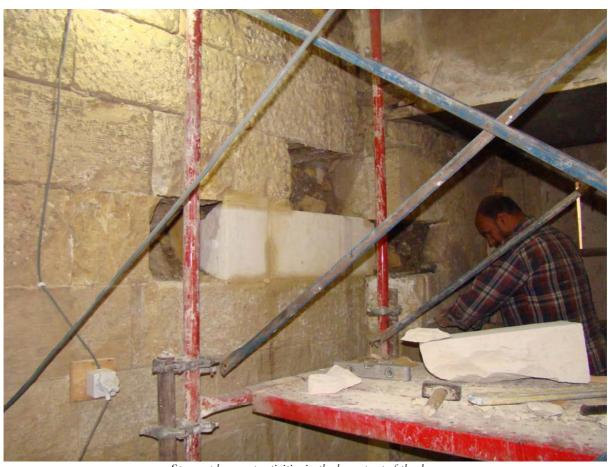
Stone replacement activities in the lower part of the dome

On the lower level, the stones were cleaned and the salt removed mechanically. Stone replacement of completely damaged stones took place.

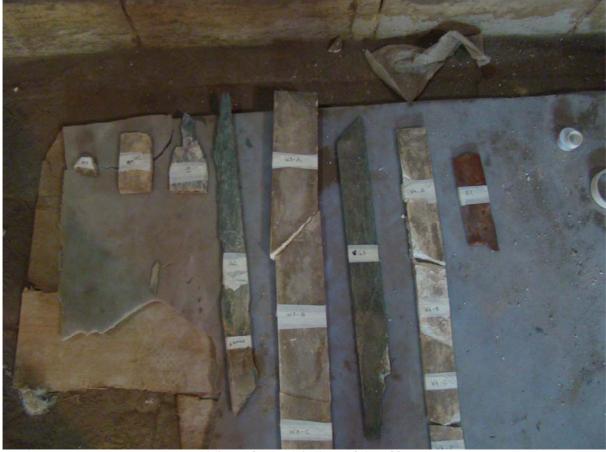
The numbering of the dismantled marble

In the mihrab area, it was necessary to remove the remaining marble decoration as they were totally detached from the background. The stones behind were in a bad condition and full of salts. The marble slabs were documented and will be returned in situ after the restoration. Also one marble column was leaning and not well fixed in place; it was temporarily removed.

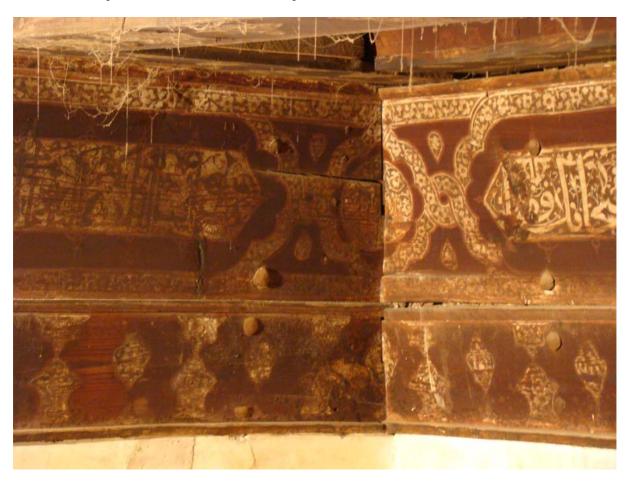
Detail of the ceiling of the West Iwan to be conserved in the period from April – June 2008

Start with the fine restoration of the wooden decorated ceilings of the iwans.

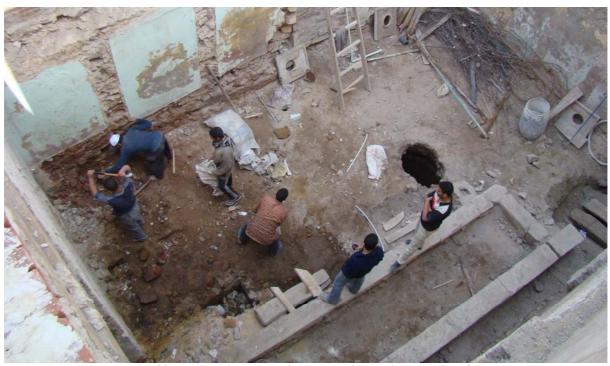
The space of the ablution area after the demolition of the old one; the archaeological remains in view

It was originally planned to construct the ablution area during 2007; nevertheless it was decided to move this activity in 2008. The old ablution area was completely dismantled and temporary toilets were built in another space. Archaeological remains of a Comite intervention were discovered after the demolition and these were taken into consideration in the design of the ablution area; The remains were numbered and temporarily removed to be able to level properly the land before putting in the foundations.

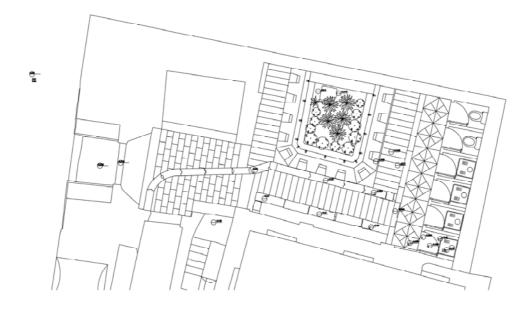
The design of the ablution showing the archaeological remains in view

Start the construction activities of the ablution area and finalize the foundations, the sanitary works, the brick and stone works and the wooden ceilings. Finishes are planned for the third quarter of the year.
