FINAL REPORT

Fall Mission: November 1, 2006 – December 15, 2006

“Conservation of Roman Wall Paintings in Luxor Temple”

Luigi De Cesaris & Alberto Sucato, Restorers

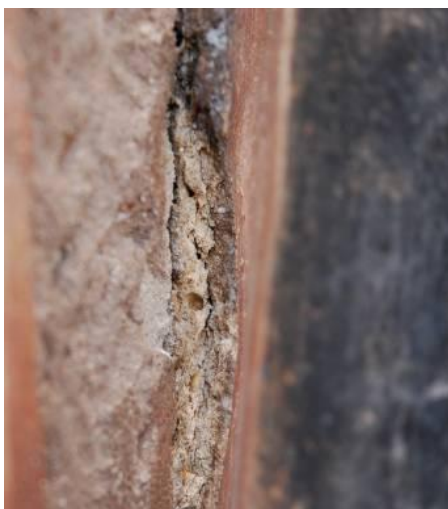
fig. 1

The plaster was applied to the stone surface of the pharaonic reliefs from top to bottom in two separate layers (fig. 1).

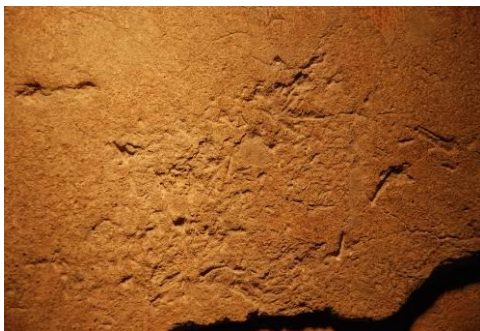
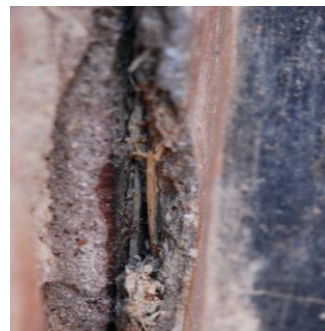
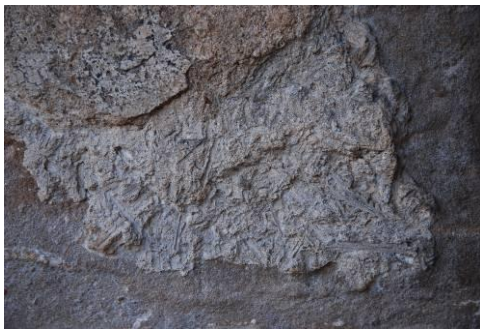
fig. 2

The first, coarser layer is made up of lime, sand¹ and a significant amount of straw (figs. 2, 3 and 4). Its function was to smooth out a surface which was highly uneven owing to both the presence of hieroglyphics and the state of the stone that was already old and deteriorating at the time the Roman paintings were executed.

Given the nature of the climate in Luxor and the fact that no joins between separate applications of plaster were observed, the function of the straw must have been to keep the plaster wet as long as possible.

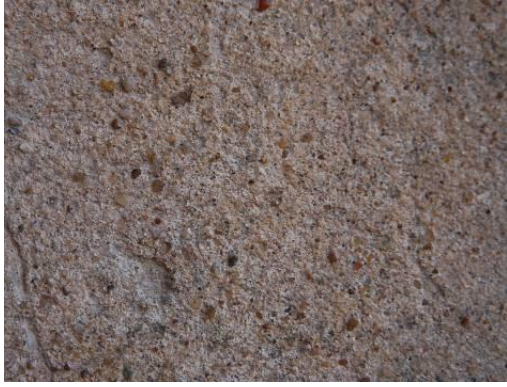
fig. 5

The second coat of plaster, a finer grained mortar not containing straw, was applied over the first in a layer 3-5 mm thick in order to obtain an even smoother surface (fig. 5).

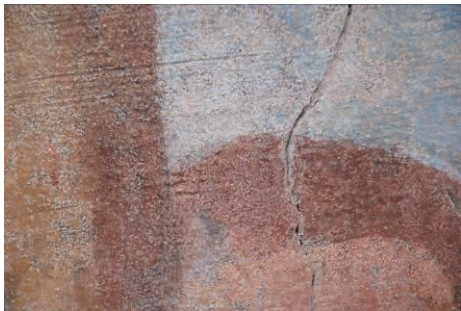
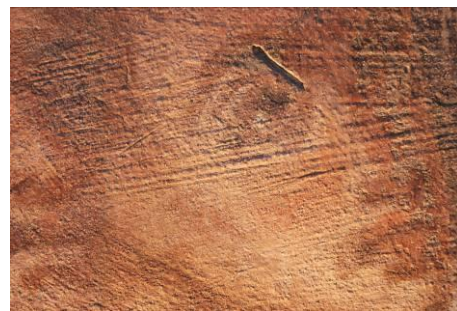
fig. 6

However, the surface of this second coat is still fairly rough and before the colour was applied it was primed with a very thin coat of lime, drips of which are still visible, applied with large brushes whose bristles left clear marks and picked up small grains of sand² (figs. 6 and 7). These features are in keeping with the swift impressionistic style in which the figures were painted.

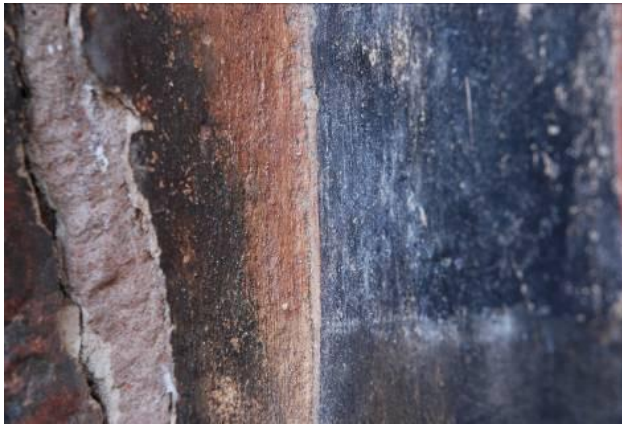
fig. 8

It appears, from observation of the corner where the north and east walls meet and the continuous nature of the plaster coat in some areas (fig. 8), that both walls had already been coated with plaster when the pigment was applied.

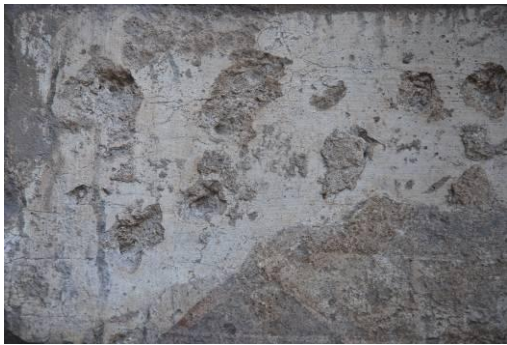
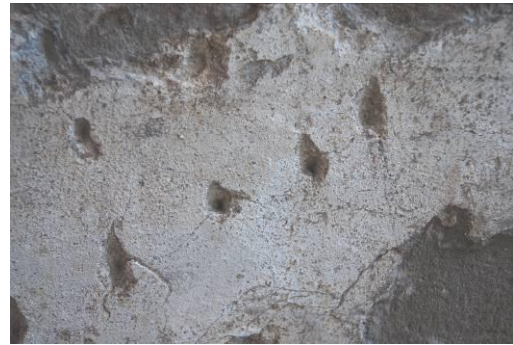
fig. 9

In the lower area alone, approximately 2.5 metres above ground level, there is a third layer of plaster with a composition similar to the previous one, which must clearly have dried out while the paintings were being executed in the higher areas. In the places where this third layer of plaster has fallen off, deep pick-holes made using a tool with a fine quadrangular end (figs. 9 and 10) can be seen on all four walls.

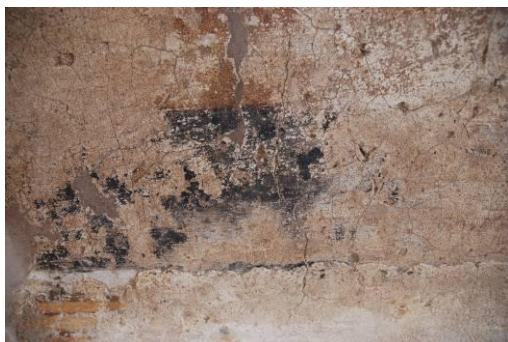
fig. 11

The fact that the plaster was applied to the lower strip when decoration of the area above it had already started is shown by the fact that numerous drips of red and black which must have fallen from above while the frescoes (or at least the upper cornices) were being painted can be seen on the second layer of plaster, again where the third layer has fallen off. The black band that

separates the *opus sectile* from the figurative zone had already been painted once on the second layer of plaster and was continued and extended downwards on the third level (fig. 11)³.

³ The fact that the black band was painted on the second layer and then continued and extended on the third layer of plaster suggests that the application of this third layer was not planned from the outset.

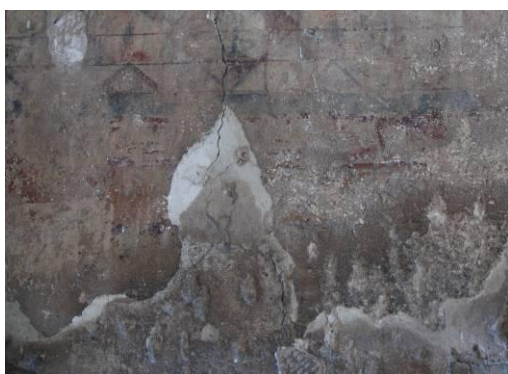
fig. 12

In any case, the colour of the surface of the second layer, which can be seen where recent falls of plaster have taken place, suggests that not much time elapsed between the application of the two plaster layers (fig. 12).

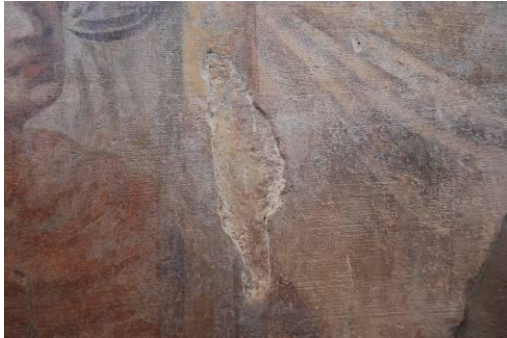
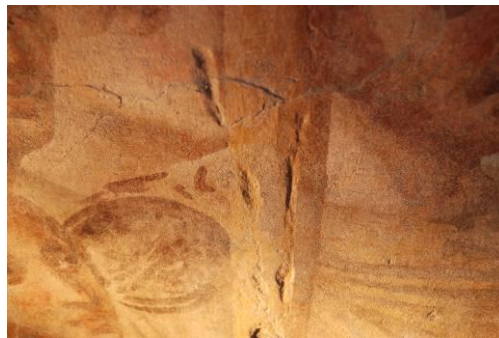
fig. 13

At the level of the flagstaff or the horse's head on the east wall, cavities in the plaster have been revealed beneath recent plaster additions inside which the original painted surface is present (figs. 13 and 14).

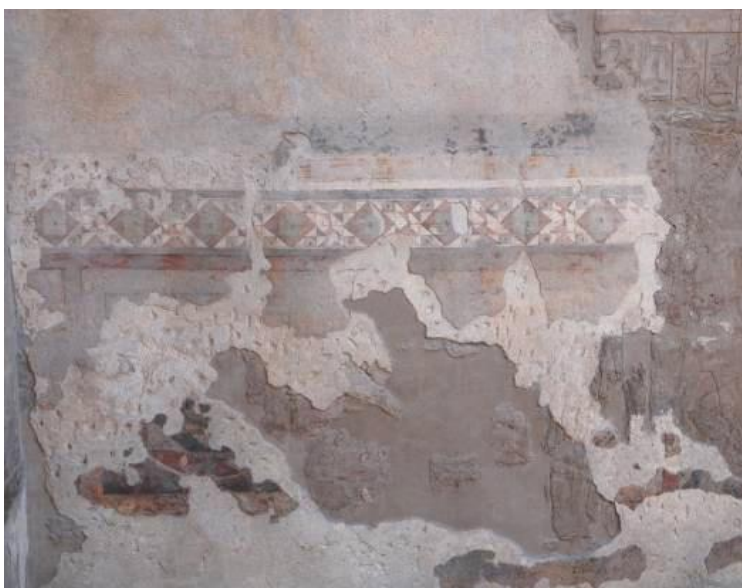
fig. 15

There may also have been purely technical reasons: the plaster beneath may have dried out too much while the overlying paintings were being executed, requiring the application of a further coat which was to guarantee more resistant *buon fresco* results in the lower area which is exposed to greater wear and tear (fig. 15).

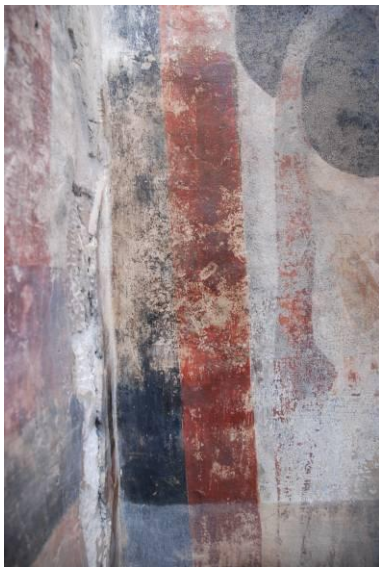
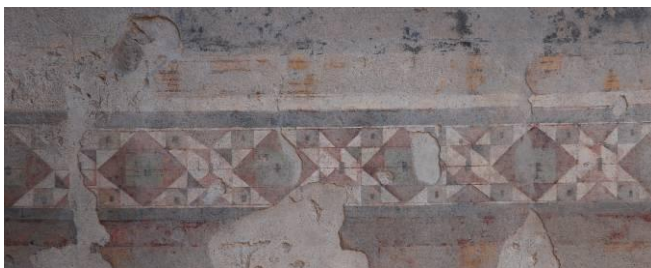
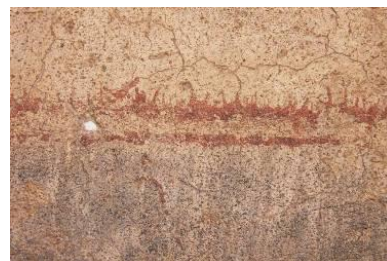
fig. 16

The preparatory design shows the same considerable care observed in the application of the plaster coats between the *opus sectile* dado and the rest of the paintings. Although the red and black bands which define and divide up the various registers are rather uncertainly executed and in some cases quite irregular (fig. 16), the false marble *crustae* were drawn using the *builder's line* method (figs. 17 and 18).

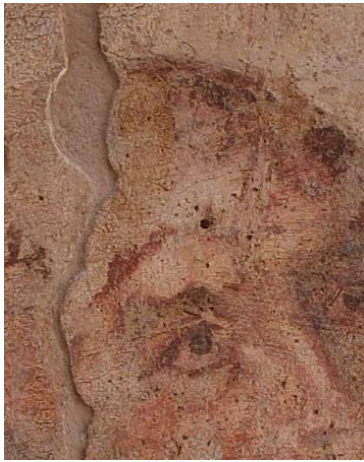
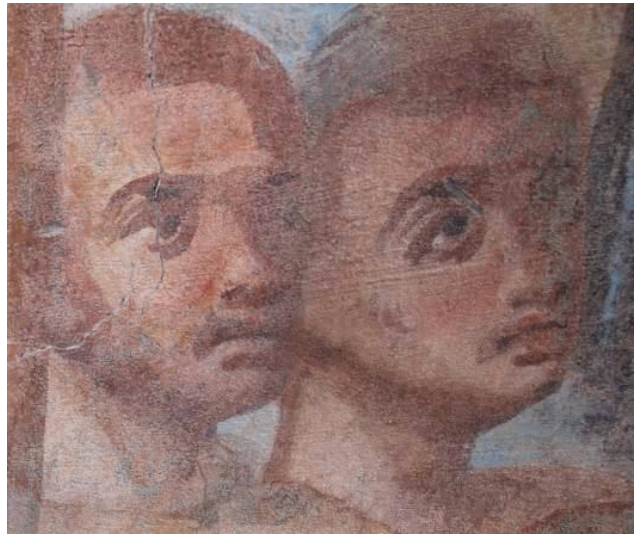
fig. 19

The same red earth pigment used to impregnate the builder's lines was used to create the square divisions of the *opus sectile* and to sketch the salient features of some of the figures. The preparatory design can be seen in places where the painted surface has been abraded. The

composition was executed rather rapidly and sketchily and in some places (such as around the lines of the faces) the preparatory design is still visible (figs. 19 and 20).

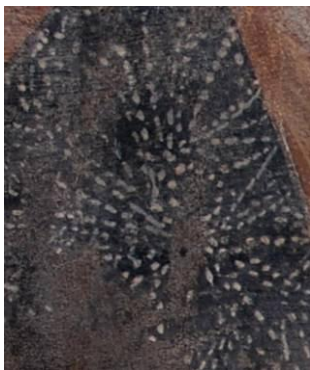
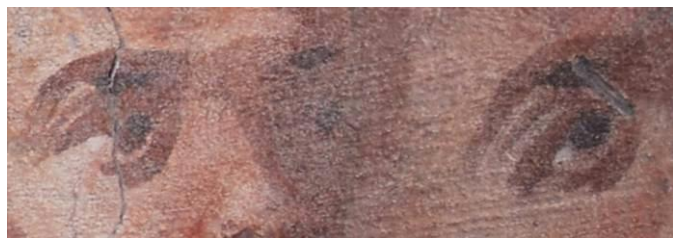
fig. 21

The extensive background areas appear to have been painted rapidly, and are enlivened by swift, impressionistic strokes rich in colour. Finishing touches such as the tiny pearls decorating the robes of the imperial dignitaries, the highlighting of the eyes and certain details such as the belt buckles, depicted in dense brush strokes using lime or pigment mixed with lime (figs. 21 and 22), stand out to great effect.

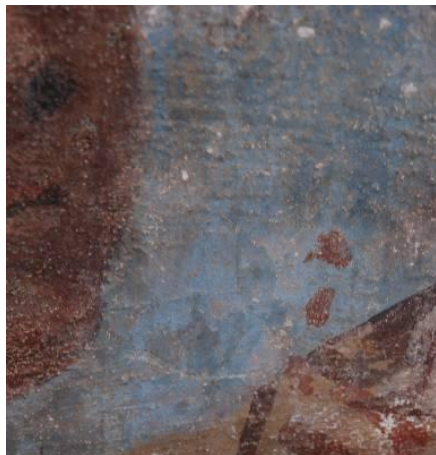
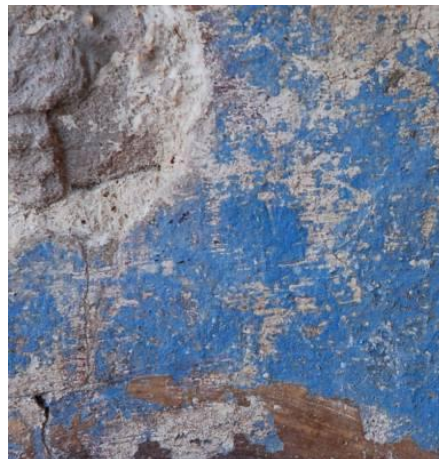
fig. 23

The background areas painted blue, using *fritta egizia*, vary in tone and intensity according to the pigment applied beneath⁴ (figs. 23 and 24).

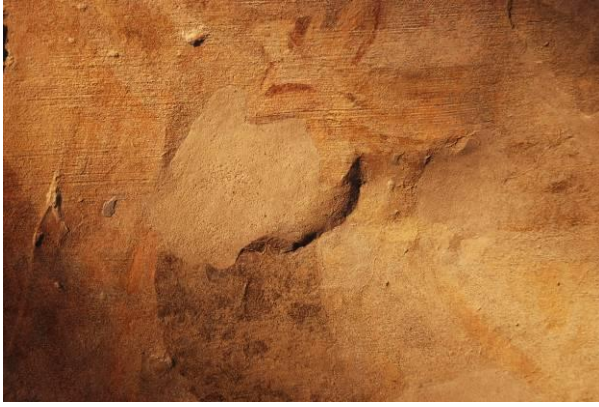
fig. 25

There is widespread detachment of the plaster, particularly in the central areas of the north and east walls, affecting a horizontal band approximately 3 metres high and causing bulging of the plaster in certain places (fig. 25).

Areas were consolidated by injecting liquid mortar similar in composition to the original plaster. In some cases it proved necessary to anchor the edges of the plaster with localized injections of acrylic resin in a 35% emulsion (Acryl 33) and strengthen some areas preventatively using small bands of Japanese paper stuck to the surface with a solution of acrylic resin. The cracks and edges of the plaster were repointed to prevent the liquid mortar from leaking out or to provide immediate support in the areas where the plaster had become detached.

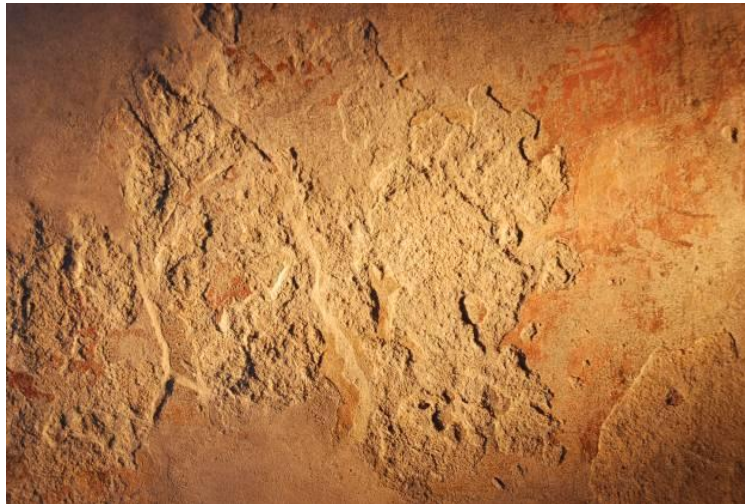
fig. 26

The surface of the plaster does not adhere in various areas and there are many abrasions. On the east wall, to the left of the horse's head some exfoliation has taken place (fig. 26).

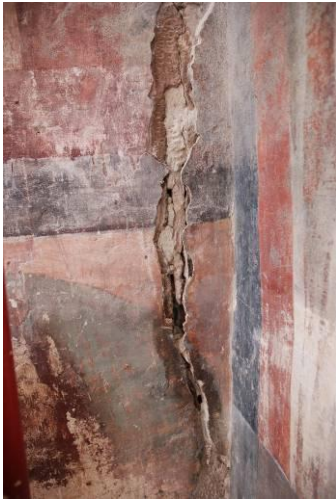
fig. 27

In the corner formed by the north and east walls, there is a sizeable crack affecting all the preparatory layers and the underlying wall (fig. 27)

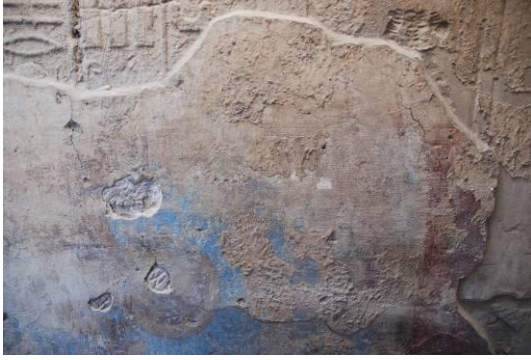
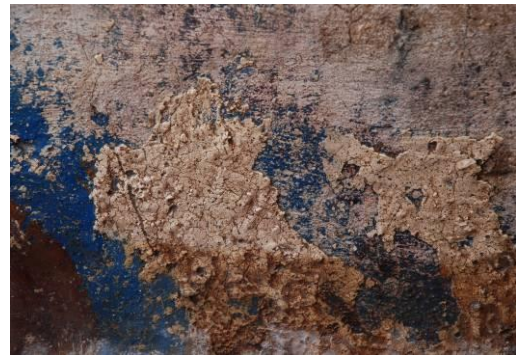
fig. 28

An area about one metre high on both walls extending over the entire surface of the upper frescoed area is covered with a pale ochre wash, which covers and actually extends beyond the hieroglyphic reliefs. This wash is composed of gypsum; substances applied over it and atmospheric particulate matter have caused it to turn ochre⁵ in colour. It is connected with additions made to the temple area during the medieval period (fig. 28) and originally covered some or all of the surface of the paintings. The thin wash is however particularly well conserved and fairly continuous in the upper right corner of the east wall on a level with the blue shield, whose surface is still partially covered by it (fig. 29).

Any traces of gypsum wash were removed mechanically using scalpels once the surface had been cleaned.

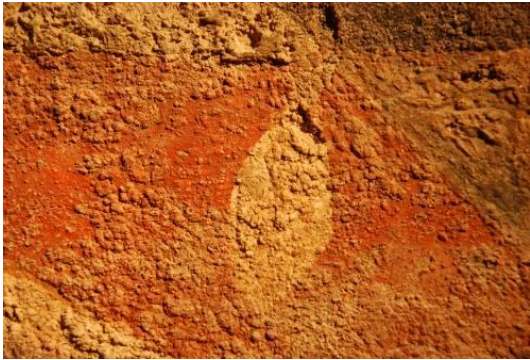
fig. 30

The thick and extensive efflorescence of salts (carbonates and sulphates) affecting the plaster of the lower part of the north wall to a height of around 1 metre above ground level (fig. 30) is the result of the regular inundation of the temple area in the past during the Nile floods.

The extensive efflorescence of salt on the second layer of plaster at the bottom of the north wall was removed mechanically using small chisels and an electric micro-drill⁸ (fig. 39).

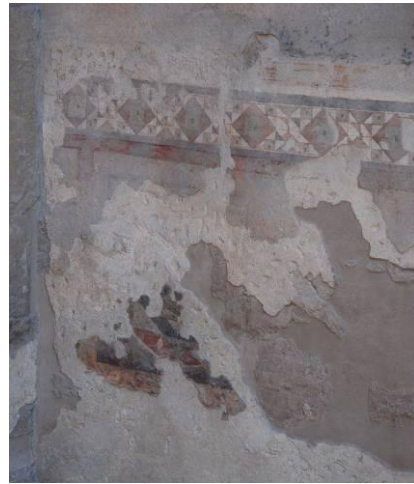
fig. 31

In places where the efflorescence is particularly extensive, it has caused optical refraction. For example, the lowest piece of *opus sectile* on the north wall (fig. 31) appears darker than the rest of the painted surface.

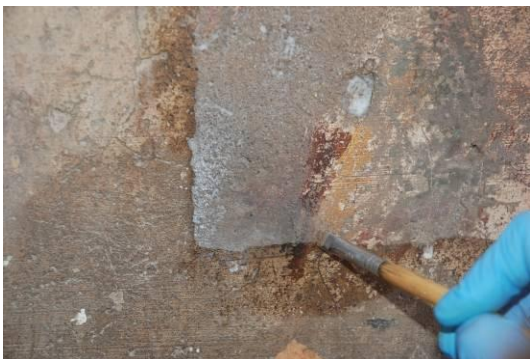
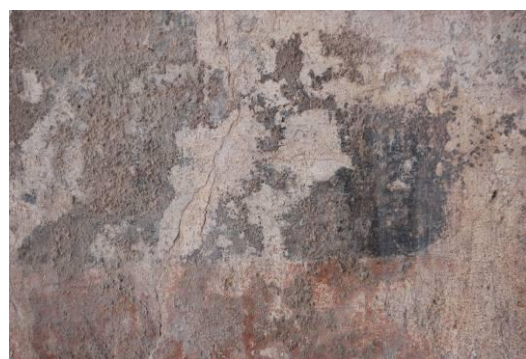
fig. 32

In some areas where the painted surface is reasonably well preserved⁶, there is a substance present that must have been applied as a brightening and consolidating agent, to improve the visibility of the figures. The reaction of this substance during cleaning allows us to conjecture that it is a vegetable gum. With the passage of time this gum has assumed the appearance of a greyish patina and exerts a significant dulling effect on the colours (fig. 32). The gum may have been applied during restoration work in the 1970s, possibly causing dust and loose deposits already present on the surface to become fixed there (fig. 33).

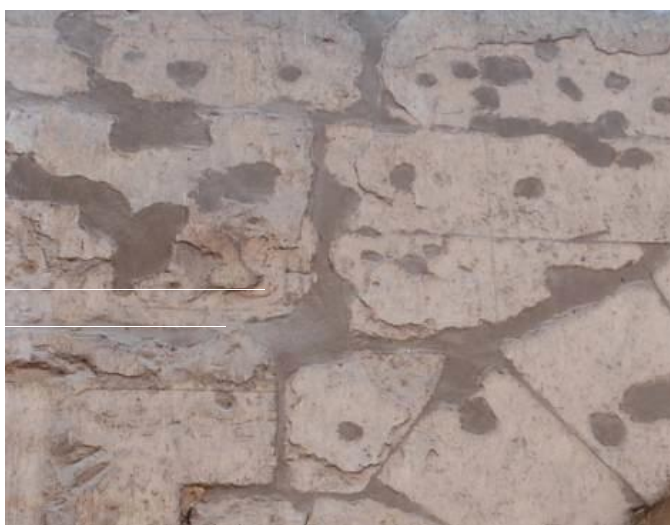
fig. 34

The same substance has also been applied to the reliefs and the mortar pointing that seals the joints between the ashlar stone blocks and some of the gaps in the plaster. These have turned a dark brown colour that is no longer in keeping with the tone of the sandstone blocks of the wall (fig. 34).
