FINAL REPORT

Fall Mission: October 29, 2007 – December 20, 2007

“Conservation of Roman Wall Paintings in Luxor Temple”

Luigi De Cesaris & Alberto Sucato, Restorers

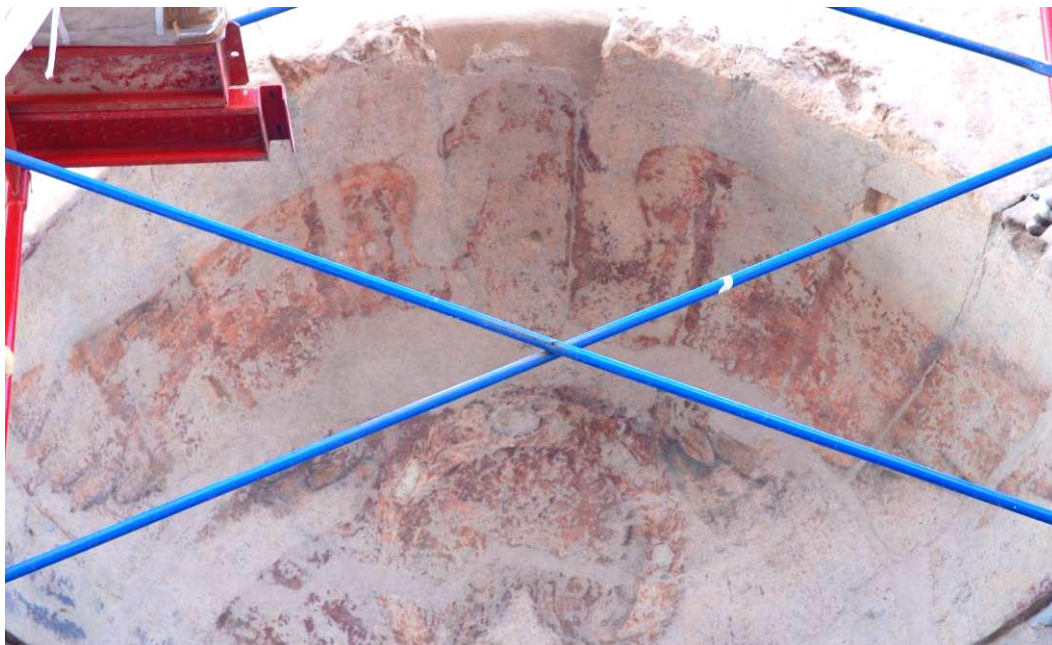
photo 1

The figures of the tetrarchs painted in the apse can be seen in a new light as a result of the restoration work: hitherto unknown features have been revealed by the cleaning operations. Of particular interest is the recovery of the large imperial eagle on the curved face of the apse. The head is seen in profile, turned to the east, the wings are outspread (**photo 1**),

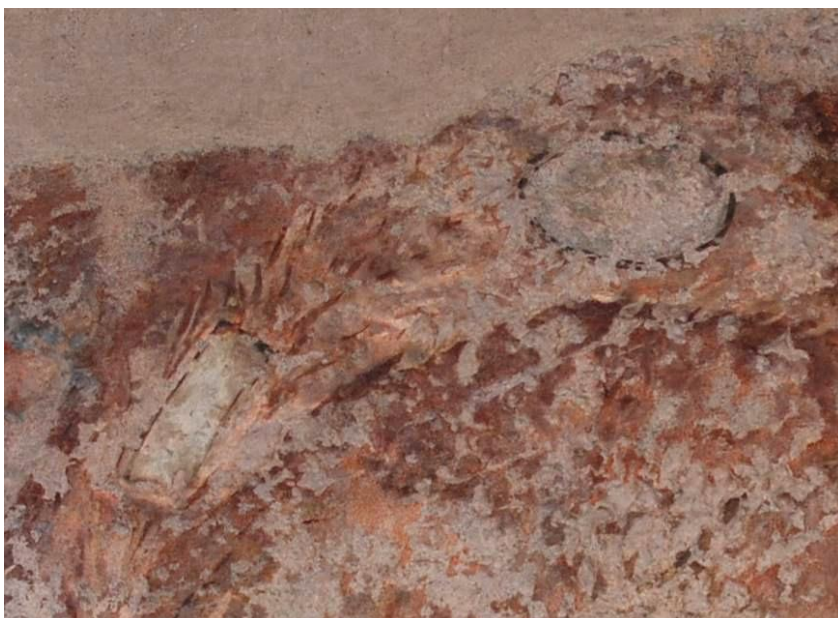
photo 2

and in its claws the bird grasps a laurel wreath decorated with blue and green rectangular and oval jewels (**photo 2**), fastened with a red and yellow ribbon (**photo 3**).

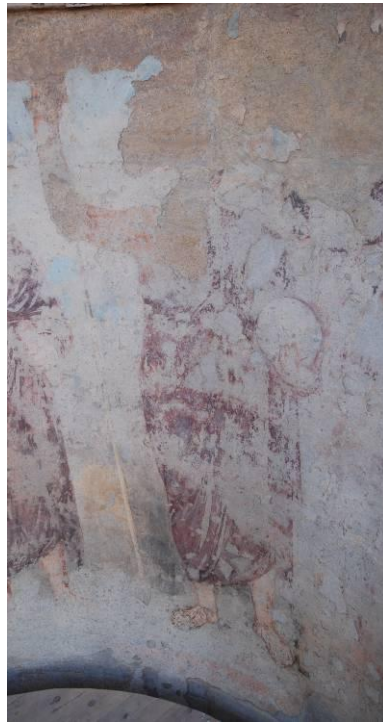
photo 4

first Tetrarchy¹, in which the *Caesar* of the East is associated with the *Augustus* of the West as a symbol of supreme concord between the emperors, then Diocletian should be the figure to the left of center, identified by the long staff and globe that were conferred upon him by Jupiter and that symbolize his role as *rector orbis* (**photo 4**).

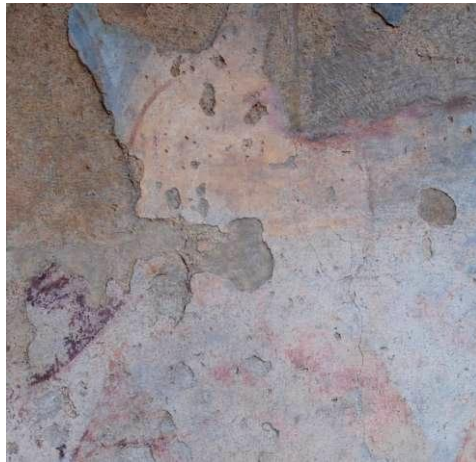
photo 5

The figure to his right should be Maximian, who, in Wilkinson's watercolors, already appeared to have been curiously effaced, probably as a result of the *damnatio memoriae* ordered by Constantine in his regard. Parts of his halo and the outline of his shoulders and legs are still visible (**photo 5**).

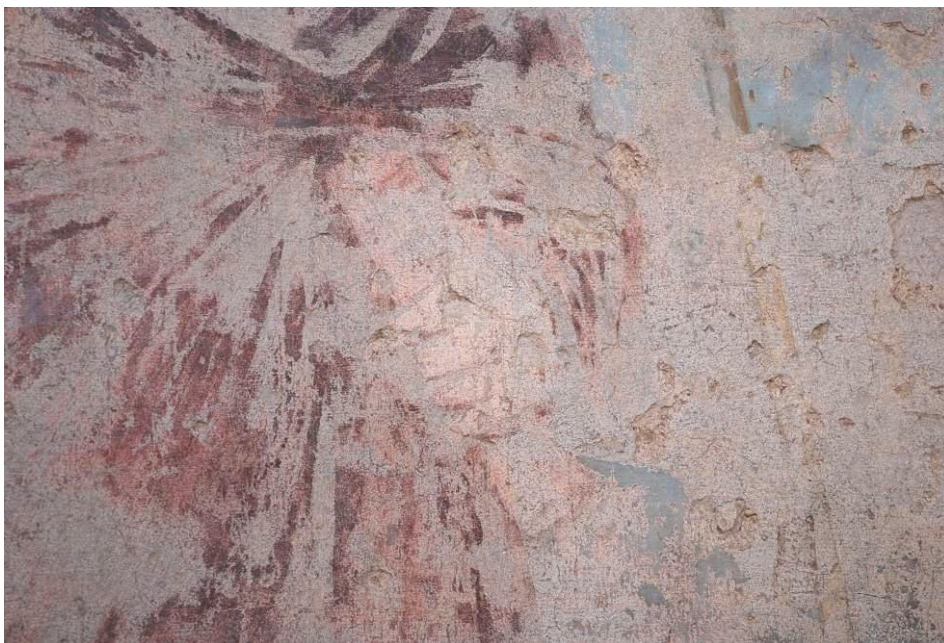
photo 6

The figure to the left of Diocletian should be the *Caesar* of the West, Constantius Chlorus who is holding a *rotulo* or scroll in his left hand (**photo 6**).

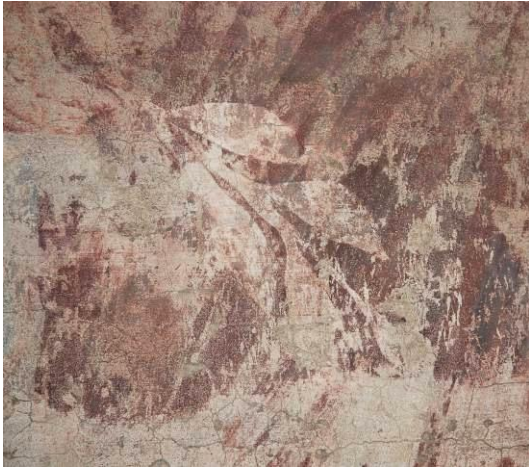
photo 7

The figure on the far right is Galerius. Unlike Wilkinson's painting, where he appears with a *rotulo* like that of Constantius Chlorus, here the *Caesar* of the East holds between the thumb and index finger of his right hand a branch that seems, from the shape of the leaves, to be laurel, similar to that depicted in the mosaics at Piazza Armerina (**photo 7 and fig. I**).

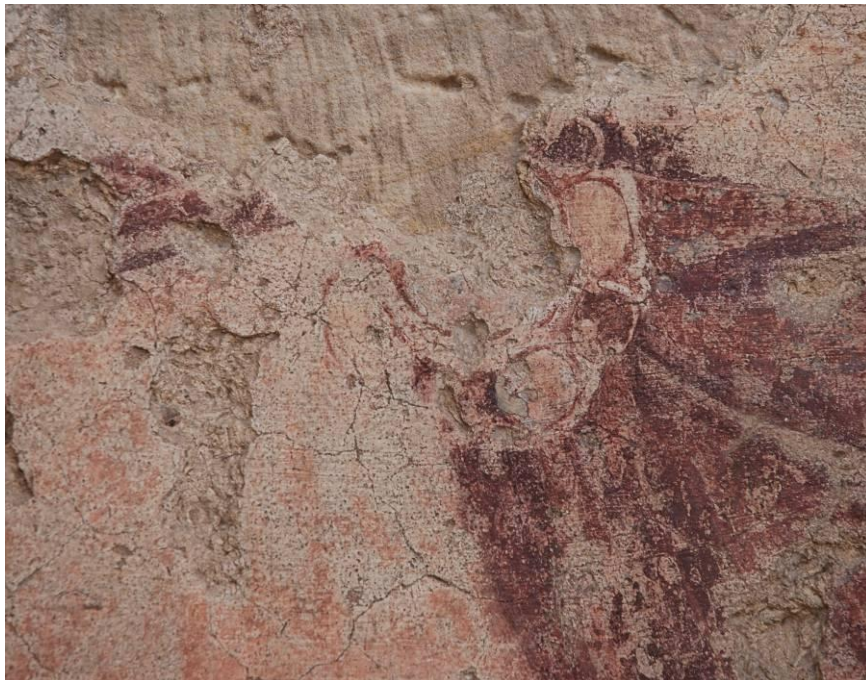
photo 9

The cabochon-cut stones forming the circular *fibula* that fastens the *pallium* on his right shoulder (**photo 9**) and the high-lacing red sandals (**photo 10**) are still clearly visible.

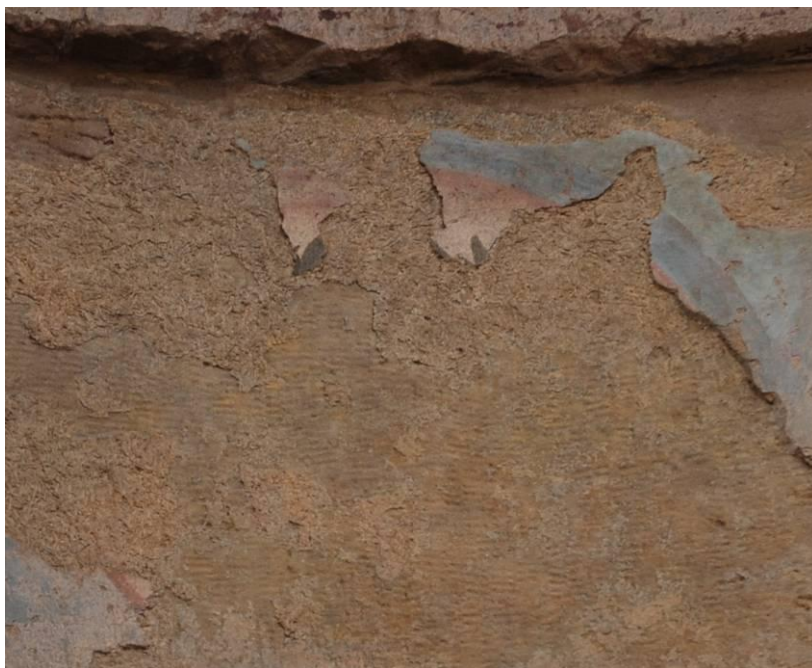
photo 11

A small portion of the laurel crown encircling the head of Jupiter, the halo and the purple-draped torso can be seen along the central axis, between the haloes of Diocletian and Maximian (**photo 11**).

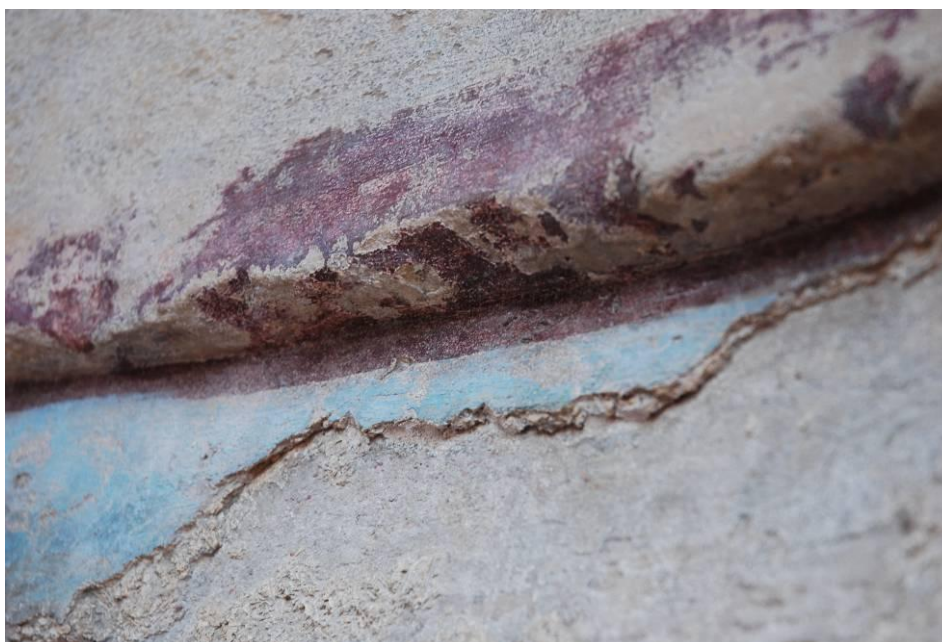
photo 12

To the right of Galerius have emerged fragments of what could be another iconographic feature; however the state of preservation of the painted layer makes it hard to distinguish. Lower down, a pole or long staff can be seen. The central portion of it is missing and there are several parallel rectilinear shapes at its top end, crowned with something red (possibly suggestive of some kind of brazier). The apse is framed by purple bands that also run around the edge of the curved face and, together with a small projecting ledge, serve to separate it from the surface below (**photo 12**).

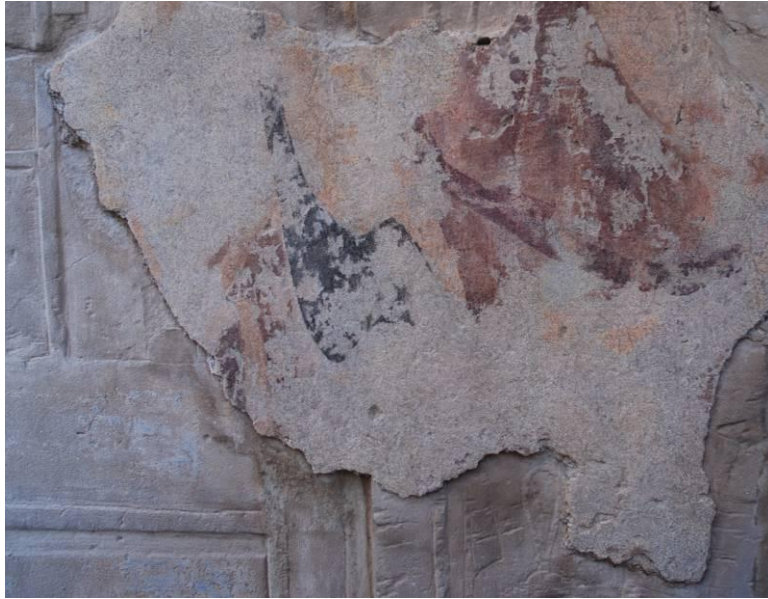
photo 13

After the cleaning work, the edge of a priestly robe, decorated with fringes and black embroidery just as Wilkinson painted it, could be made out on a small fragment to the left of the apse (**photo 13**).

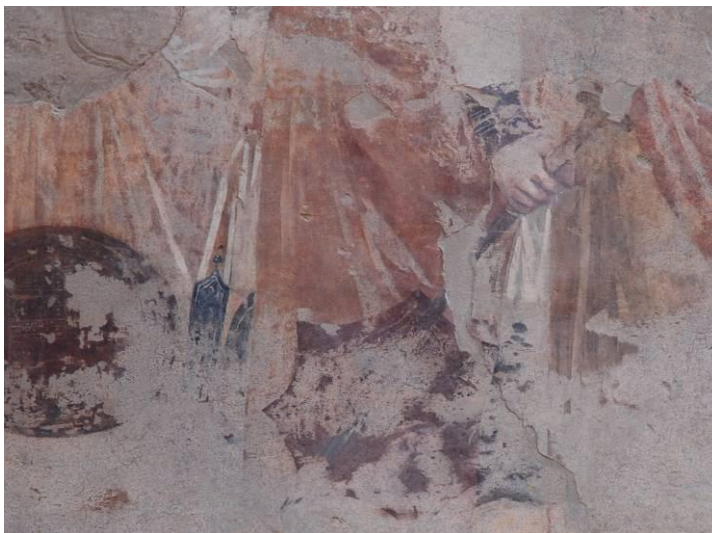
photo 14

Higher up on the right, the silhouette of a man in the second row of figures was revealed. On the west side of the wall, a well-preserved fragment shows the lower half of a priest at the rear of the procession. He is holding a *baculus* or ceremonial staff and his robe, like those of the other figures near him, is richly decorated with elaborate embroidery (**photo 14**).

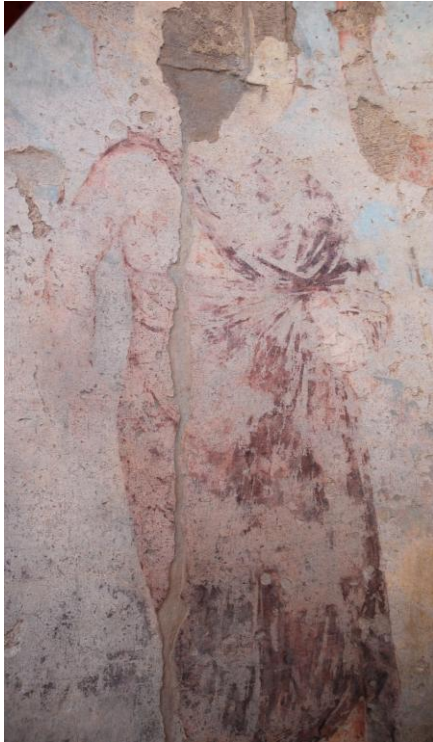
photo 15

The great door in the center of the south wall which gave access to the room behind was blocked during the Roman period in order to construct the apse. An examination of the blocked-up section from the rear shows that second-hand blocks were used and that the apse is only a few centimeters wider than the ancient door. On the right, in the lower part of the apse, where a passage was opened in recent times in order to access the room behind, the corner stones are still intact. The architrave that surmounted the ancient Egyptian doorway has clearly been removed and with it the blocks, at the height of the curved face of the apse, which were hindering the construction of the vault. The two large vertical lesions clearly visible in the apse mark the point at which the Roman masonry was grafted on to the pre-existing stonework (**photos 15 and 16**).

Along the line of the join between the Roman and Pharaonic masonry there are two clear symmetrical cracks, caused by the break in the stonework. The cracks can be seen to the right and left of the columns, above the capitals and they run vertically as far as the top of the wall. A great deal of the right half of the Pharaonic era stonework has been lost, but the upper profile of the remaining blocks follows exactly the line of the above-mentioned crack. The same break between the Roman refacing and the ancient Egyptian masonry has resulted in similar disruption inside the apse where two wide cracks run vertically from the heads of Constantius Chlorus and Galerius to the base of the exedra (**photos 15 and 16**).

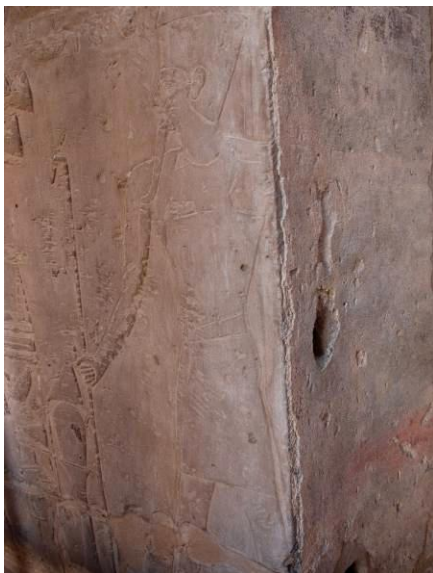
photo 17

The only blocks in the apse not to be repositioned during the Roman period were the lateral ones, however they were reworked and made concave (**photo 17**).

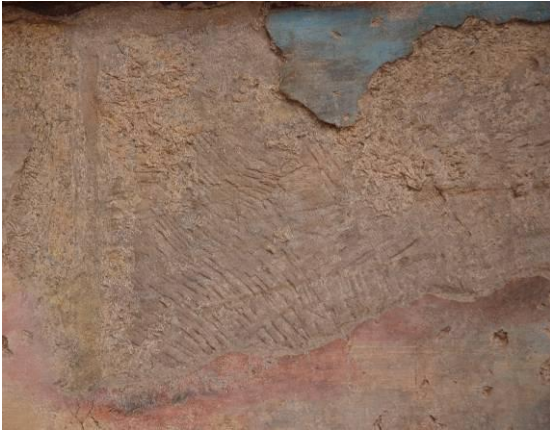
photo 18

The extensive gaps in the upper part of the apse reveal numerous signs of stone working. Chisels, toothed tools and hammers of various sizes have left distinctive vertical, horizontal and oblique marks (**photos 18, 19 and 20**).

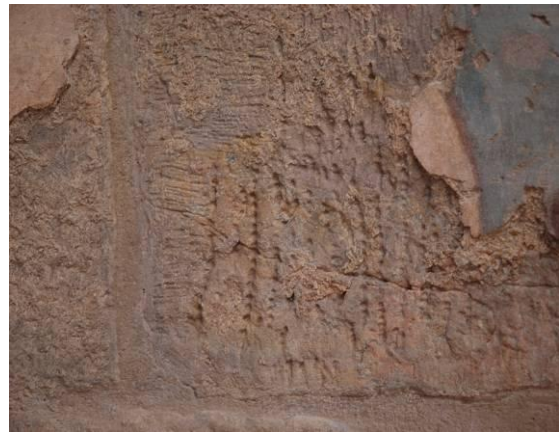
photo 21

Deep holes made by a running drill can also be seen (**photo 21**). The central part of the curved face of the apse appears to comprise a single concave block whilst the outer area is composed of wedge-shaped blocks. These blocks are also reused as can easily be seen by observing the thickness of the wall at its highest point (**photo 22**). It is worth noting the presence of four rectangular holes symmetrically positioned on the curved face of the apse. These were probably used to house the timbers supporting the vault during its construction. Once the curved face of the apse was completed and the supports removed, the holes were plastered over in readiness for the decoration of the apse (**photos 23 and 24**).

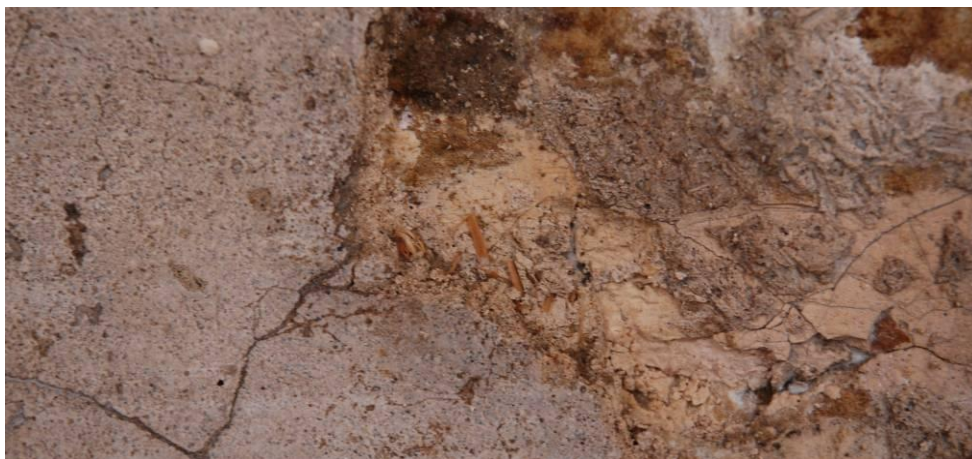
photo 25

As already noted during the previous campaign, the plaster was applied to the surface of the stone from top to bottom in two separate layers. The first layer is coarser, comprising lime, sand² and a considerable amount of vegetable fiber. The purpose of this thick layer was to smooth out the considerable irregularities in the surface resulting both from the presence of Pharaonic reliefs and the state of preservation of the stone that was already old and deteriorating at the time the Roman paintings were executed (**photo 25**). Furthermore, the thickness of the layer, coupled with the presence of straw in the mix, meant that the plaster stayed wet for a long time.

This means that the layer is not of uniform thickness, varying from approximately 1-15 mm. The second coat of plaster, a finer grained mortar not containing straw, was applied over the first in a layer 3-5 mm thick in order to obtain an even smoother surface. However, the surface of this second coat is still fairly rough and before the color was applied it was primed with a very thin coat of lime, applied with large brushes whose bristles left clear marks and picked up small grains of sand. This characteristic is in keeping with the swift impressionistic style in which the figures were painted. From a technical point of view, these paintings are a fusion of two different cultures *that came together in the multicultural world represented by Egypt under the Roman Empire*. On the one hand we are dealing with paintings typical of the Roman tradition of that period, comprising a number of layers built up to a considerable thickness. On the other, the use of straw to keep the plaster damp and elastic is a typically eastern practice.

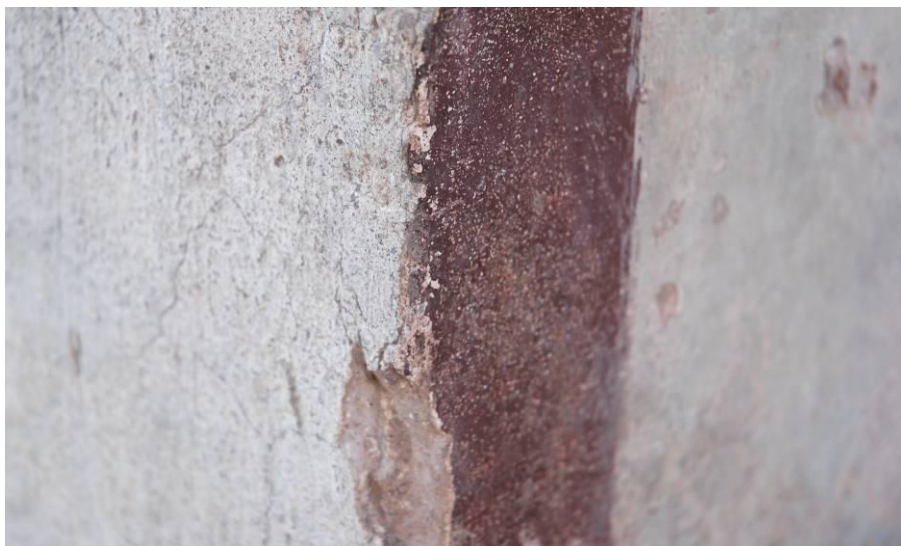
photo 26

The plaster does not appear to have breaks in it and where the side walls enter the curved face of the apse, the corners are rounded. (**photo 26**).

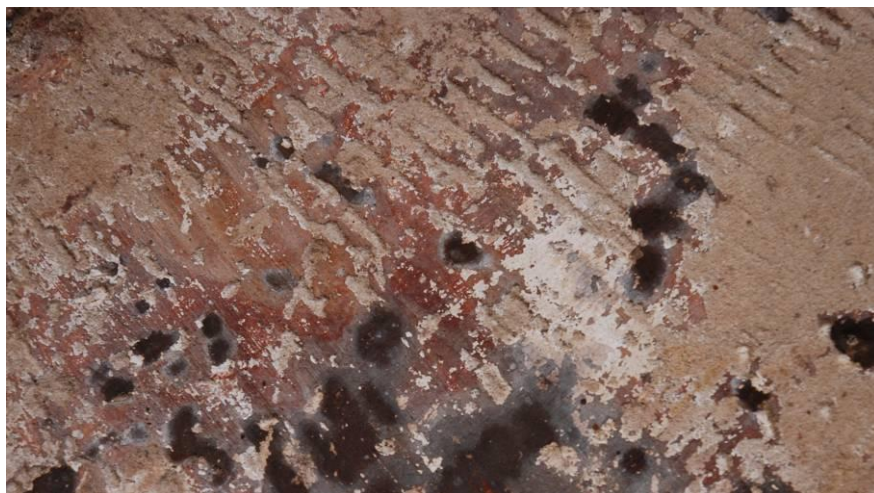
photo 27

It is interesting to observe that virtually all the plaster on the curved face of the apse is missing. With the exception of a number of holes in the stonework in the lower part that were repaired with a lime and sand mortar, only a very thin layer of lime was applied to the surface. This is because the stonework in question dates to the Roman period and was finished and smoothed to produce a regular surface (**photo 27**).

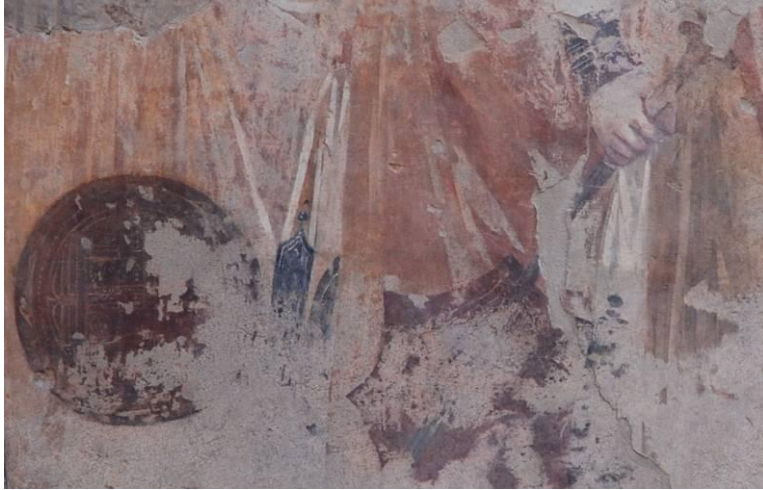
photo 28

The extensive background areas were painted rapidly, and are enlivened by swift, impressionistic strokes rich in color. In the large fragment on the wall to the right of the apse, the finishing touches can be appreciated all the more owing to the fine state of preservation of the painted layer. The highlighting of the priest's hand indicates an extremely three-dimensional style of painting and the detailing of the embroidery decorating the robes show how each figure has been carefully characterized (**photo 28**).

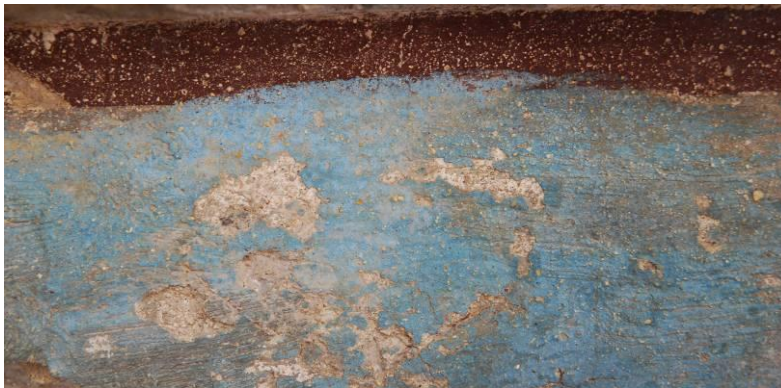
photo 29

Inside the apse the painted layer is very badly damaged but the best-preserved areas make it possible to guess at the nature of the once brightly colored painting. The *fritta egizia* used to paint the background is a particularly intense color. It can be seen immediately below the curved face of the apse where, protected by the concavity of the apse and the slight projection of the curved face itself, a few characteristically thick brushstrokes remain(**photo 29**).

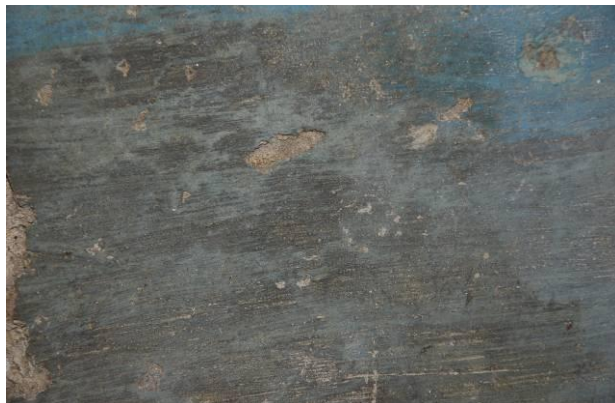
photo 30

In the central band, at the height of the tetrarchs' torsos, the *fritta egizia* seems to have been mixed with lime to lighten the tone. However, in the upper part of the background, it seems to have been applied over a dark gray preparation (presumably a black vegetable pigment mixed with whitewash⁵), according to

traditional Roman practice in order to increase the intensity of the blue (**photo 30**). Brush strokes of a darker blue surround the haloes, in order to make them stand out to better effect (**photo 31**).

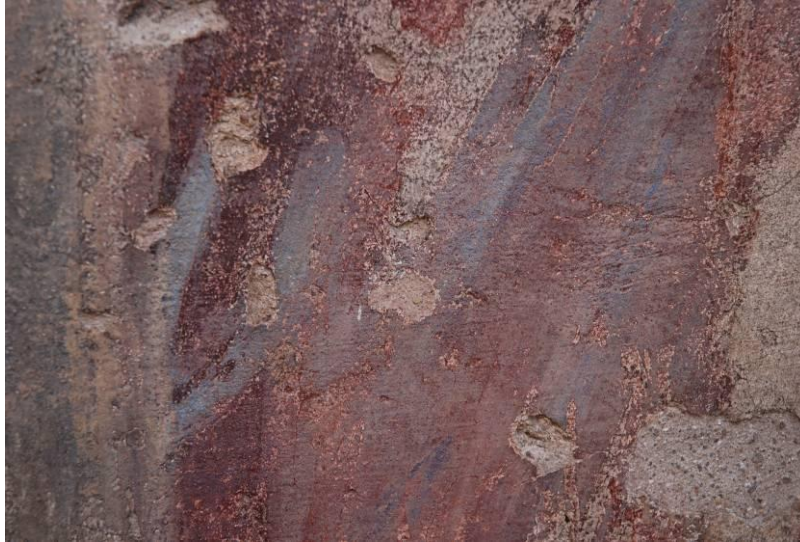
photo 32

The iridescent light effects still visible on Diocletian's *pallium*, painted in blue on a purplish background, serve to accentuate the folds and drapery (**photo 32**).

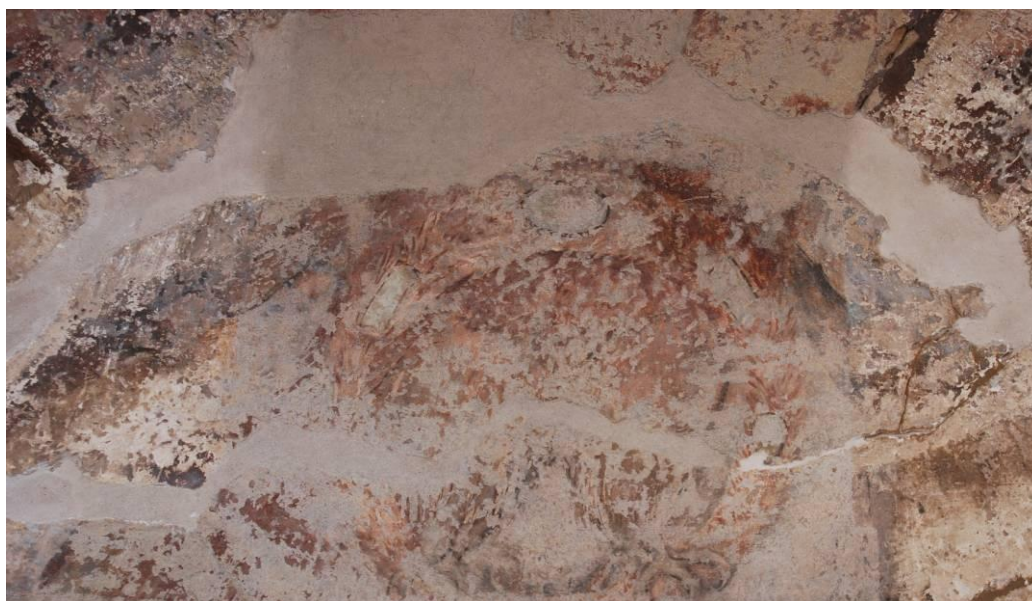
photo 33

Deep and extensive pointing work has been carried out in a semicircle, following the line of the join between the lower large single block⁸ and the wedge-shaped blocks arranged all the way around it (**photo 33**). The two anterior rectangular holes used during the construction phase can be seen since the mortar originally used to fill them has fallen out.

The extensive efflorescence of salt at the bottom of the wall decorated with *opus sectile* was removed mechanically using small chisels and an electric micro-drill. The numerous instances of pointing intended to repair gaps between the ashlar blocks were conserved since they are still performing their function well. However, they were checked and cleaned using the same method used to clean the paintings and where necessary, consolidated. Only on the curved face of the apse was the extensive semicircular pointing removed using small chisels and

scalpels and subsequently replaced as it proved to be cracked and detached from the masonry.

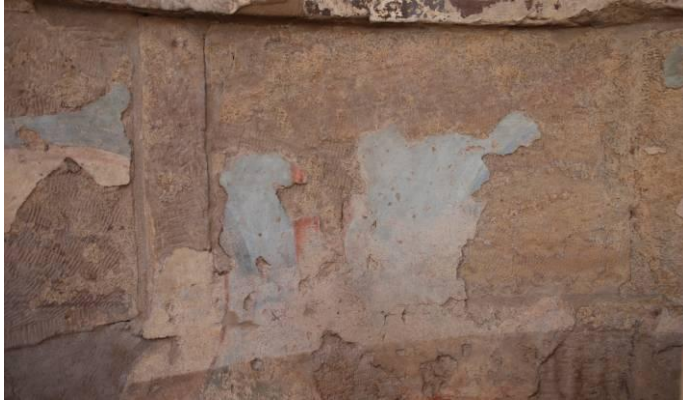
photo 34

The upper part of the apse below the curved face is the most seriously damaged area and much of the painted layer has been lost. This is because the faces of the emperors were depicted here. The features of the tetrarchs, with the exception of Maximian, who will be discussed below in connection with the painted layer, have been completely effaced right down to the preparatory layers, as is the case with the figure of Jupiter in the middle section. Only the haloes and part of the background have been saved (**photo 34**).

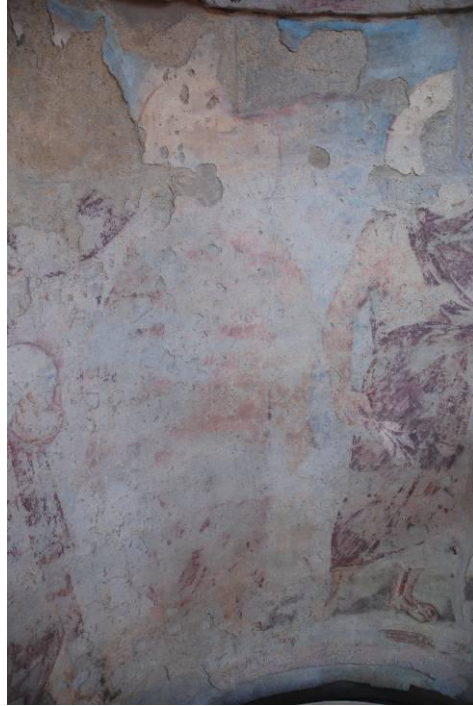
photo 35

The state of preservation of the painted layer varies considerably. As indicated earlier, the figure of Maximian was almost entirely effaced at an unspecified point in history. If it is true that the emperor was subject to a *damnatio memoriae* during the reign of Constantine, then the image of Diocletian's co-ruler must have been obliterated just a few years after it was painted. Not a trace remains of his face but the underlying plaster and a first level of painted layer have been preserved (**photo 35**).

The yellow nimbus is actually clearly visible and appreciable traces of the body, the outline of the shoulders and the edge of the *pallium* remain.

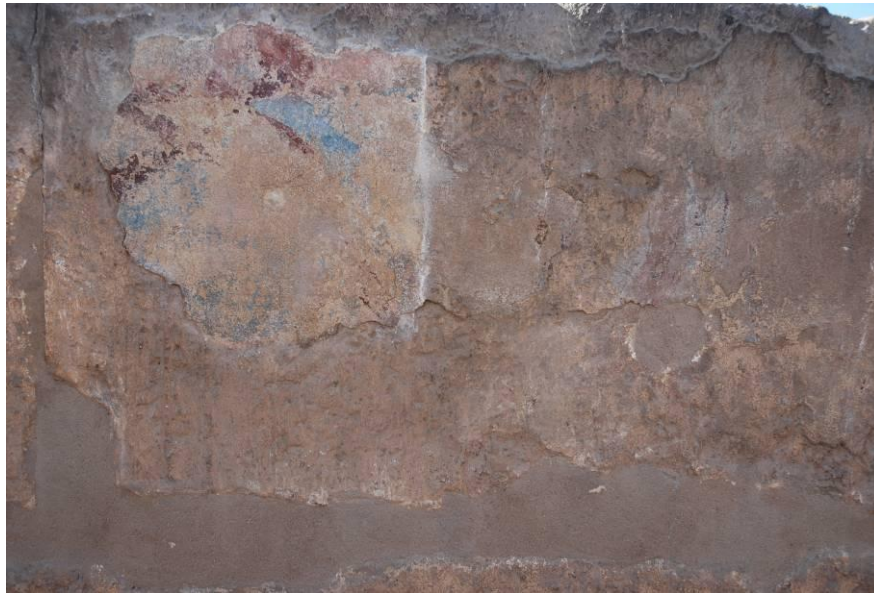
photo 36

Above the curved face of the apse, at the top of the wall, the painted surface is almost completely covered by a thin layer of wash (**photo 36**).

This layer, already identified and removed from the top part of the south east corner during the previous campaign has its origins in the additions made to this part of the temple during the medieval period⁹. The entire surface in question is covered by a substance that must have been applied as a brightening and consolidating agent, to improve the visibility of the figures. This is probably a vegetable gum that has assumed the appearance of a grayish patina with the passage of time and exerts a significant dulling effect on the colors¹⁰. The gum may have been applied during restoration work in the 1970s¹¹, possibly causing dust and loose deposits already present on the surface to become fixed there.

The same substance has also been applied to the reliefs and mortar pointing that seals the joints between the ashlar stone blocks and has been used to repair some of the gaps in the plaster. These have turned a dark brown color that is no longer in keeping with the tone of the sandstone blocks of the wall.

Fragments of painted layer were recovered from the surface above the apse. The thin layer of whitewash was removed mechanically, using scalpels.

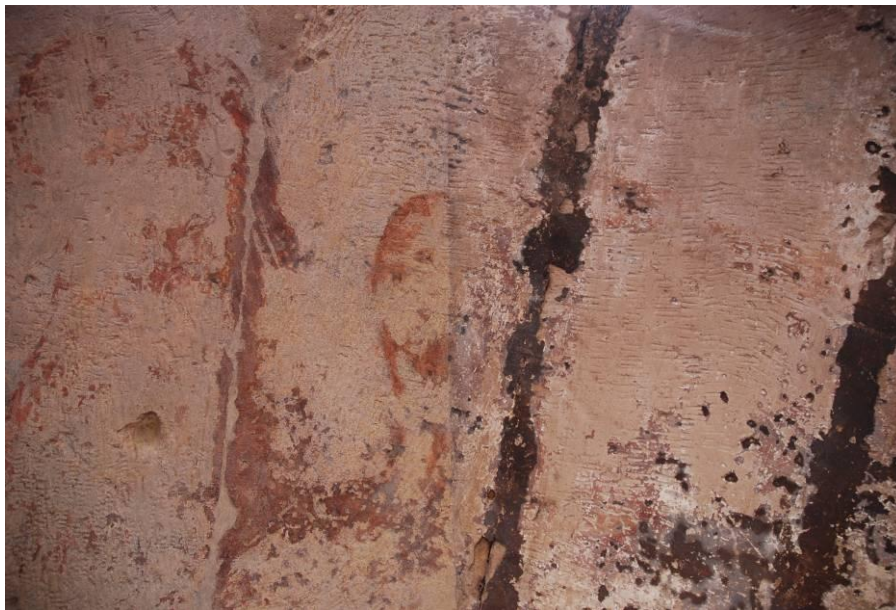
photo 37

Inside the curved face of the apse, dark colored bands are visible along the lines of the joints between the ashlar blocks (**photo 37**). These have probably been caused by the infiltration of rainwater into the mortar connecting the blocks.

This process of percolation has caused organic and inorganic substances present on the surface or that have built up on the top of the wall to dissolve and be transported to the painted layer.

Inside the curved face of the apse, several compresses had to be applied in order to remove the thin dark-colored layer adhering to the surface along the lines of the joints between the ashlar blocks. At the end of the cleaning process, the painted layer in these areas turned out to be better preserved than in the surrounding areas, suggesting that the substances deposited on the surface had exercised a protective function¹².
