# FINAL REPORT

Fall Mission: October 27, 2008 – December 21, 2008

“Conservation of Roman Wall Paintings in Luxor Temple”

Luigi De Cesaris & Alberto Sucato, Restorers

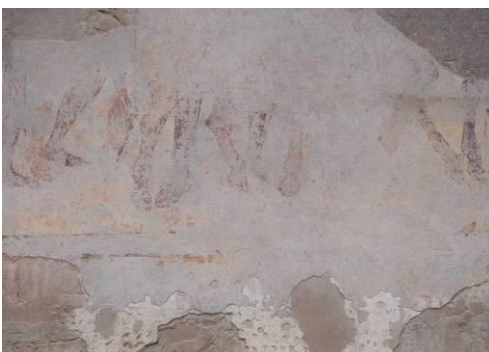
**photo 1**

The restoration work enabled us to decipher the fragments of wall painting and we can now appreciate a number of elements in the scenes depicted on the east wall (**photo 1**) and the *opus sectile* of the west wall (**photo 2**).

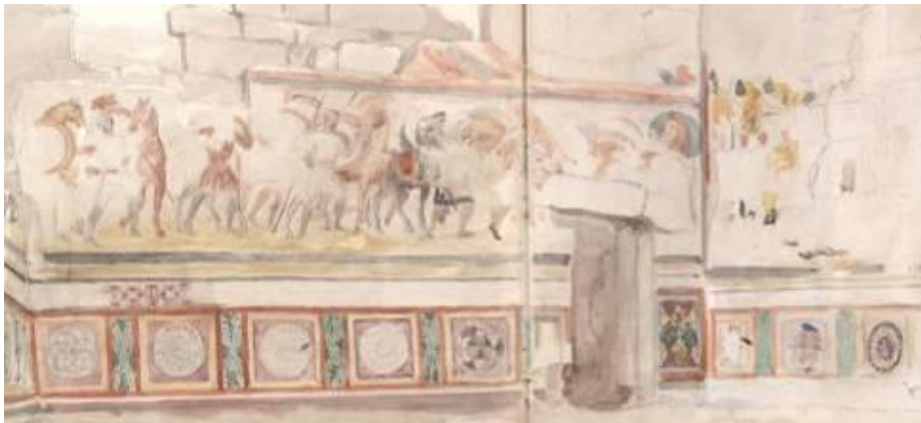
**plate I**

As can be seen in Wilkinson's watercolors, the procession in the *adventus* scene that starts at the sides of the entrance to the Imperial Cult Hall, moves in two opposing

directions (the figures in the left-hand area to the west and those in the right-hand area to the east) to converge on a single focal point on the south wall (**plate I**).

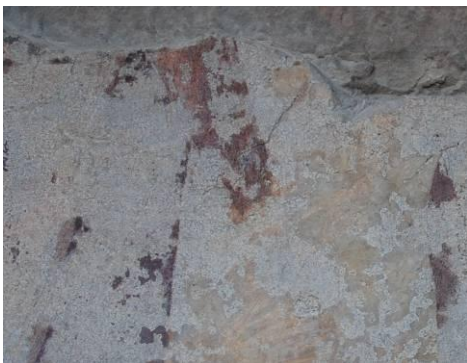
**photo 3**

The scenes painted on the east wall depict soldiers leading their own horses, armed with lances and circular shields and wearing short tunics with a decorative border. All that now remains of this in the lower tier is part of the soldiers' legs and the horses' hooves. Two elements well documented in Wilkinson's watercolors have been identified: part of a lance on the left (**photo 3**) and the point of the scabbard of the sword of one of the last soldiers at the extreme right, before the door (**photo 4**).

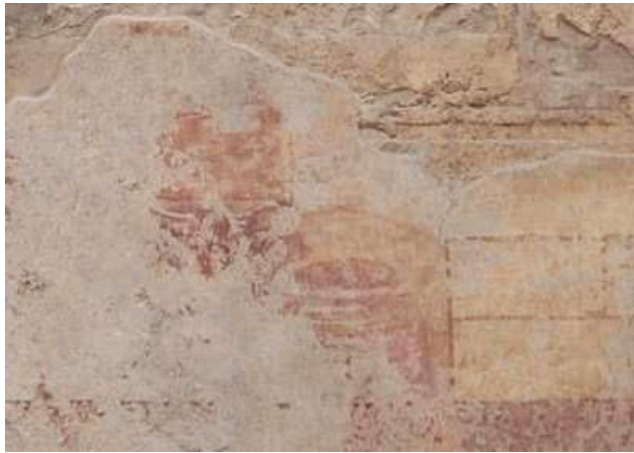
**photo 5**

The evidence derived from the fragments that reappeared after cleaning confirmed the reliability of the English archaeologist's record and, despite the loss of major portions, it is still possible to appreciate the sense of movement to the right of the numerous figures depicted. In the upper tier (not painted by Wilkinson, presumably because it was covered with wash) interesting elements can now be made out in the south east corner. The recovery of the fragment of ochre-colored masonry with the individual blocks picked out in red to the left of the blue shield has been completed. On this, painted fragments stand

out, suggestive of devotional objects (such as a decorated brazier and a large rounded vase) and an architectural feature<sup>1</sup> (**photo 5**).

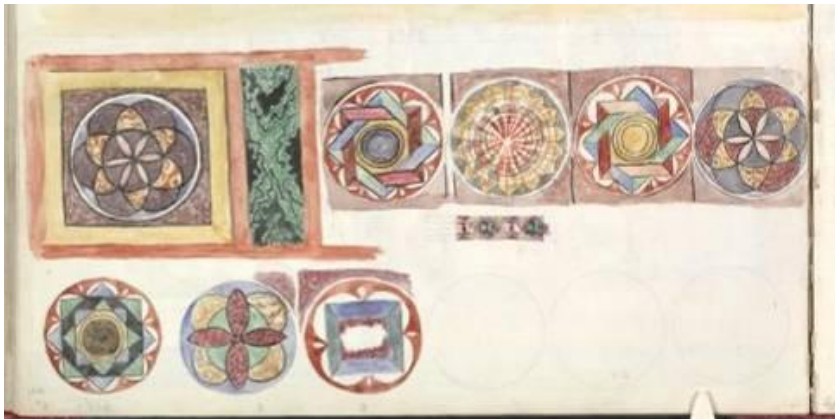
**plate II**

The striking fragments of fake marble on the west wall have enabled us to understand better the composition of the *opus sectile*. In this case too, the paintings confirmed the eighteenth-century watercolors. Wilkinson recorded the various geometrical designs that are repeated on the walls on a page of his notebook (**plate II**).

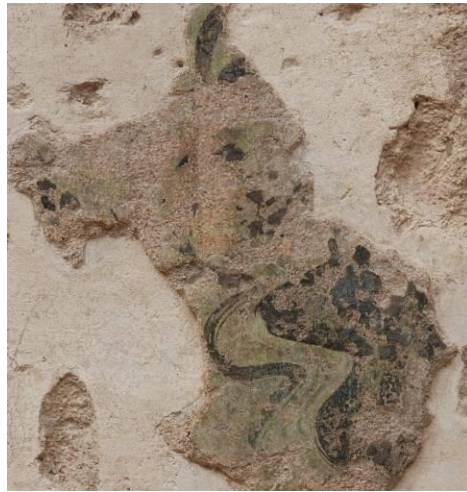
**photo 6**

Elaborate circular compositions depicting overlays of polychrome marble are inscribed in large square panels bordered by horizontal and vertical yellow bands. These alternate with rectangular panels with a portrait orientation that are painted green with black

veining (**photo 6**). Both the square and rectangular panels are outlined by thin red bands. These painted decorations rest on a wainscot of alternate gray and purplish bands and are separated from them by a thin white band.

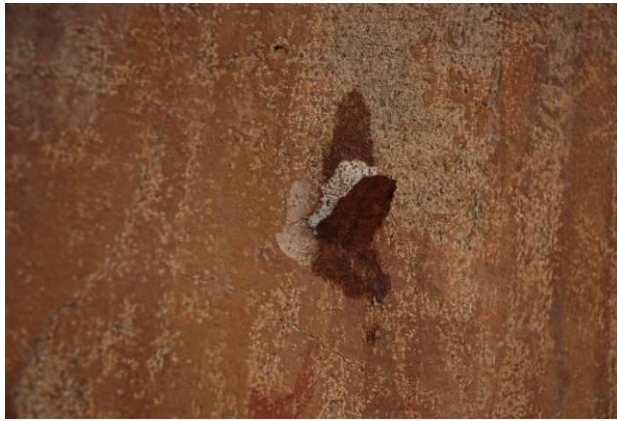
**photo 7**

During the conservation campaign the old pointing between the blocks was cleaned and maintenance was carried out in the area treated during the previous mission to remove the bird droppings deposited in the period between the second and third conservation campaigns, particularly from the faces of the dignitaries to the left of the apse and the large fragment with the priests on the right (**photo 7**).

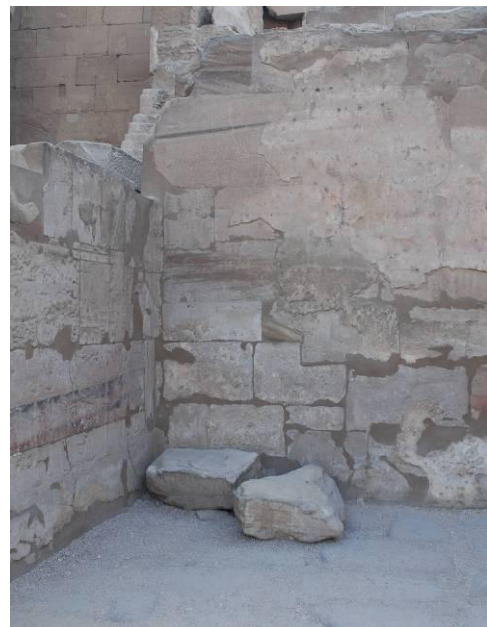
**photo 8**

In the east and west walls the pharaonic structure has been substantially preserved. The modifications made during the Roman period are associated with the blocking up of the two access doors to the side rooms, near the north east and north west corners respectively. In the first case, where the plaster is patchy, it is possible to see where the aperture was closed with sandstone blocks, the exposed faces of which bear the characteristic marks of Roman stone working already encountered in the apse (photo 8).

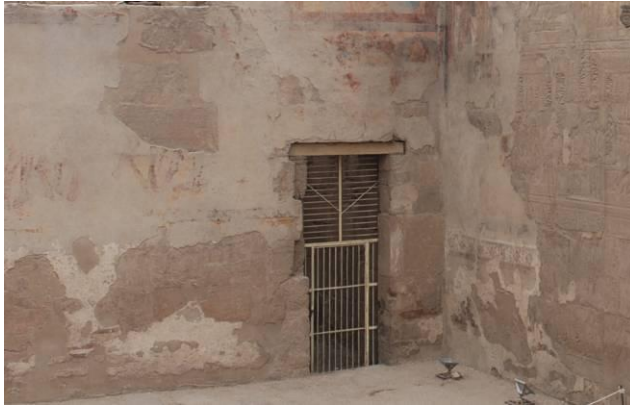
**photo 9**

south east and south west corners) through which access is still gained to the side rooms were modified during the Roman period and perhaps earlier. On the intrados of the aperture, fragments of Roman plaster are still preserved, proving that it belongs to the era of the Tetrarchy (**photo 9**).

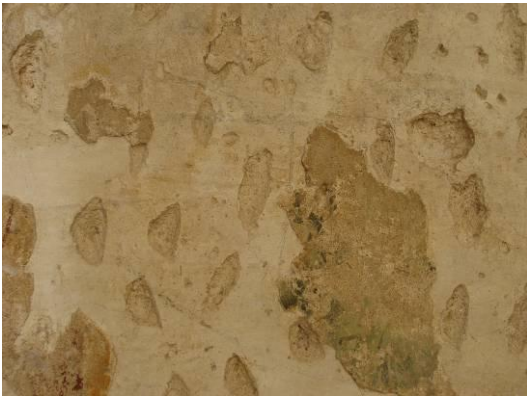
**photo 10**

As already described in the reports for the previous campaigns, the surface of the plaster was primed with a very thin layer of lime applied using brushes whose bristles left clear signs and picked up small grains of sand. Where this finish has been abraded on the fake marble wainscot on the left half of the east wall, dark rectilinear and circular markings can be seen (**photos 10 and 11**). These designs could be associated with the division of the space or, more likely, are graffiti left by the workmen before the application of the above-mentioned third coat.

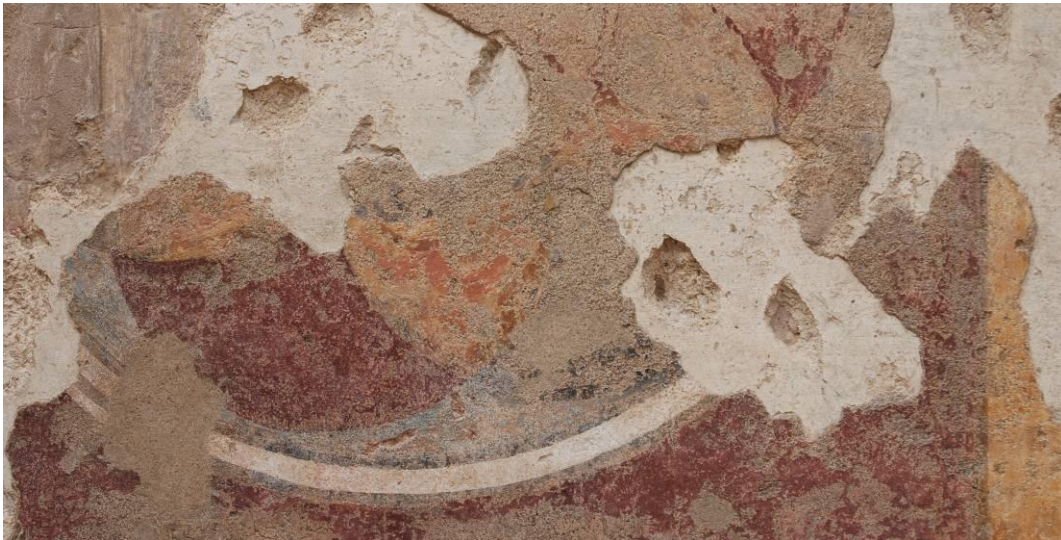
**photo 12**

Whilst working on the band of *opus sectile* on the west wall, we were able to observe certain characteristic features of the working method. Two different reds were used for the porphyry painted in the square panel and the wainscot below: the background color, which is darker, was obtained by mixing a red ocher with black whilst the drops representing inclusions in the marble were obtained by mixing the same ocher with white (**photo 12**).

At the end of the work, *fritta egizia* or Egyptian blue, a pigment widely used in all the painted decorations in the hall (**photo 12**) was used in the geometric overlays within the panels.

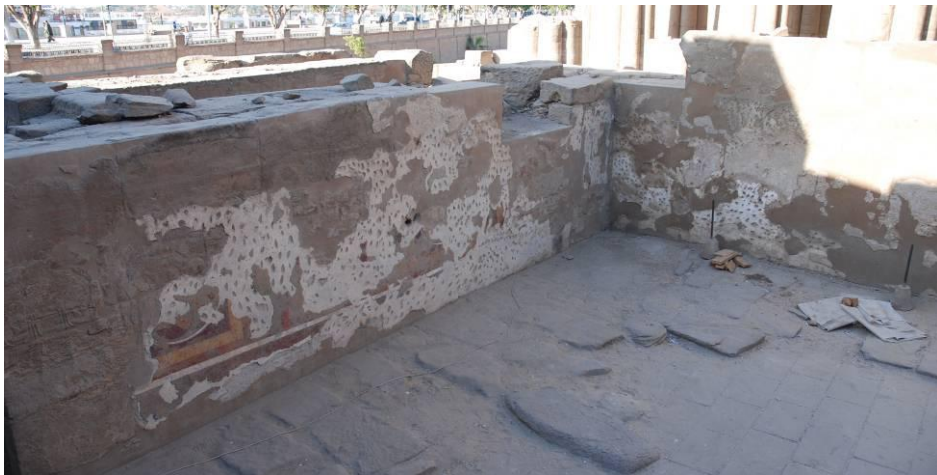
**photo 13**

Considering the hall in its entirety, the south wall is more intact than the others even though the top part is missing. A large part of the pharaonic era masonry has been lost, particularly from the east and north walls, that are only standing to the height of the strip of *opus sectile* (photo 13).

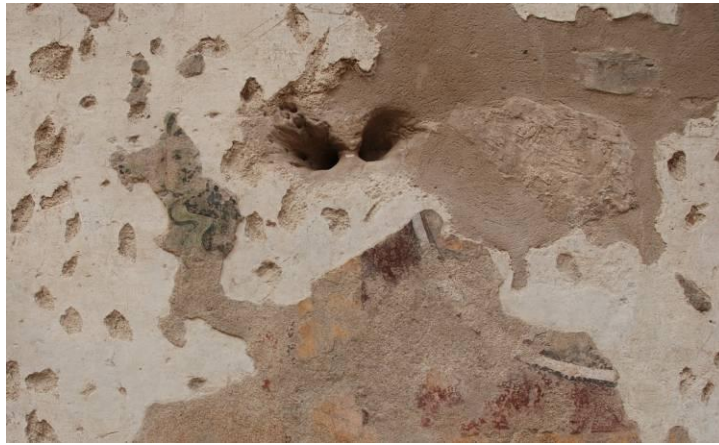
**photo 14**

In the north and west walls, two interconnecting holes have been drilled in the sandstone of the pharaonic blocks. These were used to tie up animals (**photo 14**).

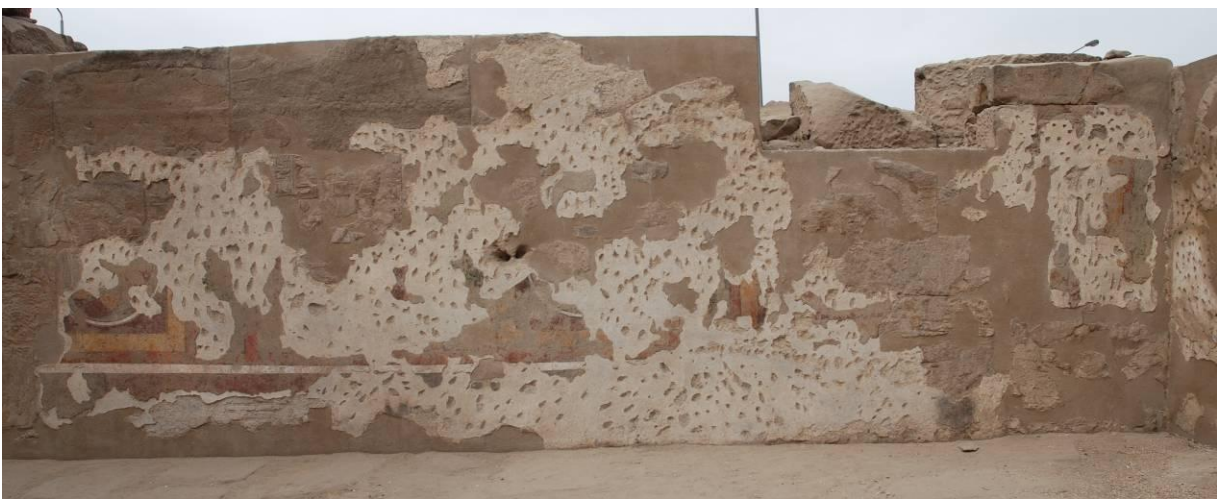
**photo 15**

On the west wall the first two layers of plaster are well preserved and show the pick marks described earlier whose purpose was to give the third layer of plaster a good purchase. However, this layer is extremely patchy, particularly in the center (**photo 15**).

On the lower part of the west wall, decorated with *opus sectile*, the widespread saline efflorescence present on the second layer of plaster was removed mechanically using small chisels and an electric micro-drill.

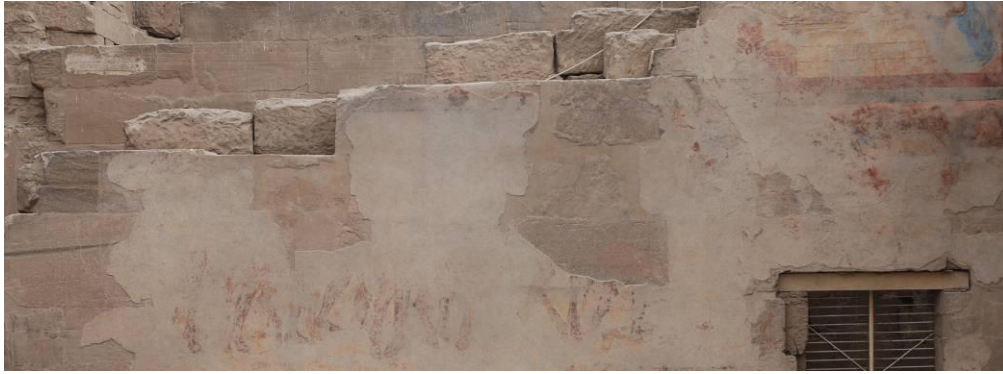
**photo 16**

The preparatory layers on the east wall are more intact than on the other walls with the exception of the strip of *opus sectile* of which only a small fragment remains in the central area. There are two large gaps in the upper part, distinguished by their rectangular shape<sup>7</sup> (**photo 16**).

<sup>7</sup>The regular shape suggests that these areas of plaster were removed intentionally either to investigate the underlying pharaonic reliefs or to remove sections of painting depicting the heads of figures on horseback.

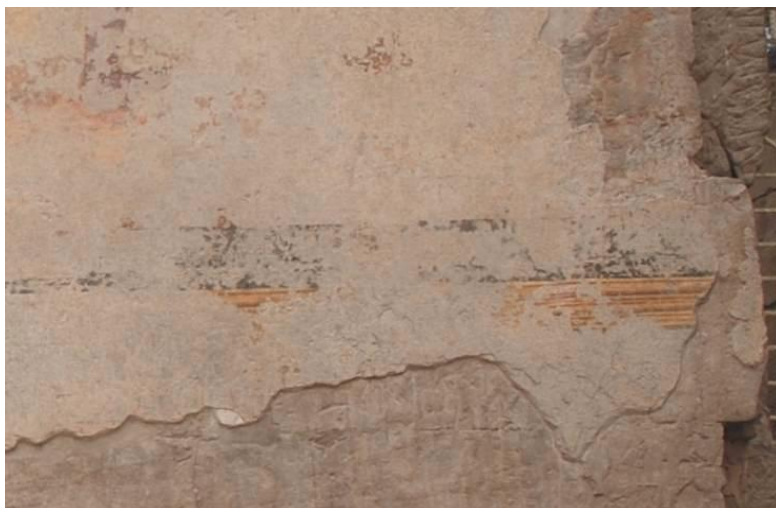
**photo 17**

With the exception of the top right corner above the door and a fragment of the yellow cornice of the *opus sectile* band (**photo 17**), the plaster is severely abraded all over the wall. As we will explain below, this is the result of exposure to atmospheric agents, namely the action of the sun, changing temperatures and wind, which have caused a gradual loss of cohesion, flaking and alveolization (**photos 18 and 19**).

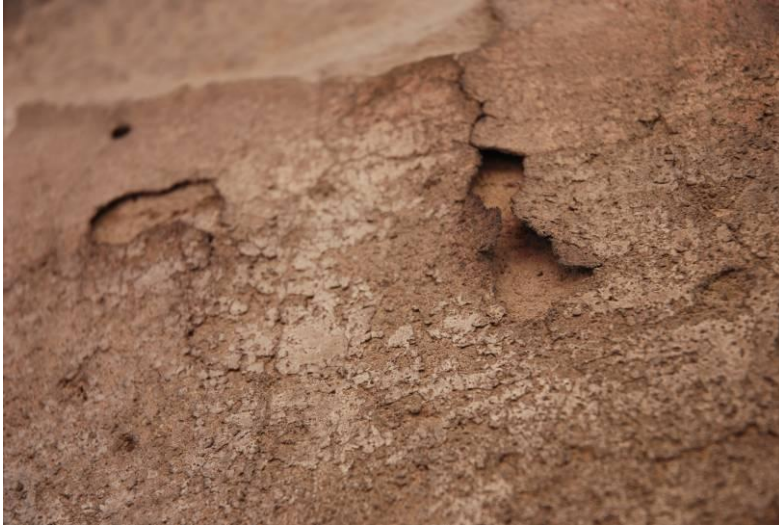
**photo 18**

All over the wall, the preparatory layers are failing to adhere to each other or to the masonry.

The preparatory layers were consolidated where they had become detached from the masonry by means of injections of a liquid hydraulic mortar similar in composition to the original plaster. In some cases, the edges of the plaster had to be anchored by means of clearly defined injections of a 30% emulsion of acrylic resin (Acryl 33) and some areas were protected against possible detachment in the future using small strips of Japanese paper stuck to the surface with a solution of acrylic resin. Some pointing was carried out in cracks and at the edges of the plaster to prevent the liquid mortar from leaking out and to give immediate support to areas where the plaster had become detached.

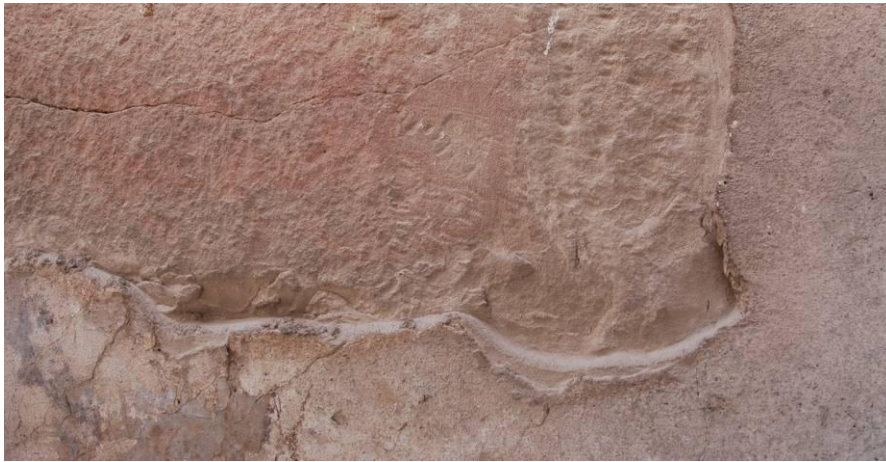
**photo 20**

As we have already seen in earlier campaigns, the edges of the plaster fragments and, in some cases, the smaller gaps were fixed during earlier restoration work with somewhat invasive ribbon pointing that encroaches on the original surface (**photo 20**).

The numerous areas of pointing filling the gaps between the stone blocks were retained on the basis that they are still serving their intended purpose. However, they were overhauled and cleaned, employing the same method used to clean the paintings, and where necessary, consolidated. Where reasons of conservation dictated, some gaps were filled using a mortar similar in composition and grain size to the original<sup>10</sup>. Small gaps in the second layer on the west wall were also filled in for esthetic reasons.

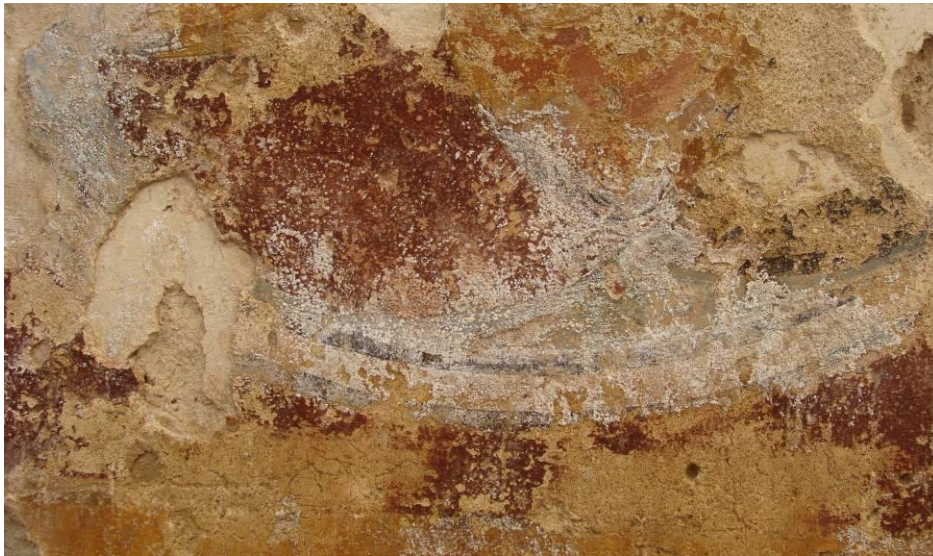
**photo 21**

On the west wall, where the third layer of plaster with *opus sectile* is present, the paint layer is in a good state of preservation, even though it is covered with a thick layer of particulate matter and a coating of salts (carbonates and sulphates) that have crystallized both on the surface and at the interface with the plaster (**photo 21 and 22**). As already observed on the south wall, the entire lower part of the wall is affected by this crystallization to a height of about one meter above ground. This has also had the effect of “fixing” the pigments by enclosing them in a thin layer of carbonates.

The surface was cleaned using the method developed during the Fall campaigns of 2006 and 2007, namely by applying compresses of cellulose fiber soaked in a solution of ammonium carbonate (60 gr/liter) with the addition of a cellulose gel-forming ether (hydroxymethylcellulose). The function of these compresses is to hold water and keep it at the interface between the compress and the plaster without unduly soaking the latter. Contact times, developed on a case by case basis depending on the state of preservation and the nature of the pigments, varied from 10 to 20 minutes. This method rehydrated the substances applied over the paint layer which were then removed using bristle brushes and natural sponges. Next, the surface was carefully rinsed by patting it with natural sponges. On the surface over the door in the east wall, large areas of the paint layer were recovered by mechanically removing the thin layer of white wash using scalpels.

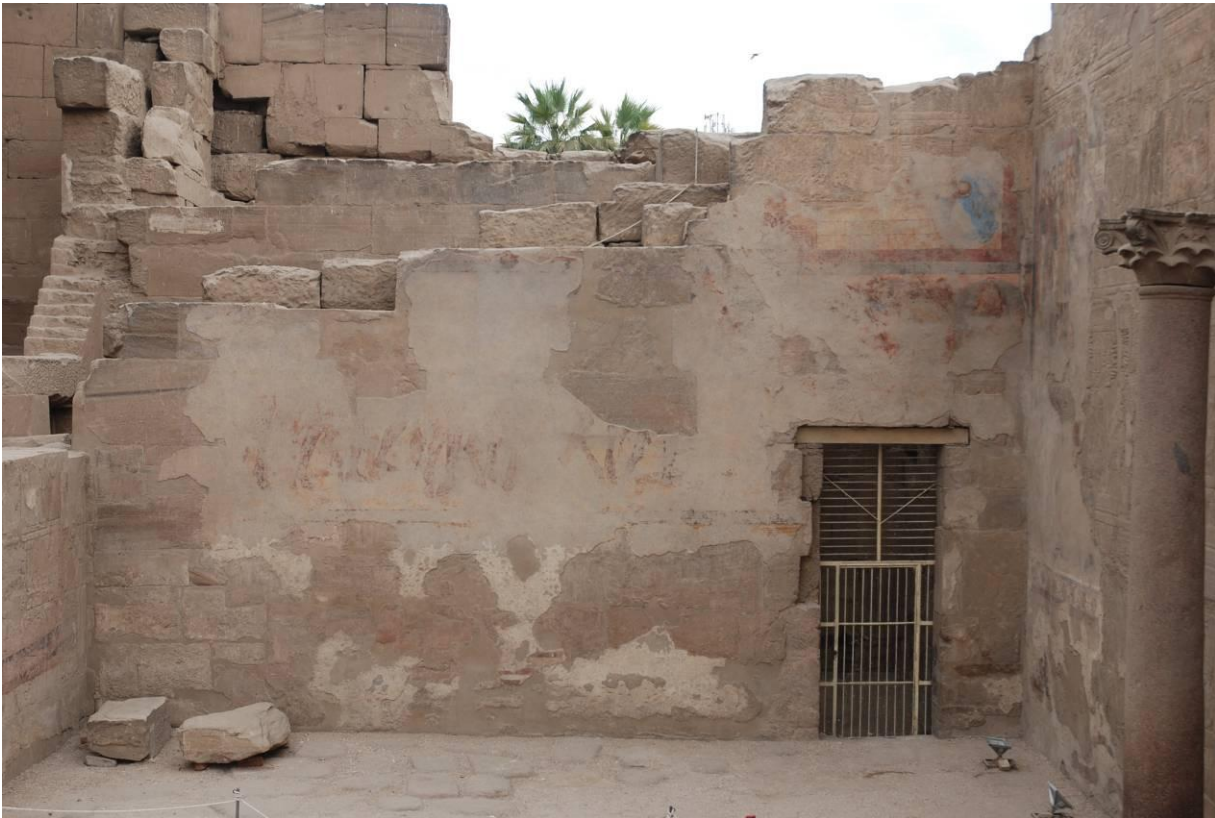
**photo 23**

The state of preservation of the east wall differs from the others in that, although its preparatory layers are more or less intact, it has almost entirely lost its paint layer (**photo 23**).

This state of affairs can be attributed confidently to a series of factors acting upon the wall simultaneously and in synergy: the climate (strong solar radiation and wind) and human causes. We can assume that when Wilkinson recorded the images in the hall in watercolor, part of the paintings must have been newly revealed following the removal of

later structures inside the Temple. By comparing the English archaeologist's record of the east wall with its current state of preservation, we can infer that the deterioration of the paintings over the last century has been both rapid and dramatic (**photo 23**).

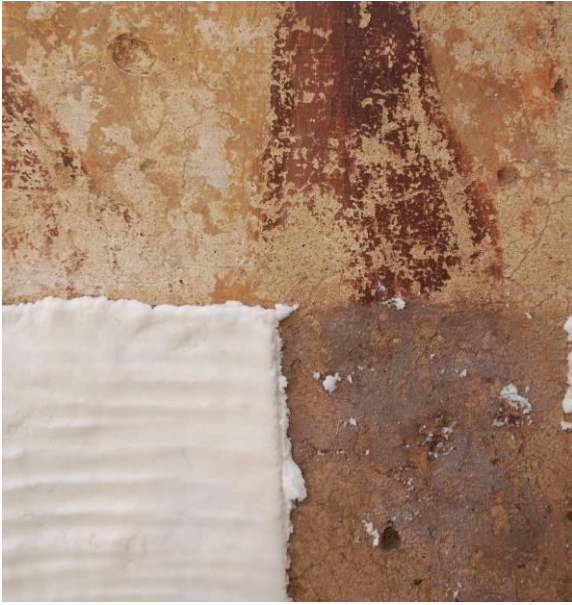
**photo 24**

During restoration work carried out in the Seventies a consolidating substance was applied that over time has assumed the appearance of a grayish patina, considerably dulling the colors of the paintings<sup>8</sup> (**photos 24 and 25**).

<sup>8</sup> Given that this is a fairly recent intervention and that the substance has not been found to contain polysaccharides (cf. Artelab s.r.l. report, Fall 2006 Campaign), it could be a polyvinilic alcohol.

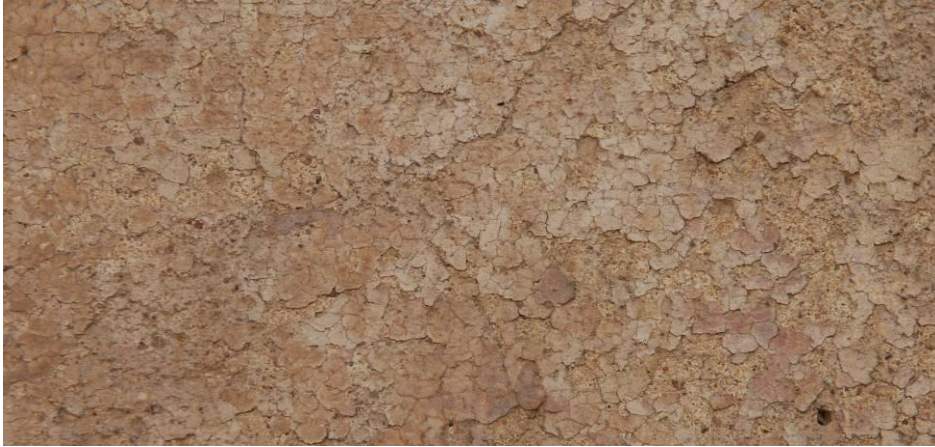
**photo26**

This layer, already encountered during earlier campaigns, has contracted considerably in some areas as a result of solar radiation and its own rapid desiccation, causing the paint layer to become raised, flake off and ultimately be lost. **(photos 26, 27 and 28).**

Where necessary, the paint layer was consolidated using an acrylic resin in emulsion injected into clearly defined areas using small syringes. In some cases light pressure with a flexible spatula was necessary, interposing a sheet of siliconized paper between the paint layer and the surface.

Areas of the paint layer that were failing to adhere were consolidated using a low percentage solution of acrylic resin applied with a brush (Paraloid B 72 at 1.5% in a nitro diluent).
