REPORT ON TEST CLEANING
(November 19, 2005 – November 24, 2005)

“Test Cleanings of Roman Wall Paintings in Luxor Temple”

Luigi De Cesaris & Alberto Sucato, Restorers

The Egyptian Antiquities Conservation Project (EAC)
USAID Agreement No. 263-A-00-04-00018-00

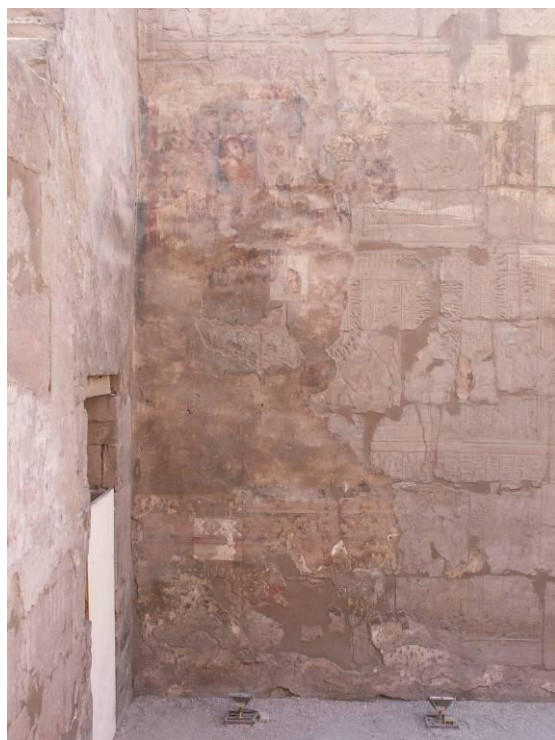
Figure 1

For this purpose, 3 sample cleaning areas measuring approximately 50x40 cm were created on the south wall, plus a small window on the east wall (Figure 1).

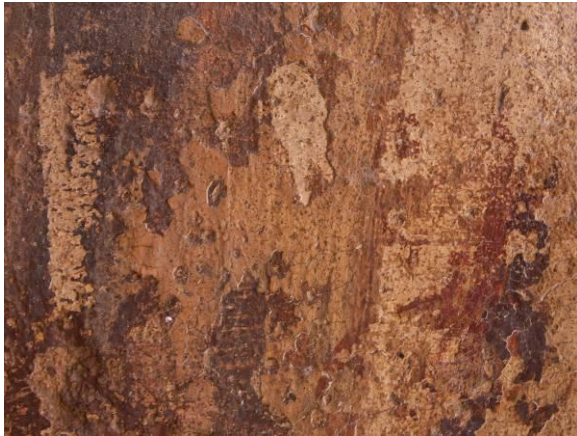
Figure 2

In the upper area, beyond the painted plaster, a layer of slightly ochre coloured wash is visible, covering and partially dulling the hieroglyphic reliefs. Presumably this layer in ancient times covered part or all of the paintings under discussion (Figure 2). Actually some fragments of this “yellow wash” have been found in the area where the test cleaning was done. Also, in the upper right hand corner of the east wall, in correspondence with the blue shield, the surface is still partially covered with this yellow wash.

One can conjecture that, at times that cannot yet be chronologically fixed, large parts of this wash were removed mechanically, partly causing the present state of conservation of the painted layer.

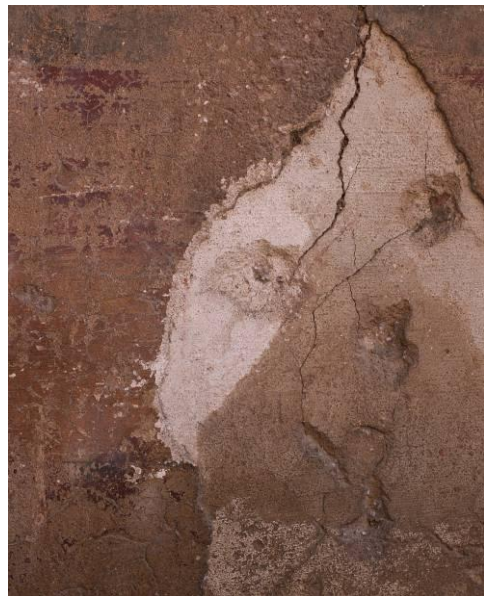
Figure 3

The surface of this rendering, now visible because the covering rendering has fallen off, appears to have been “pocked” (Figure 3). At a time when the rendering must already have been dry, it was prepared to facilitate adhesion of a second layer of rendering. In the present state it is impossible to evaluate how much time passed between the first and second layers of rendering, but it is interesting to stress that, on observing the more recent gaps in the second layer, there is no evidence of a heavy deposit of particulate and dirt between the two layers.

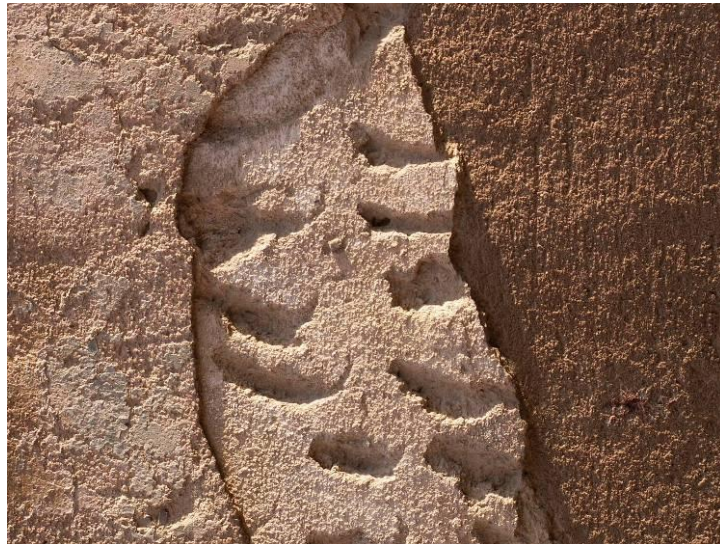
Figure 4

This has a relatively regular thickness varying from 6-7 mm to 11-12 mm (Figure 4). The mortar is presumably made up of a filler (marble dust and quartzite elements) and lime.

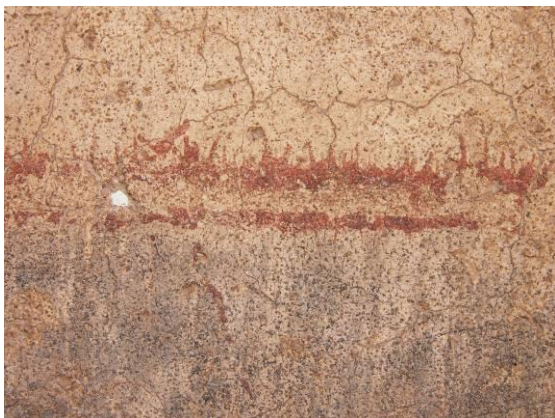
Figure 5

The architectural divisions were roughed out by dividing the horizontal bands that frame the paintings using the *battitura dei fili* technique (Figure 5).

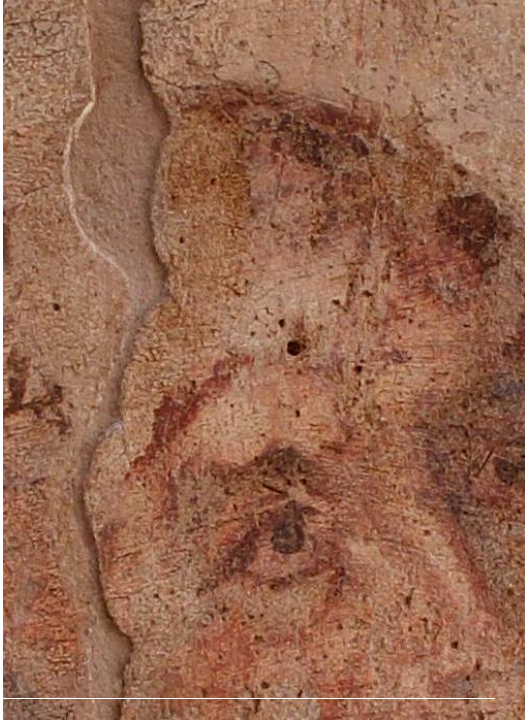
Figure 6

The same pigment used to create the lines was also used to form the square modules of the opus sectile and to sketch in the drawings of the figures (Figure 6).

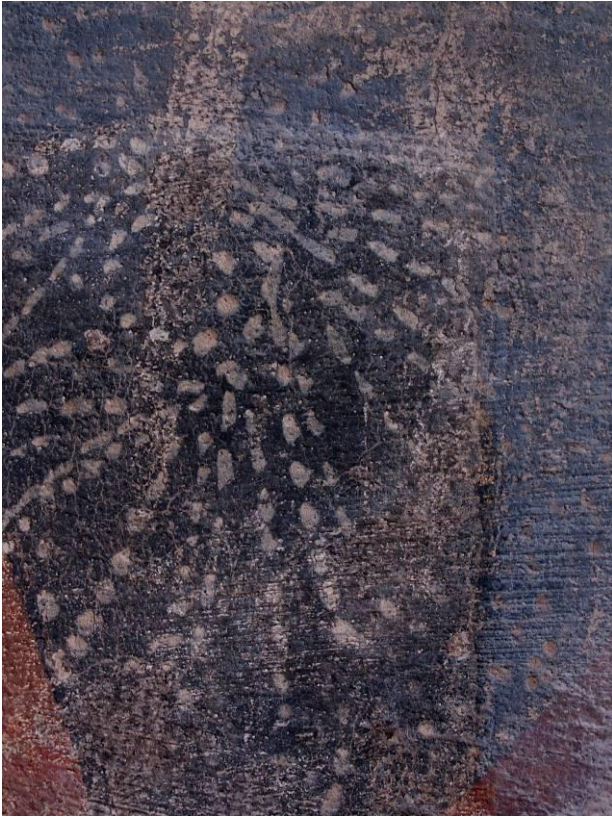
Figure 7

The painting is done in vast, rapid areas of color, revived by quick, impressionistic brush strokes rich with color; the finishing elements are also very dense, such as the small pearls

(Figure 7) decorating the garments of the imperial dignitaries.
