Report On Work At Deir Anba Pishay (Red Monastery)
Site Management and Development Report 2011

“Conservation and Documentation of the Wall Paintings at the Red Monastery, Sohag”

THE RED MONASTERY - DEIR ANBA PISHAY - IN SOHAG

Site Management and Development Report 2011

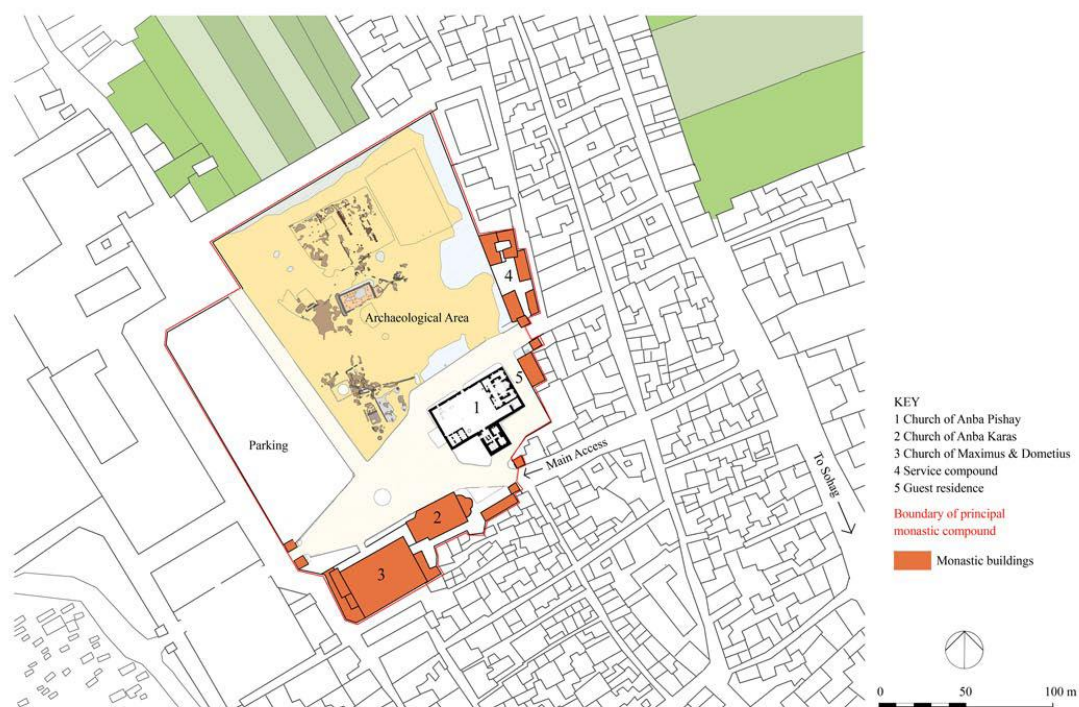
Figure 2: Context plan of the Red Monastery (after Gillian Pyke/Louise Blanke survey and GoogleEarth 2011)

The site occupies an area of approximately 3 hectares (7.4 acres) within a boundary that is clearly defined on the north, west, and east by modern masonry walls. Beyond the boundary to the west lies a modern Coptic cemetery and further monastic facilities, including a church and living quarters for monks, as well as a large area of agricultural land reclaimed from the desert. To the east lies the main approach road through a settlement mostly composed of modern reinforced concrete and fired brick structures. Construction to the north is less dense, with remaining pockets of agricultural land, and to the south lies the major part of the adjacent village. The ground level of the site rises slightly from east to west, with a general datum of approximately two metres above the level of the main approach road beside the cultivation to the east.

Access to the interior of the site is currently controlled by four modern gates, with the main approach on the south-eastern corner being made through a gatehouse with towers (the south gate). A comparable gatehouse lies to the east, which is currently unused, while the north gate is only occasionally used. The bulk of what ‘through traffic’ there is on the site passes through the west gatehouse to the monastic properties beyond. Within the boundary wall lies the ancient church of the monastery and the surviving archaeological content of the site, as well as a number of modern structures related to contemporary monastic life clustered along the southern boundary. These include two new churches, dining facilities, toilets, a souvenir shop and a pharmacy. Immediately outside the eastern boundary of the site is another group of modern buildings developed by the monastery, containing additional public toilets, dormitories for staff, an abattoir and a further dining hall.

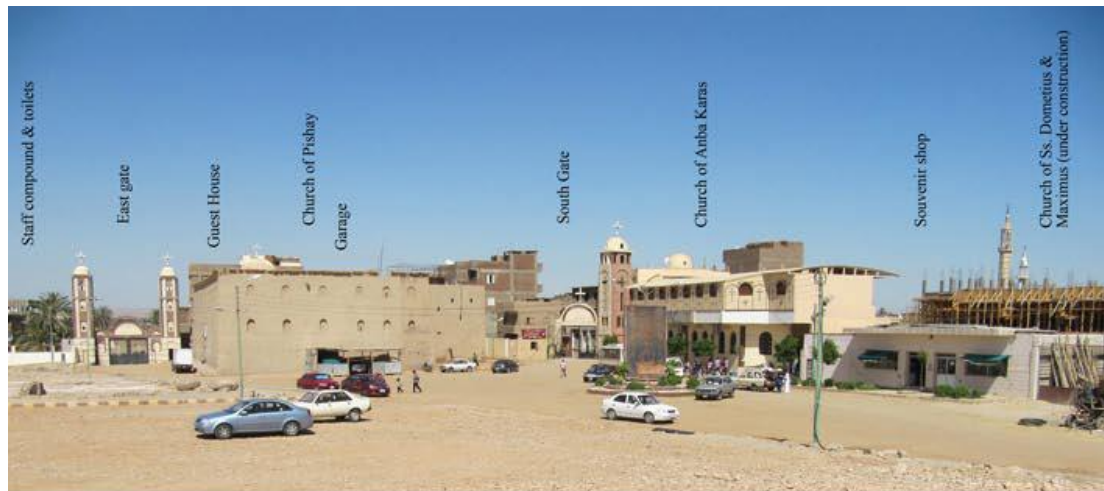
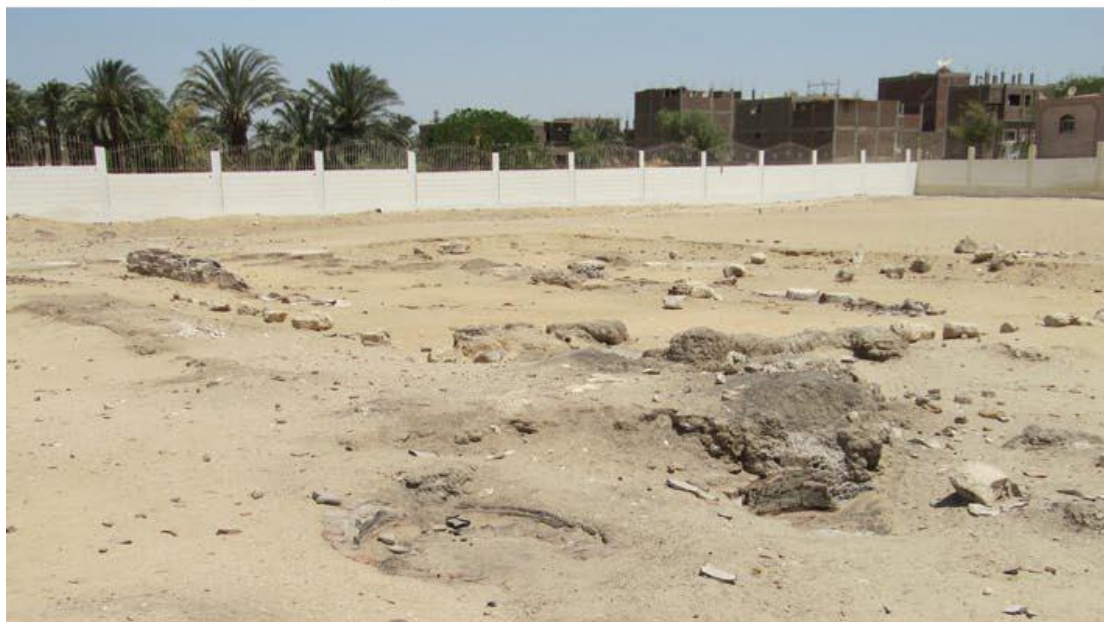
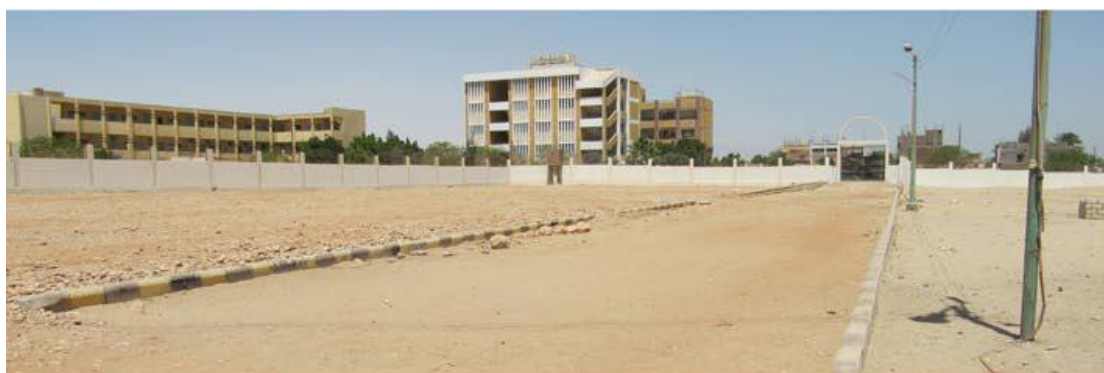
Figure 4: Views of the site looking east and north (photos 2011: N. Warner)

View of monastic compound looking east

View of archaeological area looking northeast

View of parking area and north gate

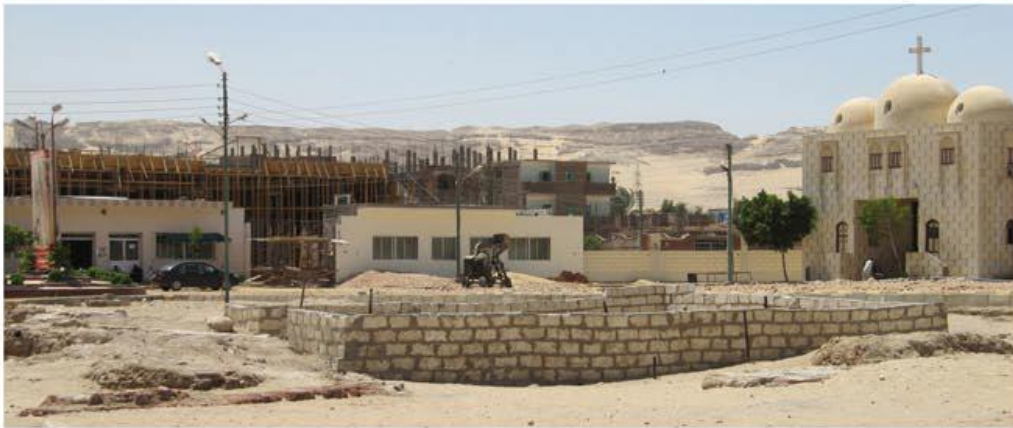
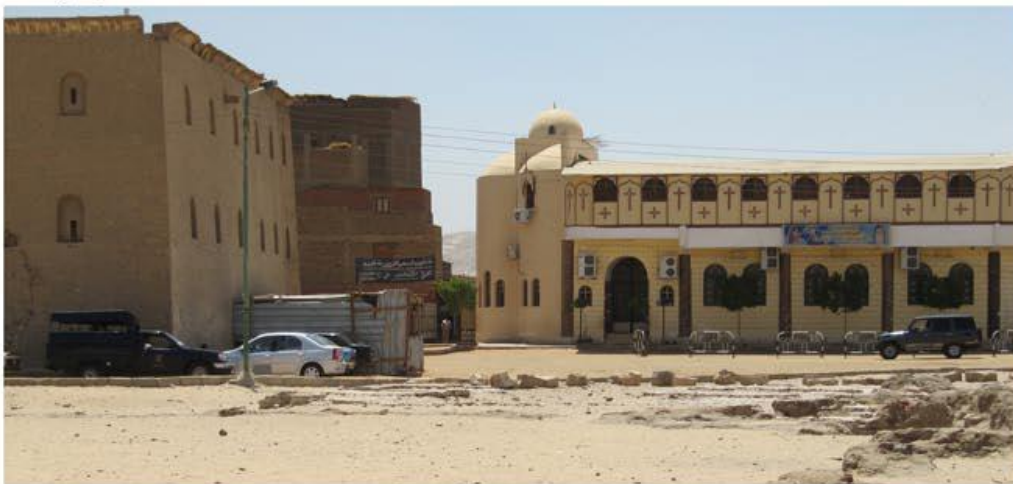
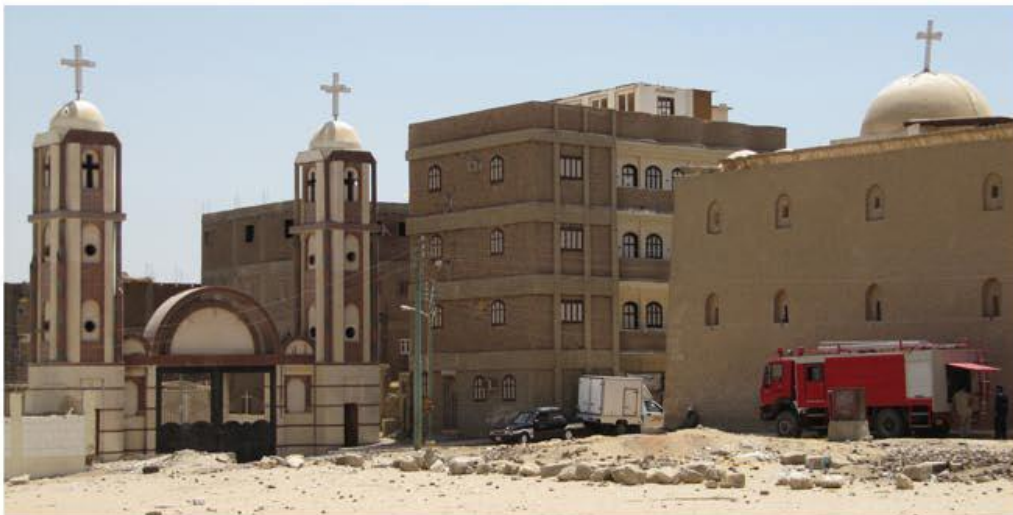
Figure 5: Views of the site looking south (photos 2011: N. Warner)

West gate, church of Ss. Dometius and Maximus and wall around well

West end of church and new church of Abuna Karas

East gate to compound, guest house, and east end of church

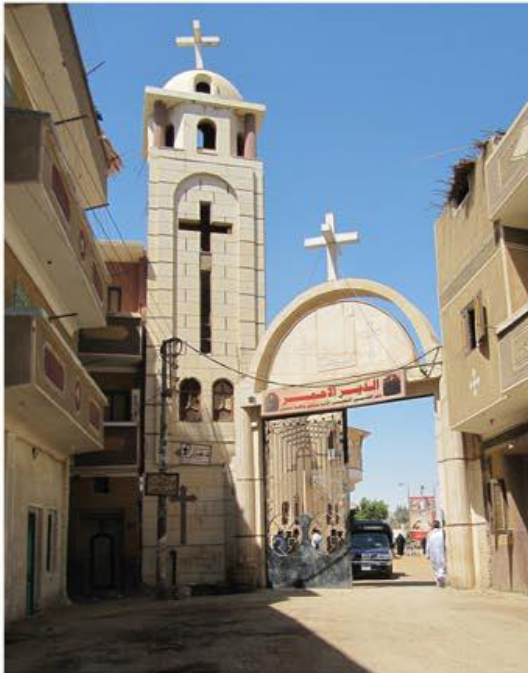
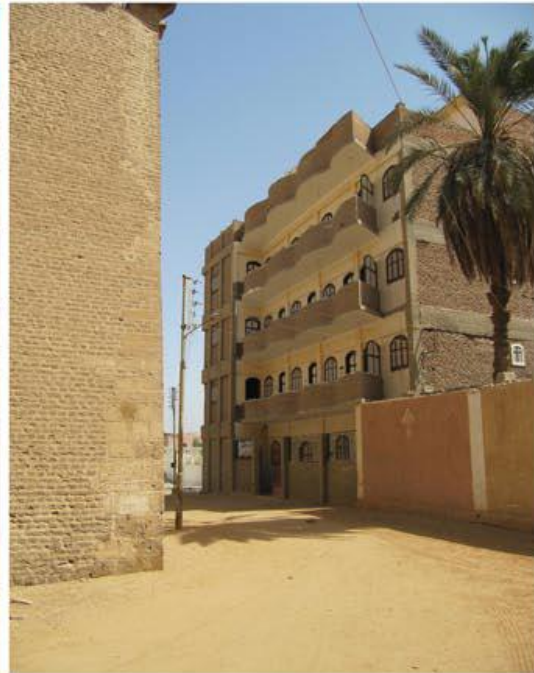
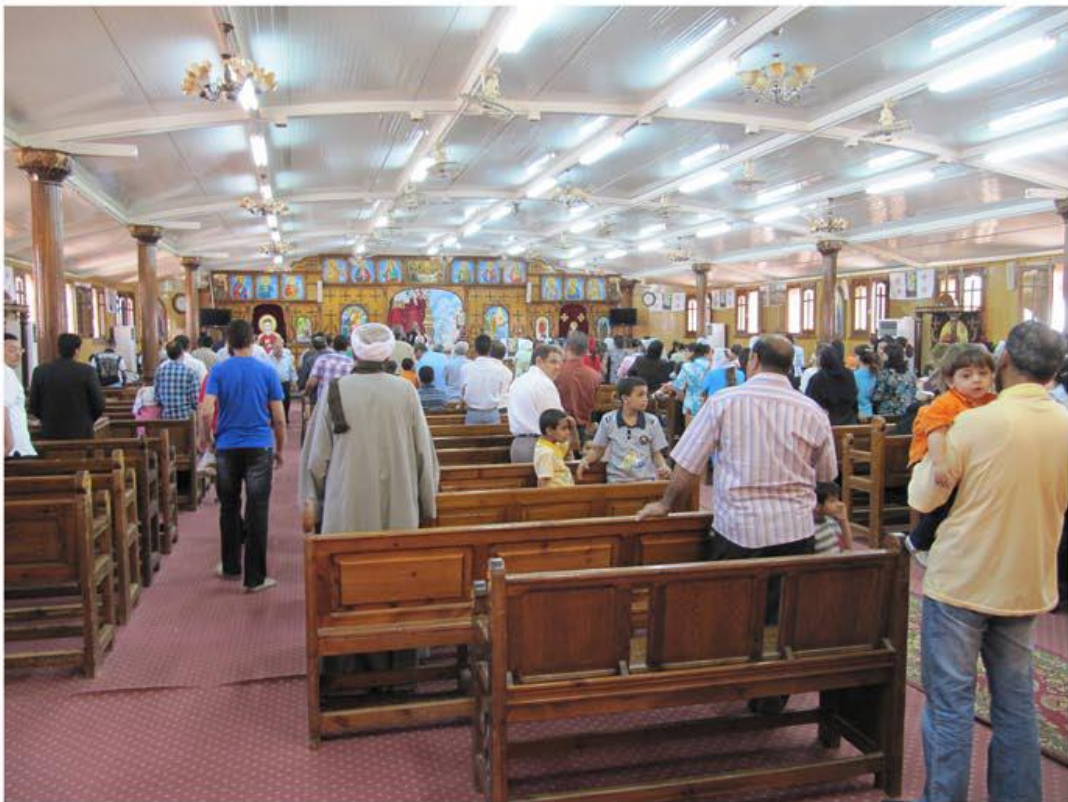
Figure 6: The south gate, guest house, and church of Anba Karas (photos 2011: N. Warner)

Exterior view of south gate

View of guest house to east of church

Interior of new church of Anba Karas (first floor)

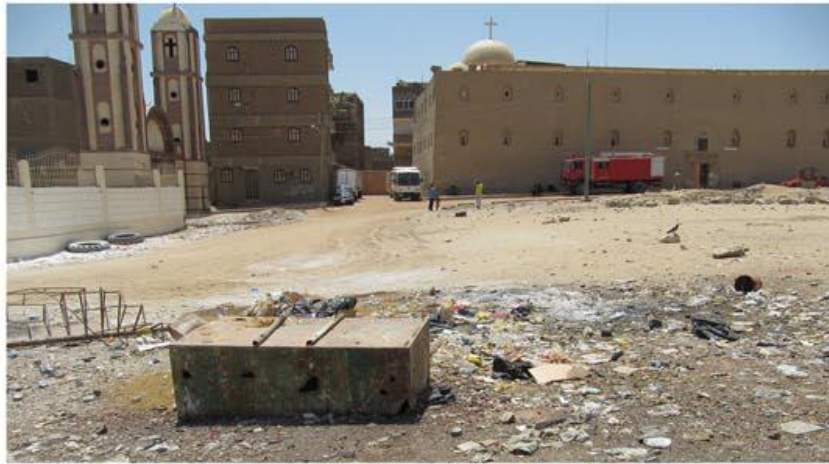
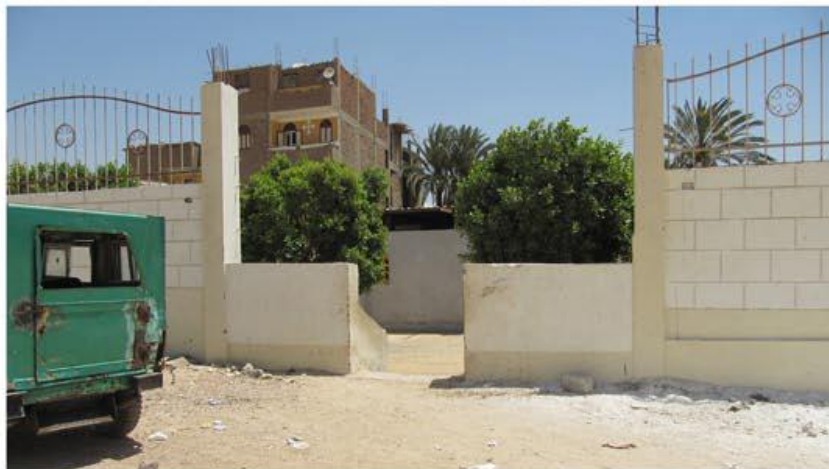
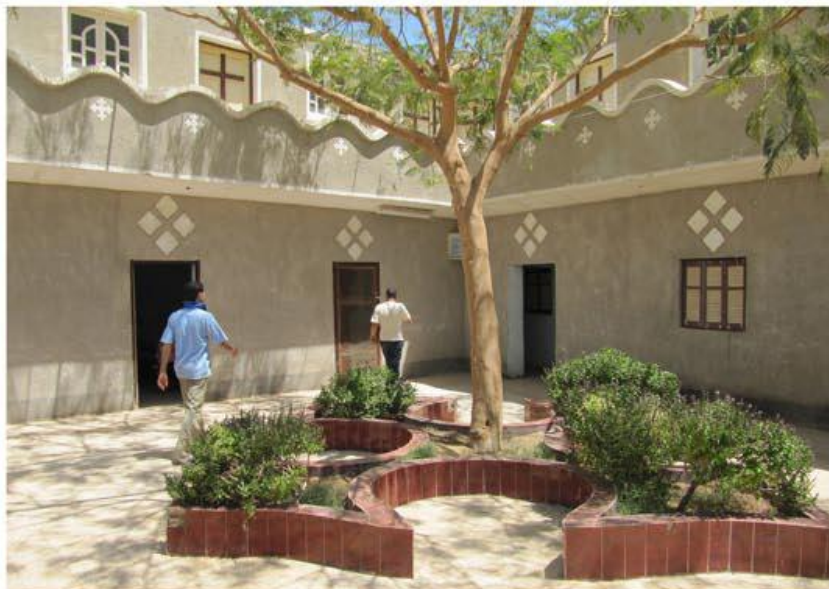
Figure 7: The area north of the church and staff compound (photos 2011: N. Warner)

View of church, guest house and east gate from garbage dump to north

Entrance to the staff compound through the east boundary wall

Living quarters in the staff compound

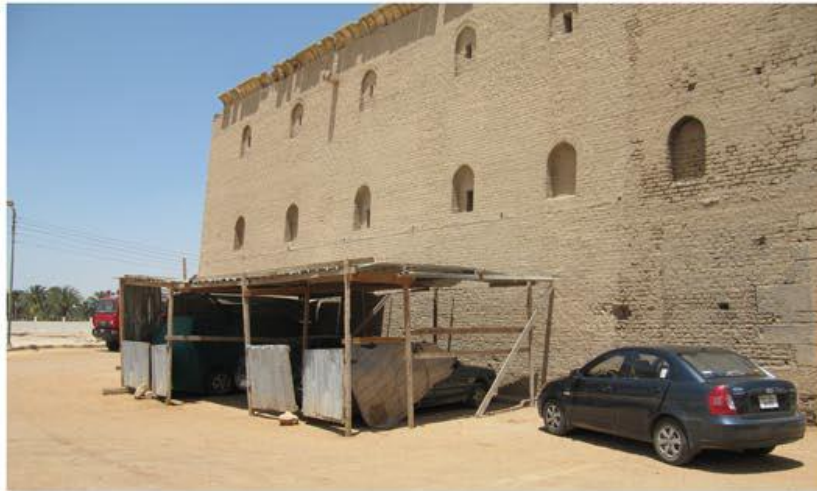
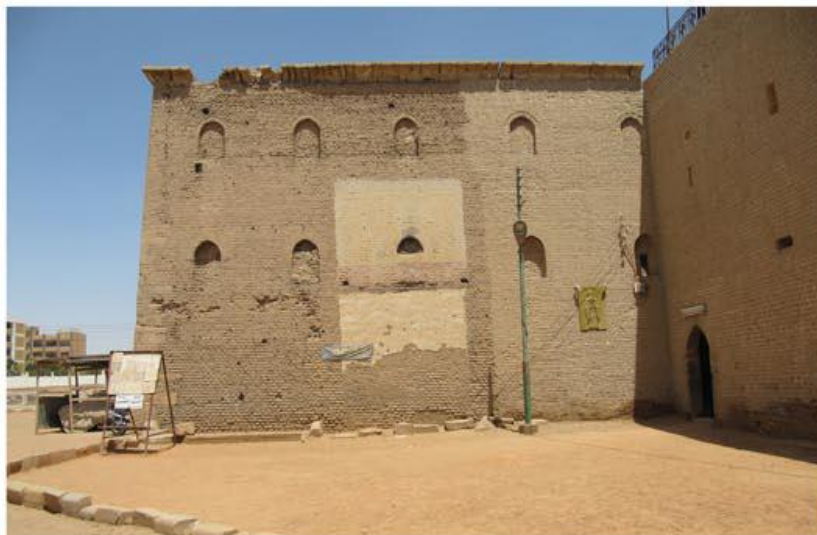
Figure 8: Exterior views of the church (photos 2011: N. Warner)

West façade of church with garage

Main entrance and south façade

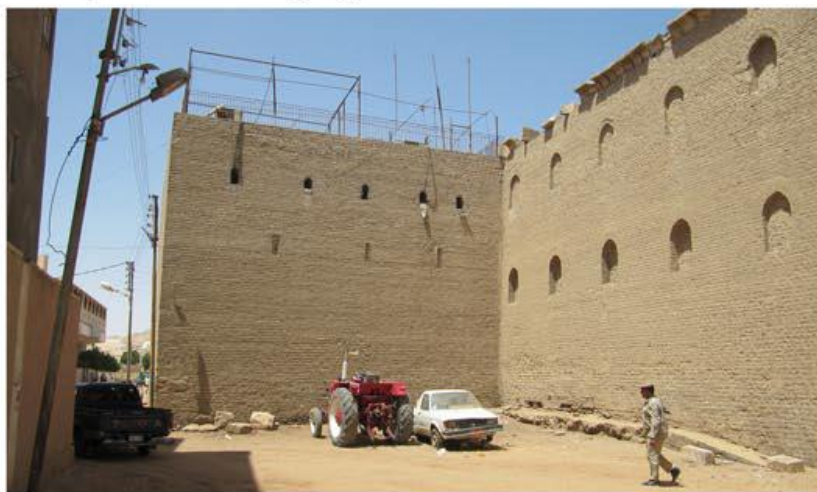
The keep and south façade with concrete ring beam

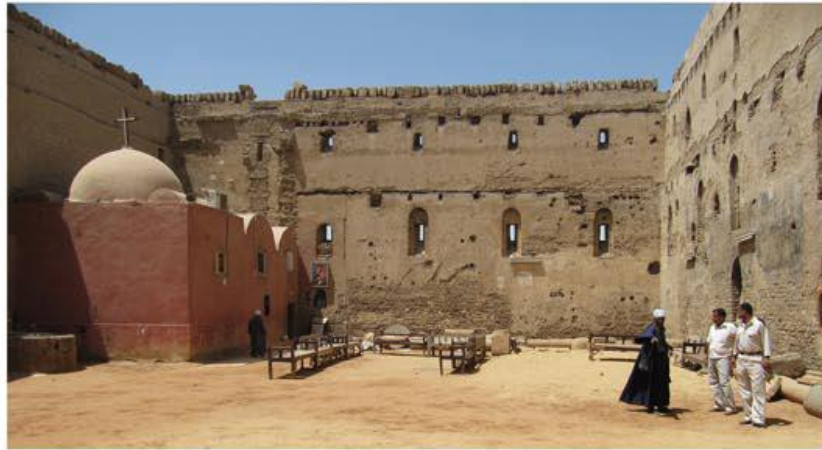
View of nave looking west (photo 2011: N. Warner)

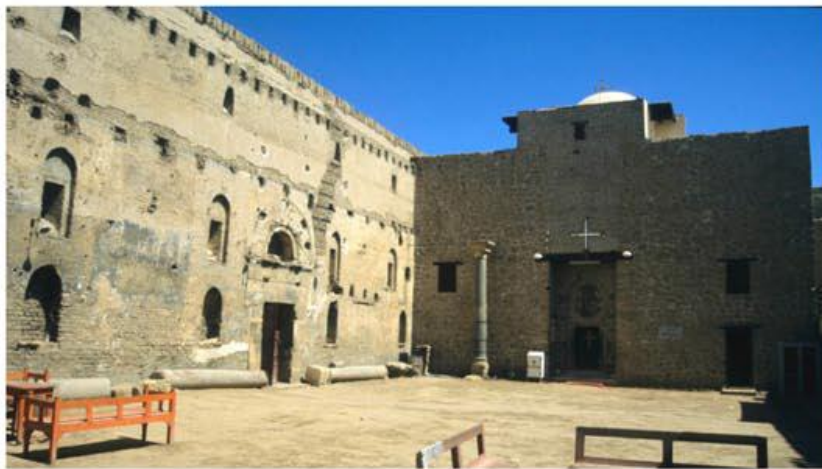
View of the nave looking east (photo 2010: M. Jones)

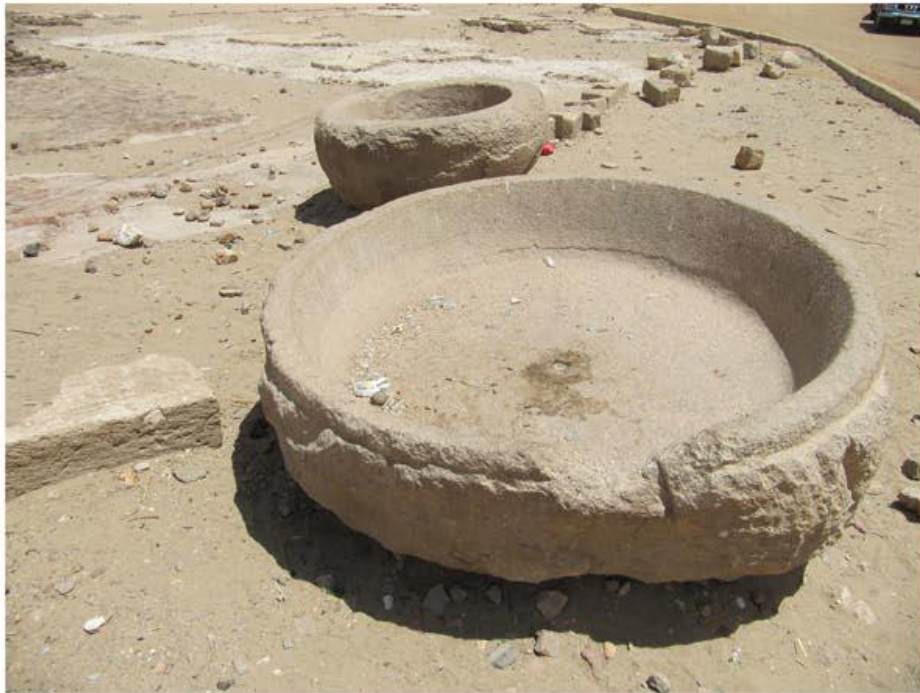
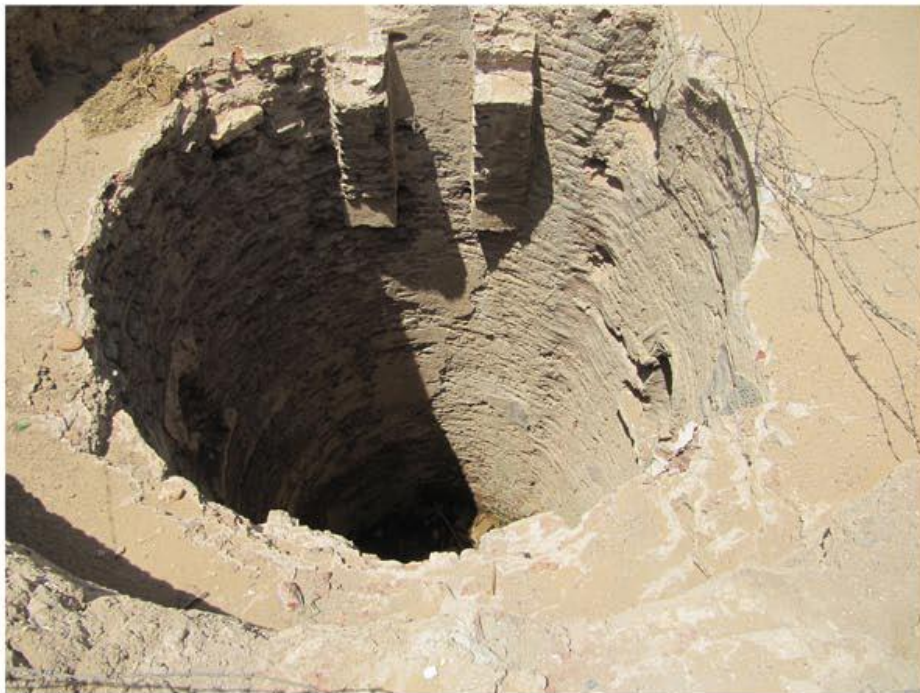
Figure 11: View of granite basins and well to northwest of church (photos 2011: N. Warner)

- 3 The water supply to the well should be cancelled and the well cleaned out. Drinking water is now available from other locations on site.
- 4 The souvenir shop should be removed, along with all other unsightly intrusions such as air-conditioning units and electrical cables hacked into the walls.

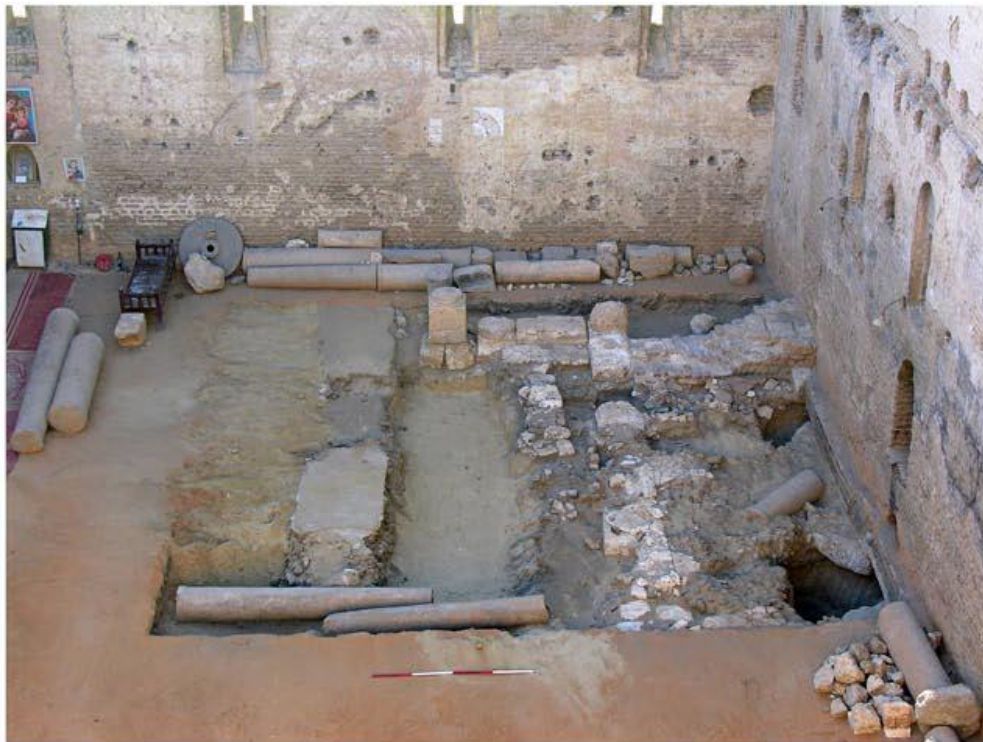
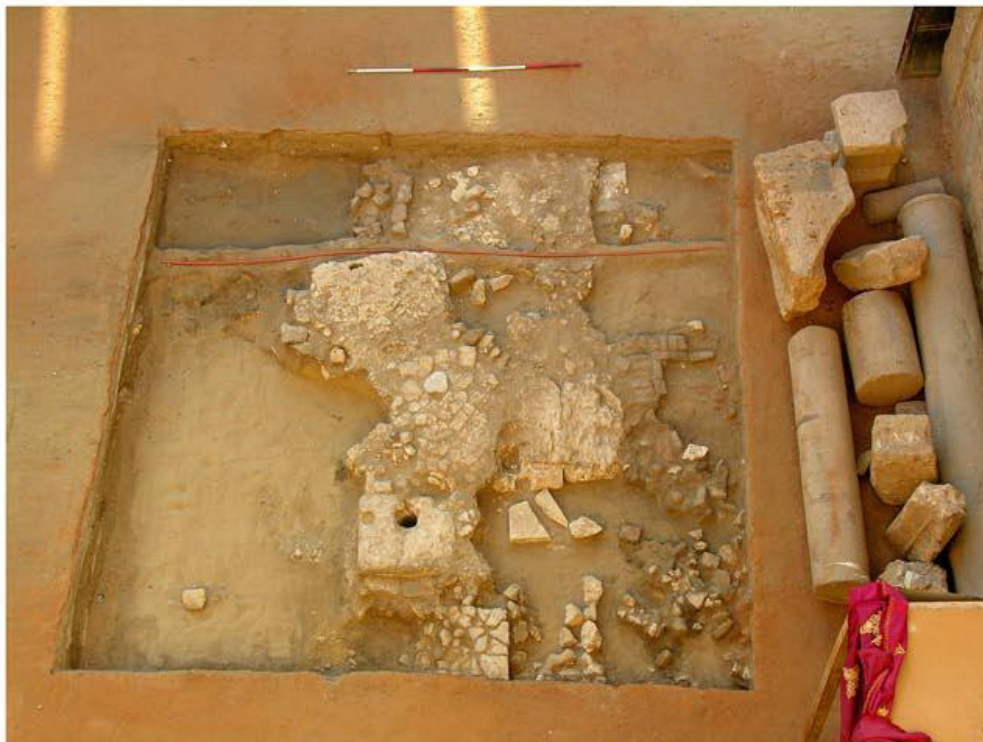
Figure 14: ARCE excavations in the church (photos 2010: M. Jones / L. Hackley)

The excavation and documentation of archaeological remains at the site is ongoing, under the direction of the Sohag Inspectorate of the MSA and the ARCE. This work normally takes place during the fall, winter and spring. As yet there is no published data on the results of these excavations, although a preliminary documentation was made in 2011 of the exposed remains to the north of the church. The church itself has been the subject of detailed architectural recording on three occasions: the first unpublished survey was carried out by a team from the Darmstadt Technical College in 1962, the second in 2003 by Michelangelo Lupo, and since 2005 the author of the present report has carried out architectural documentation of the building in tandem with the program of wall-painting conservation. This information is scheduled for publication in a monograph devoted to the church in 2013.

View of excavation at west end of the nave

View of excavation in central area of the nave

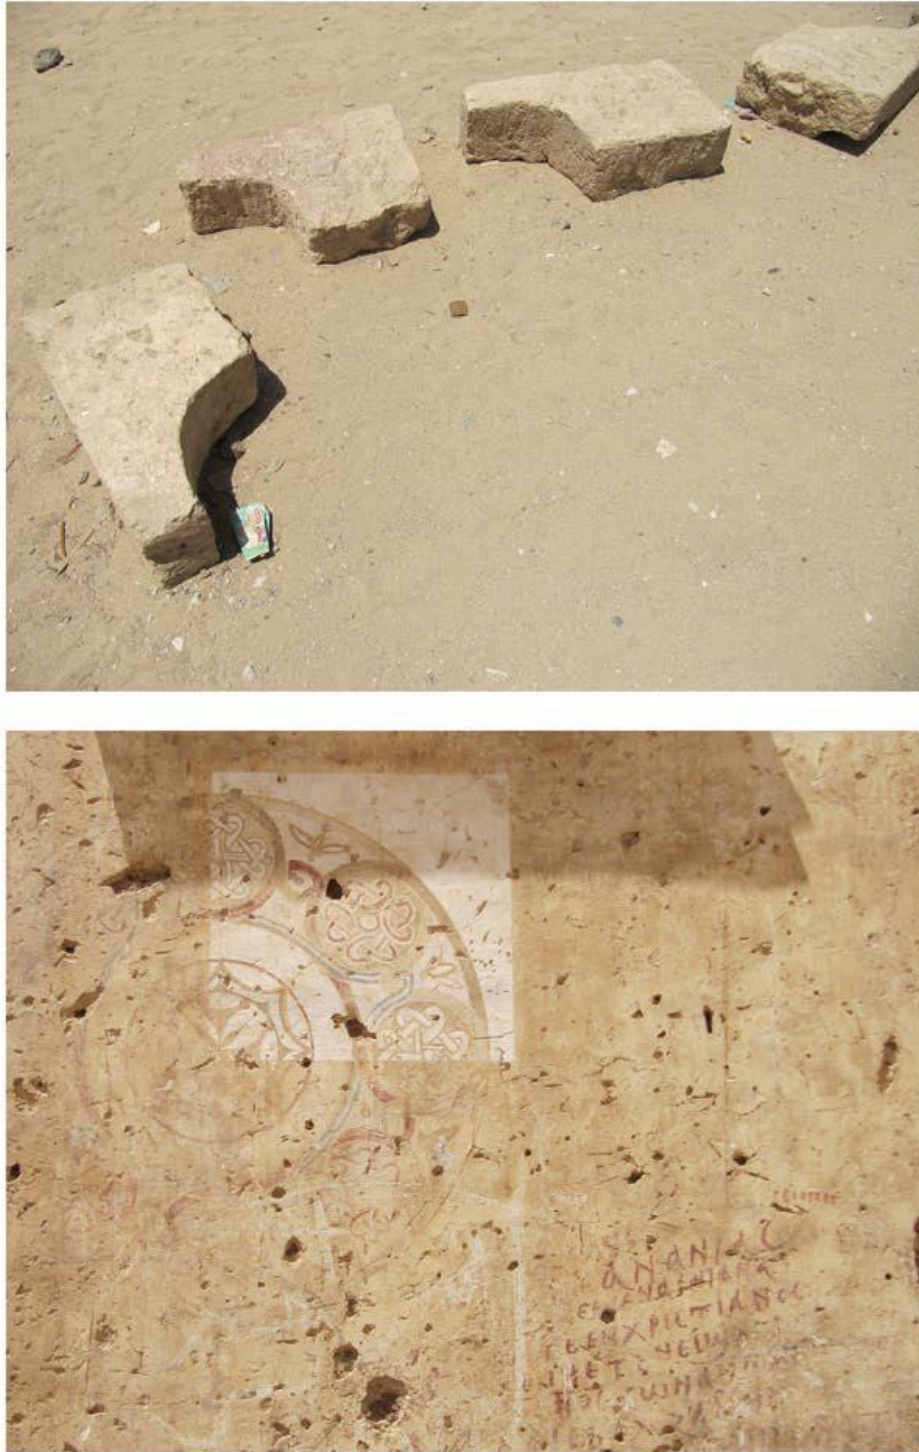
In the last twenty years, the Antiquities Department has undertaken several projects of significance in the church. These include paving the interior of the sanctuary with new limestone slabs laid over a concrete slab (circa 1986), repointing all exposed areas of brickwork in the perimeter wall, stitching cracks in the brickwork of the perimeter wall and surrounding the perimeter wall at its base with reinforced concrete ring beams both internally and externally. These interventions, carried out in the 1980s and 90s, have in some cases compromised the integrity of the building and are of dubious value from a conservation standpoint. In 2006 a structural report on the building's integrity was commissioned from Price & Myers Structural Engineers, a London-based firm. Although the building was found to be generally in a stable condition, the report made a number of recommendations that have already been addressed with the exception of the need to carry out repairs to the external brick envelope where the horizontal structural integrity of the wall has been compromised by the loss of adequate bonding in the surrounding brickwork.

Within and around the enclosure of the church there are numerous examples of loose Late-Antique and Coptic period architectural elements lying on the ground that are particularly vulnerable to damage. These include over 50 limestone cornice blocks as well as column shafts and capitals. In 2010 test cleanings of painted plaster surfaces in the nave of the church revealed high quality mediaeval wall paintings. This discovery may potentially lead to further large-scale conservation work in this area, and also raises the question of how this information may be best conserved and protected in the future.

Figure 15: Loose cornice blocks outside the church [top] and test cleaning of plaster on the west wall of the nave (photos 2011: N. Warner)

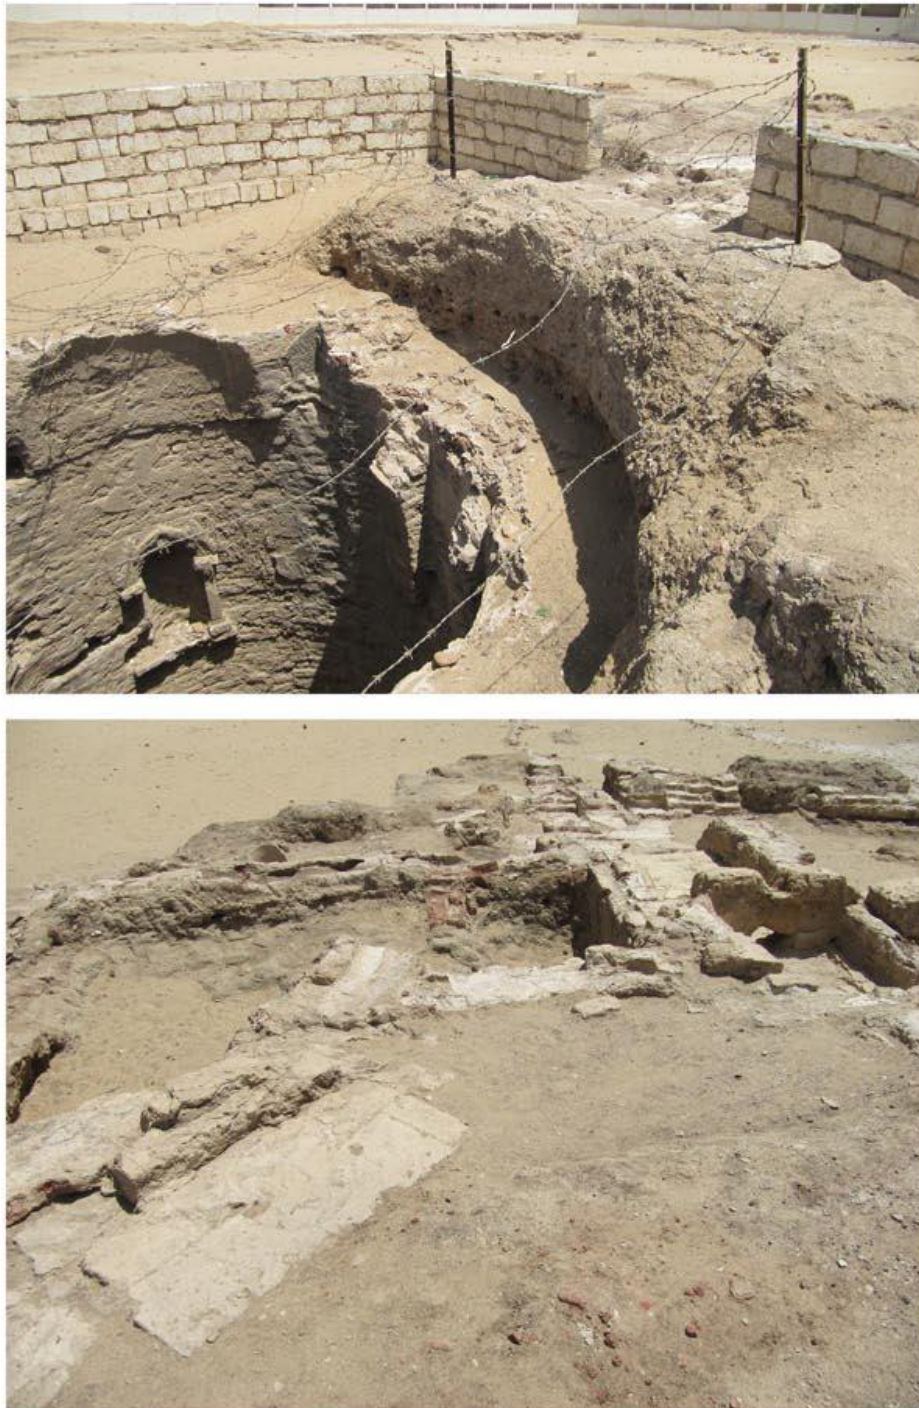
At present the majority of already excavated areas on the site are left exposed. This renders them vulnerable not only to general deterioration due to environmental factors, but also to anthropogenic damage (a football pitch occupies part of the site). Only one area, enclosing the well to the northwest of the church, is currently protected by a combination of a limestone block wall and a loose barbed-wire fence. Despite this nominal enclosure the well still poses a risk to visitor safety, and especially that of children. Spoil heaps from the excavations can be seen around the perimeter of the site. Excavations carried out within the nave of the church by the ARCE have been backfilled upon their conclusion, and pending further exploration of this area.

Figure 16: The enclosed area around the well [top] and exposed adjacent remains of water channels (photos 2011: N. Warner)

The area around the well outside the church would lend itself to a limited intervention as has already been described in II.1.1 and figure 17. The components of this would be the construction of a barrier to the perimeter of the area, the consolidation of remains within the area, the introduction of an elevated walkway and point of access, and the provision of a balustrade around the well to allow for safe viewing together with an explanatory visitor panel.

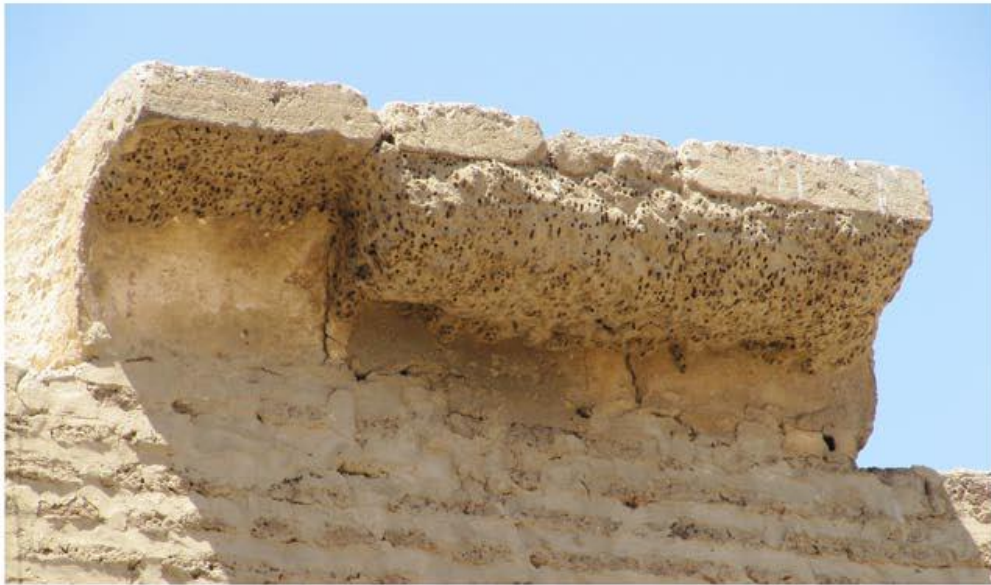
Hornets' nests attached to underside of cornice blocks

Figure 18: Conservation problems of the perimeter wall of the church (photos 2011: N. Warner)

- 4 Depending on how it is decided to protect the surfaces of the north and west walls after conservation, it might also be necessary to block the numerous existing beam holes in the walls with lime mortar plugs to within 4cm of their external face. This would prevent birds from nesting in these holes in the future and marking the surfaces of the walls with droppings.

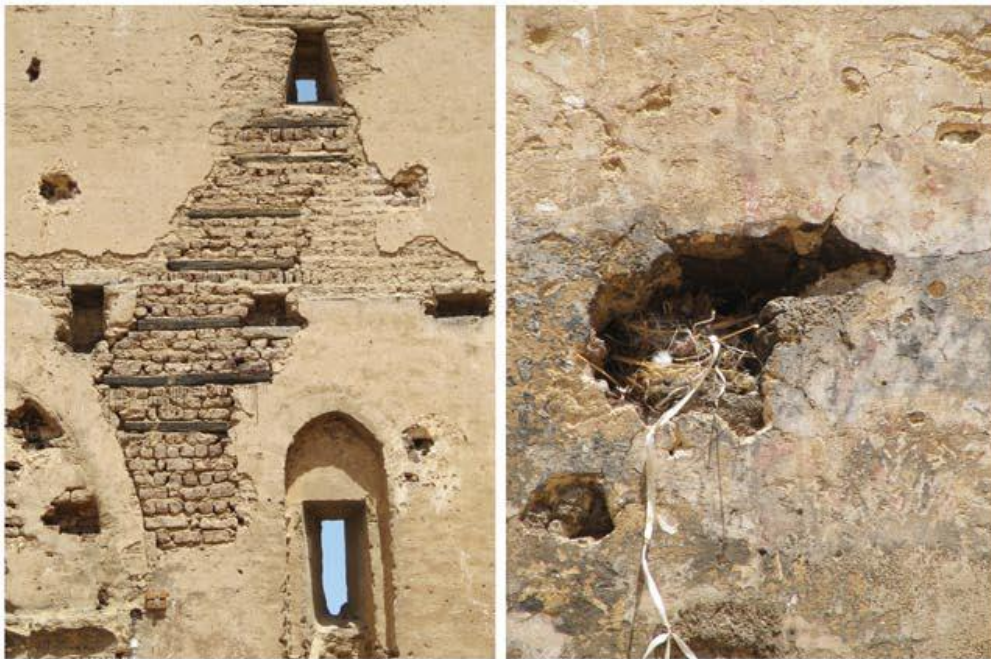
Inadequately bonded repair to brickwork of wall [left] and nesting birds in beam holes

- 1 The replacement of inadequately bonded earlier repairs to the brickwork on the north and west perimeter walls following the recommendations of the Price & Myers Structural Report of 2006.

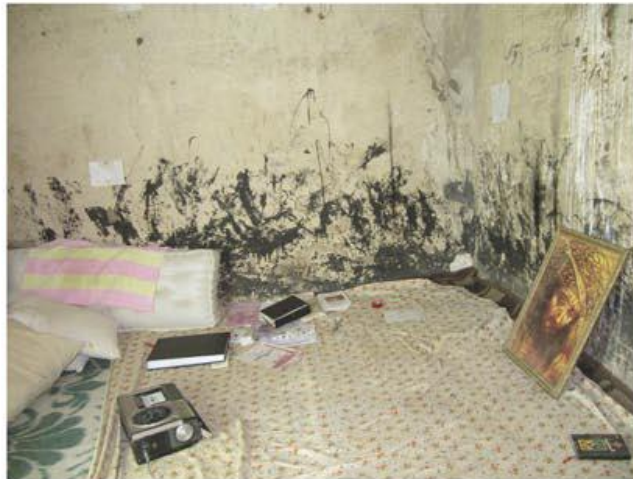
Monk's cell in interstitial space above sanctuary

- 1 To either side of the sanctuary above the pastophoria are small interstitial spaces with restricted headroom. To the south, these have been occupied by one of the monks of the monastery as a place of rest and meditation with electricity supplied through an extension cable. It is recommended that these spaces be placed strictly off limits to members of the community owing to their proximity to the sanctuary and the impossibility of preventing an electrical fire in such a location from spreading. It is also recommended that the windows into these spaces are covered with bird mesh in well-fitting frames to prevent the entry of nesting pigeons.

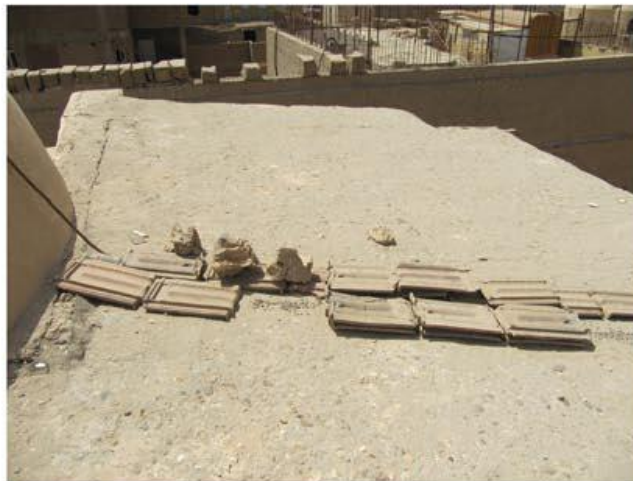
Concrete roof to west of sanctuary façade, loose cable, and original roofing tiles. Note crack at abutment of sloping roof with wall and lack of drips on leading edges

3 The cracked cement render above the Comité roofs to the west of the sanctuary façade should be removed, the integrity of the waterproof isolation examined and replaced if necessary by a bituminous membrane, and the roofs given a new finish such as 5-7cm white cement carefully laid in squares with a galvanised metal drip at their front edges. At present there is no drip on the leading edge of these roofs. This work would also require the installation of a full height scaffold. If possible, methods of improving the thermal performance of the roofs through the introduction of lightweight insulation materials or secondary roofs should also be investigated. In this context it should be noted that the *Comité* roofs of 1909 were originally covered with ceramic tiles for precisely this reason.

4 Loose electricity cables passing over the surface of the roof should, wherever possible be routed within the building where they are less likely to deteriorate from exposure to the sun. The cable leading to the apex of the dome should be housed in a sub-surface conduit that is plastered over or externally mounted within a galvanised metal pipe curved to the profile of the dome.

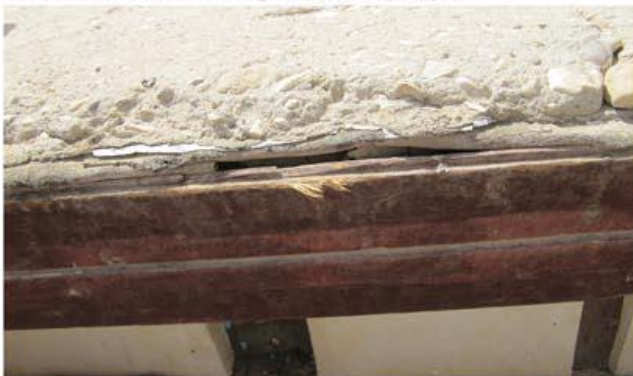
Edge of concrete roof and failed waterproof membrane to edge of roof to west of sanctuary
