RED MONASTERY CONSERVATION PROJECT

FINAL REPORT, DECEMBER 10, 2019

DR. NICHOLAS WARNER

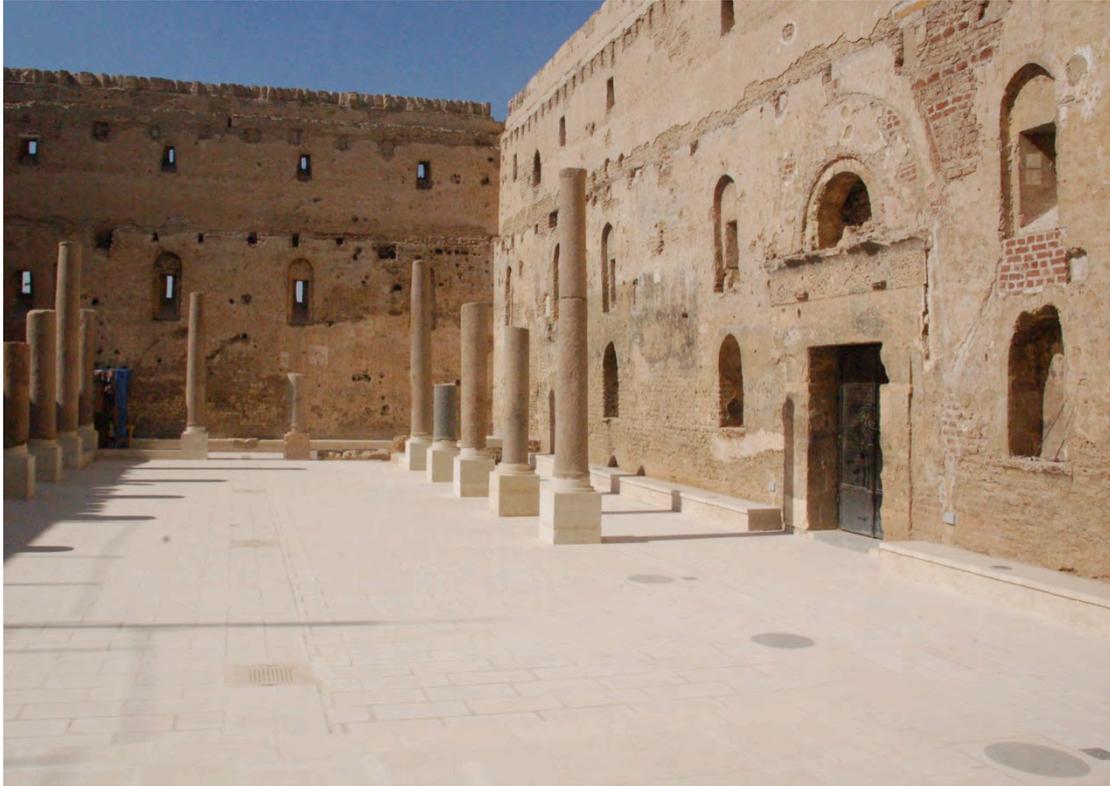
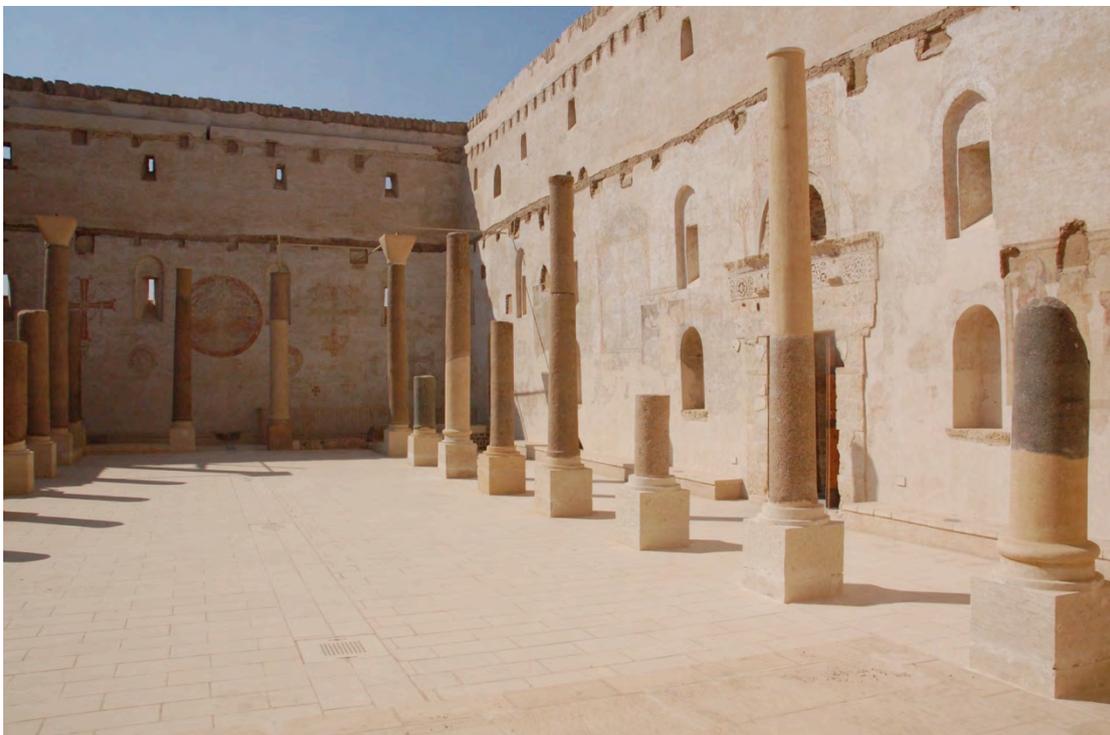
View of the north colonnade of the nave in 2015 (top) and after completion of anastylos in 2019 (bottom)

North side: an additional three loose fragments of granite columns from the structure of the nave were installed on new limestone bases at the east end of the north colonnade. One of these was completed to its full height of 4.13m with fired bricks laid in lime mortar around a stainless steel post to provide support for the planned shelter in this location. The bricks were plastered with a lime plaster of neutral color. One existing fragment, to the west of the north portal, was flipped 180 degrees to its correct orientation. This fragment was supported on a new stainless steel post made of 10 x 10cm angles and 30cm diameter base and top plates. The steel support was the concealed with a covering of fired bricks and lime plaster. Lead was poured under the damaged base of this column to provide extra stability.

West side: One existing fragment, to the north of the central axis of the nave, was flipped 180 degrees to its correct orientation. This fragment was supported on a new stainless steel post made of 10 x 10cm angles and 30cm diameter base and top plates. The steel support was the concealed with a covering of fired bricks and lime plaster. To the south of the central axis of the nave, one existing fragment was completed to its full height of 4.13m with fired bricks laid in lime mortar around a stainless steel post to provide support for the planned shelter in this location.

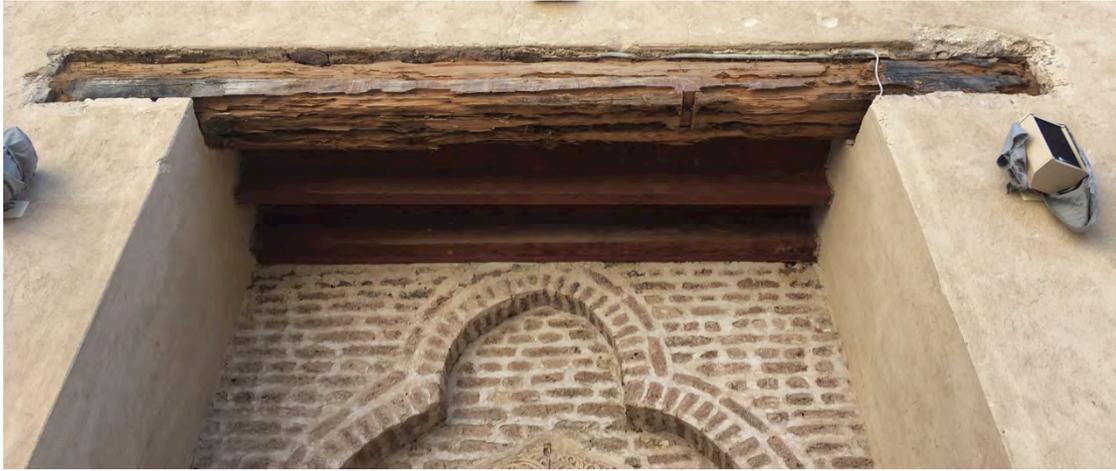
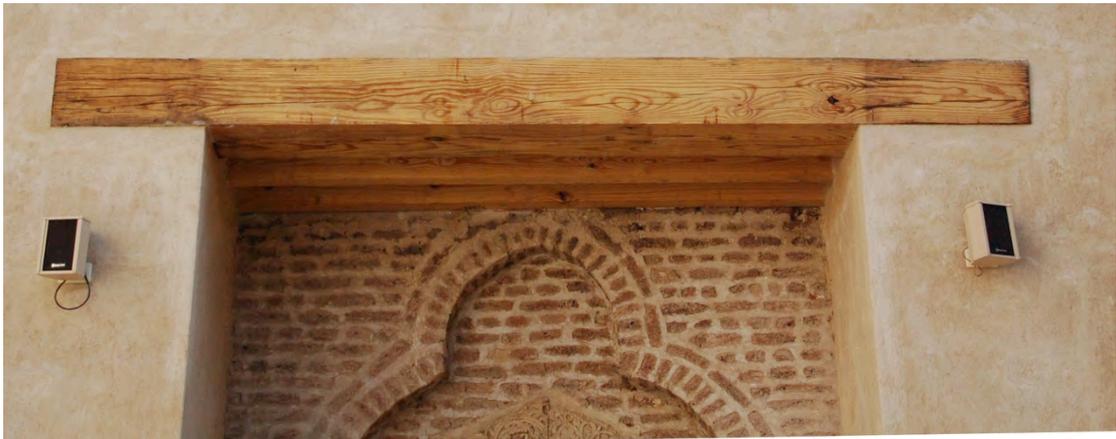
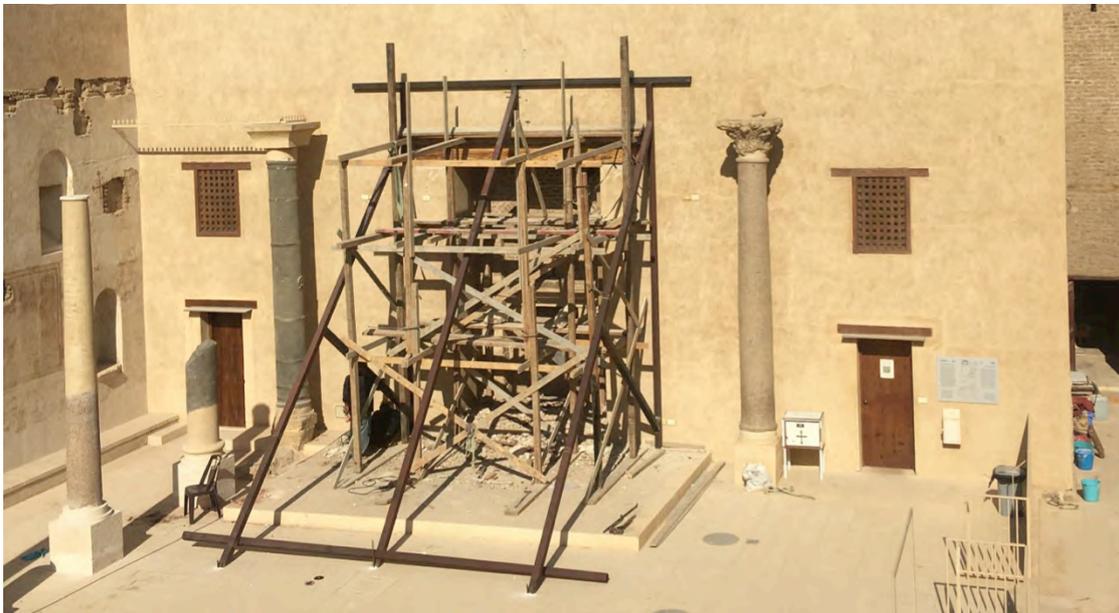
During an investigation of the timber superstructure of the central door of the nave, which is set within the limestone rubble wall constructed by the *Comité de Conservation des Monuments de l'Art Arabe* in 1912, a significant infestation of termites was discovered. This infestation has developed since 2011 when the wall was plastered. The timber structure consisted of two parts: a lintel (4m x 30cm deep x 30cm wide) supporting the wall above, and a boarded ceiling behind (an area measuring 3m x 80cm) supported on three smaller timber rafters (20cm x 10cm) with a brick and plaster fill above them.

Termite damaged lintel and timber platform above the central entrance to sanctuary before (top) and after (centre) replacement and temporary bracing constructed during the timber replacement (bottom)

All the timber in this area was replaced with new 'azizi' wood treated with chemicals to inhibit re-infestation, and all adjacent masonry surfaces were also treated with sprayed termite deterrent. Two new lintels (4m x 30cm deep x 20cm wide) were installed after the masonry of the wall had been braced with a steel structure for safety reasons. These lintels were bolted together with three 10mm diameter stainless steel rods. Following the renewal of the rafters and boarding behind the lintels, the upper surface was painted with bitumen and covered with a plastic sheet, following which the brick and plaster fill above the door was replaced.

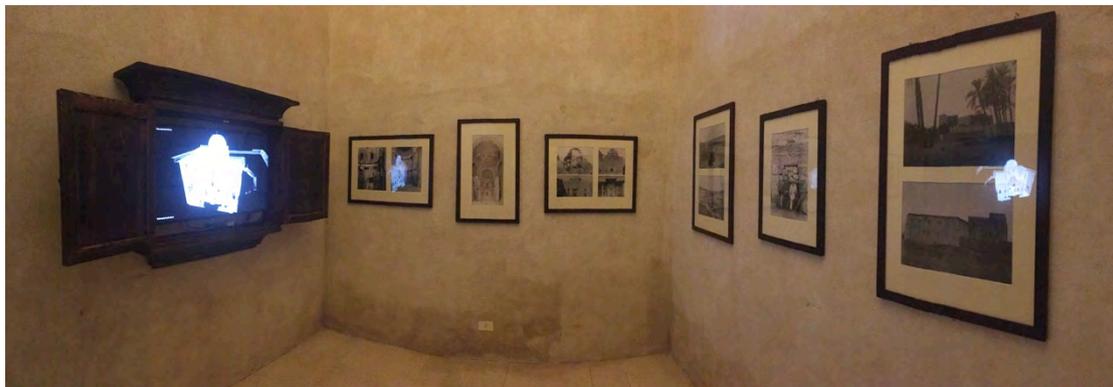
Panoramic view of southeast room of tower, ground floor, after installation of visitor information and screen in cupboard

Additional visitor information was installed in the northeast and southeast rooms on the ground floor of the tower, with the intention of using these rooms as a small visitor center. The northeast room was supplied with images showing the scope of the conservation activities in the church carried out by the American Research Center since work began at the monastery in 2002. A stainless steel lectern was also provided in this room as a support for the 2016 book on the Red Monastery edited by Dr. Elizabeth Bolman. The southeast room contains archival images relating to the church, and a flat screen television in a new timber cupboard for the screening of a short video related to the history of the church and the conservation project carried out by the American Research Center. All the images in both rooms were supplied in glazed picture frames.

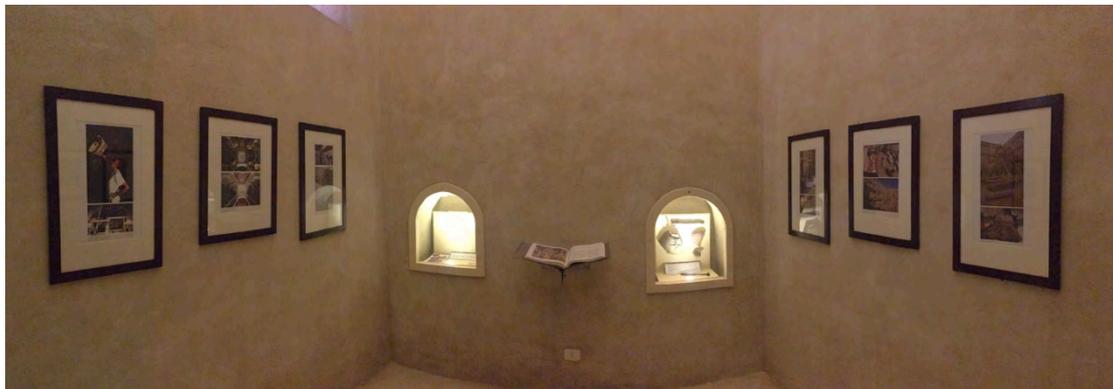
Panoramic view of northeast room of tower, ground floor, after installation of visitor information and lectern

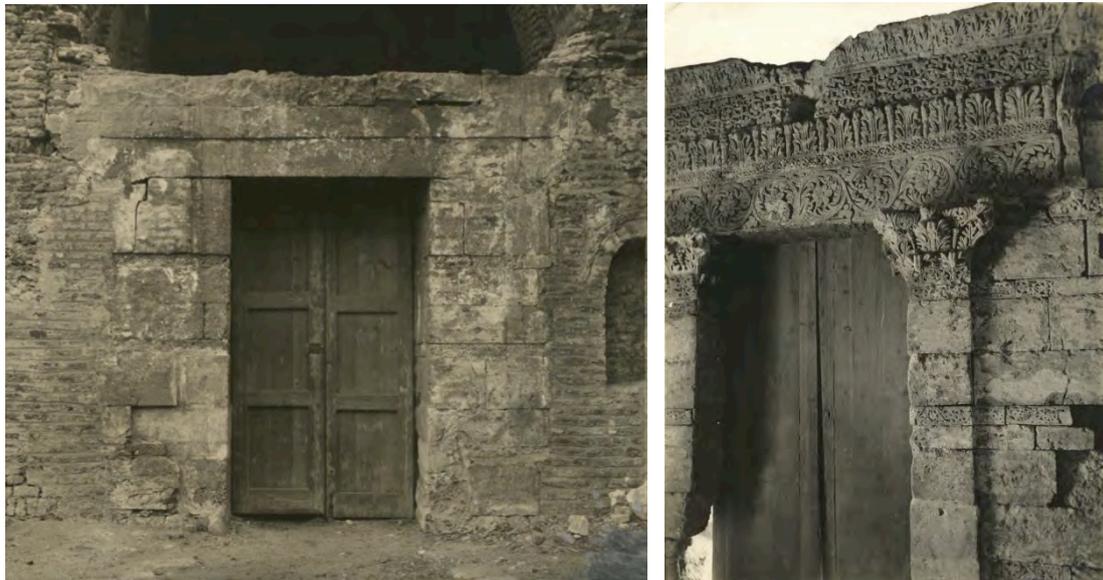
Until 1912, the south face of this portal was completely covered by the construction of the north wall of the tower and its associated barrel vault running east-west. At this time, the *Comité de conservation des monuments de l'art Arabe* removed the north wall of the tower, supporting the masonry above on a new arch made of lightweight hollow blocks. The *Comité* also removed half of the transverse barrel vault, supporting its upper edge on a steel channel, and removed all the brickwork under the large relieving arch above the portal. Subsequent to the work of the *Comité*, at an unknown date, some poor quality masonry replacements were made on the west jamb of the portal, presumably due to the need to swap out water-damaged blocks. In 2015, as part of the ARCE project, a number of limestone block replacements were made on the west jamb and south face of the portal, restoring the original coursing of the masonry. The broken lintel was pinned to a 10 x10cm stainless steel angle running behind it - now concealed by the timber framing of a door that was installed at the same time. In 2017, a stub of surviving masonry from the north wall of the tower, on the east side of the portal, was removed in order to provide access for the cleaning of the eastern niche. The Italian wall-painting conservators had also carried out a test cleaning in 2016 on the carved face of the lintel, revealing some of its polychromy.

The South Portal after the intervention by the Comité in 1912. North face (left) and south face (right)

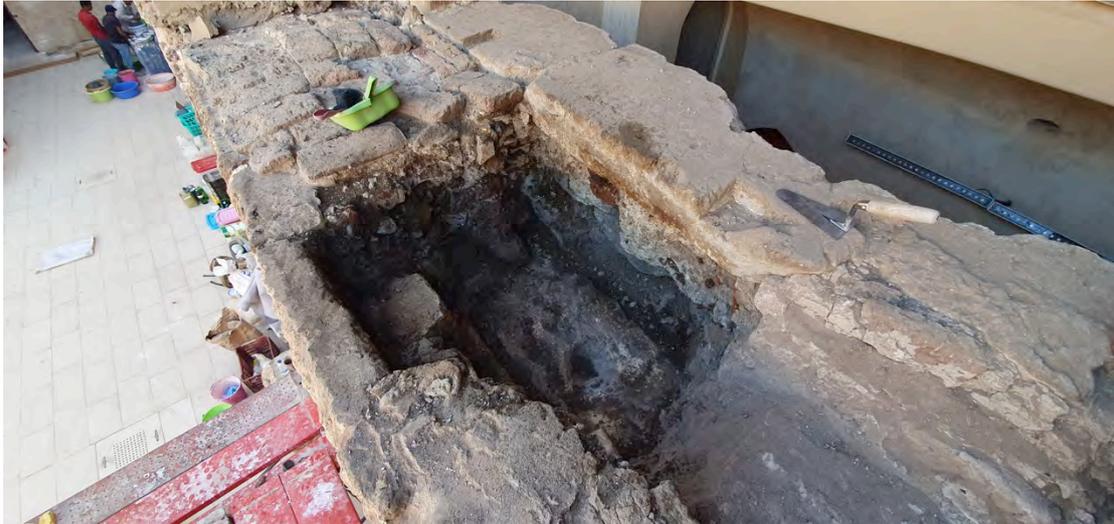
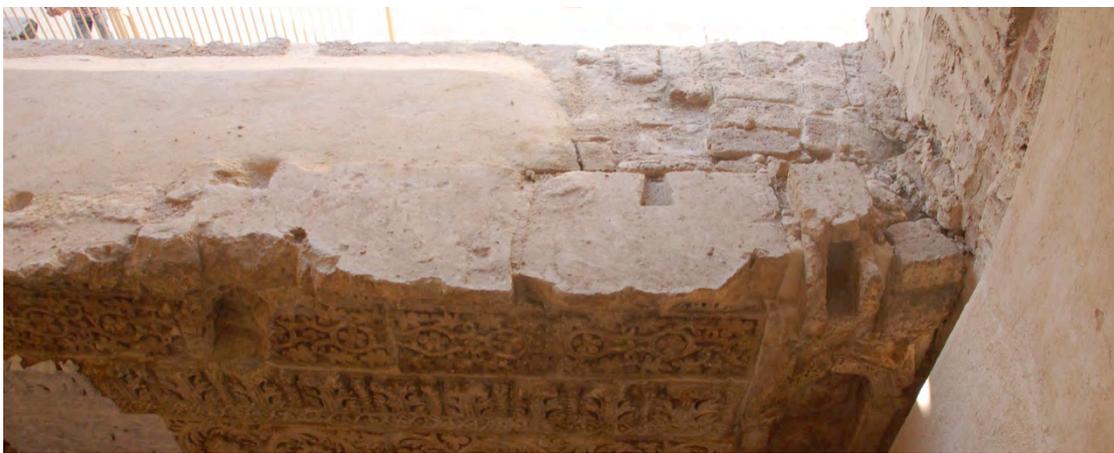
Following cleaning of the top of the portal in this campaign, it appeared that a significant quantity of brick masonry had been removed from the area above the lintels spanning between the jambs, presumably to reduce loading on these elements. The hole had subsequently been filled with debris. Rather than replace this void with solid masonry, a small, brick, relieving arch was constructed over the void, with three courses of brick above it and the top levelled off with a new layer of lime plaster.

The void above the portal after cleaning (top, seen from west) and after repair (seen from balcony to south)

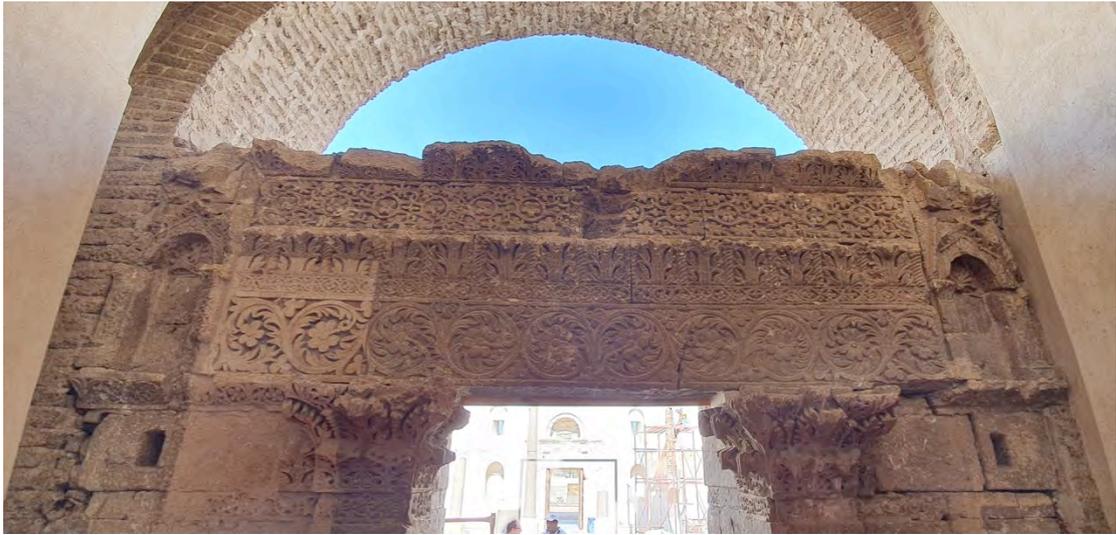
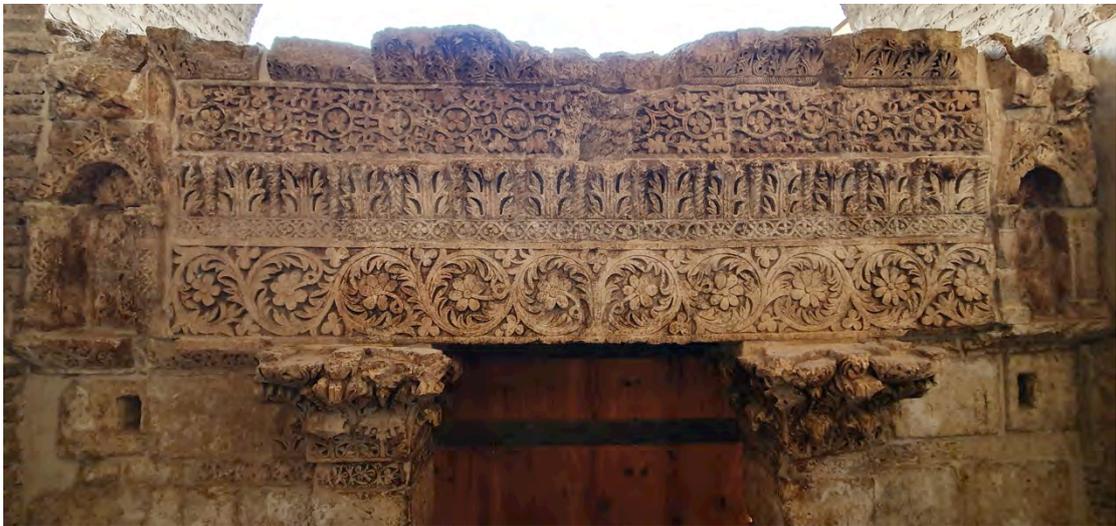
Detail of carved lintel of south portal before (top) and after (bottom) conservation

- All areas were first dusted with soft bristle brushes and then given a light wash with water and sponges
- Modern cement pointing was carefully removed using tungsten tipped chisels

- The stonework was then cleaned using a paper tissue poultice with 7% ammonium carbonate
- A paper pulp poultice with 5% ammonium carbonate was used to remove thicker deposits

- Some secondary cleaning was carried out to even the levels of cleaning using a paper tissue poultice with 5% ammonium carbonate
- Deep pointing was carried out using a pozzolanic lime-based mortar (1 lime, 2 coarse sand, 1 coarse brick)

- Open joints in adjacent brickwork were repointed using a lime-based mortar (1 lime, 2.5 coarse sand, 0.5 stone dust).
- Open joints within the stonework were repointed with a lime-based mortar (1 lime, 2.5 fine sand, 0.5 stone dust)

- Missing areas of lime plaster were completed with a lime-based render (1 lime, 1 fine sand, 1 stone dust, 1 tafla)

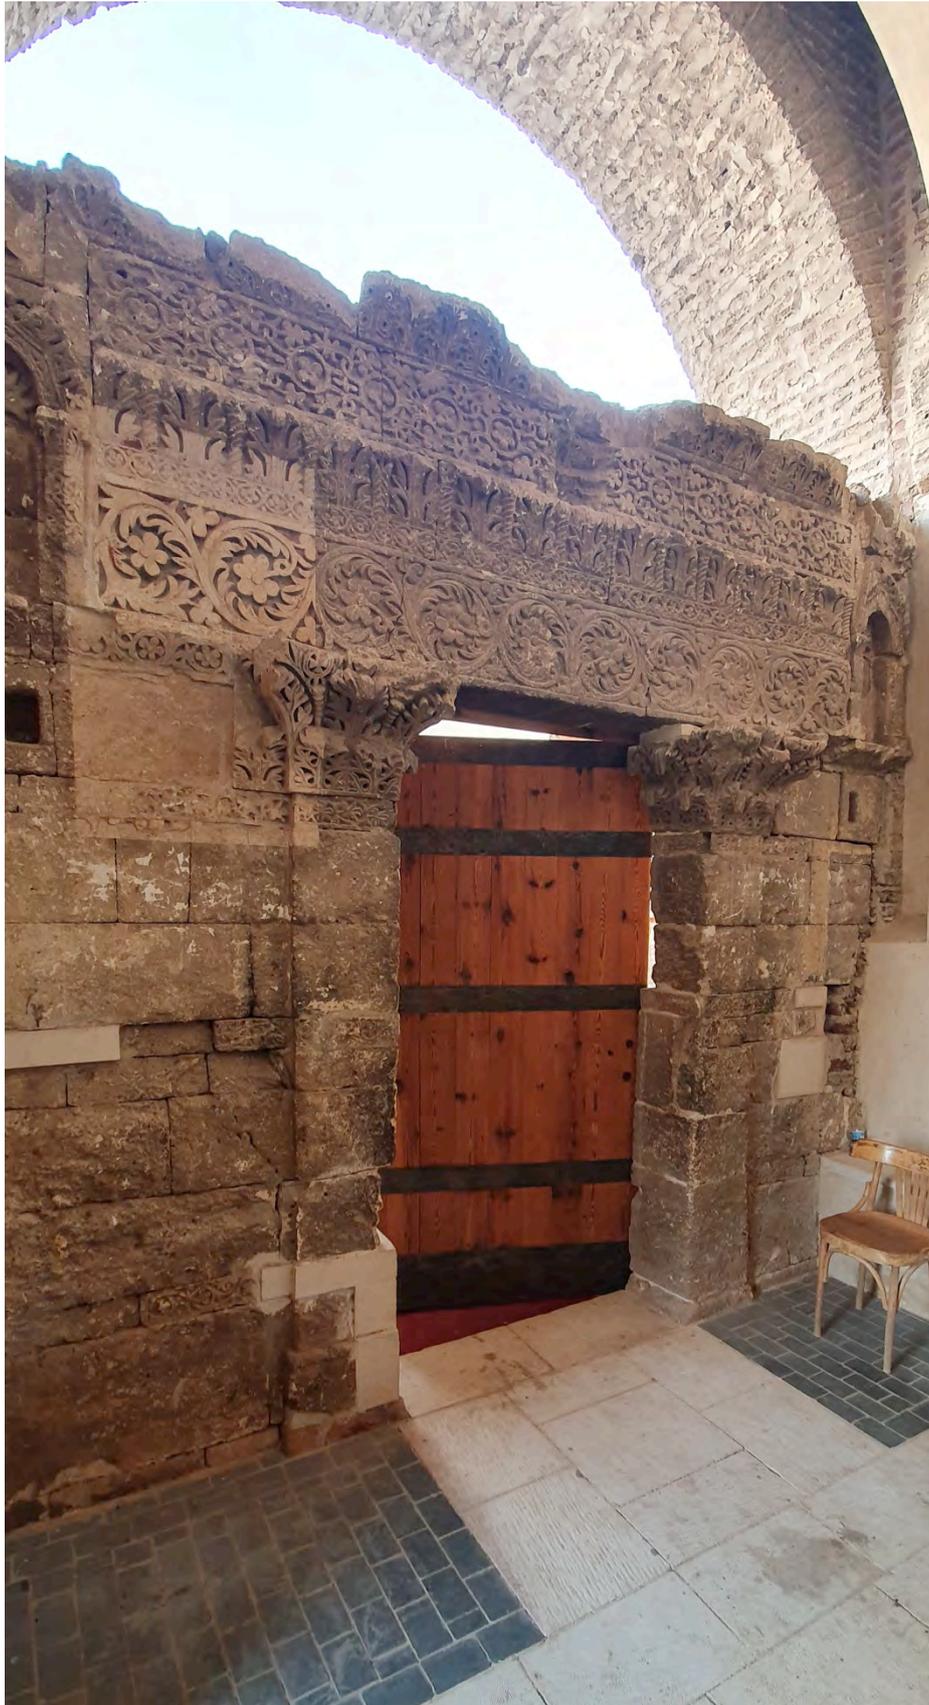
The north face of the portal had experienced considerable deformation over time, particularly on its eastern side. The cavetto cornice at the top of the portal on this face had also been deliberately hacked off. The portal had a history of inappropriate repointing with cement and had been further disfigured by the installation of conduits for electricity. Both elevations were suffering from sulphation resulting in a dark brown insoluble crust forming on the surface of the stonework. This had caused significant damage to the surface of the stones' fabric due to the interaction with ground water. The lintels and top sections of the door jambs were found to have hydrocarbon accretions associated with incomplete combustion of oil lamps or candles. This resulted in the formation of a black sooty layer with tar products having penetrated the substrate of the stone.

All surfaces of the portal were originally covered with a thin coat of lime plaster over ashlar blocks that had been toothed to receive the plaster. It was suspected that polychromy would be in evidence and, as cleaning progressed, it became clear that there was polychromy on most of the carved detail as well as fragmentary polychromy on surviving sections of plaster. On the carved details, polychromy

South face of south portal before conservation

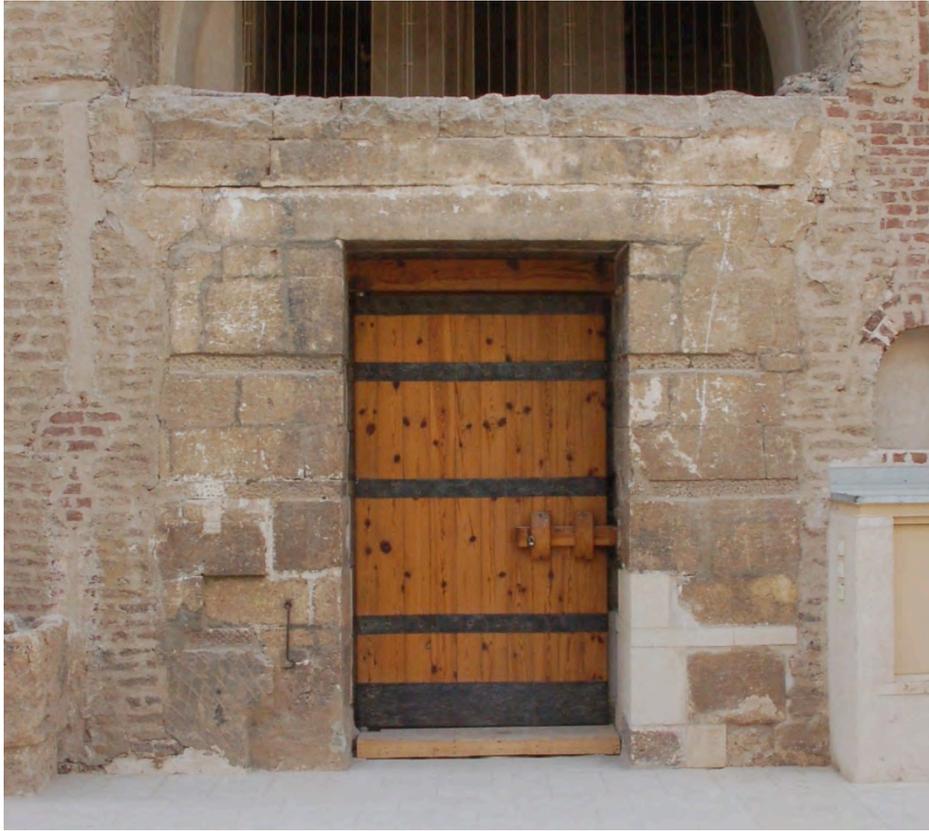
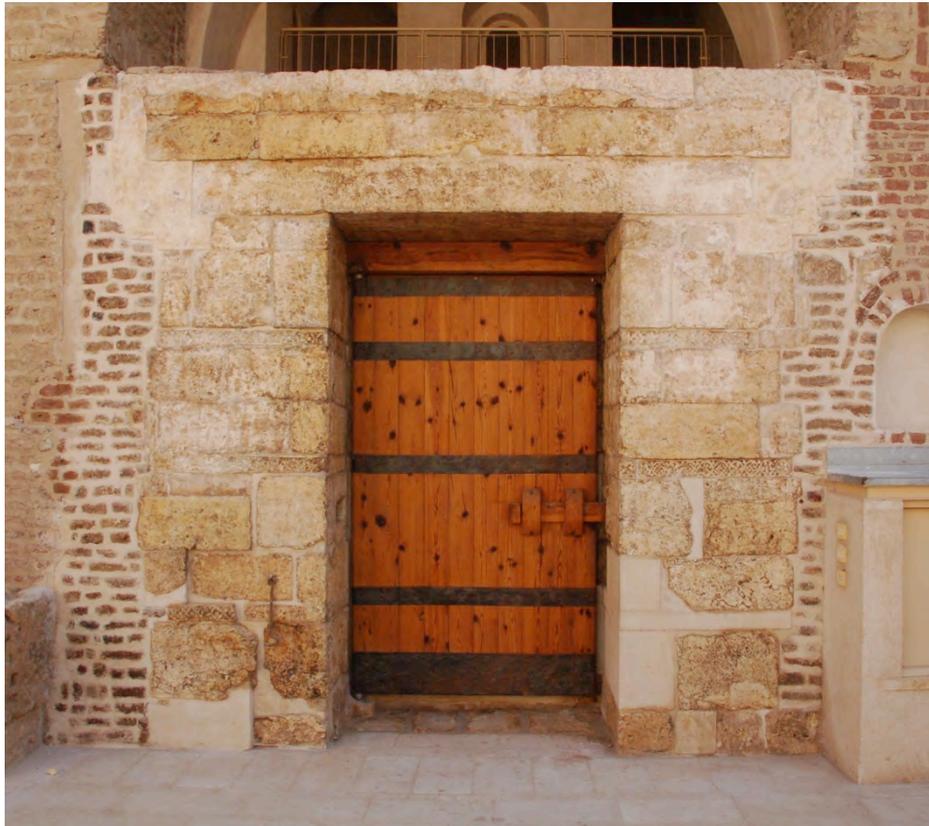
Inner face of south portal before (top) and after (bottom) conservation

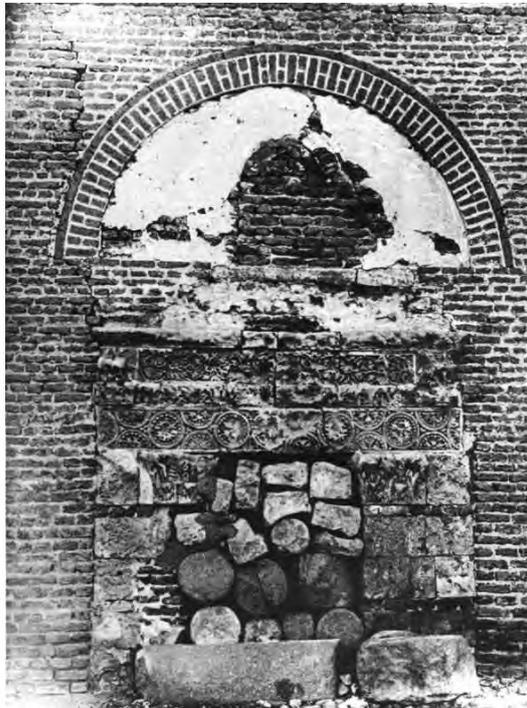
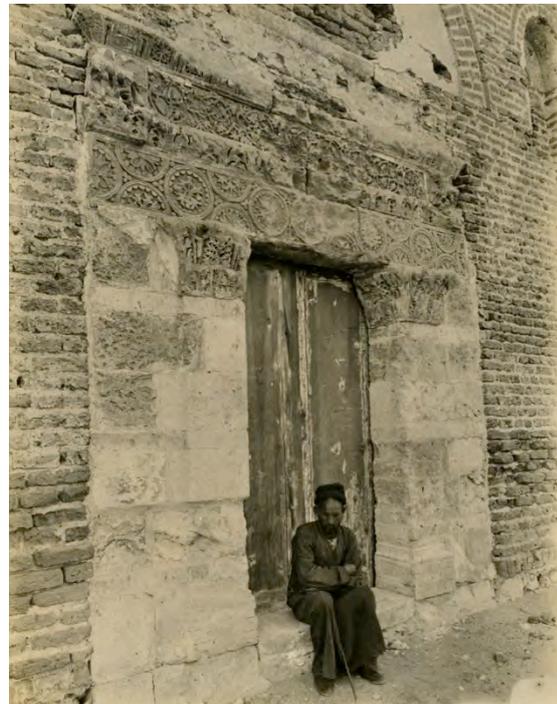
At the end of the 19th century the North Portal was not in use, having been blocked with a random collection of spolia including column drums and cornice blocks. The *Comité* removed this blocking in 1912, carried out a number of limestone ashlar replacements (perhaps using re-cut old stones), and installed a new timber door. A significant amount of original plaster remained under the relieving arch above the door until 1996, when a SCA-appointed contractor removed it during a program to repoint all the façades of the church with cement. In 2015, as part of the ARCE conservation project, a number of limestone block replacements were made in the portal, and a new pair of timber doors was installed. In 2018 the Italian team conserved the inner (south) face of the portal and internal jambs, revealing traces of the original polychrome decoration on a thin coat of lime plaster.

The exterior of the North Portal in 1897, and after conservation by the Comité in 1912

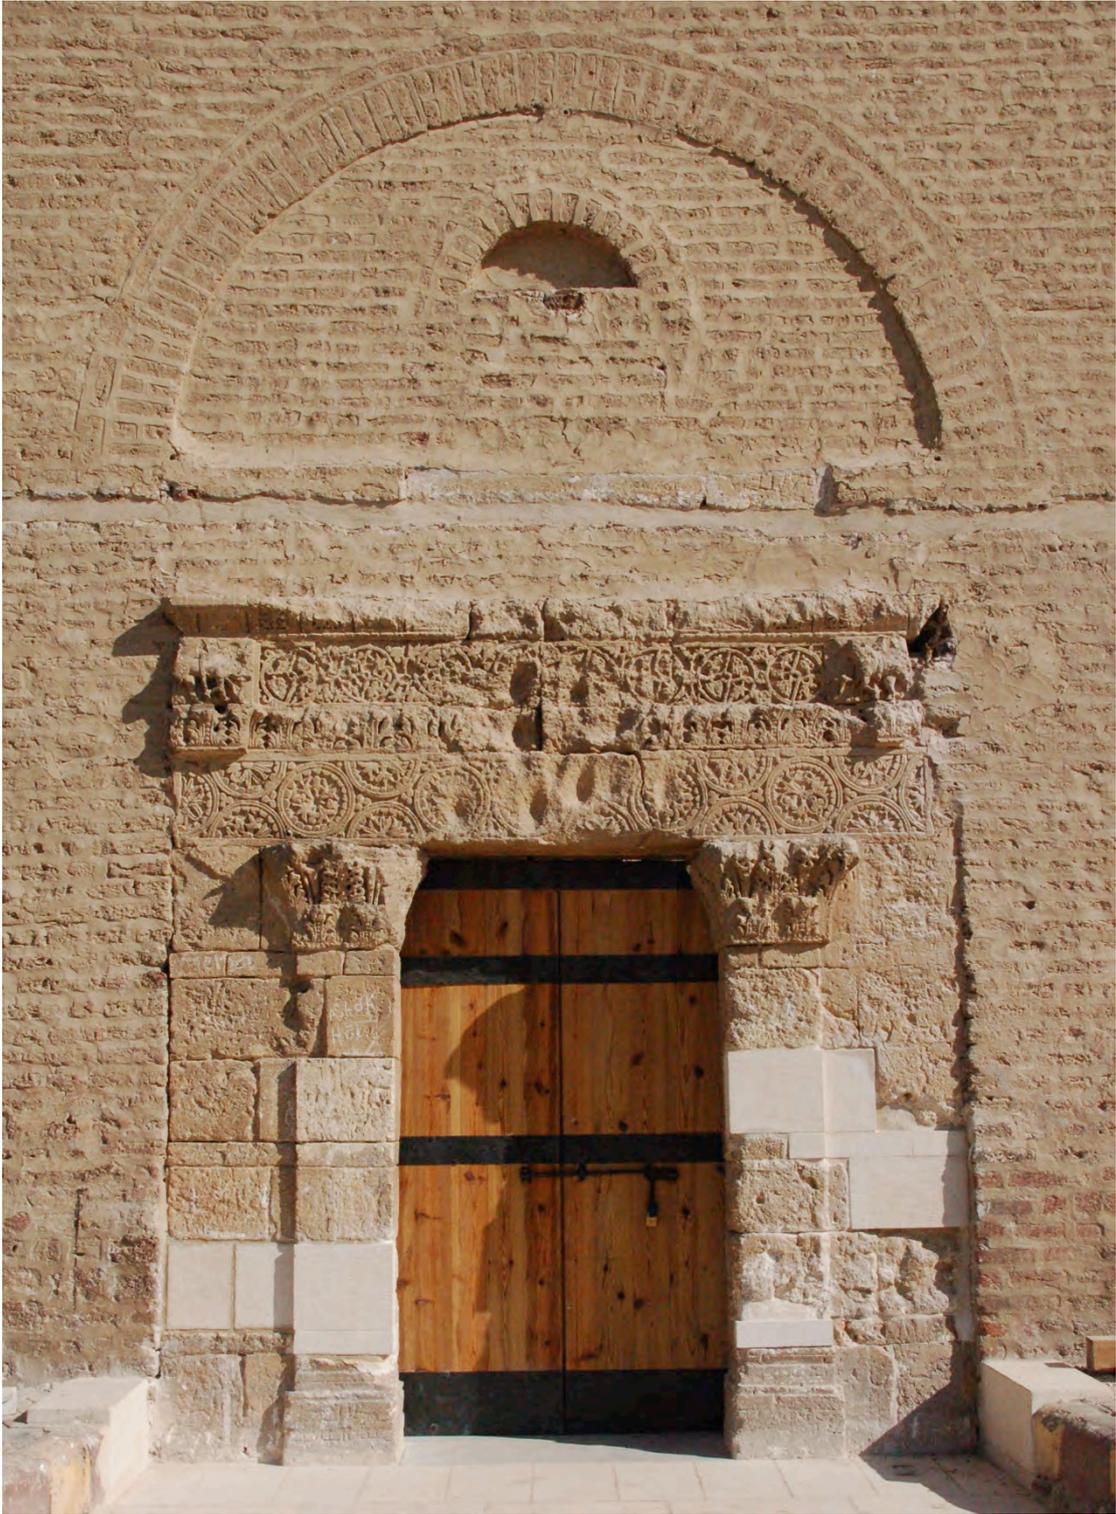
The external lintel of the door bears historic traces of having been scraped to collect stone powder for use in sympathetic magic – a practice more often associated with ancient Egyptian temples. The capitals and the decorative frieze were all historically treated with an oil or varnish, seemingly postdating the traces of polychrome that were discovered during conservation as it was found on broken as well as historic surfaces. The oil or varnish application had crosslinked with the underlying polychrome and stone fabric making it extremely difficult to reverse without the loss

of the underlying surface. The same layer of sulphation from airborne pollutants was found to have covered and disfigured all surfaces, as was the case with the south portal. The stonework at low level is still affected by ongoing decay associated with the absorption of water-borne salts, although the situation has been stabilised since the introduction of the pavement surrounding the church in 2018. In general terms, the exterior of the portal has been damaged by continuous abrasion from windborne sand (as it faces the direction of the prevailing wind) as well as increased anthropogenic damage due to its exposed location. The abrasion has disproportionately affected the carving above the lintel as this was executed in a softer stone.

The exterior of the North Portal in 2016 after preliminary conservation

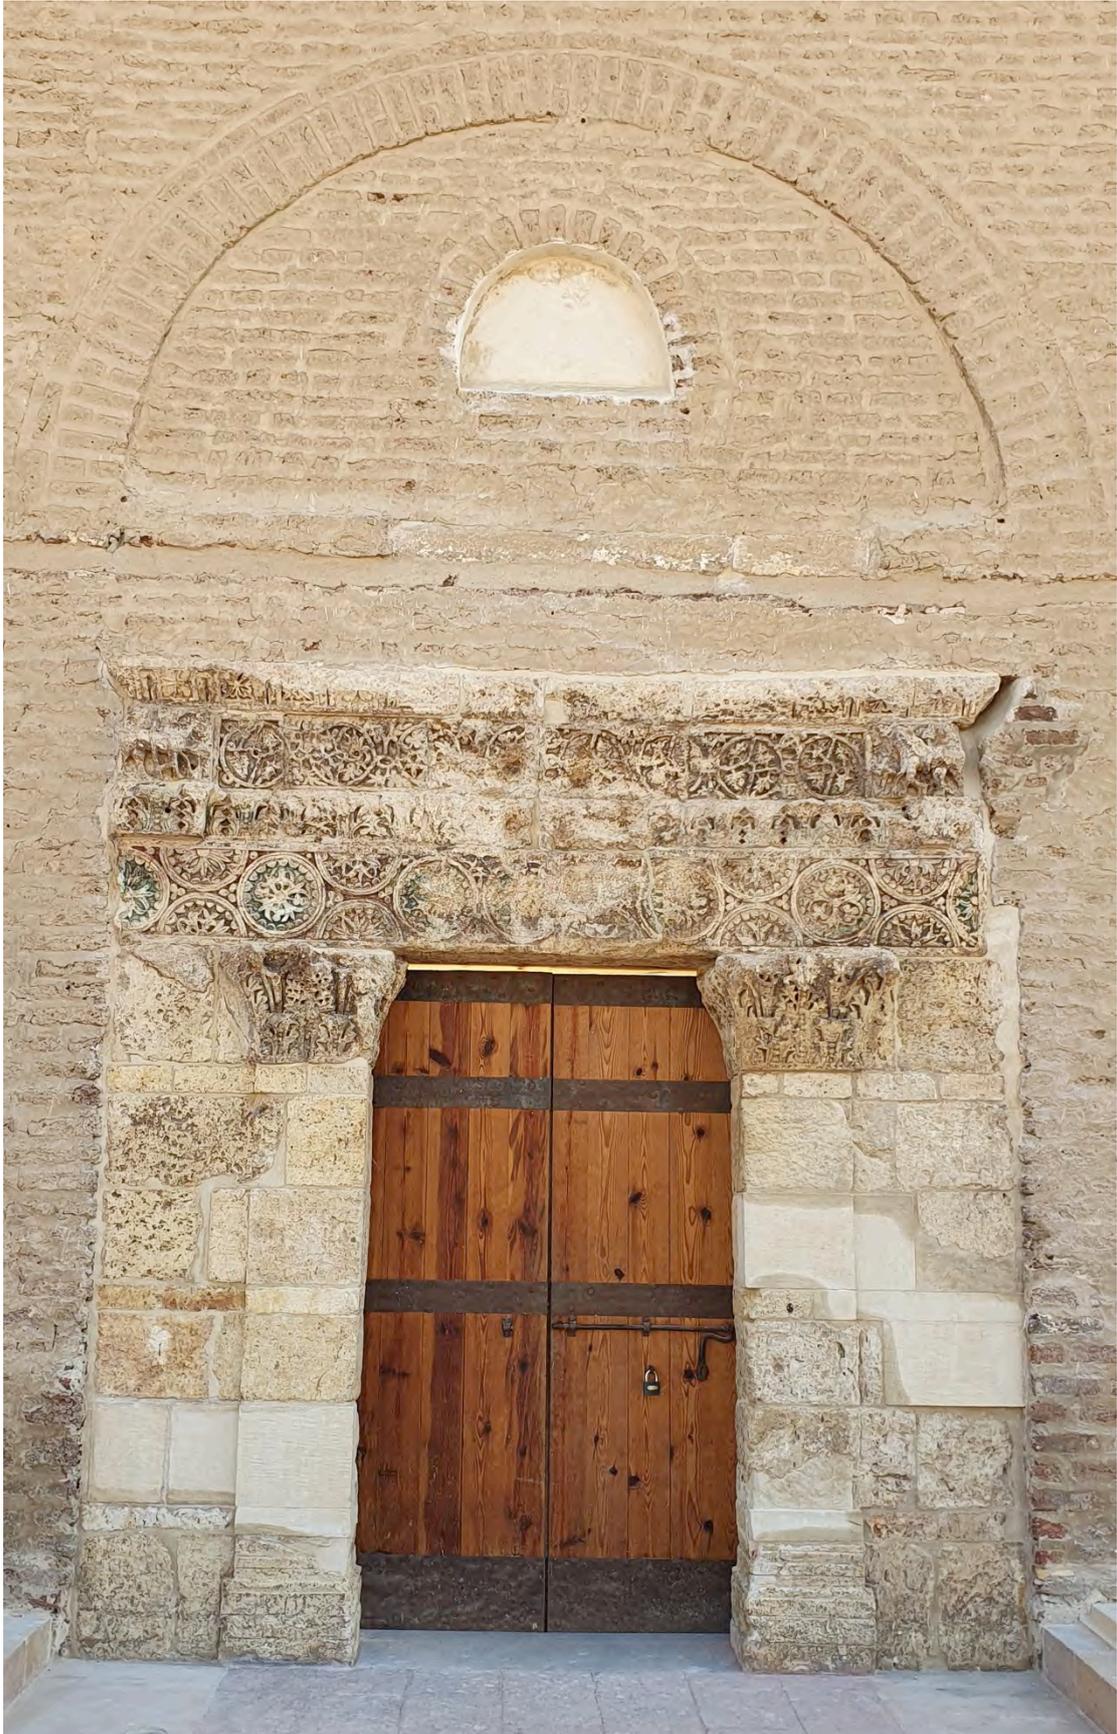
The exterior of the North Portal in 2019 after completed conservation

The portal was treated in the same manner as the South Portal (see 3.2 above).

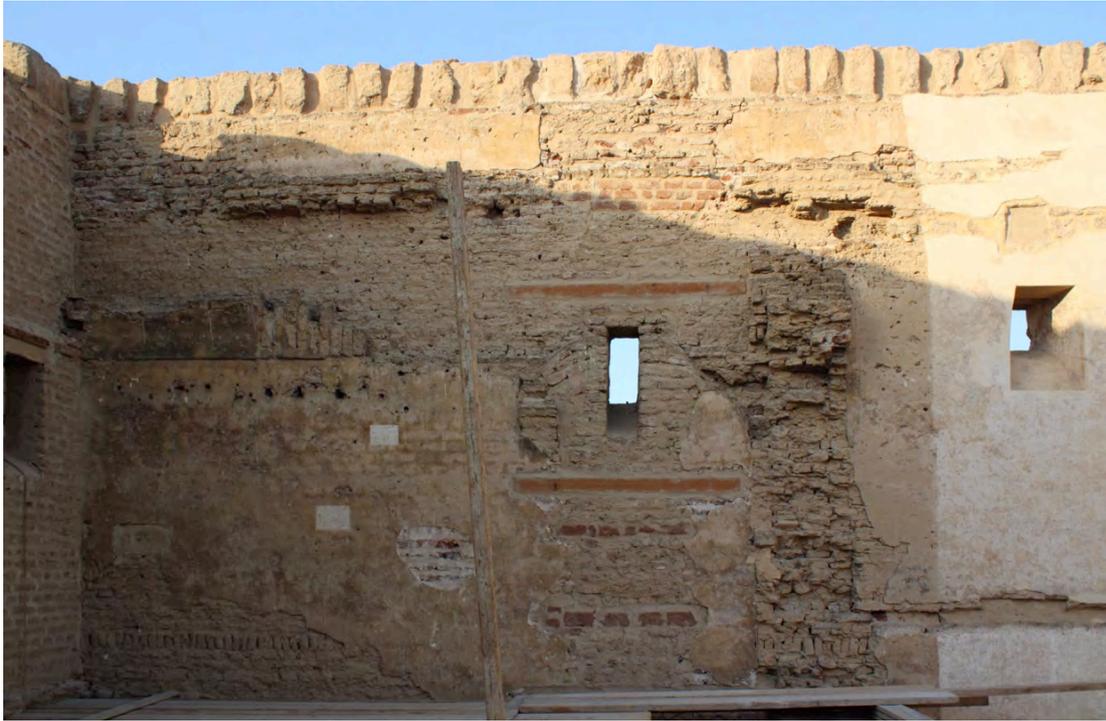
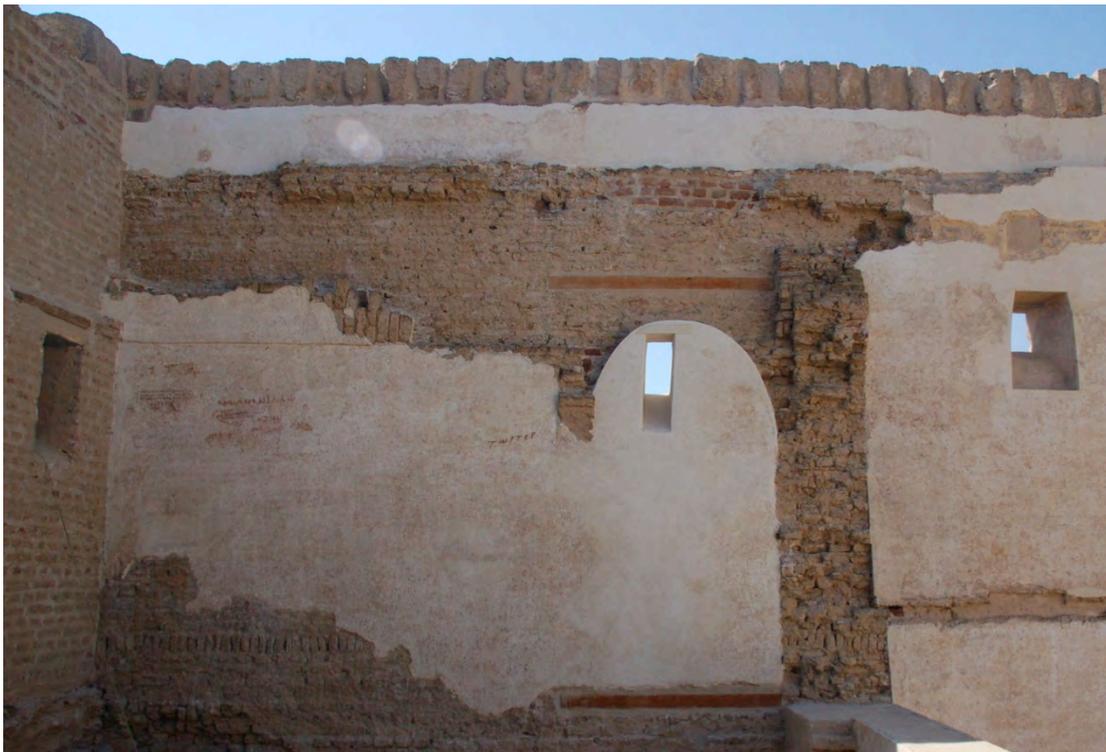
1 A large area of plaster (25 m²) on the south side of the west wall above the small Chapel of the Virgin Mary, which included five clear graffiti texts as well as some splash marks, and fragments of letters/texts. This area was once the side of a staircase that led to the roof of the church, which accounts for the presence of the graffiti here.

The west wall plaster before (top) and after (bottom) conservation

- cleaning to clear the surfaces of a build-up of dirt deposits and encrustations, largely made up of dust, soot, calcite crusts and bird lime, as well as modern red paint and splattered cement on the area next to the Chapel of the Virgin

- securing detaching plaster layers associated with areas of loss and delamination from the substrate
- repairing plaster losses to secure the areas and to avoid leaving dust/dirt traps and areas for birds to roost – all of which cause deterioration in the plaster
- toning in new repairs to match existing treatments and to reduce their visual impact

Detaching wall plasters were secured using a lime-based grout developed for the consolidation of wall plaster (PLM-AL). Further stabilisation was carried out using edge repairs and as well as fills using lime mortars. The lime mortars used varied in the aggregates used (brick dust, sands of different grades and stone powders) depending on the area, the mortar selection followed the previous Italian methodology to ensure a coherent finish to all of the walls.

Ammonium carbonate was used in gel form to remove and reduce the dirt deposits and encrustations – this was used at a lower percentage than in the previous campaigns - 5 and 10 % with contact time with the plaster depending on the dirt levels but varying between 10 -30 minutes. This had the same cleaning effect as the higher concentrations used in the previous work but with a less aggressive action. All surfaces were cleared of solubilized dirt, deposits and gel residues using brushes, sponges and water sprays. If necessary, in areas of heavier dirt/deposits, once the surface was thoroughly dried, cleaning could be repeated using the same methods to achieve an even result. A final clean of all surfaces was undertaken with dampened cotton swabs to ensure that any remaining gel had been cleared from the surfaces.

Following the stabilisation, cleaning and repairs, final presentation was undertaken. The new repairs were toned as necessary, using earth pigments in water, to achieve a final appearance that was visually sympathetic to the surrounding areas of original plaster.

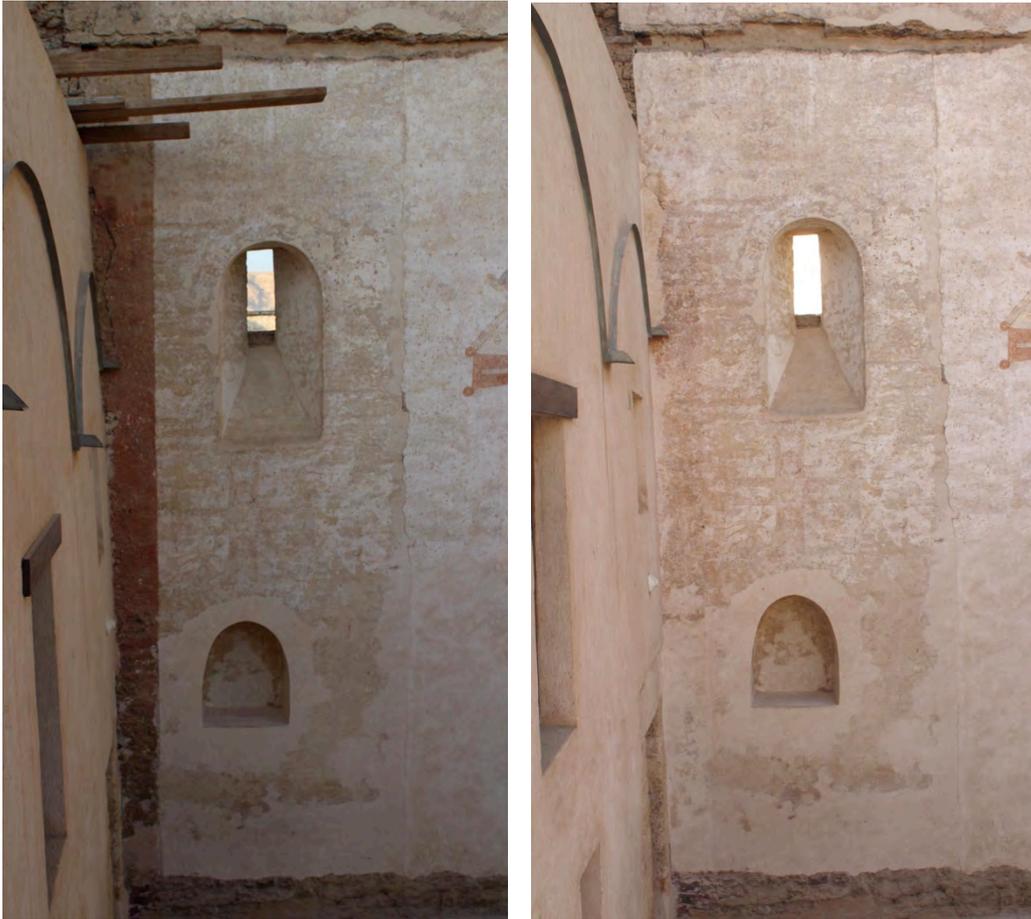
2 A strip of plaster measuring approximately 45 cm wide and running the full height of the wall between the Chapel of the Virgin at the south corner of the nave and the area of plaster conserved in previous Italian campaigns on the west wall. The alignment of this wall, that once separated the nave of the church from construction to its south (including the staircase to the roof), is defined at the upper level by the remains of brickwork toothed into the west wall of the church.

The strip of wall plaster next to the Chapel of the Virgin before (left) and after (right) conservation

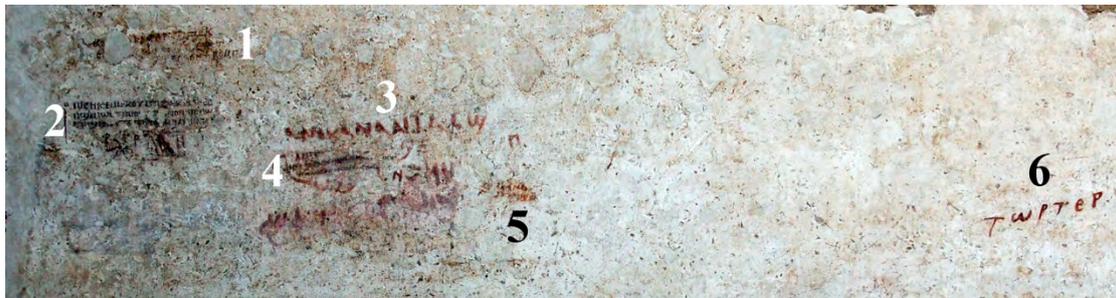
Location of graffiti on staircase wall
