RED MONASTERY CONSERVATION PROJECT

FINAL REPORT, DECEMBER 10, 2019

DR. NICHOLAS WARNER

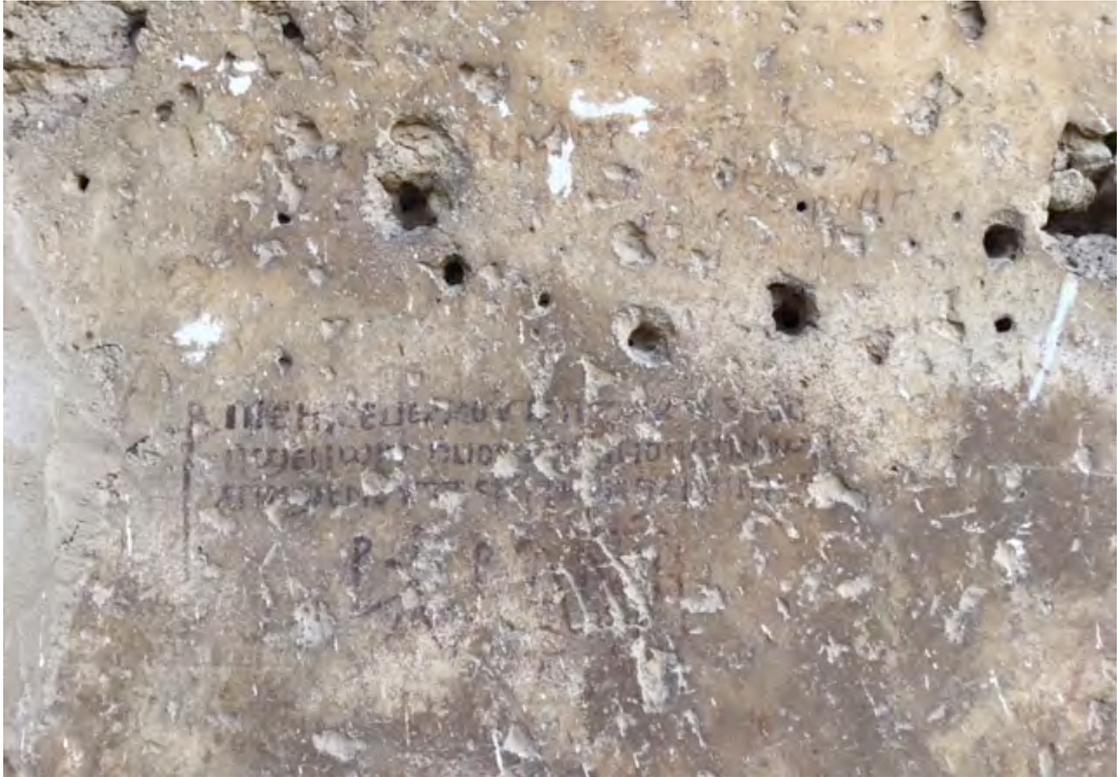
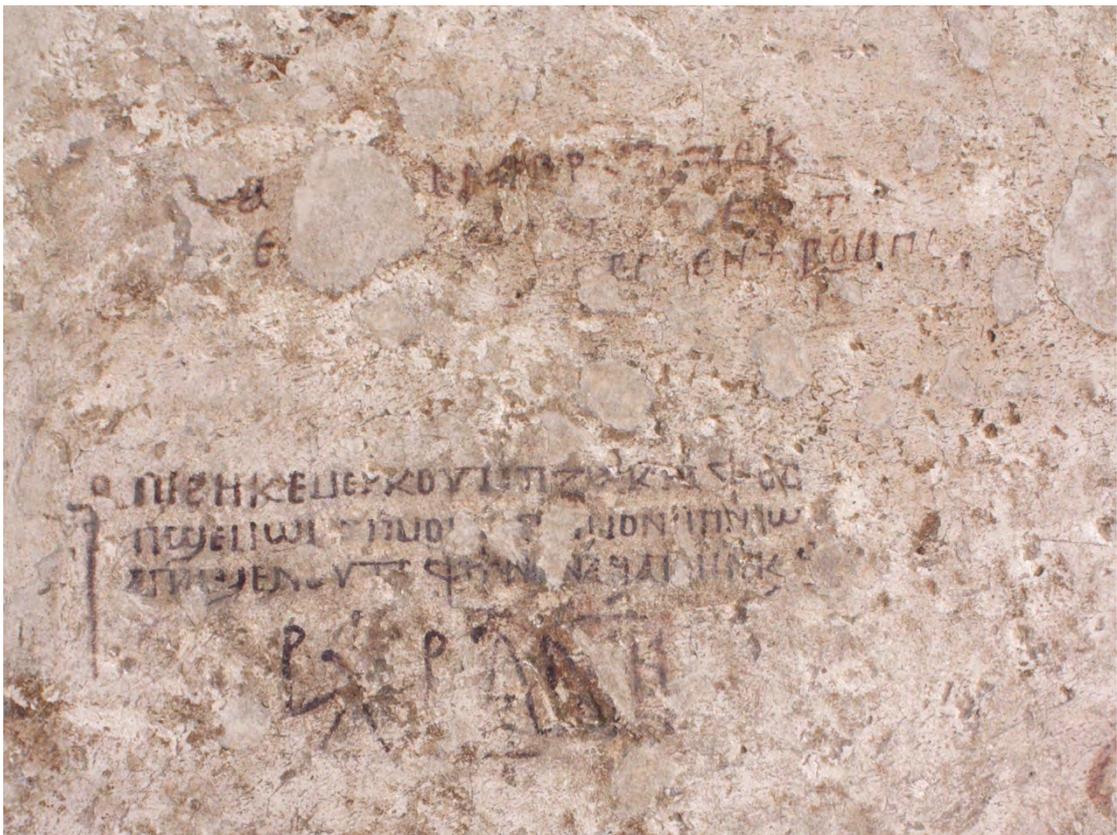
Graffiti 1 and 2 before (top) and after (bottom) cleaning

The six graffiti texts were consolidated with a 5% Paraloid B72 solution in acetone, before surface cleaning, particular attention was paid to cleaning the areas around them to allow them to read more clearly. During the conservation process, it was revealed that a black text within an area of a larger smudged red text is executed on a very thin white plaster above the red text. The blurred appearance of the red text is partly due to this covering skim of plaster but it appears that it may also have been deliberately smeared in a cleaning attempt or in preparation of the plaster to place the black text.

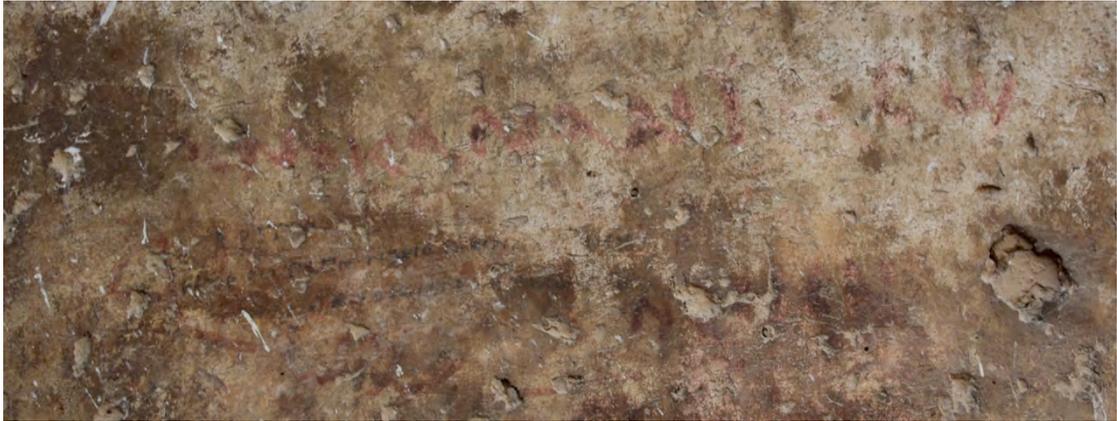
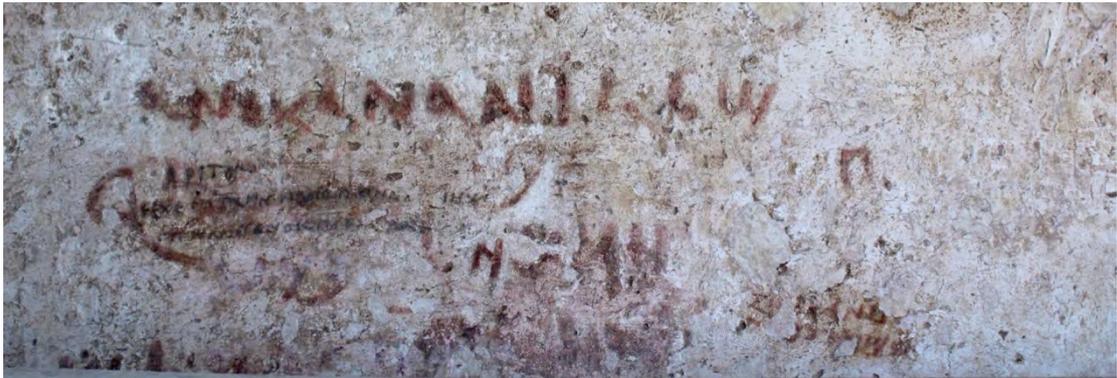
Graffiti 4 and 5 before (top) and after (bottom) cleaning

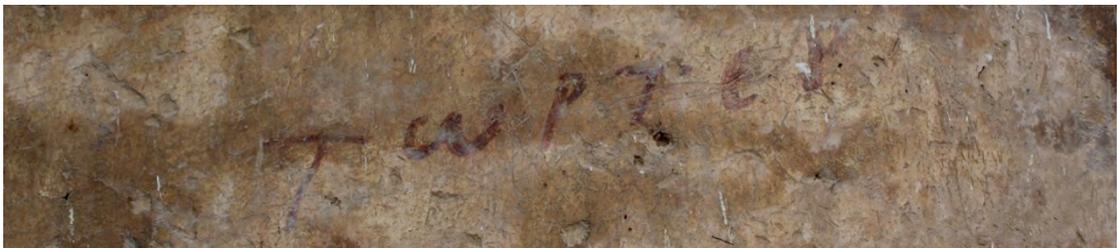
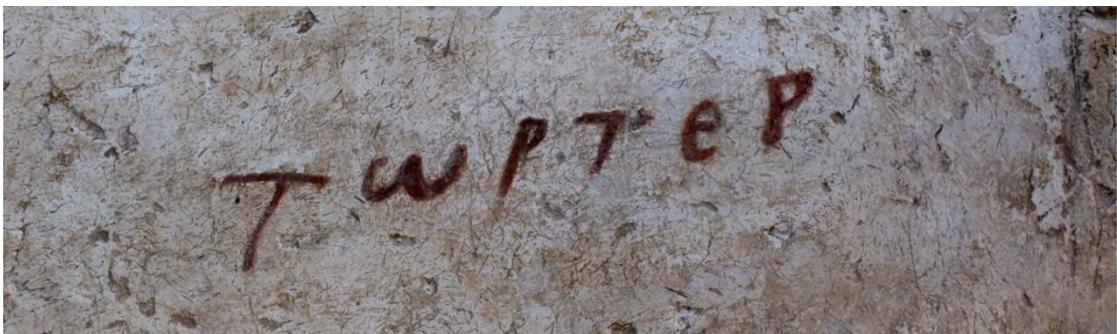
Graffiti 6 before (top) and after (bottom) cleaning

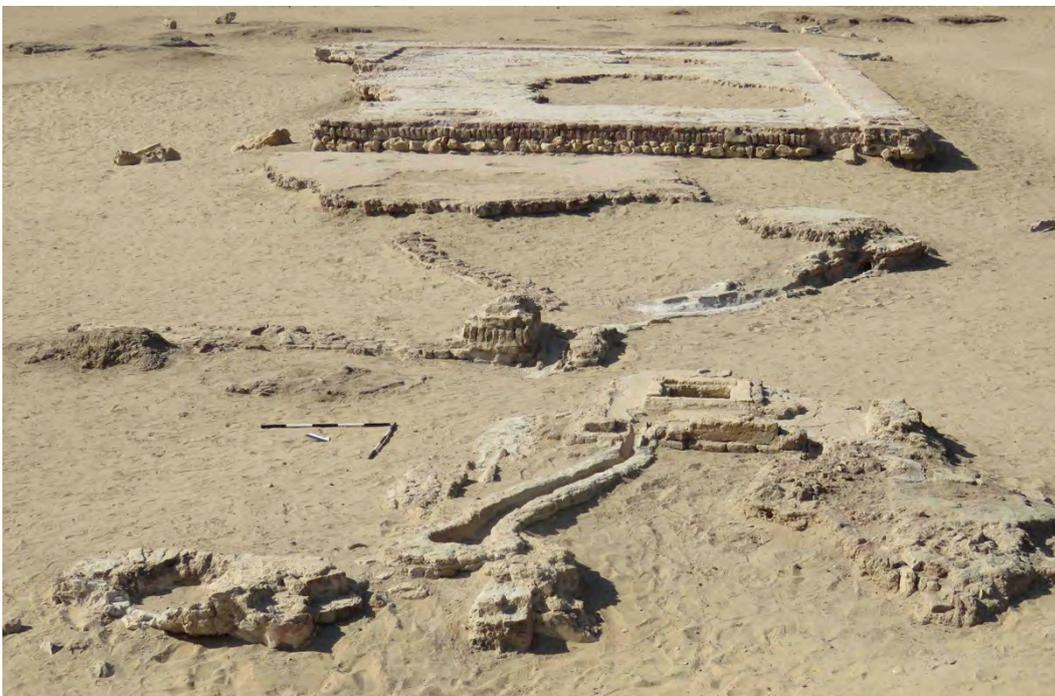
Large building at centre of archaeological area, looking southwest.

The work in the archaeological area of the Red Monastery comprised cleaning in preparation for the 3D laser-scanning conducted by Pietro Gasparri and his team. Gillian Pyke and a team of Egyptian assistants carried out the cleaning between 1.12.2019 and 4.12.2019. The strategy followed that employed in the archaeological areas at the White Monastery ahead of photogrammetry (2018) and 3D laser-scanning (2019), which yielded very successful results. Throughout the site, all loose bricks, stones and ceramic, as well as a moderate amount of modern refuse, were removed and walls, floors and other features cleaned with soft brushes.

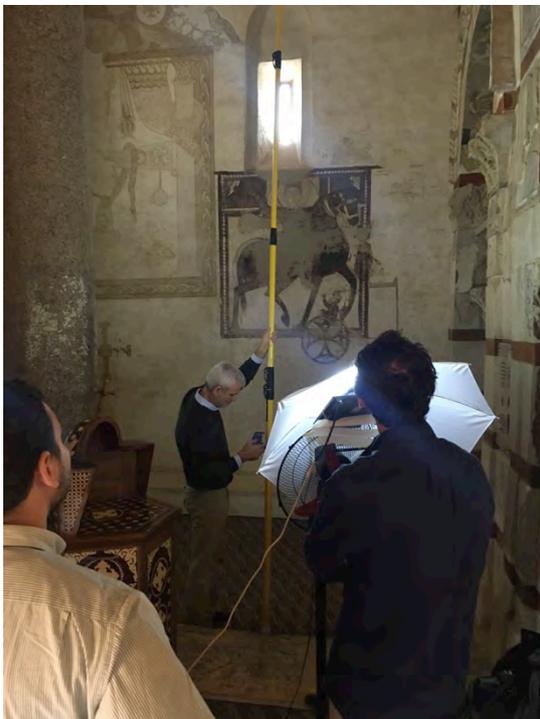
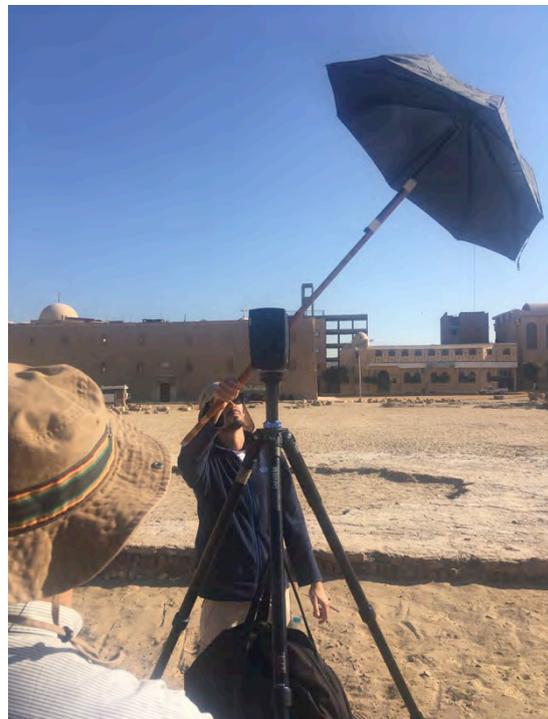
Pole photography inside the sanctuary (left) and shading the scanner in operation in the archaeological area (right).

Eos 5D Mark IV Canon digital camera: The EOS 5D Mark IV is a high-performance digital camera with a full-frame sensor with 30.4 megapixels. The camera was also equipped with calibrated lenses for photogrammetric use and to obtain the highest definition of surface textures. This additional photographic survey, in addition to the information obtained from the laser scanner, is fundamental for the recording of the elevations and sections of the church.

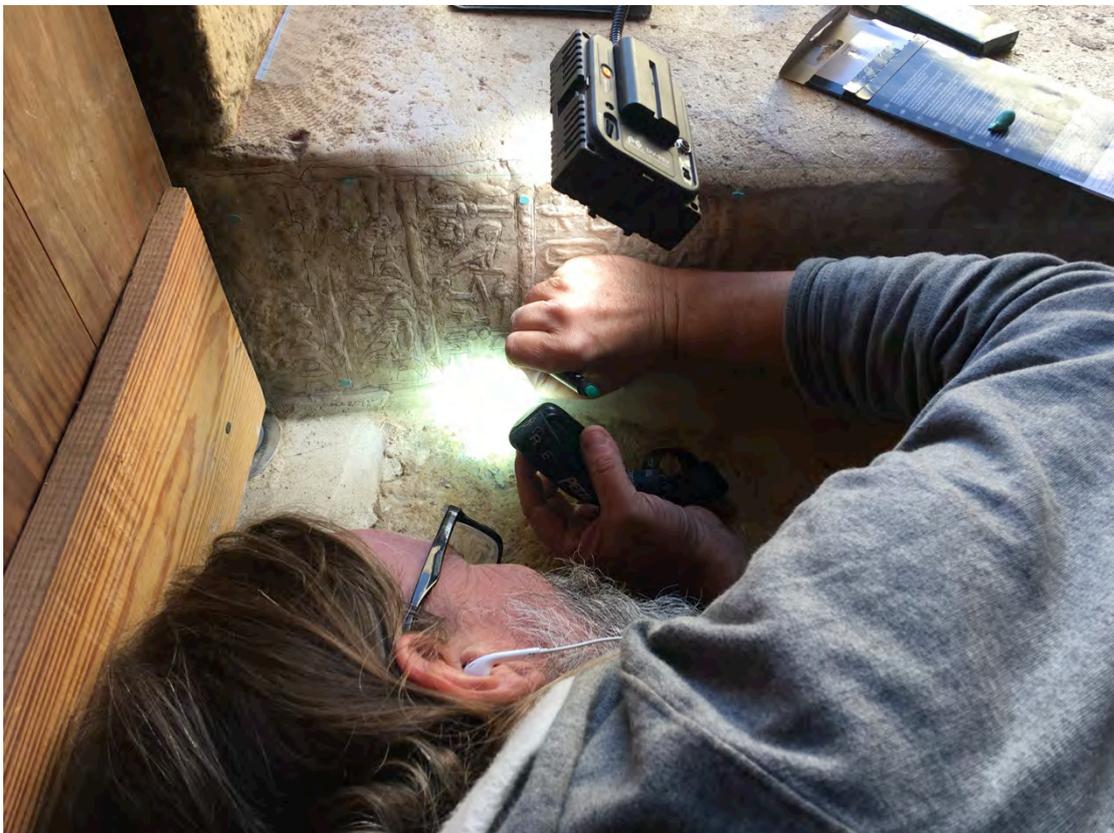
P. Collet tracing an inscribed pharaonic block re-used as a threshold in the church.

Pieter Collet recorded the inscribed pharaonic blocks re-used in the structure of the church by tracing. These included a threshold block in the central entrance to the sanctuary, the lintel of the South Portal, and a small block in the south jamb of the entrance to the tower. Another block fragment, built into the lapidarium display was also drawn. The blocks seem to be Ptolemaic in origin.
