**PROGRESS REPORT No6**

**May 2004-June 2004**

**“Documentation and Conservation of King Khasekhemwy’s Funerary Monument at Abydos”**

# DOCUMENTATION AND CONSERVATION OF PHARAOH KHASEKHEMWEY'S FUNERARY MONUMENT AT ABYDOS

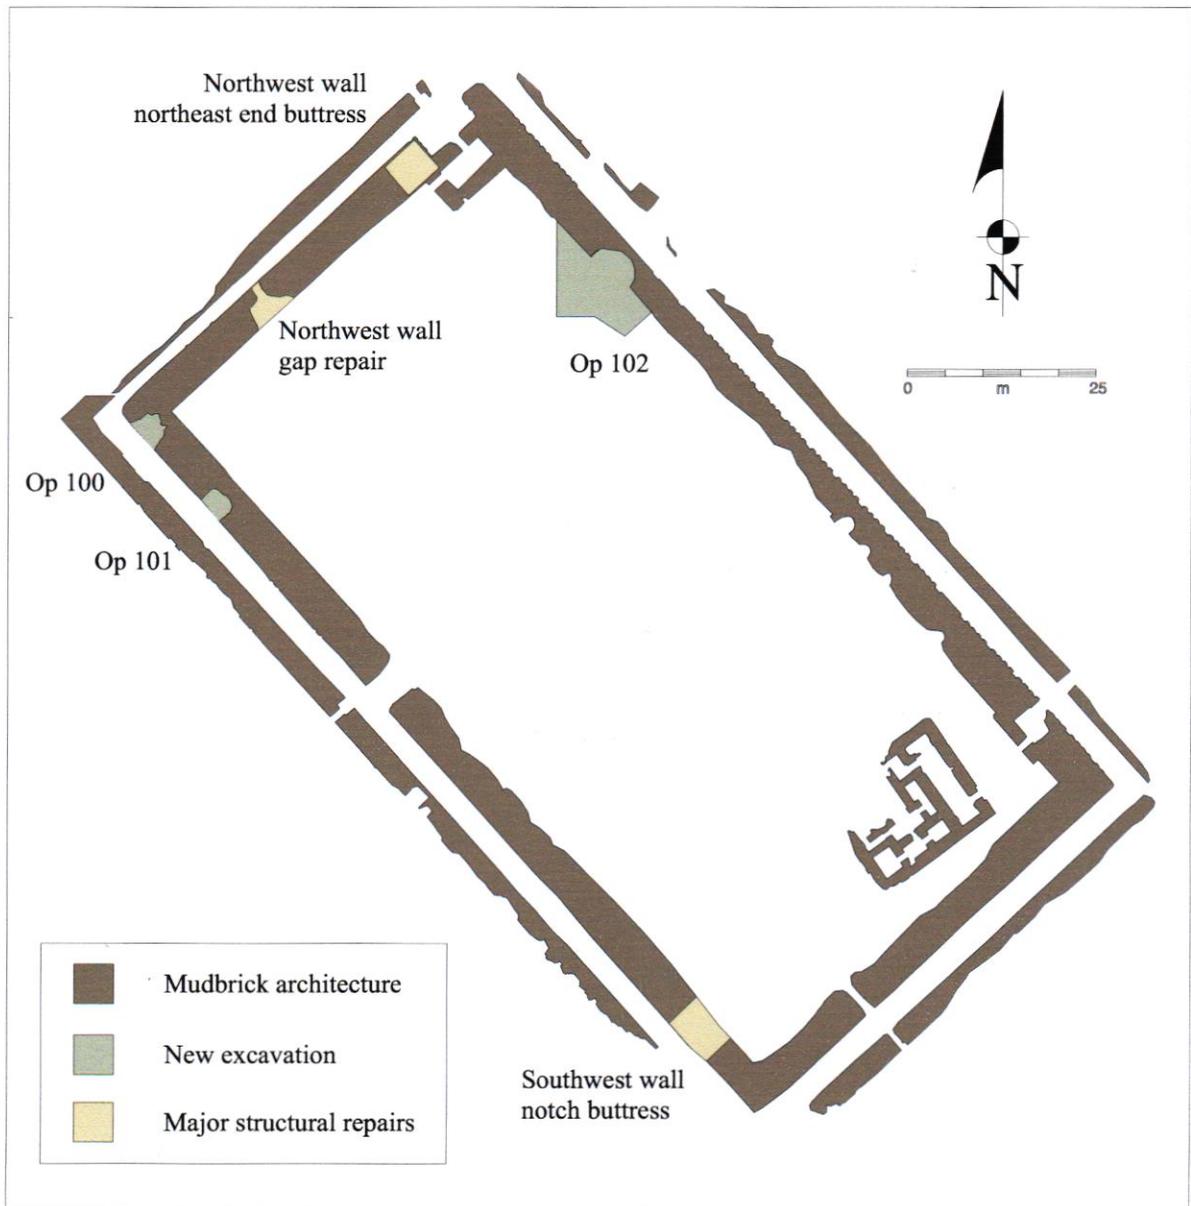
Figure 1 - Location of the new excavations and major structural stabilization work undertaken in the Shunet el-Zebib in Field Season 5.

New excavations undertaken this season were focused primarily in three areas (**Figure 1**). Operations 100 and 101 (**Figures 7, 8**) designate cells, or rooms, dug into the northwestern part of the southwest wall of the Shuneh in late antiquity, as part of the occupation and re-use of the Shuneh by a Coptic monastic community. Operation 102 was located along the inner face of the northeast wall of the main enclosure of the Shuneh and resulted in the discovery of yet another such cell (**Figures 32-34**).

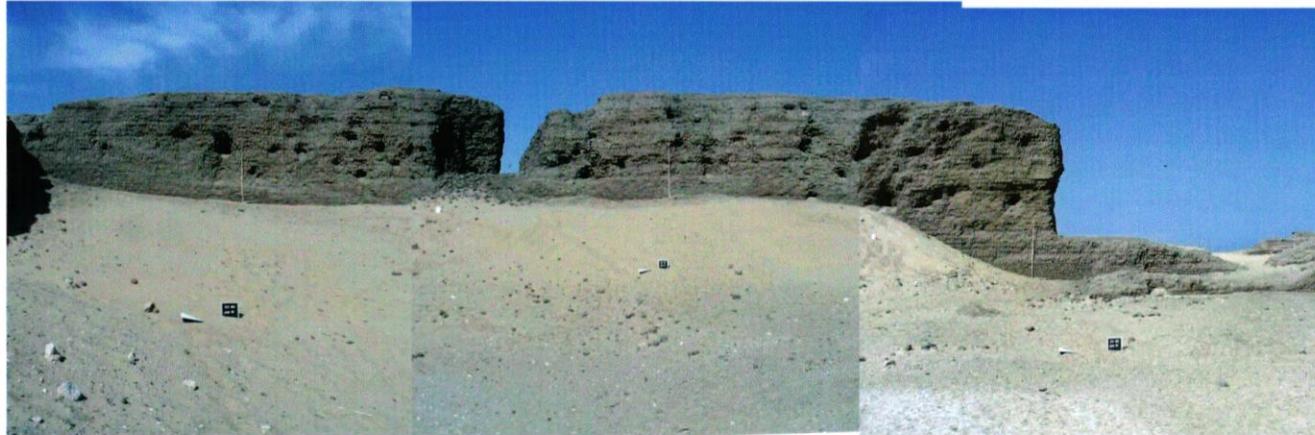
Figure 2 – panoramic image of the interior face of the northwest wall of the Shunet el-Zebib in 1999, prior to any structural stabilization work.

The vertical and partly overhanging northeast end of the northwest wall of the main enclosure is shown in **Figure 2** (at right) and **Figure 15**. This area was at risk of collapse, which would have resulted in the loss of a significant volume of the original fabric of the northeastern part of the wall.

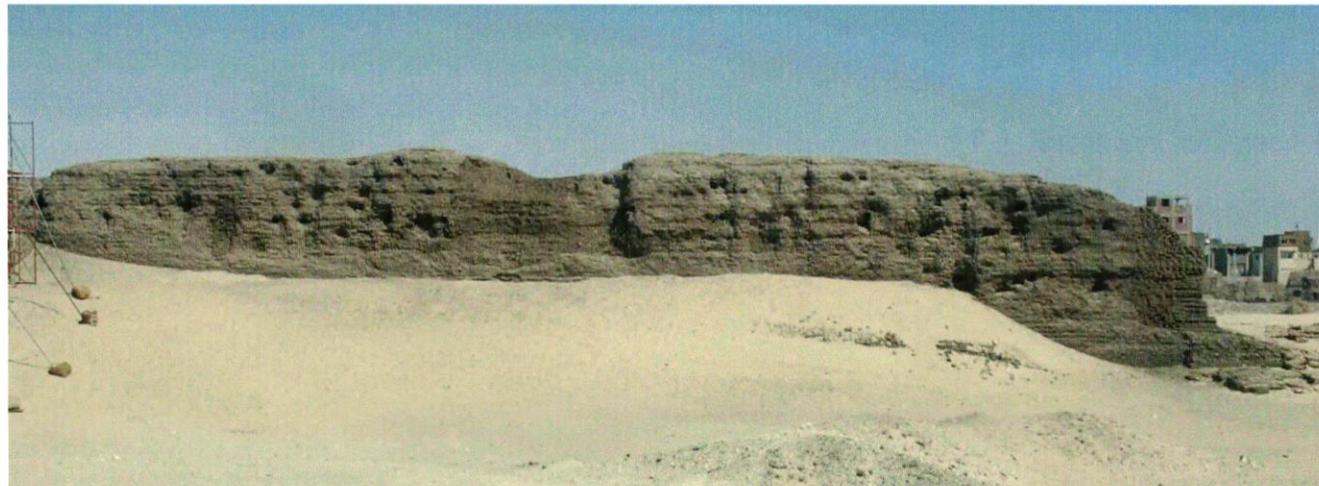
Figure 3 – the interior face of the northwest wall of the Shuneh, as of June, 2004, with the central gap filled, the northeast end buttressed, and the medium-sized hole at left filled.

The structural solution implemented by the Sub-project was the construction of a mudbrick buttress against the wall end, shown at the end of Field Season 5 in **Figure 3** (at right) and in various stages of construction in **Figures 17** and **18**. The texture of the existing, eroded wall surfaces is carried into the masonry of the buttress on its northwest and southeast faces. The northeast end of the buttress has a different, more regular character, because as the stabilization work continues, this end will be incorporated into additional new mudbrick elements that will be built as part of the comprehensive architectural stabilization work around the north gateway. The vertical wall end in the new masonry (**Figure 18**, lower right) will not exist when the additional stabilization work is done in a future season. The vertical end of the buttress is temporarily required so that it can be easily incorporated into future stabilization work.

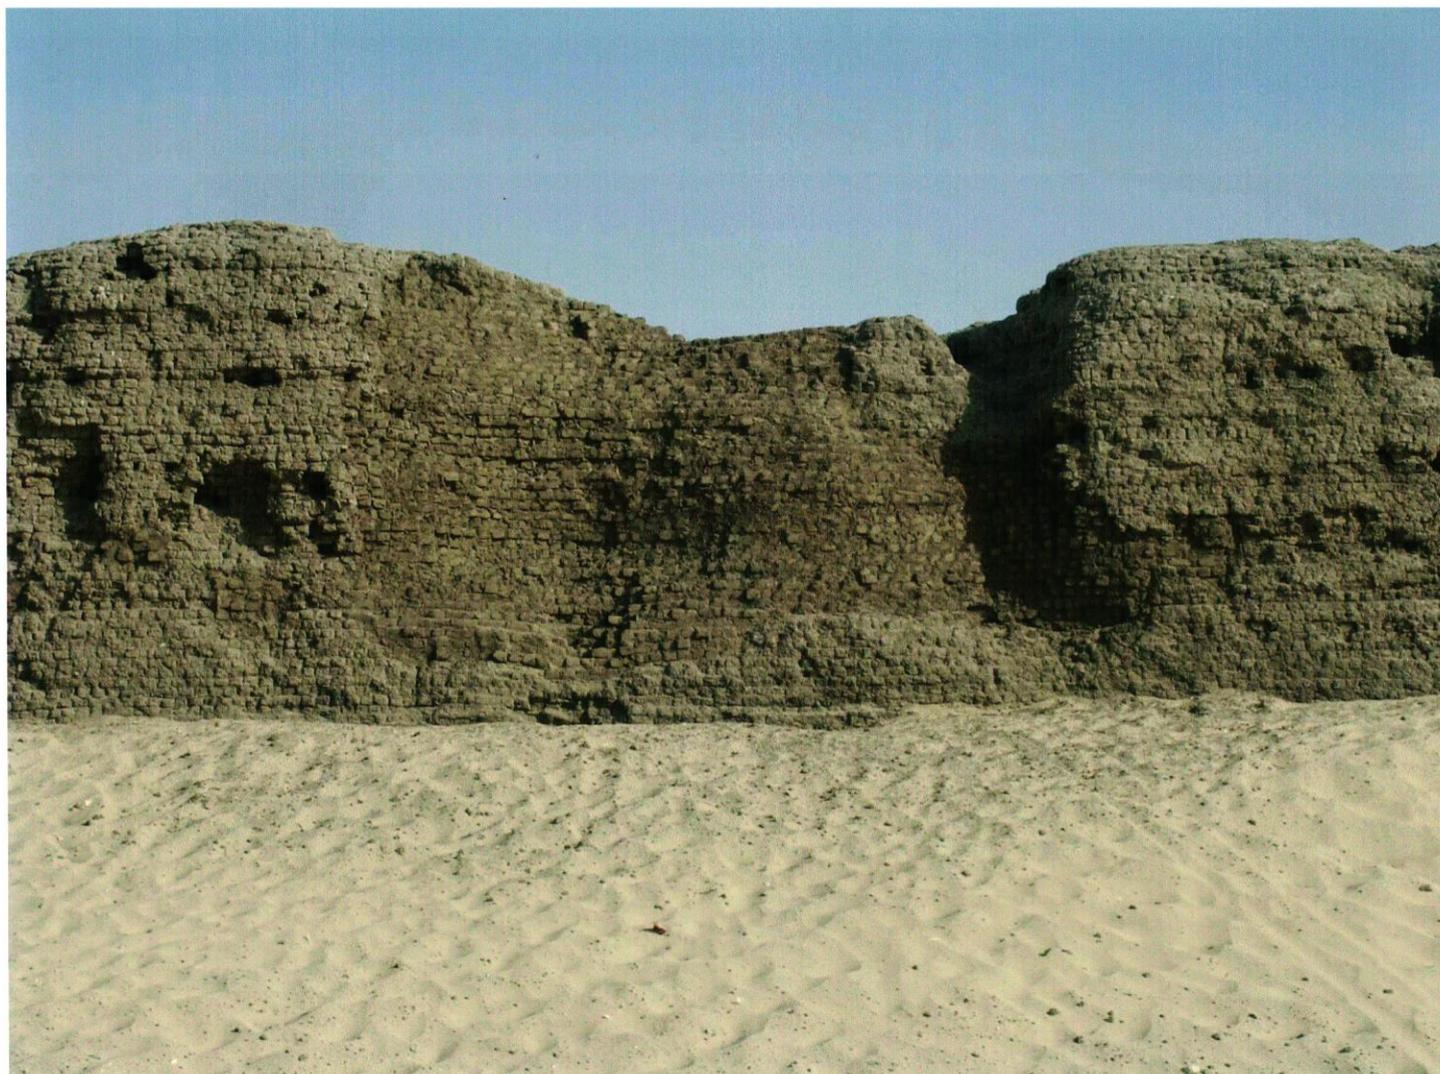
Figure 4 – Completed structural repair of the gap in the middle of the northwest wall, seen from the interior of the Shuneh. This area illustrates the basic approach to be used in the stabilization of the walls.

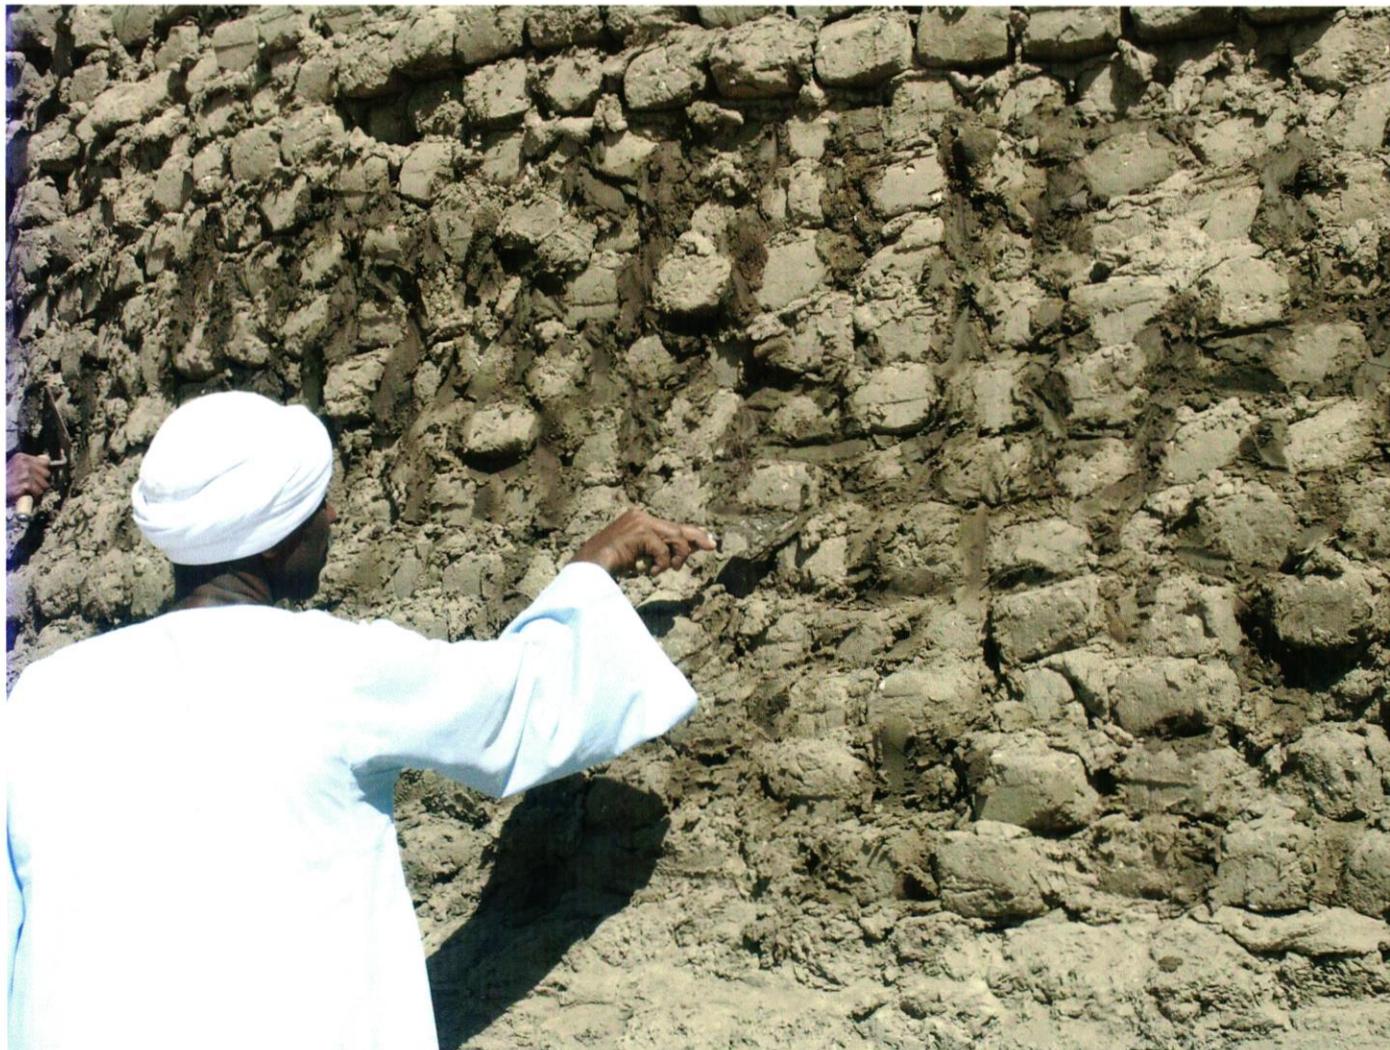
Figure 5 – pointing the joints in the mudbrick masonry filling the gap in the north wall.

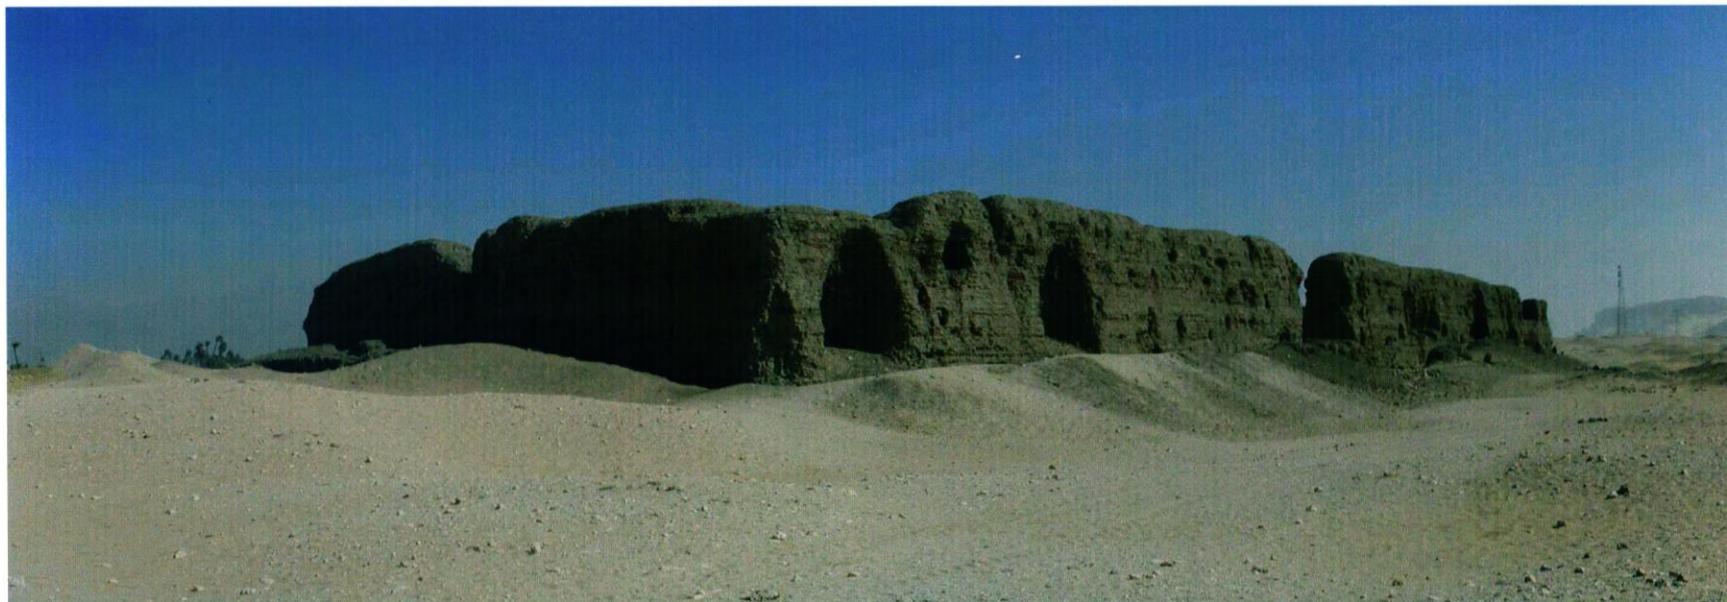
Figure 6 – view of the Shunet el-Zebib from the northwest. The two large voids in the southwest wall in the center of the photo are the two cells excavated in Field Season 5 as Operations 100 (left) and 101 (right).

Small rooms, or “cells,” were dug into the walls of the Shuneh at a number of locations during late Roman/Byzantine times, when the monument was occupied by an early Christian (Coptic) monastic community. A number of these cells are visible in **Figure 6**, which shows the southwest wall of the Shuneh, viewed from the west. The cells consist of deep holes dug into the walls, and they present very serious structural risks to the wall. In order to establish structural stability, stabilization solutions are required. In preparation for the implementation of these solutions, the two cells in the southwest wall nearest the west corner were excavated and documented this season (see the discussion of the excavation of Operations 100 and 101, below). Structural stabilization work was begun in the northwesternmost of the two cells, Operation 100 (**Figures 7, 8**). As is discussed further below, at some point after the end of the Coptic occupation, a deep hole had been dug through the floor of the cell in Operation 100, completely through the brick masonry of the wall of the Shuneh, to a depth of more than 1.5 meters below the base of the wall (**Figures 9, 11**). The hole also was found to contain the burial of a horse (**Figure 10**, and see the discussion of the excavation of Operation 100, below). After documentation of the hole, three new mudbricks stamped with “PYIFA” (for the Pennsylvania-Yale-Institute of Fine Arts Expedition) were placed at the bottom of the hole, well below the base of the wall of the Shuneh, and the hole was then filled with compacted sand. This sand bed now supports the preserved foundation course of the Shuneh wall that had been undercut around the edges of the pit (**Figure 12**) and provides a stable base for new brick masonry that fills the hole in the wall’s masonry (**Figure 13**). Once the hole under the floor level of the cell was filled, additional new brickwork was installed in the remains of the cell itself, to provide structural support to the large and structurally unstable overhang created by the cell’s original construction and by the centuries of gradual collapse of the brickwork above the cell. At the end of Field Season 5, the cell Operation 100 had been filled with new masonry to a height approximately one meter above the level of the mouth of the deep pit (**Figure 14**), with stabilization work in this area to be completed in the subsequent season.

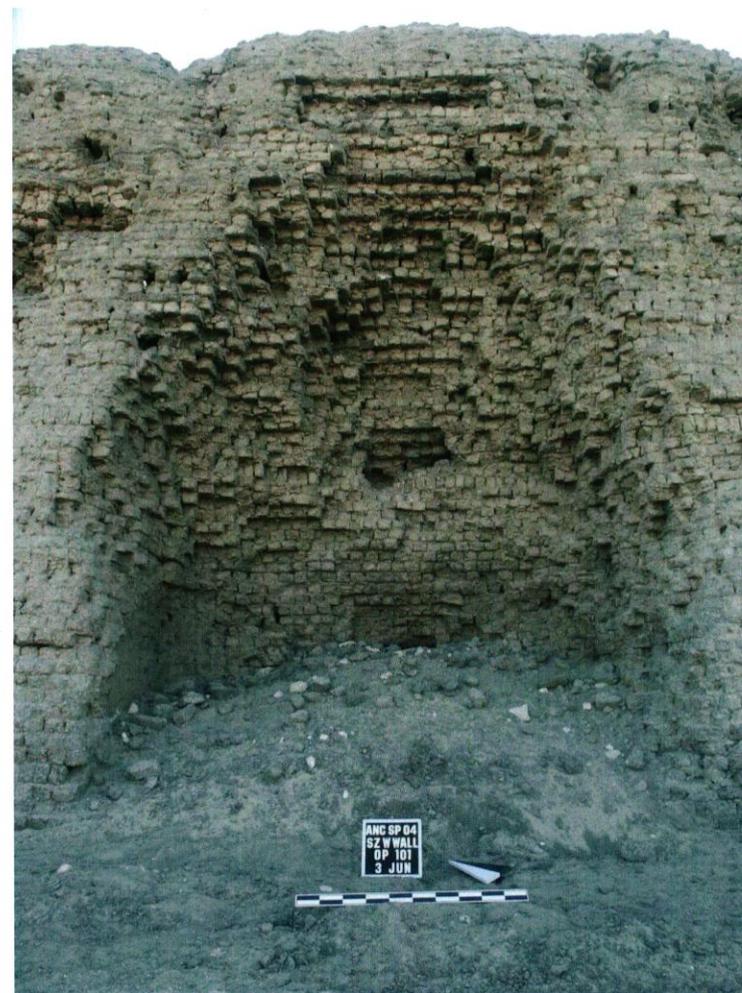
Figure 7 – Operations 100 (left) and 101 (right) before excavation.

Work in Operation 101 (**Figures 7, 8**) showed that this area, too, was a Coptic cell. The basic outline of this cell is better preserved than was the case in Operation 100 (**Figure 27**). It measured approximately 3.75 x 2 meters in plan. Its ceiling, though destroyed, can be estimated from traces of wall plaster to have been approximately 1.9 meters high. The front wall of the cell was formed by original Shuneh masonry that was left in place when the cell was created. Access to the interior was gained by means of an entrance at its southern end. In this entrance was a door pivot and just inside, a small ceramic bowl set into the floor. The floor and the lower parts of the walls were covered in a smooth white lime plaster, while, where preserved, the upper parts of the cell's walls were finished in a light brown mud plaster. At the north western end of the cell there was once a sleeping platform. This has been completely destroyed, but its position and size can be determined from the preserved plaster on the floor and adjacent wall. On the inner face of the exterior wall of the cell, some of the white plaster was preserved. Its upper edge, which bore traces of red line decoration, was found to be extremely fragile and was delaminating. Because of the significance of the traces of decoration, measures were taken to stabilize the edge of the plaster. First, it was carefully cleaned (**Figure 28**). Then, a solution of Acryloid B-72 was injected into the mud plaster backing of the finished lime plaster (**Figure 29**). Finally, a putty, consisting of a mixture of lime and sand, was applied (**Figure 30**) to provide physical protection to the exposed plaster edge. Excavation in Operation 101 also revealed that, mixed into the decayed mudbrick and mudbrick debris on the floor of the cell were many fragments of fallen wall plaster, some of which bore traces of black line decoration (**Figure 31**). This deposit was left in situ, so that it can be lifted as a block in a future season by archaeological conservators, who will then be able to clean and consolidate the fragments under the more controlled circumstances of the Sub-project's conservation lab.

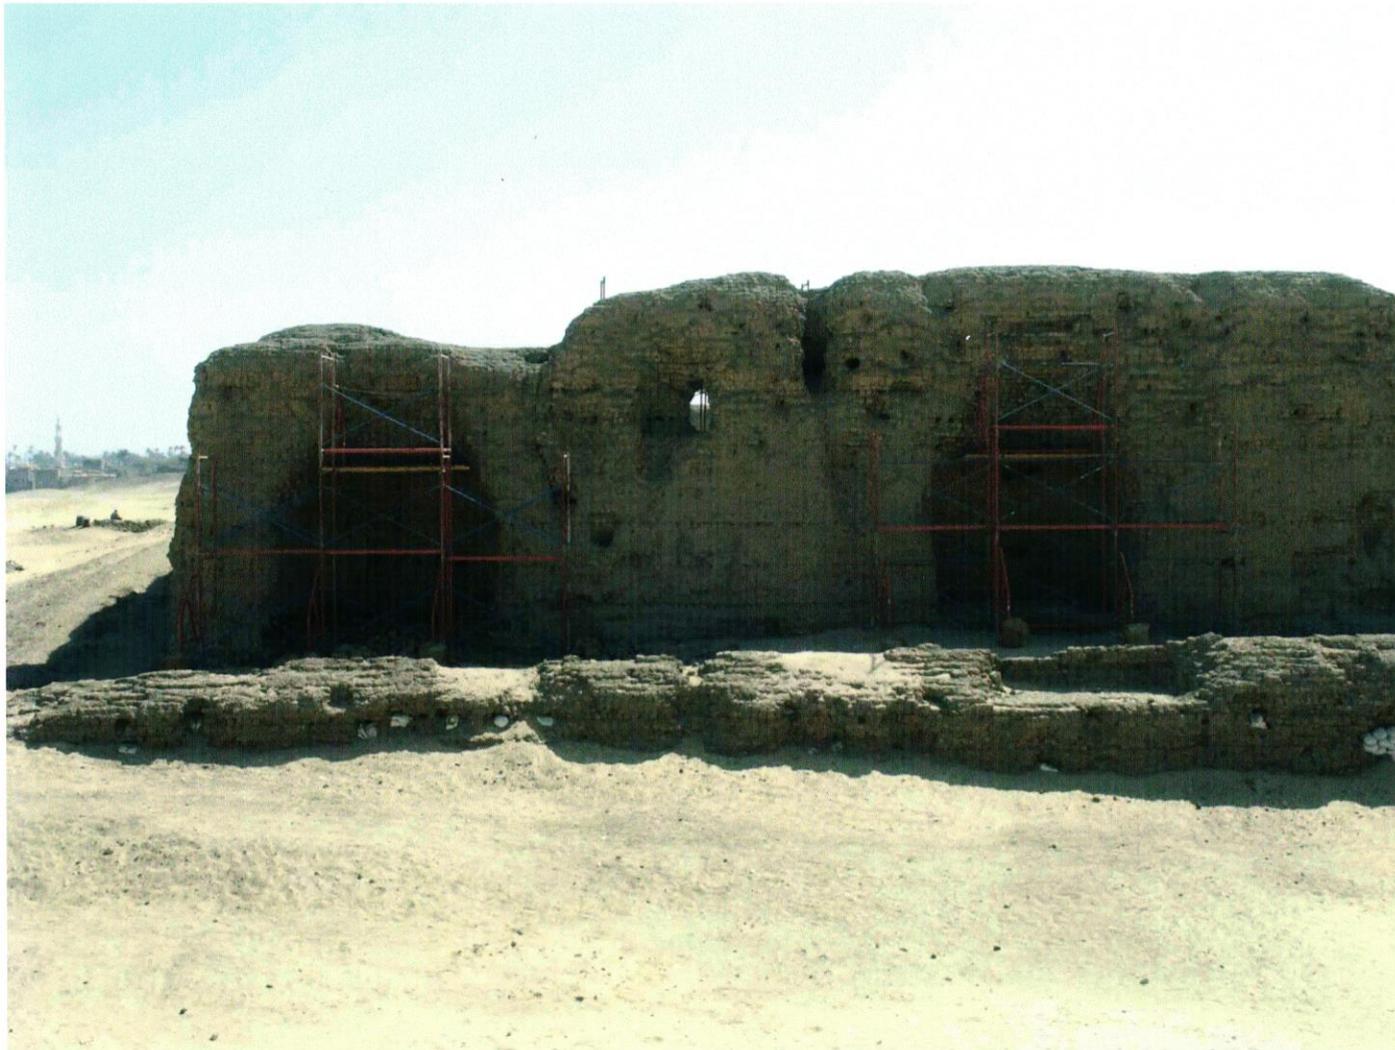
Figure 8 – Operations 100 (left cell) and 101 (right cell) in Field Season 5. Protective scaffolding was in place during all excavation and architectural stabilization work, to protect workers from the risk of falling bricks and fragments.

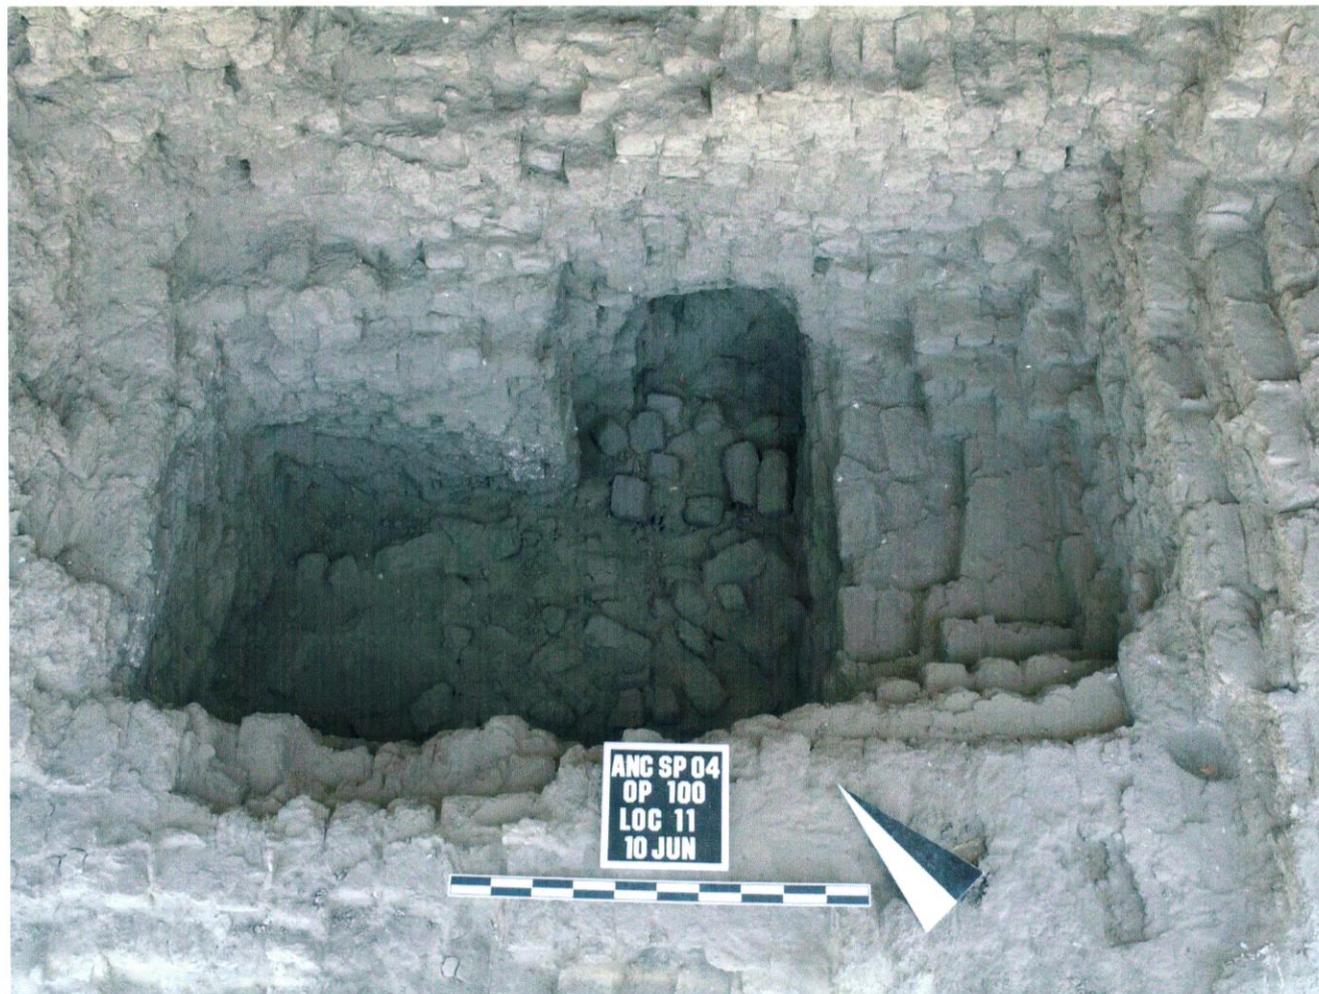
Figure 9 – Operation 100, during excavation. The only area of preservation of the features of the Coptic cell is in the lower right of the photograph, where a small area of lime plaster is visible, along with some of the mud plaster that originally underlay the lime plaster floor, as well as a circular depression in the floor that once held a small ceramic bowl, a feature common to most of the cells constructed at the Shuneh. This bowl set into the floor would have been just inside the doorway into the cell.

Work in Operation 100 revealed that, while the primary void in the masonry of the Shuneh wall in this area was created by the removal of brickwork to create a cell, or room, in the wall during the occupation of the Shuneh by a Coptic monastic community in late antiquity, very little of the fabric of that cell remains. Only a pivot stone for a wooden door, a small area of lime plaster, and a slightly larger area of mud plaster floor are preserved from the cell, all in what would have been the cell's south corner, adjacent to the doorway (**Figure 9**). They indicate that this cell was originally similar in layout to other cells visible in the southwest wall of the Shuneh, with a doorway in the front and a floor covered in hard lime plaster. Judging from the present size of the void in the masonry of the wall, its original size was approximately 3.5 x 2 meters in plan. The cell appears to have been mostly destroyed by the excavation of a large pit that removed the floor of the cell and the underlying brick masonry of the wall of the Shuneh (**Figures 9, 11**). This pit cut not only through the wall, but more than 1 meter into the sterile natural sand and gravel deposits under the wall of the enclosure (**Figure 12**). The fill of the pit was found to consist of a mixture of brick debris and sand, with a large number of pieces of lime plaster that almost certainly represent the remains of the floor and side walls of the cell. After the pit stood open for some time, a horse was buried in it (**Figure 10**) and covered by a layer of loose

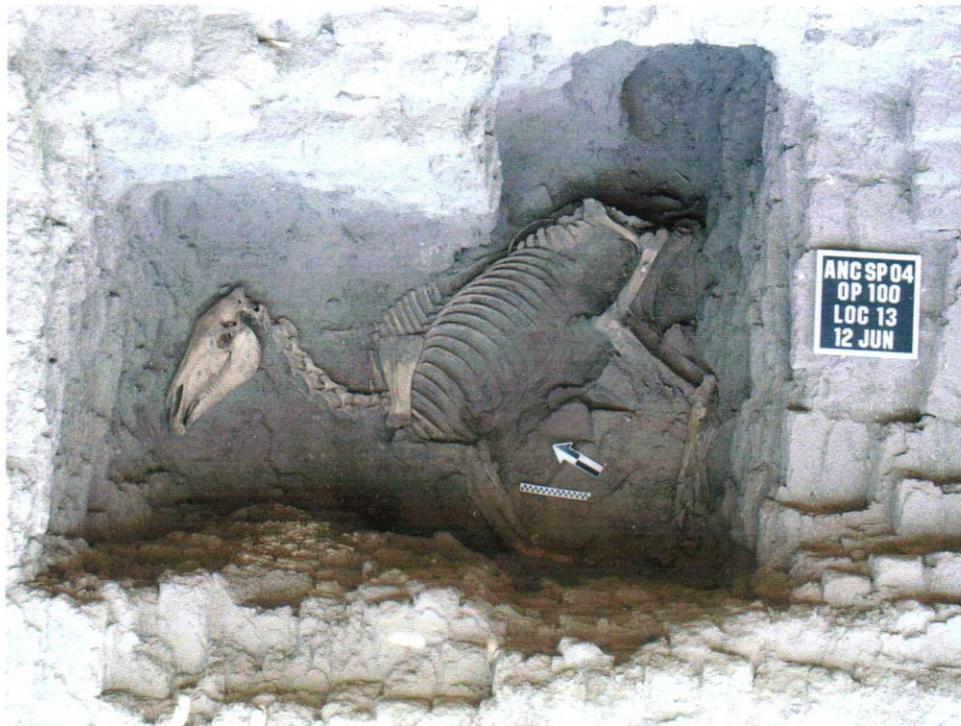
mudbricks. No artifacts were found in the pit or with the horse skeleton to determine the date of either the cutting of the pit or the interment of the horse. It is possible that the pit was cut in the 19<sup>th</sup> Century by one of the early excavators at the site of Abydos (Mariette is most likely), who may have been looking for foundation deposits under the corner of the Shuneh. There is no conclusive evidence for the date, however. A similar hole at the south corner of the Shuneh, which may also relate to a search for foundation deposits, was investigated in 2001.

Figure 10 – Operation 100, horse burial in the fill of the pit cut into the main enclosure wall of the Shuneh.

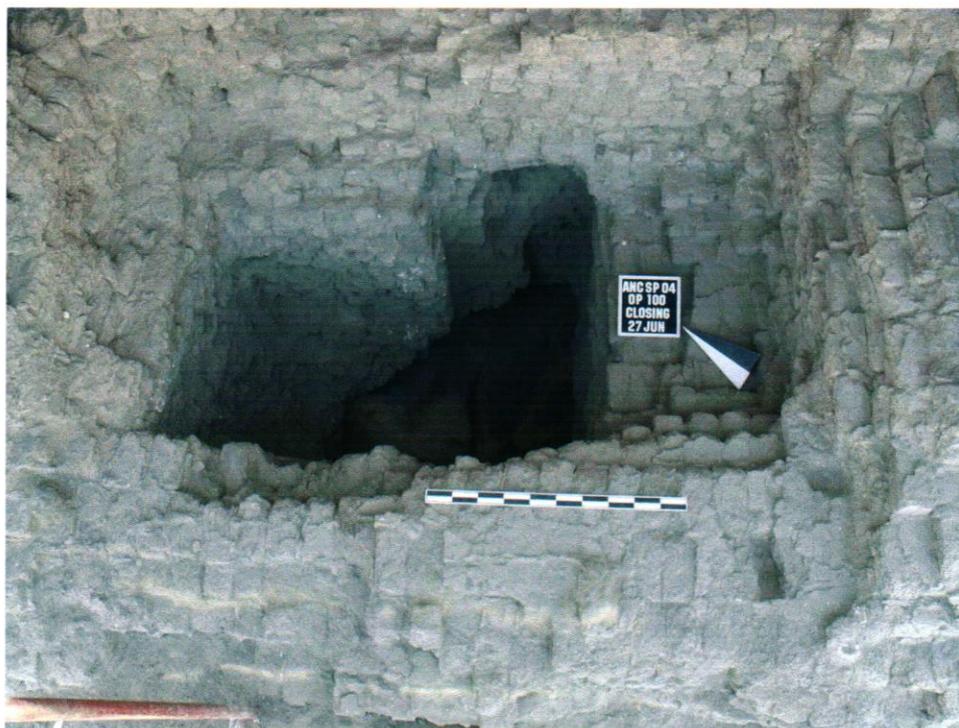
Figure 11 – Operation 100, completely excavated, with the sterile sand deposits underlying the walls of the Shuneh visible in the bottom of the pit.

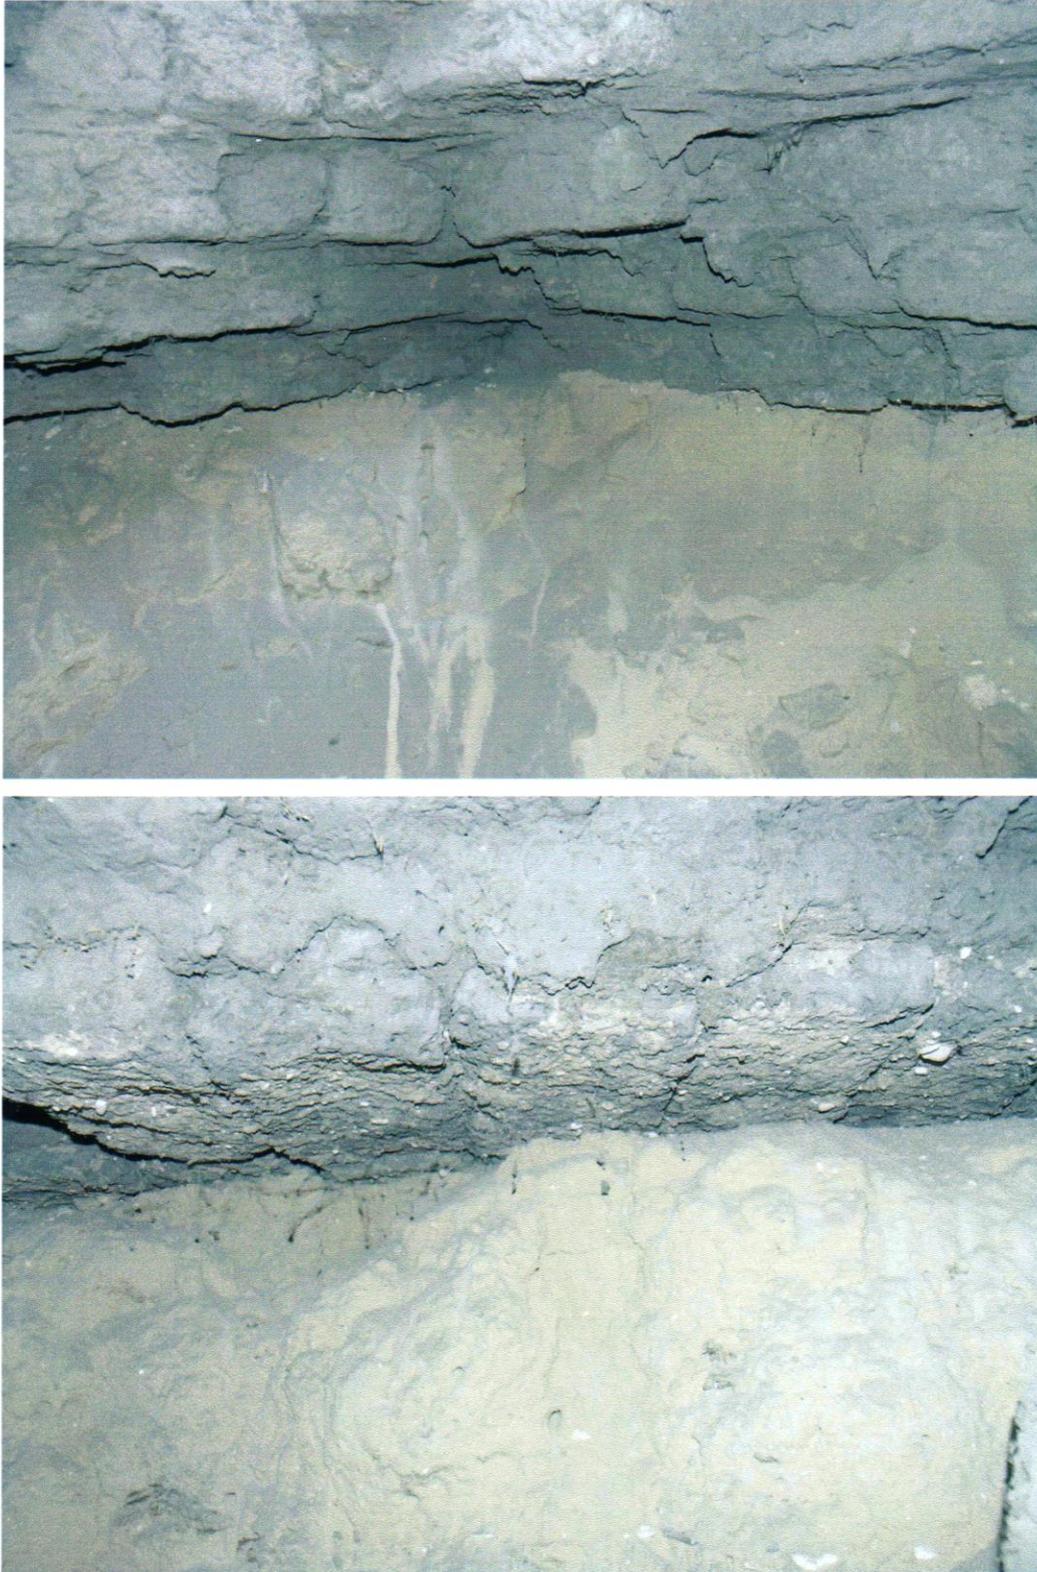
Figure 12 – Operation 100, two views of the base of the main enclosure wall of the Shuneh, exposed by the cutting of the deep pit. The sterile compact sand deposit on which the wall was constructed is clearly visible.

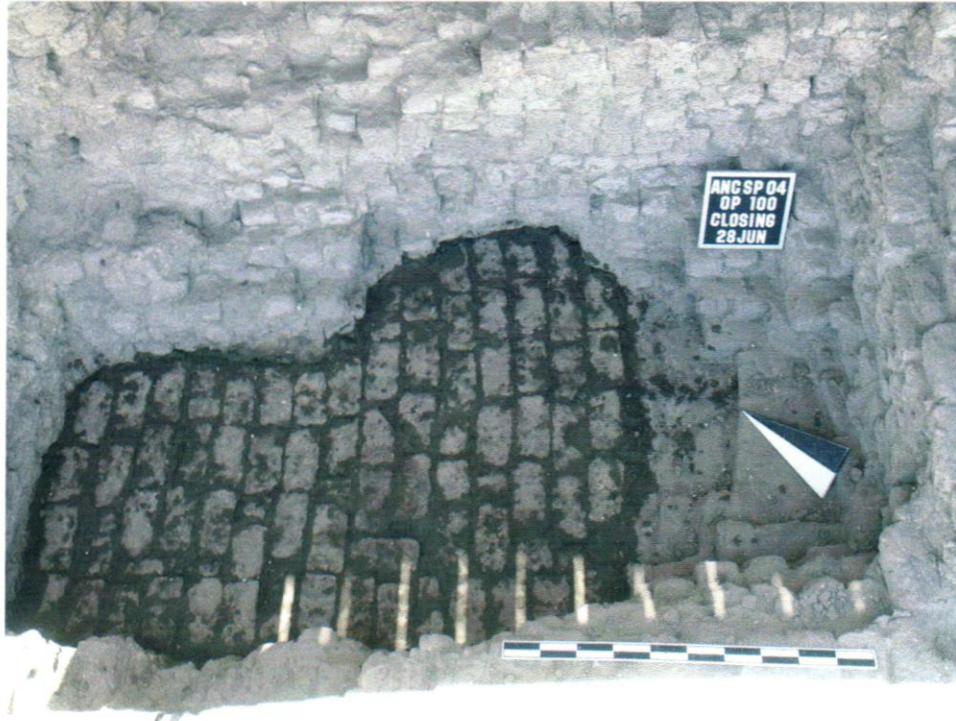
Figure 13 – Operation 100, showing the deep hole partly filled with new mudbrick masonry.

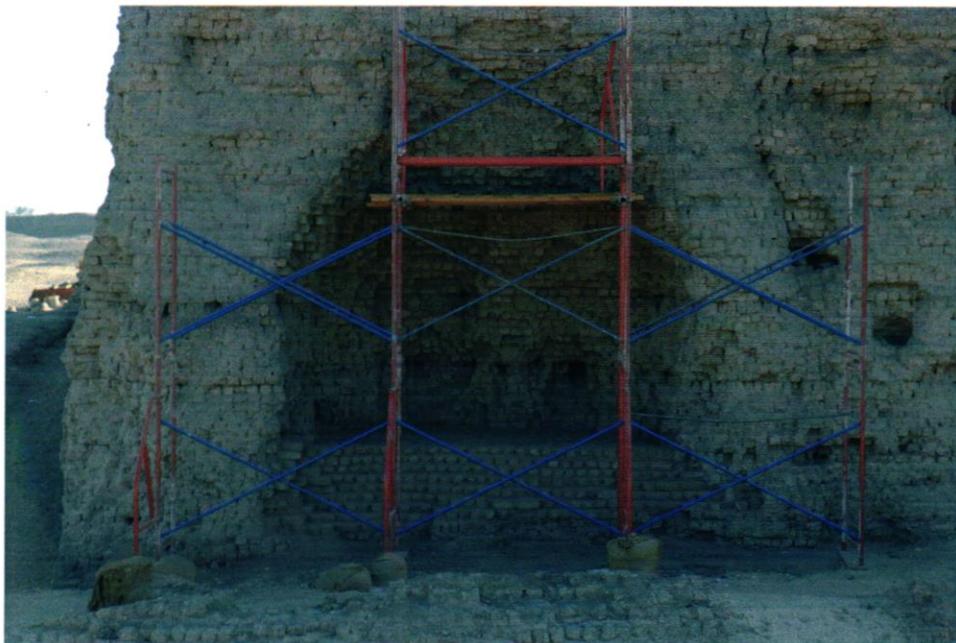
Figure 14 – Operation 100, with the stabilization work partly completed, as it stood at the close of Field Season 5. The new mudbrick masonry rises approximately one and a half meters above the mouth of the deep pit.

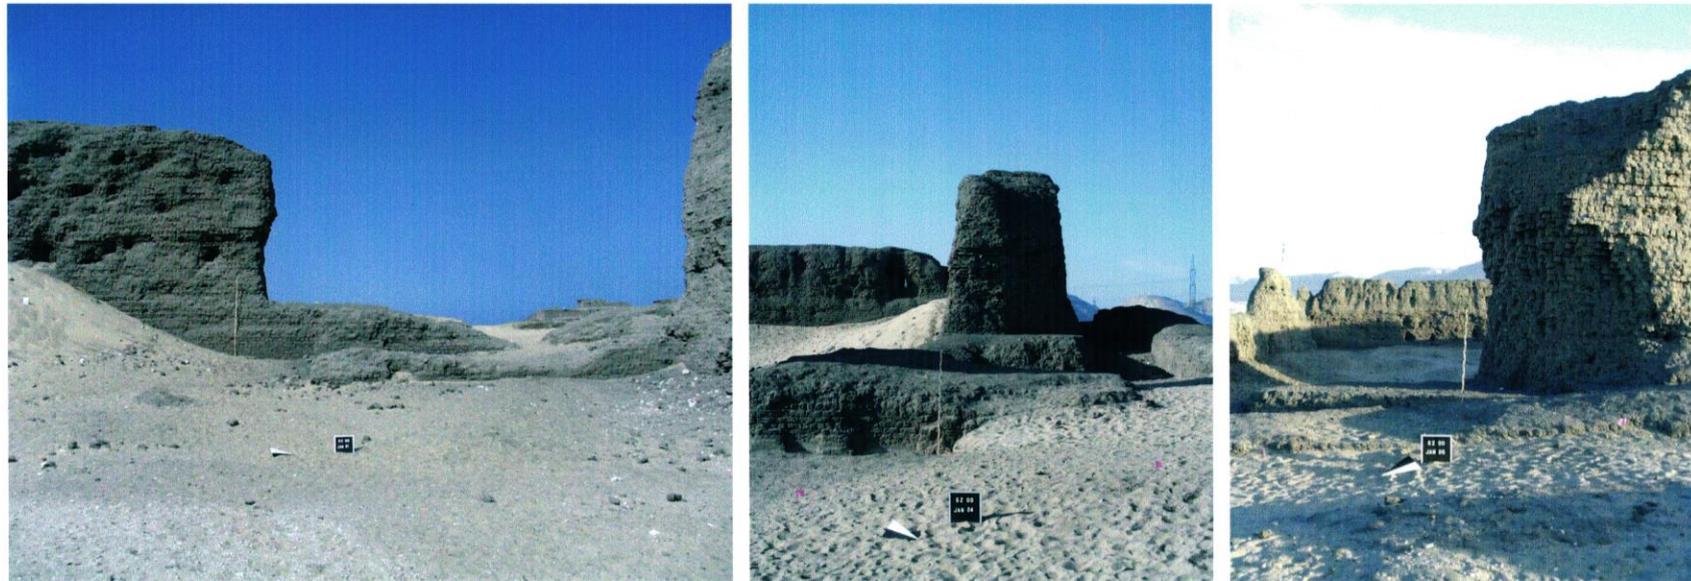
Figure 15 – three views of the vertical northeast end of the northwest wall of the main enclosure in 1999, prior to any stabilization interventions, seen from the southeast (left), the northeast (center), and the northwest (right).

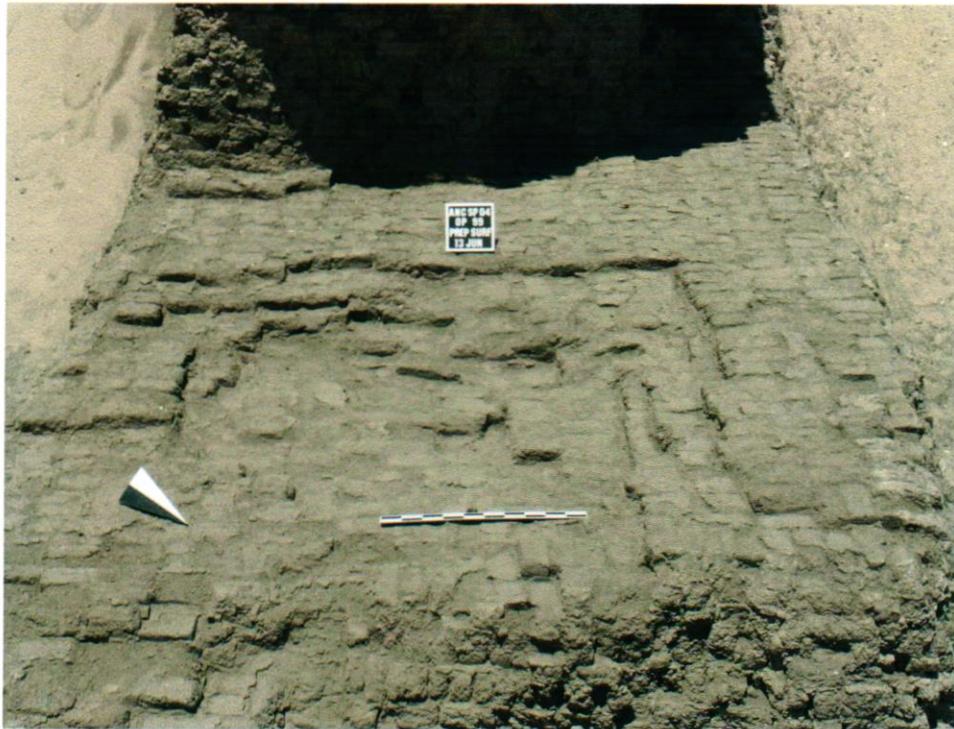
north gateway, at the northwestern end of the northeast wall of the Shuneh. Careful examination produced no indications of post-Dynasty 2 cultural features (**Figure 16**).

Figure 16 – the surface of the northeast end of the northwest wall of the Shuneh, adjacent to the vertical wall end, after cleaning but before any new construction. No traces of a cell or other features relating to the Coptic occupation of the Shuneh were detected.

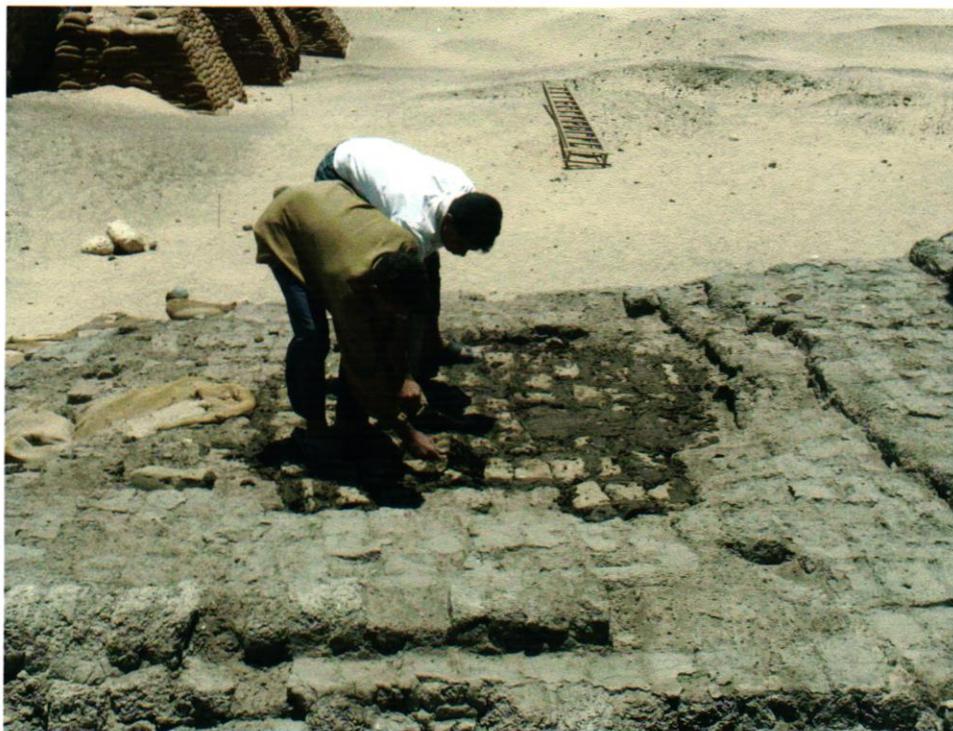
Figure 17 – filling the uneven lowest areas of the northeast end of the northwest wall with new masonry, in order to provide a level surface for the construction of the buttress.

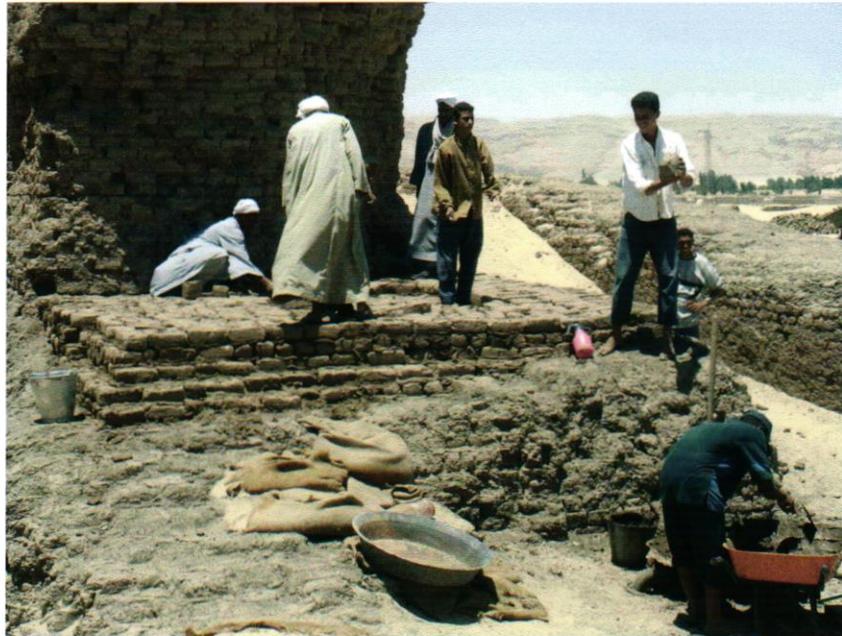
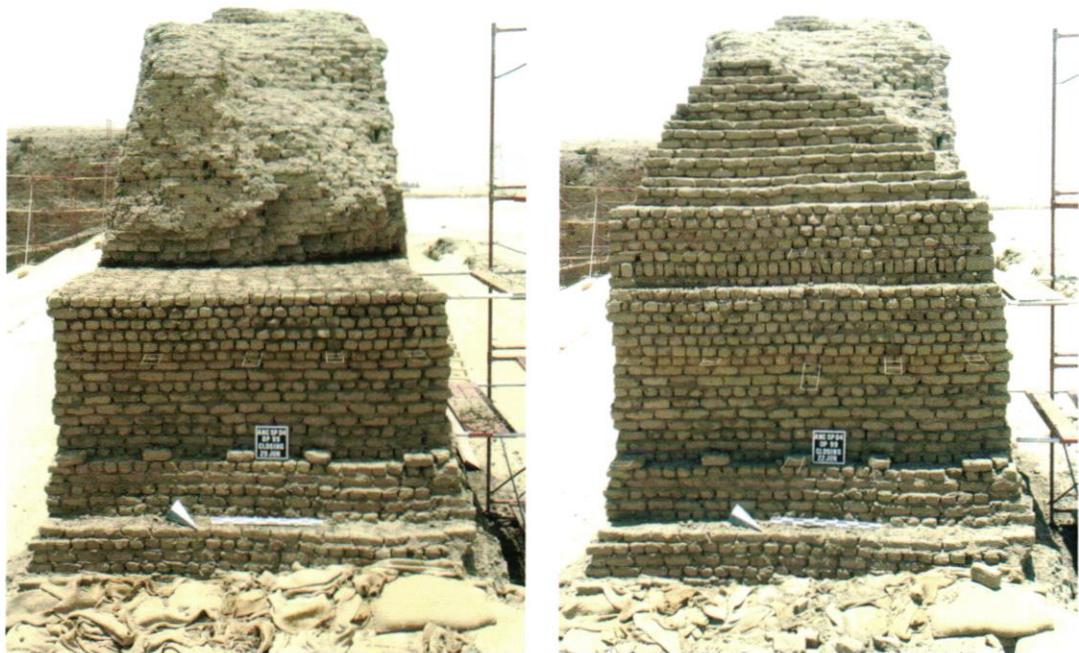
Figure 18 – stages in the construction of the buttress at the northeast end of the northwest wall of the Shuneh. The buttress as shown in the lower right photograph provides essential structural support but remains unfinished, as it is but one component of a comprehensive stabilization of the entire north gateway area. Once the remainder of the overall north gateway work is done, the sharply defined ledges and vertical faces will disappear.

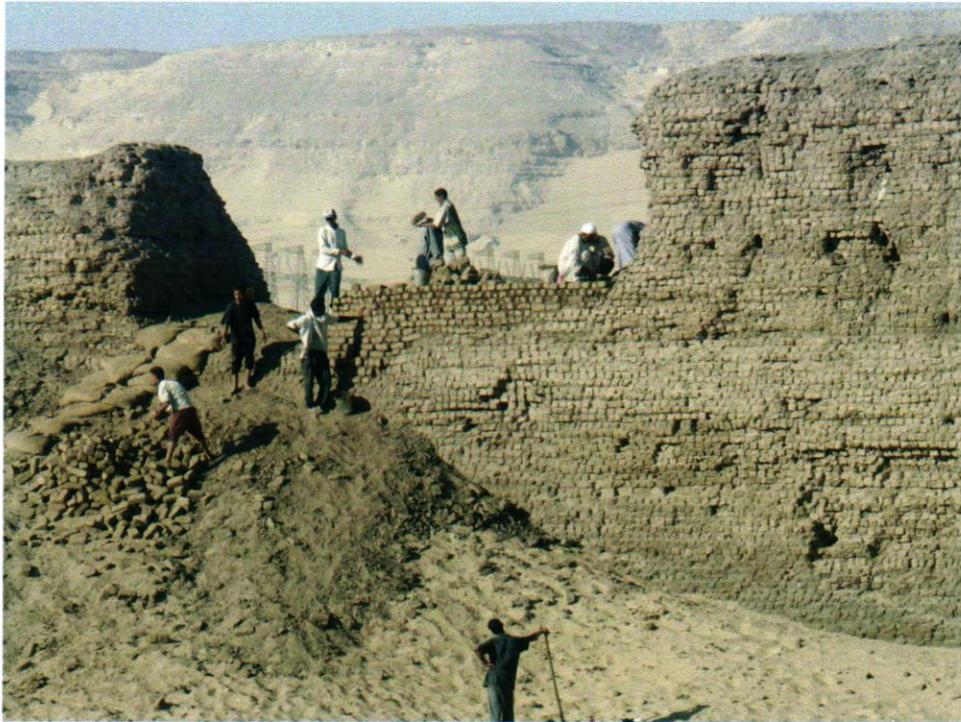
Figure 19 – stabilization work in progress in the gap in the upper part of the southeastern end of the southwest wall of the main enclosure.

In the upper part of the southern part of the southwest wall of the main enclosure a large gap in the wall poses significant structural risks. The sides of the notch consist of vertical wall sections that are associated with at least one large structural crack. Vertical wall ends pose significant risk of collapse, particularly when they occur in combination with structural cracks. In order to mitigate the most immediate risk, in Field Season 5 the Sub-project constructed a mudbrick buttress against the northwestern of the two vertical wall sections (**Figures 19-20**). This vertical section is associated with a large structural crack. The buttress provides structural support and will prevent a collapse of the vertical wall segment. As with other areas, the texture of the surrounding eroded wall surfaces in the original masonry are carried into the new work. The southeastern end of the buttress, which now presents a fairly regular profile, will, in a future season, be joined with a buttress against the southeastern vertical wall segment. This future work will soften the visual impact of the new masonry, which will then blend well into the overall profile of the wall.
