**PROGRESS REPORT No6**

**May 2004-June 2004**

**“Documentation and Conservation of King Khasekhemwy’s Funerary Monument at Abydos”**

# DOCUMENTATION AND CONSERVATION OF PHARAOH KHASEKHEMWEY'S FUNERARY MONUMENT AT ABYDOS

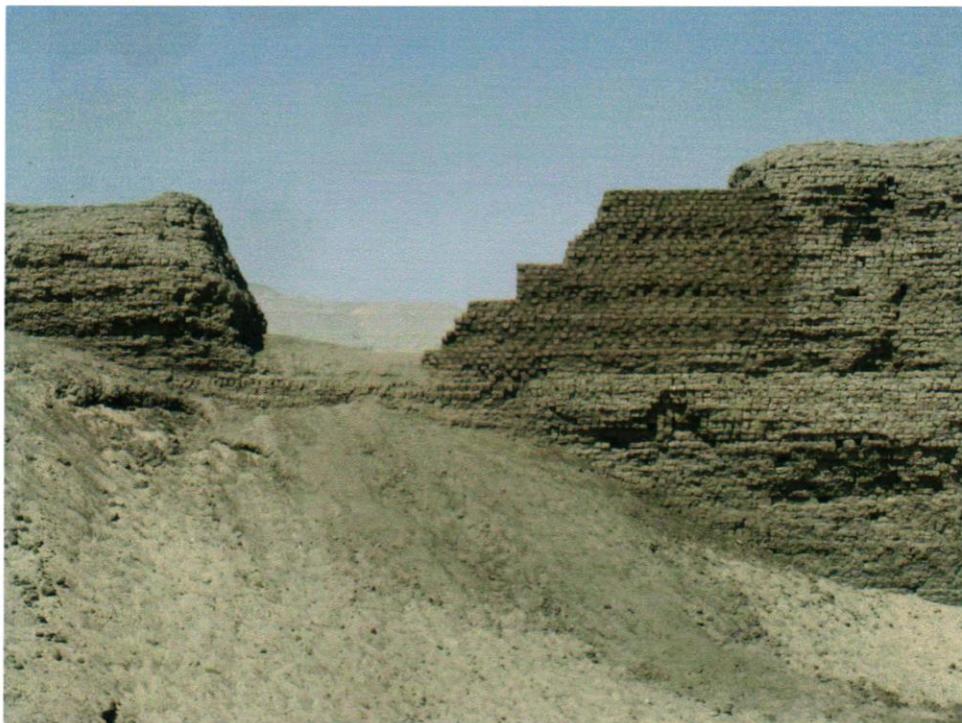
Figure 20 – the buttress constructed against the northwestern vertical wall section represents half of the structural solution to be implemented in this area. At the close of work in Field Season 5, surface texturing remained to be done in the next season.

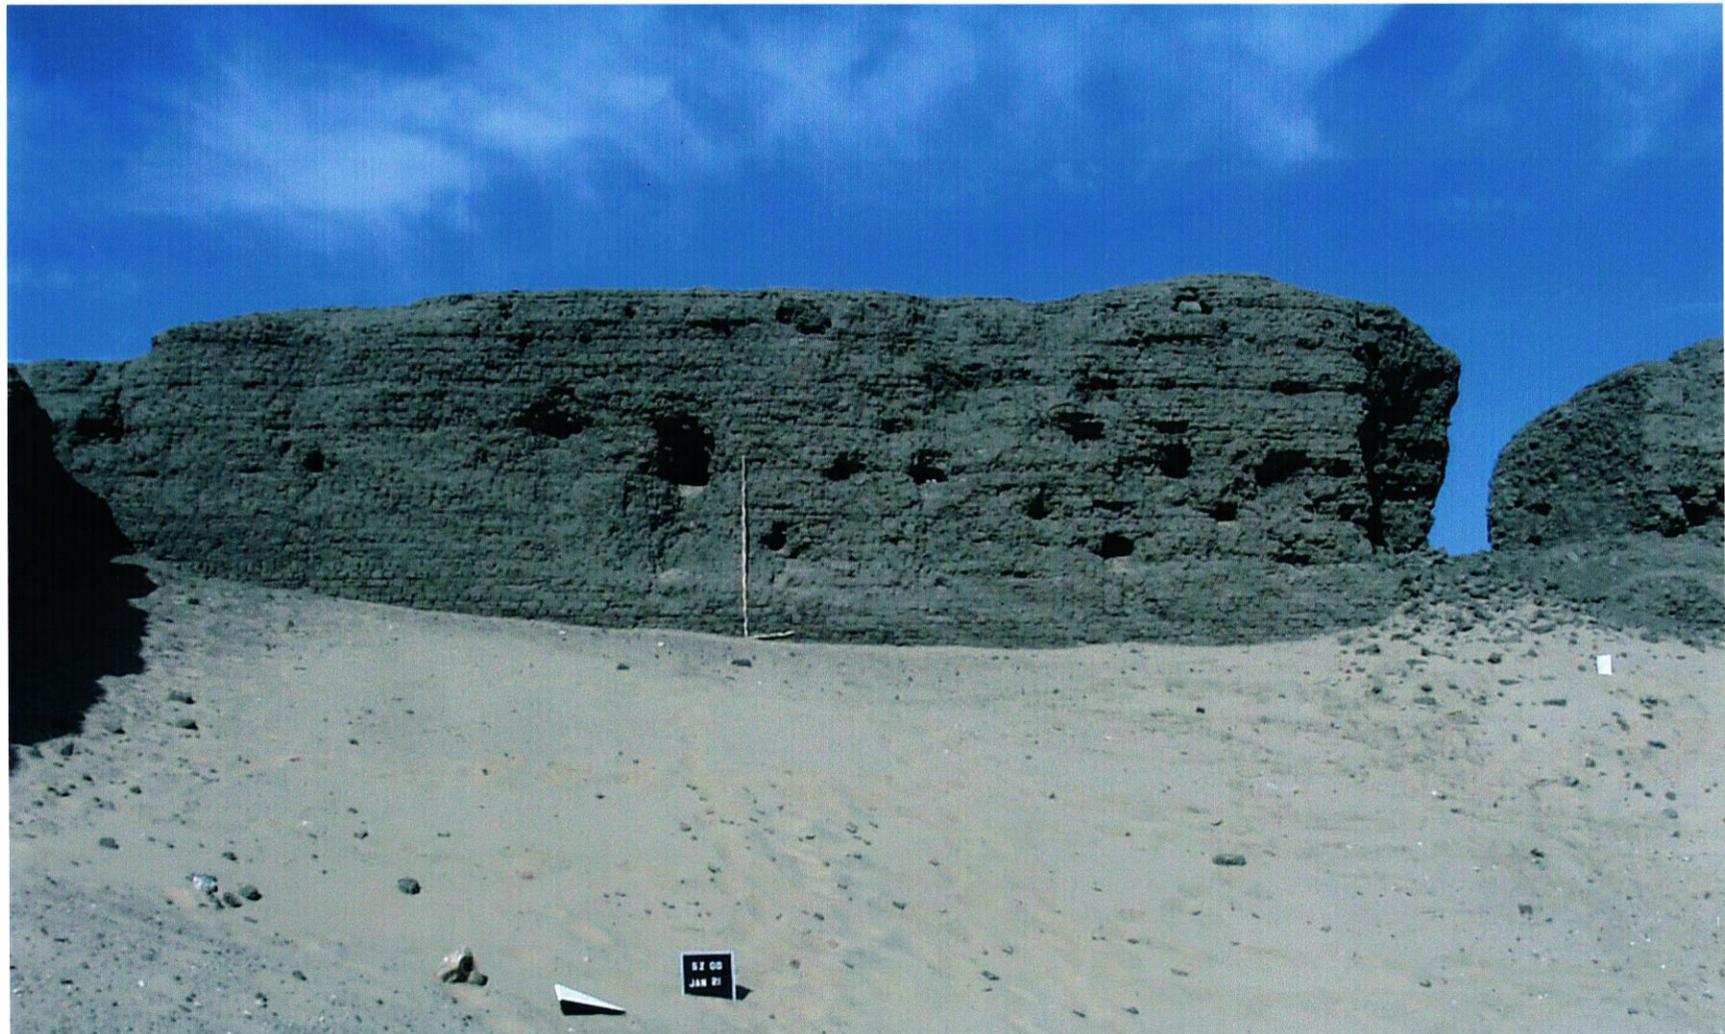
Figure 21 – inner face of the northwest wall of the Shuneh in January, 2000, with a number of medium-sized holes visible. The largest hole, just left of the vertical scale, was stabilized in Field Season 5 (see Figure 26, below).

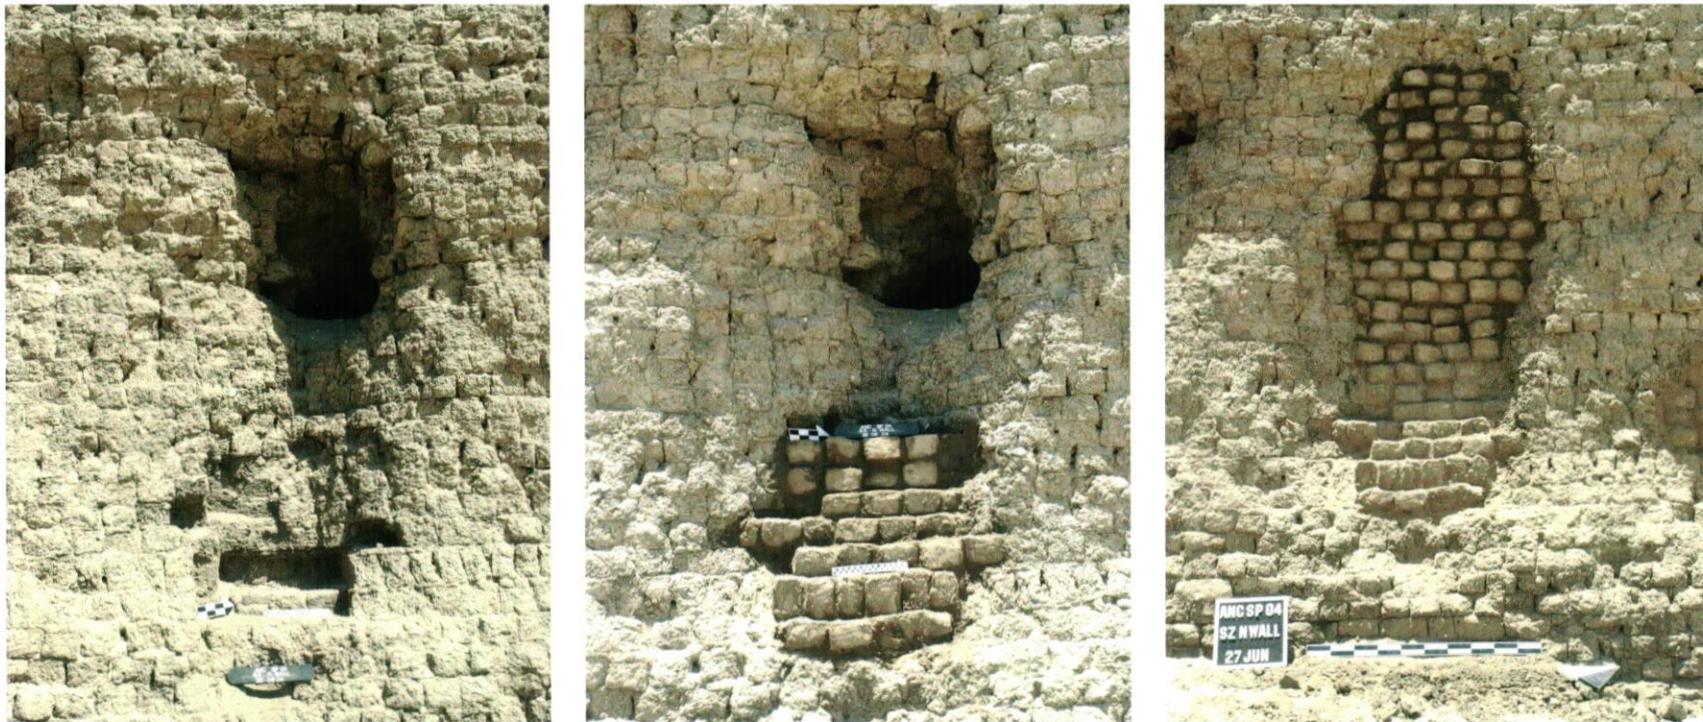
Figure 22 – stages in the stabilization of the hole in the northwest wall, inner face. Loose and decayed bricks were removed (left) below the hole, in order to allow the construction of a stepped base (center) for the additional masonry to be added above, filling the hole (right). As can be seen in the lower part of the view at right, once dry, the color of the new masonry blends well with the original. Additional finish techniques will be applied to blend the texture of the new work with the old.

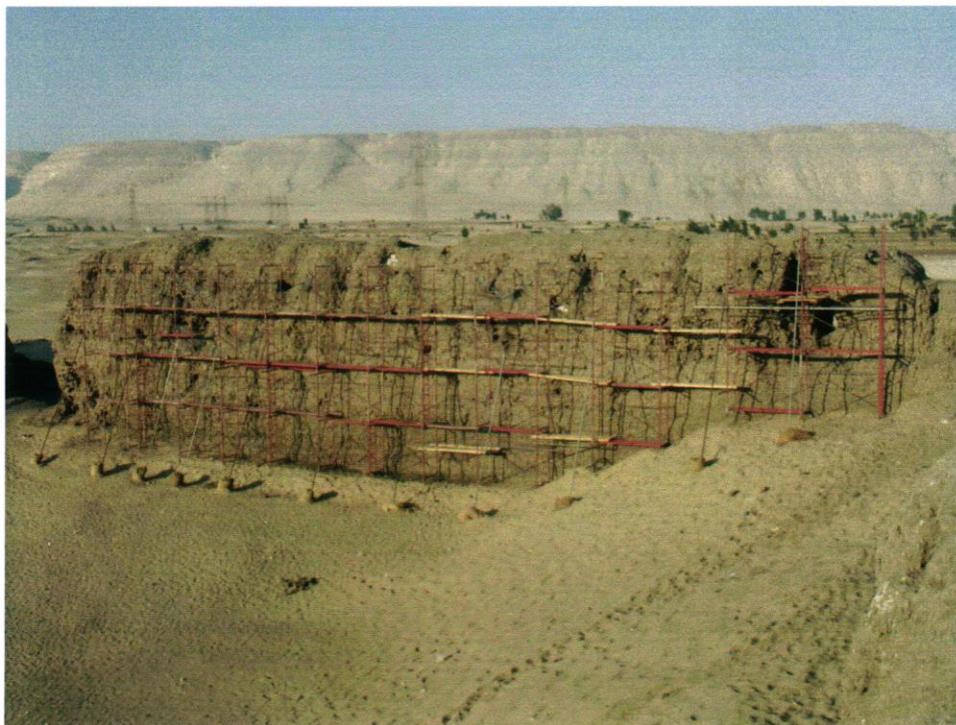
Figure 23 – inner face of the northwestern part of the southwest wall of the main enclosure, after the erection of scaffolding to provide access to the wall face for the repair of the many holes present.

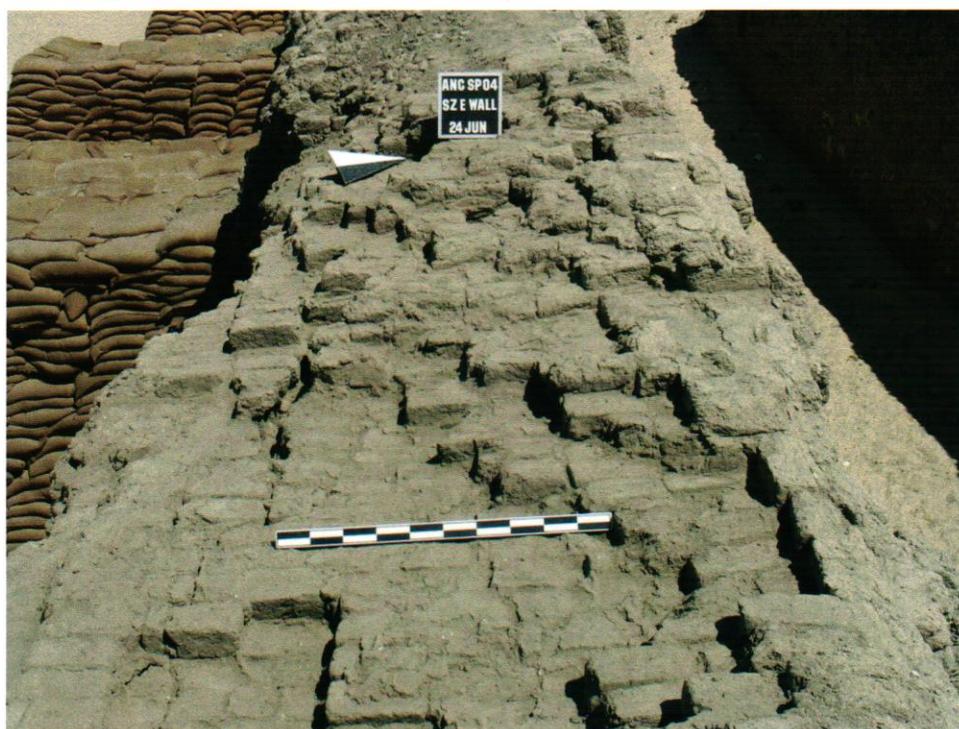
Figure 24 – top of the central part of the northeast wall of the main enclosure of the Shuneh, after cleaning. The structural crack is partly visible, just to the left of the meter scale.

In addition to the large-scale stabilization solutions, a number of smaller-scale but still significant areas where structural risks are present and where original fabric of the monument is being lost to collapse and erosion, were also treated this season. A number of large holes in the walls were cleaned, documented, and filled with new mudbrick masonry. One example is illustrated in **Figures 21** and **22**. The new masonry will prevent the holes from causing further localized collapses of the brickwork. Holes treated this season were located on the inner and outer faces of the northwest main enclosure wall and the inner face of the northwestern half of the southwestern main enclosure wall. Extensive scaffolding was erected along the inner face of the northwestern half of the southwest wall, in order to provide access to the wall face (**Figure 23**). Besides filling holes, a large structural crack in the middle of the top of the northeastern main enclosure wall (**Figures 24-26**) was cleaned out, and new mudbrick masonry installed, incorporating horizontal reinforcing material (a geogrid textile) between courses in order to tie the masonry on both sides of the crack together.

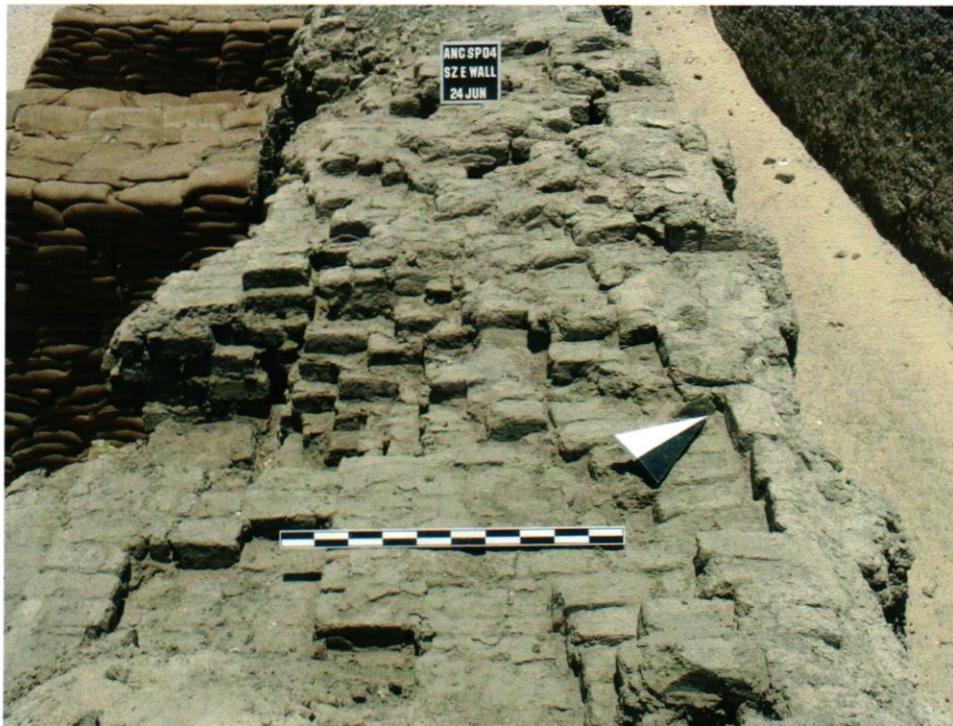
Figure 25 – the same area as in Figure 23, after the removal of some masonry adjacent to the crack, at left.

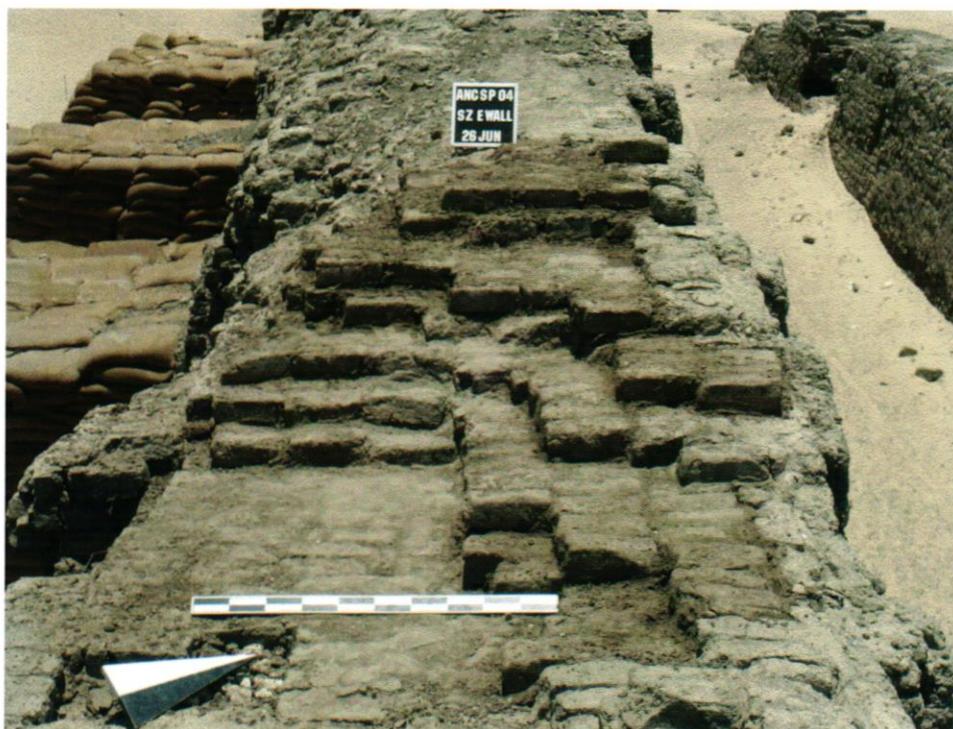
Figure 26 – the area of the top of the northeast wall, after the repair of the crack and capping.

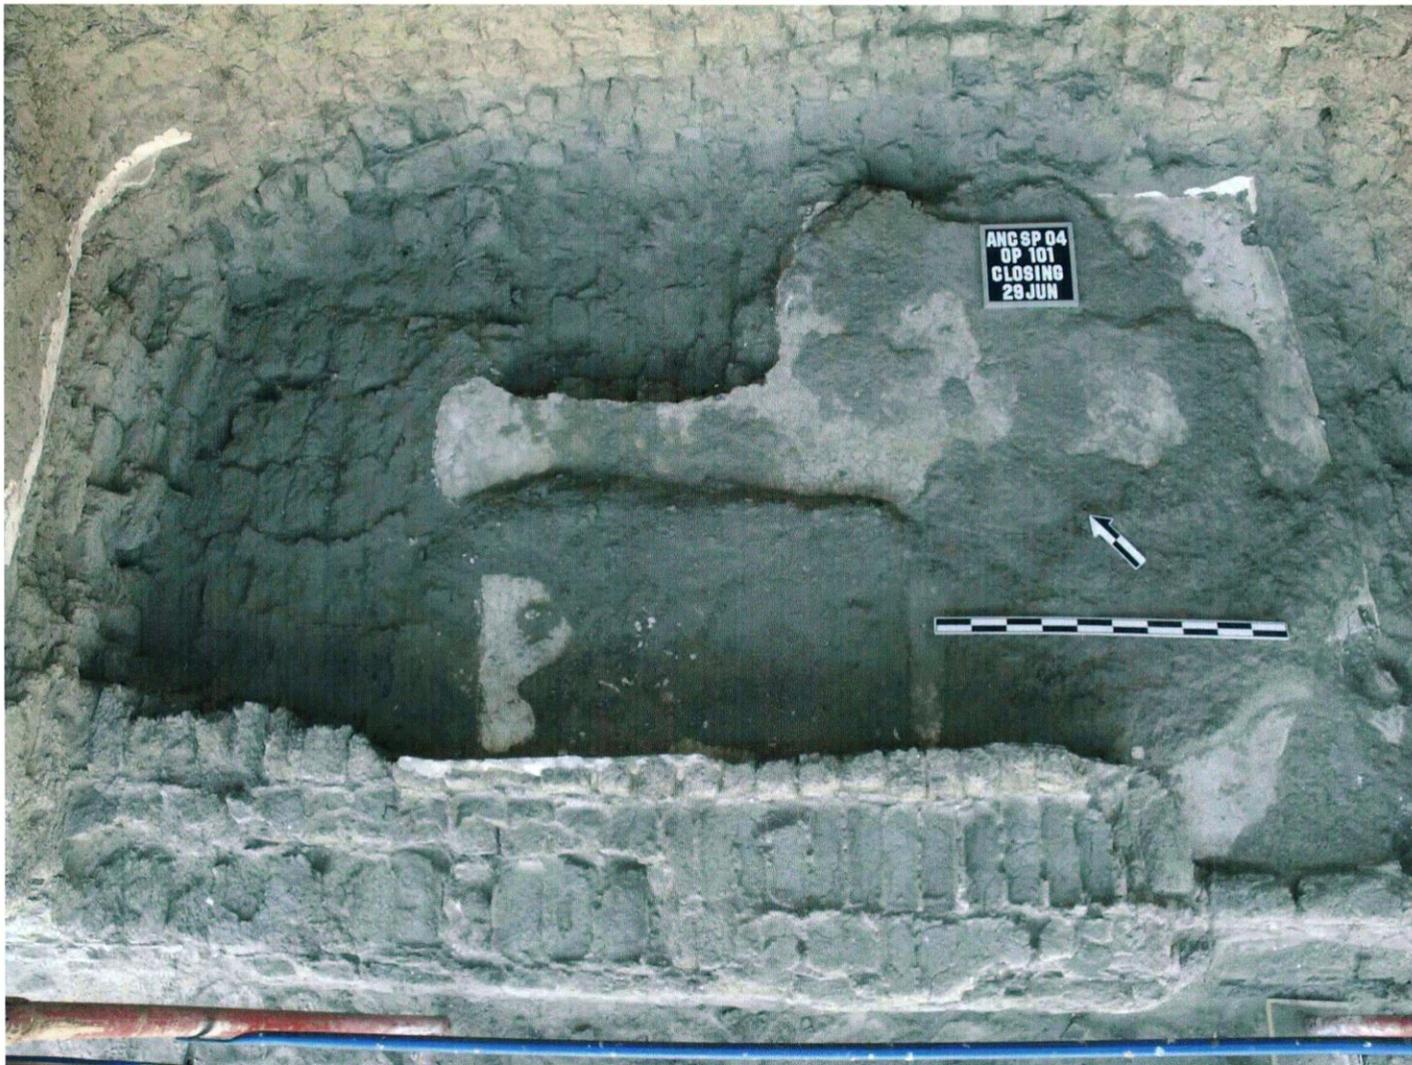
Work in Operation 101 (**Figures 7, 8**) showed that this area, too, was a Coptic cell. The basic outline of this cell is better preserved than was the case in Operation 100 (**Figure 27**). It measured approximately 3.75 x 2 meters in plan. Its ceiling, though destroyed, can be estimated from traces of wall plaster to have been approximately 1.9 meters high. The front wall of the cell was formed by original Shuneh masonry that was left in place when the cell was created. Access to the interior was gained by means of an entrance at its southern end. In this entrance was a door pivot and just inside, a small ceramic bowl set into the floor. The floor and the lower parts of the walls were covered in a smooth white lime plaster, while, where preserved, the upper parts of the cell's walls were finished in a light brown mud plaster. At the north western end of the cell there was once a sleeping platform. This has been completely destroyed, but its position and size can be determined from the preserved plaster on the floor and adjacent wall. On the inner face of the exterior wall of the cell, some of the white plaster was preserved. Its upper edge, which bore traces of red line decoration, was found to be extremely fragile and was delaminating. Because of the significance of the traces of decoration, measures were taken to stabilize the edge of the plaster. First, it was carefully cleaned (**Figure 28**). Then, a solution of Acryloid B-72 was injected into the mud plaster backing of the finished lime plaster (**Figure 29**). Finally, a putty, consisting of a mixture of lime and sand, was applied (**Figure 30**) to provide physical protection to the exposed plaster edge. Excavation in Operation 101 also revealed that, mixed into the decayed mudbrick and mudbrick debris on the floor of the cell were many fragments of fallen wall plaster, some of which bore traces of black line decoration (**Figure 31**). This deposit was left in situ, so that it can be lifted as a block in a future season by archaeological conservators, who will then be able to clean and consolidate the fragments under the more controlled circumstances of the Sub-project's conservation lab.

Figure 27 – Operation 101, at the close of excavation. The brickwork in the foreground is original Dynasty 2 masonry, left in place when the cell was created to serve as the front wall. The sleeping platform, or bench, that has been robbed out, is at left. The entrance to the cell is at the lower right.

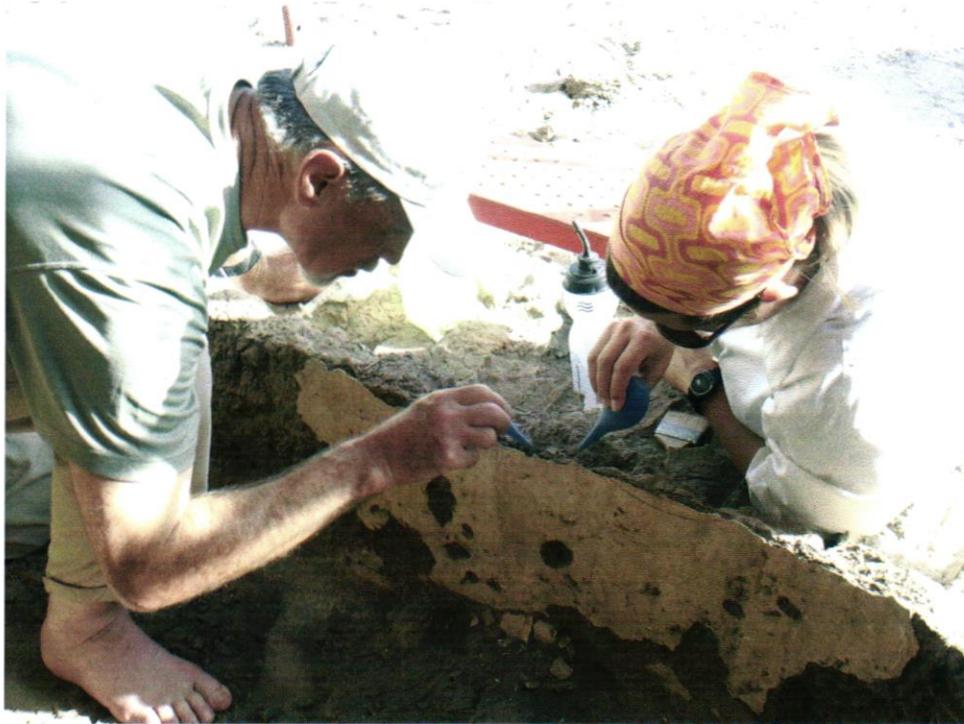
Figure 28 – Operation 101, cleaning the fragile edge of wall plaster on the inner face of the front wall of the cell. Note the trace of red painted decoration along the broken top edge.

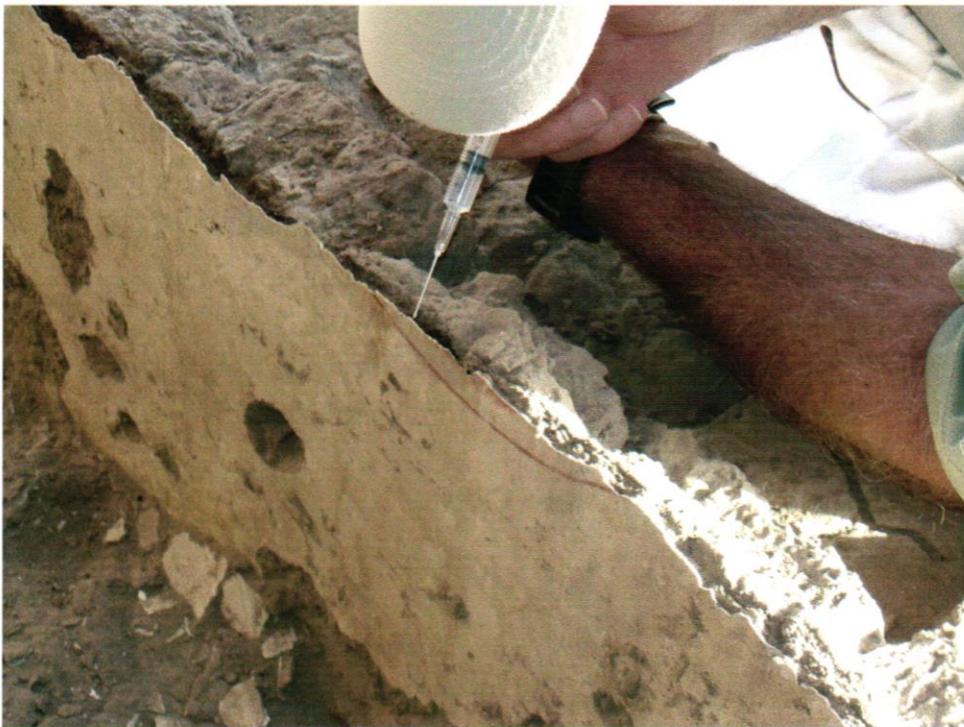
Figure 29 – Operation 101, stabilizing the mud plaster behind the fragile broken edge of the lime wall plaster using a solution of Acryloid B-72.

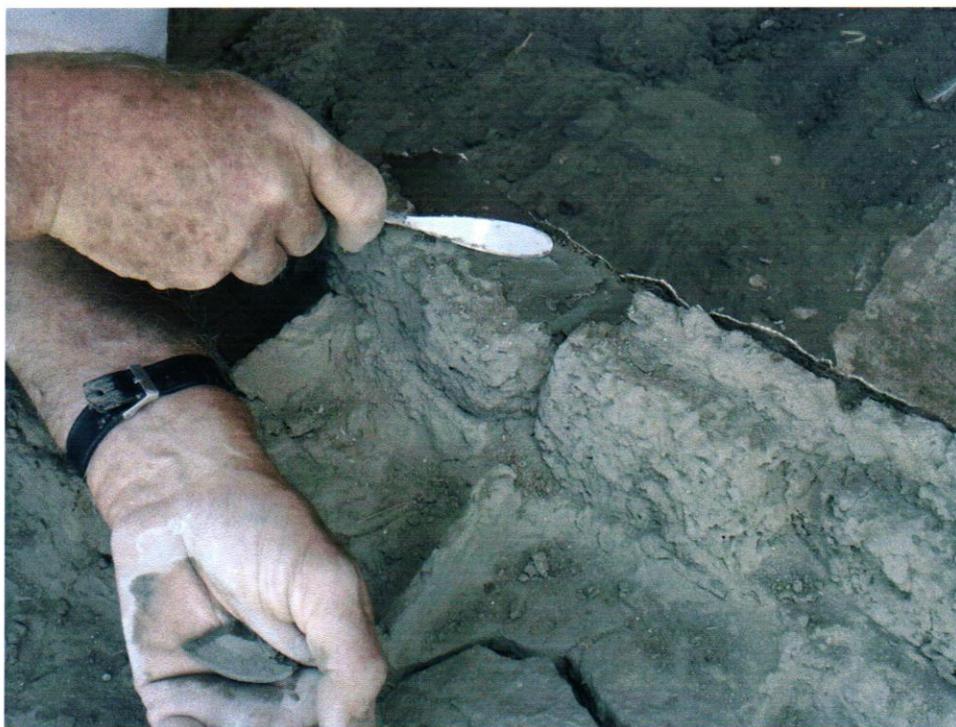
Figure 30 – Operation 101, backing the broken, delaminating edge of the Coptic wall plaster with a lime-sand mixture.

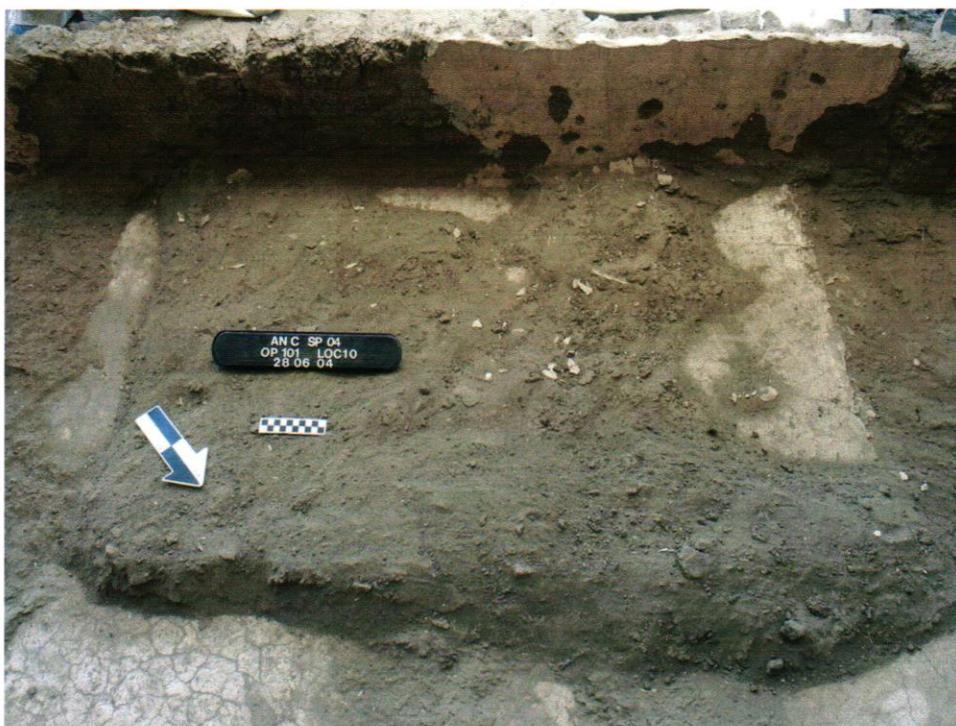
Figure 31 – Operation 101, deposit of decayed mudbrick on the floor of the Coptic cell containing many fragments of fallen wall plaster with decoration. This deposit was left *in situ* in anticipation of consolidation and lifting by an archaeological conservator in the next field season.

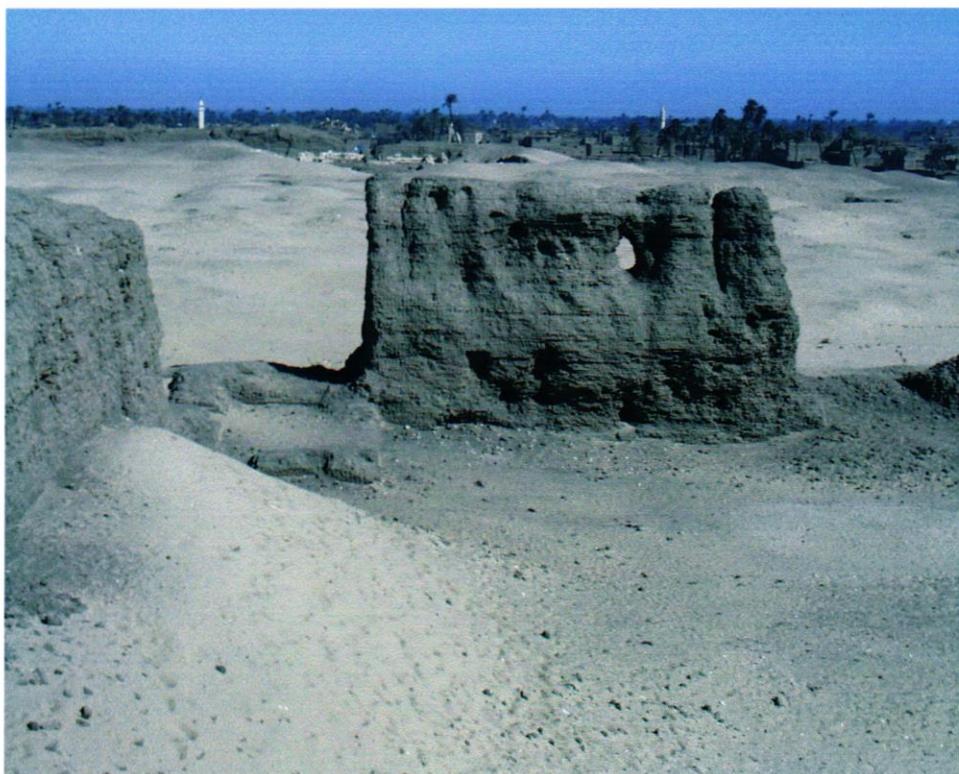
Figure 32 – northeast wall of the main enclosure, northwest part, near the north gateway (the low walls at left). The low area at right, adjacent to the vertical wall end, was the location of Operation 102.

Work in Operation 102, along the inner face of the northeast wall of the main Shuneh enclosure (**Figures 32, 33**), exposed the collapsed roof of another cell belonging to the early Christian occupation of the Shuneh (**Figure 34**). At the back (northeast) of the cell, the lime plaster finish of the interior of the cell was visible. Removal of the collapsed brickwork and the excavation of the interior of the cell will be undertaken next season.

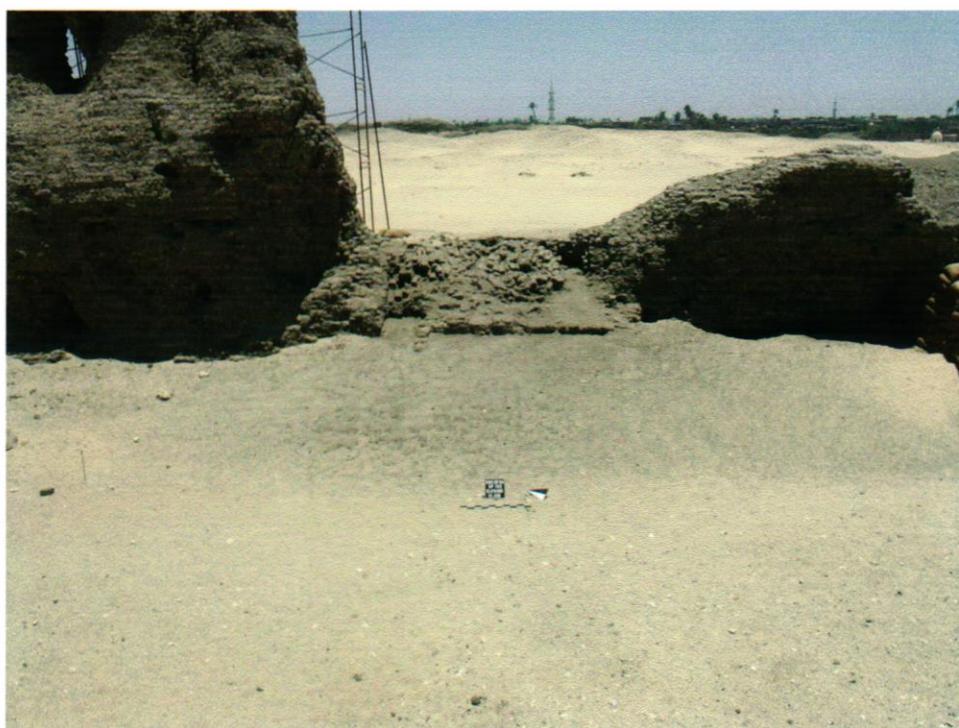
Figure 33 – Operation 102, at the close of excavation in Field Season 5.

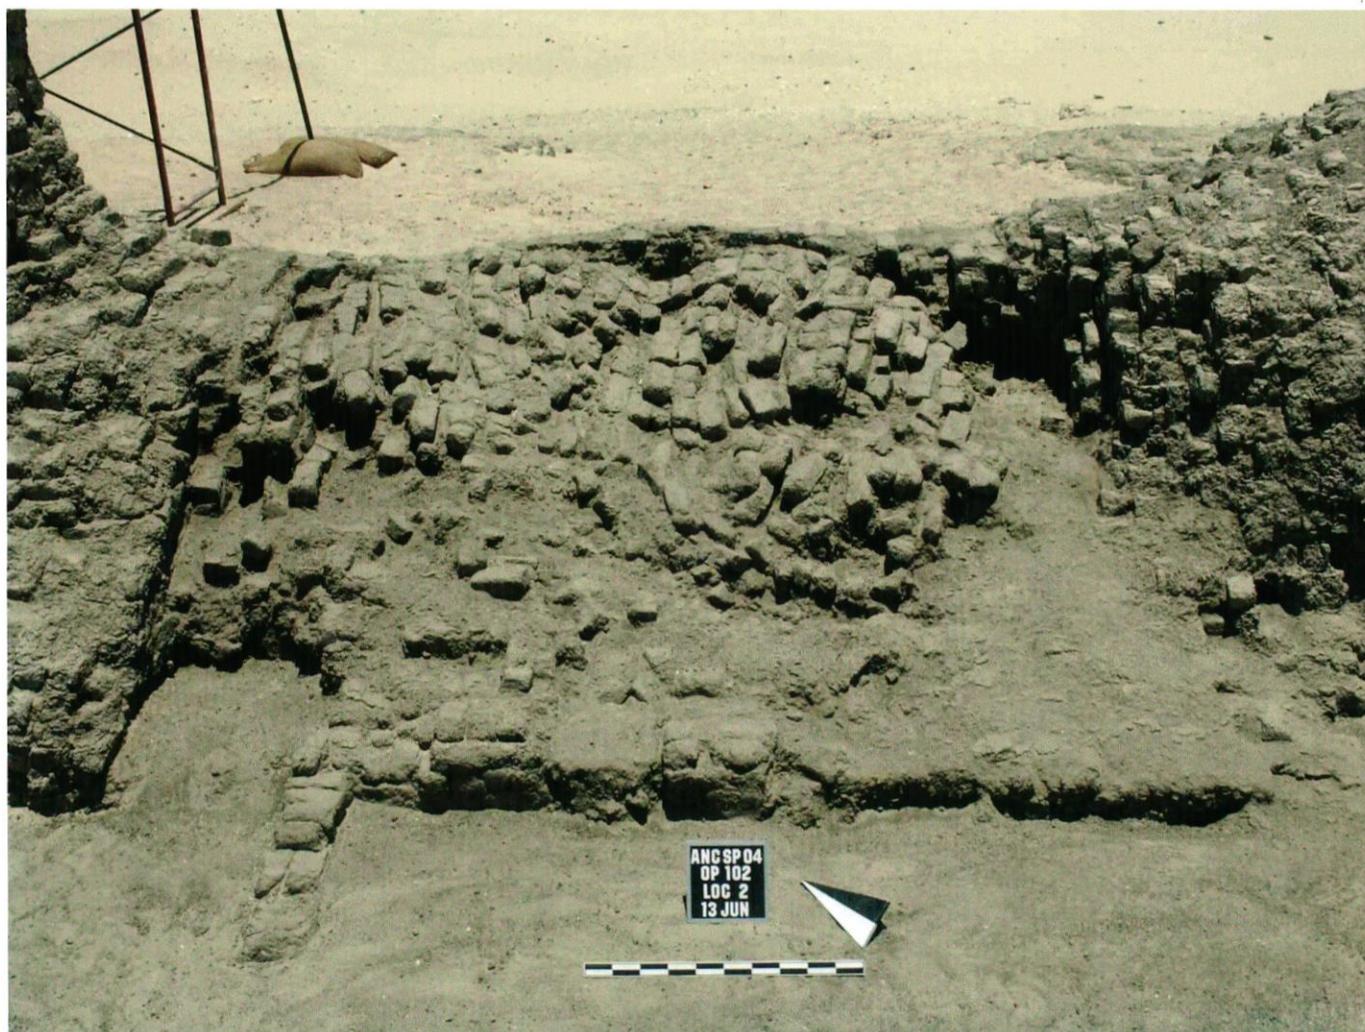
Figure 34 – Operation 102 at the close of excavation in Field Season 5. The collapsed mudbrick represents a fallen section of original Dynasty 2 masonry that served as the roof of the cell.
