PROGRESS REPORT No9

“Documentation and Conservation of King Khasekhemwy’s Funerary Monument at Abydos”

Progress Report No. 9

David O'Connor, Sub-Project Director
Matthew Adams, Sub-Project Associate Director
Institute of Fine Arts, New York University

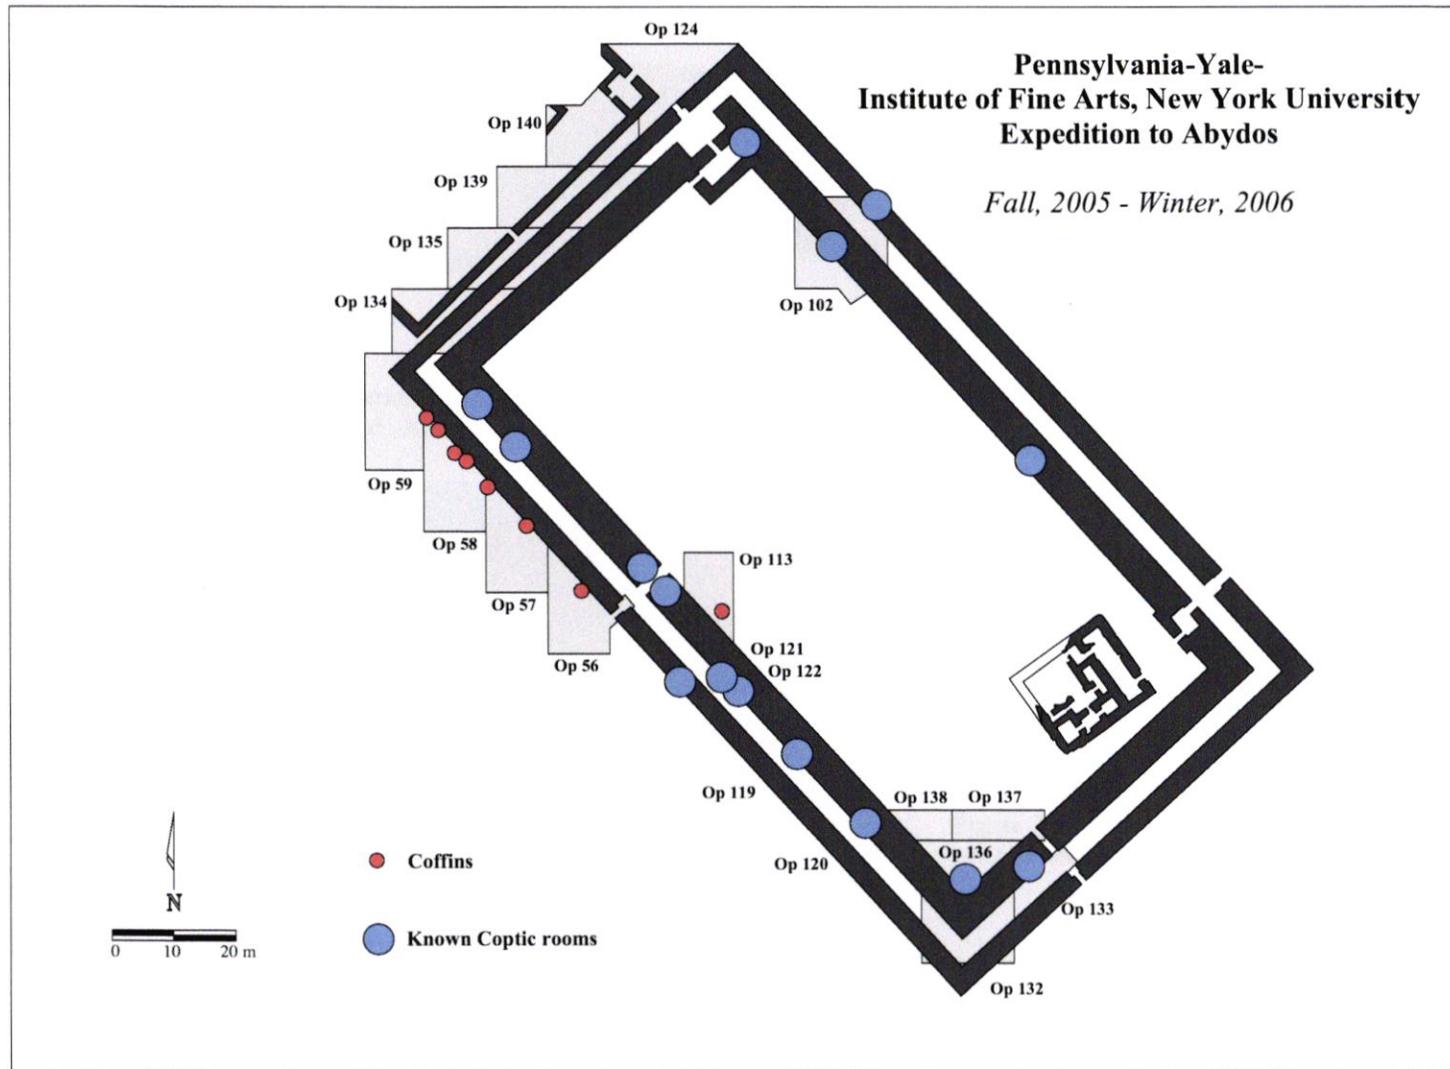
Figure 1 – Plan of the funerary cult enclosure of king Khasekhemwy, the Shunet el-Zebib, showing the locations of the excavations in Field Season 7, as well as the human burials in wooden coffins, as well as all known rooms related to the monastic occupation of the enclosure in late antiquity.

The relationship between the Khasekhemwy and Peribsen enclosures may be illuminating as to the history of the later monument. On the plan **Figure 1** it appears that the line of the northwest perimeter wall of the Shuneh has been shifted to fit it into the space between the main enclosure wall and the southeast wall of the enclosure of Peribsen. Excavations in Operations 102 and 114 in Field Season 6 found evidence that the perimeter wall may have

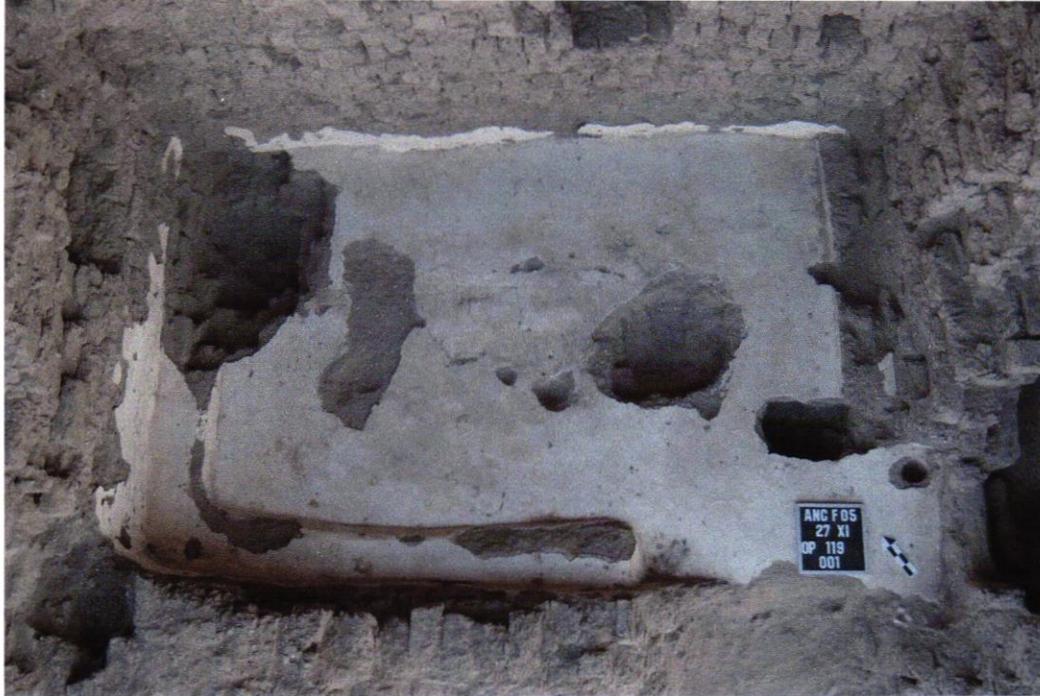
Figure 4 – Interior of the main chamber of cell Operation 119, prior to the start of stabilization work. The entrance to the cell is at lower right, just in front of the photo board. The entrance to a smaller ancillary chamber is at far right.

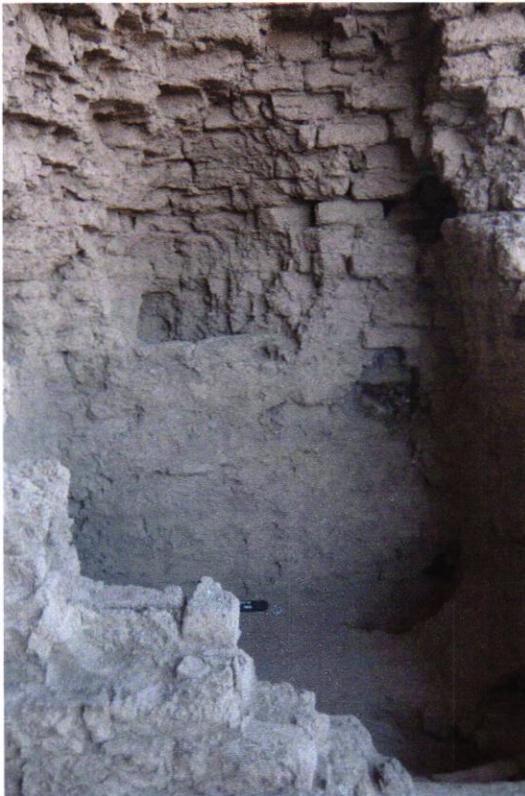
Figure 5 – View into the smaller ancillary chamber of cell Operation 119. Unlike the main chamber, this one was finished in mud plaster only.

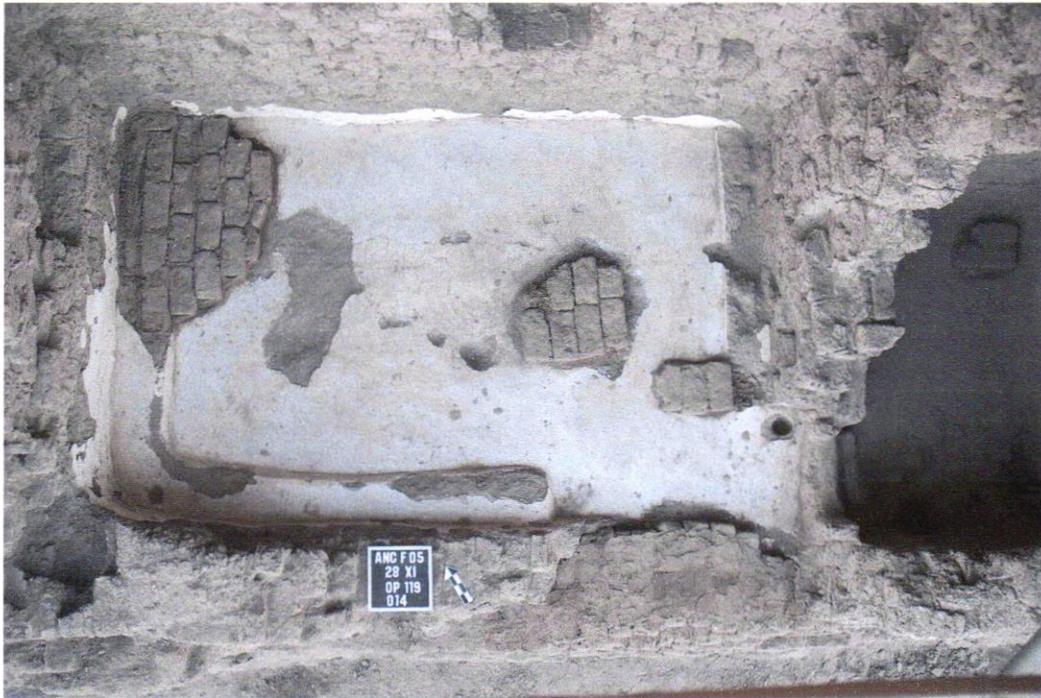
Figure 6 – The first step in the stabilization of the cell void was filling the holes in the cell floor with new bricks.

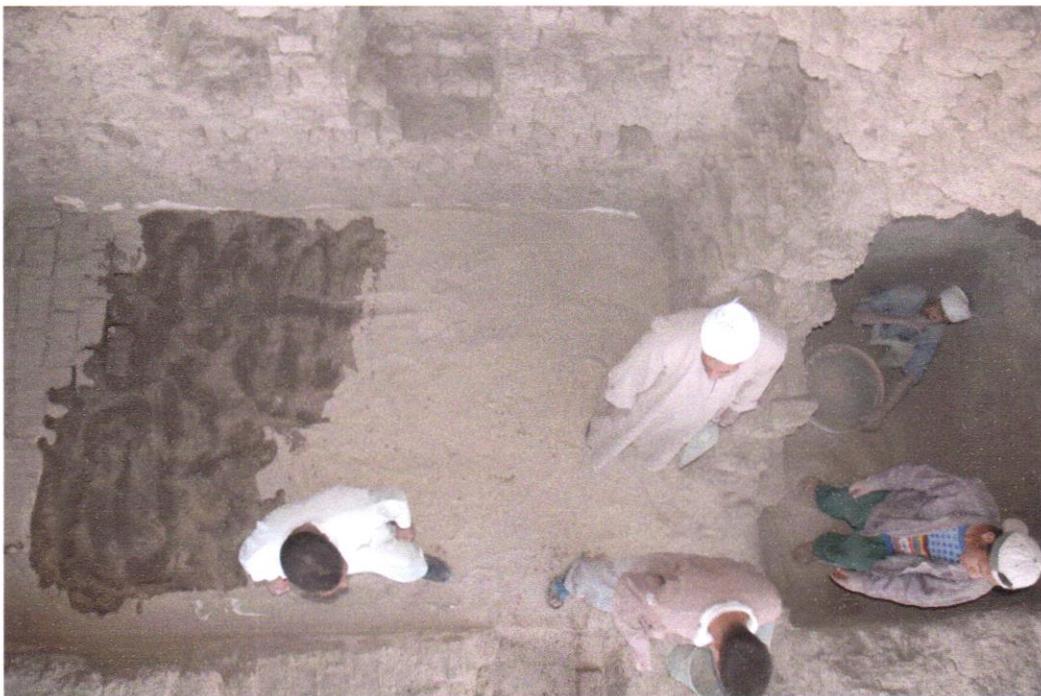
Figure 7 – All original surfaces in the cell were covered by a protective barrier layer of fine sieved sand. This sand was wetted and compacted prior to the installation of new masonry.

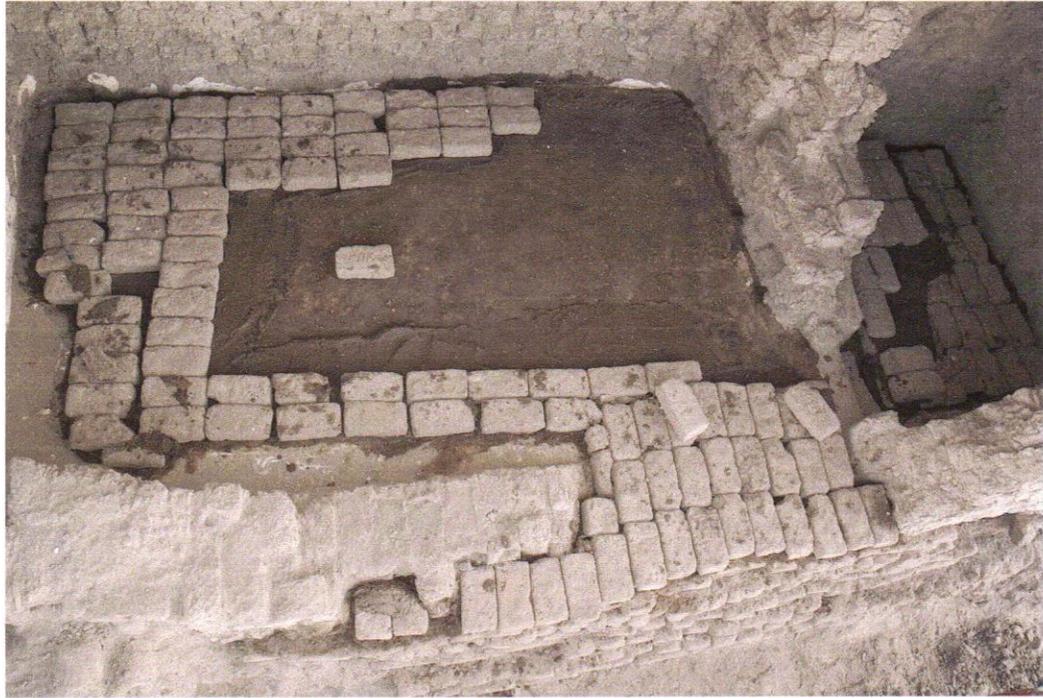
Figure 8 – As new masonry was installed, a gap was left around the edges as the level of the infilling rose.

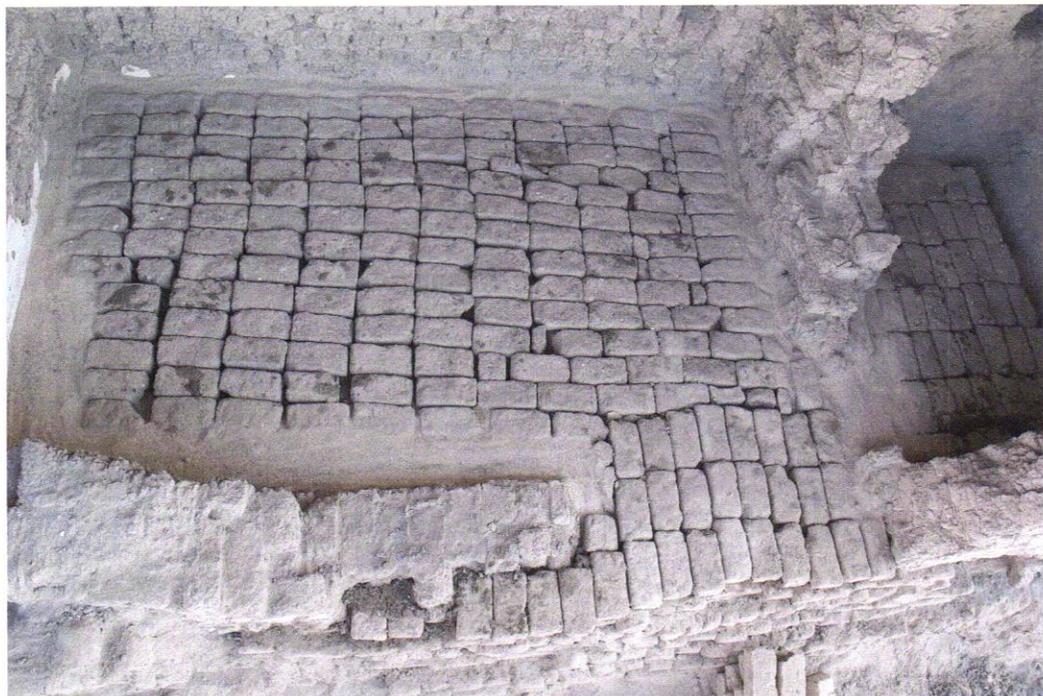
Figure 9 – The gap was filled with fine sieved sand, to provide a protective barrier layer between the new masonry and any original surfaces or features of the cell.

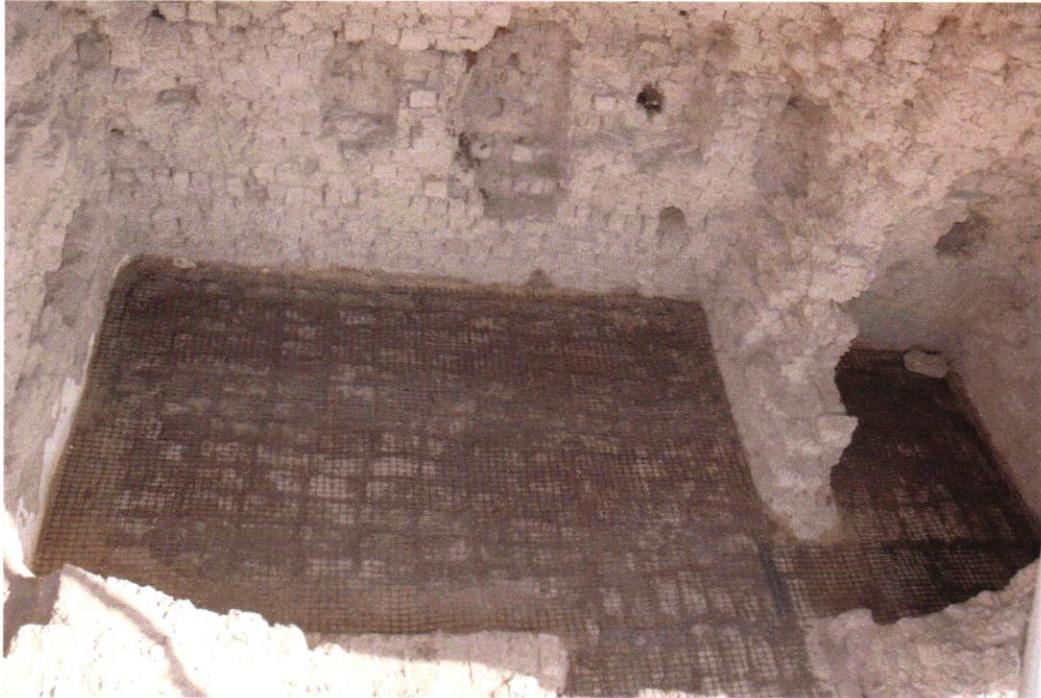
Figure 10 – Layers of geotextile were used to provide horizontal reinforcement in the new masonry.

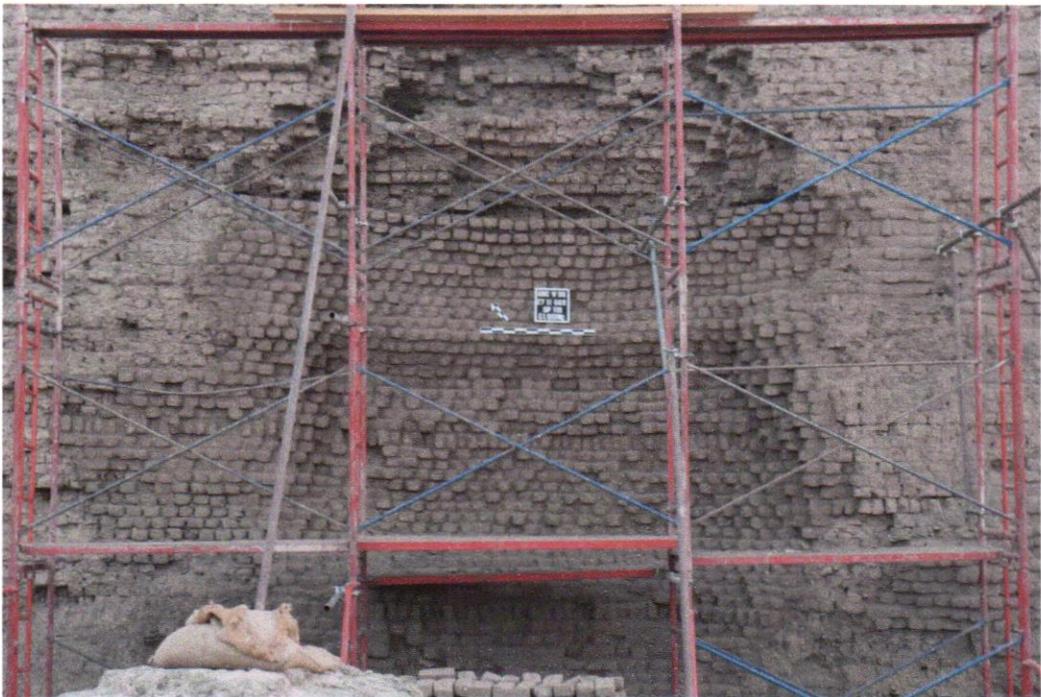
Figure 11 – Stabilization work in Operation 119 in process. The new masonry was set back from the existing wall face so as to create a concavity that creates a visual reference to the presence of the cell in the wall.

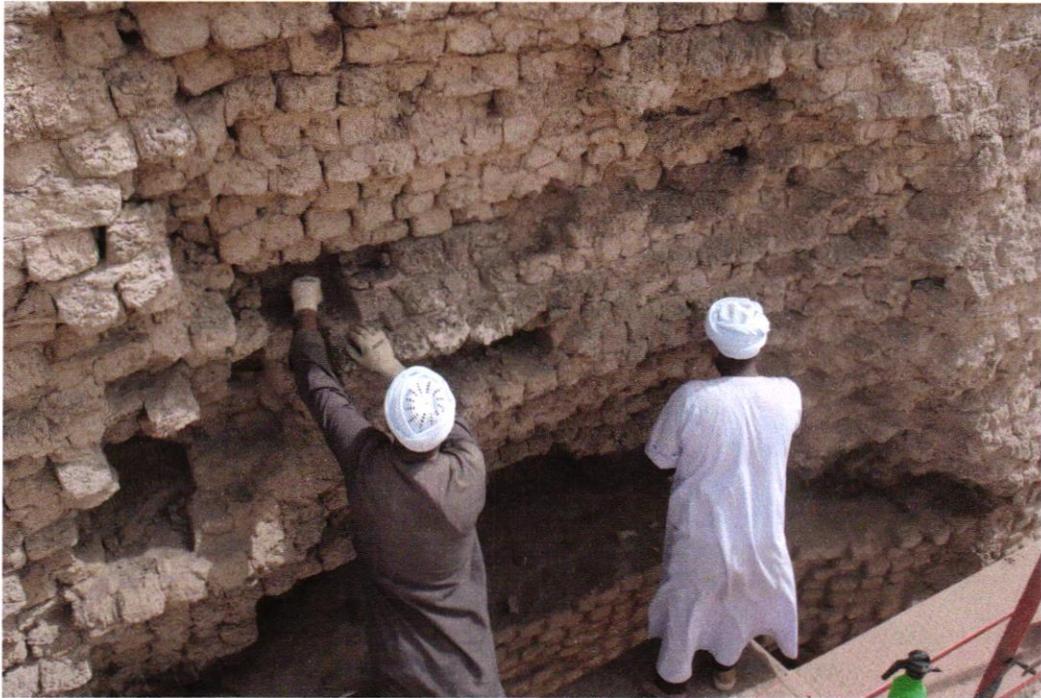
Figure 12 – In the upper part of the cell void, the depth of the infilling became gradually less. Eroded bricks were removed, and holes were filled as part of the comprehensive stabilization of the cell void.

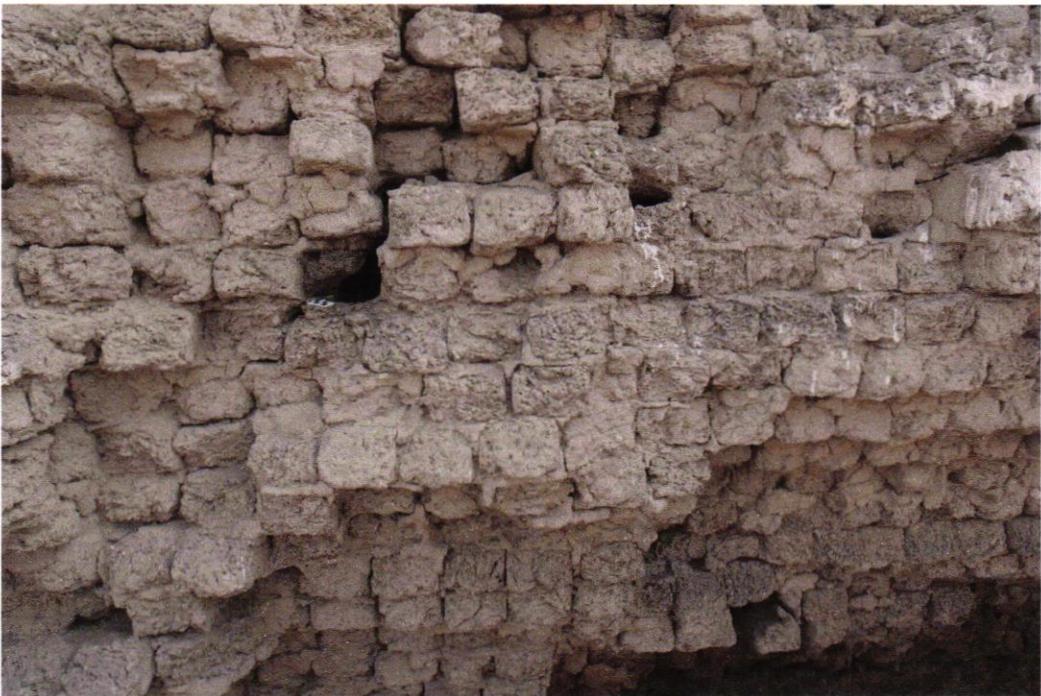
Figure 13 – Hole and crack above the cell void in Operation 119. A large mass of masonry in the center of the photo was in danger of falling.

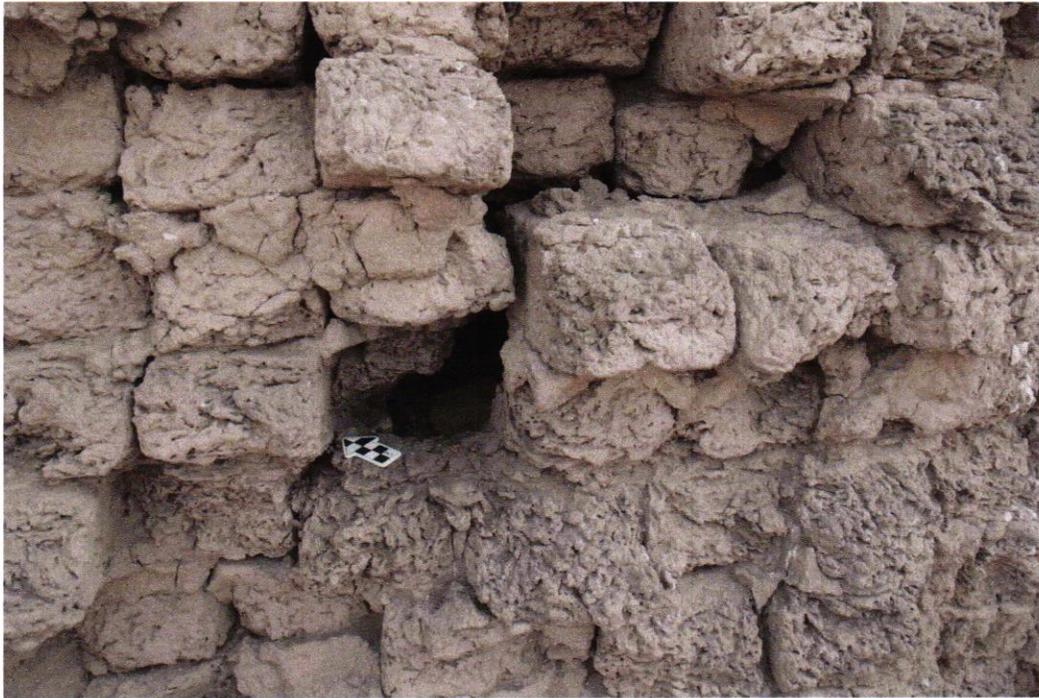
Figure 14 – Closer view of the apparently small hole shown above. The loose bricks at the right of the hole mask a large void behind.

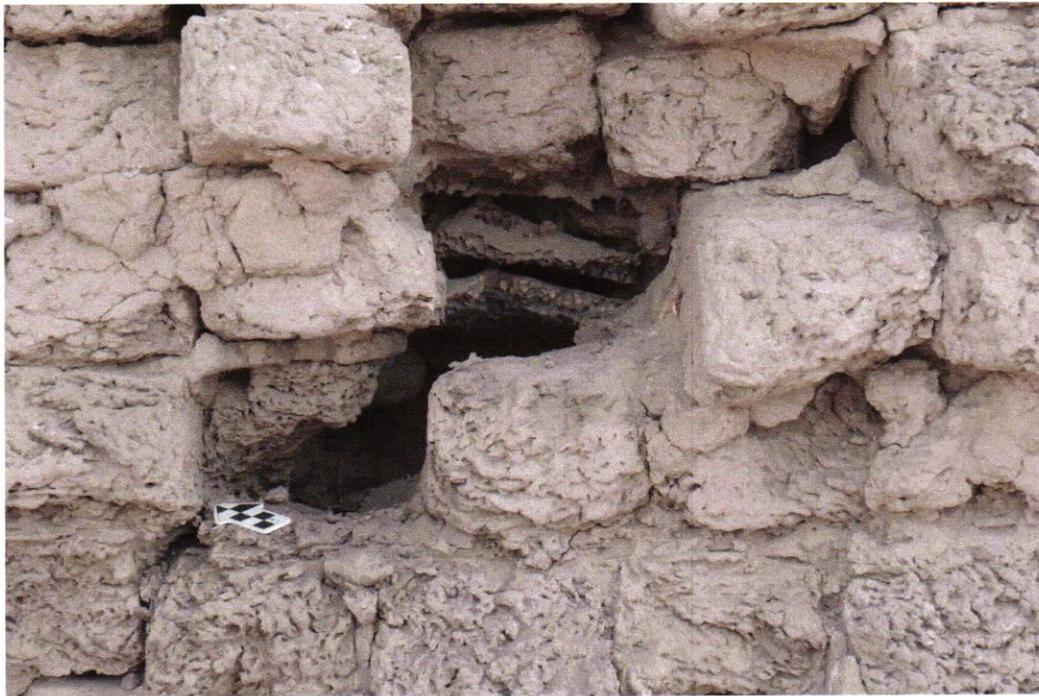
Figure 15 – Removal of one of the loose bricks revealed that the hole was created by the burrowing hornets that infest the Shuneh. Inside they built a large multi-layered paper nest.

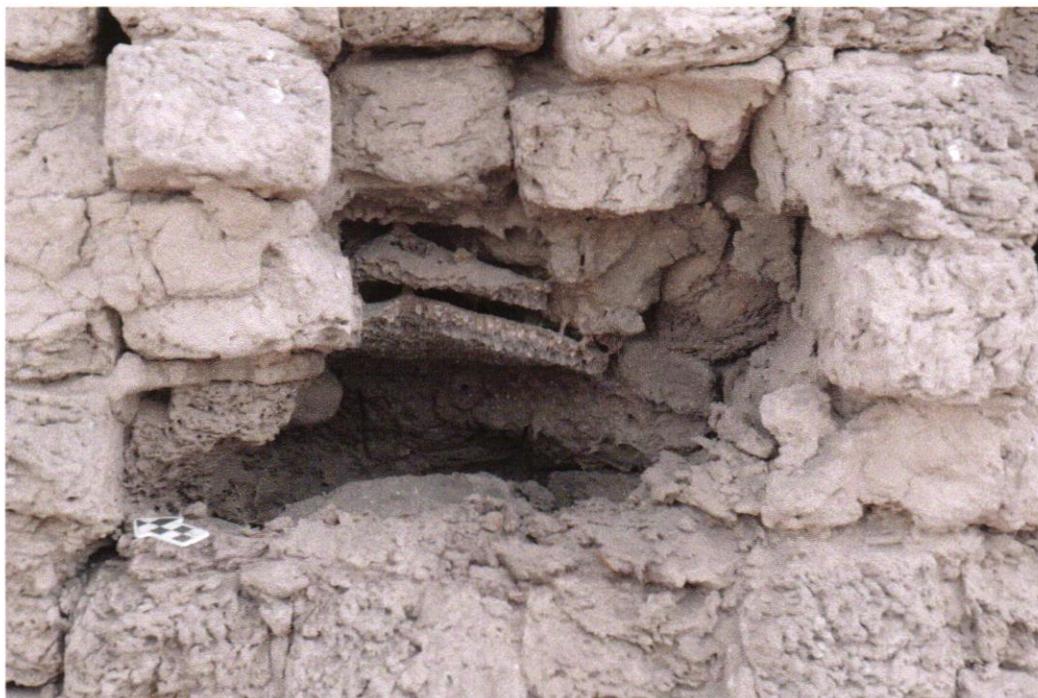
Figure 16 – Removal of additional bricks revealed more of the paper nest and the size of the hole.

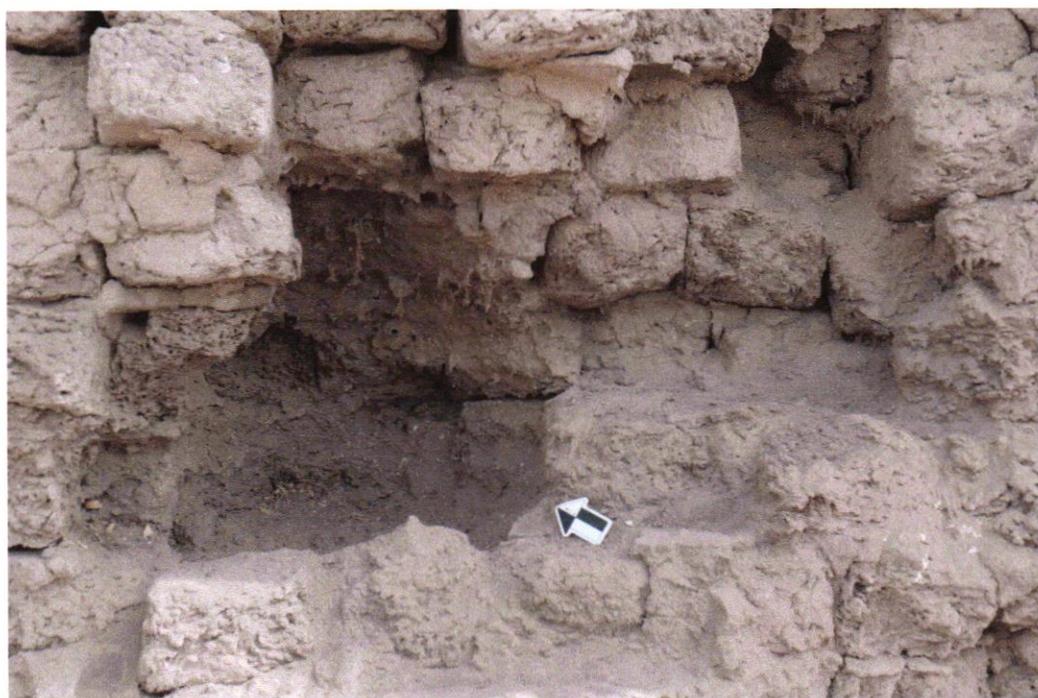
Figure 17 – The remains of the paper nest were removed, as well as all loose and eroded bricks around the hole, the full extent of which was revealed.

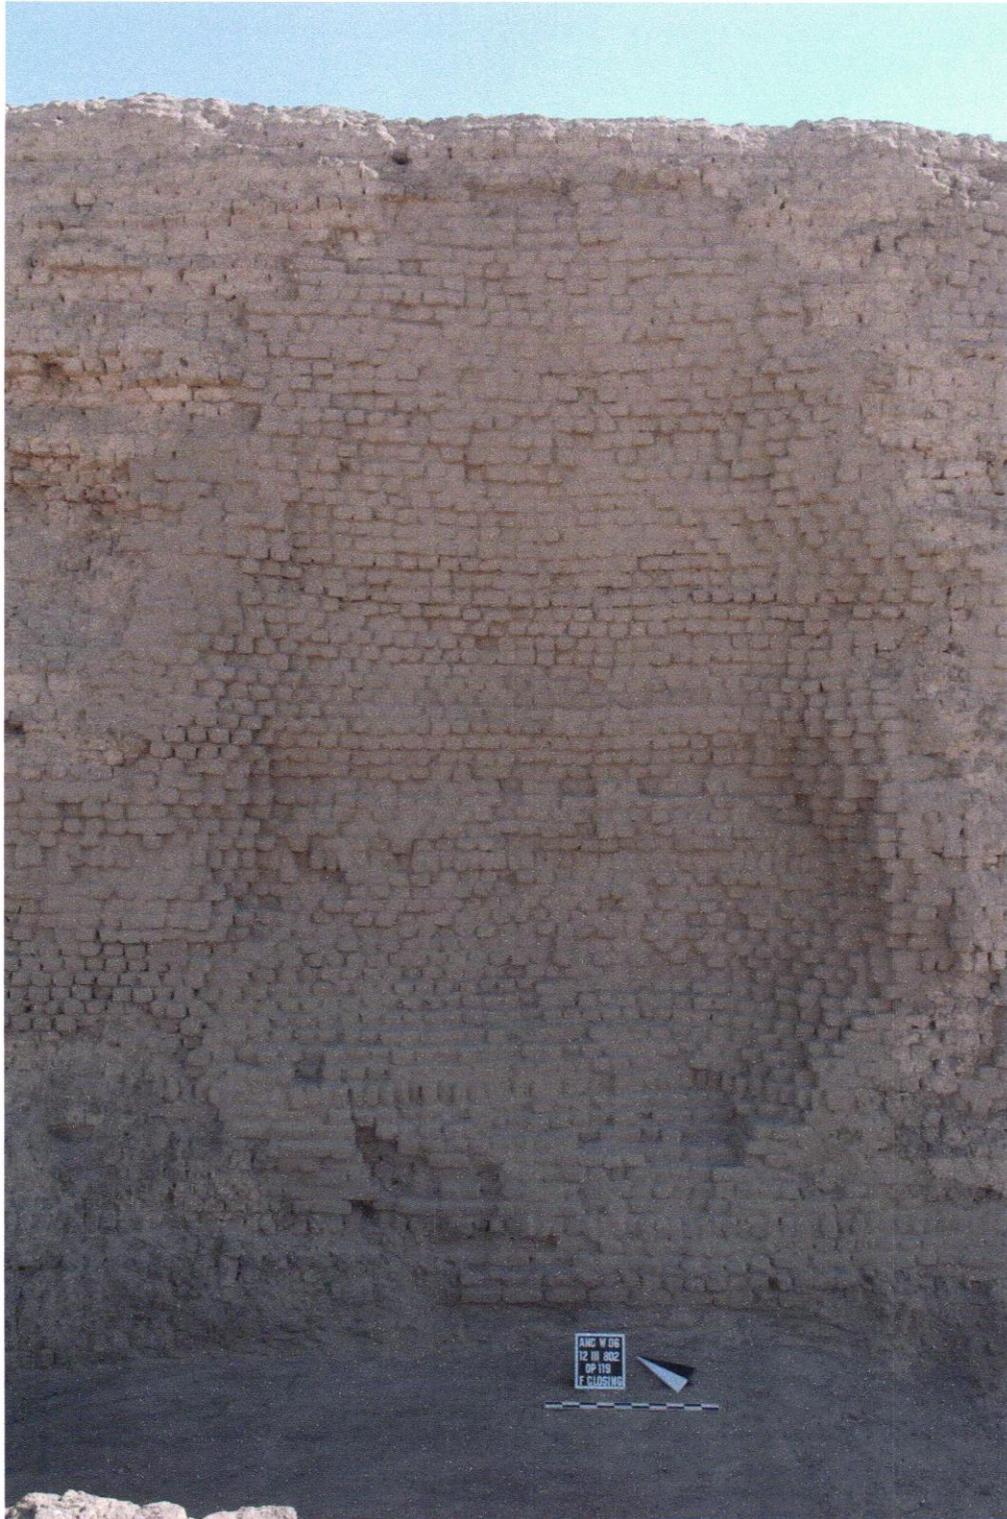
Figure 18 – Monastic cell, Operation 119, after stabilization. The new masonry infilling of the cell void has a concave profile to provide a visual cue to the presence of the cell in the wall.

The monastic cell void excavated as Operation 119 actually consisted of two rooms (**Figures 3-5**). The rooms were fully documented in Field Season 6. Architectural stabilization began with filling the small pits in the cell floor (**Figure 6**). A protective barrier layer of fine sieved sand was laid down over all original surfaces (**Figure 7**). The sand was wetted and compacted and provided a level base for the first course of new brick masonry. As the level of the new masonry was raised, a space was left along the walls where original finish was present, which was filled with sand as work progressed (**Figures 8-9**). Layers of geogrid were used to provide horizontal reinforcement (**Figure 10**). As the level of the new masonry reached the upper part of the concavity (**Figure 11**), eroded bricks in the overhanging original masonry of the wall were removed (**Figure 12**), and these spaces were used to key-in the new masonry to the old. In the case of Operation 119, a hole in the wall above the cell void was found (**Figure 13**), which, when cleaned, was found to have been a typical hornet nest hole, still filled with the remains of the paper nest (**Figures 14-17**). The finished, stabilized, cell void is shown in **Figure 18**.

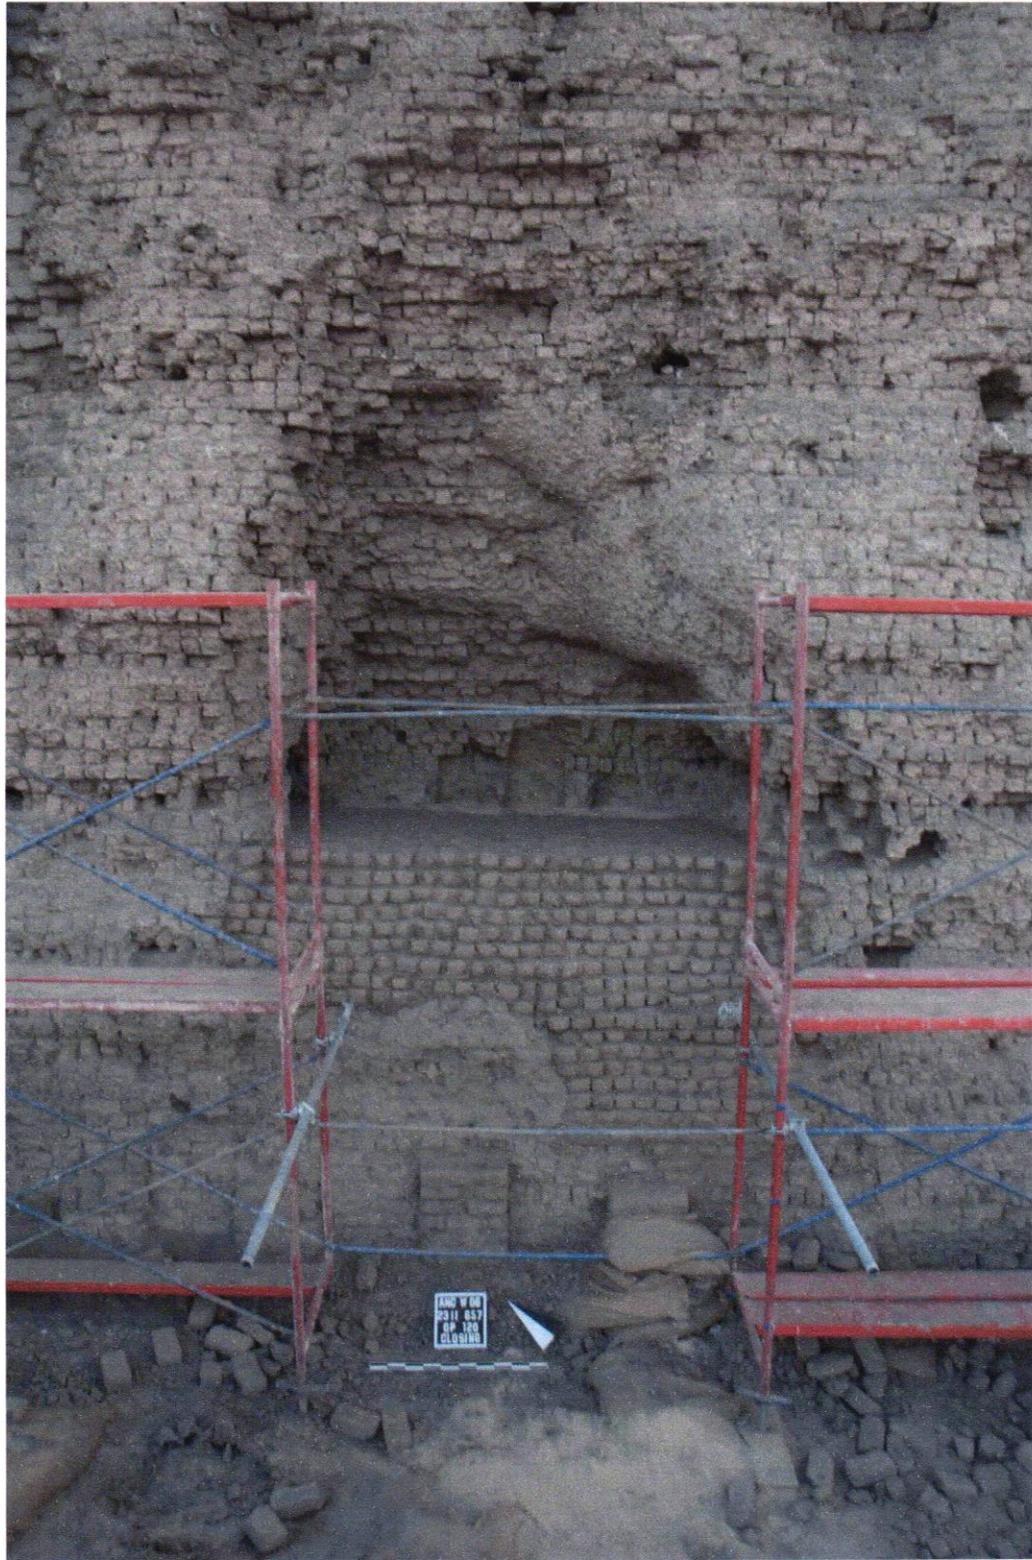
Figure 19 – Operation 120, stabilization of a monastic cell in progress. Note the massive mud wasp nest at upper right.

The cell Operation 120 was not as large as Operation 119, and, consequently, the void it created in the wall was not as large (**Figures 2-3**). It was excavated in Field Season 6 and fully documented architecturally in Field Season 7. The basic process of stabilization was the same as in other cell voids. In this case when the level of the brick infilling reached the upper part of the wall void, a large mud wasp nest was removed, in order to allow the new masonry to key with the original fabric of the wall (**Figures 19-20**). The stabilized cell void is shown in **Figure 21**.

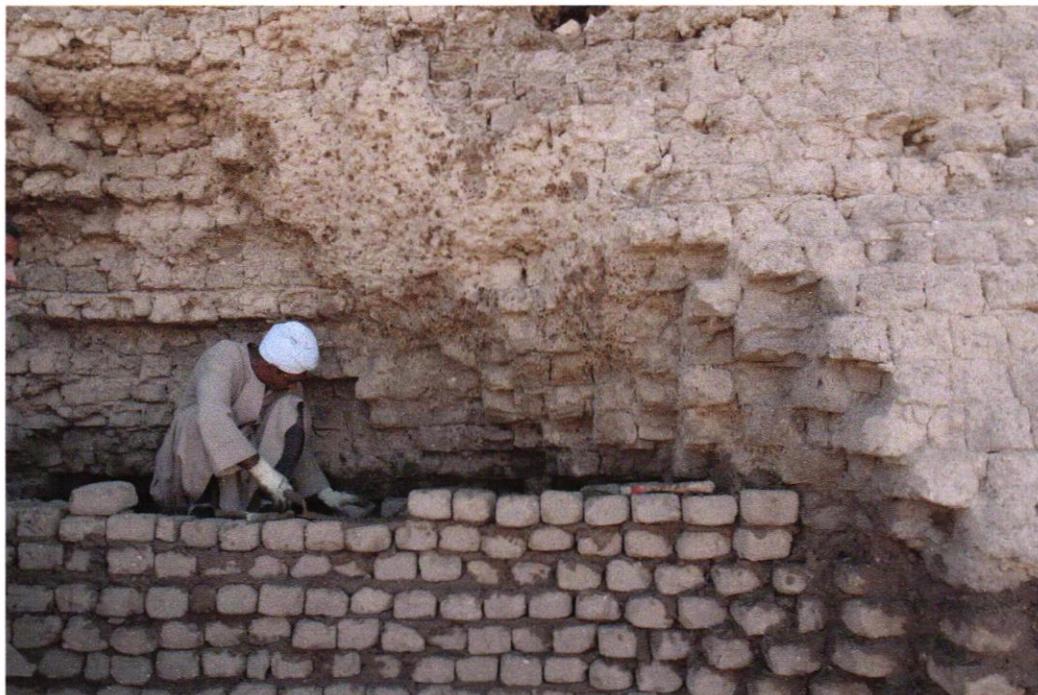
Figure 20 – Operation 120, stabilization work in progress. As the level of the new masonry rose, the mud wasp nest was gradually removed, to allow the new brick masonry to be keyed into the original wall sufficiently.

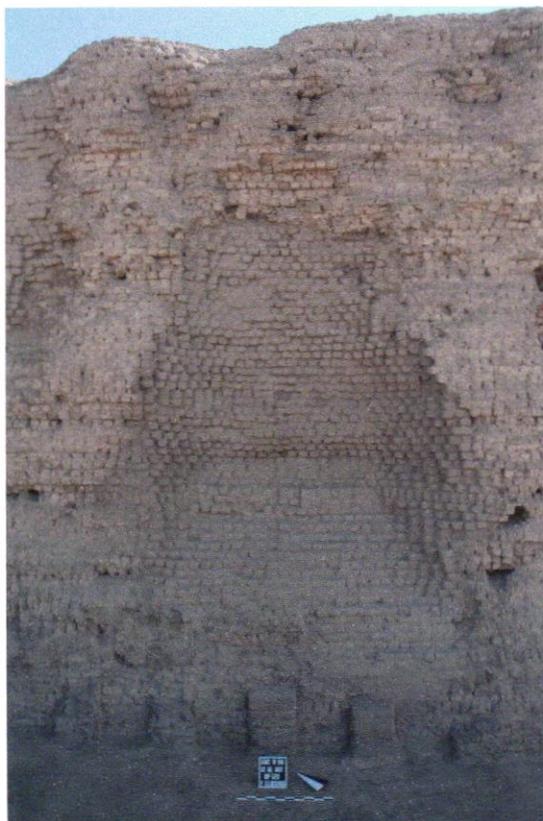
Figure 21 – Operation 120, after stabilization.

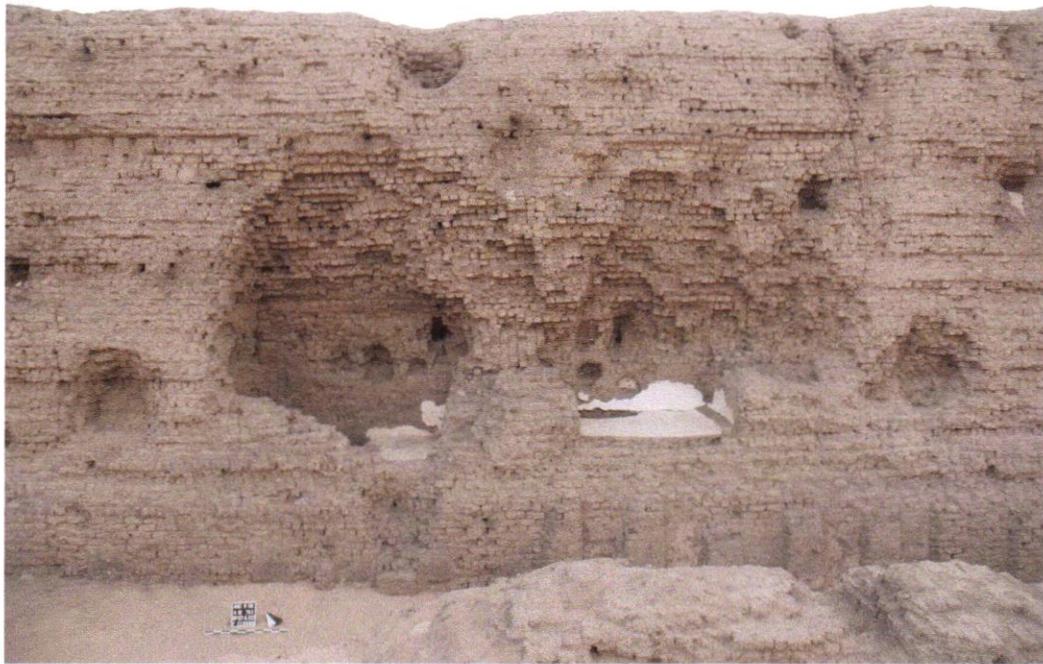
Figure 22 – Monastic cell voids, Operations 121 (left) and 122 (right), prior to the start of stabilization work. A large structural crack, related to the presence of these voids, is visible in the upper part of the wall to the right of Operation 122.

Operations 121 and 122 represent two adjacent cells (**Figures 2, 22**). The northwesternmost, Operation 121, was the substantially larger of the two. Both were excavated in Field Season 6 and documented architecturally in Field Season 7, prior to the start of architectural stabilization work. The plaster floors in both cells were covered with a protective barrier layer of sand (**Figures 23-24**). A large pit had been cut through the floor at the northwestern end of Operation 121 (**Figure 24**), and this was filled with new brick masonry first. The original masonry of the southwestern wall of the main enclosure had collapsed long ago, and, as the brick infilling of both cells rose, the new masonry spanned the space between them (**Figure 25**). As in other cells, horizontal reinforcement was provided by layers of geogrid geotextile (**Figure 26**). The finished, fully stabilized cells are shown in **Figure 27**.

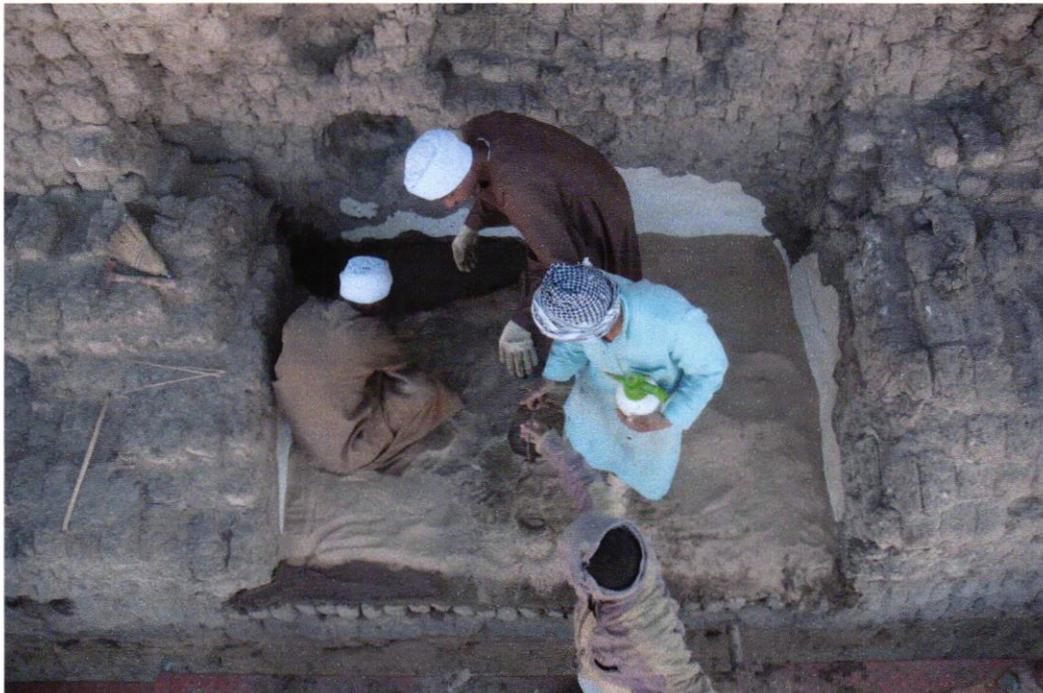
Figure 23 – Operation 122, in progress. All original surfaces were covered by a layer of fine sieved sand, which provides a protective barrier between the new brickwork and preserved original features of the cell.

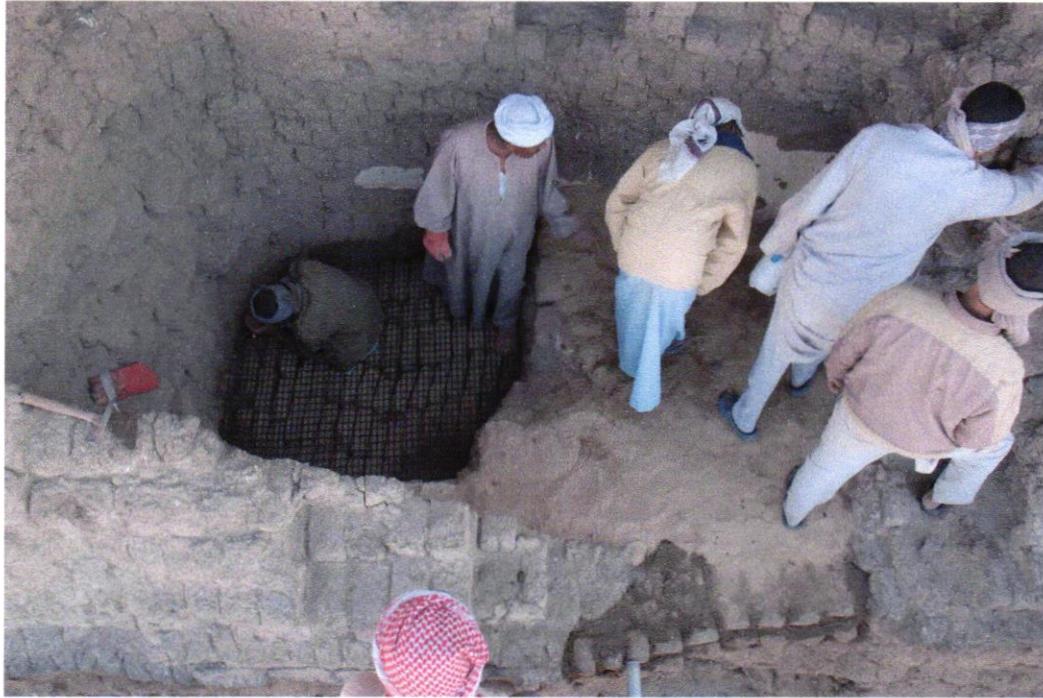
Figure 24 – Operation 121, in progress. The deep hole at the northwestern end of the cell was filled first.

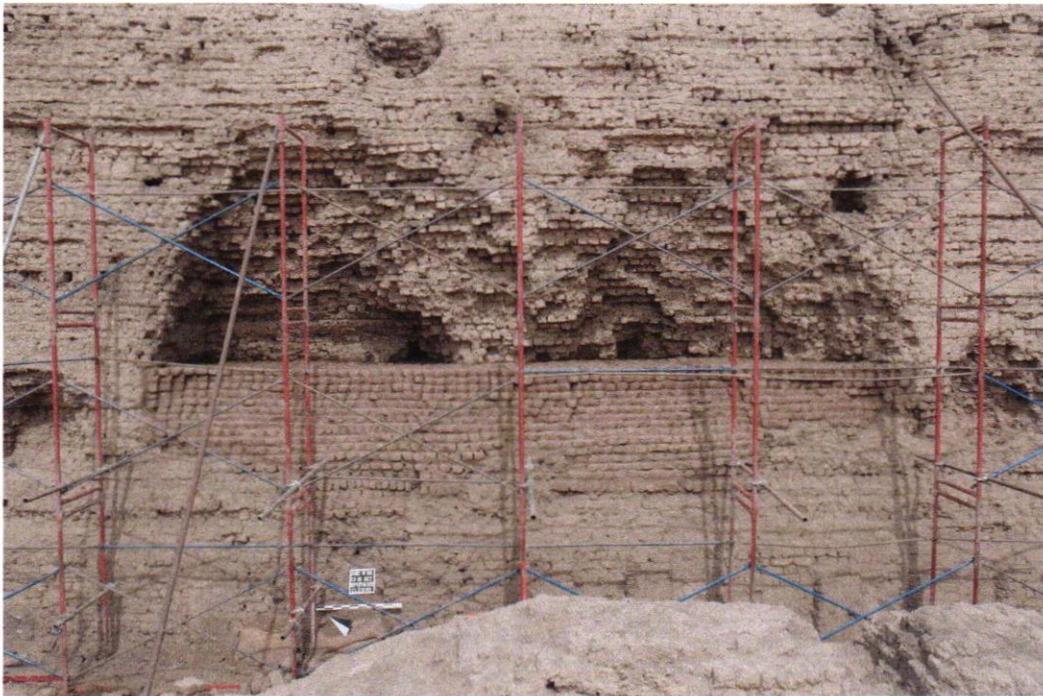
Figure 25 – Operations 121 and 122, in progress. Given that the masonry dividing the two cells had collapsed and was mostly missing, the infilling in this area comprised a single construction.

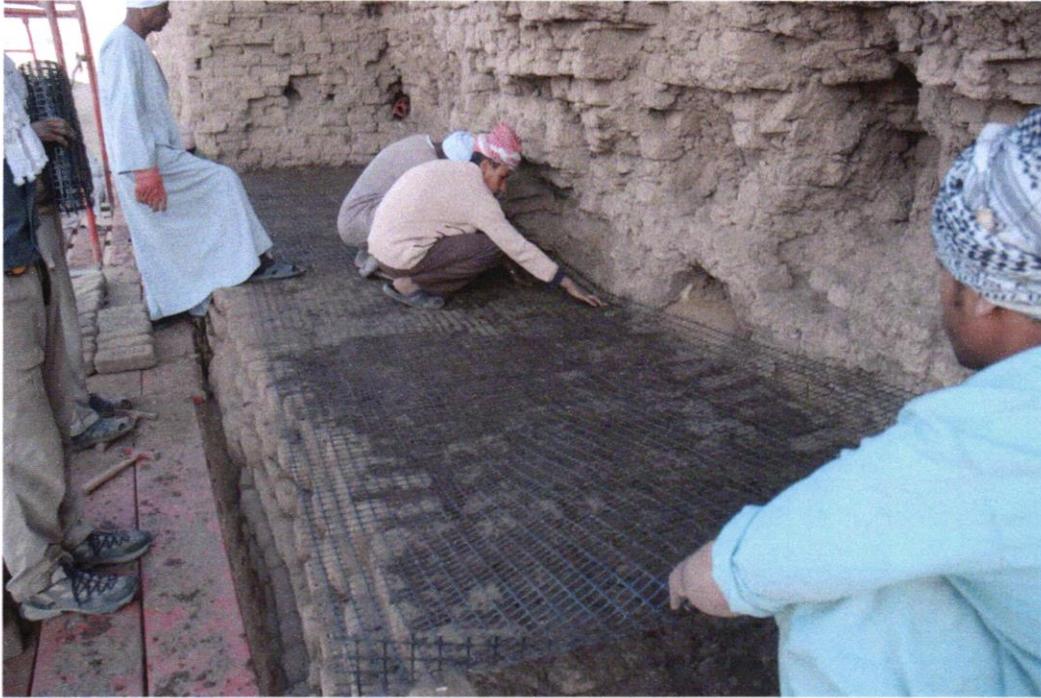
Figure 26 – Geogrid was used to provide lateral reinforcement over the entire length of the new masonry infilling in Operations 121-122.

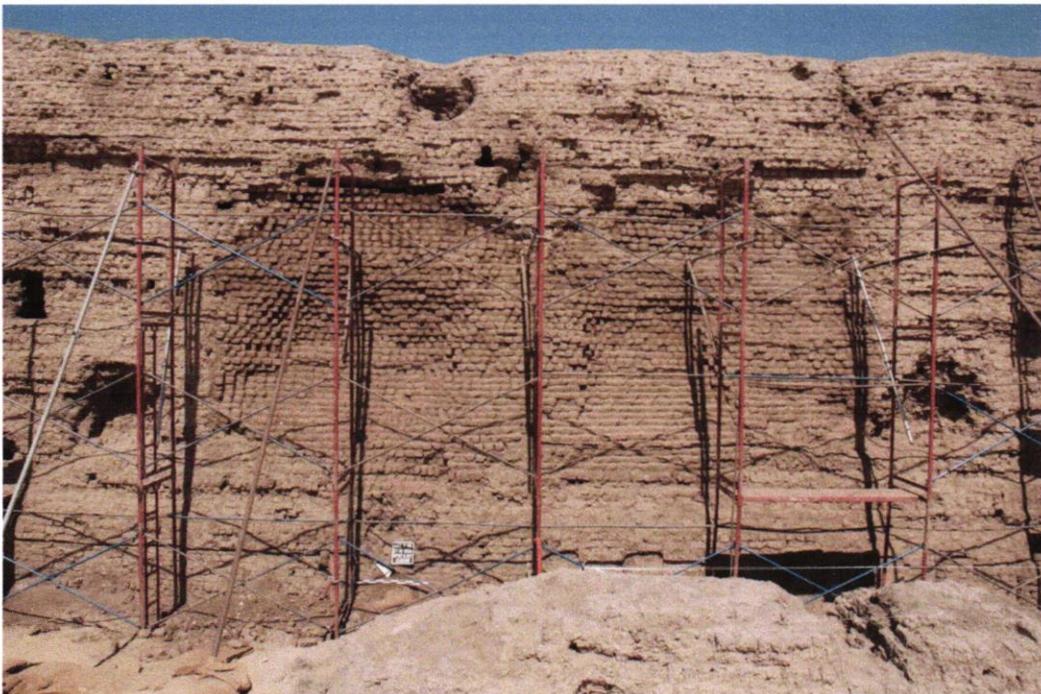
Figure 27 – Operations 121 and 122, with stabilization work of the cell voids complete.

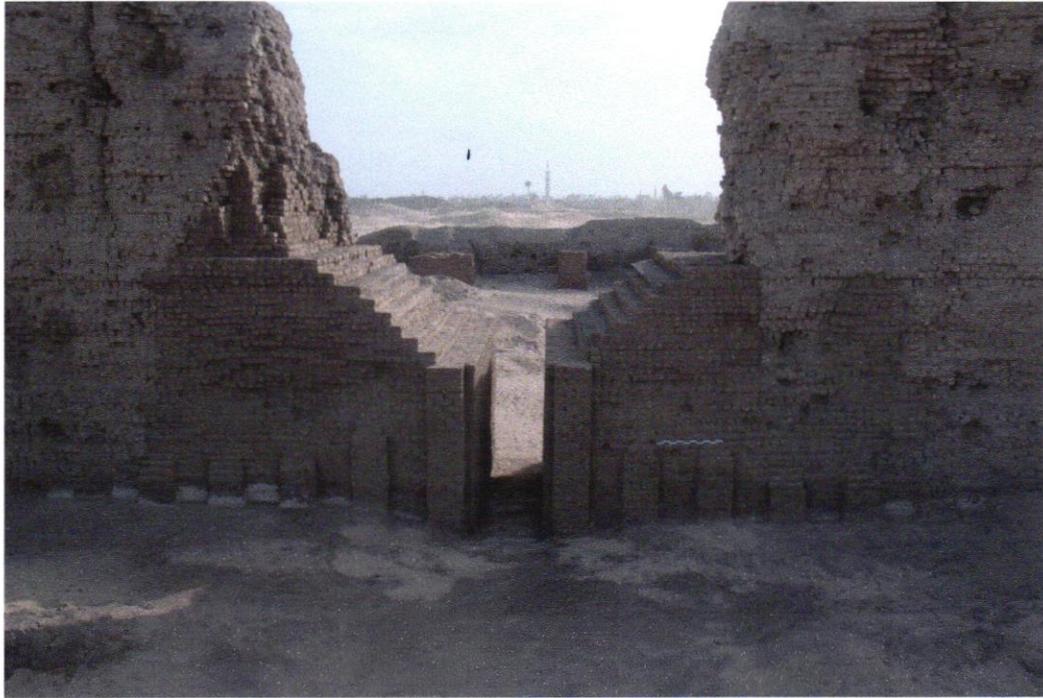
Figure 28 – The west gate, at the end of Field Season 6. Work continued with the comprehensive stabilization of this area in Field Season 7.

Architectural stabilization work continued in Field Season 7 at the gateway in the southwest wall. The state of the gateway at the close of Field Season 6, and as it was at the start of this season's work is shown in **Figure 28**. The most significant condition problem in the gateway area is represented by the high vertical wall ends on either side of the
