PROGRESS REPORT No9

“Documentation and Conservation of King Khasekhemwy’s Funerary Monument at Abydos”

Progress Report No. 9

David O'Connor, Sub-Project Director
Matthew Adams, Sub-Project Associate Director
Institute of Fine Arts, New York University

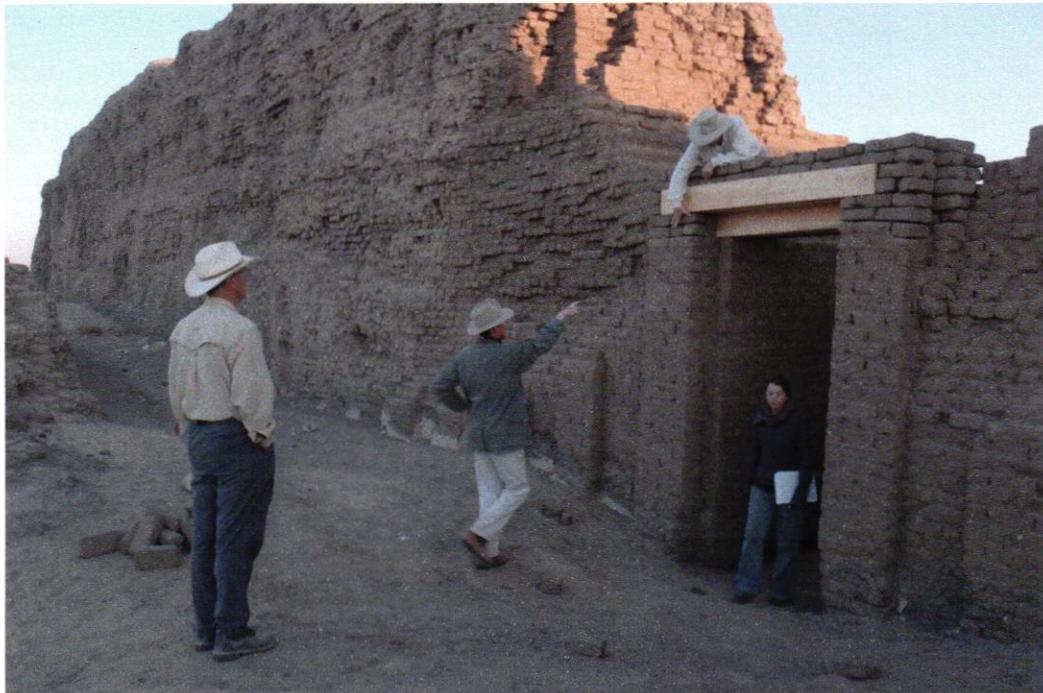
Figure 29 – Mudbrick conservation specialist Anthony Crosby and Architect William Rensen consult with Sub-project Associate Director Matthew Adams about the dimensions of a mock-up of the partial reconstruction of the west gateway.

The design of the partial reconstruction was the subject of extensive consultations between the Mudbrick Conservation Specialist, Anthony Crosby, Architect William Remsen, and the Sub-project Associate Director (**Figure 29**). After consideration of the proportions of the existing opening (two cubits¹), the design of the gateway of the most closely related preserved architectural complex, the Step Pyramid complex of Netjer-khet Djoser, Khasekhemwy's successor, at Saqqara, as well as representations of doorways in niched façade architecture in the iconography of the Early Dynastic Period and Old Kingdom, it was decided that the most likely proportion of the original gateway opening would have had proportions of 3:1, i.e., 6:2 cubits height:width.

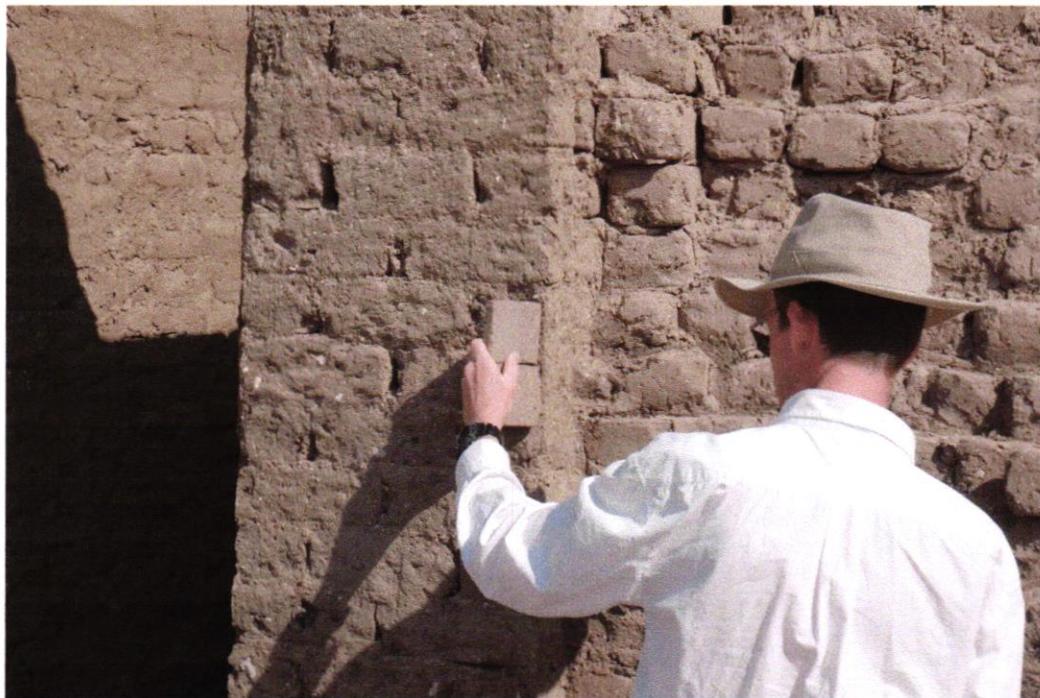
Figure 30 – Because the roofing of the gateway was to be made of reinforced concrete, a range of test panels in different shades were produced, in order to find the color that would blend best with the surrounding brickwork.

Although the gateway would have been roofed with wood originally, wood is not an appropriate material to use in the stabilization effort, as it is too vulnerable to insect damage. Instead of wood, the opening was spanned with members of cast reinforced concrete. The concrete was tinted, in order that it should blend visually with the surrounding masonry (**Figure 30**), although upon close inspection it is easily distinguishable. Two types of architectural elements were cast. At each end of the gateway opening, a rectangular lintel was set, approximating the wooden lintels that would have been used originally (**Figures 31-32**). The remainder of the gateway was roofed with pole-shaped members that evoke the wooden poles that would probably have been used in the original construction (**Figures 33-38**). It should be noted that in the Netjer-khet complex at Saqqara the gateway has representations, in stone, of a wooden pole roof. Once the gateway opening was fully roofed, construction could continue above (**Figures 39-40**). The state of the gateway area at the close of Field Season 7 is shown in **Figures 41-42**. The comprehensive stabilization of the gateway area is not yet complete, and work will continue in future seasons.

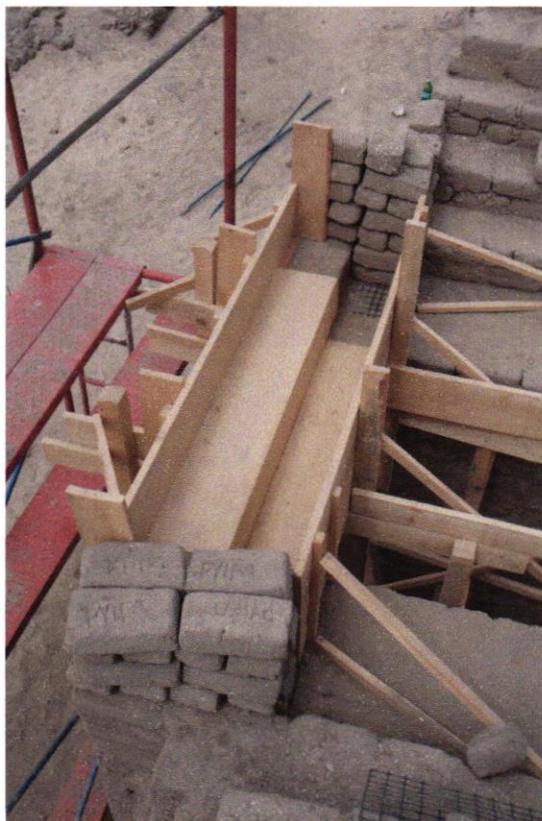
Figure 31 – Wooden forms for the lintels on the exterior and interior sides of the gateway were constructed.

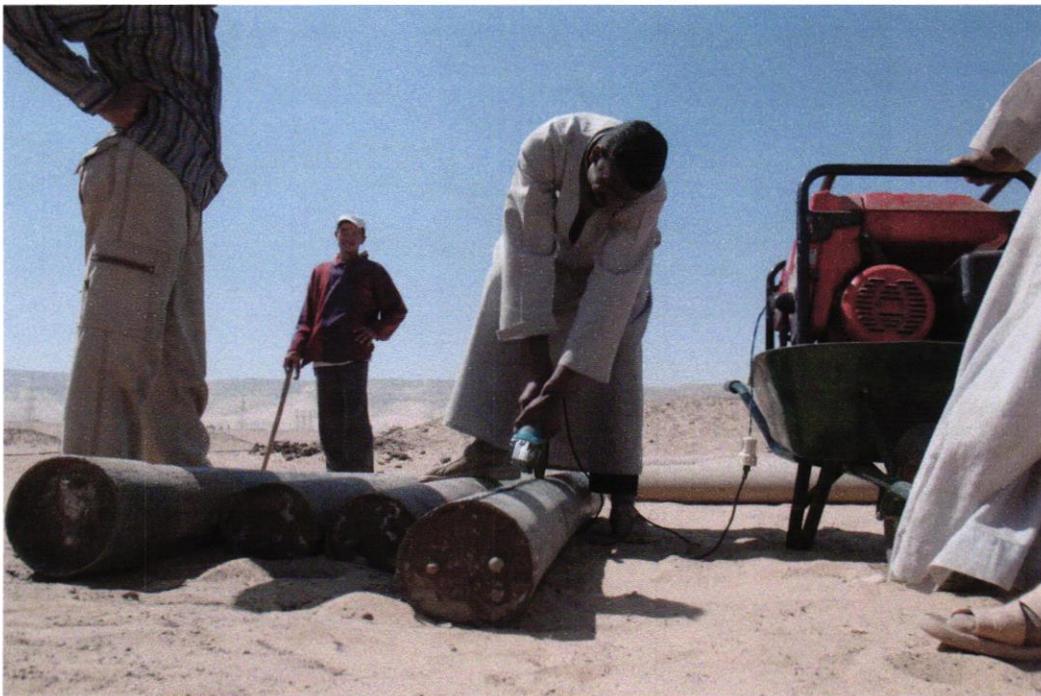
Figure 33 – The interior of the gateway was spanned with reinforced concrete “poles,” inspired by the representation in stone of a wooden pole roof in the gateway to the Step Pyramid complex at Saqqara. The “poles” were cast vertically in segments of heavy plastic pipe, which was cut away when the concrete was fully set.

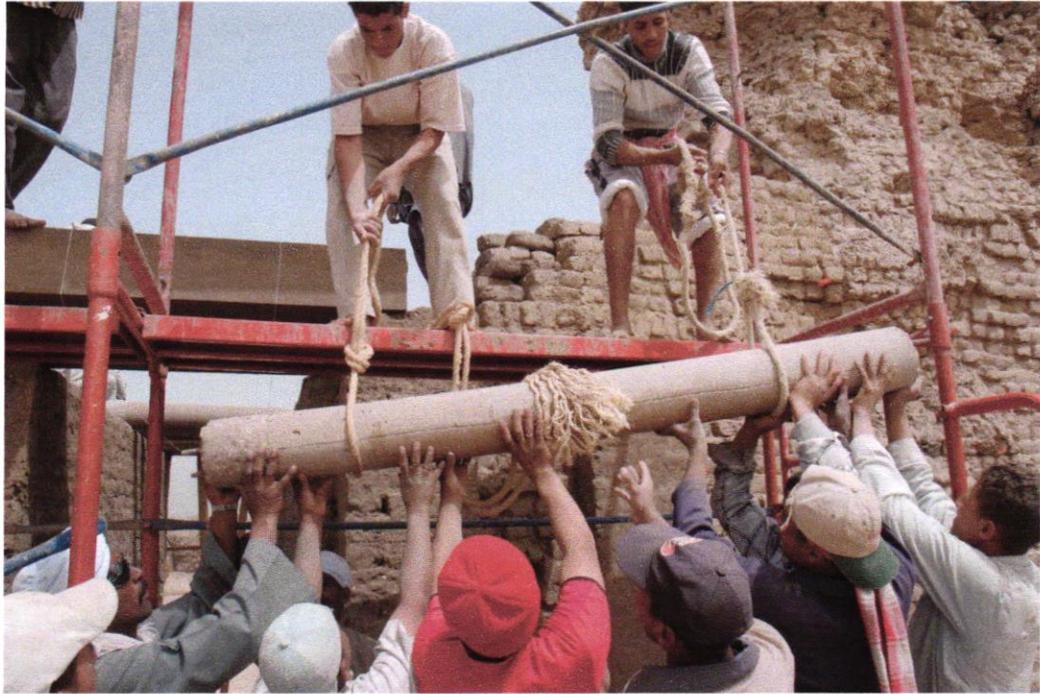
Figure 34 – Each of the concrete roofing “poles” was manually raised and set in place above the gateway opening.

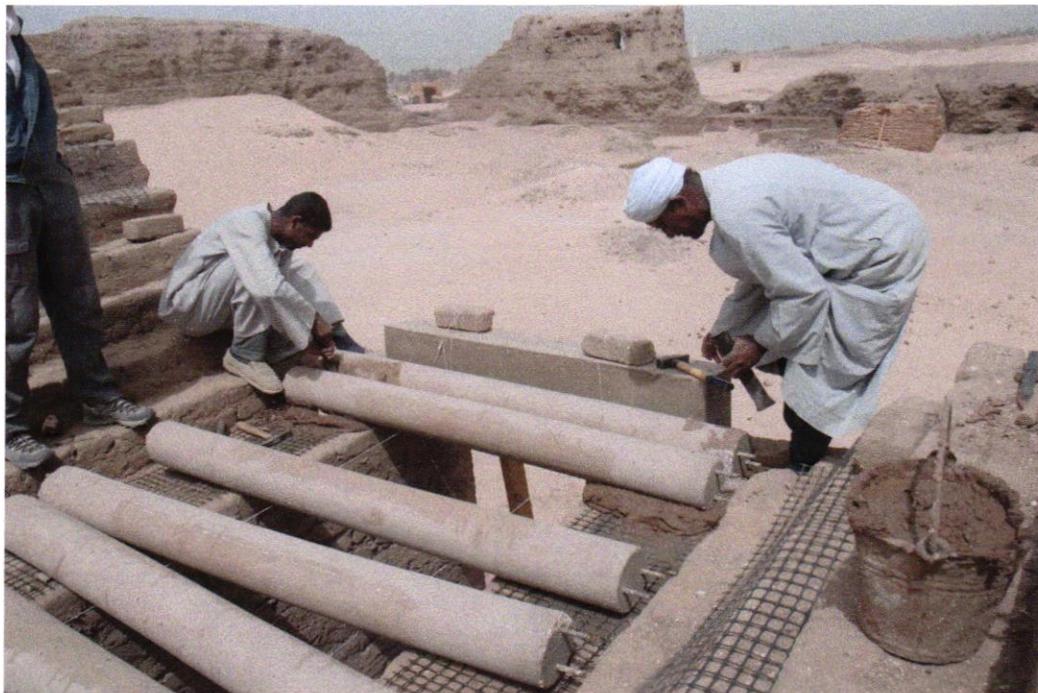
Figure 35 – Each of the roofing “poles” was maneuvered into place and set into mud mortar. Geogrid was placed under the poles on each side of the gateway opening, to provide a secure base for the mortar.

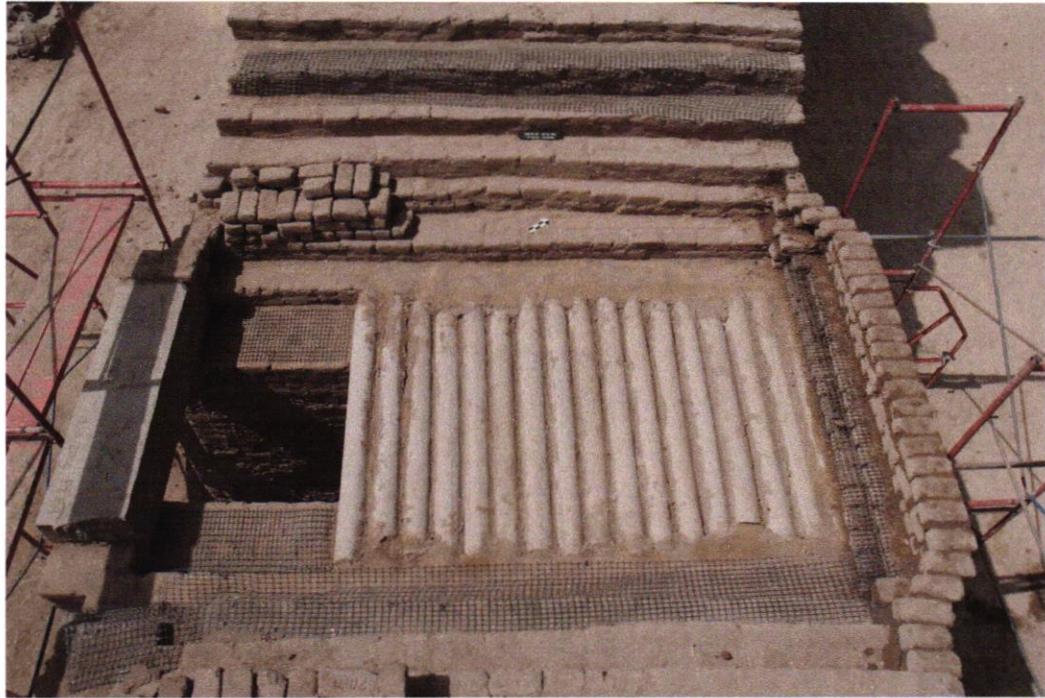
Figure 36 – The seams between the “poles” were sealed with mud mortar, which was also used to fix the ends in place.

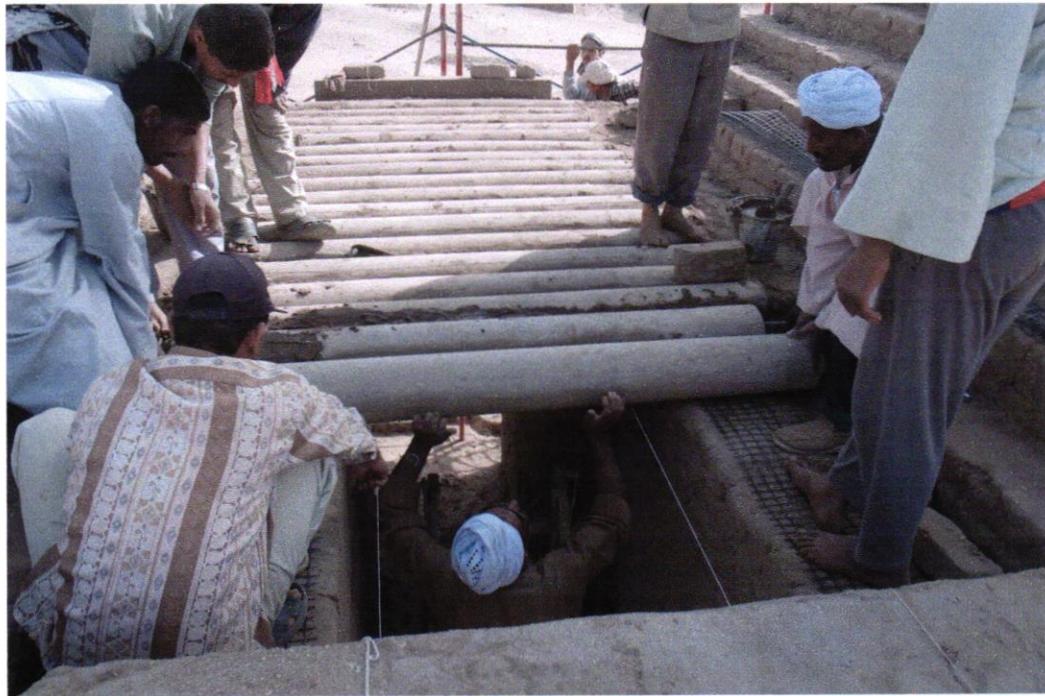
Figure 37 – Placing one of the “poles” of the roof. Even placement on the underside was maintained by means of string lines.

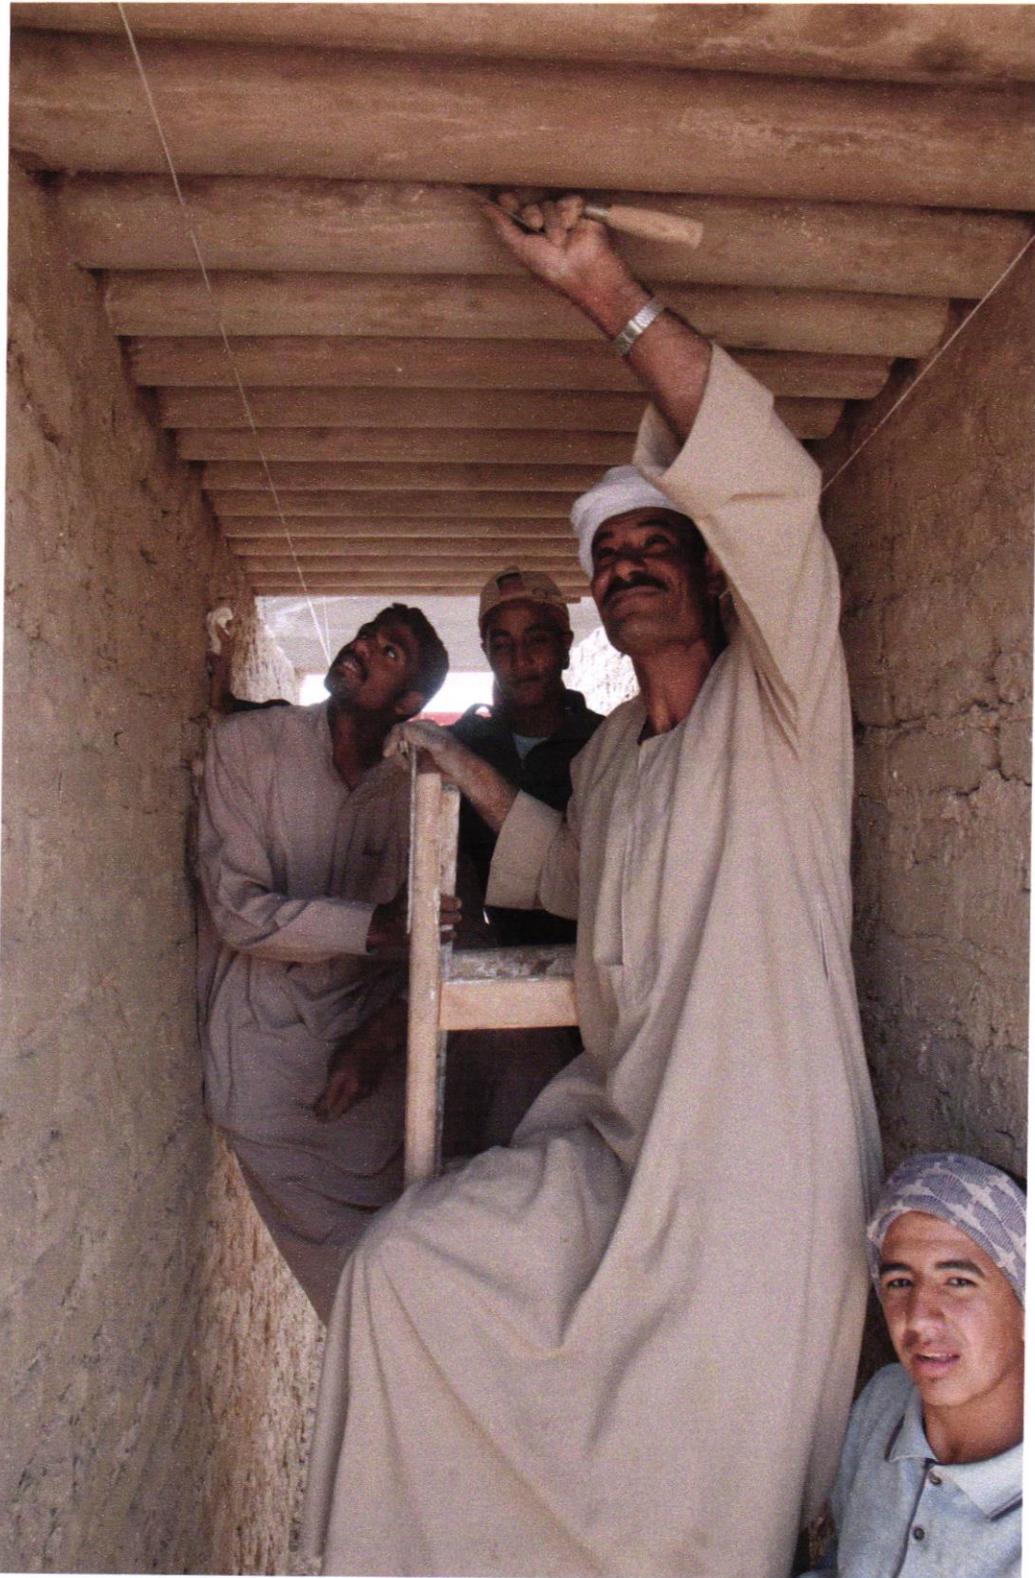
Figure 38 – The underside of the “pole” roof of the gateway, during construction. The underside of each seam was carefully pointed.

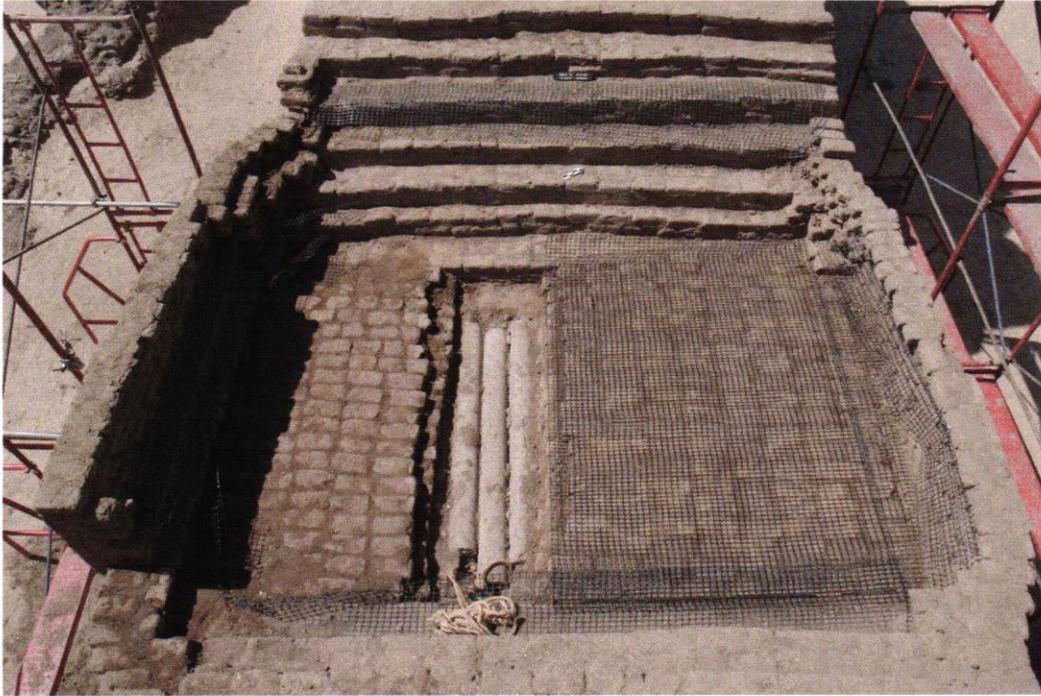
Figure 39 – Once the gateway was fully roofed, construction of the new masonry above could begin. Geogrid was used to provide horizontal reinforcement.

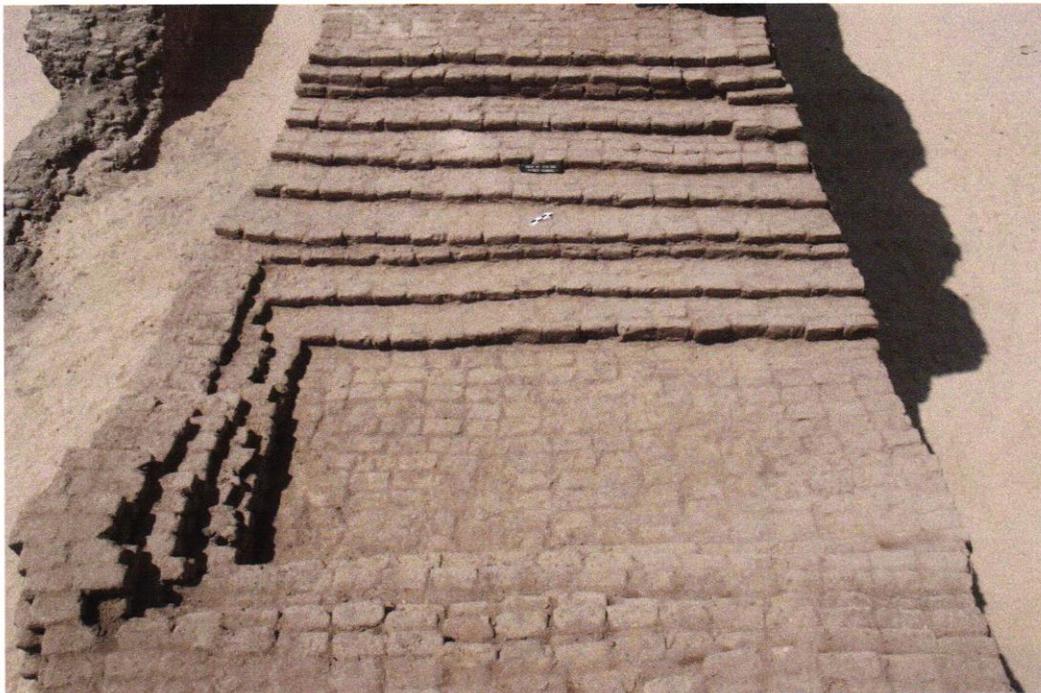
Figure 40 – Top of the new masonry above the west gate, at the end of Field Season 7.

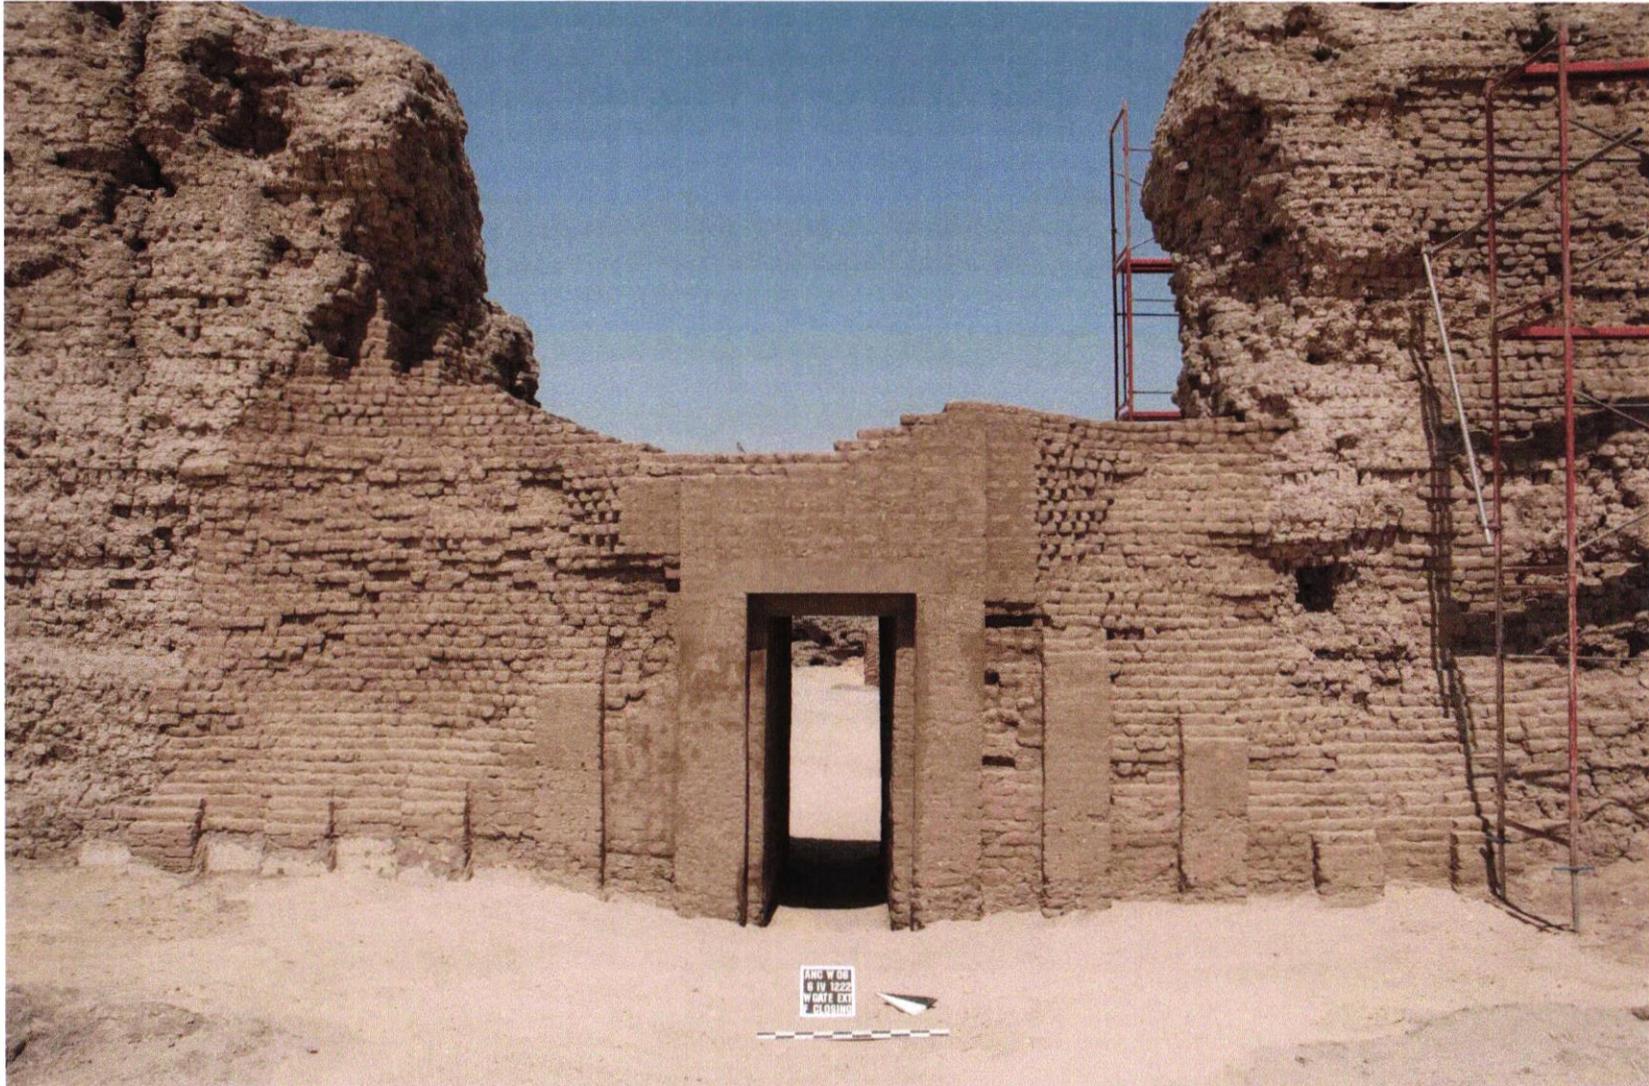
Figure 41 – The partial reconstruction of the west gateway, exterior side, as it stood at the close of Field Season 7. The upper parts of the vertical wall ends adjacent to the gateway remain to be stabilized in a future season.

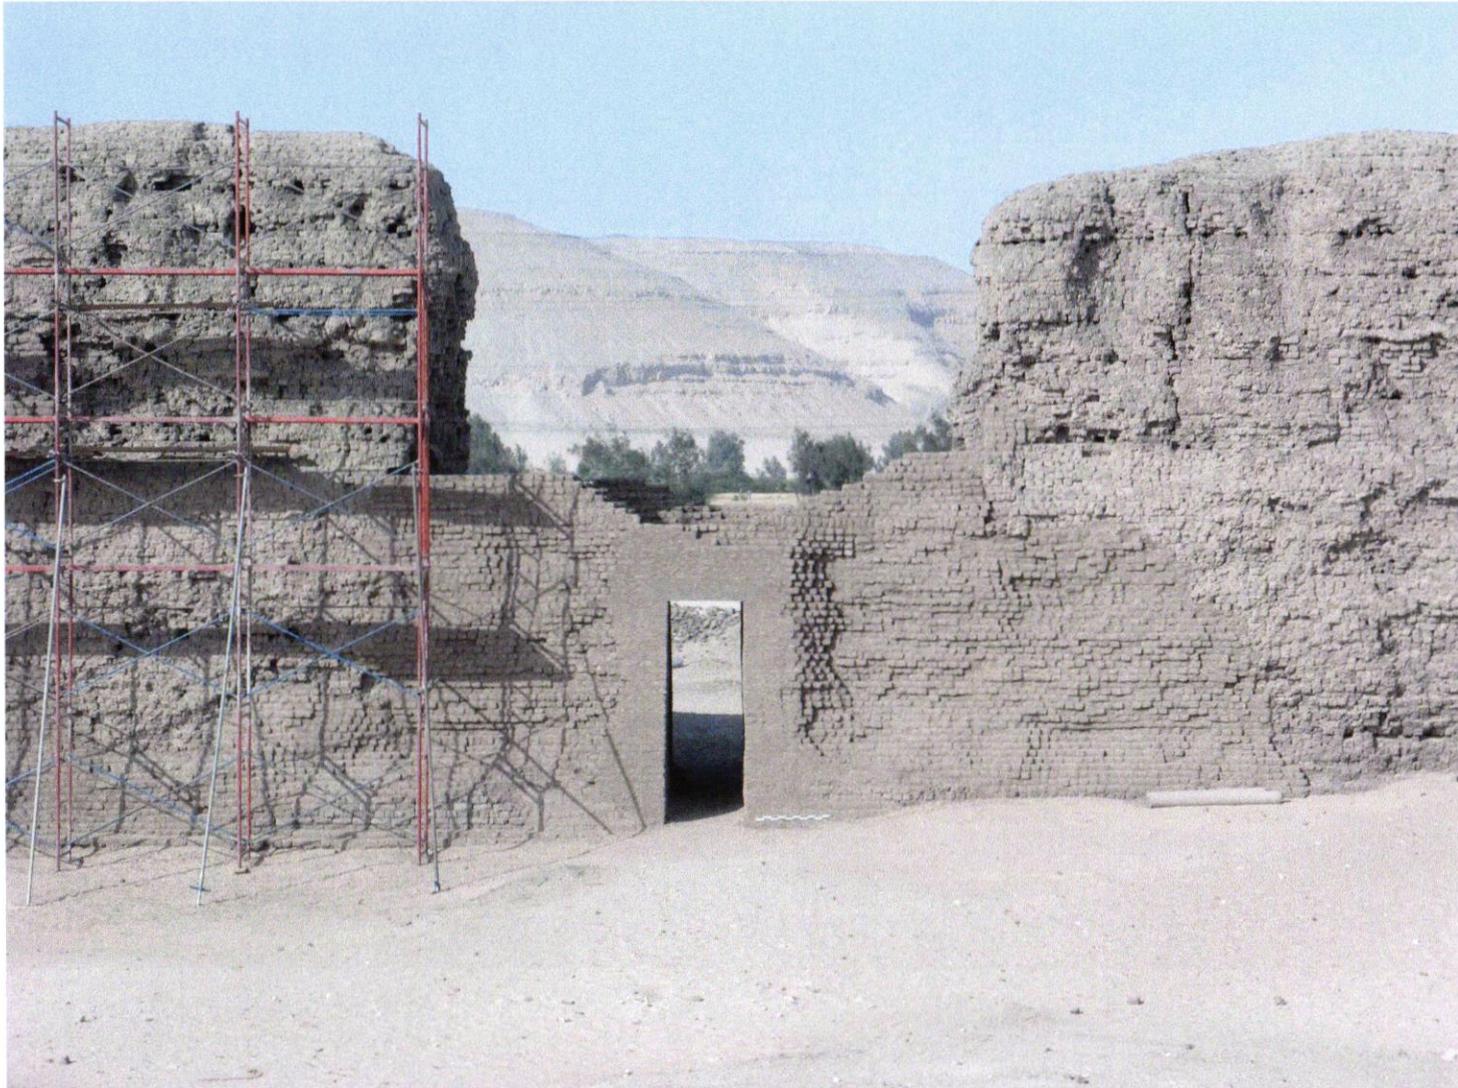
Figure 42 – Partial reconstruction of the west gateway, interior side, as it stood at the end of Field Season 7. Several meters of additional masonry will be required to support adequately the adjacent vertical wall ends.

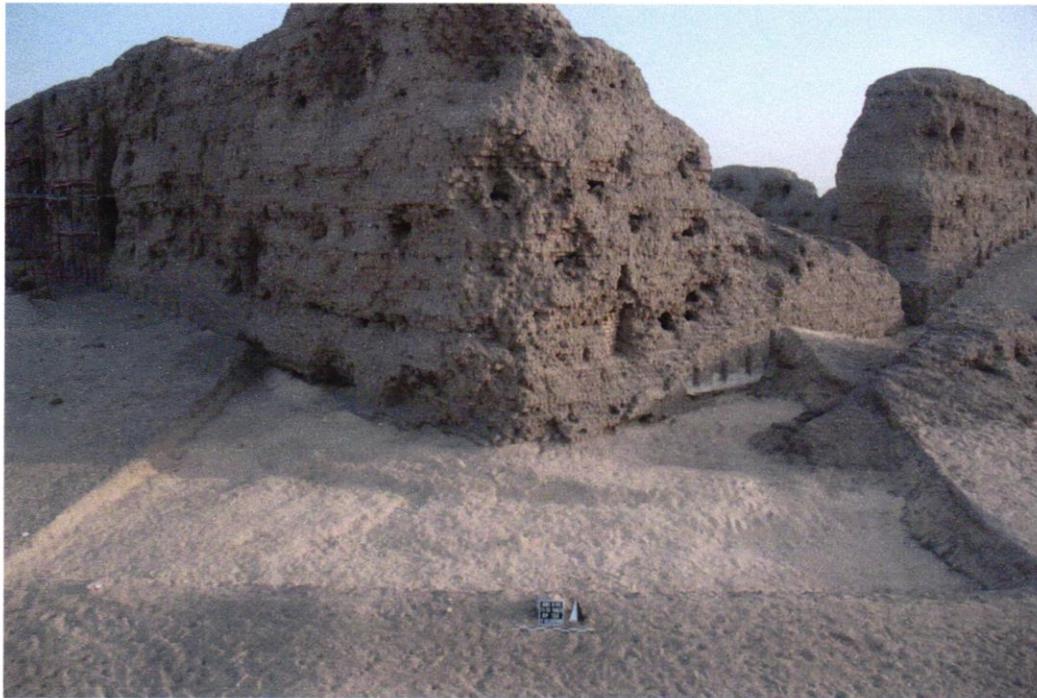
Figure 43 – Operation 132, at the south corner of the enclosure, exterior, at the close of excavation in Field Season 6. The base of the wall was significantly undermined, particularly the corner and to the left along the southwest wall. The corner itself was unstable, due to the extent of missing masonry.

Another area in which architectural stabilization work was done in Field Season 7 was the south corner, exterior, of the main enclosure, where the wall was seriously undermined at its base and had sustained damage from hole-digging hornets and from an old tunnel dug into the masonry of the wall, probably by Mariette's workers in the mid-19th Century (**Figures 43-44**). The major areas of missing masonry were replaced with new brickwork. In order to provide a stable base for the new masonry, below grade, the footing extends somewhat beyond the line of the wall (**Figure 45**). Above grade, the new construction follows the original wall line (**Figure 46**). The lower part of the wall has been stabilized, and work will continue in future seasons on the upper part. The stabilization incorporated the filled tunnel and several adjacent hornet nest holes (**Figures 47-48**). The lower part of the wall at the corner has now been stabilized (**Figure 49**). Additional work will be required in a future season to stabilize the upper part of the wall.

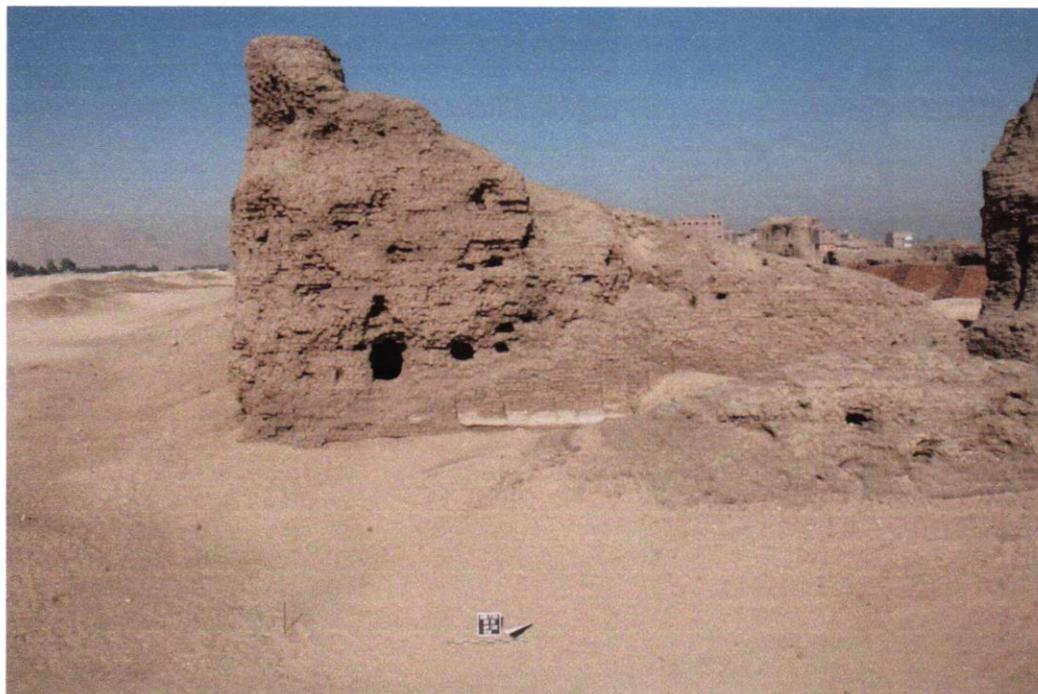
Figure 44 – Exterior side of the southeast wall, between the south corner and the southeast gateway (at far right). Just right of the corner, the large hole in the wall was the result of deliberate tunneling, probably by Mariette in the mid-19th Century, in a search for foundation deposits under the wall. The smaller holes nearby are the result of hornet activity.

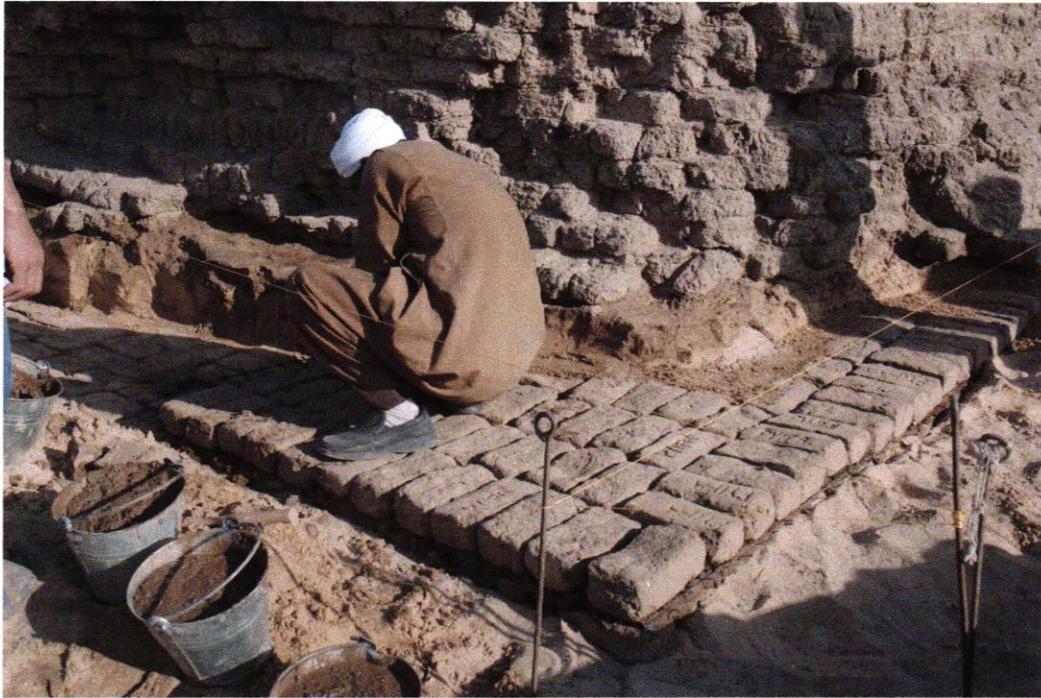
Figure 45 – In order to create a strong and stable base for the new masonry needed at the south corner, several courses were laid below grade and outside the plane of the wall. These will not be visible when the stabilization of this area is complete.

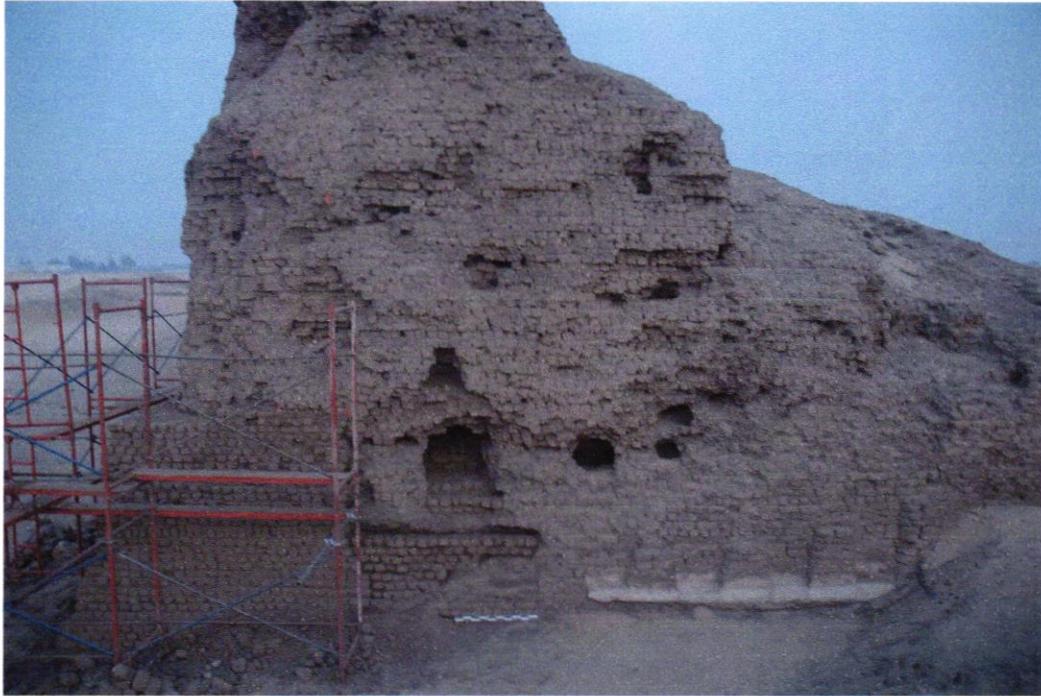
Figure 47 – South corner of the main enclosure, with stabilization work in progress. The tunnel has been filled. The extent of missing masonry at the corner can be judged by the thickness of the new construction.

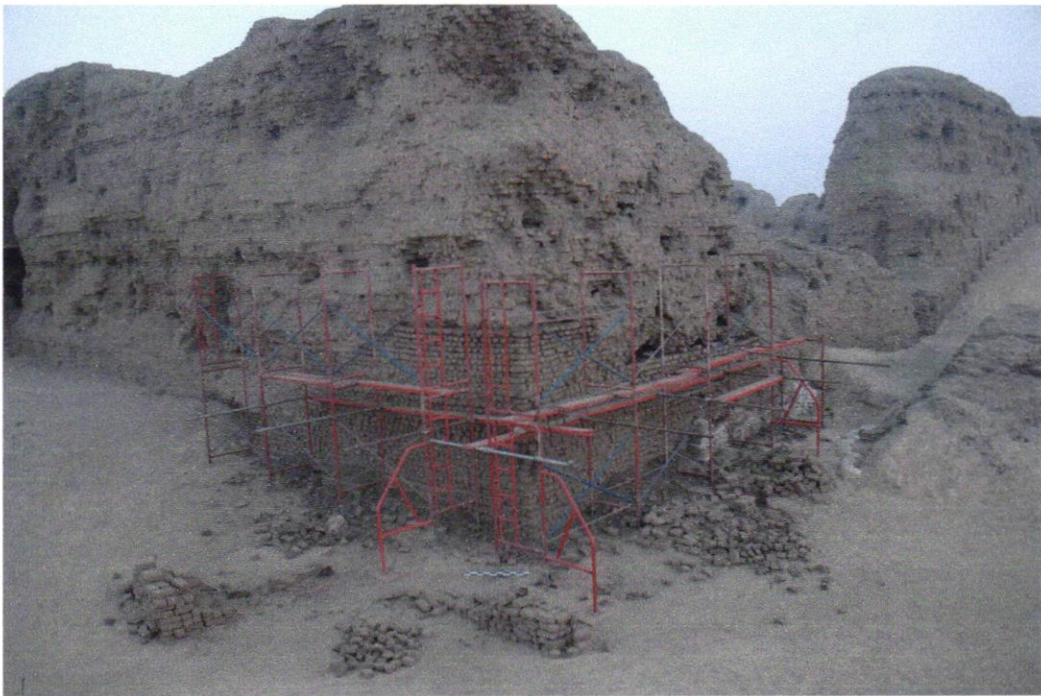
Figure 48 – South corner, with stabilization work in progress.

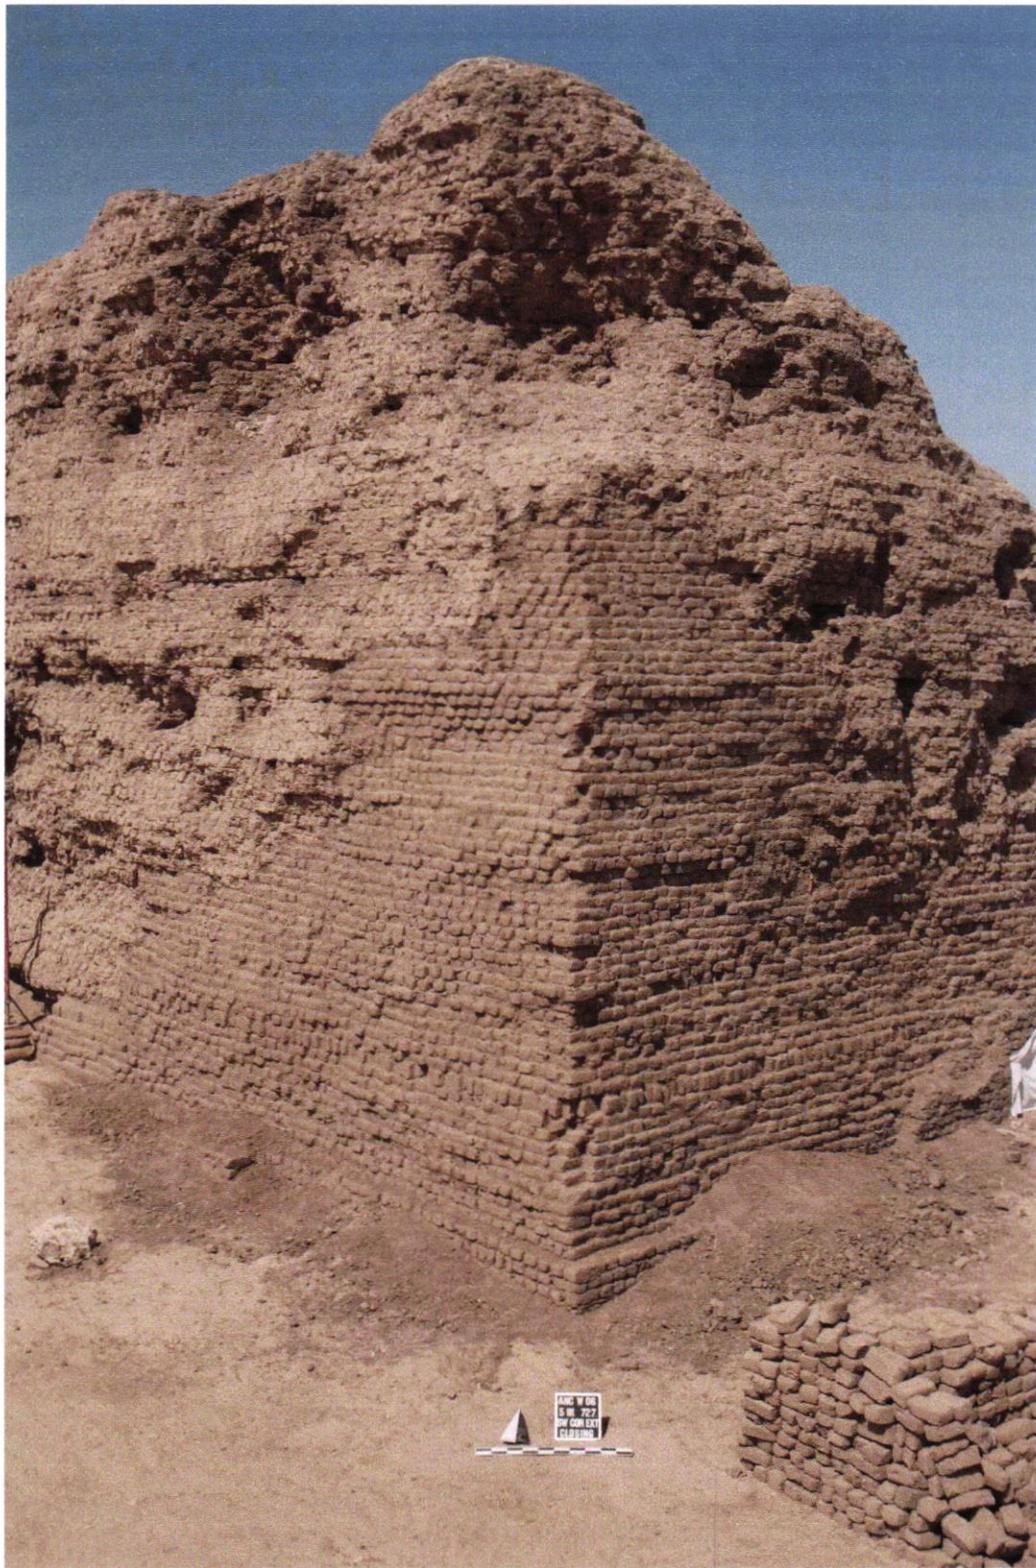
Figure 49 – The south corner, exterior, of the main enclosure, at the close of Field Season 7. The lower part of the wall has been stabilized. The upper part remains to be completed in a future season.

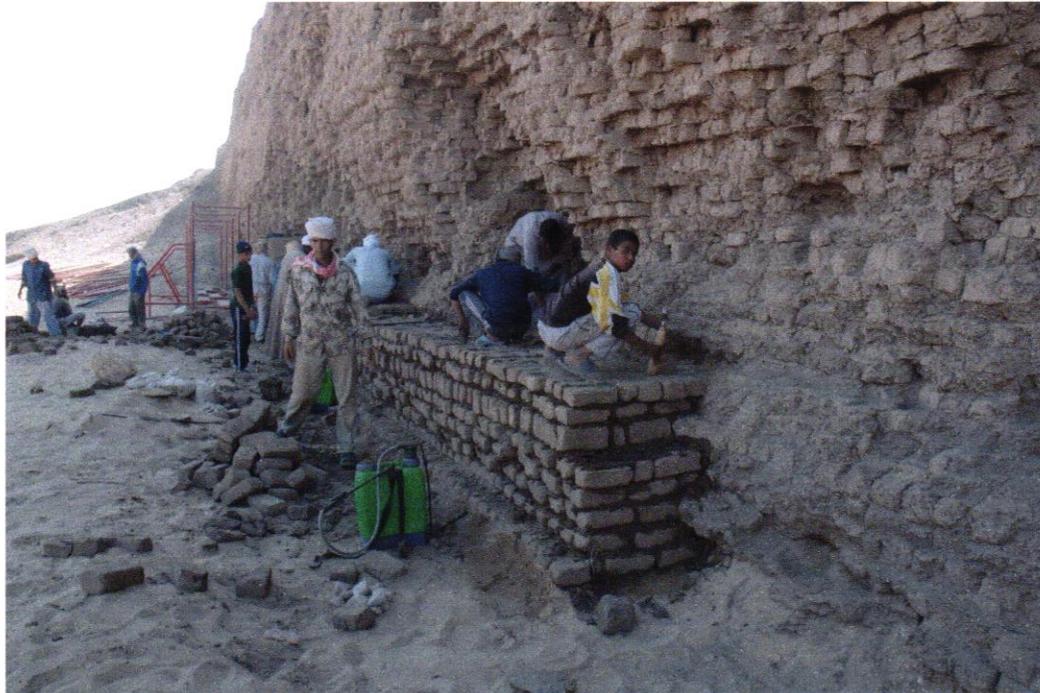
Figure 50 – Interior side of the southwest wall of the main enclosure, with stabilization work in progress. This area was begun in Field Season 6.

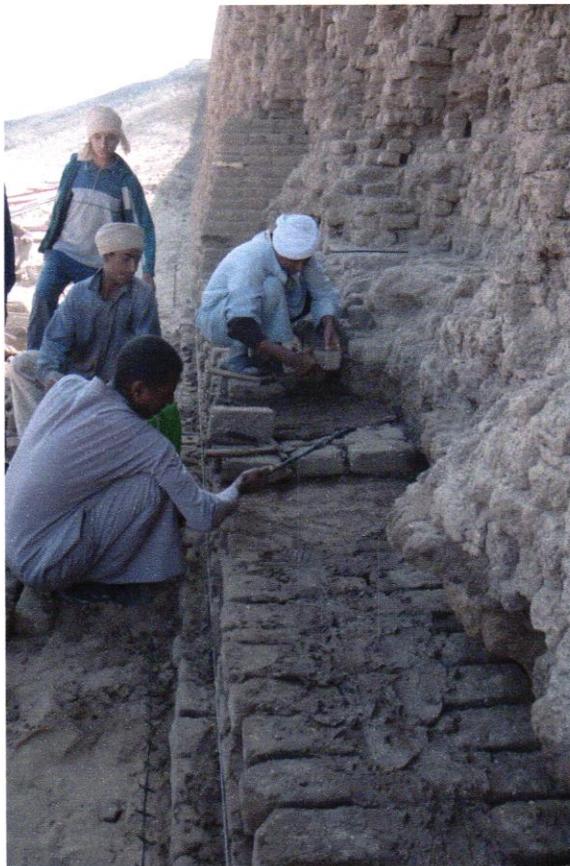
Figure 51 – The extent of missing masonry along the wall face can be judged, based on the line of the wall in the background. Note the overhang in the foreground.

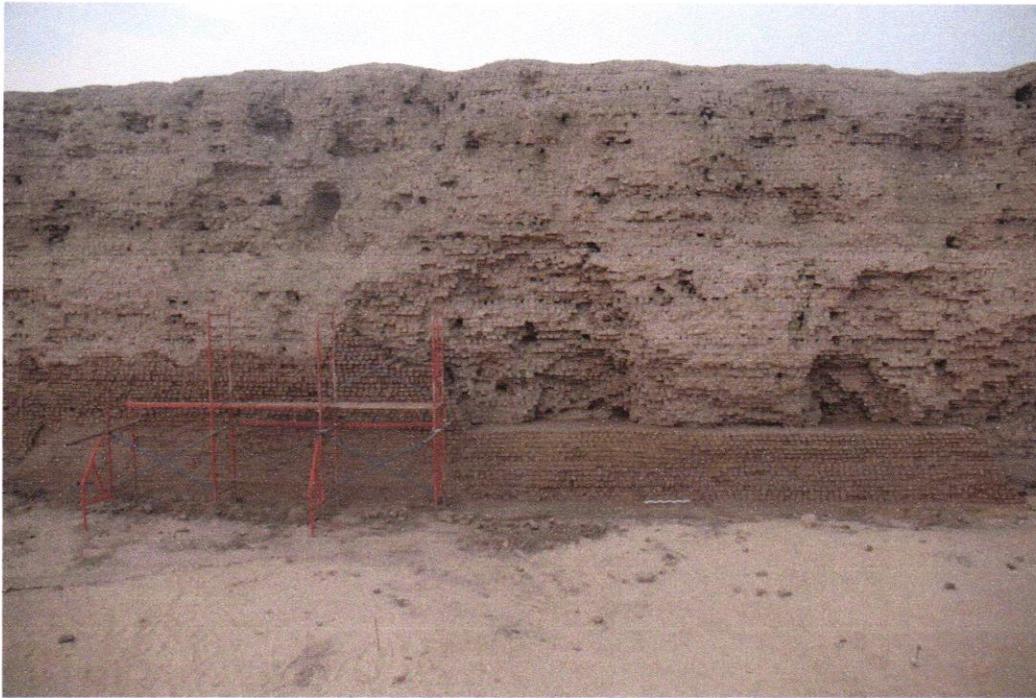
Figure 52 – Interior side of the southwest wall of the main enclosure, with stabilization work in progress. The entire lower part of the wall was missing and had to be reconstructed, in order to fill the many voids and to provide adequate structural support for the large and irregular overhangs above.

Architectural stabilization work continued along the interior side of the southwest wall of the main enclosure. Along much of the length of the wall, southeast of the gateway, a significant amount of the original masonry is missing. The masonry losses are due to a combination of animal burrowing, insect holes, and perhaps human activity as well, including the undermining of the wall base by ancient pitting, all of which have interacted to create a series of unstable concavities and overhangs, which are at risk of further collapse. The method of stabilization was consistent along the length of the wall, which has been stabilized in stages. All holes were cleaned out and any areas of loose brickwork removed. A solid base was established and new masonry installed, following the line of the original face of the wall above grade (**Figures 50-51**). The new brickwork was built up until it met and supported all overhanging areas, providing structural support to the wall above (**Figures 52-57**). As elsewhere, the new masonry is designed to blend visually with the old when seen from a distance, but to be easily distinguishable with careful inspection

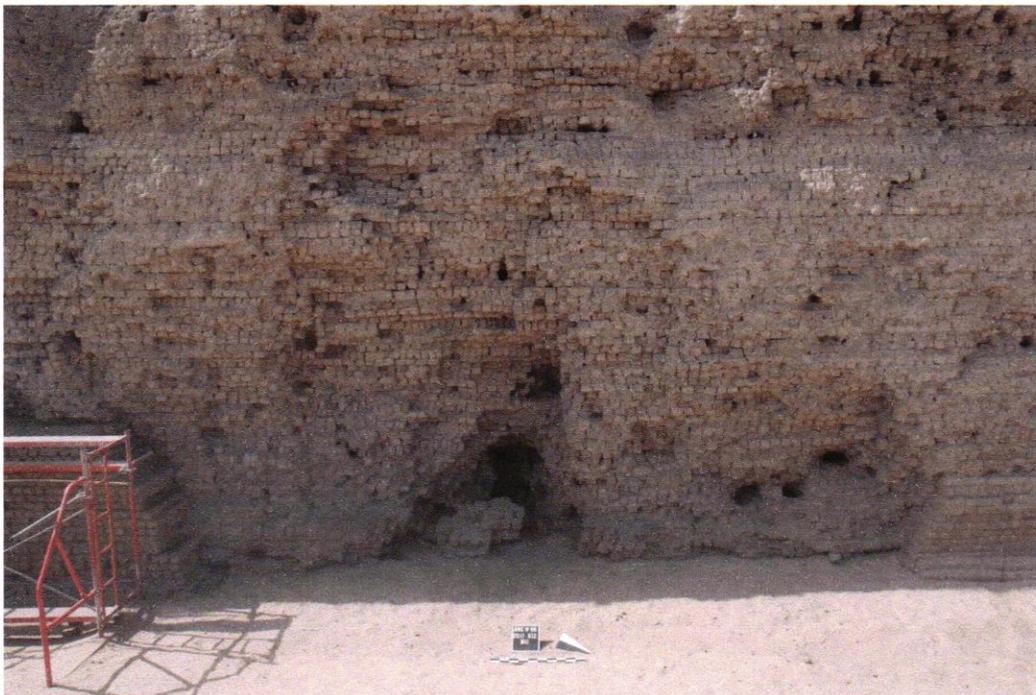
Figure 53 – A typical area of undercutting, overhanging masonry, and animal burrowing along the interior side of the southwest wall of the main enclosure. This photograph shows the section of wall just to the right (northwest) of that shown in Figure 51.

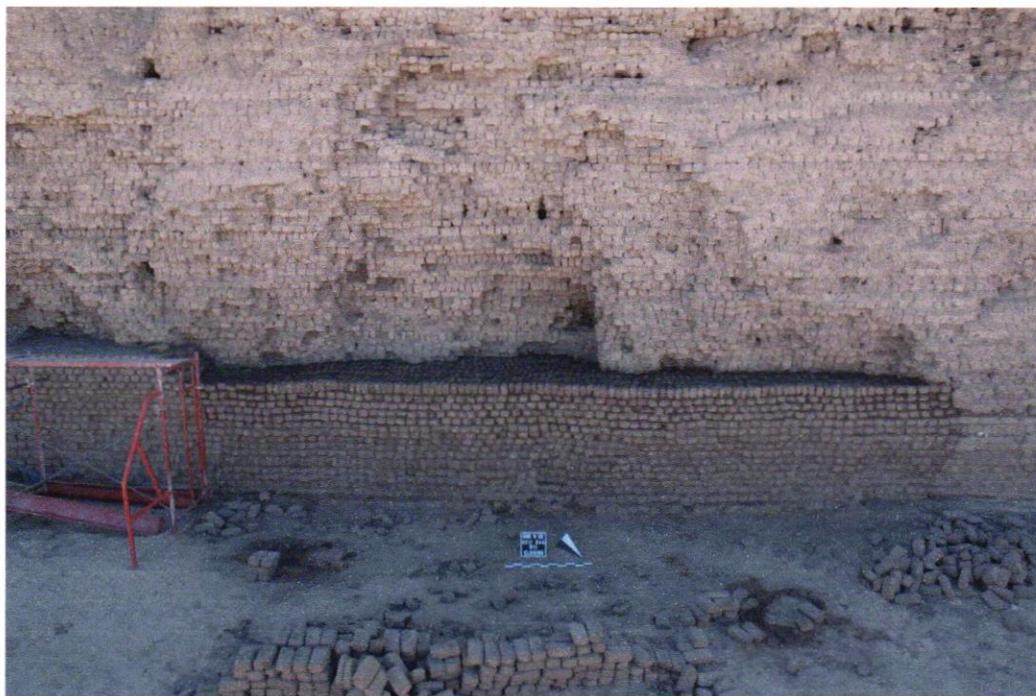
Figure 55 – The same area shown in Figures 53 and 54, with stabilization work in progress.
