PROGRESS REPORT No9

“Documentation and Conservation of King Khasekhemwy’s Funerary Monument at Abydos”

Progress Report No. 9

David O'Connor, Sub-Project Director
Matthew Adams, Sub-Project Associate Director
Institute of Fine Arts, New York University

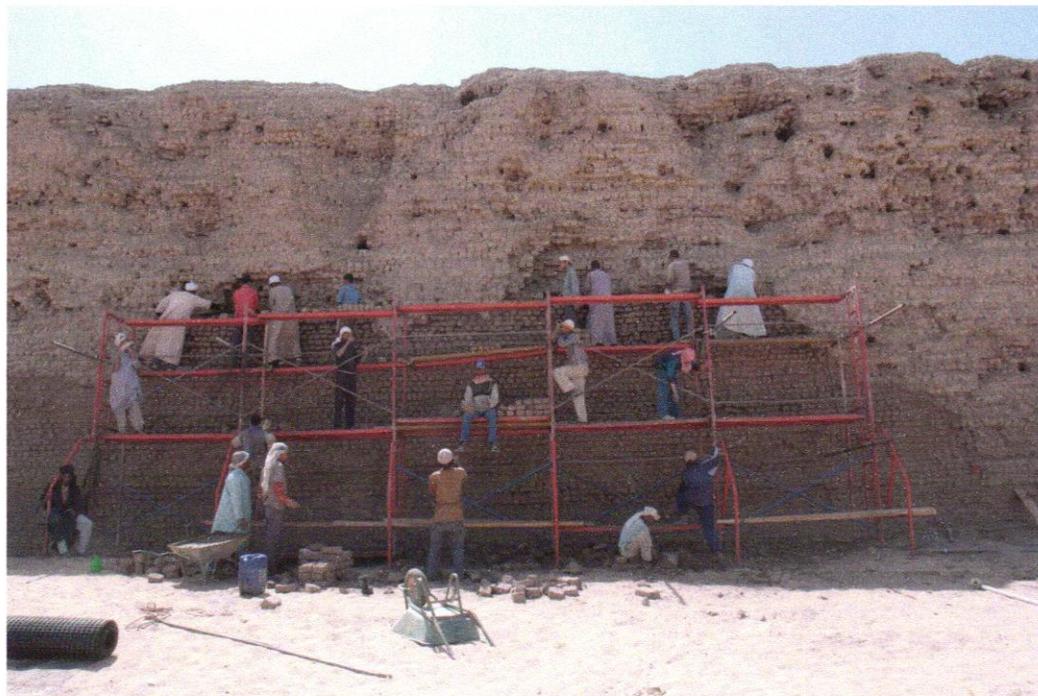
Figure 56 – The same area as in Figures 53-55, with stabilization work nearly complete. New masonry is built as high up the wall as necessary to fill fully the voids and support overhangs.

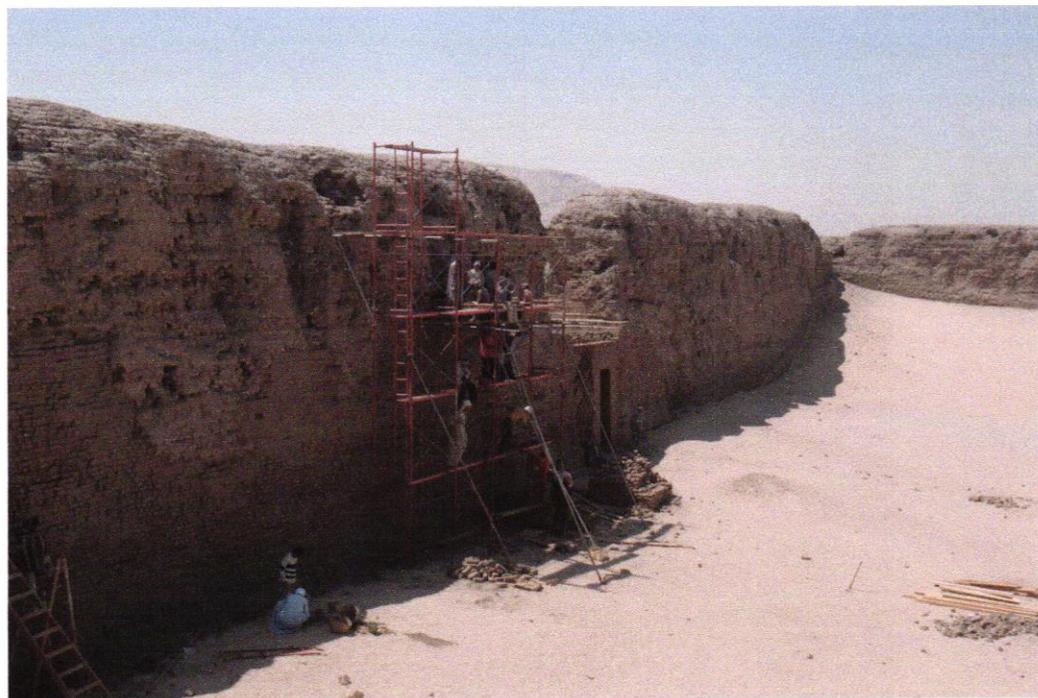
Figure 57 – Stabilization work in progress along the interior side of the southwest wall of the main enclosure.

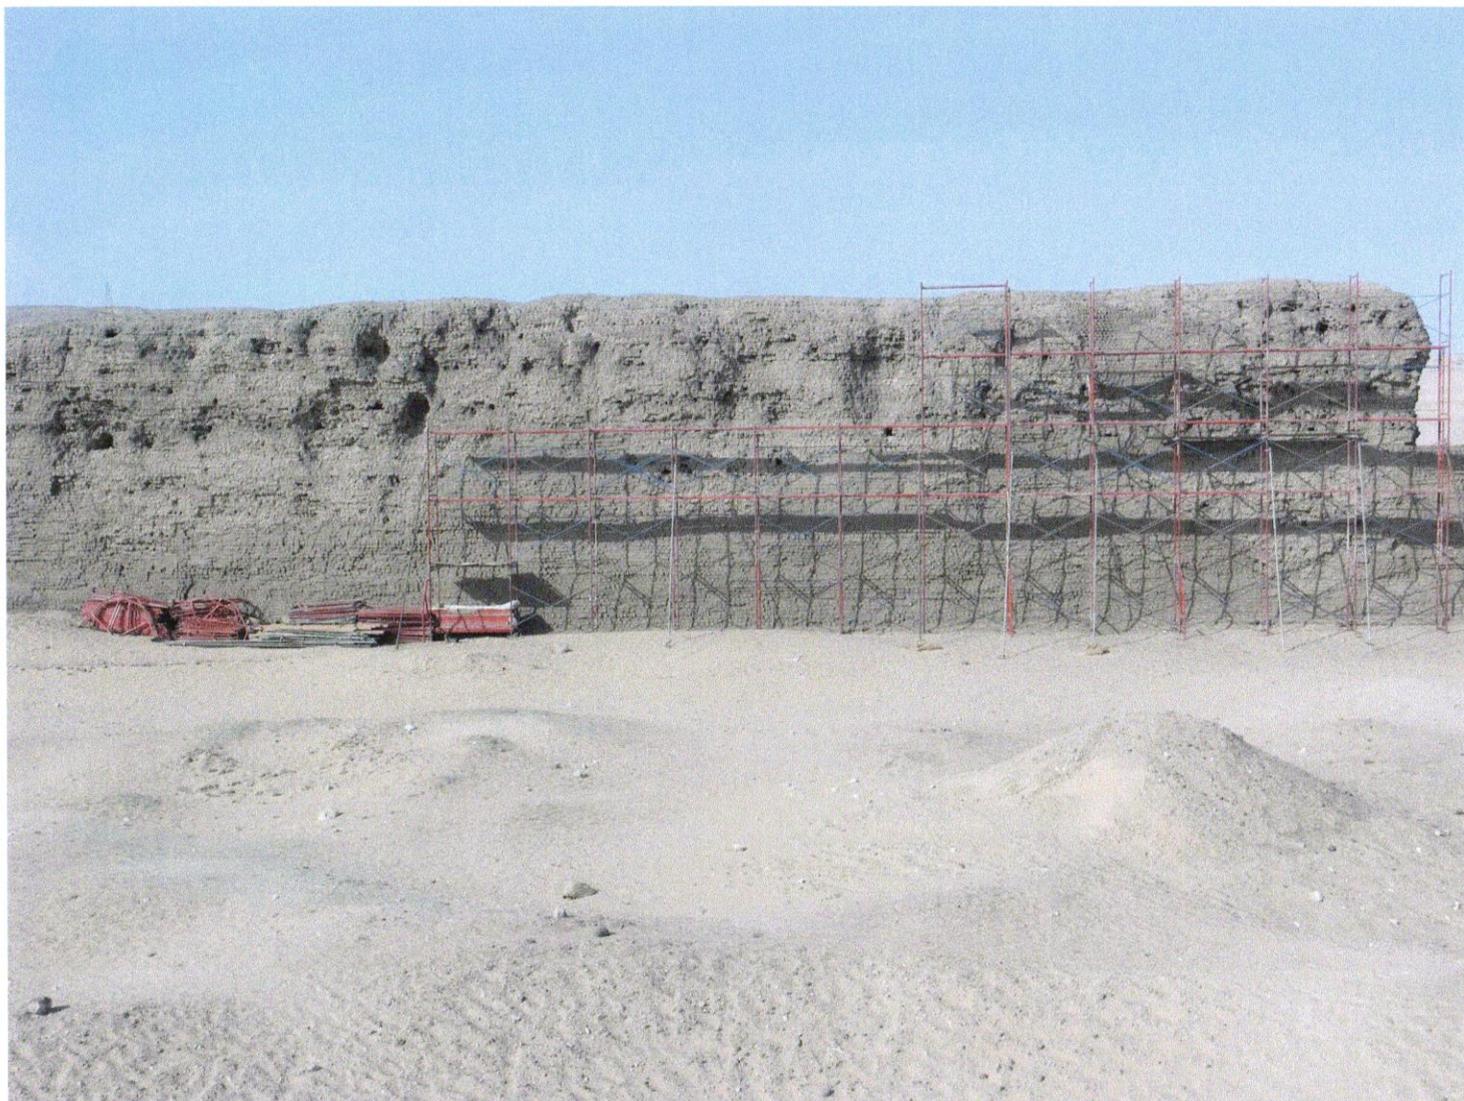
Figure 58 – Interior side of the southwest wall of the main enclosure, at the close of Field Season 7. The lower part of the wall has been stabilized. Work on the upper part of the wall will continue in a future season. The west gate is at right.

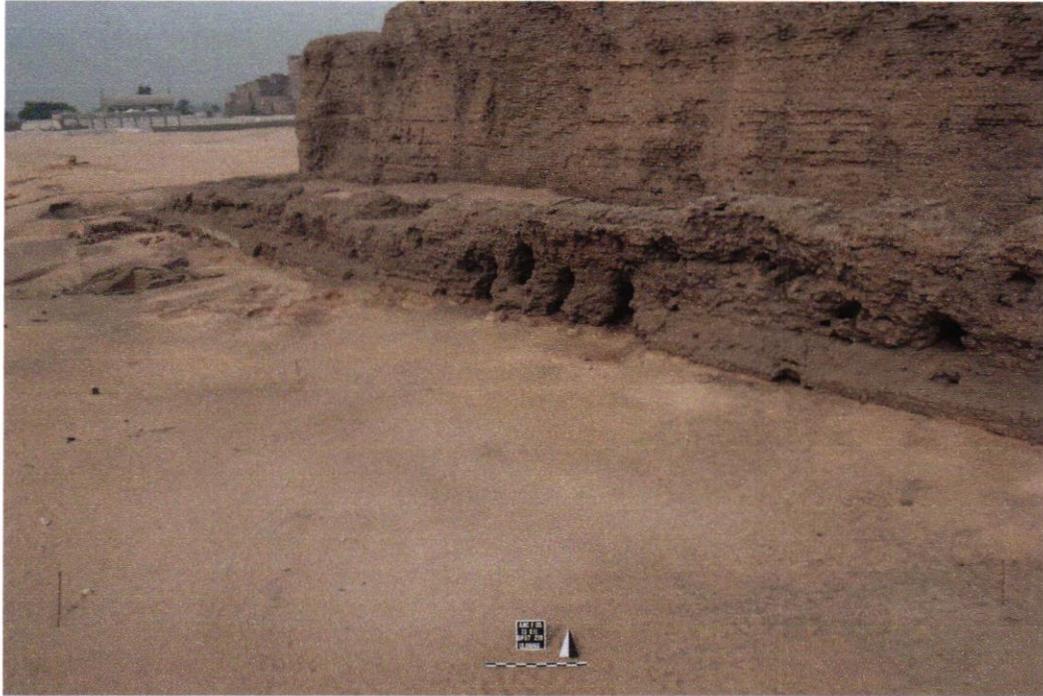
Figure 59 – Exterior side of the northwest half of the southwest perimeter wall, prior to stabilization. The outer side of the wall has been severely wind eroded. It has also been heavily damaged by animal burrowing, as well as by hornet activity.

Another major area of architectural conservation work was the exterior face of the perimeter wall, northwest of the gateway through the southwest wall. In the central part of this section of the perimeter wall, damage from burrowing animals, hornets, and wind erosion created an extremely unstable situation (**Figures 59-60**). In order to prevent further losses to the perimeter wall, new masonry was used to support what remained of the original fabric of the wall in the most unstable area (**Photos 61-62**). A temporary sandbag buttress was constructed to support another unstable area. Substantial additional work on this section of the perimeter wall will be required in a future season to stabilize the wall fully.

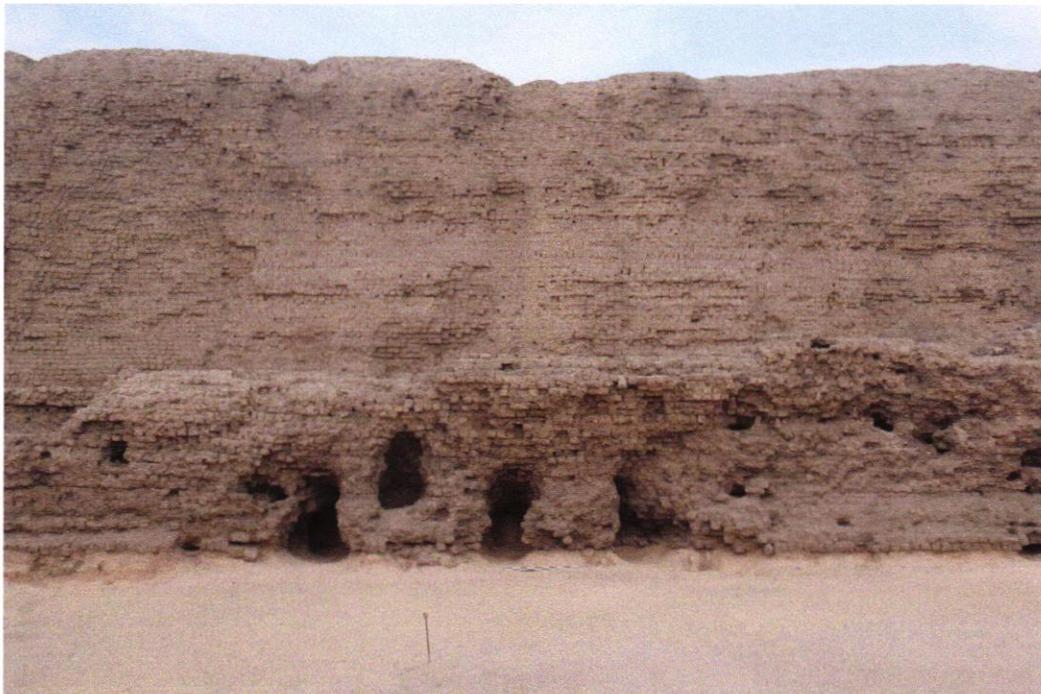
Figure 60 – Central part of the section of the southwest perimeter wall shown above. The extent of the damage from animal burrowing is clear. This was the most structurally unstable part of the wall examined in Field Season 7.

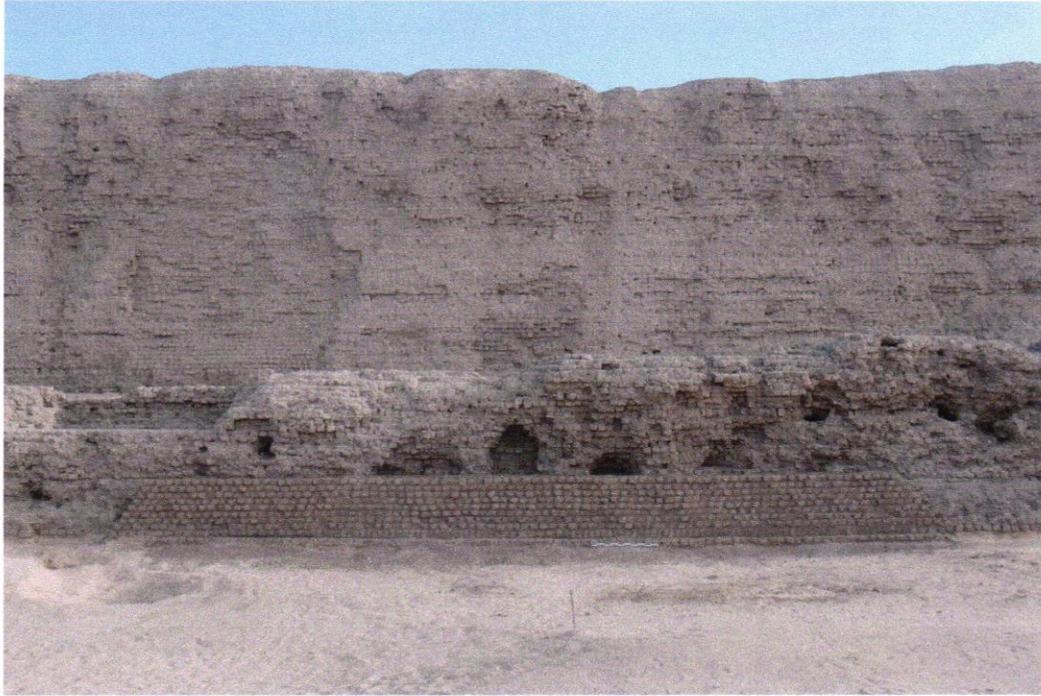
Figure 61 – Southwest perimeter wall, with stabilization work in progress.

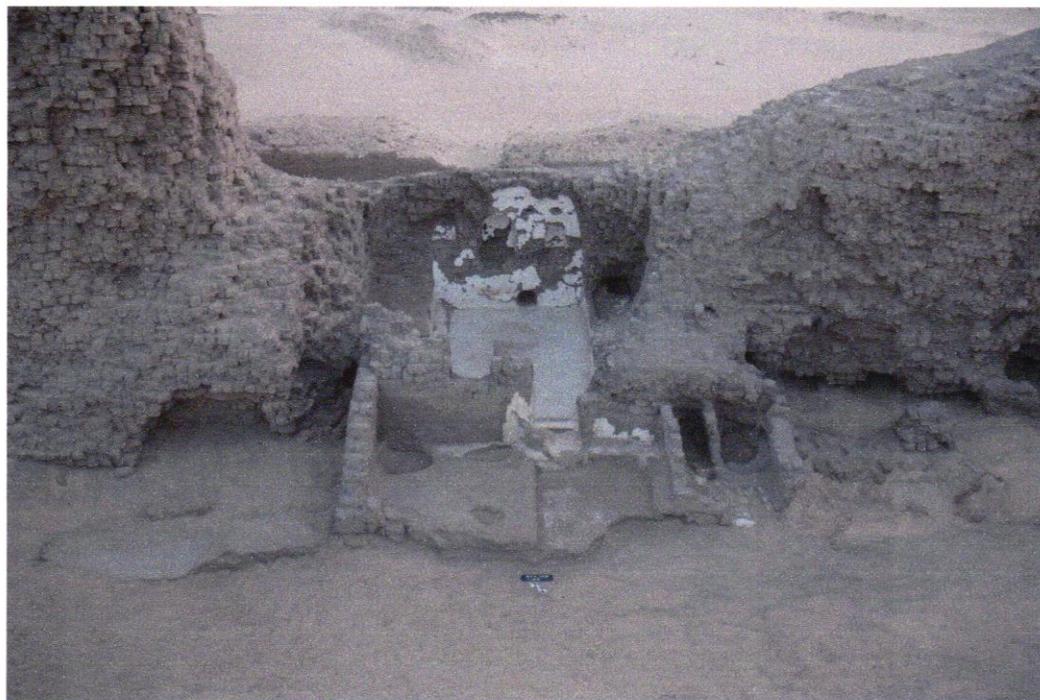
Figure 63 – Suite of rooms excavated in Field Season 6 as Operation 102, before the start of stabilization work. The main, plastered, room, or cell, had been excavated into the northeast wall of the main enclosure. A court was constructed against the front wall of the cell. The walls and floor of the court, as well as some associated features, have been artificially truncated, probably by early excavations in the Shuneh.

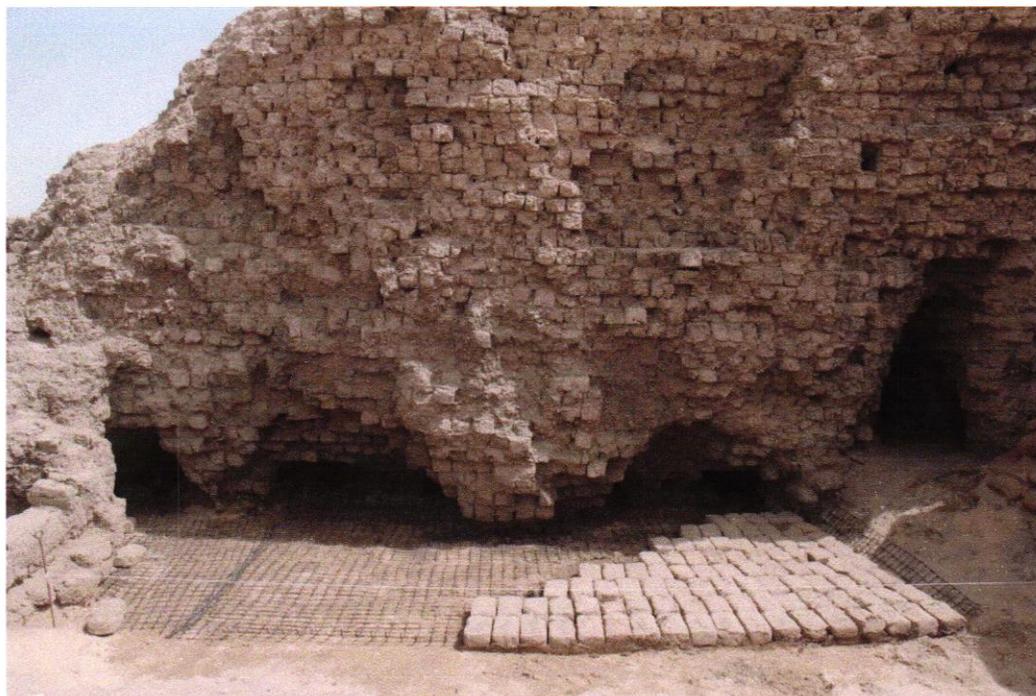
Figure 64 – The base of the enclosure wall adjacent to the cell was heavily undermined and highly unstable, requiring stabilization.

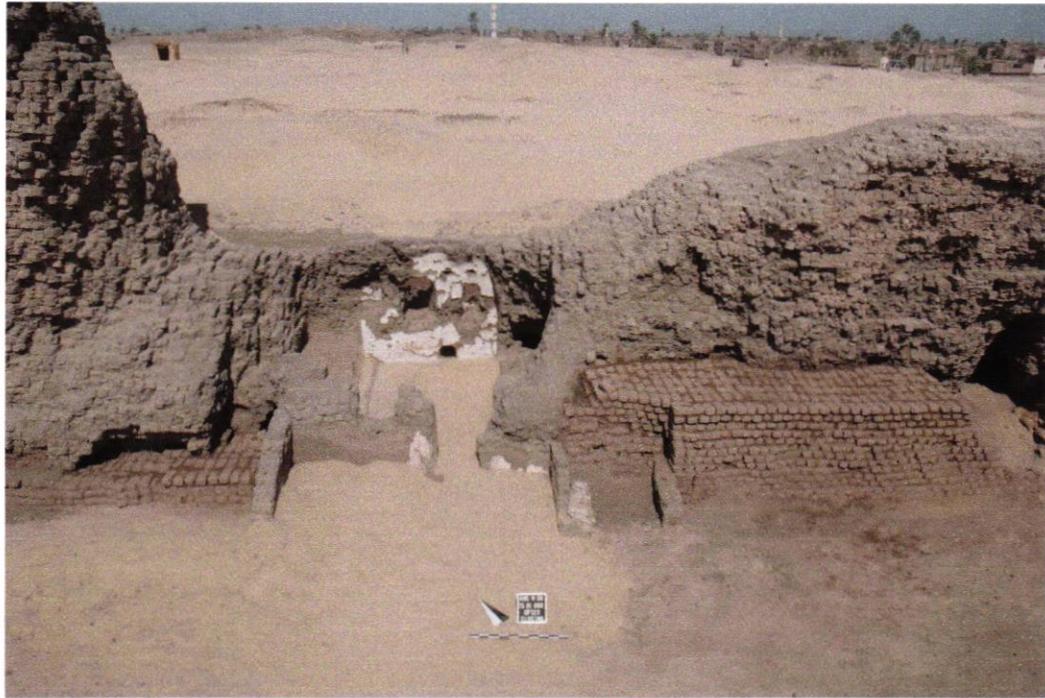
Figure 65 – Once the base of the wall was stabilized on both sides of the cell, work could proceed in the cell itself.

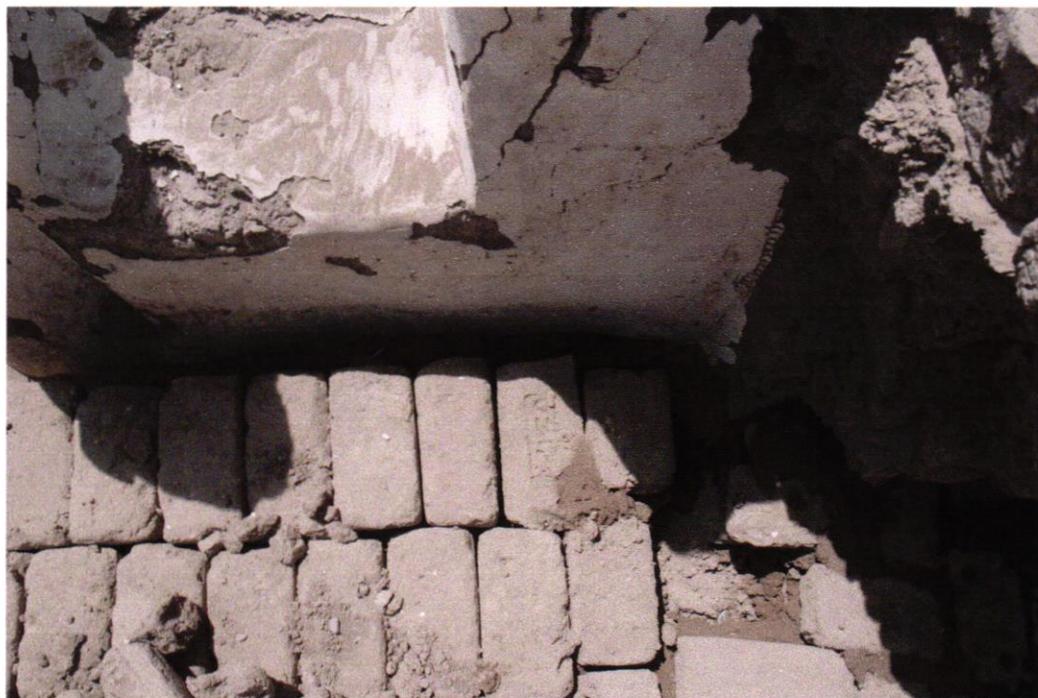
Figure 67 – As the level of the brick infilling rose, a gap was left adjacent to any plaster surfaces.

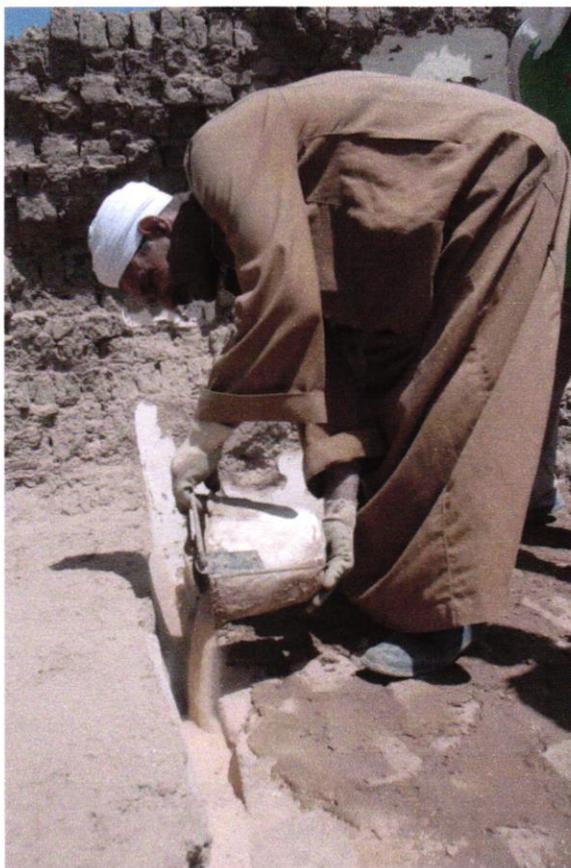
Figure 68 – This gap was filled with sieved sand, to maintain a barrier layer between new masonry and original surfaces.

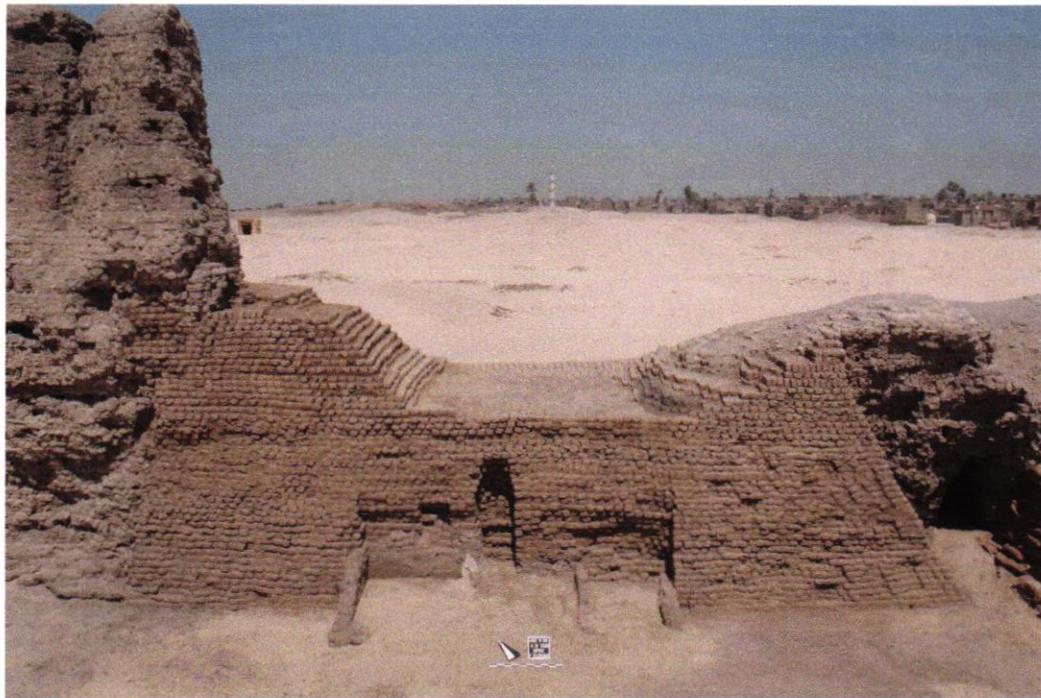
Figure 69 – Operation 102, at the close of work in Field Season 7. A solid base has been created for the additional masonry that will be required to support the unstable vertical wall end at left.

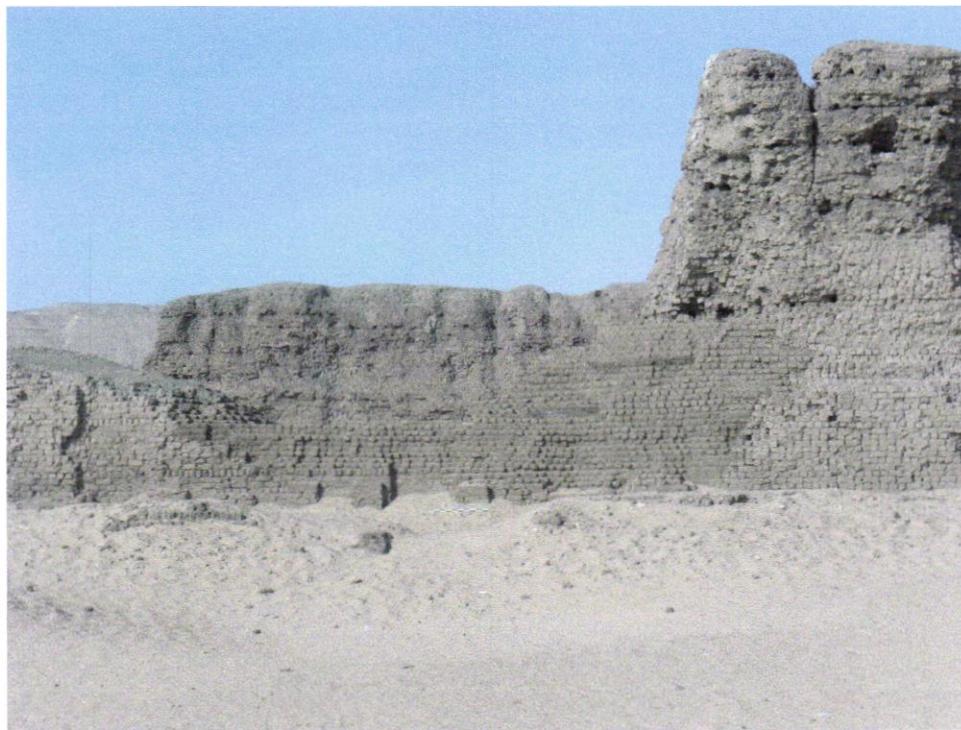
Figure 70 – The same area as in Figure 69, viewed from outside the Shuneh, from the northeast.

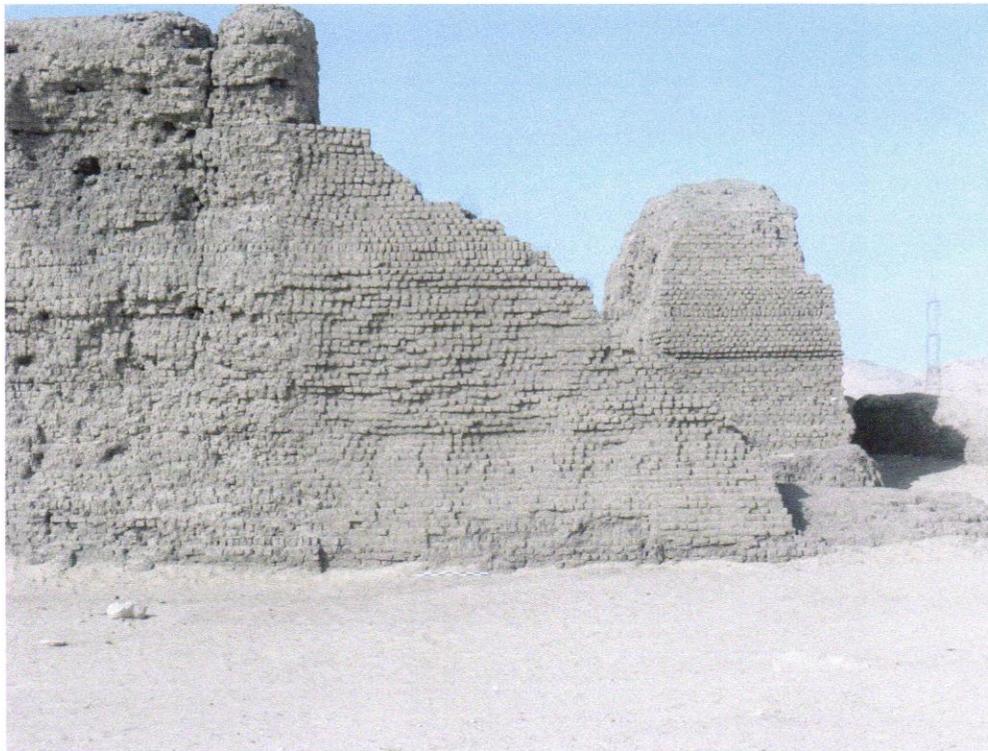
Figure 72 – Northwest end of the northeast wall, at the close of Field Season 7. Additional work will be done in this area in future seasons, as part of the comprehensive stabilization of the north gateway area.

Stabilization work continued at the northwest end of the northeast wall, beside the north gateway. Architectural work began here in Field Season 6, in 2004-2005 (**Figure 71**). The vertical end of this wall, the result of ancient collapses of the gateway and of a monastic cell beside it, was inherently highly unstable and was made more so by the existence of a deep vertical crack about one meter behind the wall end. In order to provide structural support to the end of the wall, and thus protect it from the risk of further collapse, the wall in this area is being rebuilt. This work was begun in Field Season 6, and in Field Season 7 additional work was done (**Figure 72**). Work in this area will continue in future seasons, as part of the comprehensive stabilization of the north gateway area.

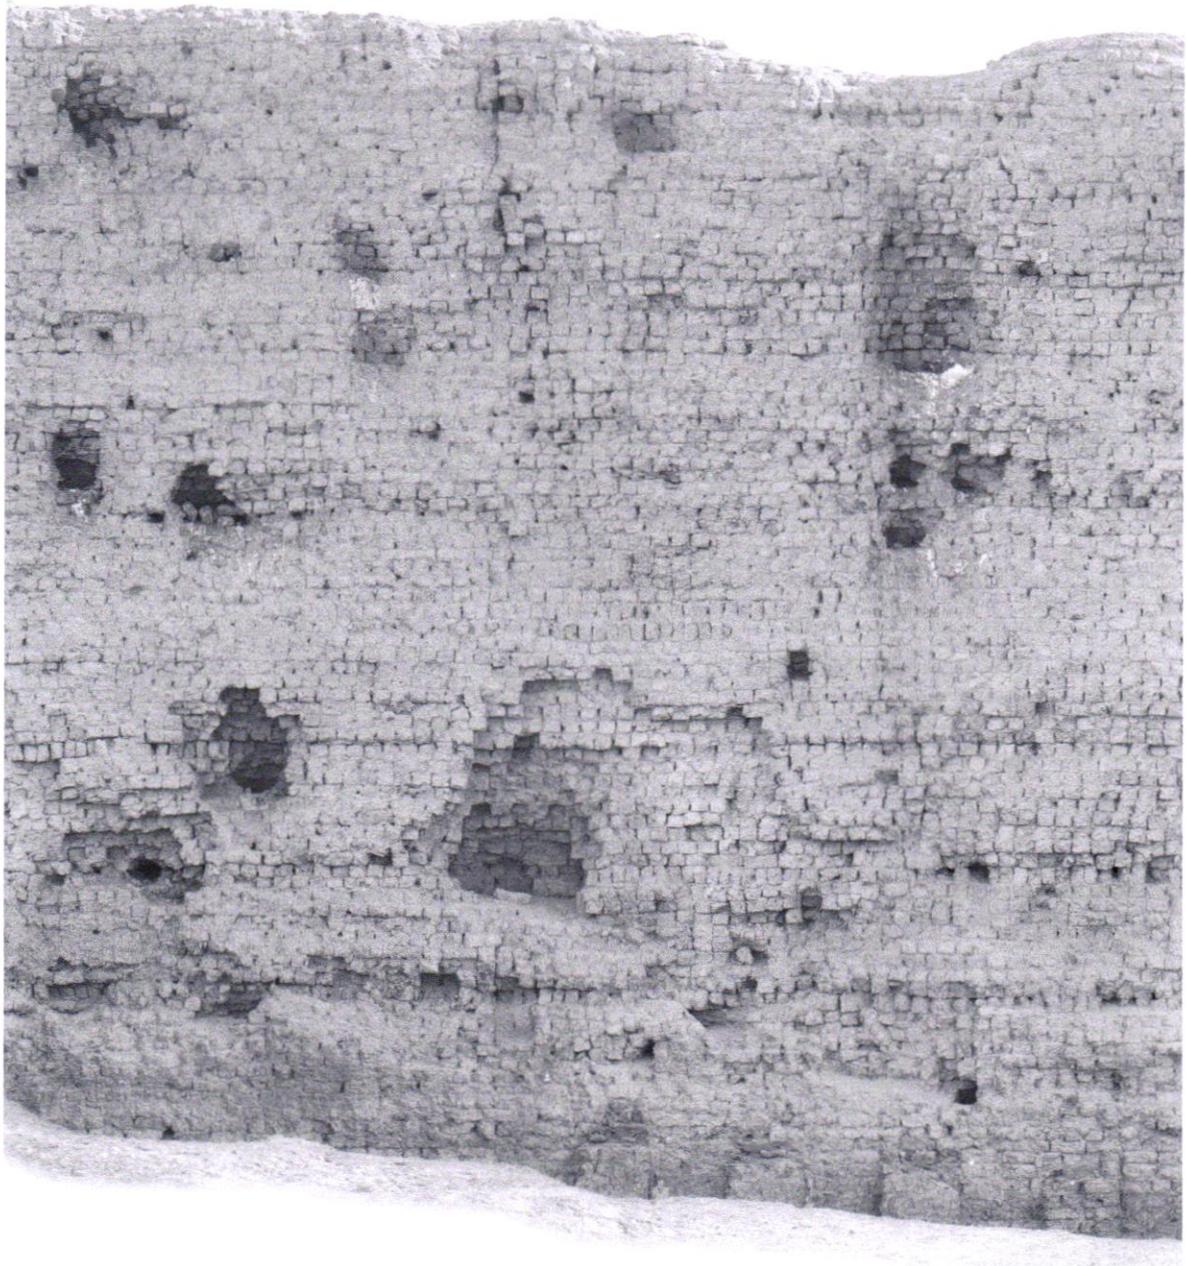
Figure 73 – Section of the exterior side of the southwest wall of the main enclosure, showing a typical distribution of medium-sized and small holes. Most of these holes were, initially, the result of hornet activity.

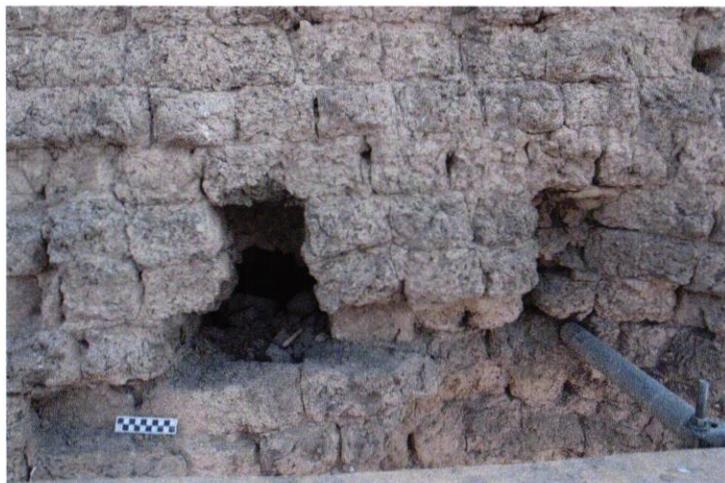
Figure 74 – A typical medium-sized hole in the exterior side of the southwest wall of the main enclosure.

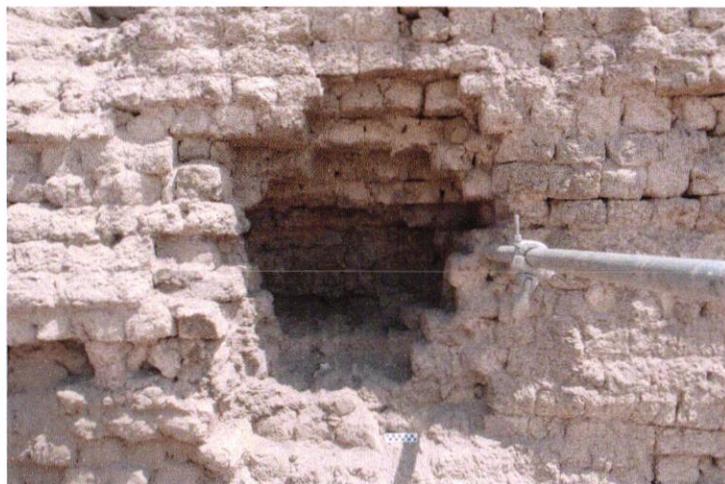
Figure 75 – The same hole in Figure 74, after cleaning. Frequently, cleaning reveals that a hole that appears to be relatively small at the wall face is actually much larger.

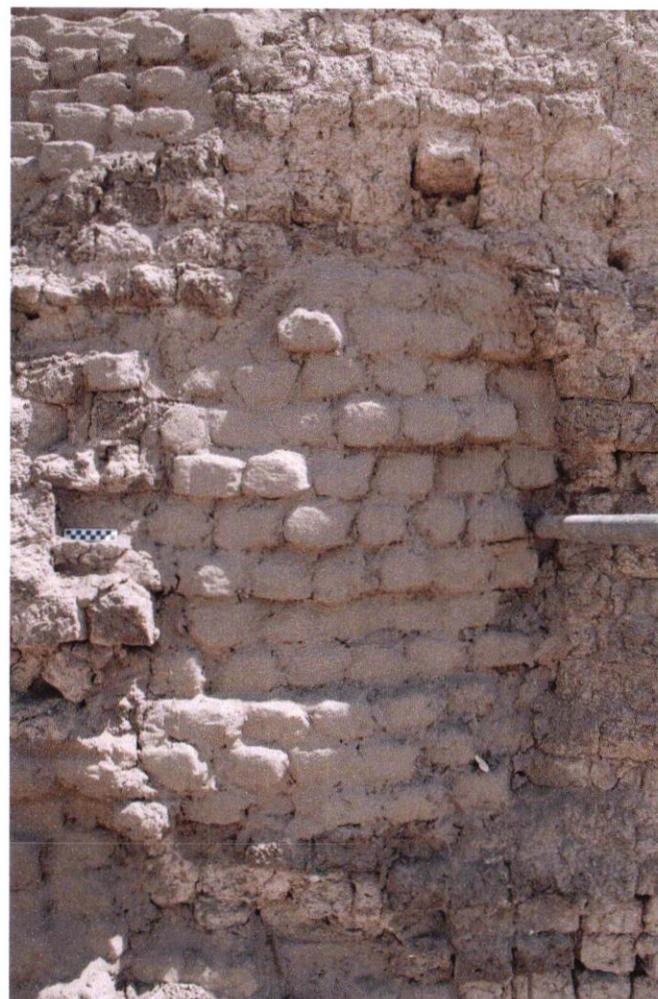
Figure 76 – The hole shown in the preceding figures, filled with new brick masonry.

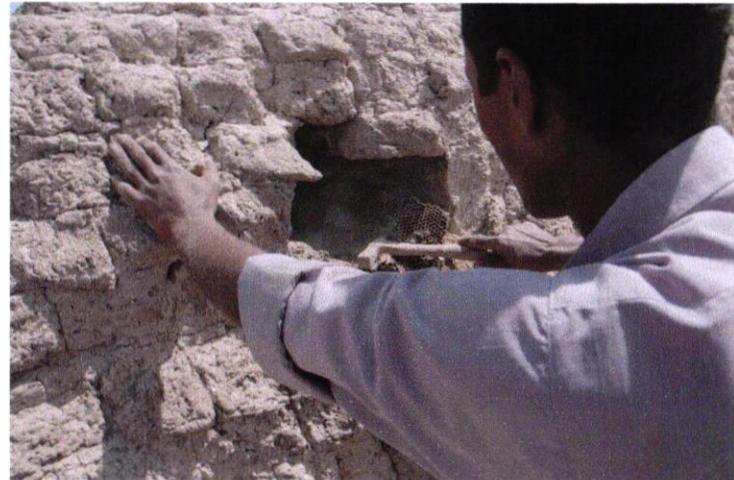
Figure 78 – Cleaning revealed that the upper of the two holes shown in Figure 77 was filled with the remains of a paper hornet nest.

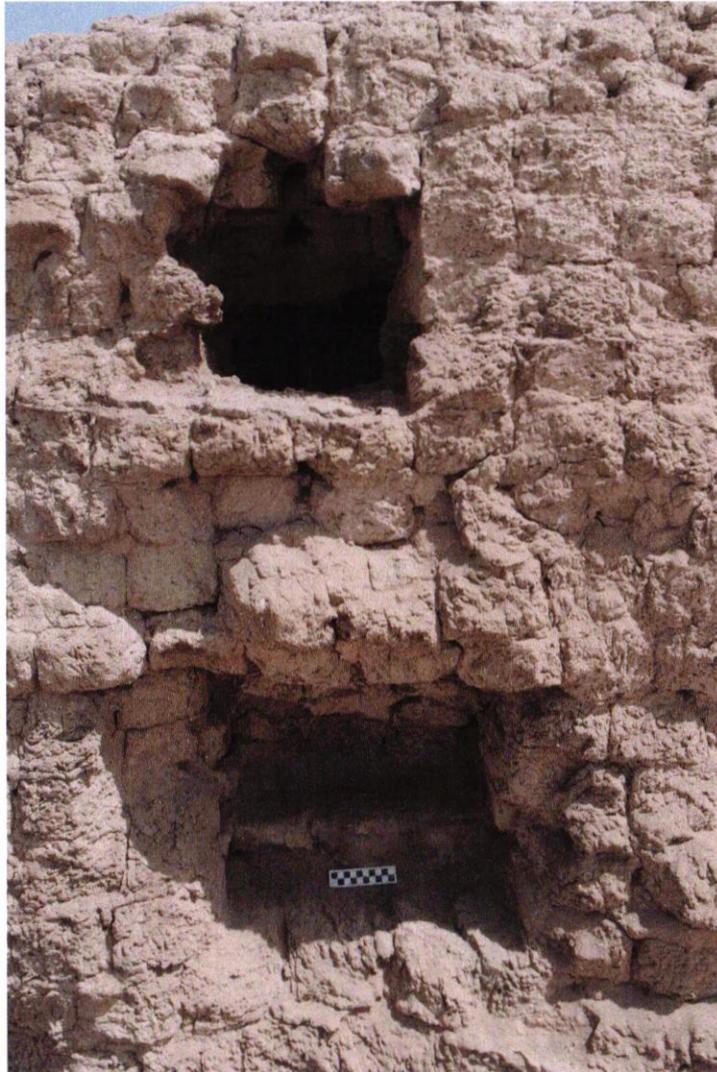
Figure 80 – The two holes shown in Figure 77, after cleaning preparatory to infilling.

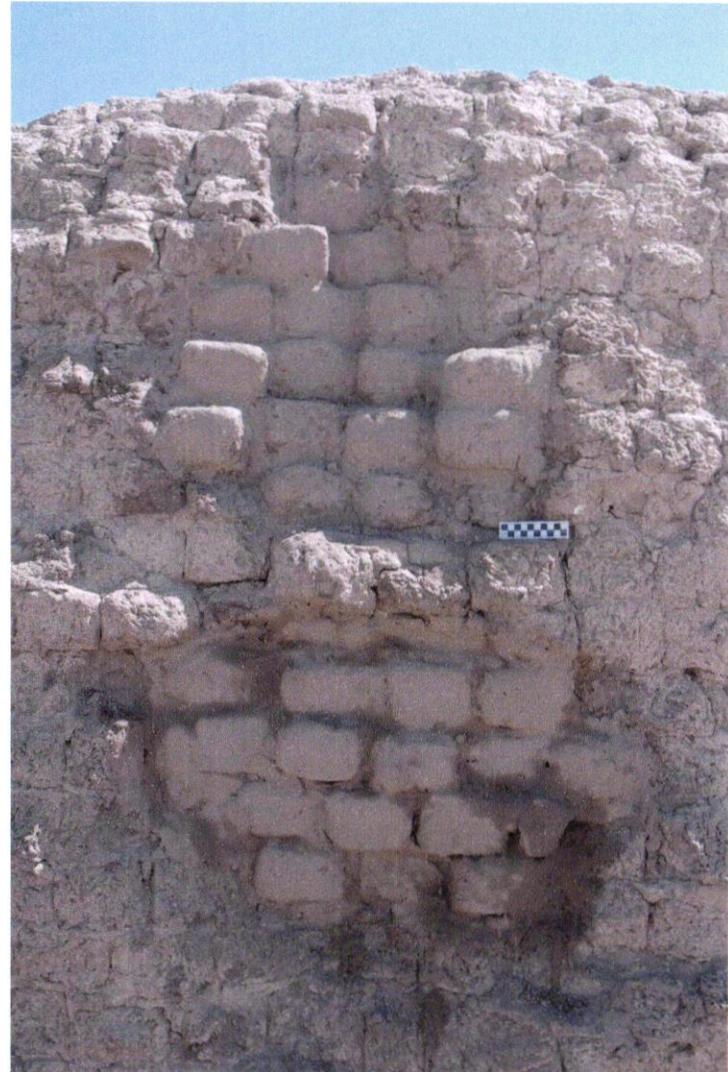
Figure 81 – The same holes as in the preceding figures, after stabilization.

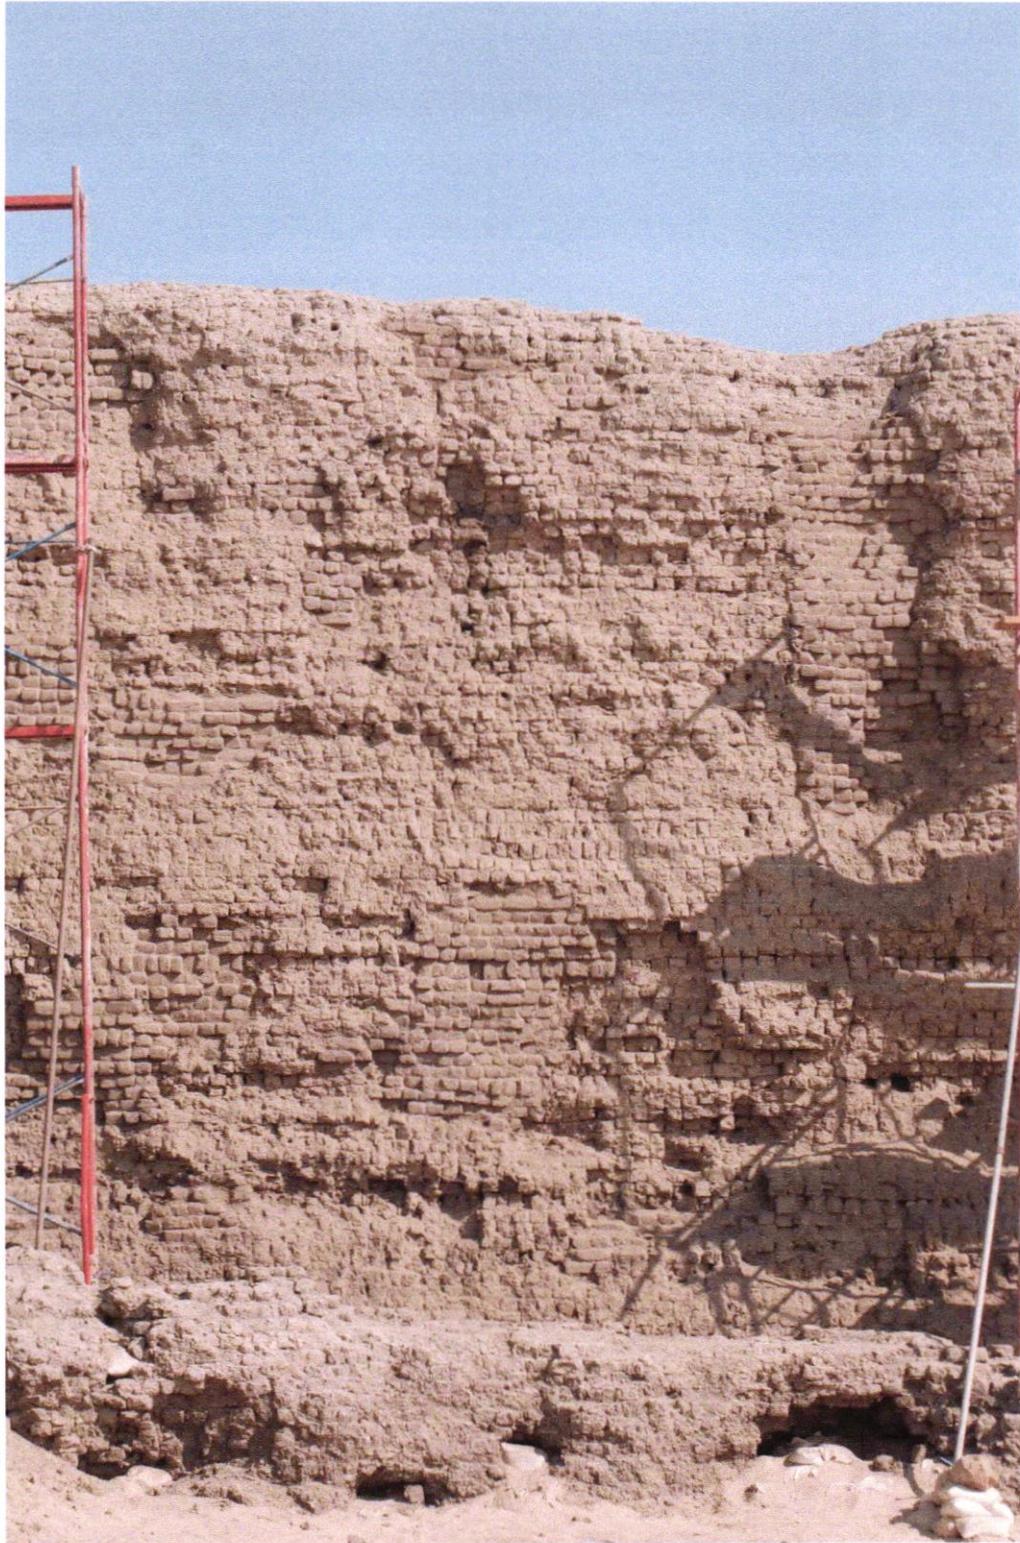
Figure 82 – The same section of wall as shown in Figure 73, after the stabilization of the medium-sized and smaller holes. The eroded wall top in the foreground is the southwest perimeter wall.

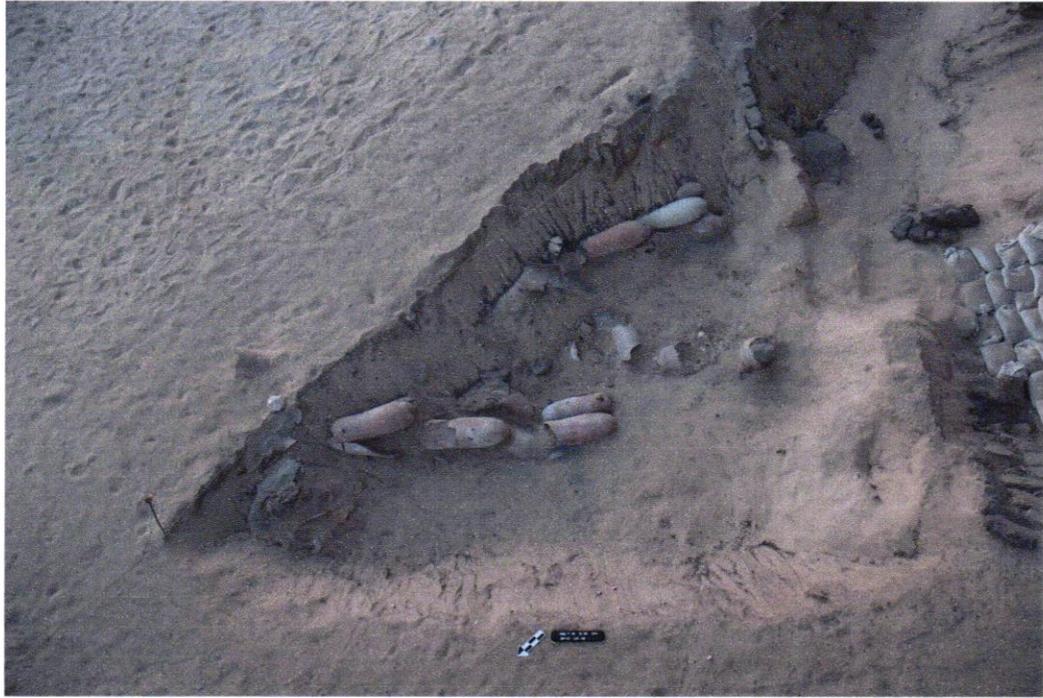
Figure 83 – Operation 113, along the interior side of the southwest wall of the main enclosure. Although excavation in Field Season 6 was completed along most of the length of this part of the wall, a portion of Operation 113 remained to be finished in Field Season 7. As was demonstrated by the previous excavations, the area had been repeatedly pitted in ancient times for the deposition of ceramic vessels containing the remains of sacred ibises.

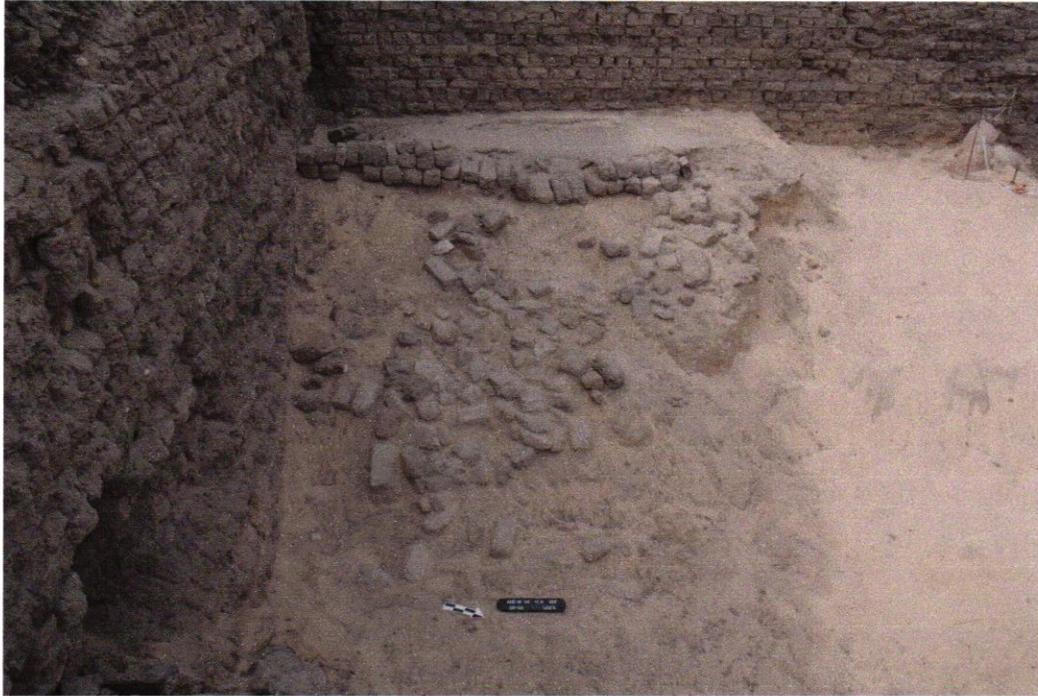
Figure 91 – The front wall of the corner room, which was dry-laid, collapsed anciently down the slope of the underlying sand deposit.

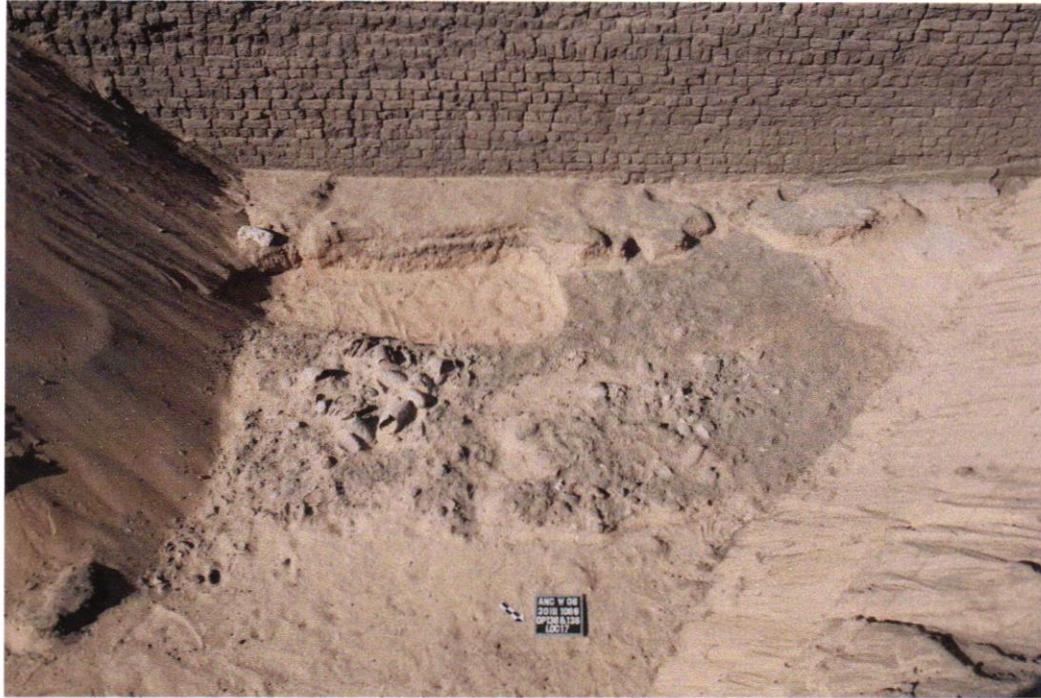
Figure 101 – Preserved section of the Dynasty 2 mud floor of the Khasekhemwy enclosure. On the floor is a deposit of broken offering pottery, of the “beer jar” type.

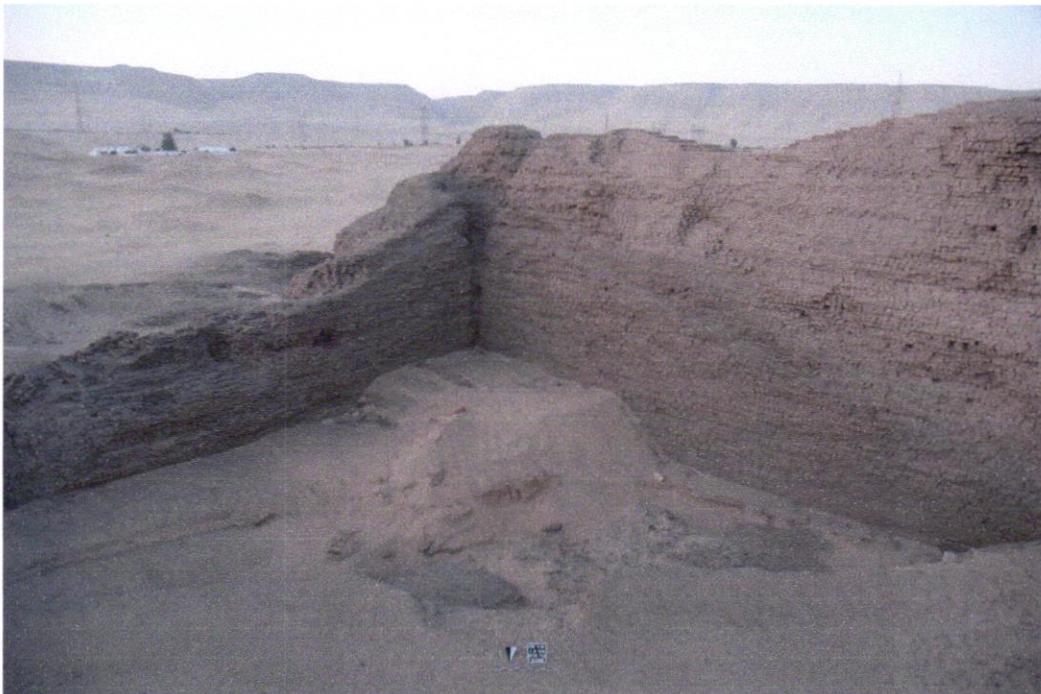
Figure 102 – South corner, interior, of the main enclosure of the Shuneh, at the close of excavation in Field Season 7. The Dynasty 2 mud floor of the enclosure is visible in the lower center and lower right of the excavation area. The erosion line on the adjacent wall face shows the profile of the sand deposit. Excavation will continue here in a future season.

The state of the south corner area at the close of Field Season 7 is shown in **Figure 102**. Additional excavation will be required in a future season to reach the Dynasty 2 floor level over the entire area. This will permit evaluation of the condition of the southeast wall adjacent, prior to the large-scale work that will be required for the stabilization of the south gateway area.

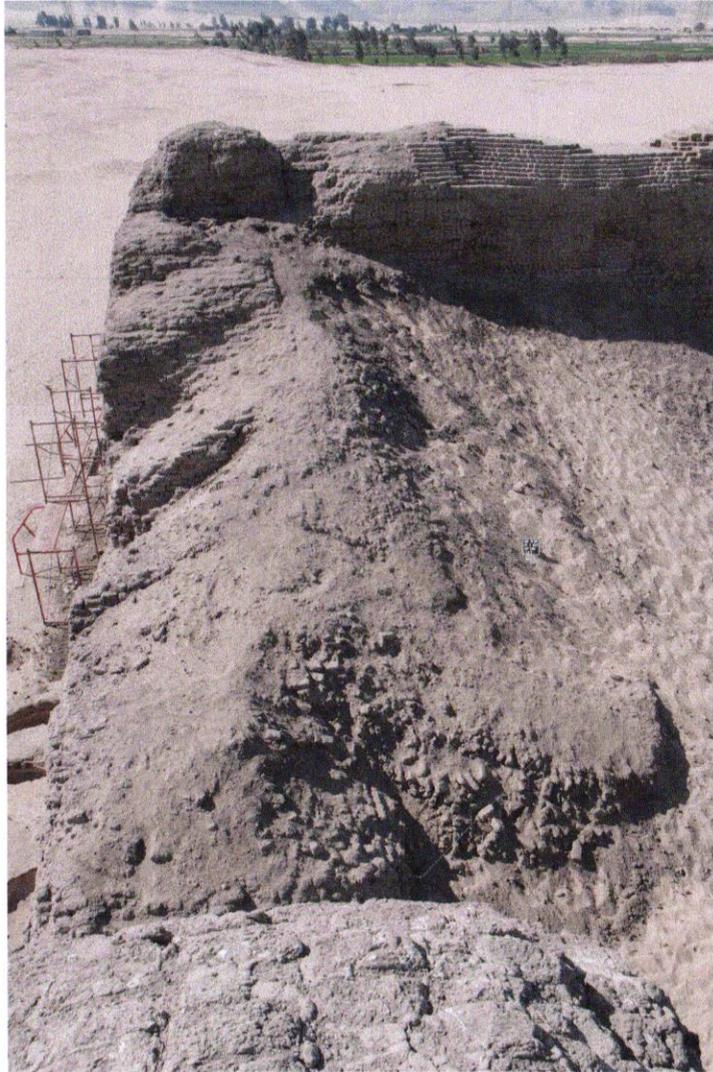
Figure 103 – Top of the southeast wall of the main enclosure, between the southeast gate and the south corner, prior to excavation.

In the eroded top of the southeast wall of the Shuneh, between the corner and the gateway, excavation revealed that a Coptic cell had been cut into the wall from the exterior side (**Figures 103-105**). The structural weakness created by the cell void eventually resulted in the collapse of a large section of the wall, which fell onto the surface of the sand deposit inside the south corner. Although the cell was very poorly preserved (**Figure 106**), evidence was found that the walls and possibly floor of the cell had been covered with the same hard white lime-based plaster used in most other Coptic cells at the Shuneh. Pieces of fallen wall plaster were found inside the cell, and some of these had traces of inscriptions and drawings in red (**Figures 107-108**). A few scattered small fragments of papyrus and parchment documents, with traces of Coptic inscriptions in black ink, were found loose in the brick debris inside the cell.
