PROGRESS REPORT No9

“Documentation and Conservation of King Khasekhemwy’s Funerary Monument at Abydos”

Progress Report No. 9

David O'Connor, Sub-Project Director
Matthew Adams, Sub-Project Associate Director
Institute of Fine Arts, New York University

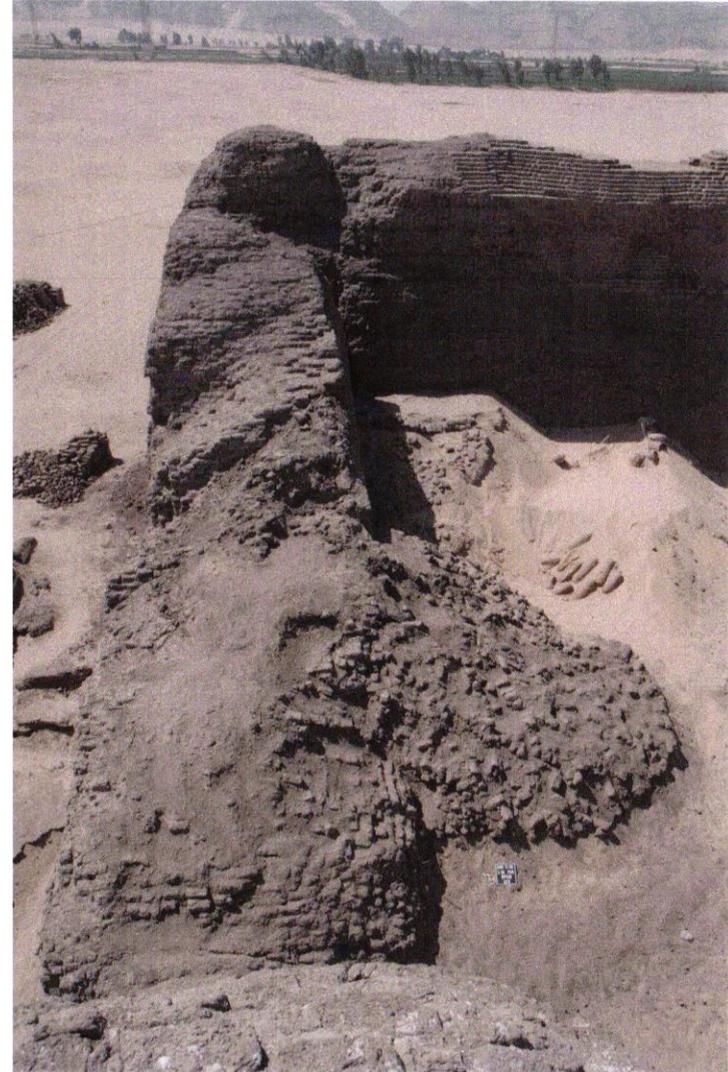
Figure 104 – A large section of the wall collapsed to the northwest at some point in the past.

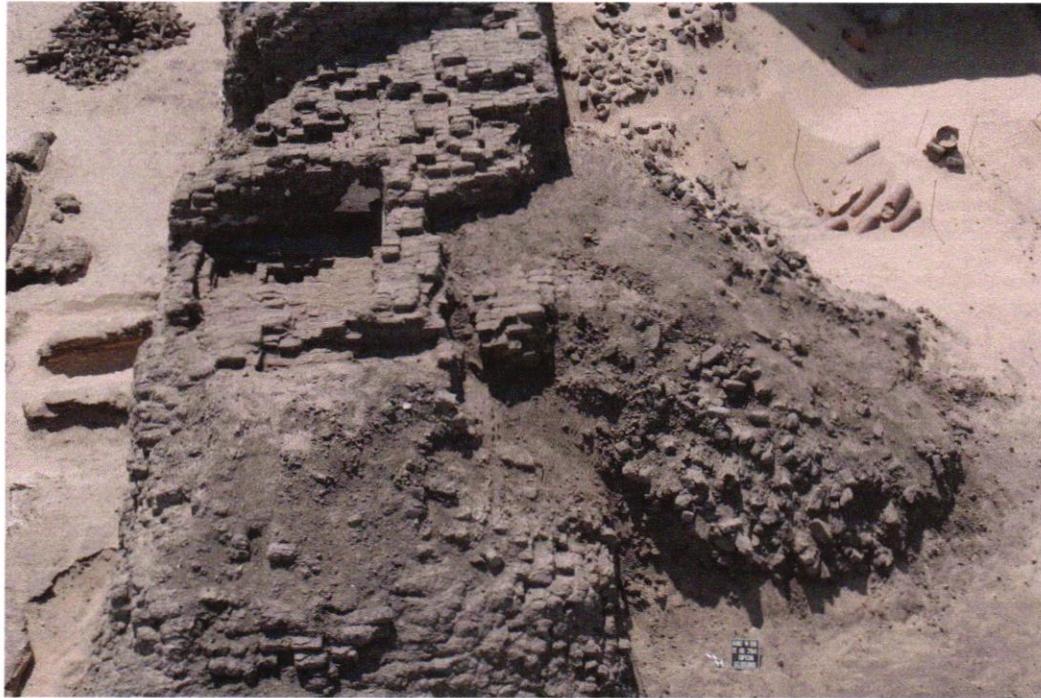
Figure 105 – Excavation revealed that the collapse of this part of the wall was due to structural instability created by a monastic cell void. The remains of the cell are visible in the wall top at left.

In the eroded top of the southeast wall of the Shuneh, between the corner and the gateway, excavation revealed that a Coptic cell had been cut into the wall from the exterior side (**Figures 103-105**). The structural weakness created by the cell void eventually resulted in the collapse of a large section of the wall, which fell onto the surface of the sand deposit inside the south corner. Although the cell was very poorly preserved (**Figure 106**), evidence was found that the walls and possibly floor of the cell had been covered with the same hard white lime-based plaster used in most other Coptic cells at the Shuneh. Pieces of fallen wall plaster were found inside the cell, and some of these had traces of inscriptions and drawings in red (**Figures 107-108**). A few scattered small fragments of papyrus and parchment documents, with traces of Coptic inscriptions in black ink, were found loose in the brick debris inside the cell.

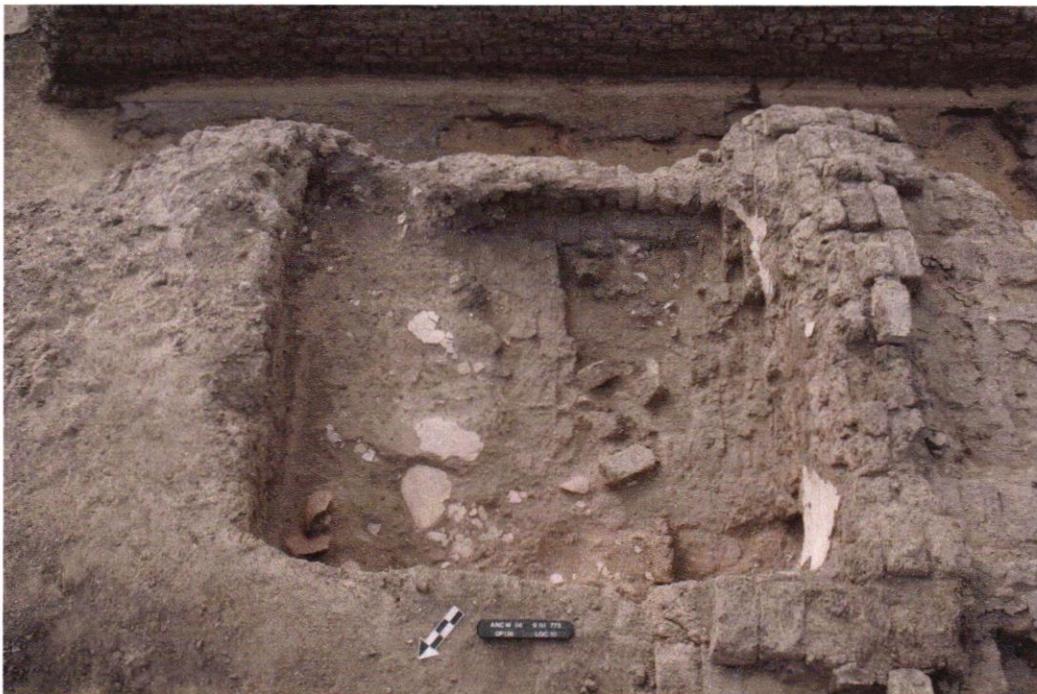
Figure 106 – The cell in the southwest wall of the main enclosure, excavated as part of Operation 136, although poorly preserved, contained a large number of pieces of fallen wall plaster.

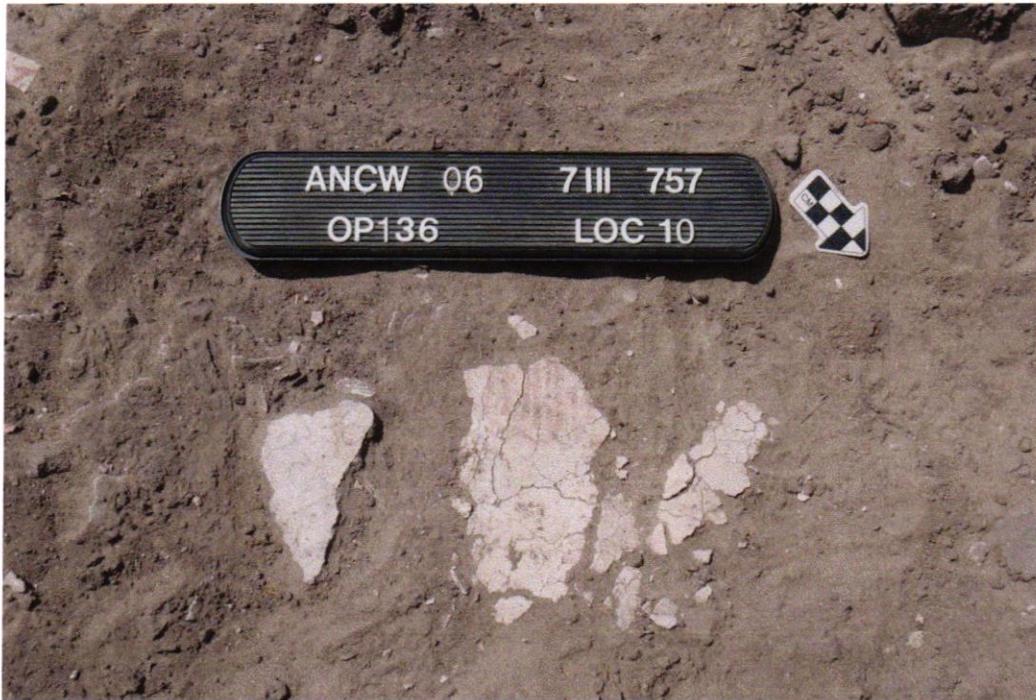
Figure 107 – Some of the fallen plaster had traces of Coptic inscriptions, as does the fragment at left, while others appear to have had abstract or geometric designs.

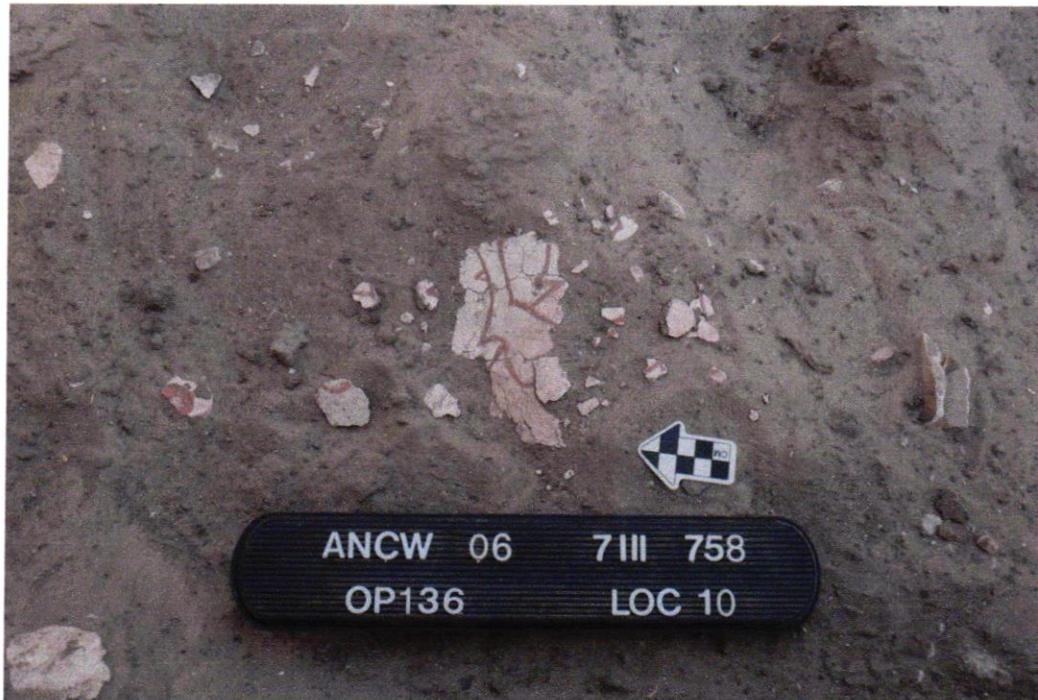
Figure 108 – Other fragments had traces of more distinctive designs, in bolder lines.

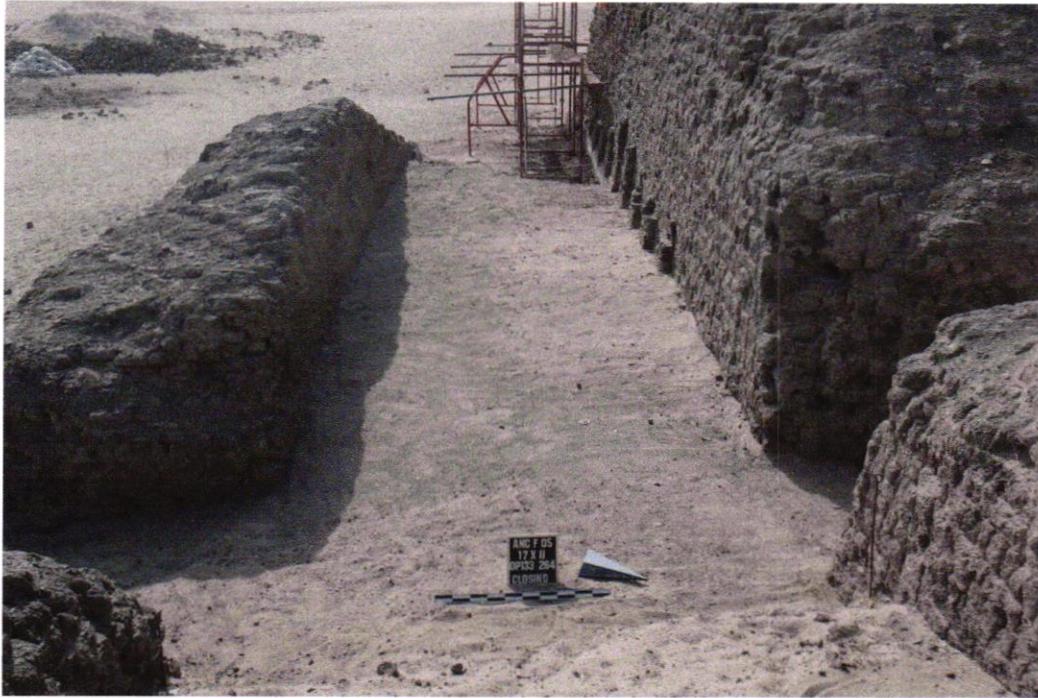
Figure 109 – Operation 133, the southeast perimeter corridor between the southeast gateway and the south corner, prior to excavation.

In addition to the work done inside the Shuneh, excavations were undertaken in the southeast perimeter corridor, preparatory to the future stabilization of the southeast gateway area. Operation 133 was located in the perimeter corridor southwest of the southeast gateway (**Figure 109**). Excavation reached the original Dynasty 2 floor level and found that the mud floor had been cut by a series of parallel holes spanning the entire width of the perimeter corridor (**Figure 110**). The pattern seen here is identical to that in the northwest perimeter corridor (see below), and the parallel holes probably are the sondages of earlier excavations, most likely those of E. R. Ayrton on behalf of the Egypt Exploration Society at the beginning of the 20th Century and published in *Abydos, Part III* (1904).

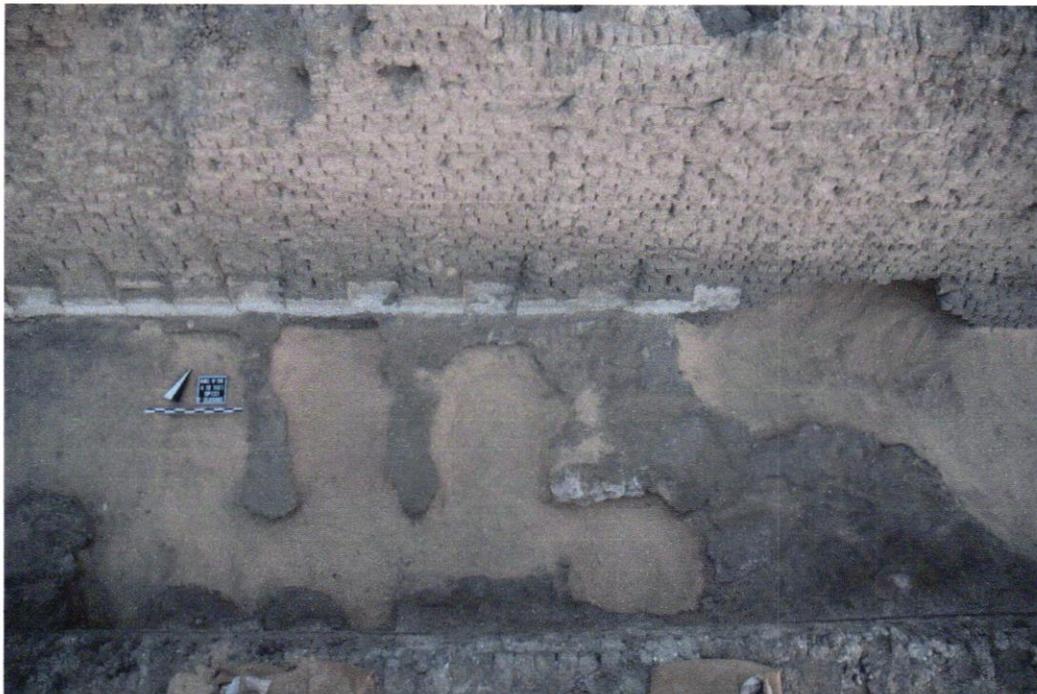
Figure 110 – Operation 133, with the remains of the Dynasty 2 mud floor of the perimeter corridor. Much of the pitting of the floor appears to have been the result of early excavations. The original plastered and whitewashed finish of the main enclosure wall is preserved along the lower part of the wall in this area.

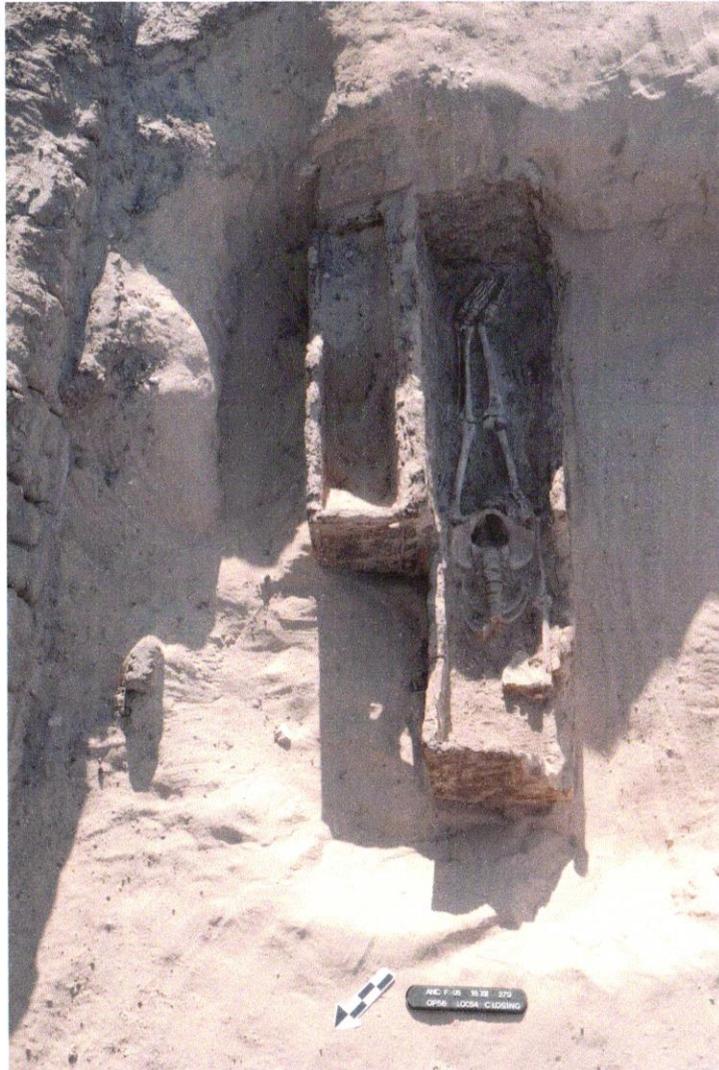
Figure 111 – Two disturbed coffin burials, probably of Middle Kingdom date, in Operation 56 along the exterior of the southwest perimeter wall.

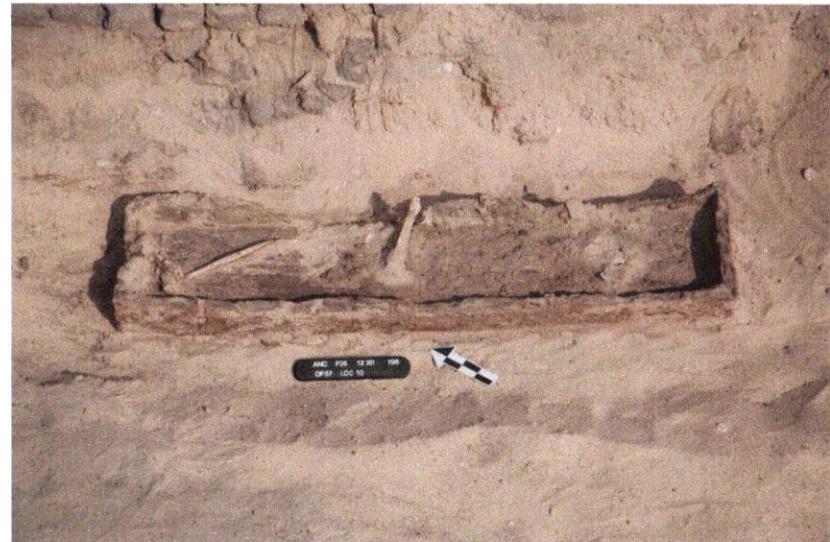
Figure 112 – Another disturbed coffin burial, likely Middle Kingdom, in Operation 57 along the exterior of the southwest perimeter wall.

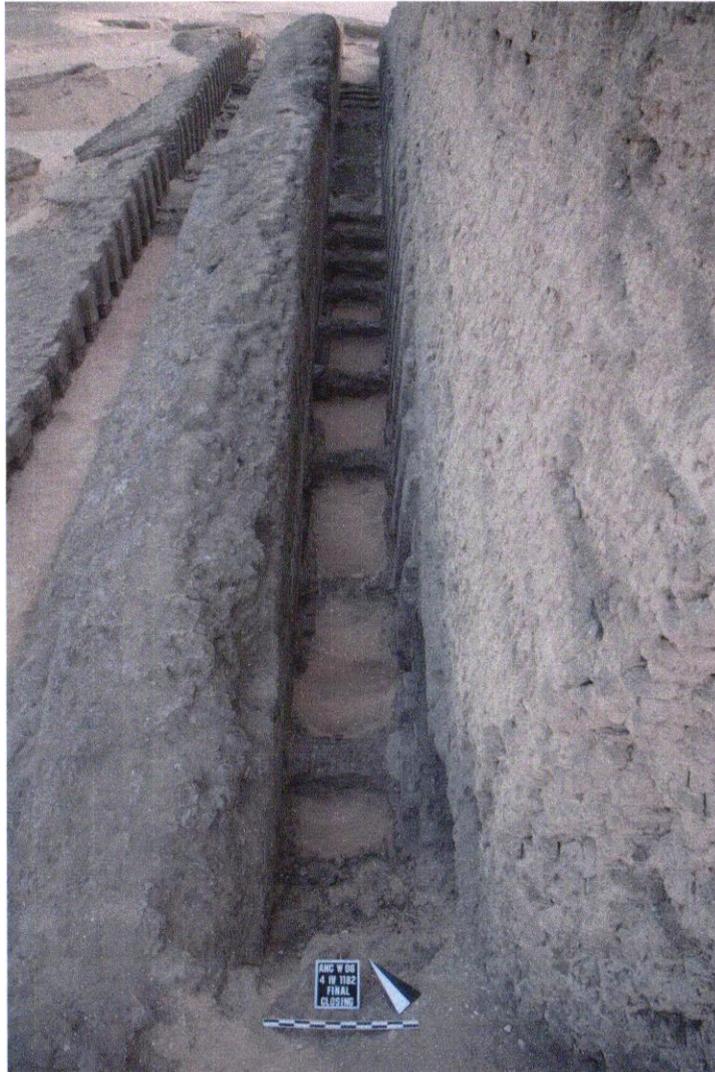
Figure 113 – The northwest perimeter corridor of the Shuneh, after excavation. The regular pitting appears to be the result of early excavations.

2 mud floor of the perimeter corridor had been systematically trenched by earlier excavations, presumably those of Ayrton (**Figure 113**). The façade of the main enclosure wall, as revealed in the perimeter corridor, retained a significant amount of its original finish, although this appears to have suffered significant losses after exposure by the earlier excavations (**Figure 114**).

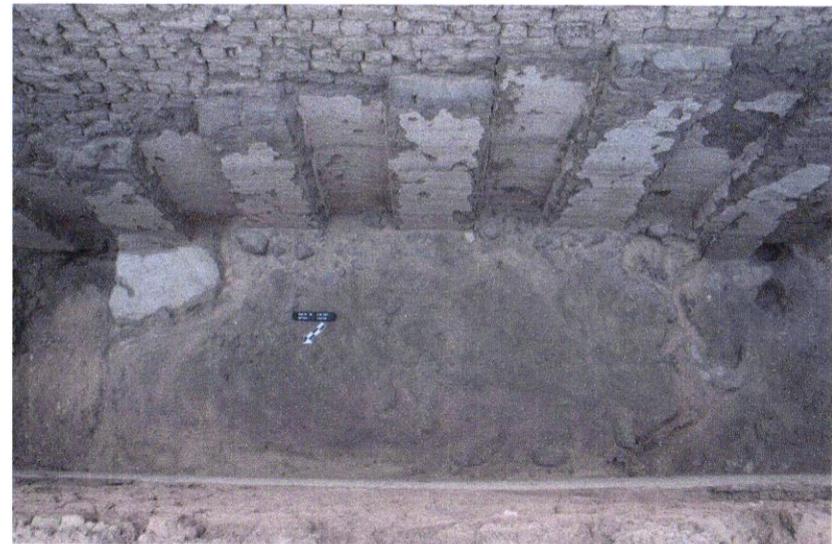
Figure 114 – One section of the Dynasty 2 floor appears to have been left intact, covered by mudbrick erosional debris. The original niched design and plastered and whitewashed finish of the main wall of the enclosure is preserved here.

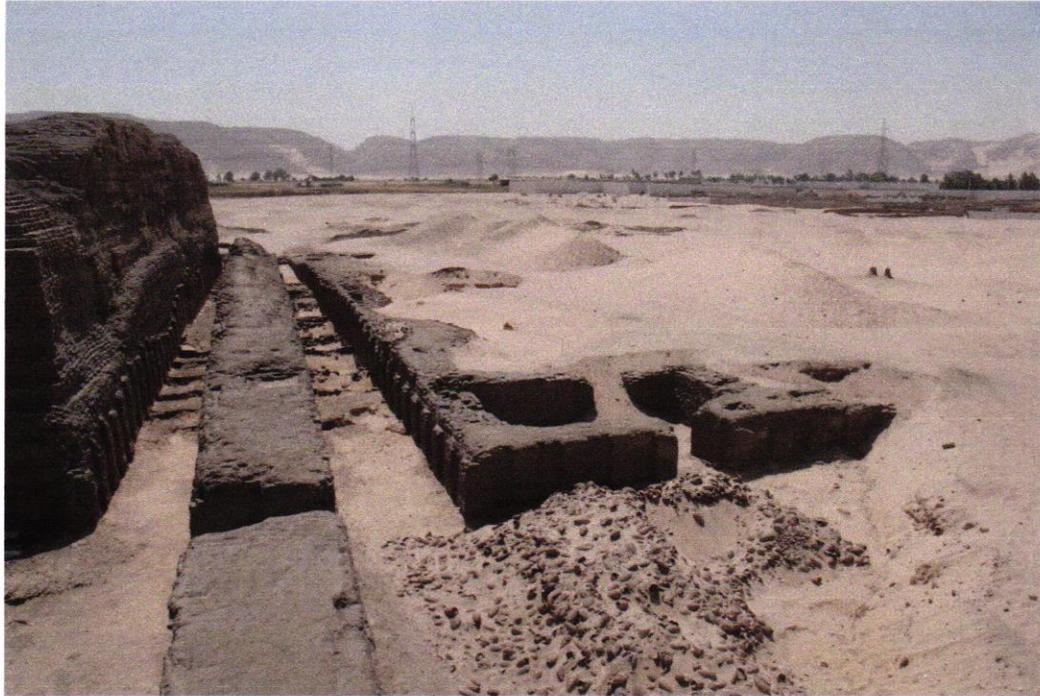
Figure 115 – General view looking southwest of the northwest wall of the main enclosure of the Shuneh, far left, northwest perimeter wall, left, and the southeast wall and east corner gateway of the funerary cult enclosure of king Peribsen, center. The corridor between the Peribsen enclosure and the perimeter wall of the Shuneh has been trenched like the perimeter corridor, probably by Ayrton.

Like the other Abydos enclosures, that of Peribsen had a gateway at the east corner (**Figure 115**) and a small cult chapel in the southeastern part of the interior. The gateway and the area immediately adjacent to the gateway on the east were investigated in Field Season 6 (2004-2005) in Operation 124. In Field Season 7, work continued in this unit, including study of the architecture of the gateway itself and the stratigraphic relationships between the large deposit of offering pottery, the walls of the Peribsen enclosure, and the walls of the Shuneh.

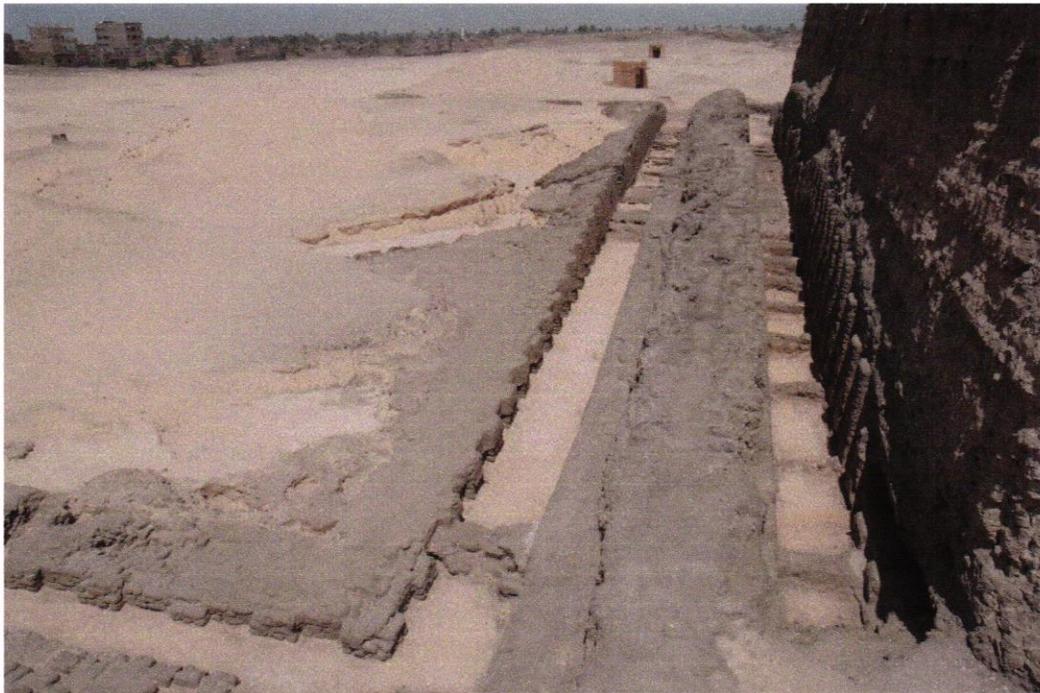
Figure 116 – General view looking northeast, with the northwest wall of the main enclosure of the Shuneh at the far right, the northwest perimeter wall middle right, and the southeast wall and south corner of the enclosure of Peribsen, middle and left.

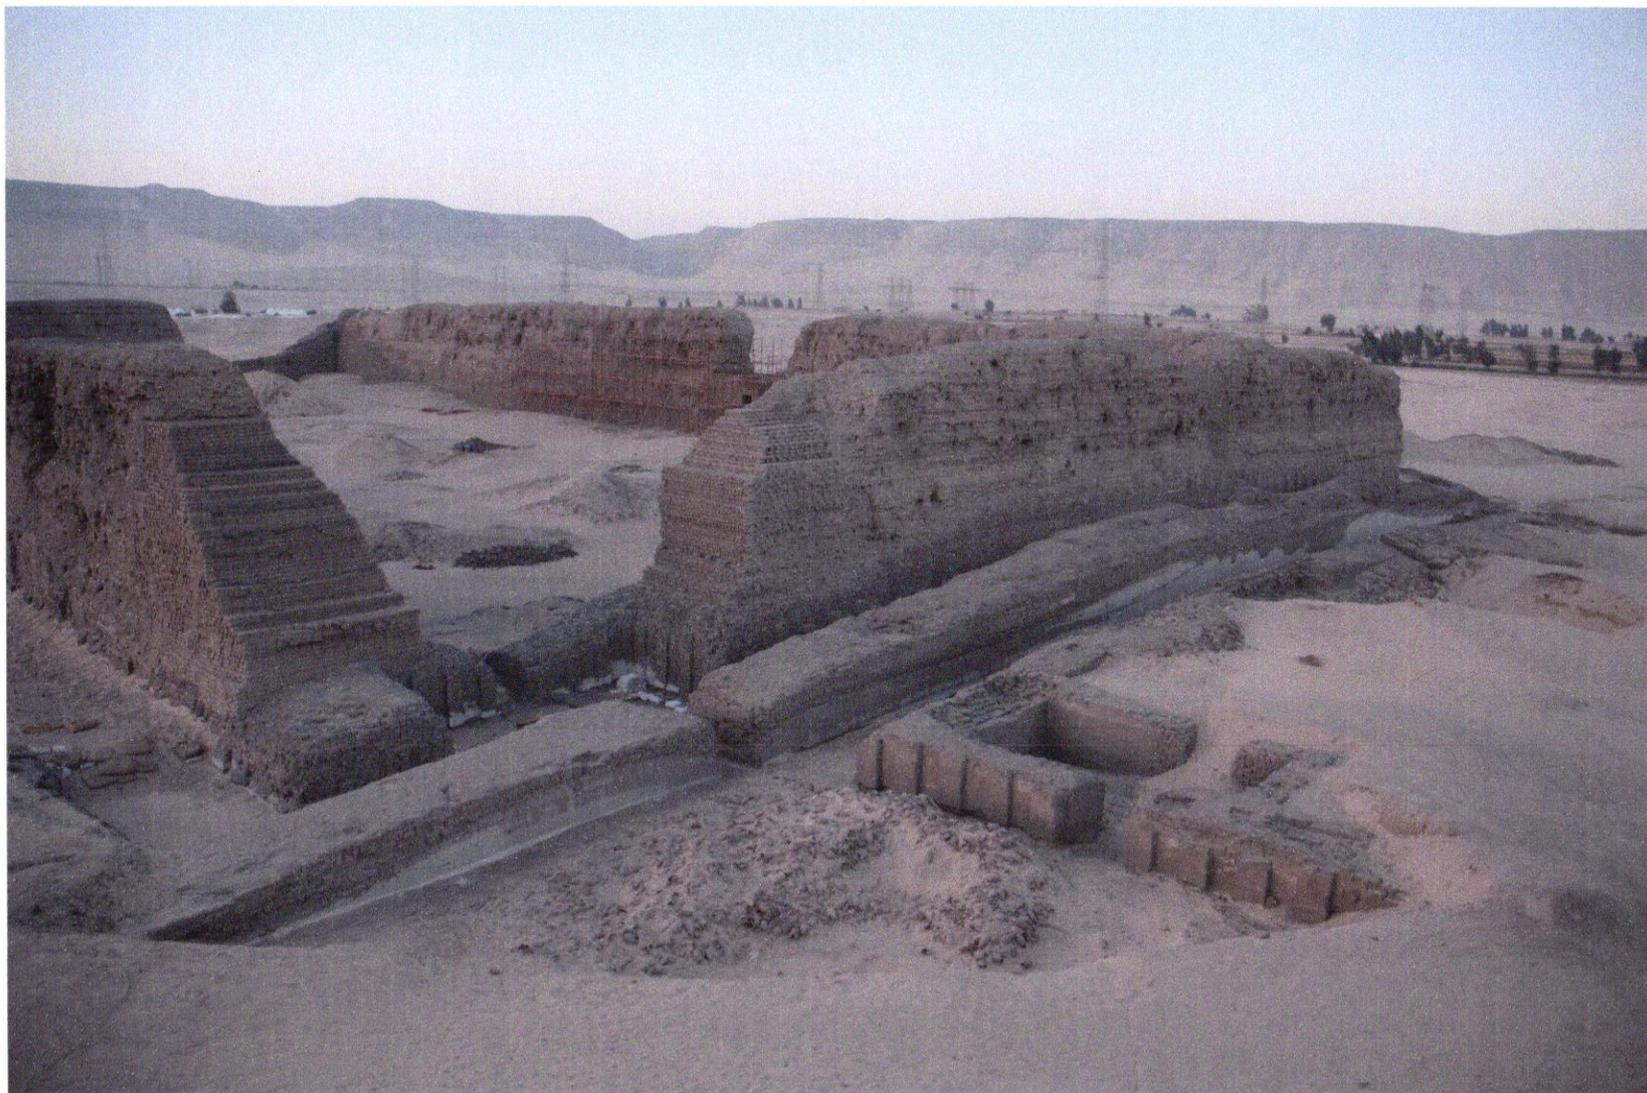
Figure 117 – General view of the northwest side of the Shunet el-Zebib and the southeast end of the enclosure of king Peribsen. Despite that the perimeter wall has been much more heavily eroded than the main wall, much remains of its original plastered and whitewashed finish.
