"Conservation of the Shunet el-Zebib, Abydos"

# **Technical Report on the 2010 Fieldwork Undertaken by the EAC-Supported Sub-project “Conservation of King Khasekhemwy’s Funerary Monument at Abydos”**

## **Introduction**

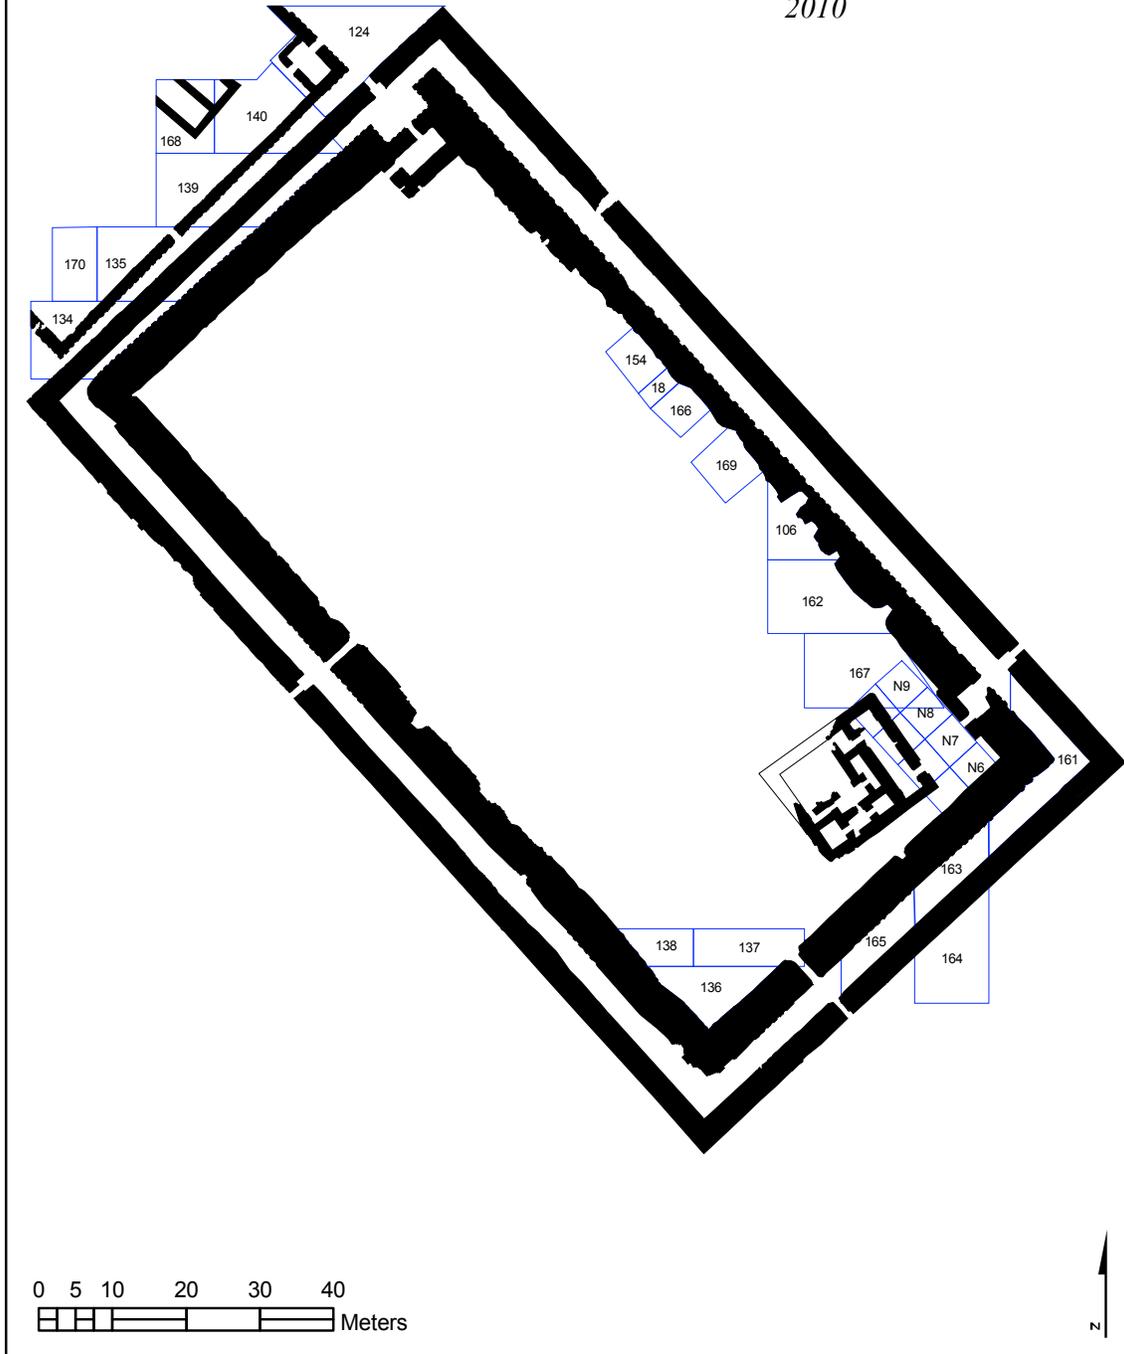
Figure 2 – Partly reconstructed plan of the enclosure of king Khasekhemwy (Shunet el-Zebib) and the southern part of the enclosure of king Peribsen, showing the excavation units of the 2010 field season.

Large-scale stabilization work was undertaken in five areas in 2010 (Figure 2):

Excavation in 2010 was undertaken in six areas (Figure 2):

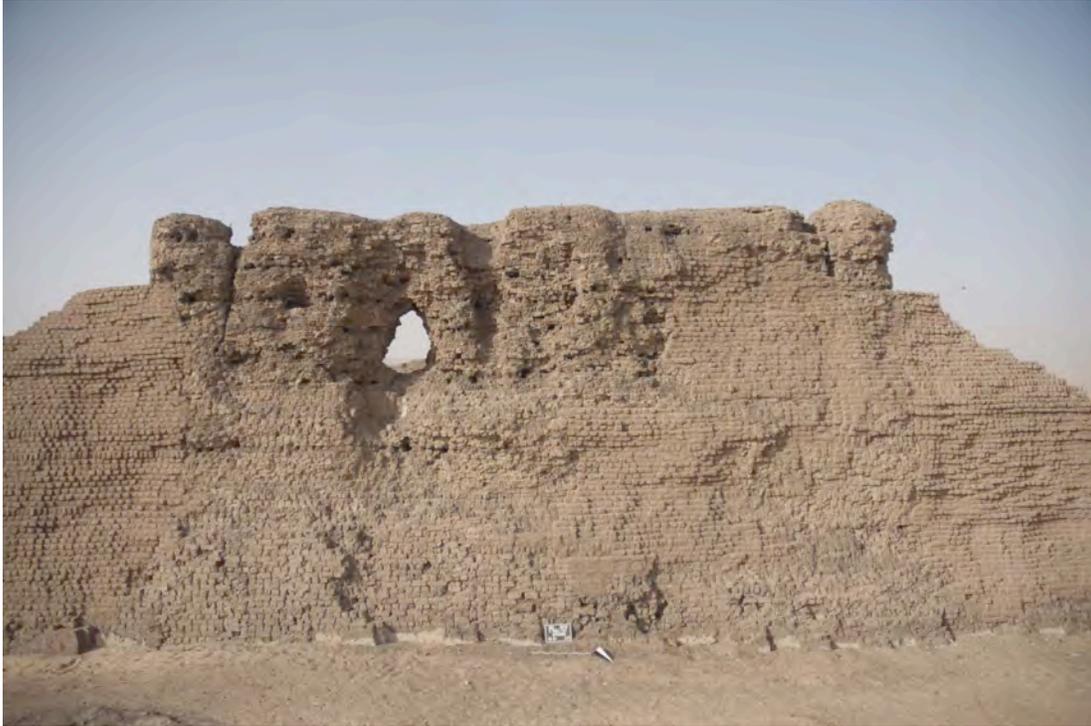
Figure 3 – General view of the tall northwest part of the northeast wall of the main enclosure, prior to stabilization work in 2010. Photo by Greg Maka for the Institute of Fine Arts, New York University, 2010.

(i) Stabilization work on the tall standing section of the northeast wall of the main enclosure near the north gateway focused on the upper part of the wall on both the interior and exterior sides. The lower part of the interior side had been stabilized in the Expedition's 2009 field season. A large hole that penetrated completely through the wall was filled, as were a number of smaller holes. Two large cracks, one at each end of the tall wall section, were repaired. The wall prior to the 2010 work is illustrated in Figure 3, and at the close of the 2010 season in Figure 4.

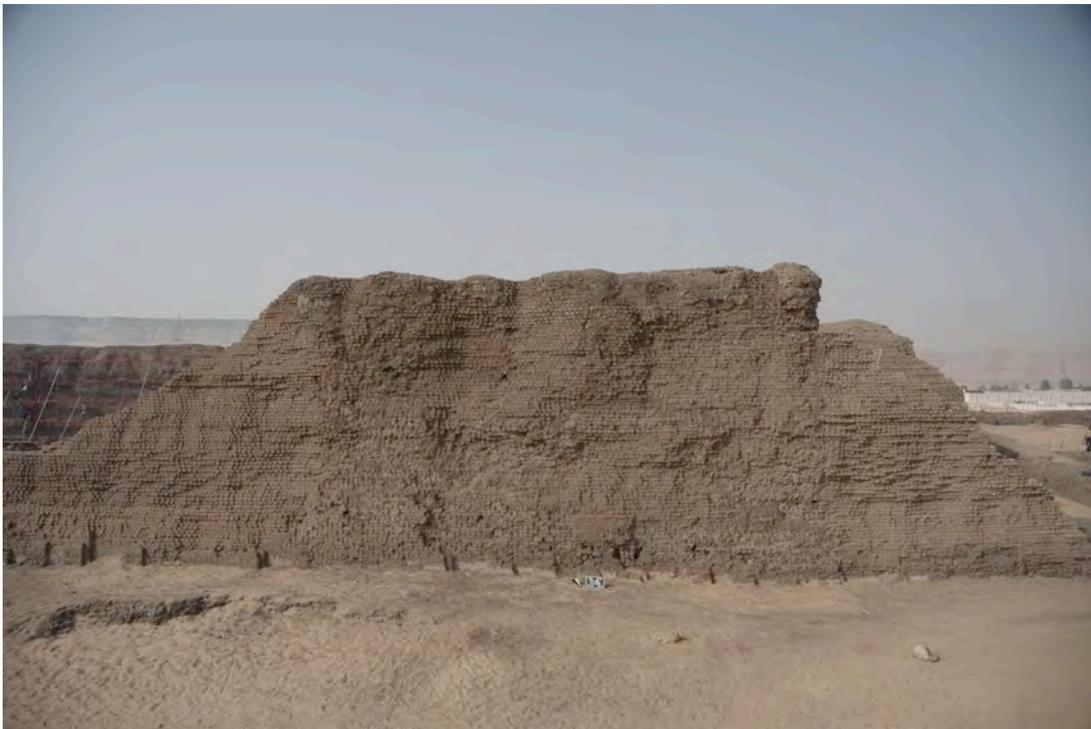
Figure 4 – The same section of the northeast wall illustrated in Figure 3, after stabilization in 2010. Photo by Greg Maka for the Institute of Fine Arts, New York University, 2010.

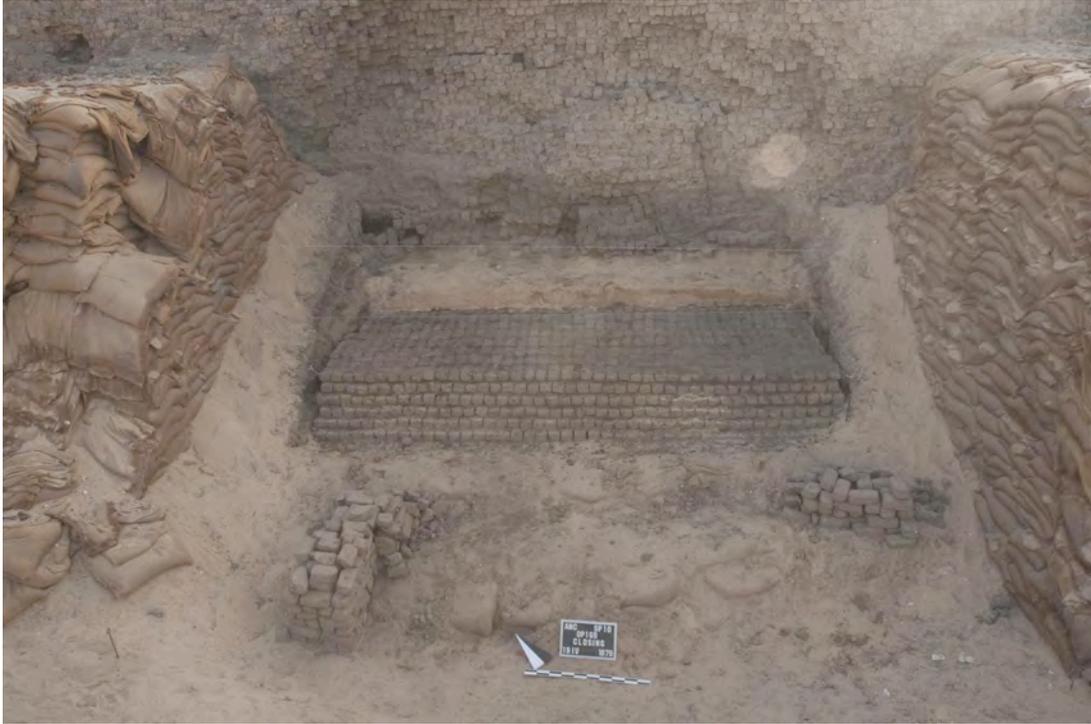
Figure 5 – Below-grade foundation under construction in Operation 169 on the interior side of the northeast wall of the main enclosure of the Shuneh. Photo by Greg Maka for the Institute of Fine Arts, New York University, 2010.

In each area the methodology was the same. After the completion of archaeological excavation adjacent to a section of wall, which removed the disturbed deposits in a 19<sup>th</sup> Century trench and defined the sterile compacted sand, or "gebel," deposit on which the wall was built, the first step in the stabilization process was to cut back the sand to close to the existing interior side of the wall. The deposits in the bottom of the excavation unit were then compacted, and a mudbrick foundation platform constructed (Figure 5). This foundation, which is entirely below the level of the base of the original wall and will not be left exposed when the stabilization of the wall is completed, extends some meters beyond the line of the original wall face. The southwest side of the foundation, i.e., that facing the interior of the monument, was stepped back with each course of masonry, while the northeast side was built directly against, so as to support and stabilize, the cut into the

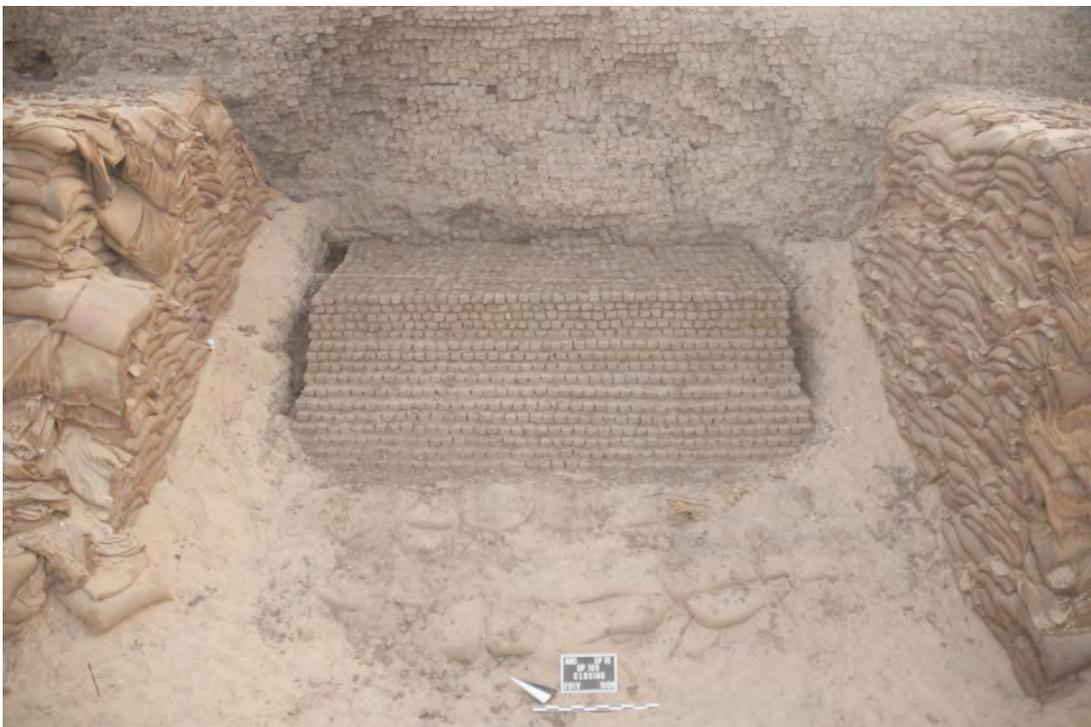
Figure 6 – The foundation was built to the level of the base of the original wall. Photo by Greg Maka for the Institute of Fine Arts, New York University, 2010.

“gebel” deposit under the wall. The top of the foundation platform was established at the level of the base of the original masonry of the wall (Figures 6, 7). With the sand deposits under the wall stabilized by the foundation, any animal burrows under or in the wall were cleaned and filled with new masonry. The first course of masonry built on the foundation platform followed the line of the original face of the wall, which could be established based on preserved areas near the north and southeast gateways. This line created a distinct boundary between the below-grade foundation and the masonry that will remain exposed and visible above it in the completed intervention (Figure 8). Masonry courses above were gradually stepped back as the new masonry was built up to meet and support the existing original wall fabric (Figures 9, 10).

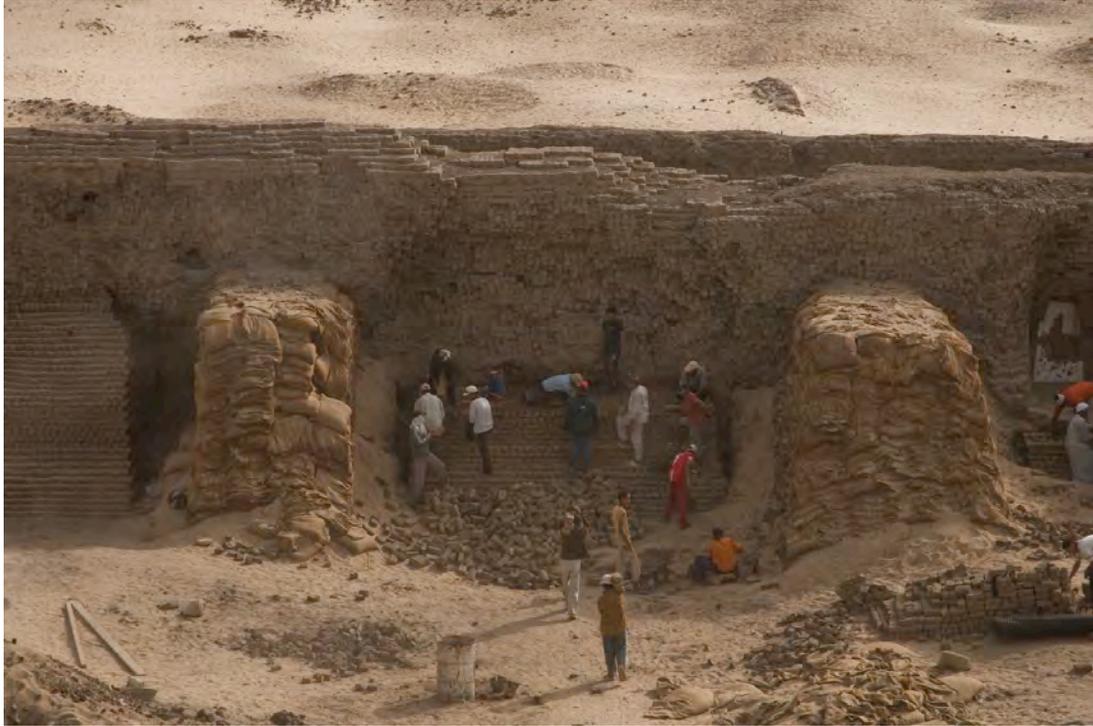
Figure 7 – Stabilization work in progress in Operation 169. Photo by Greg Maka for the Institute of Fine Arts, New York University, 2010.

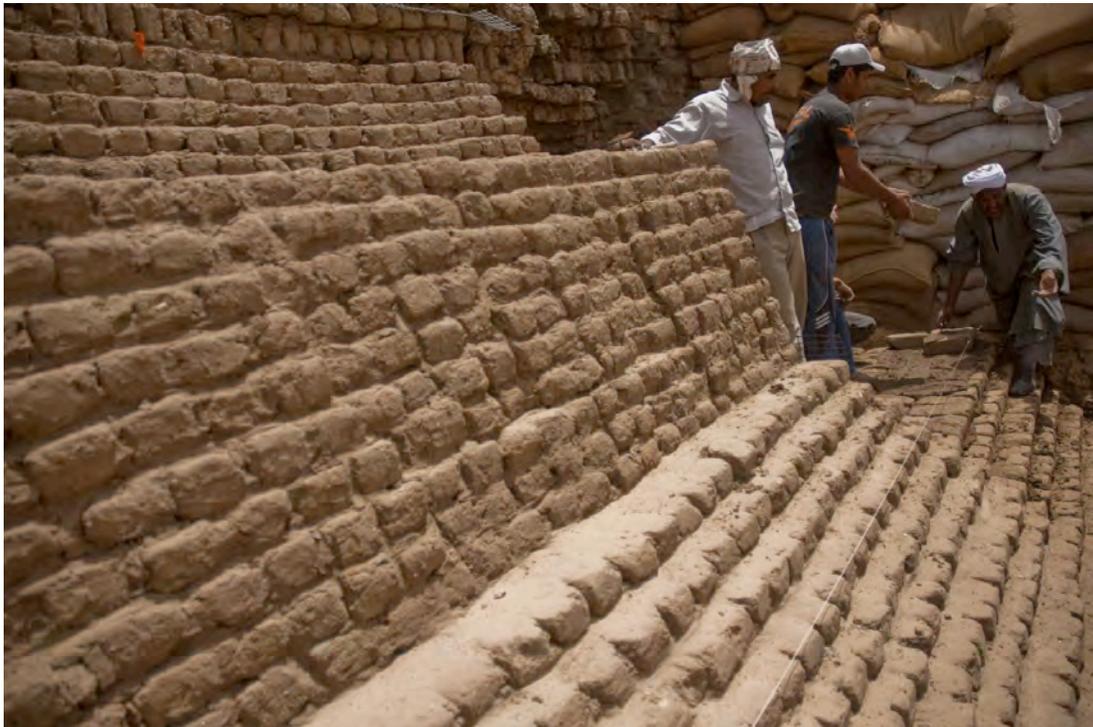
Figure 8 – The transition between the below-grade foundation, at lower right, and the finished face of the replaced section of wall above is marked by a distinct change in angle. Photo by Greg Maka for the Institute of Fine Arts, New York University 2010.

The new masonry above the foundation essentially replaces original wall fabric lost through a series of cascading collapses since the 19<sup>th</sup> Century, whereas the foundation, while required for the stabilization of the wall, represents an element not present in the original architecture of the monument. Finished surfaces of new masonry that will be visible are textured to reflect the existing eroded character of the original masonry of the walls, as in most interventions at the Shuneh. At present only the lowest courses above the foundation are in a finished state. The upper parts of the replaced wall sections were constructed so as to provide structural support to the adjacent original masonry, but they were not brought to what will be their finished state. Sections of geotextile have been left exposed temporarily, such that when additional new masonry is added in a future season, as part of the finalization of the treatment of the wall, it can be easily bonded to the earlier work. The full length of the new construction along the interior side of the northeast wall will ultimately be finished in a uniform and integrated fashion.

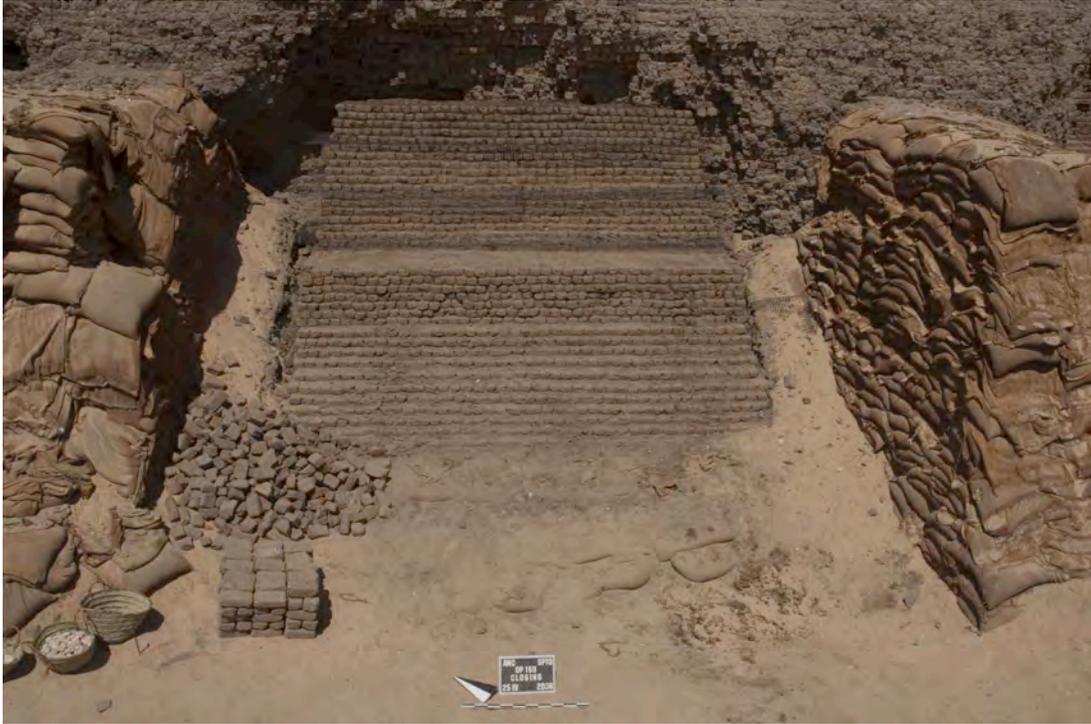
Figure 9 – Stabilization work in progress in Operation 169. Photo by Greg Maka for the Institute of Fine Arts, New York University, 2010.

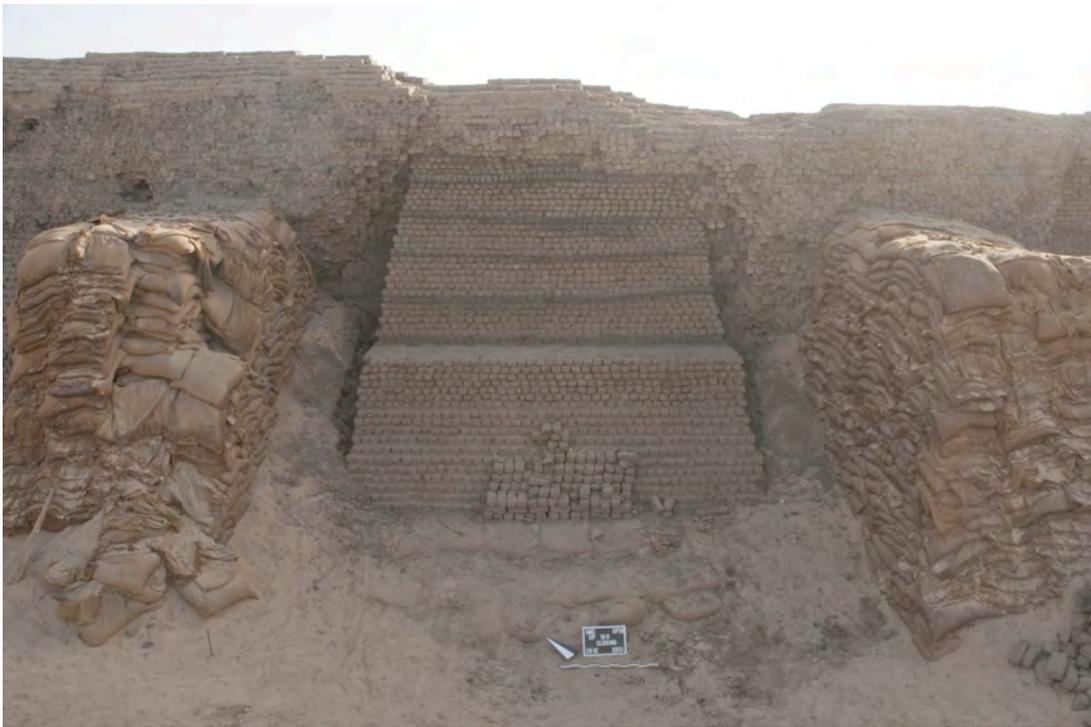
Figure 10 – Operation 169 at the close of work in 2010. Additional work will take place here in future seasons. Photo by Greg Maka for the Institute of Fine Arts, New York University, 2010.

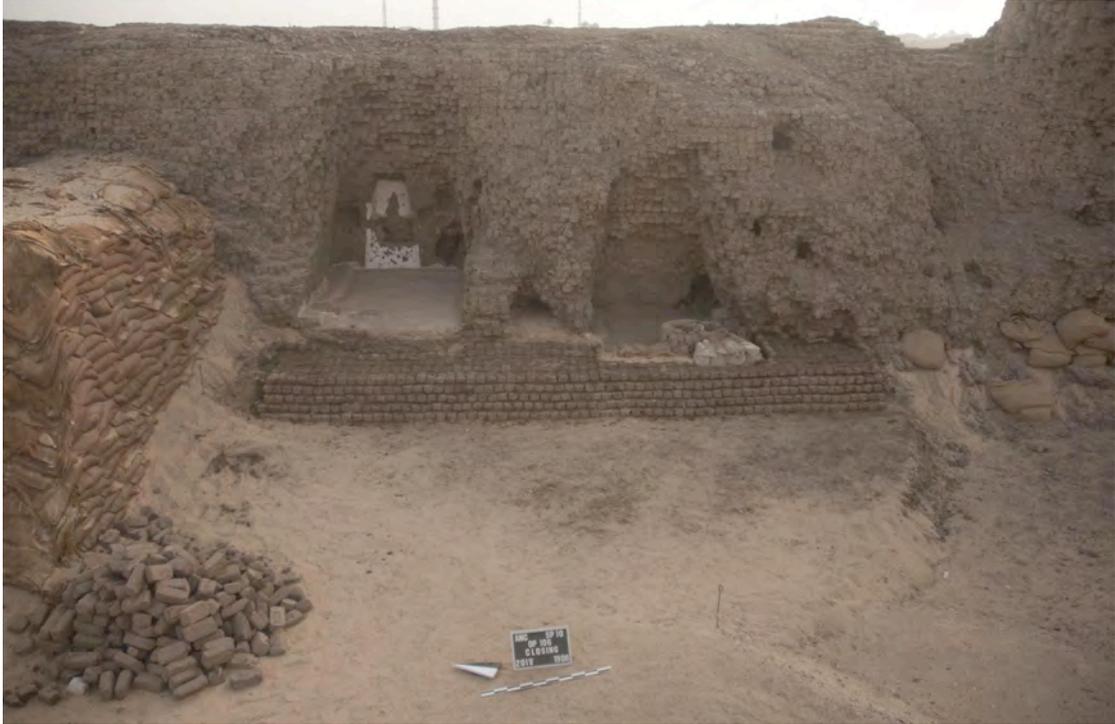
Figure 11 – Stabilization work in Operation 106 began with the construction of a small foundation adjacent to and below the masonry of the original wall. Photo by Greg Maka for the Institute of Fine Arts, New York University, 2010.

(iii) After the detailed documentation of the late antique rooms and associated features in Operation 106, which had been excavated in 2009, architectural stabilization of the area began. As with “Coptic” rooms in other parts of the Shuneh, the voids represented by these rooms and the collapse of original masonry around them create serious structural weaknesses that would, without intervention, ultimately result in the collapse of large sections of wall. The solution adopted is to fill the voids with new masonry. Work in Operation 106 began with a small foundation platform that was constructed below the level of the base of the original wall in front of the rooms (Figure 11). Thereupon, the rooms themselves were filled with new mudbrick masonry. All original plasters on the floors and walls were protected with a separation layer of fine sand (Figures 12, 13). The voids were filled in the 2010 season (Figure 14), but work in this area will continue in a future season and will be incorporated into the comprehensive stabilization of the interior side of the wall.

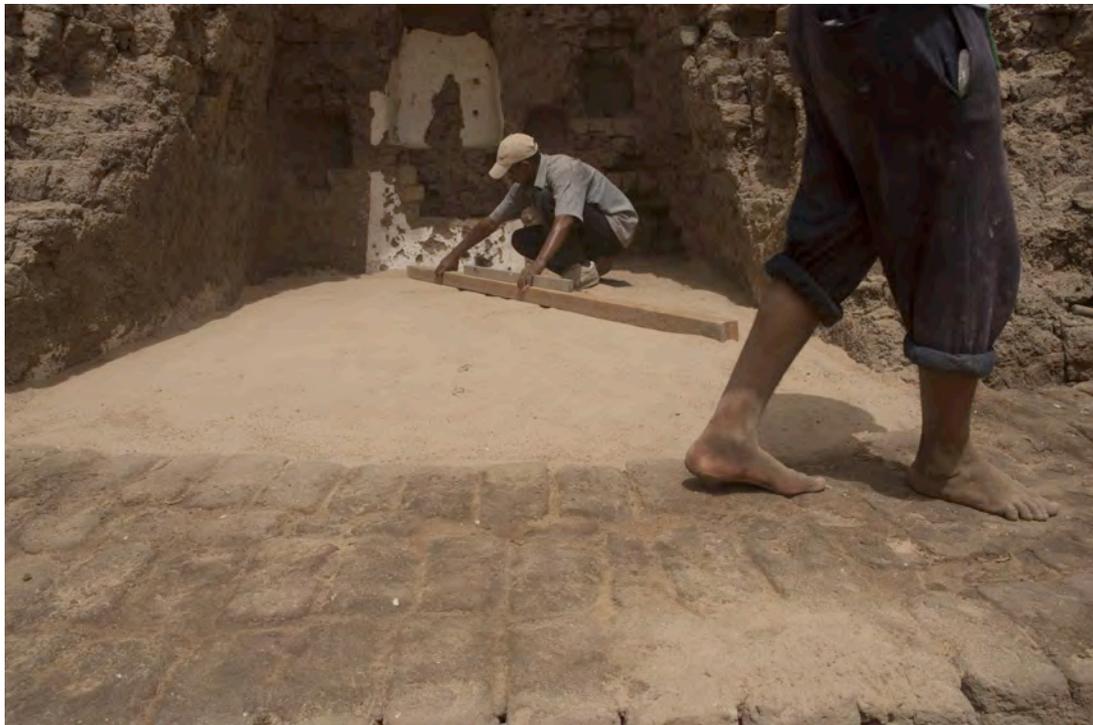
Figure 12 – The floors and preserved plasters of the late antique rooms are protected by a separation layer of clean sand. Photo by Greg Maka for the Institute of Fine Arts, New York University, 2010.

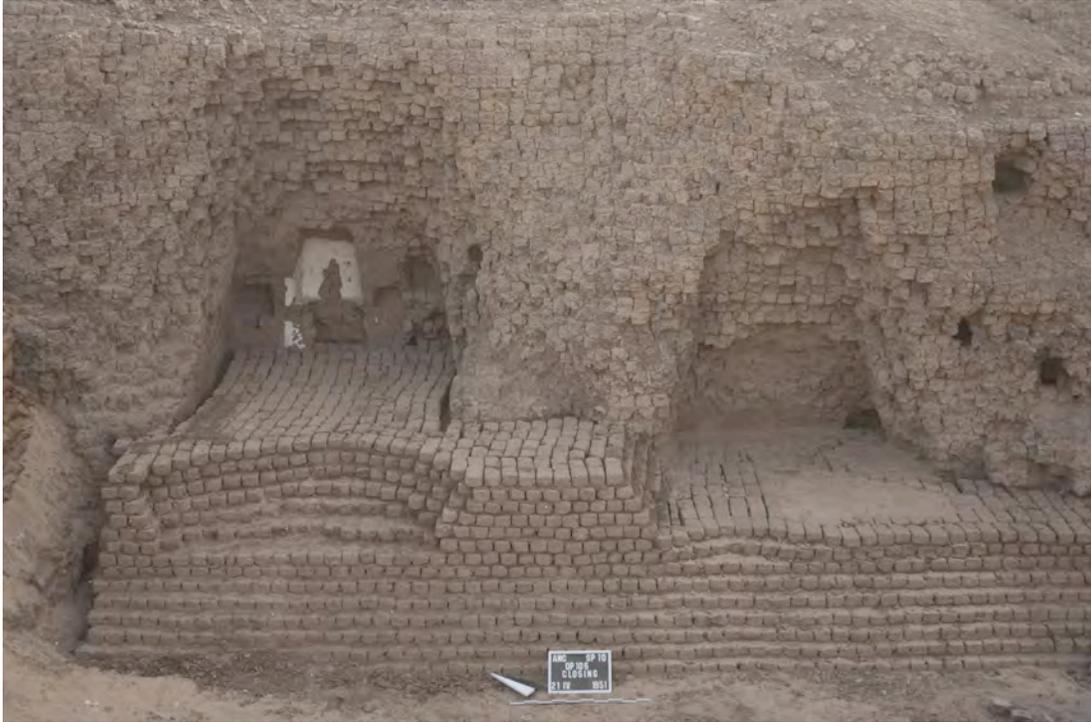
Figure 13 – As the room voids were filled, spaces were left along the walls for the separation layer of sand. Photo by Greg Maka for the Institute of Fine Arts, New York University, 2010.

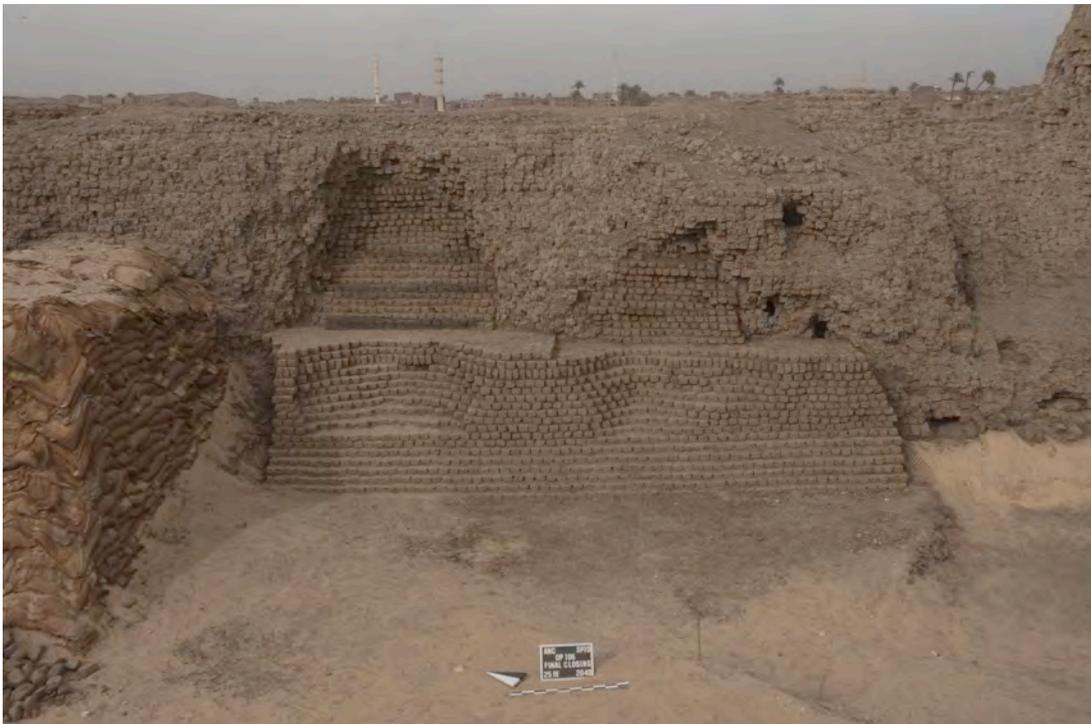
Figure 14 – Operation 106 at the close of work in 2010. The stabilization of this area will be completed in the Expedition's next season. Photo by Greg Maka for the Institute of Fine Arts, New York University, 2010.

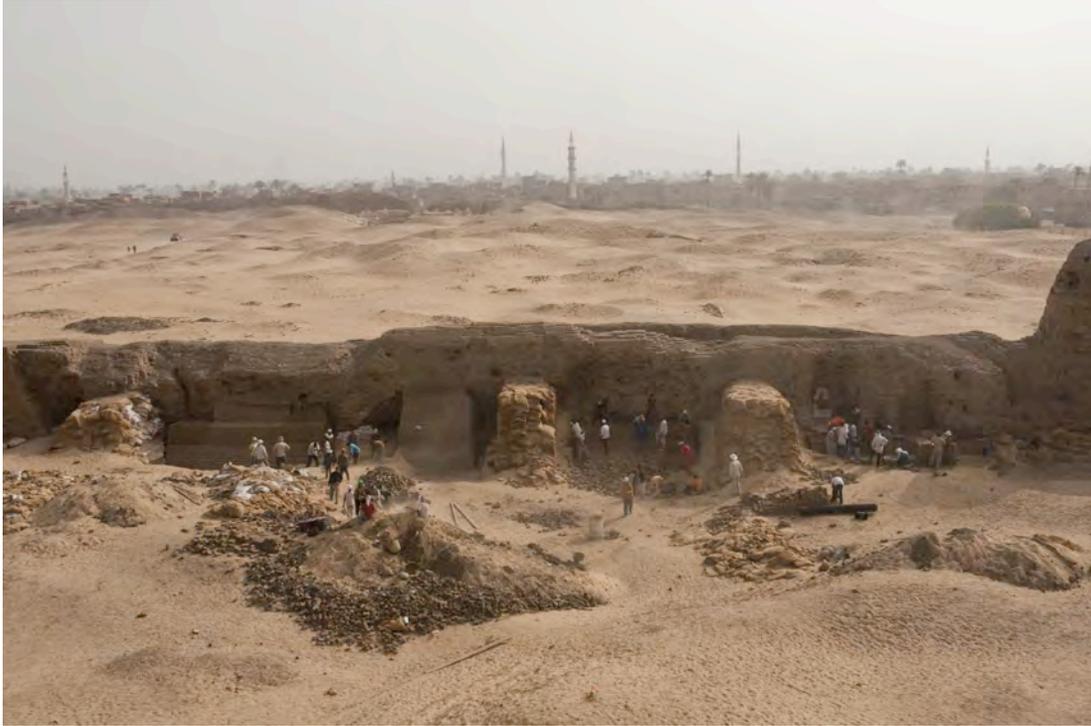
Figure 15 – The stabilization work in progress on the interior side of the northeast wall of the main enclosure in, from left to right, Operations 154, 18, 166, 169, and 106. Photo by Greg Maka for the Institute of Fine Arts, New York University, 2010.

All the areas along the interior side of the northeast wall of the main enclosure in which stabilization work was undertaken in 2010 (Figures 15, 16) will ultimately be incorporated

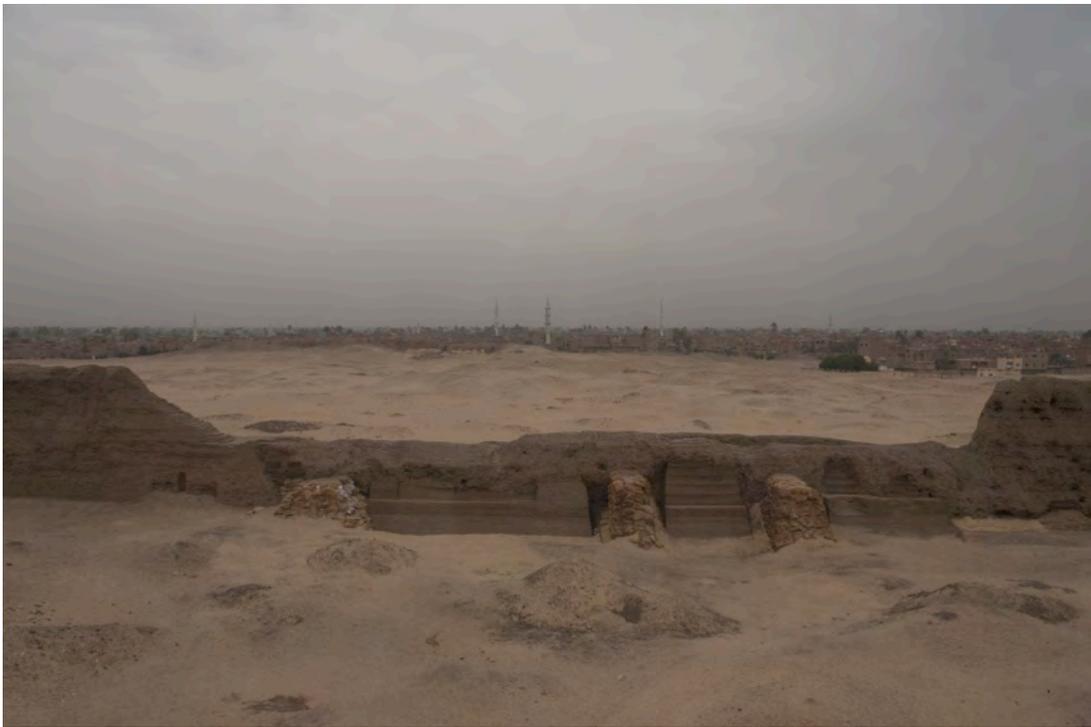
Figure 16 – The interior side of the northeast wall of the main enclosure of the Shuneh at the close of the 2010 season. Photo by Greg Maka for the Institute of Fine Arts, New York University, 2010.

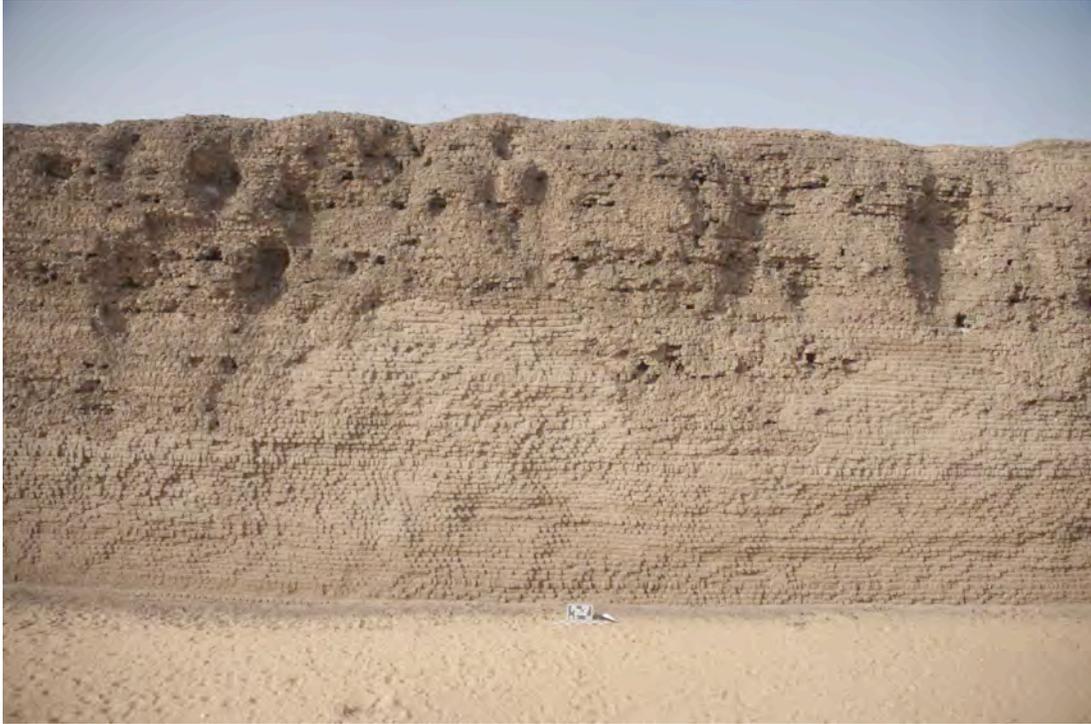
Figure 17 – A section of the interior side of the southwest wall of the main enclosure of the Shuneh, prior to the start of work on the upper part of the wall in 2010. Photo by Greg Maka for the Institute of Fine Arts, New York University, 2010.

(iv) Stabilization work continued on the interior side of the southwest wall of the main enclosure, primarily focused on the upper part of the wall. A large number of small and medium sized holes were identified, documented, cleaned, and filled with new masonry. Many of these holes were, in origin, nest holes for the species of burrowing hornets, *Vespa orientalis*, that has been previously identified as one of the most destructive forces affecting the Shuneh. Part of the wall before and after the 2010 work is illustrated in Figures 17 and 18.

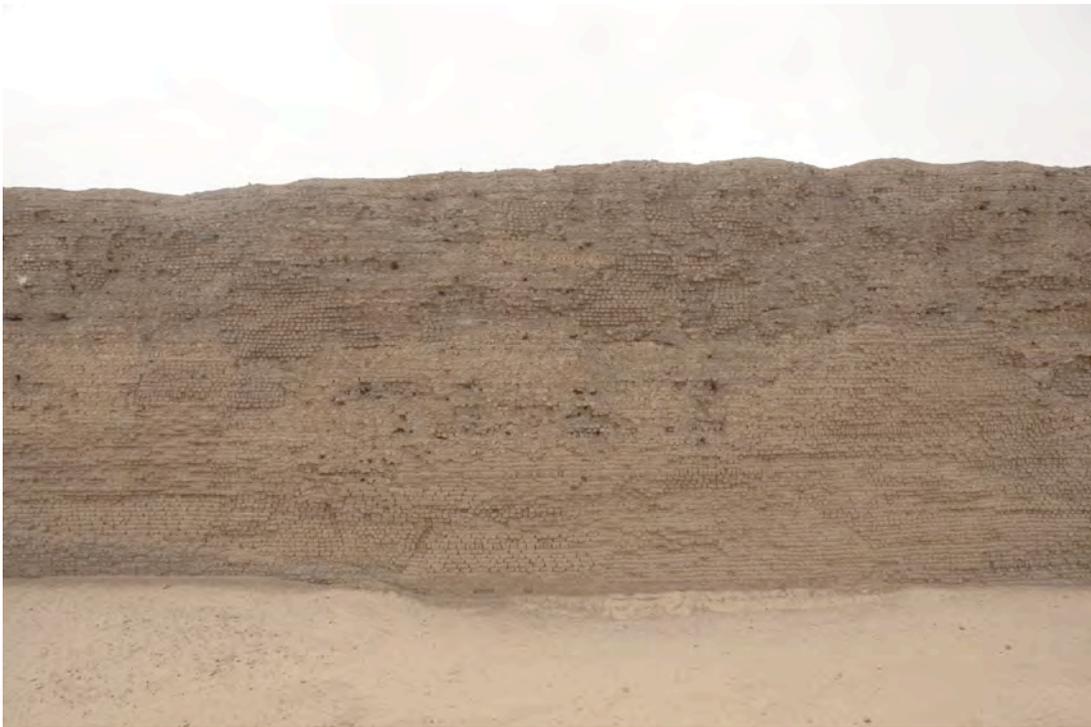
Figure 18 – The same section of the interior side of the southwest wall of the main enclosure, after stabilization work. Photo by Greg Maka for the Institute of Fine Arts, New York University, 2010.

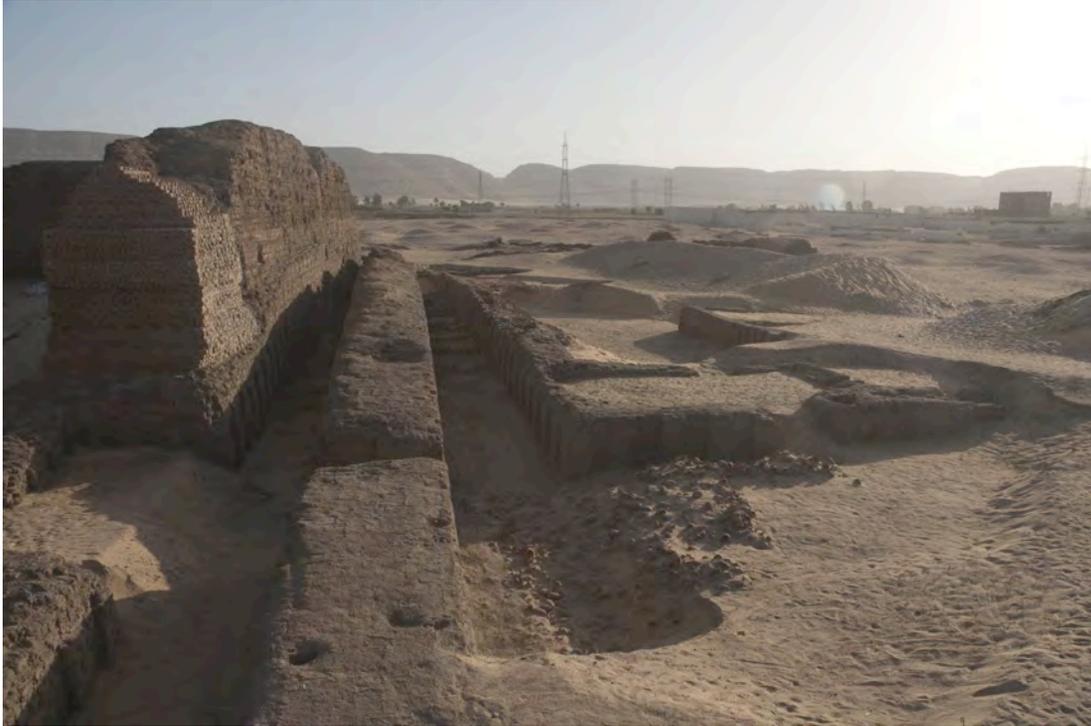
Figure 19 – The northwestern end of the Shunet el-Zebib, showing the northwest perimeter wall between the main enclosure wall, at left, and the enclosure of king Peribsen at right. Photo by Greg Maka for the Institute of Fine Arts, New York University, 2010.

(i) Both sides of the northwest perimeter wall were previously excavated during the project’s 2005-2006 field season. The area was re-exposed during the 2010 season (Figure 19) to allow further investigation and documentation of the architecture of the wall, in preparation for planned architectural conservation, and further investigation of the stratigraphic relationships between the perimeter and main enclosure walls of the Shuneh and the southeast wall of the nearby enclosure of Peribsen. Excavation units in this area were Operations 124, 134, 135, 139, 140, 168, and 170 (Figure 2).

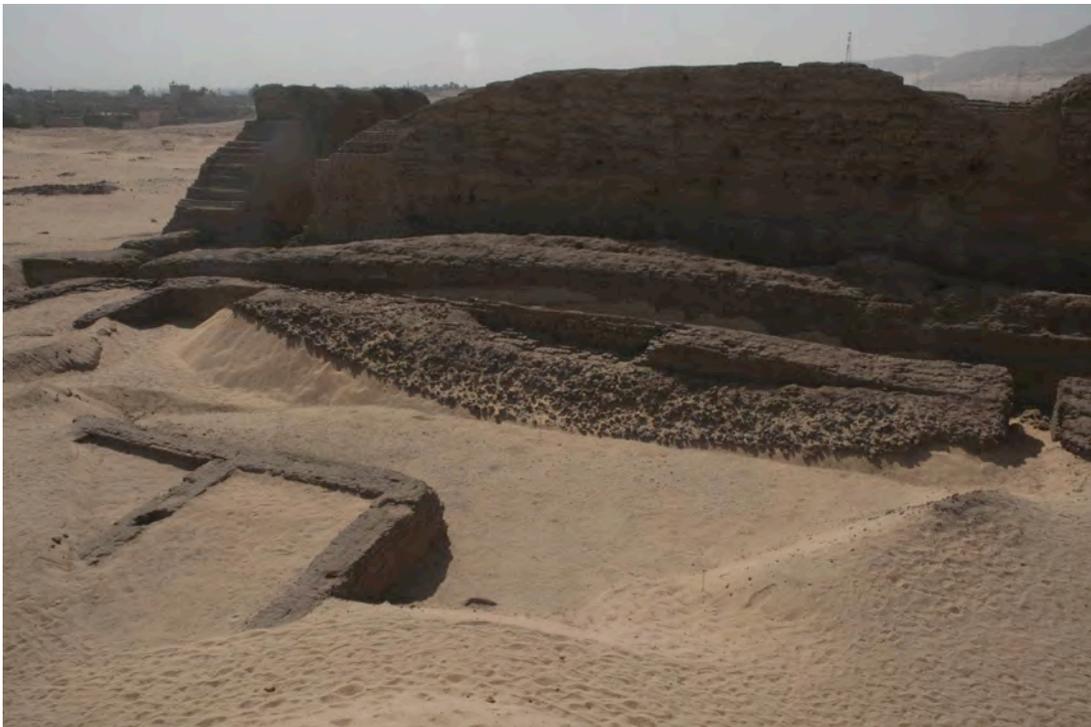
Figure 20 – General view of the interior of the southern part of the enclosure of king Peribsen, showing the brick demolition debris. Photo by Greg Maka for the Institute of Fine Arts, New York University, 2010.

In conjunction with the excavation of the north perimeter wall of the Khasekhemwy enclosure, the southeastern wall and part of the interior of the enclosure of king Peribsen of Dynasty 2 were also excavated during the 2010 season. This area had been partly excavated previously in the 2005-2006 field season. Like all the known earlier royal enclosures at Abydos, that of Peribsen was demolished anciently. Brick debris from the demolition was exposed by excavation along the interior side of the southeast wall of the enclosure (Figure 20). A portion of the demolition debris at the eastern end of the southeastern wall was removed and the stratigraphic relationships examined between the wall, the demolition debris, and sand on which the demolition debris was deposited. Ceramics found in the demolition debris and the sand under it indicate that the date of the demolition episode is roughly contemporary with the enclosure itself, i.e., Dynasty 2, and it is likely that it occurred only a relatively short time after the end of the reign of the king.

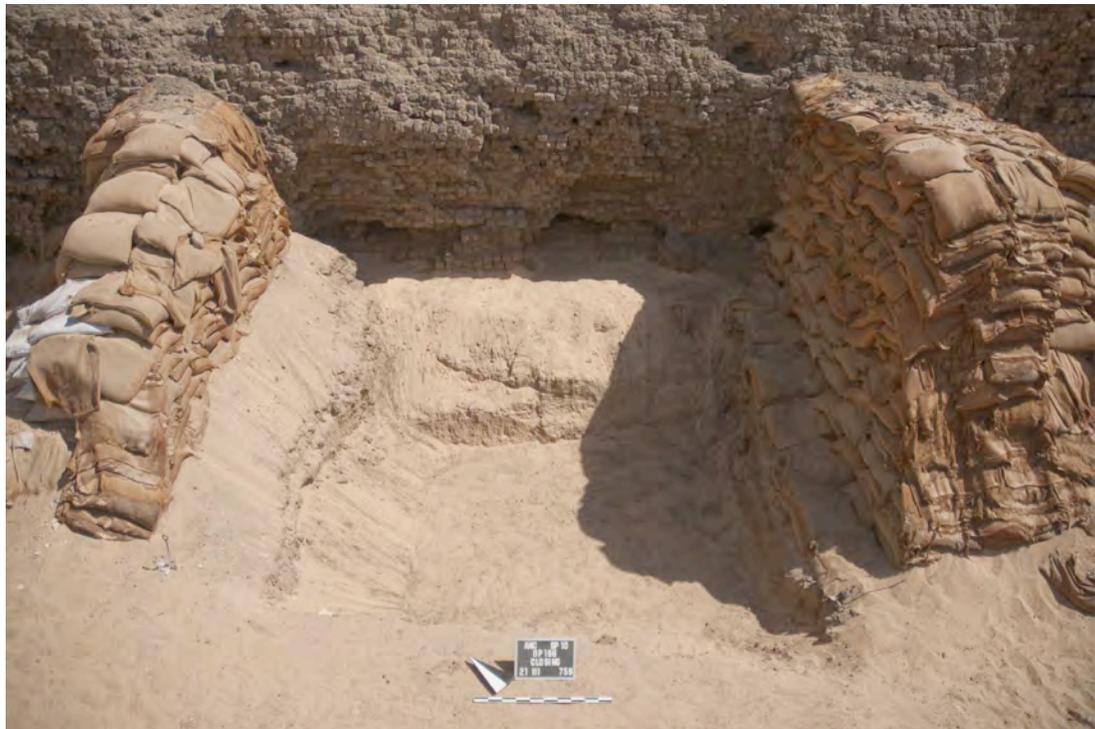
Figure 22 – Operation 166, after excavation of the brick debris from Mariette’s sondage. The yellow sand is the “gebel,” or natural substrate, on which the walls of the Shuneh were constructed. Photo by Greg Maka for the Institute of Fine Arts, New York University, 2010.

The basic archaeological situation in all these units was the same. The area along the interior side of the northeast wall of the main enclosure was highly disturbed, primarily as a result of the excavation of a huge sondage by Auguste Mariette in his capacity as head of the *Service des Antiquites de l'Égypte* in the middle of the 19<sup>th</sup> Century. This sondage appears to have been made in search of an underground tomb that Mariette assumed would be located inside the Shuneh, but of which he found no trace.<sup>1</sup> The sondage completely destroyed the original floor of the enclosure along the northeast wall and penetrated to a level several meters below that of the base of the wall. The sondage appears to have been left open by Mariette's workers, with the result that the sand under the base of the northeast wall collapsed into the sondage, undermining the wall, which in turn caused the collapse of large sections of original masonry, and exposing the wall base to additional damage from burrowing foxes. The general archaeological situation is illustrated by work in Operations 166 and 169 (Figures 21-24). In both instances

excavation defined the existing limits of the natural deposits, the “gebel,” on which the walls of the Shuneh were built, which mark the slumped edge of Mariette’s sondage. With the losses of sand from under the wall and the subsequent cascading series of localized collapses, as much as two meters has been lost of the original five meters thickness of the wall. In Operation 106 Mariette’s sondage almost certainly destroyed additional features that were constructed in front of, i.e., southwest of, the “Coptic” rooms. Excavation in Operations 162 and 167 demonstrated that the southeastern limit of the sondage appears to have been in Operation 167 (Figures 25, 26). The northwestern end of the sondage, near the north corner gateway, was defined in 2009.

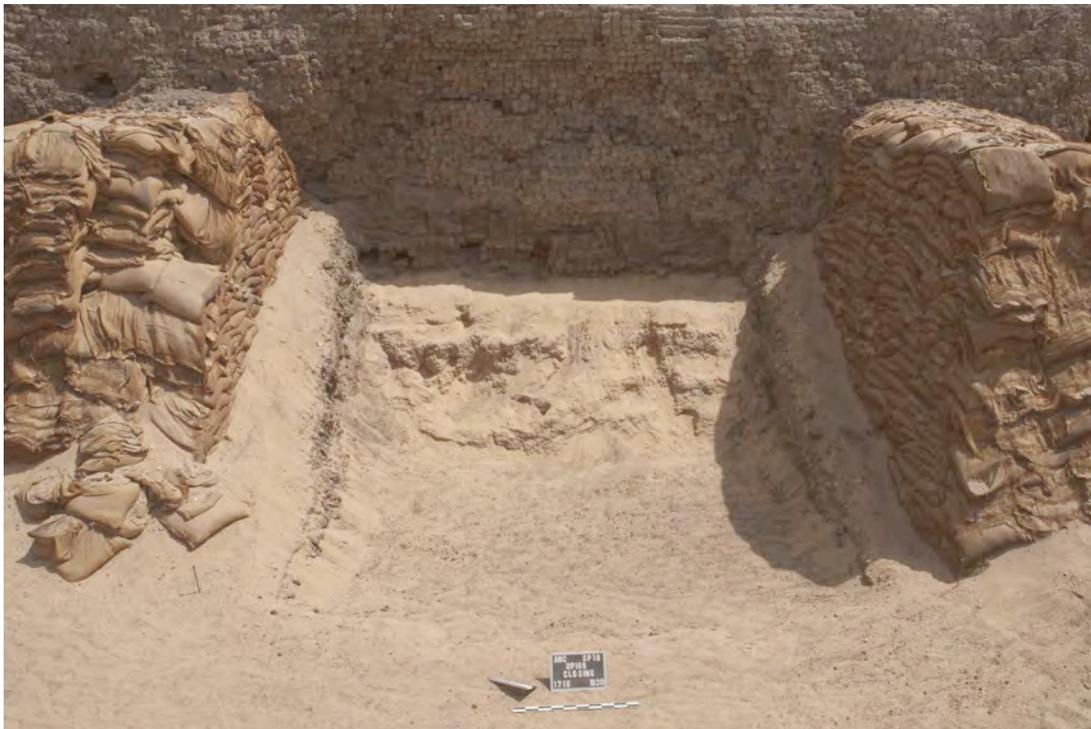
Figure 24 – Operation 169, after excavation of the brick debris from Mariette's sondage. The yellow sand is the "gebel," or natural substrate, on which the walls of the Shuneh were constructed. Photo by Greg Maka for the Institute of Fine Arts, New York University, 2010.

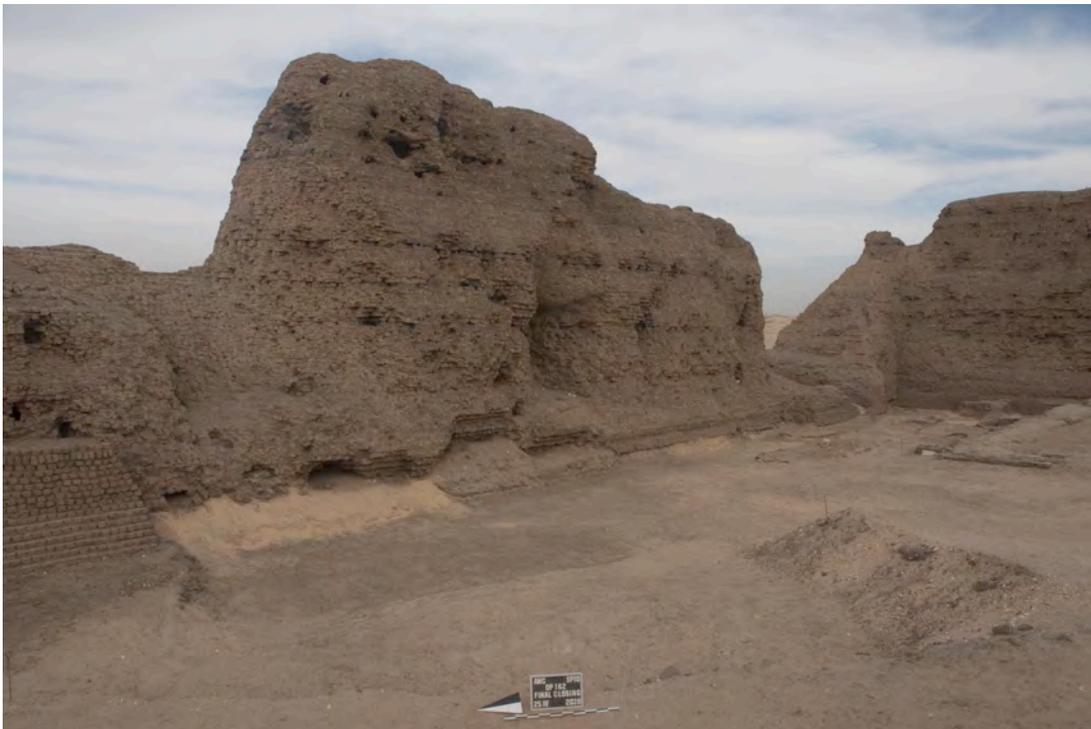
Figure 26 – Operation 162, after excavation. The boundary between lighter deposits in the foreground and darker deposits nearer the wall represents the edge of Mariette's sondage. Photo by Greg Maka for the Institute of Fine Arts, New York University, 2010.
