"Conservation of the Shunet el-Zebib, Abydos"

# **Technical Report on the 2010 Fieldwork Undertaken by the EAC-Supported Sub-project “Conservation of King Khasekhemwy’s Funerary Monument at Abydos”**

## **Introduction**

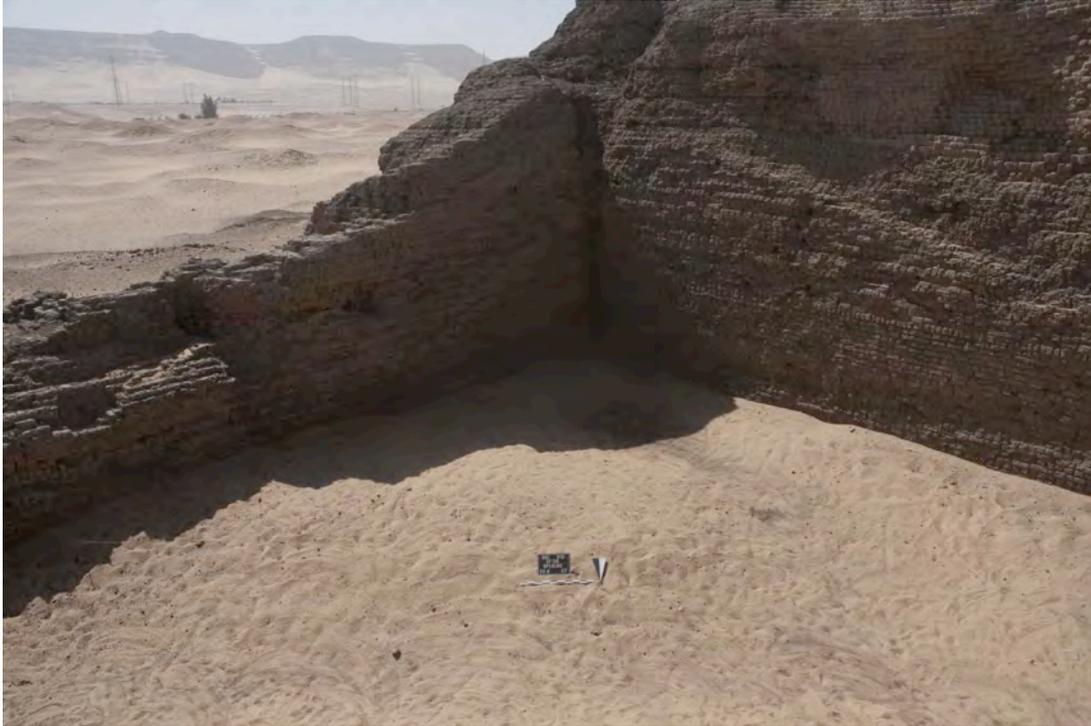
Figure 27 – The interior south corner of the main enclosure of the Shunet el-Zebib, prior to excavation in 2010. Photo by Greg Maka for the Institute of Fine Arts, New York University, 2010.

(iii) Excavation continued in 2010 in the interior south corner of the main enclosure of the Shuneh, in excavation units Operations 136, 137, and 138 (Figure 27). Excavation was begun in this area in 2005-2006 and continued in 2009. Prior to 2005 the south corner was completely filled with a large sand dune, which was found to contain substantial deposits of animal mummies, usually inside ceramic vessels. During the 2010 season deposits of vessels filled with the remains of mummified ibises were found (Figure 28). The vessels date to the Third Intermediate Period or slightly later.

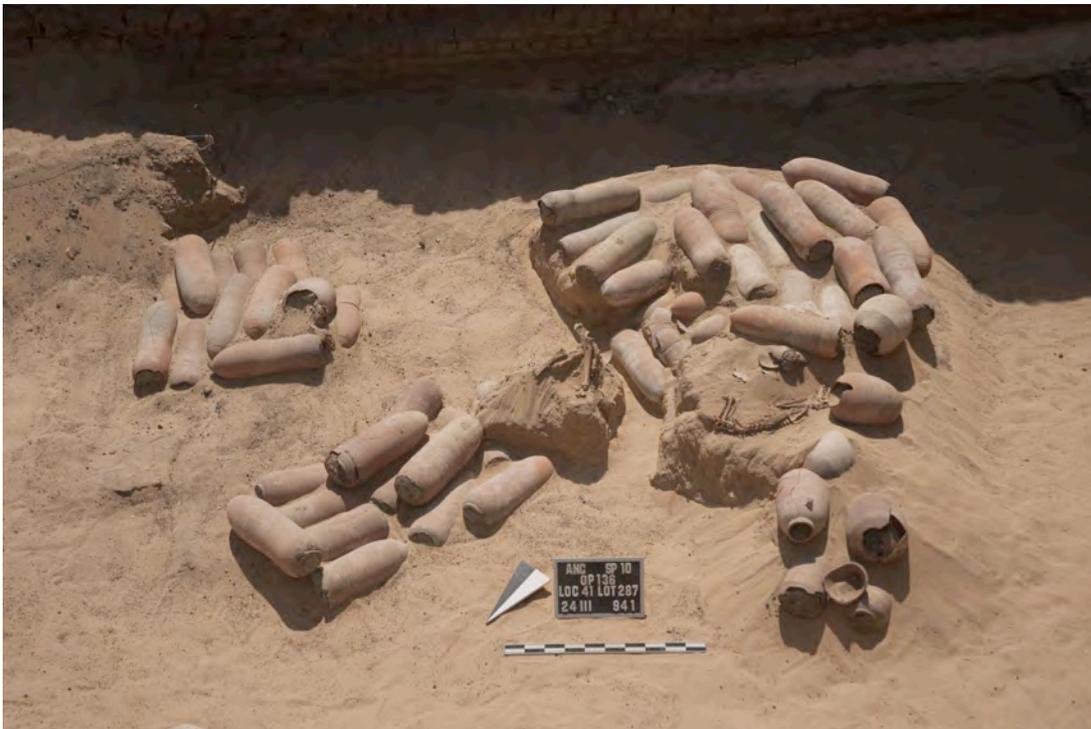
Figure 28 – A large deposit of ceramic vessels in Operation 136. Most of the vessels contain the remains of mummified ibises. Photo by Greg Maka for the Institute of Fine Arts, New York University, 2010.

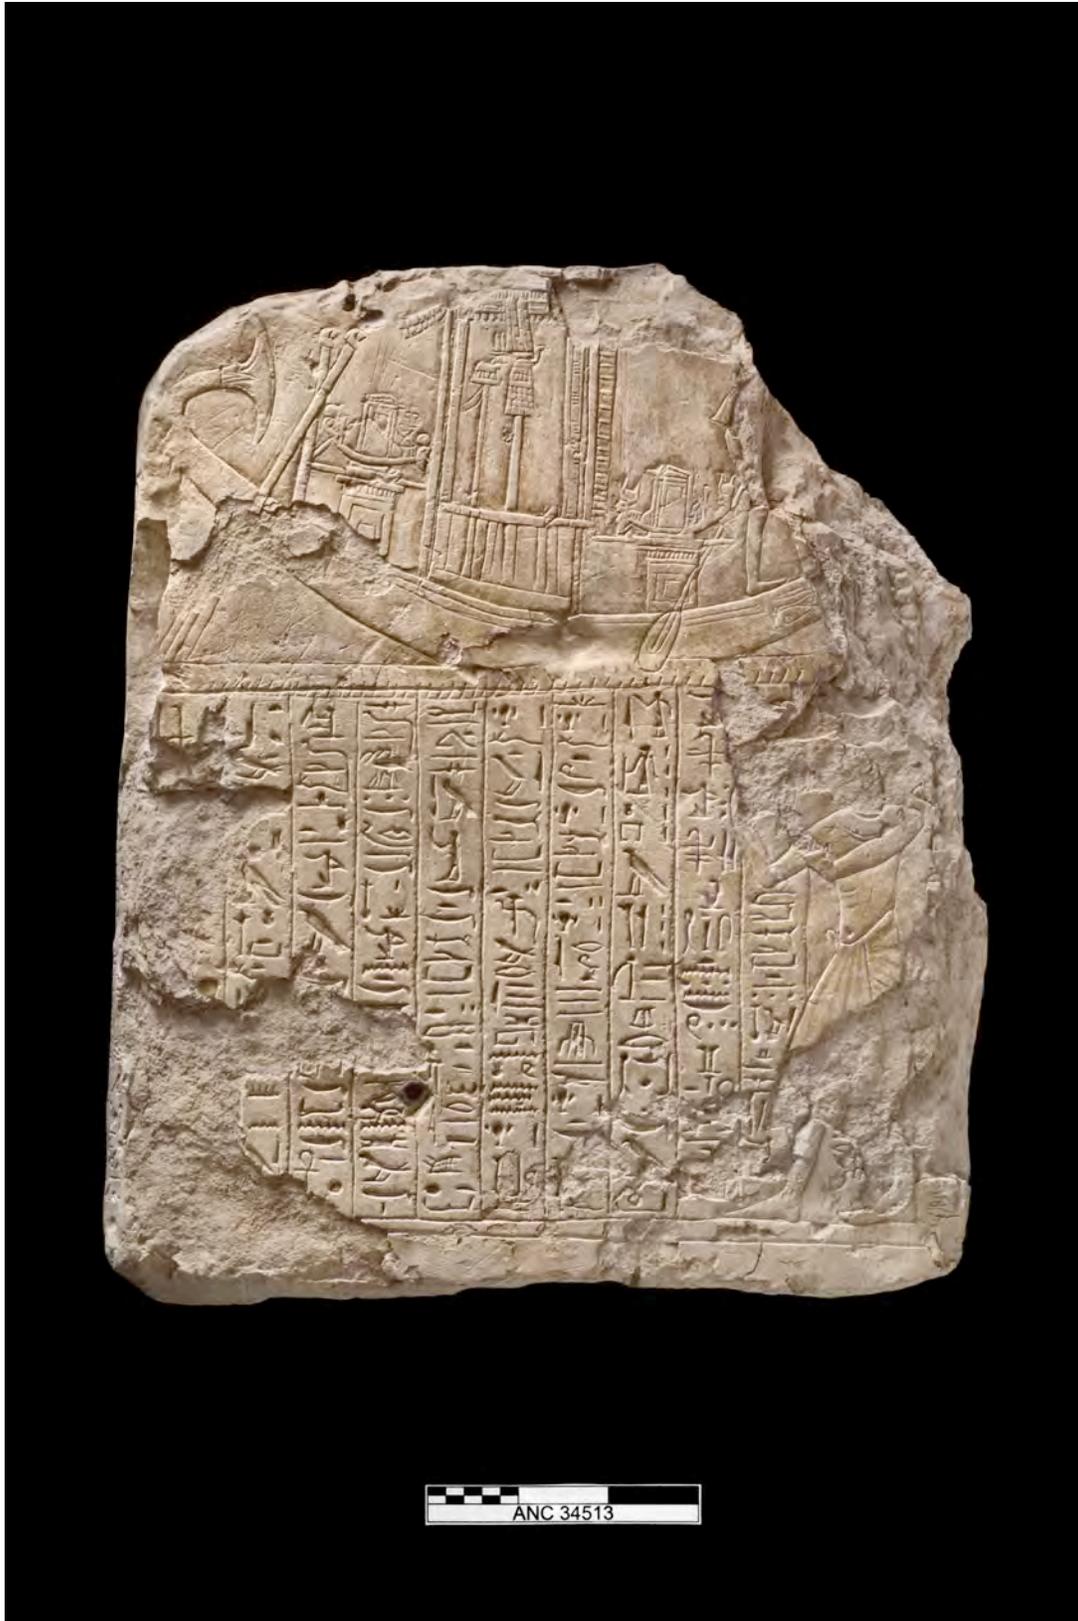
Figure 29 – Limestone stela of the New Kingdom found in Operation 136 (ANC34513, SCA Reg. 162). Photo by Amanda Kirkpatrick for the Institute of Fine Arts, New York University, 2010.

At the base of the sand deposit, just inside the south gateway, a limestone stela of New Kingdom date was found (Figure 29). The stela is unusual in that it depicts a boat on water carrying the so-called “Abydos fetish,” an emblem well known in Osirian iconography of the New Kingdom and later, which is shown inside a shrine. The large central shrine is flanked by smaller barque shrines of Isis (in front) and Horus (behind). The name of the dedicator of the stela is broken but may contain the elements *Jmn-m-j...*, perhaps the not uncommon Ramesside period name Amenemope. The boat is likely the *neshmet*-barque, a central element of the rituals associated with the great Osiris festival at Abydos.

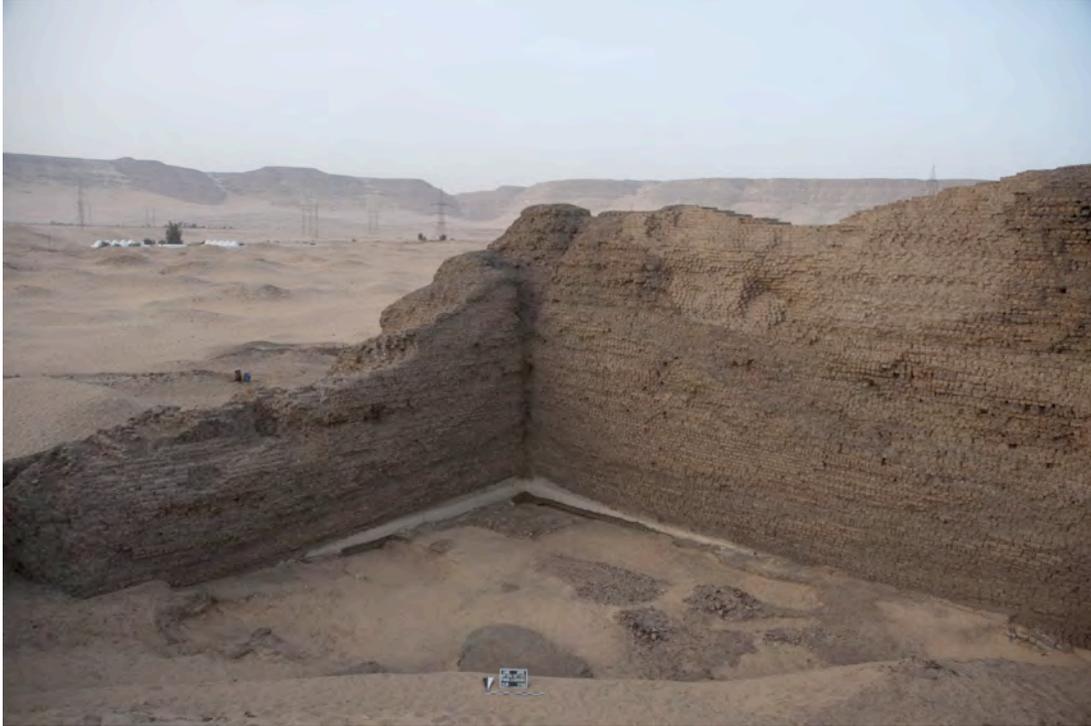
Figure 30 – The interior south corner of the main enclosure, after excavation. Photo by Greg Maka for the Institute of Fine Arts, New York University, 2010.

Dynasty 2 floor deposits were partly preserved in Operations 136, 137, and 138, although they had been cut through by intrusive pits mostly associated with the votive animal mummy deposits (Figure 30). The floor appears to have consisted of a somewhat irregular mud surface that was created on top of a thick layer of broken ceramics, primarily beer jars (Figure 31) that had been deposited on an earlier mud working surface. This situation is similar to that found in excavations near the chapel (see below).

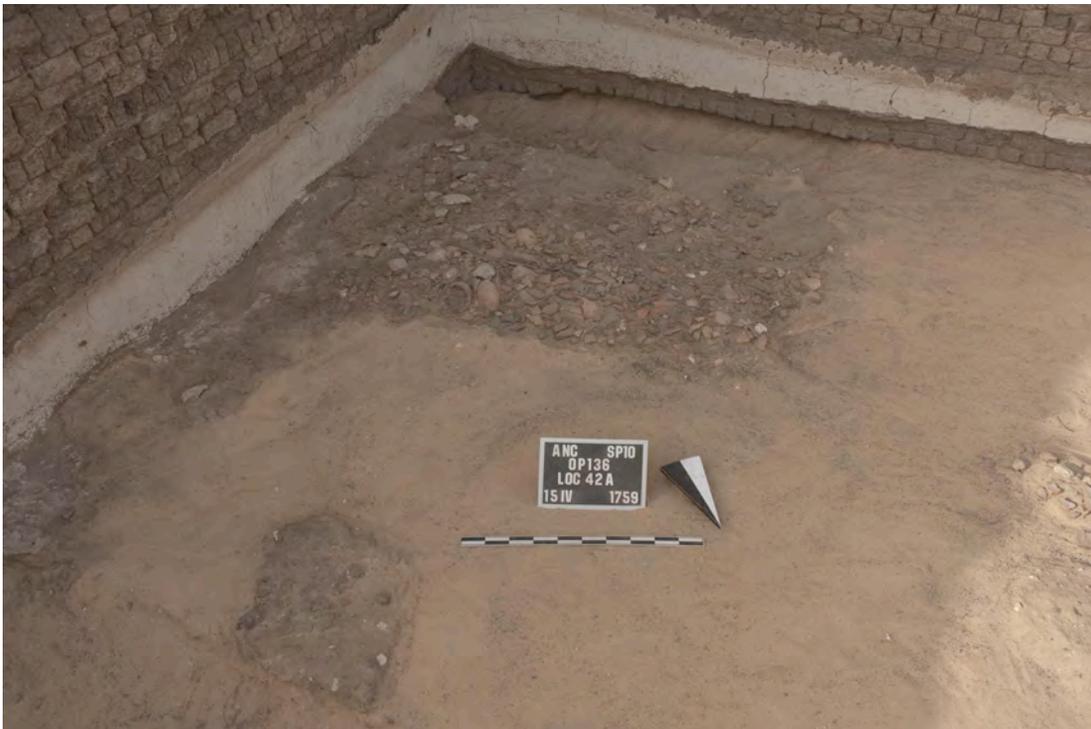
Figure 31 – Detail of a preserved area of original Dynasty 2 floor and the white original finish of the walls in Operation 136. Photo by Greg Maka for the Institute of Fine Arts, New York University, 2010.

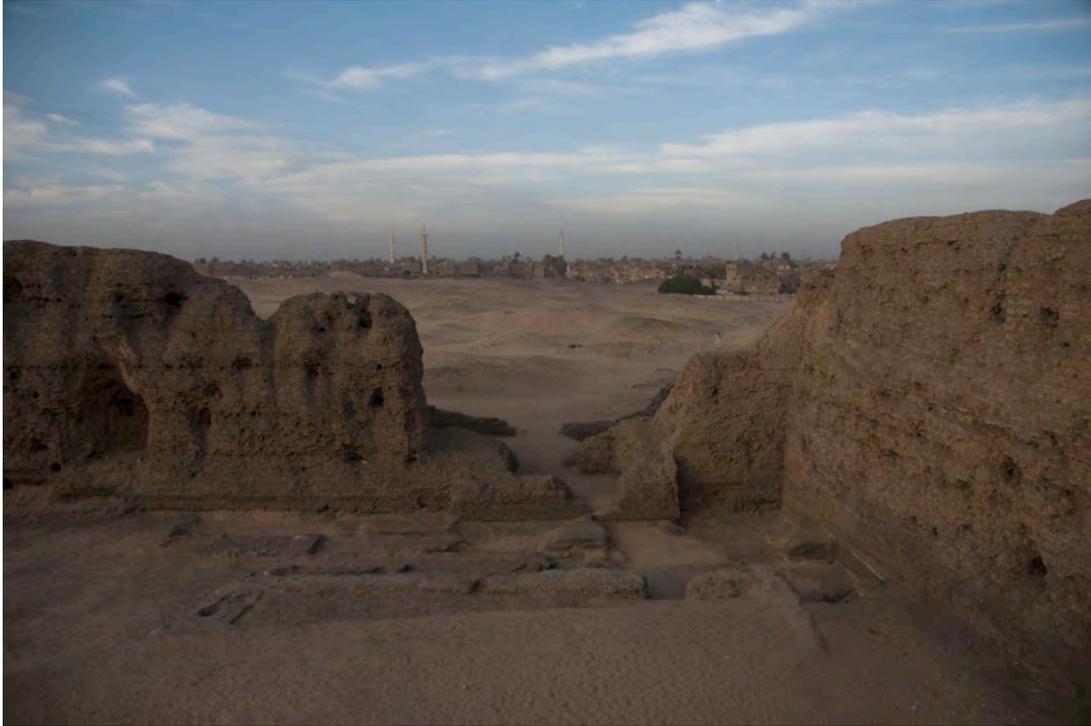
Figure 32 – General view of the area of the 1986 excavations that were reopened during the 2010 season. Photo by Greg Maka for the Institute of Fine Arts, New York University, 2010.

(iv) In the east corner of the interior of the enclosure the area between the mudbrick chapel structure and the east gateway was previously excavated by the Pennsylvania-Yale Expedition in its 1986 season. Six 5 x 5 meter units from 1986, M8, N8, M7, N7, M6, and N6,<sup>2</sup> were reopened during the 2010 season (Figures 32, 33), in order to allow further study of the stratigraphic relationships and the condition of the enclosure wall in this area. Significantly, the chapel is stratigraphically earlier than the finished floor of the enclosure, which consisted of a layer of mud that was put down on top of a thick deposit of packed ceramic sherds and brick debris that overlay an earlier working surface (Figure 34).

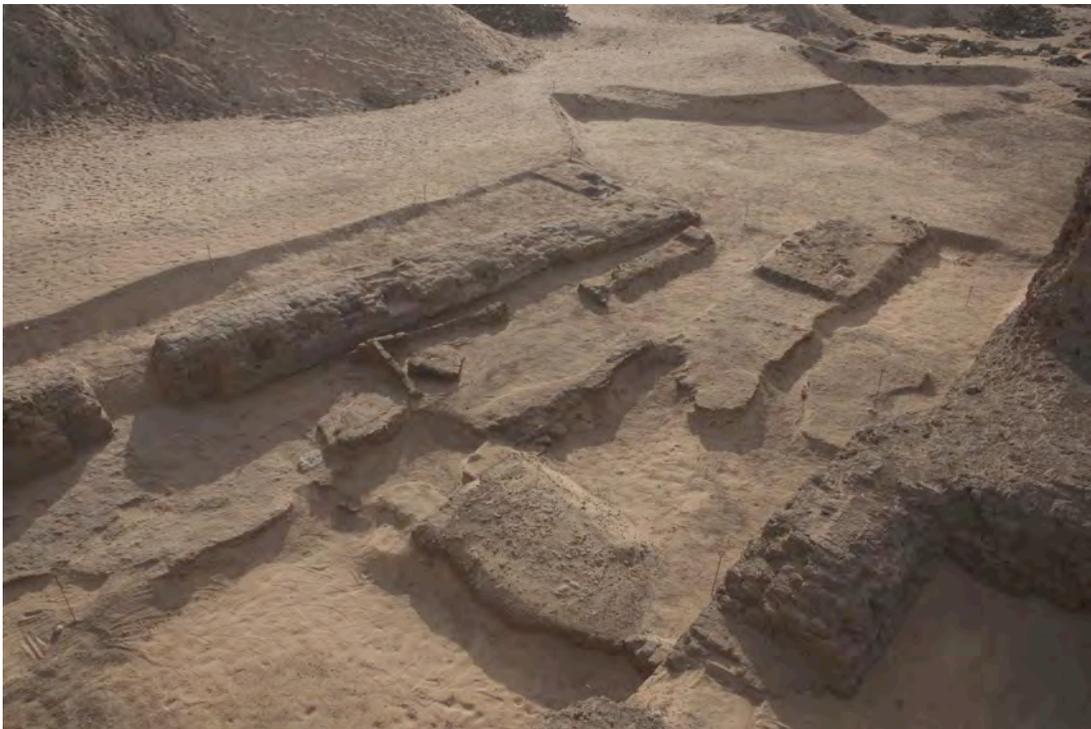
Figure 33 – A portion of the 1986 excavation area that was reopened in 2010. The northeast wall of the cult chapel is at upper left. A number of areas of the original Dynasty 2 floor were preserved in this area. Photo by Greg Maka for the Institute of Fine Arts, New York University, 2010.

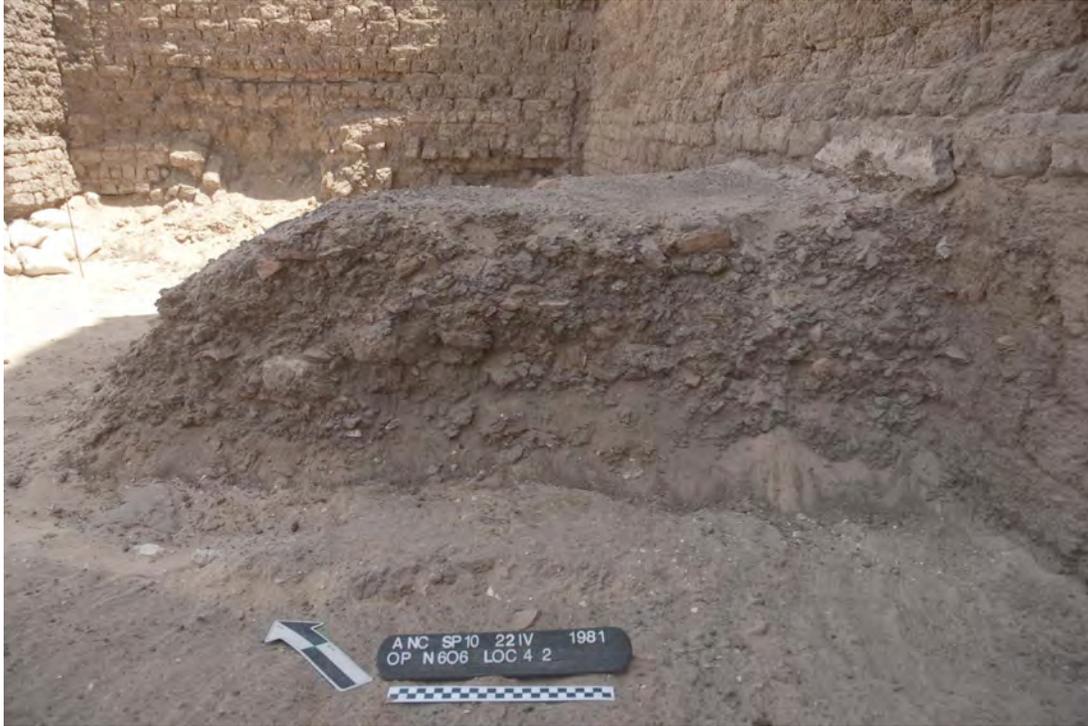
Figure 34 – The finished floor of the Shuneh in the east corner was established on top of a thick deposit of ceramic sherds, which, in turn, was deposited on an earlier working surface. Photo by Greg Maka for the Institute of Fine Arts, New York University, 2010.

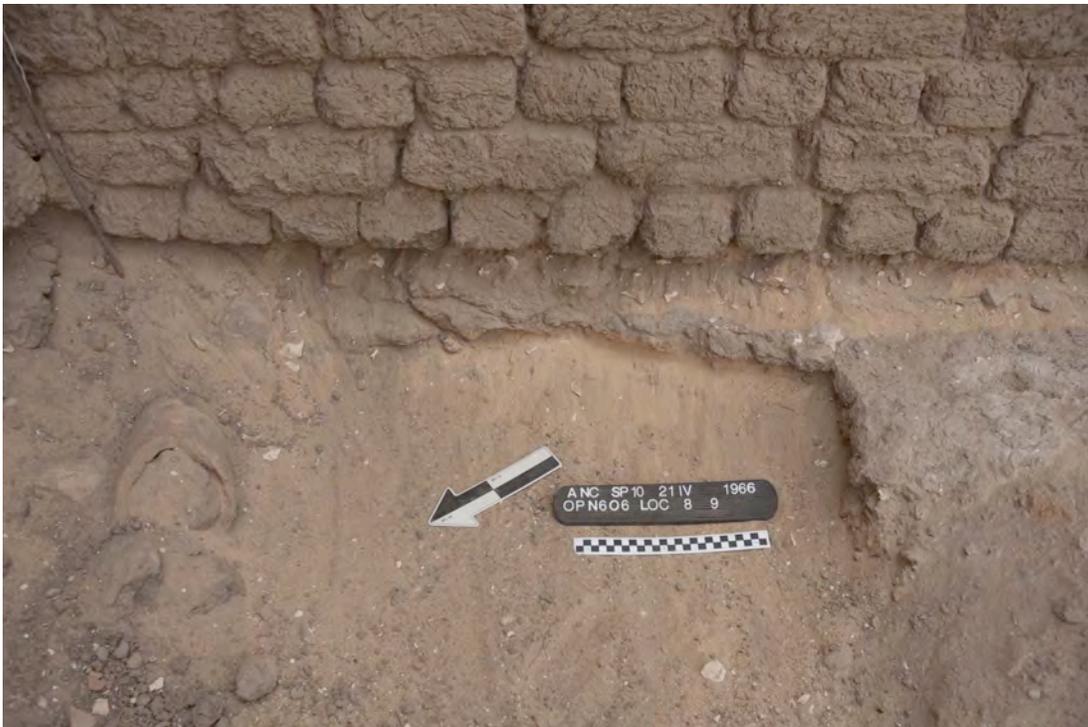
Figure 35 – The mud working surface in units N6/O6 runs under the main enclosure wall of the Shuneh. Photo by Greg Maka for the Institute of Fine Arts, New York University, 2010.

Portions of this earlier surface appear to run under the base of the main wall (Figure 35), with the implication that the chapel predates the construction of the main wall.

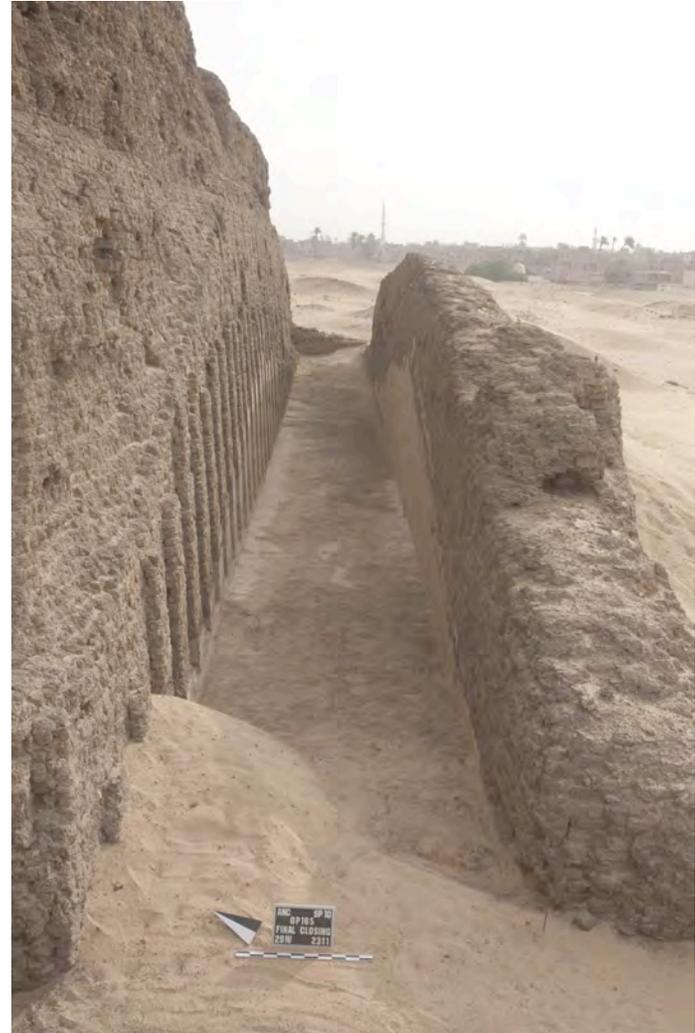
Figure 37 – The southeast perimeter corridor at the close of the 2010 season. Photo by Greg Maka for the Institute of Fine Arts, New York University, 2010.

The perimeter corridor in Operations 163 and 165 was, at the start of the 2010 season, filled with a large deposit of sand (Figure 36). Excavation in the corridor removed the sand and reached the original floor level (Figure 37). The original finish on the lower part of both the main enclosure wall and the perimeter wall was found to be in relatively good condition. Traces of red paint were found on the main enclosure wall, as well as drips of red paint in the bottom of several wall niches. Not enough was preserved, however, to permit determination of the nature of the painted decoration.

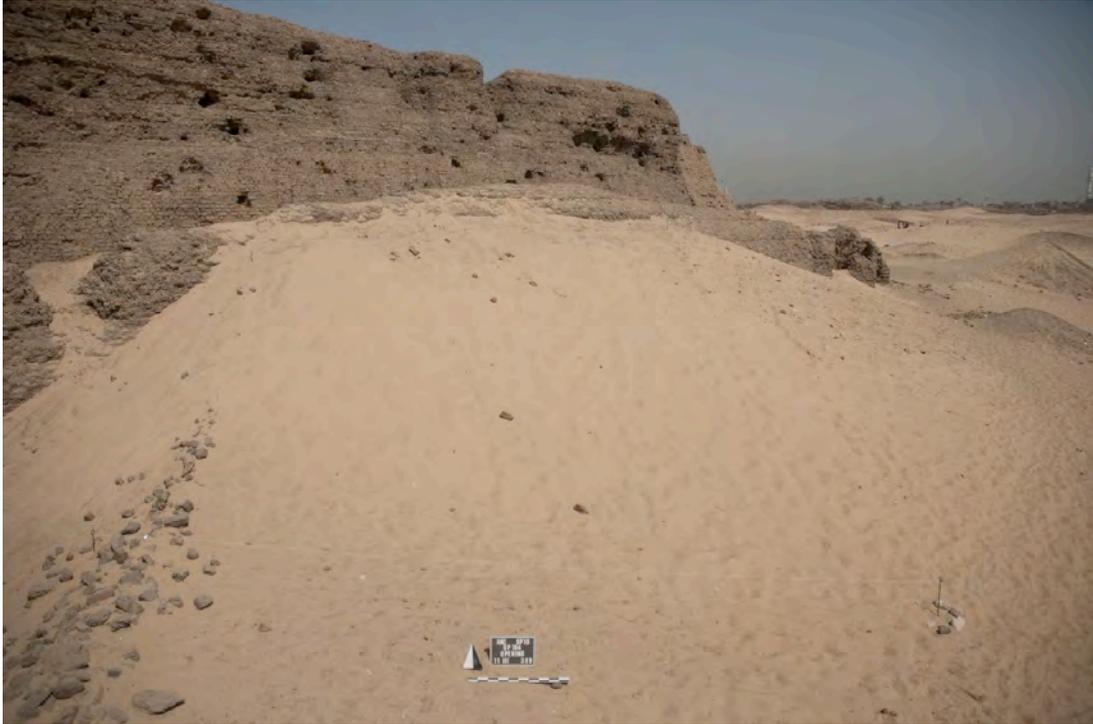
Figure 38 – Operation 164 on the exterior side of the southeast perimeter wall of the Shuneh, prior to excavation. Photo by Greg Maka for the Institute of Fine Arts, New York University, 2010.

(vi) Like the adjacent corridor, the exterior side of the southeast perimeter wall was, prior to excavation, characterized by the presence of a large sand dune (Figure 38). Excavation unit Operation 164 was located on the exterior side of the southeast perimeter wall, and work in this area started the removal of the large sand deposit (Figure 39), which will be continued in future seasons. A large number of limestone fragments with traces of inscription and decoration, all in raised relief, were also found in Operation 164 (Figure 40). It seems likely that one or more large stelae or decorated architectural blocks were broken up nearby at some point in the past. Two small fragments bore the remains of cartouches containing signs that appear to be from the prenomen and nomen of king Horemhab of Dynasty 18. In addition to the decorated fragments a small painted limestone stela (Figure 41) of Third Intermediate Period or later date was found in Operation 164. Although the painted decoration is worn, it is clear that the stela depicts a woman worshipping Osiris and Isis.

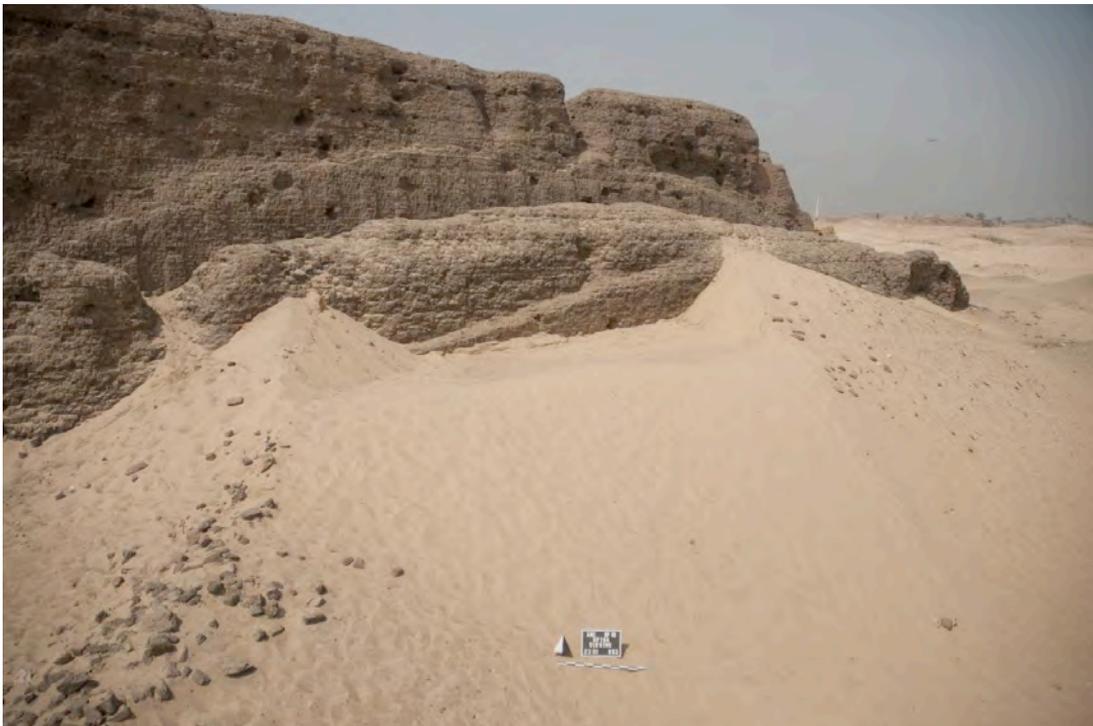
Figure 39 – Operation 164, at the close of work in this area in 2010. Photo by Greg Maka for the Institute of Fine Arts, New York University, 2010.

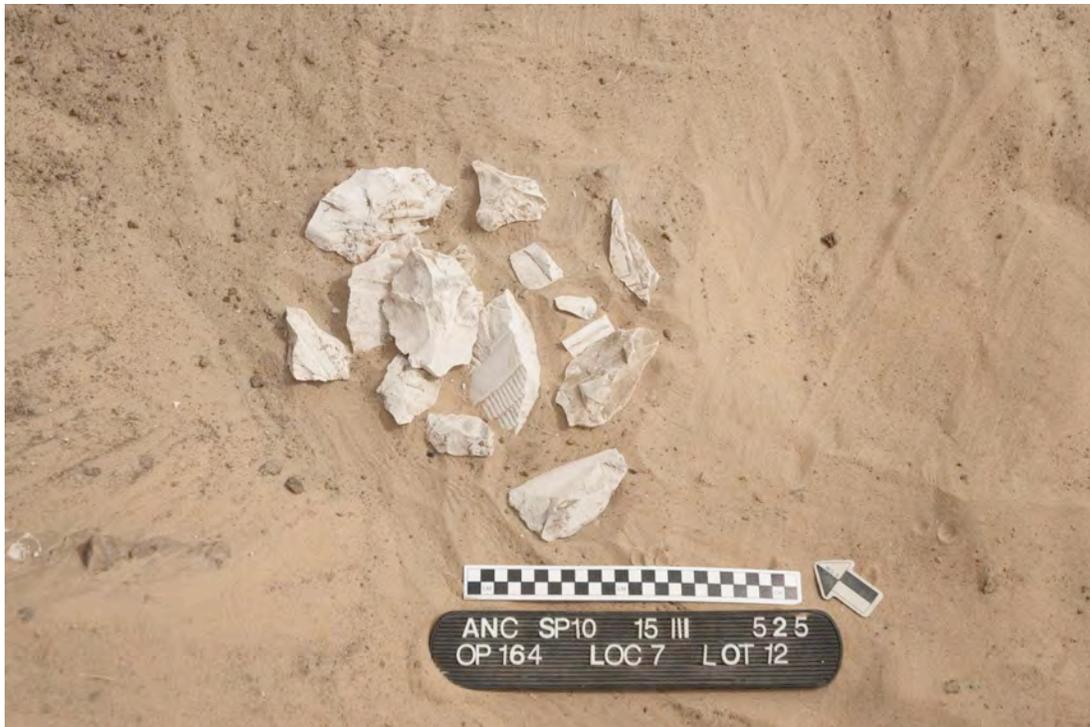
Figure 40 – Limestone fragments with traces of relief decoration found in Operation 164. Photo by Greg Maka for the Institute of Fine Arts, New York University, 2010.

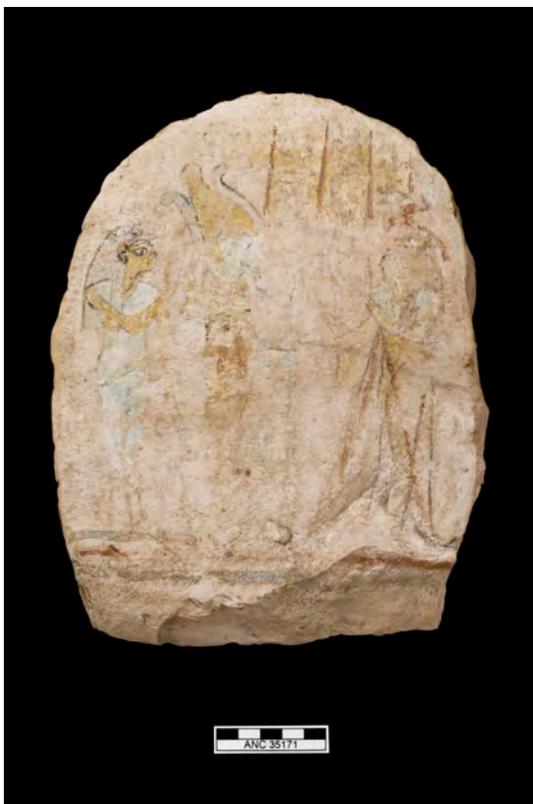
Figure 41 – Painted limestone stela (ANC35171, SCA Reg. 163) found in Operation 164. At the right is the figure of a woman adoring Osiris and Isis, depicted at left. Photo by Amanda Kirkpatrick for the Institute of Fine Arts, New York University, 2010.
