AMERICAN RESEARCH CENTER IN EGYPT (ARCE)

TOMB OF MENNA (TT69) CONSERVATION AND DOCUMENTATION PROJECT

Assessment Season Report

April 8-16, 2007

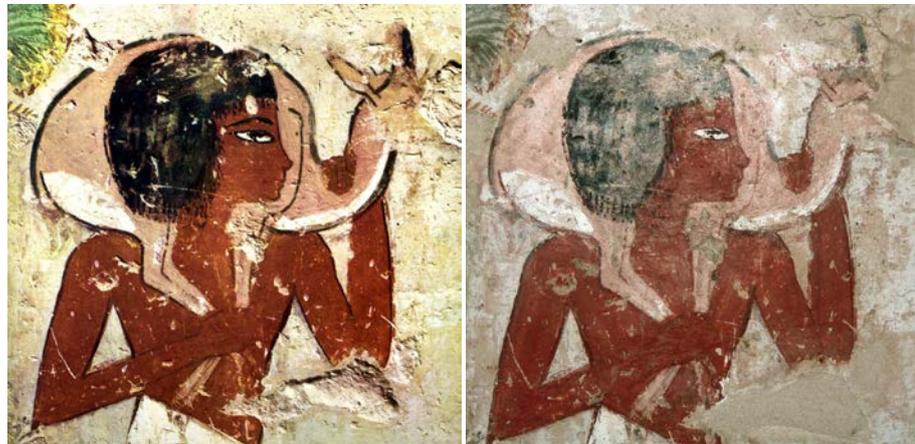
The chief conservator, Bianca Madden, identified a number of conservation issues based on a visual survey of the paintings with the help of raking light and cleaning tests. These issues are illustrated by means of comparison

between the photograph taken by Arpag Mekhitarian in 1954 (near right) and the photograph taken by our photographer, Andreas Paasch in April 2007 (far right). Immediately apparent is the lack

of cohesion between the plaster layer and the paint layer, pigment powdering, and repair mortar that goes over the original painting.

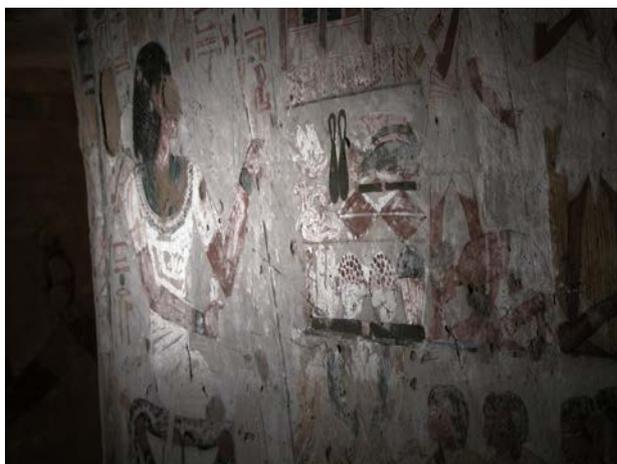
Throughout the tomb there is also evidence of Paraloid (an acrylic polymer) to fix powdering or flaking areas of pigment which is seen in the raking light photograph to the left of the near left wall in the broad hall of the tomb. Paraloid was popular in the 1970's to stabilize the pigment, but is problematic because it produces a heavy plastic layer that is visually distracting, catches dirt, and does not allow water vapor to pass through which could eventually result in the paint flaking off due to a build up of salts.

1. Surface clean
2. Fixing of powdering paint
3. Fixing of flaking paint
4. Removal of Paraloid from paint surfaces
5. Removal of old mortar repairs and lime wash colors from the surface of the paintings.
6. Reduction of the remains of wasp's nests and removal of bat droppings
7. Fix detachments between the paint and plaster layers
8. Repairs of small losses and edge repairs
9. Fill old fills and repairs to the level of the paintings to make them less visually distracting and more supporting to the surrounding plaster.
10. Reduction of old and visually distracting retouching
11. Injecting Hydraulic lime in hollow areas or areas with evidence of movement to stabilize the support.
12. Reintegration (no new retouching)

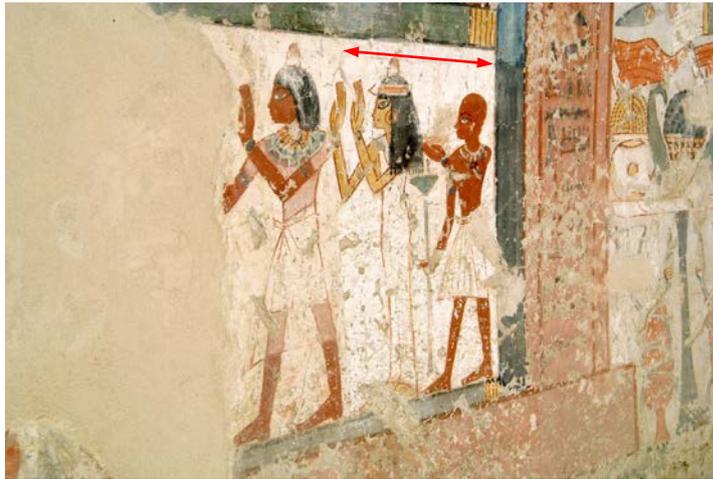
A test cleaning of a Paraloid-coated area showed how much dirt has bound with the coating. The photograph below shows the conserved area indicated by the red arrow. Removal of this

coating will reduce the distracting shine and the fluorescing effect. Removing the bound surface dirt will also make the paintings look significantly cleaner. The goal is to bring the paintings back to their near-original state.

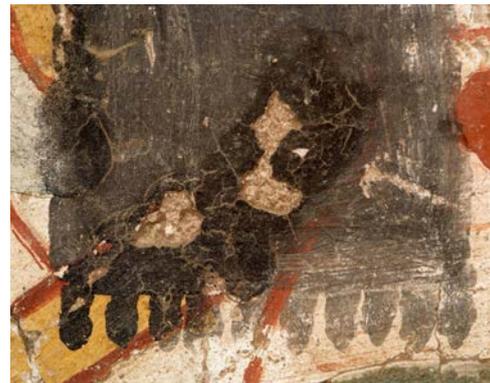
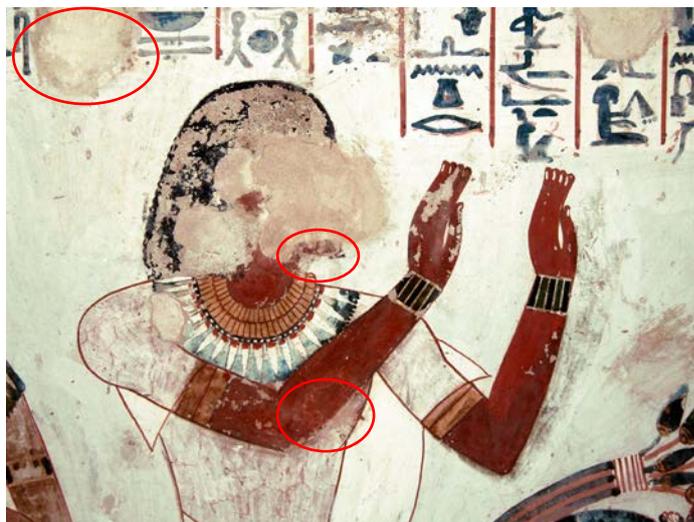
Cracking and flaking of the pigment occur frequently in the tomb as seen here (below) in the black of a woman's wig. The flaking responded well to a 10% solution of Syton x30 (a silica)

Another significant problem in the tomb of Menna is the result of previous restoration attempts. These can be seen in over-painting of Menna's arm and elbow; the sloppy application of the fill layer that obscures many details as seen here on Menna's chin; and visually distracting fills that are recessed into the wall as seen here in the text register above. In addition, previous restorers removed the remains of wasp's nests which resulted in pigment loss.

that was brushed on through Japanese facing tissue, pressed with a spatula and then removed, fixing the flakes and removing the dirt. On areas with thicker paint flakes, Plextol B500 (an acrylic resin), used at low percentage was the most effective method. The advantage of these procedures are that they do not effect the color or texture of the paint layer or ground, and allow for water vapor permeability as well as avoid any future salt damage. Stabilization of the paintings and support structure will prevent further damage and loss, and ensure their continued survival.

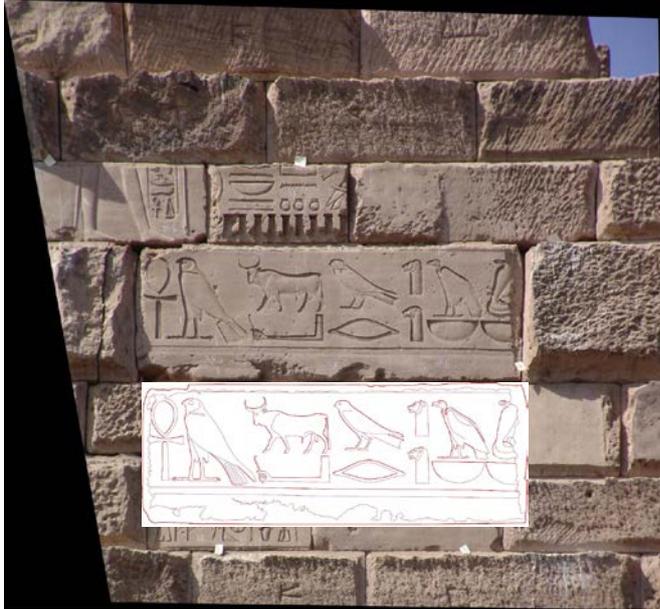
on the computer as vector drawings and saved as a separate file by an experienced digital draftsman, Pieter Collet. The benefits of digital drawings are two-fold: high-quality, true-to-scale drawings can be produced without harming the walls and can be sized accordingly. The photograph to the left illustrates a block from Elephantini and the resulting digital drawing that was done using the same process (Photo courtesy of P. Collet)

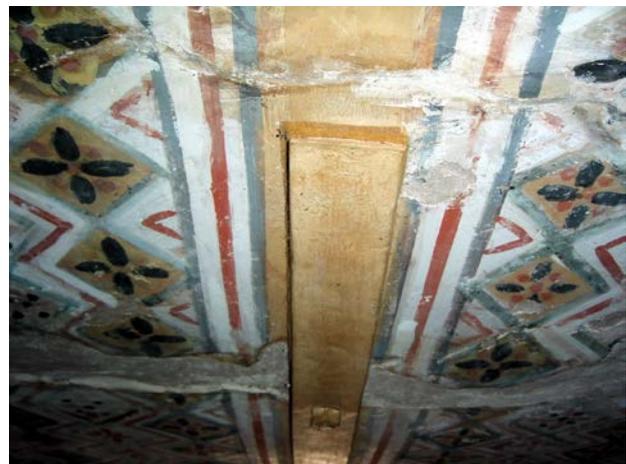
One final note concerns the previous structural interventions in the tomb. In the tomb chapel, six metal bars in the long hall and one metal bar in the broad hall are bolted into the ceiling. These bars are visible in photos of the tomb taken during the 1960s. Most likely the bars are part of a grid system in the rock that is stabilizing the ceiling from above. In areas where the ceiling cracks were repaired, there are also patches of water damage. During the Assessment Season, it was noted that the house that was once above the tomb has been cleared and no longer exists. The grid system may have been built to reinforce the ceiling from the house which was built above the tomb. No evidence of new movement or cracking in the ceiling was observed since these repairs, and with the removal of the house, it can be assumed that the water problem is now resolved.
